2022 ANNUAL INSPECTION REPORT RANGE ROAD LANDFILL ASH DISPOSAL FACILITY

China Township, St. Clair County, Michigan

DTE Electric Company Range Road Landfill Annual Inspection 19 April 2022

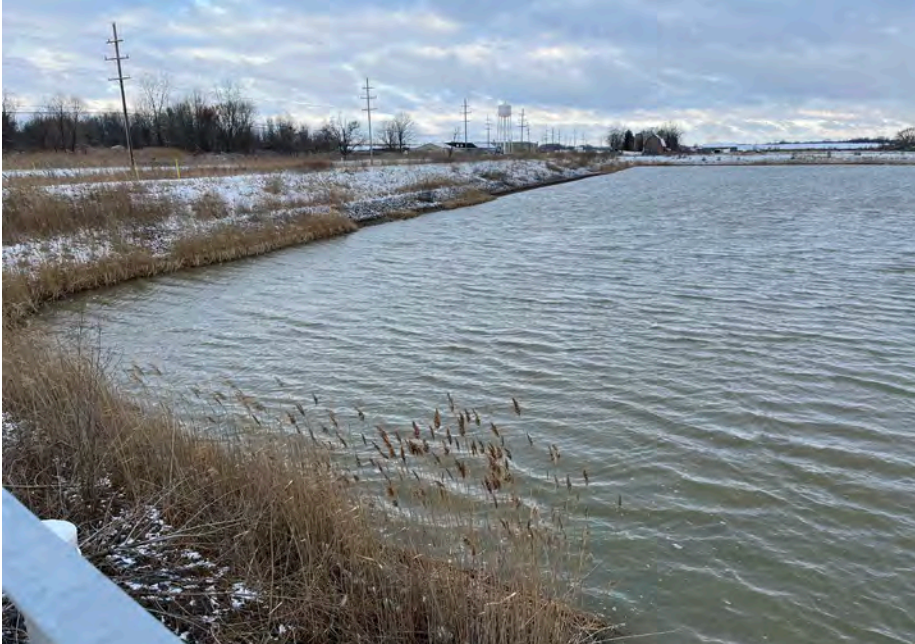
SDB: The SDB appeared in good condition. Basin slopes and intake screens are shown in Photographs 1, 2 and 4. The pump control panel is shown in Photograph 3. Pumps 1 and 2 were not running at the time of the inspection, but there was no indication of pumps taken out of service. The basin intake screen was unblocked as shown in Photograph 2.

1. Storm Water Detention Basin (SWDB), S & W Sides. Slopes are Protected with Stone. No Visible Slope Erosion on All Sides. Same for N & E Sides.

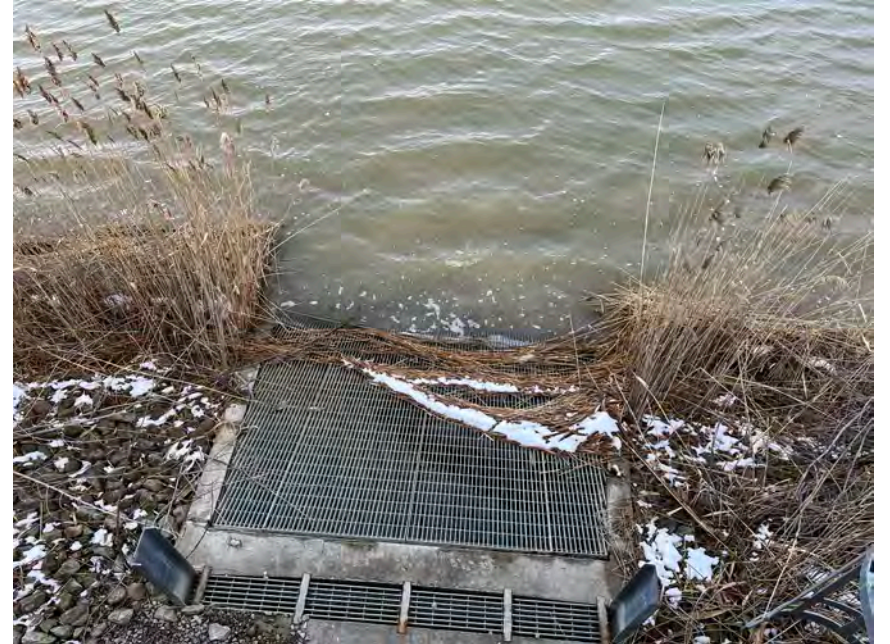
2. Intake Screens at SWDB with Some Minor Vegetation at Bottom. Water from Basin is Pumped Back to Power Plant Using One or More of 3 Pump3.

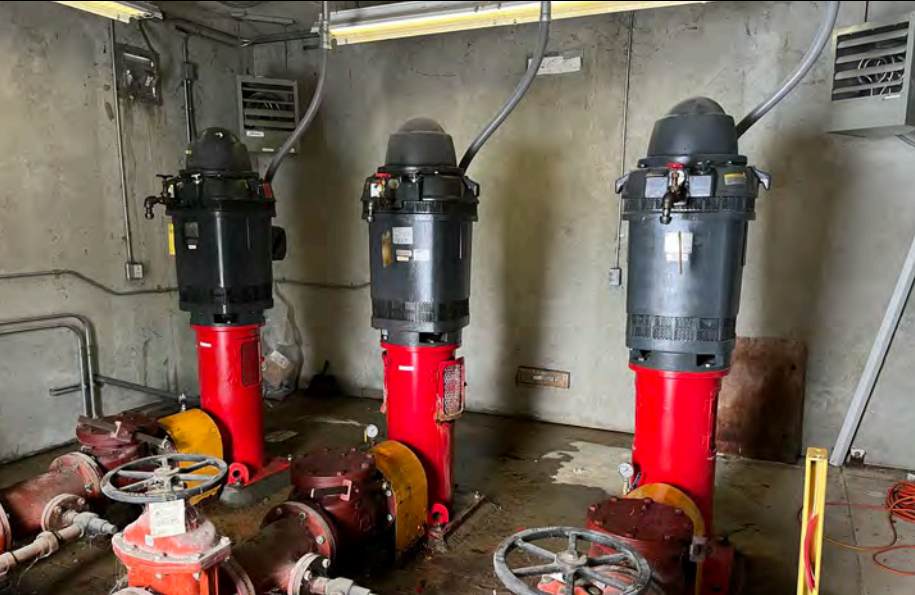
3. Pump Control Panel. All 3 Pumps were Available for Use. Wall Flow Meter (Not Shown) appeared OK. Pumps were Observed but not Pumping at the Time.

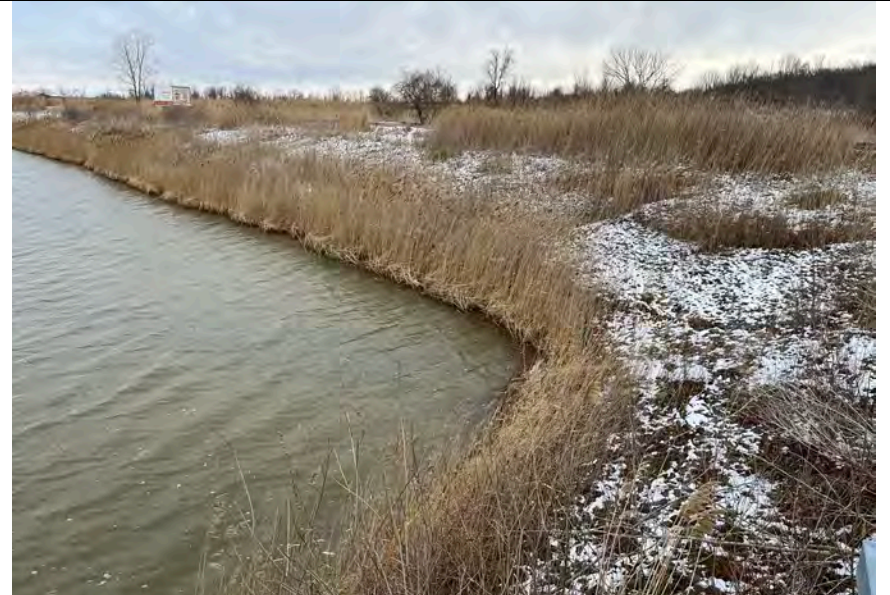
4. Looking at NE Corner of SWDB. Slope Protected from Erosion with Stone. Staff Gauge SG-13 in Middle of Photo at or Just Above the Water.

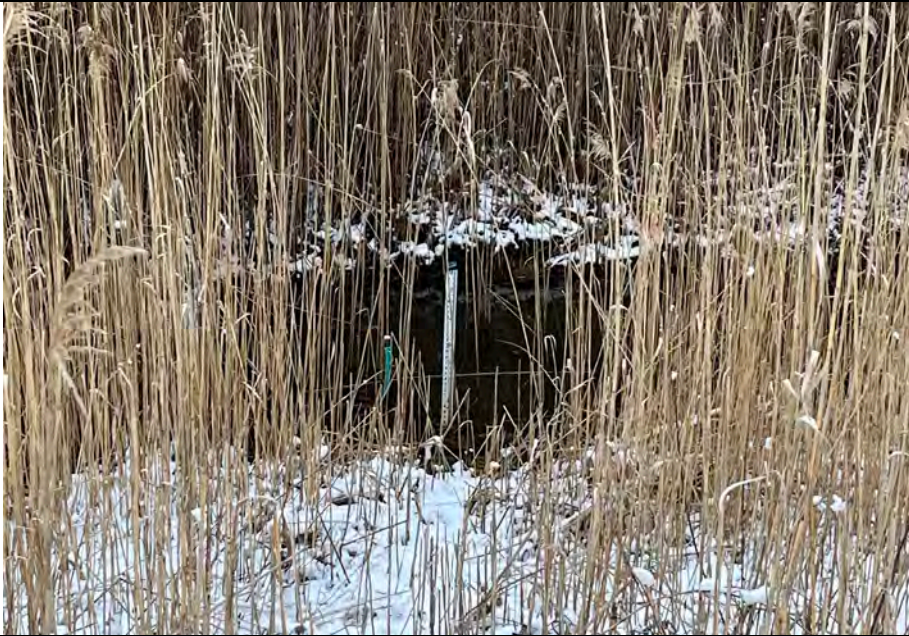
5. Staff Gauge Along East Side. Ditch Open. Light Snow Night Before Inspection.

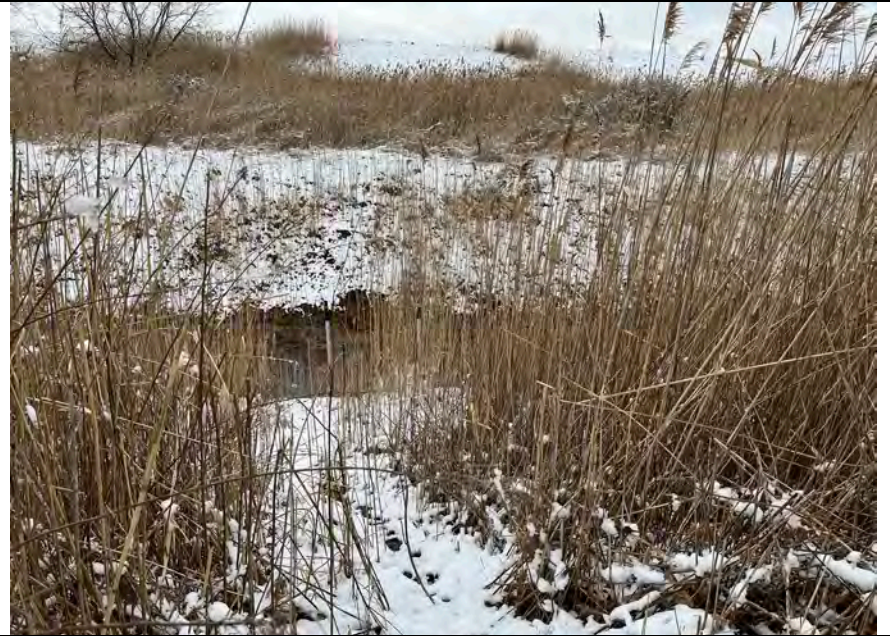
6. Another Staff Gauge Along East Side. Ditch Flow Open. Observed Past Slope Vegetation Maintenance.

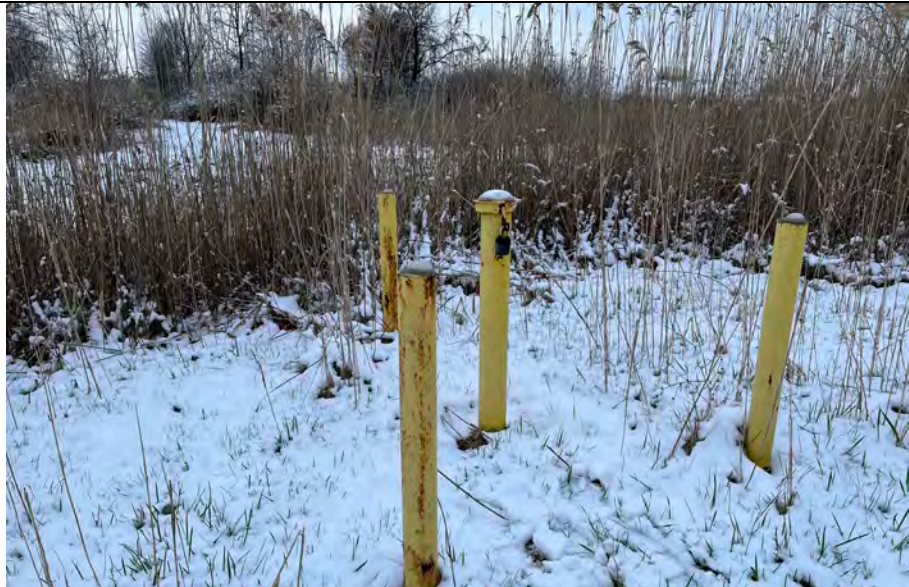
During the 2022 annual inspection locations of seven (7) groundwater monitoring wells were observed. Observations indicated that that the monitoring wells were well protected with casing caps or covers keyed and locked. Photos 7 and 13 show typical examples of well protections.

7. Monitoring Well 16-05. Well Protected and Cap Locked. Well Protection and Capping Typical of Inspected Above Ground Monitoring Wells.

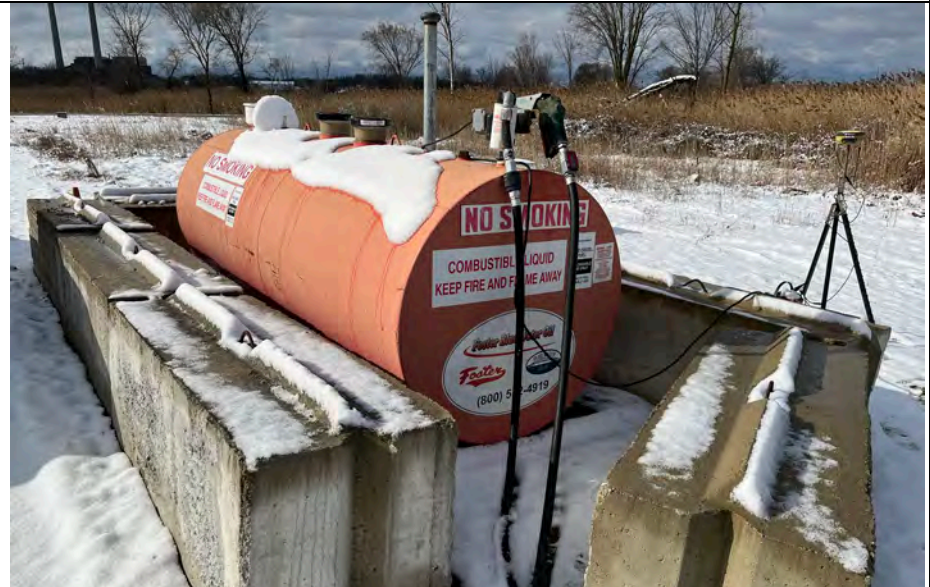
8. Single AST at Contractor Onsite Yard/Office. No Leakage Observed.

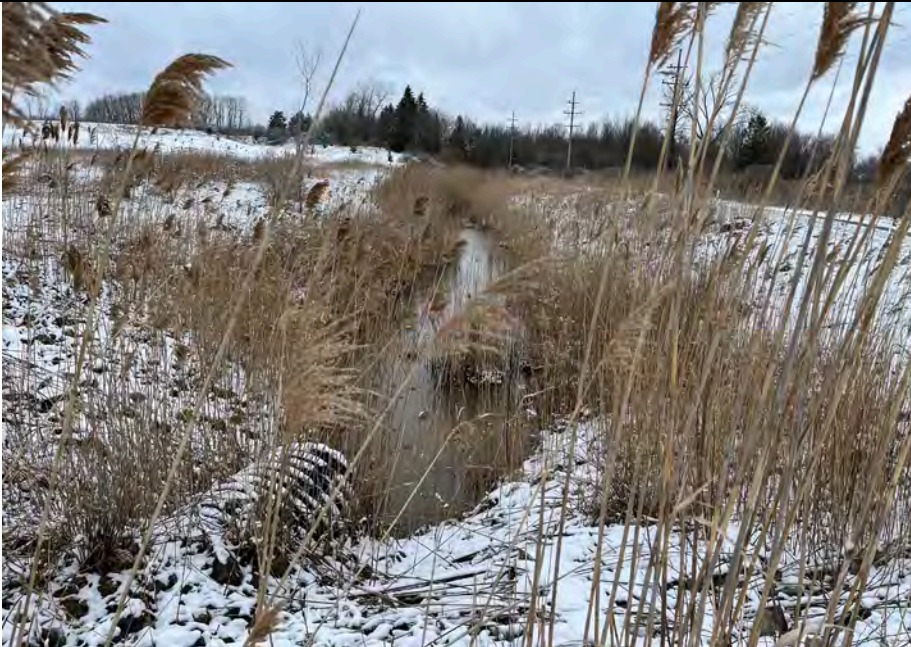
9. Flow from Culvert into Perimeter Ditch. Culvert and Ditch Remain Open.

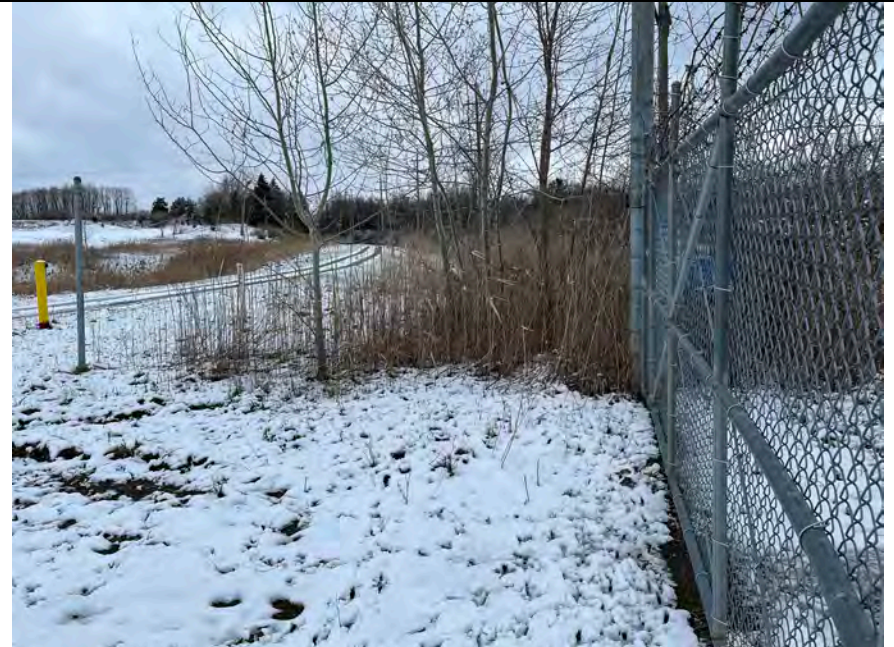
10. View of Locked Gate with Signage. All Gates observed had Signage and were Locked.

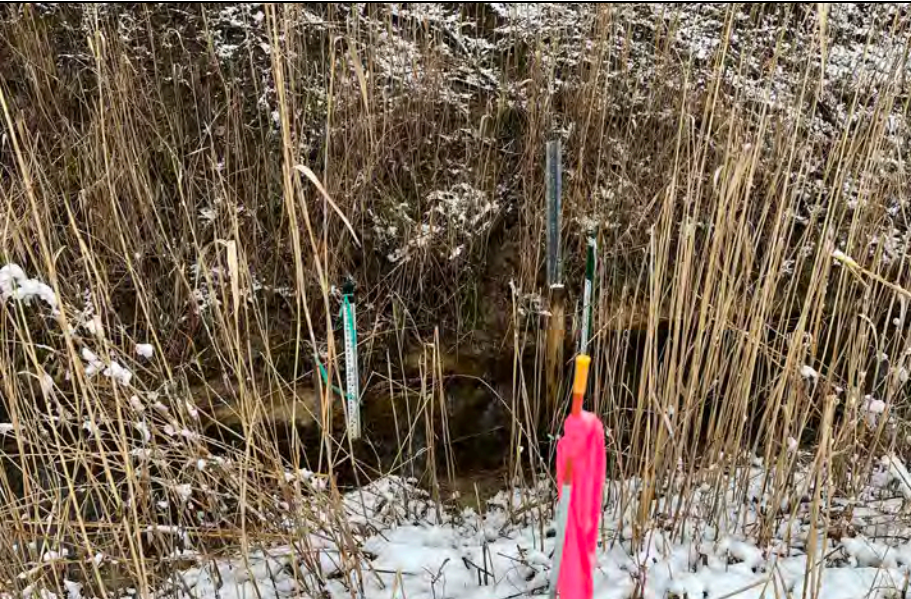
11. Looking at Staff Gauge Location Along Northeast Corner. Ditch Open but Flow not Observed. Some slope drainage into ditch.

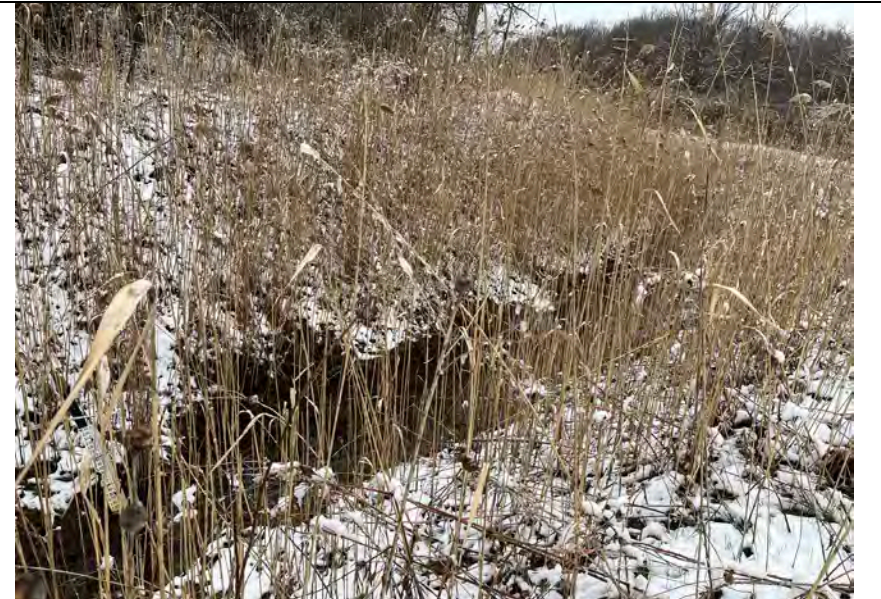
12. Perimeter Ditch at Corner with Vegetation but Still Open.

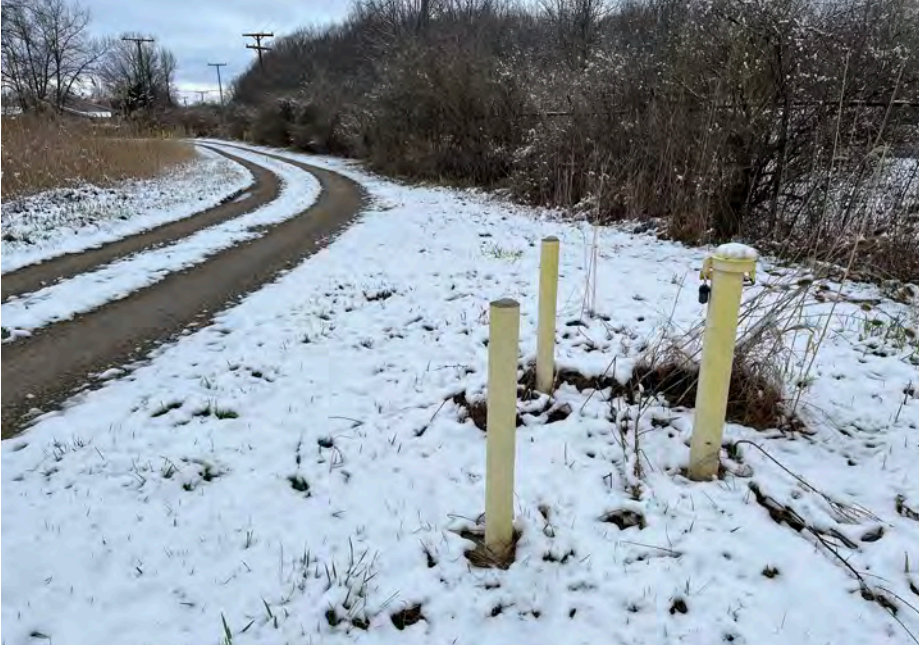
13. Monitoring Well and Perimeter Road Along Northeast Corner. Road in Good Condition and Well Locked.

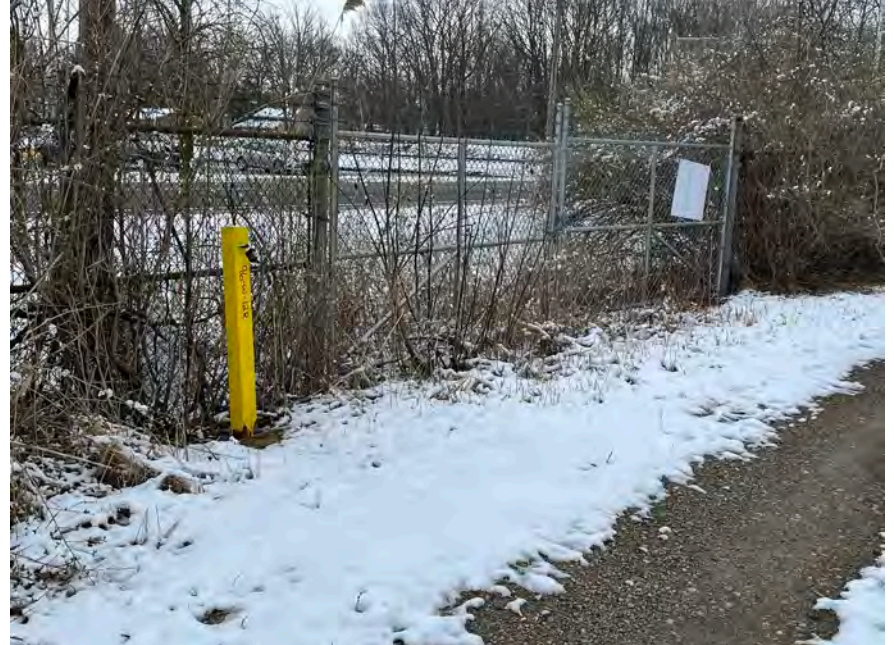
14. Another Perimeter Fence Gate Locked and Signage Postage. Gates Only Used for Maintenance Access if Necessary. Piezometer 96-W-12R, Locked.

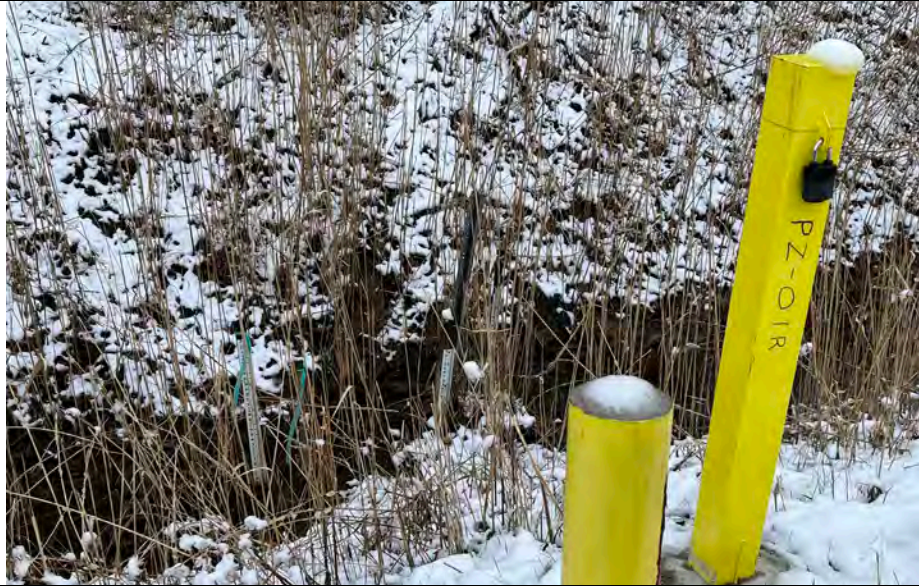
15. Locked Piezometer PZ-01R and Staff Gauge Location.

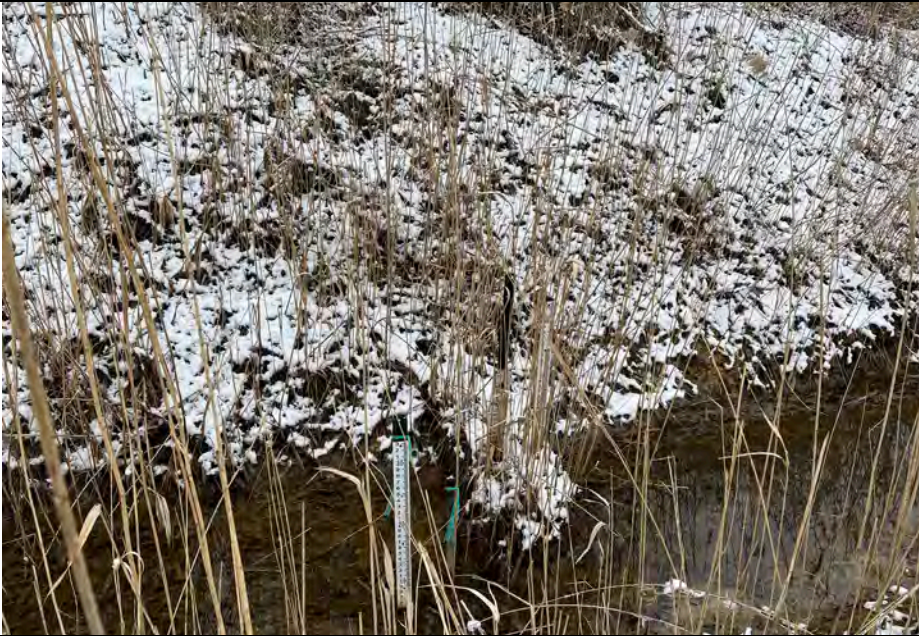
17. Looking at Location of Staff Gauge SG-01. Water Present. No Visible Flow Noted.

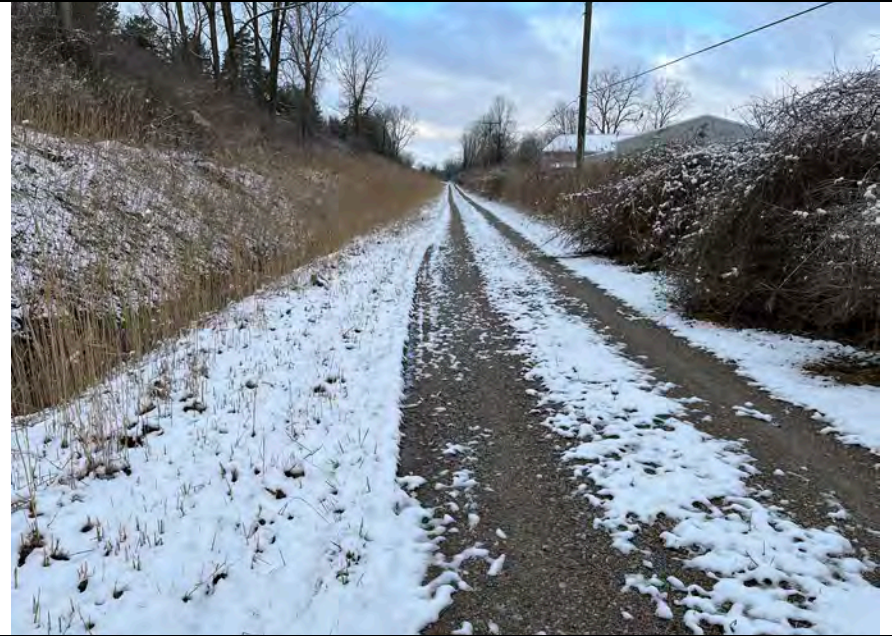
18. Ditch Alignment and Perimeter Road in Good Condition. Trees Along Outside Slope of Closed Landfill Areas at North End of Landfill.

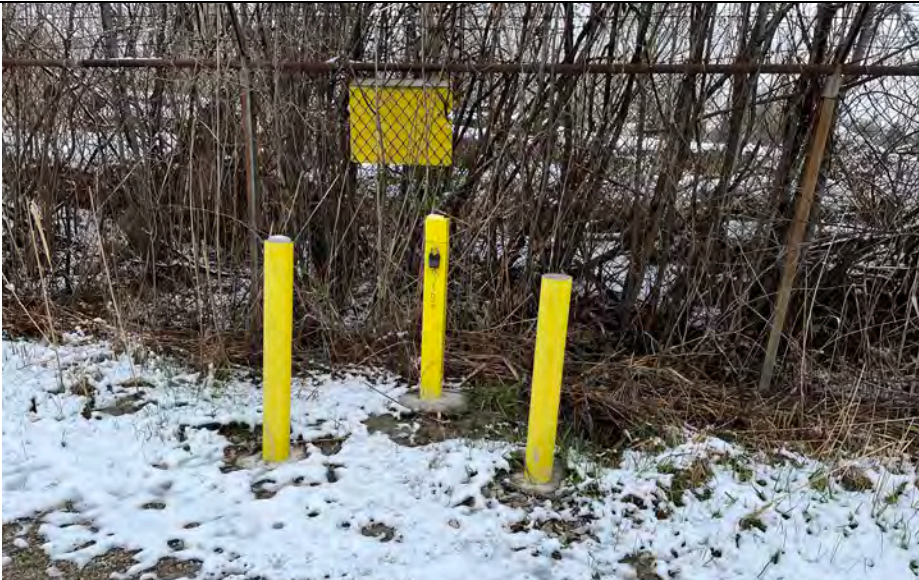
19. Locked Piezometer W-01R Along Perimeter Road and Perimeter Fence, Note Fence Signage.

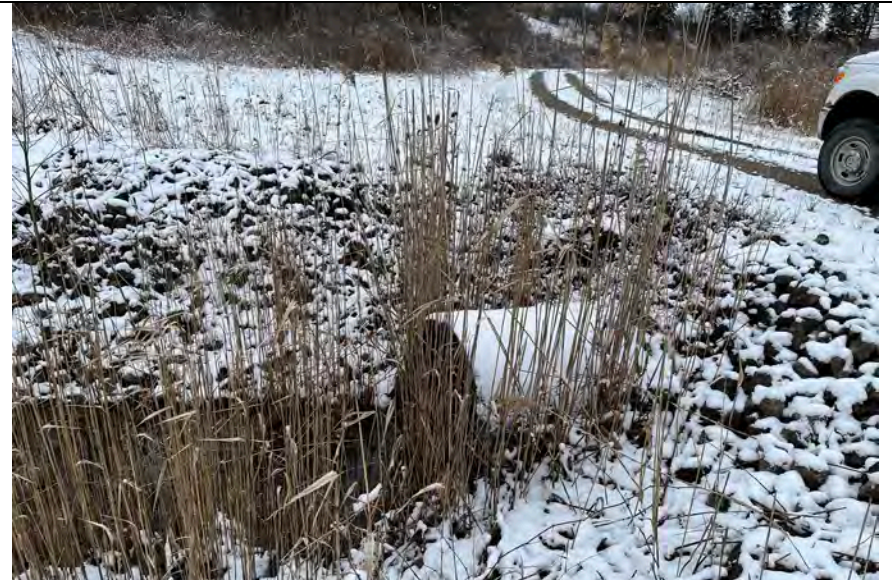
20. Culvert and Riprap Downslope Where Ditch Clearing of Vegetation Had Been Performed in 2021. Flow did not Appear to be Blocked.

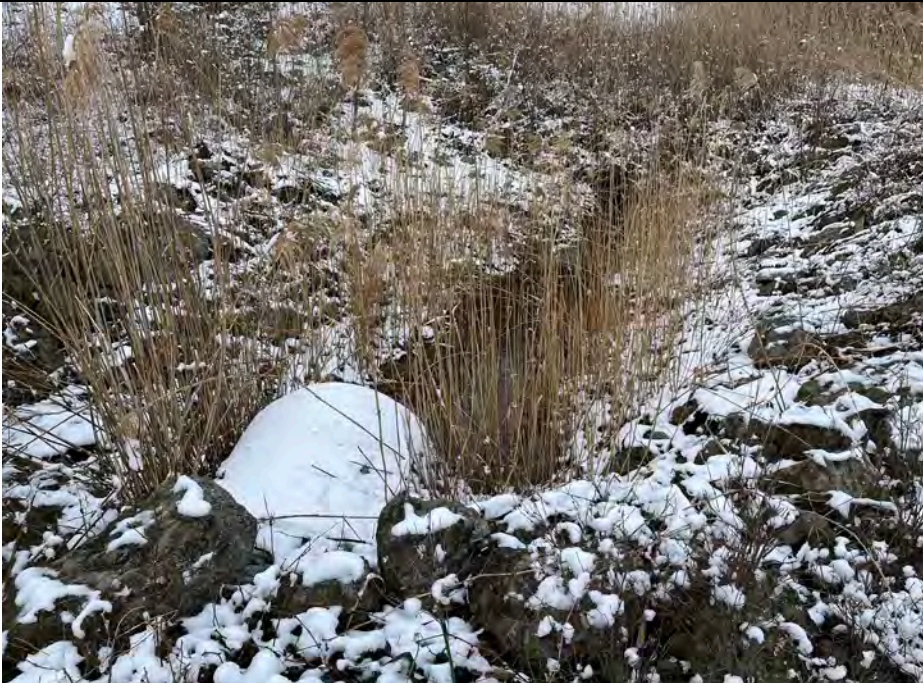
21. Bottom of Downchute Shown in Photo 22 Drains Through Culvert to Perimeter Ditch Along Perimeter Road.

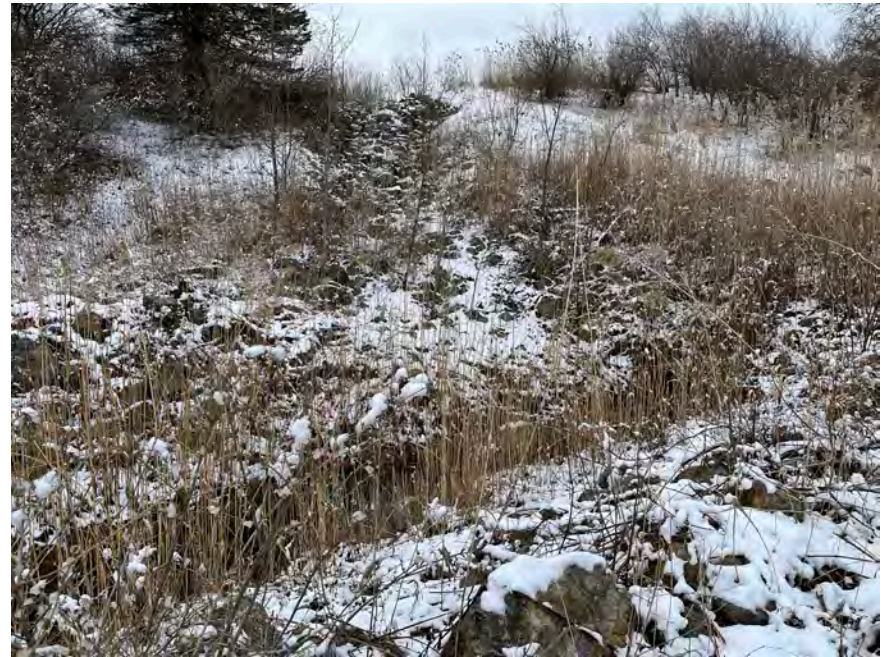
22. Looking Up Along Landfill Surface Runoff Ditch Downchute Protected from Erosion with Riprap. Flow Drains into Ditch Culvert in Photo 21.

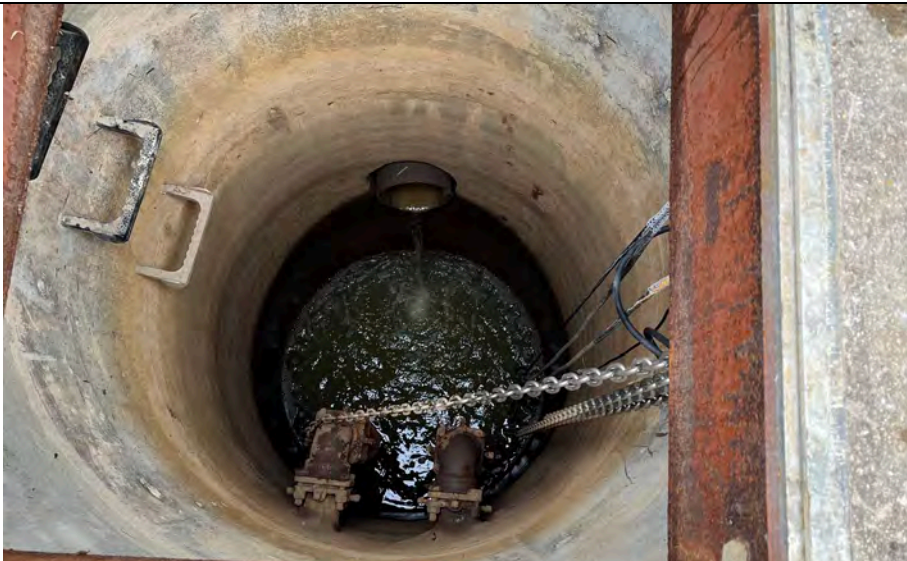
23. Sump Pumps in Manhole. New Pumps were Installed In 2018. Discharge to Culvert Connected to Ditch. Inlet Pipe Shown Little Flow.

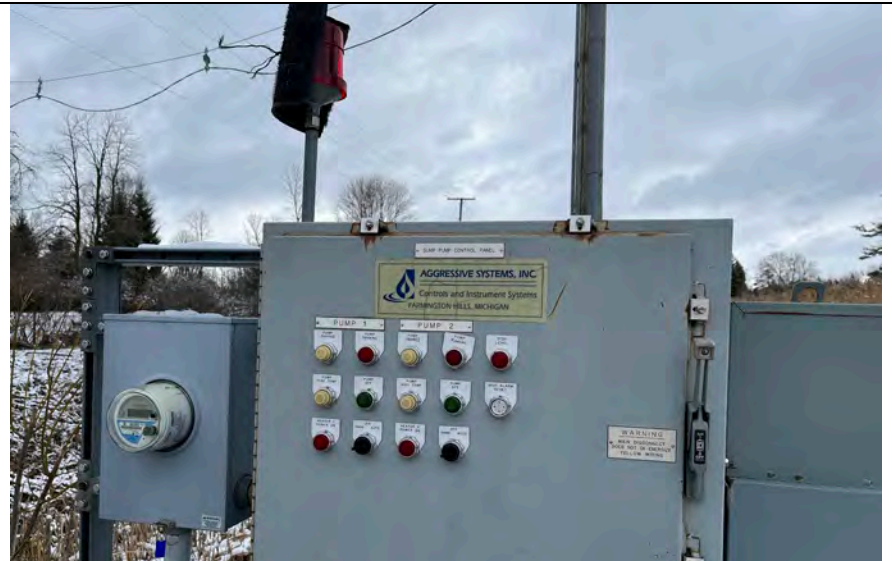
The northwest groundwater capture system and collection has had its two pumps replaced in late 2017. The pumps are used to transfer the captured water to the perimeter ditch for gravity flow to the SDB. At the time of the inspection DTE tested each pump for operation. The pump control switches have been placed in the auto position and pump operation confirmed by DTE.

24. Neither Pump Running and in Hand Operation Per Panel Controls. DTE Inspector Manually Verified Pumps Operation. Controls Restored to Auto.

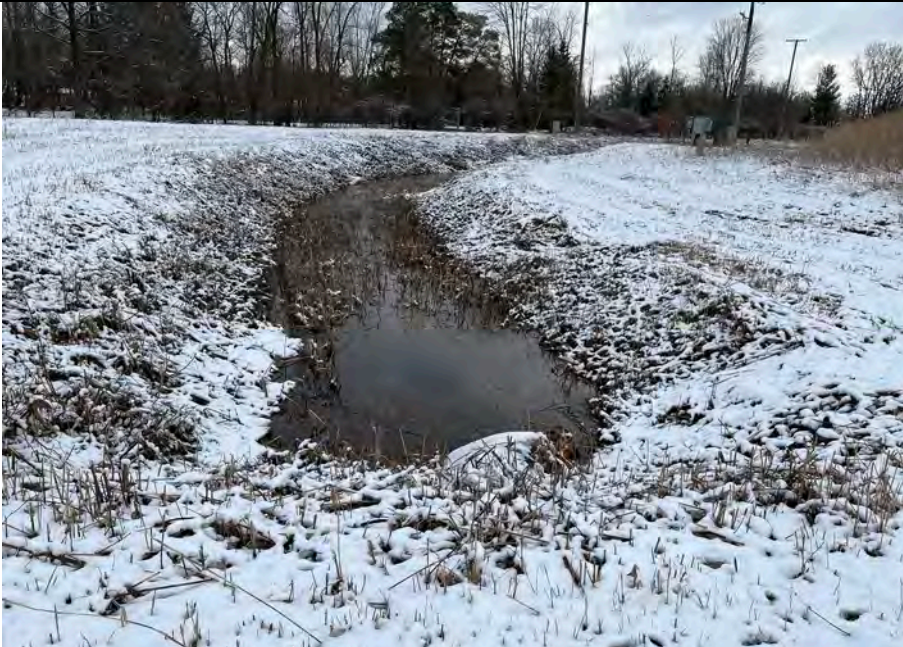
25. Ditch Open and Not Blocked but Some Vegetation Shown in Center Area of Ditch Photo. Culvert Open.

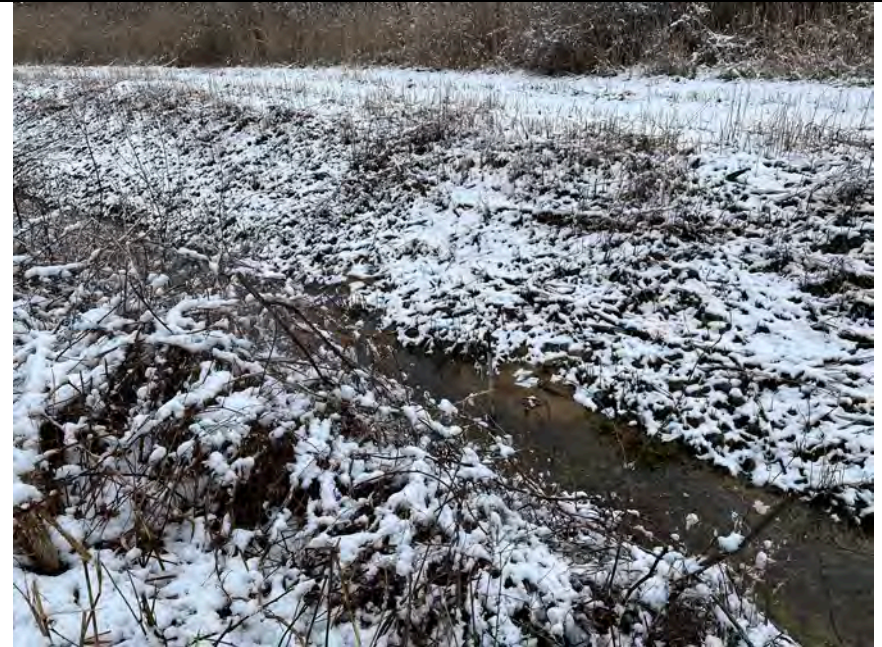
26. Note Circular Light Brown Sand in Ditch Indicating Possible Discharge Location of a Downslope Location of Small Below Grade Discharge Pipe.

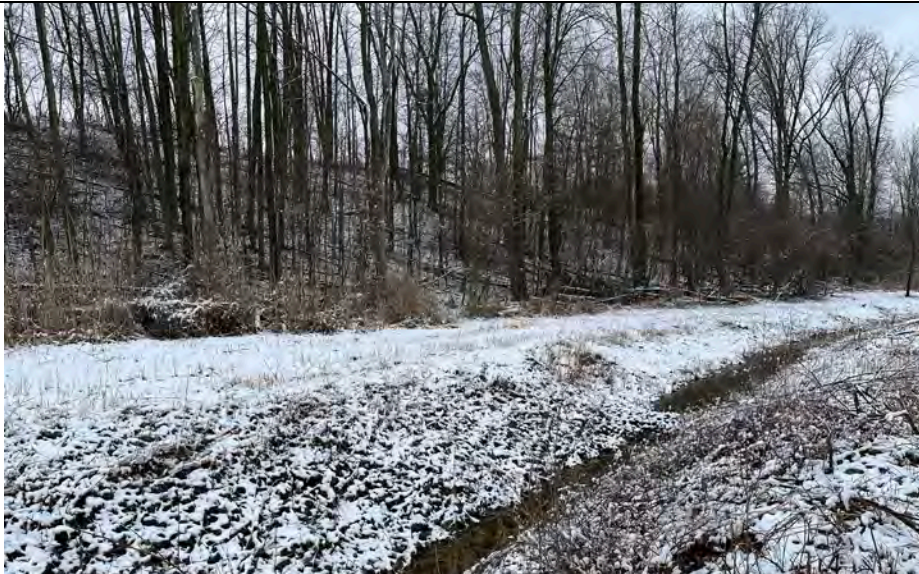
27. View of Perimeter Ditch Past Maintenance with Small Riprap Check Dam. Ditch Slope Maintenance has been Completed Previously.

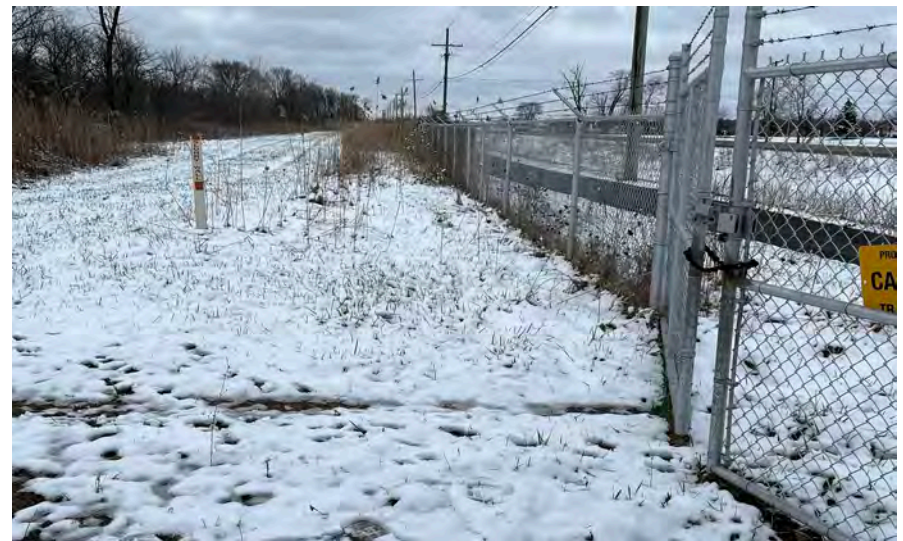
28. West Side Access Fence, Locked and Signage Posted. Perimeter Slurry Wall Marker Shown.

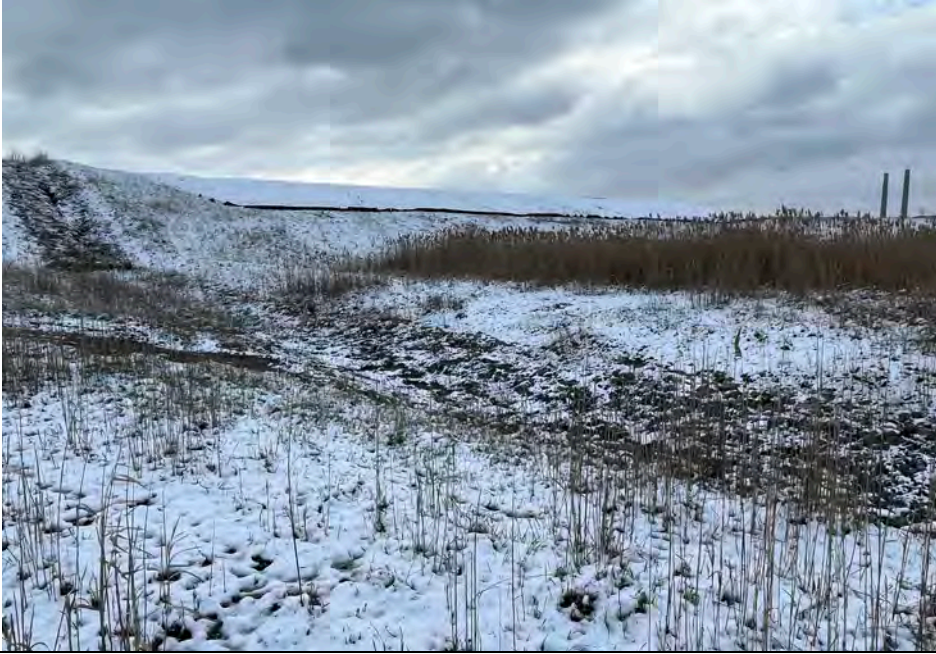
29. Downchute Located at Southwest Corner of Landfill Area F1. Chute Protected from Erosion with Riprap & Steel Mesh. Some Slope Bottom Erosion Noted.

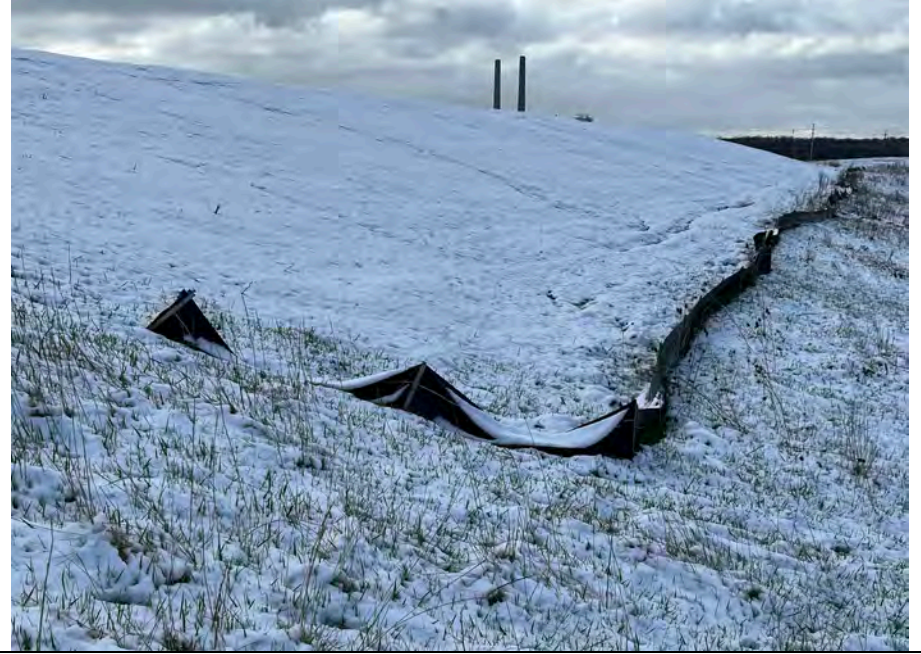
30. Western Side of Area G2 Graded and Seeded. Some Minor Slope Runoff Erosion Shown and Should be Observed and Inspected As Vegetation Grows.

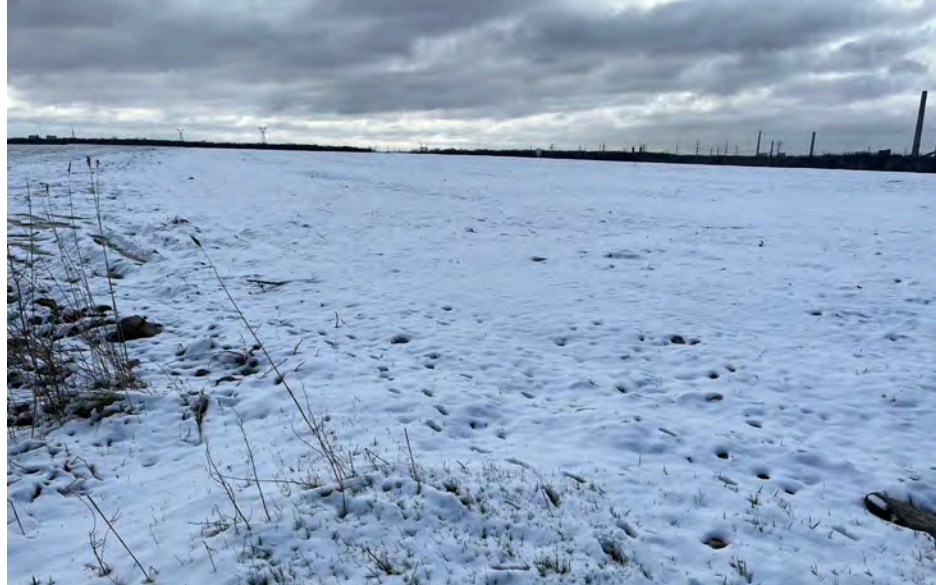
31. View of Top of Landfill Area G2 Phase 1 that has been Graded and Capped in Accordance with Landfill Cover Design. Initial Seeding Completed.

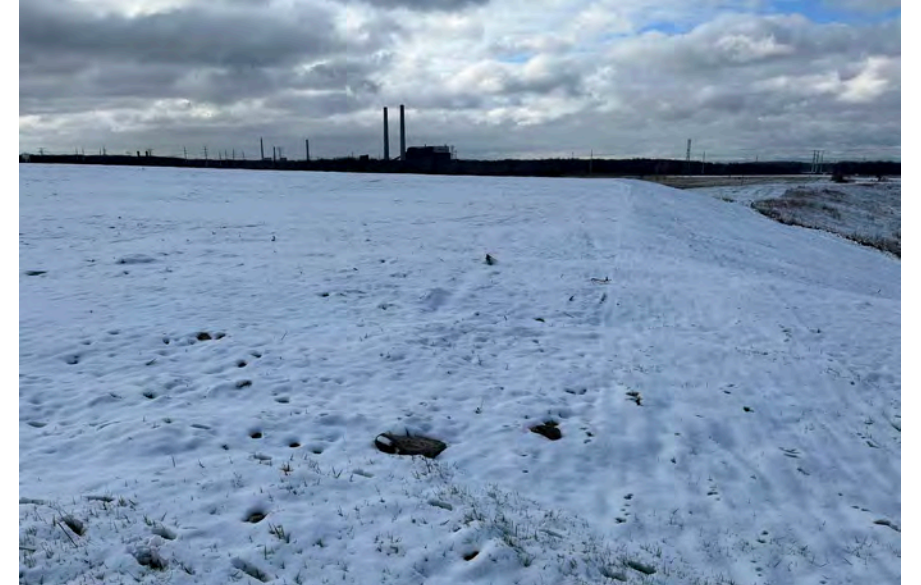
32. Top of Landfill Area G2 Phase 1 Along West Side Slope where Grading and Initial Seeding had Taken Place in Fall of 2021.

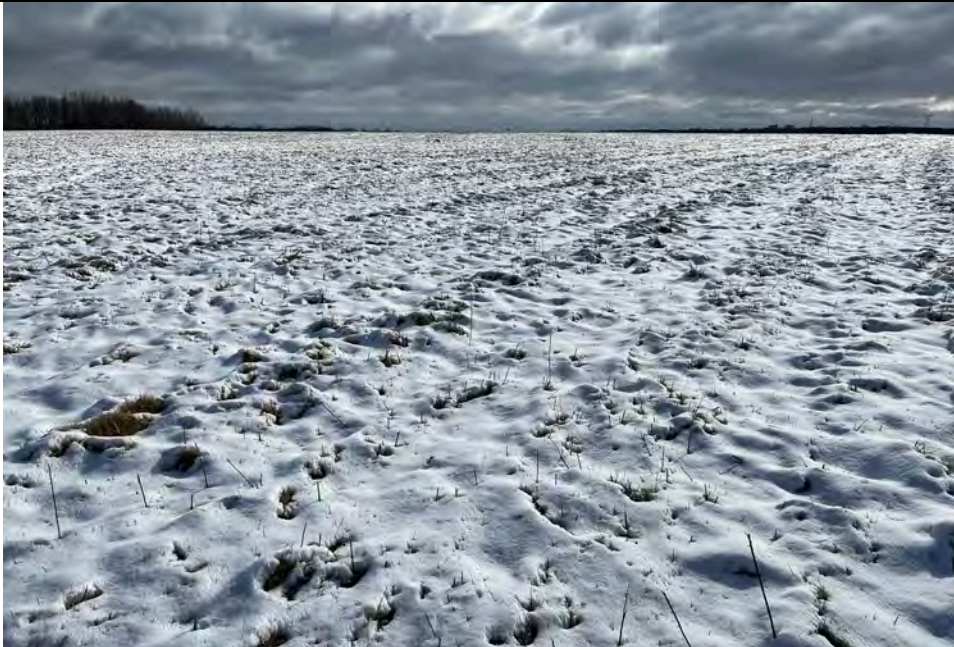
33. Top of Closed Landfill Areas Well Vegetated and Mowed in 2021.

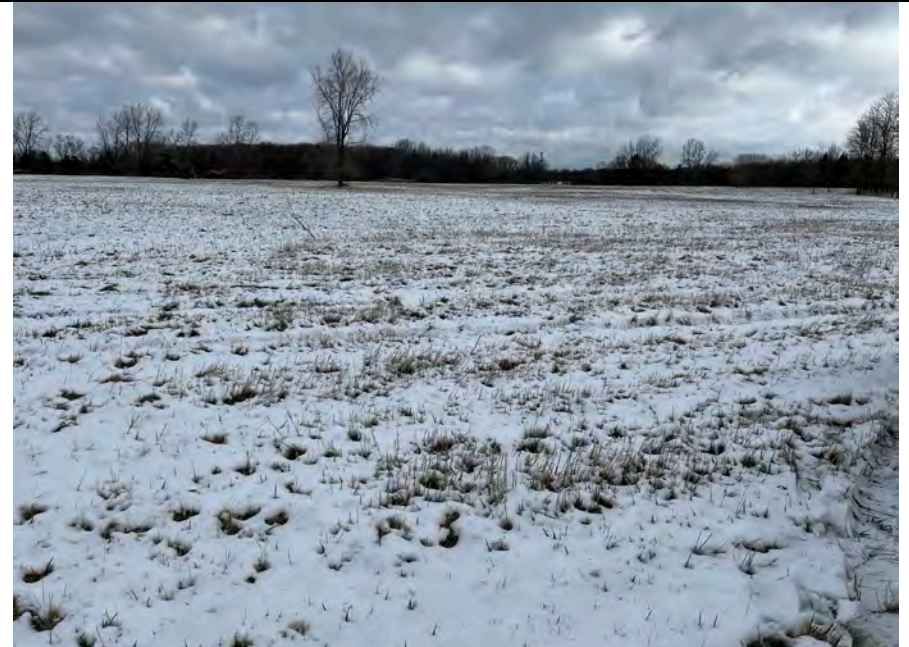
Landfill Final Cover: Closed work area phase covers were intermittently inspected by this Engineer including slopes. Conditions appeared good considering agreements approved with EGLE allowing trees remaining along and on the downstream slope at the north end of the Landfill, predominately in historical Areas A and B. These slopes were observed from the perimeter toe. The top cover was covered with some very light snow but appeared well vegetated. The entire cover was mowed during 2021 as part of on-going maintenance work. No woody vegetation was observed. Photographs 33, 34, and 36 show typical cover surface conditions in Areas F1, F2, and part of B.

34. Top of Closed Landfill Areas Well Vegetated and Mowed in 2021. Isolated Past Small Brush/Tree Growth has been Removed.

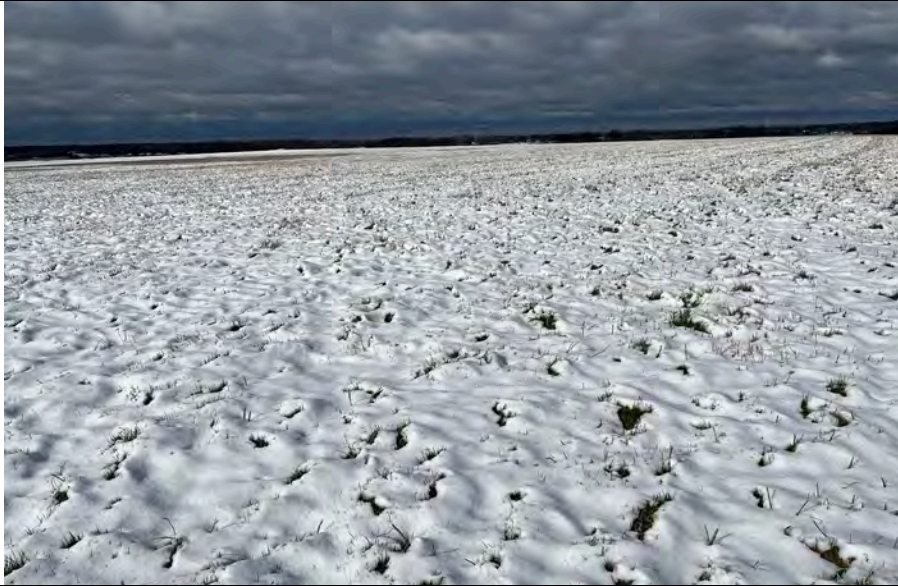
35. Another View of Top of Closed Landfill Areas where Top was Mowed in 2021. Mowing of Complete Final Cover was a Major Maintenance Activity.

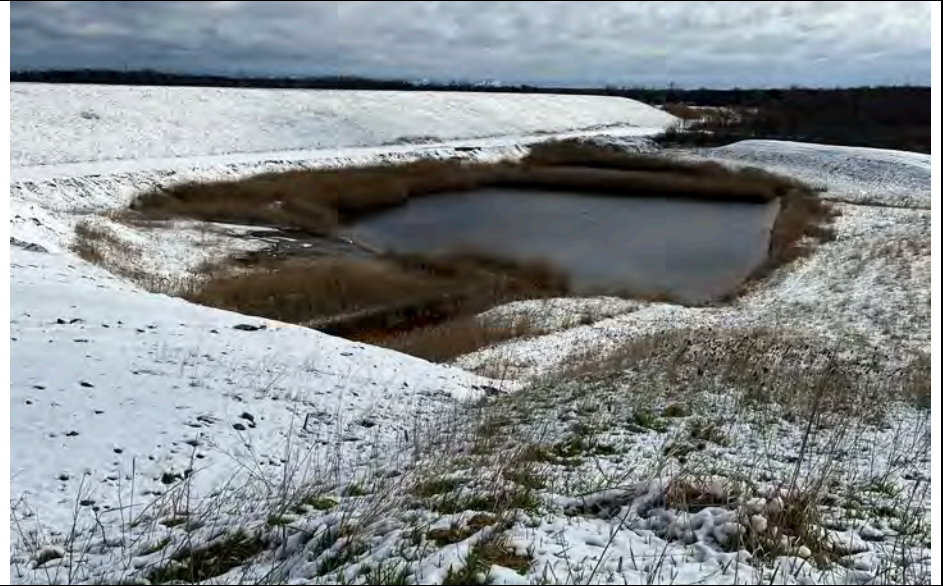
36. Central Runoff Holding Ponds. No Blockage Observed and Ditch Vegetation Appeared Satisfactory Although Not Walked Due to Slip, Trip & Fall Safety.

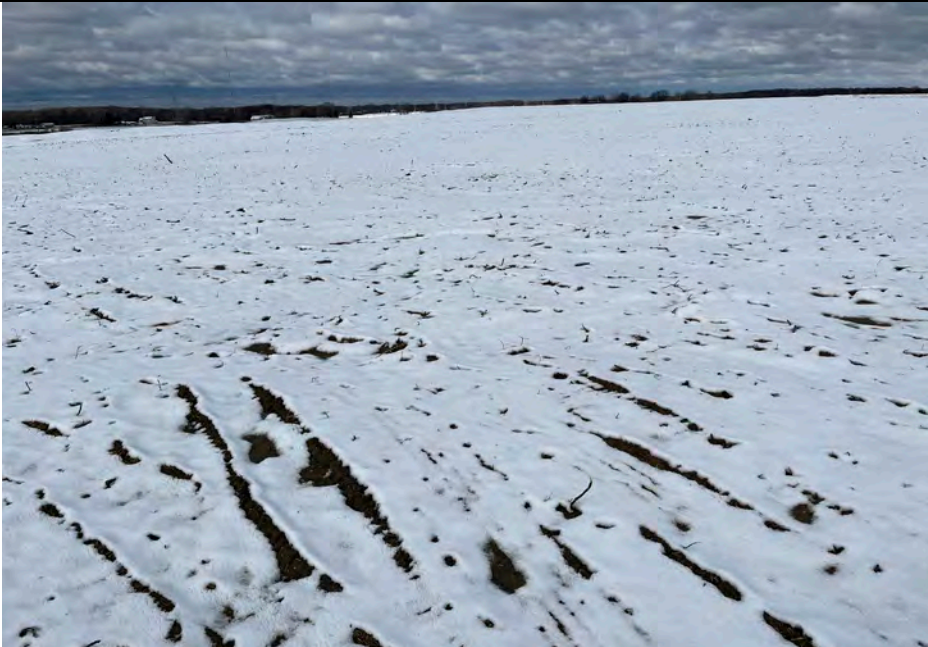
37. View of Top of Capped Area G2 Phase 1. Cover Initial Seeding was Completed but Necessary Re-seeding in Spring 2022 was Completed.

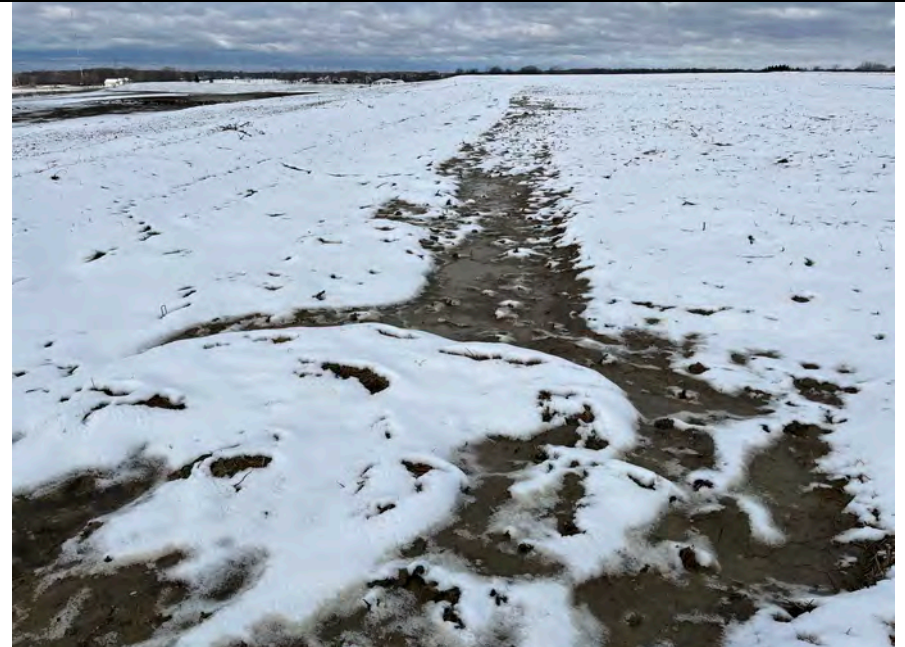
38. Surface Drainage Swale Top Area G2 Phase 1 with Slope into Phase 2. Some Rutting but Repair/Re-seeding Completed in Spring 2022, per DTE.

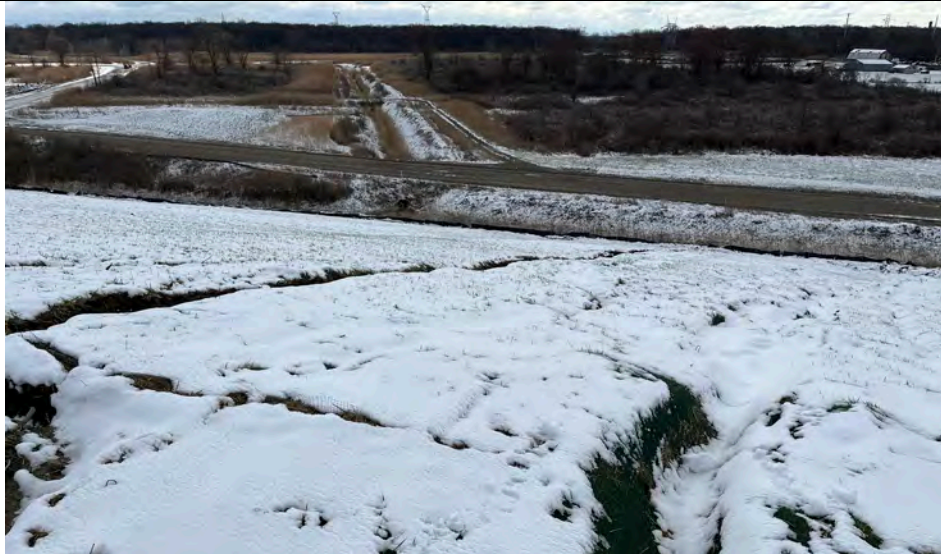
This annual visual inspection did not identify any evidence of structural weakness or instability. The inspection did confirm that there had been slope erosion gullies on the east slope of Area G2 Phase 1. However, DTE confirmed and provided photographs of vegetation growth that these areas were repaired and reseeded as planned during the spring 2022. The perimeter ditch, perimeter slurry wall, offsite capture system pumping, and collection appeared to be working as designed and in accordance with recognized and generally accepted good engineering standards.

39. East Side Slope of Capped Area G2 Phase 1. Slope Erosion Gully. Cover & Slope Repair & Re-Seeding Completed in Spring. See Photos 40, 41 and 42.
