2022 ANNUAL INSPECTION REPORT RANGE ROAD LANDFILL ASH DISPOSAL FACILITY

China Township, St. Clair County, Michigan

DTE Electric Company Range Road Landfill Annual Inspection 19 April 2022

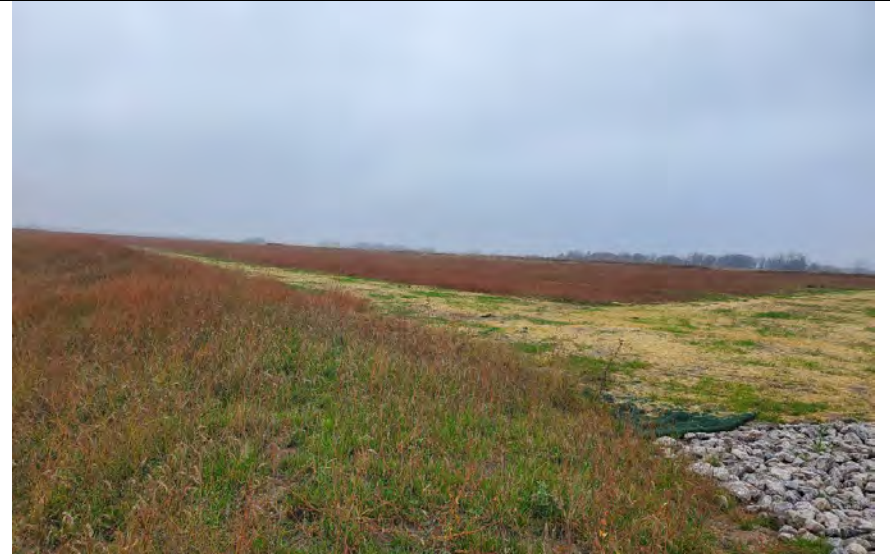
40. DTE Photo of Area G2 Phase 1 Slope Erosion Gullies Repaired and Re-Seeded in Spring 2022 after April Annual Inspection.

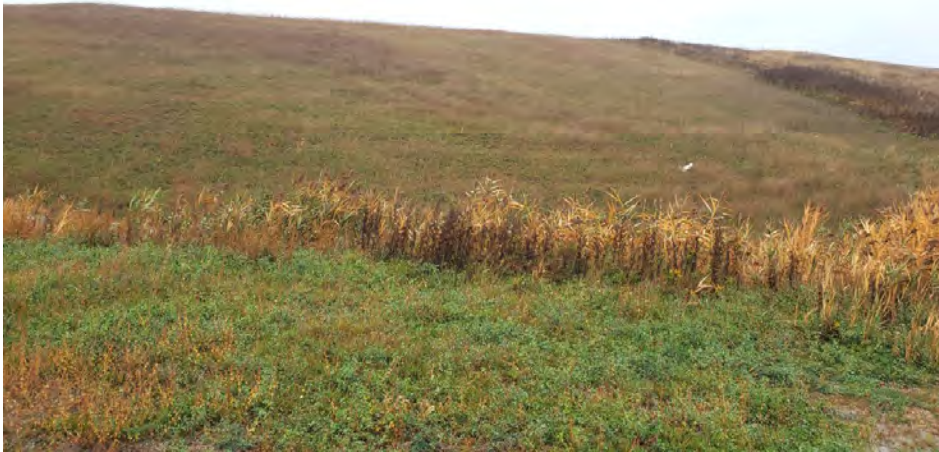
41. DTE Photo of Area G2 Phase 1 Slope after Seeding Growth and Typical of Slope and Cover Seeding and Spring Re-Seeding.

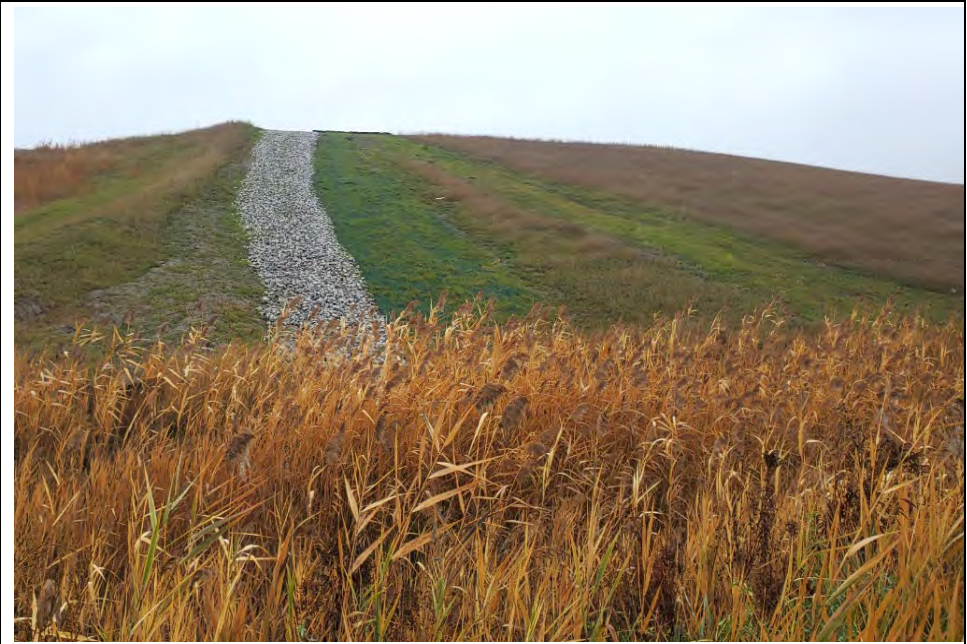
42. DTE Photo of Area G2 Phase 1 Downslope Drain from Cover Swale on Top of Cover.

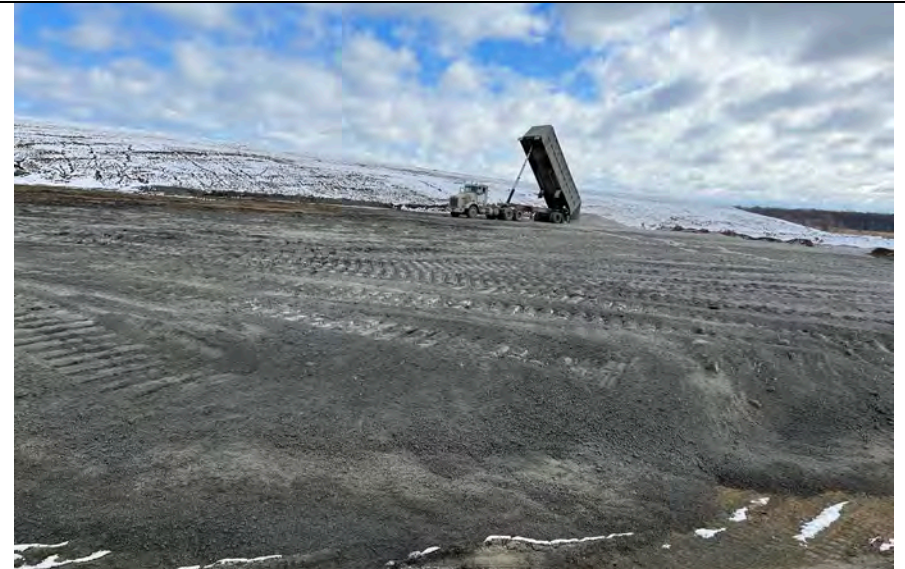
New or freshly conditioned CCR waste was observed in Area G2 Phase 2. At the time of the inspection there was hauling, and placement activities as shown in Photographs 44 and 45. Placement and compaction procedures of conditioned CCR would closely follow the Ash Filling Procedures discussed in the Landfill Development Plan. However, during the inspection only placement and grading was occurring.

44. CCR Haul Trucks Safely Unloading What from a Distance Appears to be Bottom Ash and/or Fly Ash. Active Area G2 Phase 2 Shown.

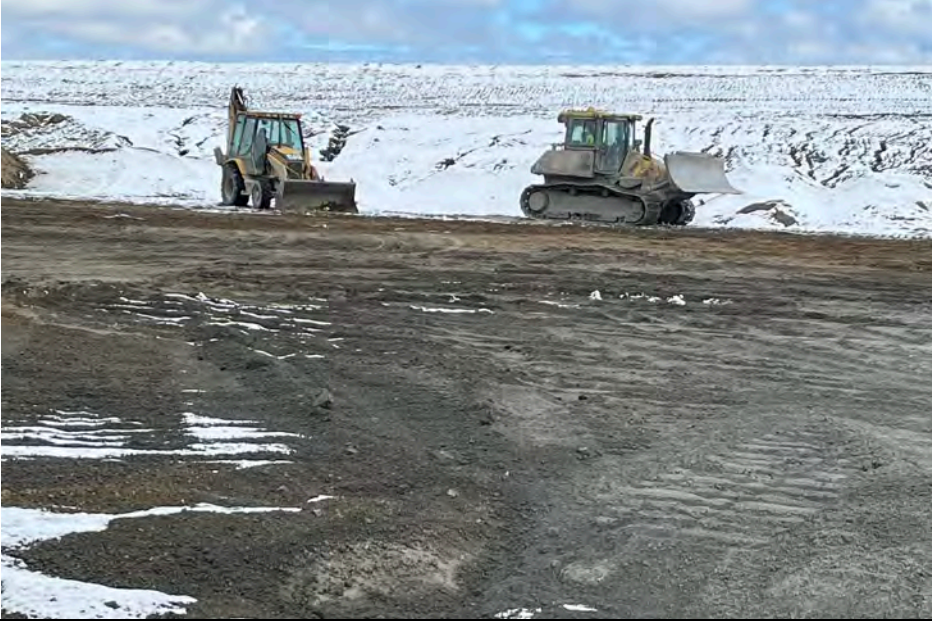
5. Active Area G2 Phase 2 Construction Equipment Working. The Light Snow Cover Occurred the Day/Evening Before.

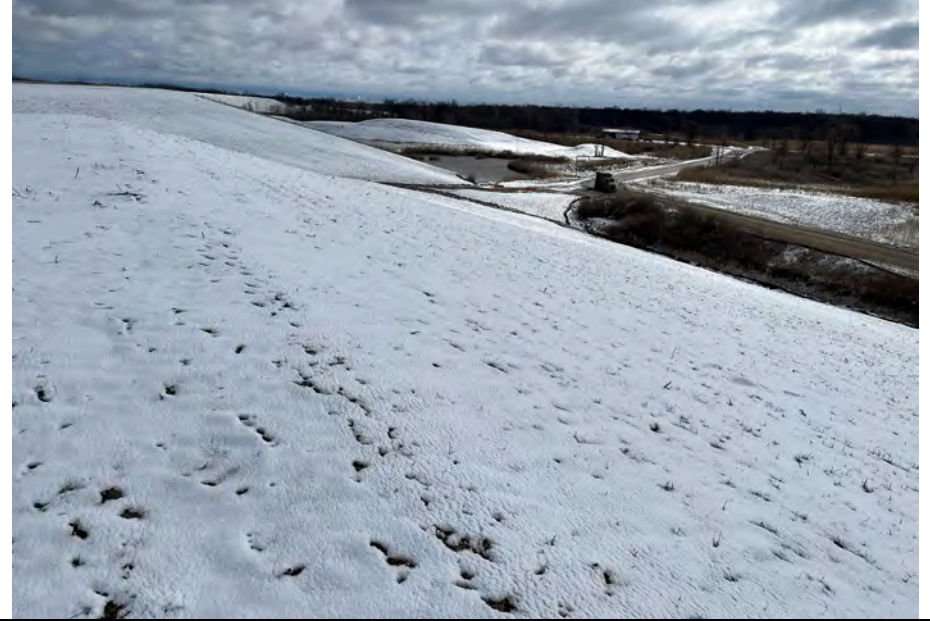
46. Light Snow Cover East Side Slopes of Areas Fe and G2 Phase 1. Slopes Appeared in Good Condition & Stable. See Erosion Gullies Shown in Photo 42.

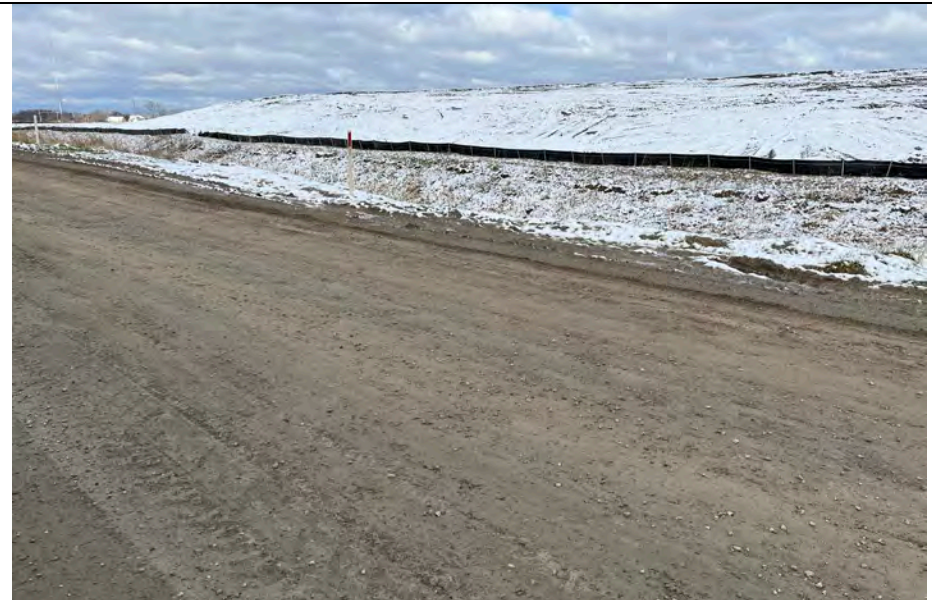
47. Haul Road in Excellent Condition and Internal Drainage Ditch Outside of Landfill Silt Fence. Silt Fence in General Satisfactory Condition.

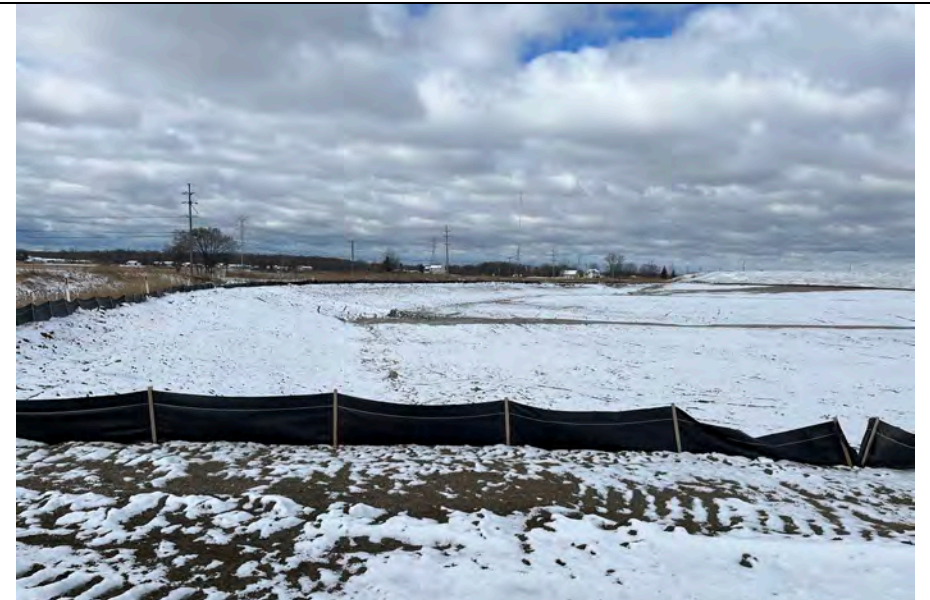
48. Construction Fencing Around Landfill G2 Areas. Internal Drainage Ditch Located Forefront of Photo (Same Ditch as in Photo 47).

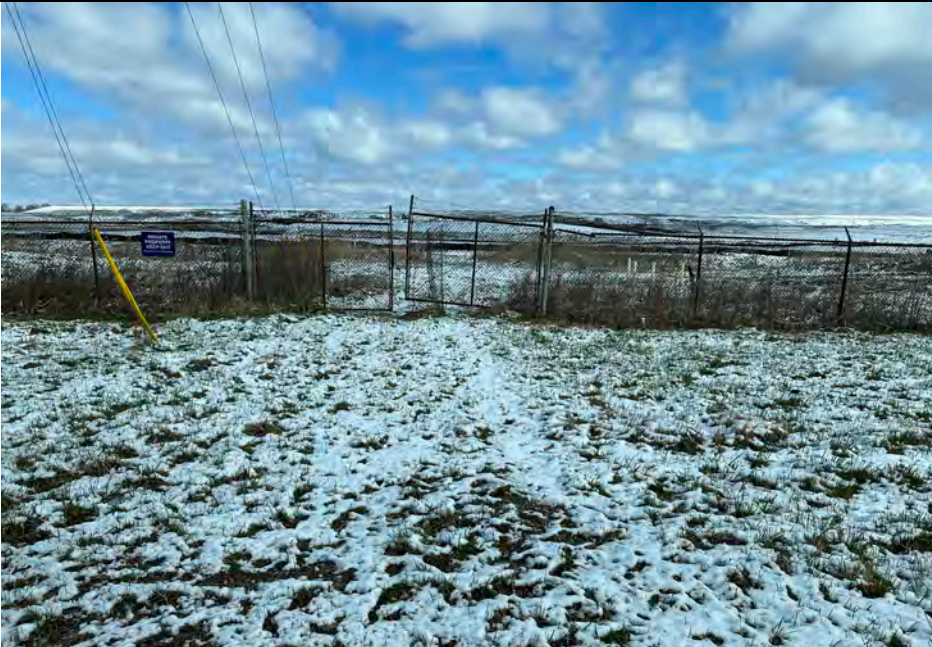
49. Photo Taken from Highway of Locked Gate Only Used for Special Construction or Maintenance Entrance. Monitoring Well No. 16-05 Inside Fence.

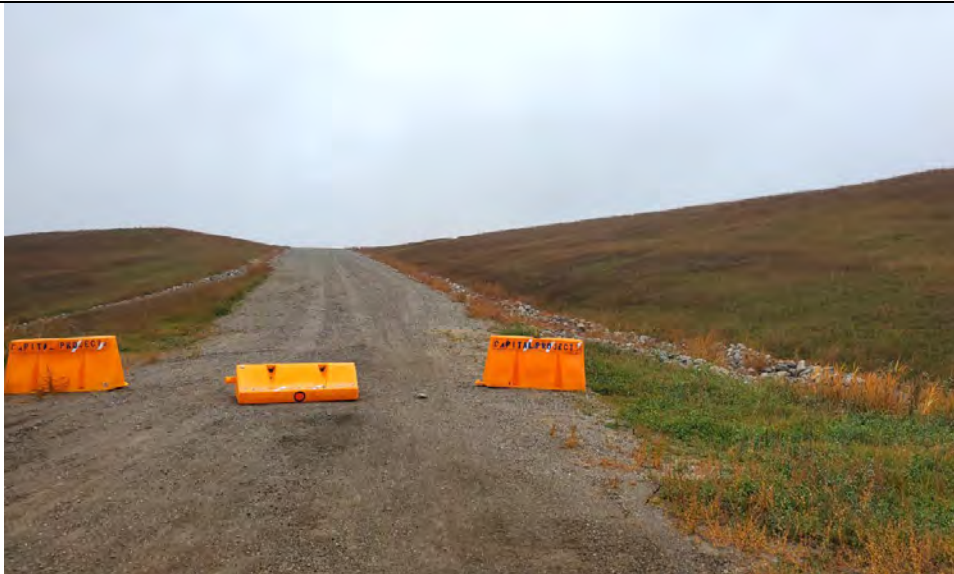
53. DTE Photo of Haul Road to Top of Final Cover with Runoff Collection Ditches Either Side of Road. Previous Re-Occurring Slope Erosion Right Side.

Surface erosion repair and re-seeding along the east side of the main haul road to the top of the closed landfill area was completed in 2022 after the annual inspection. DTE provided Photos 53 and 54 showing the completed repair.

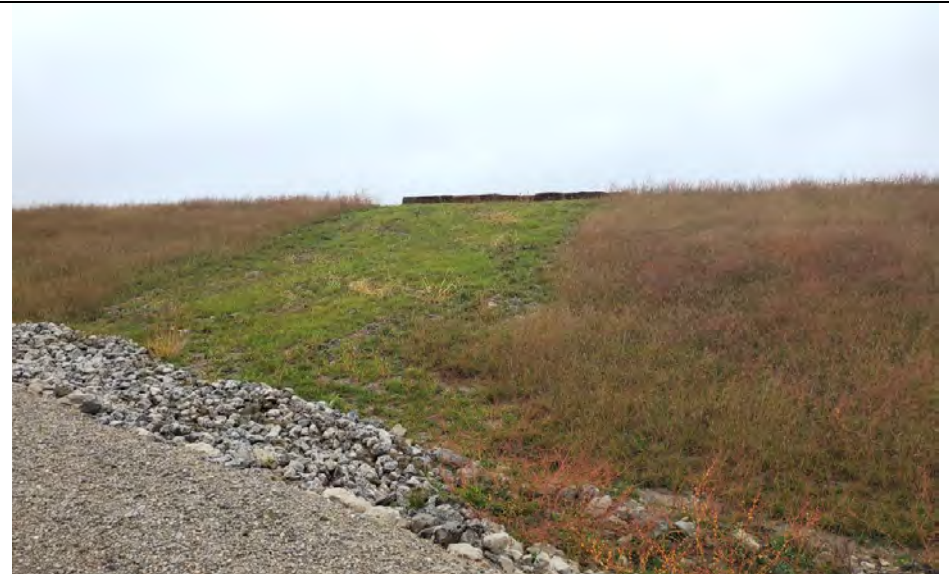
54. DTE Photo of Repair with Added Riprap and Slope Erosion Repair/Re-Seeding. Note Silt Fence at Top where Surface Runoff Meets Slope.
