DTE Energy Monroe Power Plant

Inactive Bottom Ash Impoundment CCR Rule Compliance Project

Annual Inspection Report - 2017

Project Number: 60516675

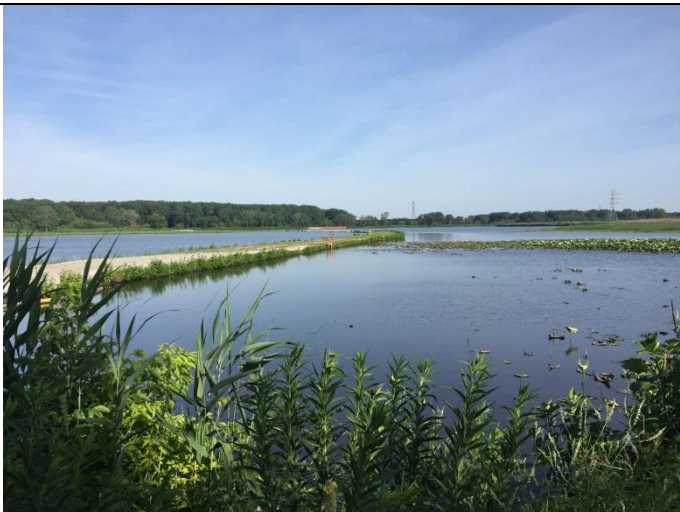
Photo 3: Looking west from east access road at south separation berm

Comments /Action Items Pool level has been steady since observations were first began by this inspector in late 2015. Southern separation berm has 2 pipes and a lowered section to allow for equalization of water levels between the Inactive Bottom Ash Impoundment and the process waste water Basin.		
Actions <input checked="" type="checkbox"/> None <input type="checkbox"/> Maintenance <input type="checkbox"/> Monitoring <input type="checkbox"/> Minor Repair <input type="checkbox"/> Engineering			
OTHER	OBSERVATIONS

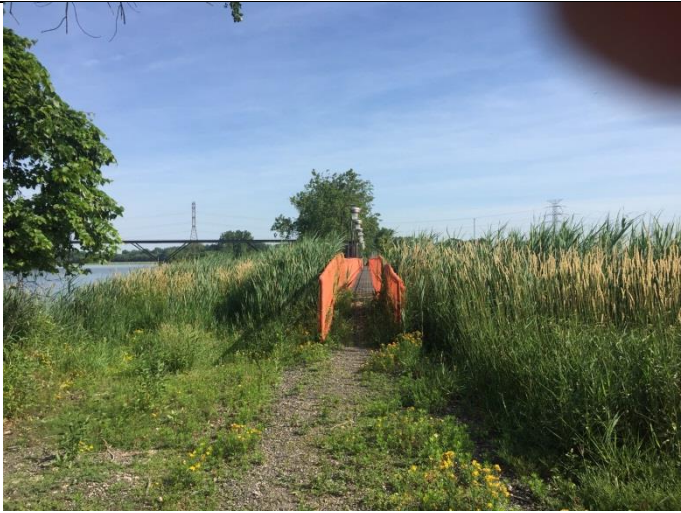
Photo 5: Looking north at walkway for spillway

Comments /Action Items Spillway appears to be in good repair although the downstream weir is overgrown with vegetation; there are no control systems so the spillway acts as both principal and emergency.					
Actions <input type="checkbox"/> None <input type="checkbox"/> Maintenance <input type="checkbox"/> Monitoring <input type="checkbox"/> Minor Repair <input type="checkbox"/> Engineering					
EMERGENCY SPILLWAY	OBSERVATIONS				
	<input type="checkbox"/> No emergency spillway			<input checked="" type="checkbox"/> Same as primary spillway	
	PROBLEMS				CHANNEL LINING
	<input type="checkbox"/> 1. None <input type="checkbox"/> 2. Debris in channel <input type="checkbox"/> 3. Gates <input type="checkbox"/> 4. Misalignment	<input type="checkbox"/> 5. Joint deterioration <input type="checkbox"/> 6. Joint displacement <input type="checkbox"/> 7. Exposed reinforcement <input type="checkbox"/> 8. Erosion	<input type="checkbox"/> 9. Undermining <input type="checkbox"/> 10. Voids <input type="checkbox"/> 11. Cracks <input type="checkbox"/> 12. Holes <input type="checkbox"/> 13. Outlet erosion	<input type="checkbox"/> 14. Displaced rip rap <input type="checkbox"/> 15. Sparse rip rap <input type="checkbox"/> 16. Outlet undercutting <input type="checkbox"/> 17. Inadequate capacity <input type="checkbox"/> 18. Other	<input type="checkbox"/> Vegetation <input type="checkbox"/> Rip rap <input type="checkbox"/> Concrete <input type="checkbox"/> Asphalt <input type="checkbox"/> Other

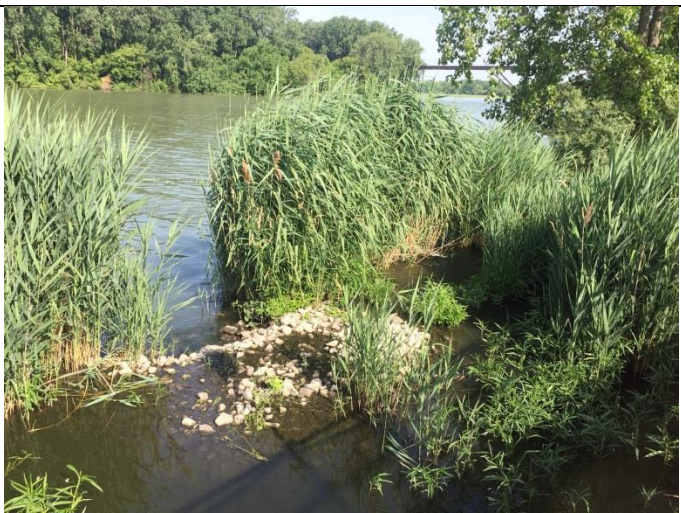
Photo 5: Looking west at discharge from spillway into canal

- The downslope sides of the Impoundment are heavily vegetated and a thorough inspection of the entire surface area of the impoundment is not practical.
- The downstream side of the spillway is heavily vegetated and flow through the spillway is redirected preferentially due to this vegetation. Flow through the spillway is not impeded due to the vegetation at this time.
