# **DTE Energy Monroe Power Plant**

## **Inactive Bottom Ash Impoundment CCR Rule Compliance Project**

### **Annual Inspection Report - 2018**

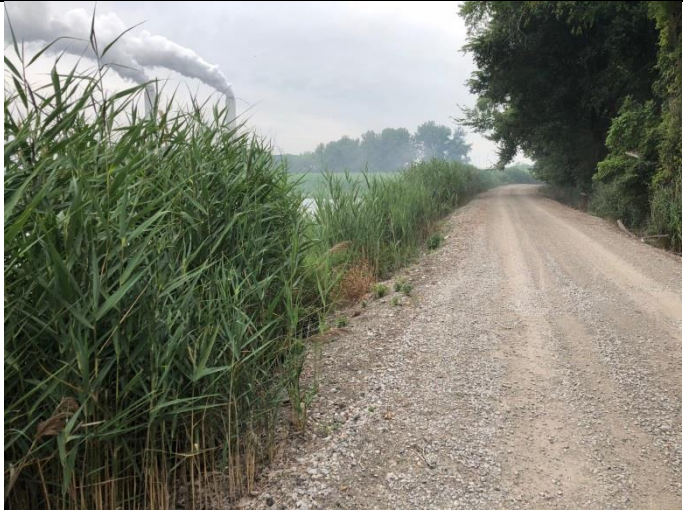
**Photo 1: Looking north along east access road; note overgrown vegetation on inboard edge of berm.**

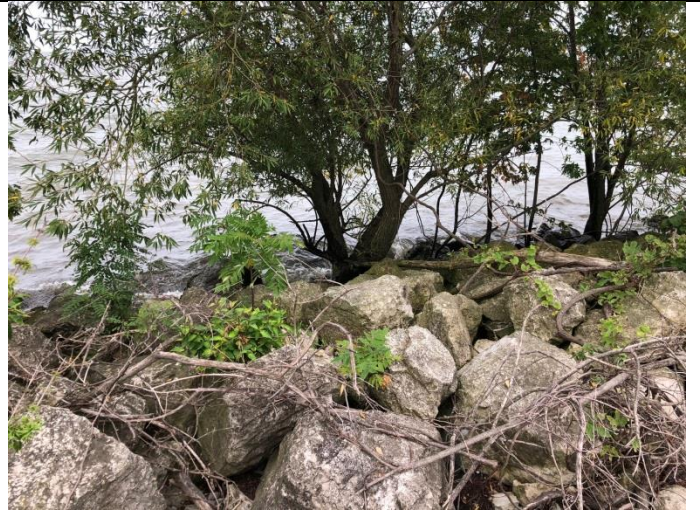
**Photo 2: Looking east downslope at the large rip-rap protecting the berm along Lake Erie.**

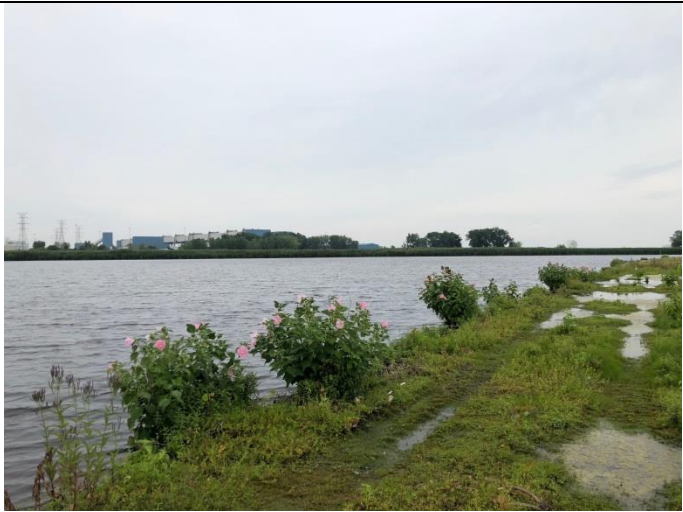
**Photo 3: Looking east from west access road at south separation berm.**

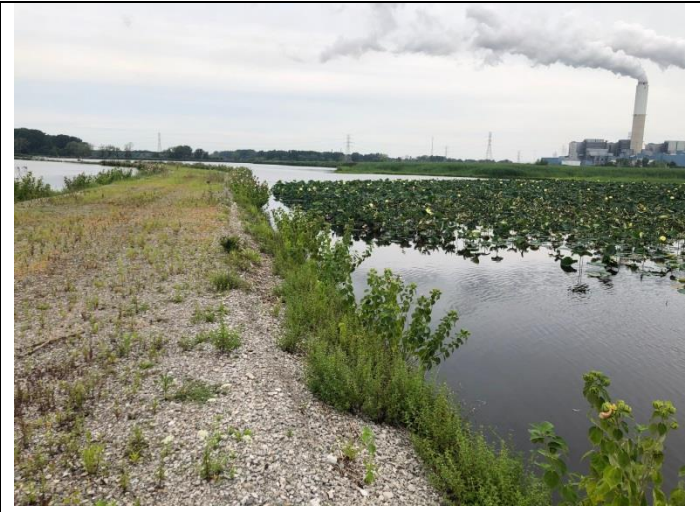
**Photo 4: Looking west from east access road at south separation berm.**

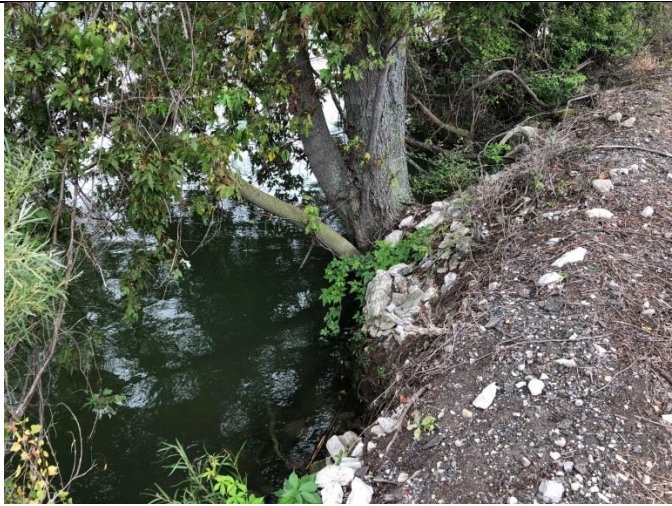
**Photo 5: Area along the west berm needing rip-rap replacement due to sloughing into the discharge canal.**

- The downslope sides of the Impoundment are heavily vegetated and a thorough inspection of the entire surface area of the impoundment is not practical.
- The downstream side of the spillway is heavily vegetated and flow through the spillway is redirected preferentially due to this vegetation. Flow through the spillway is not impeded due to the vegetation at this time.
- There are two areas along the western side of the berm surrounding area 15 (along the discharge canal) where the rip-rap has slid down the slope; DTE should consider replacing this rip-rap to prevent future erosion of the berm in these areas.
