2017 ANNUAL INSPECTION REPORT ASH BASIN EMBANKMENT

MONROE POWER PLANT

Monroe, Michigan

January 2018

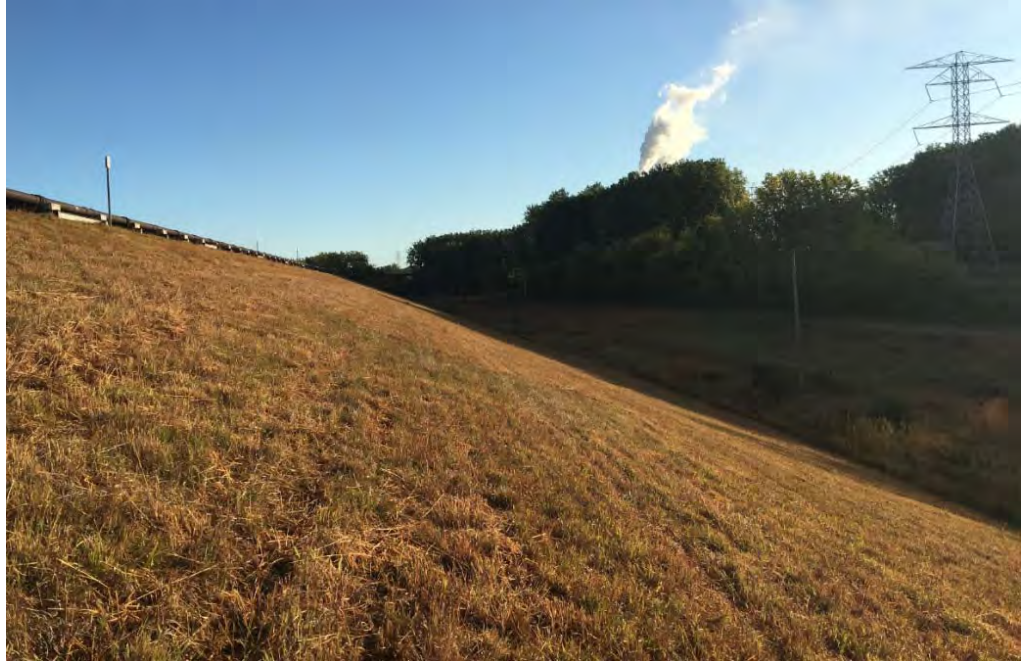
Comments: Photo taken at Station ~175+00, facing north. The embankment appeared to have uniform slopes without sign of distress.

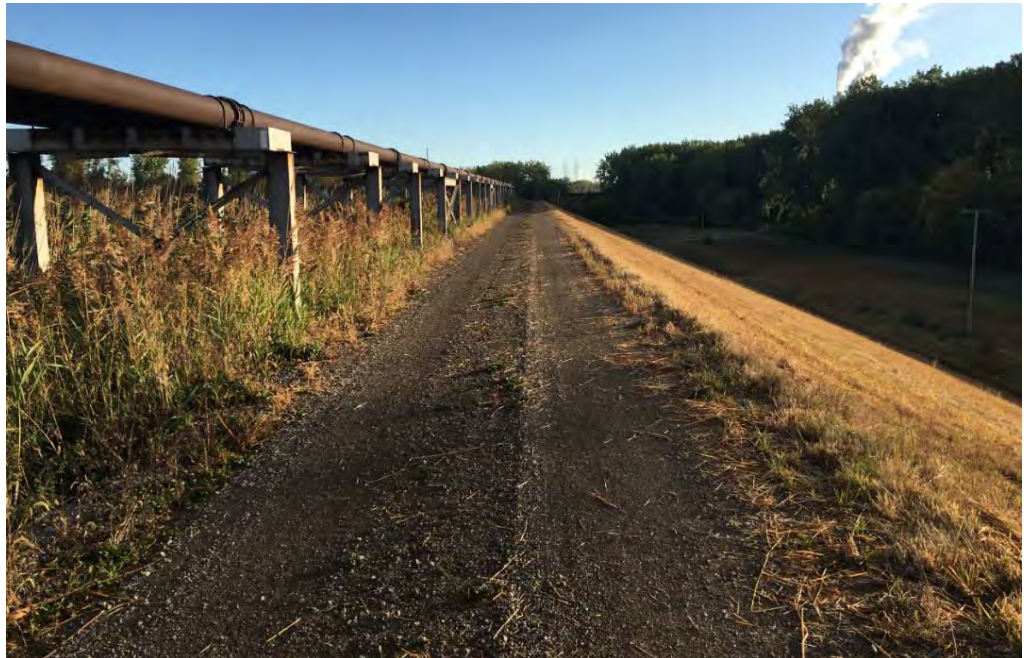
Photograph 2

Comments: Photo taken at Station ~179+00, facing north. Crest road appeared to be in good condition.

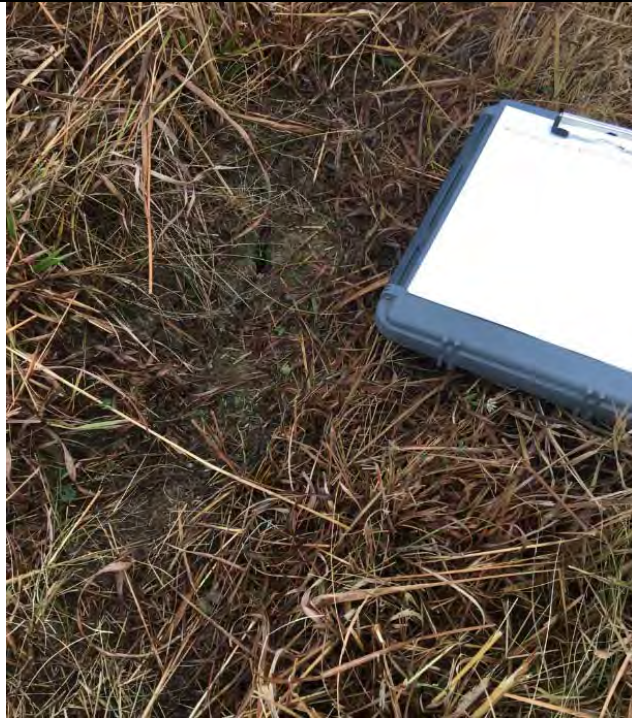
2. Cracks that are one-inch wide or less were observed on the exterior slope of the embankment at various areas: (i) discrete locations from Station ~122+00 to ~135+00; (ii) Station ~69+00; (iii) between Stations ~176+00 and ~177+00; and (iv) from ~32+00 to ~35+00. Typical cracks are provided on Photographs 3, 13, 14 and 25.

Up to one-inch wide cracks were observed from station 176 to 177 in the area downslope of the mid-slope blanket drain (Photograph 3).

Comments: Up to approximately one-inch wide cracks were observed on the embankment. Inspection sheet provides detailed locations of the cracks.

- Cracks one-inch wide or less were observed on the exterior slope of the embankment at discrete locations from Station ~122+00 to ~135+00, at Station ~69+00, from Station ~176+00 to Station ~177+00, and from Station ~32+00 to ~35+00 do not represent an immediate concern for global stability of the Ash Basin embankment; these cracks should be monitored on a regular basis at a frequency of once every 30 days (maximum).

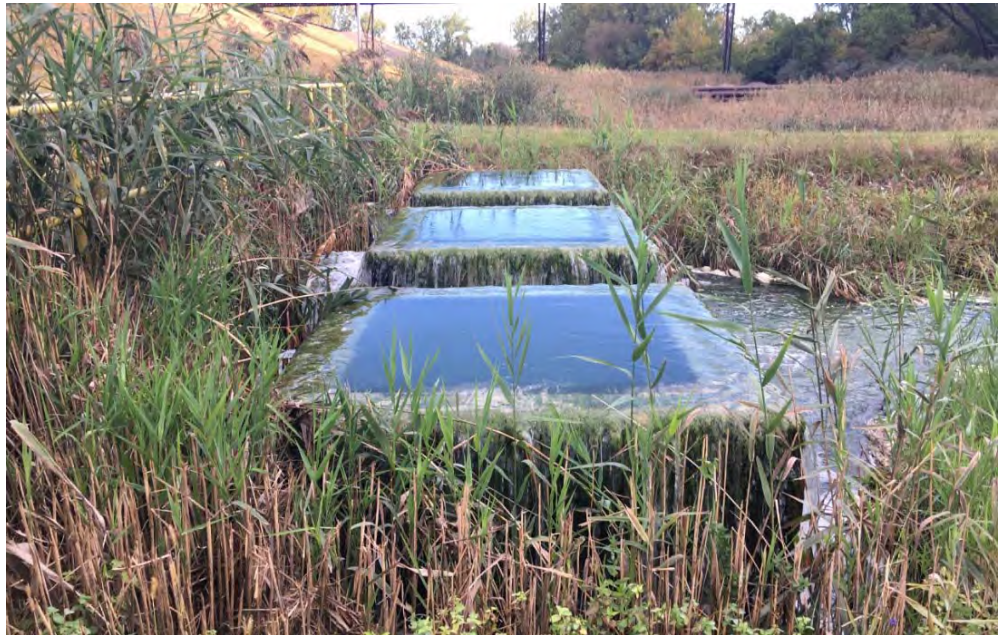
Photograph 4

Comments: Aerators located at the downstream end of discharge structure appeared to be in good condition.

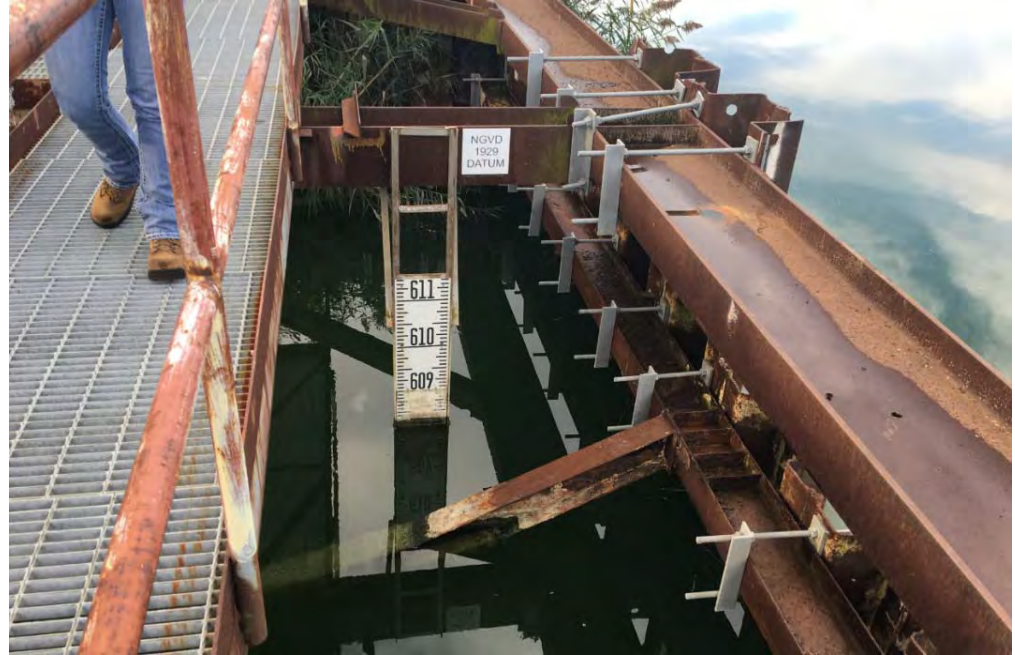
Comments: Ash Basin water level during the time of inspection was at ~698.5 ft.

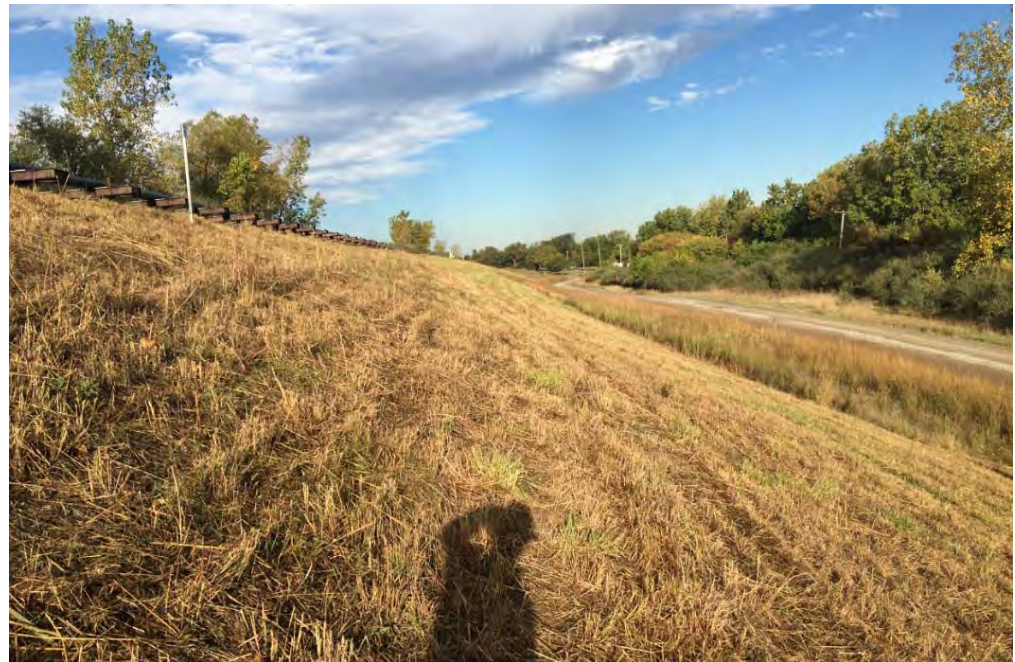
Photograph 6

Comments: Photo taken at Station ~6+00, facing west. The embankment appeared to have uniform slopes without sign of distress.

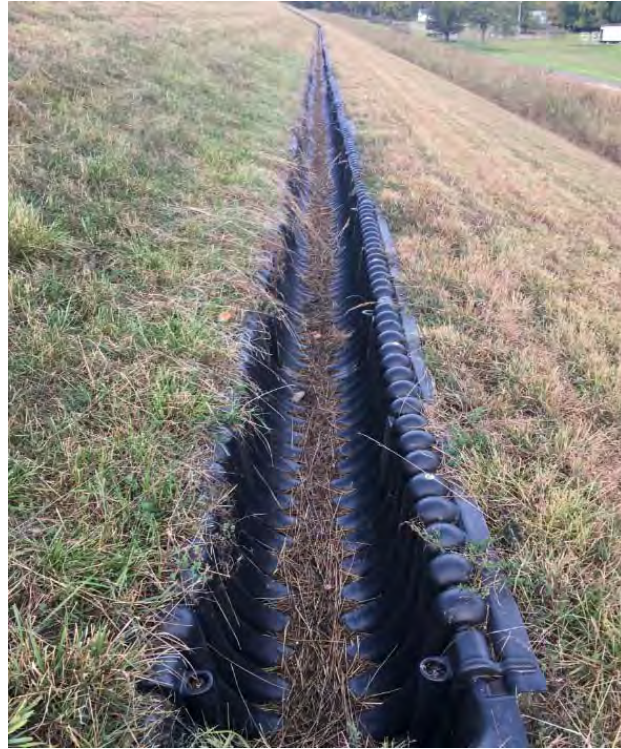
Comments: In general, the mid-slope stormwater ditch appeared to be in good condition. Vegetation has washed into the ditch, and was generally observed in the ditches.

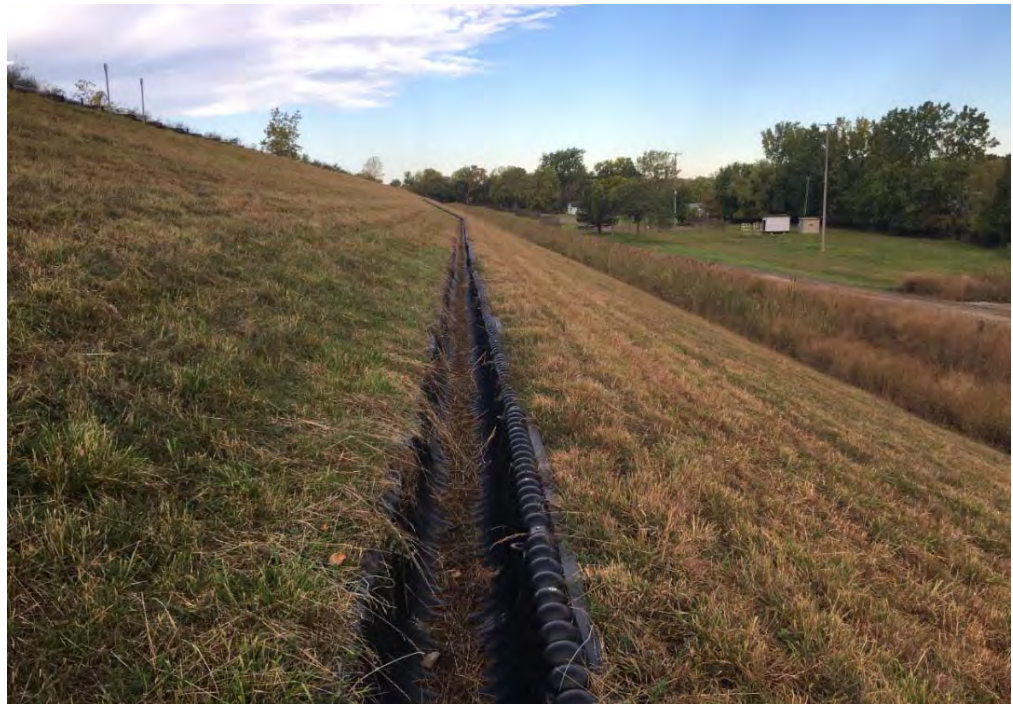
Photograph 8

Comments: Photo taken at Station ~15+00, facing west. The embankment appeared to have uniform slopes without sign of distress.

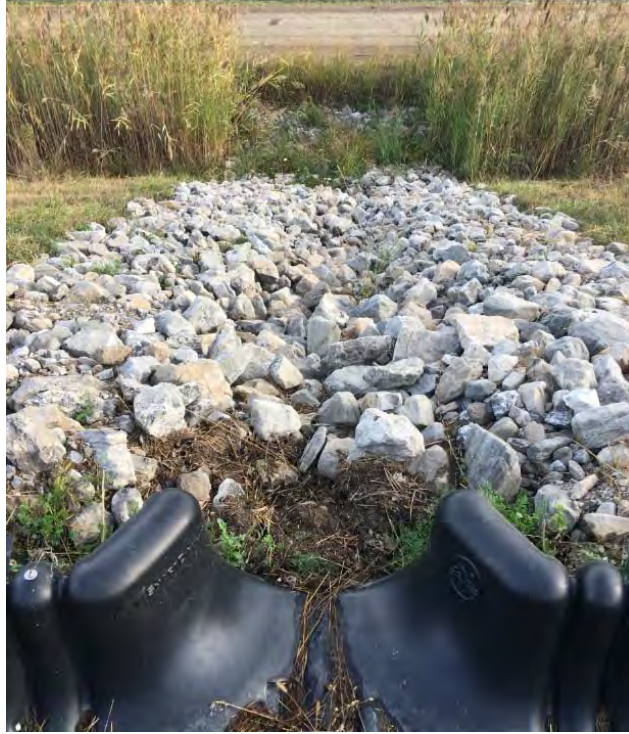
Comments: Downchute at Station 18+00. In general, vegetation was observed to be washed out at each downchute location.

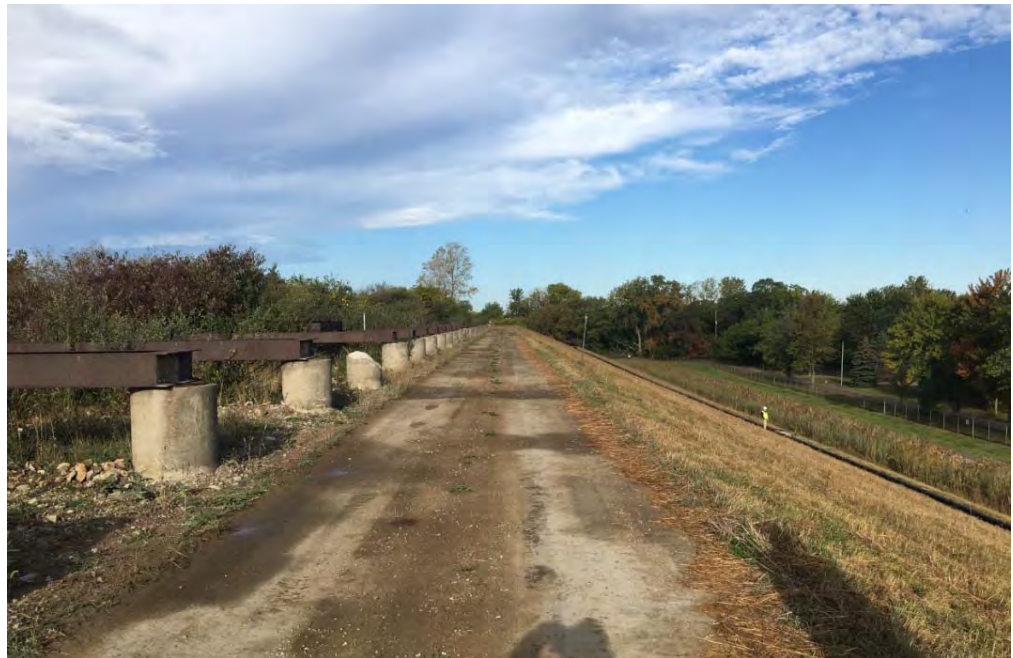
Photograph 10

Comments: Photo taken at Station ~20+00, facing west. Crest road appeared to be in good condition.

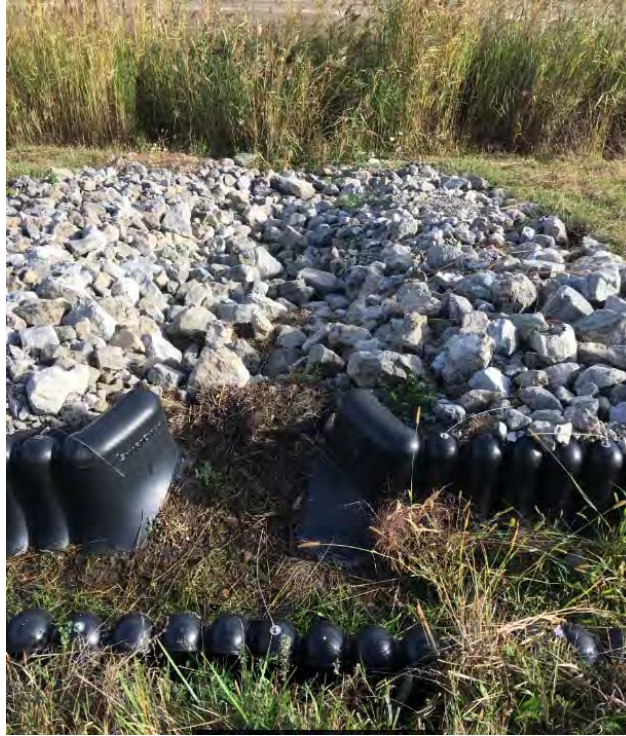
4. Downchute at Station 26+00 has lost contact with the embankment at the upstream end of the downchute (Photograph 11).
5. Erosion rills were observed on the embankment, close to the crest, at stations approximately 29+00, 32+00, 35+00 and 115+00 (Photographs 12 and 28).

Comments: Upstream end of downchute at Station 26+00. Couple of inches wide gap was observed between the mid-slope ditch and upslope soil. Vegetation was also observed at the downstream ends of ditches.

- Isolated problems with the midslope ditch bedding (i.e. pea stone and underlying soil) washing out were observed at downchute at Station 26+00. The observed problems do not represent an immediate concern for the safe operation or stability of the Ash Basin embankment. However, this downchute shall be fixed in accordance with IMM Manual.

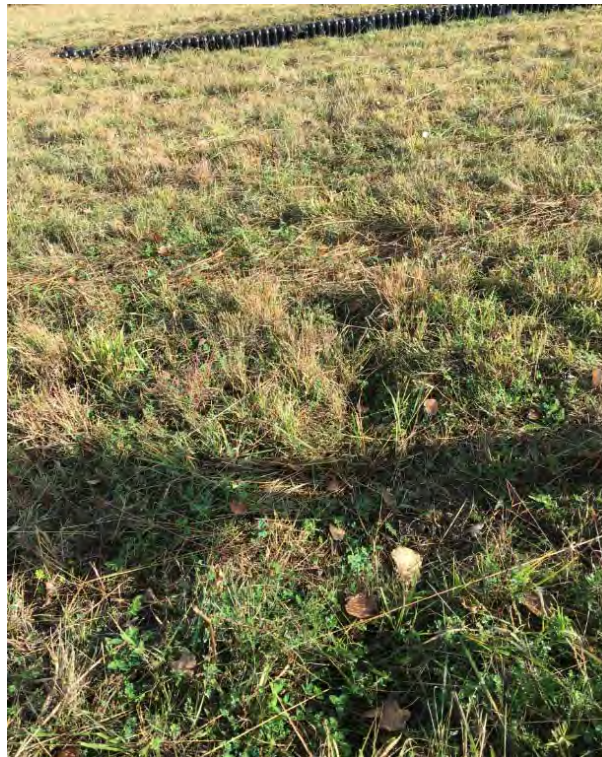
Photograph 12

Erosion rills were observed on the embankment, close to the crest, at stations approximately 29, 32, 35 and 115 (Photographs 12 and 28).

Comments: Erosion rills were observed on the embankment at discrete locations between Stations 29+00 and 35+00.

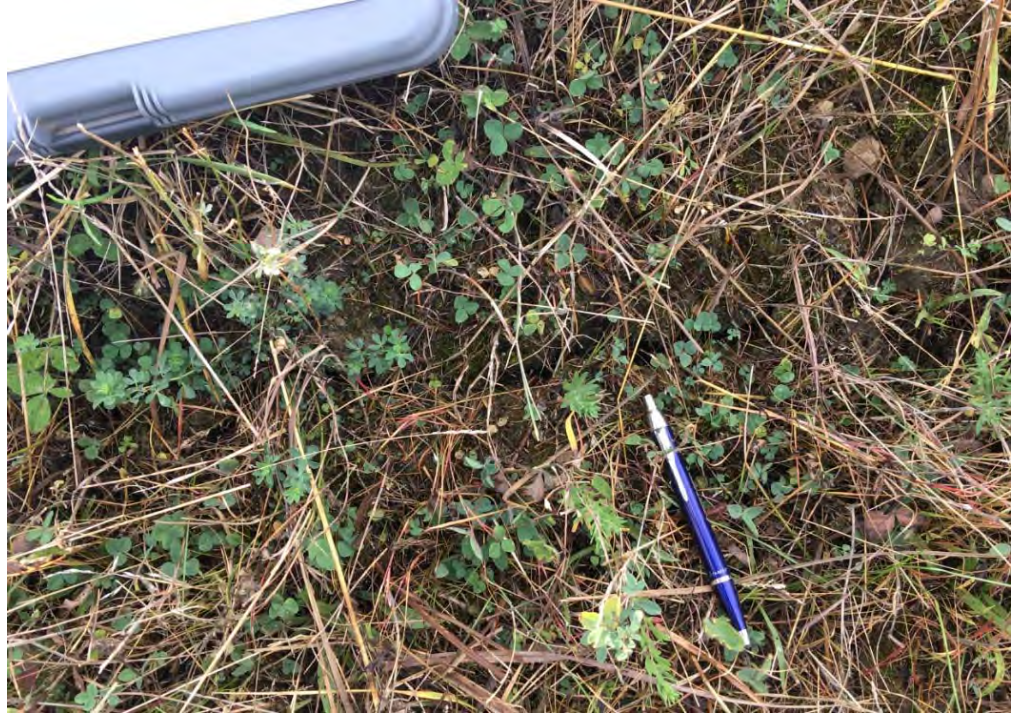
Up to 3/4-inch wide cracks were observed on the upper half of the embankment station 32 to 35 (Photographs 13 and 14).

Comments: Up to approximately one-inch wide cracks were observed on the embankment. Inspection sheet provides detailed locations of the cracks.

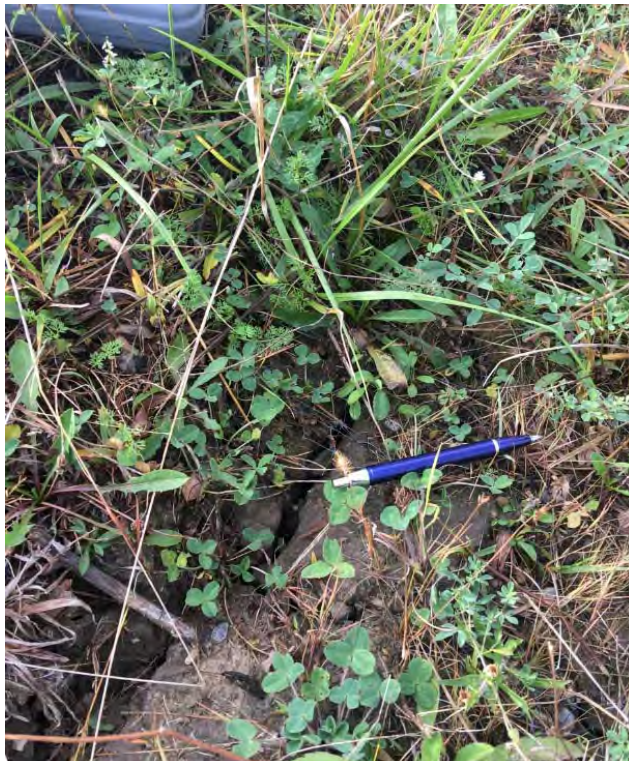
Photograph 14

Comments: Up to several inches wide cracks were observed on the embankment. Inspection sheet provides detailed locations of the cracks.

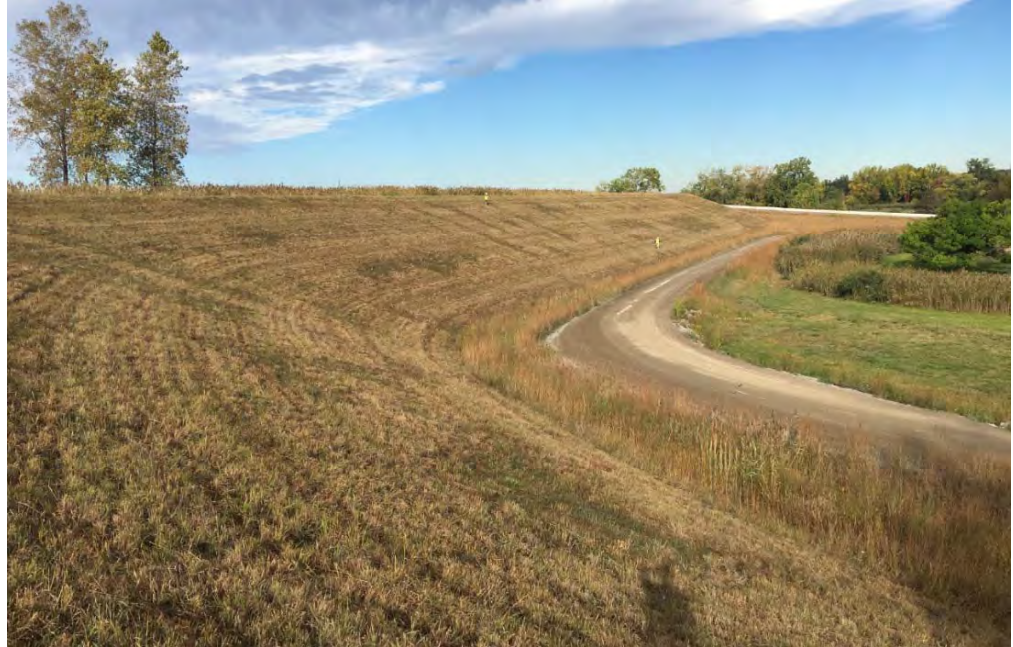
Comments: Photo taken at Station 35+00, facing west. The embankment appeared to have uniform slopes without sign of distress.

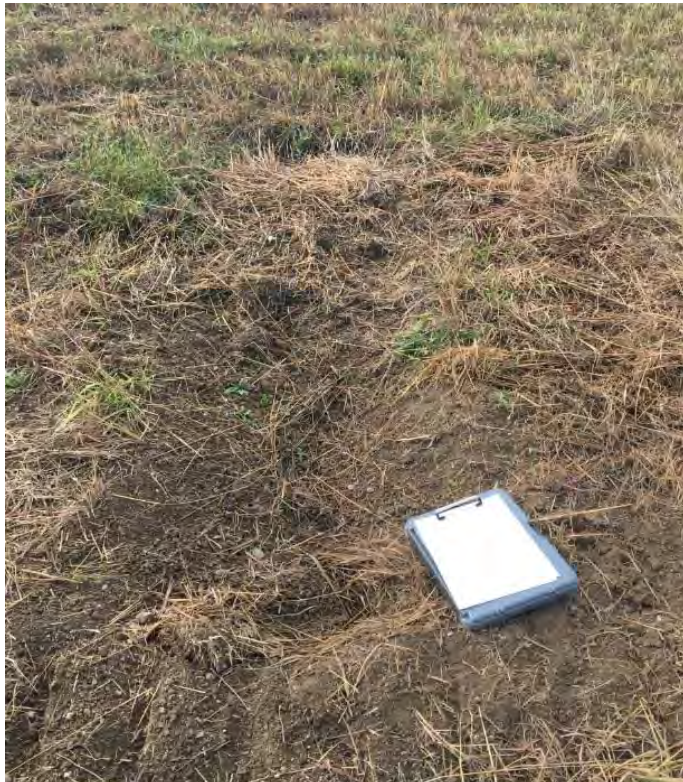
Photograph 16

Comments: Local depression was observed at the toe of the embankment at Station 62+00. No sign of sloughing or cracks were observed on the embankment.

- Local depression that was observed at the toe of the embankment at Station 62+00 does not represent an immediate concern for the safe operation or stability of the Ash Basin embankment.

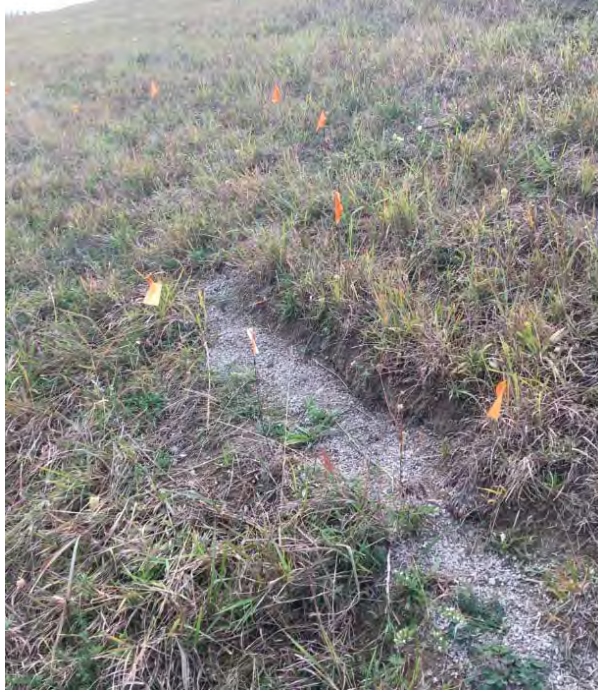
Comments: Cracks on the embankment between Stations 60+00 and 65+00 have been filled with bentonite-sand mixture as part of current construction activities. There are areas that require further filling.

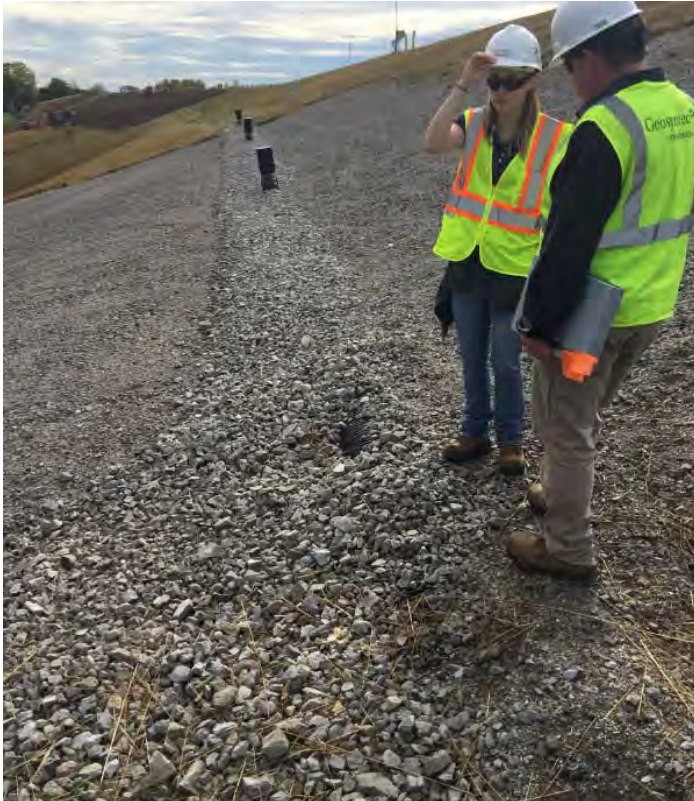
Photograph 18

Comments: Photo taken at Station 66+00, facing east. The embankment appeared to have uniform slopes without sign of distress. Part of the culvert in the mid-slope stormwater conveyance structure, at this location, is exposed. It shall be covered with aggregate.

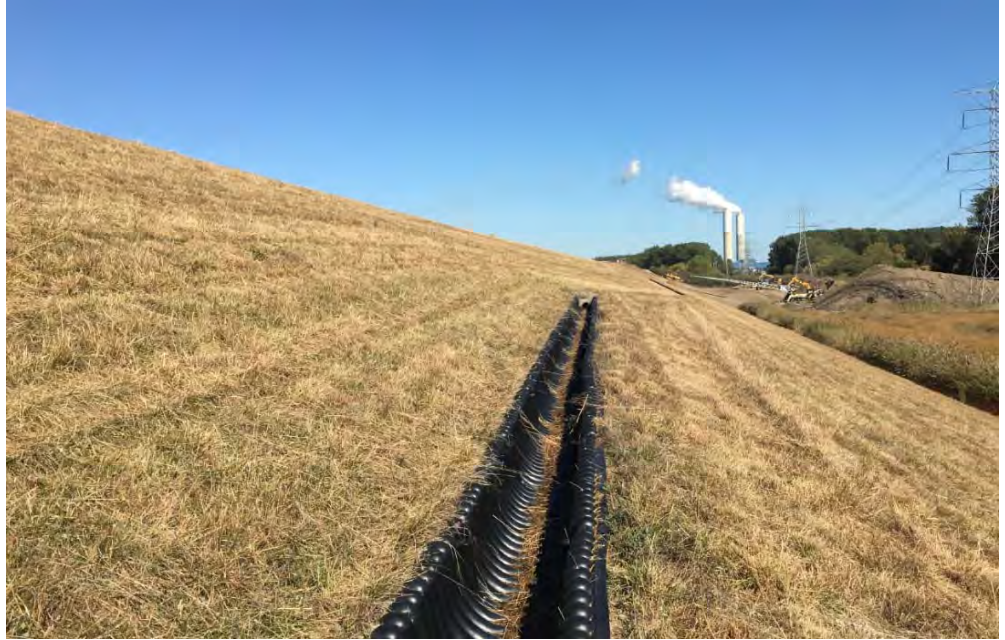
Comments: Photo taken at Station 156+00, facing northwest. The embankment appeared to have uniform slopes without sign of distress.

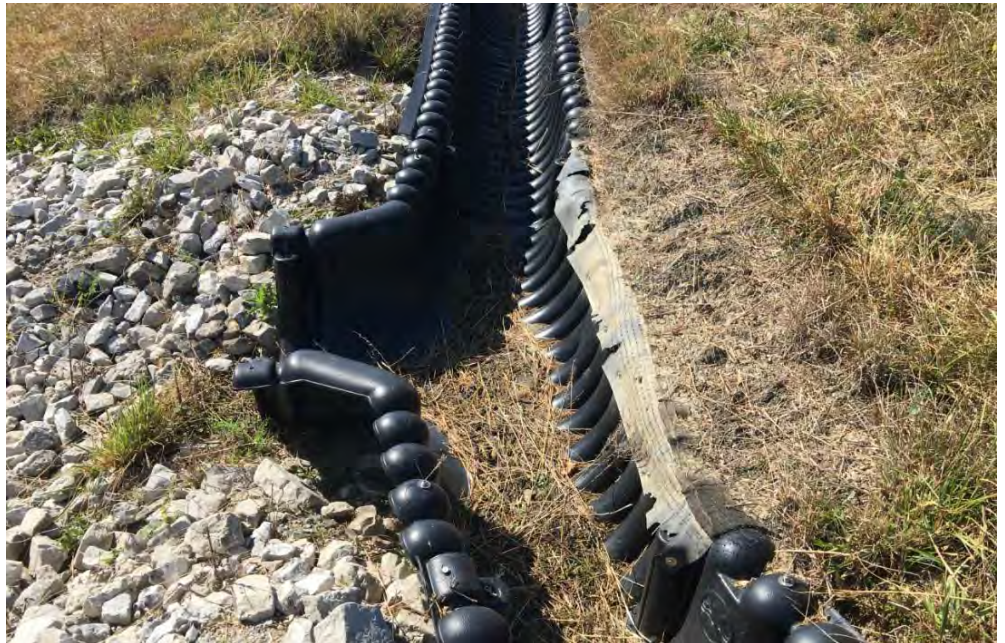
Photograph 20

Comments: Downchute at Station 156+50. The upslope section has a good connection with the embankment.

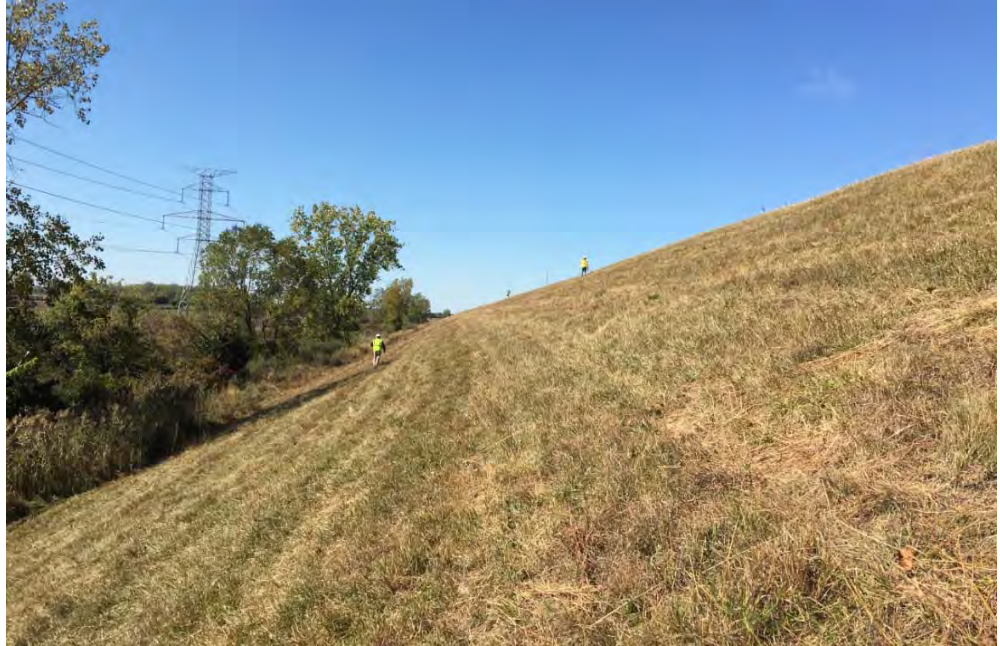
Comments: Photo taken at Station 135+00, facing east. The embankment appeared to have uniform slopes without sign of distress, except those areas where cracks were observed. The locations of cracks are provided in detail in the inspection sheet.

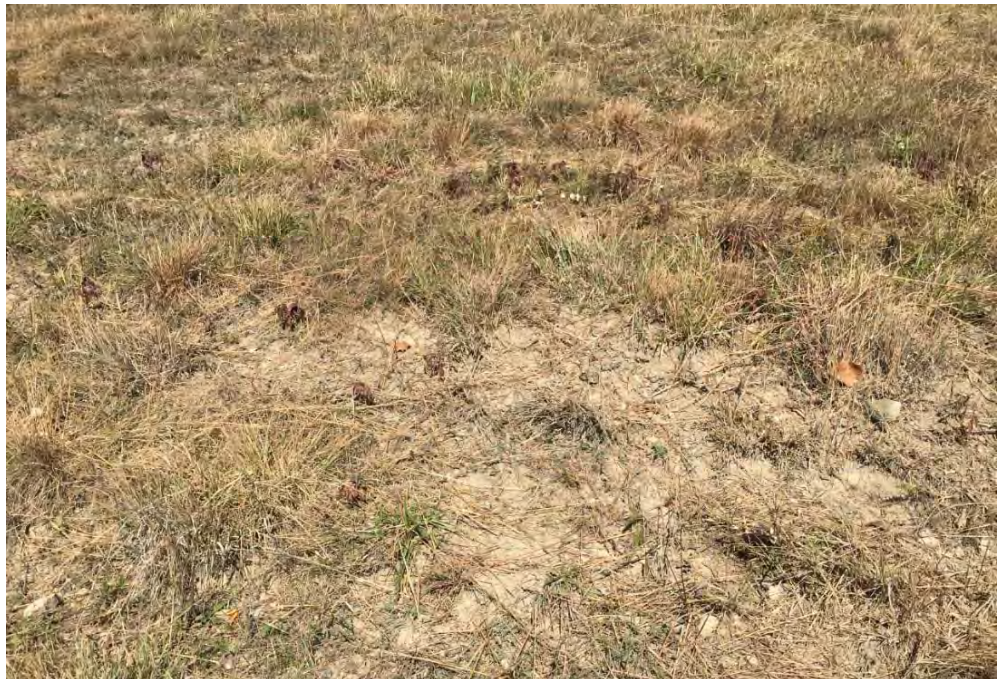
Photograph 22

Comments: Photo take at Station 136+50. Several areas with sparse vegetation was observed around the embankment.

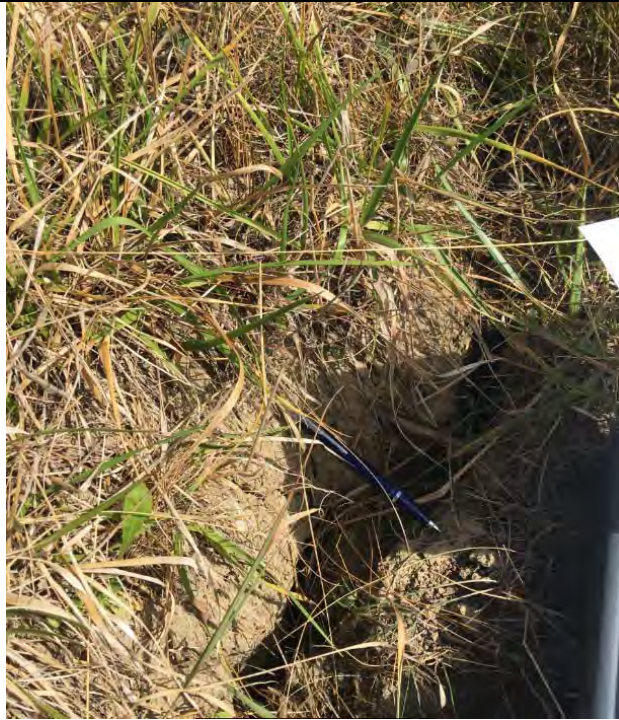
1. Cracks up to several inches wide were observed on the exterior slope of the embankment at Station ~132+00 and ~122+00 (see Photographs 23, 24 and 27).

Up to approximately five-inch wide and one-foot deep cracks were observed on the upper half of the embankment at stations approximately 122 and 132. These cracks were flagged. (Photographs 23, 24 an 27)

Comments: Up to several inches wide cracks were observed on the embankment. Inspection sheet provides detailed locations of the cracks.

- Cracks wider than one inch were observed on the exterior slope of the embankment at Station ~132+00 and Station ~122+00. The cracks do not represent an immediate concern for global stability of the Ash Basin embankment. The cracks should be fixed as soon as practical by means of filling with bentonite-sand mixture³.

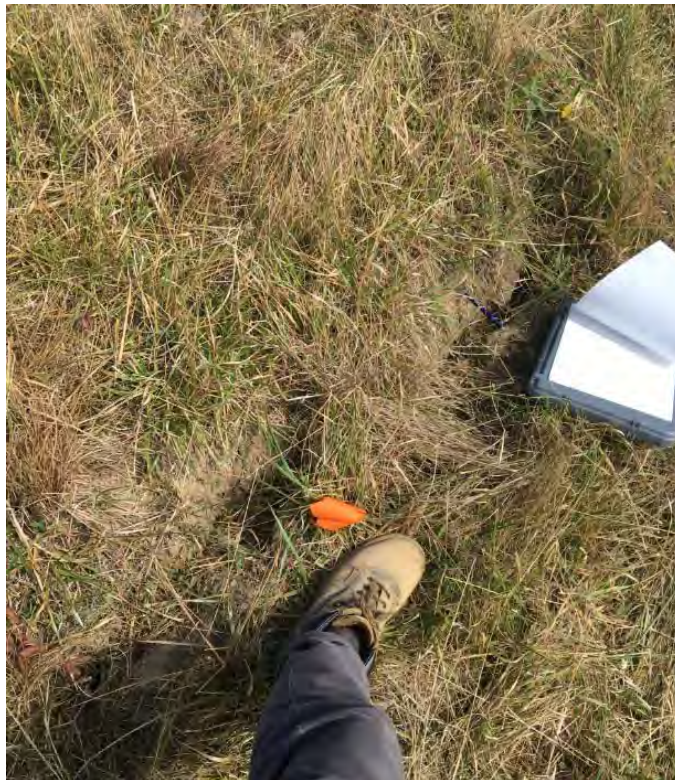
Photograph 24

Comments: Up to several inches wide cracks were observed on the embankment. Inspection sheet provides detailed locations of the cracks.

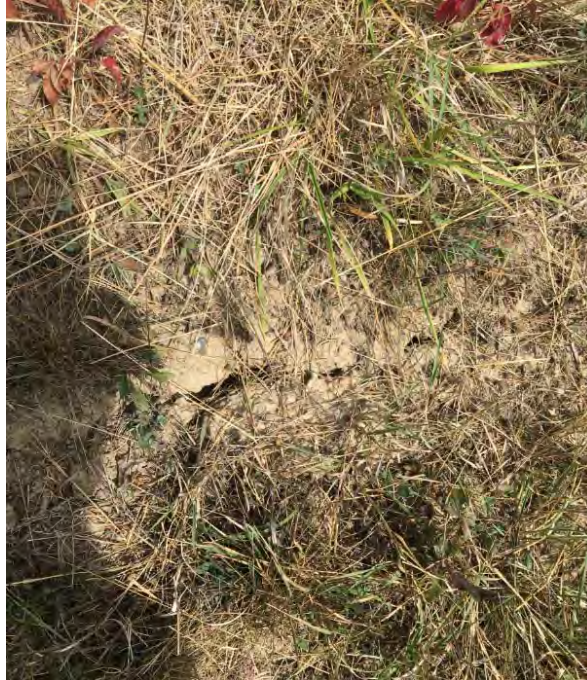
Up to one-inch wide cracks were observed on the upper half of the embankment between stations 122 and 135. They appeared to be discrete but follow generally a consistent alignment (Photographs 25). These cracks were flagged.

Comments: Up to one-inch wide cracks were observed on the embankment. Inspection sheet provides detailed locations of the cracks.

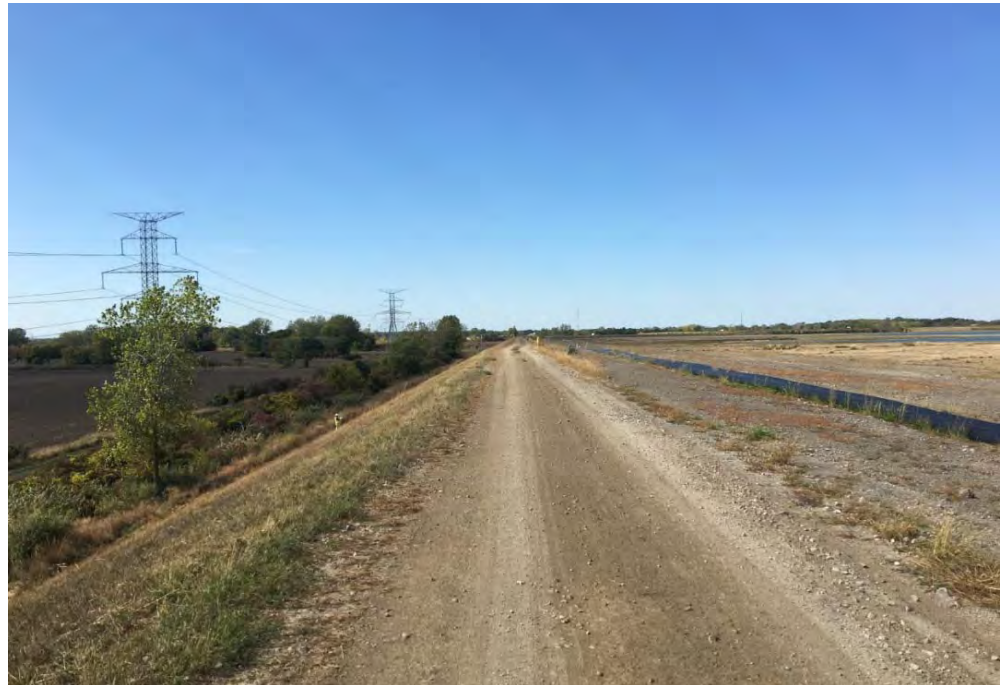
Photograph 26

Comments: Photo taken at Station ~130+00, facing west. Crest road appeared to be in good condition.

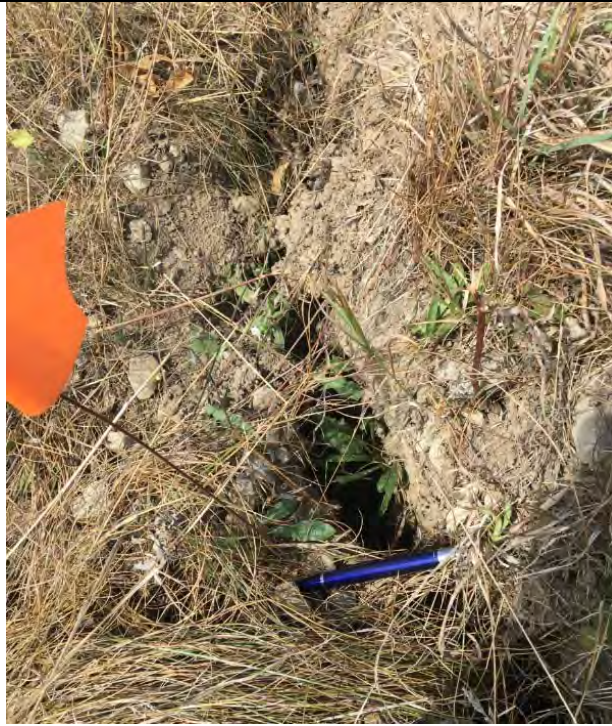
Comments: Up to several inches wide cracks were observed on the embankment. Inspection sheet provides detailed locations of the cracks.

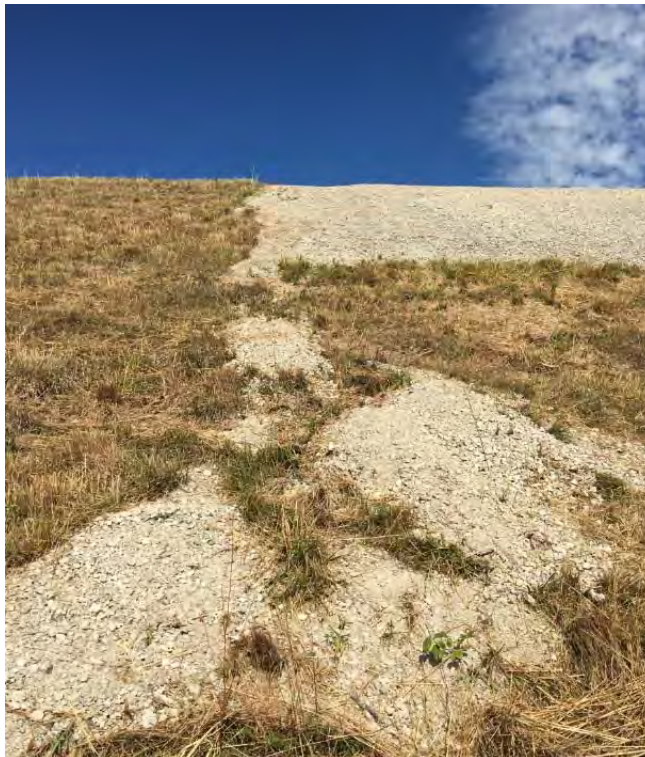
Photograph 28

Comments: Section of the embankment that was mitigated with aggregate at Station ~115+00 has eroded.

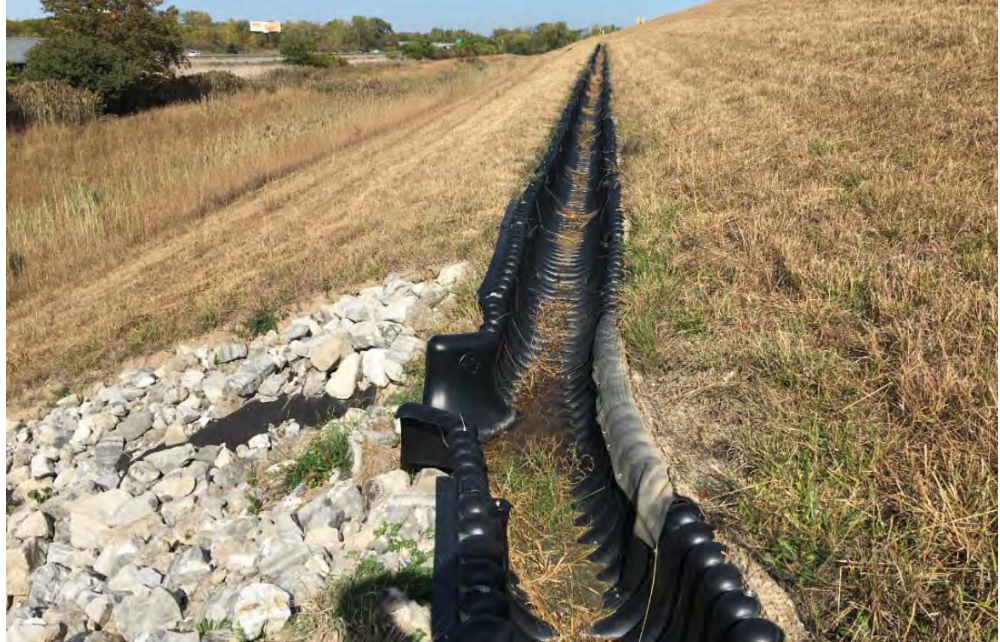
Comments: Downchute at Station 87+00. The upslope section has a good connection with the embankment.

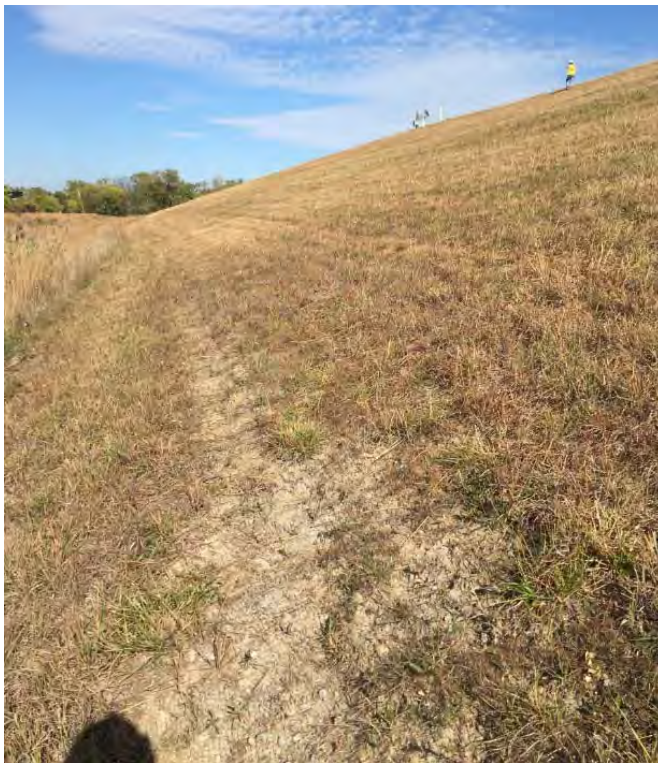
Photograph 30

Comments: Photo taken at Station 80+00, facing north. Several areas with sparse vegetation was observed around the embankment.

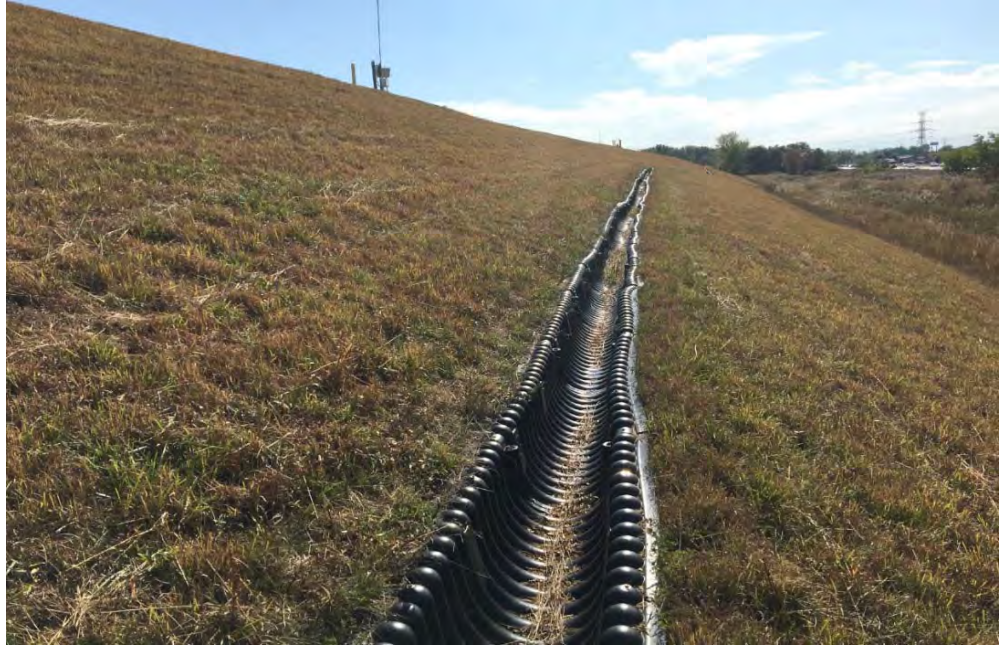
Comments: Photo taken at Station 75+00, facing south. The embankment appeared to have uniform slopes without sign of distress.

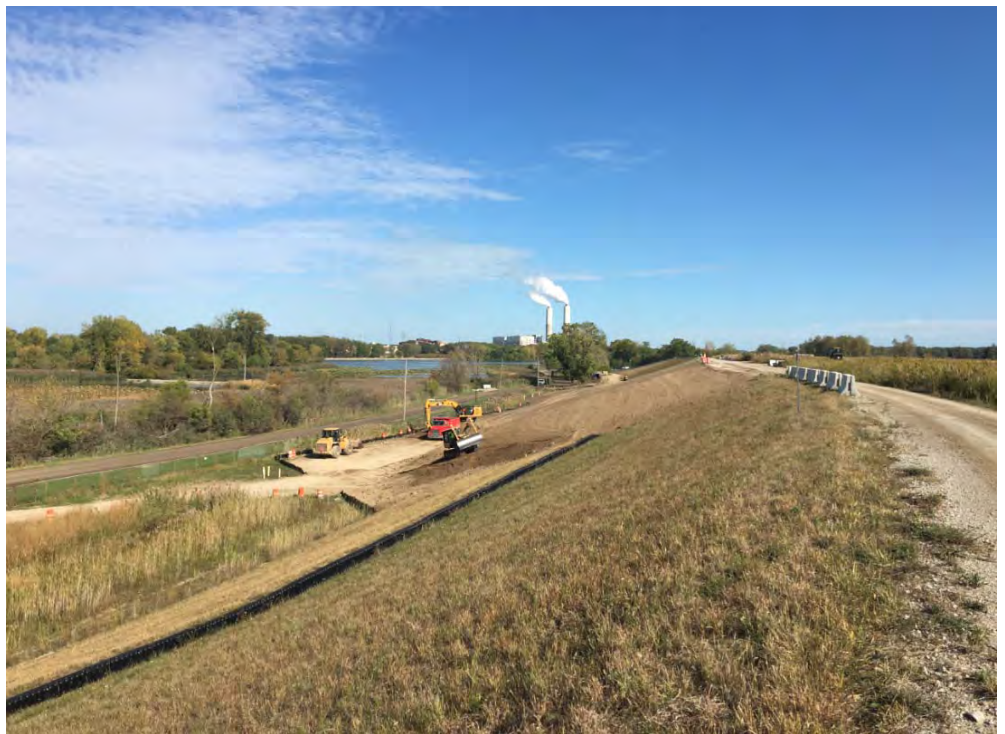
Photograph 32

Comments: Photo taken at Station 65+00, facing east. The embankment appeared to have uniform slopes without sign of distress.
