2019 ANNUAL INSPECTION REPORT ASH BASIN EMBANKMENT

MONROE POWER PLANT

Monroe, Michigan

January 2020

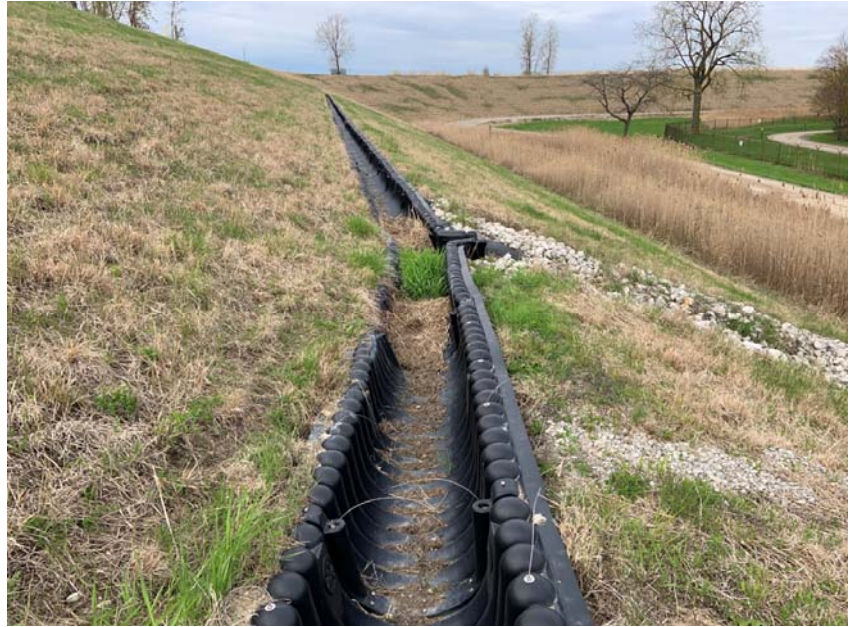
- Vegetation growth and sediment buildup was observed inside of the mid-slope stormwater ditch (Photograph 1). This condition does not represent an immediate concern for the safe operation or stability of the Ash Basin.

Comments: Photo taken at Station ~31+00. Sediment buildup and vegetation growth observed in most of the mid-slope stormwater downchutes. This is a typical example.

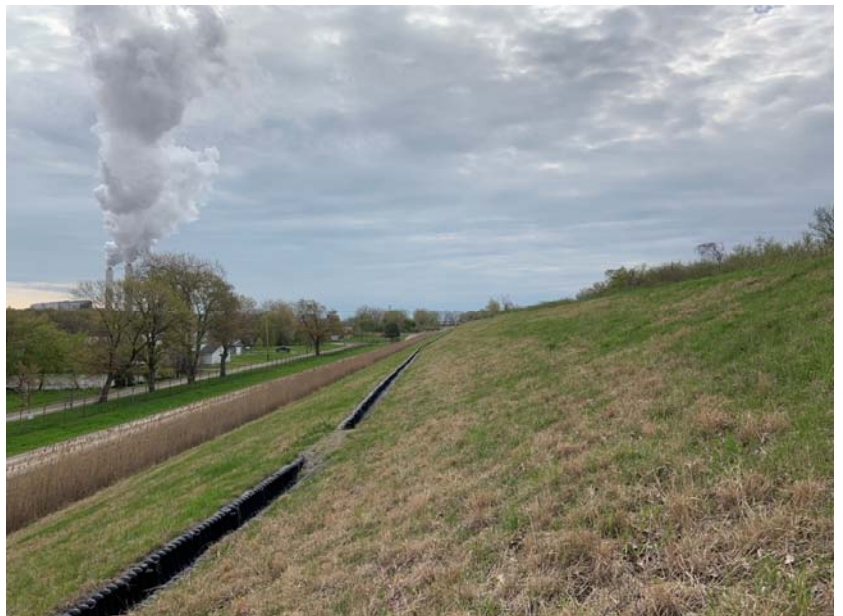
Photograph ID: 2

Comments: Photo taken at Station ~30+00. The embankment appears to have uniform slopes without signs of distress.

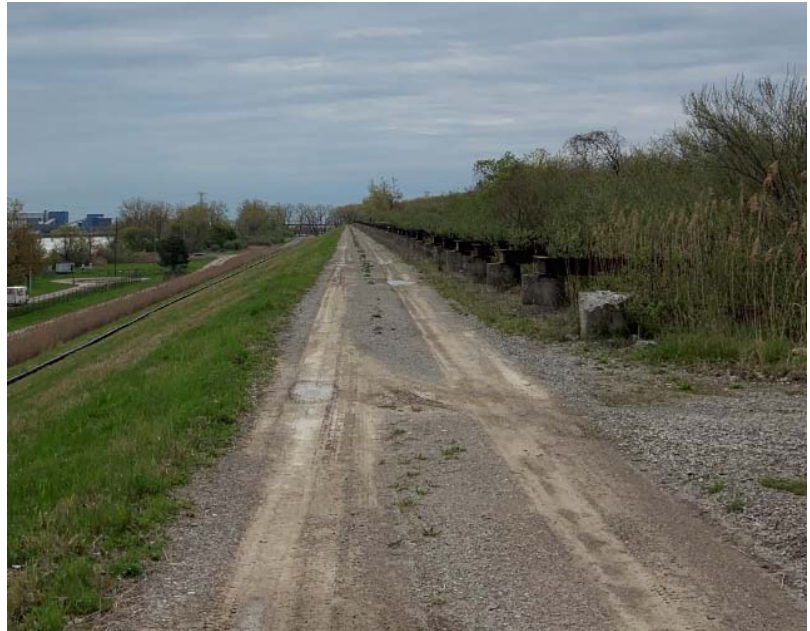
- Potholes and ruts were observed on the perimeter access road (Photograph 3). This condition does not represent an immediate concern for the safe operation or stability of the Ash Basin. DTE has repaired the potholes and ruts identified in this inspection.

Comments: Photo taken at Station ~25+00. Potholes and ruts were observed around the top of perimeter access road.

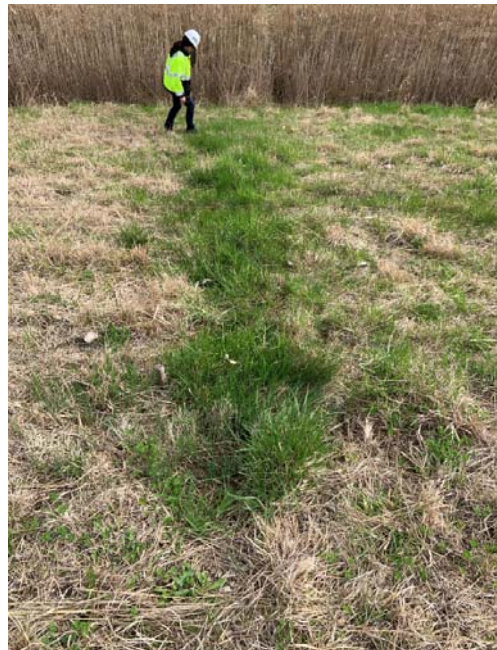
Photograph ID: 4

Comments: Photo taken above a mid-slope drain on the north side. The purpose of drain is to relieve water that gets under the mid-slope stormwater ditch. These drains were observed to be working. At the midslope drain locations, ground was wet and vegetation growth was observed.

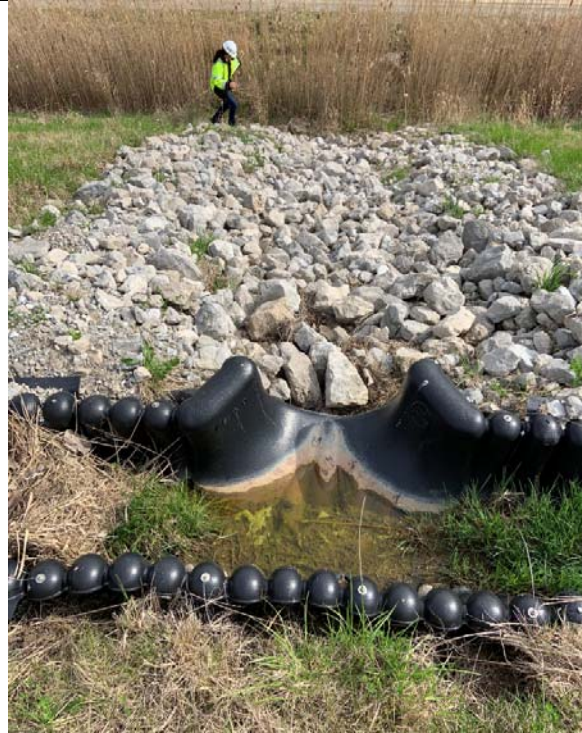
**Comments: Downchute at
Station 26+00. Some sediment
buildup in mid-slope ditch is
observed.**

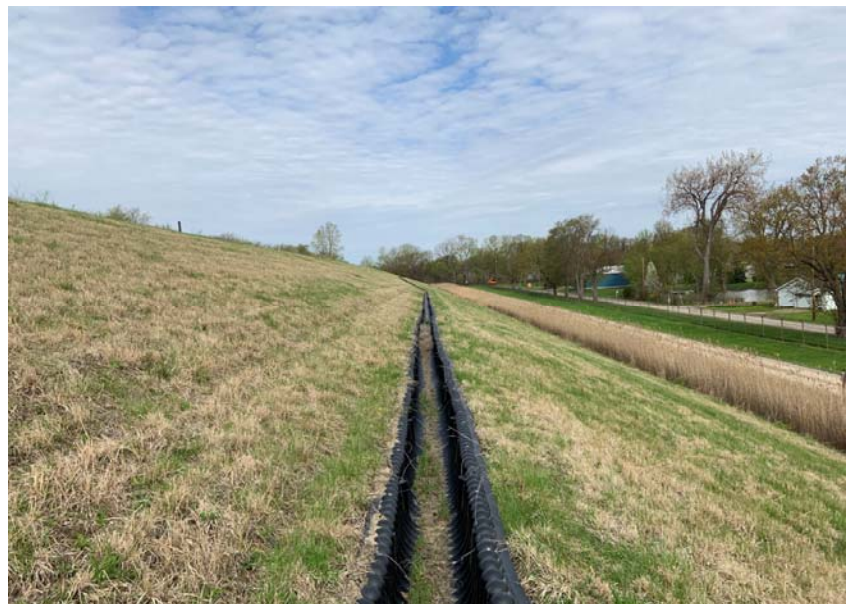
Photograph ID: 6

**Comments: Photo taken at
Station ~14+00. Mid-slope ditch is
linear, and the embankment
appears to have uniform slopes
without signs of distress.**

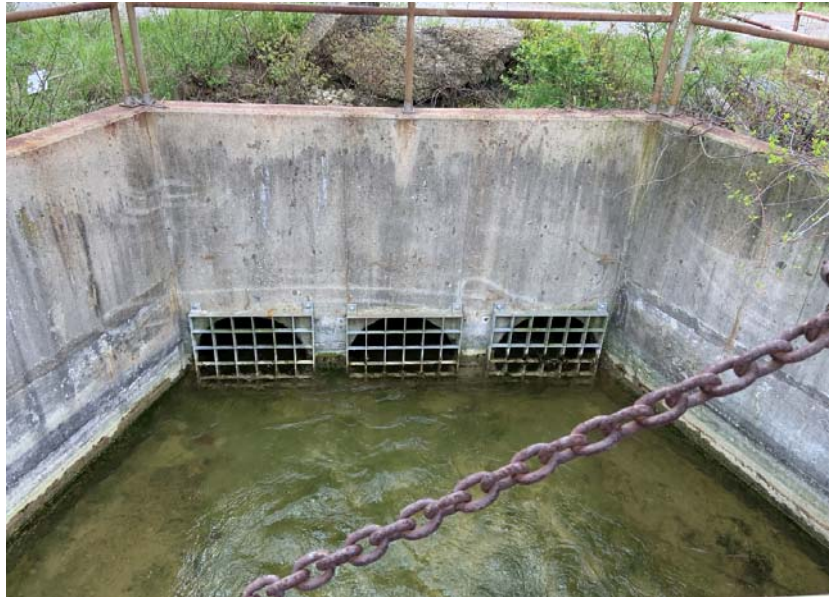
Comments: Photo taken at the discharge structure. It appeared to be in satisfactory working condition.

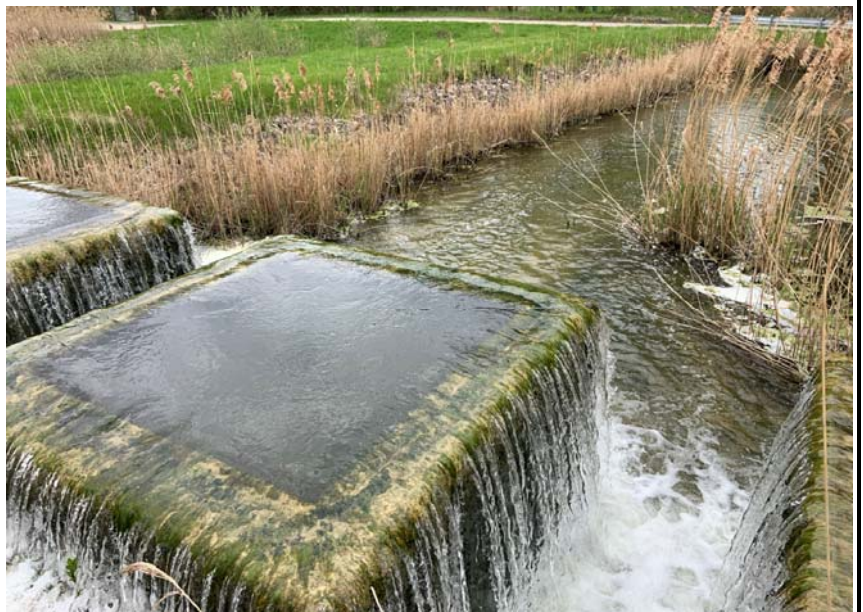
Photograph ID: 8

Comments: Photo taken at the outlet of discharge structure. Water coming out of the aerators appeared to be clear.

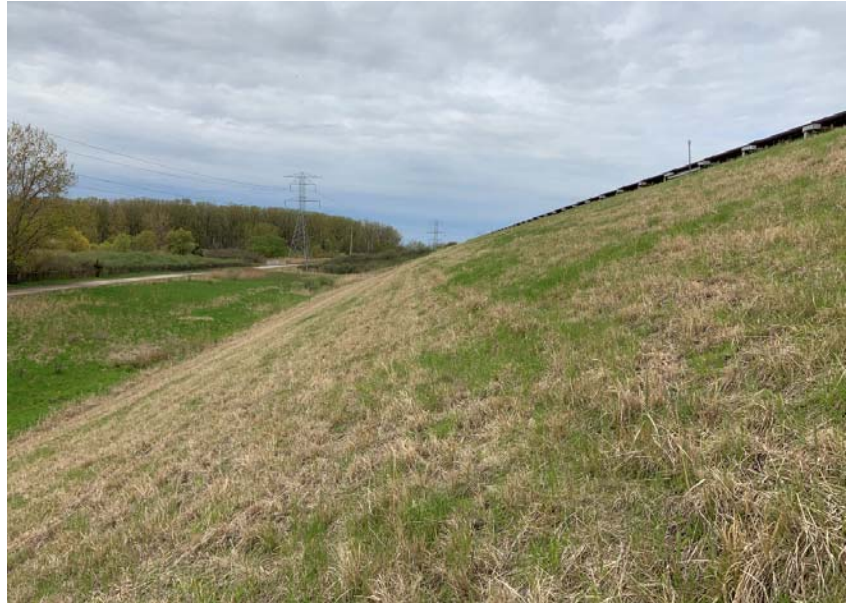
Comments: Photo taken at Station ~175+00. The embankment appears to have uniform slopes without signs of distress.

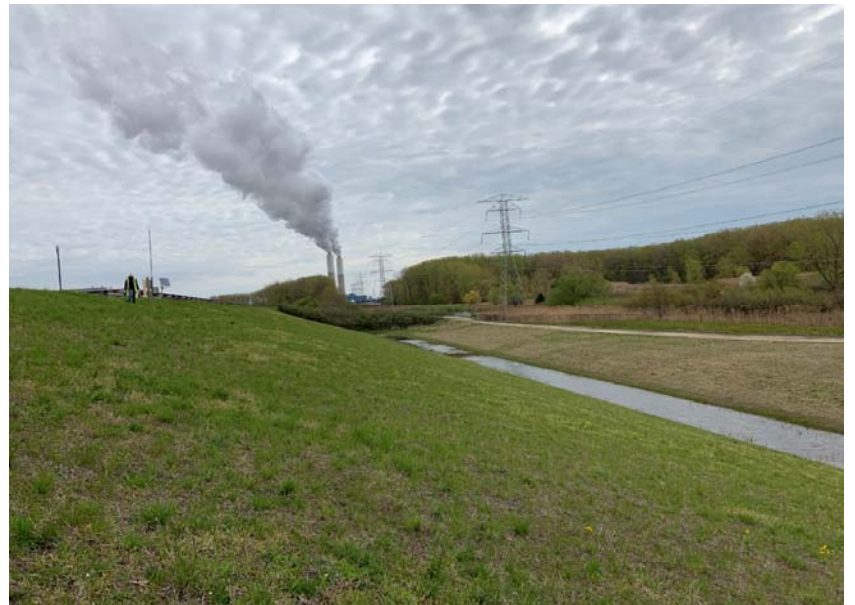
Photograph ID: 10

Comments: Photo taken at Station ~160+00. The embankment appears to have uniform slopes without signs of distress. Standing water was observed in the toe ditch.

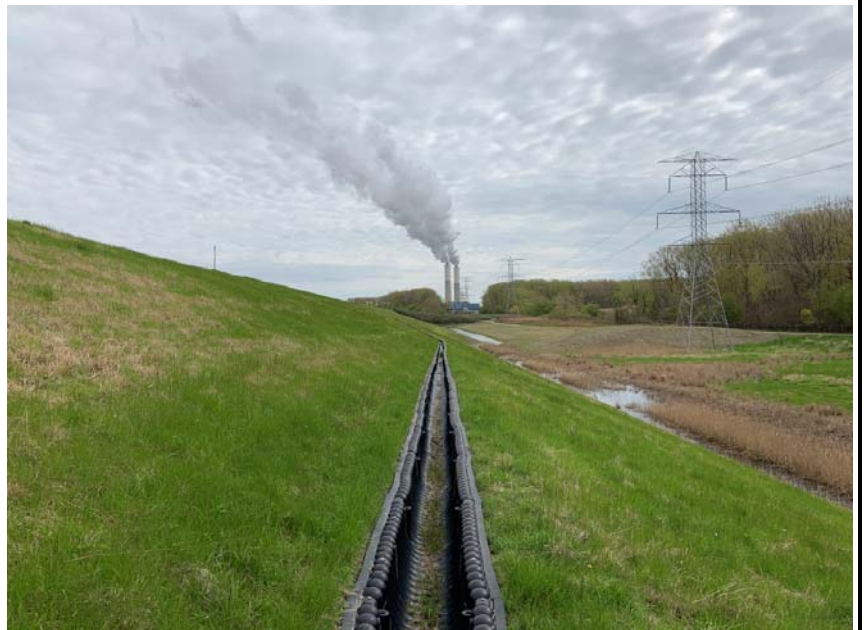
Comments: Photo taken at Station ~151+00. Mid-slope ditch is linear, and the embankment appears to have uniform slopes without signs of distress.

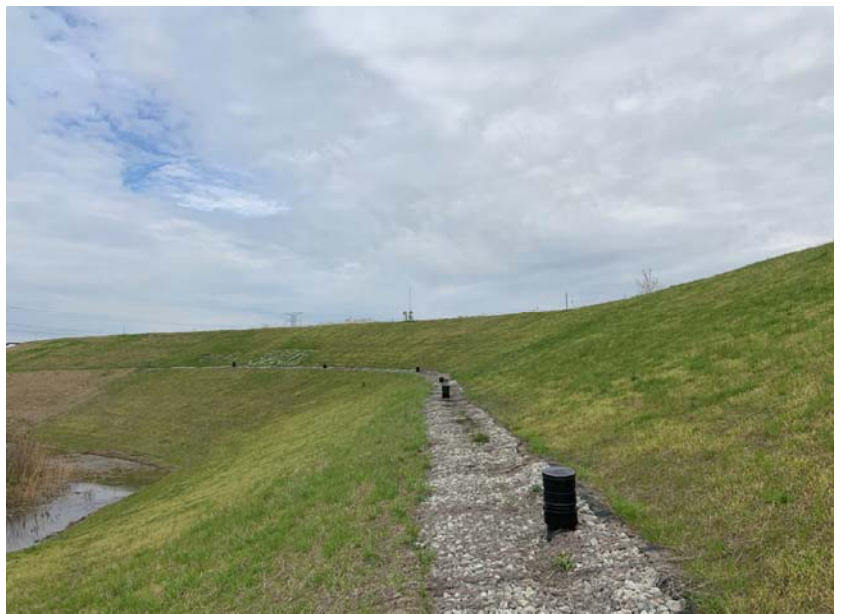
Photograph ID: 12

Comments: Photo taken at Station ~147+00. The embankment appears to have uniform slopes without signs of distress.

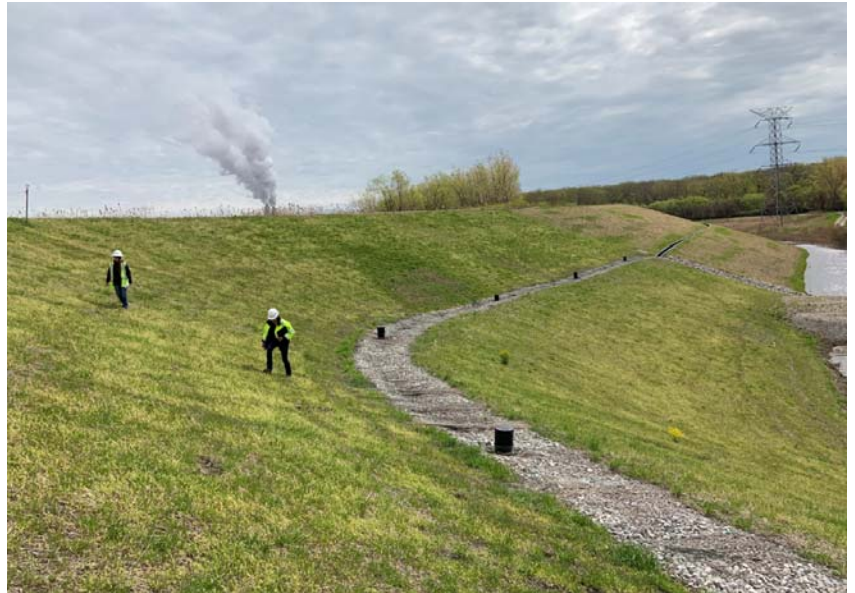
- Hairline cracks and localized depression up to several inches were observed within slough areas that were mitigated in 2018 (Photographs 13, 14 and 15). This condition does not represent an immediate concern for the safe operation or stability of the Ash Basin. These areas have been flagged and are monitored in accordance with IMM Manual.

Comments: Photo taken at Station ~142+00. Inspection of SE corner of the ash basin. Near surface sloughs that were observed during 2018 inspection have been mitigated.

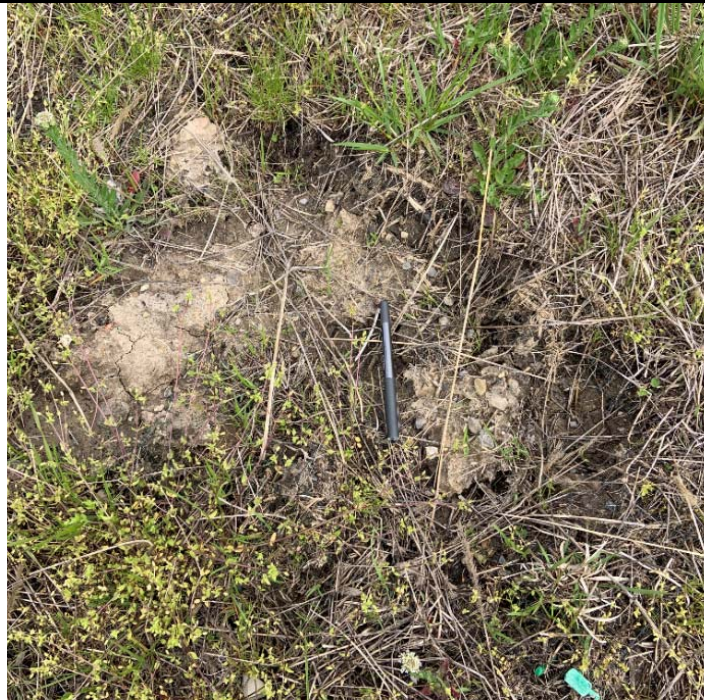
Photograph ID: 14

Comments: Hairline cracks and up to several inches of depression areas were observed at discrete locations within the areas where sloughs were mitigated in 2018.

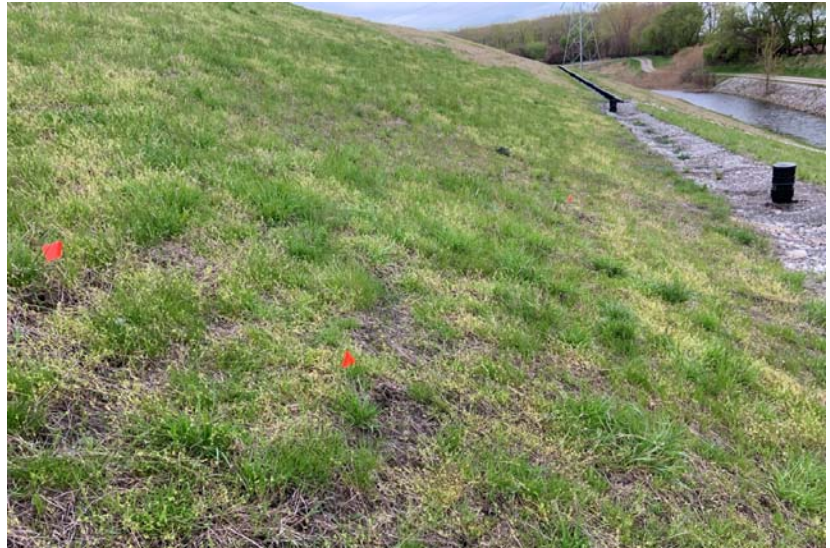
Comments: Hairline cracks and up to several inches of depression areas were observed at discrete locations within the areas where sloughs were mitigated in 2018. These areas were flagged.

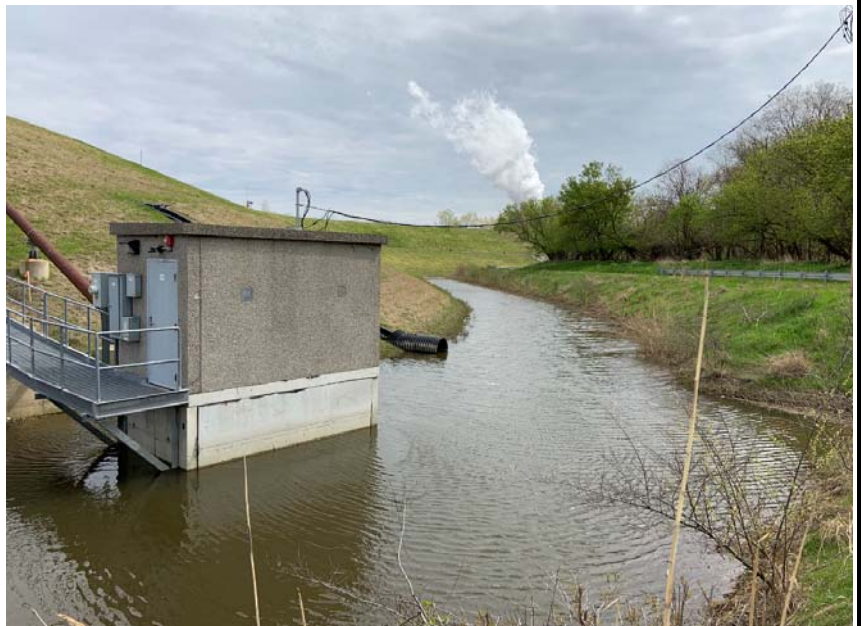
Photograph ID: 16

- One of the pumps at the pump house was not working (Photograph 16) at the time of the inspection. This condition does not represent an immediate concern for the safe operation or stability of the Ash Basin. DTE has subsequently repaired the pump.

Comments: Photo taken at Station 139+00. High water level at the pump house was observed. DTE reported that one of the pumps is not working. Pump maintenance has been scheduled.

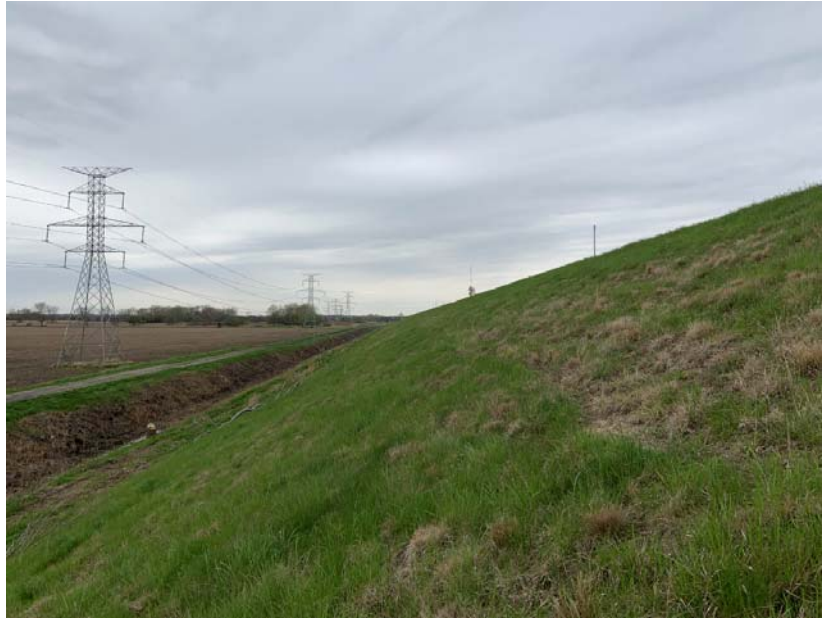
**Comments: Photo taken at
Station ~136+00. The
embankment appears to have
uniform slopes without signs of
distress.**

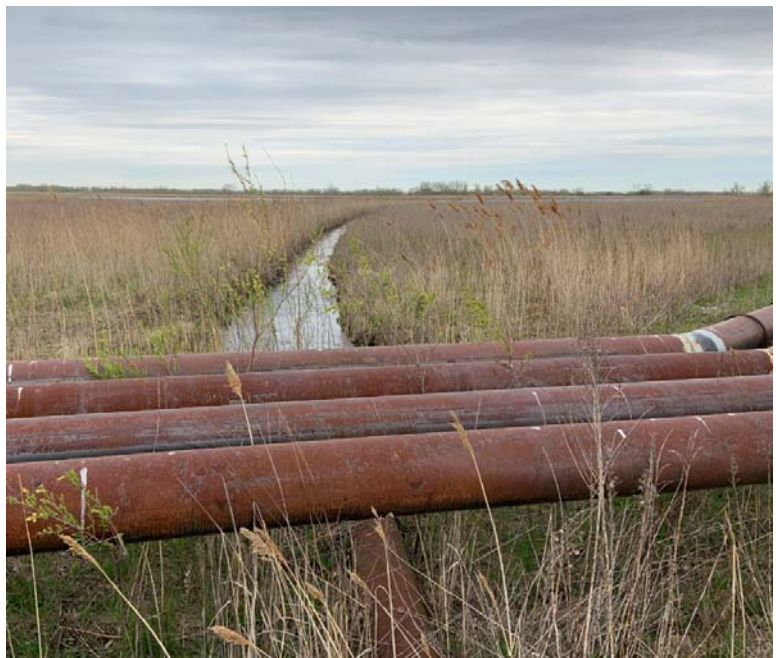
Photograph ID: 18

**Comments: Photo taken at
Station ~139+00. No obstruction
was noticed for the pump house
discharge channel within the ash
basin.**

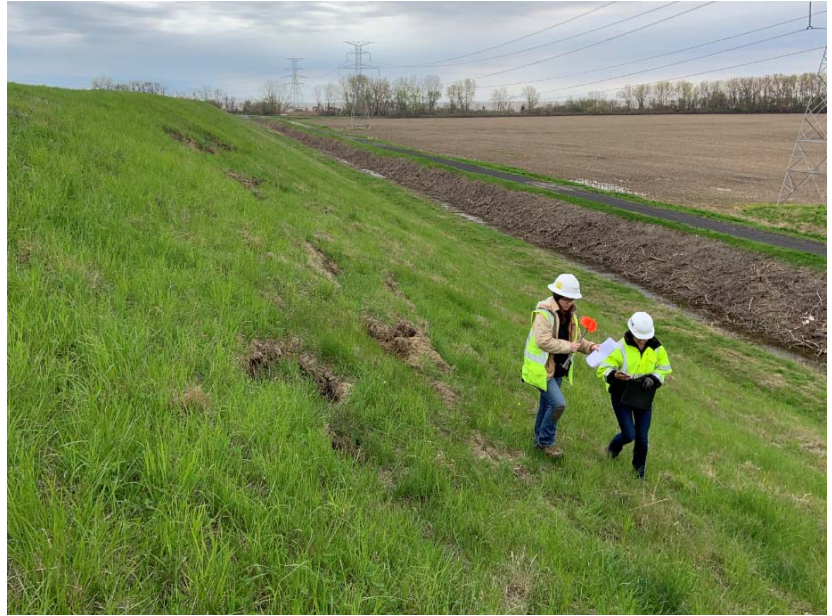
- Near surface sloughs were observed on the exterior slope of the embankment near Station ~121+00 (Photographs 19, 20 and 21), these sloughs do not represent an immediate concern for global stability of the Ash Basin embankment; this area has been recently reconstructed to a more stable configuration.

**Comments: Photo taken near
Station ~120+00. Surface sloughs
were observed on the
embankment.**

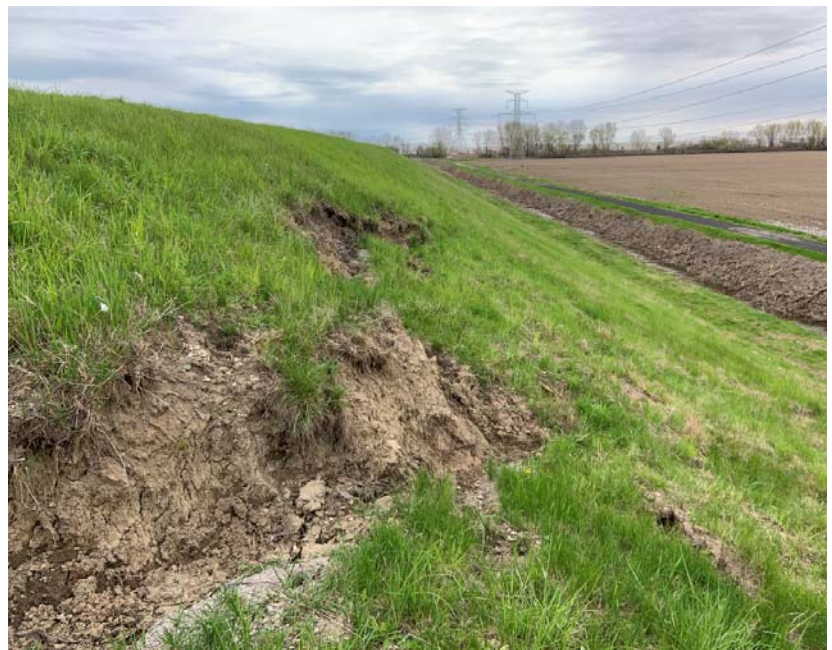
Photograph ID: 20

**Comments: Photo taken near
Station ~120+00. Surface sloughs
were observed on the
embankment.**

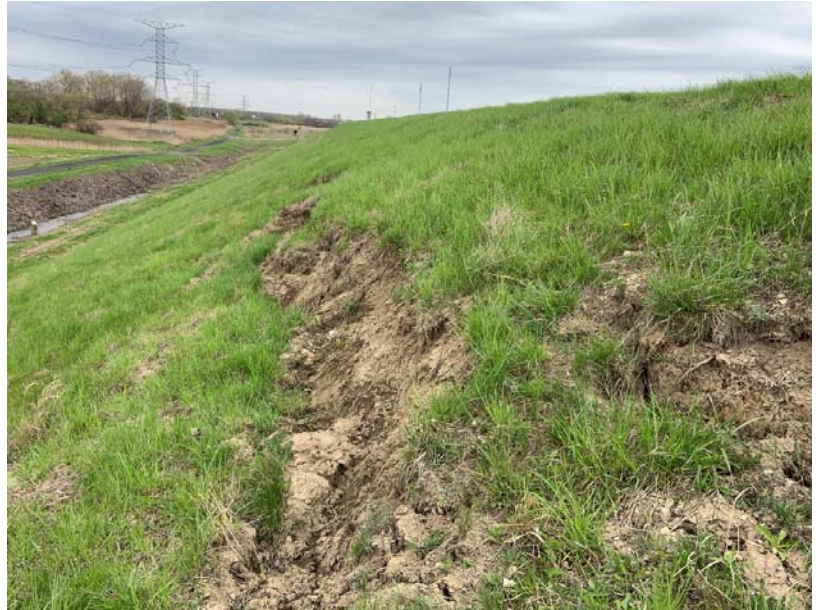
**Comments: Photo taken near
Station ~120+00. Surface sloughs
were observed on the
embankment.**

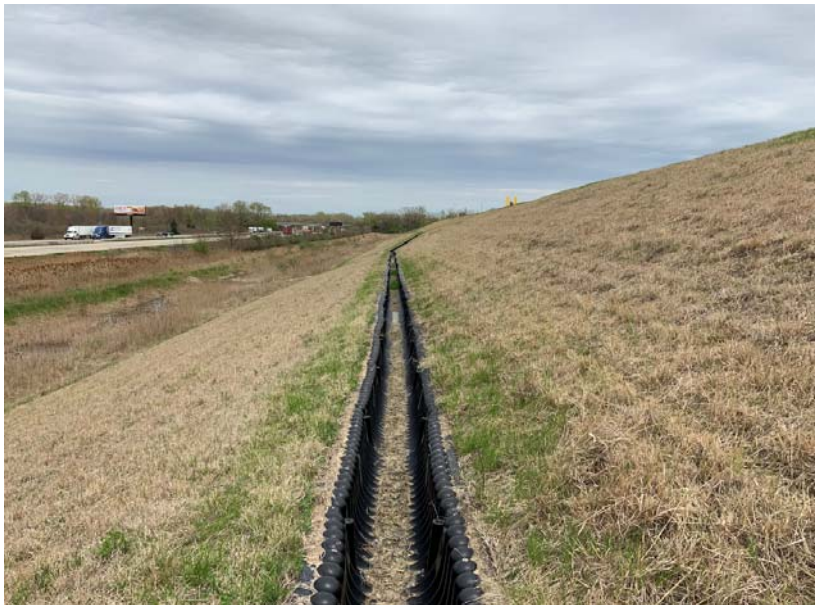
Photograph ID: 22

**Comments: Photo taken at
Station ~85+00. Mid-slope ditch is
linear, and the embankment
appears to have uniform slopes
without signs of distress.**

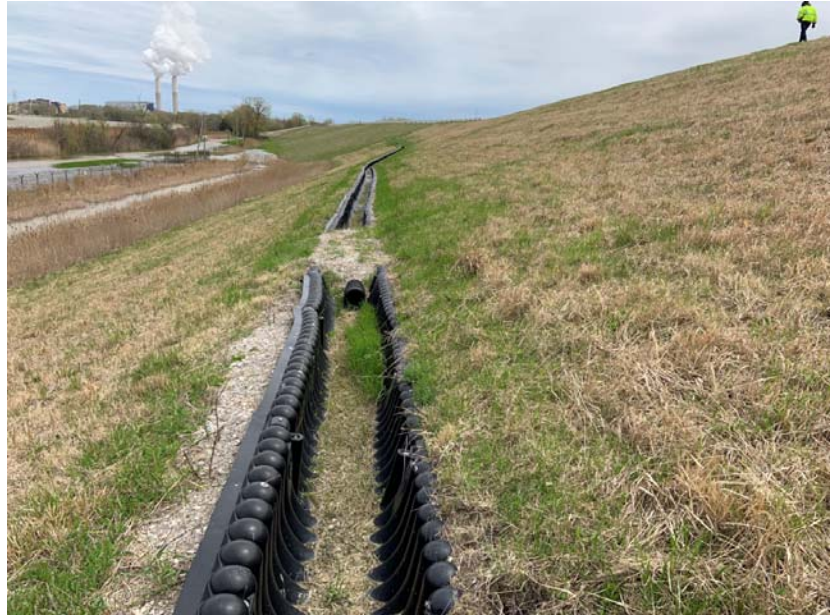
Comments: Photo taken at Station ~60+00. Mid-slope ditch is linear, and the embankment appears to have uniform slopes without signs of distress.

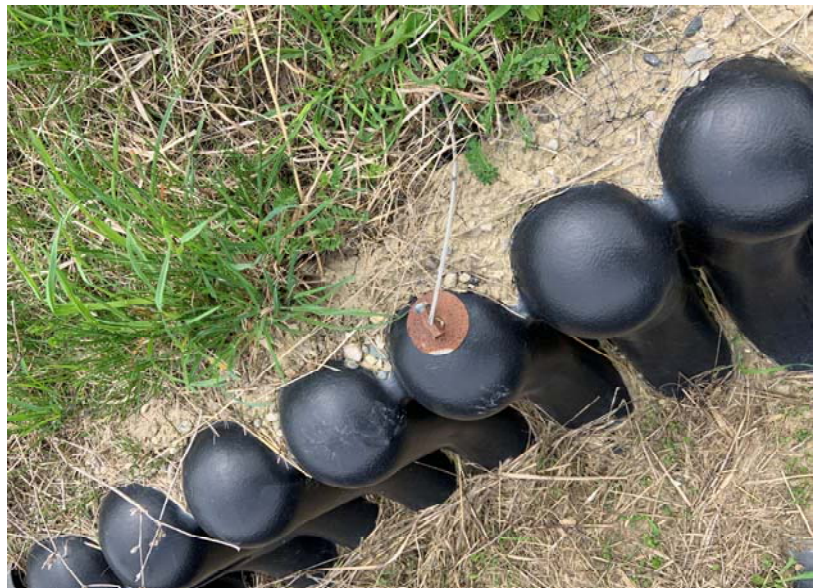
Photograph ID: 24

- Up to several inches of gap between mid-slope ditch and the adjacent ground was observed at various sections along the embankment. Furthermore, some of the washers and bolts were observed to be rusted. These gaps and rusts do not represent an immediate concern for the safe operation or stability of the Ash Basin.

Comments: Some of cable parts have been rusted and loose along the mid-slope stormwater ditch.
