DTE Energy Monroe Power Plant

Bottom Ash Impoundment CCR Rule Compliance Project

Annual Inspection Report - 2023

September 1, 2023

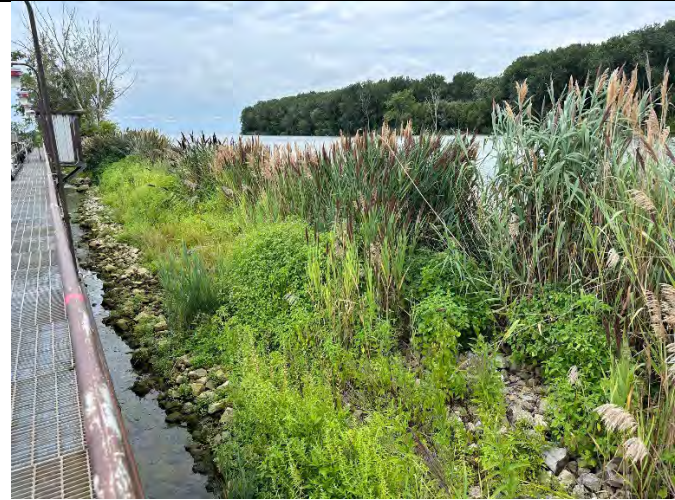
Comments /Action Items Spillway appears to be in good repair – water levels in the pond and discharge canal are lower than in 2021. There are no control systems so the spillway acts as both principal and emergency. See Photo 1 of this report for debris and vegetative overgrowth of weir discharge.				
	Actions <input checked="" type="checkbox"/> None <input type="checkbox"/> Maintenance <input type="checkbox"/> Monitoring <input type="checkbox"/> Minor Repair <input type="checkbox"/> Engineering				
EMERGENCY SPILLWAY	OBSERVATIONS				
	<input type="checkbox"/> No emergency spillway			<input checked="" type="checkbox"/> Same as primary spillway	
	PROBLEMS				CHANNEL LINING
	<input type="checkbox"/> 1. None <input type="checkbox"/> 2. Debris in channel <input type="checkbox"/> 3. Gates <input type="checkbox"/> 4. Misalignment	<input type="checkbox"/> 5. Joint deterioration <input type="checkbox"/> 6. Joint displacement <input type="checkbox"/> 7. Exposed reinforcement <input type="checkbox"/> 8. Erosion	<input type="checkbox"/> 9. Undermining <input type="checkbox"/> 10. Voids <input type="checkbox"/> 11. Cracks <input type="checkbox"/> 12. Holes <input type="checkbox"/> 13. Outlet erosion	<input type="checkbox"/> 14. Displaced rip rap <input type="checkbox"/> 15. Sparse rip rap <input type="checkbox"/> 16. Outlet undercutting <input type="checkbox"/> 17. Inadequate capacity <input type="checkbox"/> 18. Other	<input type="checkbox"/> Vegetation <input type="checkbox"/> Rip rap <input type="checkbox"/> Concrete <input type="checkbox"/> Asphalt <input type="checkbox"/> Other

Photo 1: Looking south at discharge weir; heavily vegetated at discharge as water levels continue to decrease along the discharge canal

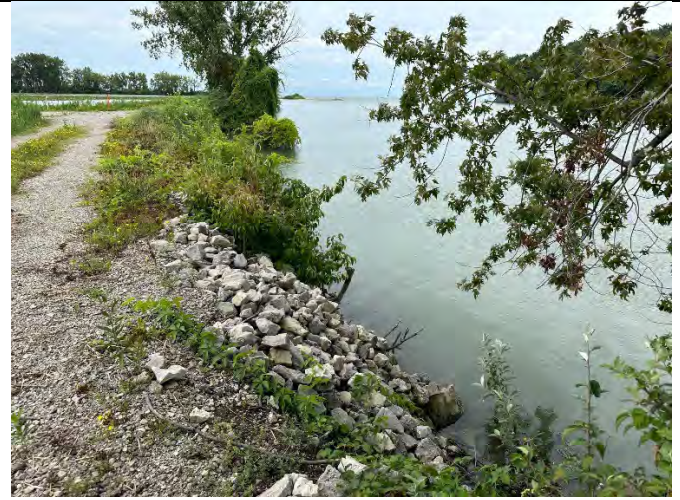
Photo 2: Area of sloughing along discharge canal that was augmented by rip-rap placement in previous years. Slope looks stable; DTE personnel monitor suspect areas without rip-rap on a weekly basis

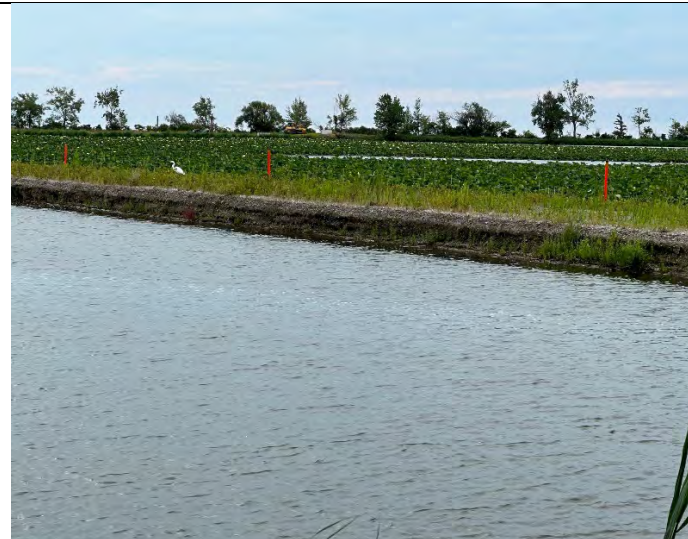
- The northern/upstream face side of the separation berm is showing signs of sloughing; especially on the western edge for a length of 100-150' where plastic bollards have been impacted. Repair of this upstream section will occur either with completion of the closure project or immediately after – the sloughing is not an immediate threat (a width of over 20+ feet of the separation berm still exists and DTE has limited vehicle traffic over the berm)

Photo 3: The south separation berm (looking southeast) – this northern slope has experienced significant sloughing due to construction activities; plastic bollards placed by DTE on both sides of the berm have been impacted on the northern edge.

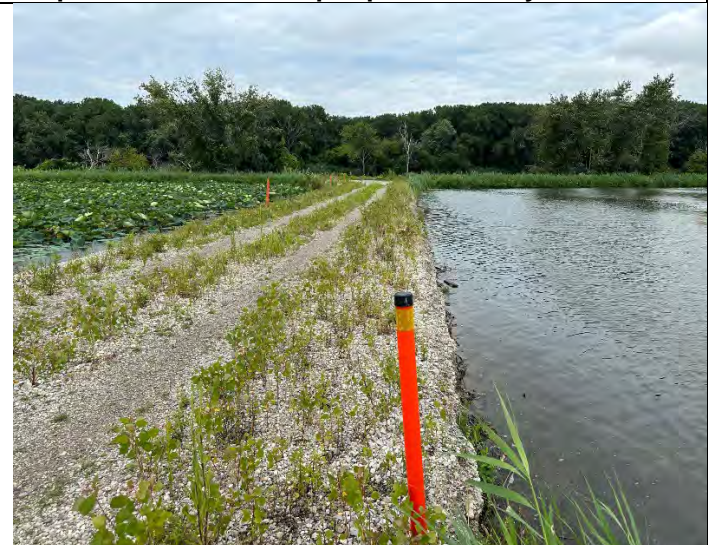
Photo 4: Another view of the southern separation berm (looking west) showing the area affected by increased sloughing

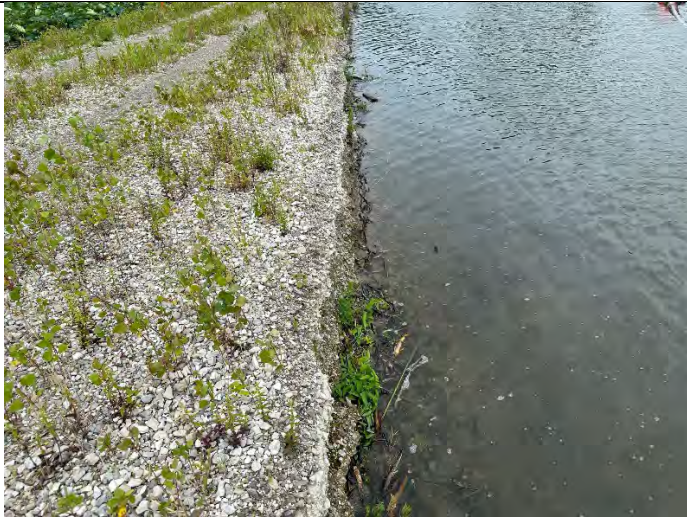
Photo 5: Sloughing along separation berm – material appears to be at angle of repose below the water surface and stable.

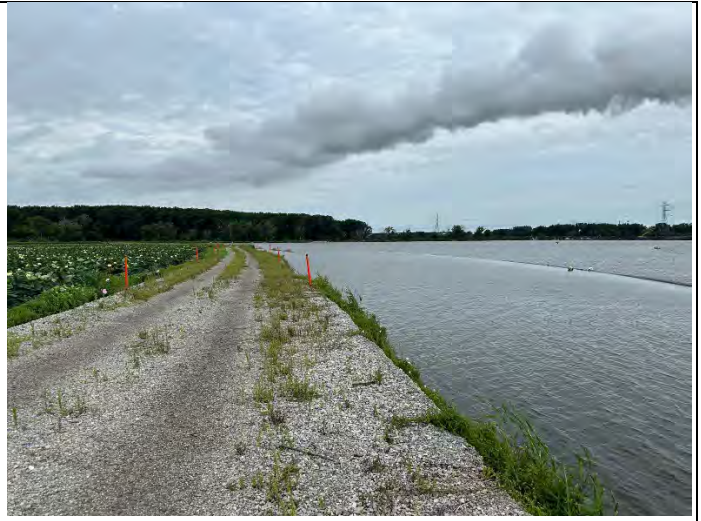
Photo 6: Looking west from the eastern edge of the southern separation berm

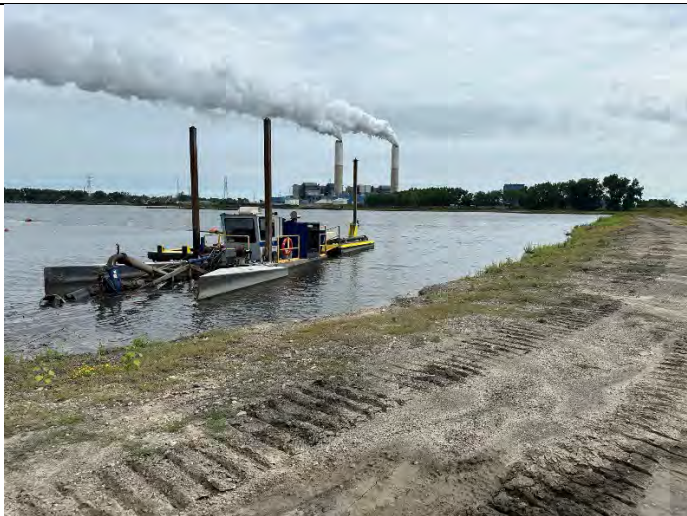
Photo 7: Looking northwest from the south separation berm; dredging activities associated with impoundment closure continue.

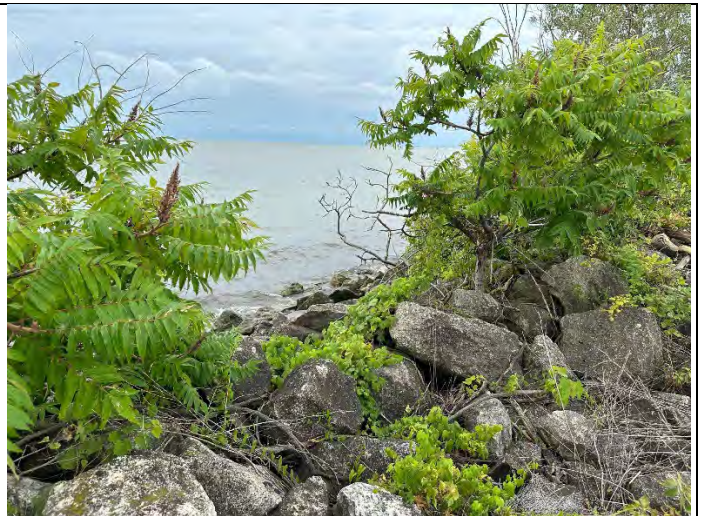
Photo 8: Heavy rip-rap along the eastern shore of the perimeter dike facing Lake Erie. No changes are noted in this area.
