DTE Electric Company
One Energy Plaza
Detroit, Michigan 48226

**2022 ANNUAL
INSPECTION REPORT
VERTICAL EXTENSION LANDFILL**

MONROE POWER PLANT

January 2023

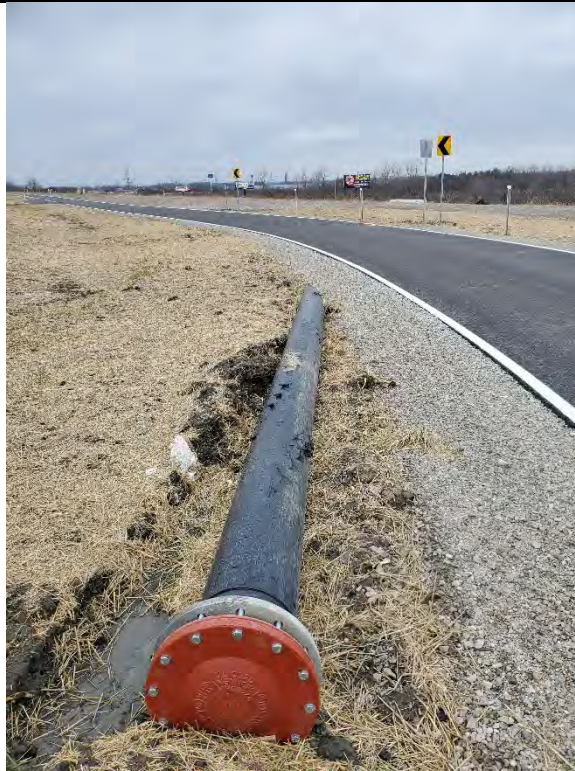
Comments: New asphalt access road for the Vertical Extension Landfill. Northwest side of Landfill.

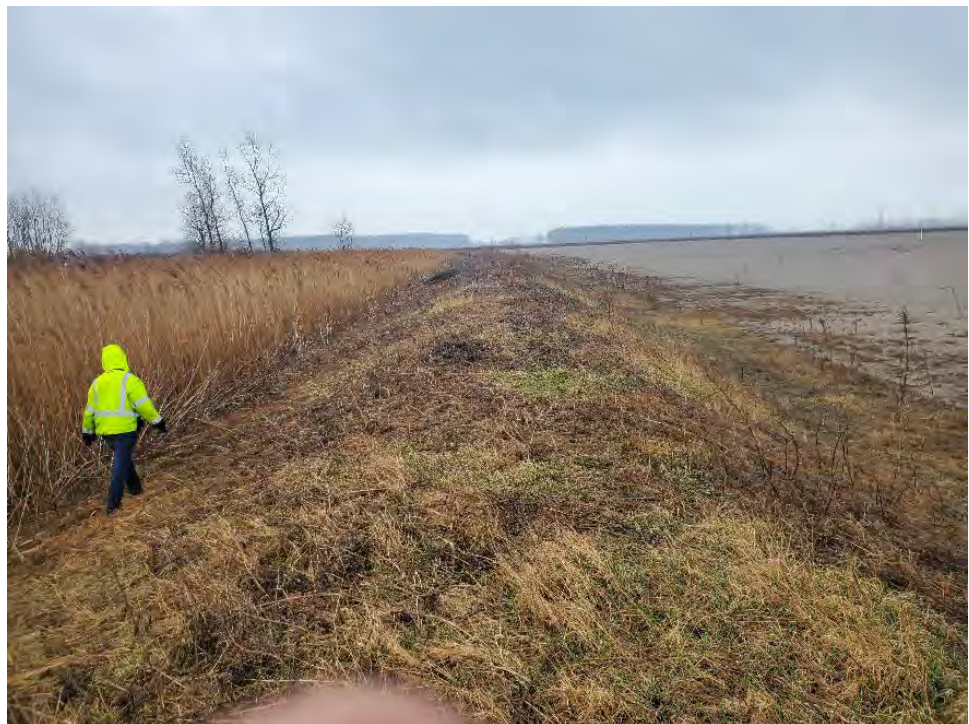
Photograph 2

5. Proper vegetation was present on the perimeter berms of the Landfill with minimal erosion or settlement observed (see Photographs 2, 6, 14, 21, 24, 26, 28, and 36).

Comments: Perimeter berm slopes and crest along northeast side.

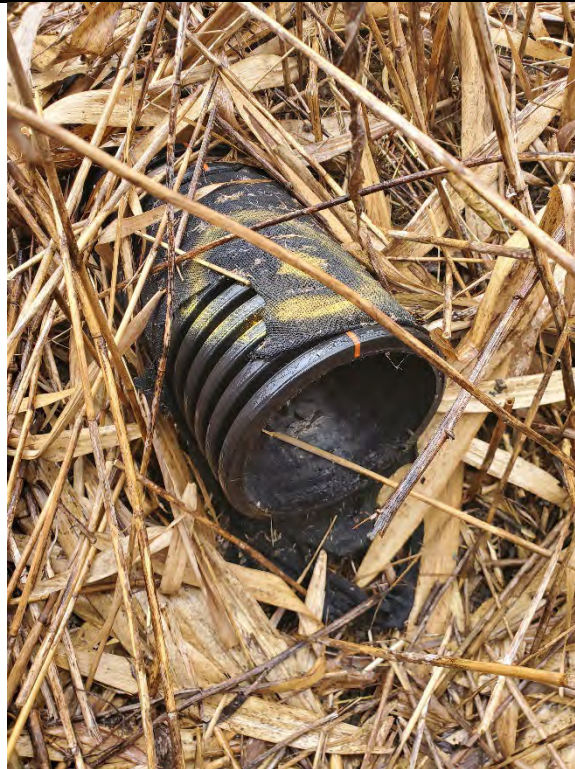
6. Many of the pore pressure relief pipes had minimal or no sediment build-up at the outlets. Any observed sediment does not impede the overall ability of the pore pressure relief pipes to sufficiently drain (see Photographs 3, 5, 9, 27, and 34).

Comments: Pore pressure relief pipe outlet. Minimal sediment and no flow observed.

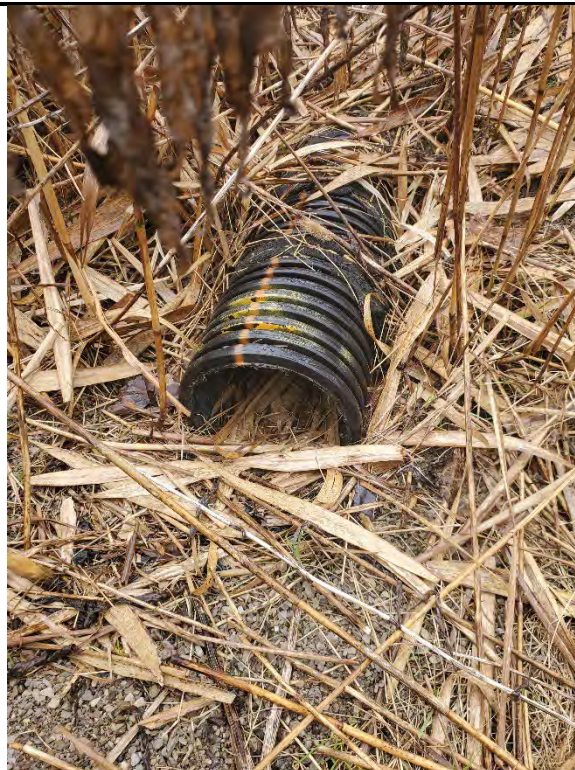
Photograph 4

Comments: Pore pressure relief pipe outlet. Minimal sediment and no flow observed. Some vegetation inside the pipe.

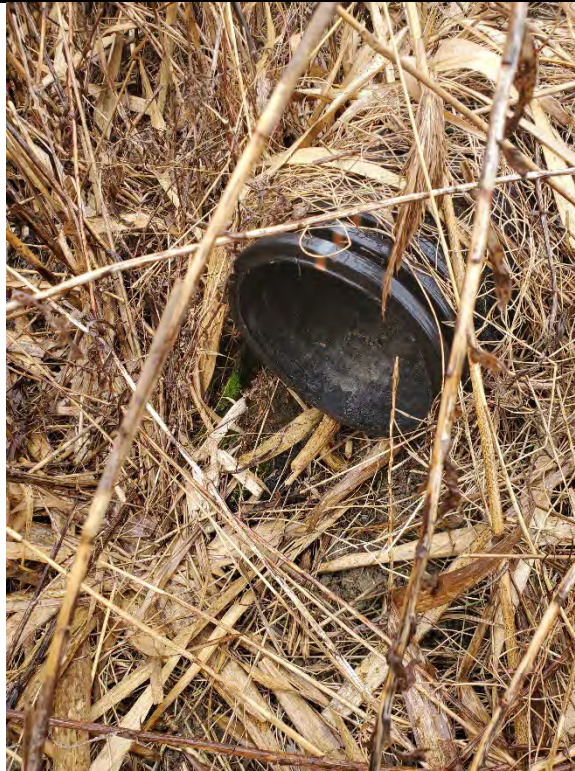
Comments: Pore pressure relief pipe outlet. Minimal sediment and no flow observed.

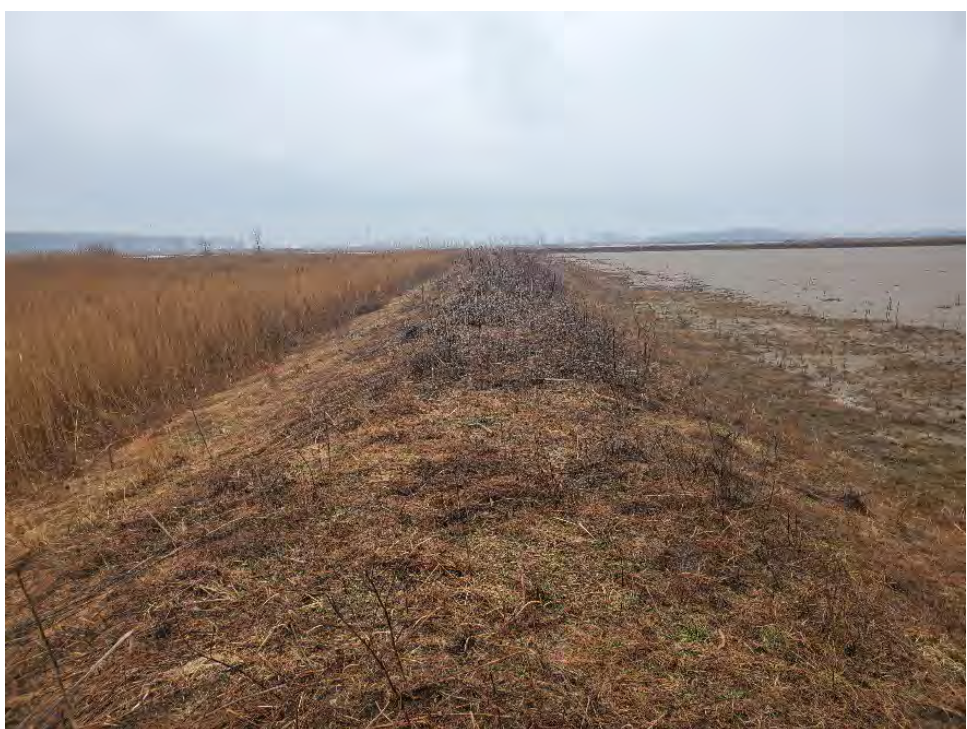
Photograph 6

Comments: Perimeter berm slopes and crest along east side.

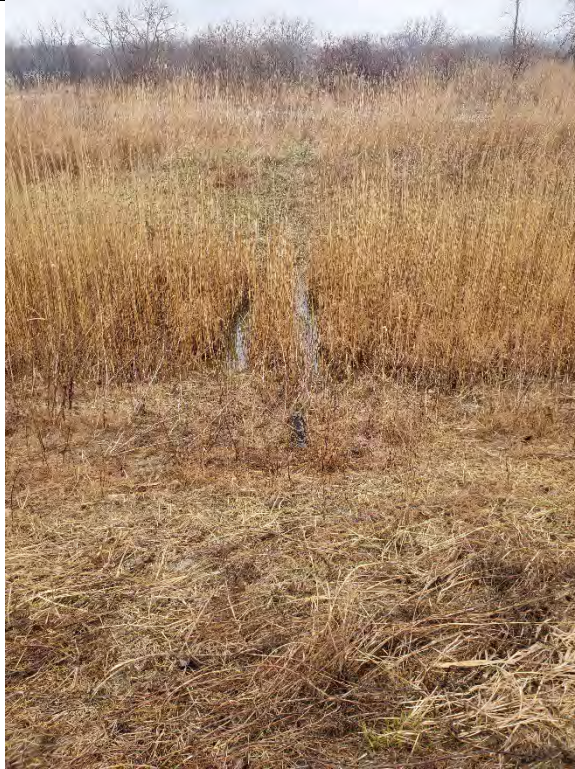
3. Perimeter drainage swales have a minimal slope, and standing water was observed in some areas on the eastern and southern sides of the Landfill (see Photographs 7, 10, 12, 16, 17, 18, and 20). Water was contained in the swales and levels were generally below the pore pressure relief pipe outlets at the time of the inspection, so the overall ability of the pore pressure relief pipes to sufficiently drain was not impeded.

Comments: Standing water observed in the perimeter swale.

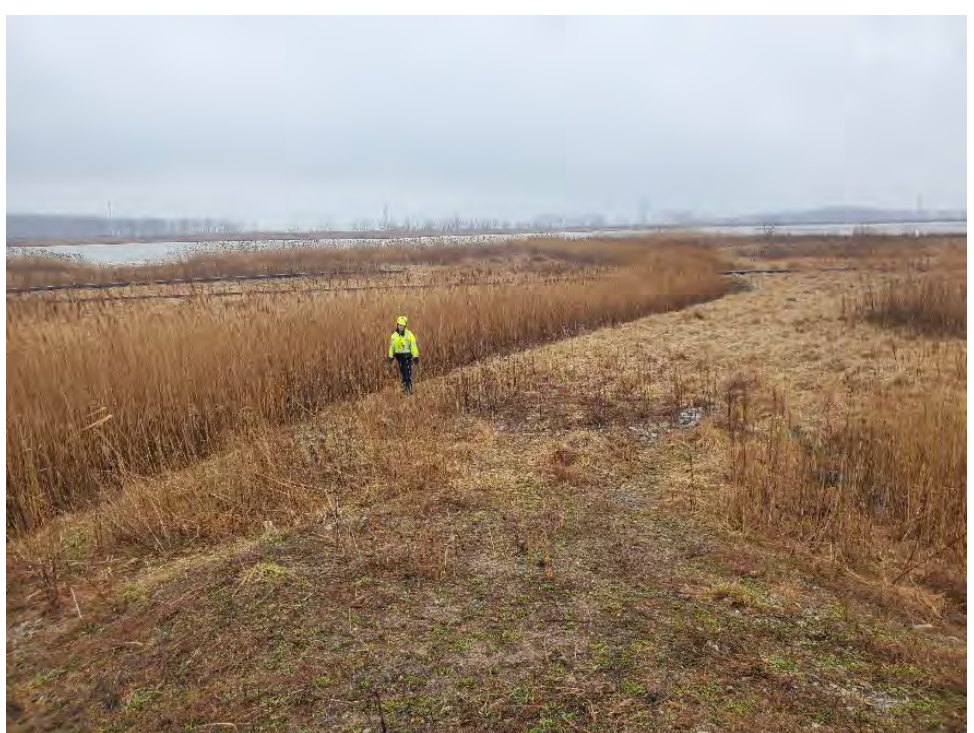
Photograph 8

4. The culvert at the intersection of the R2 and R4 perimeter swales in the southeast corner of the Landfill drains water from the R3 and R4 perimeter channels (see Photograph 8). Standing water was observed in the swales adjacent to the culvert at the time of the inspection (see Photograph 10).

Comments: Existing culvert in the southeast corner of the Landfill.

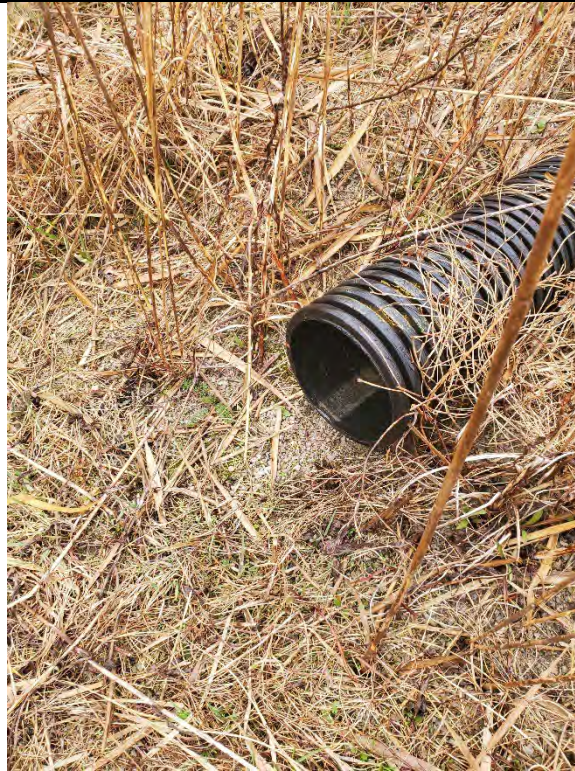
Comments: Pore pressure relief pipe outlet. Minimal sediment and no flow observed.

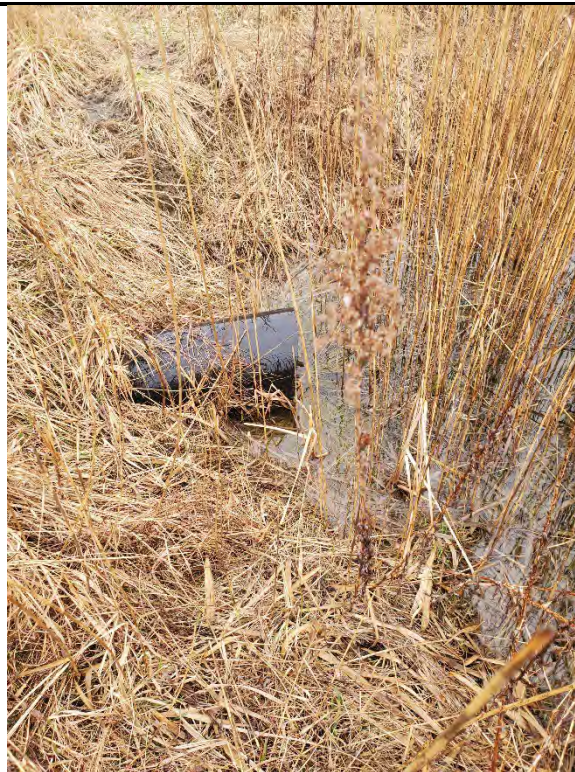
Photograph 10

Comments: Southeast culvert pipe. Water observed in perimeter swale.

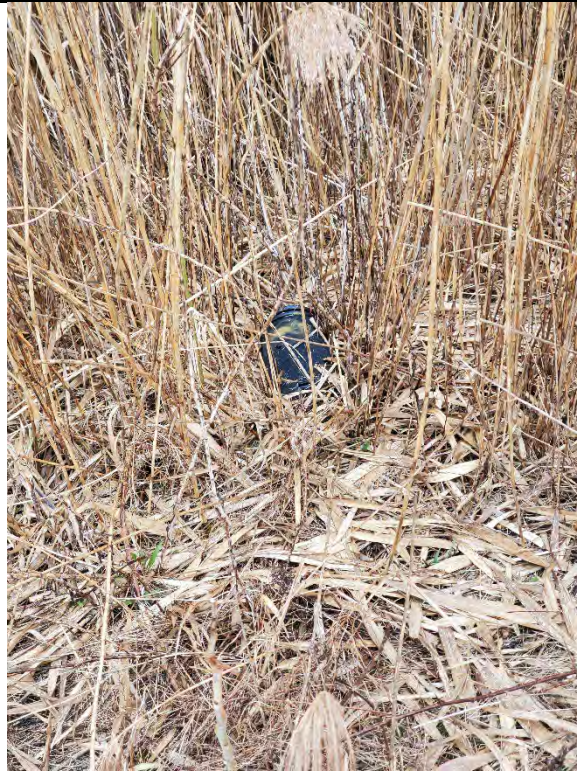
7. Heavy vegetation was observed around many of the pore pressure relief pipe outlets along the southern and northwestern sides of the Landfill (see Photographs 11, 13, 15, 17, 18, 19, 22, 29, 33, and 35). In some instances, some vegetation was observed in the pipes (see Photograph 4). However, the vegetation does not impede the sufficient draining of the pore pressure relief pipes.

Comments: Pore pressure relief pipe outlet. Minimal sediment and no flow observed. Area is heavily vegetated.

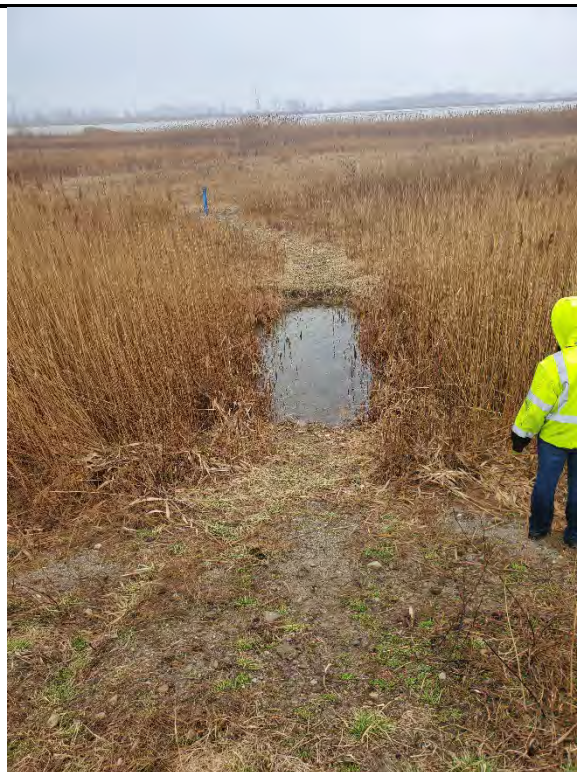
Photograph 12

Comments: Standing water observed in the perimeter swale.

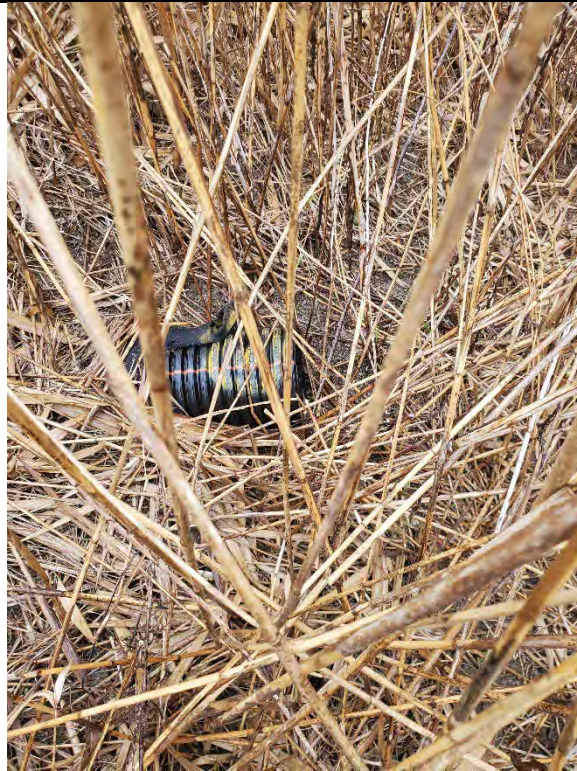
Comments: Pore pressure relief pipe outlet. Minimal sediment and no flow observed. Area is heavily vegetated.

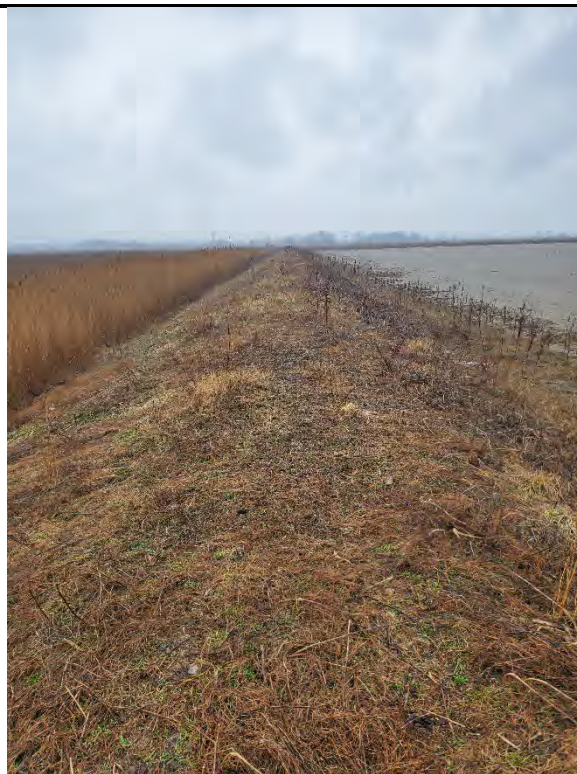
Photograph 14

Comments: Perimeter berm slopes and crest along south side.

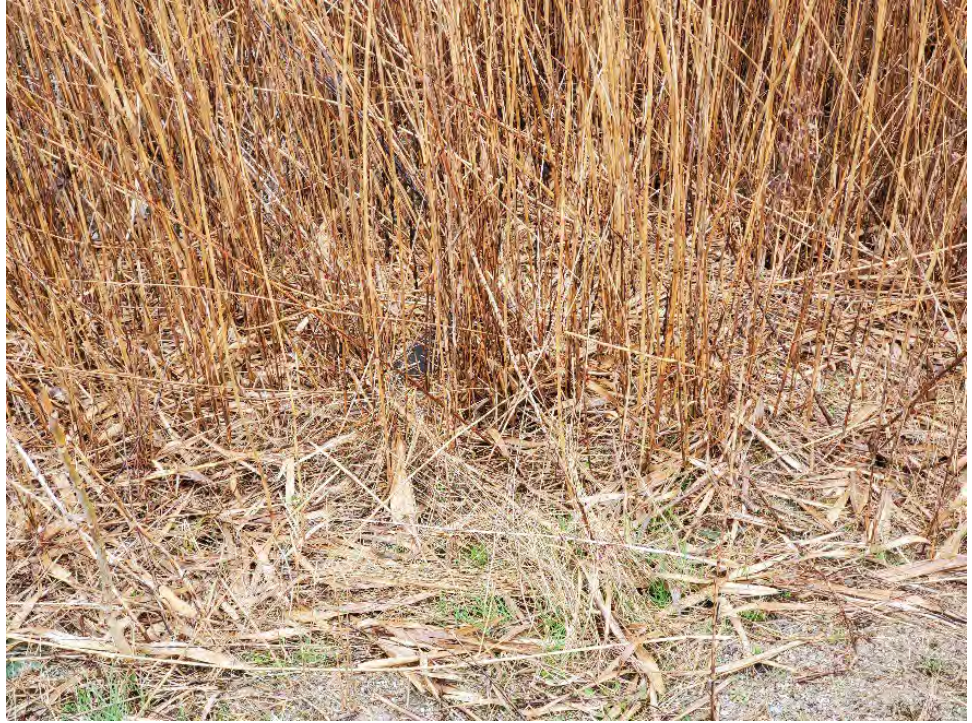
Comments: Pore pressure relief pipe outlet. Minimal sediment and no flow observed. Area is heavily vegetated.

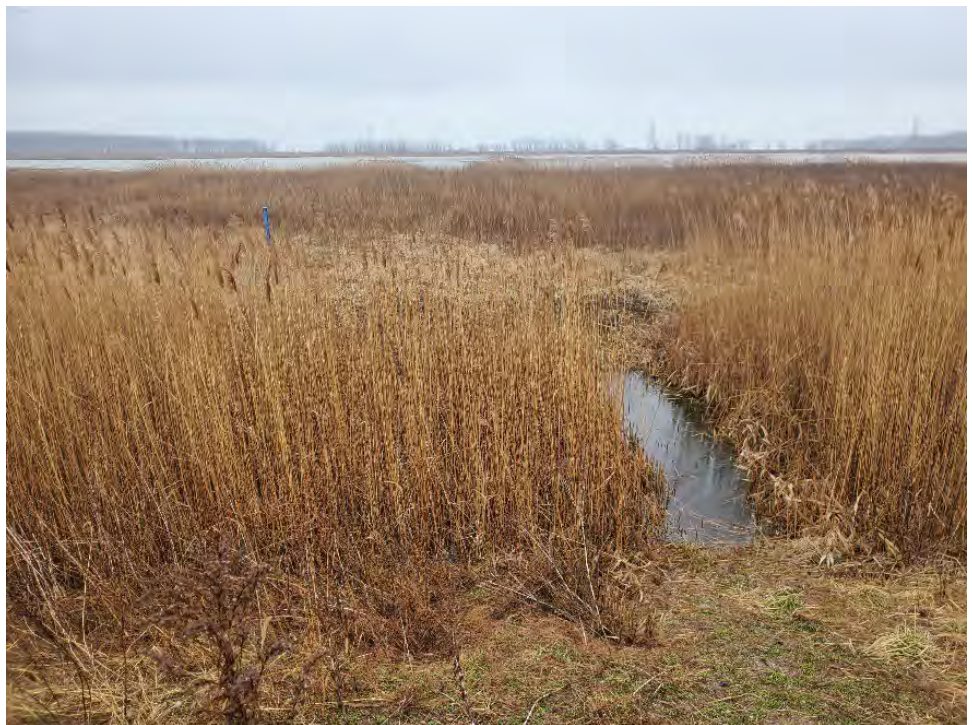
Photograph 16

Comments: Standing water observed in the perimeter swale.

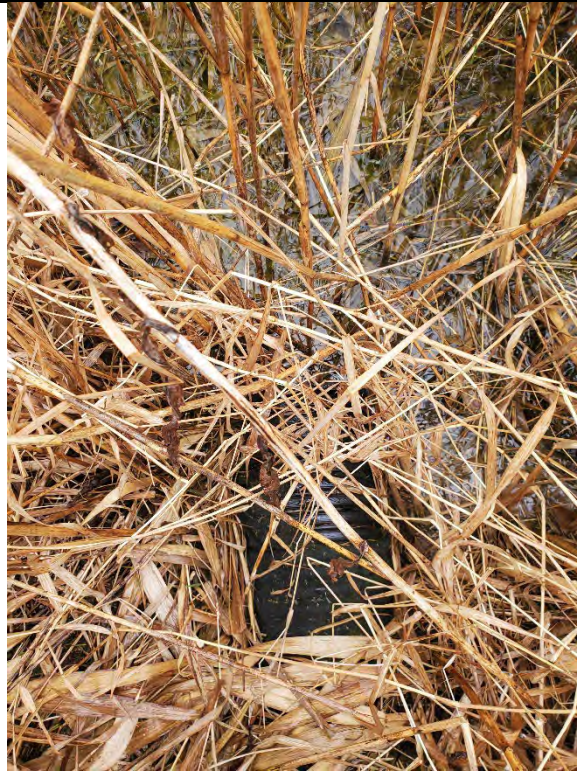
Comments: Pore pressure relief pipe outlet. Minimal sediment and no flow observed. Area is heavily vegetated. Standing water is observed in the perimeter swale.

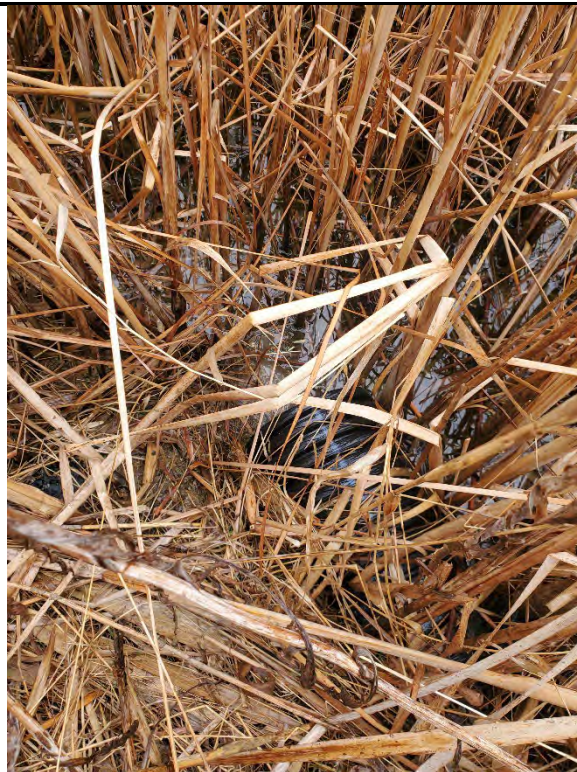
Photograph 18

Comments: Pore pressure relief pipe outlet. Minimal sediment and no flow observed. Area is heavily vegetated. Standing water is observed in the perimeter swale.

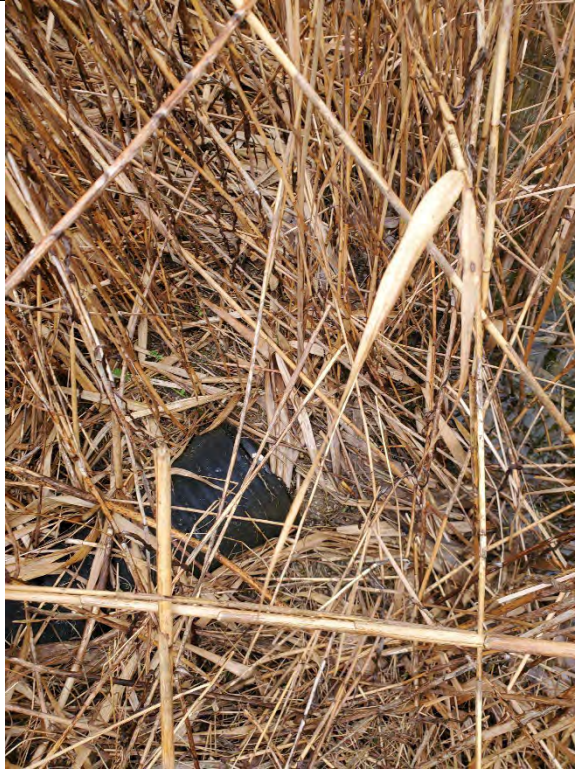
Comments: Pore pressure relief pipe outlet. Minimal sediment and no flow observed. Area is heavily vegetated.

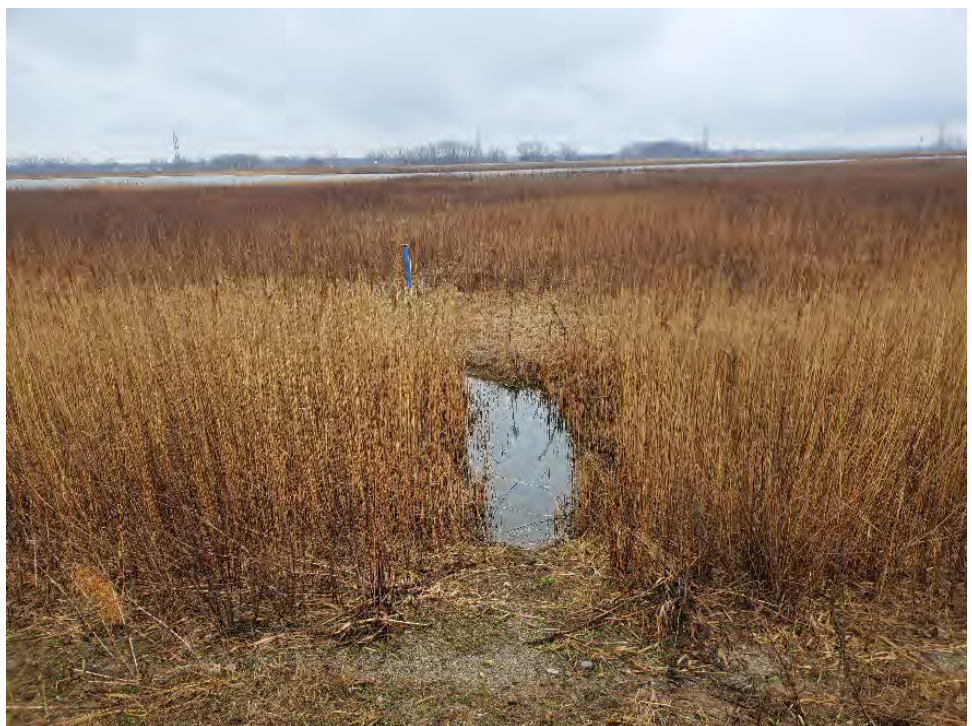
Photograph 20

Comments: Standing water observed in the perimeter swale.

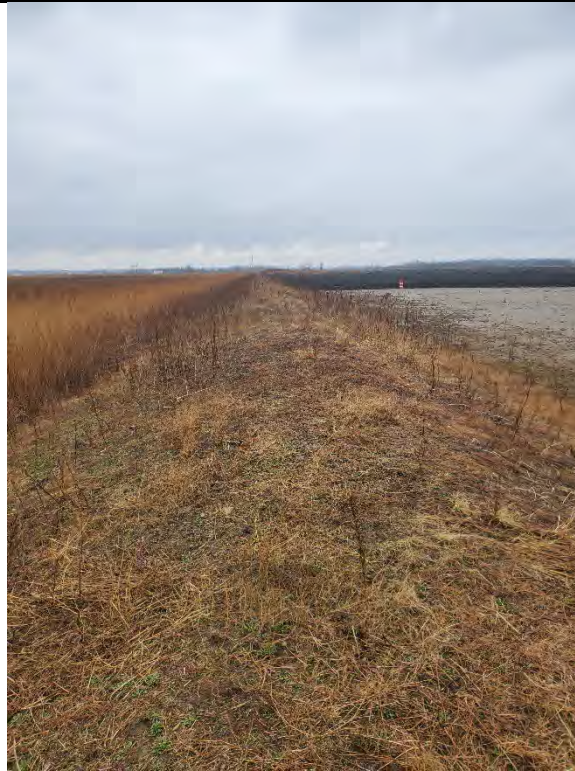
Comments: Perimeter berm slopes and crest along south side.

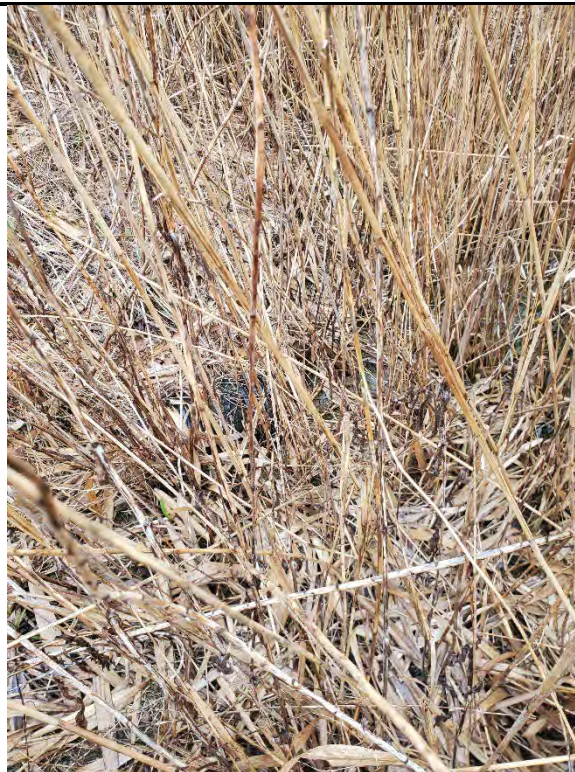
Photograph 22

Comments: Pore pressure relief pipe outlet. Minimal sediment and no flow observed. Area is heavily vegetated.

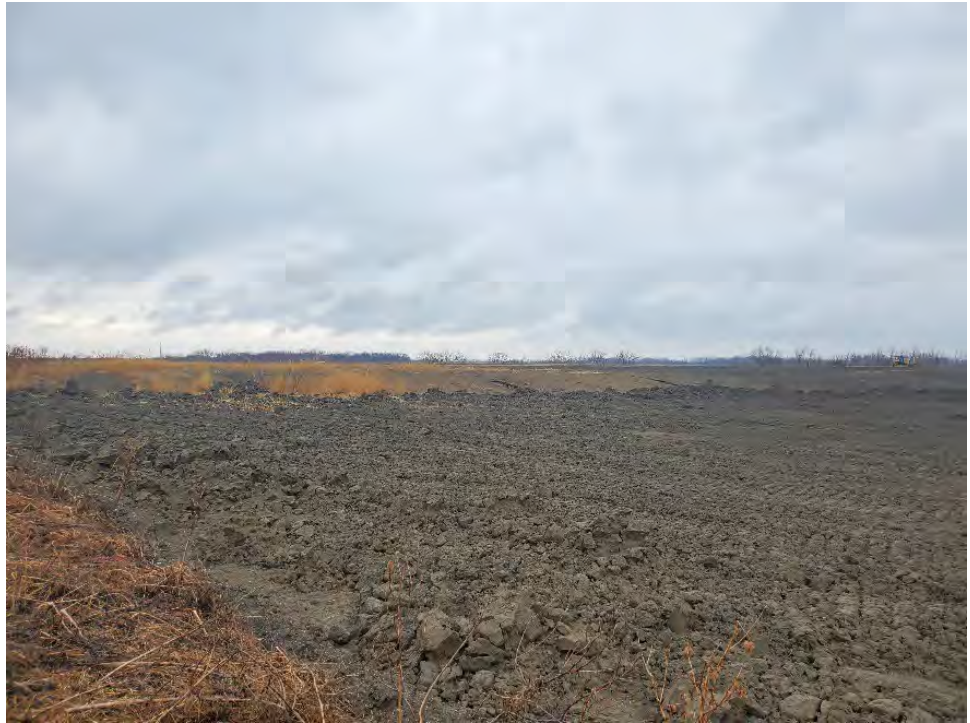
Comments: CCR and other material beginning to be placed in Phase 2 of the Landfill.

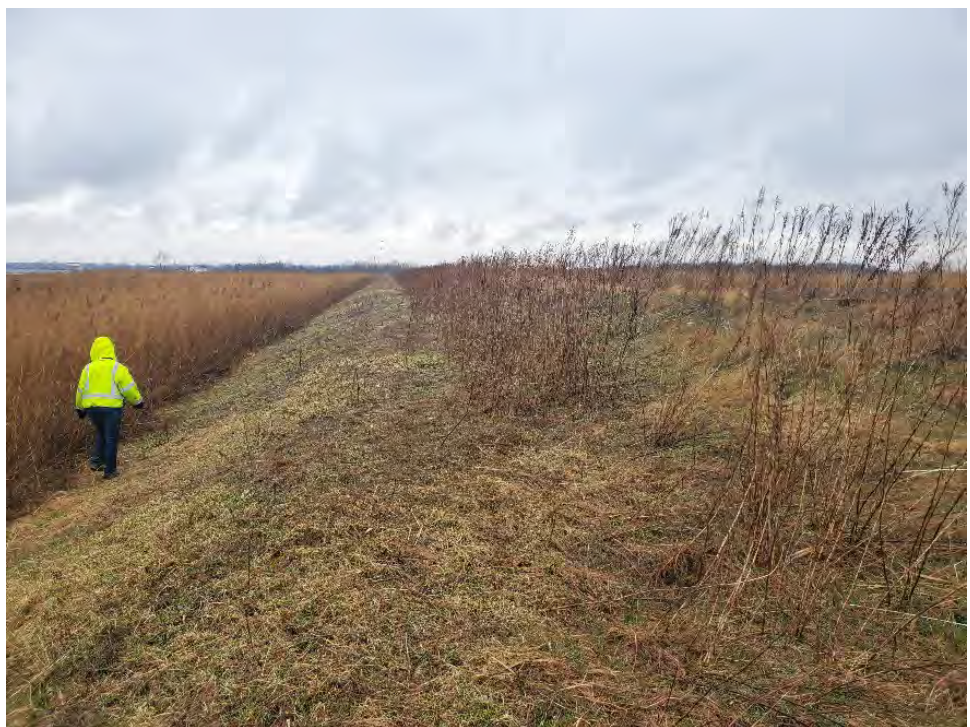
Photograph 24

Comments: Perimeter berm slopes and crest along south side adjacent to Phase 1 of the Landfill.

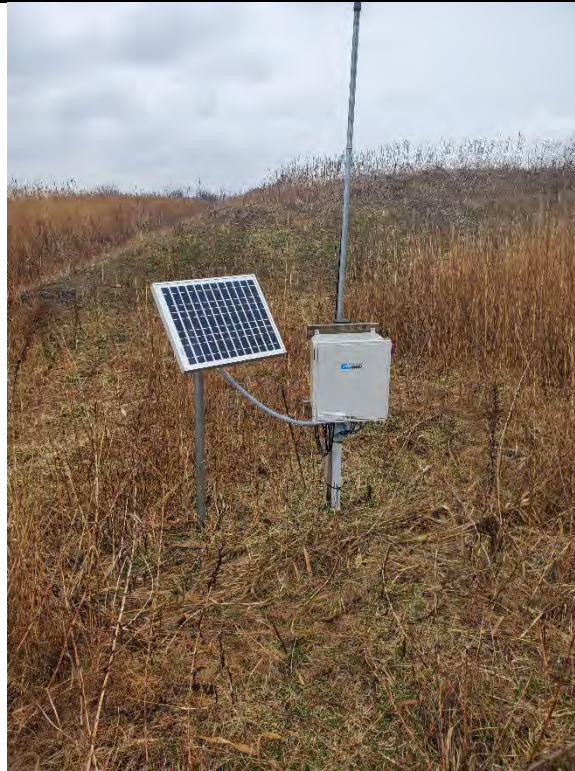
Comments: Data Logger-4 for continuous monitoring system. Maintenance was performed in April 2022 to repair the antenna and restore connectivity with a portion of the monitoring system.

2. Have any repairs been made since the last inspection? X Yes No
 If 'Yes', describe. _____
Repairs were made to Data Logger-4 for the continuous monitoring system.

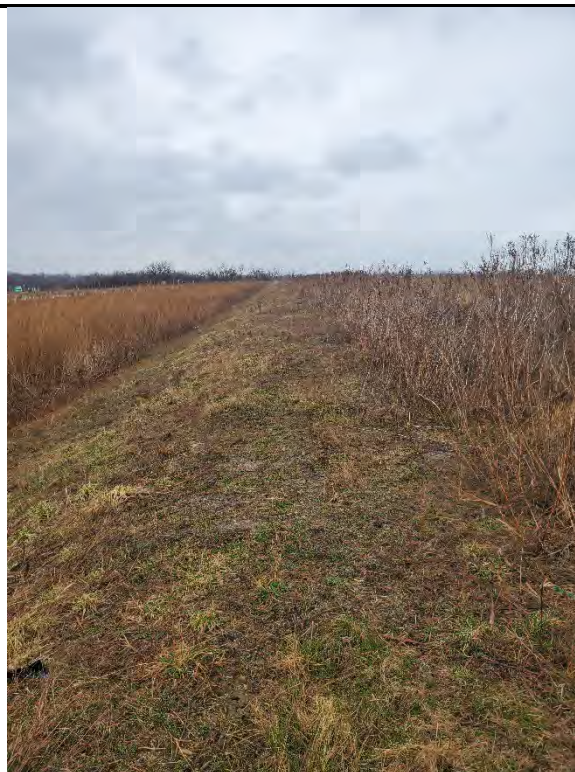
Photograph 26

Comments: Perimeter berm slopes and crest along west side adjacent to Phase 1 of the Landfill.

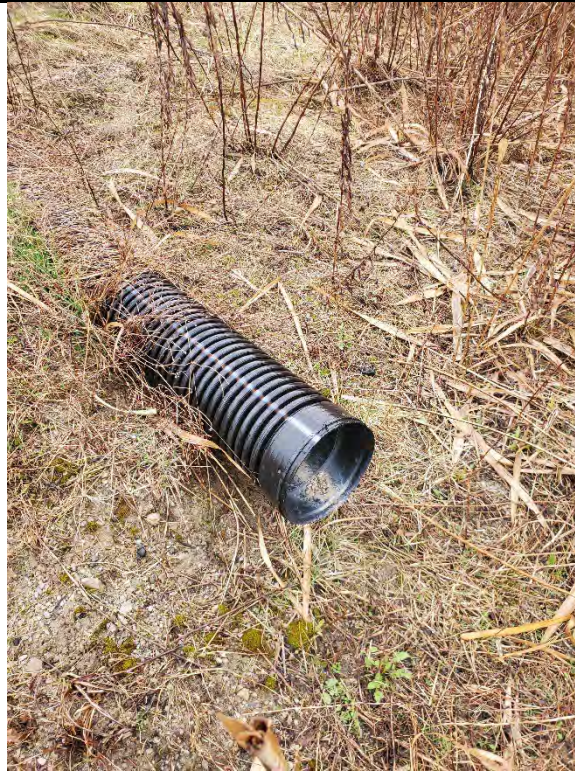
Comments: Pore pressure relief pipe outlet. Minimal sediment and no flow observed.

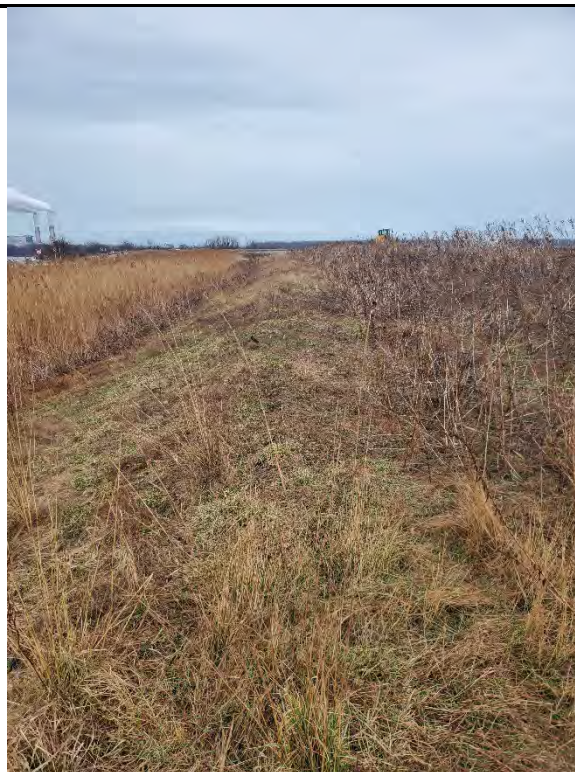
Photograph 28

Comments: Perimeter berm slopes and crest along north side adjacent to Phase 1 of the Landfill.

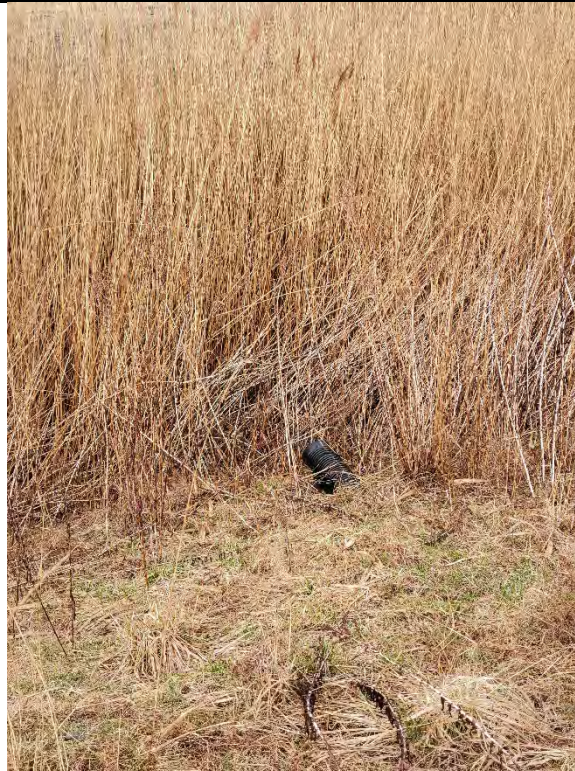
Comments: Pore pressure relief pipe outlet. Minimal sediment and no flow observed. Area is heavily vegetated.

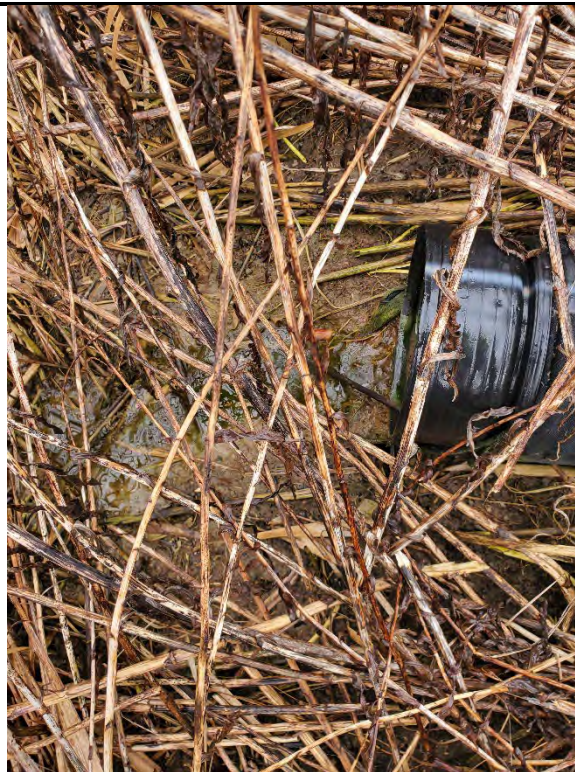
Photograph 30

8. One pore pressure relief pipe along the northwest side of the Landfill was observed to have a very small amount of water flowing out of the outlet (see Photograph 30). This is expected

for pore pressure relief pipes in the area below the active filling area of the Landfill. No water was observed to be flowing out of the remaining pipes.

Comments: Pore pressure relief pipe outlet. Minimal sediment. Some flow observed. Pipe is below northeastern portion of Phase 1 Landfill.

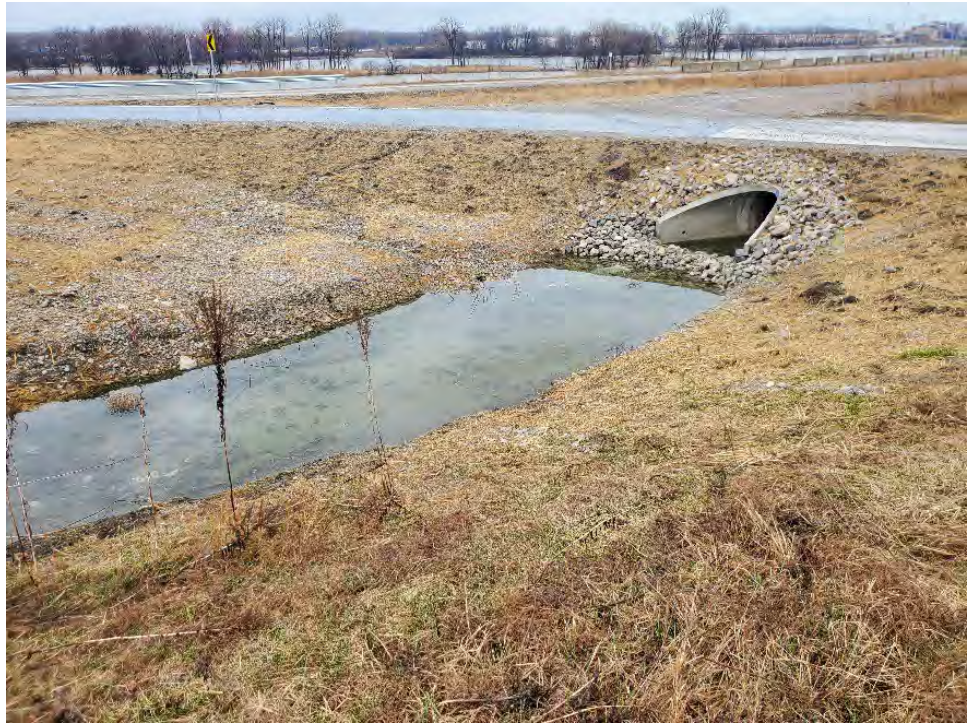
Comments: Culvert constructed for the new asphalt access road to the Landfill.

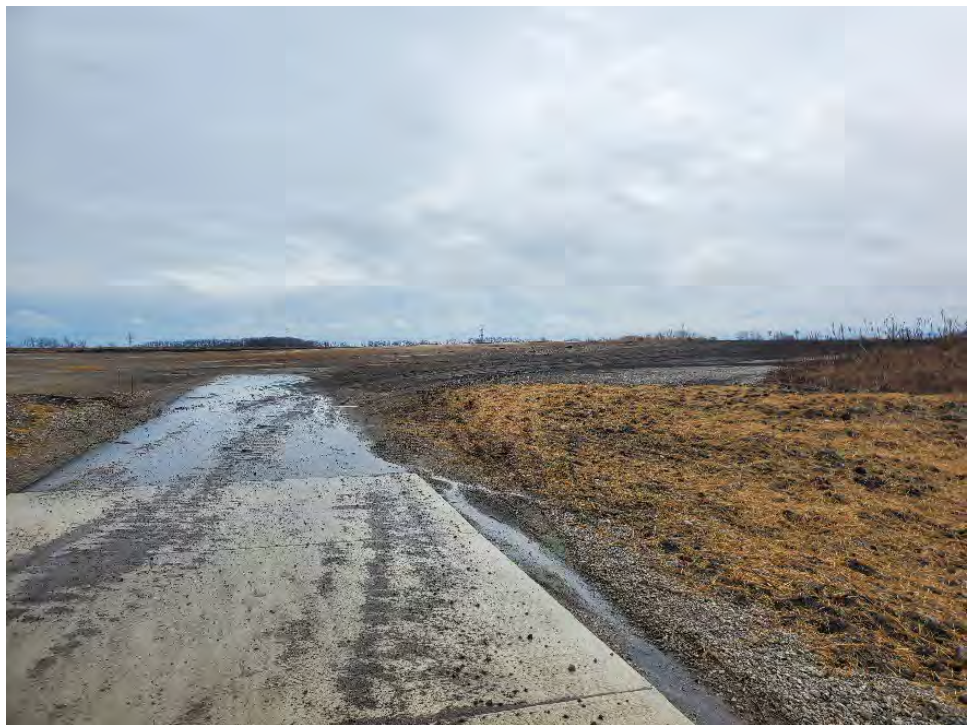
Photograph 32

Comments: Entrance of the new asphalt access road to the Landfill.

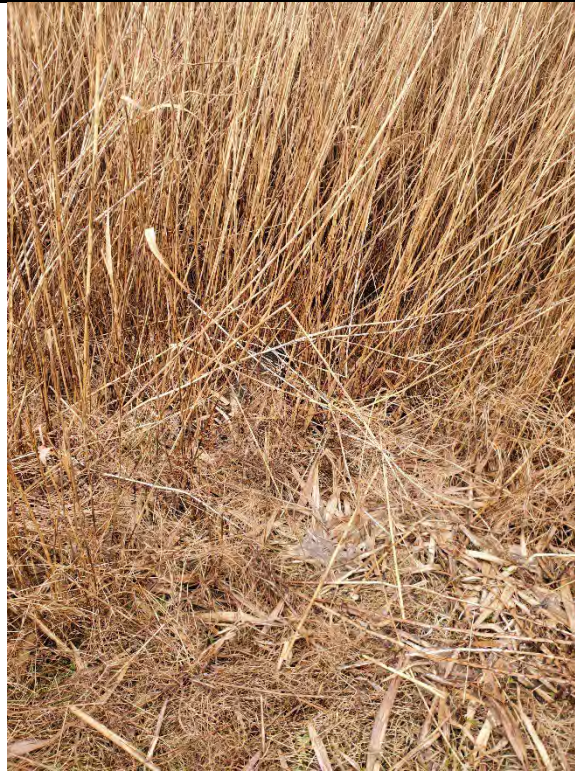
Comments: Pore pressure relief pipe outlet. Minimal sediment and no flow observed. Area is heavily vegetated.

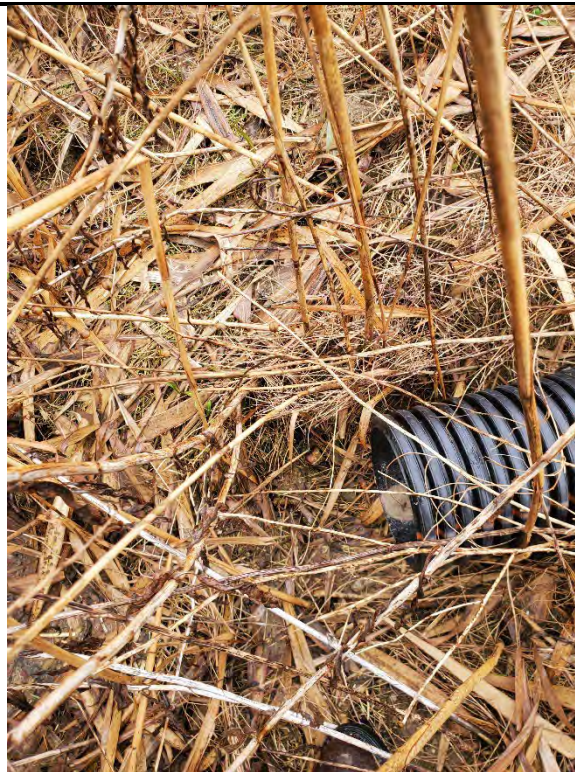
Photograph 34

Comments: Pore pressure relief pipe outlet. Minimal sediment and no flow observed.

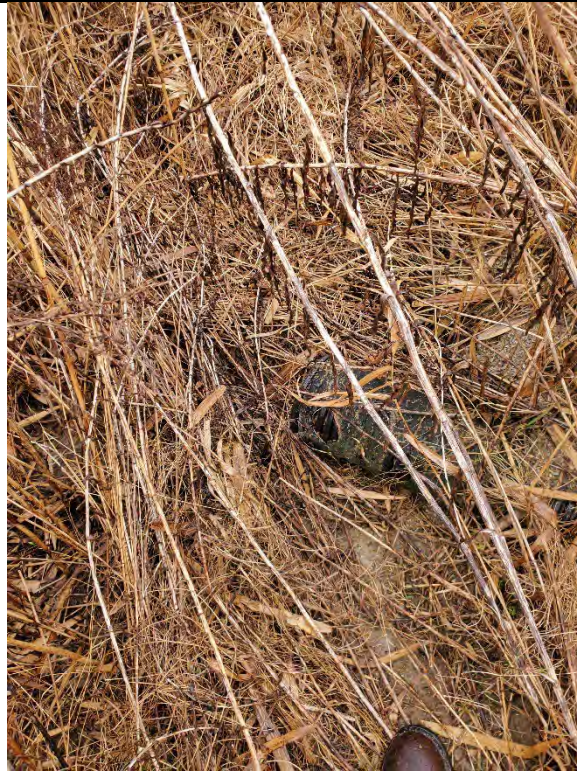
Comments: Pore pressure relief pipe outlet. Minimal sediment and no flow observed. Area is heavily vegetated.

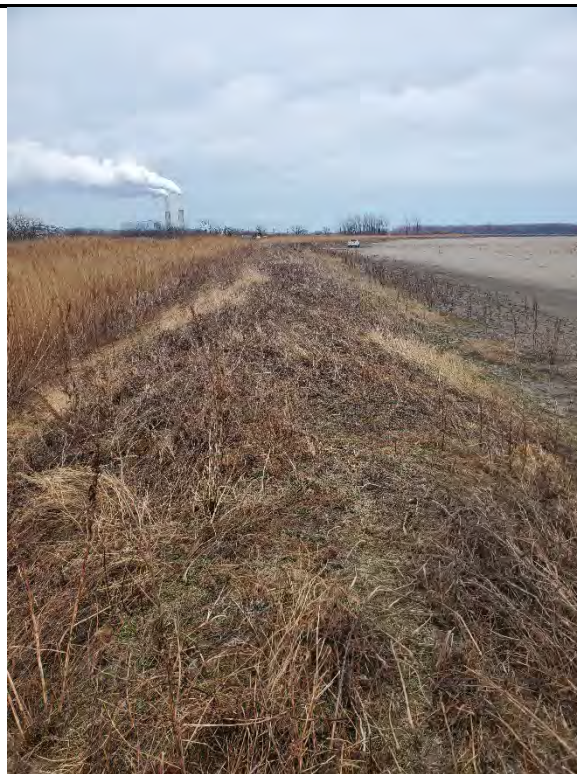
Photograph 36

Comments: Perimeter berm slopes and crest along north side.
