DTE Electric Company
One Energy Plaza
Detroit, Michigan 48226

**2022 ANNUAL
INSPECTION REPORT
ASH BASIN**

MONROE POWER PLANT

January 2023

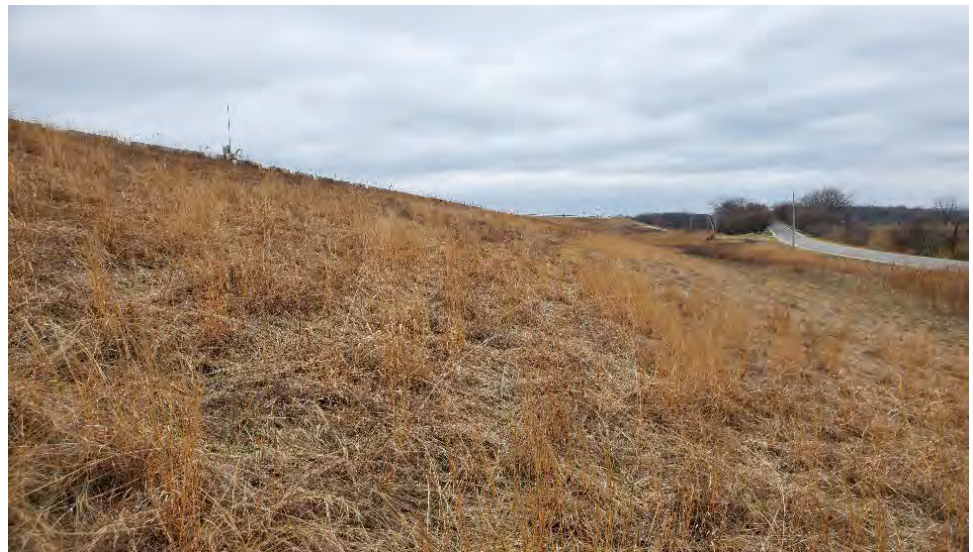
5. Small Autumn Olive shrubs (see Photograph 1) were observed on portions of the perimeter embankment slopes in the northeast (approximate Stations 0+00 to 15+00), northwest (approximate Stations 55+00 to 65+00), and east (approximate Stations 150+00 to 160+00) (see Photograph 3).

Comments: Autumn Olive shrubs were observed on the perimeter berms in certain locations. Chemical sprays were applied to the embankment slopes after the visual inspection to kill the shrubs and prevent future growth.

3. Small Autumn Olive shrubs were observed on portions of the perimeter embankment slopes. Chemical sprays were applied to the embankment slopes with Autumn Olive shrubs to kill the shrubs and prevent future growth.

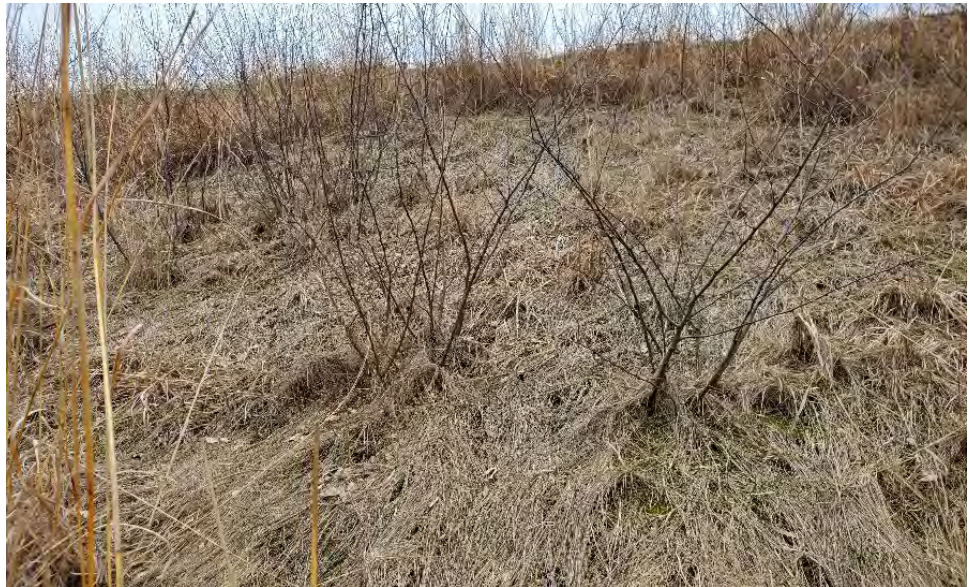
Photograph 4

1. A crack/slough was observed on the perimeter embankment slope near approximate Station 12+00 (see Photographs 4 through 7). The crack was approximately 6-inches wide, 12-inches deep, and 100-feet long. The crack was initially identified by DTE personnel in March 2022 and staked. Geosyntec inspected the crack shortly after it was identified by DTE. Geosyntec did not observe any significant changes in the crack at the time of the visual inspection or in adjacent instrumentation monitoring.

- The crack/slough observed on the perimeter embankment slope near approximate Station 12+00 was believed to be the result of the freezing and thawing cycle of the surficial soils as no movements were observed in the adjacent instrumentation monitoring. Therefore, the crack was judged not to be indicative of an existing structural weakness in the perimeter embankment.

Comments: Crack/Slough observed on the perimeter berm near approximate Station 12+00. Crack was approximately 6-in. wide and 12-in. deep. A bentonite-sand mix was used to backfill and repair the crack after the visual inspection.

1. The crack/slough on the embankment slope near approximate Station 12+00 was repaired in accordance with the IMMM to prevent further surficial movements and cracks. Minimal change in the extent of the crack was observed between the initial inspection by Geosyntec and the annual inspection and no other cracks were observed in this area so a bentonite and sand mix was used to backfill and repair the crack in accordance with the IMMM repairs for ground cracks. If additional movements or cracks are observed prior to the 2023 annual

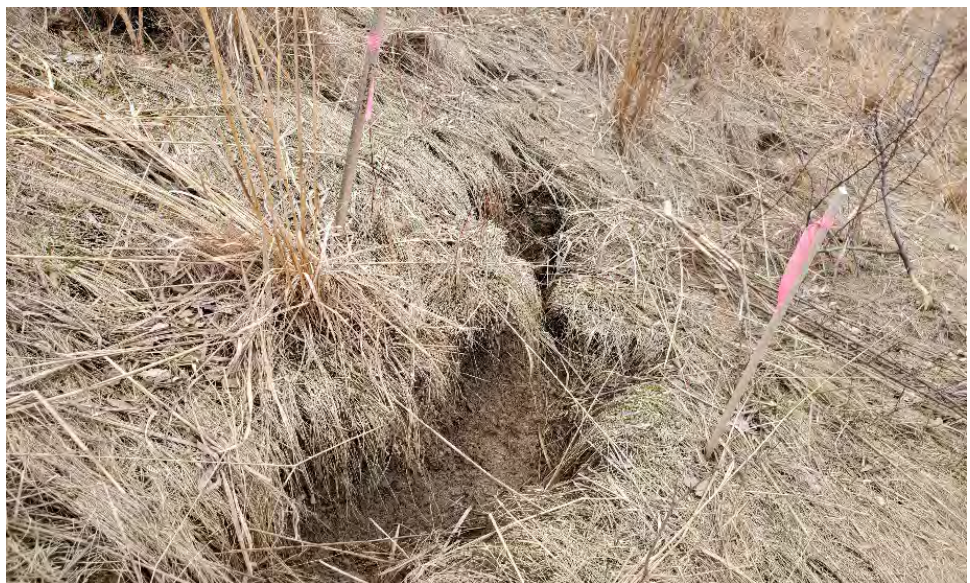
Comments:
Crack/Slough observed on the perimeter berm near approximate Station 12+00. A bentonite-sand mix was used to backfill and repair the crack after the visual inspection.

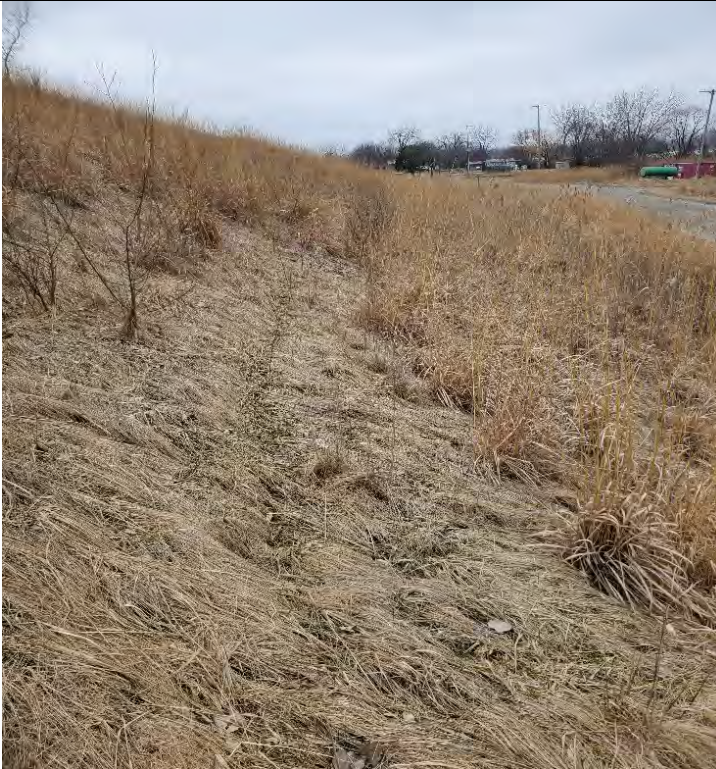
Photograph 6

Comments:
Crack/Slough observed on the perimeter berm near approximate Station 12+00. Crack was approximately 100 feet long. A bentonite-sand mix was used to backfill and repair the crack after the visual inspection.

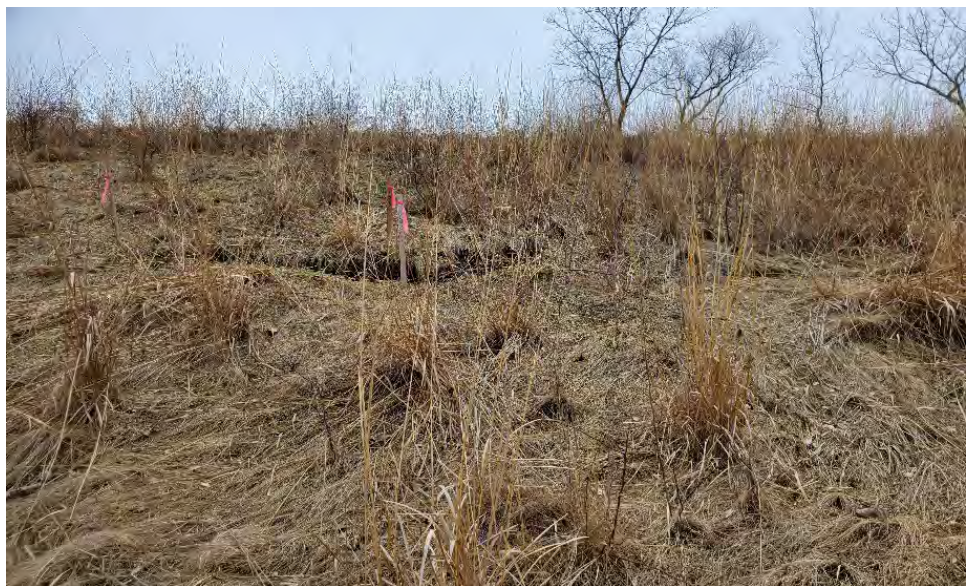
Comments: Crack/Slough observed on the perimeter berm near approximate Station 12+00. A bentonite-sand mix was used to backfill and repair the crack after the visual inspection.

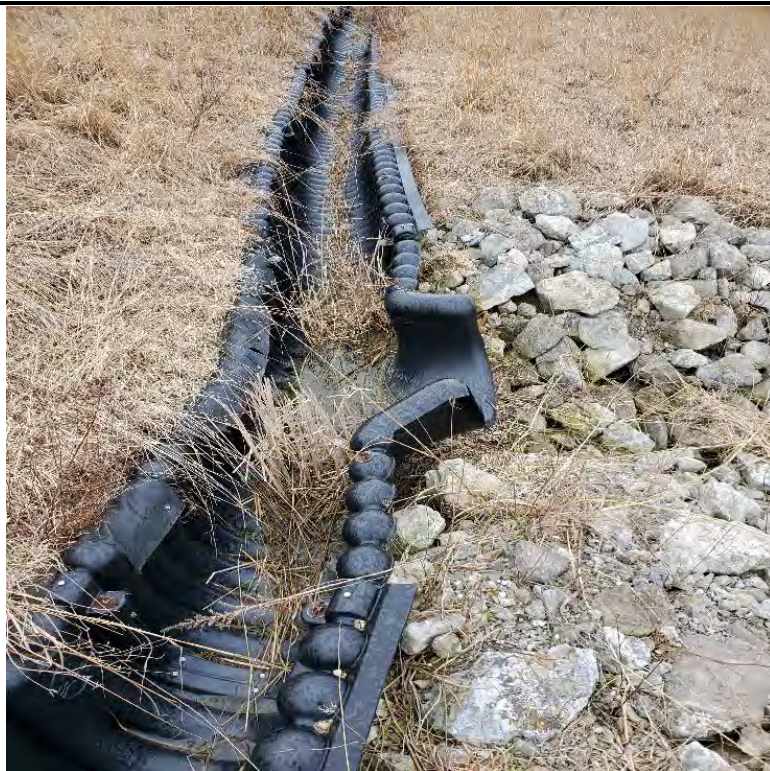
4. Many of the riprap downchutes had noticeable erosion of riprap near the SmartDitch outlets and within the downchutes (see Photograph 9). Vegetation was also observed in some of

Comments: Erosion of riprap and vegetation were observed in many of the riprap downchutes. Eroded riprap should be replaced and vegetation should be cleared.

1. The SmartDitches had multiple conditions that should be addressed in accordance with the IMMM.
 - a. Erosion was observed at many of the SmartDitch outlets into the riprap downchutes. The eroded riprap around the outlets should be replaced.
 - b. Vegetation was observed within the SmartDitches at multiple locations. This vegetation should be cleared out of the SmartDitches.
 - c. One of the inspection ports for the covered HDPE pipe near approximate Station 143+00 was missing a cover. The cover should be replaced.
2. Many of the riprap downchutes had noticeable erosion of riprap near the SmartDitch outlets and within the downchutes. Vegetation was also observed in some of the riprap downchutes. These conditions did not appear to affect the functionality of the features, but the eroded riprap should be replaced and the vegetation should be cleared.

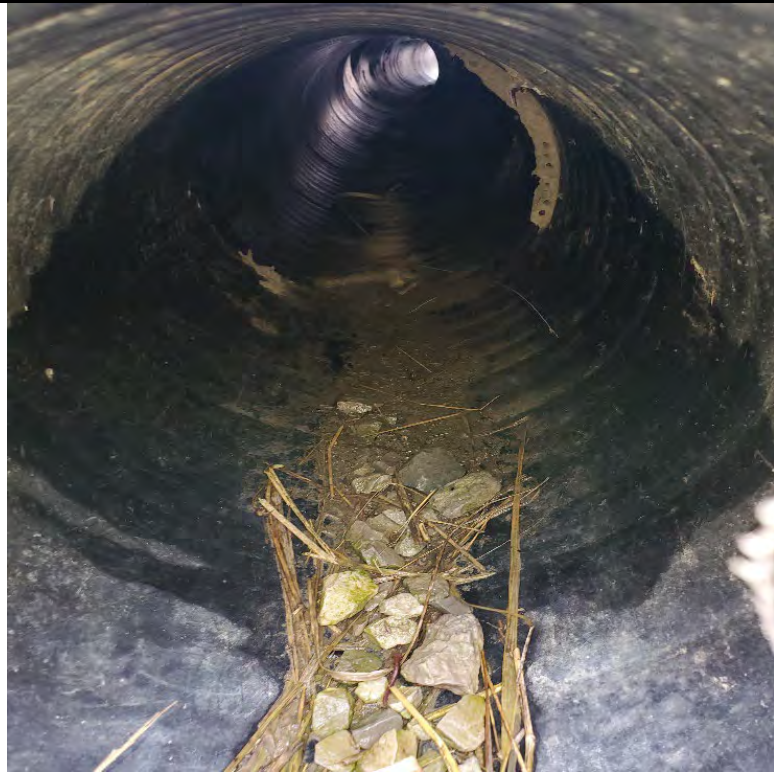
Photograph 12

Comments: The covered HDPE pipes used to connect portions of SmartDitches were in good condition.

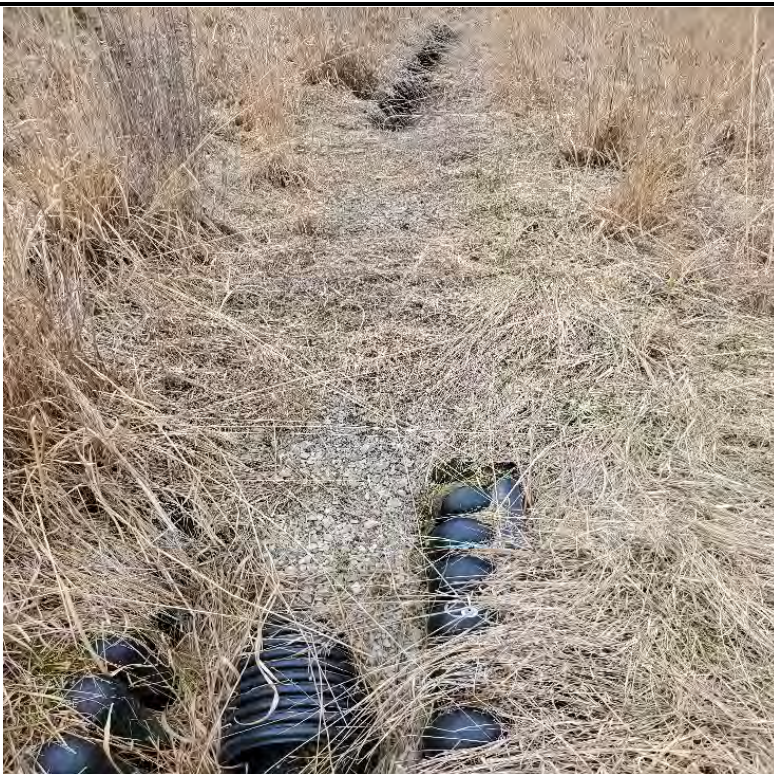
- b. Vegetation was observed within the SmartDitches at multiple locations (see Photograph 13). The vegetation did not affect the functionality of the SmartDitches to conduct sufficient stormwater flow.

Comments:
Vegetation was observed within the SmartDitch drainage features at multiple locations. The vegetation did not affect the functionality of the SmartDitch to sufficiently convey stormwater.

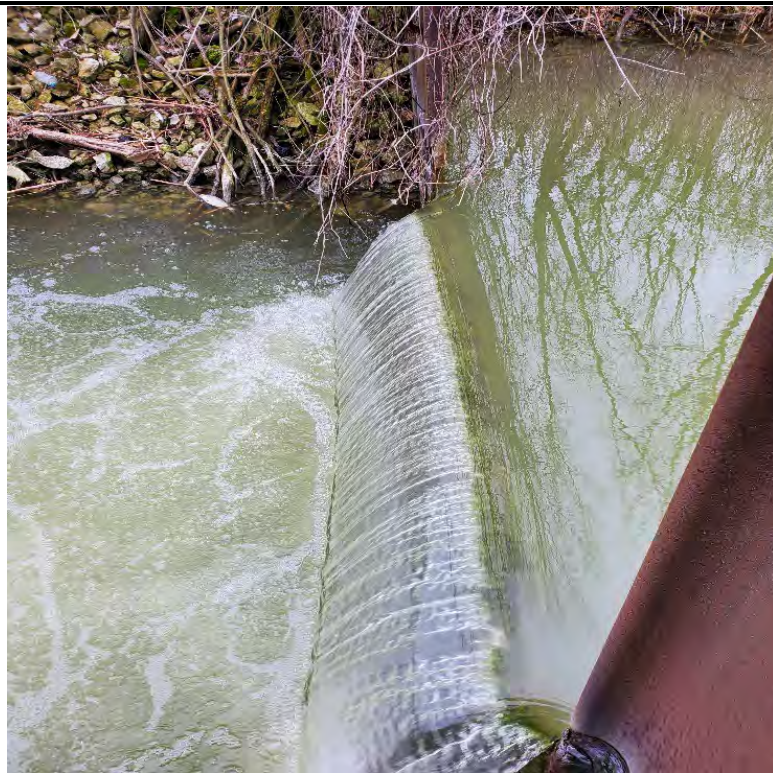
6. Bentonite and sand repairs had been made to cracks that formed near approximate Stations 65+00 (see Photograph 19) and 78+00 (see Photographs 21 and 22). DTE personnel indicated the cracks formed during construction of the asphalt road. The repairs were in good condition and no indications of additional movement were observed at these locations during the visual inspection.

Comments: Bentonite and sand backfill repair made to a crack observed near approximate Station 65+00. No additional movement was observed at the time of the inspection. DTE has continued to monitor the repairs during the weekly inspections.

4. Bentonite and sand backfill repairs were made to cracks that formed near approximate Stations 65+00 and 78+00 were in good condition at the time of the inspection but should continue to be monitored. DTE has continued to monitor these repairs during weekly inspections.

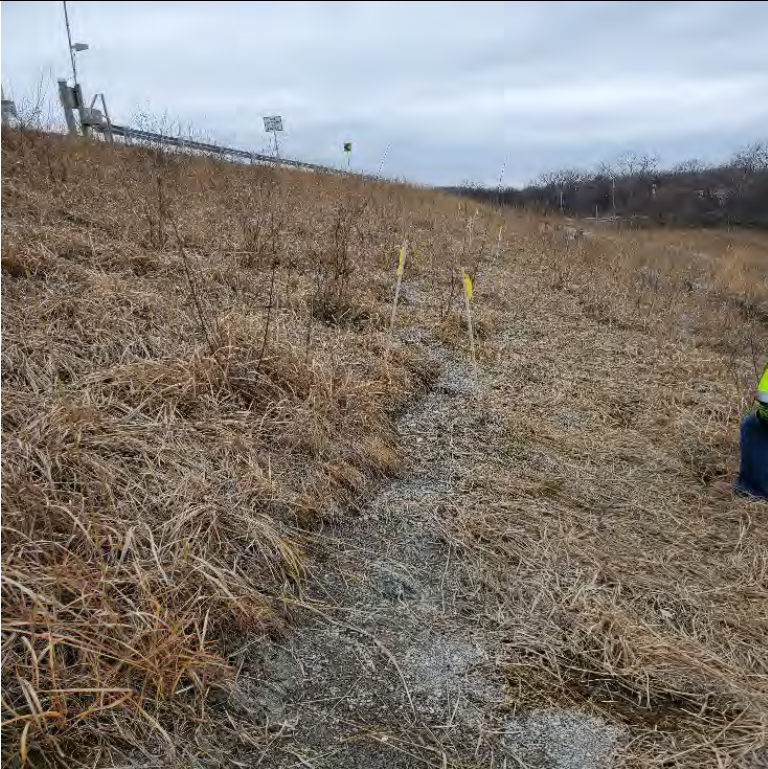
Photograph 20

8. An HDPE pipe was observed near approximate Station 67+00 under the asphalt road within the Vertical Extension Landfill (see Photograph 20). DTE personnel indicated they had tried to identify the extent of the pipe via a remote-operated vehicle inspection and ground penetrating survey. These inspections identified the pipe was filled with ash and water and could only locate approximately 50 feet of the pipe. The HDPE pipe was capped.

- The HDPE pipe observed near approximate Station 67+00 under the asphalt road was likely used for previous operations and abandoned in-place. Geosyntec does not believe the pipe represents an existing structural weakness or has the potential to develop into a structural weakness that would affect the operation and safety of the Ash Basin. The pipe has been capped and can be left in-place.

Comments: New asphalt access road for the Vertical Extension Landfill. An HDPE pipe was observed to extend under the new road. The source and extent of the pipe was not identified during the inspection. The pipe was capped.

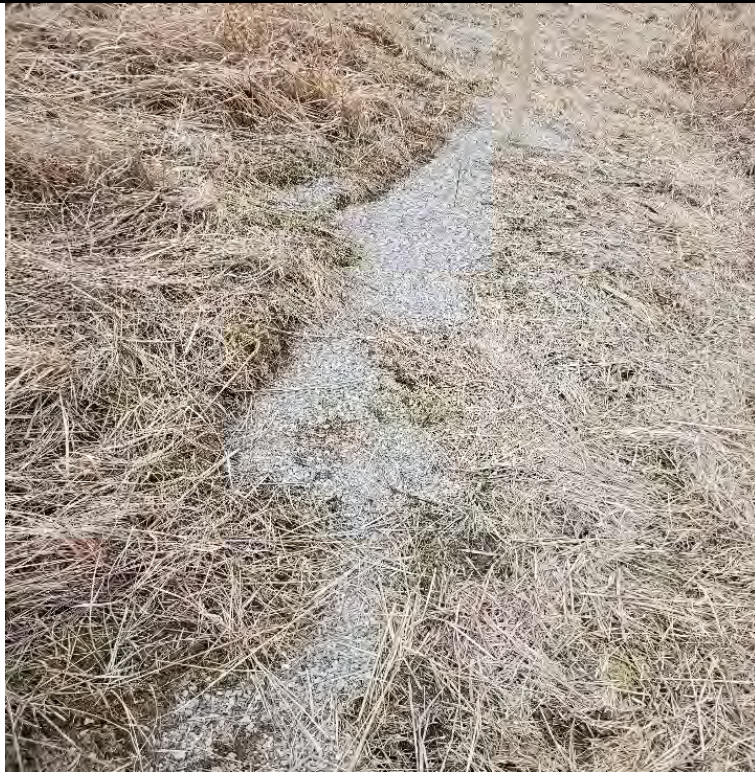
Photograph 22

Comments: Bentonite and sand backfill repair made to a crack observed near approximate Station 78+00. No additional movement was observed at the time of the inspection. DTE has continued to monitor the repairs during the weekly inspections.

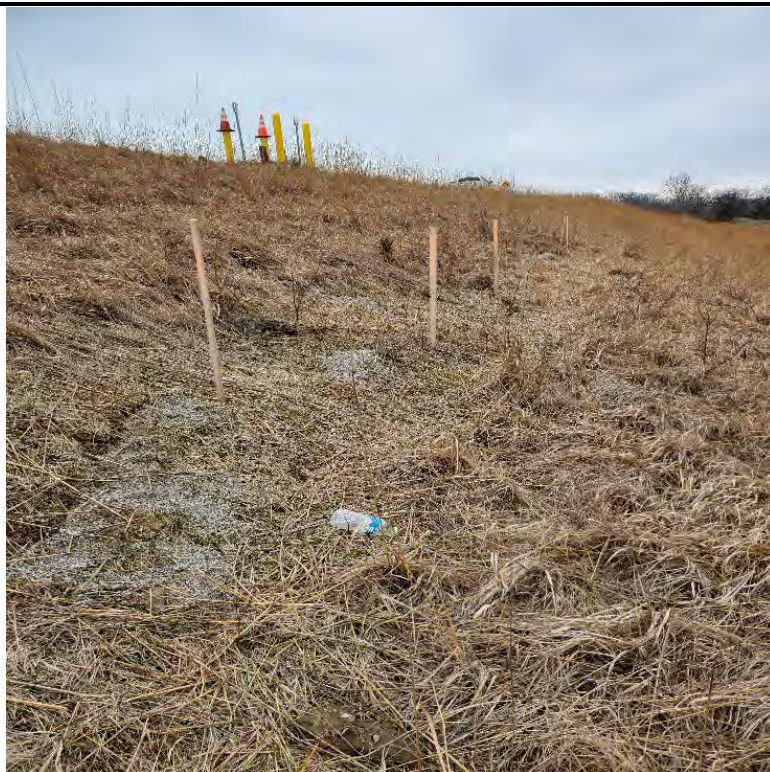
2. A gouge in the perimeter embankment slope was observed near approximate Station 88+00 (see Photograph 23). The gouge was approximately 6-inches wide and 12-inches deep and appeared to be from construction equipment.

- The gouge in the perimeter embankment slope observed near approximate Station 88+00 was likely from construction equipment as no other cracks were observed in the area. Therefore, the crack was judged not to be indicative of an existing structural weakness.

Comments: Gouge observed in the perimeter berm near approximate Station 88+00. Gouge was approximately 6-inches wide and 12-inches deep and appeared to be from construction equipment. A bentonite-sand mix was used to backfill and repair the crack after the visual inspection.

2. The gouge in the perimeter embankment slope near approximate Station 88+00 was repaired to prevent further surficial movements and cracks. A bentonite and sand mix was used to backfill and repair the gouge.

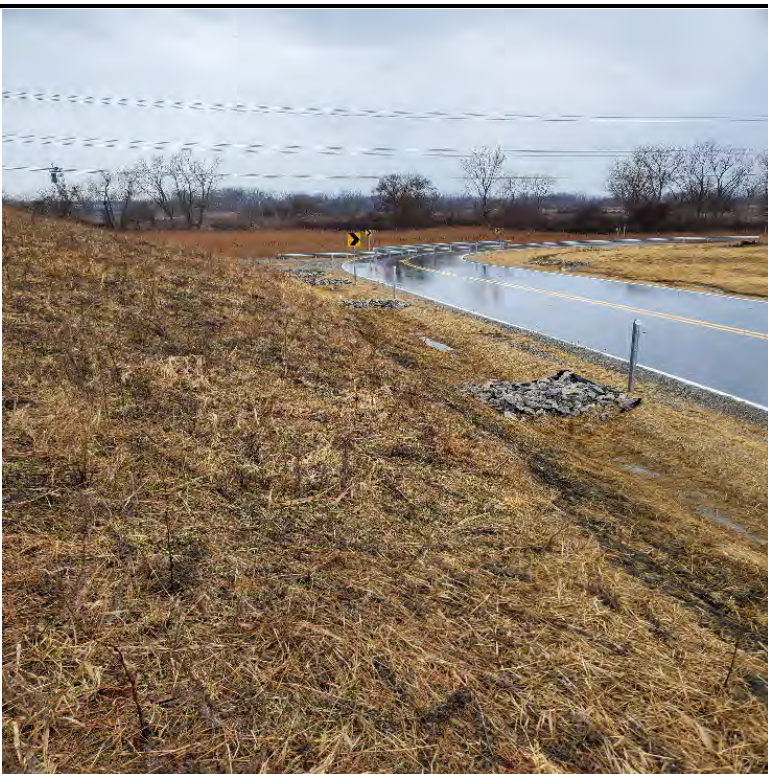
Comments: Access to perimeter road on crest for new asphalt access road for Vertical Extension Landfill. Stormwater swale and features and slope were in good condition.

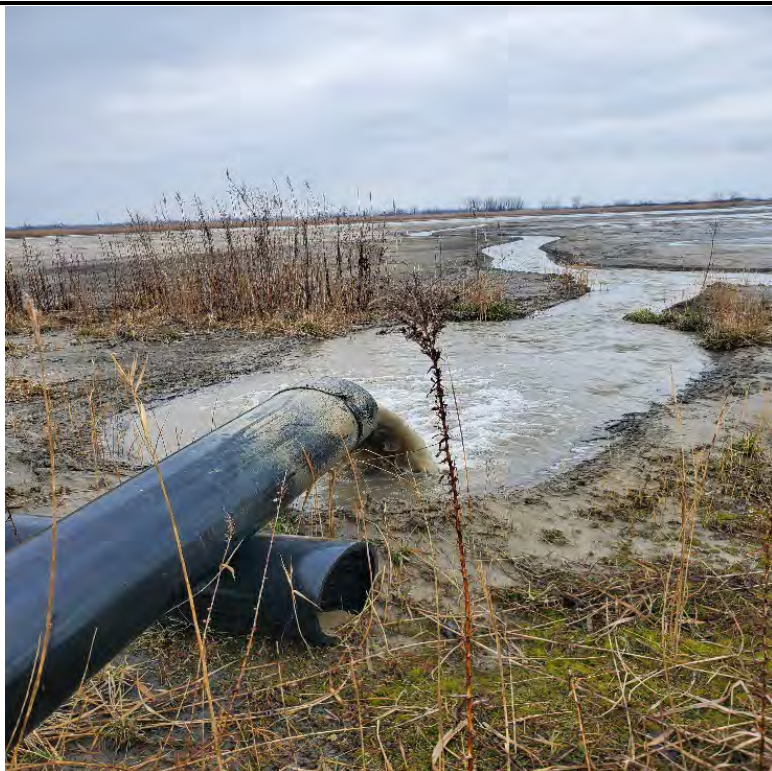
Comments: No obstructions were observed in sluice lines 1, 3, and 6. Two of these sluice lines were actively sluicing ash to the Ash Basin at the time of the inspection.

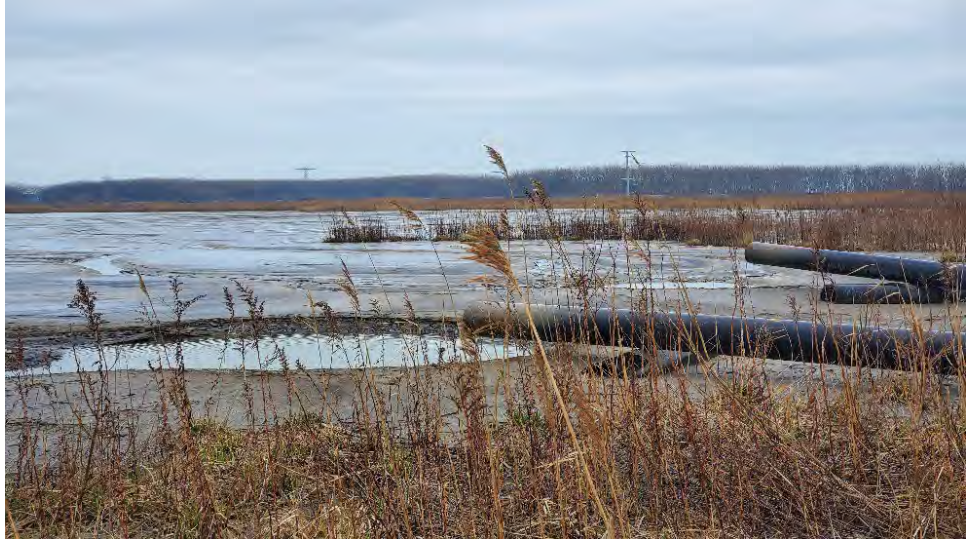
Photograph 28

Comments: No obstructions were observed in sluice lines 1, 3, and 6. Two of these sluice lines were actively sluicing ash to the Ash Basin at the time of the inspection.

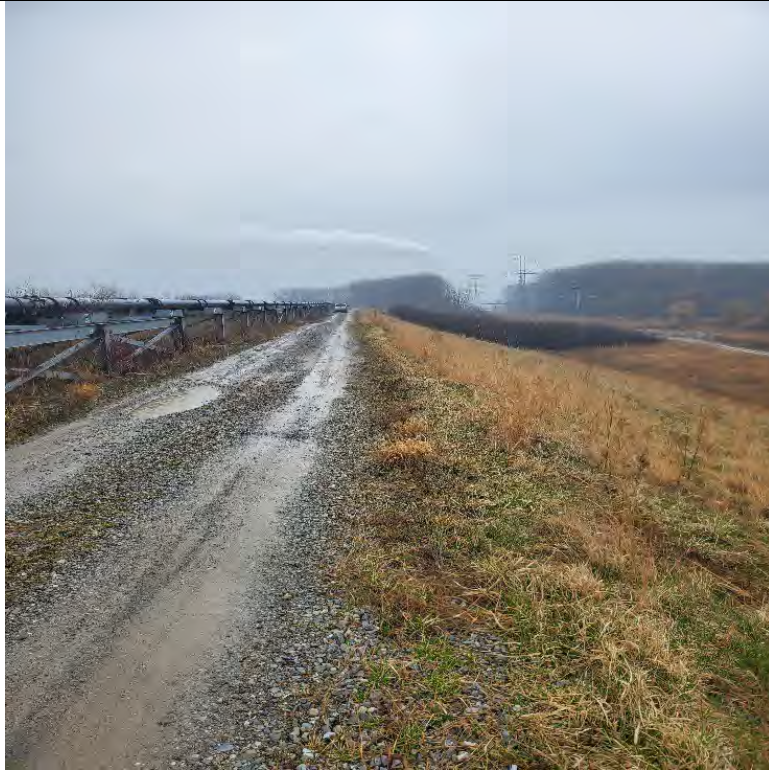
Photograph 32

Comments: The access road to the perimeter berm near approximate Station 168+00 were in good condition with no observed erosion rills.

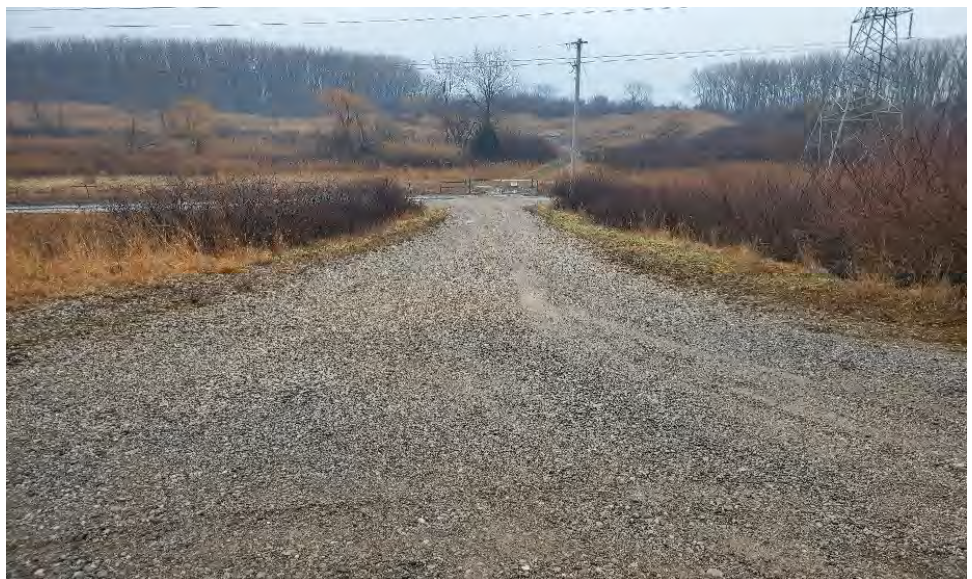
10. A prior wet area filled with gravel near approximate Stations 175+00 to 177+00 was inspected and not observed to be wet (see Photograph 33).
11. Sluice lines 5 (northern side of Ash Basin) (see Photograph 15) and 1, 3, and 6 (southern side of Ash Basin) (see Photographs 26 through 28) were inspected. The outlets of the sluice lines were near open water after repositioning lines 1, 3, and 6 since the last annual inspection. Line 5 and two of lines 1, 3, and 6 were actively sluicing ash into the Ash Basin at the time of the inspection. Access to the sluice lines was inspected and in good condition

Comments: A prior wet spot filled with gravel on the perimeter berm near approximate Stations 175+00 to 177+00 was observed during the inspection. No wet spots were observed. DTE has continued to monitor the repairs during the weekly inspections.

5. Small, mossy areas and a prior wet area filled with gravel near approximate Stations 175+00 to 177+00 were not wet at the time of inspection but should continue to be monitored. DTE has continued to monitor these repairs during weekly inspections.

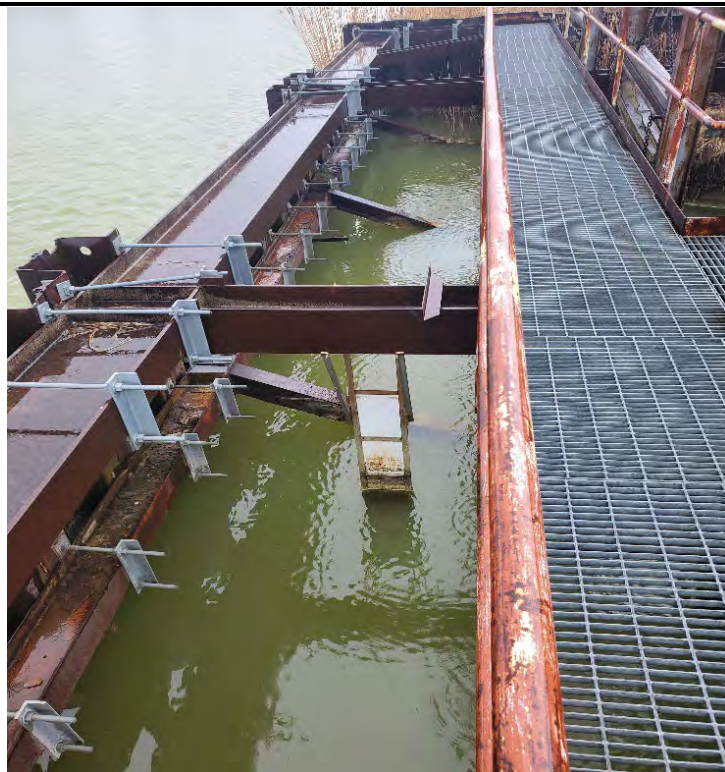
Comments: Sluice gates and discharge pipes for discharge structure were not obstructed.

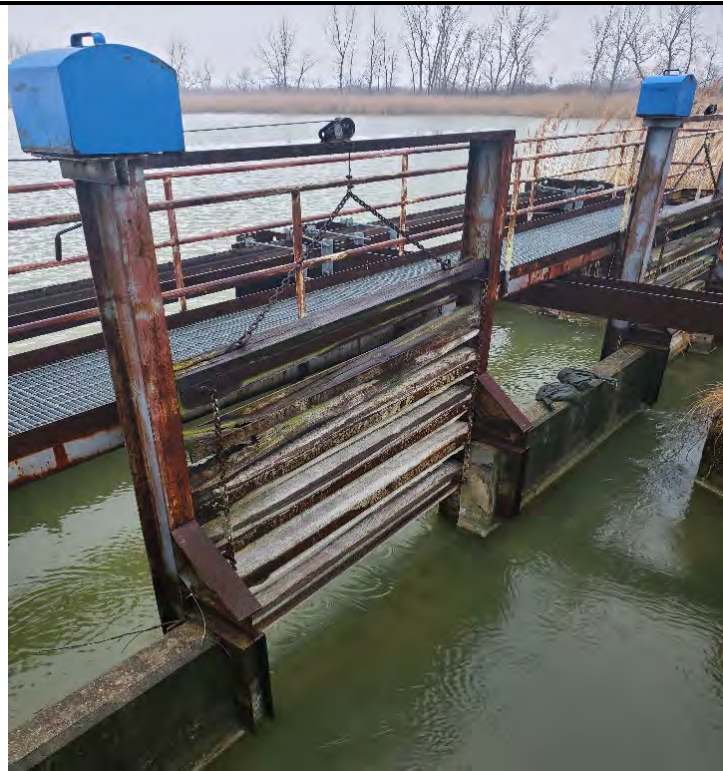
Comments: Exit from discharge structure to discharge canal was not obstructed. No slope disturbances were observed.
