**DTE Electric Company**  
One Energy Plaza  
Detroit, Michigan 48226

# **2020 ANNUAL INSPECTION REPORT ASH BASIN EMBANKMENT**

**MONROE POWER PLANT**

January 2021

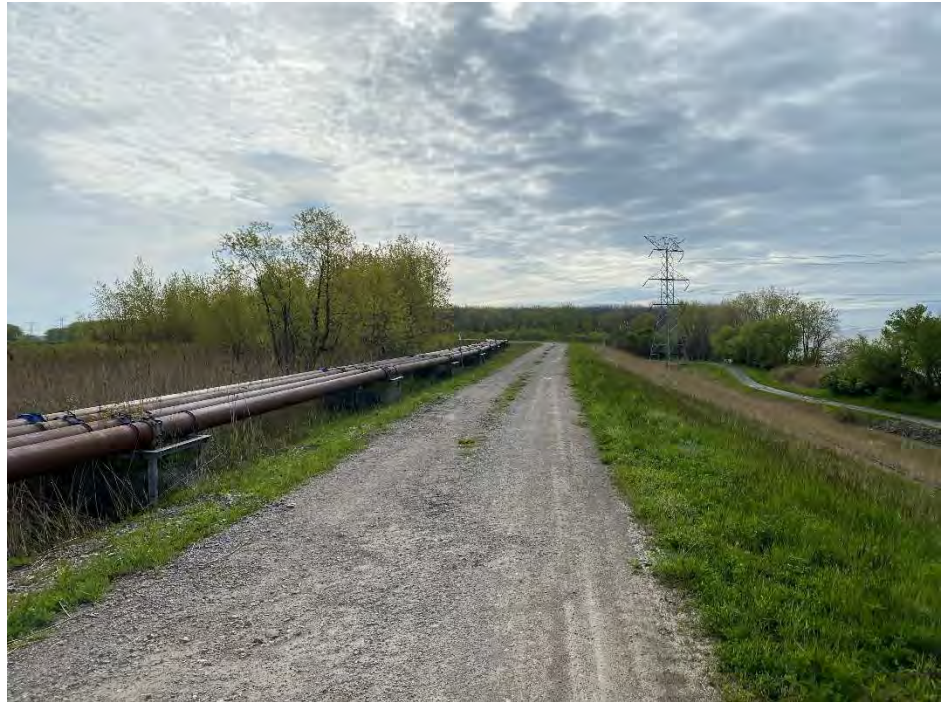
**Photograph 1**

**Comments: Photo taken at Station ~145+00. The Perimeter road appears to be in good, working condition.**

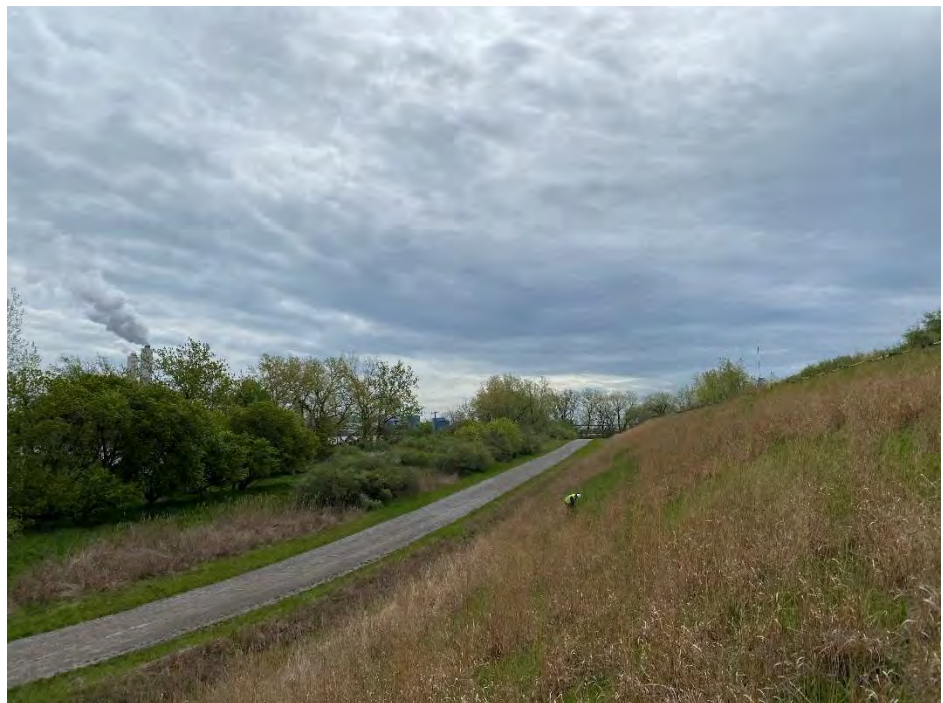
**Photograph 2**

**Comments: Photo taken at Station ~15+00. The embankment appears to have uniform slopes without signs of distress.**

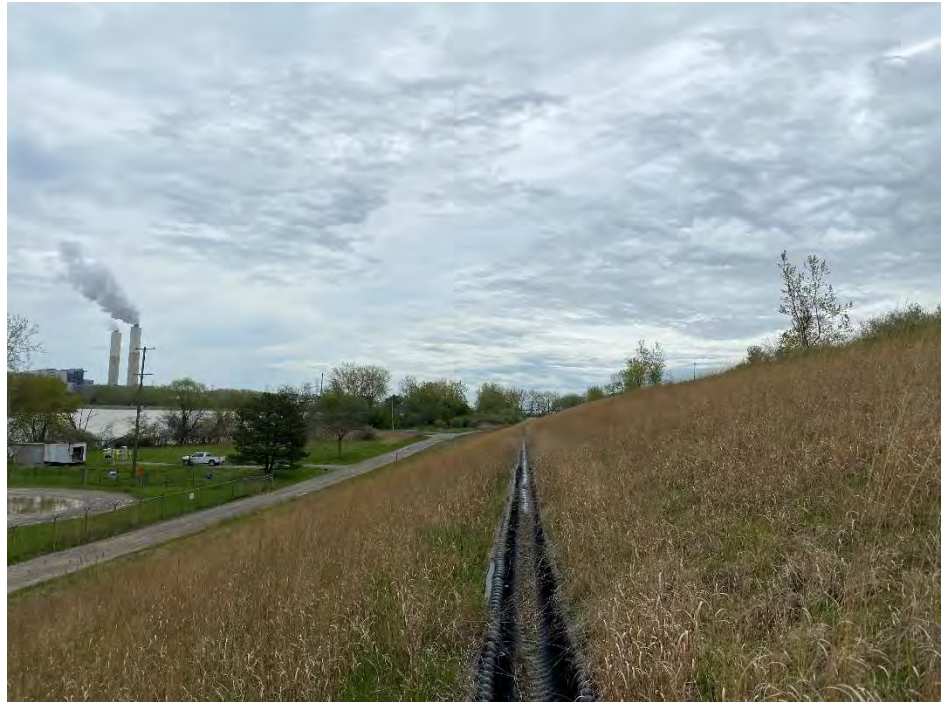
**Photograph 3**

**Comments: Photo taken at Station ~18+00. The embankment appears to have uniform slopes without signs of distress. The midslope ditch appears to be in functioning condition.**

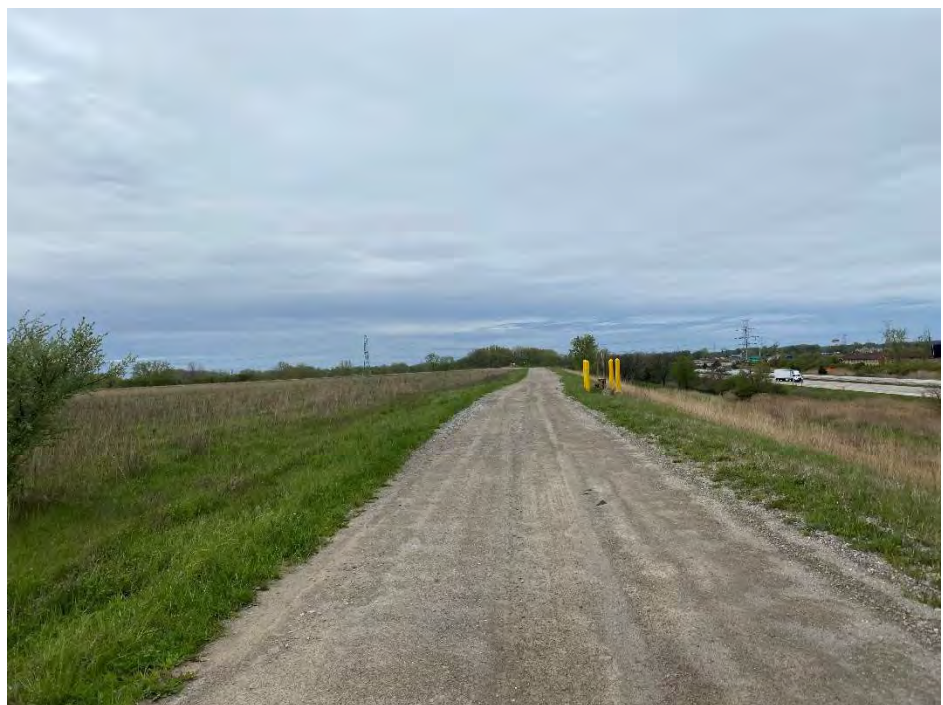
**Photograph 4**

**Comments: Photo taken at Station ~72+00. The Perimeter road appears to be in good, working condition.**

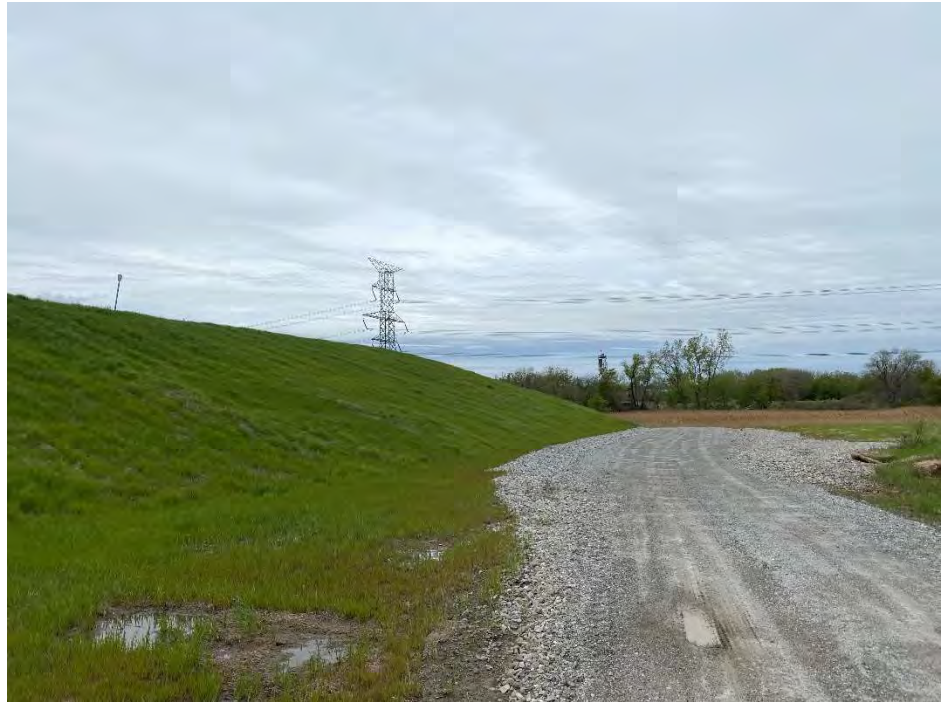
**Photograph 5**

**Comments: Photo taken at Station ~106+00. The embankment appears to have uniform slopes without signs of distress.**

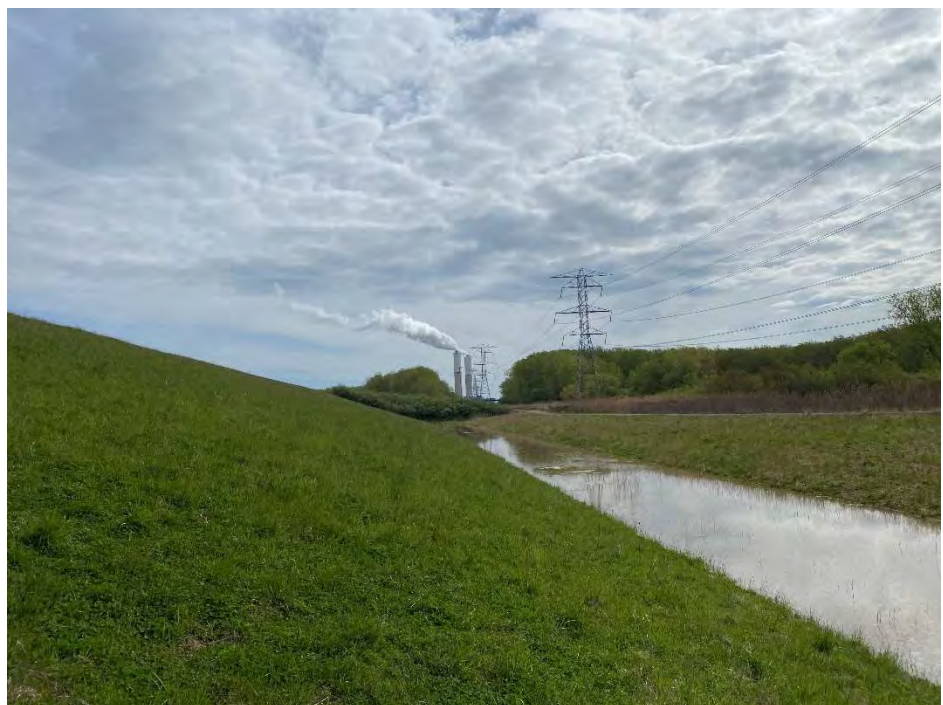
**Photograph 6**

**Comments: Photo taken at Station ~162+00. The embankment appears to have uniform slopes without signs of distress.**

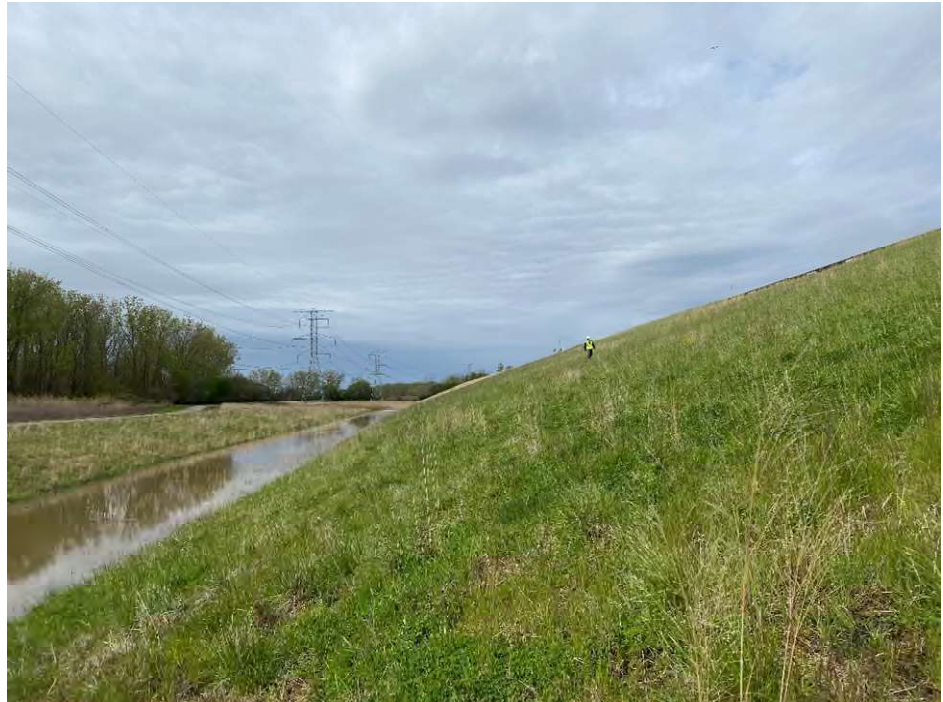
**Photograph 7**

**Comments: Photo taken at Station ~168+00. The embankment appears to have uniform slopes without signs of distress.**

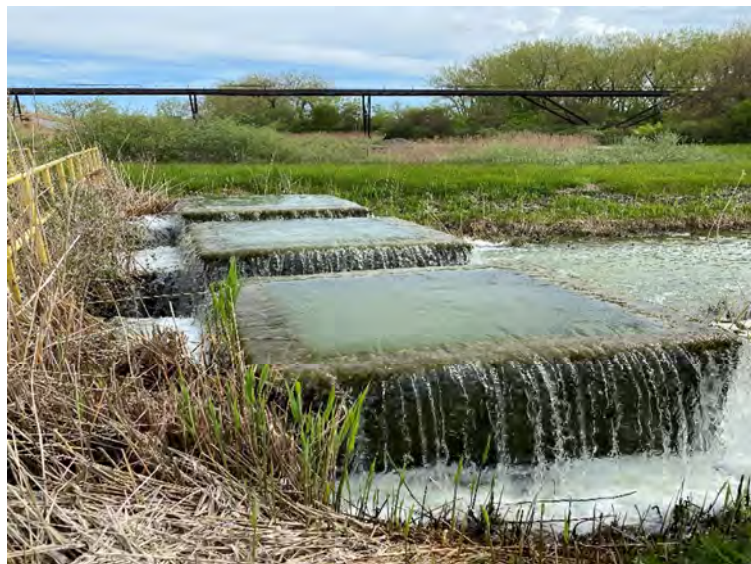
**Photograph 8**

**Comments: Photo taken at the outlet of the discharge structure. Water coming out of the aerators appears to be clear.**

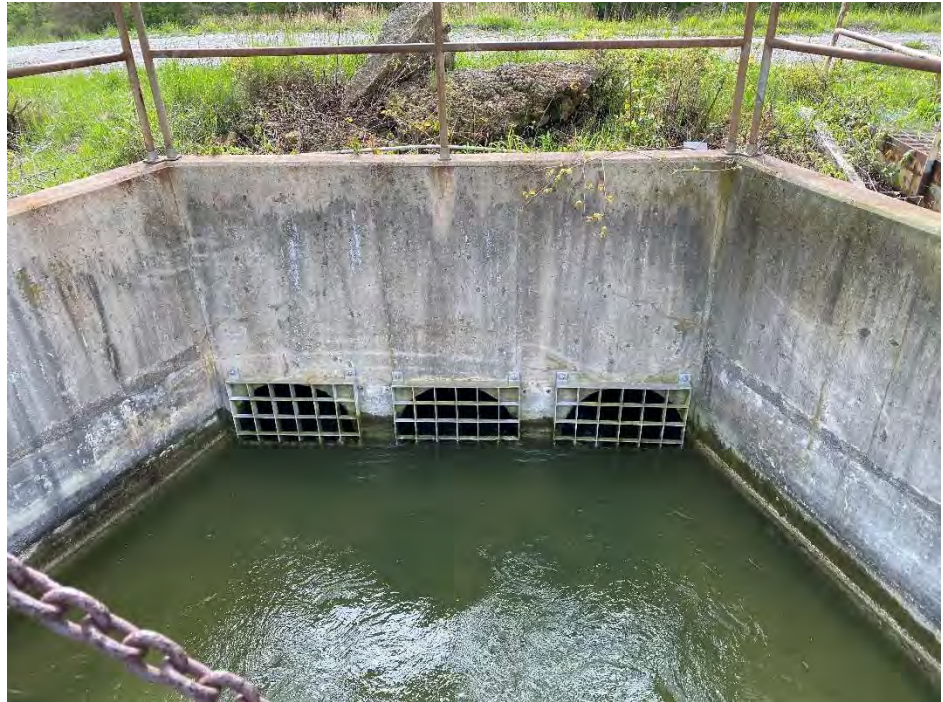
**Photograph 9**

**Comments: Photo taken at the discharge structure. The structure appeared to be in satisfactory working condition.**

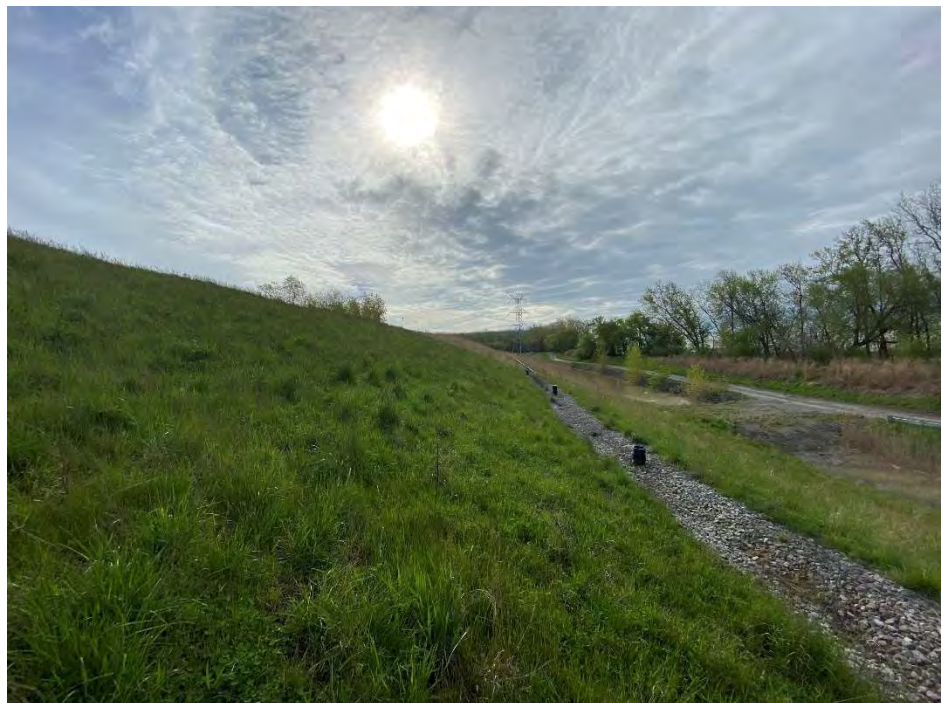
**Photograph 10**

**Comments: Photo taken at Station ~145+00. The embankment appears to have uniform slopes without signs of distress.**
