# **2020 ANNUAL INSPECTION REPORT VERTICAL EXTENSION LANDFILL**

**MONROE POWER PLANT**

**Monroe, Michigan**

January 2021

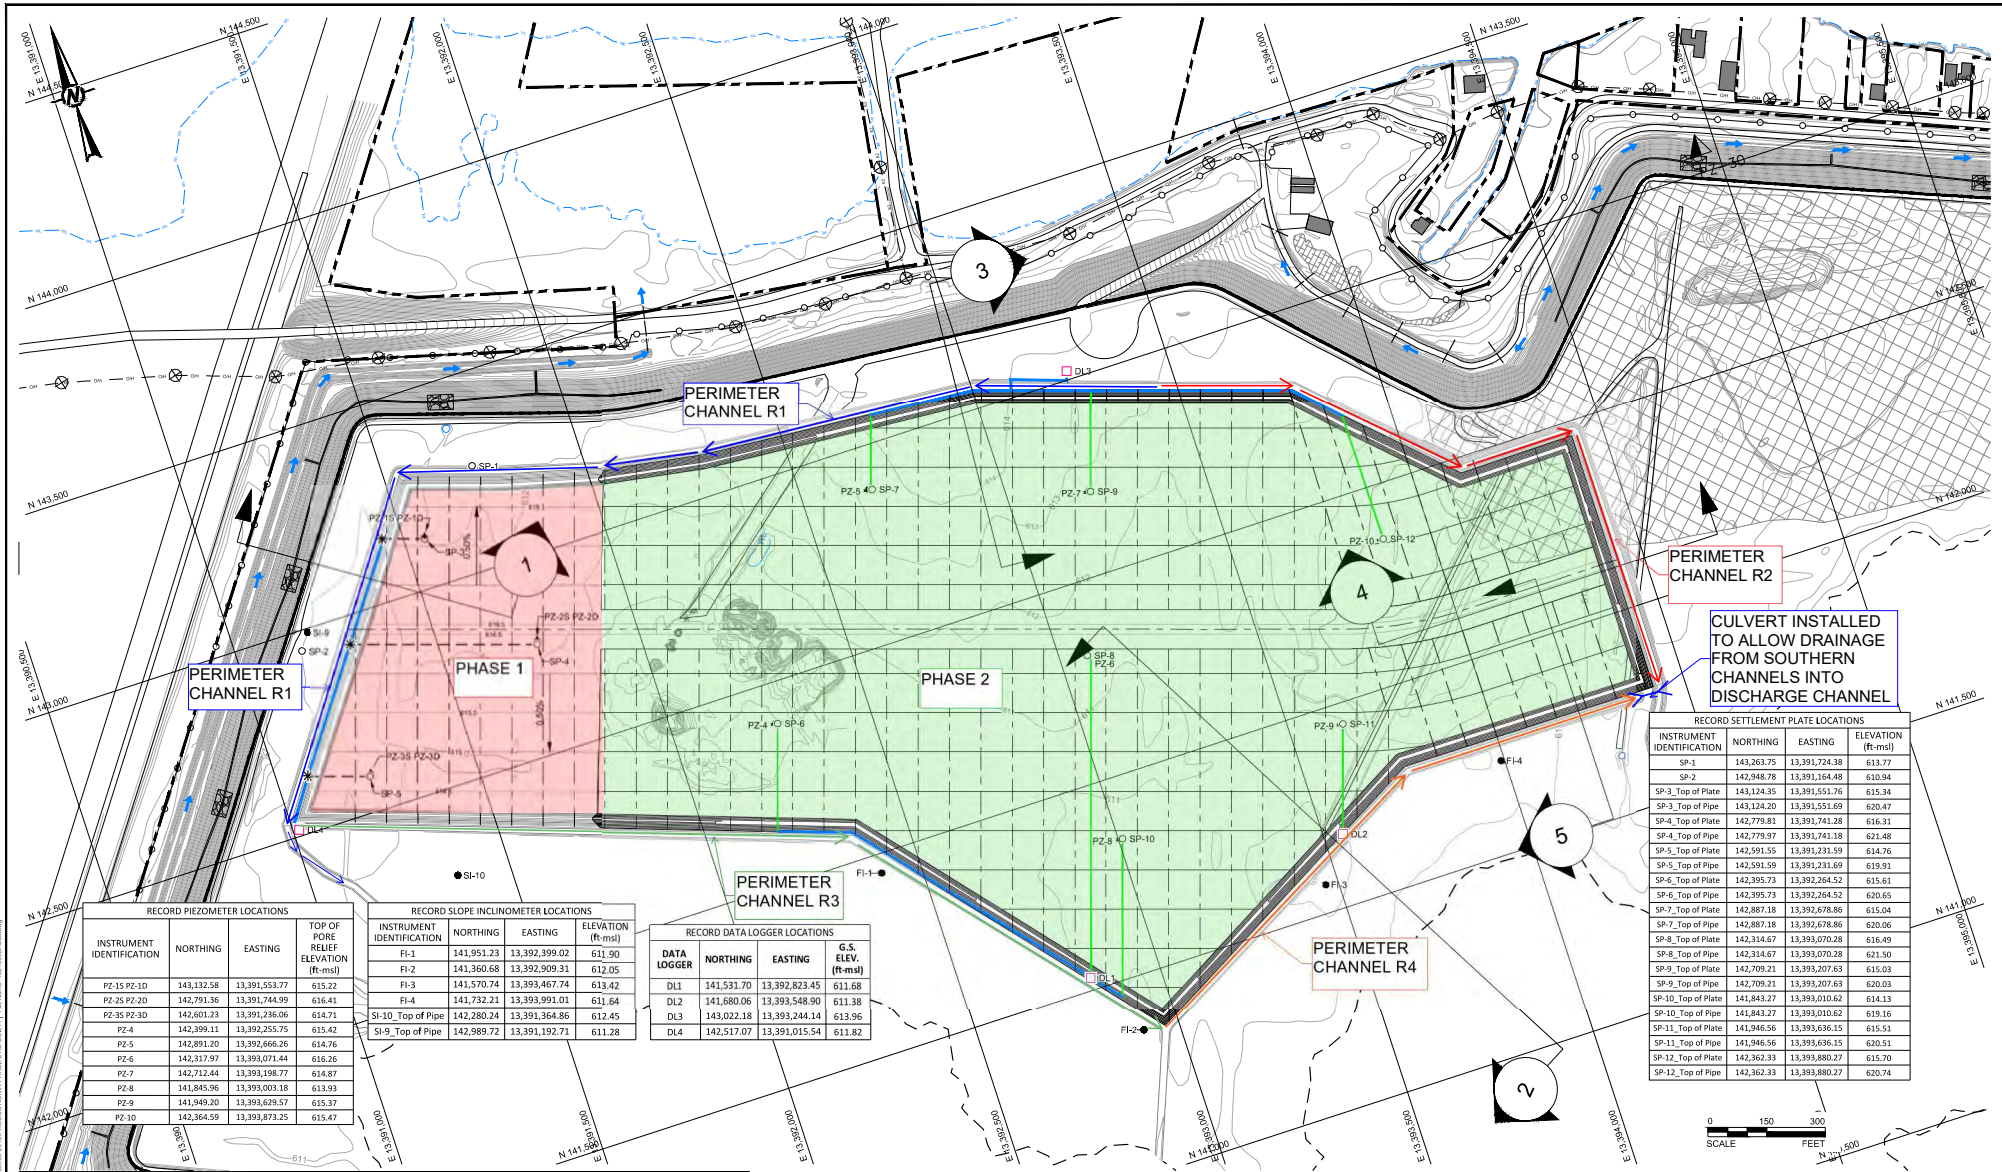
PROJECT No. 1521809D CONTROL 1521809DA005.dwg Rev. 0 FIGURE 2

**CULVERT INSTALLED TO ALLOW DRAINAGE FROM SOUTHERN CHANNELS INTO DISCHARGE CHANNEL**

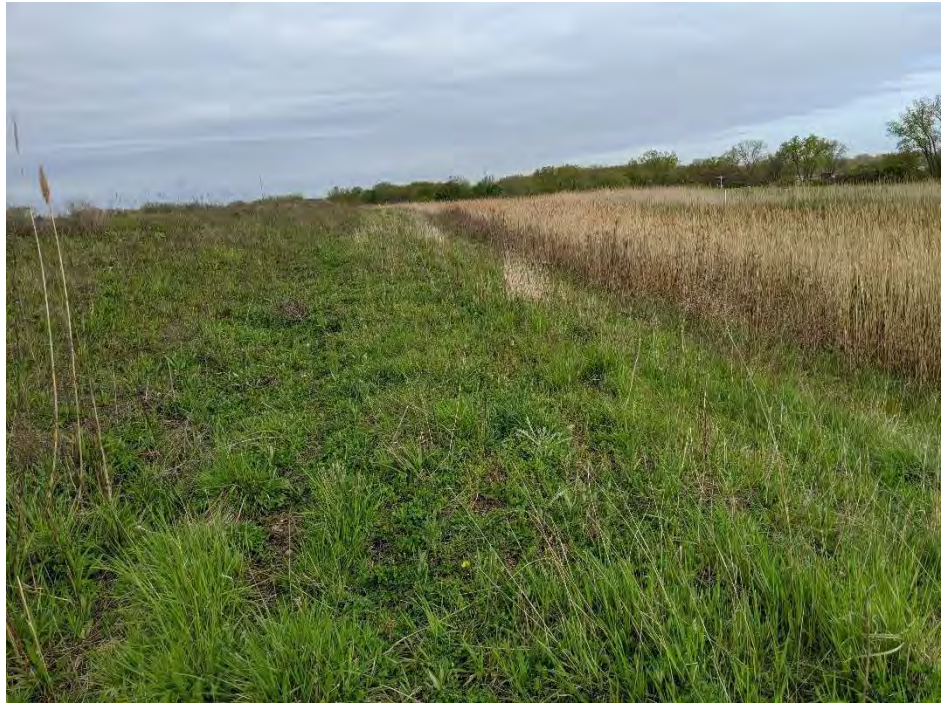
3. Are there indications of erosion on the landfill perimeter berm?      x Yes      \_\_\_ No  
If 'Yes', describe what type and its condition (rill, gully, dimensions, etc.) \_\_\_\_\_  
Some erosion rills were observed on the exterior slope of the perimeter berm. Overall, vegetation observed on exterior slope of perimeter berms (Photos 1 and 3).

**Comments: Perimeter berm on the north side, west of access road near Station 62 shows vegetation growth and erosion features not observed.**

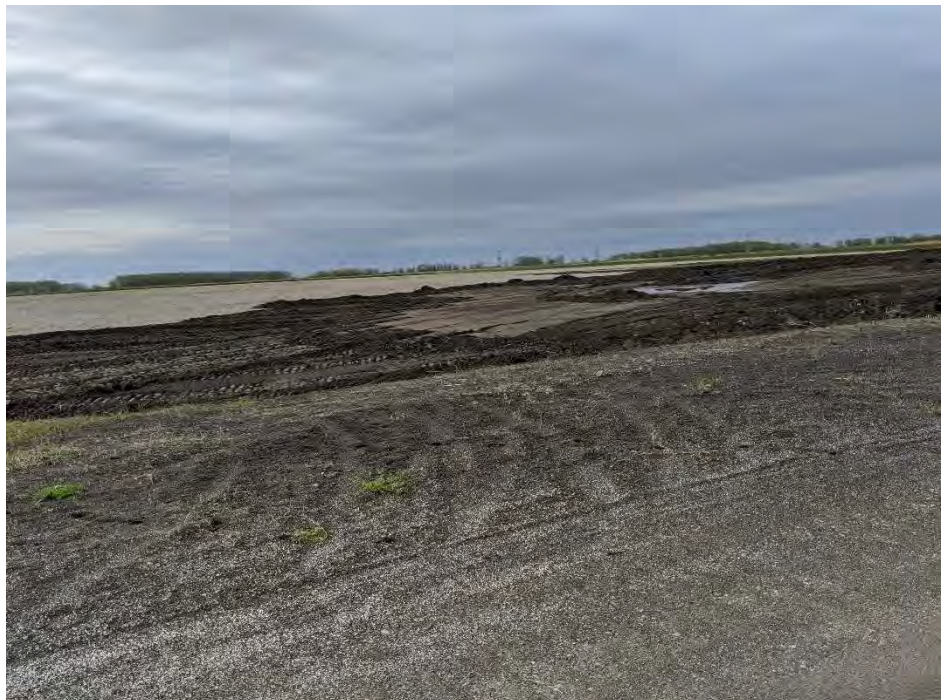
**Photograph 2**

**Comments: Filling in Phase 2 began in 2020. Perimeter access roads are in good condition.**

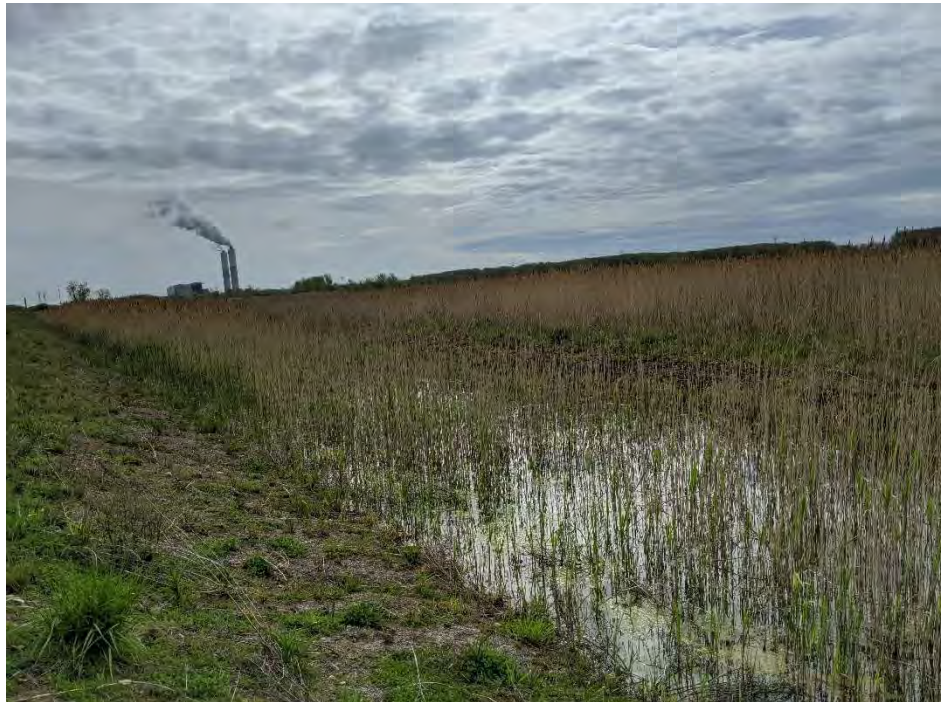
1. Describe operations in the landfill: Disposal of fly ash, bottom ash, economizer ash, FGD sludge  
Other: \_\_\_\_\_
2. Are any stormwater swales obstructed?      \_\_\_ Yes      x No  
If 'Yes', describe (type of debris, reason for obstruction, etc.) \_\_\_\_\_  
Standing water is observed in some areas; however, perimeter swales still drain (Photo 3).

4. Is runoff from the landfill surface contained by the perimeter ditch or Ash Basin?      x Yes      \_\_\_ No  
If 'No', describe where runoff flow is not contained. \_\_\_\_\_  
Perimeter swales were generally observed to have standing water. Water was contained in the swales and levels are generally below the pore pressure relief pipe outlets (Photos 3 and 4).

**Comments: Standing water observed in R4 perimeter swale on the southwest side. Water level well below perimeter berm crest. Minor rill erosion was observed on the perimeter berm.**

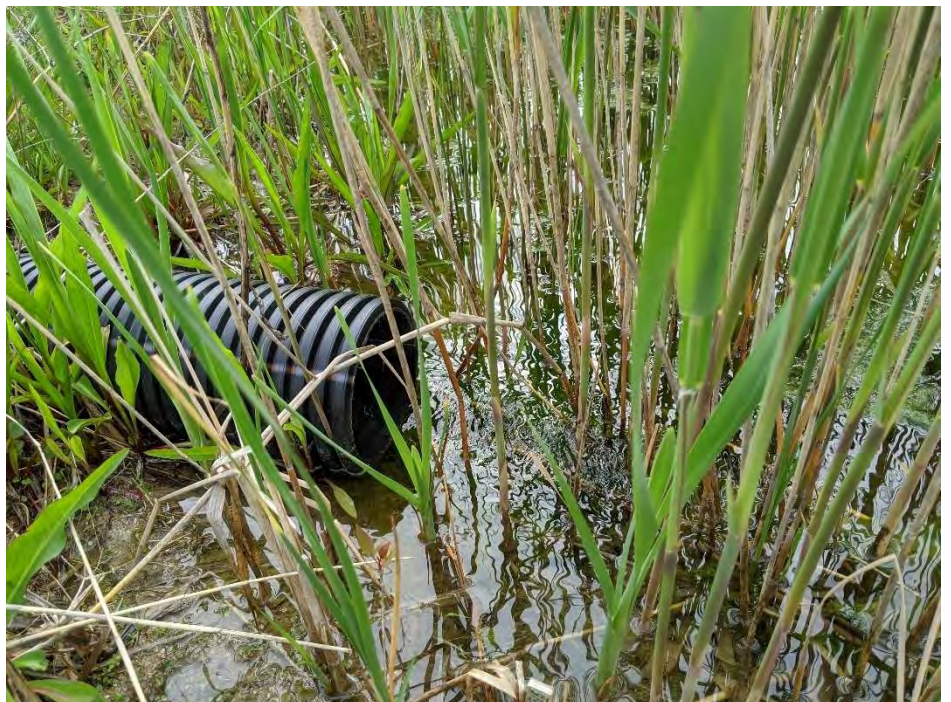
**Photograph ID: 4**

**Comments: Several of the pore pressure relief pipes were observed to be draining water into the perimeter swale. The water level in the swale is above the invert of the pipe.**

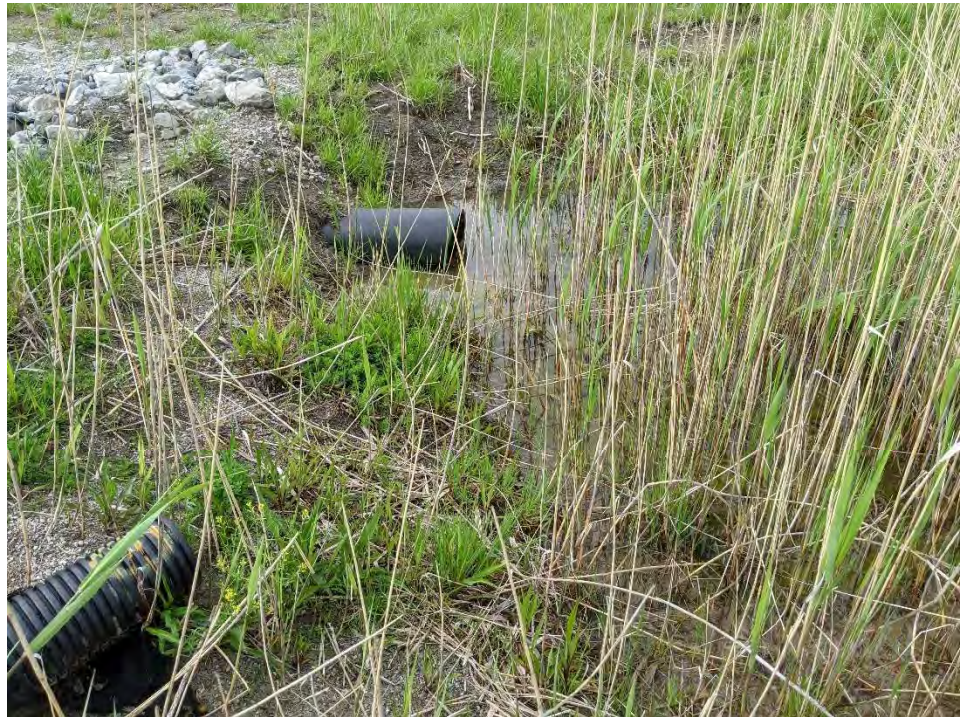
7. Is there any unusual settlement causing "birdbaths"?      \_\_\_ Yes      x No  
If 'Yes', describe. \_\_\_\_\_
8. Other observations around the landfill (changes since last inspection):      x Yes      \_\_\_ No  
If 'Yes', describe. New culvert was installed between R2 and R4 perimeter swales in southeast corner to collect flow from R3 and R4. Flow observed through the recently installed culvert (Photo 5).

**Comments: New culvert  
between R2 and R4  
perimeter swales in the  
southeast corner  
observed to be flowing.**

1. Has any routine maintenance been conducted since the last inspection?  Yes  No  
If 'Yes', describe. To lower water levels in perimeter swale, new culvert was installed between R2 and R4 perimeter swales in southeast corner to collect flow from R3 and R4. Flow observed through culvert (Photo 5).

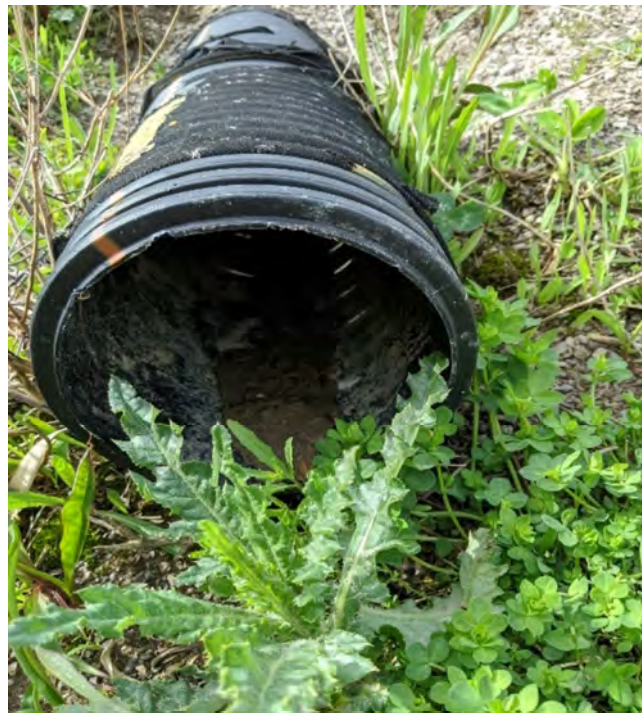
**Photograph ID: 6**

5. Is runoff prevented from entering the landfill area?      x Yes      \_\_\_ No  
If 'No', describe where runoff flow is not contained. \_\_\_\_\_
6. Is the underdrain collection system draining?      x Yes      \_\_\_ No  
Describe flow conditions. Many of the pore pressure relief pipes were observed to have some sediment build-up at the outlets (generally < 0.5 inches deep). Some of the pipes were draining at the time of inspection.  
Sediment build-up does not appear to impede flow. (Photo 6)

**Comments: Typical  
sediment build-up in  
pressure relief pipes at  
the outlet. Sediment  
depth < 0.5 inches and  
does not appear to  
impede flow.**

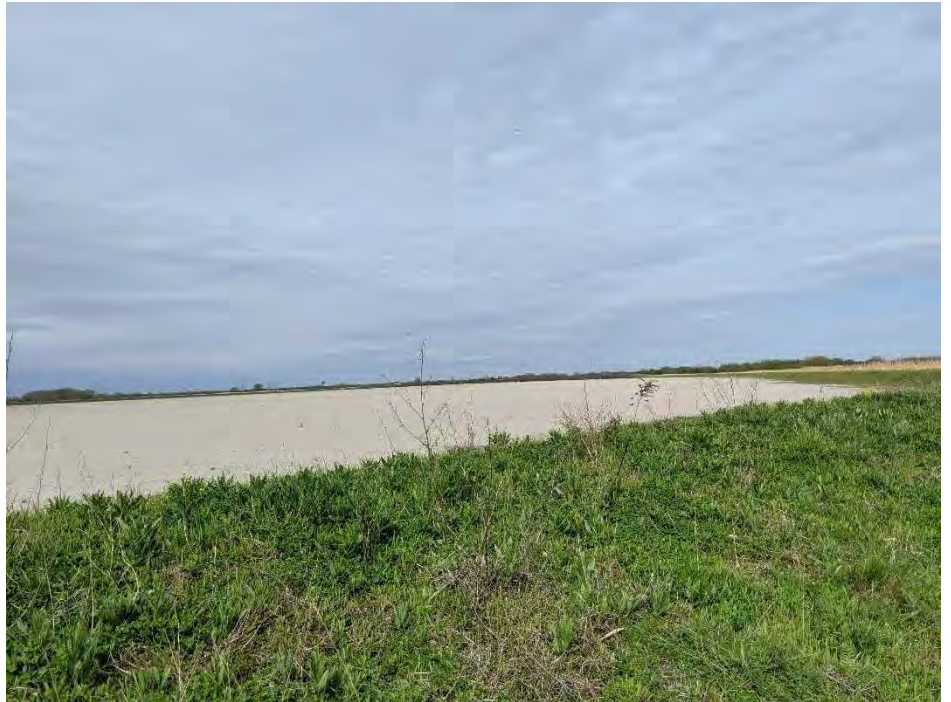
**Comments: View of  
over liner in Phase 2 on  
the east side of Landfill.  
No filling activities in  
this area. Vegetation  
growth was observed on  
perimeter berm.**

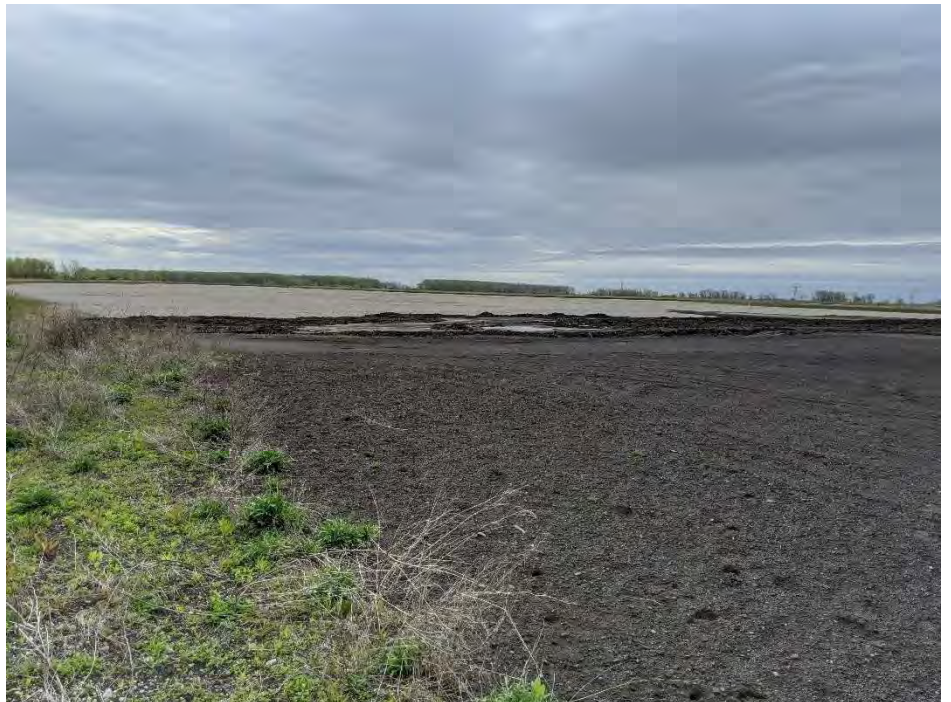
**Photograph ID: 8**

**Comments: View of  
Phase 2, where filling  
started. CCR grade is  
near the top of the  
perimeter access road in  
Phase 1. No observed  
low spots.**

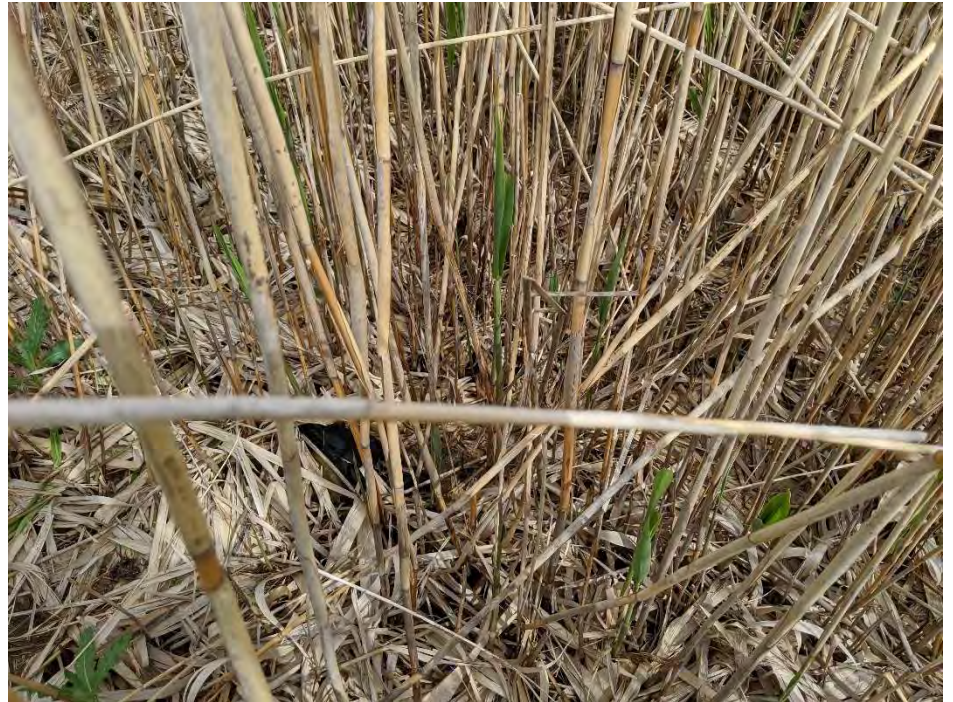
**Comments: Small  
standing water observed  
in R1 and R2 perimeter  
swales along the north  
side.**
