# **2015 ANNUAL INSPECTION REPORT ASH BASIN EMBANKMENT**

**MONROE POWER PLANT**

**Monroe, Michigan**

January 2016

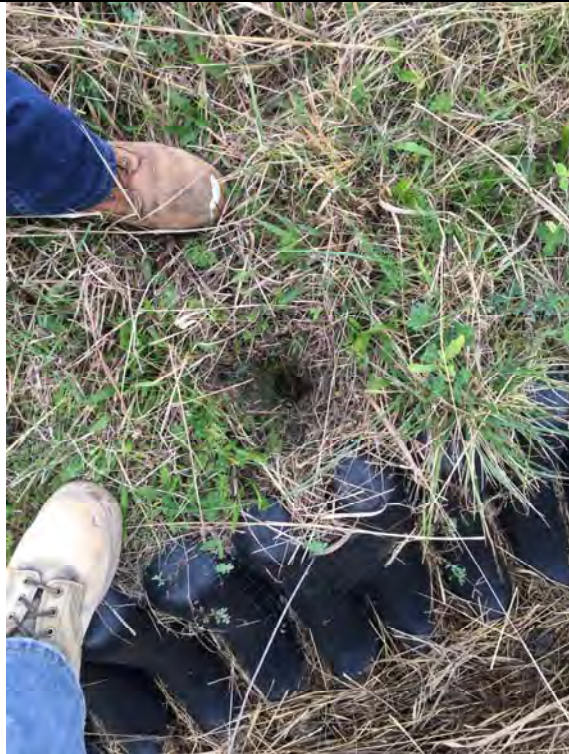
8. Numerous holes, approximately two-inch in diameter, were observed on the upslope side of the midslope stormwater ditch between Stations 14+00 and 35+00 (see Photograph 11 in Appendix A); they appeared to be animal burrows.

Comments: Numerous holes in ~2-in diameter, appeared to be animal burrows, were observed on the upslope side of the midslope stormwater ditch between Stations 14+00 and 35+00.

- Numerous approximately two-inch diameter holes, which appeared to be animal burrows, do not represent an immediate concern for the safe operation or stability of the ash basin embankment. However, animal burrows should be maintained in accordance with IMM Manual.
- Potholes and ruts on the embankment crest do not represent an immediate concern for the safe operation or stability of the ash basin embankment. However, they should be maintained within a year in accordance with IMM Manual.
- Erosion rills observed on the access ramp at Station 110+00 do not represent an immediate concern for the safe operation or stability of the ash basin embankment. The repair was reportedly made in accordance with the IMM Manual after the annual inspection and will be further inspected in 2016.

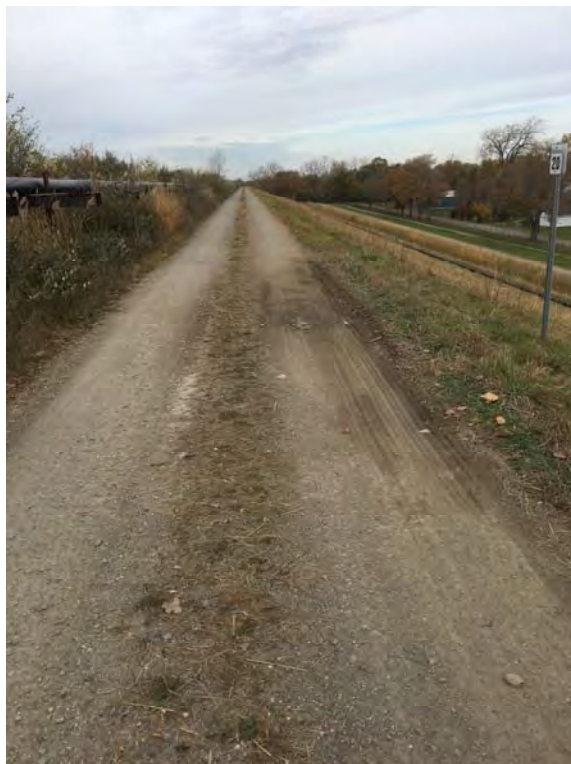
Photograph 4

Comments: Photo taken at Station ~20+00, facing west. The crest between Stations 4+00 and 45+00 appeared to be level without sign of distress. A localized rutting by the outer edge of the road was observed at this station.

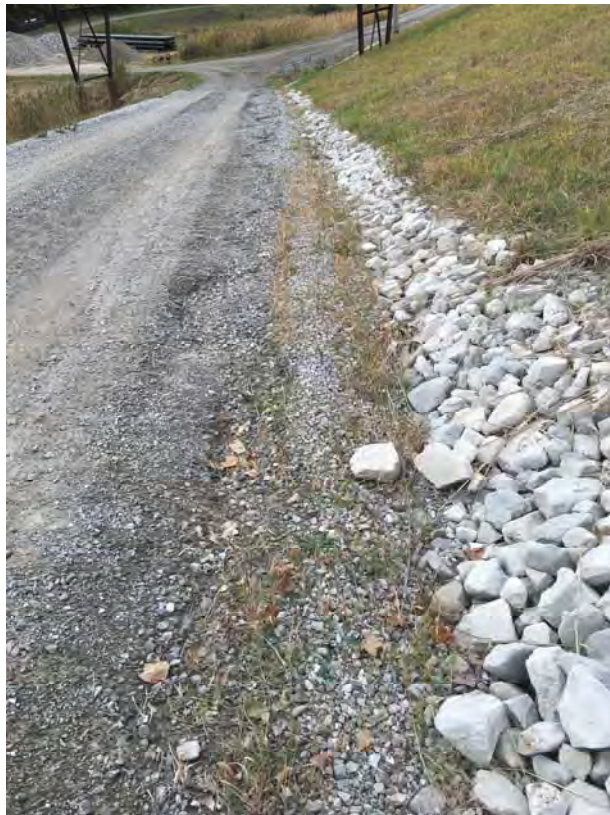
Photograph 10

Comments: Photo taken at Station ~2+00, facing south. Erosion rills were observed on access ramps at Station 0+00.

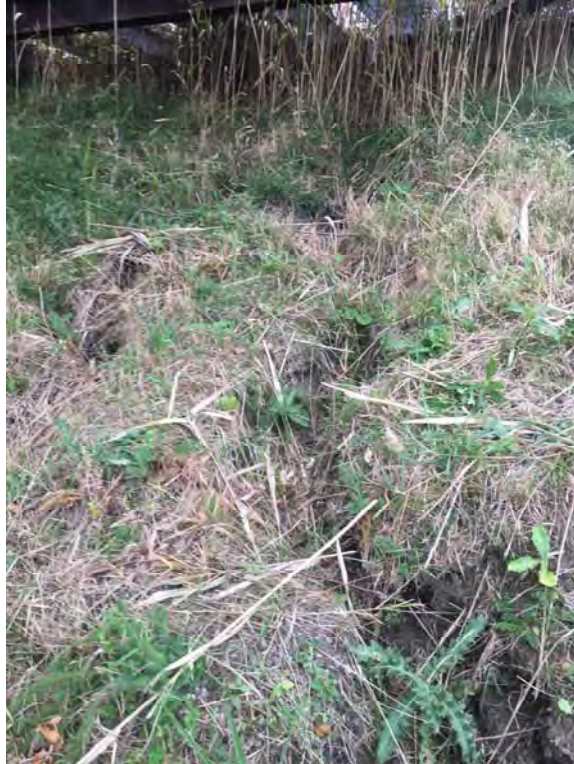
2. An erosion gully approximately one-foot deep was observed on the embankment under the trestle structure, where slurry lines reach the embankment at Station 0+00 (see Photograph 11 in Appendix A).

Comments: Photo taken at Station 0+00 under the pipe trestle. Approximately a foot deep gully was observed under the northern most pipe. No ash was observed on the slope.

- Approximately one-foot deep erosion gully that was observed on the embankment under the trestle structure does not represent an immediate concern for the safe operation or stability of the ash basin embankment; the repair was reportedly made in accordance with the IMM Manual after the annual inspection and will be further inspected in 2016.

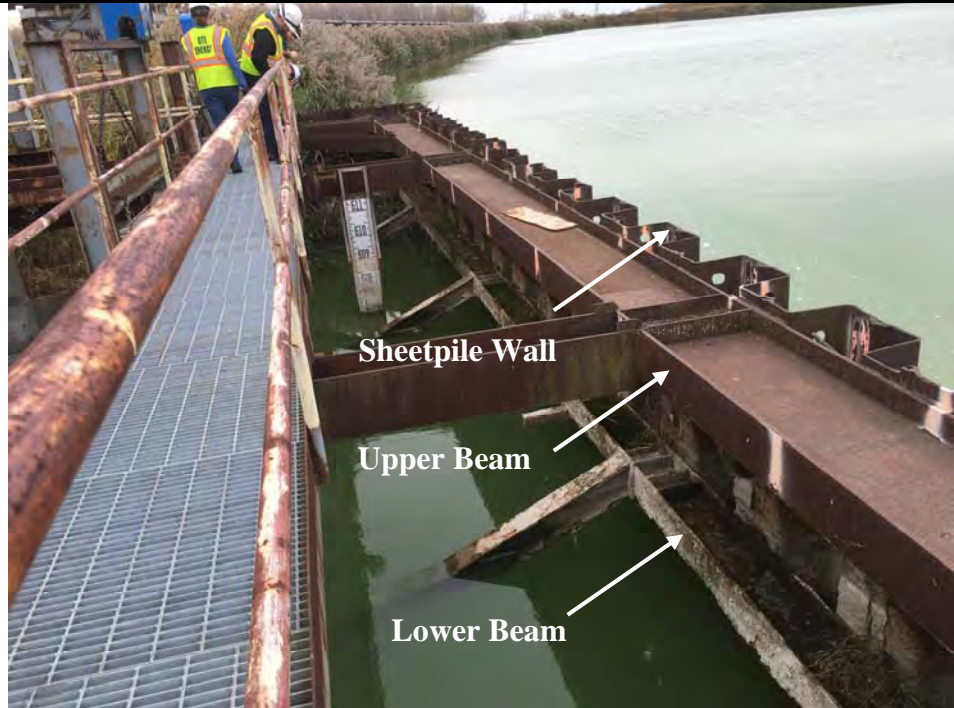
3. Some of the welds along the western sheet pile flow control wall between the upper beam and sheet pile, and between lower beam and sheet pile appeared to be broken (see Photographs 12 and 13 in Appendix A).

Comments: Photo taken at Station 179+00 at the discharge structure, facing south. Some of the welds between the beam and Sheetpile wall appeared to be cracked. DTE is currently in the process of design and repair of broken welds.

- Multiple broken welds that were observed at the discharge structure do not represent an immediate concern for the safe operation or stability of the ash basin embankment. DTE is currently working on designing modifications to the discharge structure and repair of the broken welds.

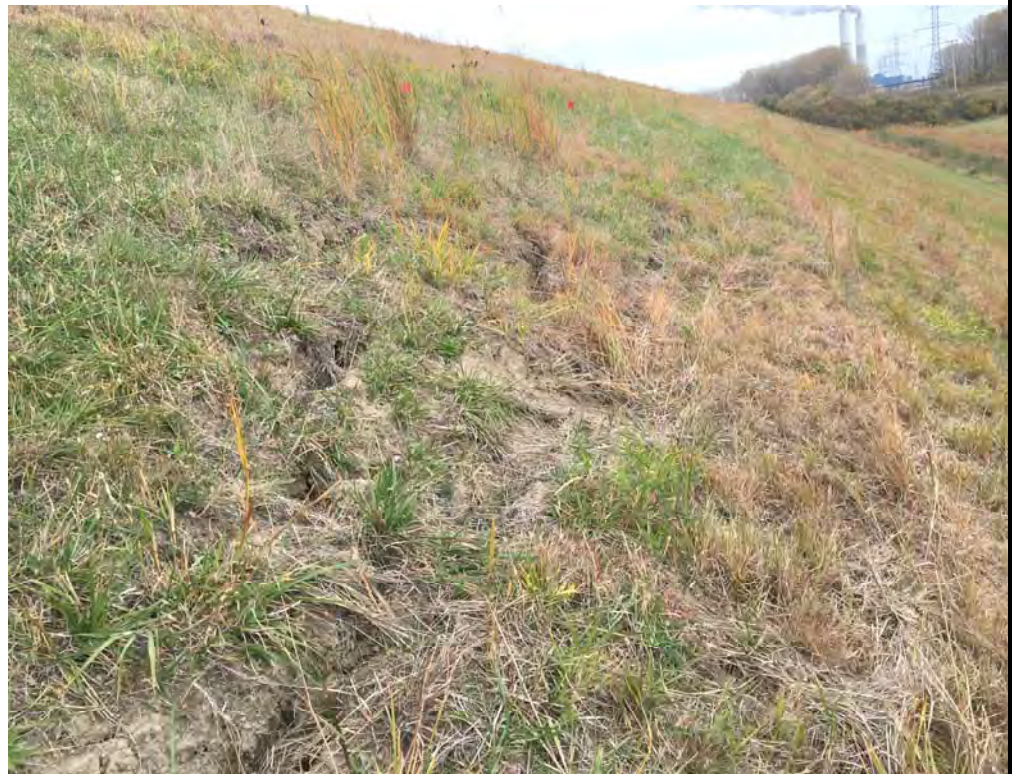
Photograph 20

1. Surficial sloughs up to several feet deep were observed on the exterior slope of the embankment at three separate areas: (i) at Station ~67+00 extending approximately 120 ft along the embankment, which damaged the midslope stormwater ditch (see Photographs 37 thru 40 in Appendix A); (ii) from Station 140+00 to 145+00 causing damage to the midslope stormwater ditch (see Photographs 24 thru 26 in Appendix A); and (iii) at Station 162+00 extending approximately 90 ft along the embankment (see Photographs 20 and 21 in Appendix A).

Comments: Photo taken at Station ~162+00, facing north. Sloughs, cracks and heave were observed on the slope along ~90 ft of the embankment. DTE is currently in the process of design and repair of the embankment at this location.

- Sloughs observed on the embankment at Stations 67+00, from 142+00 to 145+00, and at 162+00 do not represent an immediate concern for global stability of the ash basin embankment; these sloughs were reportedly repaired after the annual inspection and will be further inspected in 2016.

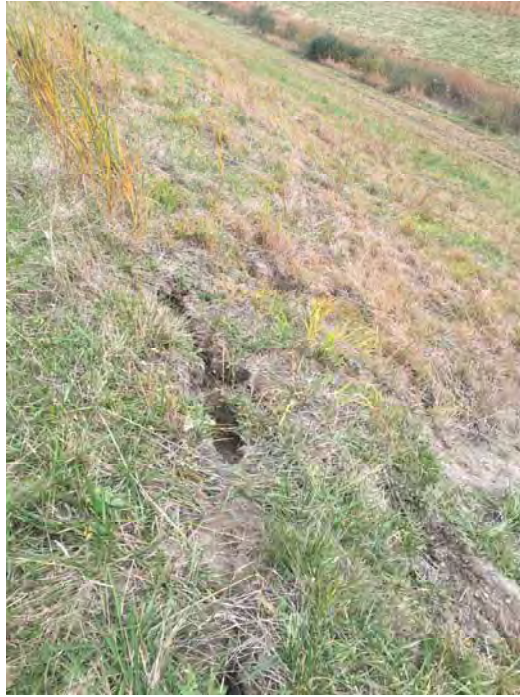
Comments: Photo taken at Station ~162+00. Sloughs, cracks and heave were observed on the slope along ~90 ft of the embankment. DTE is currently in the process of design and repair of the embankment at this location.

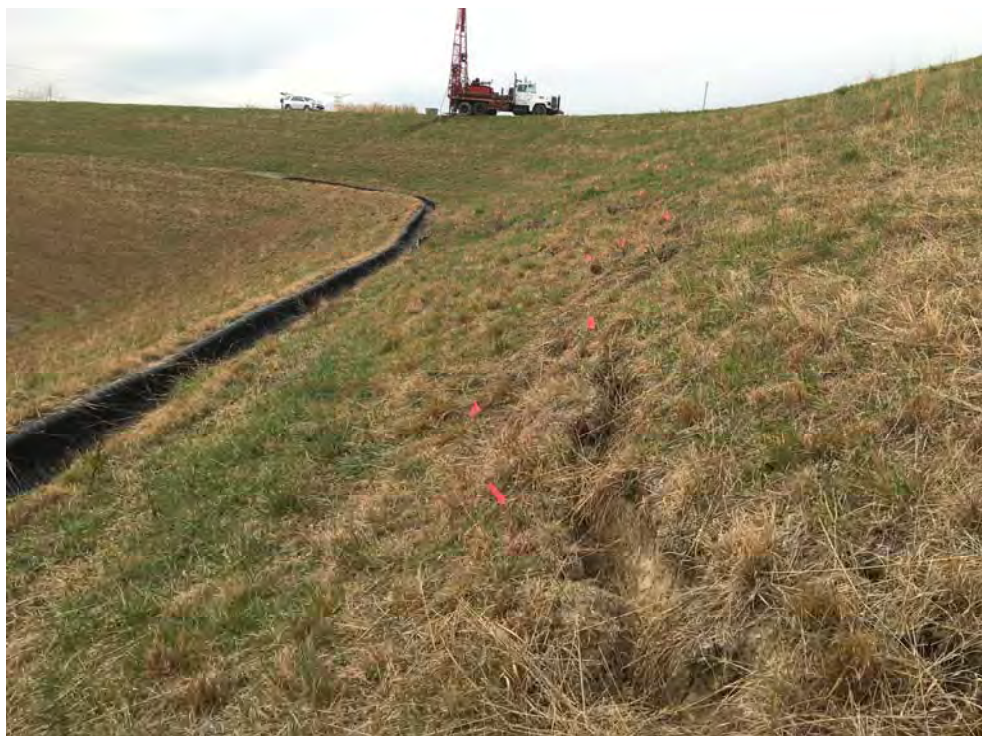
Photograph 24

Comments: Photo taken at Station ~145+00, facing west. Sloughs, cracks and heave were observed on the embankment between Stations 140+00 and 145+00. DTE is currently in the process of design and repair of the embankment at this location.

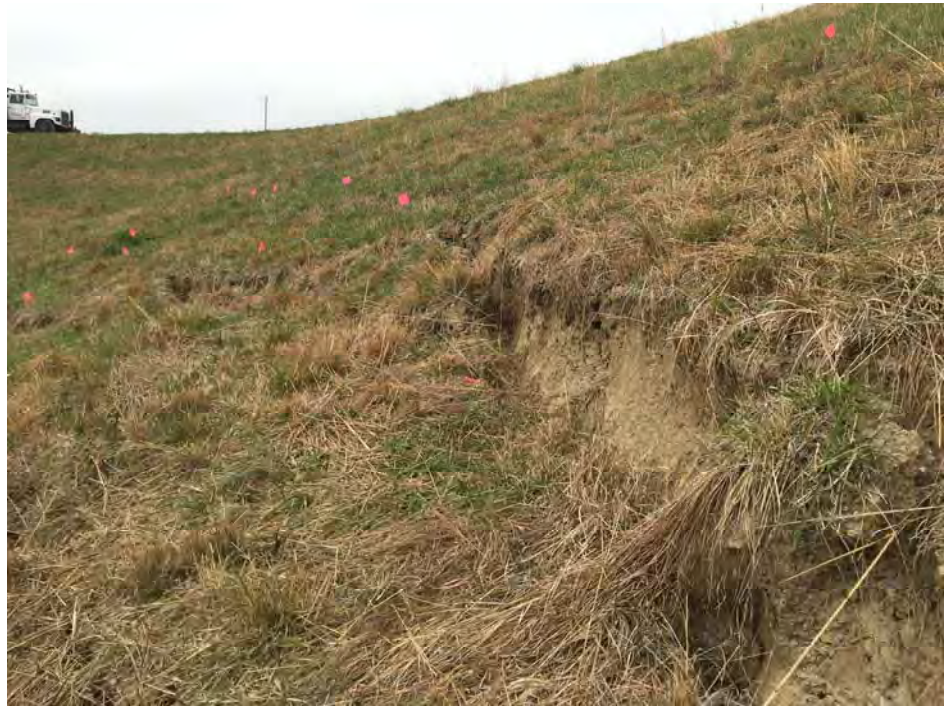
Comments: Photo taken at Station ~145+00, facing west. Sloughs, cracks and heave were observed on the embankment between Stations 140+00 and 145+00. DTE is currently in the process of design and repair of the embankment at this location.

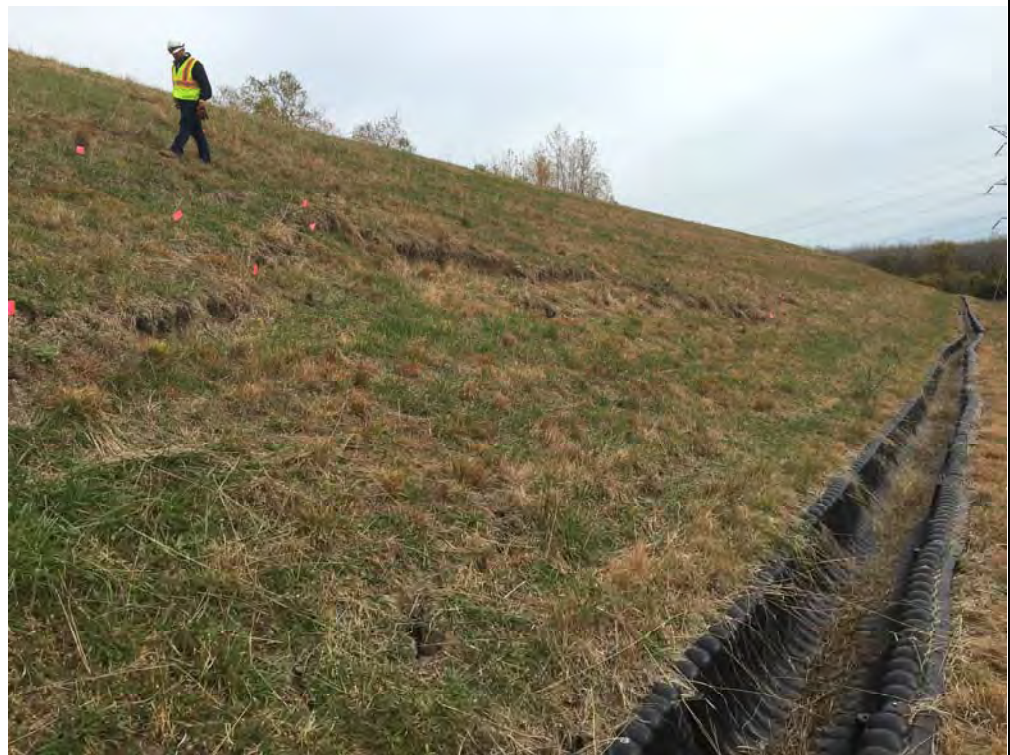
Photograph 26

Comments: Photo taken at Station ~143+00, facing east. Sloughs, cracks and heave were observed on the embankment between Stations 140+00 and 145+00. DTE is currently in the process of design and repair of the embankment at this location.

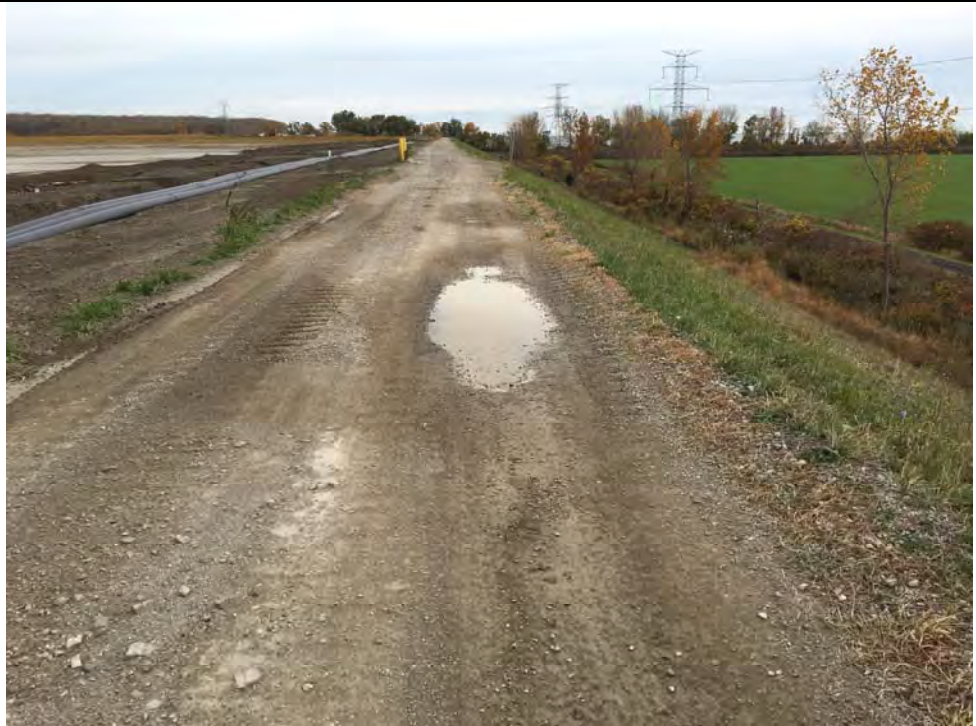
Comments: Photo taken at Station ~130+00, facing east. The crest of the southern embankment between Stations 110+00 and 139+00 appeared to be generally level without sign of distress. Several ruts and potholes were observed.

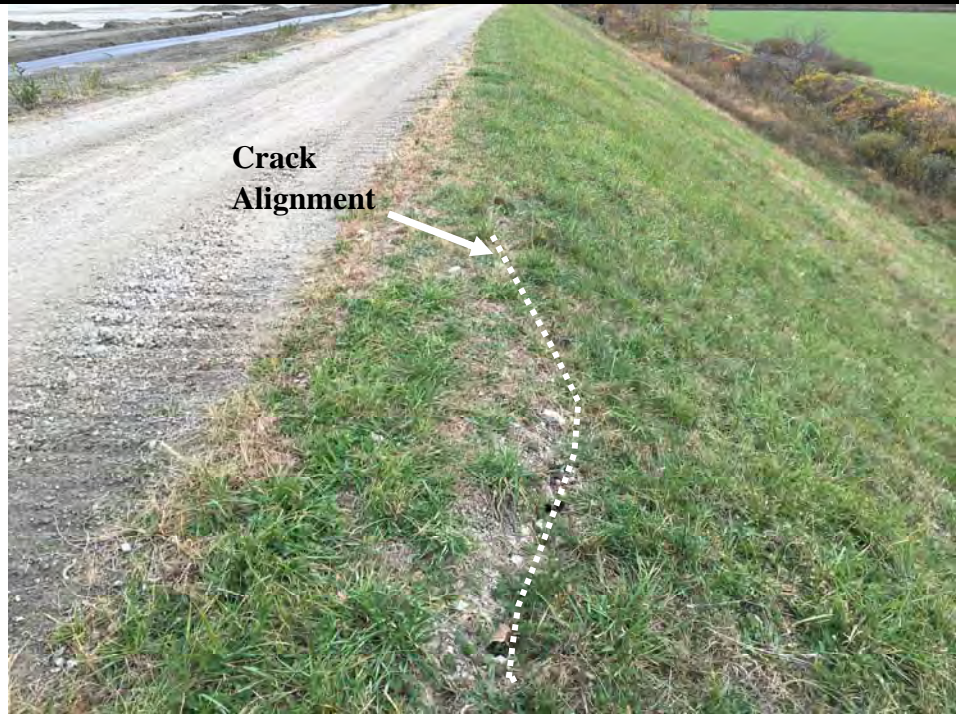
4. A crack, approximately 20-ft long and up to several inches wide, was observed at Station ~122+00 by the outer edge of the crest perimeter road (see Photographs 29 and 30 in Appendix A). Approximately 5-ft long, an inch wide crack was observed in the middle of upper slope at Station 78+50 (see Photograph 36 in Appendix A).

Comments: Photo taken at Station ~122+00, facing east. Up to a couple of inches wide ~20-ft long crack was observed along the upper embankment by the road.

- The crack that was observed at the top of the embankment at Station 122+00 does not represent an immediate concern for the safe operation or stability of the ash basin embankment. The crack should be monitored on a regular basis at a frequency of once every 30 days (maximum).

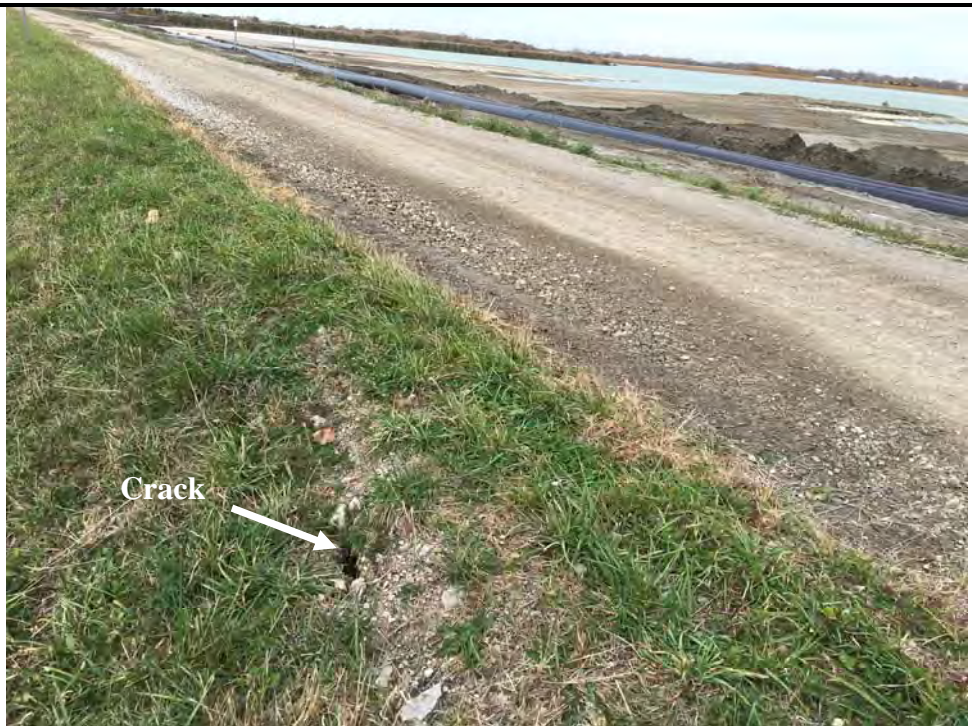
Photograph 30

Comments: Photo taken at Station ~122+00, facing east. Up to a couple of inches wide ~20-ft long crack was observed along the upper embankment by the road. Rutting was also observed on the road immediately adjacent to the crack.

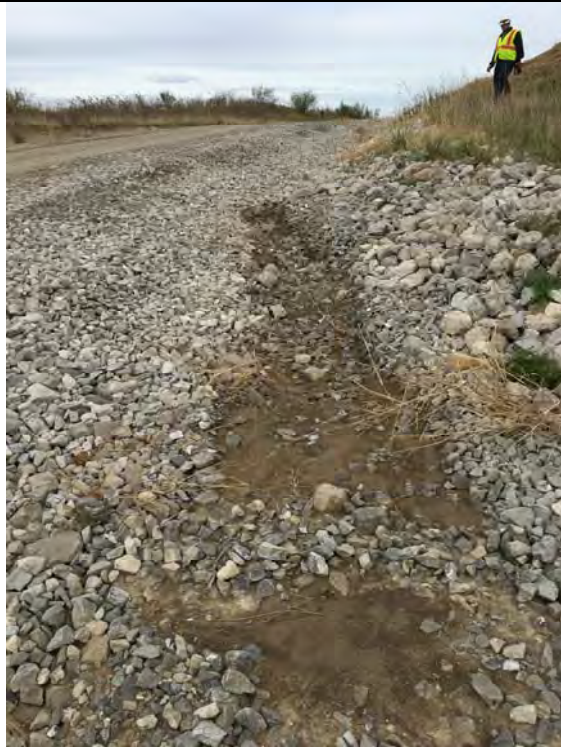
5. An erosion gully, approximately six-inches deep, was observed at the toe of the embankment at Station ~110+00 (see Photographs 31 and 32 in Appendix A). An erosion gully, approximately one-foot deep, was observed at the same station on the other side of the perimeter road away from the embankment (Photograph 33 in Appendix A).

Comments: Photo taken at Station ~110+00, facing north. Erosion was observed at the toe of the embankment. Aggregate that was previously placed washed out.

- Erosion features observed by the toe of the embankment and by the lower perimeter road at Station 110+00 do not represent an immediate concern for the safe operation or stability of the ash basin embankment; however, these erosion features can be a source of sediment in stormwater runoff. The repair was reportedly made in accordance with the IMM Manual after the annual inspection and will be further inspected in 2016.

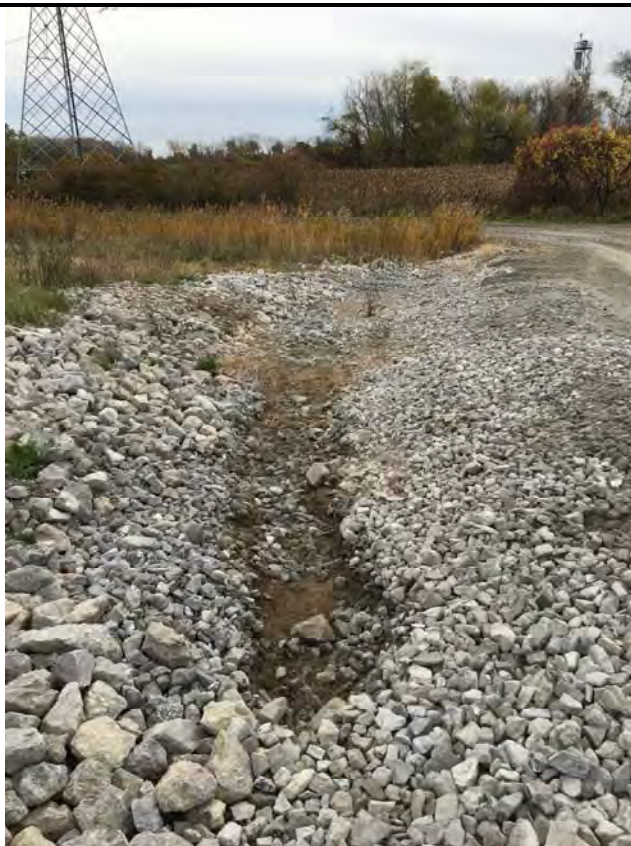
Photograph 32

Comments: Photo taken at Station ~110+00, facing south. Erosion was observed at the toe of the embankment. Aggregate that was previously placed washed out.

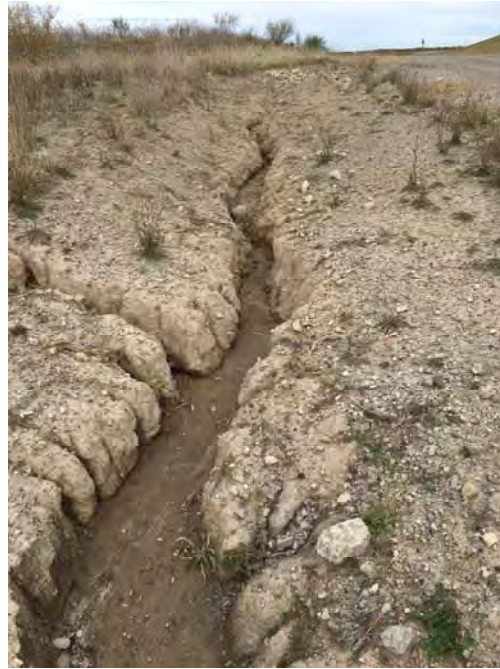
Comments: Photo taken at Station ~110+00, facing north. Erosion was observed along the side of the perimeter road (away from the embankment).

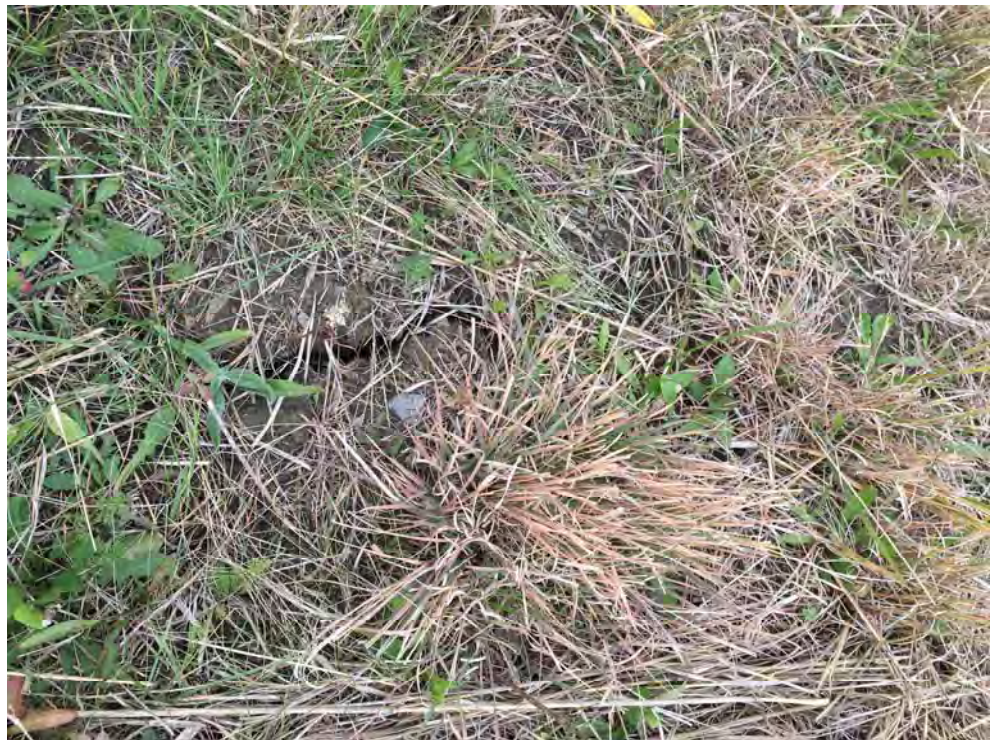
Photograph 36

Comments: Photo taken at Station ~78+50. An inch wide, five-foot long crack was observed on the middle of upslope (upslope of the midslope stormwater ditch).

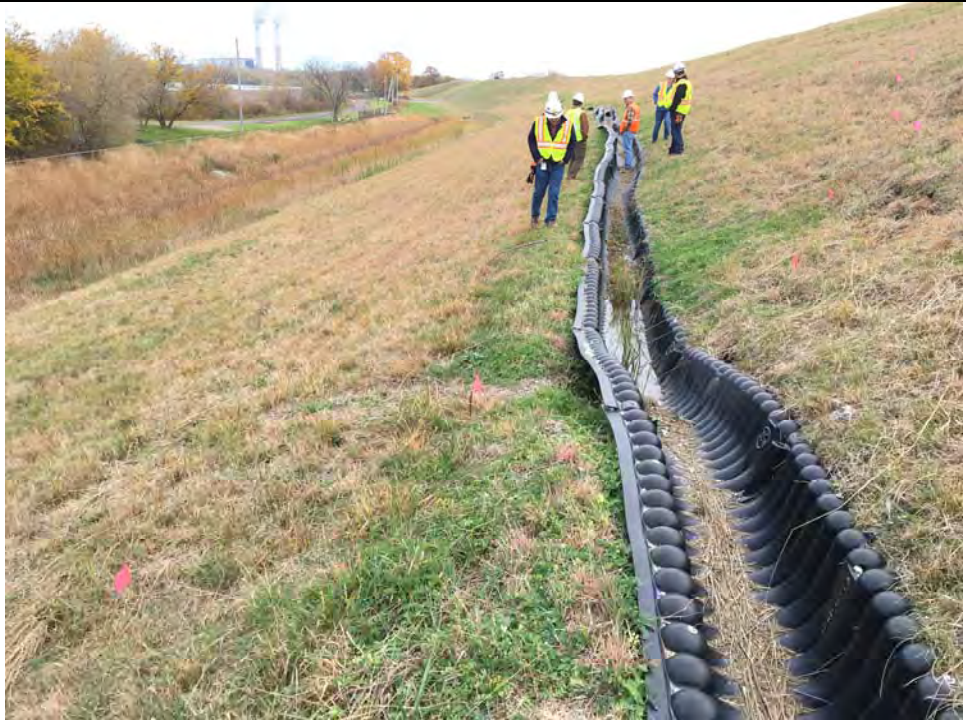
Comments: Photo taken at Station ~67+00, facing east. Sloughs and heave were observed on the embankment that stretch ~120 ft along the embankment. DTE is currently in the process of design and repair of the embankment at this location.

- The HDPE downchute at Station 150+50 was replaced with a rock downchute (see Photograph 48 in Appendix A).
- DTE is currently in the process of repairing the sloughed areas at Stations 67+00, from Station 140+00 to 145+00, and Station 162+00. The repair procedure consists of replacing sloughed soil with compacted aggregate (combination of MDOT 6AA and 21AA), and re-anchoring or replacing the existing midslope stormwater ditch with a drainage system consisting of a perforated pipe culvert and a 3-inch gravel fill.

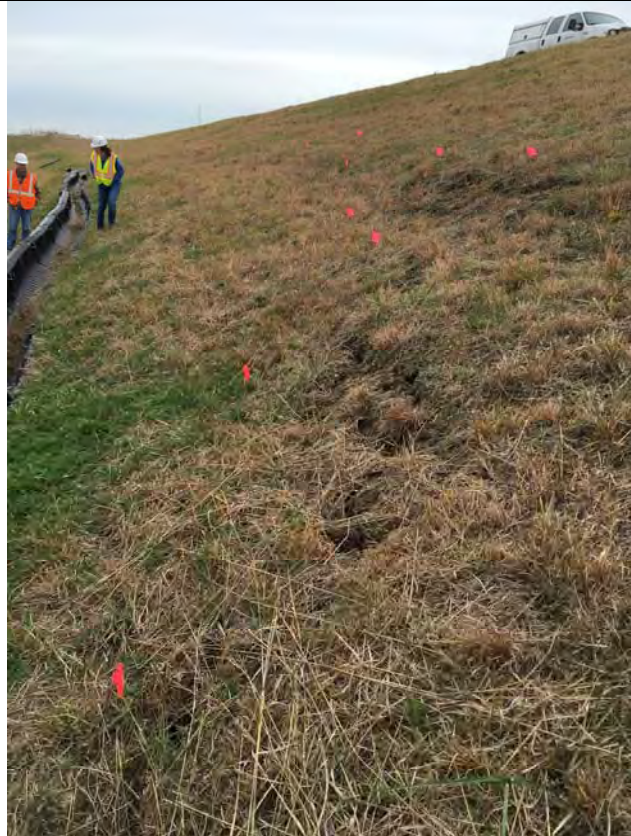
Photograph 38

Comments: Photo taken at Station ~67+00, facing east. Sloughs and heave were observed on the embankment that stretch ~120 ft along the embankment. DTE is currently in the process of design and repair of the embankment at this location.

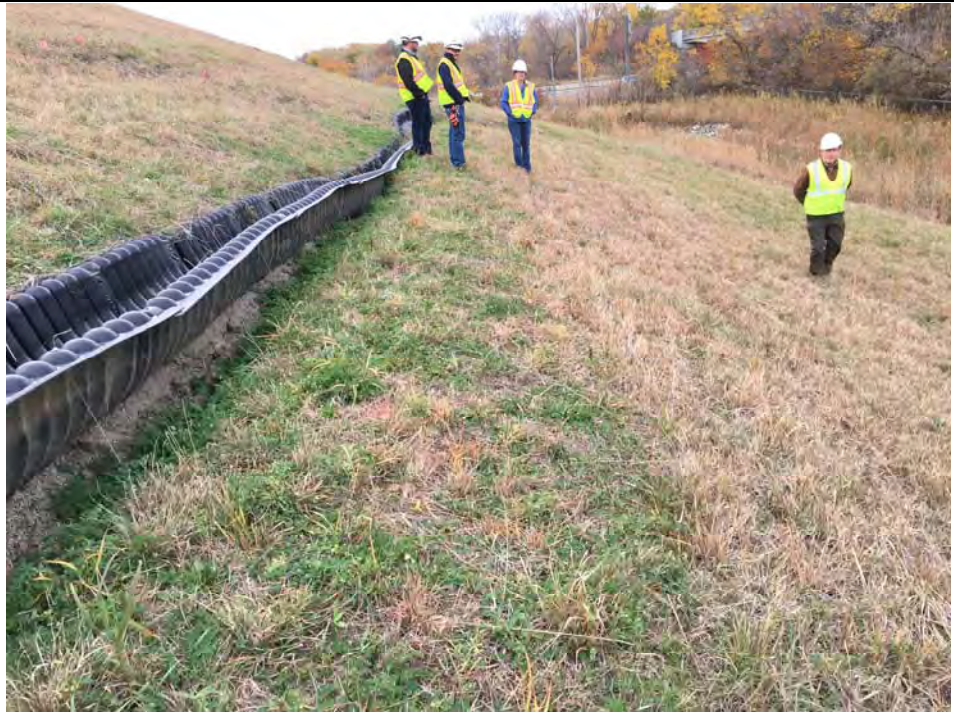
Comments: Photo taken at Station ~67+00, facing west. Sloughs and heave were observed on the embankment that stretch ~120 ft along the embankment. DTE is currently in the process of design and repair of the embankment at this location.

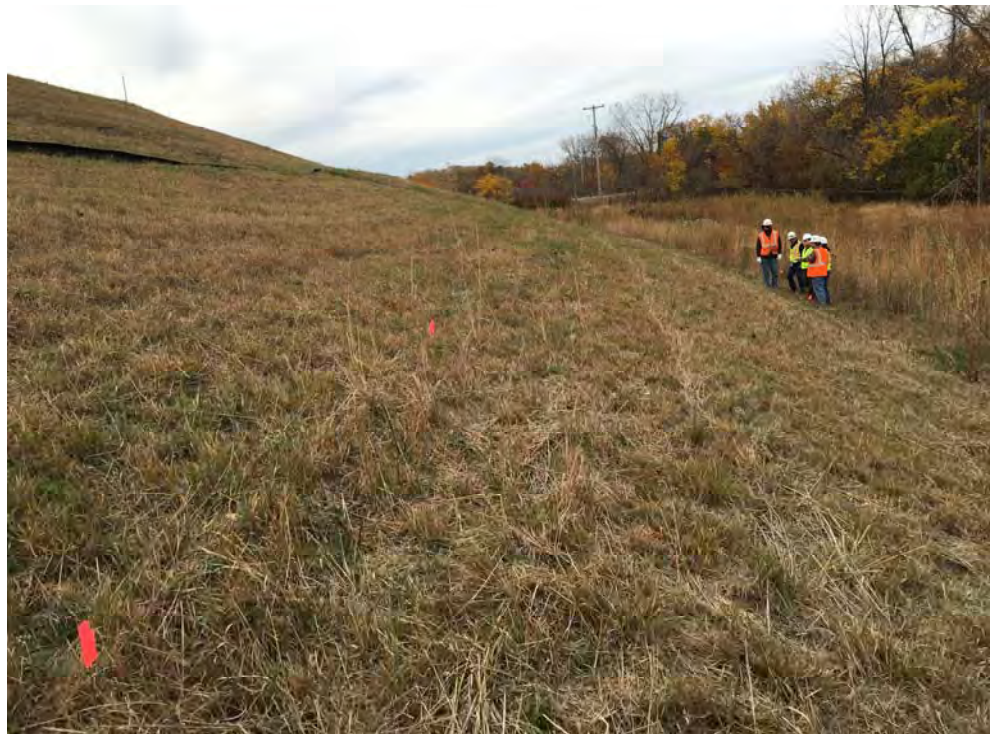
Photograph 40

Comments: Photo taken at Station ~67+00, facing west. Sloughs and heave were observed on the embankment that stretch ~120 ft along the embankment. DTE is currently in the process of design and repair of the embankment at this location.

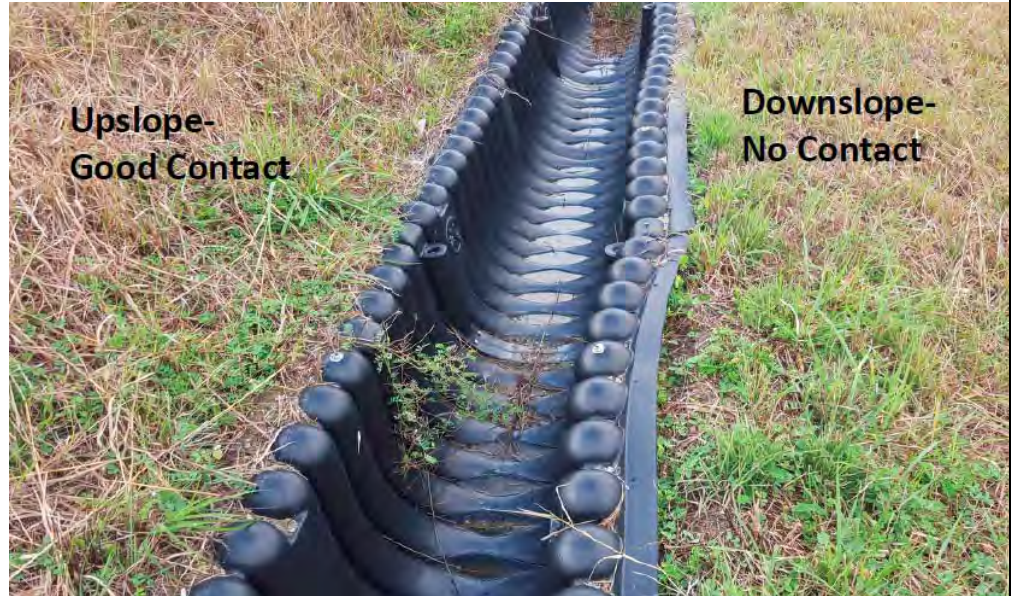
Comments: Midslope stormwater ditch appeared to lose contact with adjacent soil along the downstream edge at multiple locations.

- The gap between midslope ditch flap and adjacent ground was observed at various sections along the embankment. These gaps do not represent an immediate concern for the safe operation or stability of the ash basin. However, gaps on the upstream side of the

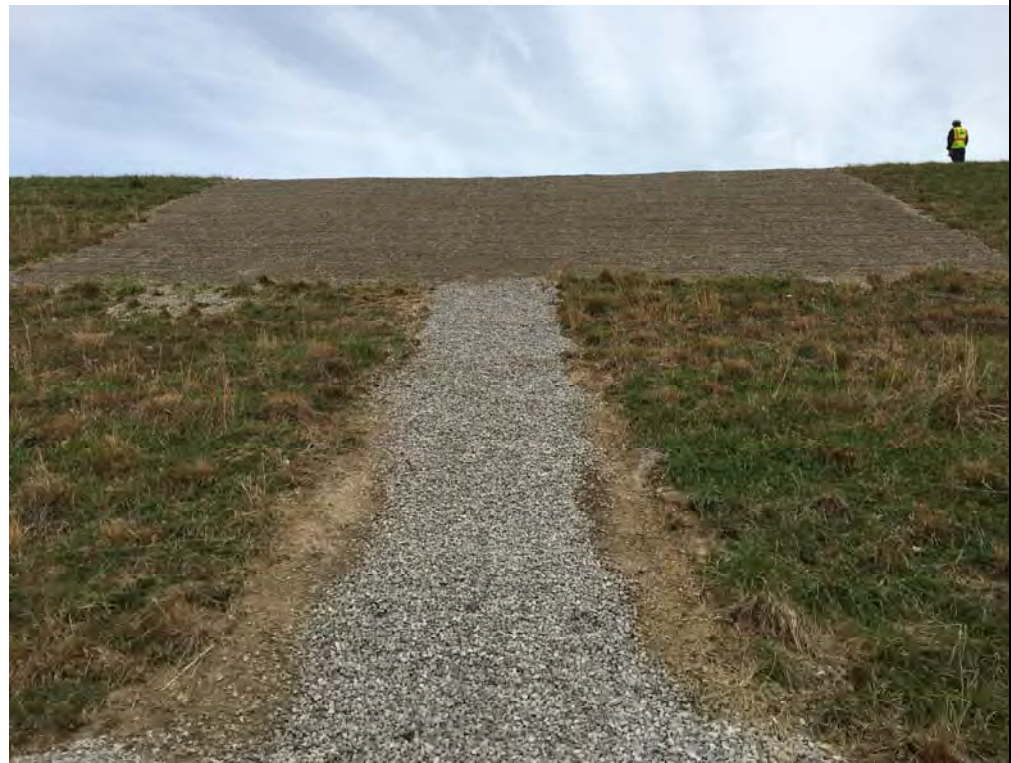
In addition to non-optimal conditions summarized above, sloughing was observed on the exterior slope of the embankment between spring and fall inspections. Sloughs, up to several feet deep, were observed at Stations 55+00 and 115+00. Both of these areas were repaired by the fall inspection (see Section 5 for more information).

Comments: Photo taken at Station 115+00, facing north. The embankment after slough repairs. Sloughing was observed between spring and fall inspections.

- Exterior slope of the embankment, where up to several feet deep sloughs were observed at Stations approximately 55+00 and 115+00, were repaired by replacing sloughed soil with compacted aggregate. MDOT 6AA coarse aggregate was placed as the base aggregate and capped with MDOT 21AA dense graded aggregate. A downchute consisting of MDOT 6AA was constructed at Station 115+00 to convey stormwater to the toe of the embankment (see Photograph 46 in Appendix A). No downchute was constructed for the slough repair at Station 55+00, because the sloughed area was by the toe of the embankment (see Photograph 47 in Appendix A).

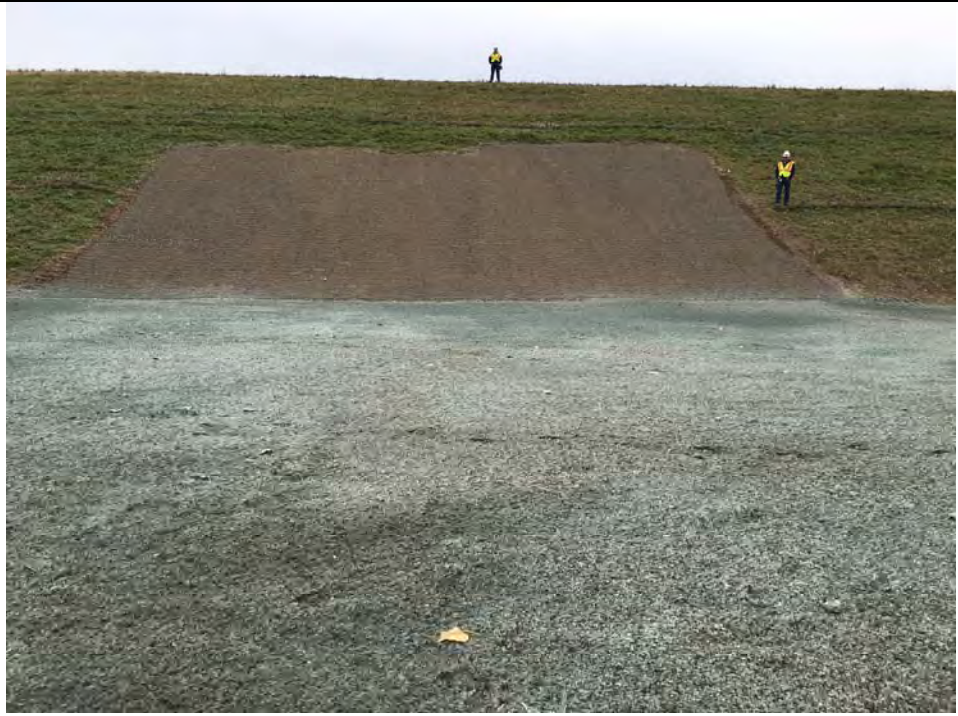
Comments: Photo taken at Station 55+00, facing south. The embankment after slough repairs. Sloughing was observed between spring and fall inspections.

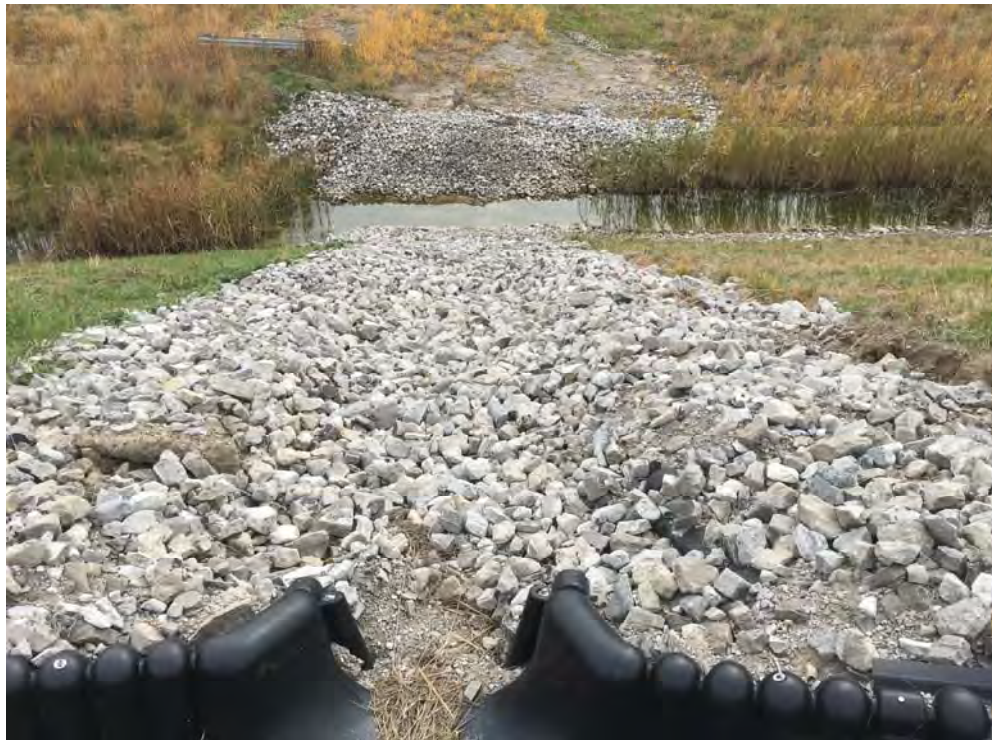
Photograph 48

Comments: HDPE downchute at Station 150+50 was replaced with rock downchute.
