2016 ANNUAL INSPECTION REPORT ASH BASIN EMBANKMENT

MONROE POWER PLANT

Monroe, Michigan

January 2017

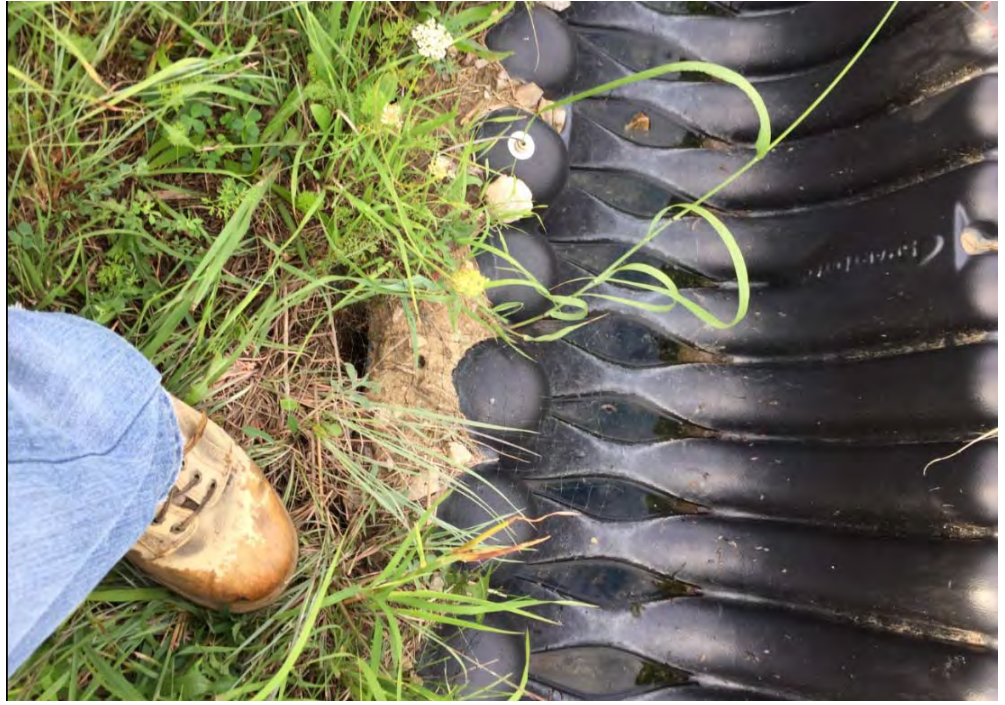
Photograph 4

Comments: In general,
the mid-slope ditch has a
good contact with
upslope, but there are
often localized gaps
between the edge and the
adjacent soil.

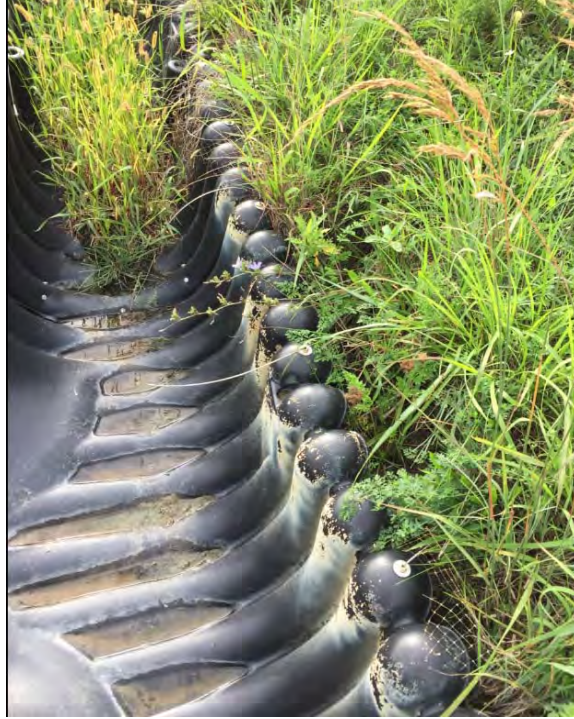
Comments: Upstream end of downchute at Station 26+00. Couple of inches wide gap was observed between the mid-slope ditch flange and upslope soil.

- Isolated problems with the midslope ditch bedding (i.e. pea stone and underlying soil) washing out were observed at downchutes at Stations 26+00, 81+00 and 145+00. The observed problems do not represent an immediate concern for the safe operation or stability of the ash basin embankment. However, these downchutes shall be fixed in accordance with IMM Manual to reduce erosion along downchutes.

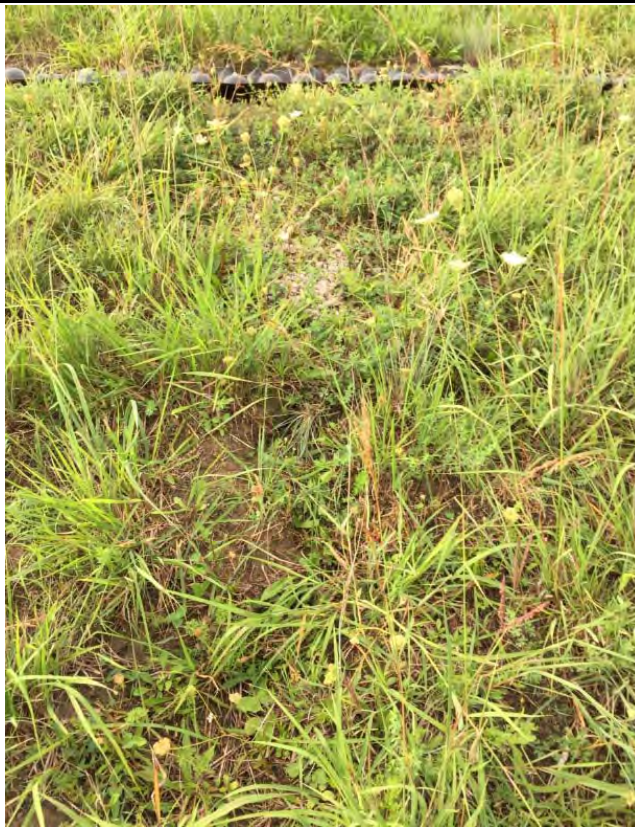
Photograph 14

Comments: Station ~22+50. Erosion rill was observed downstream of bleed-out.

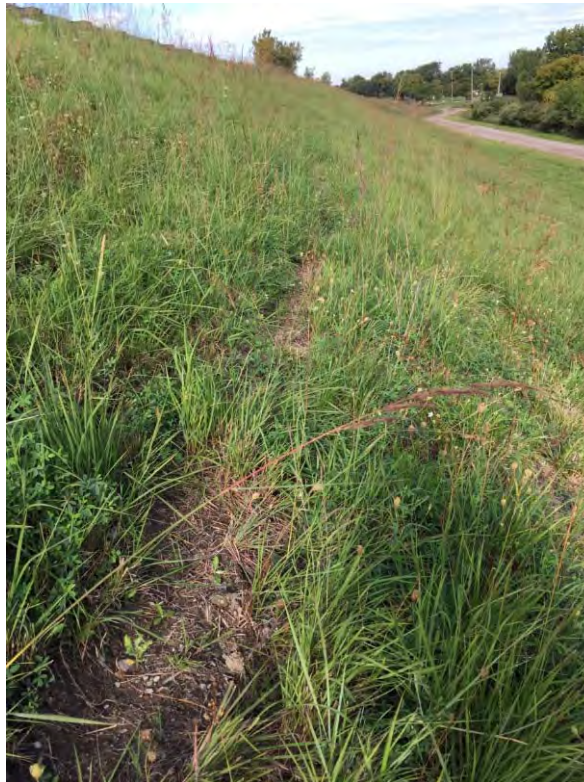
Photograph 20

Comments: Vegetation at Station ~8+00 appeared to be damaged during mowing operations.

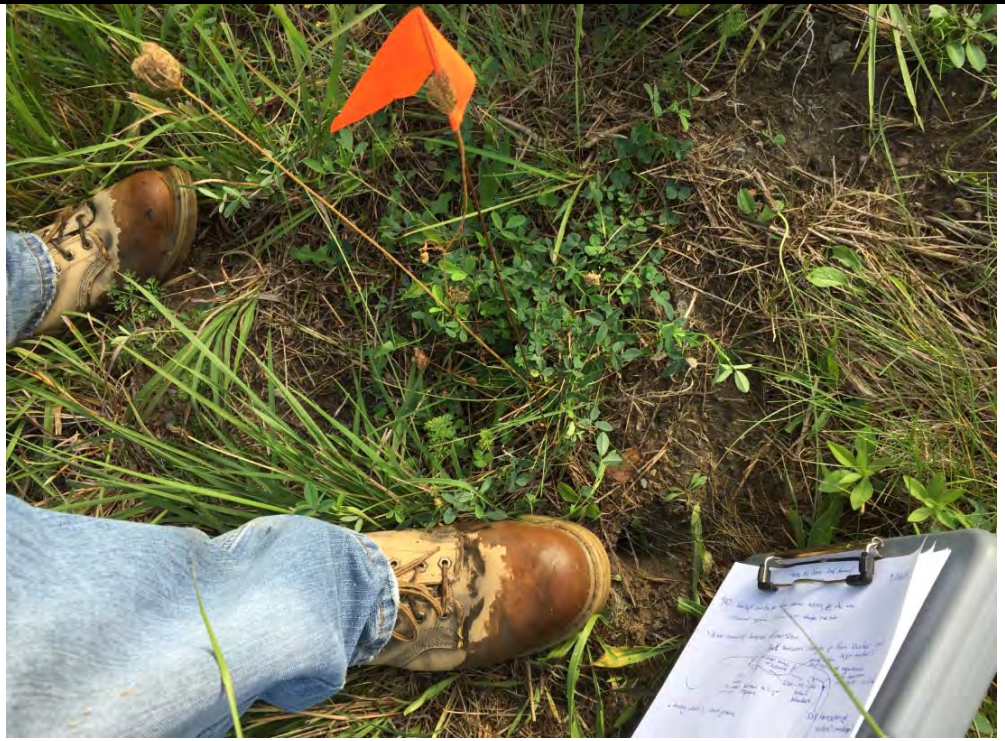
Comments:
Approximately one-inch
diameter animal burrows
were noticed on the
embankment at discrete
locations.

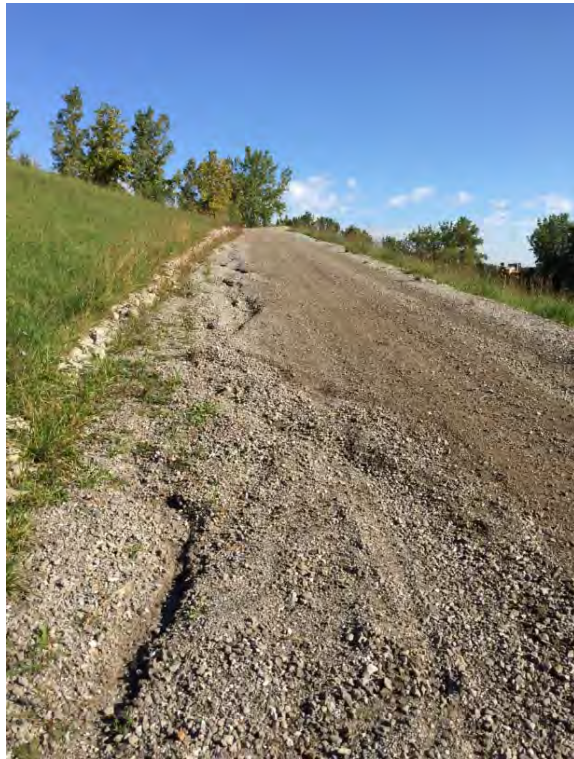
Photograph 24

Comments: Erosion rills
were observed on the
access ramps at Station
0+00.

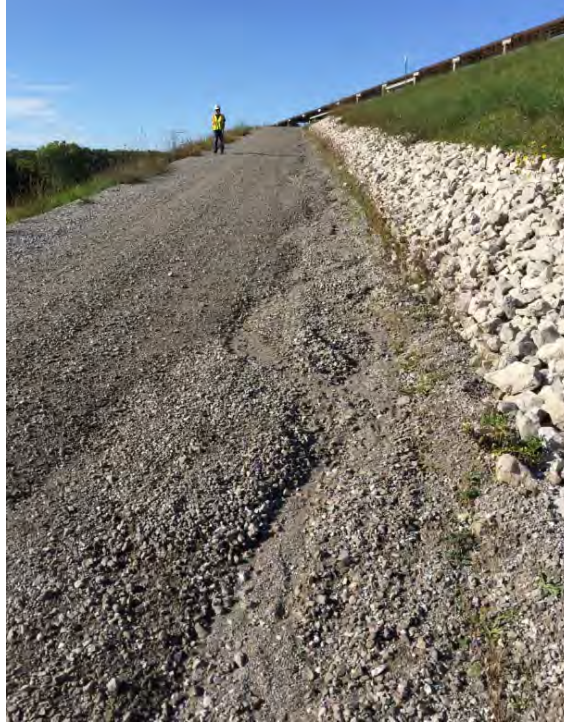
Comments: Erosion rills
were observed on the
access ramps at Station
0+00.

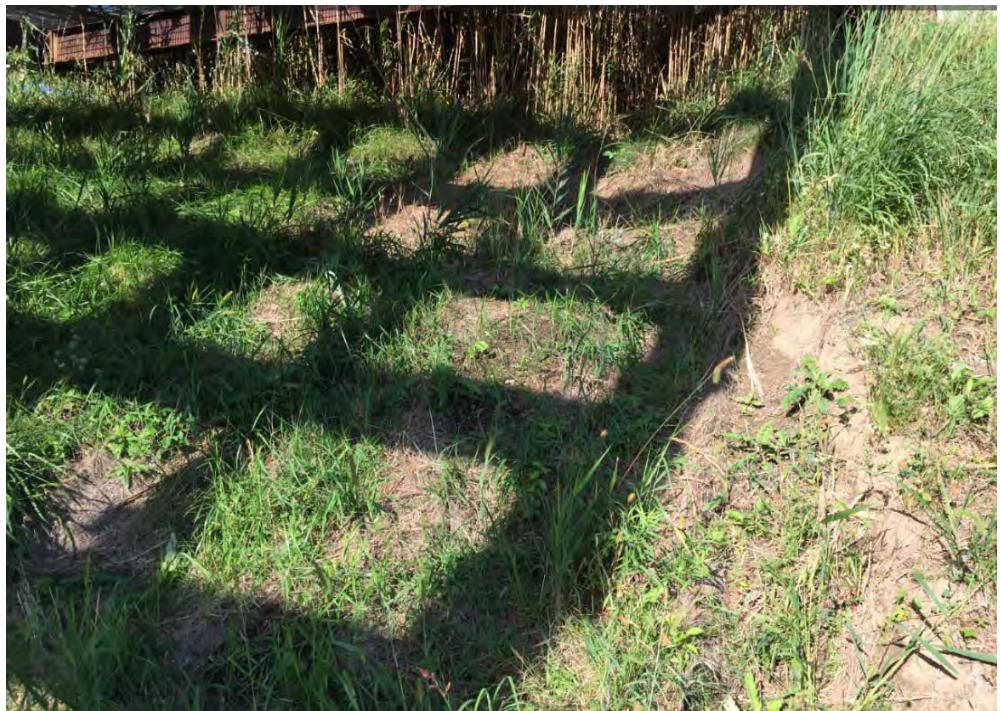
Photograph 26

4. A depression was observed on the outside slopes under the trestles at Station 0+00. The area was approximately 20 ft by 20 ft and the approximately 8-in deep. This area was identified to have erosion gullies in 2015, and subsequently filled. It appears that the

repaired area settled after installation. No erosion features were observed during this inspection.

- A depression area observed under the trestle structure does not represent an immediate concern for the safe operation or stability of the ash basin embankment.

Comments: The area that
had erosion gullies under
the trestles in 2015
appeared to be filled in,
but the area appeared to
be lower than the
surrounding ground.

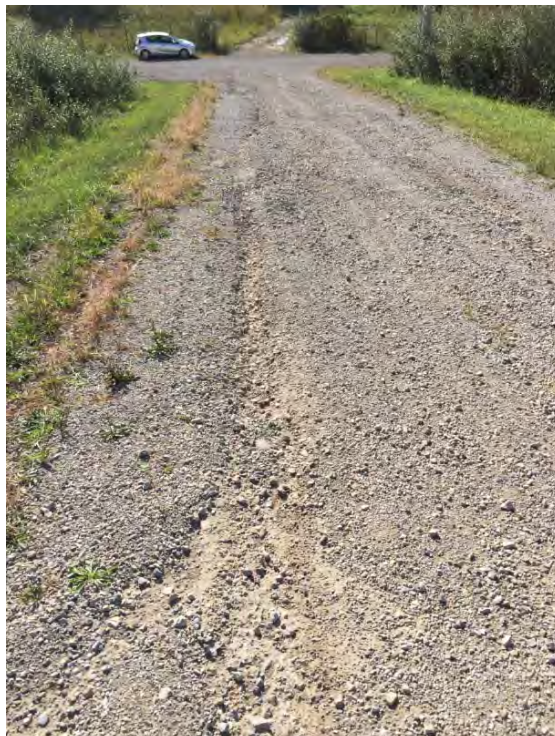
Photograph 32

Comments: Erosion rills
were observed on the
access ramp at Station
~169+00.

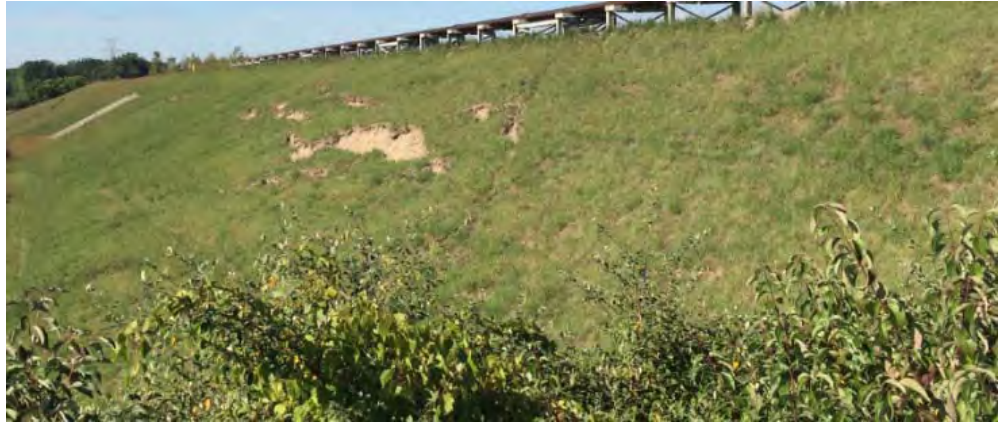
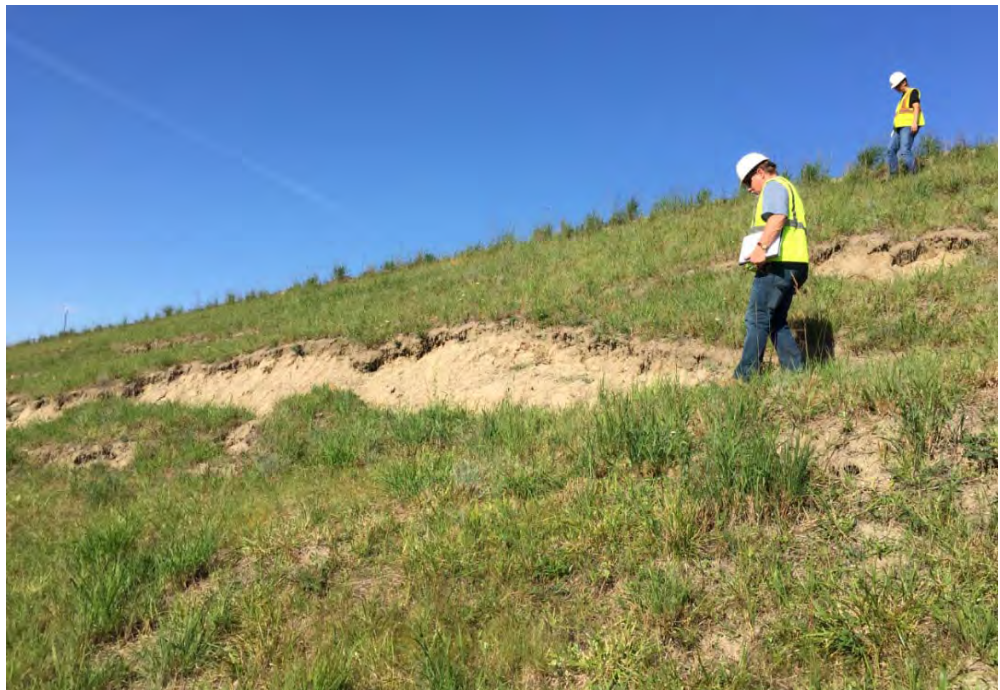
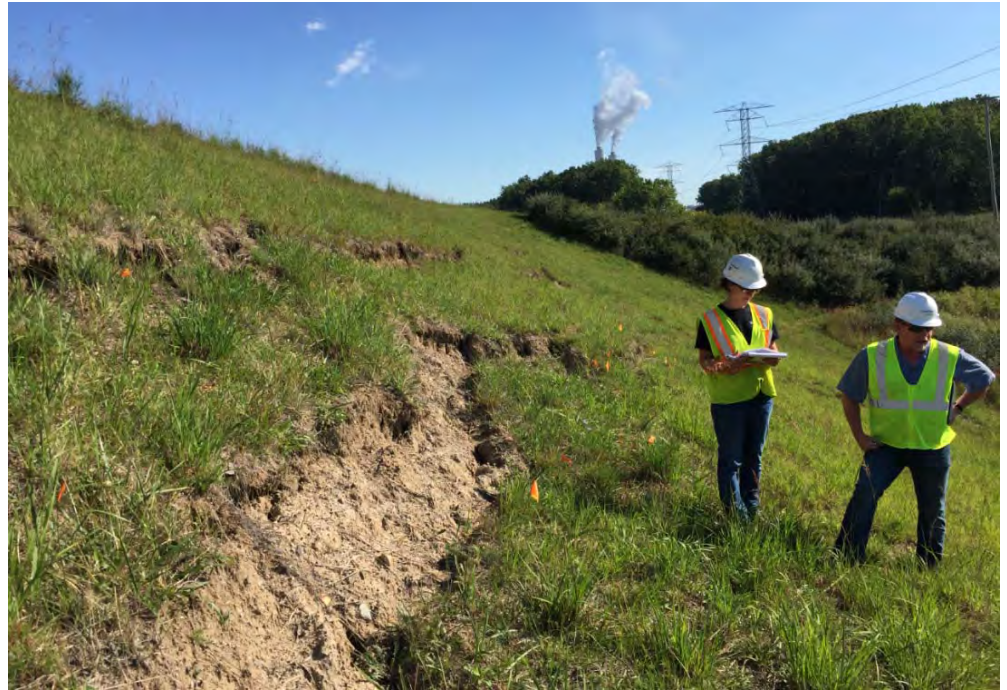
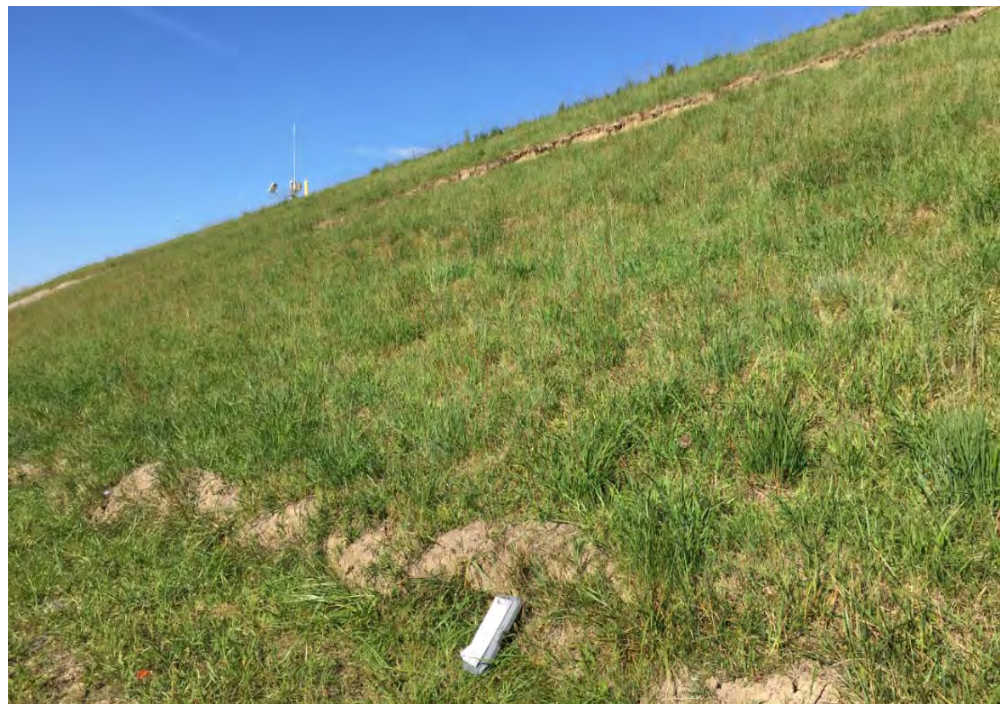
1. Surficial sloughs up to several feet deep were observed on the exterior slope of the embankment at two separate areas: (i) from Station ~162+00 to ~168+00 (Photographs 33 thru 36 in Appendix A); and (ii) from Station ~53+00 to ~58+00 (Photograph 82 in Appendix A).

- Sloughs observed on the embankment from Station ~162+00 to ~168+00, and from ~53+00 to ~58+00 do not represent an immediate concern for global stability of the ash basin embankment; these sloughs should be fixed as soon as practical.

Comments: Photo taken
at Station 169+00, facing
south. Surficial sloughs
and cracks were
observed at some areas
between Station 162+00
and 168+00.

Comments: Surficial
sloughs and cracks were
observed at some areas
between Station 162+00
and 168+00.

Comments: Surficial sloughs and cracks were observed at some areas between Station 162+00 and 168+00.

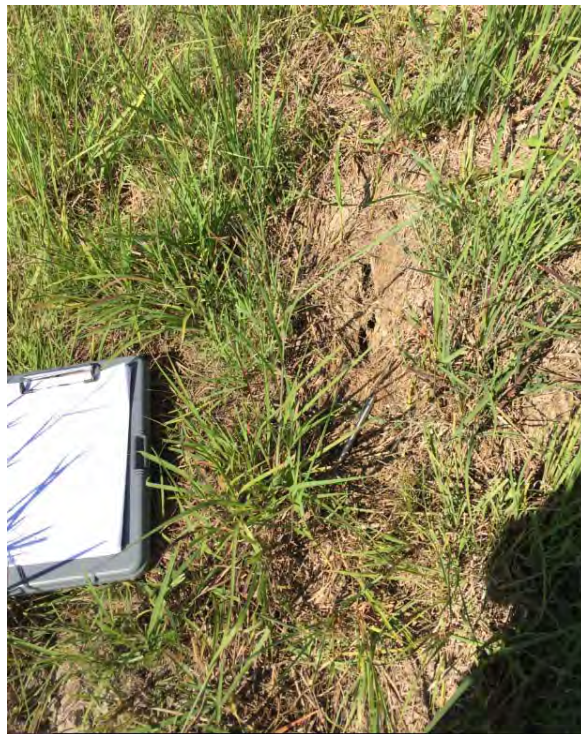
Photograph 38

- Several inches wide cracks were observed on the exterior slope of the embankment at Station ~161+75, from Station ~142+00 to Station ~145+00, at Station ~122+00, Station ~65+00, and at Station ~62+00 do not represent an immediate concern for global stability of the ash basin embankment; these cracks should be fixed as soon as practical.

Comments: Crack forming (approximately 1.5-in wide, 10-ft long) upslope of the repaired area at Station 161+75.

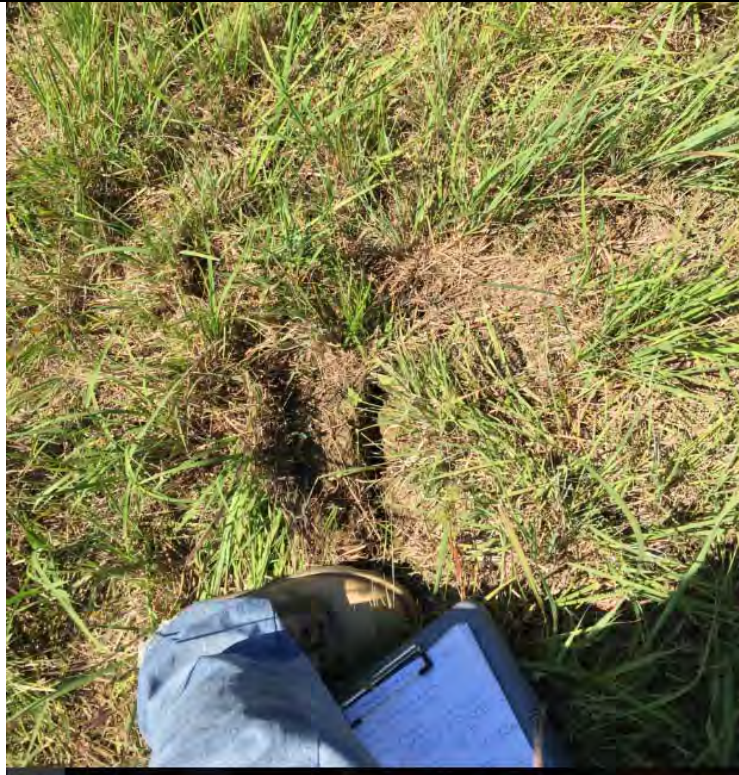
Comments: Crack
forming (approximately
1.5-in wide, 8-ft long)
upslope of the repaired
area at Station 162+00.

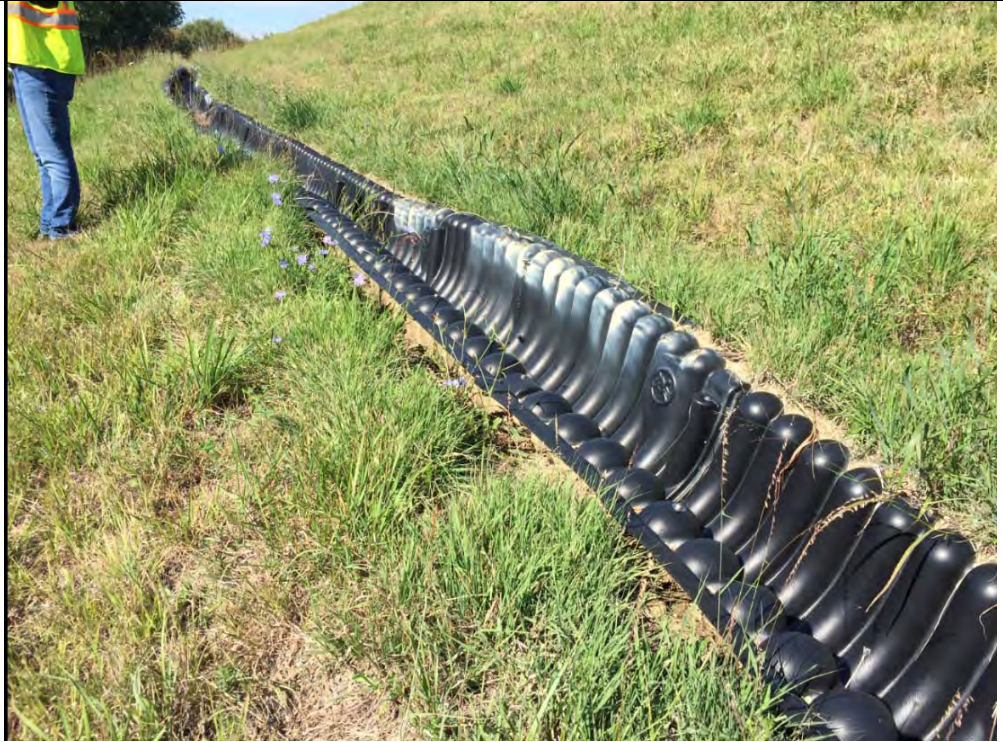
Comments: Mid-slope
ditch at Station ~150+00
appeared to heave.

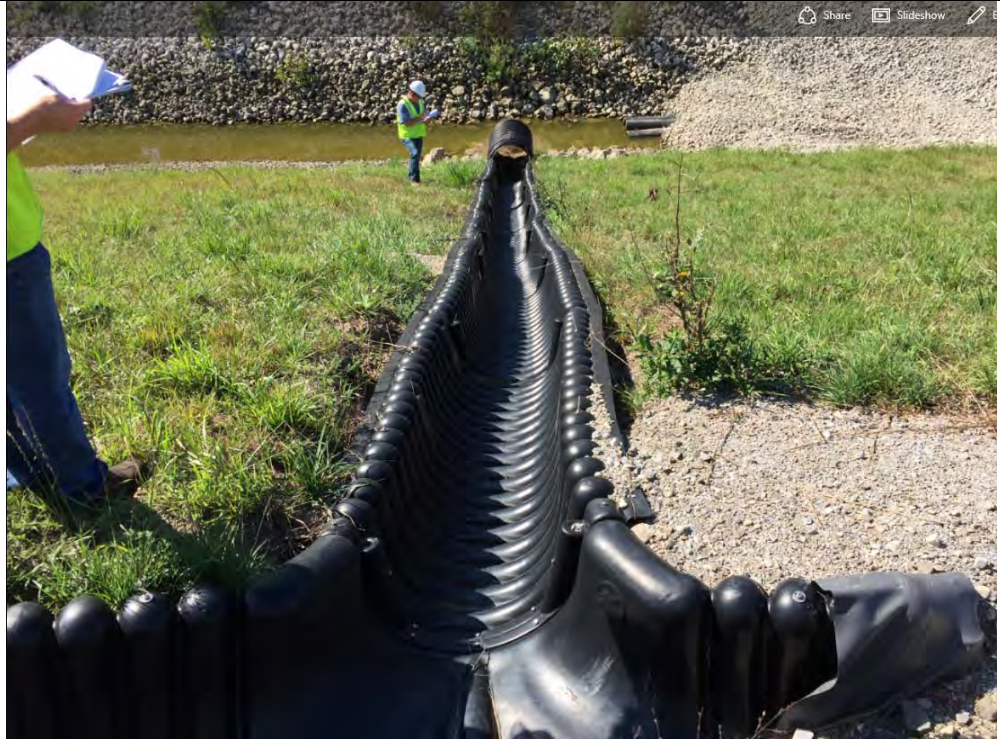
Comments: Downchute
at Station 145+00
appeared to be in good
working condition.
However, up to six-
inch wide gaps were
observed along the
sides.

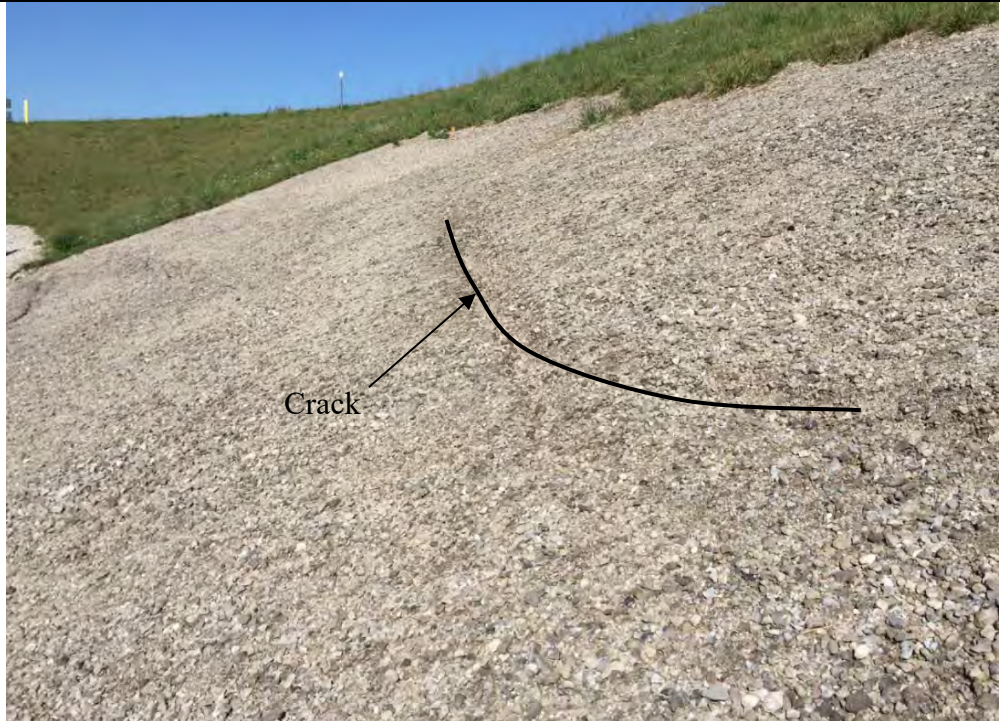
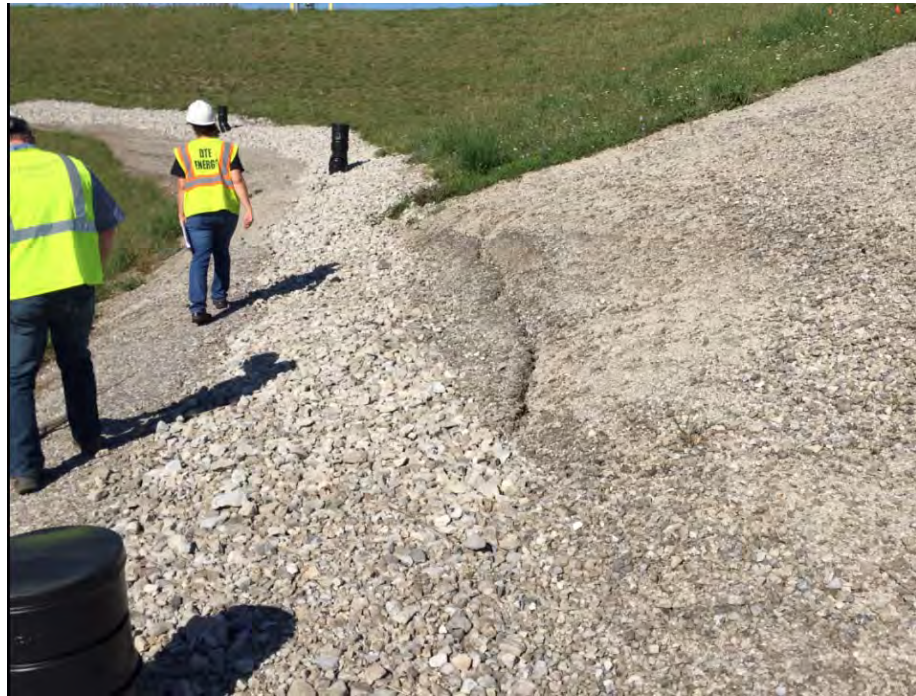
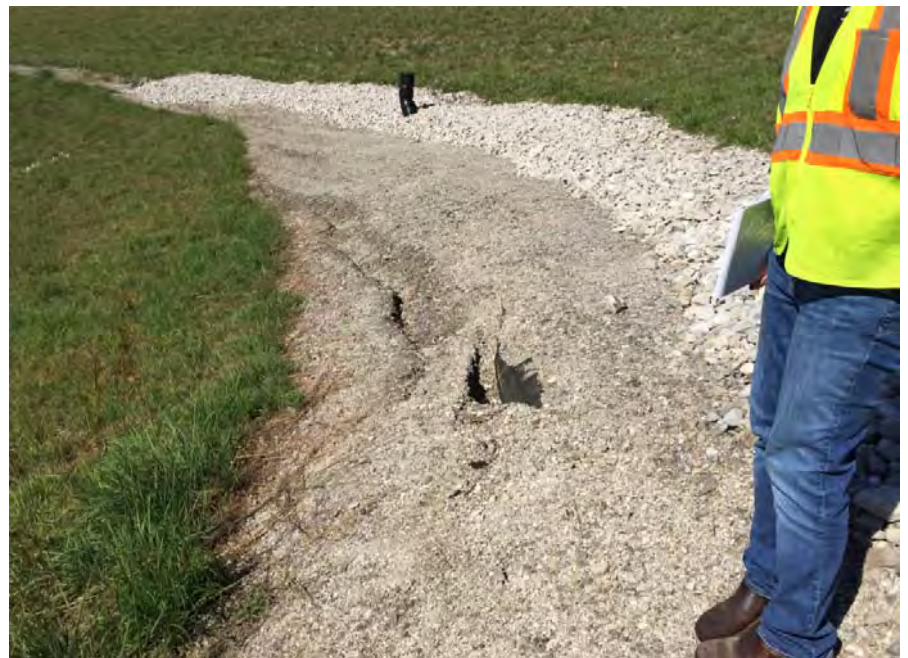
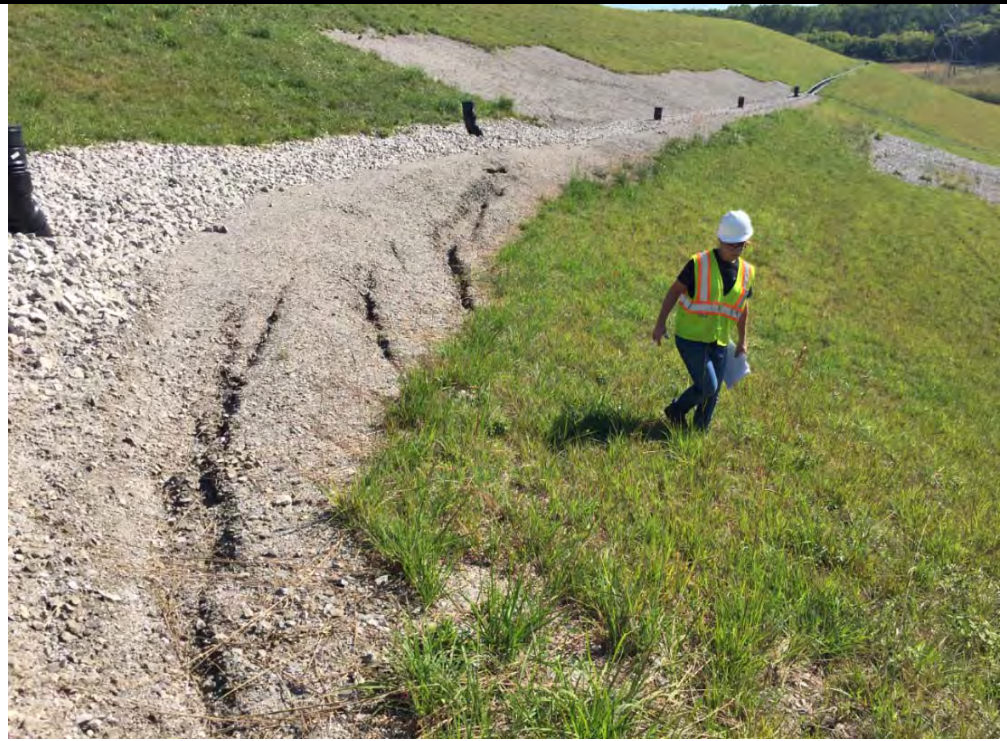
Photograph 46

Comments: Various
cracks were observed
within the area (from
142+00 to 145+00) that
was repaired in 2015.

Comments: Various cracks were observed within the area (from 142+00 to 145+00) that was repaired in 2015.

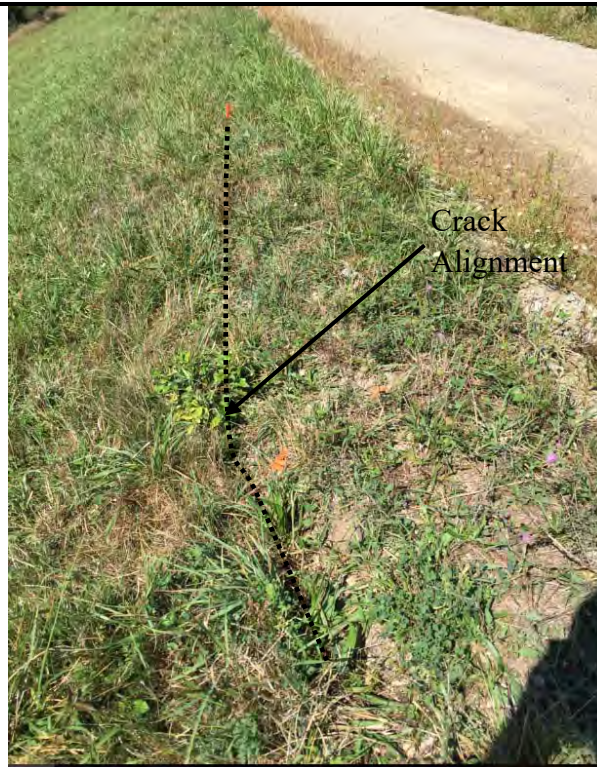
Comments: Crack (several inches wide and 20-ft long) that was observed in 2015 at Station 122+00 did not appear to have worsened.

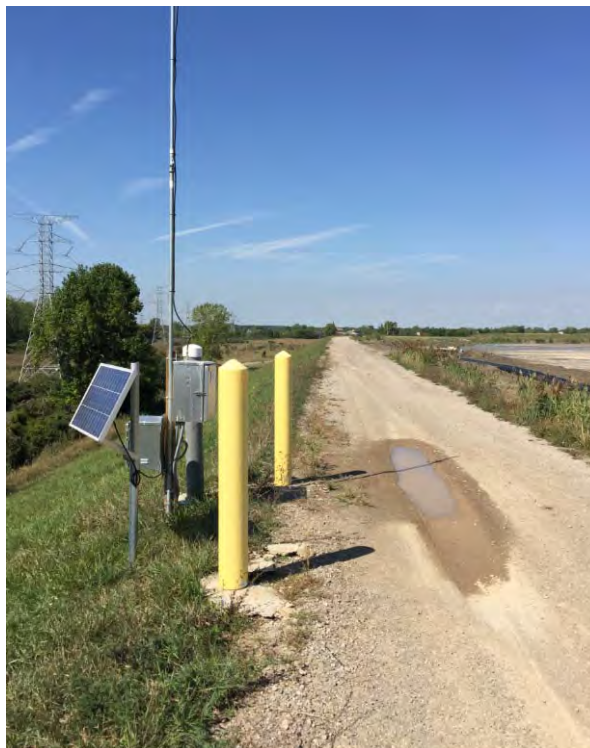
Photograph 58

Comments: Photo taken at Station 118+00, facing west. Tire rut and standing water were observed at the crest.

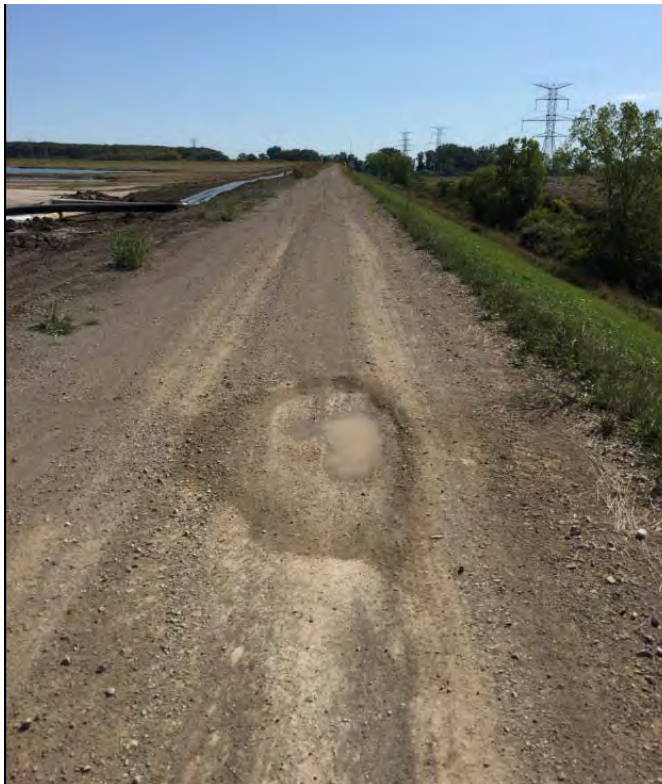
Photograph 60

Comments: Photo taken
at Station 114+00, facing
east. Low spot was
observed at the
embankment crest.

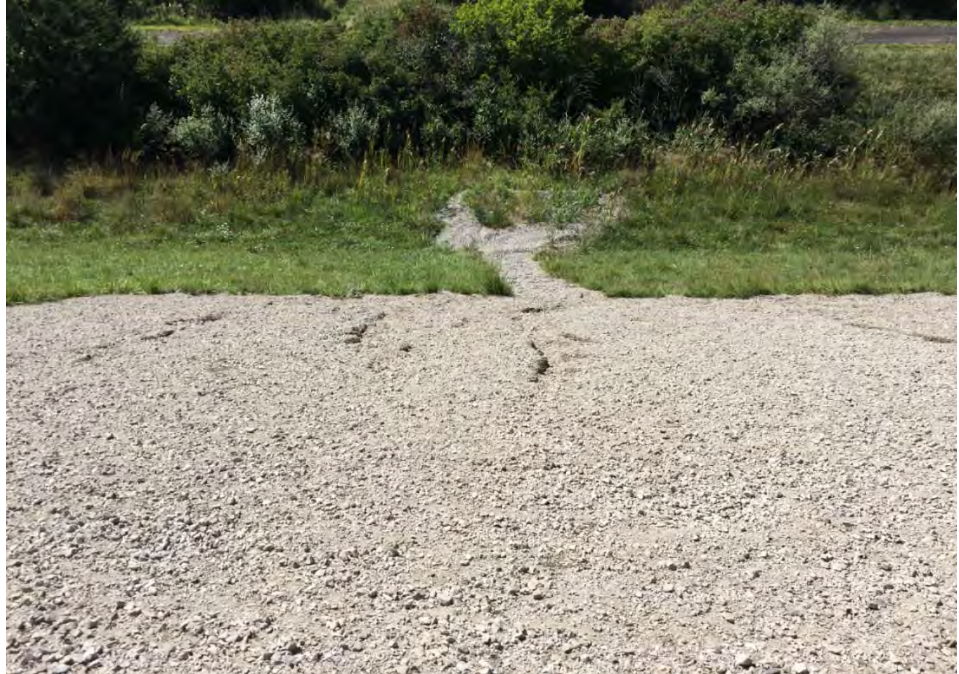
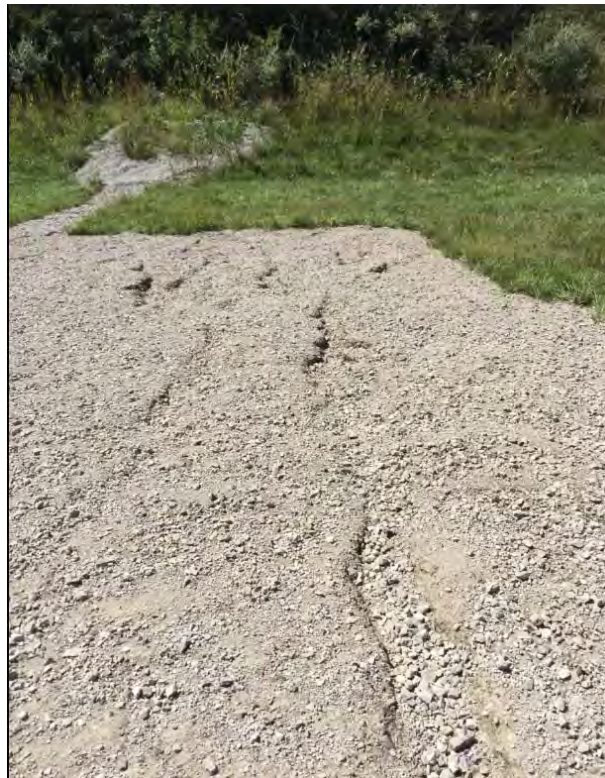
Photograph 62

Comments: Erosion rills were observed with the area that was repaired last year at Station 110+00.

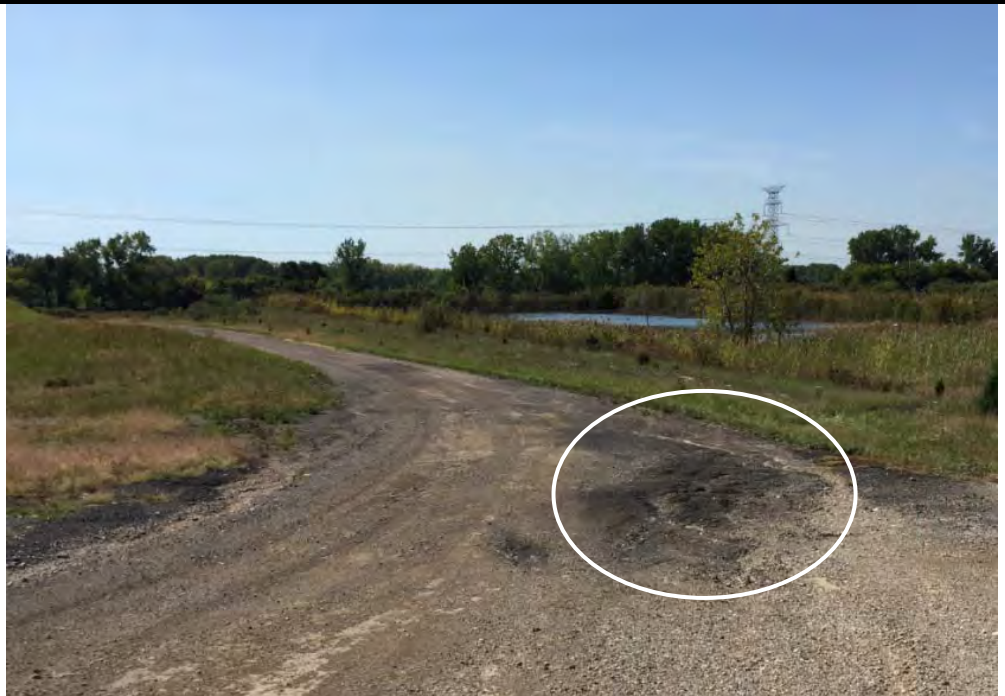
Comments: Access ramp at Station 104+00 has erosion rills.

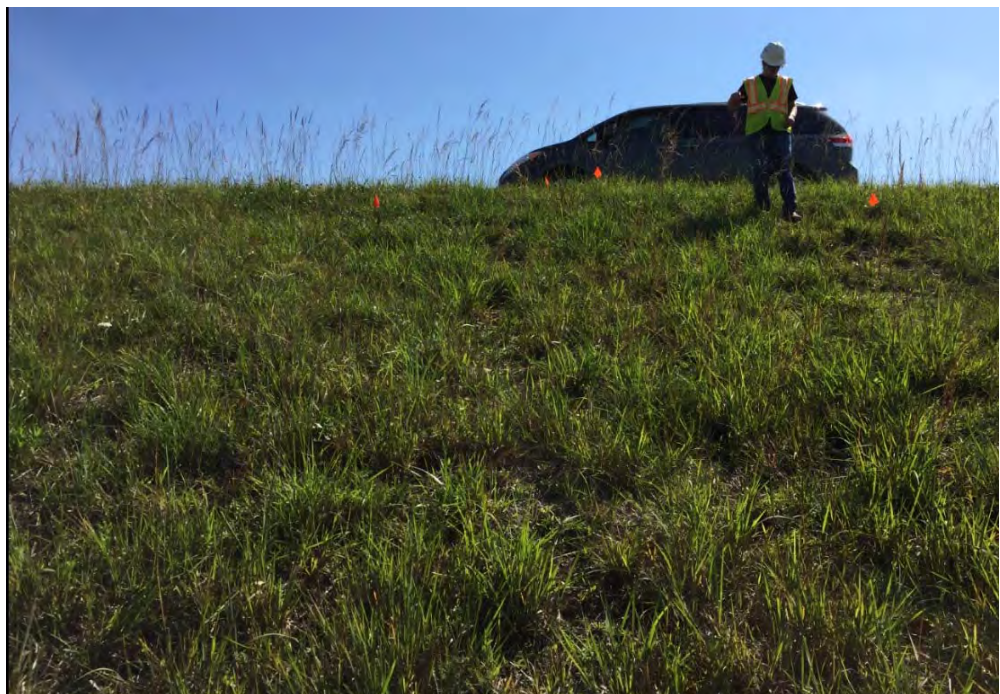
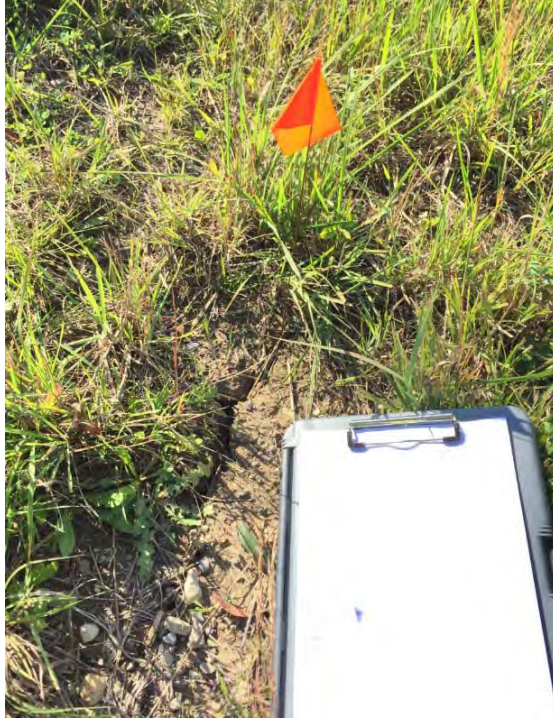
Photograph 68

- One-inch wide cracks and thinner were observed on the exterior slope of the embankment at Station ~88+00, Station ~84+50, and Station ~75+00 do not represent an immediate concern for global stability of the ash basin embankment; these cracks should be monitored on a regular basis at a frequency of once every 30 days (maximum).

Comments: Cracks (less
than an inch wide) were
observed at Station
~84+50 across 30 ft.
These cracks are
flagged. Similar cracks
were observed at Station
88+00 (towards the top
of embankment, by the
crest).

Comments: Cracks (less than an inch wide) were observed at Station ~84+50; along 30 ft. These cracks are flagged. Similar cracks were observed at Station 88+00 (towards the top of embankment, by the crest).

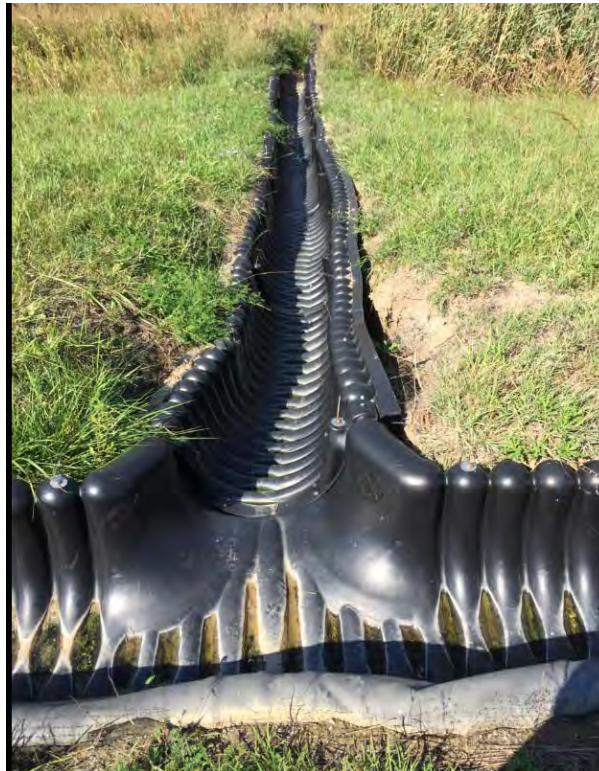
Photograph 72

Comments: Downchute
at Station 81+00
appeared to be in
working condition.
However, the soil along
the sides have been
washed off.

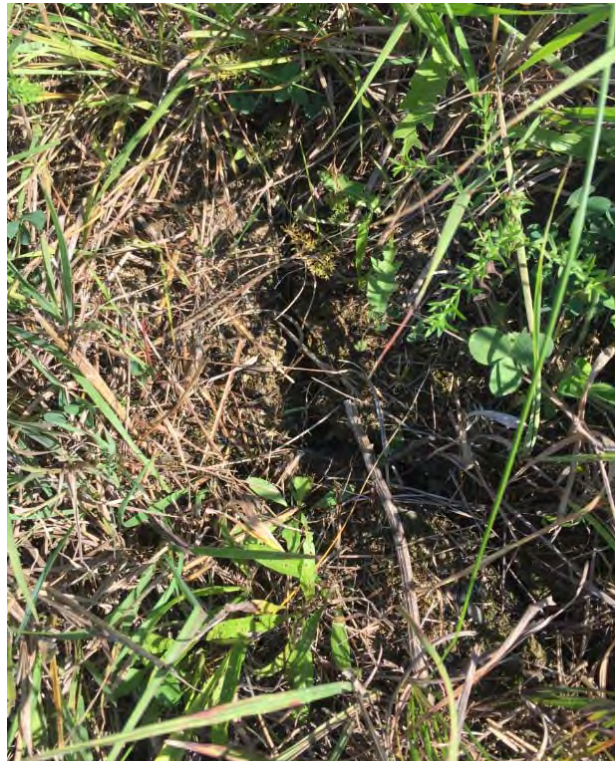
Photograph 74

Comments:
Approximately one-inch
wide, 25-ft long cracks
were observed at Station
~75+00 towards the top
of the embankment.

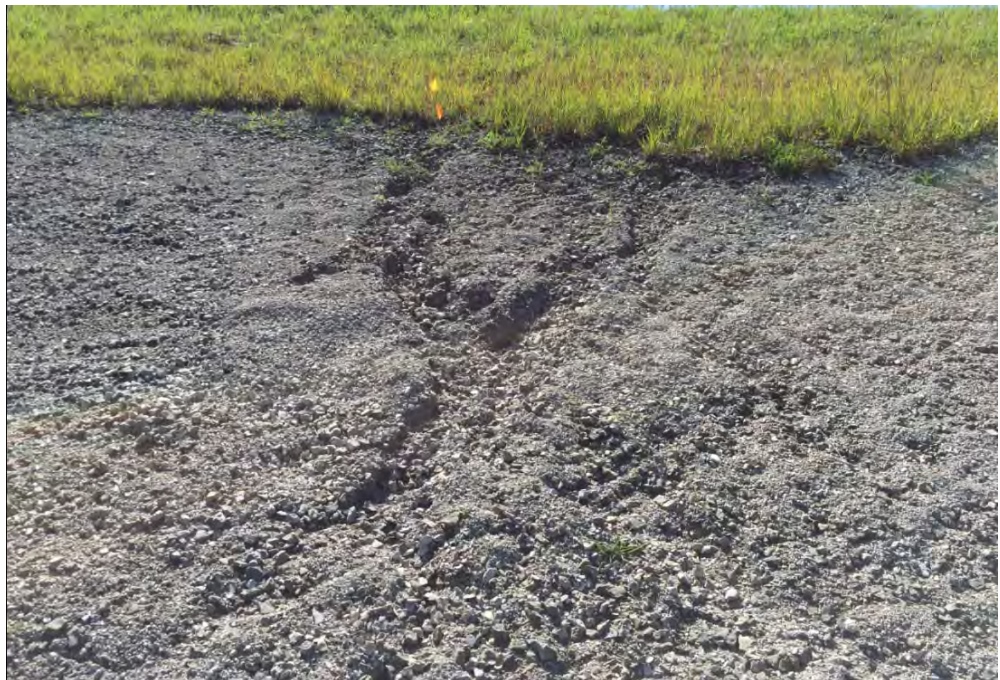
Photograph 76

Comments: Erosion rills were observed within the area that was repaired in 2015 (Station ~68+00).

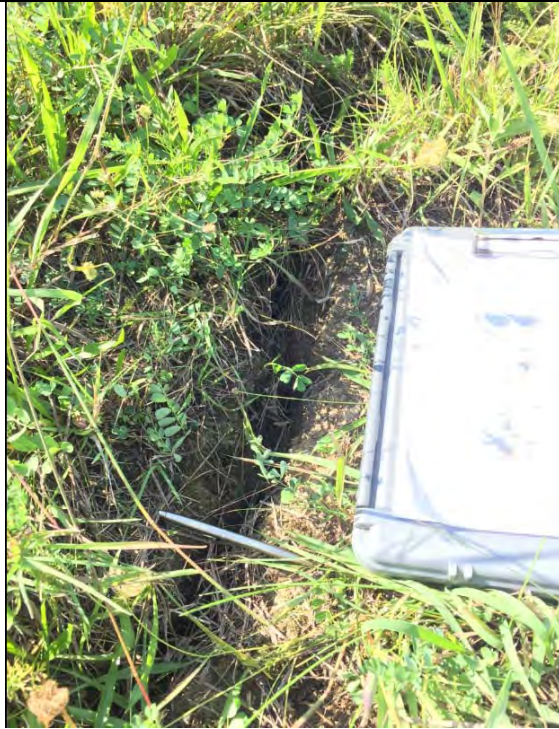
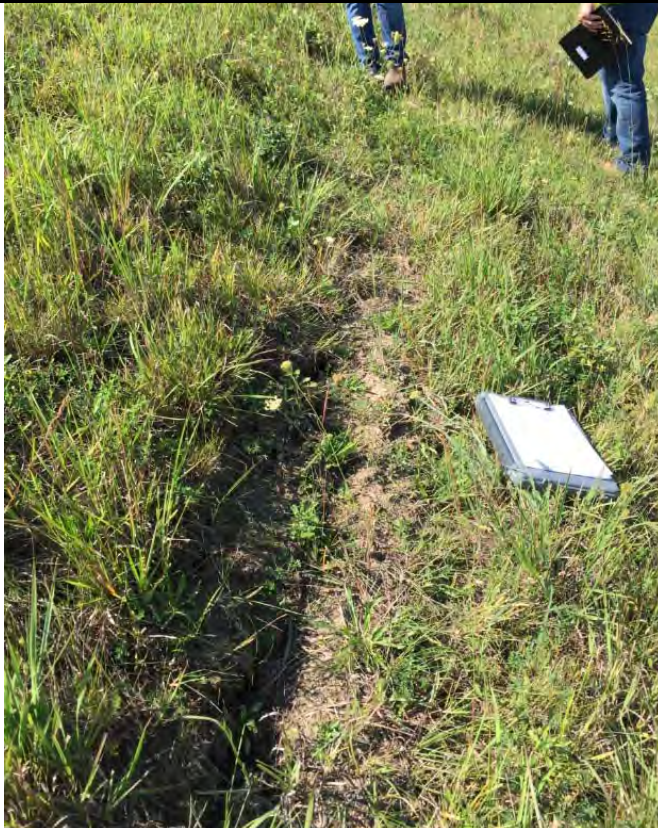
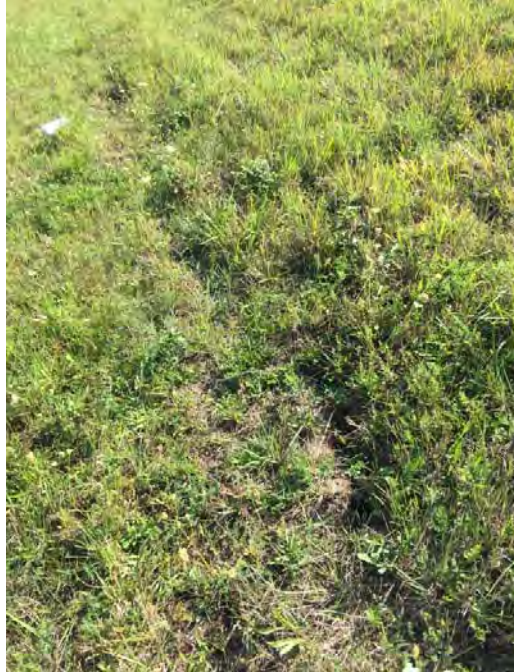
Photograph 78

Comments: Up to approximately 3-in wide cracks were observed along approximately 75-ft stretch around Station 65+00 (between mid-slope ditch and crest).

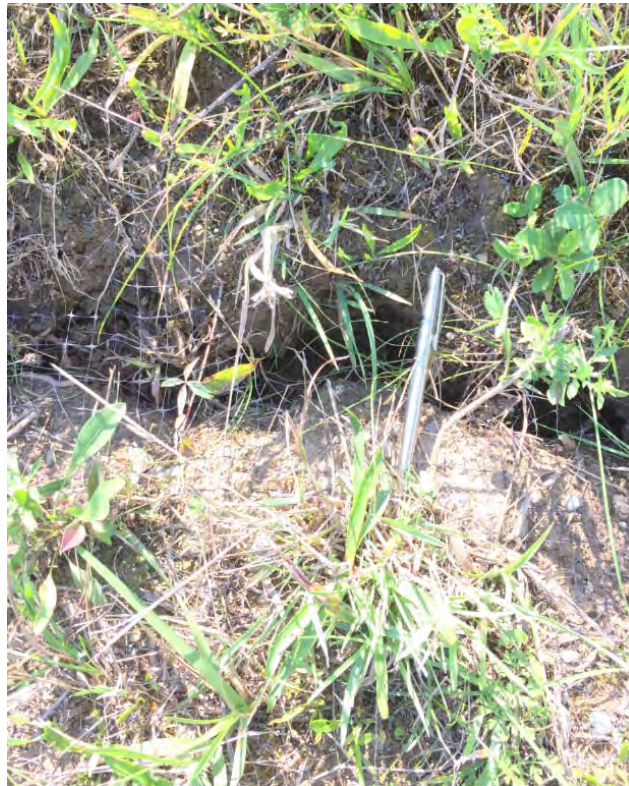
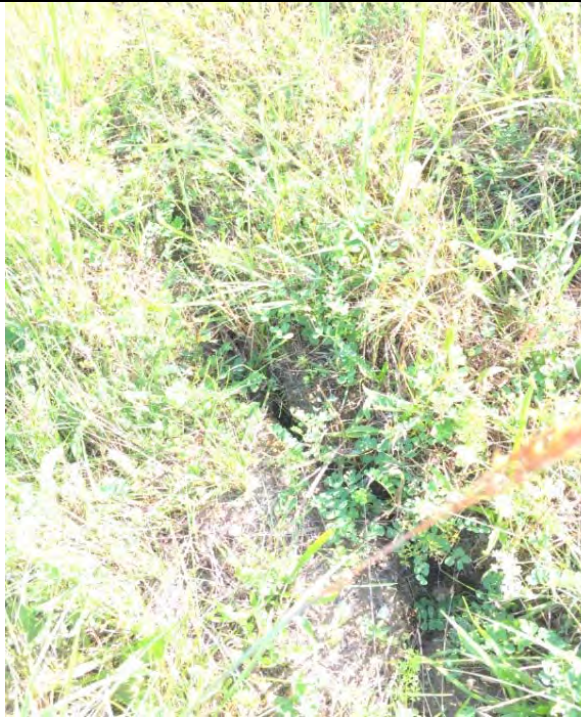
Photograph 80

Comments: Up to approximately 3-in wide cracks were observed along approximately 5-ft stretch around Station 62+00 (between mid-slope ditch and crest).

Comments: Up to
approximately 3-in wide
cracks were observed
along approximately 5-ft
stretch around Station
62+00 (between mid-
slope ditch and crest).

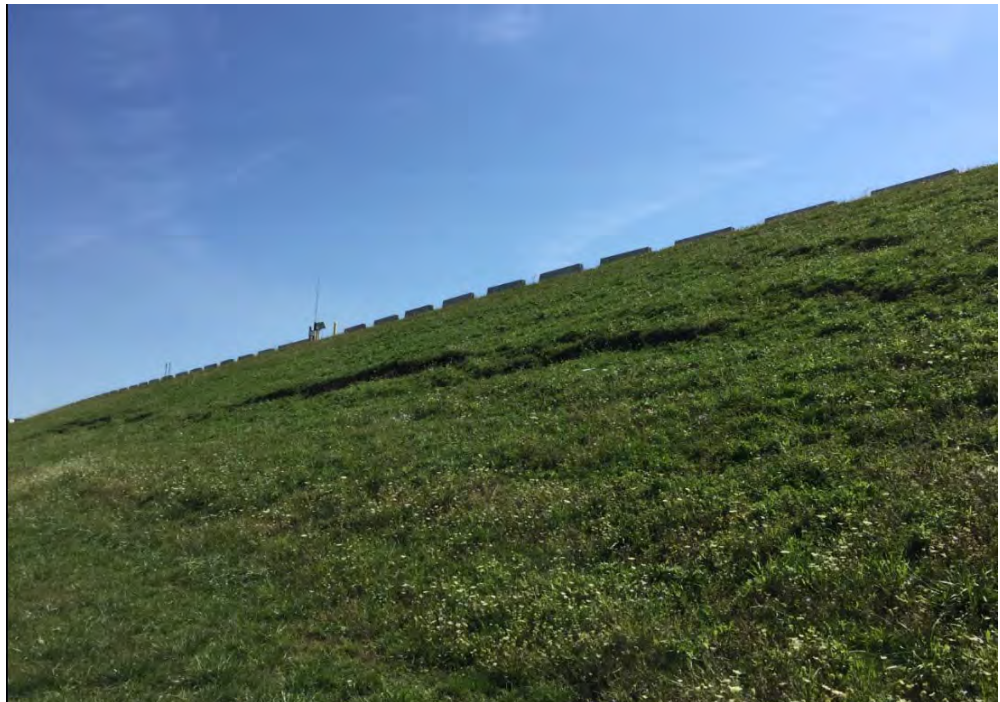
Photograph 82

Comments: Up to 3-ft
deep surficial sloughs
were observed in areas
between Station ~53+00
and ~58+00.
