October 15, 2021

**Subject: Five-Year Regulatory Compliance Reporting: Hazard Potential Assessment
Monroe Power Plant Fly Ash Basin Facility
Monroe, MI**

This letter presents Geosyntec Consultants of Michigan, Inc.'s (Geosyntec's) five-year periodic hazard potential assessment for DTE Energy's (DTE's) Monroe Power Plant Fly Ash Basin (FAB).

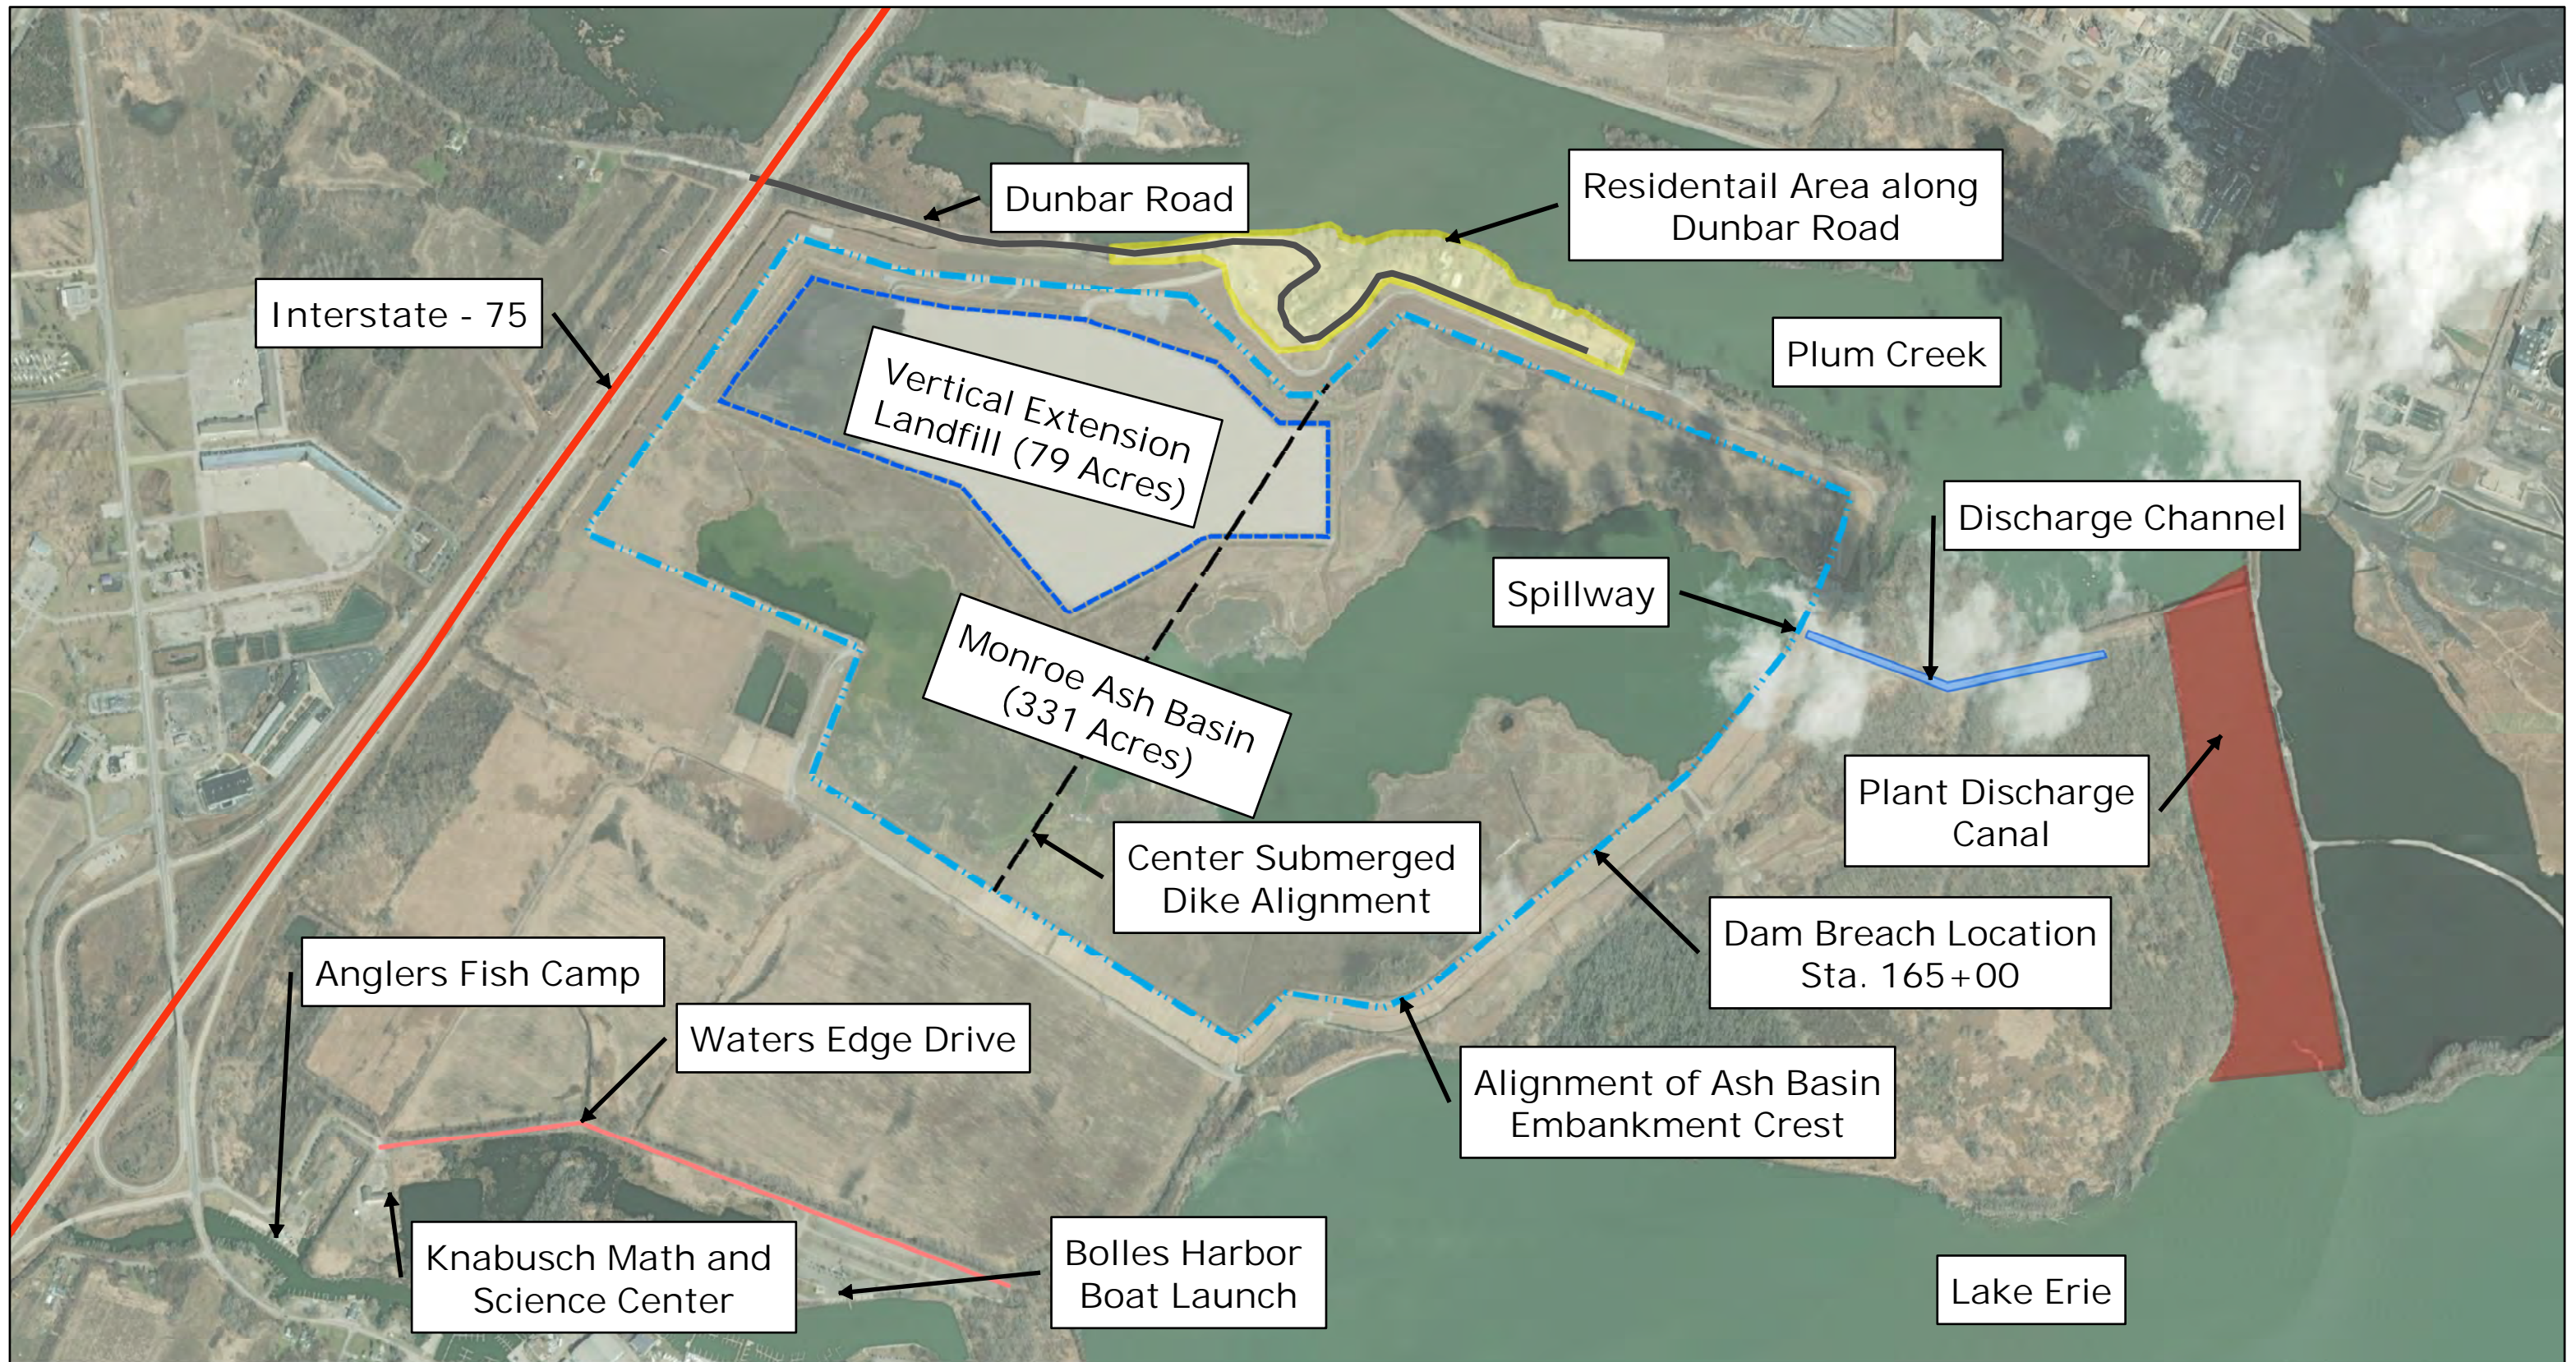
<h2>Monroe Ash Basin and Surrounding Features</h2>		
<h3>Monroe Ash Basin Hazard Impact Classification</h3>		<h1>Figure 1</h1>
CHE8242W	September 2021

The FAB is about 331 acres in plan area and is located in Section 16, Township 7 South, Range 9 East, of Monroe Township, Michigan shown on Figure 1. The containment embankment was constructed by excavation of native clay subsoils and placing the clay in controlled lifts and compacted to a standard specification. The native subsoils are consistent clay soils extending down 30 to 50 ft below ground surface. The embankment is 14 to 46 ft high with a consistent crest elevation of approximately 615 ft (National Vertical Geodetic Datum/NGVD, 1929). The outer slopes range from approximately 2 horizontal to 1 vertical (2H:1V) to 3H:1V. The inner slopes are approximately 2H:1V. In addition, there is a submerged center dike, approximately in the middle of the FAB (see Figure 1), which has a crest elevation of approximately 592.4 ft.

There are residents along the northern side of the facility and I-75 is located to the west as shown on Figure 1. To the south lies farm fields and Waters Edge Road, a paved road leading to a boat launch facility. To the south of Waters Edge Road is the Knabusch Mathematics & Science Center. To the east of the facility lies Lake Erie; there are no habitable structures and no public roads to the east and southeast.

The location of the overtopping and subsequent breach was assessed. The elevation of the crest of the embankment is relatively consistent around 615 ft with a low elevation of 613.0 ft along the eastern side at approximately Station 165 as shown on Figure 1. That area of the embankment is also one of the tallest embankment areas with a height of 45 ft above the downstream toe. The low point at Station 165 was selected as the point of overtopping.

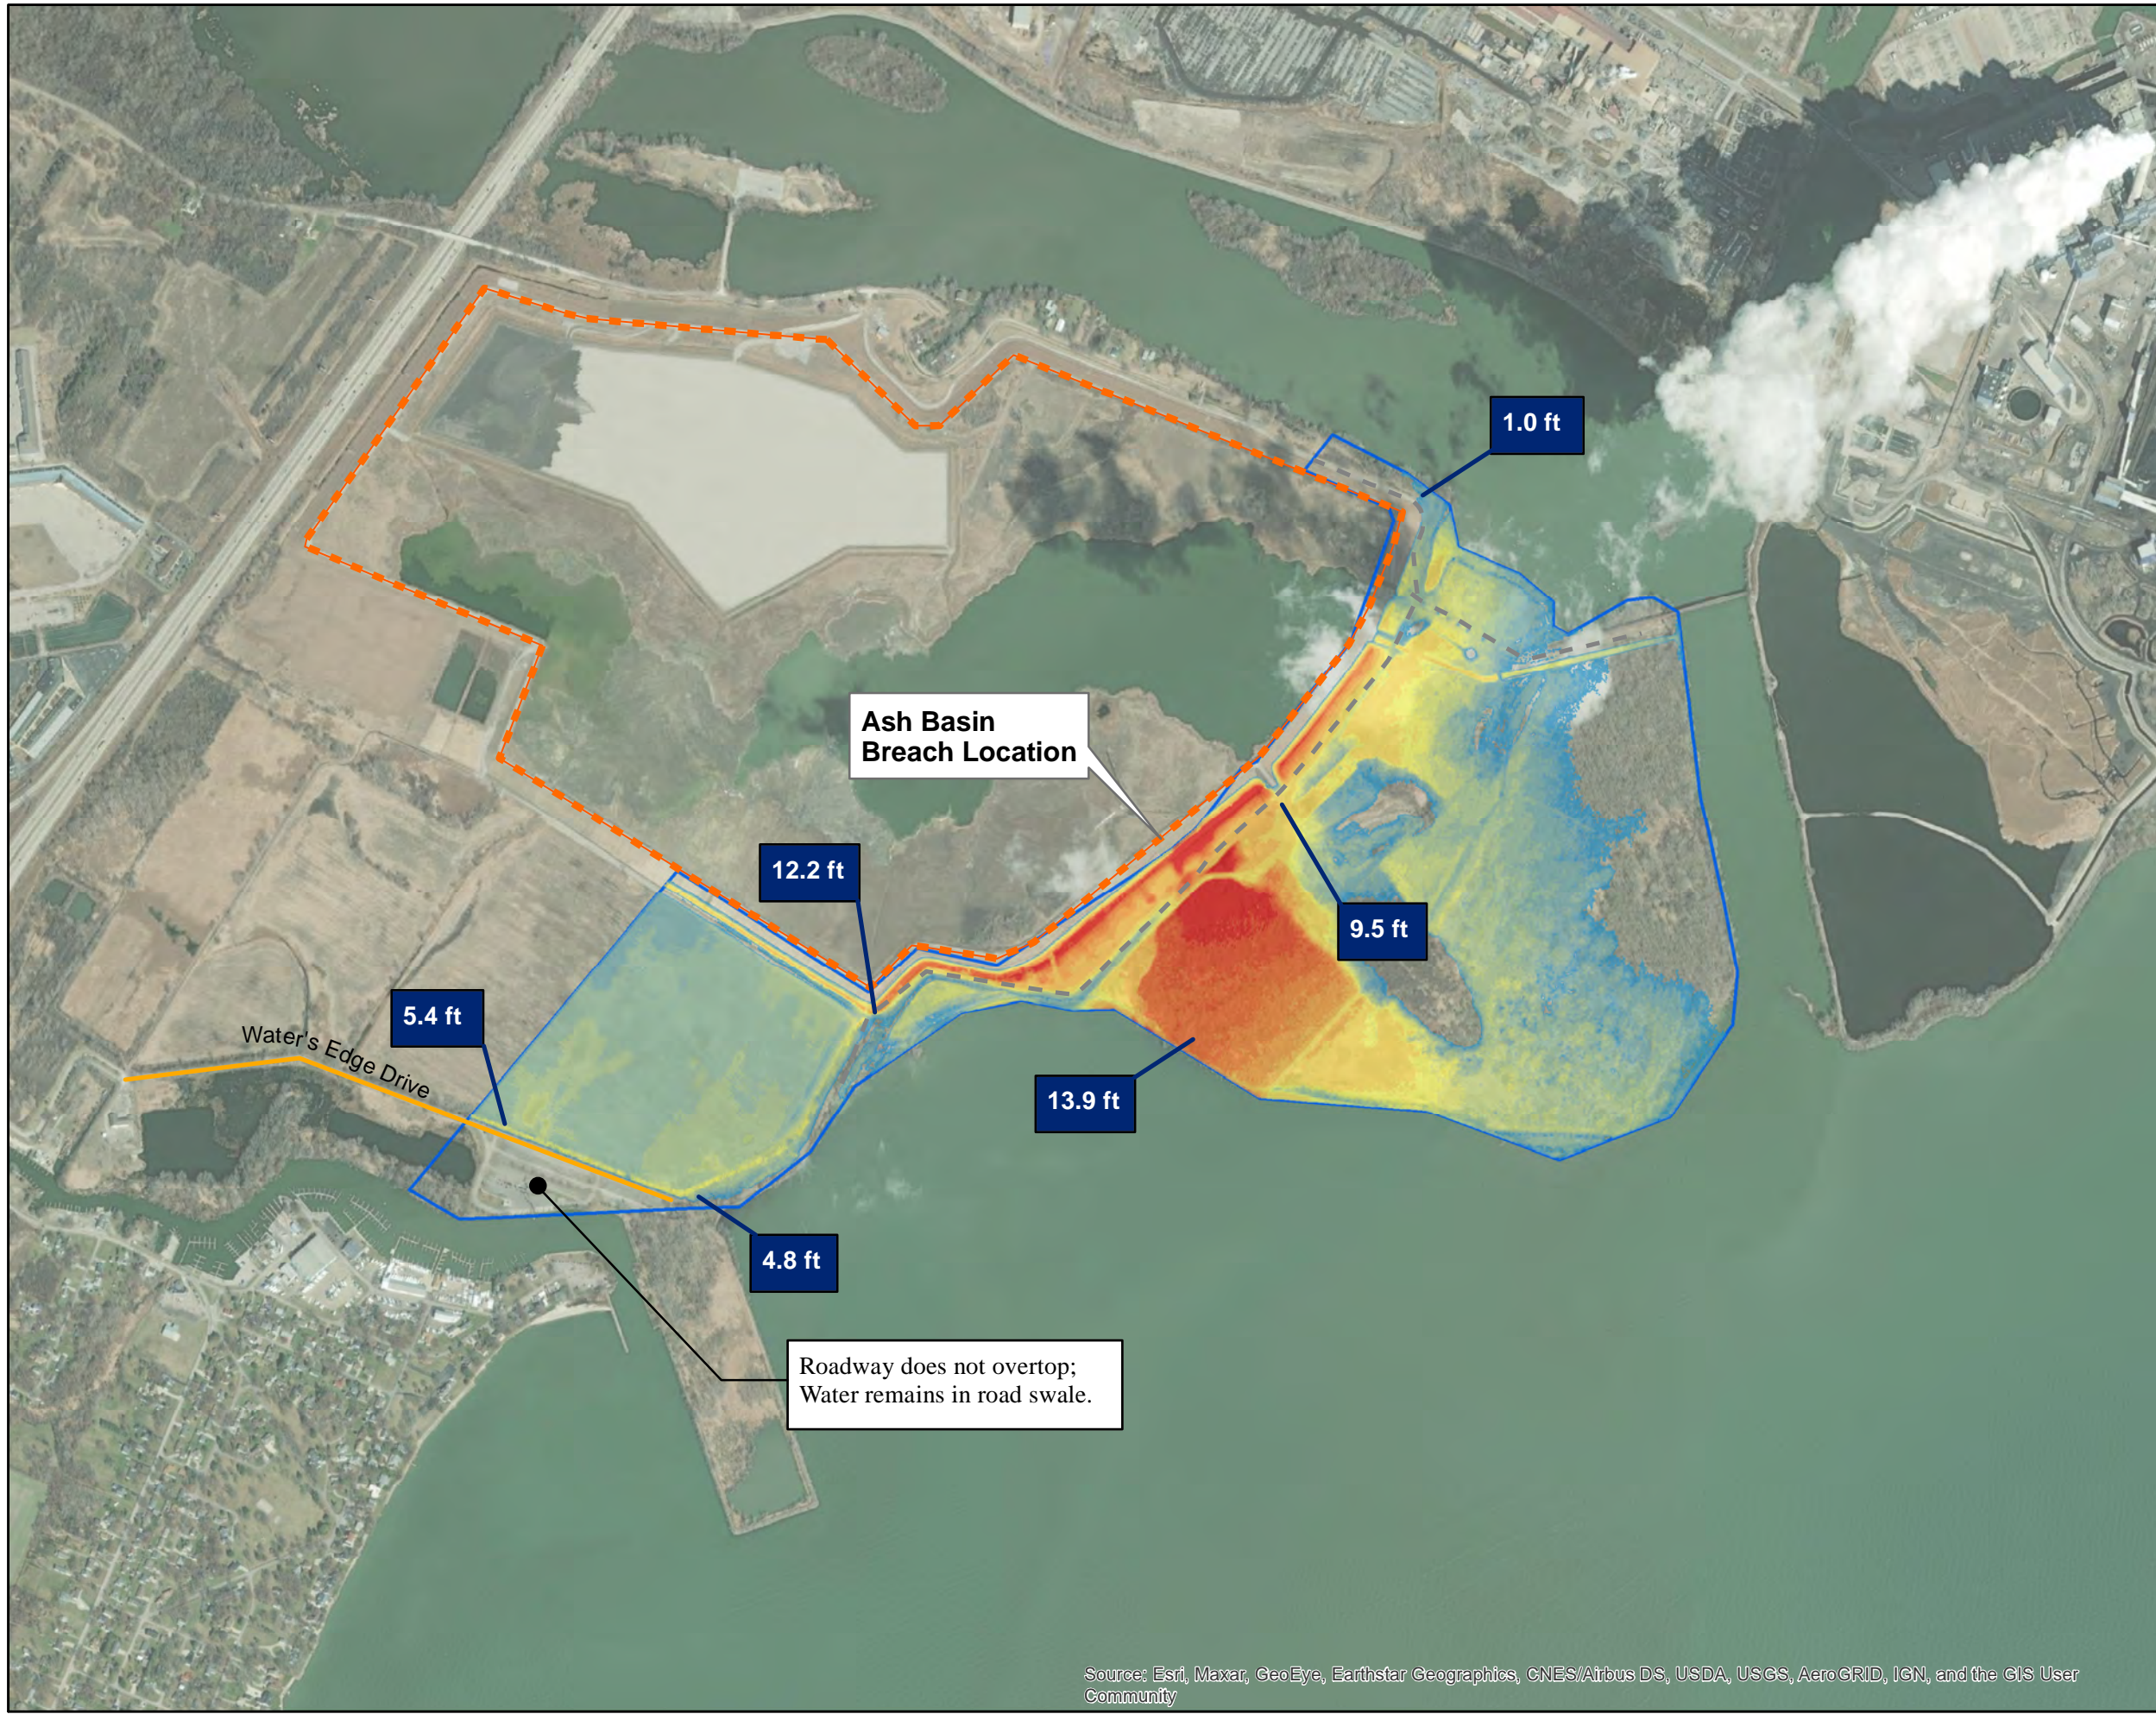
INUNDATION MAP - DEPTH OF WATER

for performing dam breach and inundation studies. The maximum depth of inundation and velocity of water from the embankment breach analysis are presented on Figures 2 and 3.

The areas that are shown to be inundated have no habitable structures and no public roads. The only possibility for the presence of people would be temporary workers at the facility and the occasional fisherman. FEMA does not take into account improbable (transient) loss of life, such as that of a recreational user, passer-by or occasional, non-overnight user of the downstream area (FEMA 2004). Consequently, there would not be probable loss of life due to the embankment breach.
