DTE Energy Monroe Power Plant

Inactive Bottom Ash Impoundment CCR Rule Compliance Project

Annual Inspection Report - 2021

Project Number: 60662907

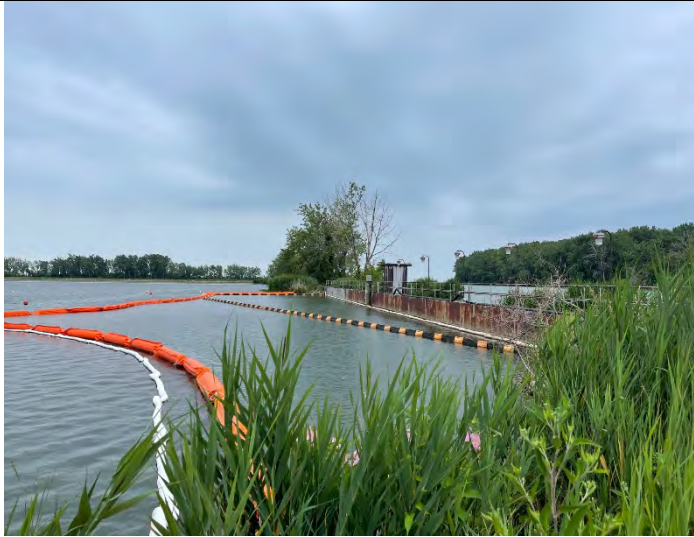
Photo 1: Looking south at discharge weir with additional turbidity curtains installed to protect during closure construction

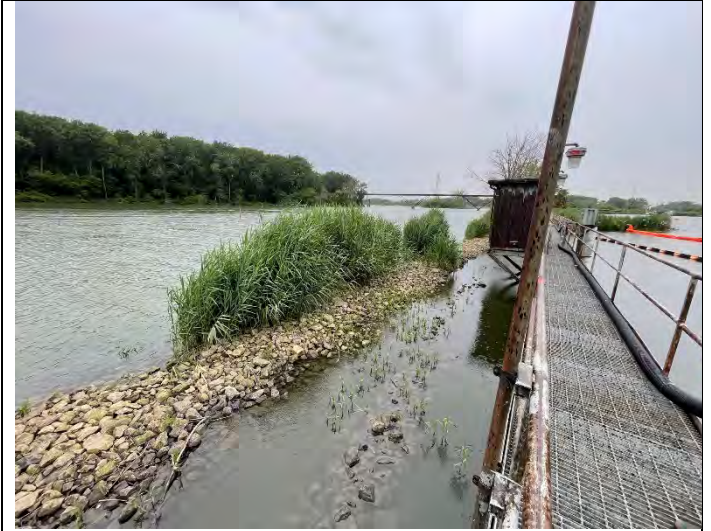
Comments /Action Items Spillway appears to be in good repair – water levels in the pond and discharge canal are lower than in 2020. There are no control systems so the spillway acts as both principal and emergency.					
Actions <input checked="" type="checkbox"/> None <input type="checkbox"/> Maintenance <input type="checkbox"/> Monitoring <input type="checkbox"/> Minor Repair <input type="checkbox"/> Engineering					
EMERGENCY SPILLWAY	OBSERVATIONS				
	<input type="checkbox"/> No emergency spillway		<input checked="" type="checkbox"/> Same as primary spillway		
	PROBLEMS				CHANNEL LINING
	<input type="checkbox"/> 1. None <input type="checkbox"/> 2. Debris in channel <input type="checkbox"/> 3. Gates <input type="checkbox"/> 4. Misalignment	<input type="checkbox"/> 5. Joint deterioration <input type="checkbox"/> 6. Joint displacement <input type="checkbox"/> 7. Exposed reinforcement <input type="checkbox"/> 8. Erosion	<input type="checkbox"/> 9. Undermining <input type="checkbox"/> 10. Voids <input type="checkbox"/> 11. Cracks <input type="checkbox"/> 12. Holes <input type="checkbox"/> 13. Outlet erosion	<input type="checkbox"/> 14. Displaced rip rap <input type="checkbox"/> 15. Sparse rip rap <input type="checkbox"/> 16. Outlet undercutting <input type="checkbox"/> 17. Inadequate capacity <input type="checkbox"/> 18. Other	<input type="checkbox"/> Vegetation <input type="checkbox"/> Rip rap <input type="checkbox"/> Concrete <input type="checkbox"/> Asphalt <input type="checkbox"/> Other

Photo 2: Weir – water levels in the discharge canal are lower than in 2020.

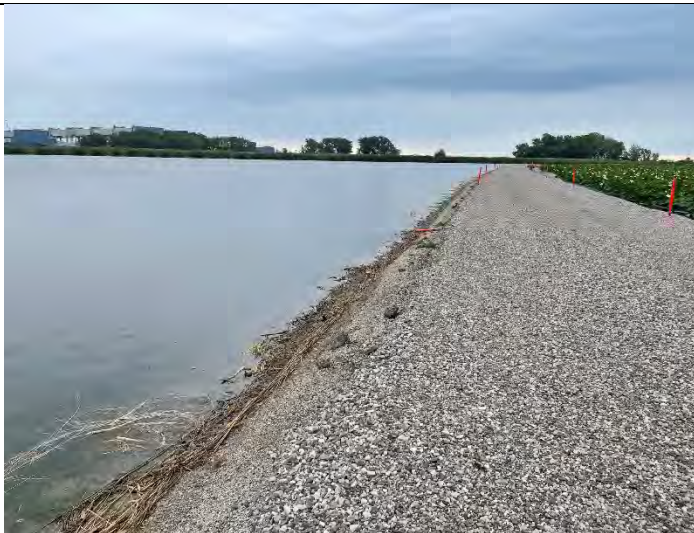
Photo 3: Looking east along the south separation berm – the berm has been raised 1 to 1.5' since the last annual inspection

DTE installed additional stone materials along the southern berm; raising the top crest elevation 12 to 18 inches. Site access roads have also been improved as part of the ongoing closure construction.

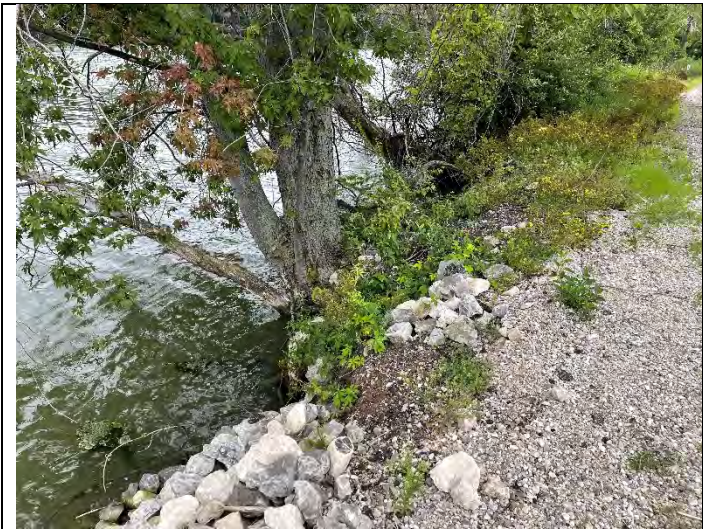
Photo 4: Area along the west berm repaired with additional rip-rap in previous years. Slope looks stable; DTE personnel monitor suspect areas without rip-rap protection on a weekly basis.

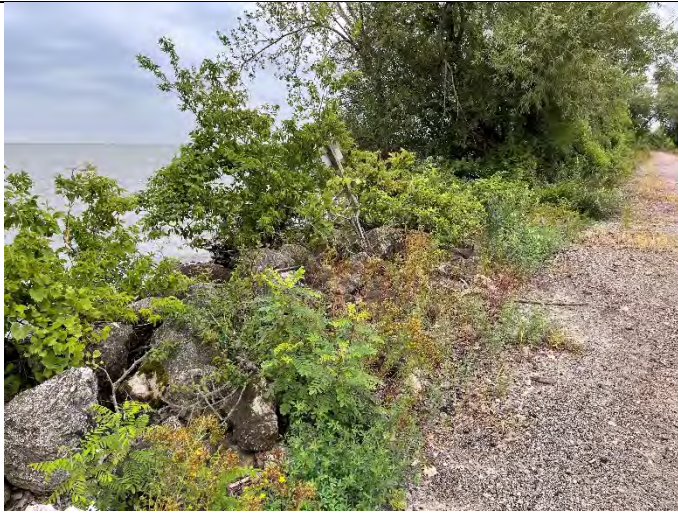
Photo 5: Vegetated slope and large rip-rap along the eastern perimeter.

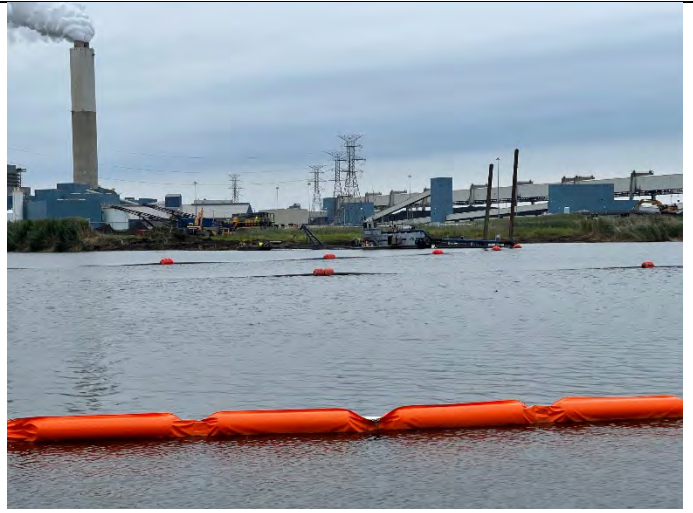
Closure construction in the Bottom Ash Impoundment commenced in March 2021. As of July 23, approximately 5% of the volume of the pond in the northeast quarter has been removed through wet excavation and transported off-site. The northern third of the impoundment has been regraded to accommodate the construction contractor's equipment, access roads, settling basins, and a geotube field.

Photo 6: Looking north from access road at closure construction in progress; dredge is clearly visible along with additional turbidity curtains installed as protection

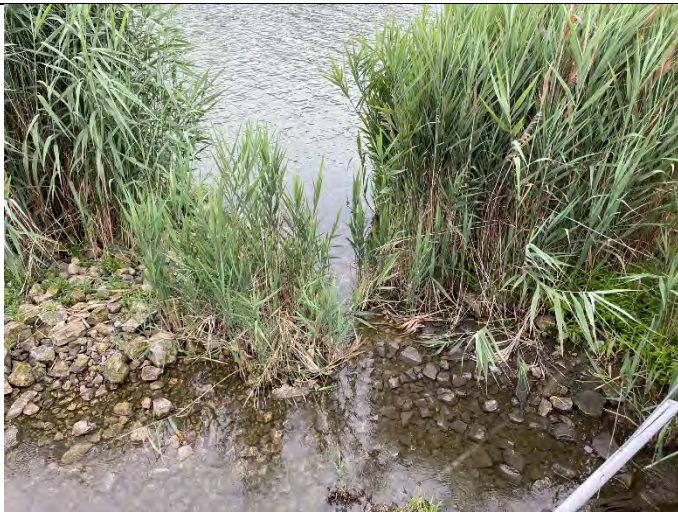
Photo 7: Discharge 'path' from weir to the discharge canal; water level has decreased in both the pond and the discharge canal to make this the primary discharge point between the two water bodies.
