DTE Energy Monroe Power Plant

Inactive Bottom Ash Impoundment CCR Rule Compliance Project

Annual Inspection Report - 2018

Project Number: 60516675

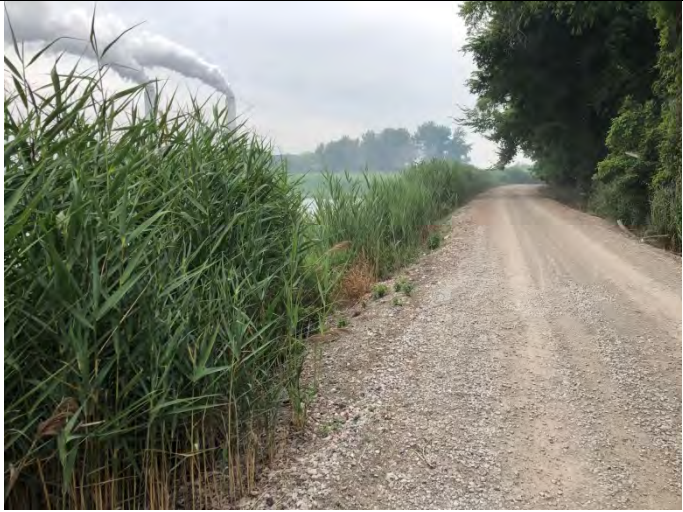
Photo 1: Looking north along east access road; note overgrown vegetation on inboard edge of berm.

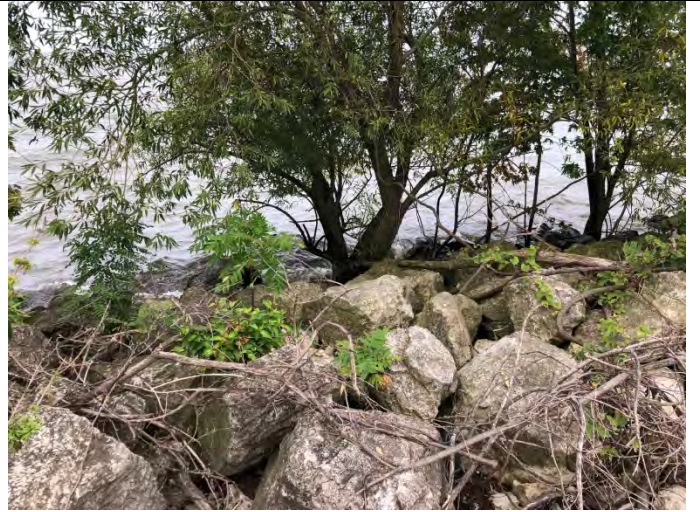
Photo 2: Looking east downslope at the large rip-rap protecting the berm along Lake Erie.

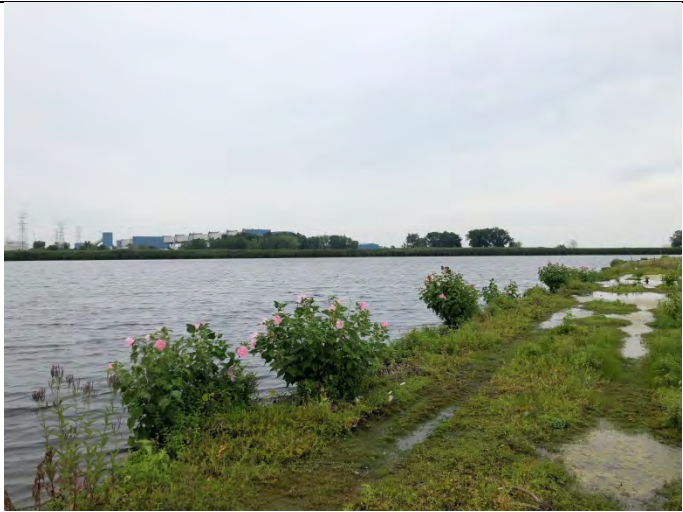
Photo 3: Looking east from west access road at south separation berm.

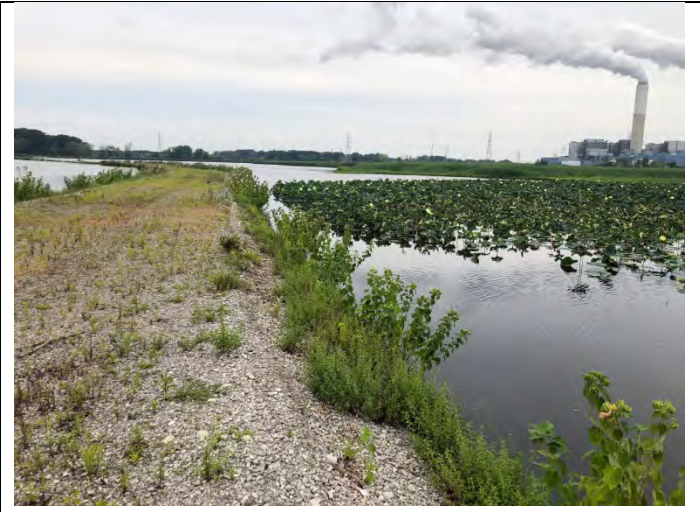
Photo 4: Looking west from east access road at south separation berm.

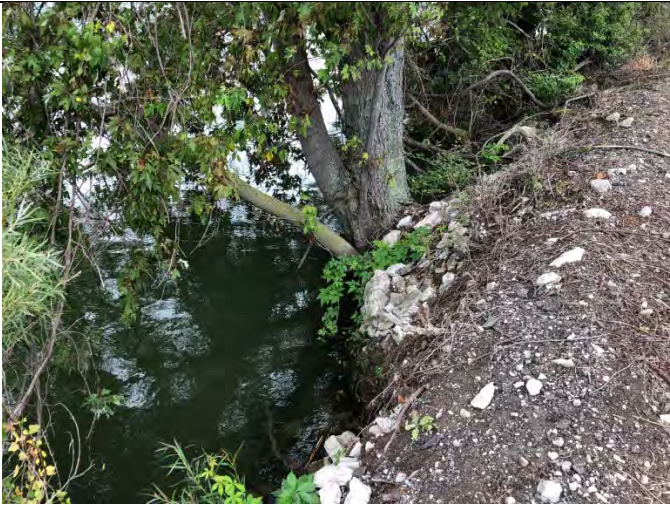
Photo 5: Area along the west berm needing rip-rap replacement due to sloughing into the discharge canal.

- The downslope sides of the Impoundment are heavily vegetated and a thorough inspection of the entire surface area of the impoundment is not practical.
- The downstream side of the spillway is heavily vegetated and flow through the spillway is redirected preferentially due to this vegetation. Flow through the spillway is not impeded due to the vegetation at this time.
- There are two areas along the western side of the berm surrounding area 15 (along the discharge canal) where the rip-rap has slid down the slope; DTE should consider replacing this rip-rap to prevent future erosion of the berm in these areas.
