DTE Energy Monroe Power Plant

Inactive Bottom Ash Impoundment CCR Rule Compliance Project

Annual Inspection Report - 2020

September 4, 2020

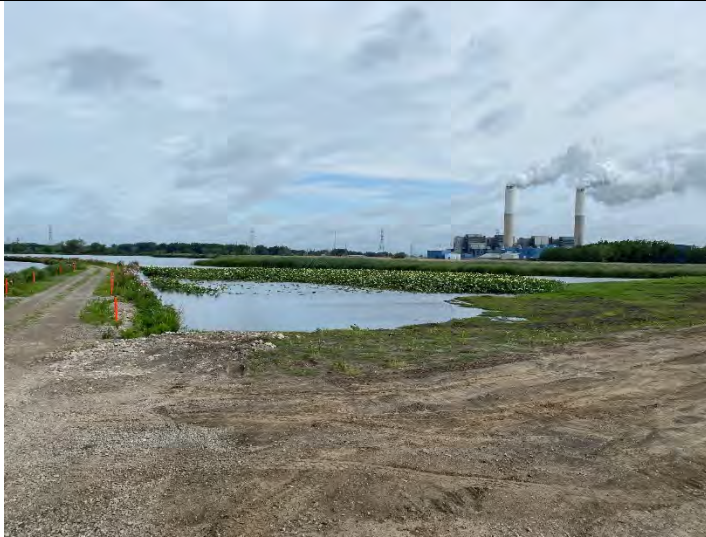
Photo 1: Looking northwest from east edge of separation berm

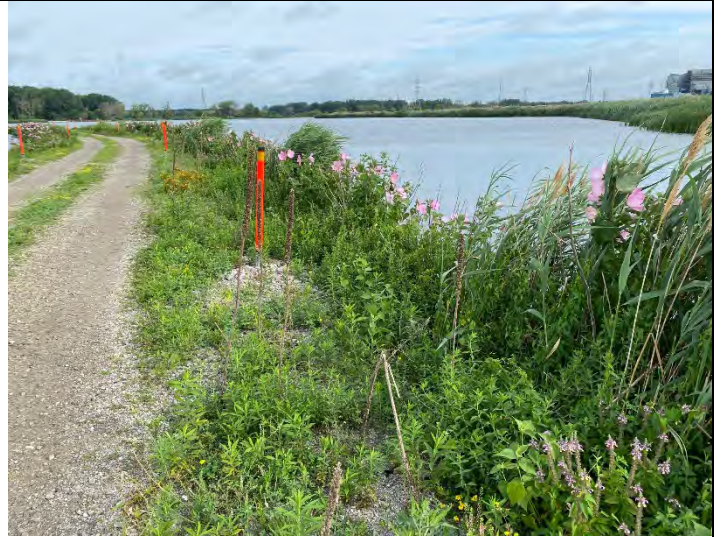
Photo 2: Looking west from east access road at south separation berm.

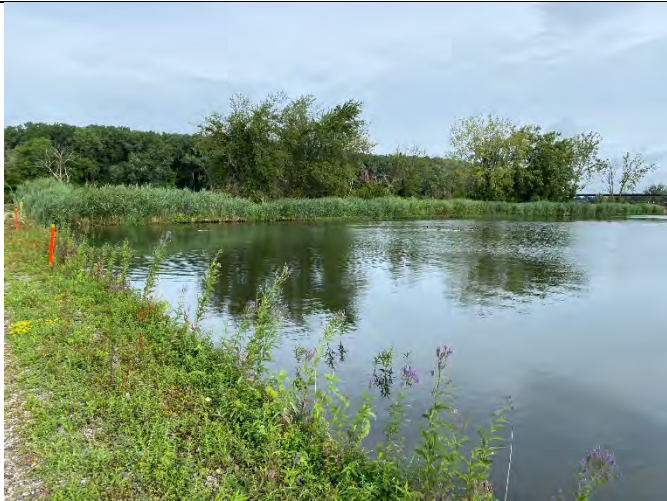
Photo 3: Looking west south separation berm to western edge of impoundment.

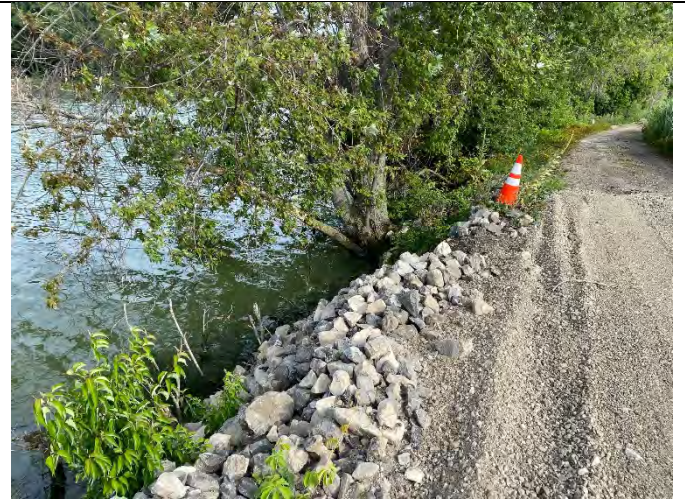
Photo 4: Area along the west berm repaired with additional rip-rap since 2019 inspection. Additional aggregate placed on road since 2019 is also shown. Area near cone on north edge of photo needs to be monitored during the coming year.

DTE installed additional rip-rap along the western slope of the impoundment to repair areas where rip-rap has sloughed down the slope. DTE also has made extensive repairs to the site access roads surrounding the pond on the east and west side; on the east side the road has been significantly widened and new aggregate has been placed. On the western berm south of the weir additional aggregate has also been placed.

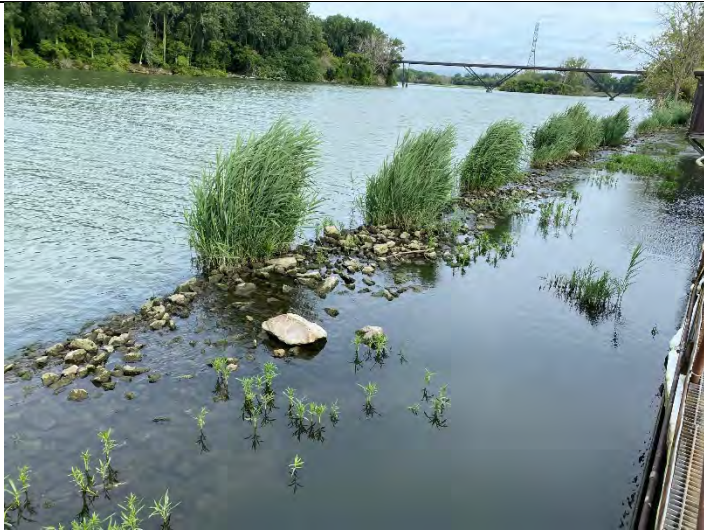
Photo 5: Looking northwest from the walkway of the weir – water levels is lower than in 2019.

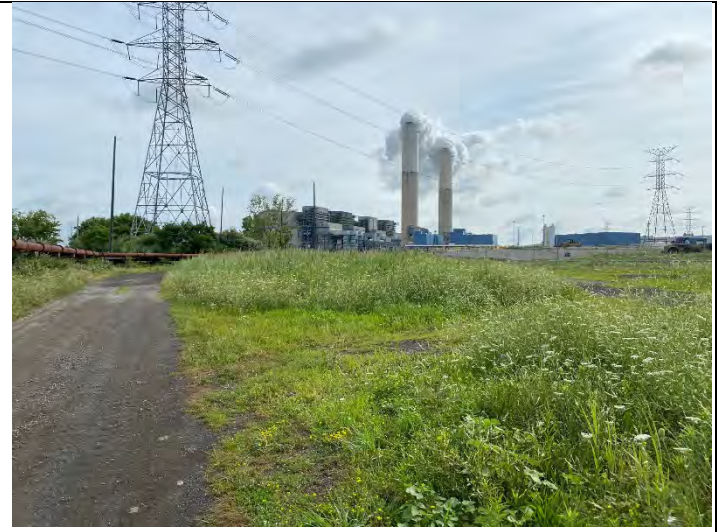
Photo 6: Looking north from access road on northwest side of impoundment

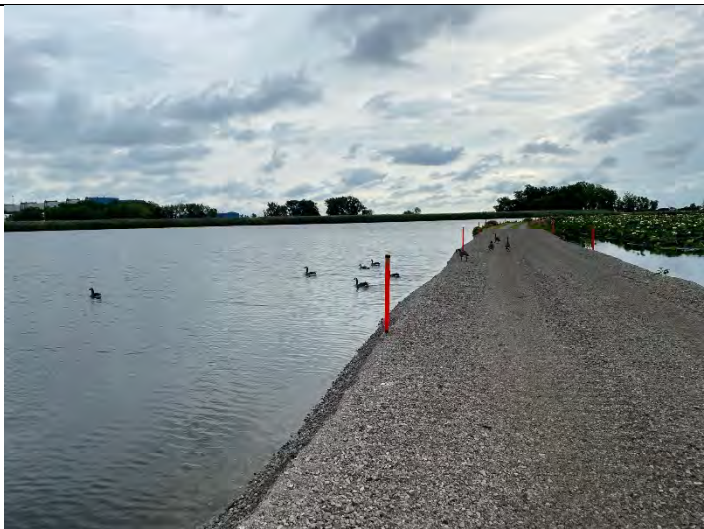
Photo 7: Looking east at south separation berm where the lowered area was filled in since the last inspection.

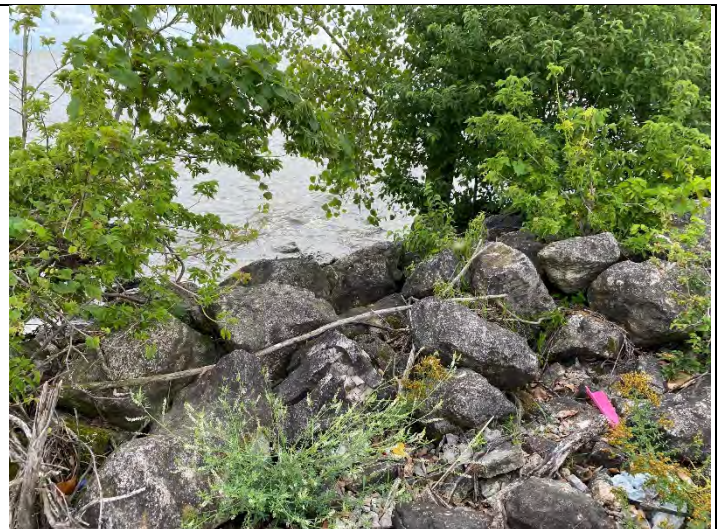
Photo 8: Looking east at riprap shore protection along Lake Erie.
