DTE Energy Monroe Power Plant

Bottom Ash Impoundment CCR Rule Compliance Project

Annual Inspection Report - 2022

Project Number: 60689329

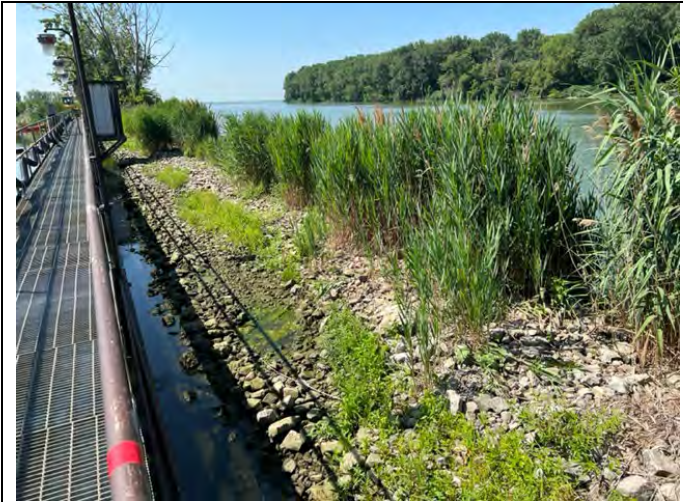
Comments /Action Items Spillway appears to be in good repair – water levels in the pond and discharge canal are lower than in 2021. There are no control systems so the spillway acts as both principal and emergency. Outfall of spillway is overgrown with vegetation that has created preferential flow pathways across the discharge.					
Actions <input checked="" type="checkbox"/> None <input type="checkbox"/> Maintenance <input type="checkbox"/> Monitoring <input type="checkbox"/> Minor Repair <input type="checkbox"/> Engineering					
EMERGENCY SPILLWAY	OBSERVATIONS				
	<input type="checkbox"/> No emergency spillway			<input checked="" type="checkbox"/> Same as primary spillway	
	PROBLEMS				CHANNEL LINING
	<input type="checkbox"/> 1. None <input type="checkbox"/> 2. Debris in channel <input type="checkbox"/> 3. Gates <input type="checkbox"/> 4. Misalignment	<input type="checkbox"/> 5. Joint deterioration <input type="checkbox"/> 6. Joint displacement <input type="checkbox"/> 7. Exposed reinforcement <input type="checkbox"/> 8. Erosion	<input type="checkbox"/> 9. Undermining <input type="checkbox"/> 10. Voids <input type="checkbox"/> 11. Cracks <input type="checkbox"/> 12. Holes <input type="checkbox"/> 13. Outlet erosion	<input type="checkbox"/> 14. Displaced rip rap <input type="checkbox"/> 15. Sparse rip rap <input type="checkbox"/> 16. Outlet undercutting <input type="checkbox"/> 17. Inadequate capacity <input type="checkbox"/> 18. Other	<input type="checkbox"/> Vegetation <input type="checkbox"/> Rip rap <input type="checkbox"/> Concrete <input type="checkbox"/> Asphalt <input type="checkbox"/> Other

Photo 1: Looking south at discharge weir; heavily vegetated and water levels continue to decrease along the discharge canal

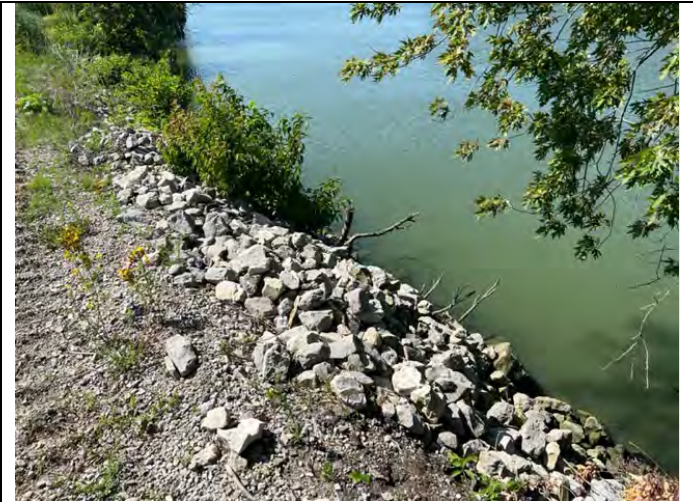
Photo 2: Area of previous sloughing along discharge canal that was augmented by rip-rap placement in previous years. Slope looks stable; DTE personnel monitor suspect areas without rip-rap on a weekly basis

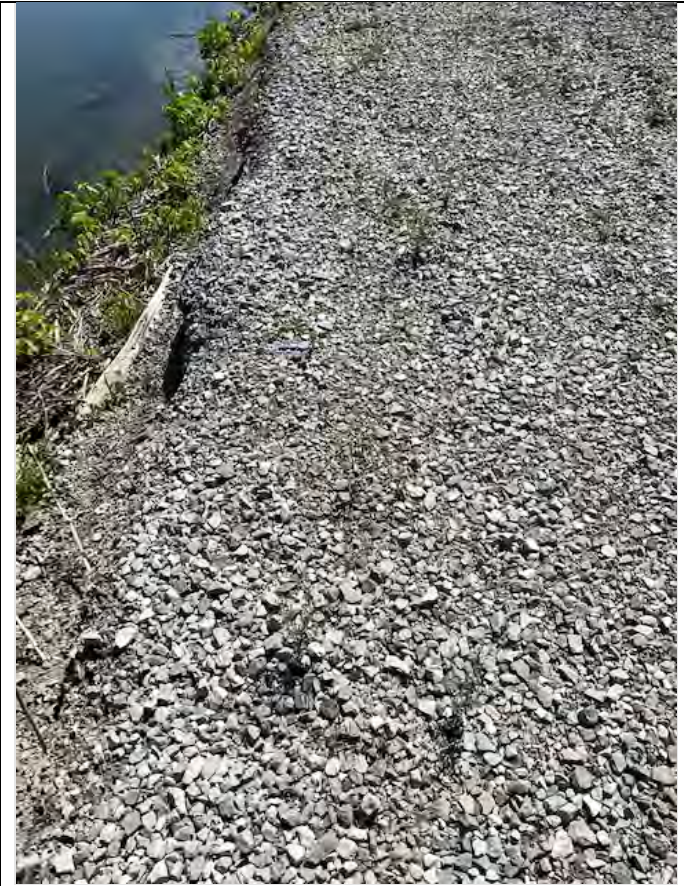
Photo 3: The south separation berm – while the area of upgraded stone placement (12-18" inches) has experienced some sloughing the berm continues to be stable at lower depths.

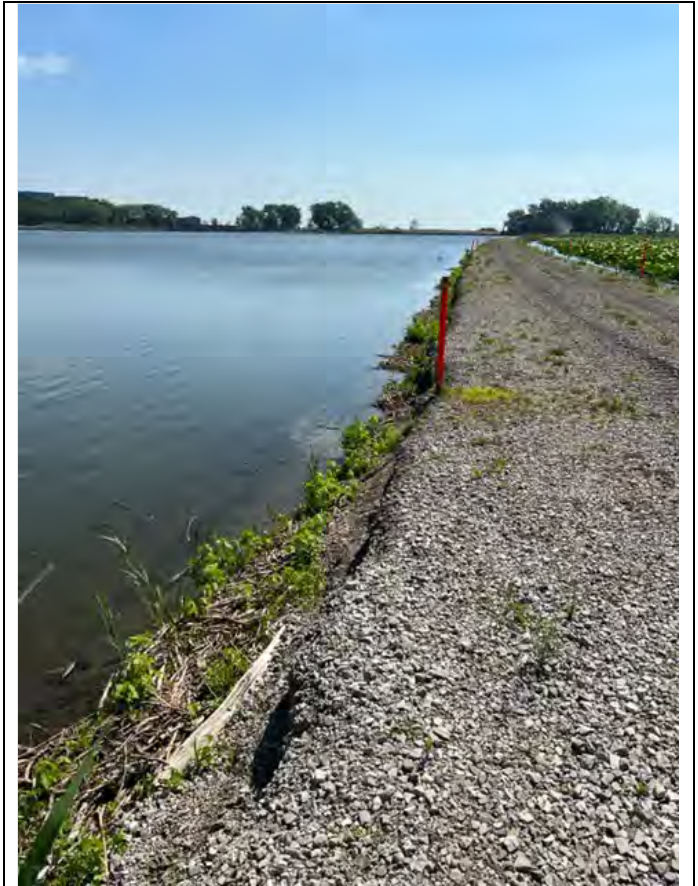
Photo 4: Another view of the southern separation berm showing the additional stone placement and sloughing along with the stable inboard slopes

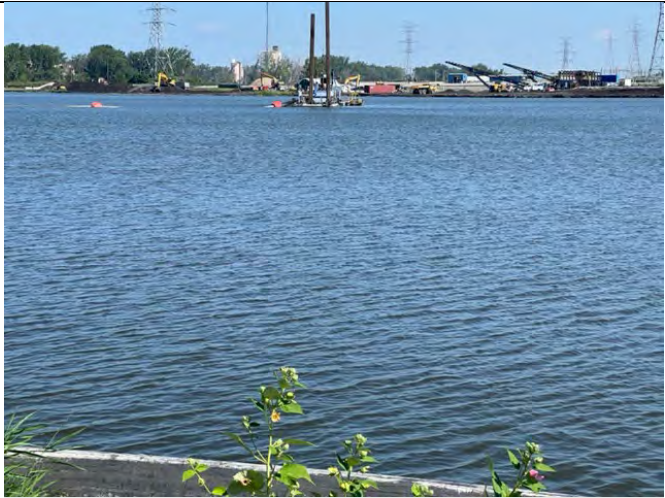
Photo 5: Looking north at dredging and closure construction from the south separation berm

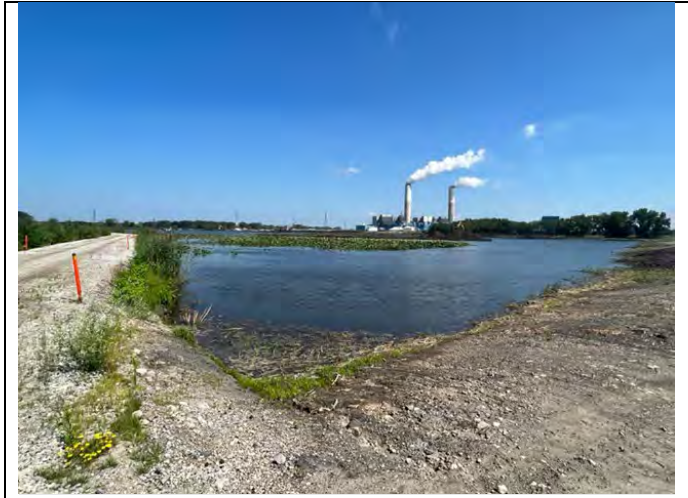
Photo 6: Looking northeast from the eastern end of the south separation berm

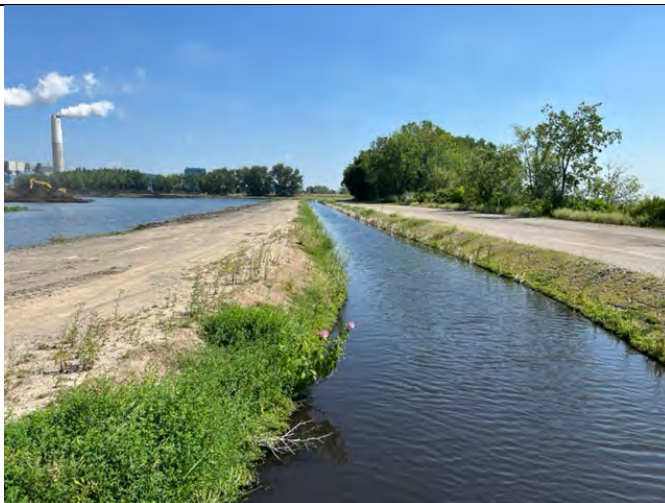
Photo 7: Looking north from the south separation berm at the waste water ditch (center) and the impoundment (to the left).

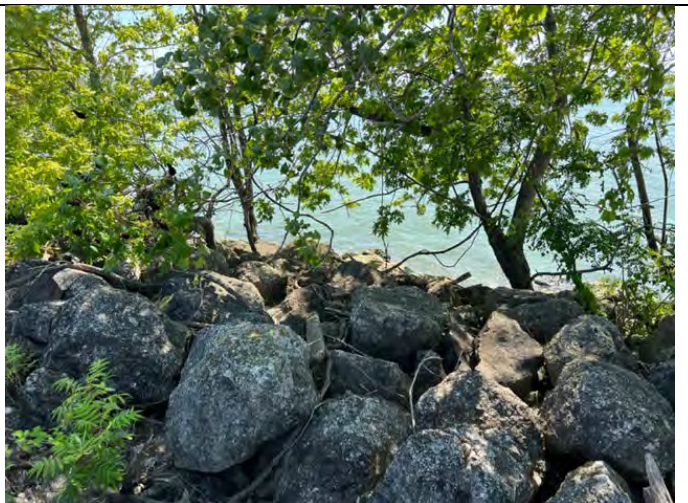
Photo 8: Heavy rip-rap along the eastern shore of the perimeter dike facing Lake Erie. No changes are noted in this area.
