**DTE Electric Company**  
One Energy Plaza  
Detroit, Michigan 48226

# **2018 ANNUAL INSPECTION REPORT VERTICAL EXTENSION LANDFILL**

**MONROE POWER PLANT**

January 2019

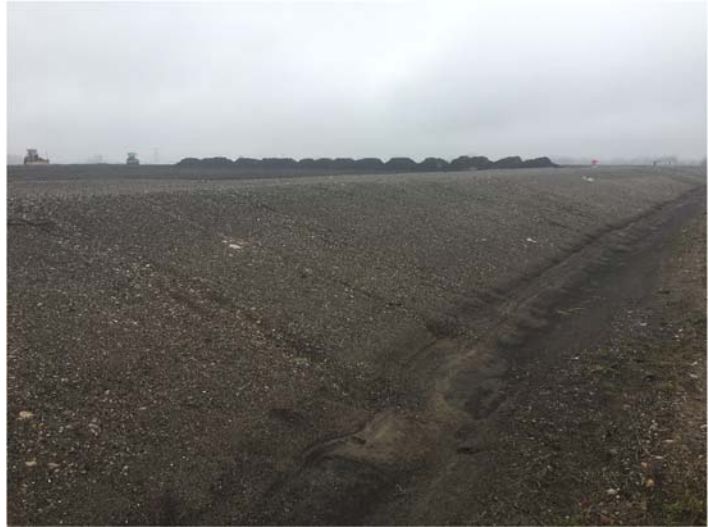
**Comments: Photo taken at  
Station ~53+00. Minor erosion  
rills observed on perimeter access  
road embankment.**

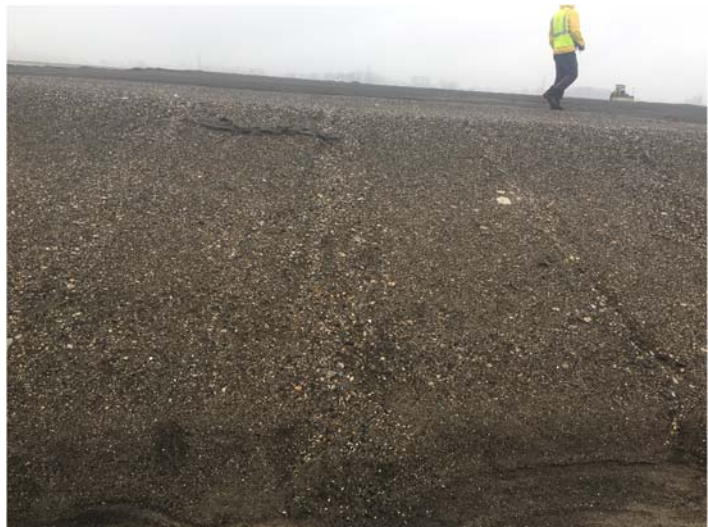
**Photograph ID: 2**

**Comments: Photo taken at  
Station ~53+00. erosion rills  
observed on perimeter access  
road embankment.**

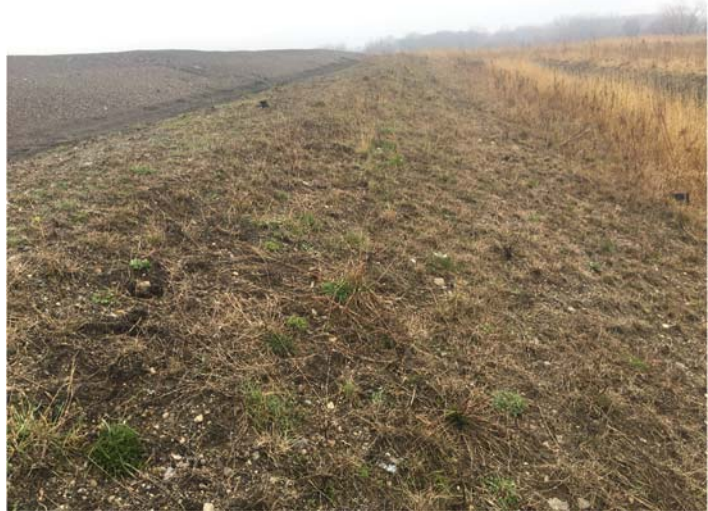
- (i) sediment build-up within the pore pressure relief pipes within Phase 1 footprint;
- (ii) erosion on the perimeter access road embankment and perimeter clay embankment; and
- (iii) sparse vegetation on the perimeter clay embankment. Most of the pore pressure relief pipes were observed to have sediment build-up (Photograph 6) and most of these pipes appeared to be pitched inward. Erosion features such as rills and gullies were observed at numerous locations on both perimeter access road embankment and perimeter clay embankment (see Photographs 1, 2, and 7 for typical conditions). Most of the perimeter clay embankment has sparse vegetation (Photograph 3).

**Comments: Photo taken at  
Station ~55+00. Areas of sparse  
vegetation observed on perimeter  
clay embankment.**

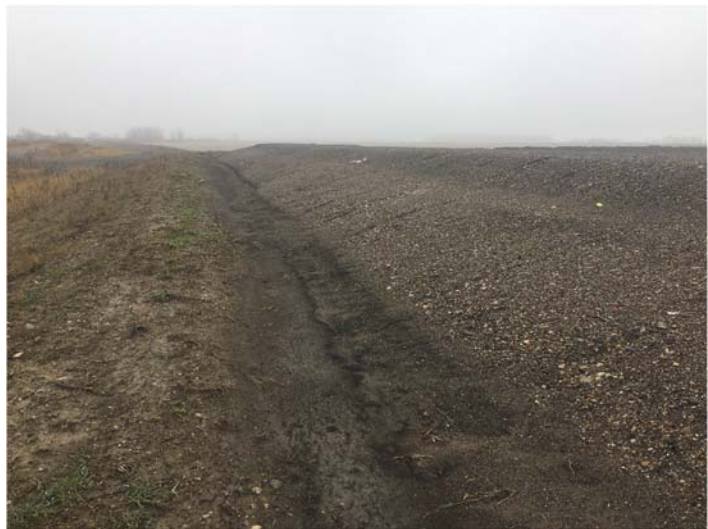
**Photograph ID: 4**

**Comments: Photo taken at  
Station ~60+00. Low spot  
observed between perimeter  
access road embankment and  
perimeter clay embankment.**

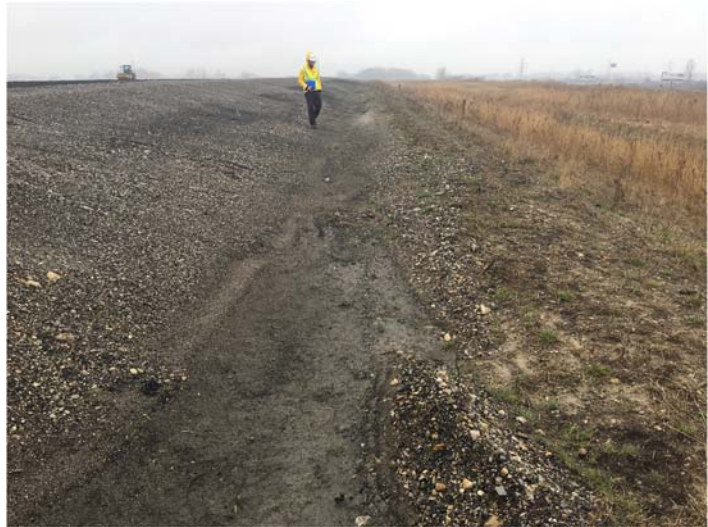
**Comments: Photo taken at Station ~70+00. Low spot observed between perimeter access road embankment and perimeter clay embankment.**

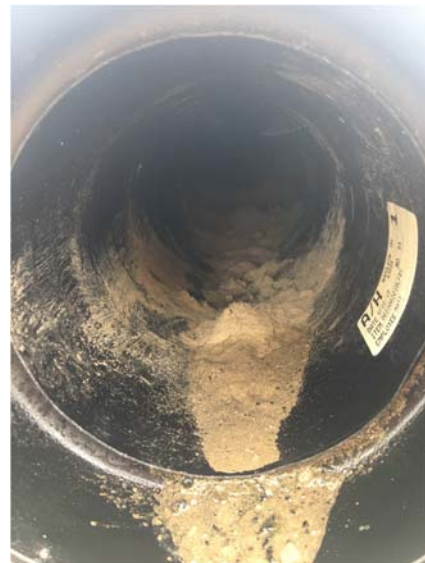
**Photograph ID: 6**

6. Is the underdrain collection system draining? Yes No
Describe flow conditions. Many of the underdrain collection system drains have sediment build up.
Only one of the pipes were draining at the time of inspection.

**Comments: Photo taken at Station ~72+00. Typical sediment buildup in a pore pressure relief drain.**

DTE should inform the design engineer about the sediment build-up within pore pressure relief pipes. In summary, no evidence of instability or detrimental settlement was noted. The entire Landfill, including the Perimeter Berms and Perimeter Swales, are located within the interior drainage area of the Ash Basin. Any potential sediments from erosion will be deposited in the Ash Basin. Any potential runoff will be managed under the NPDES permit for the Ash Basin

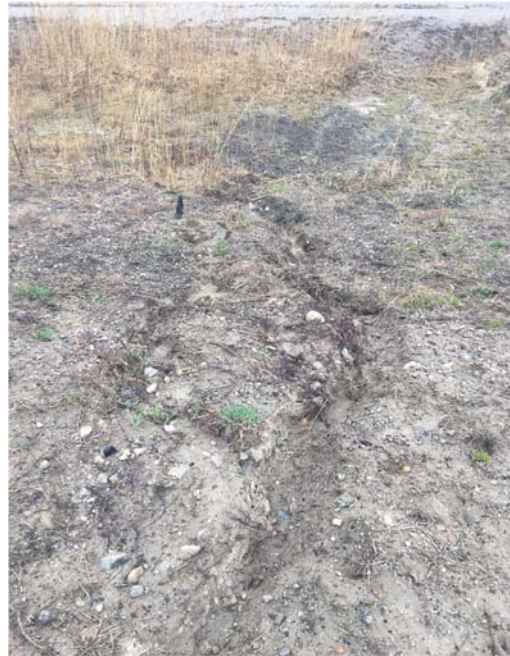
**Comments: Photo taken at  
Station ~78+00. Erosion gully  
observed on perimeter clay  
embankment.**

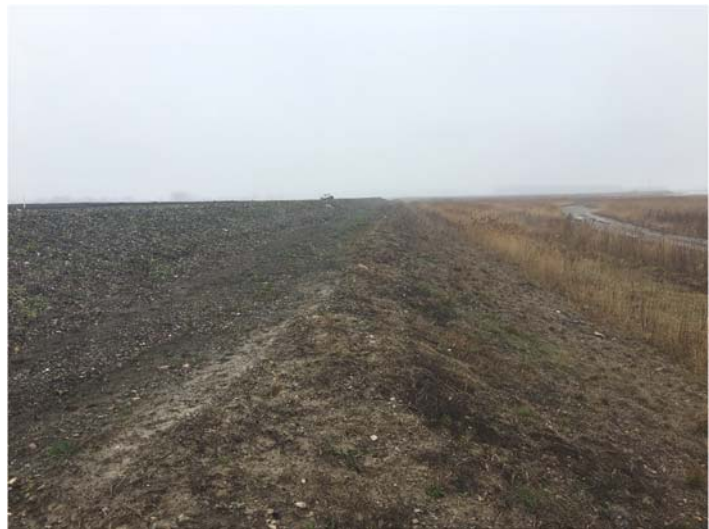
**Photograph ID: 8**

**Comments: Photo taken at  
Station ~78+00. General condition  
of perimeter clay embankment.**

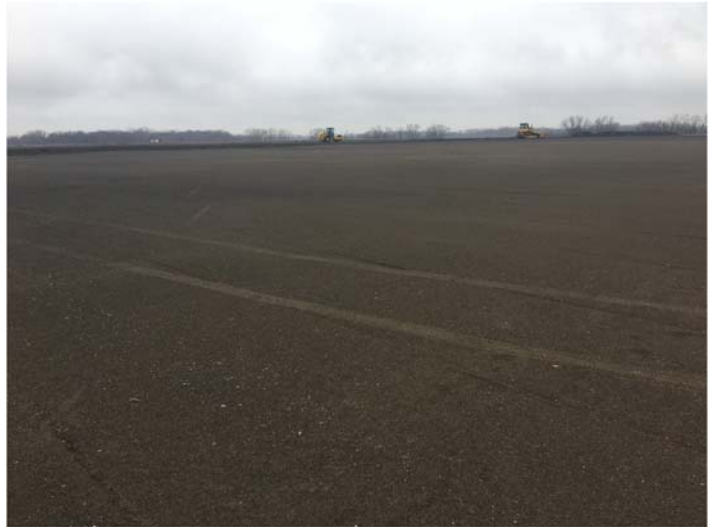
**Comments: General condition of  
Phase 2 area.**
