2019 ANNUAL INSPECTION REPORT VERTICAL EXTENSION LANDFILL

MONROE POWER PLANT

Monroe, Michigan

January 2020

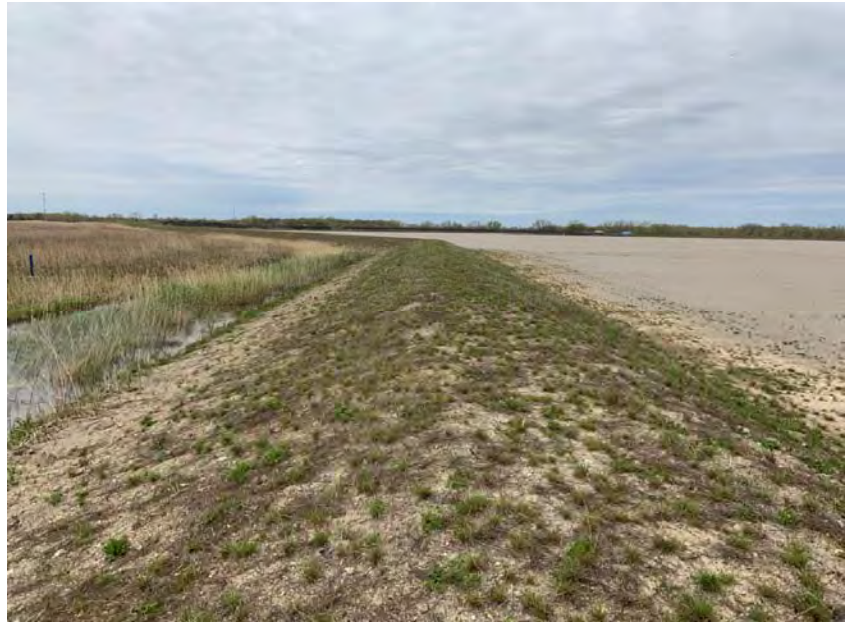
Comments: View of Landfill (on the right side) from perimeter clay embankment along Phase 2.

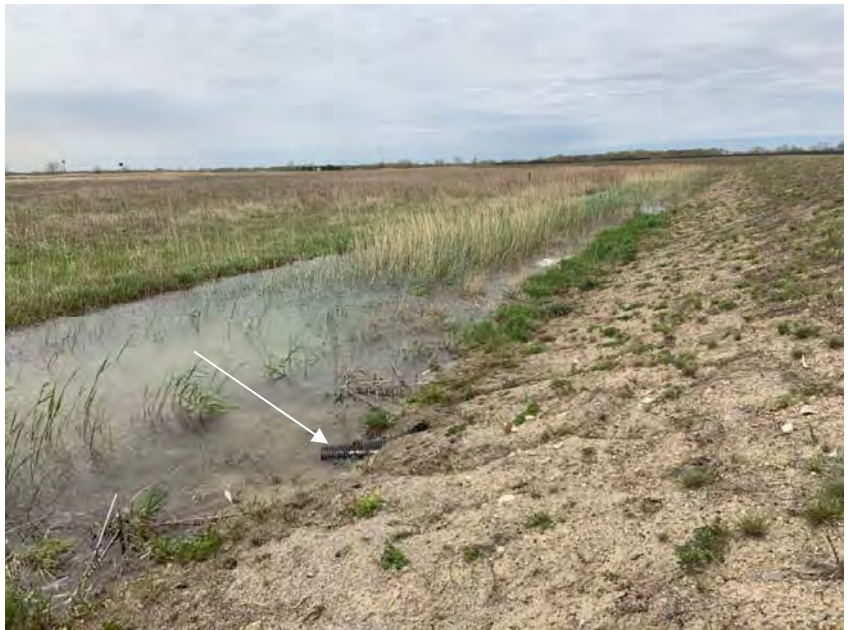
Photograph ID: 2

Comments: Water level in the perimeter swale is high, it backs into pore pressure relief drain of the Landfill under Phase 2.

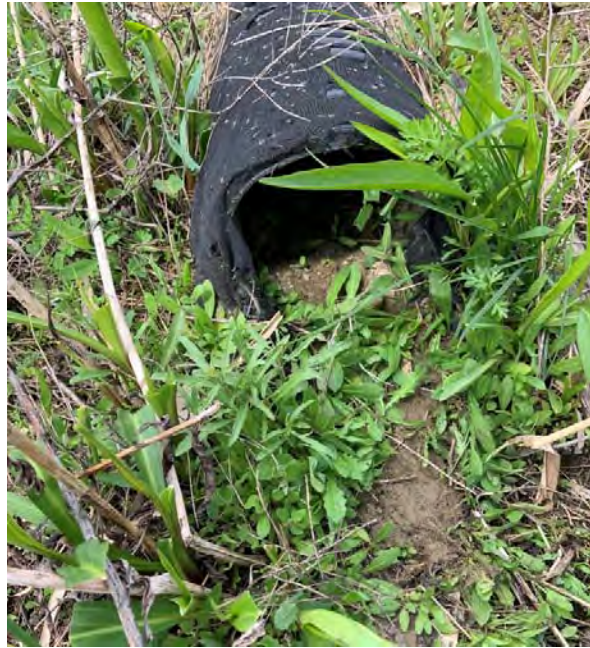
- (i) sediment build-up within the pore pressure relief pipes within Phase 1 footprint (see Photograph 3);
- (ii) erosion and sparse vegetation on the perimeter access road embankment and perimeter clay embankment (see Photograph 5 for typical conditions);
- (iii) high water level in the perimeter swale. One of the pore pressure relief drain under Phase 2 footprint was underwater.

6. Is the underdrain collection system draining? Yes No
Describe flow conditions Many of the underdrain collection system drains have sediment build up (Photograph 3
Some of the pipes were draining at the time of inspection (Photograph 4).

Comments: Typical sediment buildup in a pore pressure relief drain under Phase 1.

DTE should inform the design engineer about the sediment build-up within pore pressure relief pipes. **In summary, no visual and monitoring evidence of instability or detrimental settlement was noted.** The entire Landfill, including the Perimeter Berms and Perimeter Swales, are located within the interior drainage area of the Ash Basin. Any potential sediments from erosion will be deposited in the Ash Basin. Any potential runoff will be managed under the NPDES permit for the Ash Basin

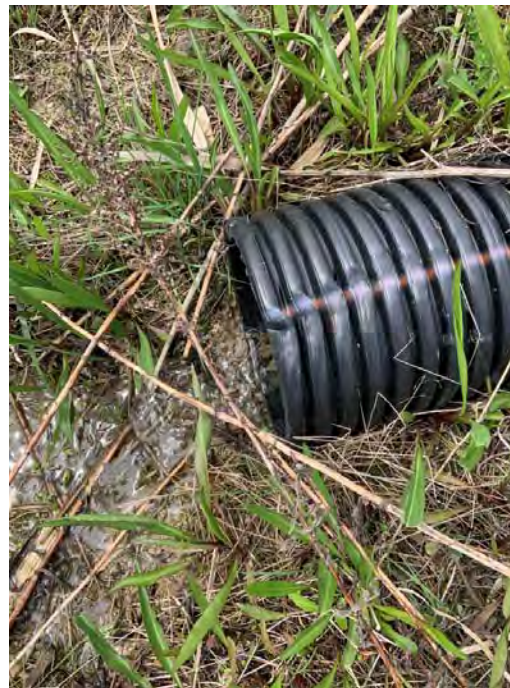
Photograph ID: 4

Comments: Several of pore pressure relief drains were observed to be draining water in to perimeter swale. Also appears to have some sediment buildup.

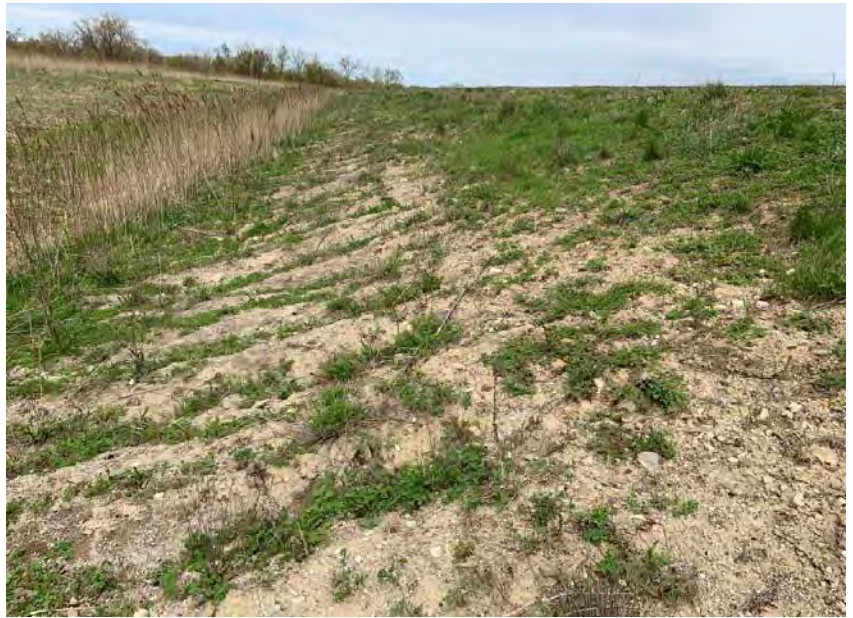
3. Are there indications of erosion on the landfill perimeter berm? Yes No
If 'Yes', describe what type and its condition (rill, gully, dimensions, etc
Numerous erosion rills and gullies were observed on the perimeter access berm and perimeter clay berm (up to 12-in dep
(Photograph 5)

Comments: Sparse vegetation and numerous erosion rills and gullies up to about 12-inches deep were observed on the exterior face of perimeter clay embankment. These erosion features were observed to have vegetation growth.

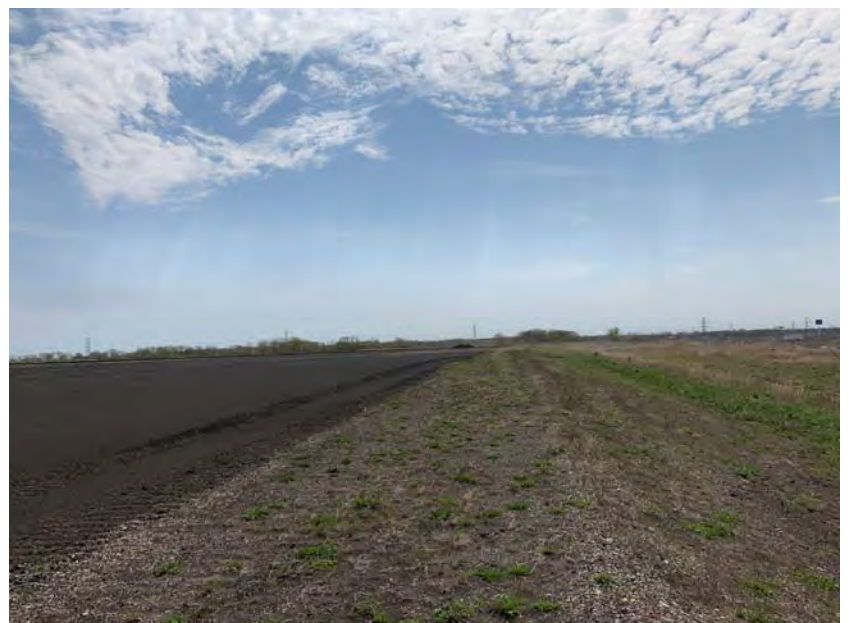
Photograph ID: 6

Comments: View of Phase 1 area from perimeter access road (on left side). CCR grade is near the top of perimeter access road
