# **2021 ANNUAL INSPECTION REPORT VERTICAL EXTENSION LANDFILL**

**MONROE POWER PLANT**

**Monroe, Michigan**

January 2022

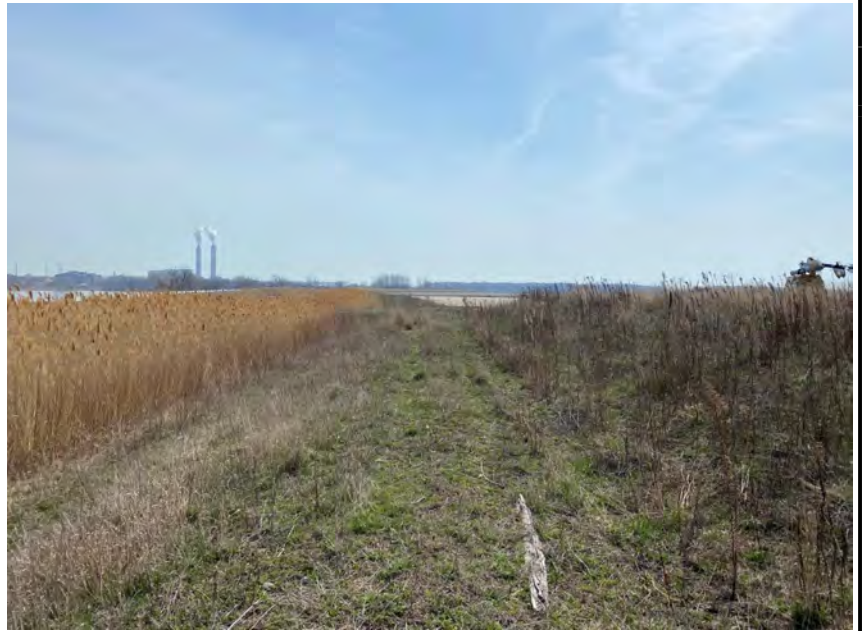
**Comments: View of Landfill  
from the top of perimeter clay  
embankment along the North side  
(Dunbar Road side).**

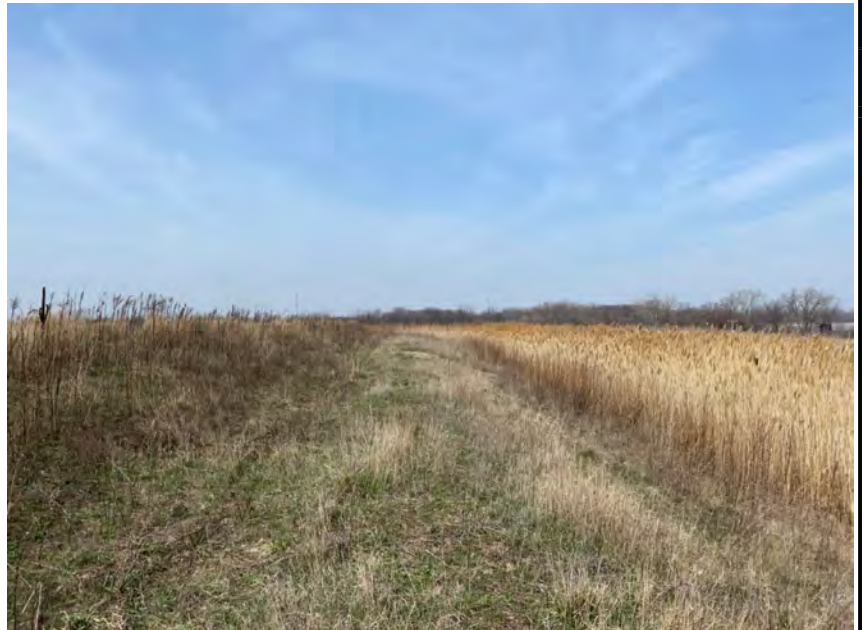
**Photograph ID: 2**

**Comments: View of Landfill  
from the top of perimeter clay  
embankment along the North side  
(Dunbar Road side).**

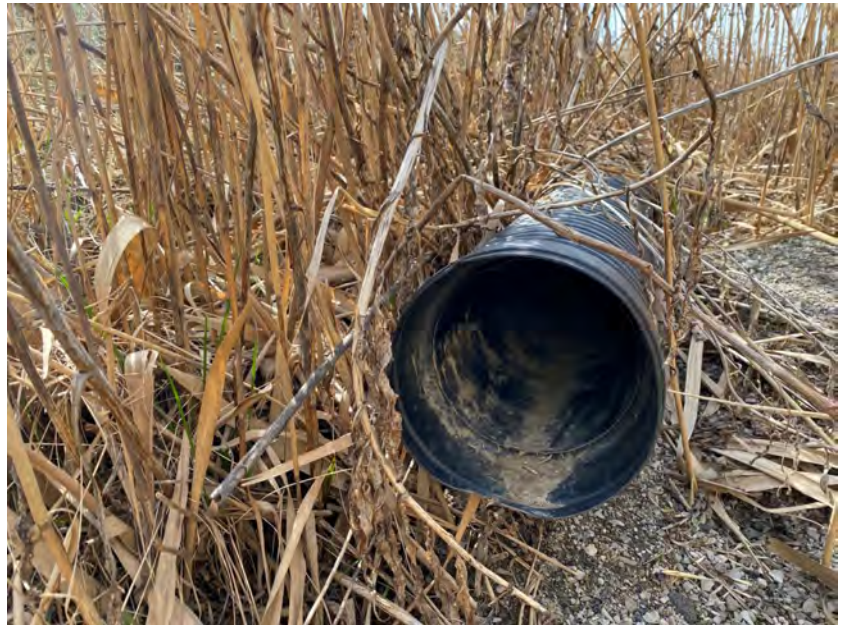
6. Is the underdrain collection system draining?      x Yes      \_\_\_ No  
Describe flow conditions. Many of the pore pressure relief pipes were observed to have some sediment build-up at the outlets (generally < 0.5 inches deep). The pipes were not draining at the time of inspection.  
Sediment build-up does not appear to impede flow. (Photo 3)  
\_\_\_\_\_

**Comments: Most pore pressure  
relieve system pipes were  
inspected. No flowing water was  
observed.**

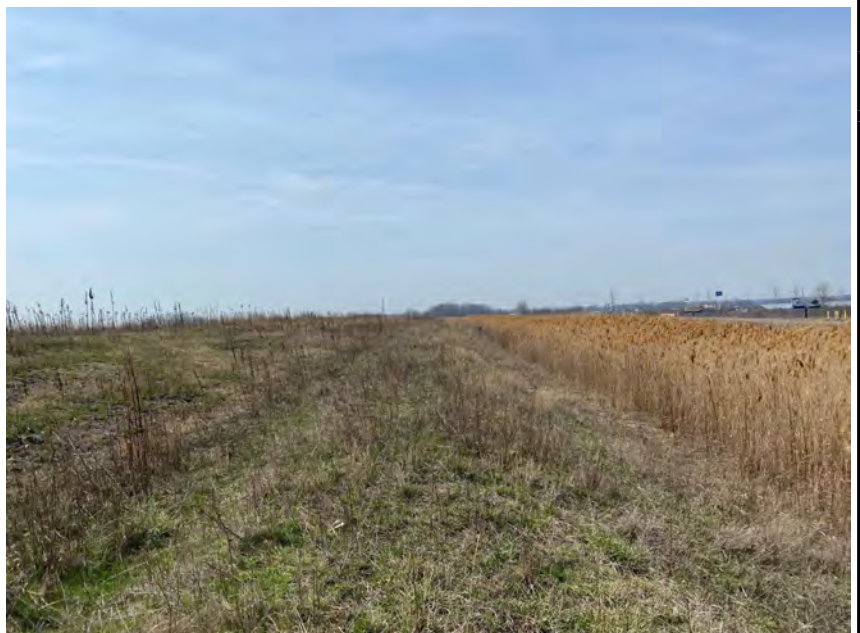
**Photograph ID: 4**

**Comments: View of Landfill  
from the top of perimeter clay  
embankment along the west side  
(I-75 side).**

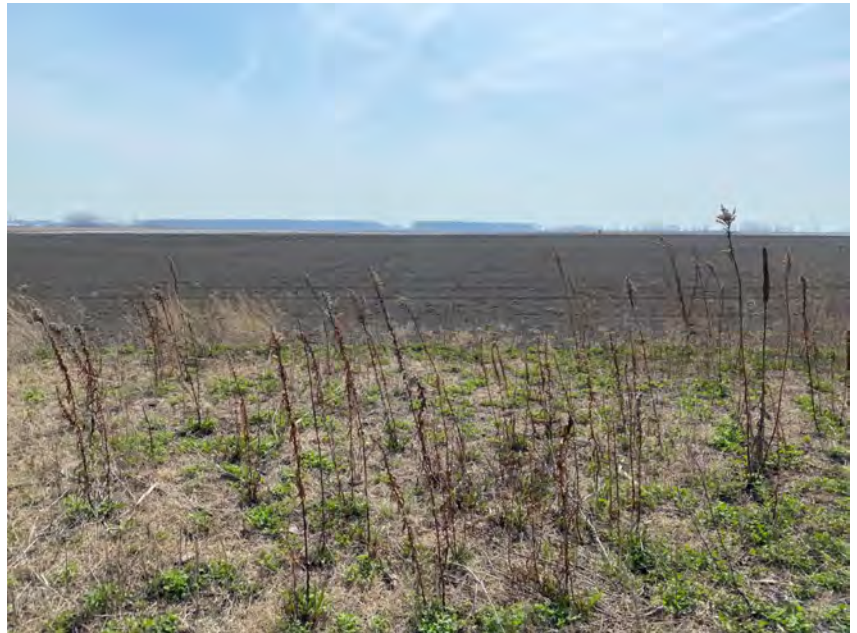
**Comments: View of Phase 1 from  
the west side of the Landfill.**

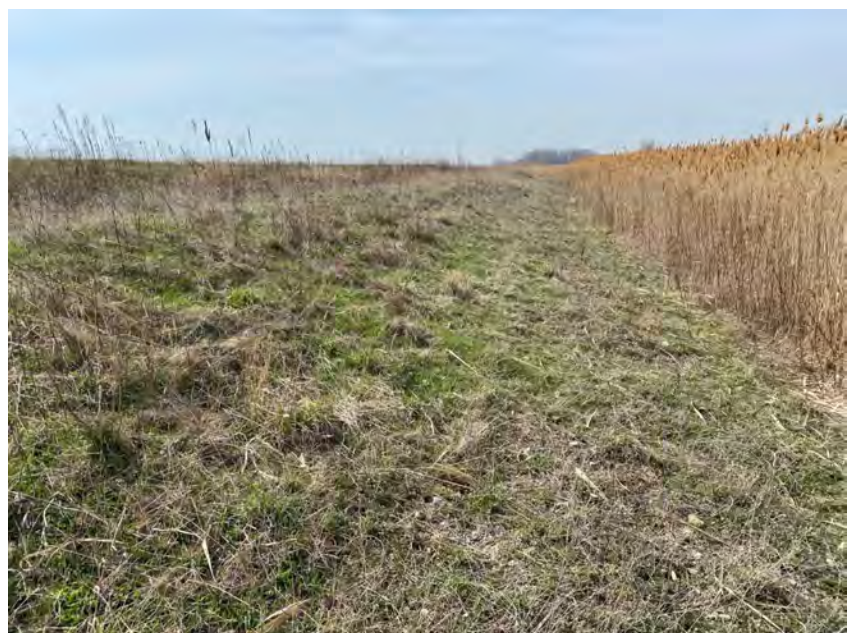
**Photograph ID: 6**

**Comments: Vegetation on the  
perimeter clay embankment  
appeared to have denser  
vegetation compared to previous  
years.**

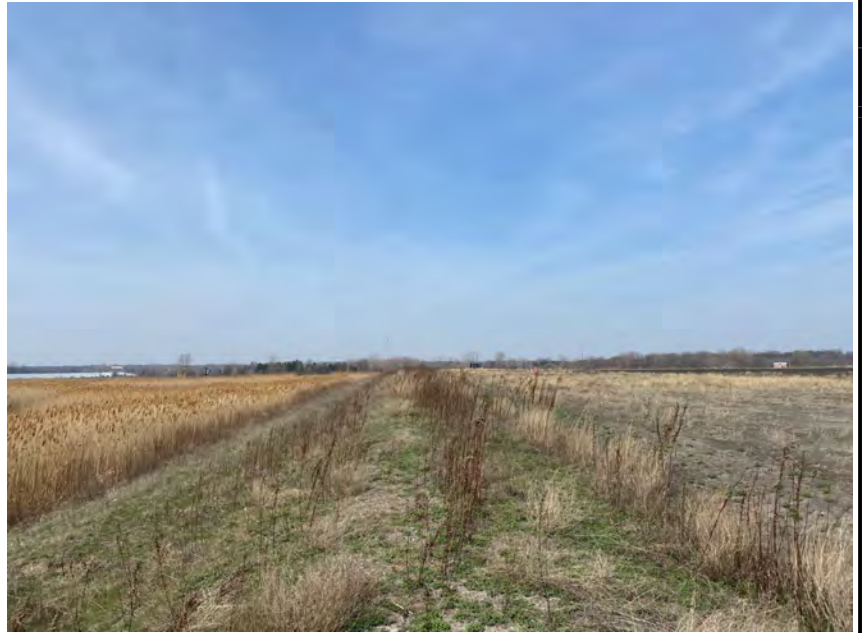
**Comments: View of Landfill  
from the top of perimeter clay  
embankment along the South  
side.**

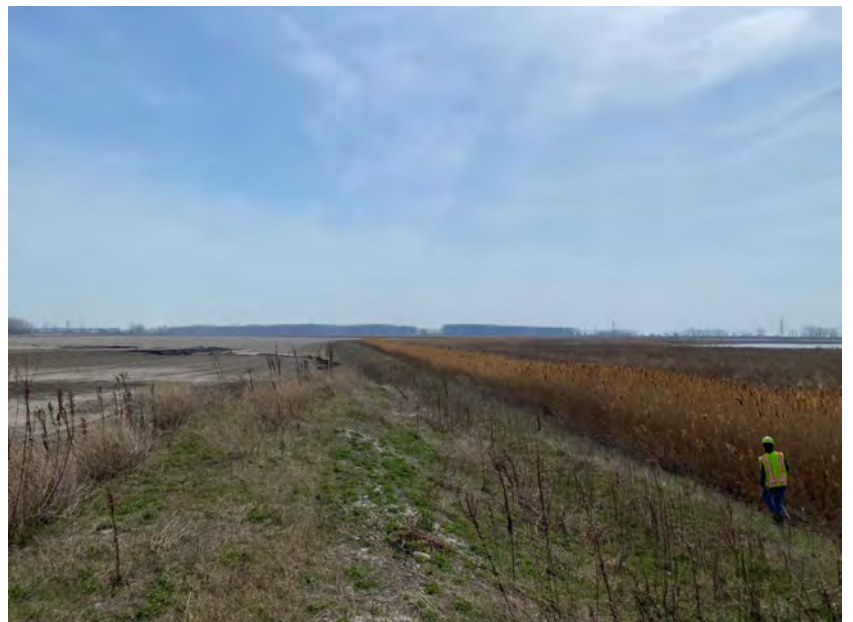
**Photograph ID: 8**

**Comments: View of Landfill  
from the top of perimeter clay  
embankment along the South  
side.**

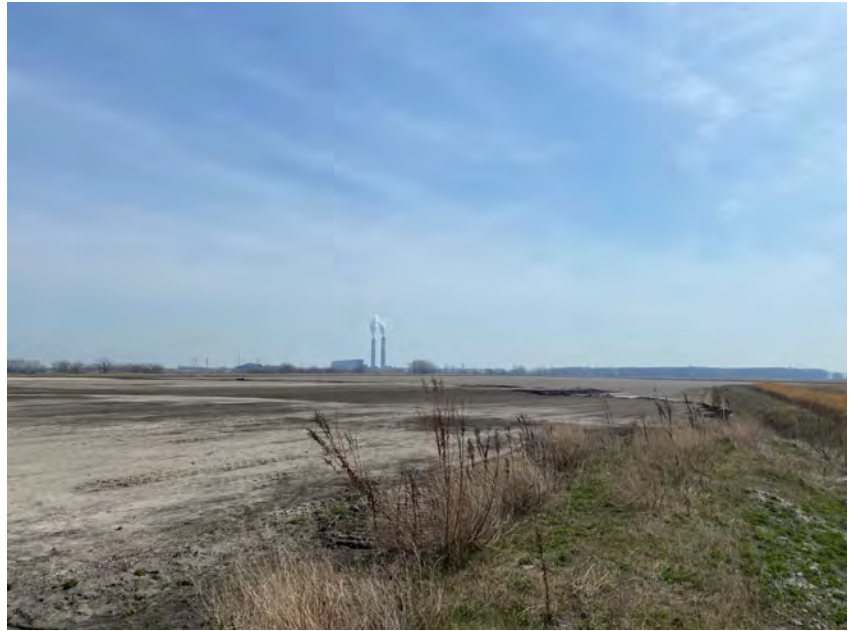
**Comments: View of Landfill  
from the top of perimeter clay  
embankment along the South  
side.**

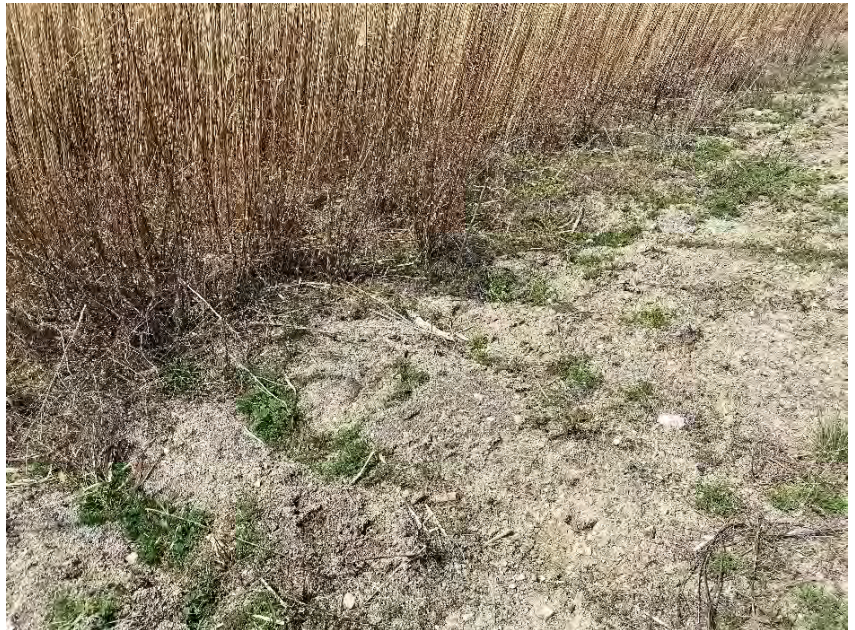
**Photograph ID: 10**

The four-foot-high perimeter berm and swale had some vegetation growth and minor erosion features were identified on the exterior slopes of the berm. However, the design approved by EGLE did not include a requirement to vegetate the berm and swale. Any potential sediments from erosion will be deposited in the Ash Basin. Any potential run-off will be managed under the NPDES permit for the Ash Basin.

3. Are there indications of erosion on the landfill perimeter berm?      x Yes      \_\_\_ No  
If 'Yes', describe what type and its condition (rill, gully, dimensions, etc.) \_\_\_\_\_  
Some erosion rills were observed on the exterior slope of the perimeter berm. Overall, vegetation observed on exterior slope of perimeter berms.  
\_\_\_\_\_

**Comments: Erosion rills were  
observed towards the bottom of  
perimeter clay embankment,  
along the south side of the  
Landfill.**

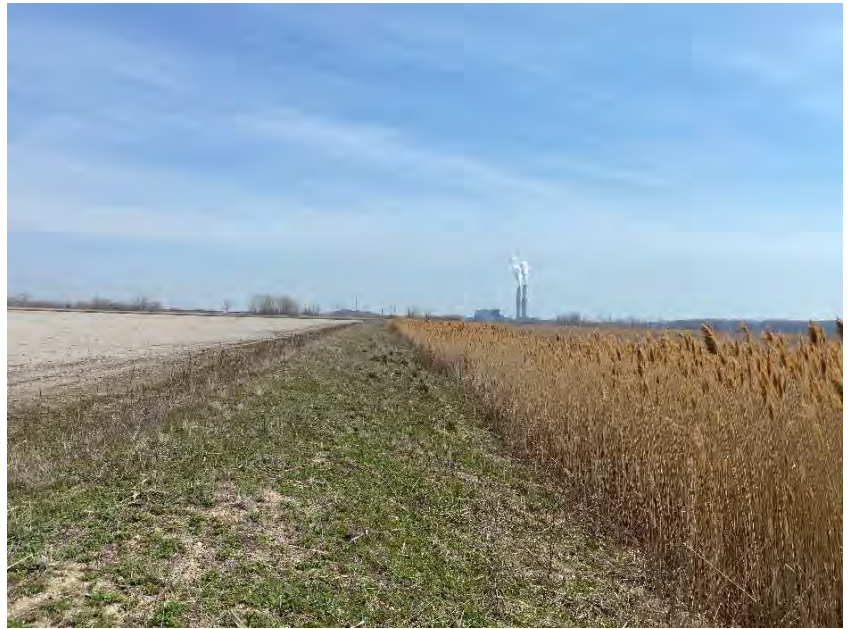
**Comments: View of Landfill  
from the top of perimeter clay  
embankment along the Southwest  
side.**

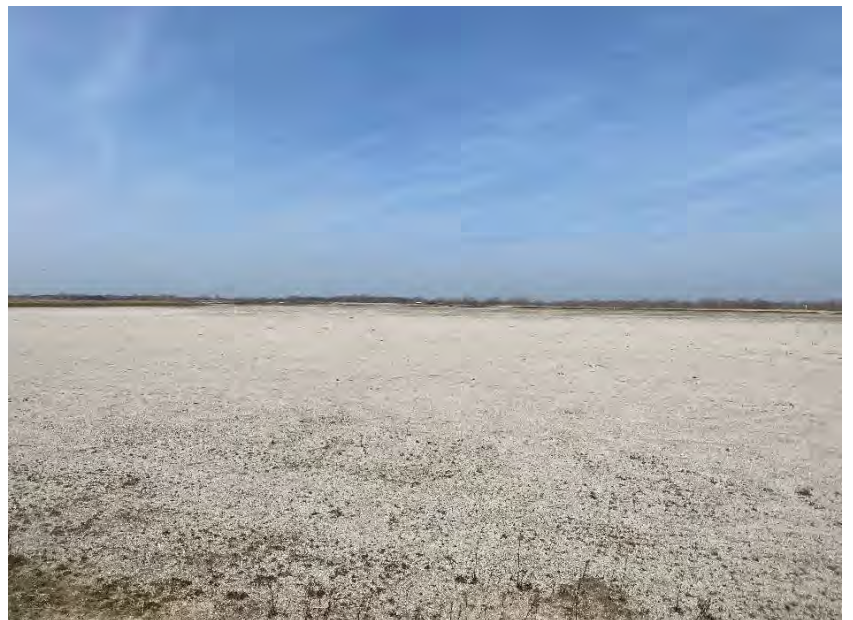
**Photograph ID: 12**

**Comments: View of Landfill  
from the top of perimeter clay  
embankment along the East side.**

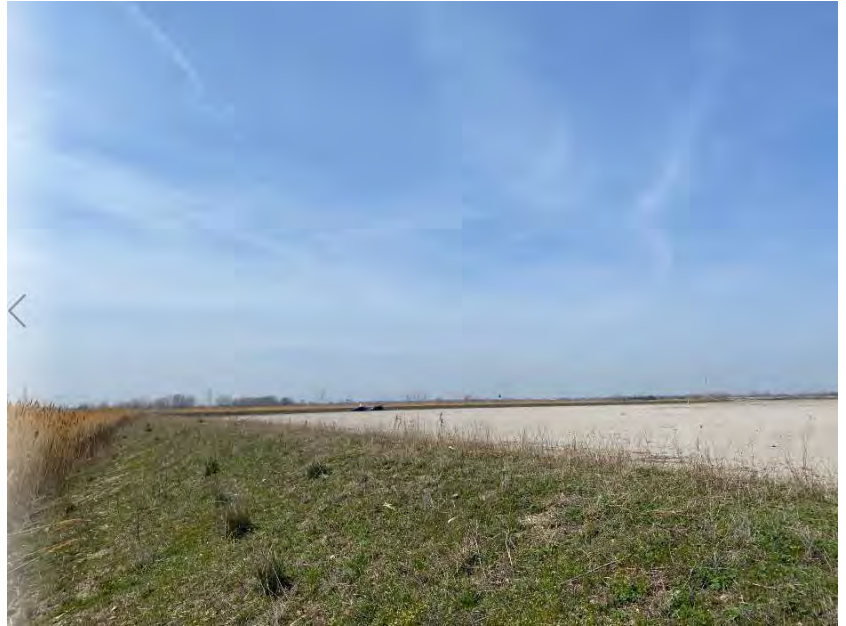
**Comments: View of the  
perimeter clay embankment and  
the Landfill disposal area from  
the East side of the Landfill.**

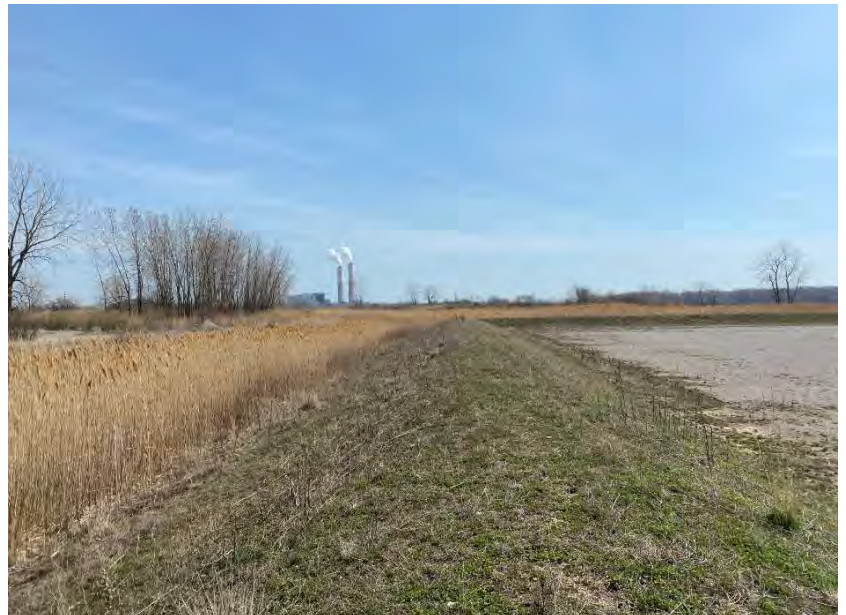
**Photograph ID: 14**

**Comments: View of the  
perimeter clay embankment and  
the Landfill disposal area from  
the North side of the Landfill.**
