2018 ANNUAL INSPECTION REPORT ASH BASIN EMBANKMENT

MONROE POWER PLANT

Monroe, Michigan

January 2019

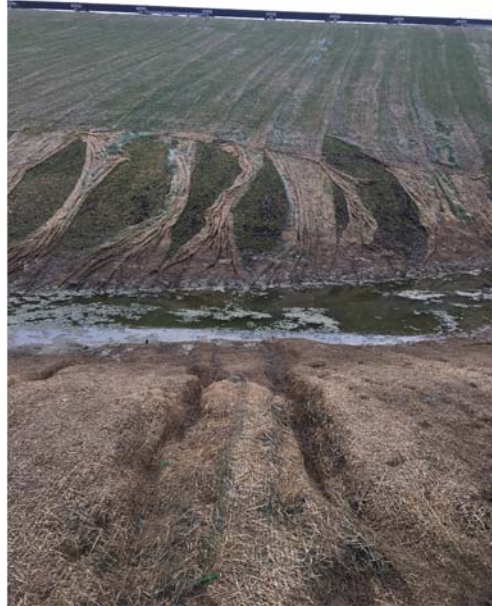
**Comments: Photo taken at
Station ~167+00. Erosion blankets
have been disrupted by wind.
Erosion gully visible on channel
side slope.**

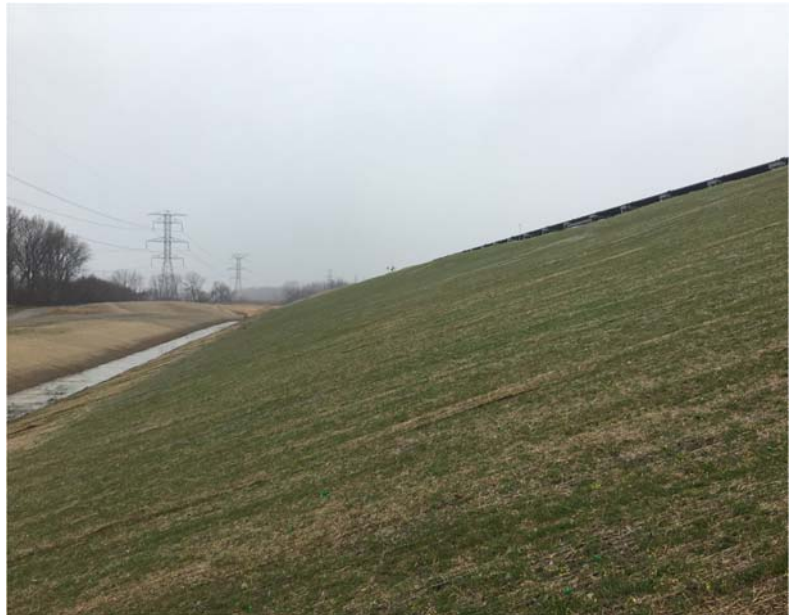
Photograph ID: 2

**Comments: Photo taken at
Station ~166+00. The
embankment appears to have
uniform slopes without signs of
distress between Stations ~167+00
and ~160+00.**

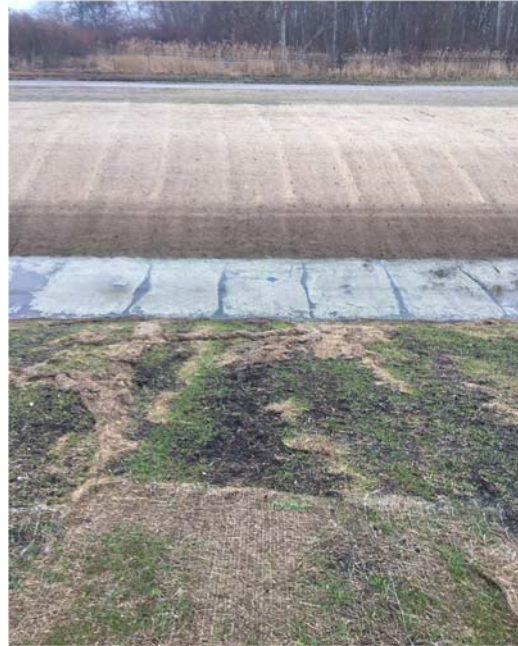
**Comments: Photo taken at
Station ~162+00. Minor erosion
rills where erosion blankets have
been disturbed.**

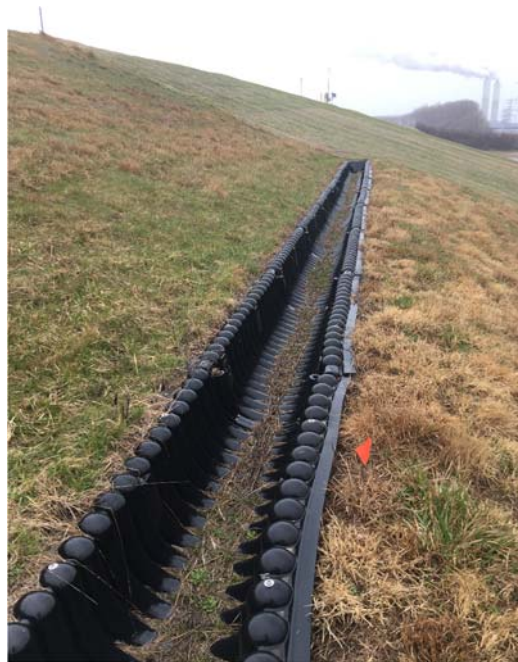
Photograph ID: 4

**Comments: Photo taken at
Station ~158+00. Missing cable
bolt on mid-slope ditch. Location
has been flagged.**

- The gap between mid-slope ditch flap and adjacent ground was observed at various sections along the embankment. These gaps do not represent an immediate concern for the safe operation or stability of the Ash Basin. However, gaps on the upstream side of the mid-slope ditch should be filled in accordance with IMM Manual to direct storm water into the mid-slope ditch. Furthermore, detailed inspection of mid-slope ditch cables should be performed, and missing cable bolts should be replaced.

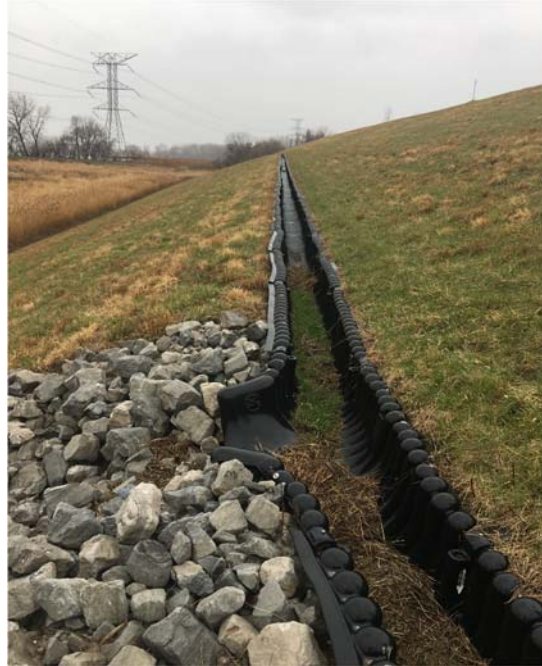
Comments: Photo taken at Station ~157+00. Mid-slope ditch is linear, and the embankment appears to have uniform slopes without signs of distress.

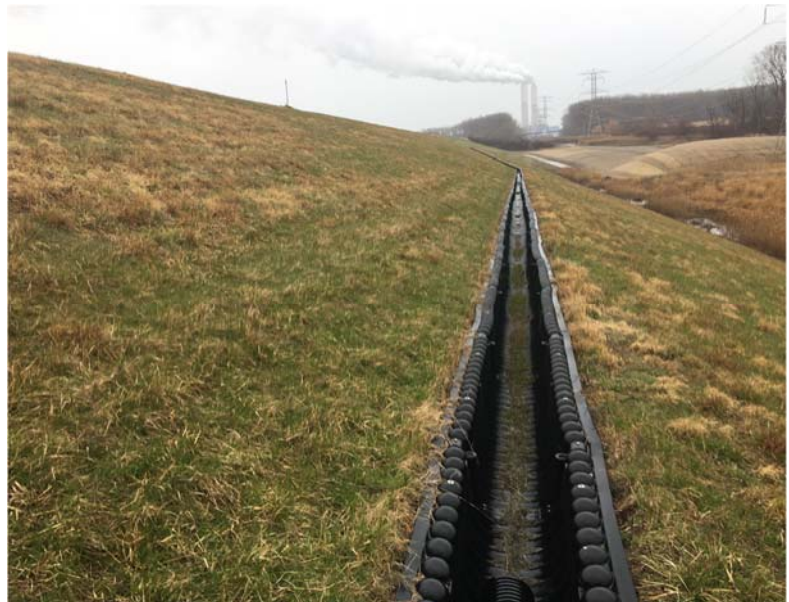
Photograph ID: 6

Comments: Photo taken at Station ~154+00. Mid-slope ditch is linear, and the embankment appears to have uniform slopes without signs of distress.

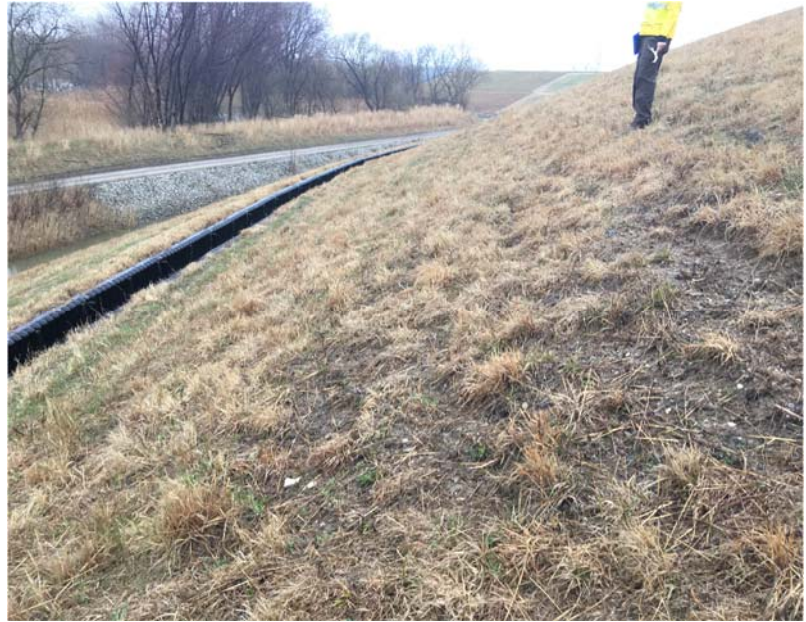
Comments: Photo taken at Station ~148+00. Area of sparse vegetation observed on the embankment above the mid-slope ditch.

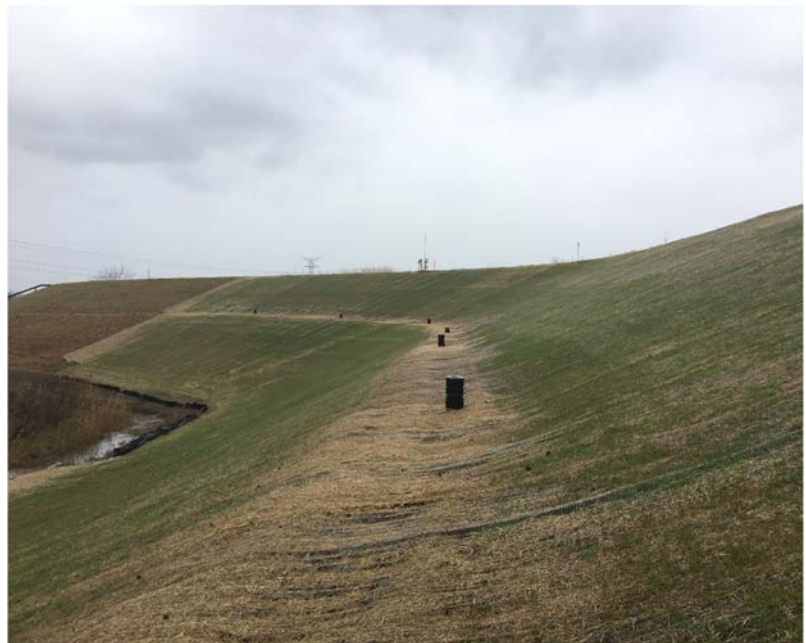
Photograph ID: 8

Comments: Photo taken at Station ~147+00. Embankment between stations 147+00 and 140+00 have uniform slopes without signs of distress, except for localized areas detailed in following photos.

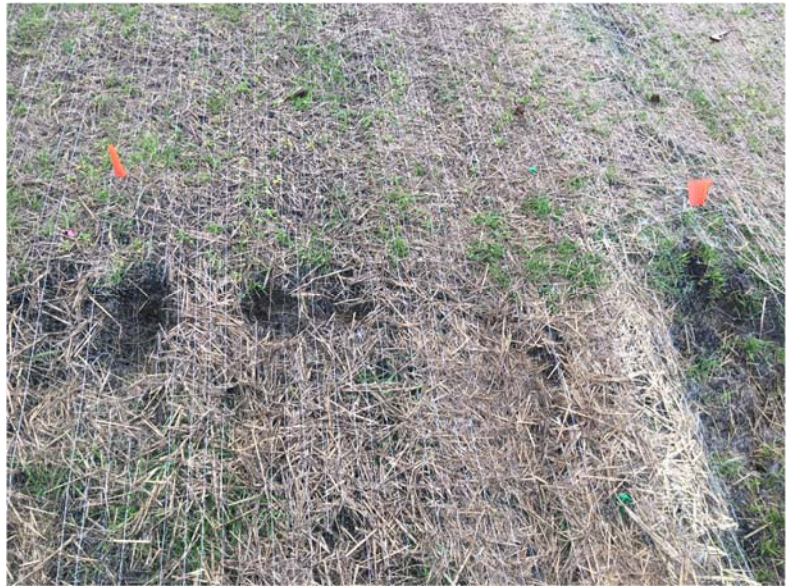
**Comments: Photo taken at
Station ~143+00. 25-foot area of 6
to 8-inch deep slough above mid-
slope trench.**

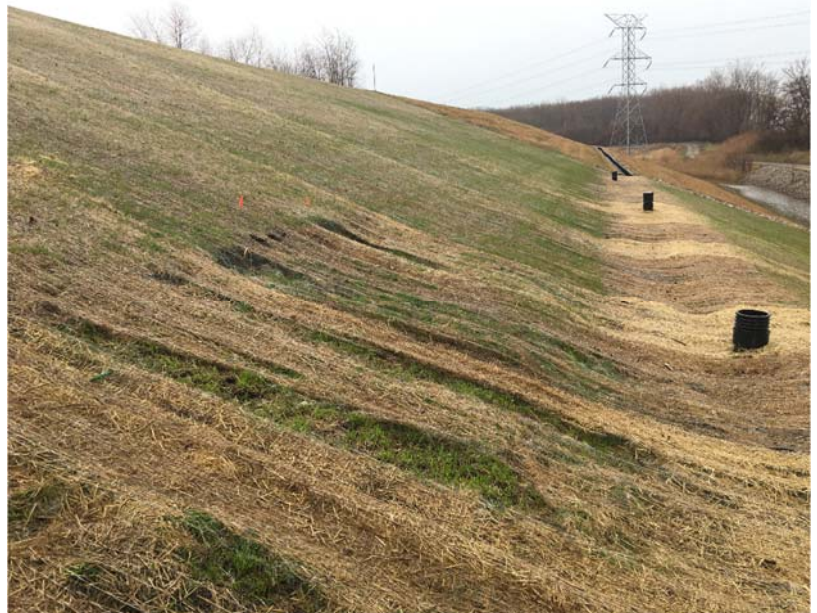
Photograph ID: 10

**Comments: Photo taken at
Station ~142+50. 25-foot area of 6
to 8-inch deep slough above mid-
slope trench.**

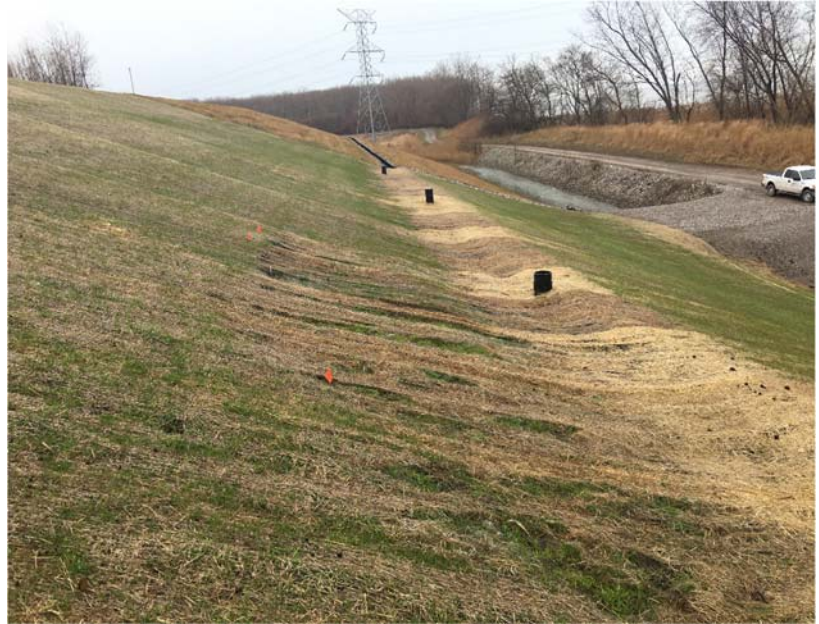
**Comments: Photo taken at
Station ~142+00. 25-foot area of 6
to 8-inch deep slough above mid-
slope trench.**

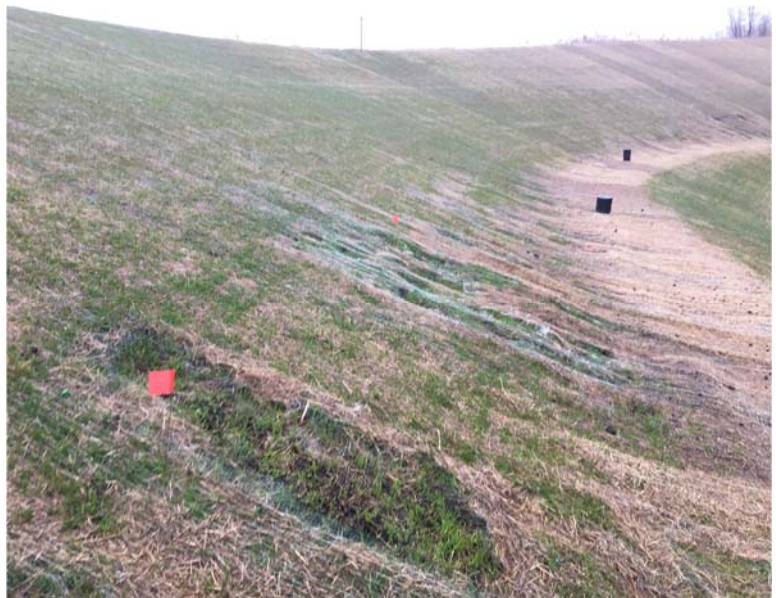
Photograph ID: 12

**Comments: Photo taken at
Station ~141+00. 15-foot area of 6
to 8-inch deep slough above mid-
slope trench.**

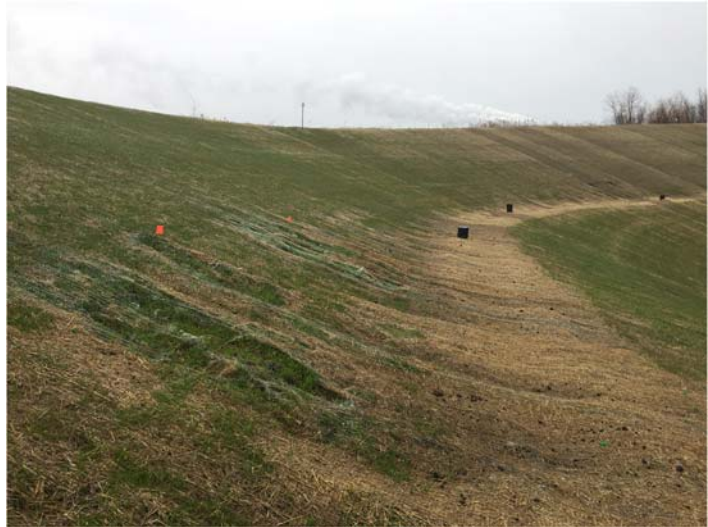
**Comments: Photo taken at
Station ~141+00. 15-foot area of
6- to 8-inch deep slough above
mid-slope trench.**

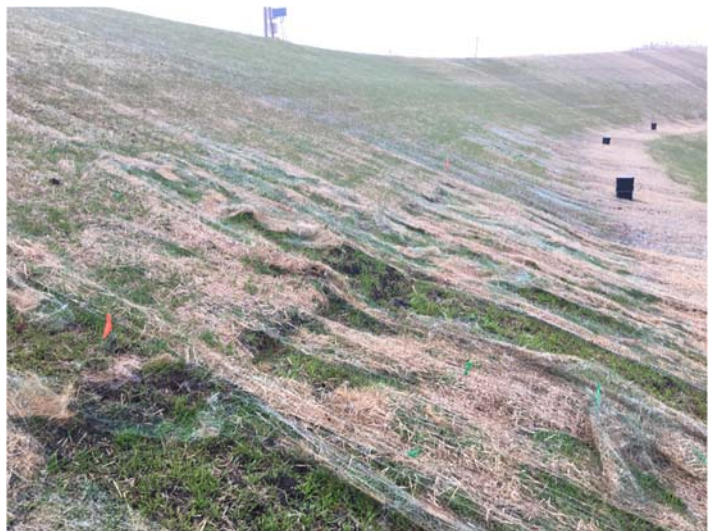
Photograph ID: 14

**Comments: Photo taken at
Station ~140+50. 25-foot area of
6- to 8-inch deep slough above
mid-slope trench.**

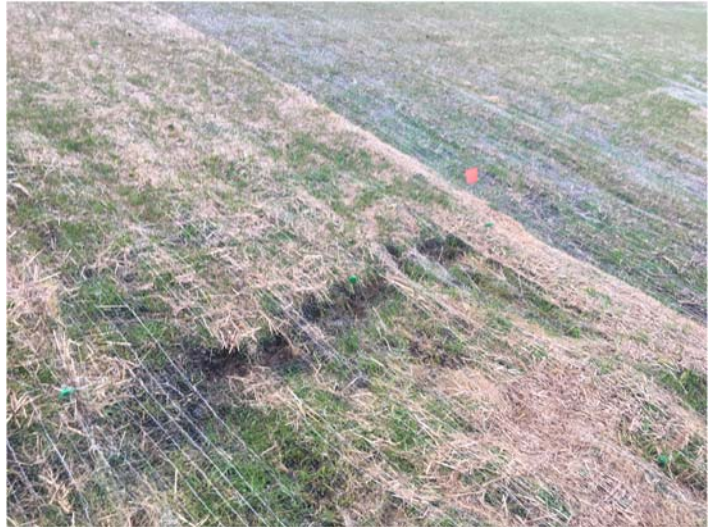
**Comments: Photo taken at
Station ~140+50. 25-foot area of
6- to 8-inch deep slough above
mid-slope trench.**

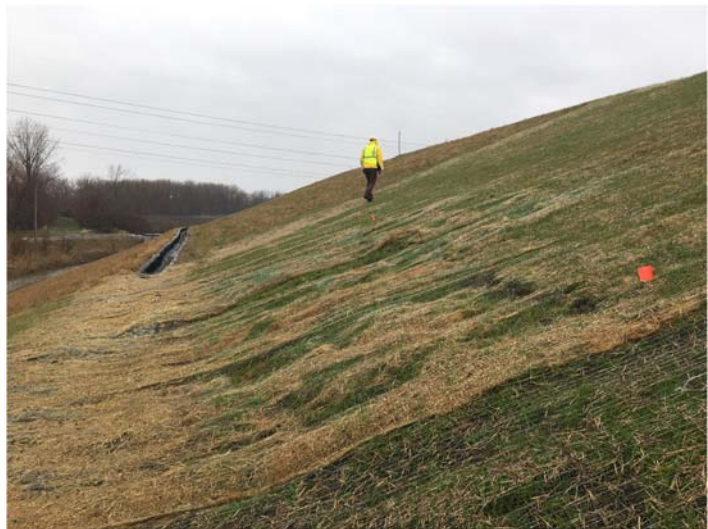
Photograph ID: 16

**Comments: Photo taken at
Station ~140+50. 25-foot area of
6- to 8 inch deep slough above
mid-slope ditch.**

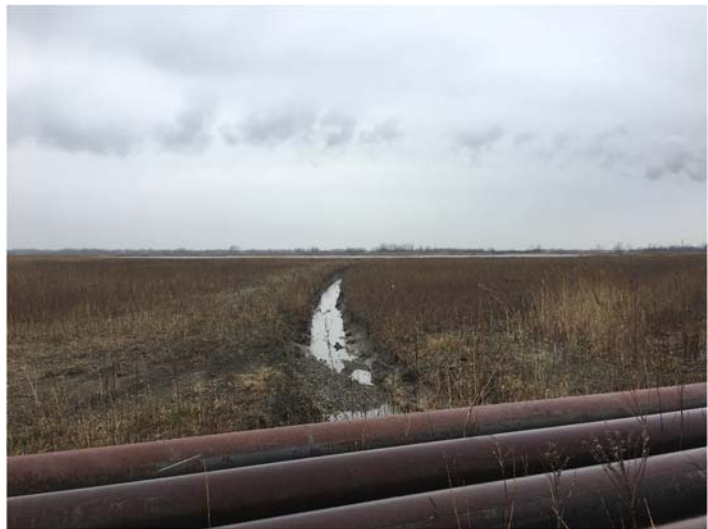
Photograph ID: 18

**Comments: Photo taken at
Station ~139+00. No obstruction
was noticed for the pump house
discharge channel within the ash
basin.**

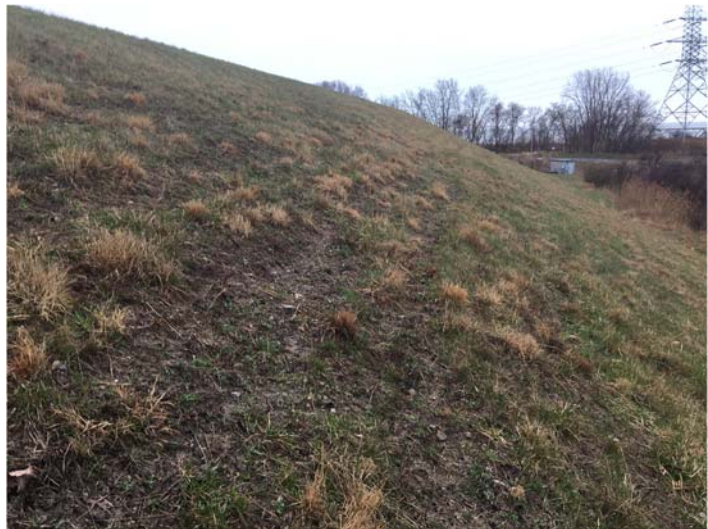
Photograph ID: 20

Comments: Photo taken at Station ~136+00. Area of sparse vegetation observed on the embankment.

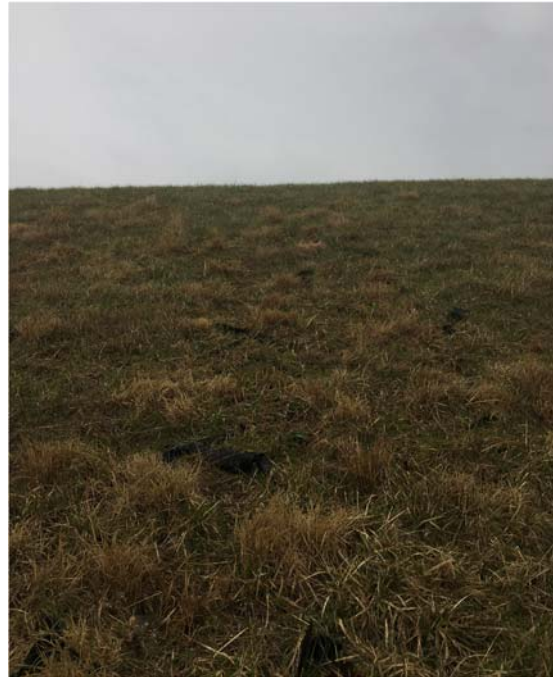
**Comments: Photo taken at
Station ~136+50. Area of exposed
geo-cells observed on the
embankment.**

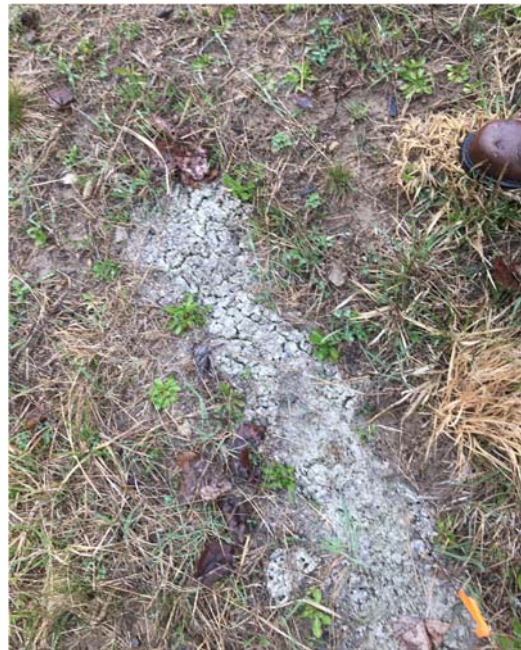
Photograph ID: 22

**Comments: Photo taken at
Station ~143+00. Cracks filled
with bentonite-sand mixture show
no signs of further opening.**

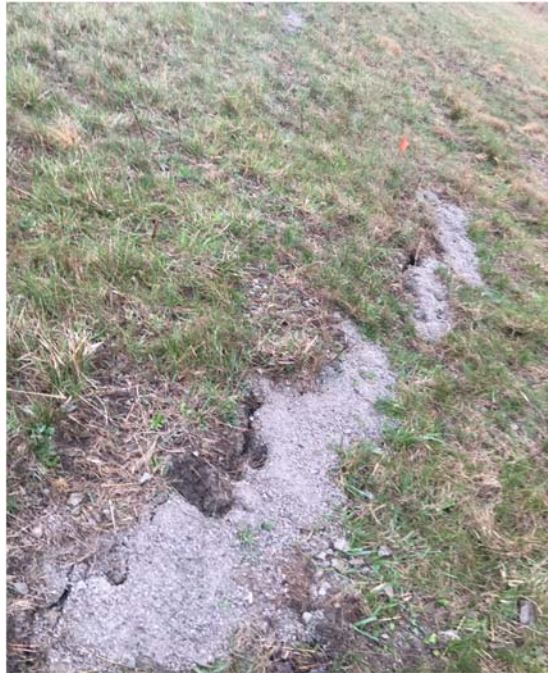
Comments: Photo taken at Station ~122+00. 20-foot-long crack along the embankment that was previously filled with bentonite-sand mixture that is showing further signs of movement.

- Cracks one-inch wide or less were observed on the exterior slope of the embankment between Station ~121+00 and ~122+00, these cracks do not represent an immediate concern for global stability of the Ash Basin embankment; these cracks should be monitored on a regular basis at a frequency of once every 30 days (maximum).

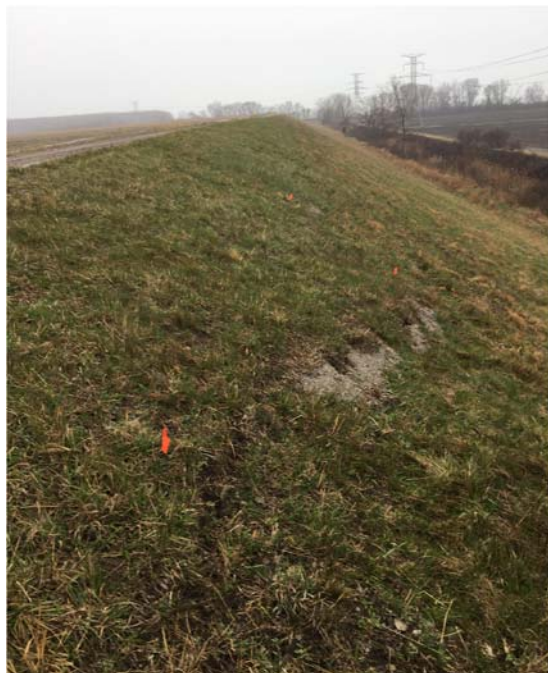
Photograph ID: 24

Comments: Photo taken at Station ~122+00. 20-foot-long crack along the embankment that was previously filled with bentonite-sand mixture that is showing further signs of movement.

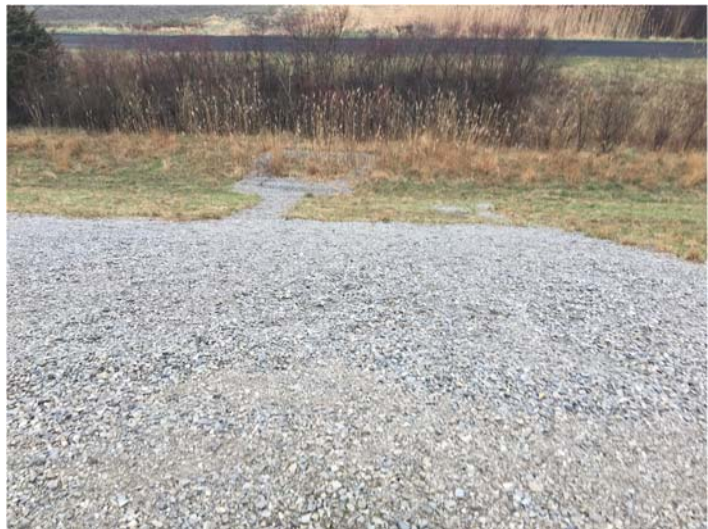
Photograph ID: 26

**Comments: Photo taken at
Station ~113+00. The erosion rills
that were observed in 2017
appeared to be mitigated.**

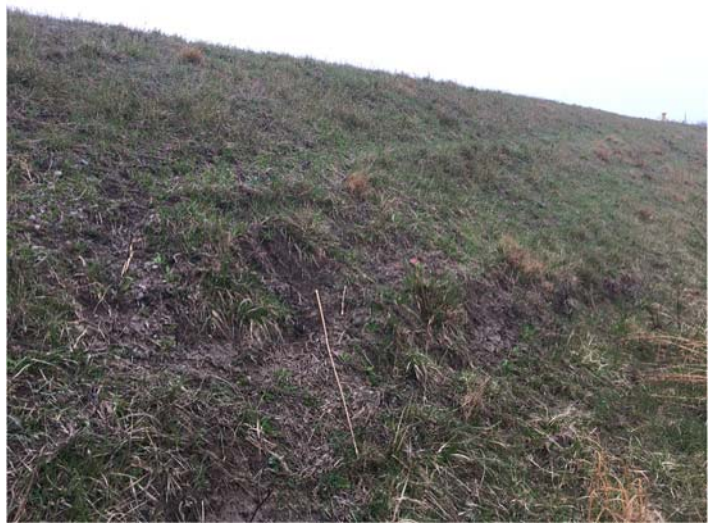
Photograph ID: 28

**Comments: Photo taken at
Station ~100+00. Localized area
of uneven, sparse vegetation
observed on the embankment.**

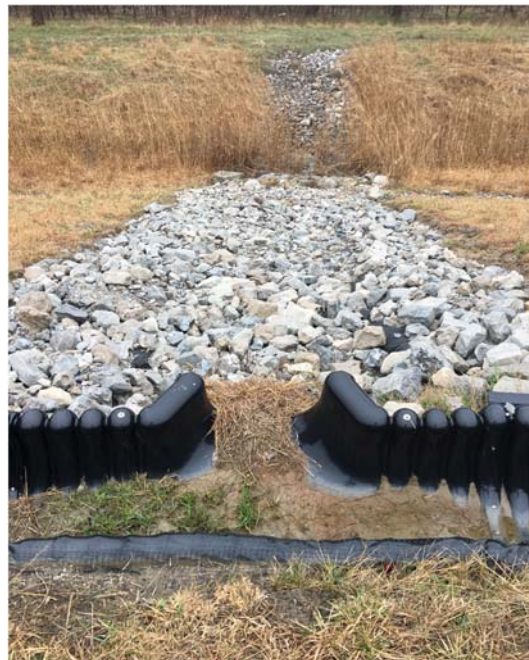
Photograph ID: 30

Comments: Photo taken at Station ~87+00. In general, vegetation was observed to be washed out at each down-chute location.

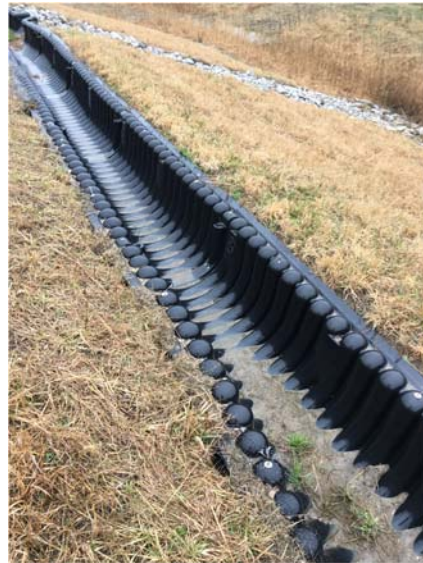
Comments: Photo taken at Station ~86+00. In general, mid-slope ditch appears to be snug against the embankment and in good condition. There are small localized areas where a gap is visible.

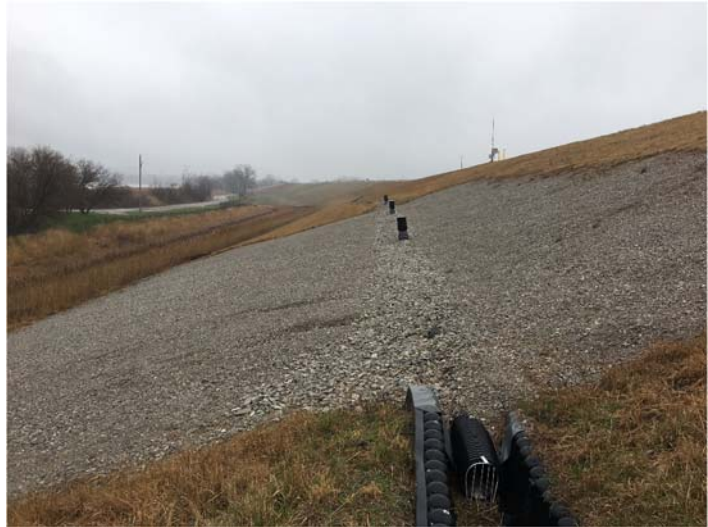
Comments: Photo Taken at Station ~67+00. The embankment appears to have uniform slopes with signs of erosion rills in the aggregate.

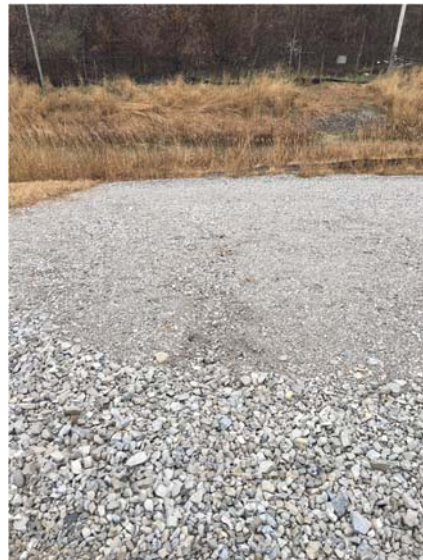
Photograph ID: 36

Comments: Photo Taken at Station ~67+00. Signs of erosion rills in the aggregate.

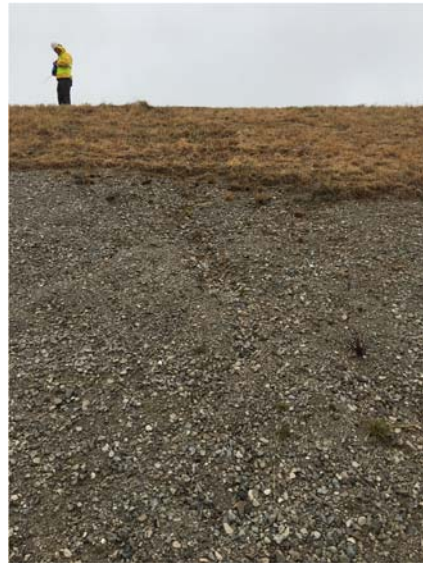
**Comments: Photo Taken at
Station ~67+00. Signs of erosion
rills in the aggregate.**

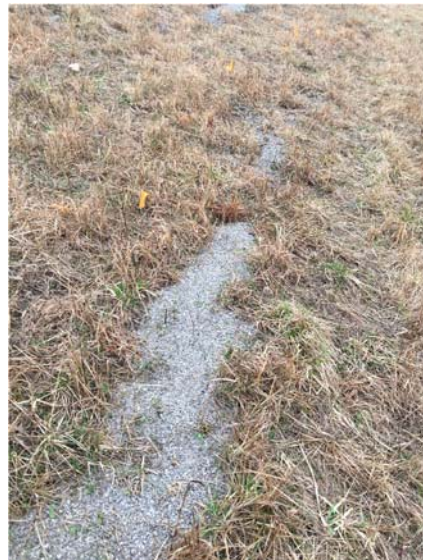
Photograph ID: 38

**Comments: Photo take at Station
~63+00. Cracks filled with
bentonite-sand mixture from
Station ~60+00 to 65+00 show no
signs of further opening.**

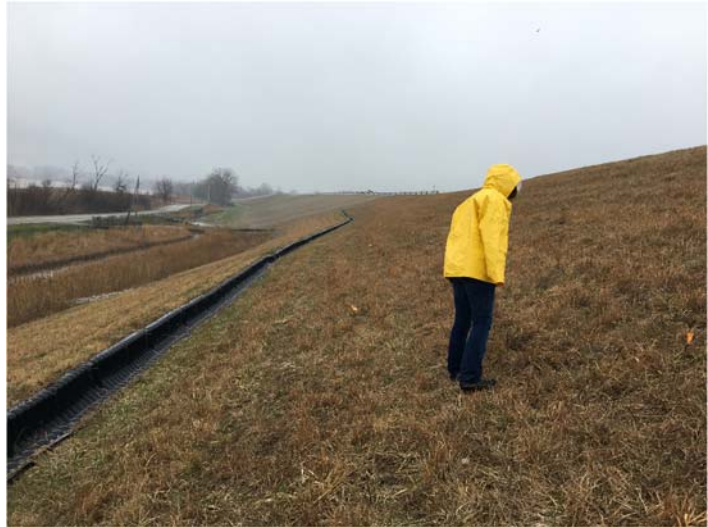
Comments: Photo take at Station ~65+00. Cracks filled with bentonite-sand mixture from Station ~60+00 to 65+00 show no signs of further opening. Flags mark the areas that were filled last year.

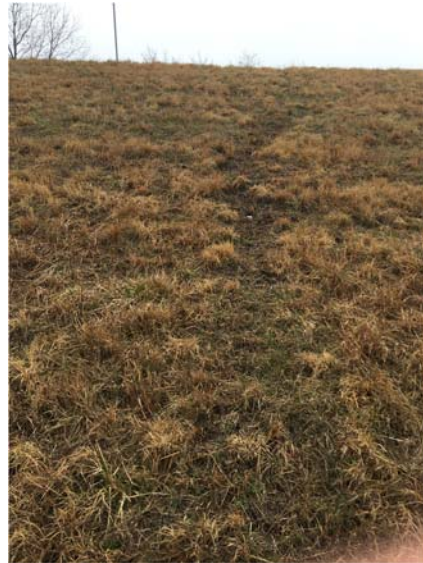
**Comments: Photo taken at
Station ~30+00. Signs of erosion
rills.**

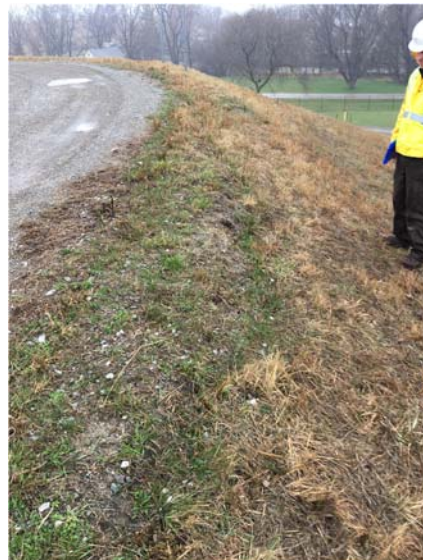
Photograph ID: 44

- A local depression that was observed near the crest of the embankment at Station ~28+00 does not represent an immediate concern for the safe operation or stability of the Ash Basin embankment.

**Comments: Photo taken at
Station ~28+00. Localized
depression observed at the crest,
which appeared to be a tire rut.
No bulging observed.**

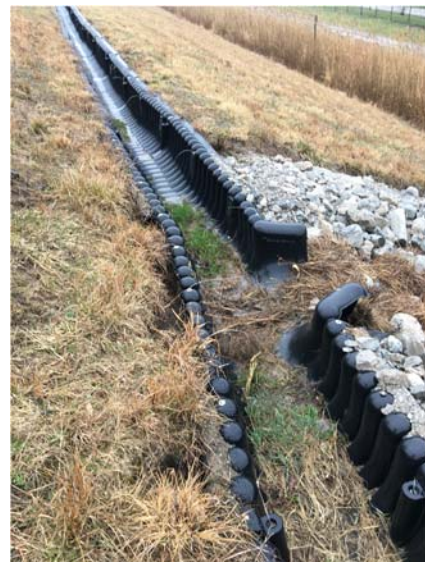
Photograph ID: 46

Comments: Photo taken at Station ~26+00. Gap observed between embankment and mid-slope ditch. Sediment buildup in down-chute.

- Isolated problems with the mid-slope ditch bedding (i.e. pea stone and underlying soil) washing out were observed at down-chute at Station 26+00. The observed problems do not represent an immediate concern for the safe operation or stability of the Ash Basin embankment. However, this down-chute should be fixed in accordance with IMM Manual.

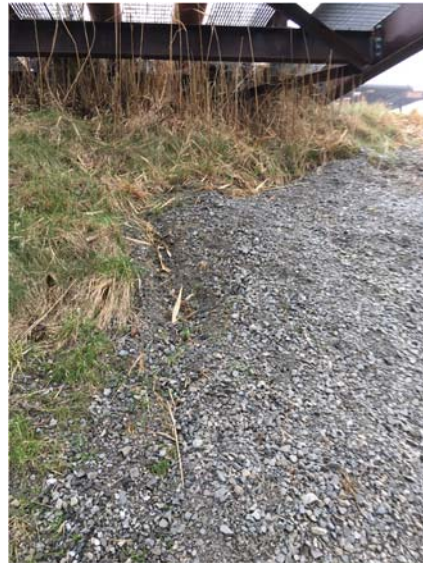
**Comments: Photo taken at
Station ~0+00. Minor signs of
erosion rills beneath trestle
structure.**

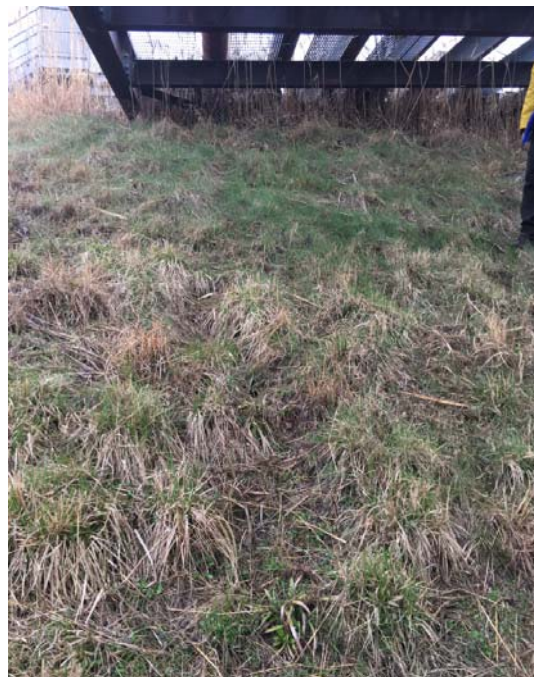
Photograph ID: 52

**Comments: Photo taken at
Station ~0+00. Minor signs of
erosion rills beneath trestle
structure.**

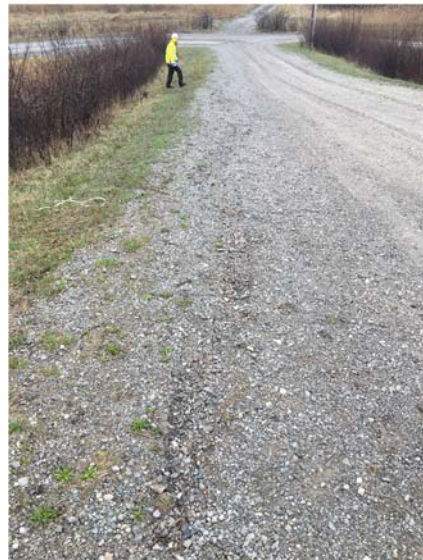
Photograph ID: 58

**Comments: Photo taken at
Station ~169+00. Minor erosion
rills visible on access ramps.**
