**2015 ANNUAL INSPECTION REPORT  
RANGE ROAD LANDFILL  
ASH DISPOSAL FACILITY**

**China Township, St. Clair County, Michigan**

January 2016

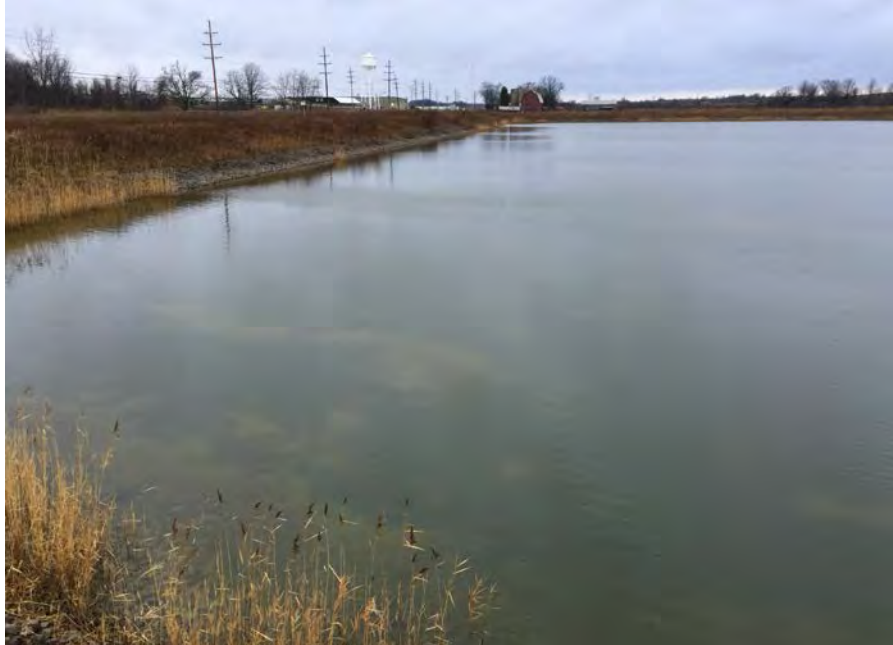
1. Storm Water Detention Basin, South and West Sides. Slopes Protected with Stone. No Visible Slope Erosion or Woody Vegetation on Slope.

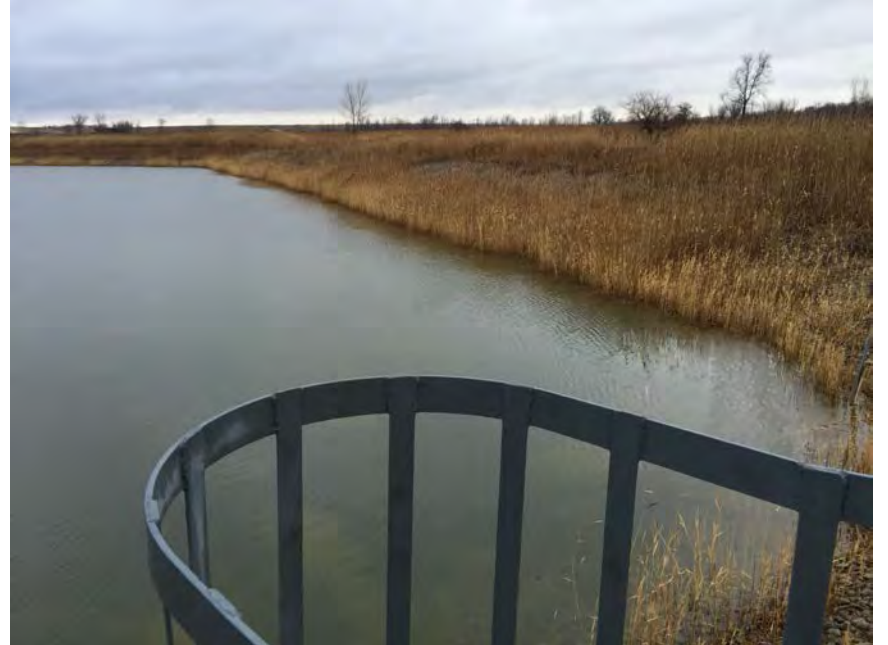
2. Storm Water Detention Basin, North and East Sides. Slopes Protected with Stone. No Visible Slope Erosion or Woody Vegetation on Slope.

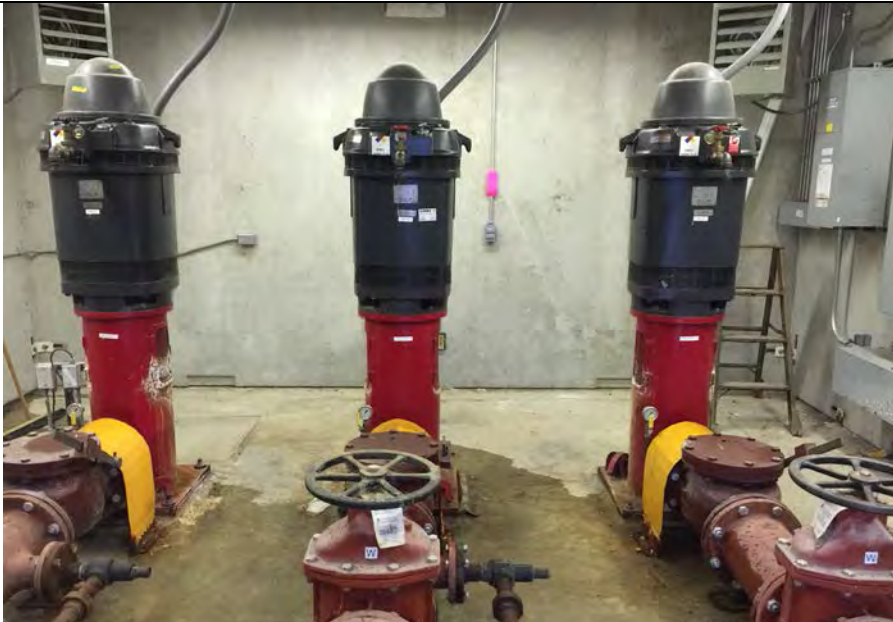
3. Pump House Pumps and Valves. Water from Basin is Pumped Back to Power Plant. DTE Plant Inspects Daily and Records Pump Observations.

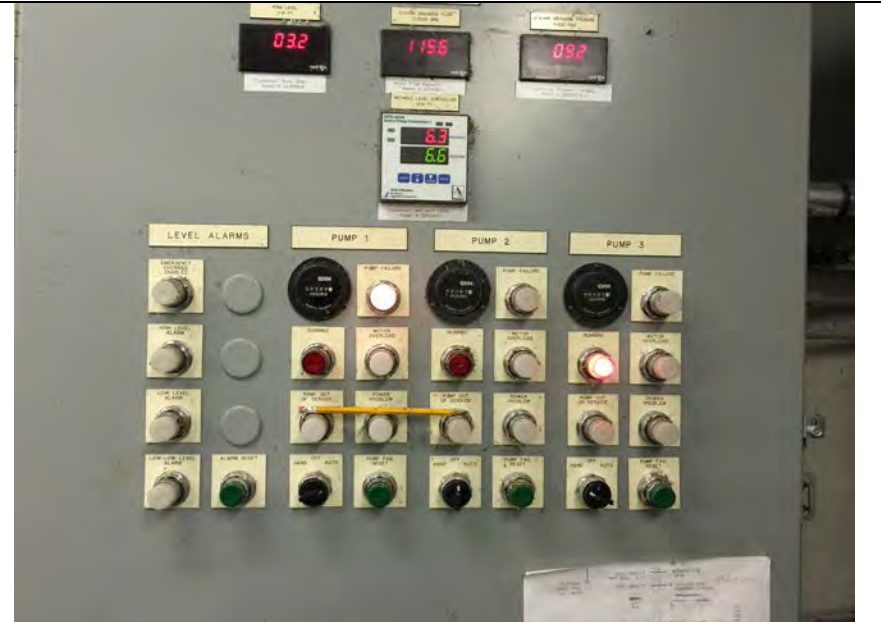
17. Stormwater Detention Pond Water Quality (unnatural films, foams, oils, etc.) and pump operating condition (panel, meter etc)	<input checked="" type="checkbox"/> <input type="checkbox"/> <input type="checkbox"/>	1, 2,3, 4,5 & 6	Quality appeared Good. Pump Run & Light Conditions Checked (DTE person). One Pump Lights to be Re-checked by Operations.

4. Pump Control Panel. Pumps were Run Checked. Pump #3 Running. Pump #1 Light Indicates Failure, but Cause was No Reset after Inspection.

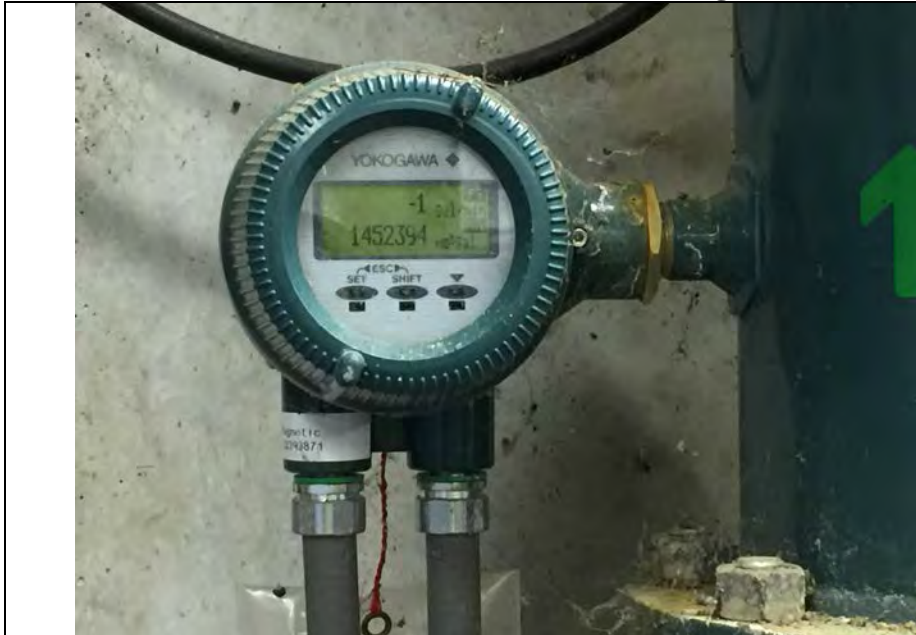
5. Pump System Discharge Rate & Total Meter in Gal/Min and Gallons. Total Recorded Daily on Day Shift Report.

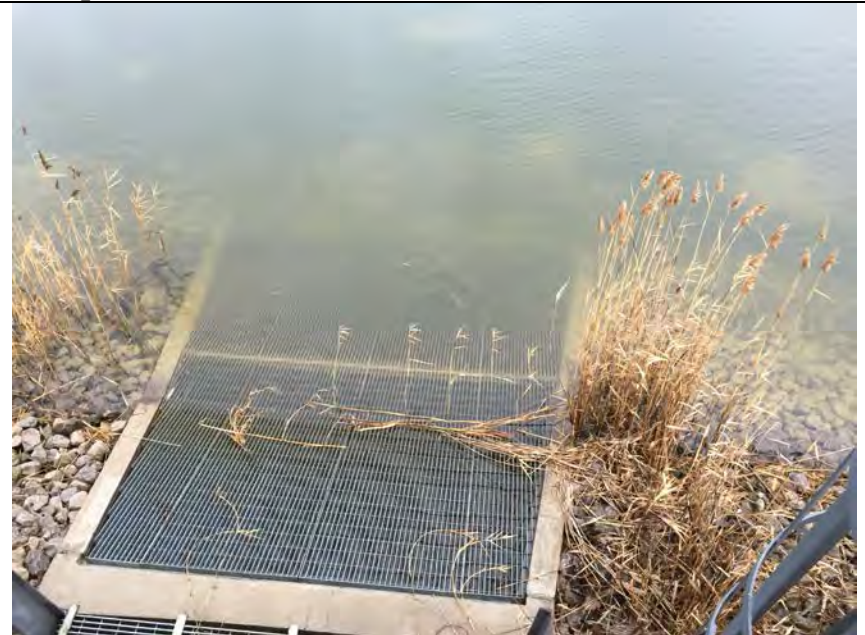
6. Basin Intake Screens. No Significant Blockage Noted.

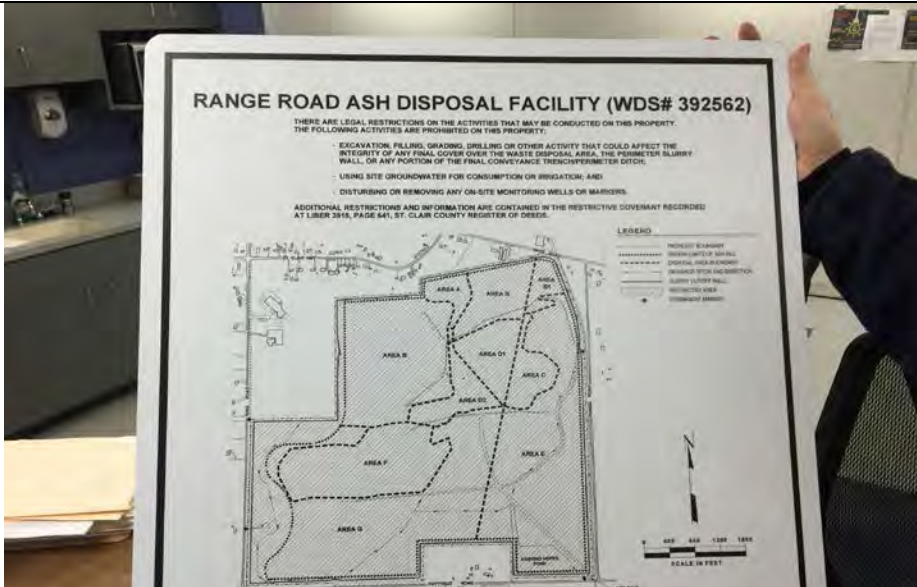
7. View of Landfill Phasing Plan Board. Missing Was Phase D3 and Brake-down of Phase F to F1, F2 and F3 that are Shown on Drawings.

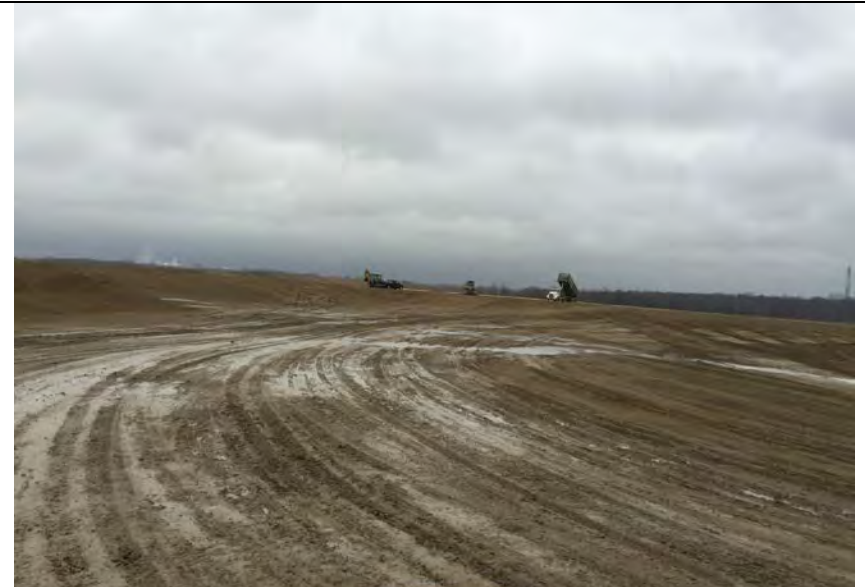
8. Entrance to Active Landfilling Areas over Unconstructed Phase G3 and E Areas. Light Rain (0.38 in) During Inspection. Temperature Reported 48°F.

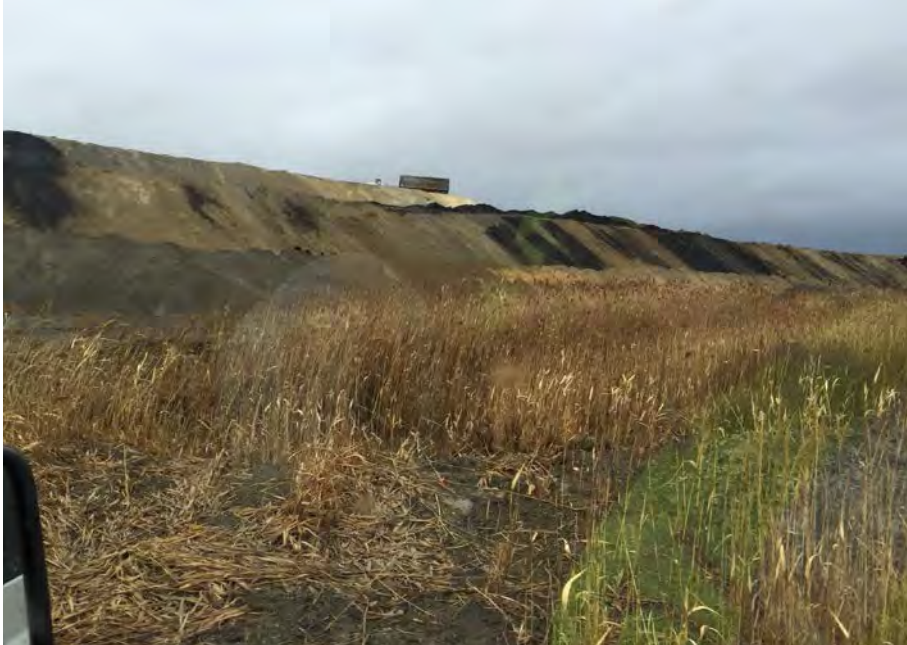
9. Face of Active Placement in Landfill Phase F3. Placement from Top and Bottom. Small Runoff Collection Pond in Center of Photo.

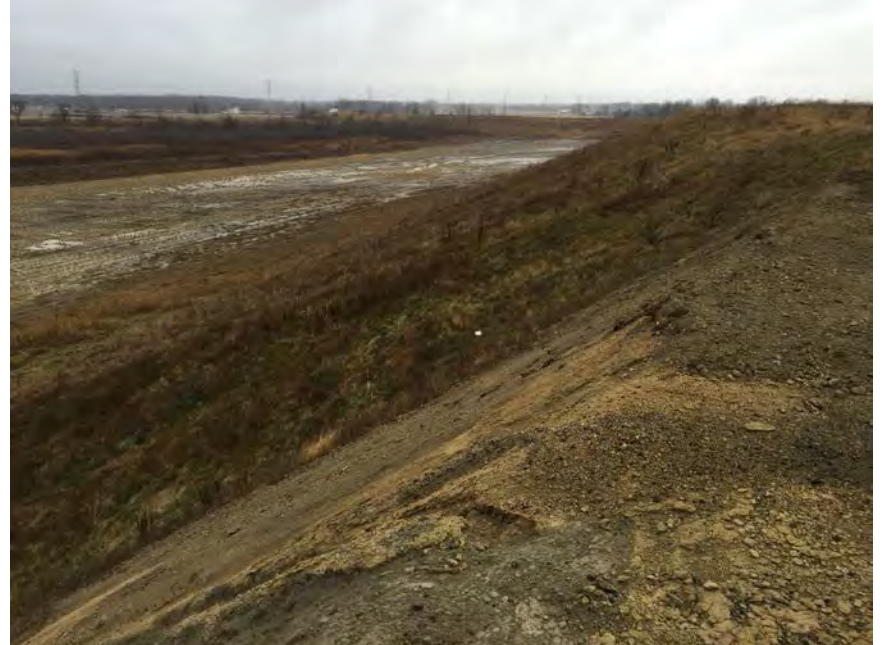
10. Borrow Area in G2. G2 Just Became Active, Approved for Placement. Drilling Confirmed Thick Layer of Clay Soils Beneath.

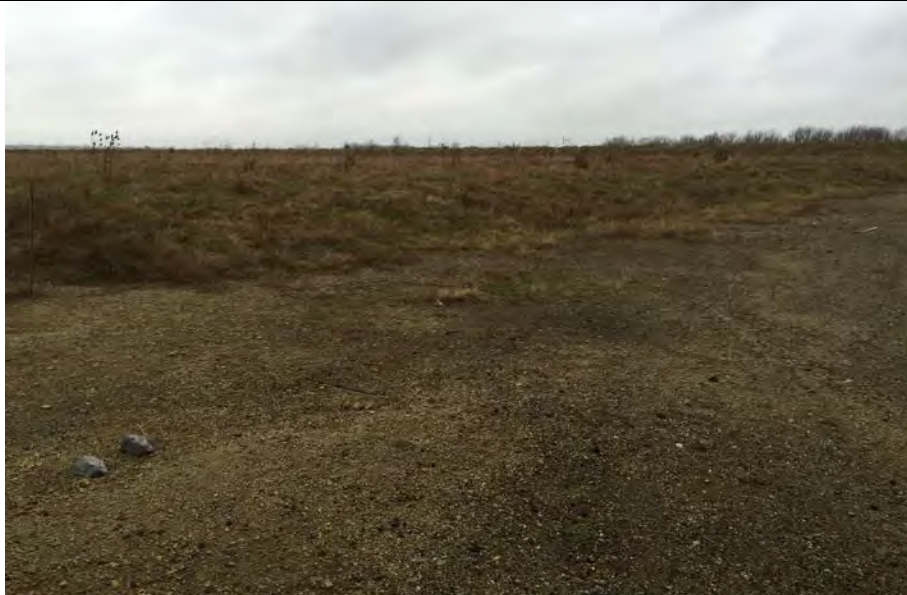
11. Top of Phase F2 Cover in Top of Photo. Phase 2 Closed in October 2012. Certification Report Viewed.

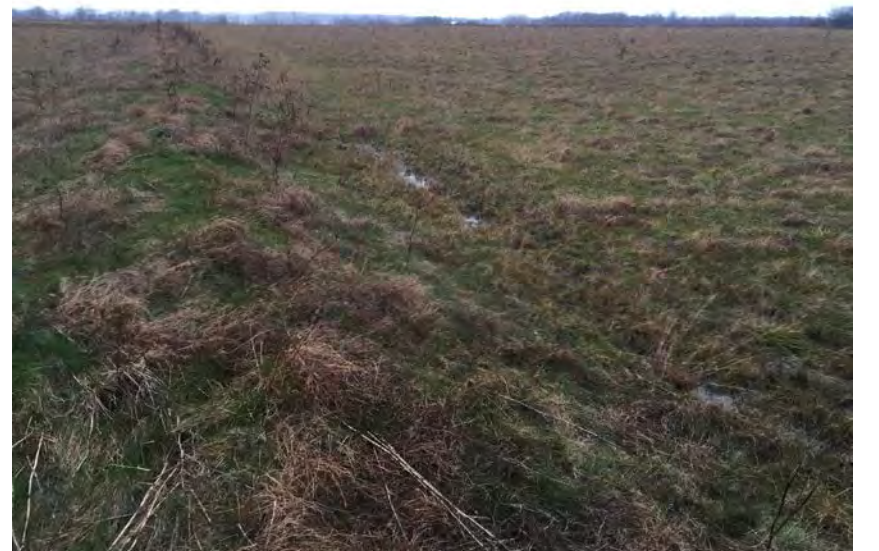
12. Final Cover Temporary Clay Berm at Top of Phase 2 Controlling and Directing Surface Runoff at Boundary with Phase G2.

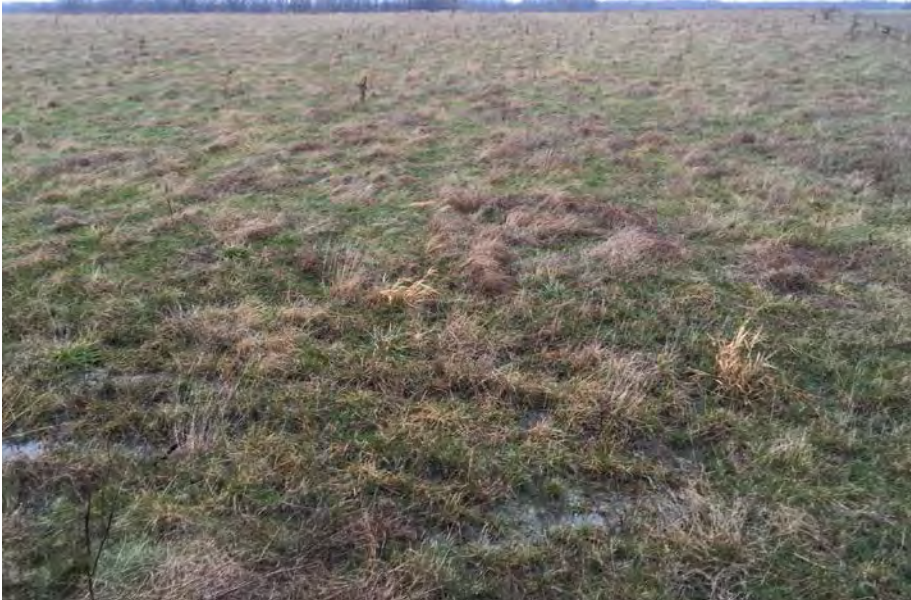
13. Typical Vegetation Conditions Top of Closed Phase F1 and F2.

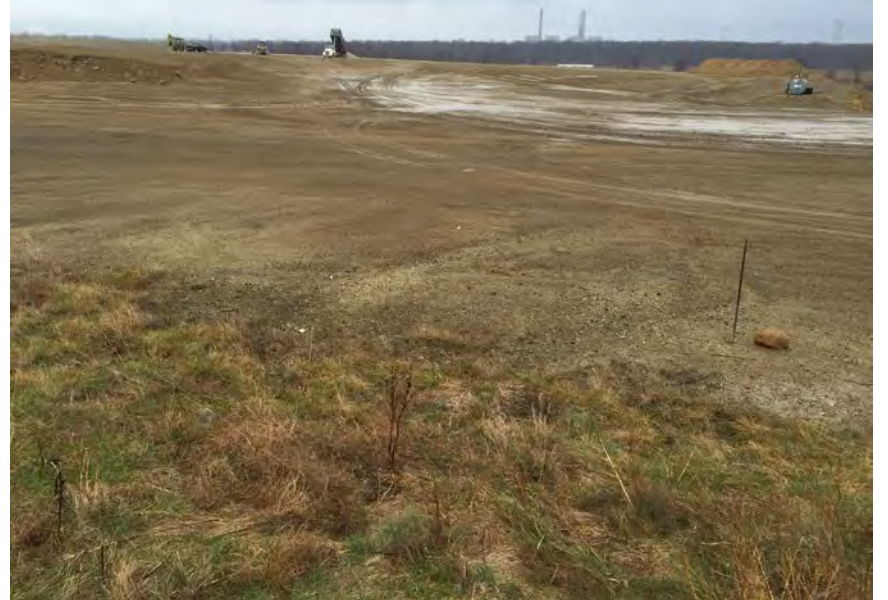
14. View of Active Portion of Phase F3 from Top of Phase F2. Ash Dry Handled Transported in Trucks Dumped and Spread.

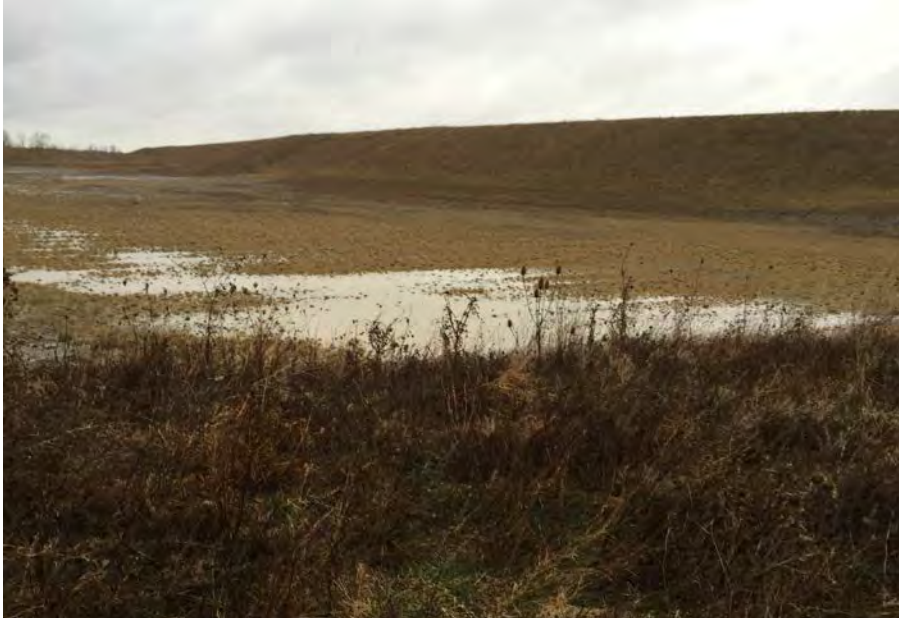
15. Another View of Completed Borrow Area in Phase G2 where Surface Water Drains to Corner Where Below Rd Culvert has been Installed to Drain East.

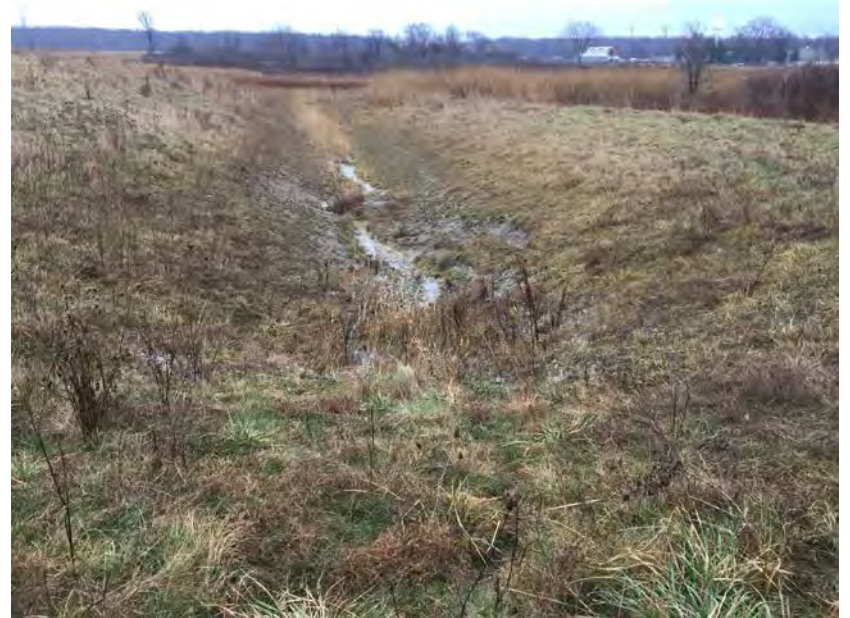
16. Culvert Drains to Existing Ditch which Connects to Ditches Draining into Storm Water Detention Basin.

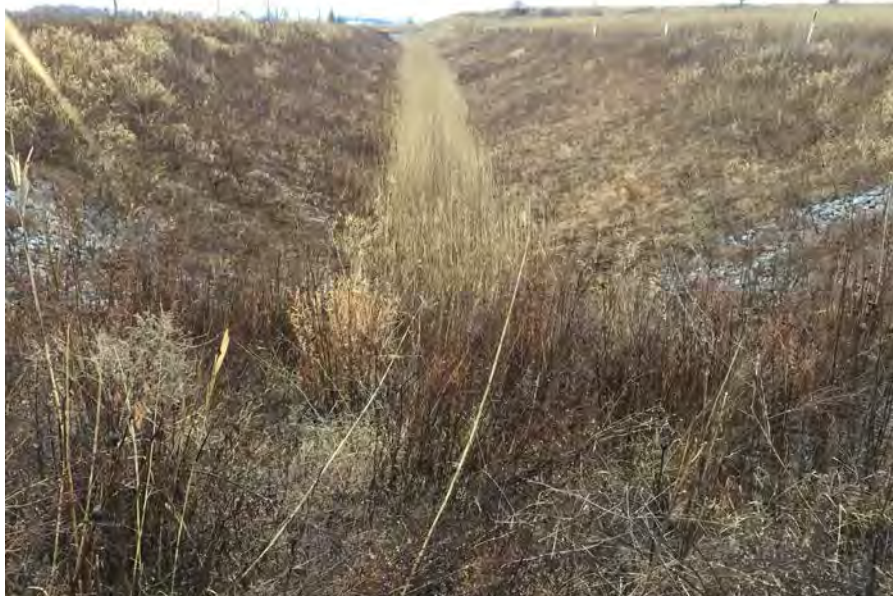
17. Looking West at Perimeter Ditch Parallel to Puttygut Road. Ditch Slopes were Reconstructed in 2010 and Remain Stable and Visually Erosion Free.

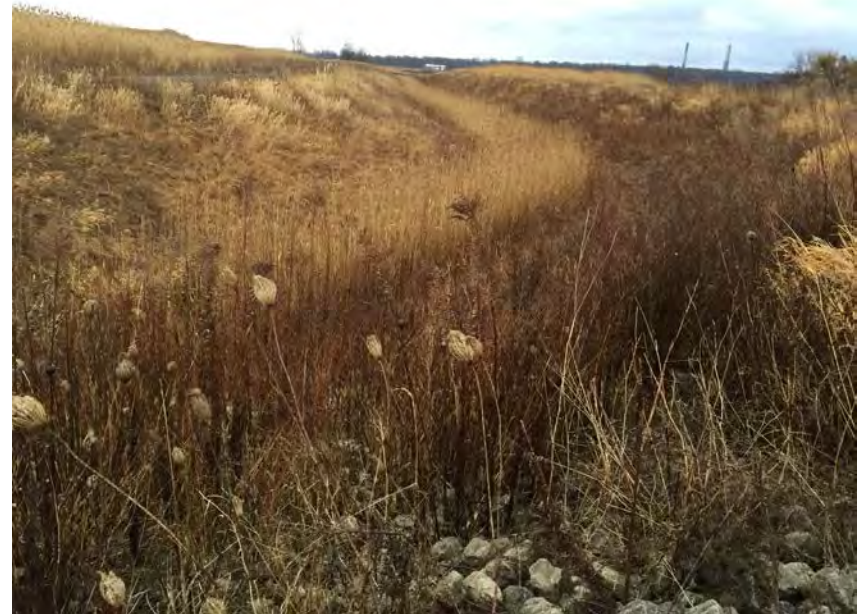
18. View of Perimeter Ditch at Road Crossing Looking Northeast. Slopes Appeared Stable and Well Vegetated. No Observed Woody Vegetation.

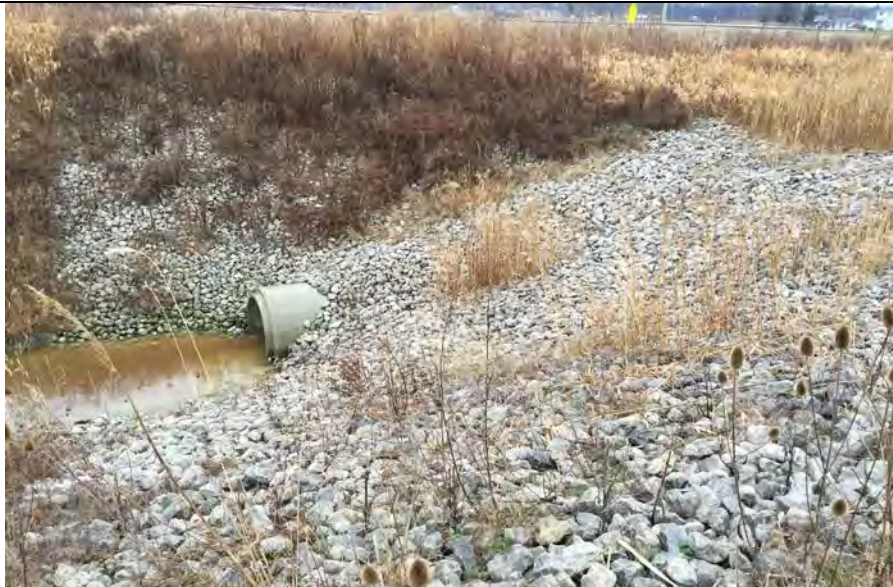
19. North End of Culvert Installed where Perimeter Ditch Located too Close to Existing Landfill Slope. No Blockage. Slurry Wall Exist Along Property Line.

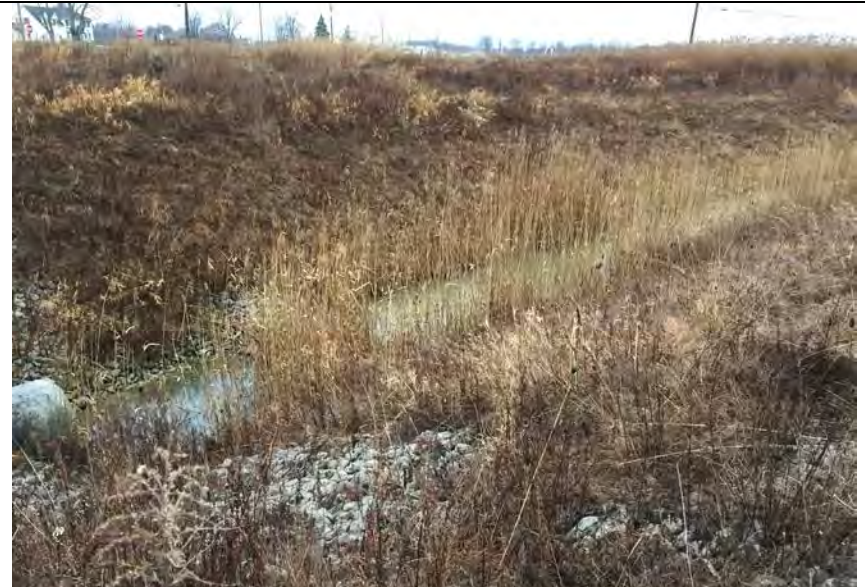
20. Looking South at Perimeter Ditch Near West Corner of Landfill. Slopes Remain Vegetated and Generally Erosion Free. Ditch Flow Observed.

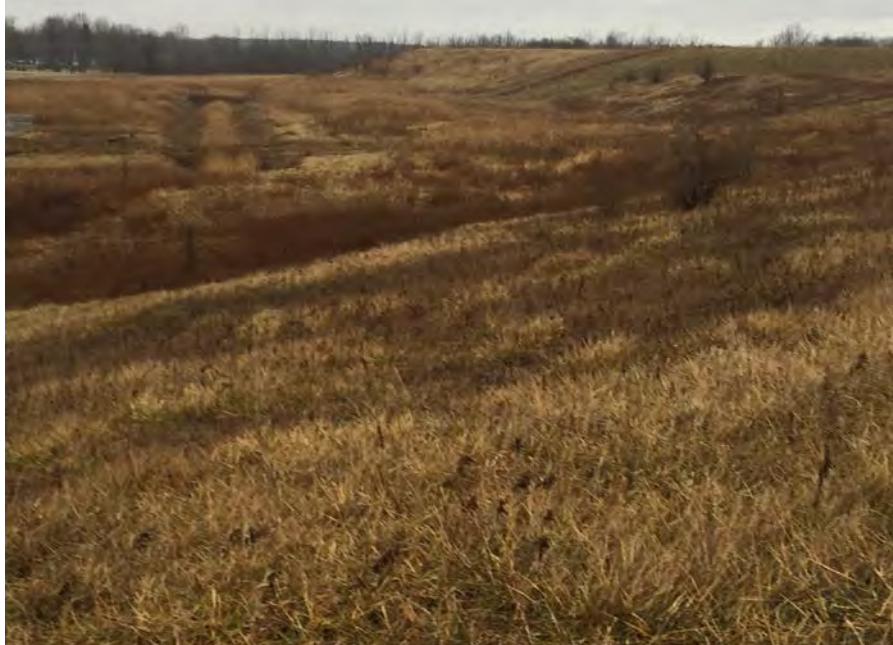
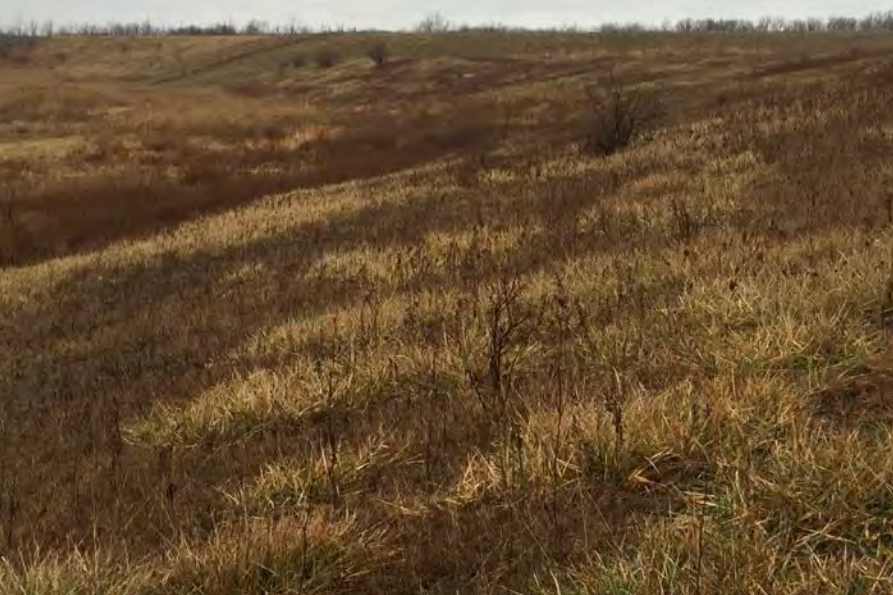
21. West Southwest Side of Landfill. Slopes Well Vegetated and Stable with No Significant Areas of Slope Erosion. Perimeter Ditch w/2 Road Crossings Shown.

23. Same Photo as Photo 21.

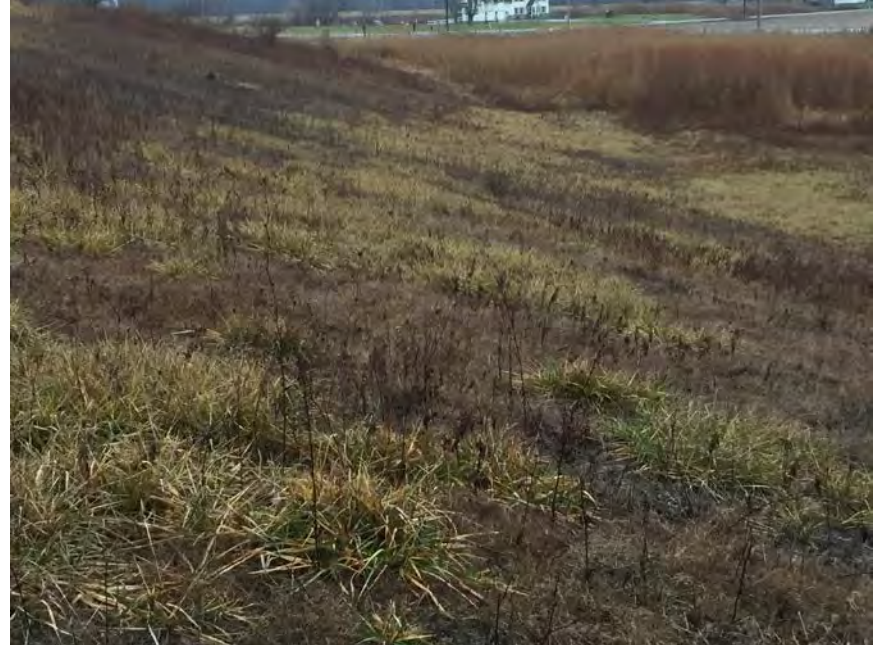
22. Close-up View of Typical Exterior Slope. Southwest Corner. Woody Vegetation on Slopes in Photos 21 - 23 and Others. Planned for Removal.

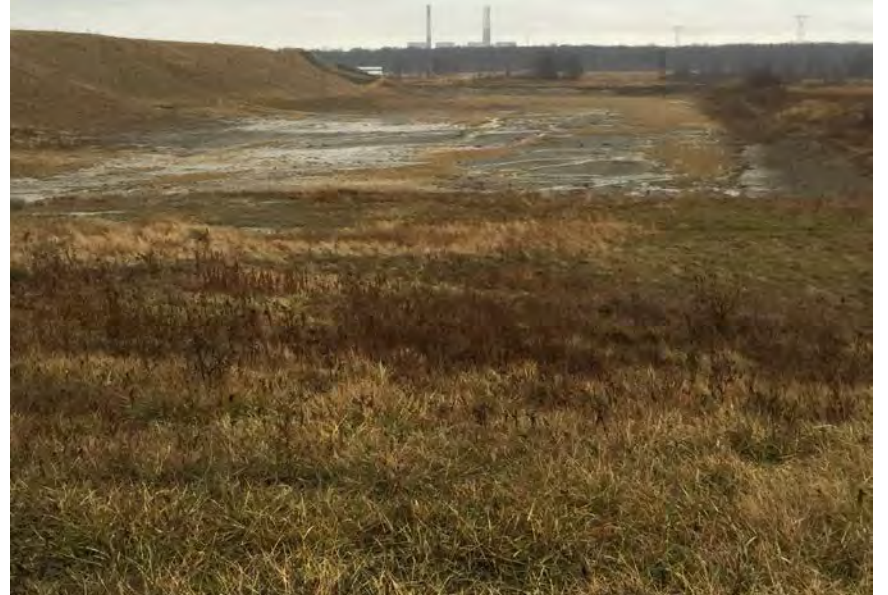
24. Another View of Completed Borrow Area in Phase G2 Looking from the East Side.

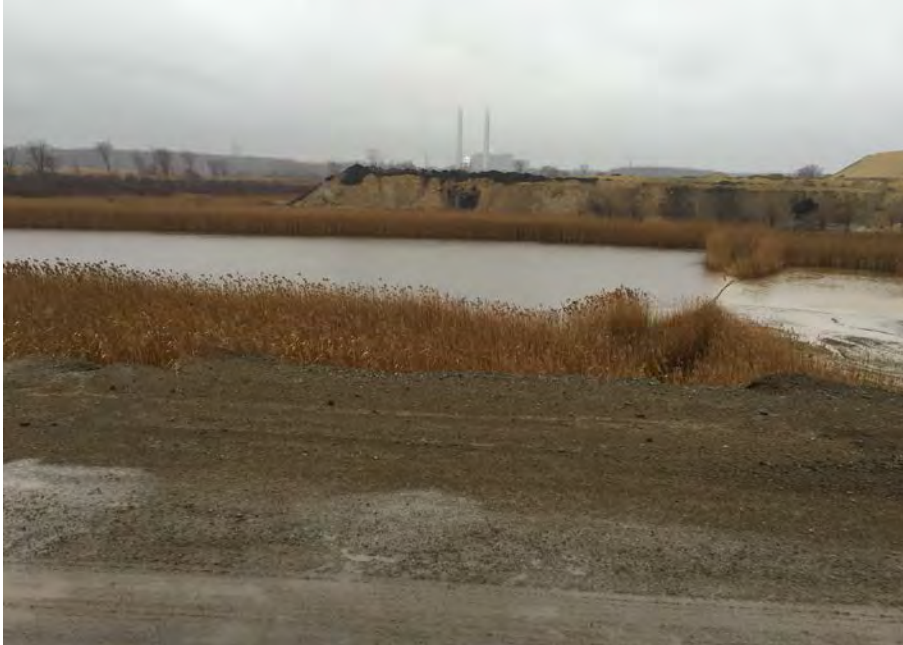
25. Runoff Collection Pond Located in Center of Landfill and Which Drains into Ditch Leading to Detention Basin.

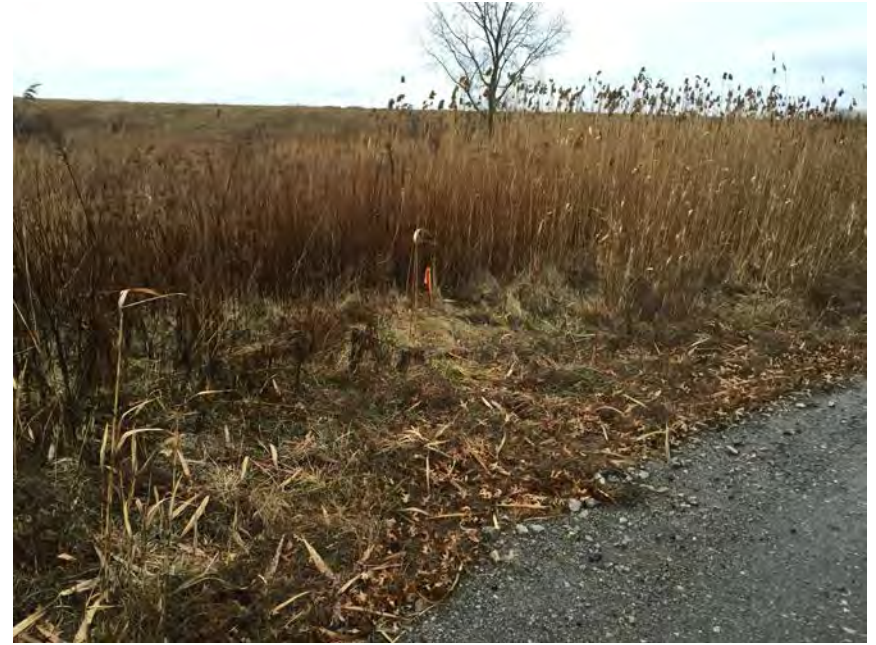
26. Location of Proposed New Monitoring Well, Located within Landfill Property, but in an Undeveloped Area. Planned Downgradient Well.

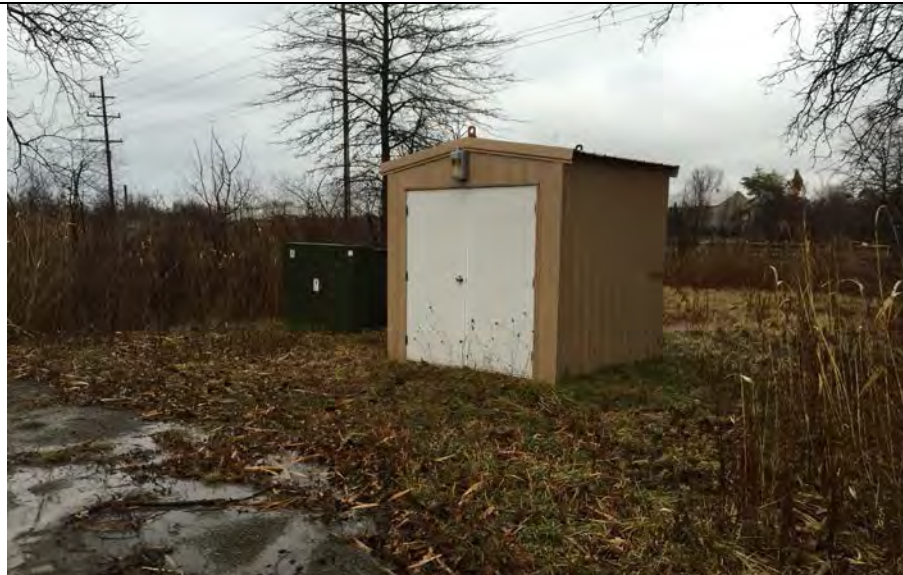
27. Northeast Off-Site Groundwater Capture System Building. Capture System Inspected Routinely and Sumps (not shown) Inspected and Cleaned 3<sup>rd</sup> Q 2015.

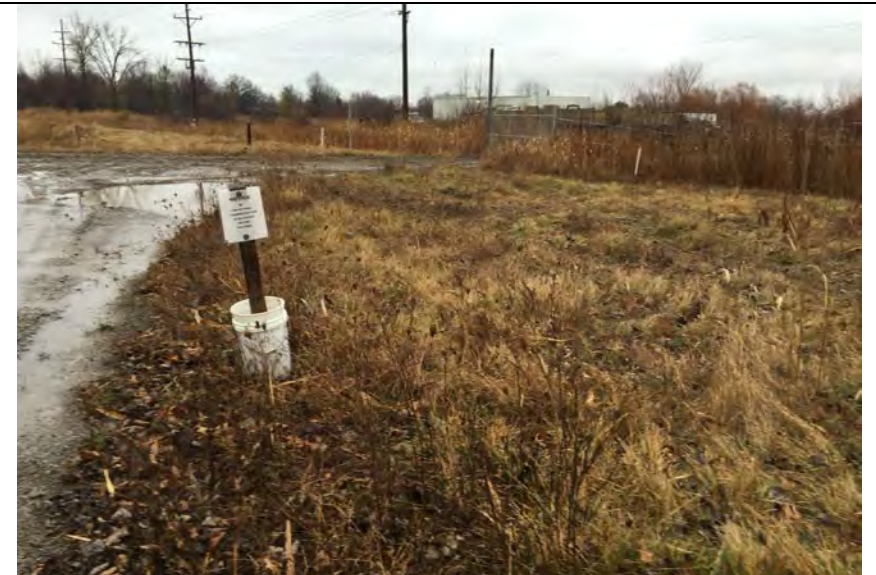
28. Gate Location Along Northeast Off-Site Groundwater Capture System. Slurry Wall Location Inside Fence at White Markers. Raining Thru-out Day.

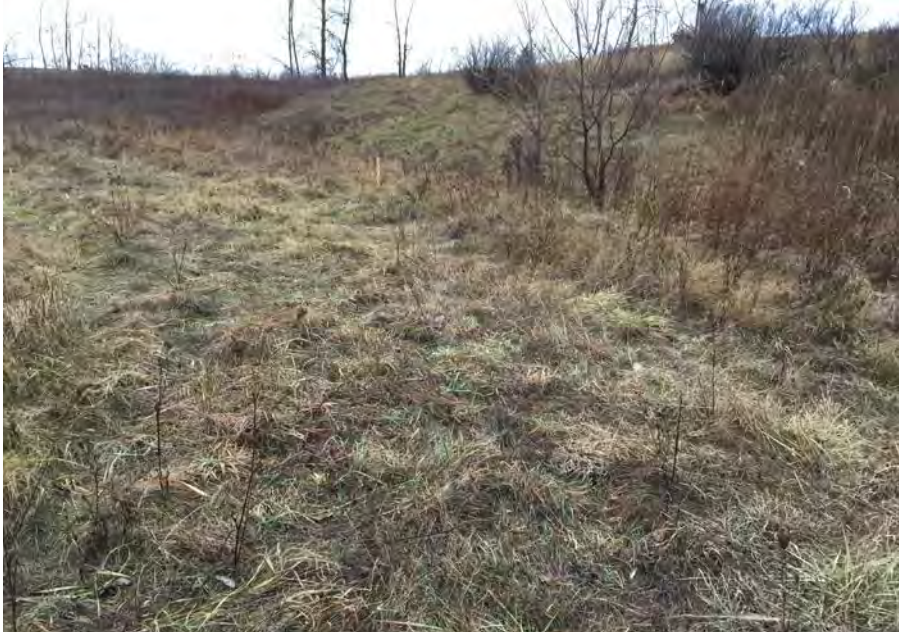
29. Location of Proposed Downgradient Monitoring Well. Some Woody Vegetation on Slope.

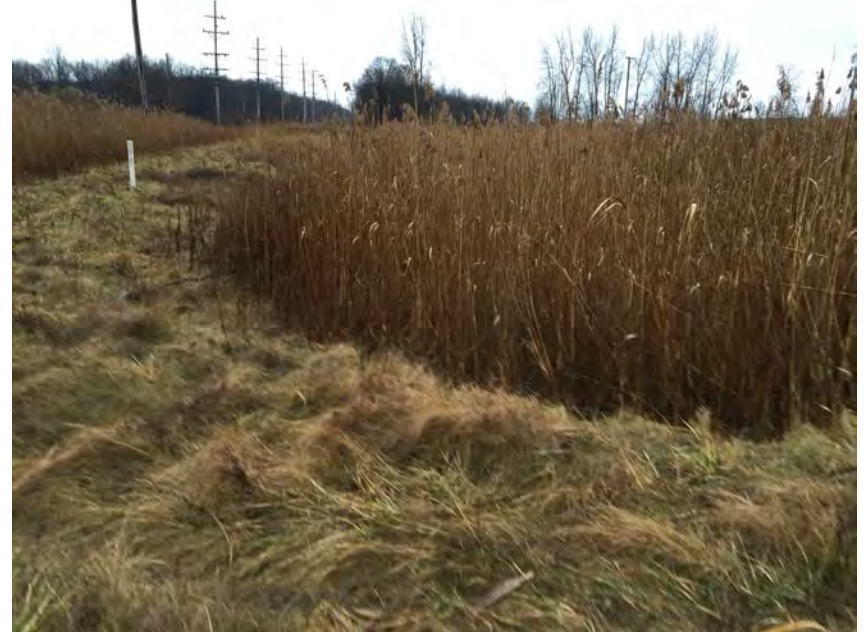
30. Looking South at Perimeter Ditch. Slurry Wall Marker on Left. Range Road Outside of Property. Ditch Perimeter was Walked.

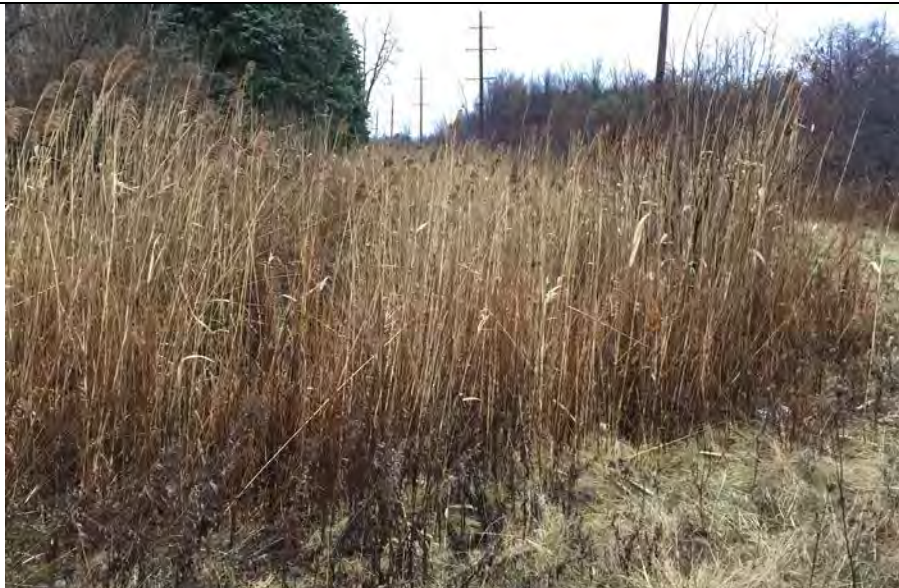
31. Perimeter Ditch Looking North from Ditch Crossing Near NE Capture System. Non-Woody Vegetation Allowed in Ditch as long as Still Flowing.

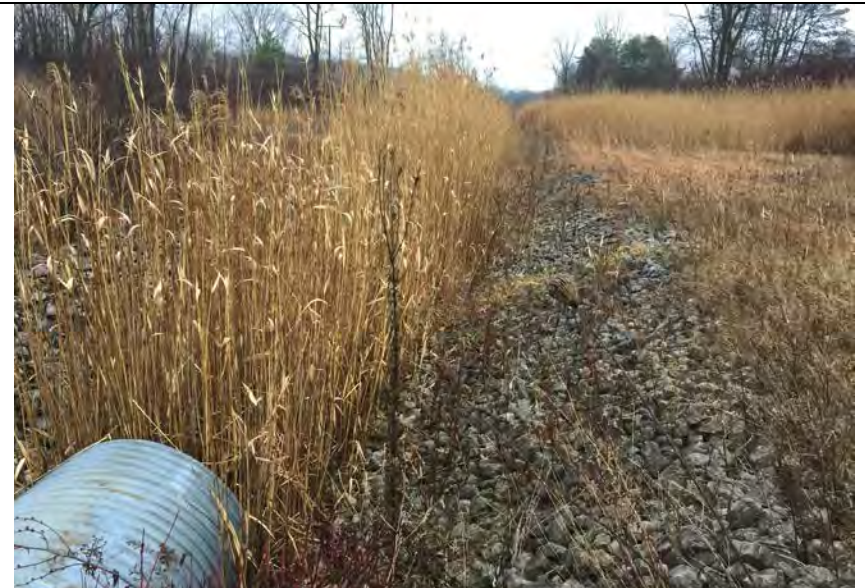
32. Looking South at Perimeter Ditch. Small Riprap Protection Provided in Several Ditch Slope Areas. Slopes were Intermittently Closely Inspected.

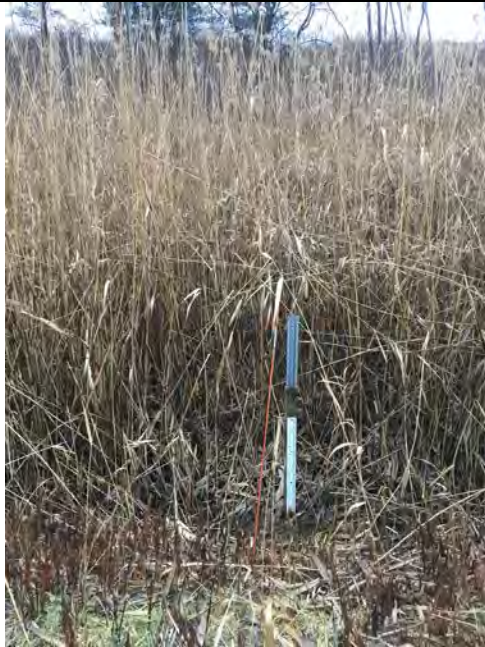
33. Location of Ditch Staff Gauge, SG 12 North End of Landfill. Water Level Estimated at 0.75 Plus-Minus Feet.

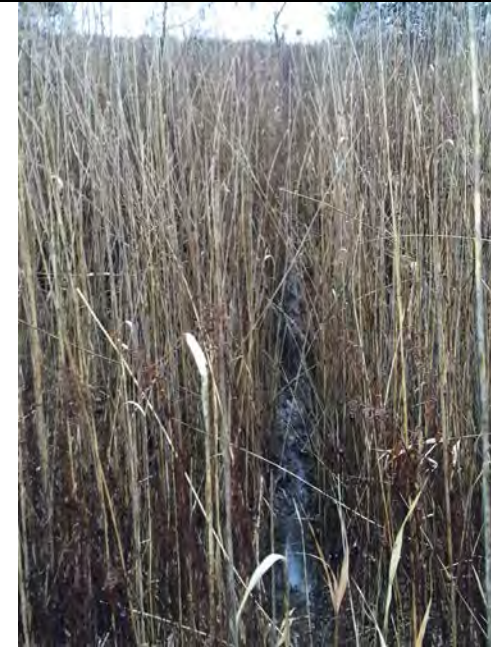
34. Perimeter Ditch Location Showing that Water is Still Flowing within Vegetation. DTE & MDEQ Allow Grassy Vegetation if Flow Maintained.

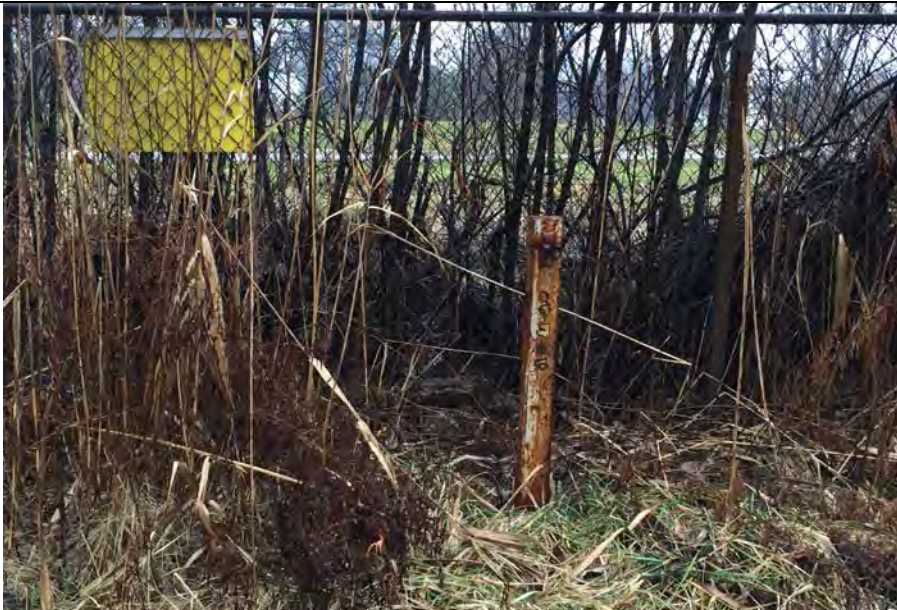
35. Observation Well or Piezometer, Believed to be OW or PZ-1R, Located Along Perimeter Property Fence Along Bree Road.

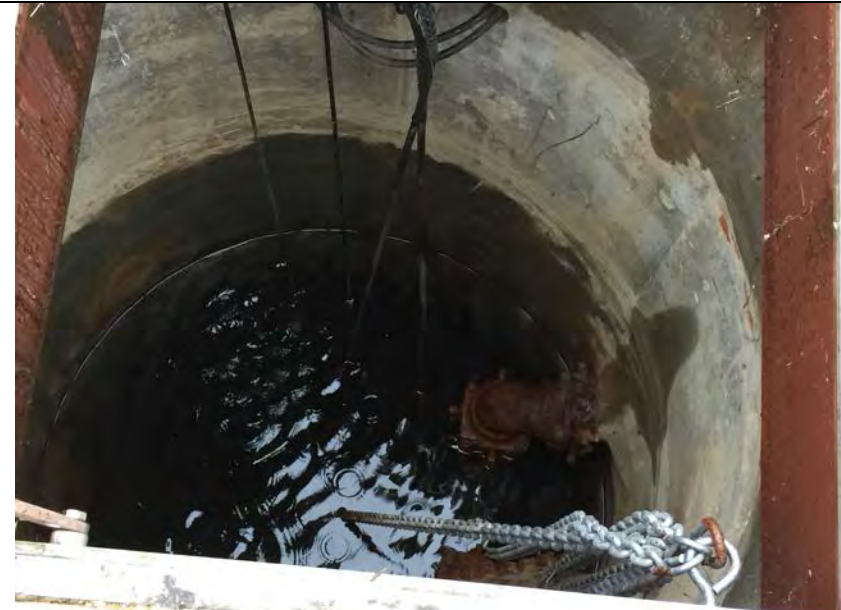
36. Sump with Discharge Pump for Northwest Groundwater Capture System.

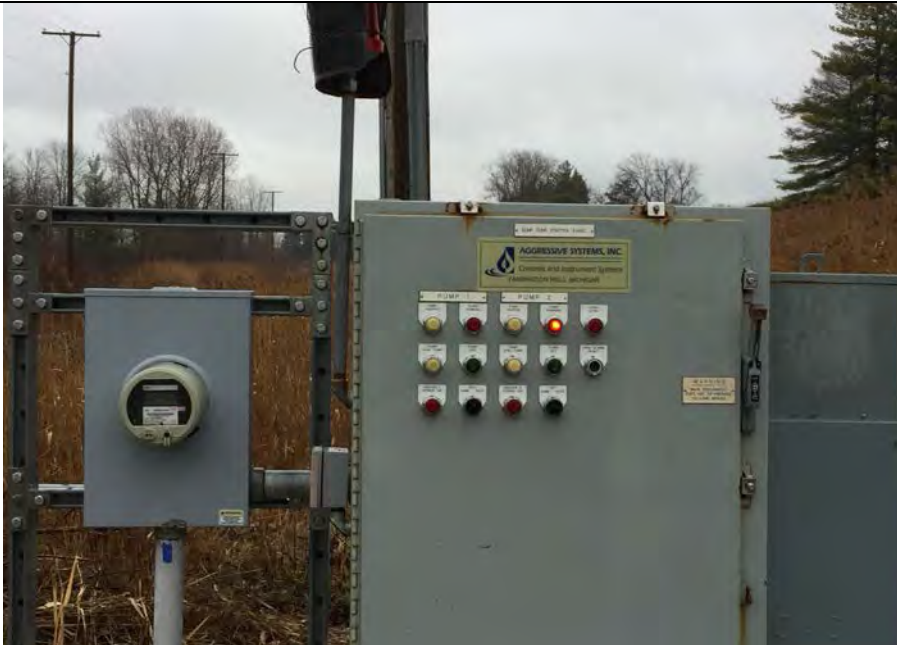
37. Northwest Groundwater Capture System Sump Pump Control Panel. Pump No. 2 is Running. Running was Verified for Pump Nos. 1 and 2.

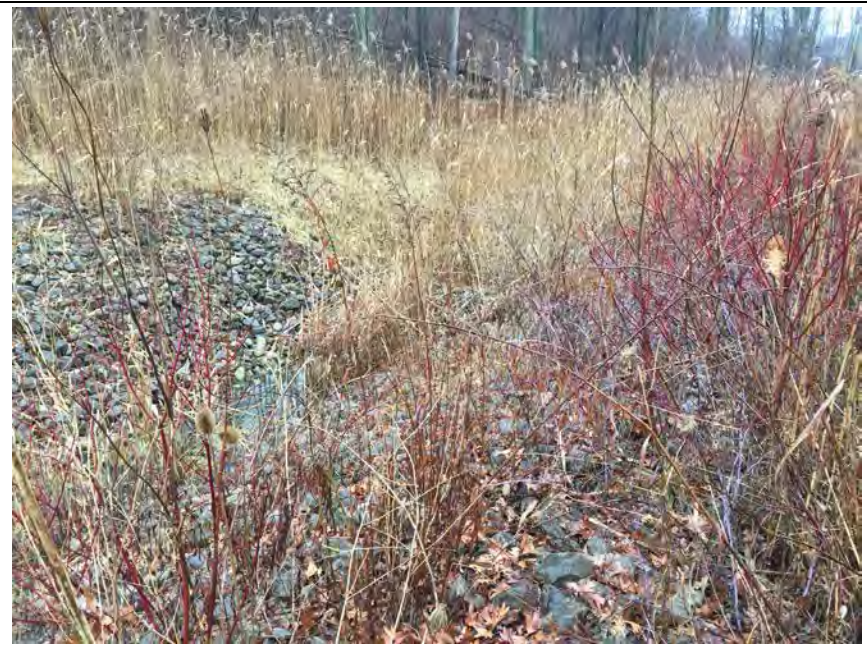
38. Riprap Along Perimeter Ditch at this Location Near NW Capture System. Riprap Placed in Several Locations Especially Near Culverts.

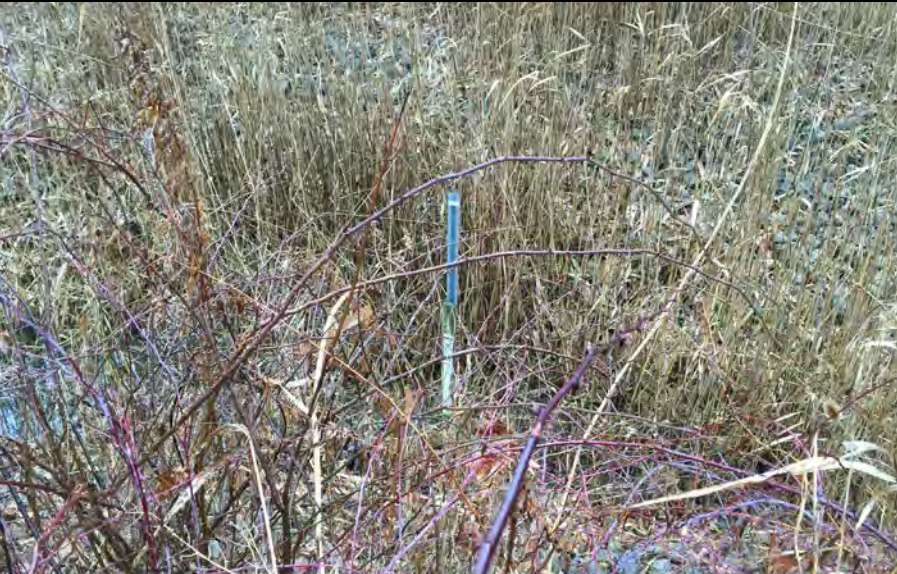
39. Perimeter Ditch Staff Gauge. Water Level Approximately 0.3 feet.

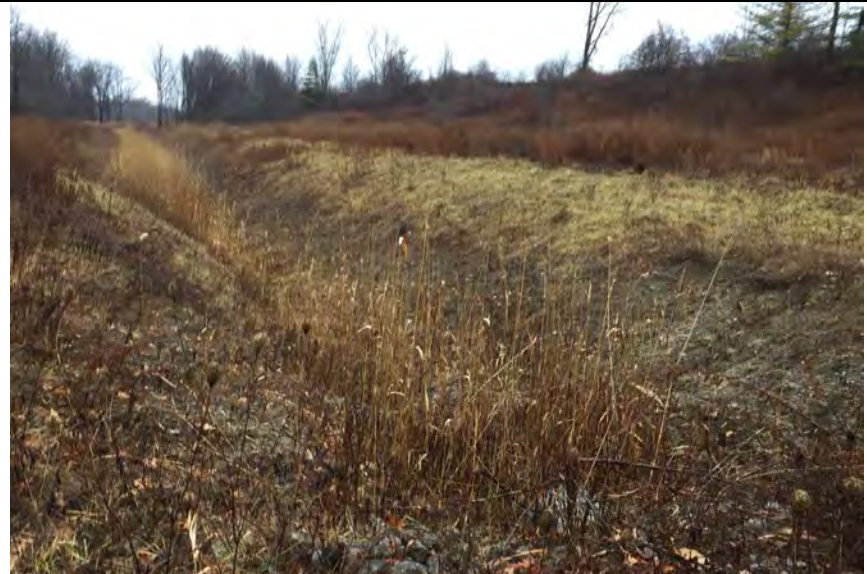
40. Perimeter Ditch Along North Side of Landfill. Road Crossing and Culvert Shown was Open for Flow (Lower Right in Photo).
