**2015 ANNUAL INSPECTION REPORT  
RANGE ROAD LANDFILL  
ASH DISPOSAL FACILITY**

**China Township, St. Clair County, Michigan**

January 2016

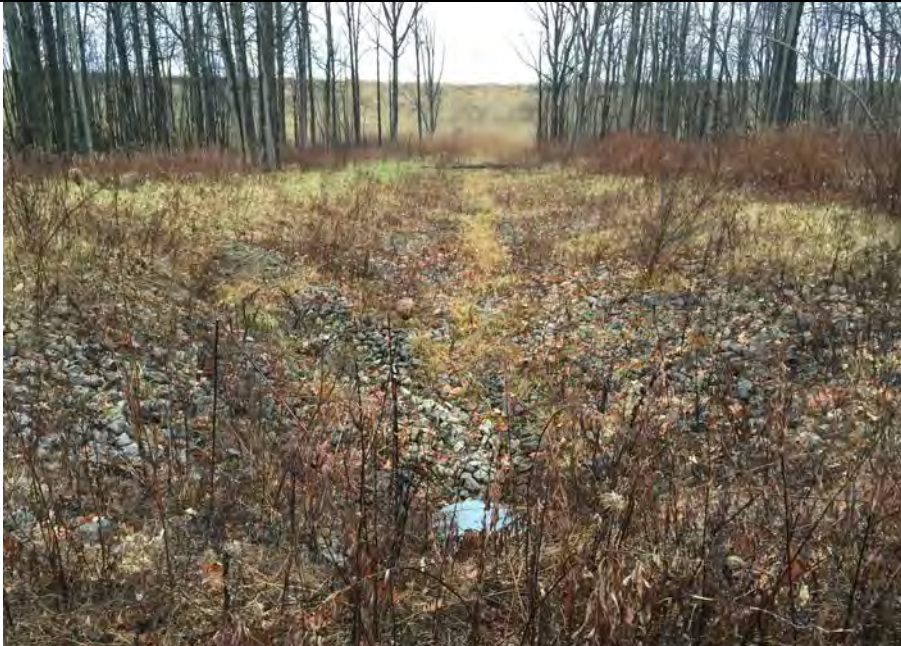
41. Culvert and Secondary Ditch Perpendicular to Landfill Slope. Fallen Tree Across Ditch.

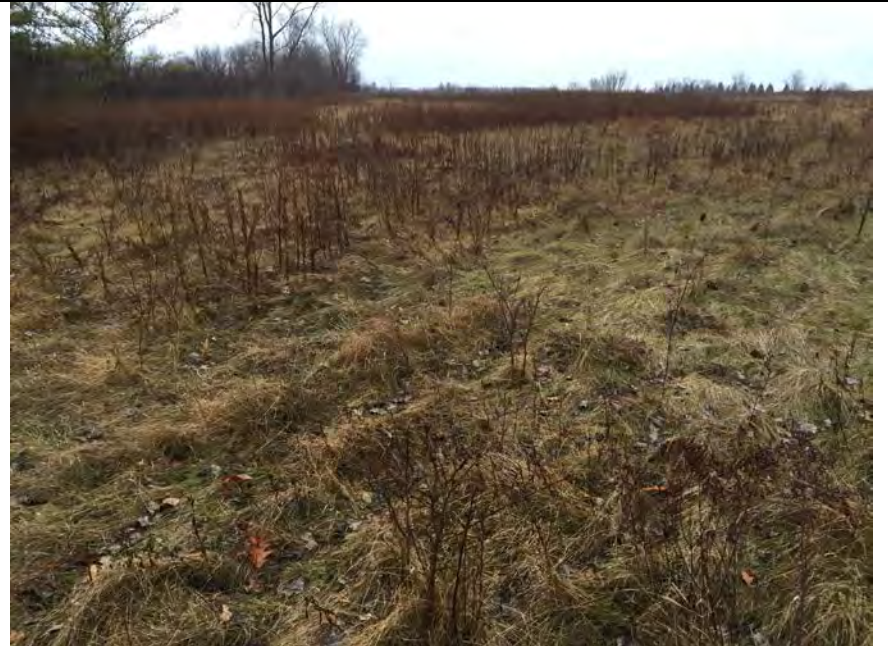
42. Typical Top of Landfill. Looking Toward Area B from Area F1.

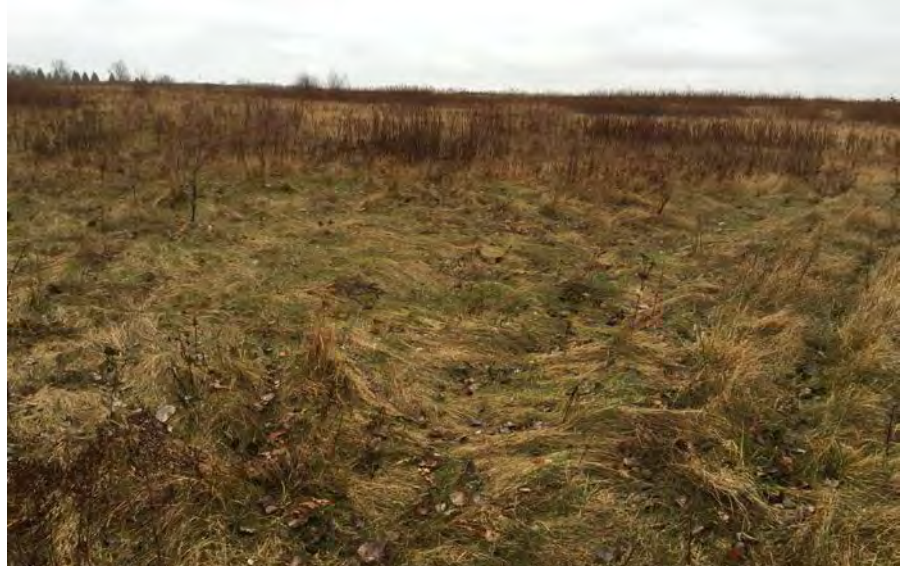
43. Typical Top of Closed Portion of Landfill, Believed to be Areas F1 and F2 to the Right.

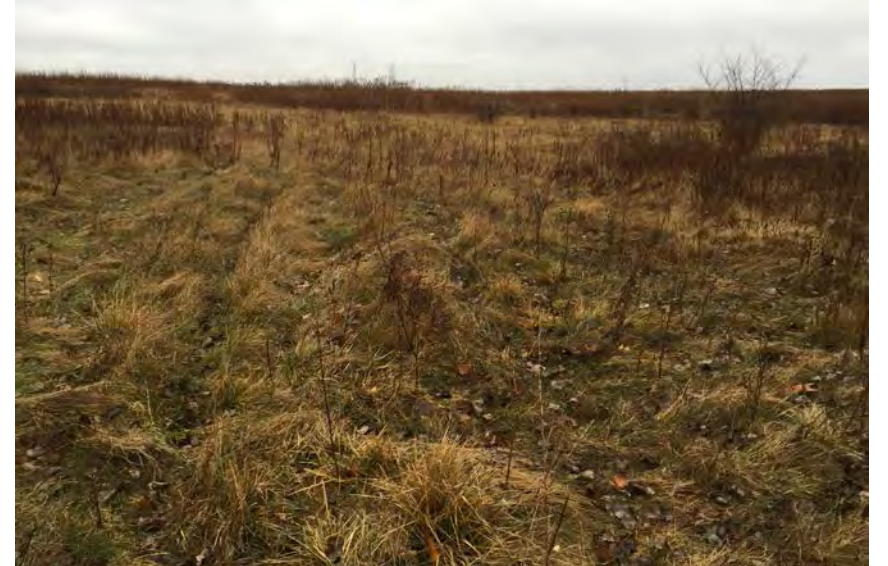
44. Another Adjacent View of Top of Closed Portion of Landfill. Here a Couple of Small Woody Brush Growing. DTE Plans Removal.

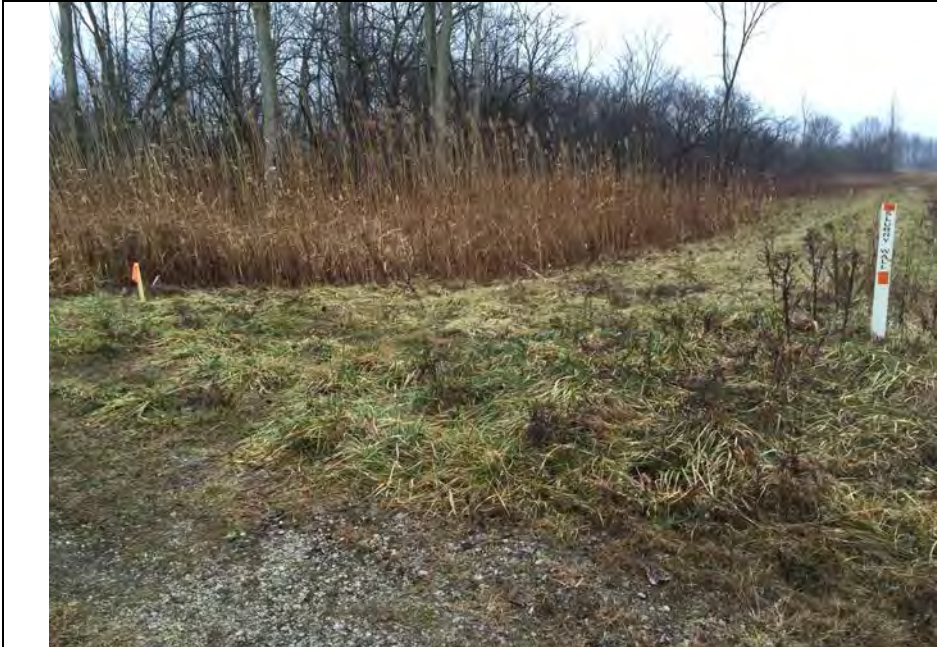
45. Looking South West Side of Property where Proposed Upgradient Well is Located and Slurry Wall Alignment is on the Right. Gate to Road Not Shown.

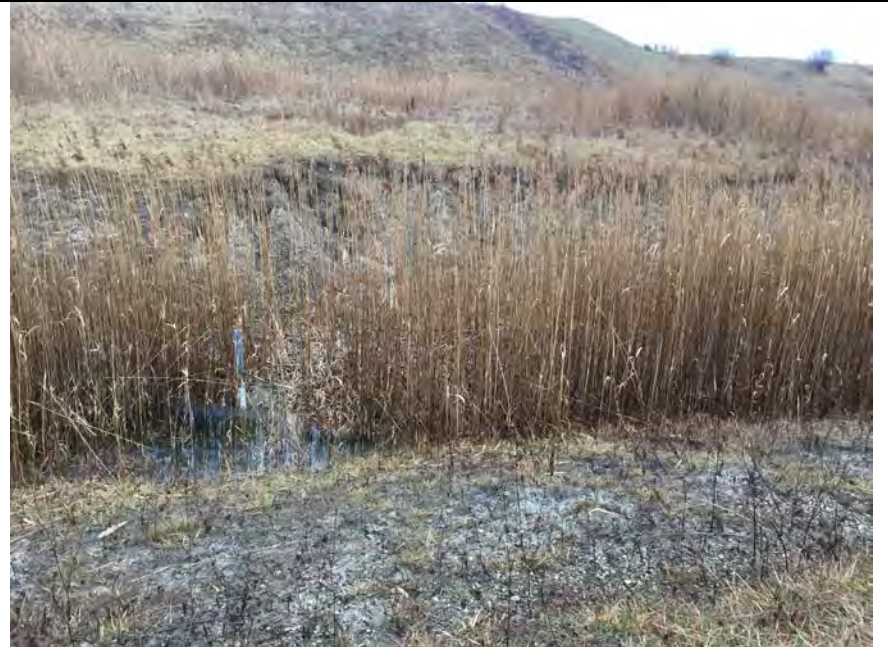
46. Location of Perimeter Ditch Staff Gauge, Believe to be SG 09. Some Ditch Slope Erosion Noted in Photo.

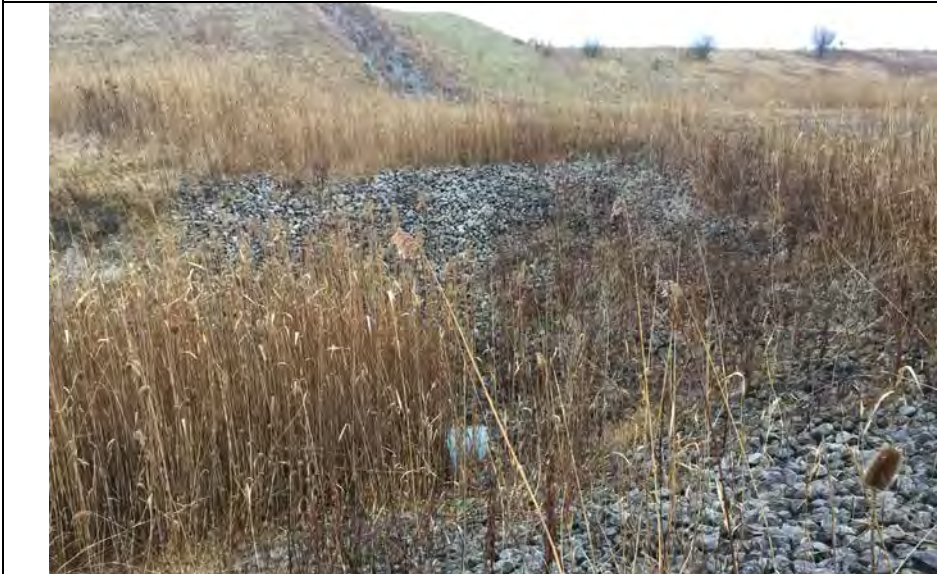
47. Construction Road Crossing of Perimeter Ditch. Culvert Shown and Stone on Slope for Surface Runoff Channel Draining to the Ditch. Runoff at Areas F1/F2 Boundary.

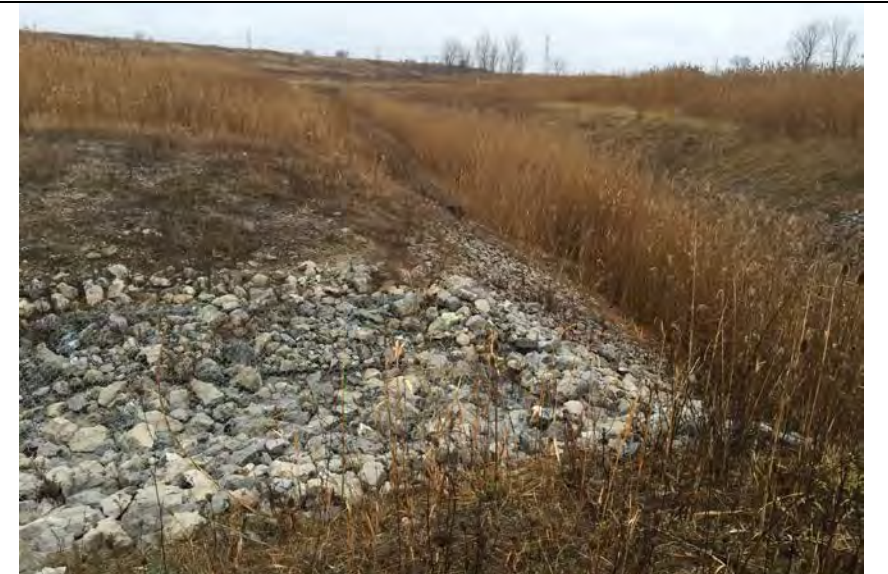
48. Looking South Along Perimeter Ditch Toward Southwest Corner and Fenced Area. Some Woody Vegetation of Landfill SW Berm W of Area G2.
