**2016 ANNUAL INSPECTION REPORT
RANGE ROAD LANDFILL
ASH DISPOSAL FACILITY**

China Township, St. Clair County, Michigan

Geosyntec  
consultants

November 2016

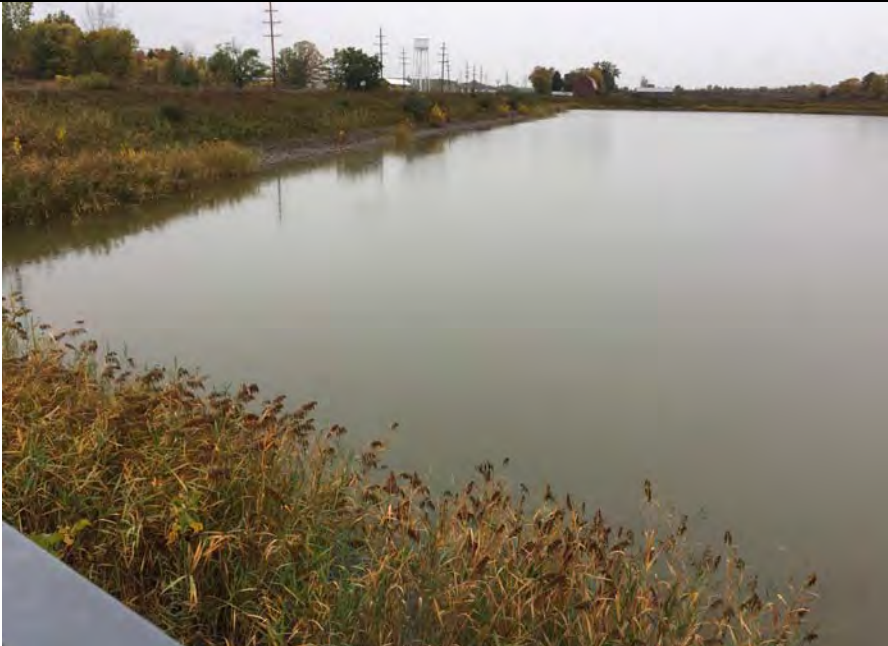
1. Storm Water Detention Basin (SWDB), South and West Sides. Slopes are Protected with Stone. No Visible Slope Erosion or Woody Vegetation on Slope.

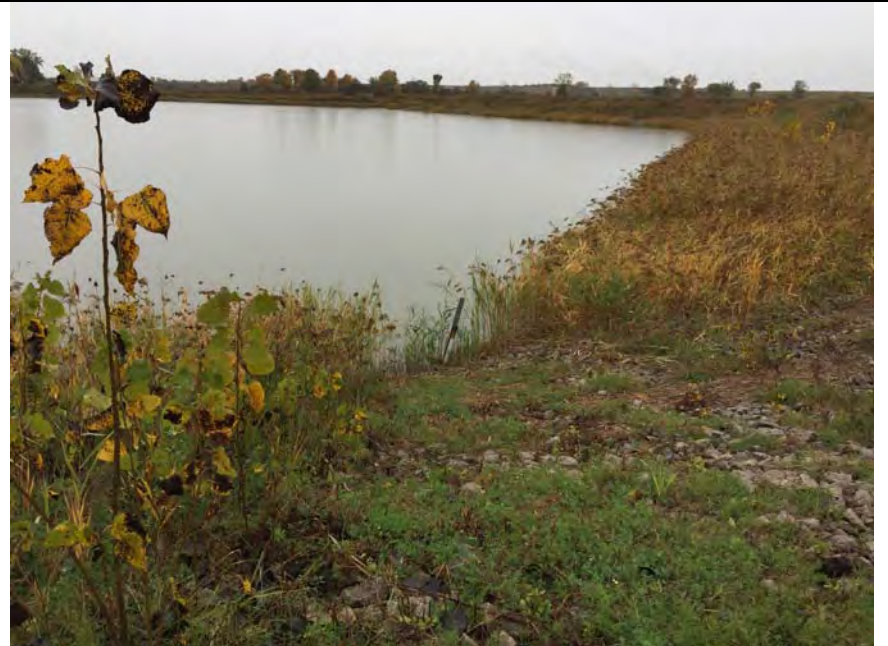
2. Storm Water Detention Basin, North and East Sides. Slopes are Protected with Stone. No Visible Slope Erosion or Woody Vegetation on Slope.

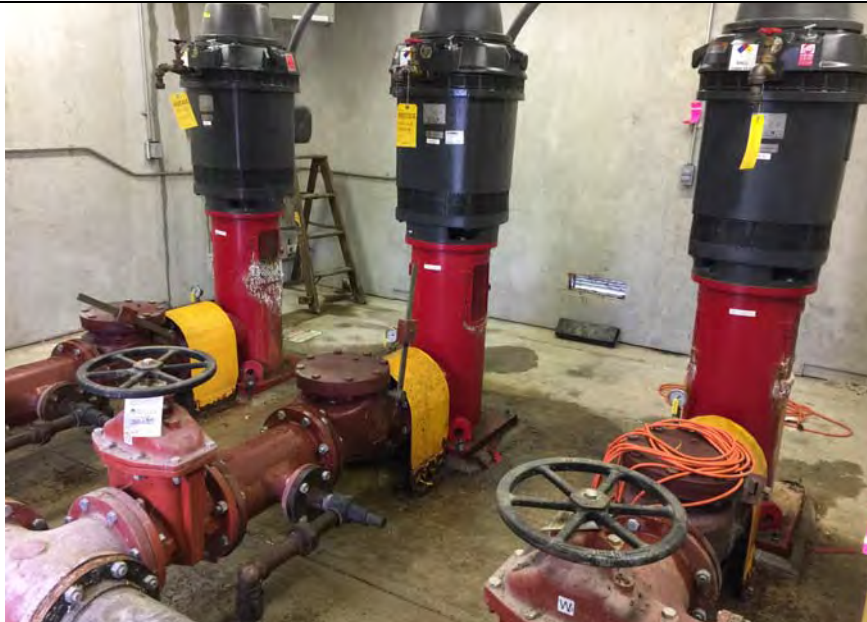
3. Pump House Pumps and Valves. Water from Basin is Pumped Back to Power Plant. DTE Plant Inspects Daily and Records Pump Observations and Flow.

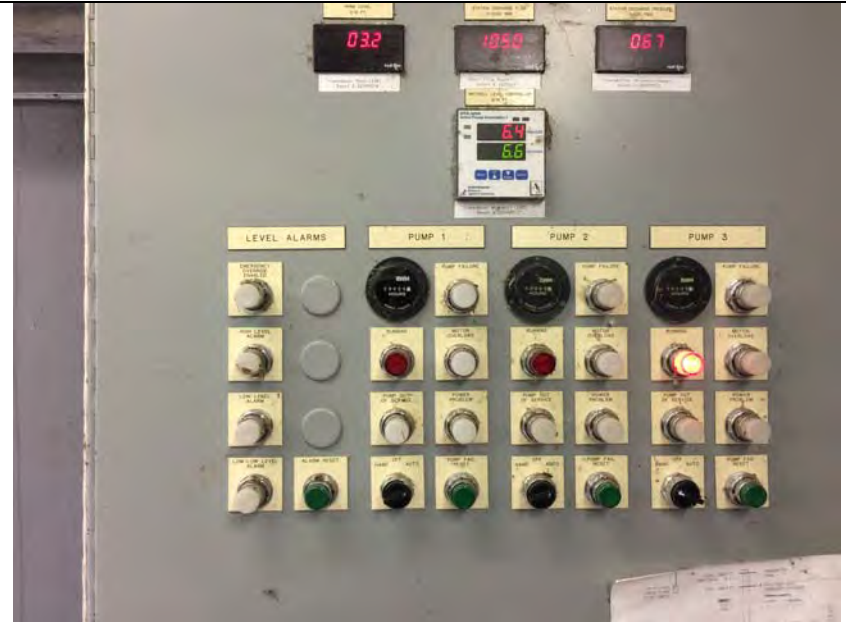
4. Pump Control Panel. Each Pump was Run Checked. Pump #3 Running. Pumps Cycle Each Run Unless Higher Pond Level Needs More Pumps On.

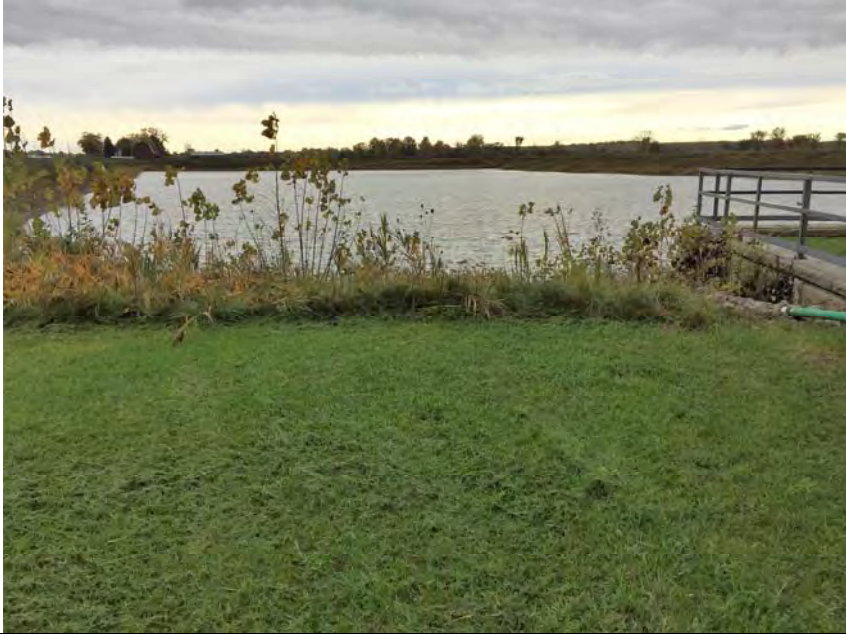
5. View of SWDB on Morning of 21 Oct. 16. Light Rain Falling.

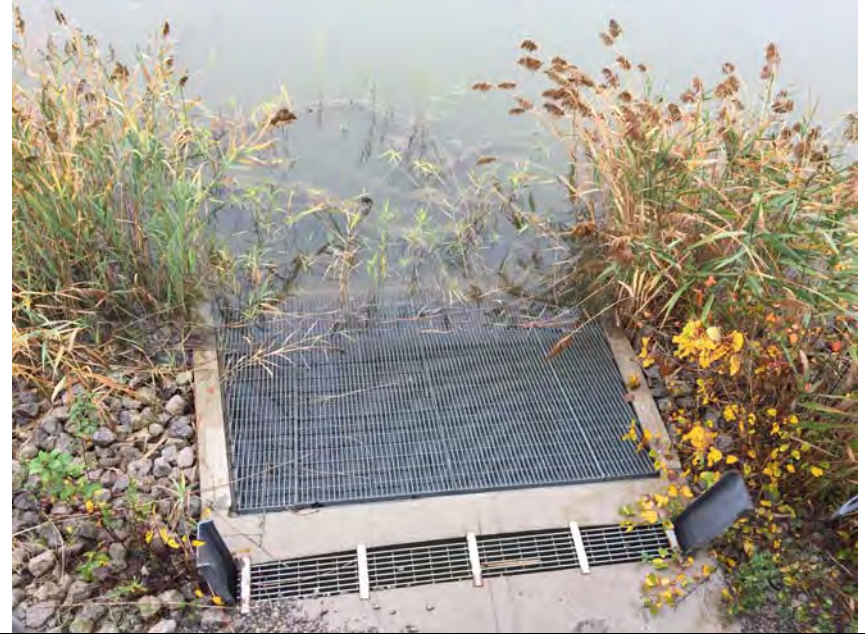
6. Basin Intake Screens. No Significant Blockage Noted.

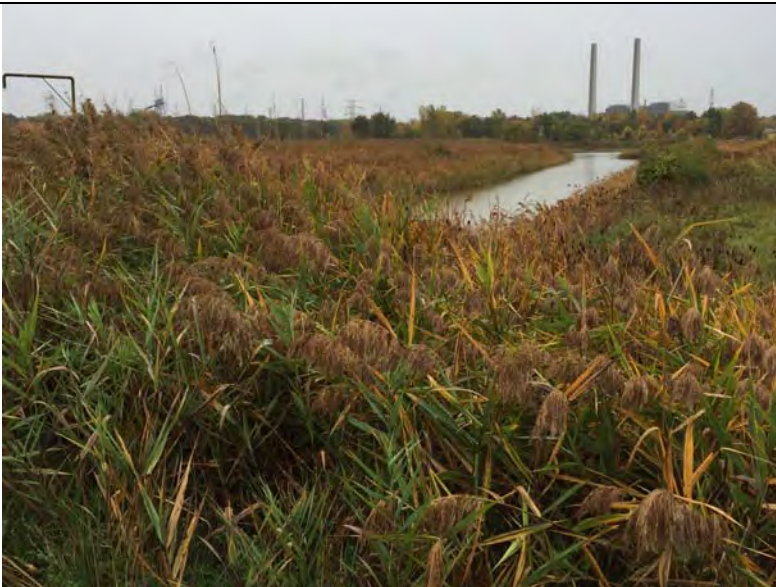
7. View of North/South Drainage Canal Leading to SWDB from Perimeter Ditch System.

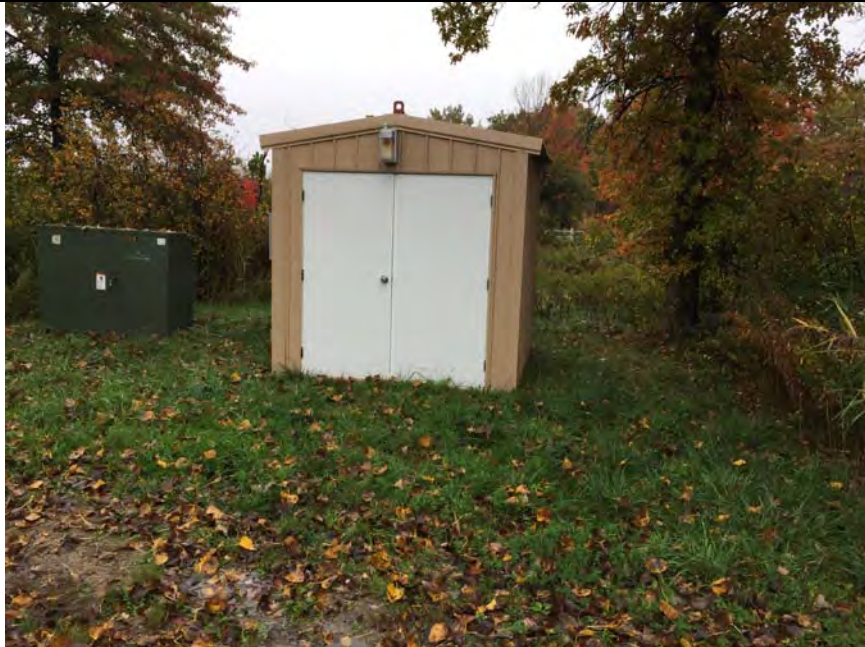
9. Northeast Off-Site Groundwater Capture System Building. Capture System Inspected Routinely and Sumps Not at this Location Inspected and Cleaned.

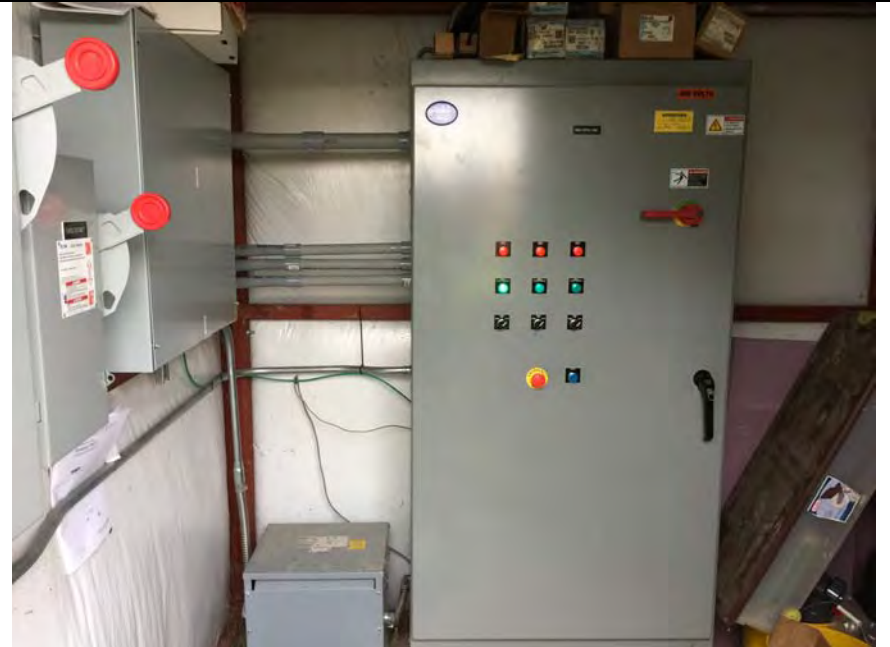
10. Inside of NE Off-Site GW Capture System Building. Pump #1 (Left Green Light On) Running. Water Discharging to Ditch During Inspection.

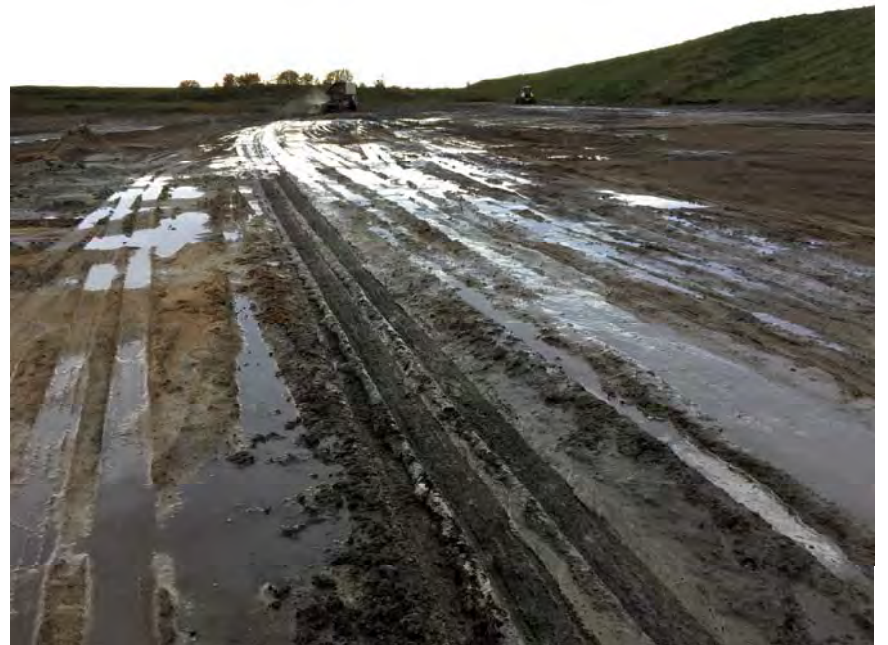
14. Active Area G2 North End. Rain Falling. Ash Being Placed at Far End Near Temporary Area F2 Slope. Little or No Tire Ruts in Ash Surface.

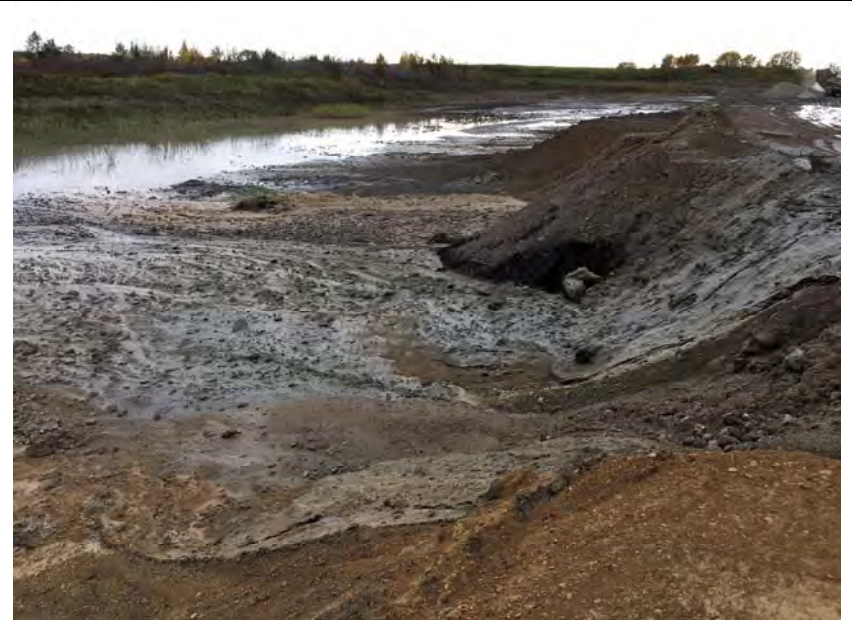
16. Water in Area G2 Drains to the Left of Photo (See Photo 15). Ash Placement In progress Far Right Corner. Heavy Rain 0.92" for 20 Oct. 16.

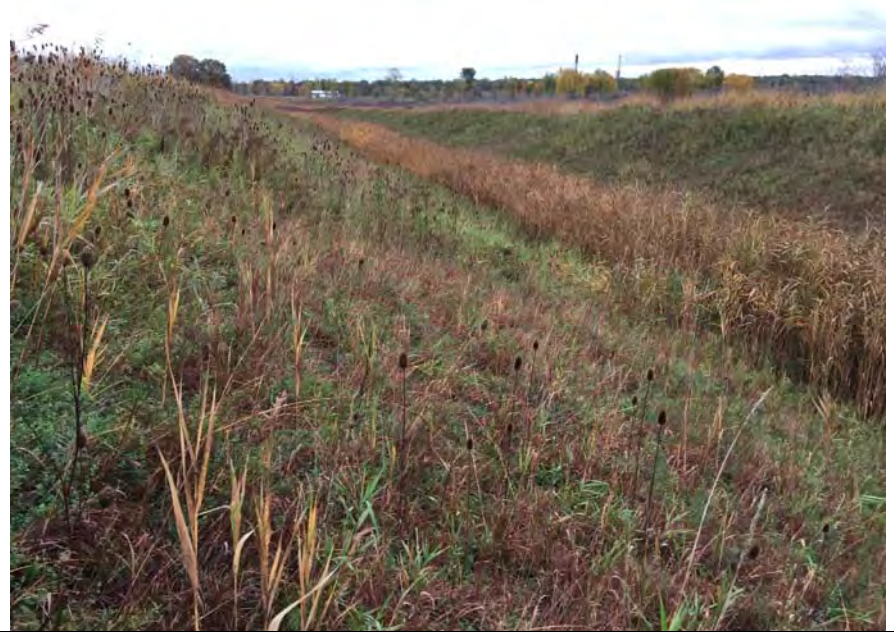
18. View of Perimeter Ditch Along South Side that was Reconstructed in 2010. Slopes Appeared Stable, Well Vegetated and Erosion Free.

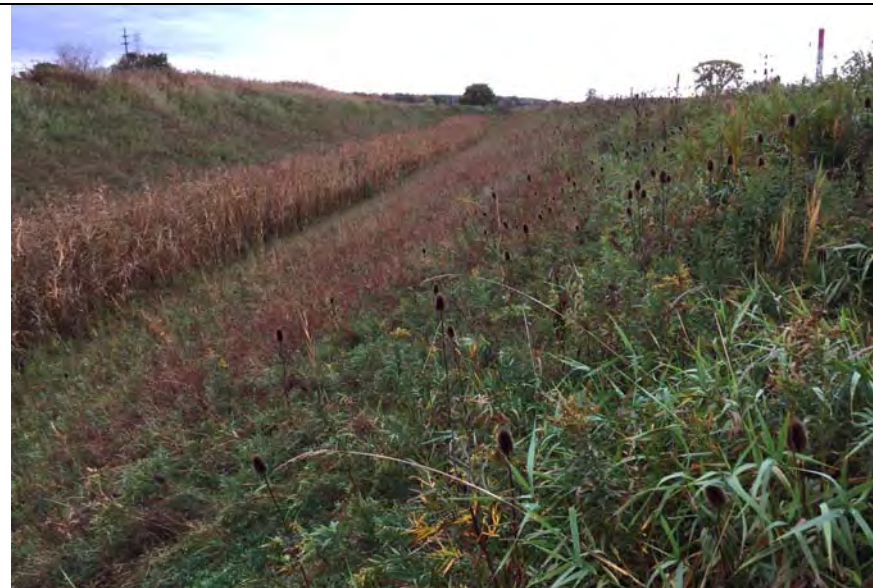
19. View of Another Portion of Reconstructed Perimeter Ditch Looking in Opposite Direction from that in Photo 18. Ditch is Open and Flowing.

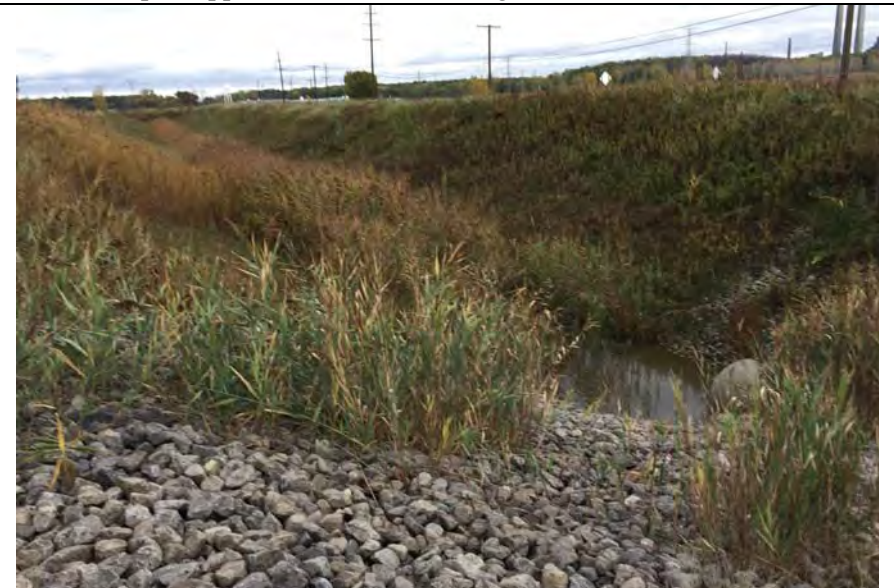
20. Perimeter Ditch at Road Crossing on South Side. Flow was Observed Through the Culvert.

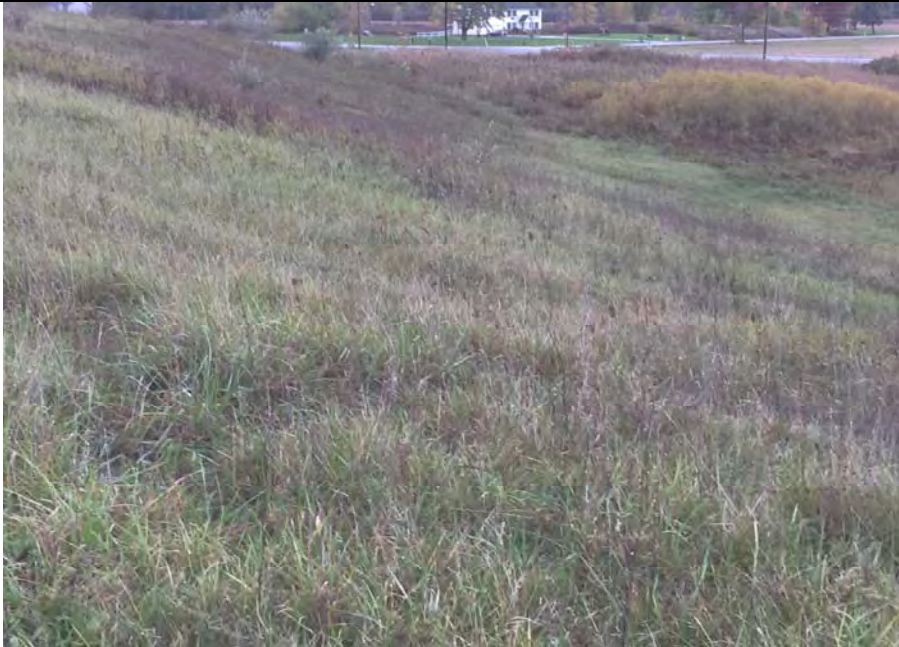
21. West Southwest d/s Side of Landfill Slope. Well Vegetated and Stable with No Significant Areas of Slope Erosion. Couple Small Woody Vegetation Noted.

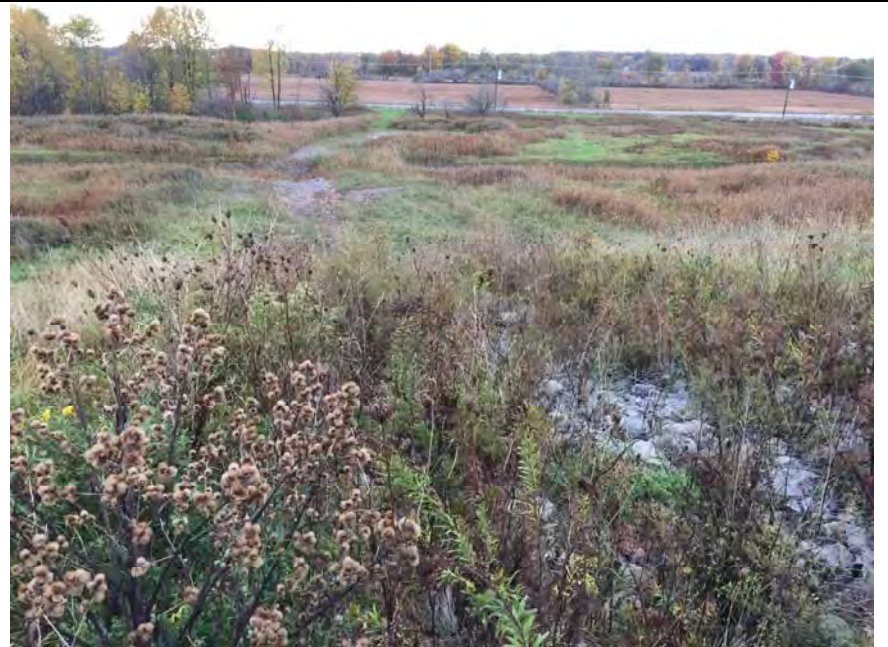
22. Ripped Downslope Drainage Flume Central West Side of Landfill at Corner of Closed Areas F1 and F2.

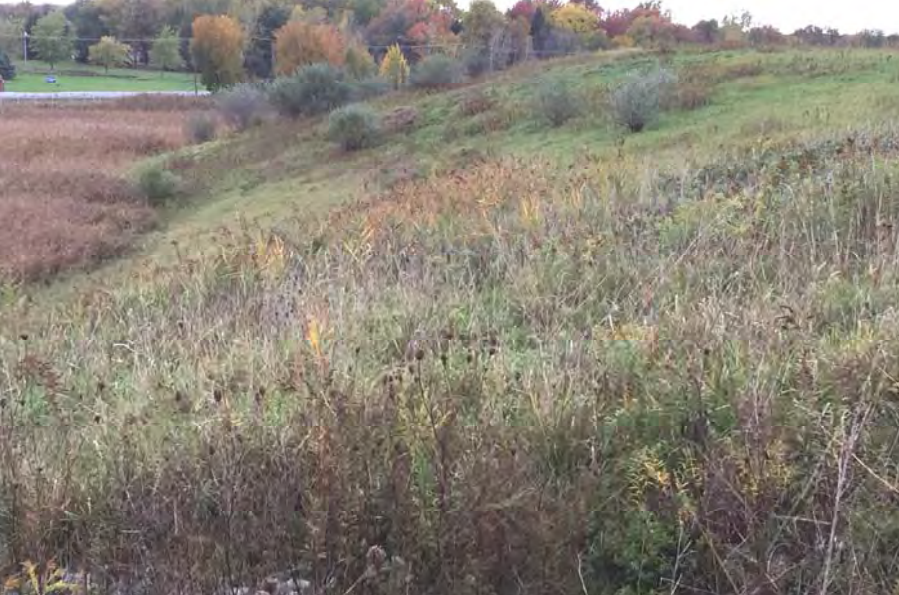
15. Landfill Side Slope Condition (i.e.-no seeps, no cracking, no settling, no burrows, adequate vegetation)	<input type="checkbox"/>	<input checked="" type="checkbox"/>	<input type="checkbox"/>	31, 32 & 40 21,22,23,& 47	No erosion noted. Trees on N, NE, NW sides, reported approved to stay. Other (F1) woody veg. noted and scheduled for removal.

23. Looking at d/s Slope of Closed Area F1 where Small Woody Bushes/Trees Developing. Woody Vegetation was Scheduled for Removal.

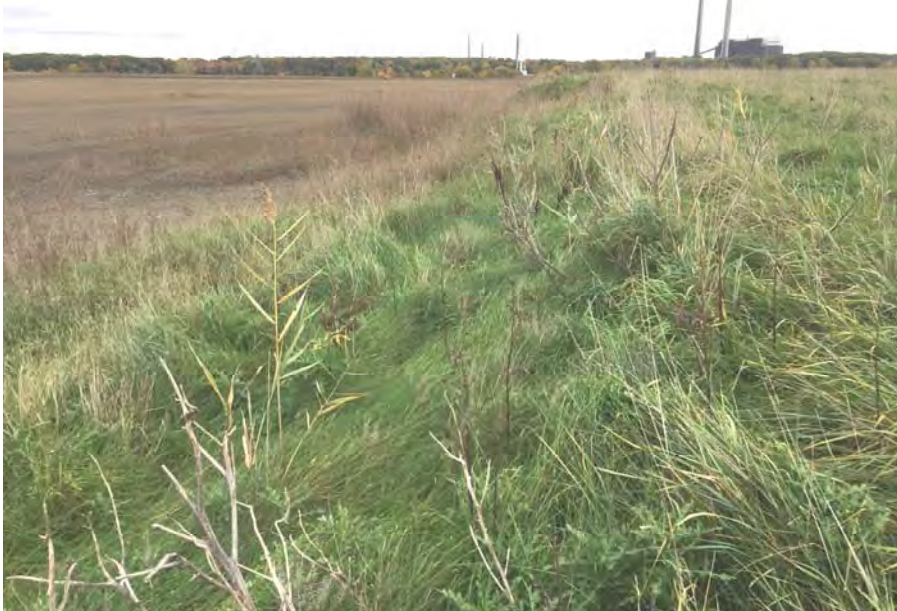
29. Top of Landfill Looking at Drainage Berm. Active Area F3 on Left. No Berm Erosion Noted.

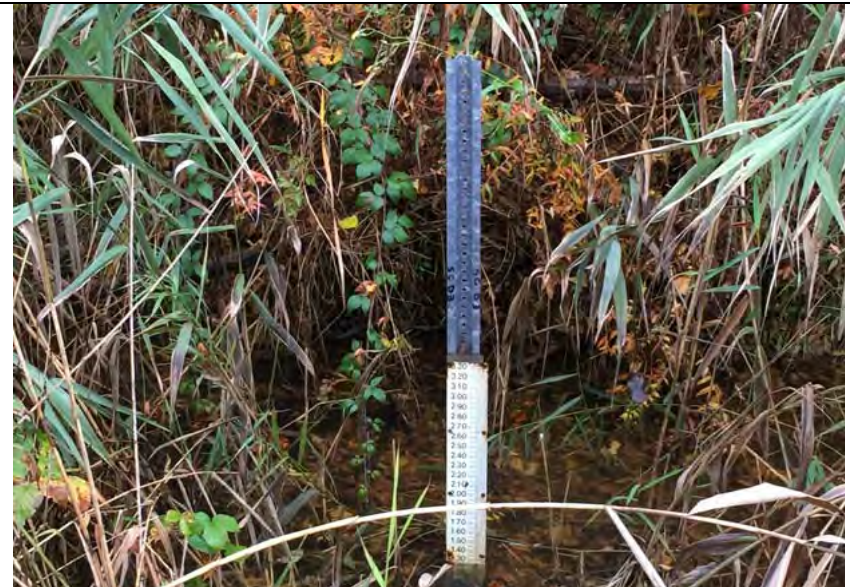
32. Perimeter Ditch Staff Gauge SG-03. Water Level Reading was About 1.25 ft.

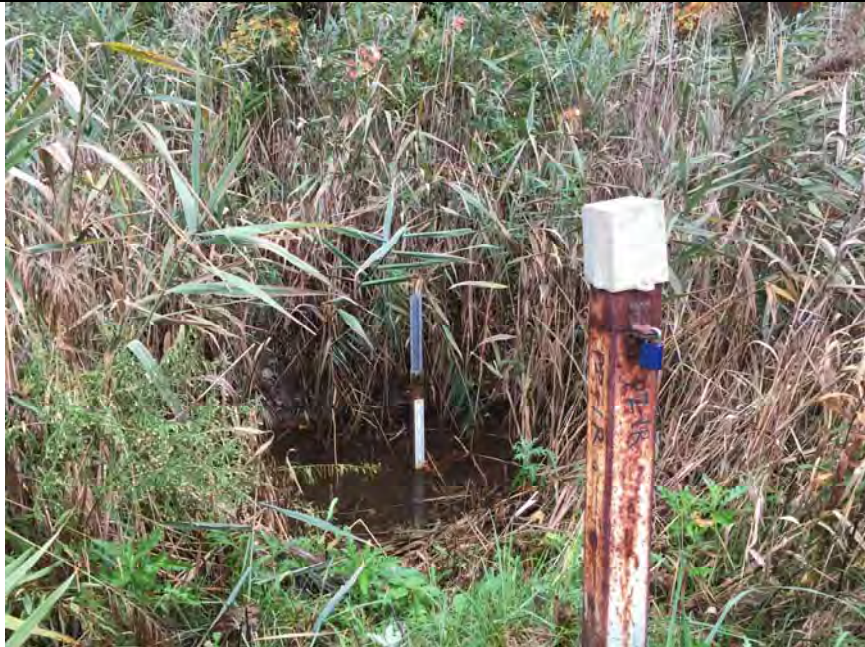
33. Perimeter Ditch Staff Gauge SG-02. Water Level Reading About 1.50 ft. Piezometer PZ-1R.

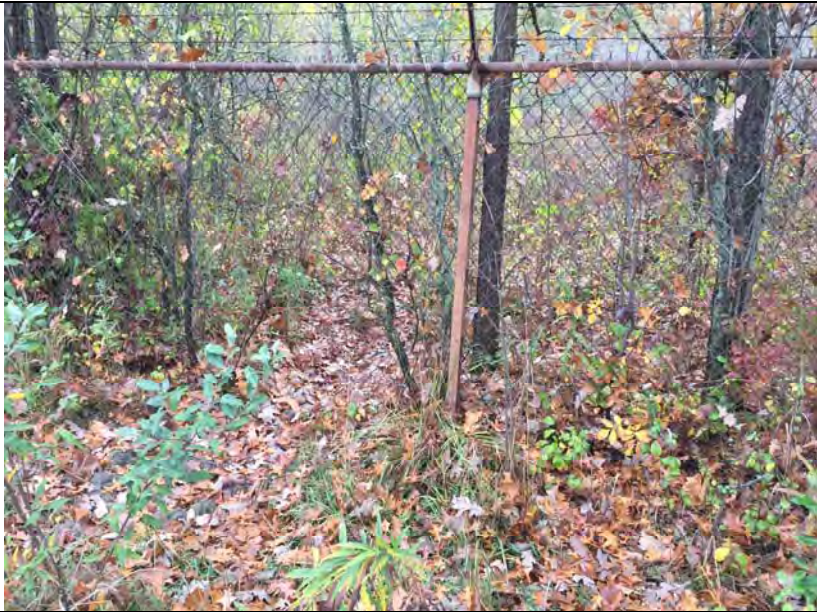
2. Security Fence / Gates	<input checked="" type="checkbox"/>	<input type="checkbox"/>	<input type="checkbox"/>	35	Good, one minor cut opening N side, DTE plans to repair.

35. Small Hole in Fence At North Side Scheduled for Repair.

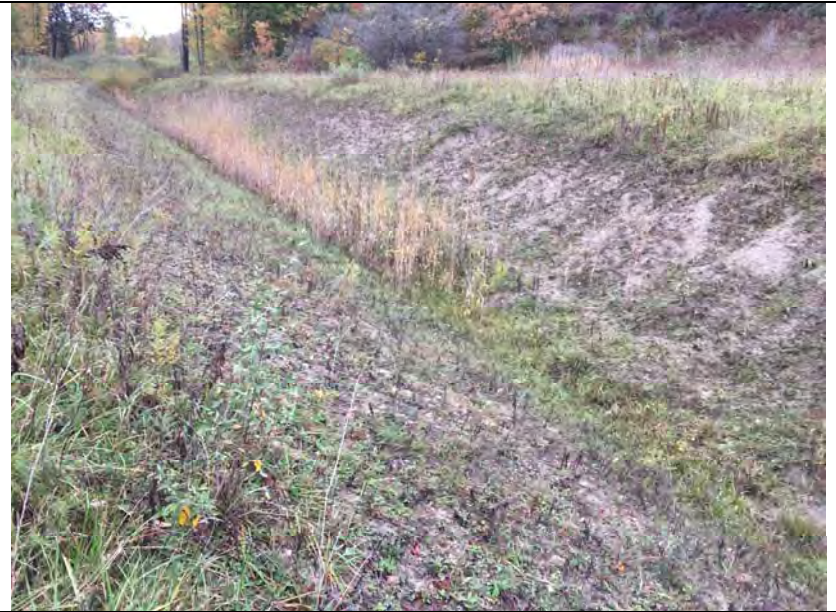
36. Perimeter Ditch Along North Side That is Scheduled for Stone Slope Protection.

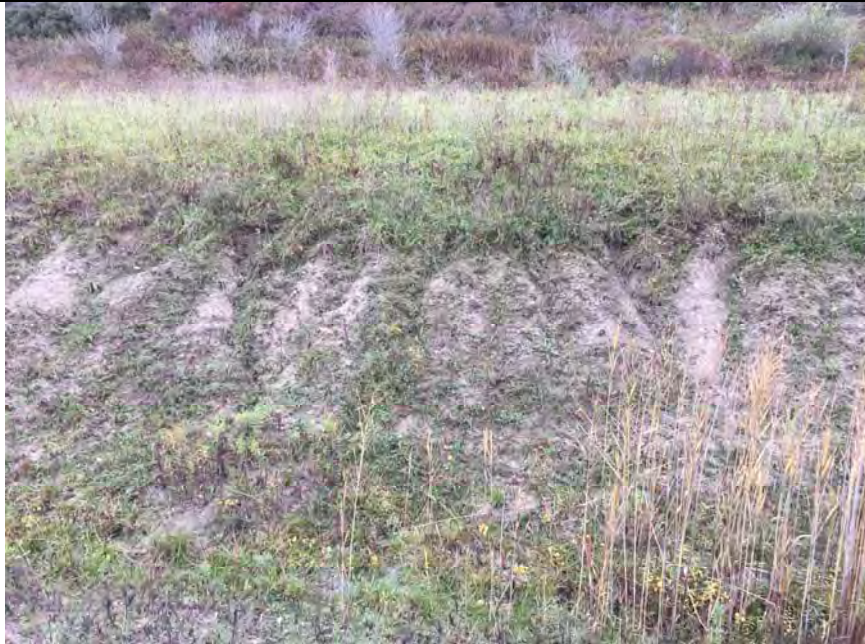
37. Close-up of the Ditch Scheduled for Stone Slope Repair. Erosion Noted and Past Vegetation Seeding Did Not Take Hold.

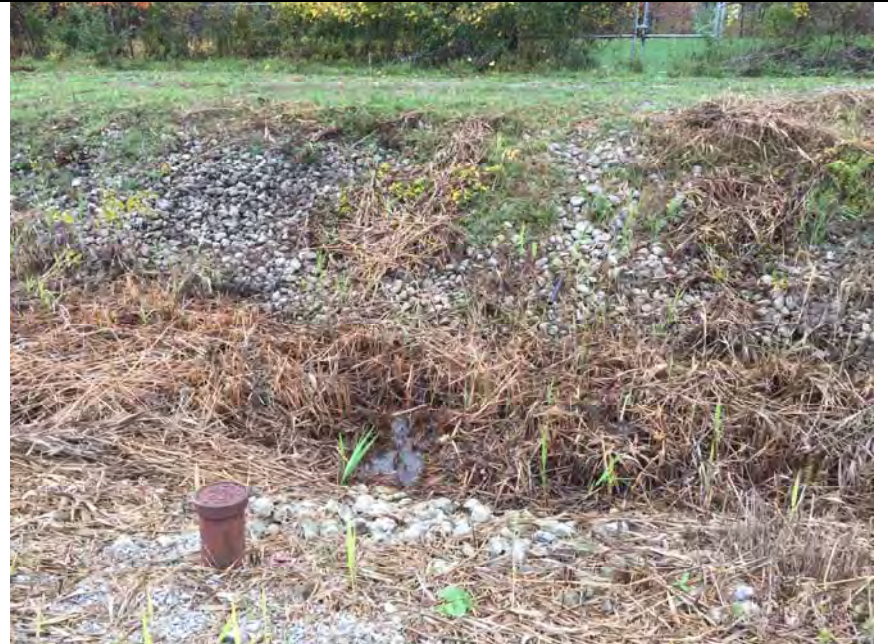
38. Location of Discharge from Sump to Perimeter Ditch. Flow was Observed. Pump #2 was Pumping as Control Panel in Photo 40 Indicates.

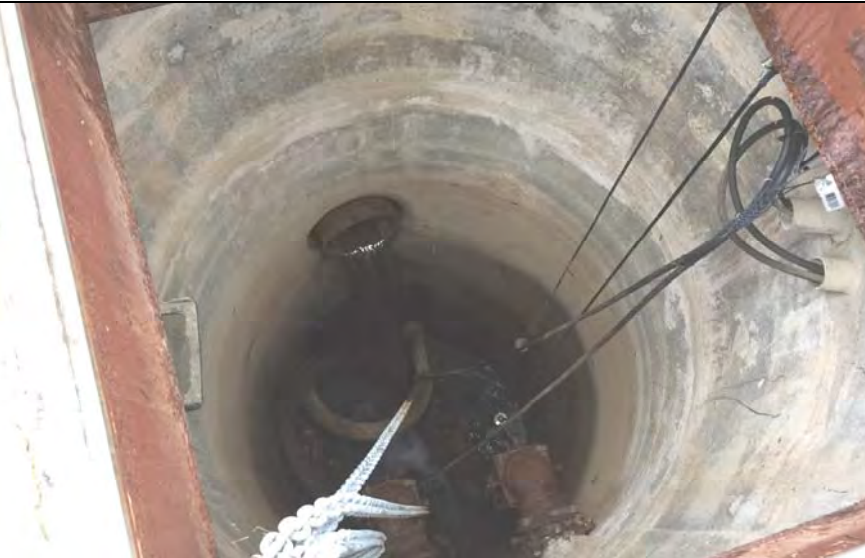
39. Sump Observed at NW Pump Control Location. Water from Offsite Wells is Trickling in.

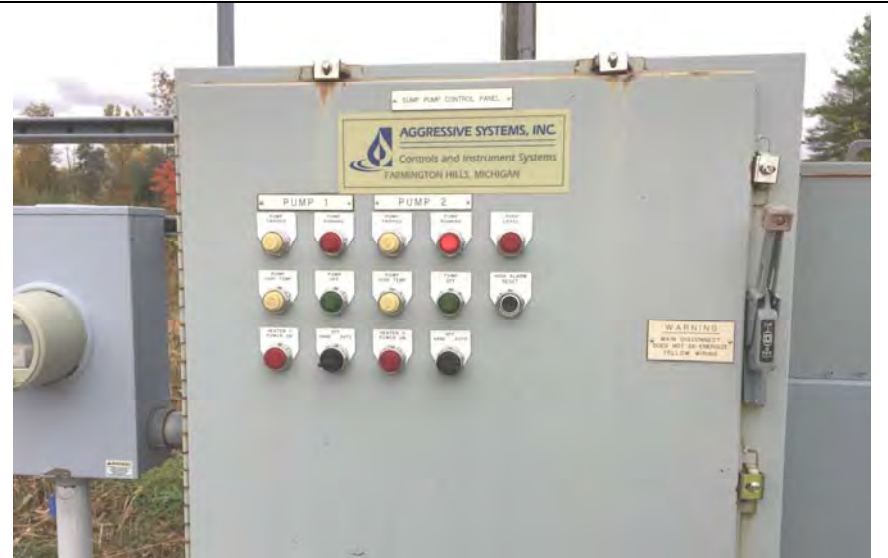
40. NW Pump Station Control Panel in Operation. Pump #2 Running.

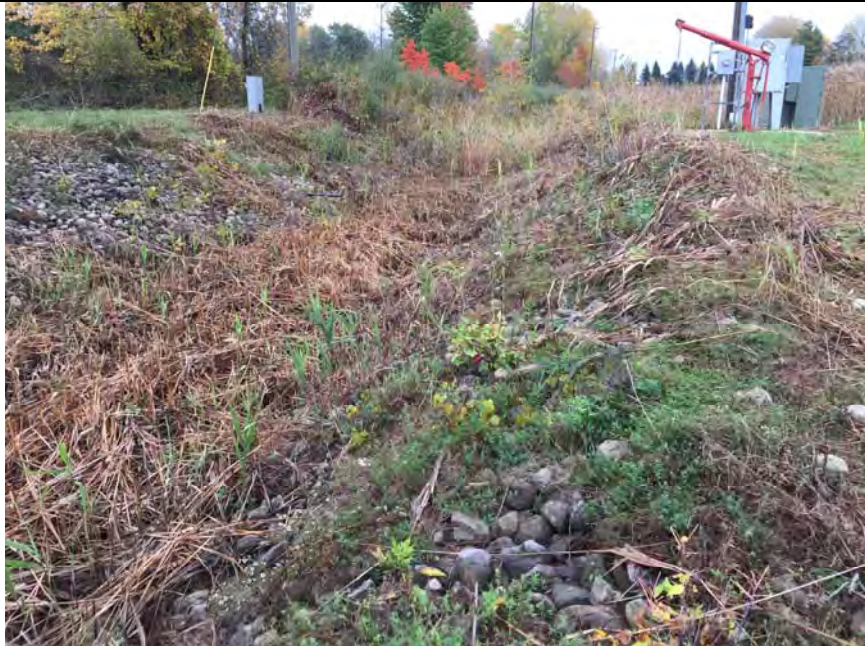
41. Perimeter Ditch Recently Cleared of Vegetation. Control Panel and Sump Location, Northwest Corner Pump Station for Offsite GW Collection System.

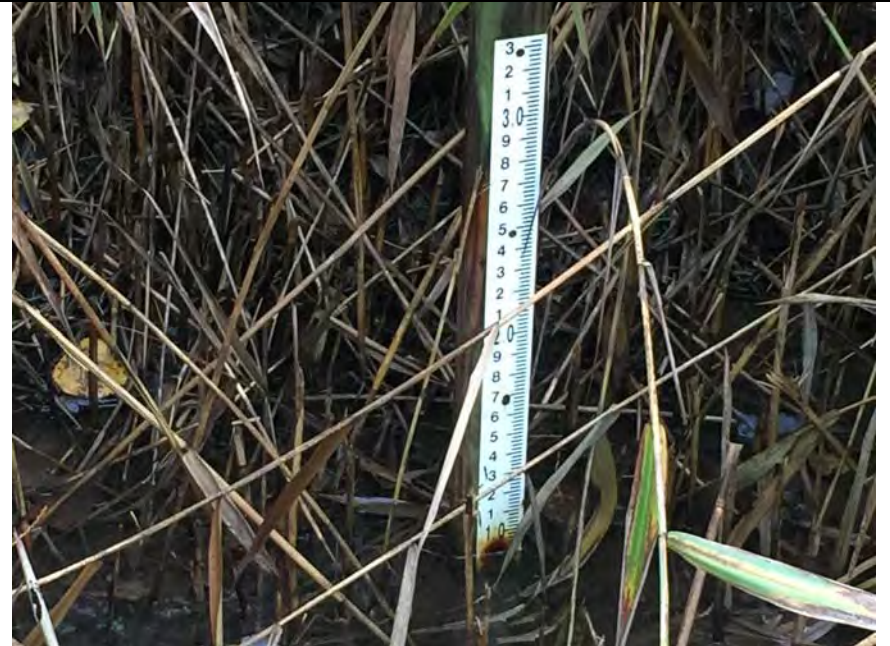
42. Perimeter Ditch Staff Gauge SG-12 Water Level Reading About 0.88 ft.

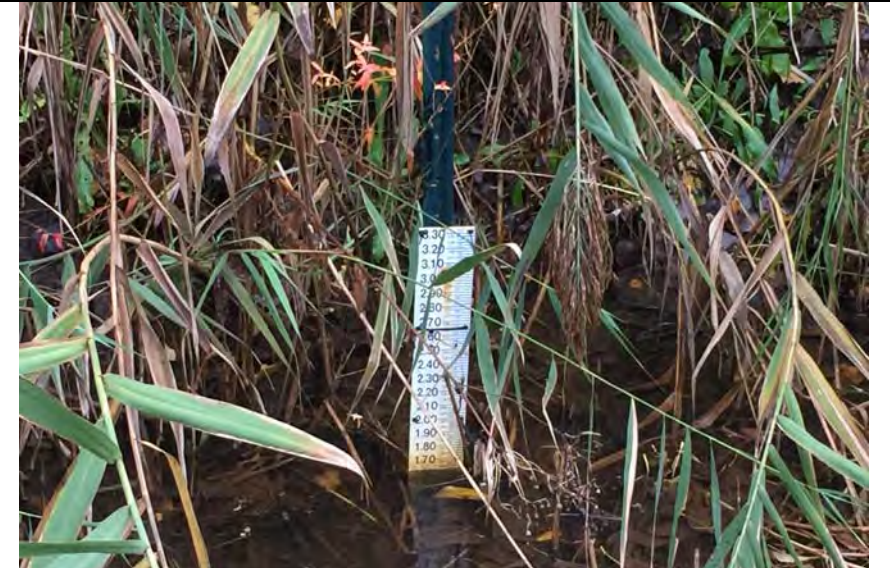
44. Perimeter Ditch Staff Gauge SG-01. Water Level Reading About 1.65 ft.

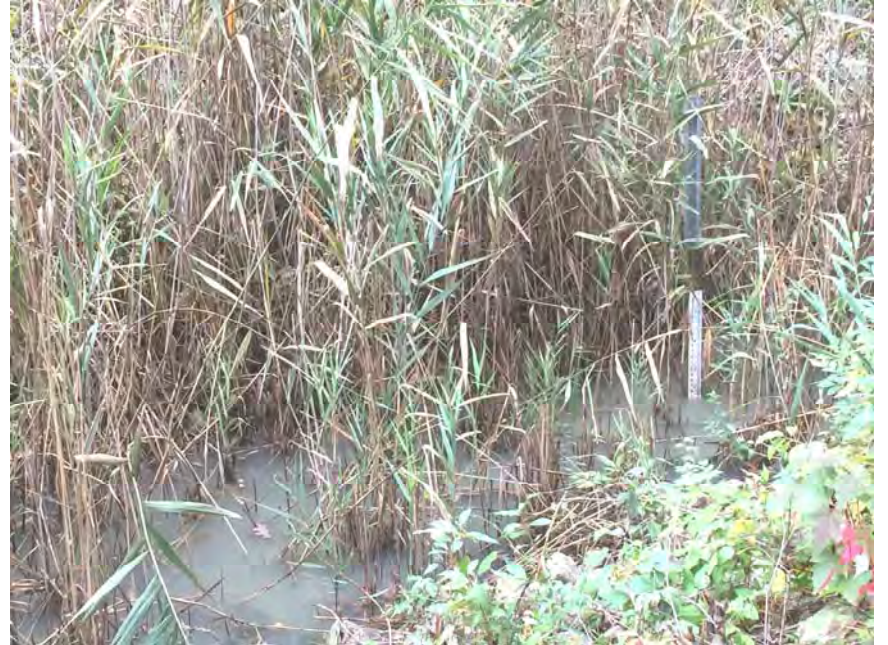
46. Perimeter Ditch at Location of Staff Gauge SG-01. Water Level Reading About 1.25 ft.

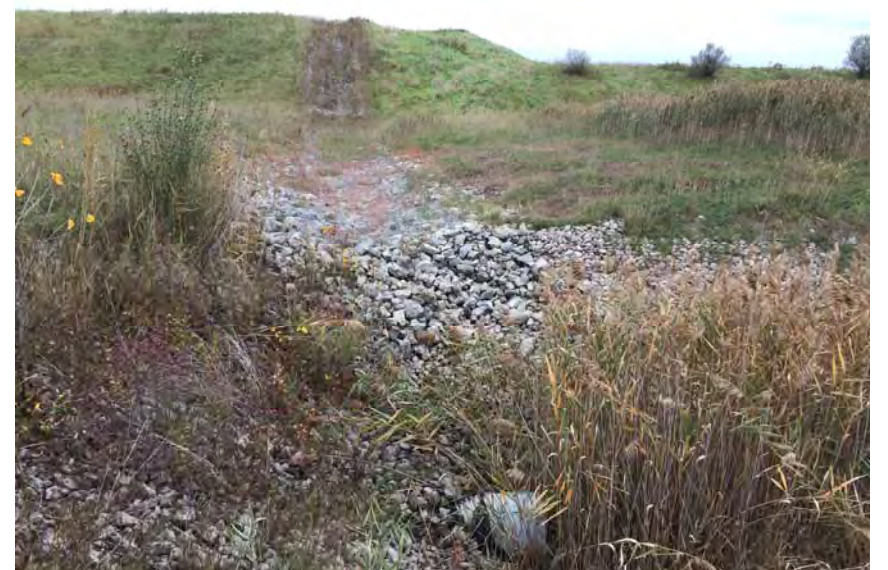
48. Looking East at Drainage Flume as it Enters Perimeter Ditch. Some Woody Vegetation on Outside Existing Slope from Active Area G2.

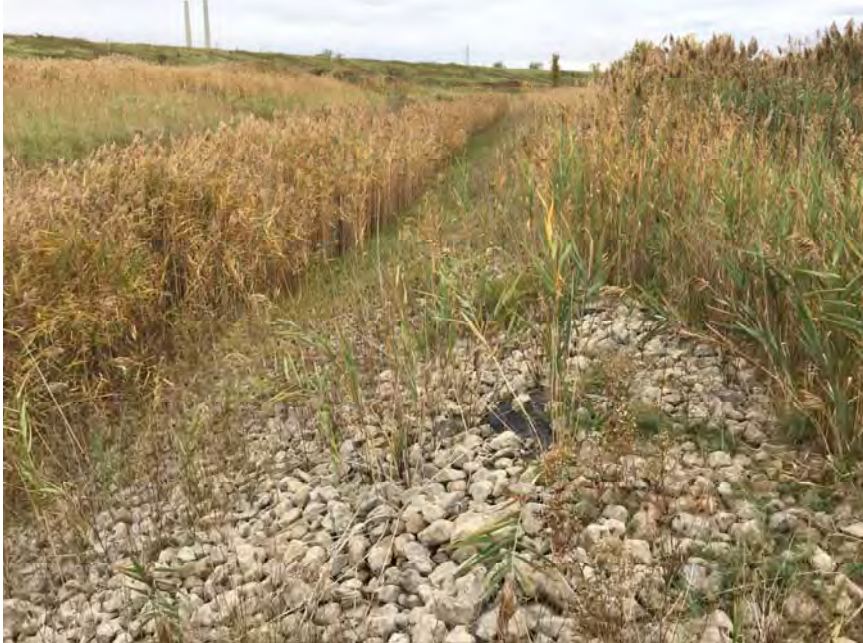
49. Looking South at Close-up of Perimeter Ditch. A 3-year Rotation Ditch Maintenance Schedule is Planned by DTE.

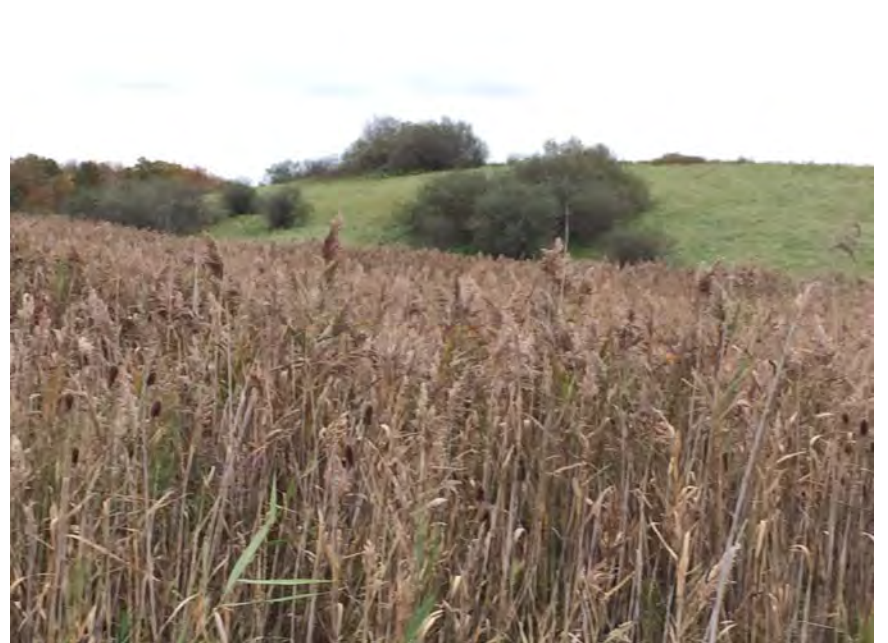
50. Looking North at Woody Vegetation on Outside Slope of Closed Areas F1 and Possibly B.

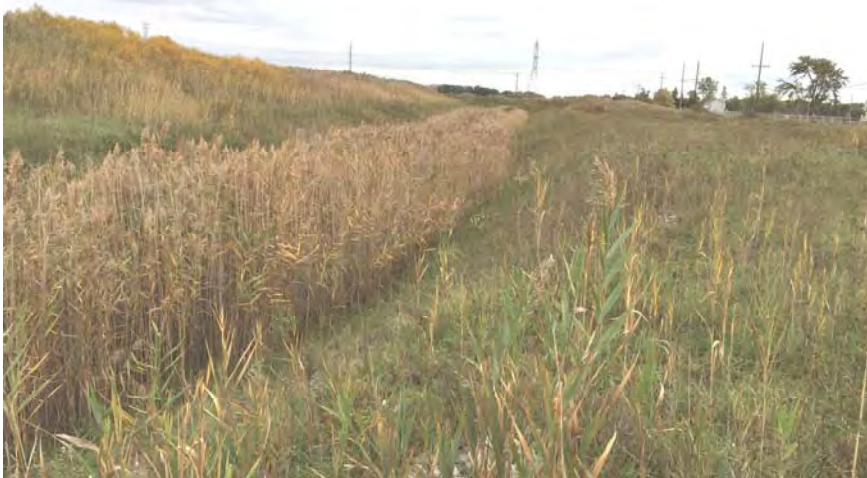
51. Looking South along SW Side at Perimeter Ditch. Vegetation has Not Blocked Ditch Flow. A 3-year Rotation Ditch Maintenance Schedule is Planned by DTE.

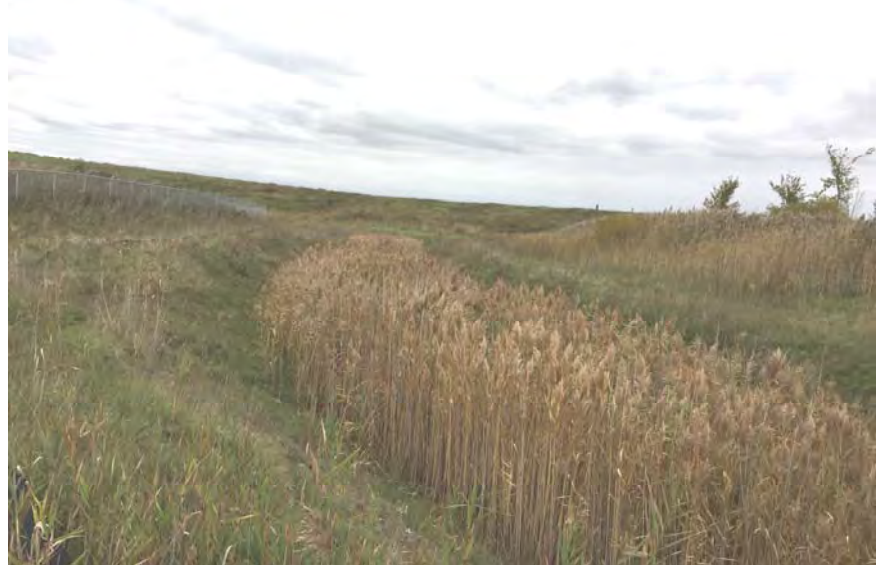
52.. Looking North at Perimeter Ditch. Ditch Slopes Appeared Stable and Well Vegetated.
