**2017 ANNUAL INSPECTION REPORT  
RANGE ROAD LANDFILL  
ASH DISPOSAL FACILITY**

**China Township, St. Clair County, Michigan**

January 2018

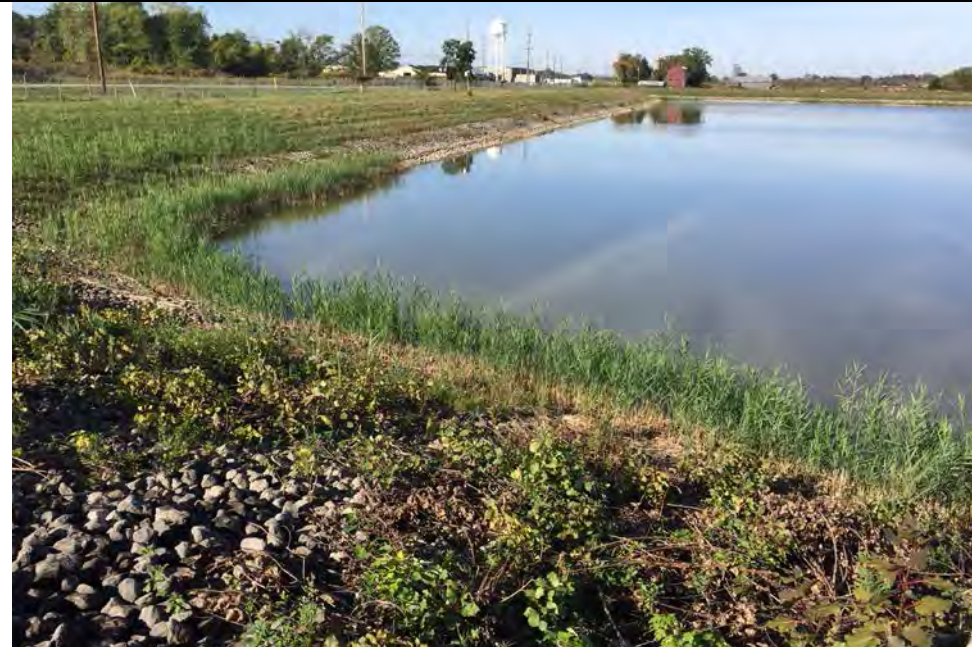
Stormwater Detention Basin: The basin and pump system appeared in good condition. Basin slopes and entrance flume also appeared in good condition with vegetation recently cut as shown in Photographs 1 and 2. Pumps were tested for operation and all operated. Control panel and pumps are shown in Photographs 3 and 4. The discharge flow meter, shown in Photograph 5, appeared to be working correctly. The basin intake screen was unblocked as shown in Photograph 6.

1. Storm Water Detention Basin (SWDB), South and West Sides. Slopes are Protected with Stone. No Visible Slope Erosion Vegetation Cut on Slopes.

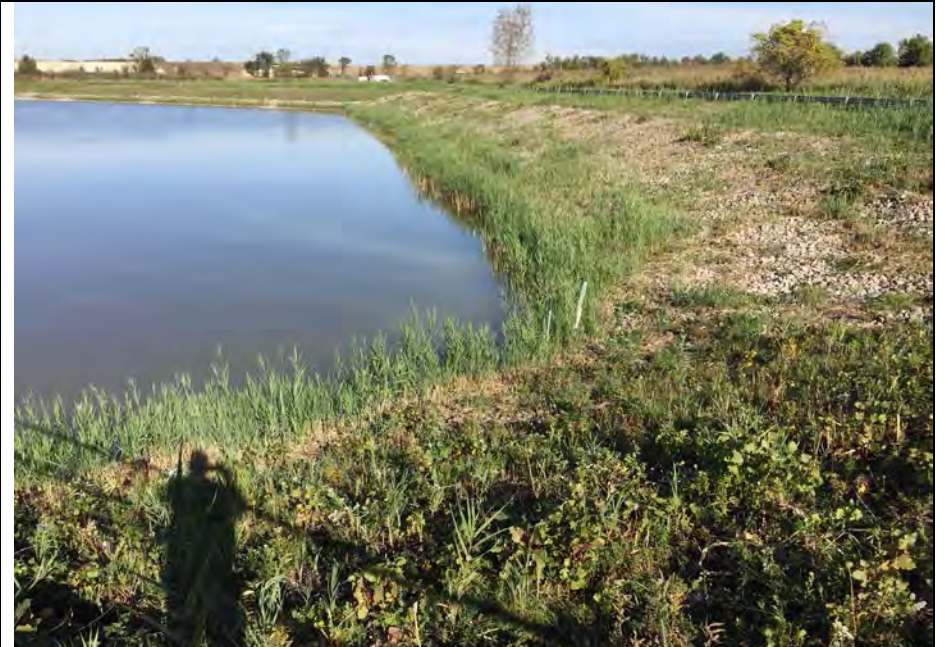
2. SWDB, North and East Sides. Slopes are Protected with Stone Within Water Level Range. No Visible Slope Erosion. Vegetation Cut on Slopes.

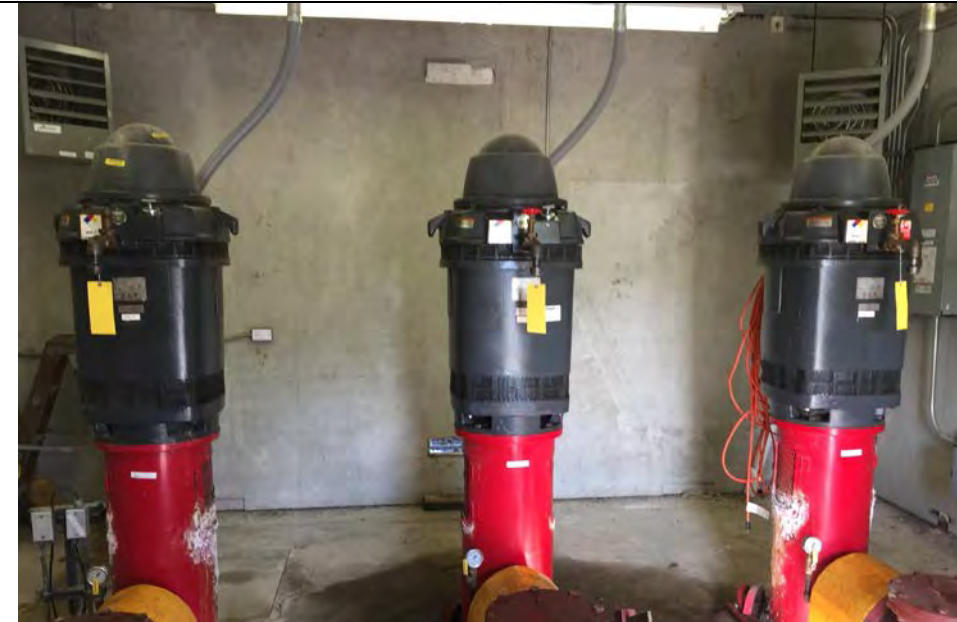
3. Pump House Pumps. Water from Basin is Pumped Back to Power Plant. DTE Plant Inspects Daily and Records Pump Observations and Flow.

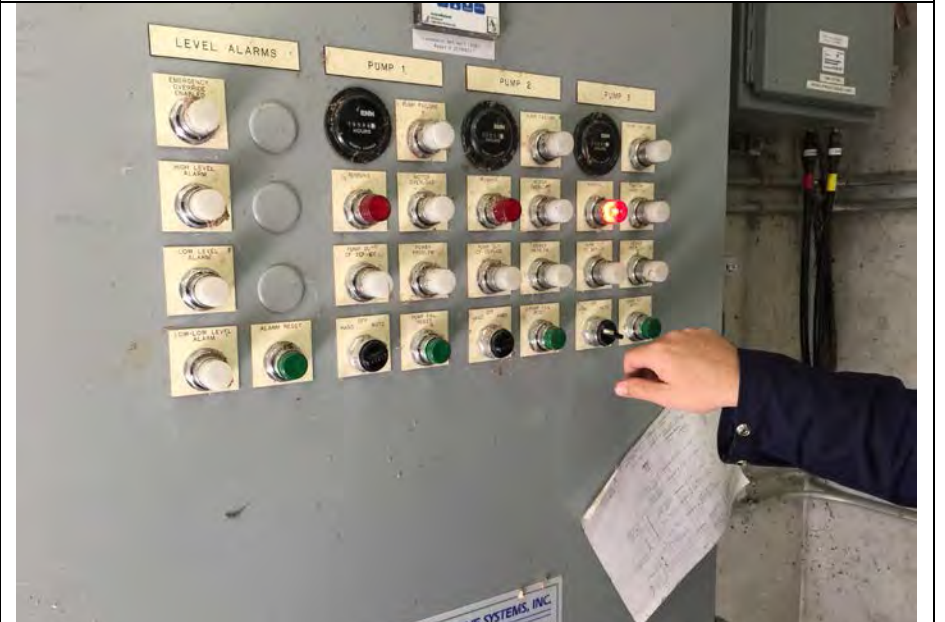
4. Pump Control Panel. Each Pump was Run Checked. Pump #3 Running. Pumps Cycle Each Run Unless Higher Pond Level Needs More Pumps On.

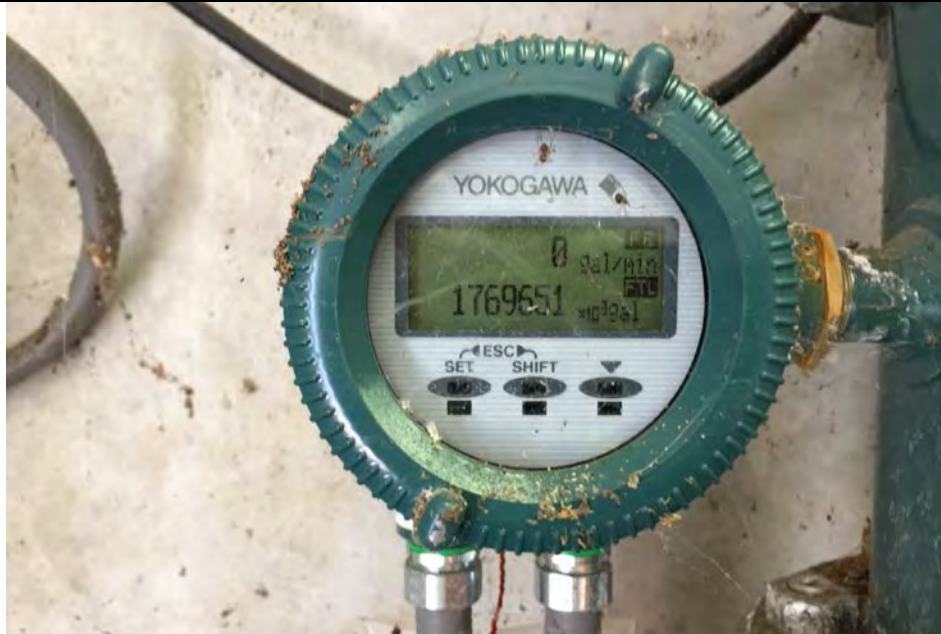
5. View of SWDB Pump Flow Meter. No Pumps On at Time of Photo, Therefore No Flow Rate Other Than "0" Shown. Total Flow Pumped is Given

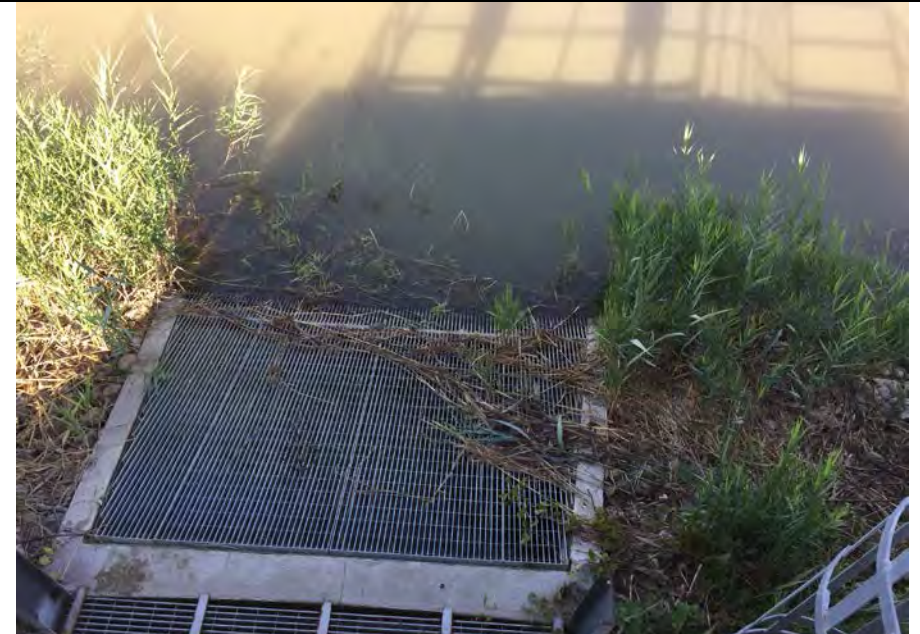
6. Basin Intake Screens. No Significant Blockage Noted. DTE Routinely Inspects and Cleans Grate Area.

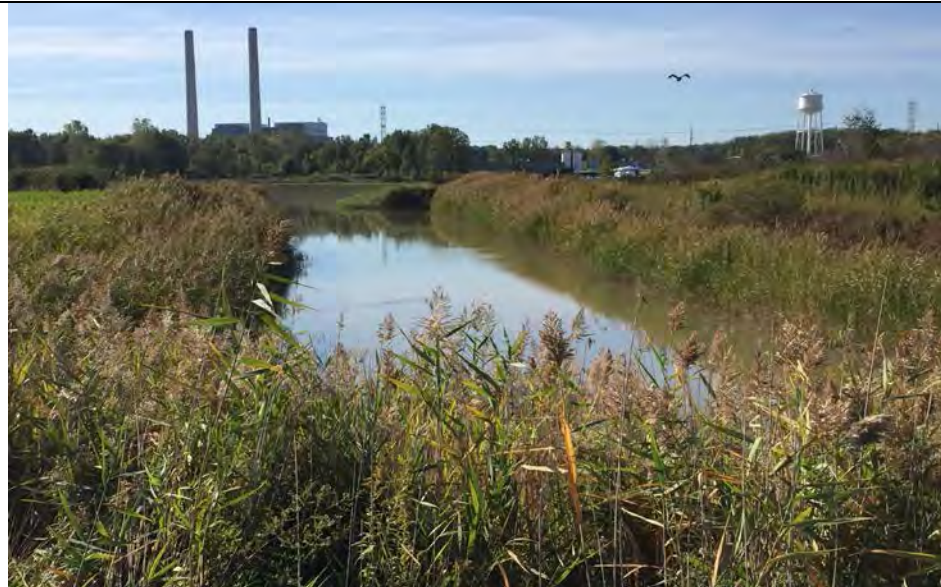
7. View of North/South Drainage Canal Leading to SWDB from Perimeter Ditch System.

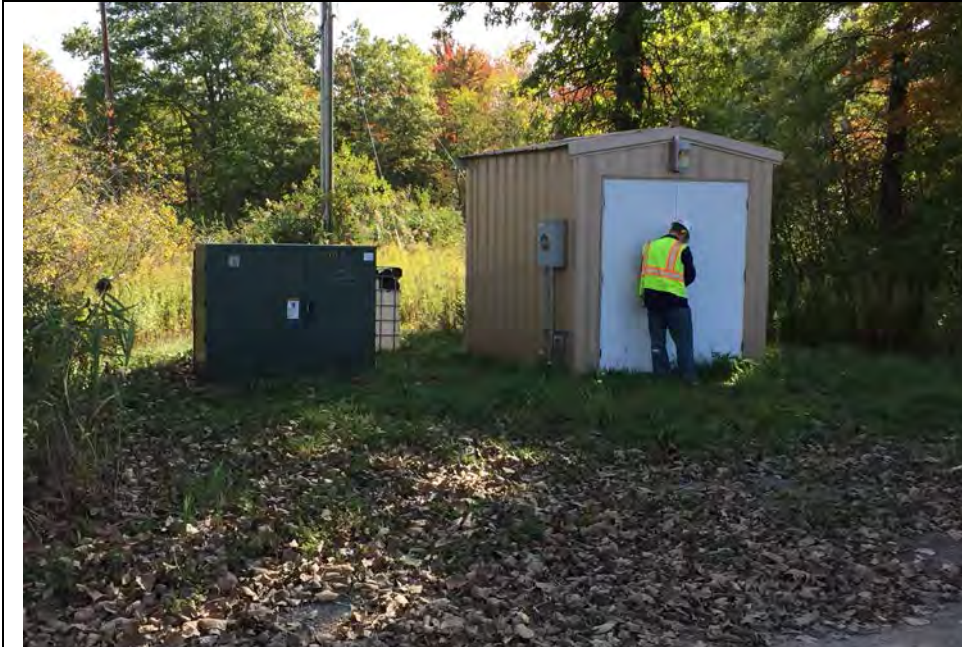
9. Northeast Off-Site Groundwater Capture System Building. Capture System Building Controls Inside were not Inspected Due to Wrong Key Available.

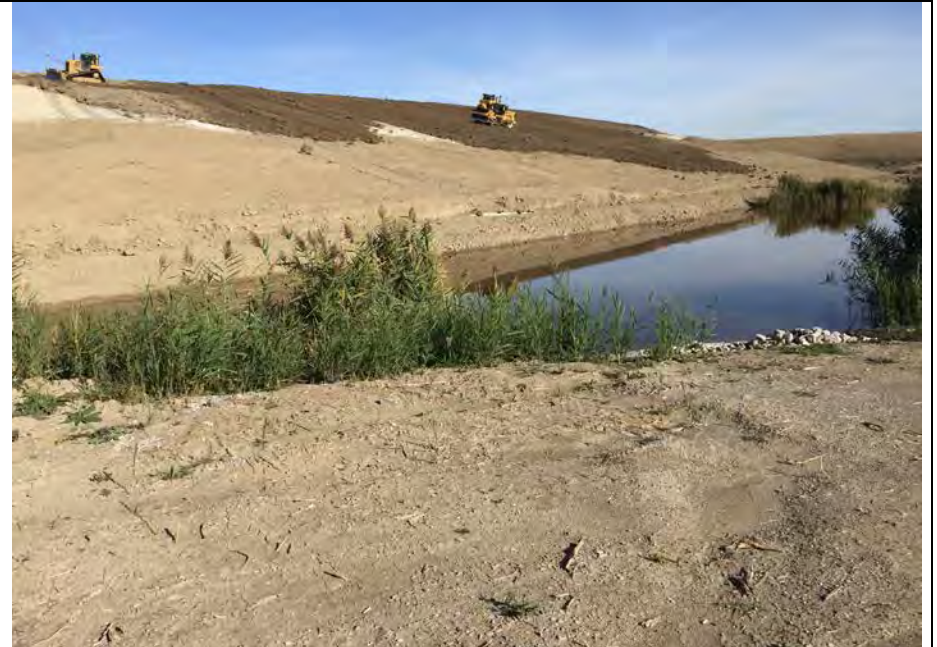
New or fresh conditioned CCR waste in Area G2 Phase I is shown in Photographs 13 and 14. Placement and compaction procedures of conditioned CCR waste closely follows the Ash Filling Procedures discussed in the Landfill Development Plan. CCR waste is now being placed and compacted in horizontal lifts. The waste slope along the east side of Area F3 was reported by DTE as constructed in horizontal layers. The slope is now being capped with clay as shown in Photographs 10 and 11 and discussed below.

10. Looking NW at Cover Placement on 4H to 1V Interim Slope of Area F3. Waste Placement & Compaction to Construct Slope is from Bottom Up.

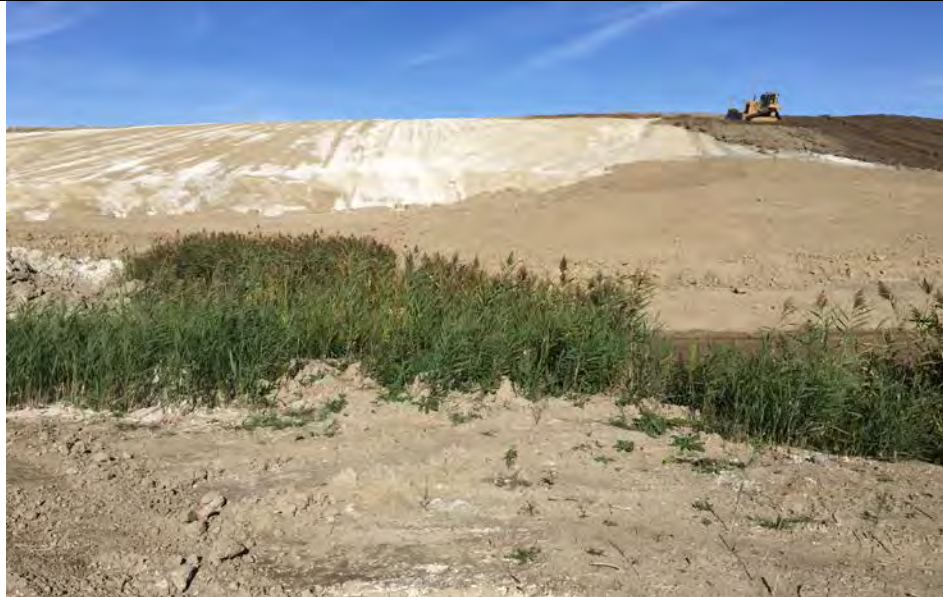
11. Looking North at Interim Slope of Area F3. Slope Reported to be 4H to 1V or Flatter.

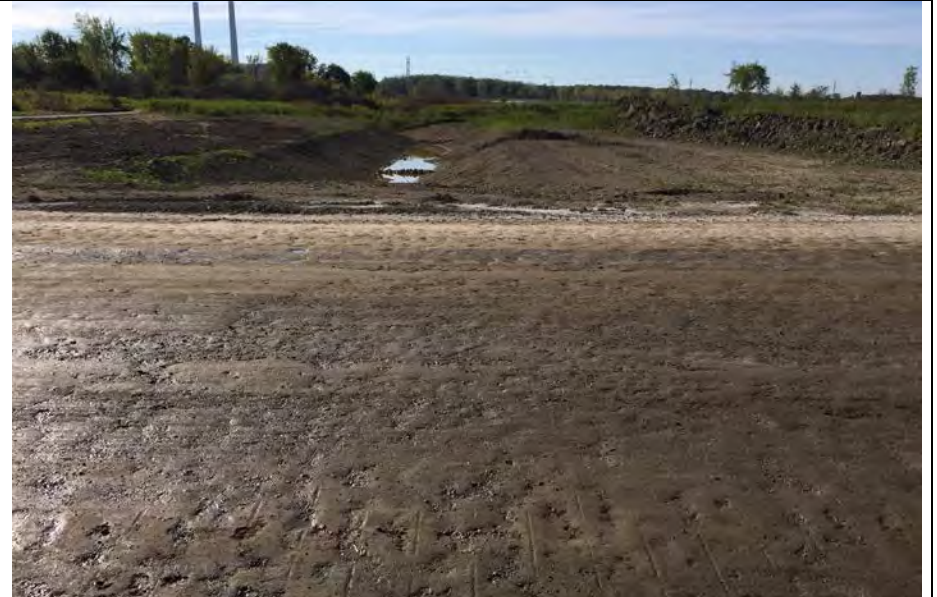
12. View of Active Clay Borrow Area from Top of G2 Fill Area.

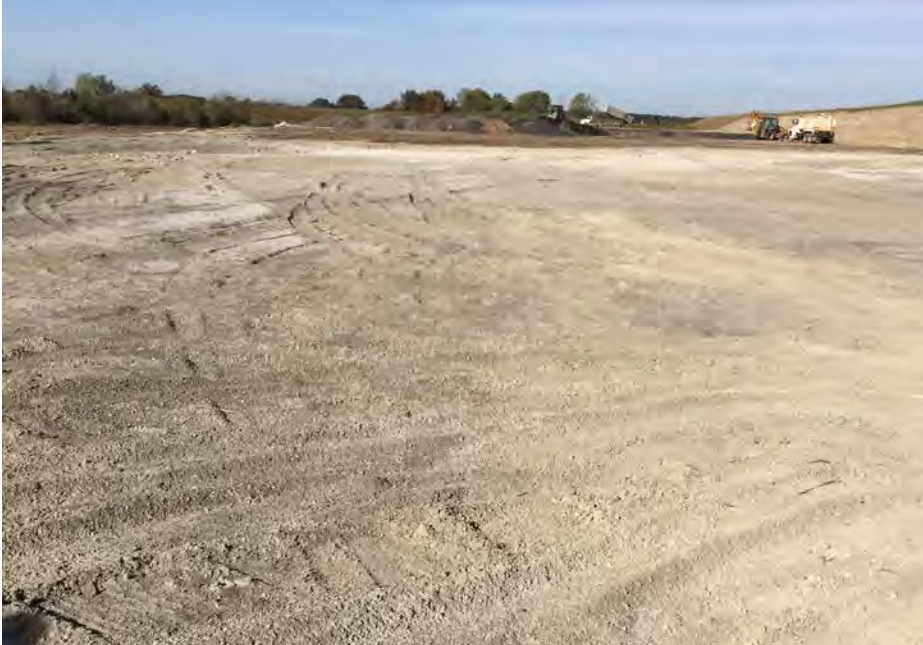
13. View Active Waste Placement Area G2 (North Side). At Top Center are Stockpiles of Dry Waste Waiting to be Spread and Compaction.

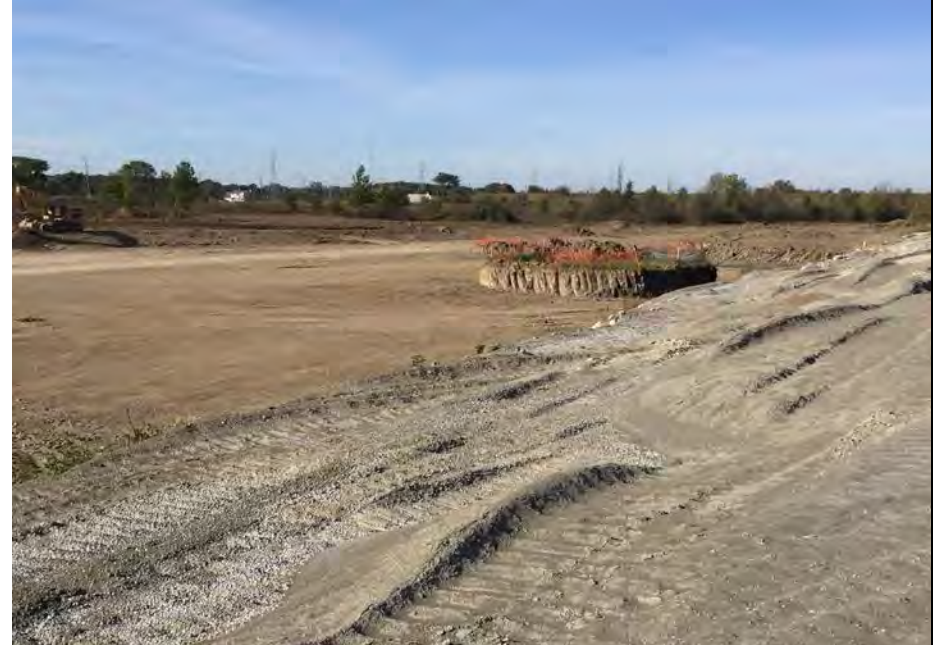
14. Looking Southwest from Waste Area at Portion of Clay Subgrade Where Historical Artifact was Found and Roped Off for Further Investigation.

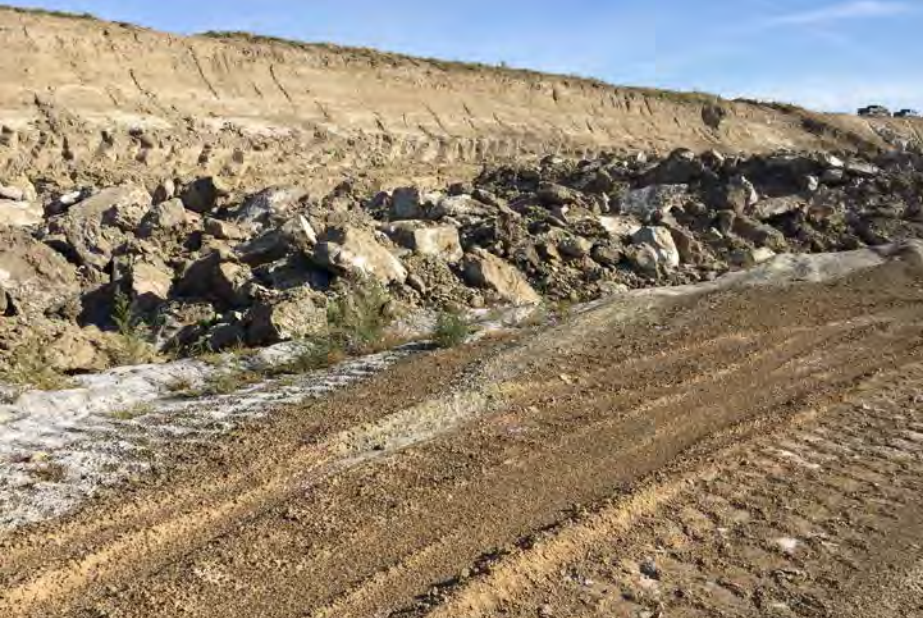
15. Looking NNE at Large Cemented Portions of Waste Removed During Removal of Interim Clay Slope on West Side of F2 Adjacent to G2 Placement.

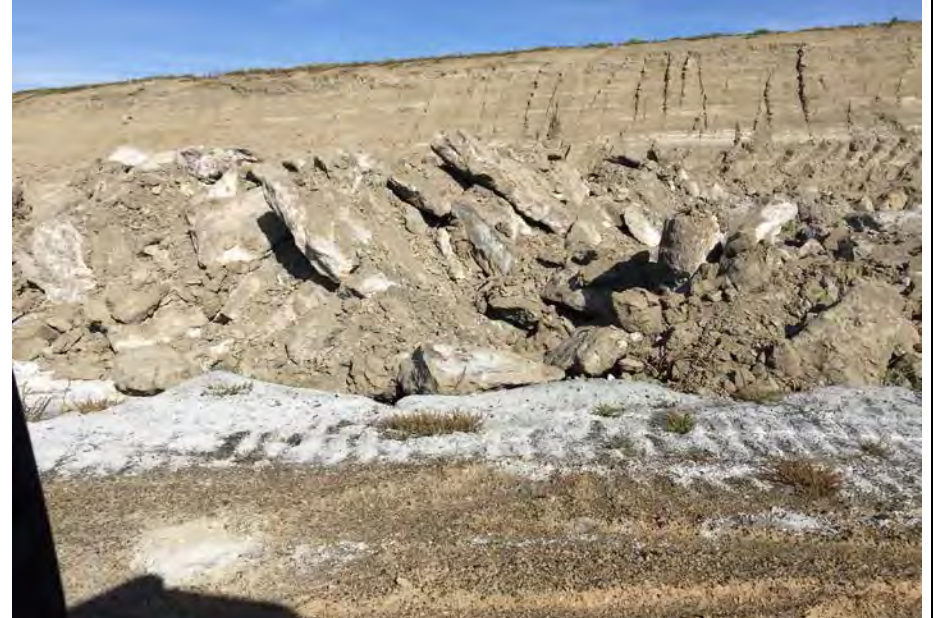
16. Closeup View of Cemented Chunks of Waste. Some Soil Mixed In. Chunks are Planned to be Broken-Up and Placed & Compacted.

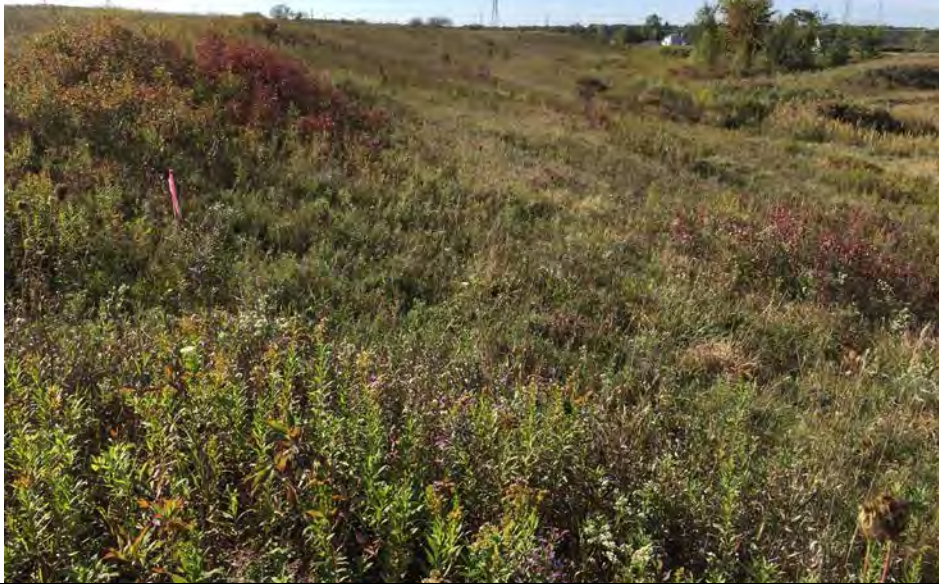
the closed landfill final cover areas appeared well vegetated and acceptable. Photographs 17 and 18 show portions of the unconstructed Area G2 west slope. Photographs 37, 39, 41, 61, 70-72, and 74-82 show views of the landfill top and slopes of closed areas or areas recently capped. The site typically does not have problems getting cover vegetation to grow, but does have a battle getting the phragmite vegetation under control within the landfill ditches. The one cover related significant erosion noted and shown in Photographs 67 and 69 is the gully erosion in the slope runoff downchute. Repair should be scheduled in near future maintenance activates. However, this does not pose any current structural stability problem.

17. Looking West at West Outside Slope of Unconstructed Areas of G2. Stake is One of Group of Survey Stakes Placed to Mark the Perimeter Limits of Waste.

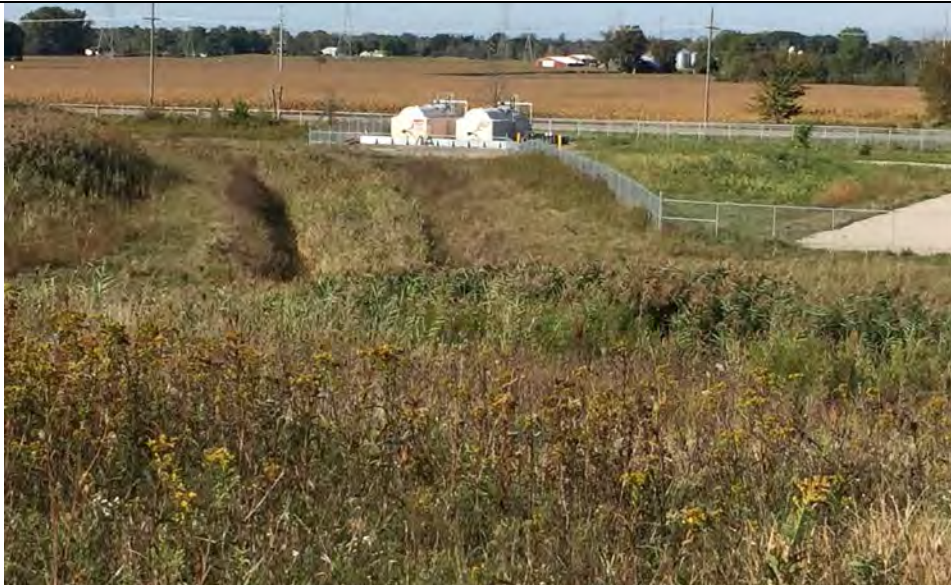
19. Looking West at Portion of Perimeter Ditch Located in the SW Quadrant of the Landfill Property. Heavy Vegetation in Bottom of Ditch.

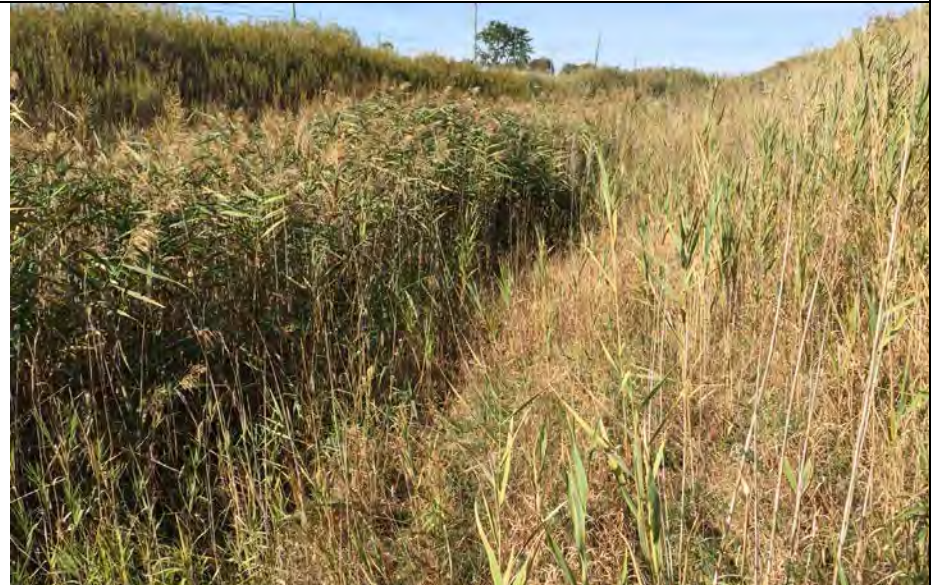
20. Close-up of Typical Vegetation Along Perimeter Ditch Located in SW Quadrant of Property.

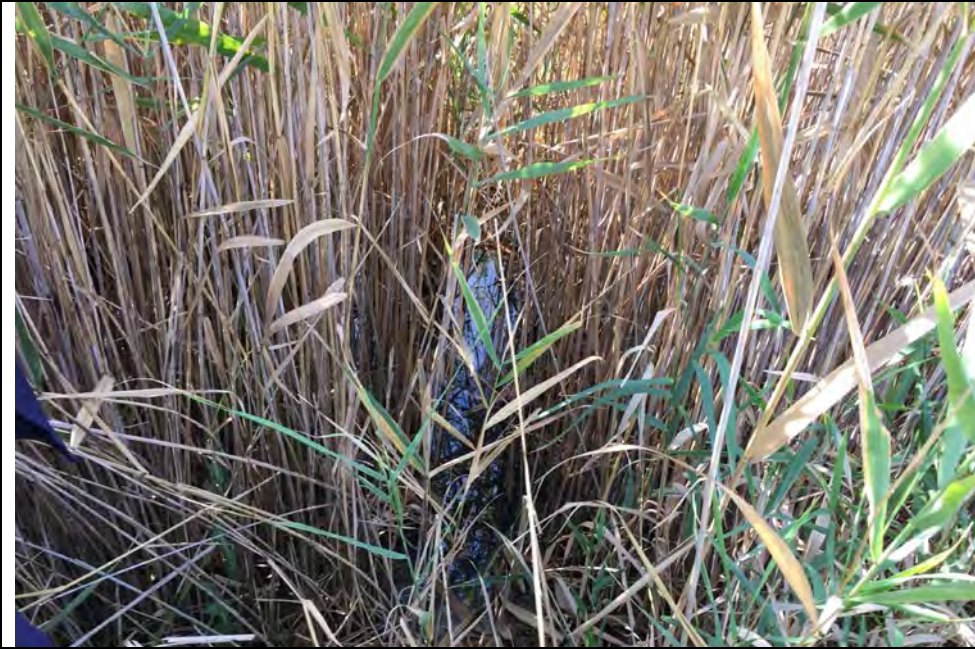
21. Perimeter Ditch View of Water Level at Bottom of Typical Heavy Vegetation Where Ditch Cleaning Has Not Occurred.

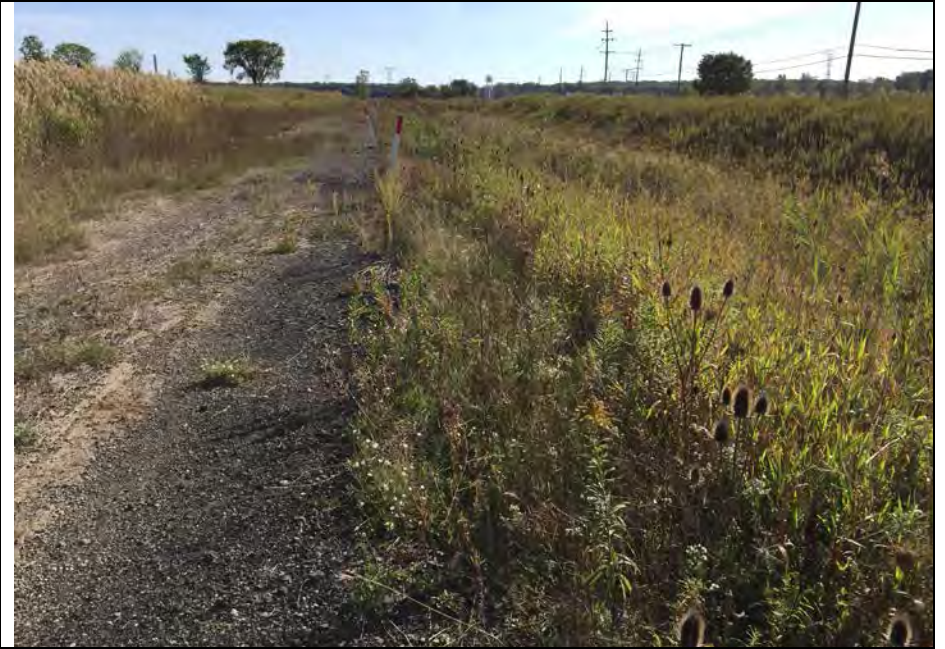
22. Looking West Along Perimeter Ditch Modified in 2010 at Right and on Alignment of Markers for Property Perimeter Installed Slurry Wall.

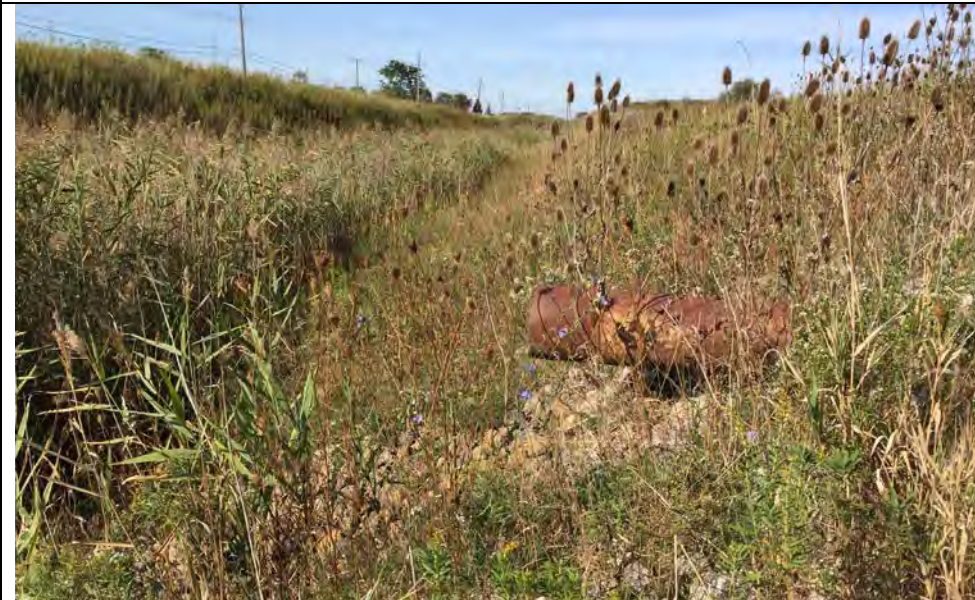
23. Looking East Along Inside Slope of Perimeter Ditch Where Drainage Pipe Enters and Slope Protected by Riprap. Slope Protection Appeared Satisfactory.

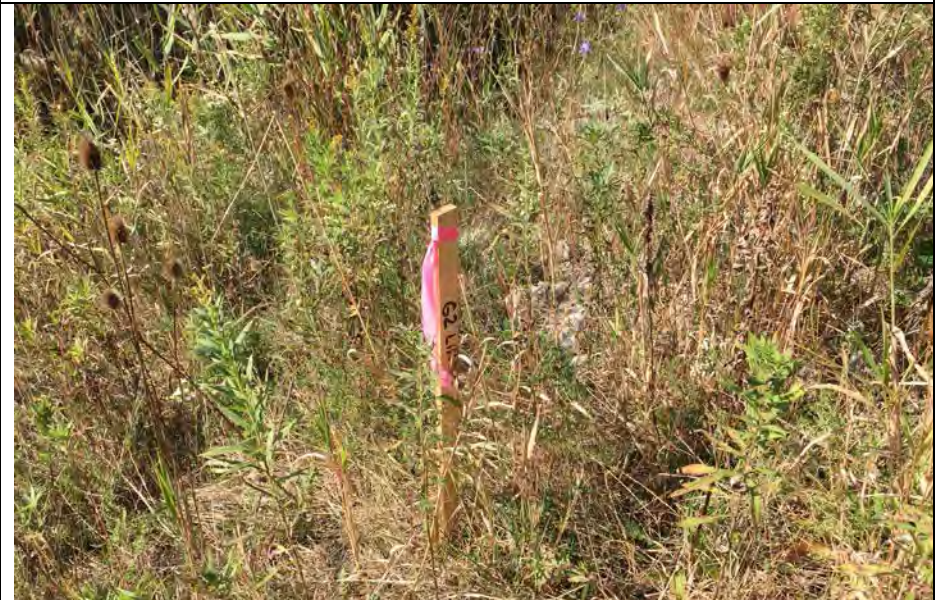
24. Close-up of Survey Stake Indicating a Boundary of Area G2 Along the Perimeter Ditch West Side of Landfill.

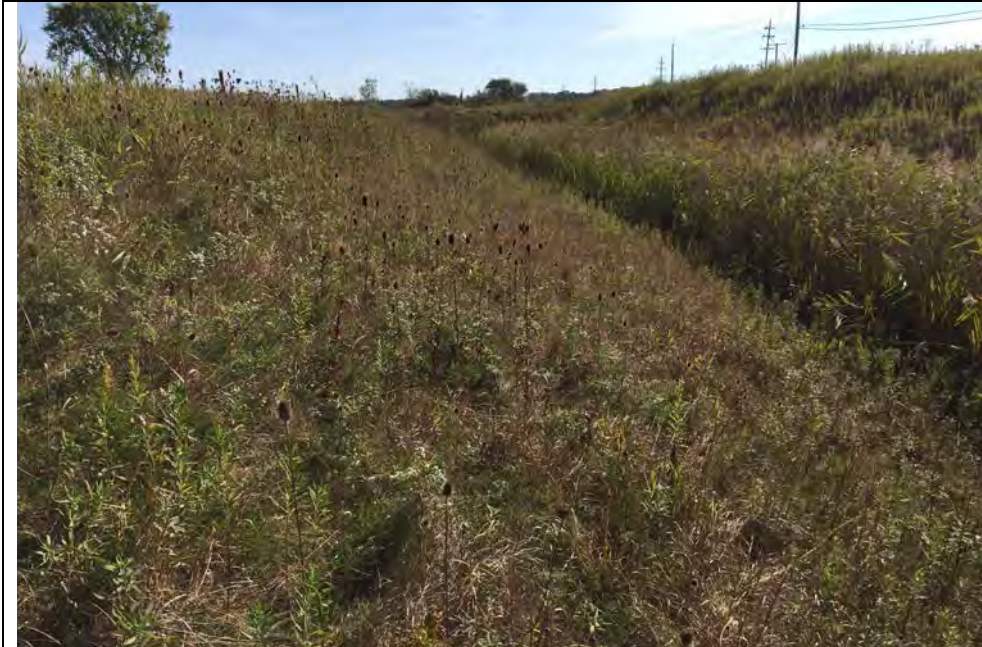
25. View of Perimeter Ditch Slopes West Side Ditch. Heavy Vegetation Bottom of Ditch. Survey Stakes Like that Shown in Photo 24 Present Middle of Slope.

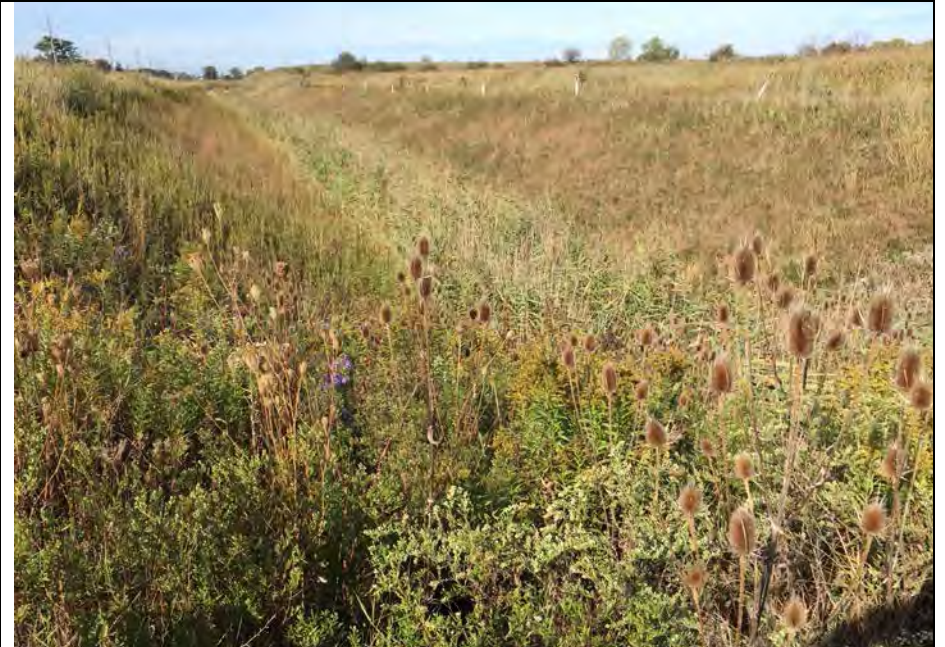
26. View Looking West at Modified Perimeter Ditch. G2 Survey Stakes Right Side Slope. White Markers Along Top of Slope at Road for Safety.

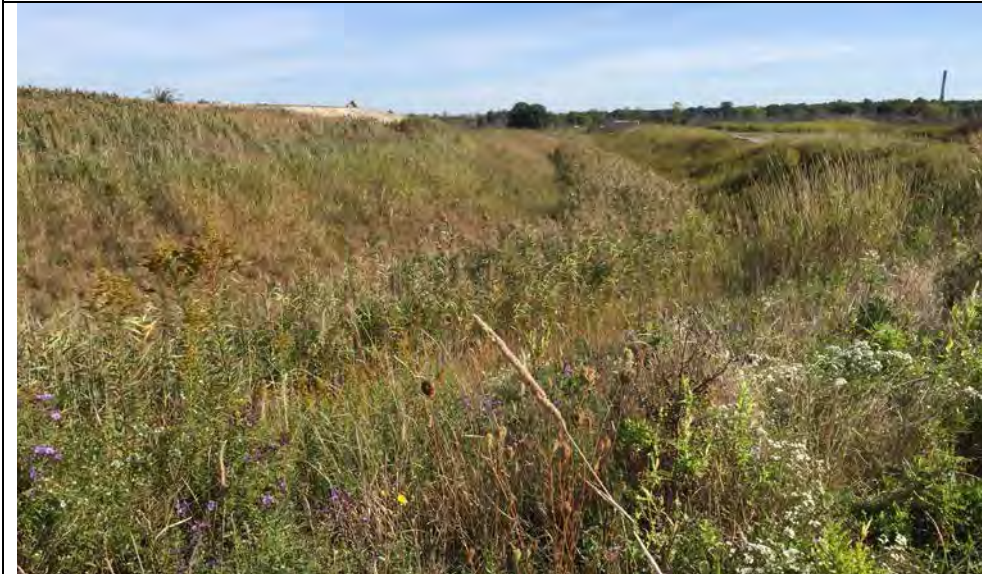
27. View of Perimeter Ditch at the SW End of Area G2. A G2 Development Survey Stake, One with Red Flags Shown, is Located at Middle of Ditch Slope.

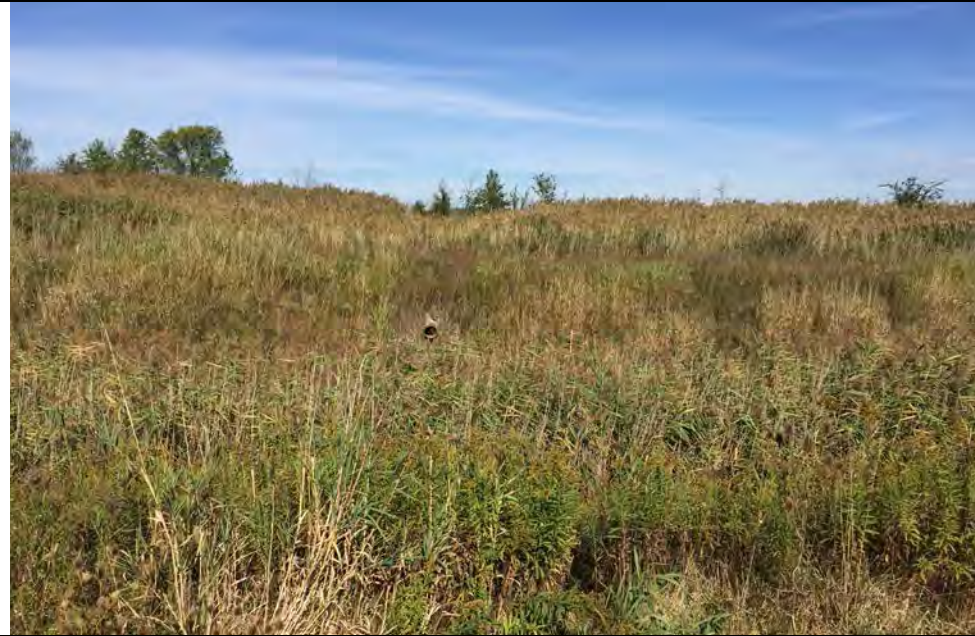
29. View of Drainage Discharge Pipe Shown in Photo 30 and Heavy Vegetation Within Perimeter Ditch.

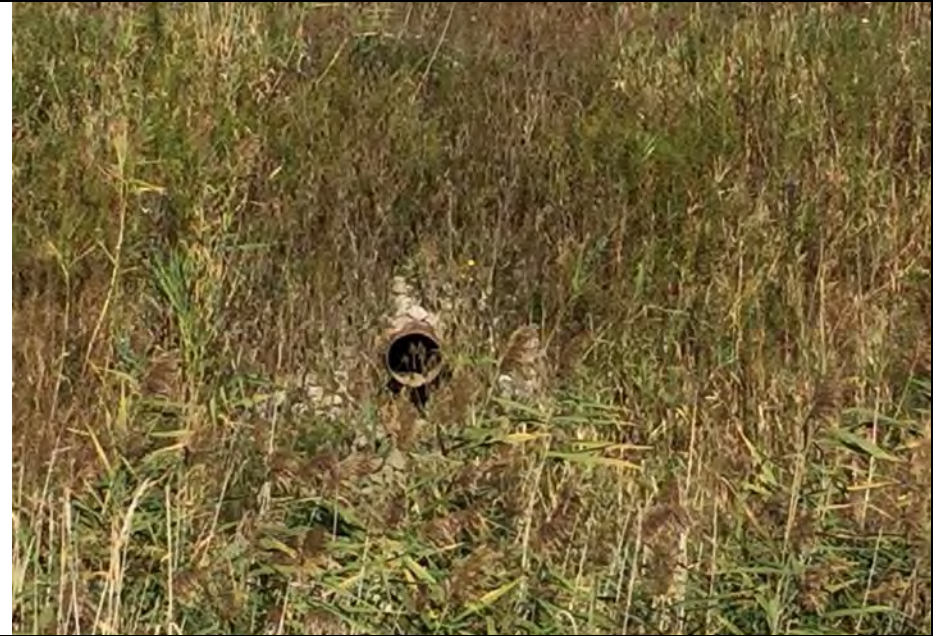
30. Close-up View of Drainage Pipe Discharging into Perimeter Ditch. Some Small Stone Riprap Protecting Slope. Protection Appeared Satisfactory.

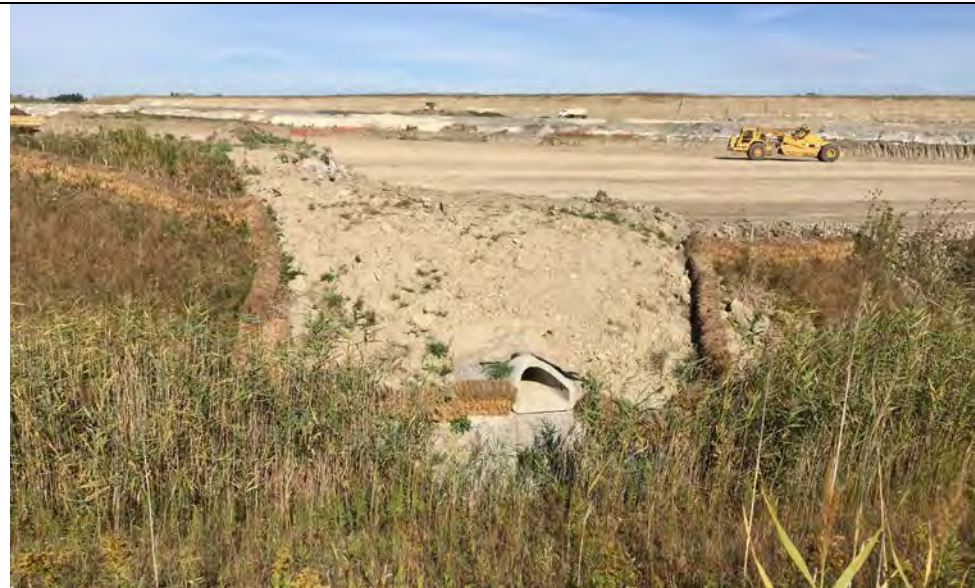
31. Culvert Flare Draining Surface Water to Perimeter Ditch from a G2 Borrow Development Area.

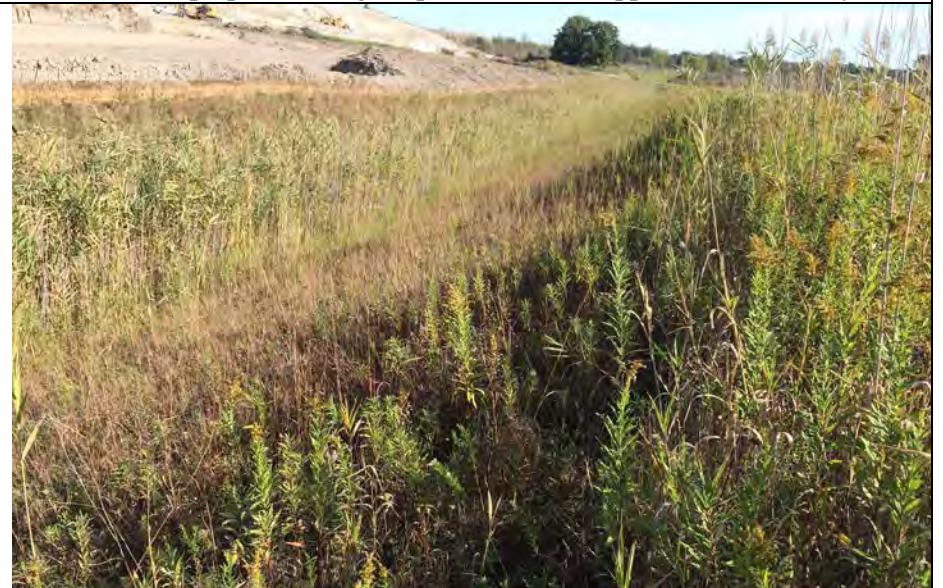
32. Internal Drainage Ditch. Vegetation Not as Heavy as Portions of the Perimeter Ditch.

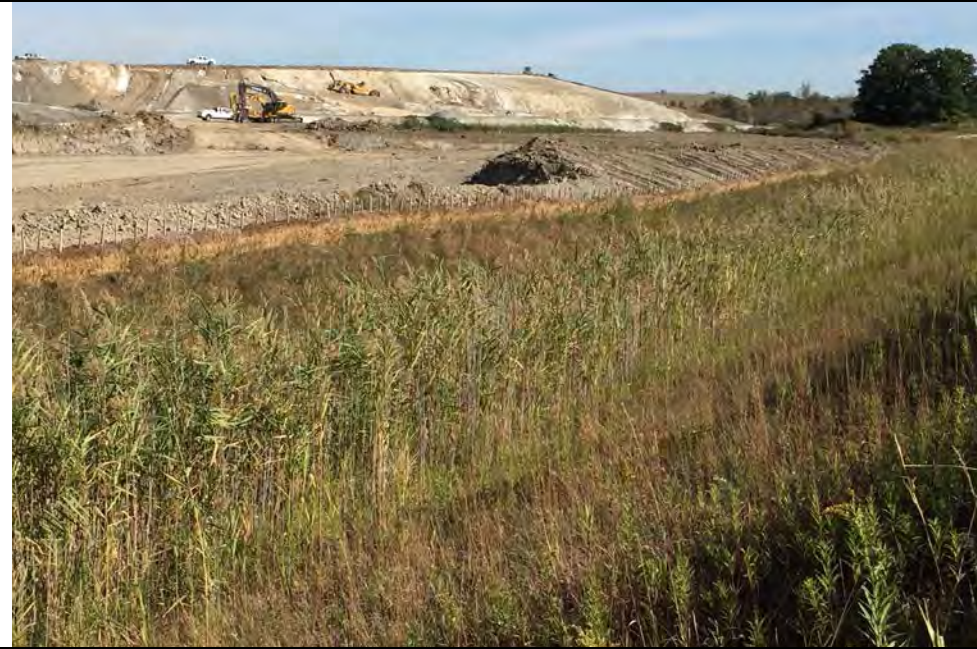
33. Internal Landfill Drainage Ditch on South Side and Capping on Top of Area F3.

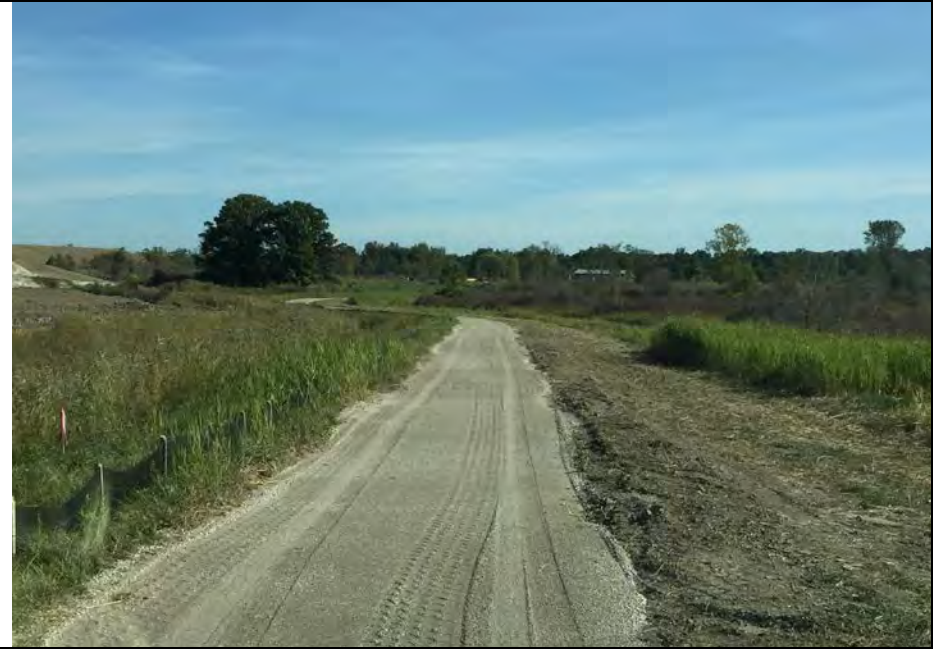
34. Reconstructed Roadway Along Perimeter Ditch on East Side.

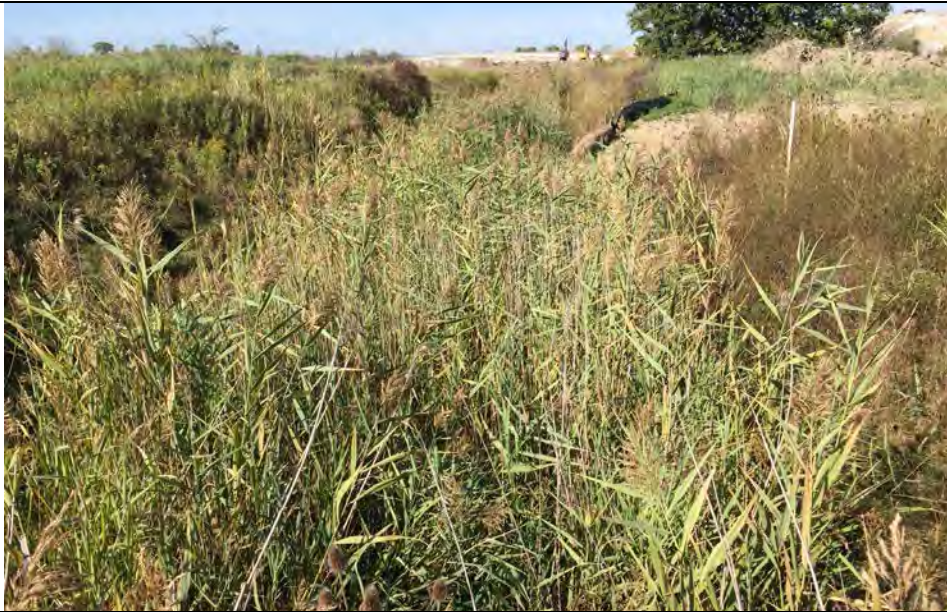
35. Internal Drainage Ditch Filled with Vegetation.

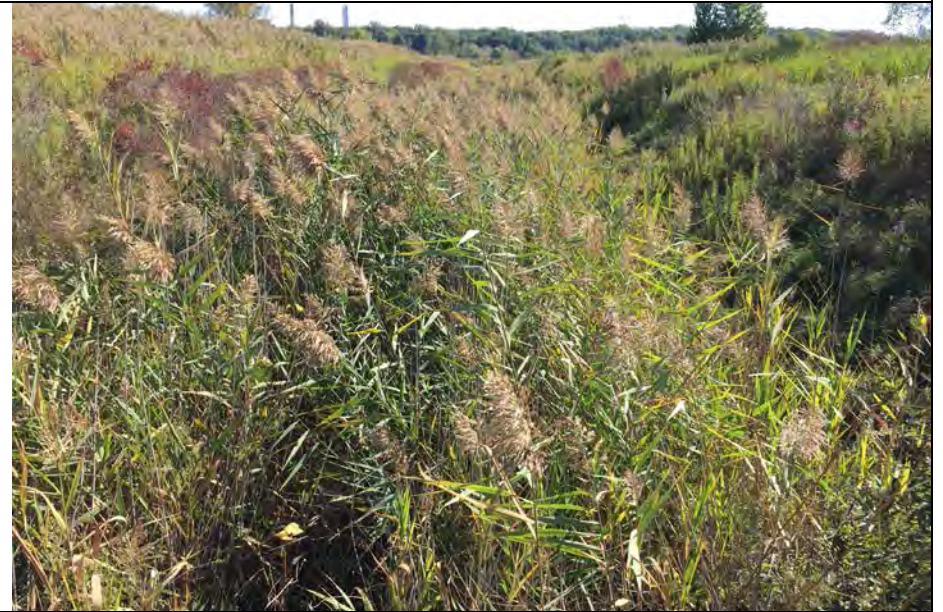
36. Internal Drainage Ditch Filled with Vegetation.

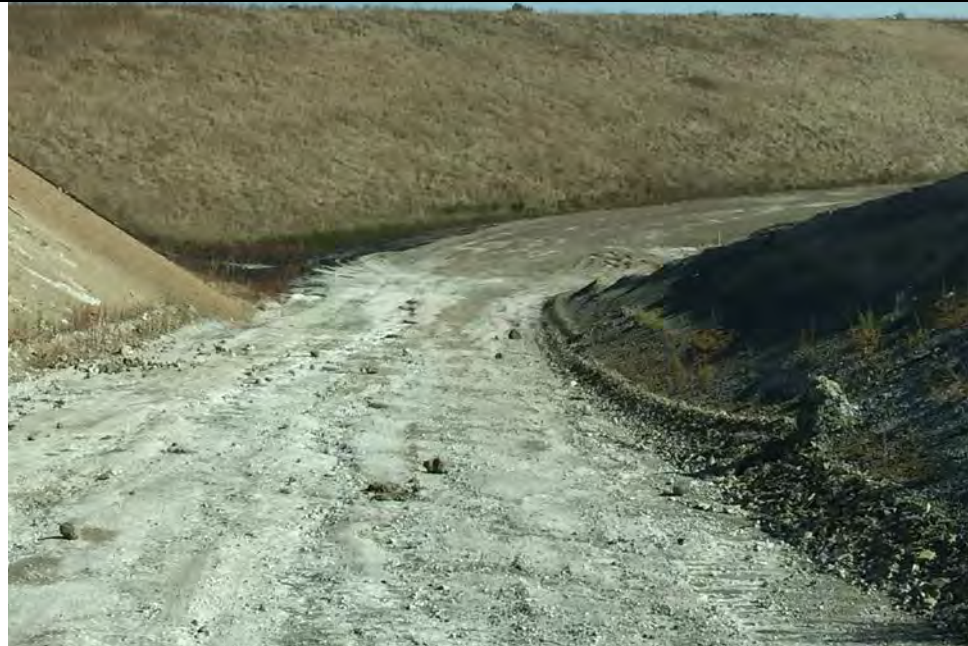
37. Roadway to Top of Active Area G1, Renamed Area F3/D3. Vegetative Slope of Closed Area C at Top of Photo is Well Vegetated and Appeared Stable.

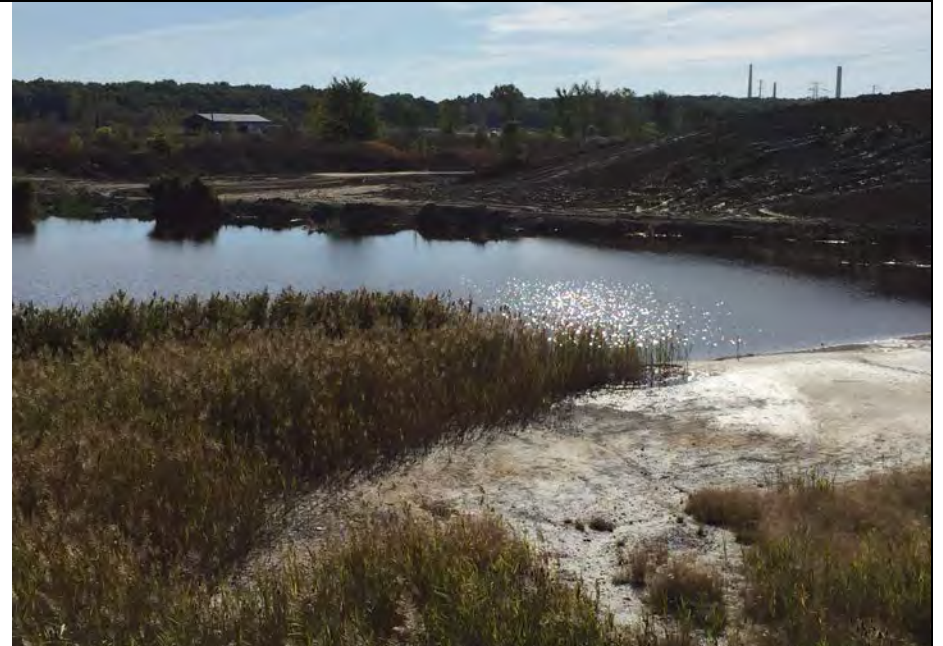
38. View of West Side of Internal Water Collection Pond Near Area F3/D3.

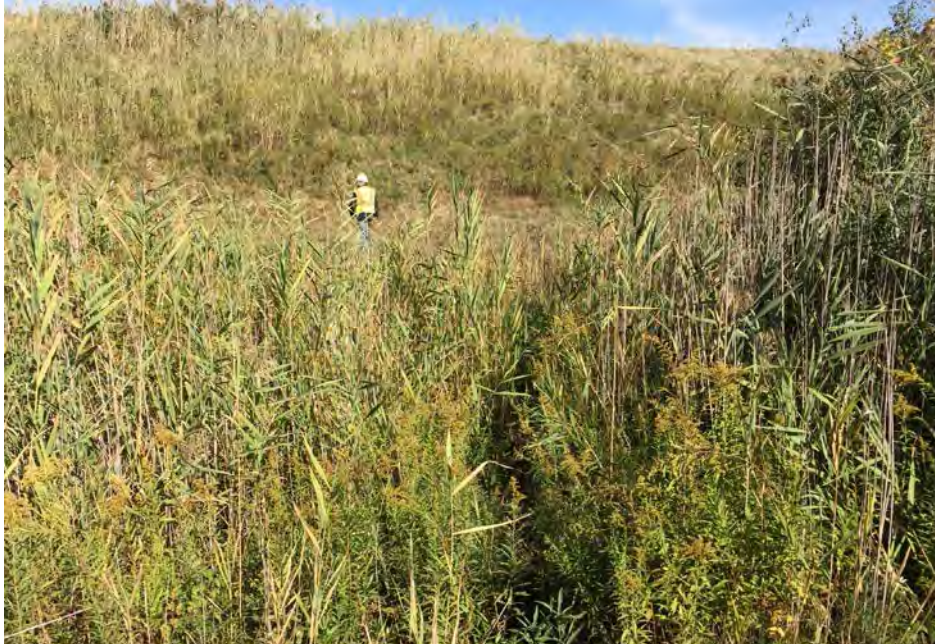
41. DTE Representative Inspection Slope Vegetation.
