**2017 ANNUAL INSPECTION REPORT  
RANGE ROAD LANDFILL  
ASH DISPOSAL FACILITY**

**China Township, St. Clair County, Michigan**

January 2018

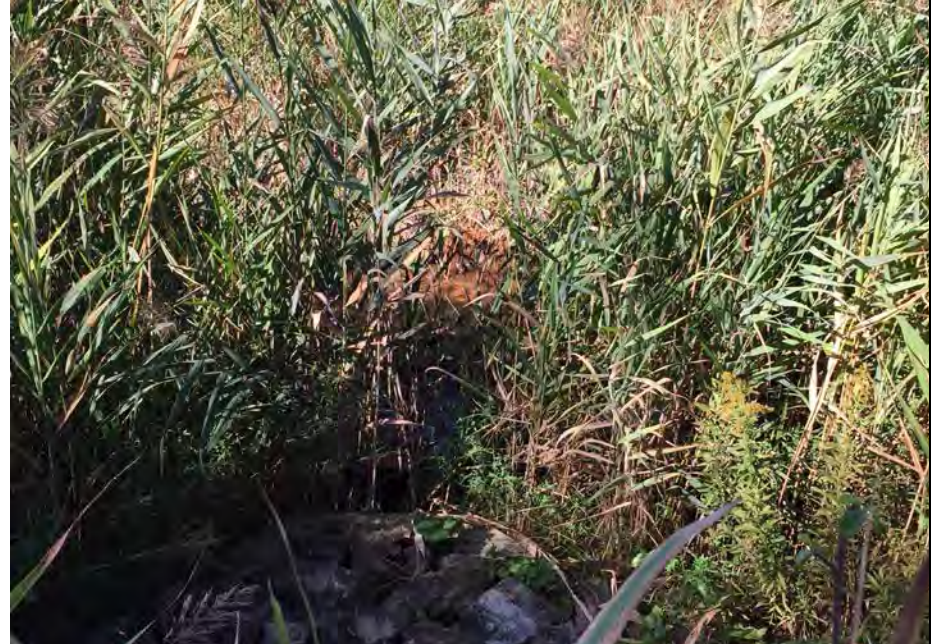
42. Discharge from Concrete Culvert into Internal Ditch. No Significant Erosion Observed.

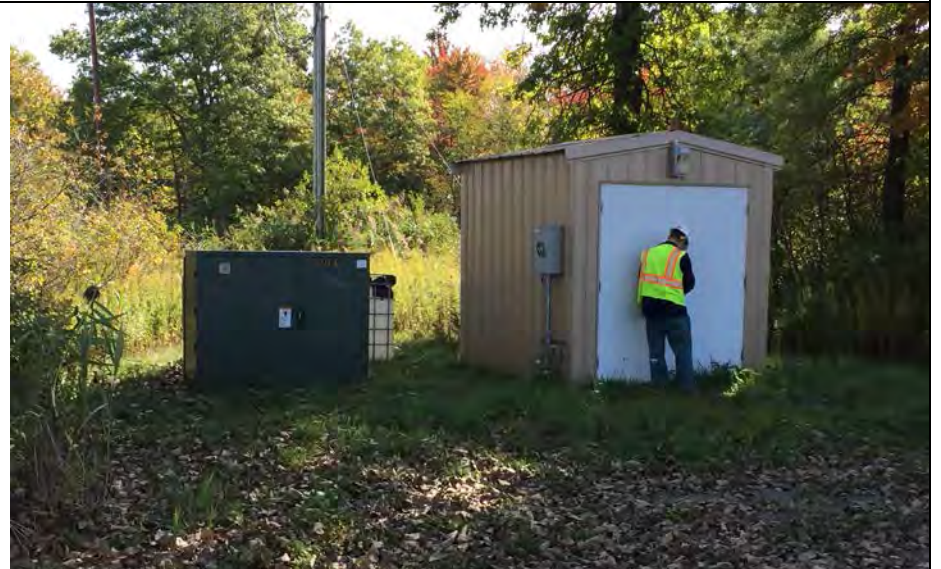
44. Offsite Groundwater Capture System Building. Controls Inside were not Observed as Door Remained Locked. No Issues Reported in DTE Reports.

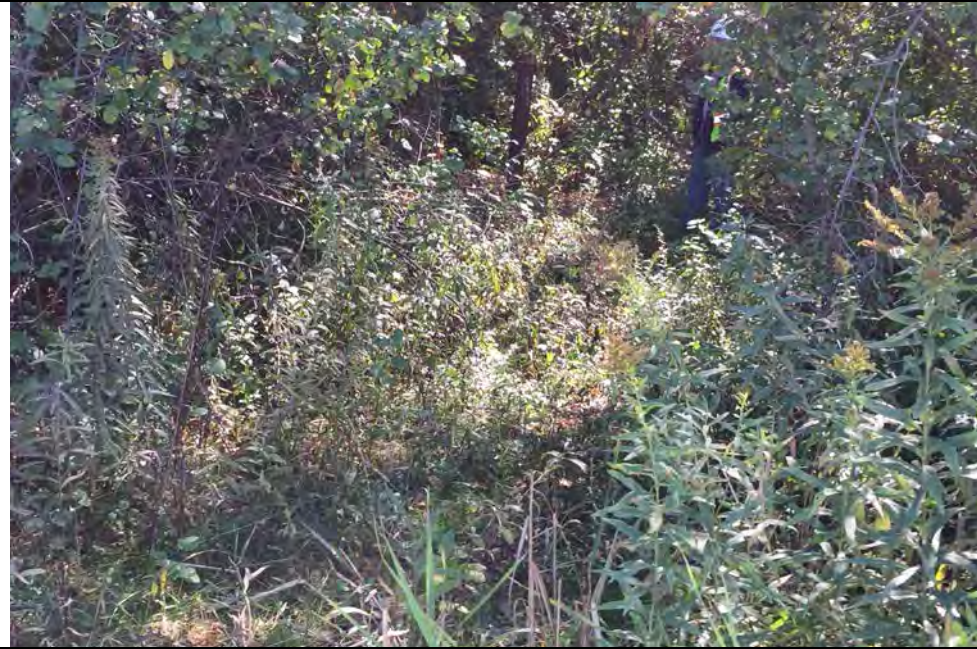
45. Piezometer PZ-96-W-15 Left Side of DTE Rep Checking Ditch Water Level.

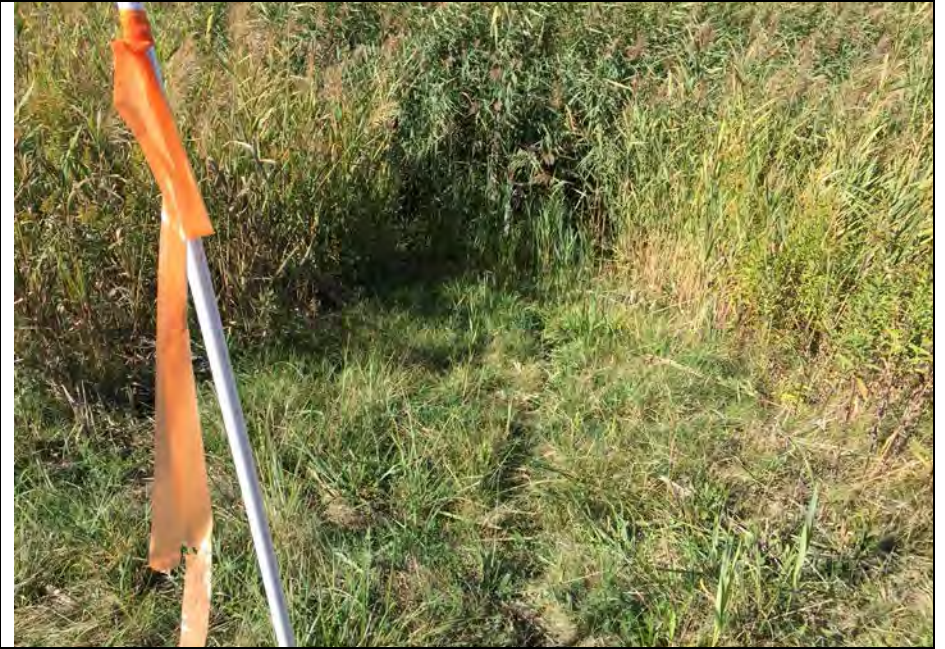
46. Perimeter Ditch Staff Gauge SG-06. White Small Stake in Center of Photo in Bottom of Ditch.

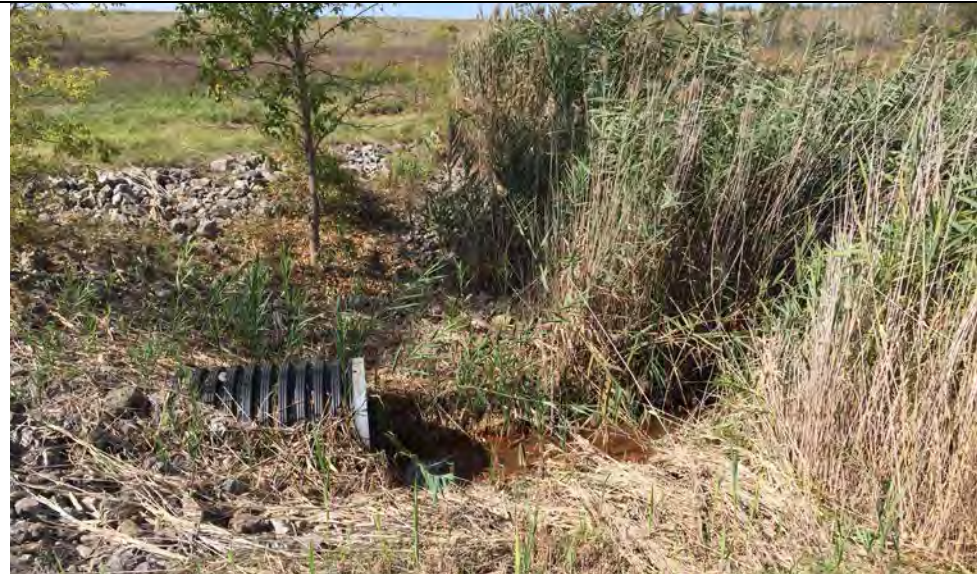
47. Perimeter Ditch Culvert Beneath Road Crossing Has Been Cleared of Vegetation Around Entrance.

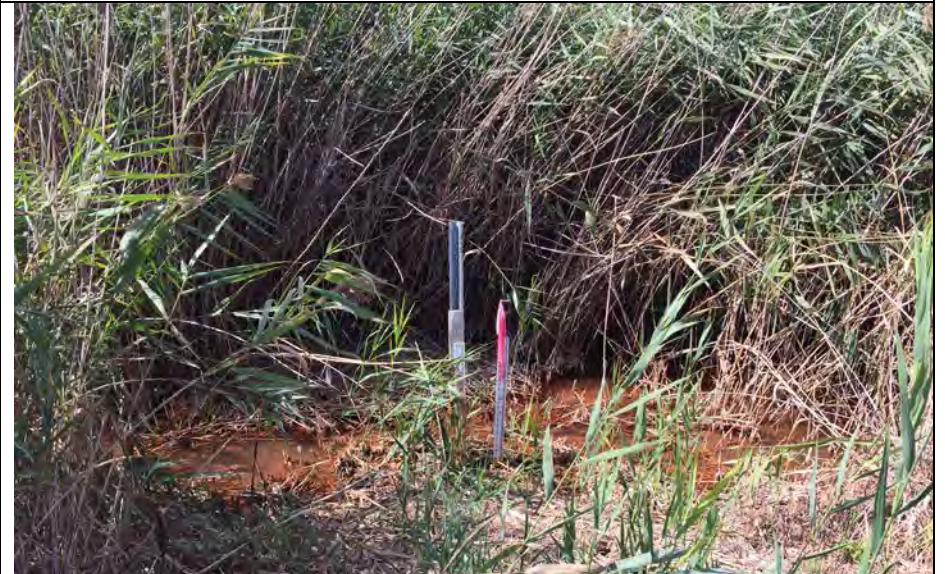
48. Perimeter Ditch Staff Gauge SG-05. Water Observed Flowing.

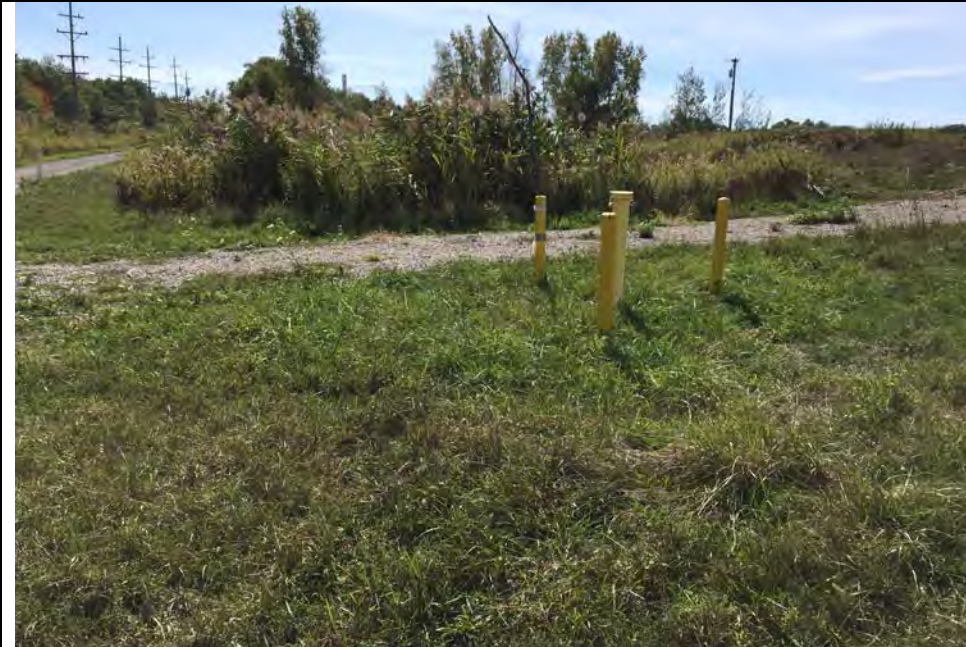
During the 2017 annual inspection locations of seven (7) groundwater monitoring wells were observed. Two of the 7 wells with their protective bollards are shown in Photographs 49 and 55. All 7 of the well locations were shown in the 2016 AIR. They were all stick-up wells except for MW 16-05, a flush mount well, which was located within an alternate construction entrance for the landfill located on the south side of the property near Puttygut Road.

49. Typical View of One of Six Stick-up Monitoring Wells Around Perimeter of Landfill. Well is MW-16-02. One More Well is a Flush Type (MW-16-05).

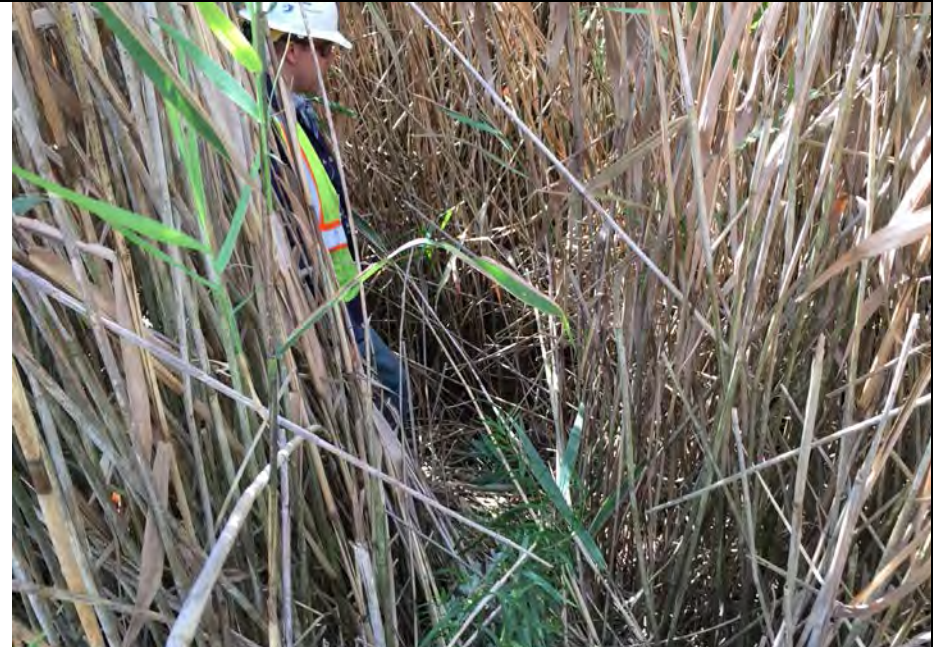
50. DTE Engineer Checking Perimeter Ditch for Observance of Water Level on East Side of Landfill.

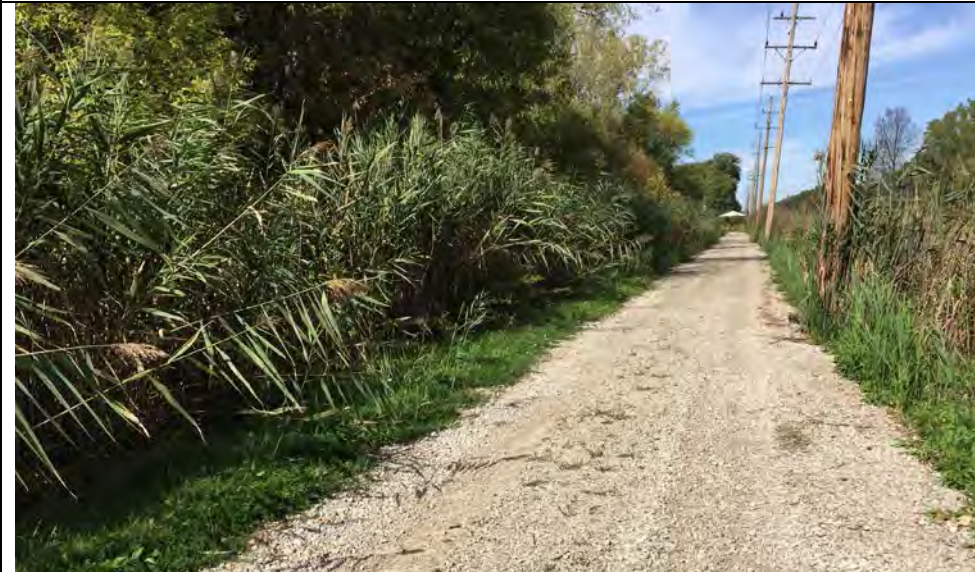
51. Perimeter Road Along East Side Maintained. Perimeter Ditch Along Left Side and Slurry Wall Alignment Beneath Road in this Photo.

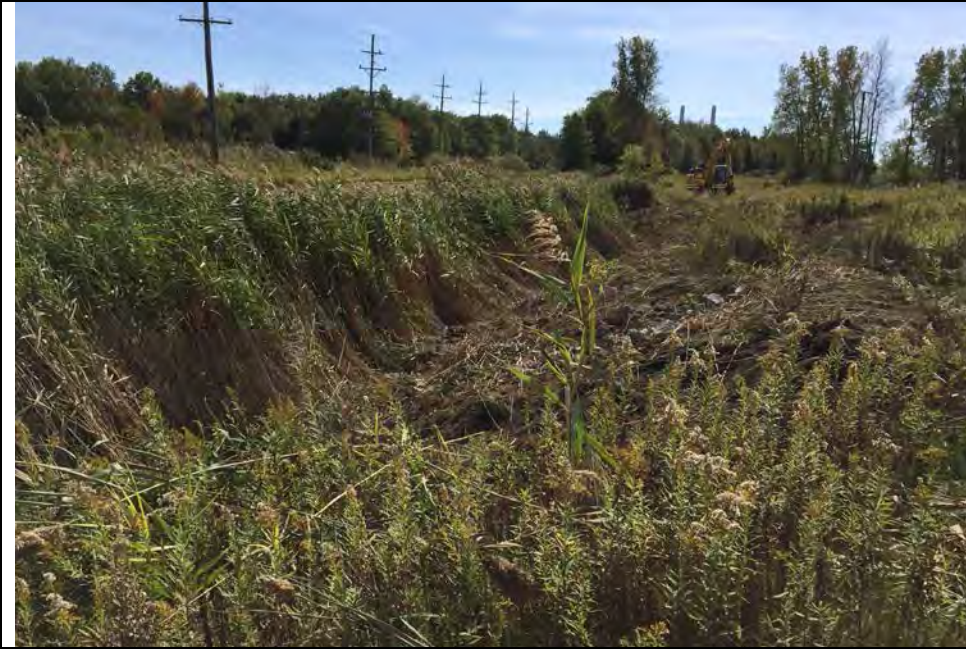
Control of vegetation growth in the site ditches has been identified by DTE as a significant maintenance activity. DTE has instituted a 3-year rotation ditch maintenance program where 1/3 of the perimeter ditch alignment is cleared of excessive vegetation. DTE's weekly and quarterly inspections report on the status of this activity. Photographs 8, 19, 20, 22, 23, 25-27, 32, 33, 35, 36, 53, and 65 show various conditions and stages of vegetation growth, and ditch clearing maintenance.

53. Ditch Maintenance and Vegetation Removal In progress. Equipment Shown Currently Under Repair or Maintenance.

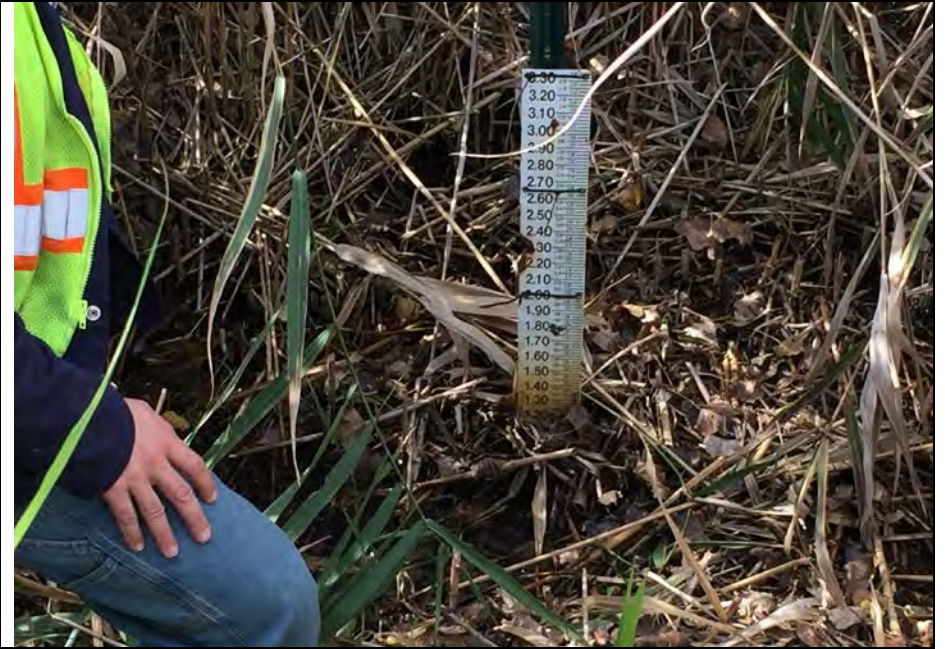
54. Perimeter Ditch Monitoring Staff Gauge SG-02. Gauge Numbering Not Visible. No Visible Flow.

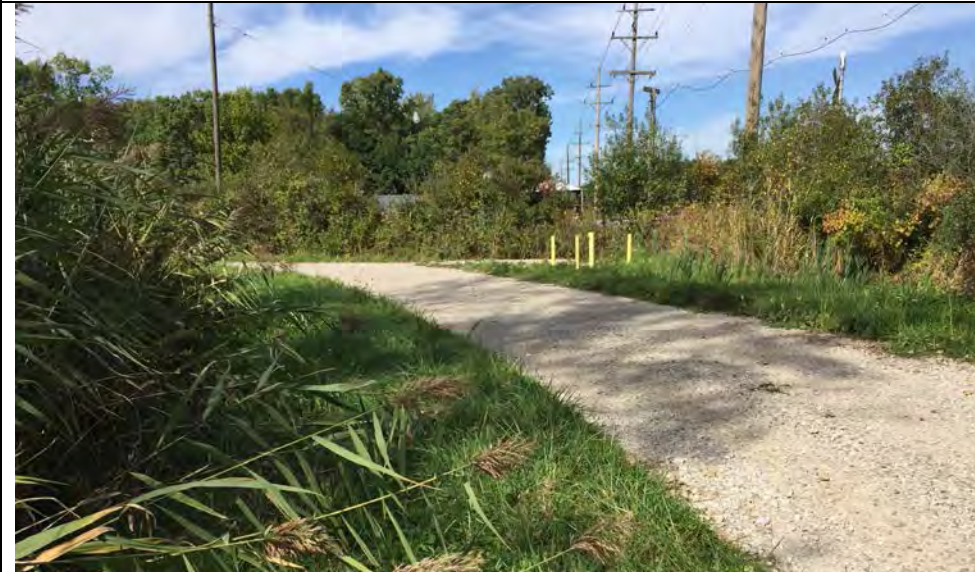
55. View of Roadway and Monitoring Well MW-16-03. Access and Well Protection in Place.

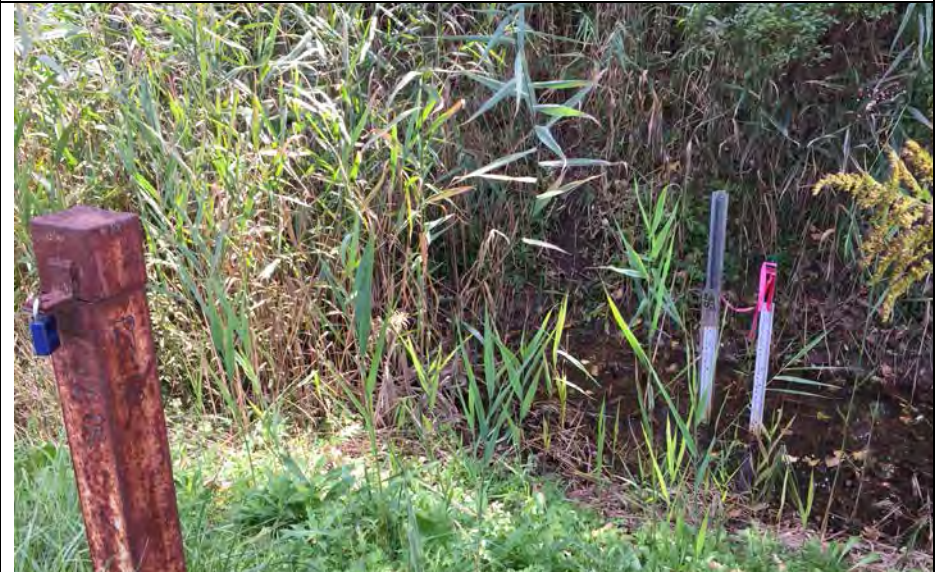
56. Perimeter Ditch Monitoring Staff Gauge SG-02 and Piezometer PZ-01R. No Visible Flow Noted.

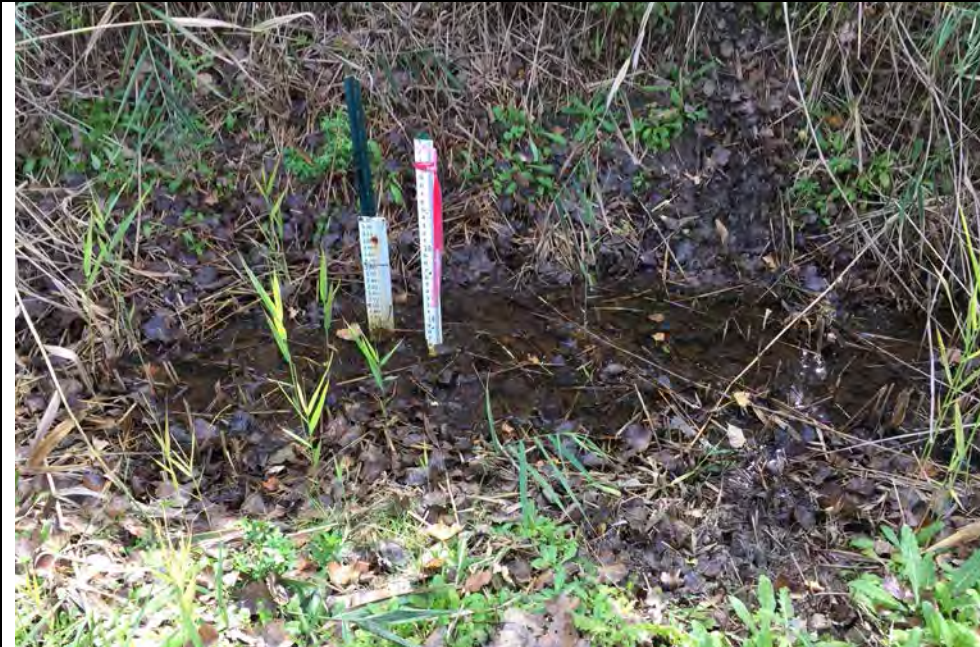
57. Perimeter Ditch Monitoring Staff Gauge SG-01. No Visible Flow Noted.

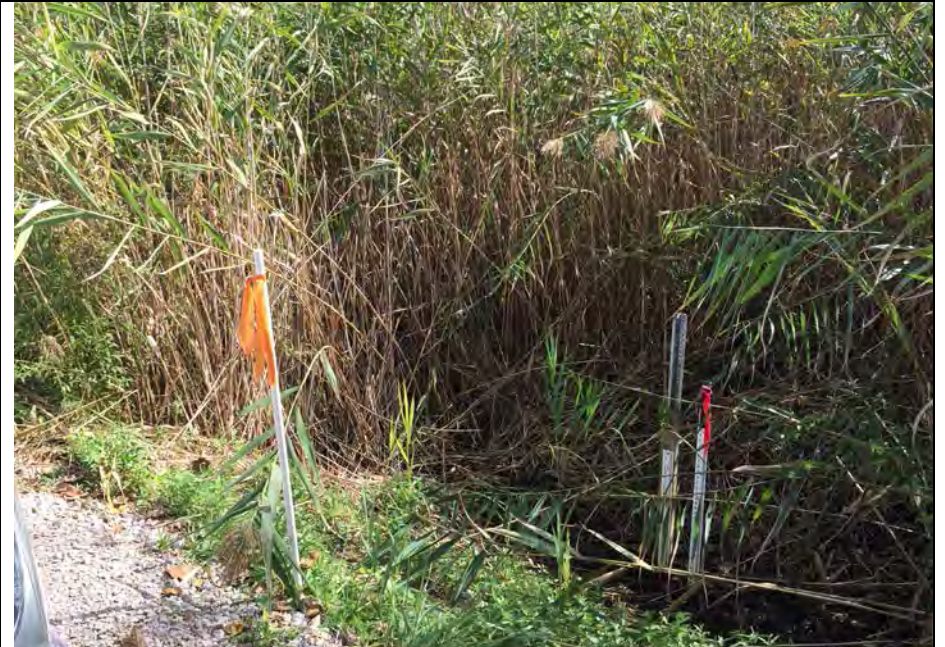
58. Perimeter Ditch Monitoring Staff Gauge SG-06. Video of Visible Flow in Ditch on File.

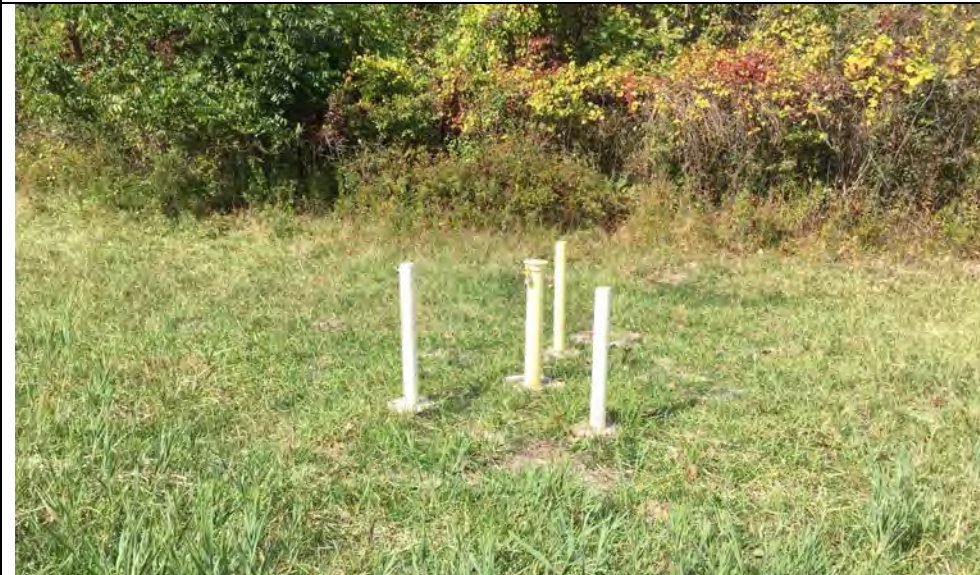
59. View of Monitoring Well MW-16-06. Access Clear and Well Protected.

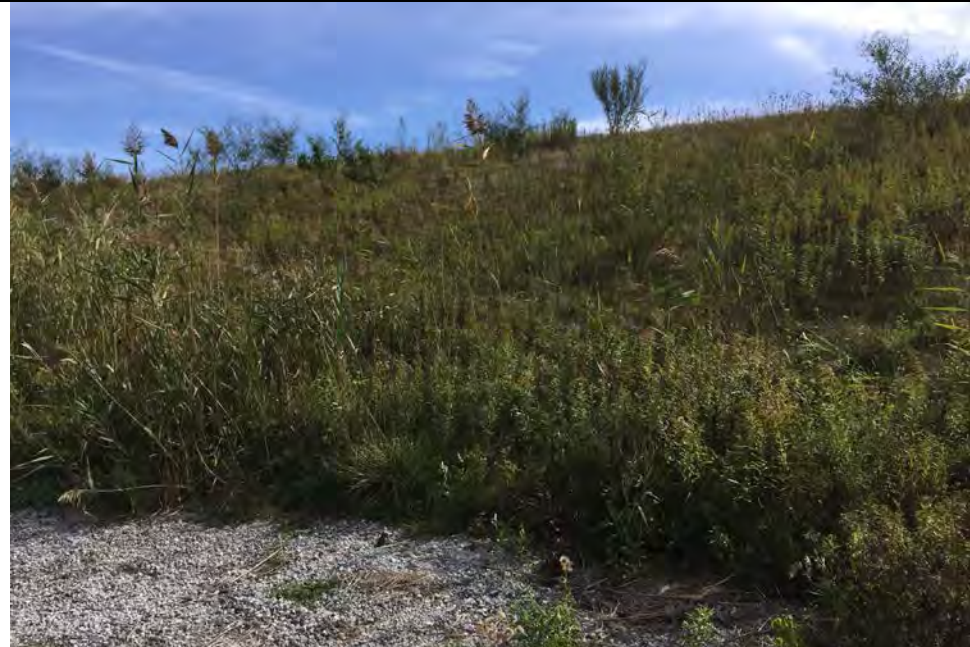
61. Brush and Small Woody Vegetation Growing on North Slope of Closed Area B of Landfill.

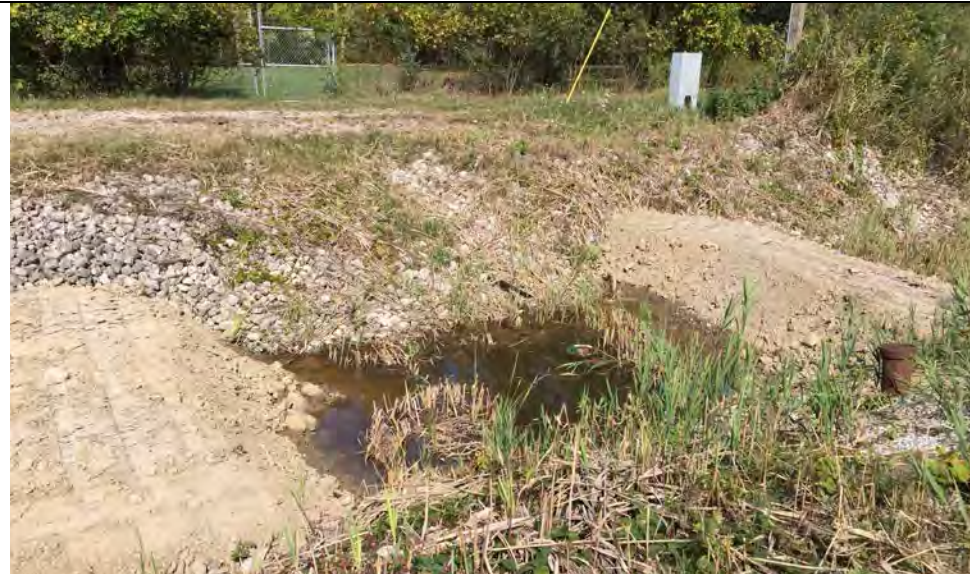
63. Collection Ditch Temporary Berms to Dam-up Water Flow.

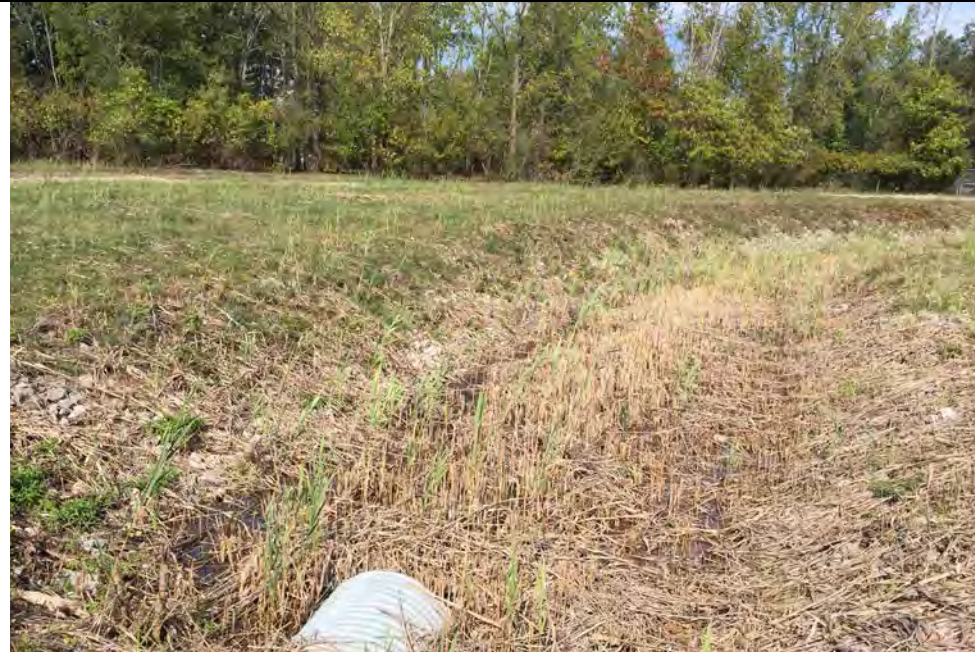
65. Area of Recent Vegetation Removal Along Perimeter East Side. Removal Equipment Observed, but Undergoing Repair or Maintenance.

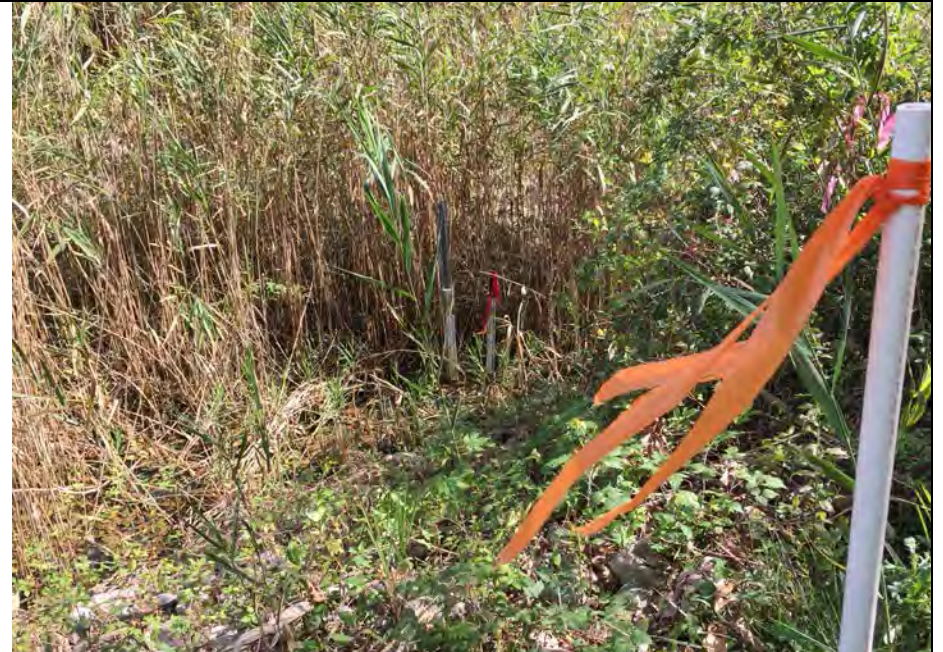
66. View of Perimeter Ditch Staff Gauge SG-10. Vegetation Heavy, but Review of Recorded Elevations Show Ditch is Still Flowing as Designed.

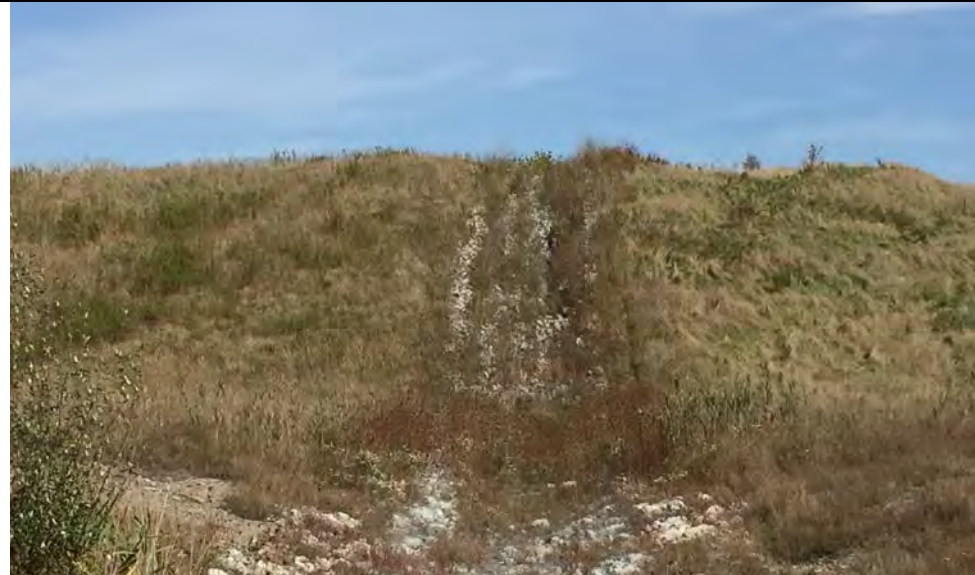
67. Looking at Slope Downchute From Intersection of Closed Areas F1 and F2. Some Runoff Erosion in Riprapped Area. Downchute Drains to Perimeter Ditch.

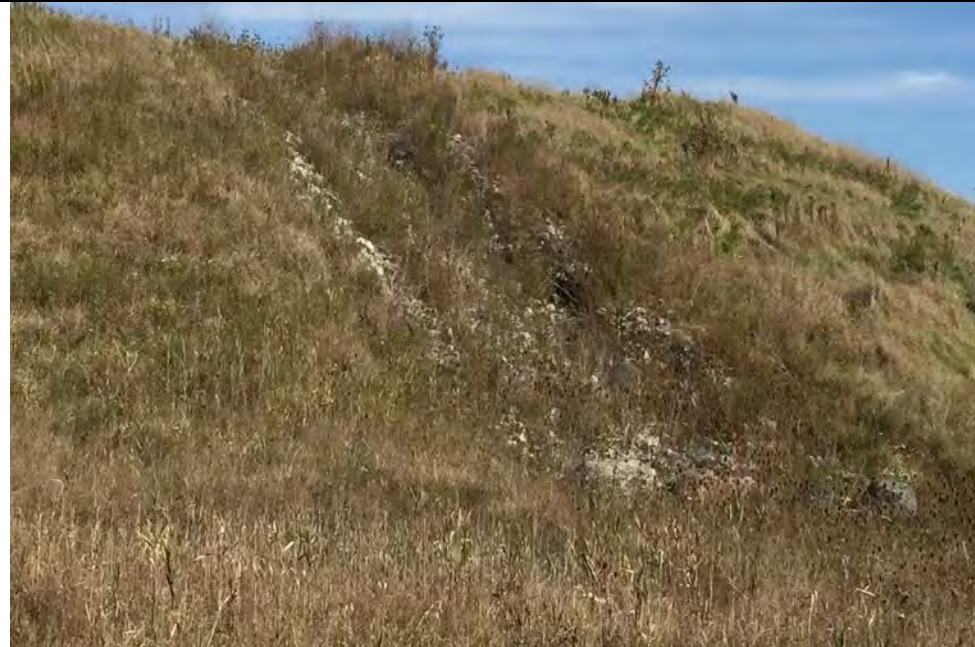
69. Close-up of Slope Downchute From Intersection of Closed Areas F1 and F2. Some Runoff Erosion in Riprapped Area. Same as Photo 67.

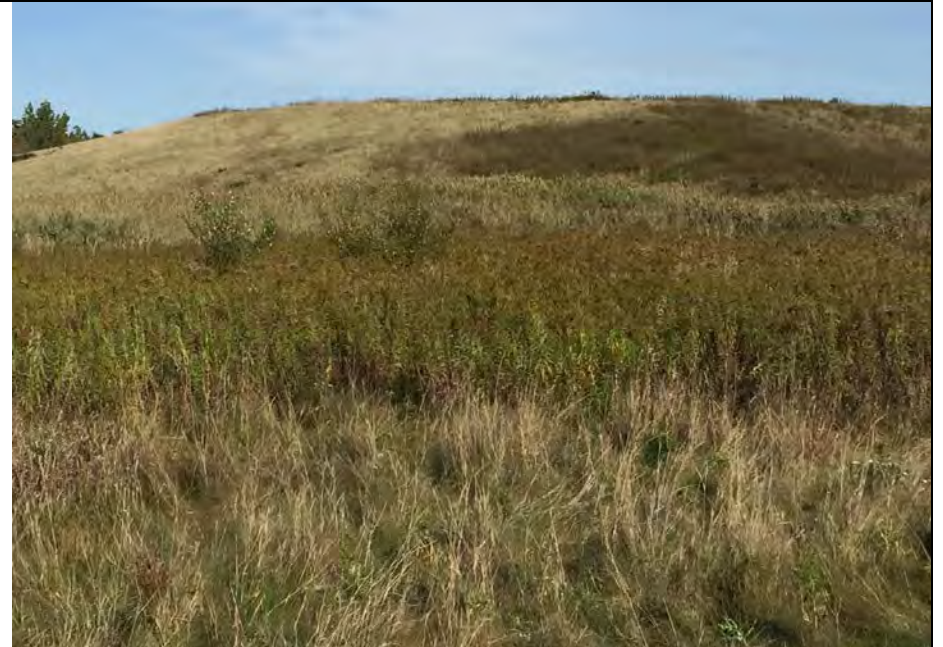
70. Looking North at Vegetated Slope of Closed Area F2.

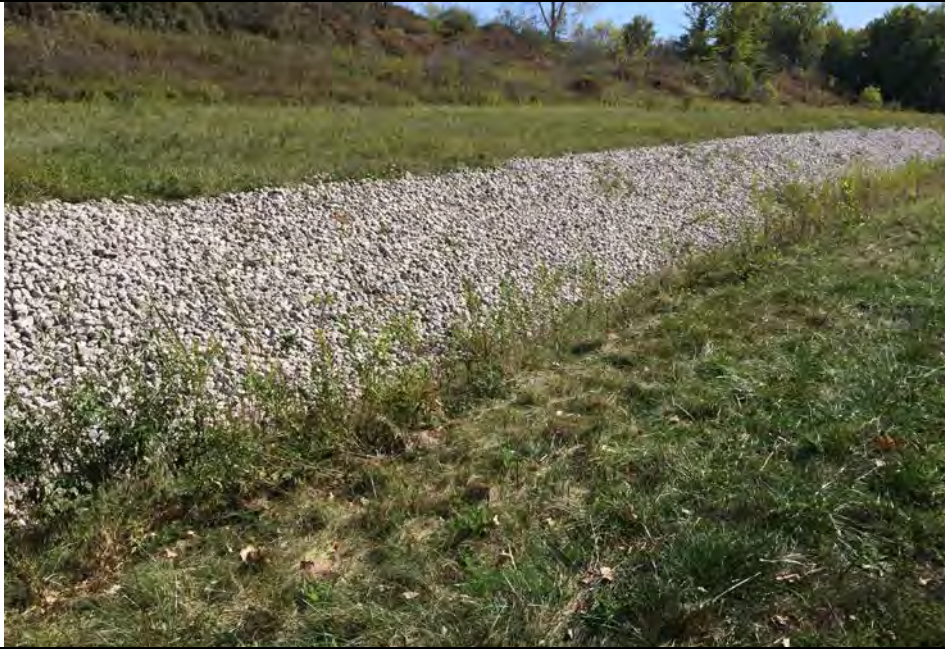
73. Looking SE at Repaired Slope of Perimeter Ditch Along West Side.

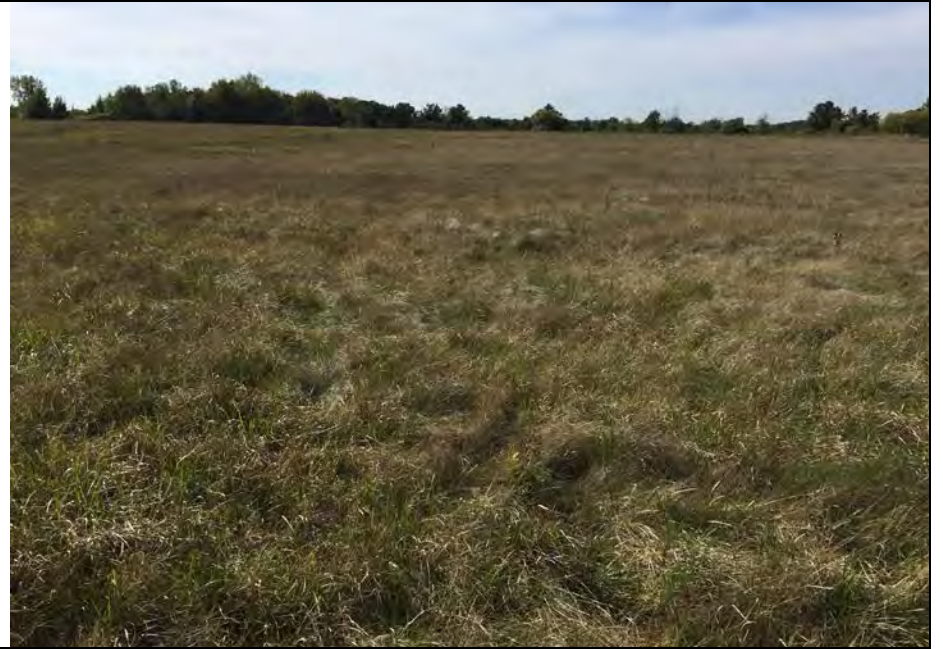
74. View of Typical Top of Closed Landfill Areas.

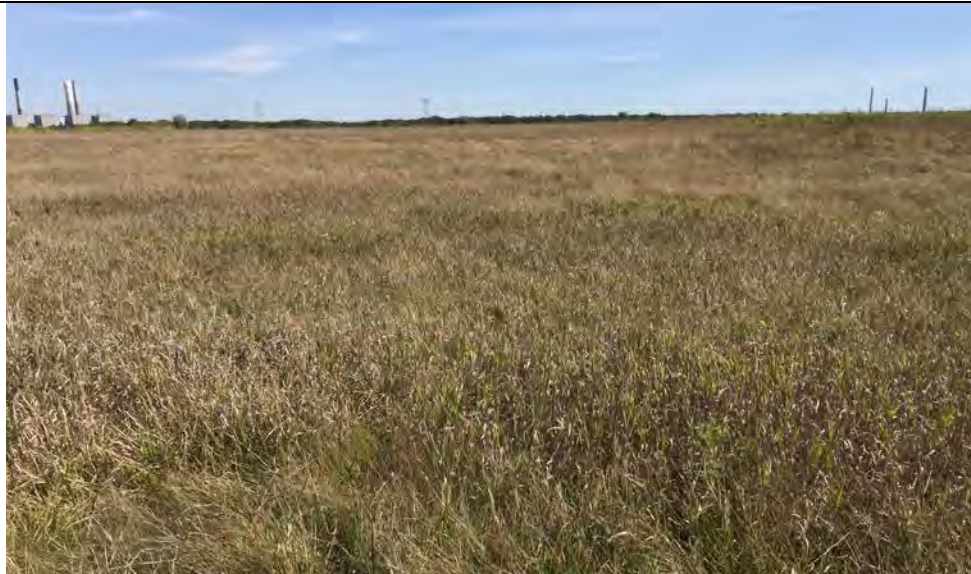
75. View Looking East of Typical Top of Closed Landfill Areas.

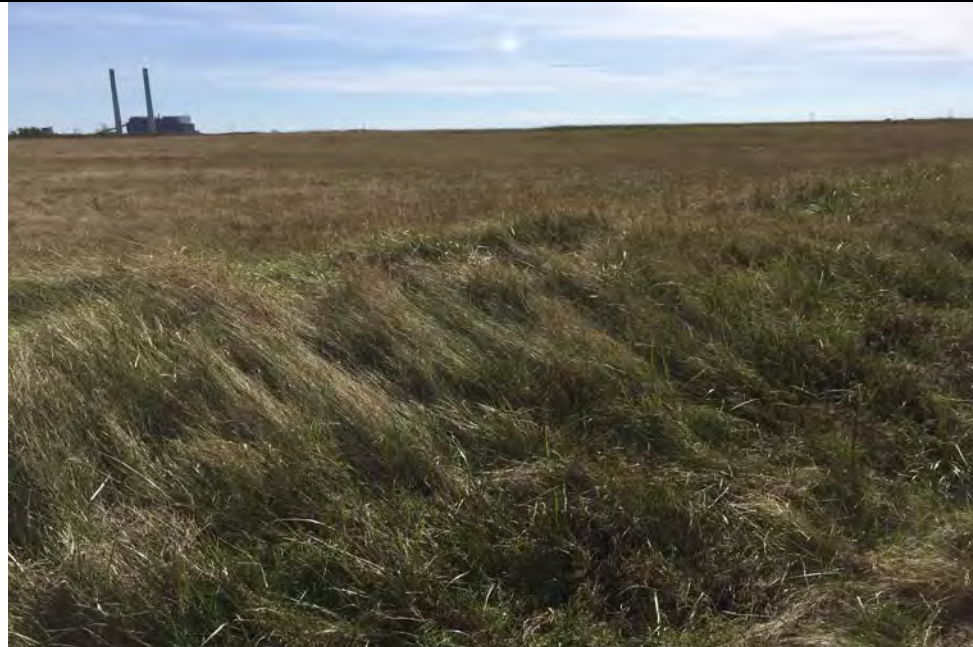
77. View of Typical Top of Closed Landfill Areas. Small Drainage Berm on Cover Shown to Contain and Direct Surface Flow.

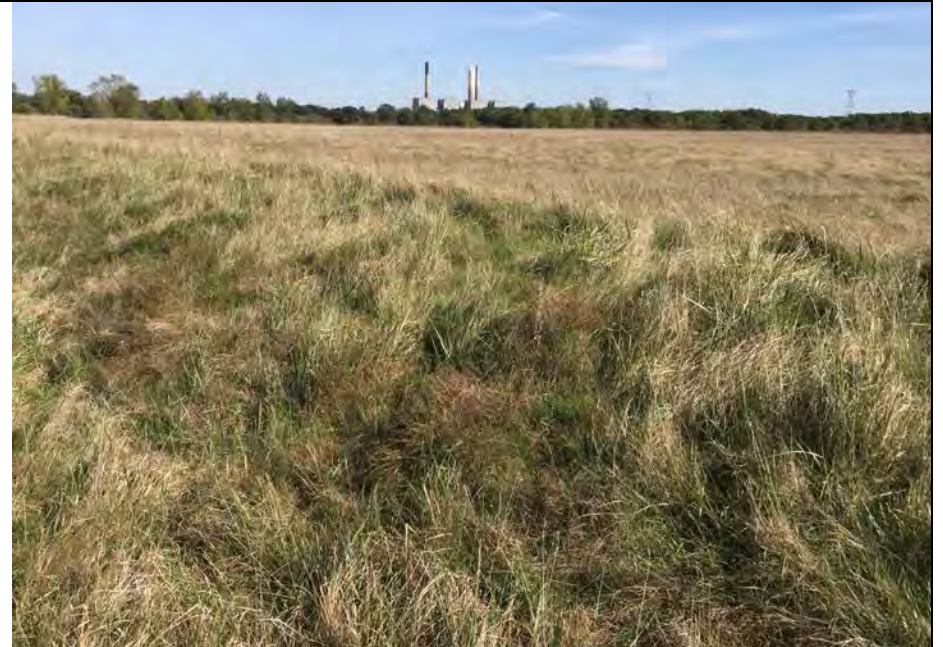
78. View of Typical Top of Closed Landfill Areas. Small Drainage Berm on Cover Shown to Contain and Direct Surface Flow.

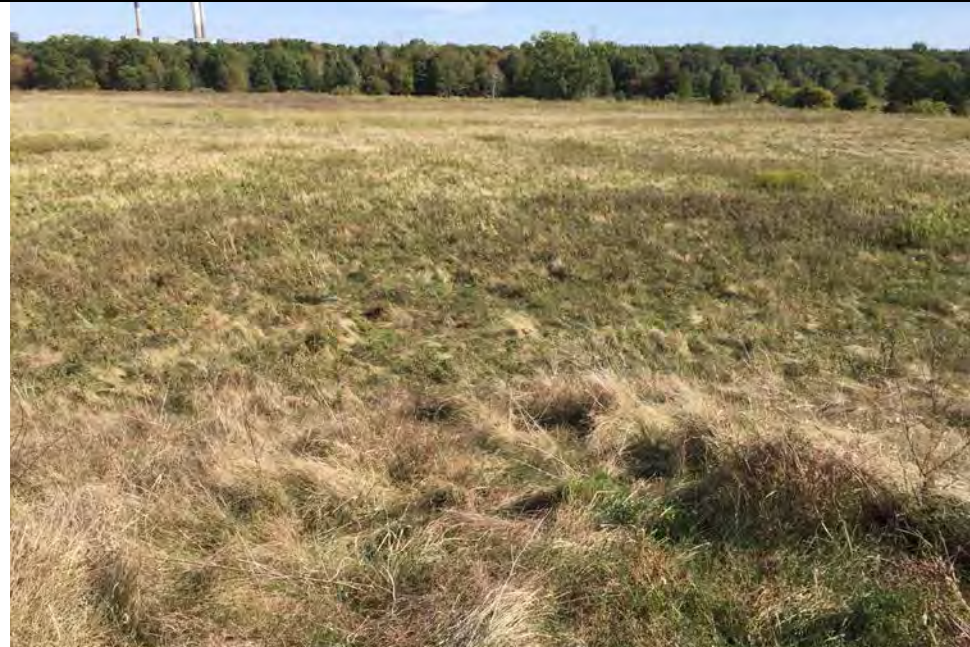
81. Another View of Typical Top of Closed Landfill Areas.

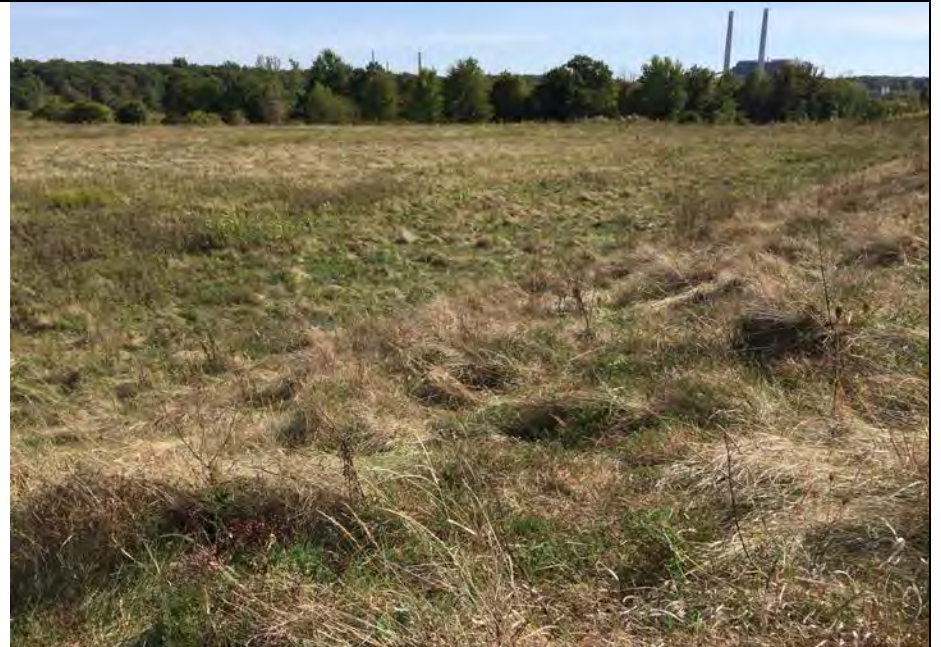
82. Another View of Typical Top of Closed Landfill Areas.
