**2018 ANNUAL INSPECTION REPORT  
RANGE ROAD LANDFILL  
ASH DISPOSAL FACILITY**

**China Township, St. Clair County, Michigan**

January 2019

**APPENDIX B**  
**DTE Range Road Landfill Annual Inspection 29 March 2018**

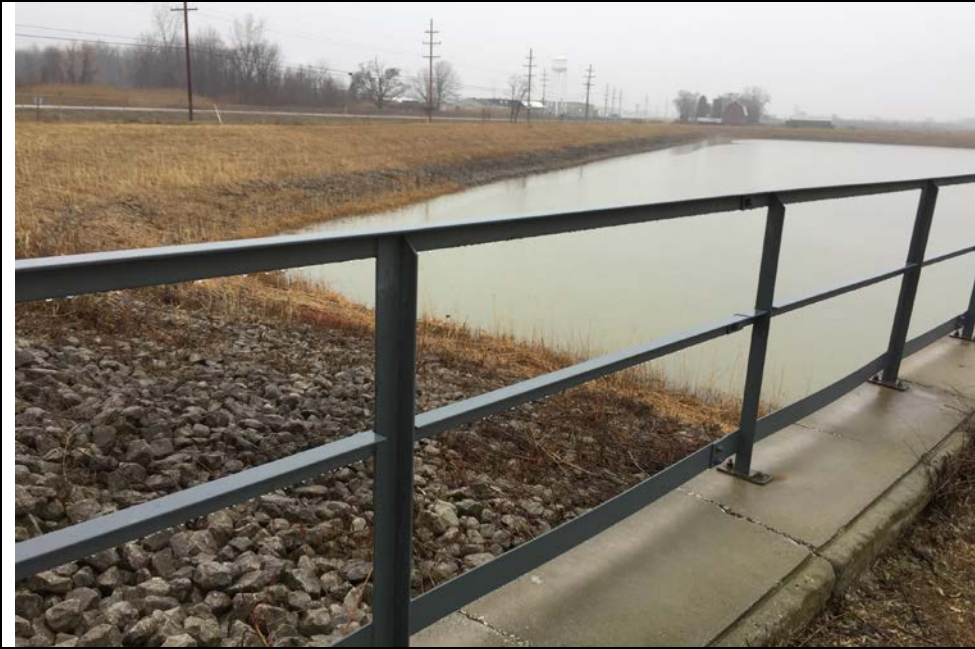
Stormwater Detention Basin: The basin and pump system appeared in good condition. Basin slopes and entrance flume also appeared in good condition with vegetation recently cut as shown in Photographs 1 and 2. Pump 1 was operating, and all pump switches were in the auto mode. The Pump control panel is shown in Photograph 4. The discharge flow meter, shown in Photograph 5, appeared to be working correctly. The basin intake screen was unblocked as shown in Photograph 3.

1. Storm Water Detention Basin (SWDB), South and West Sides. Slopes are Protected with Stone. No Visible Slope Erosion. Vegetation Cut on Slopes.

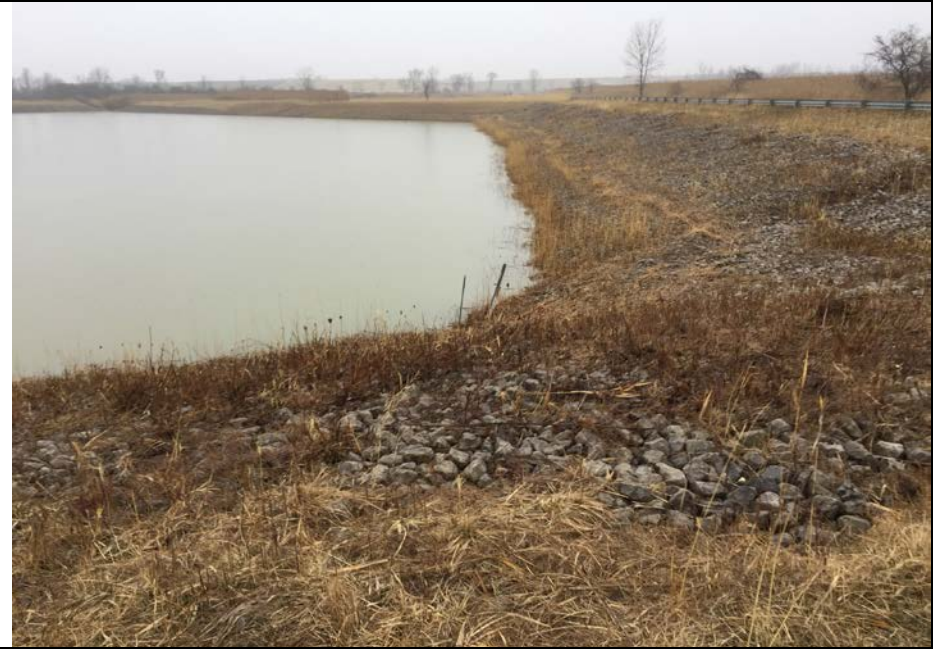
2. SWDB, North and East Sides. Slopes are Protected with Stone Within Water Level Range. No Visible Slope Erosion. Vegetation Cut on Slopes.

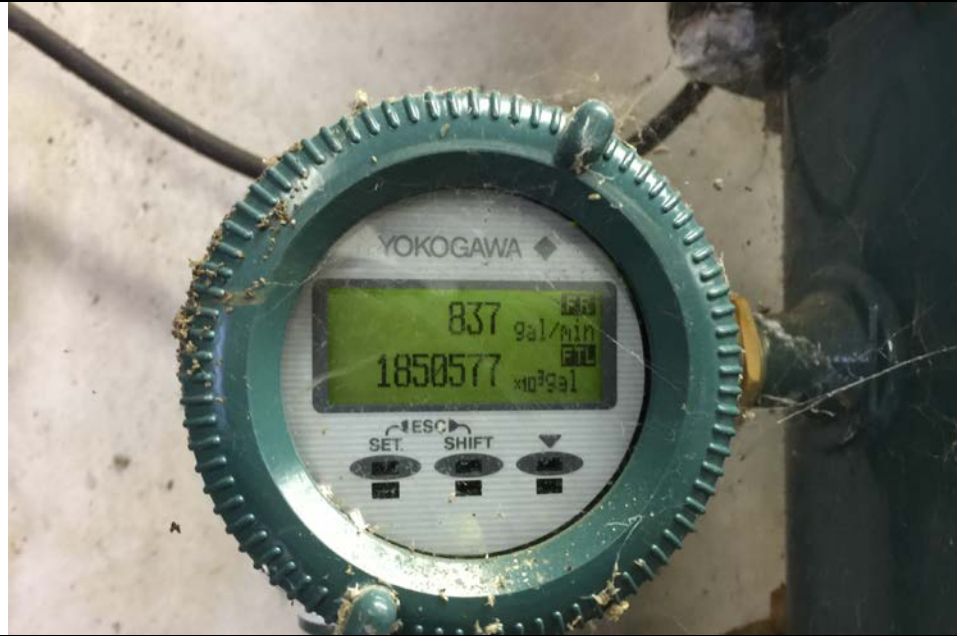
5. View of SWDB Pump Flow Meter. One Pump On at Time of Photo, Therefore Flow Rate Shown at 837 gal/min. Total Flow Pumped is Given.

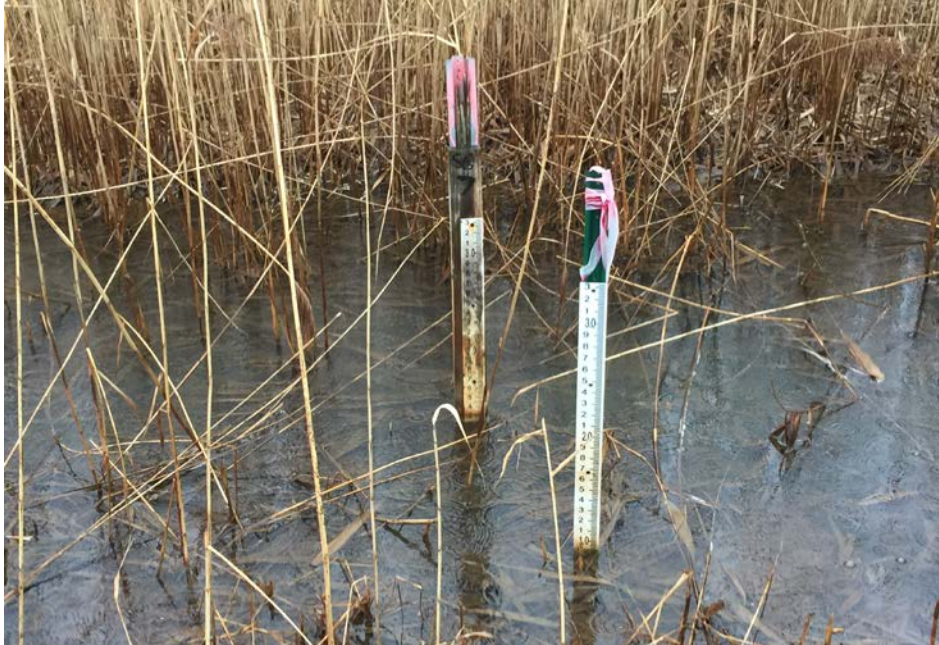
9. Looking at Perimeter Ditch Staff Gauge SG-07. Flow Observed Within Ditch.

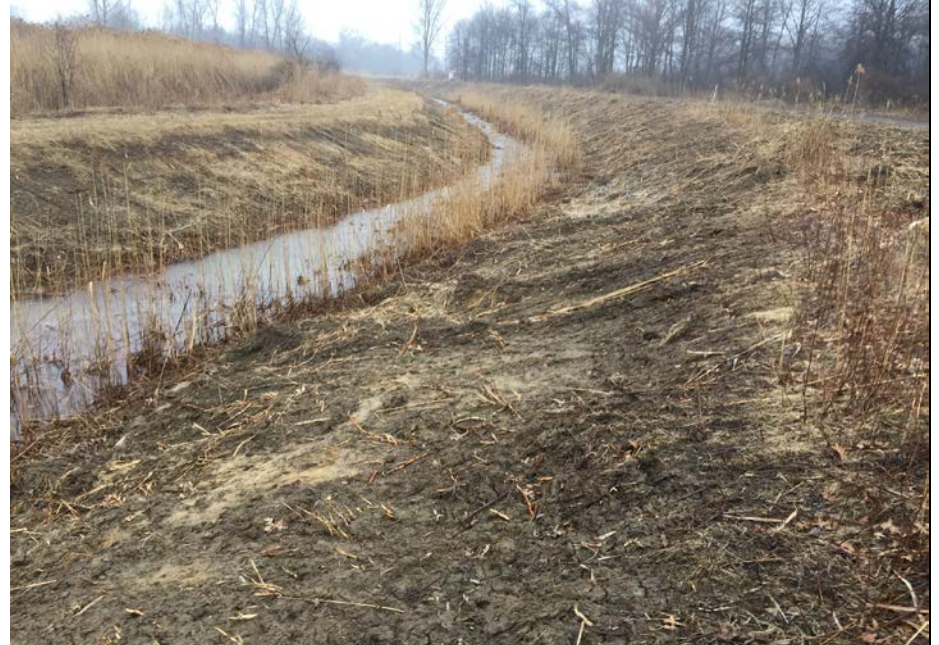
10. Looking at Perimeter Ditch Where Ditch Maintenance and Vegetation Removal Occurred Late Last Year (2017).

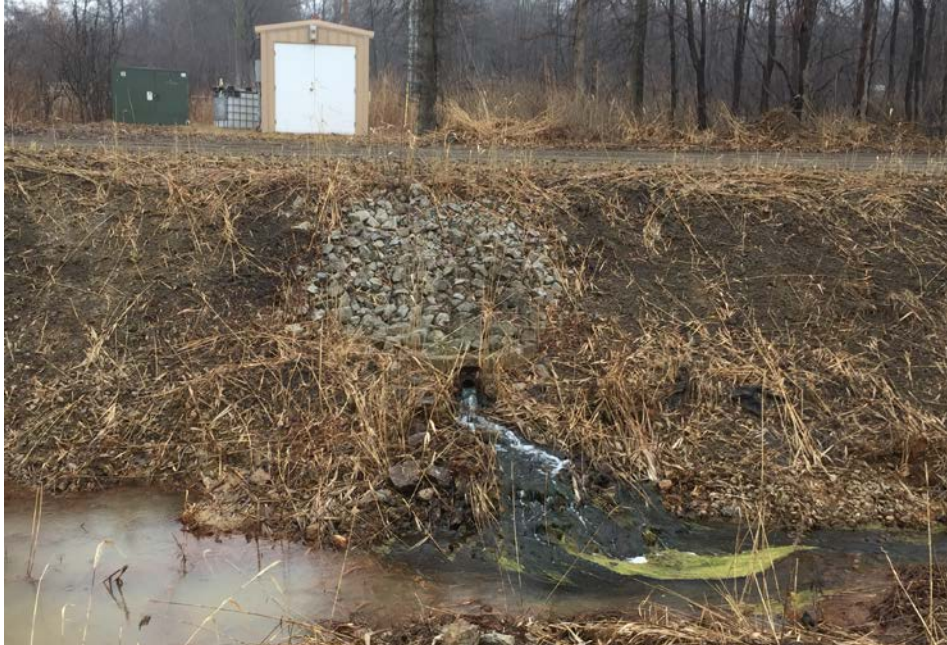
13. View of Discharge Flow into Perimeter Ditch from NE Off-Site GW Capture System at 11:47AM. Also Ditch Slope Vegetation Cleared Late Last Year

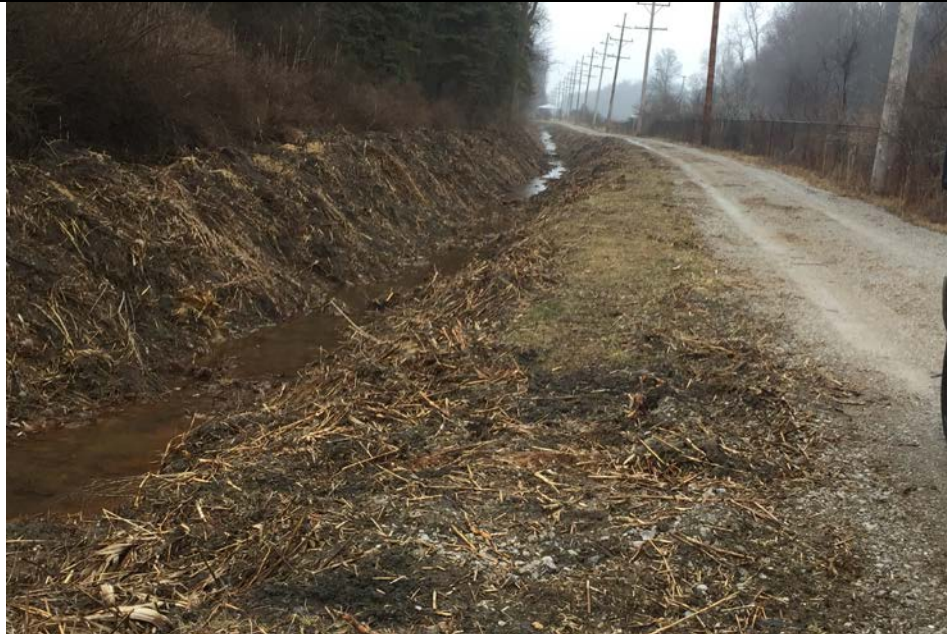
17. Looking at Recent Maintenance Along East Side Perimeter Ditch. Road Remains in Good Condition. No Slurry Wall Markers Shown. New Road.

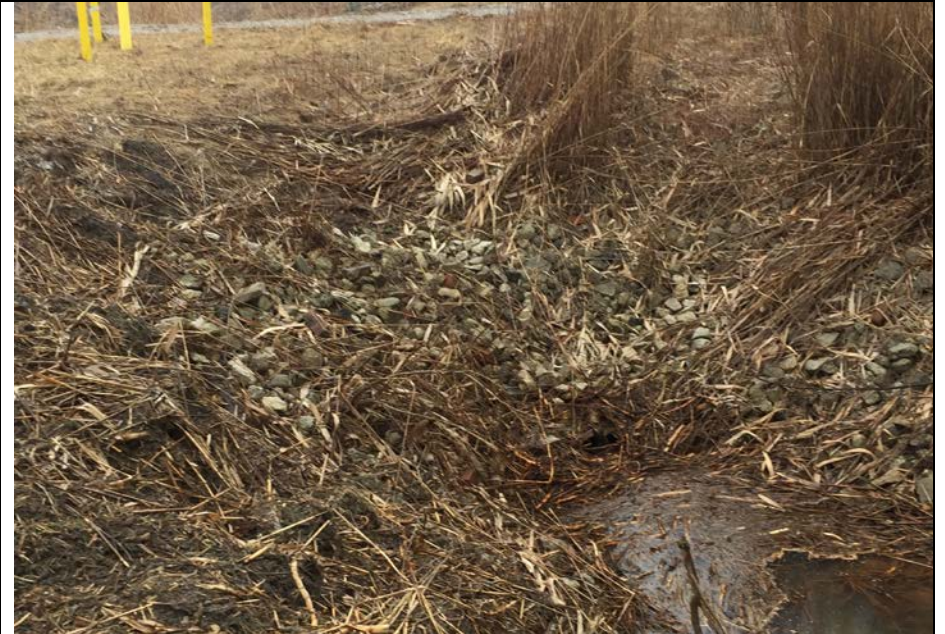
18. Clogged Culvert Entrance at Road Crossing Along East Side. DTE Indicated Removal of Vegetation will be Scheduled. MW 16-03 Shown.

In addition to clearing the culvert vegetation blockage shown in Photograph 18 and runoff erosion on the temporary waste slope shown in Photographs 102 and 103, it is recommended that ditch

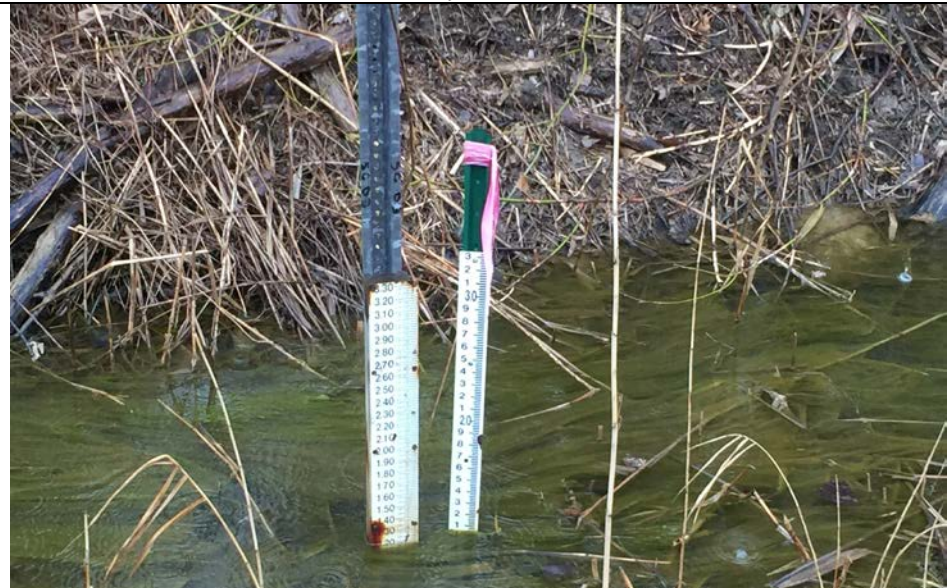
19. Looking at SG-03. Some Ditch Flow Observed.

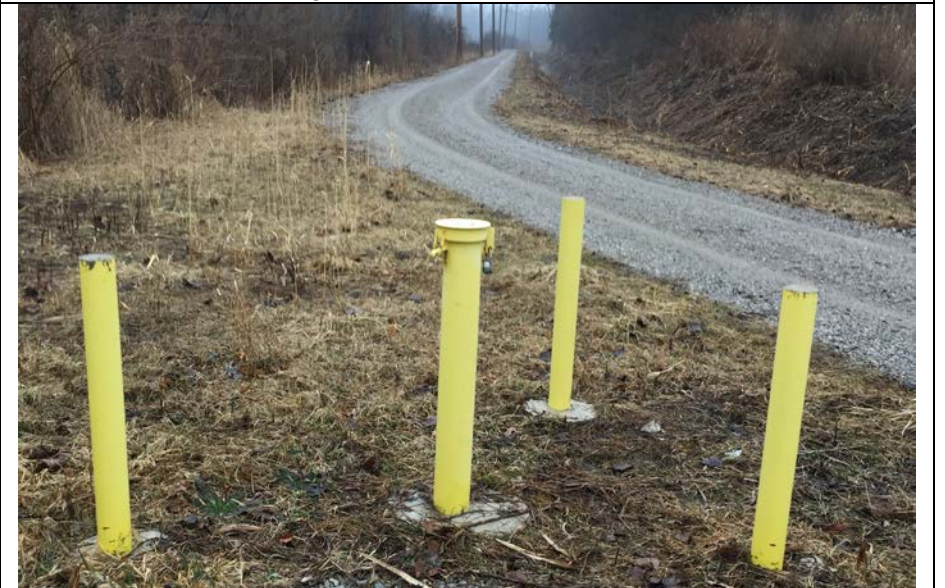
20. Close-up of Monitoring Well 16-04 and Perimeter Road Along Ditch. Ditch and Road Maintenance has been Performed. No Slurry Wall Markers.

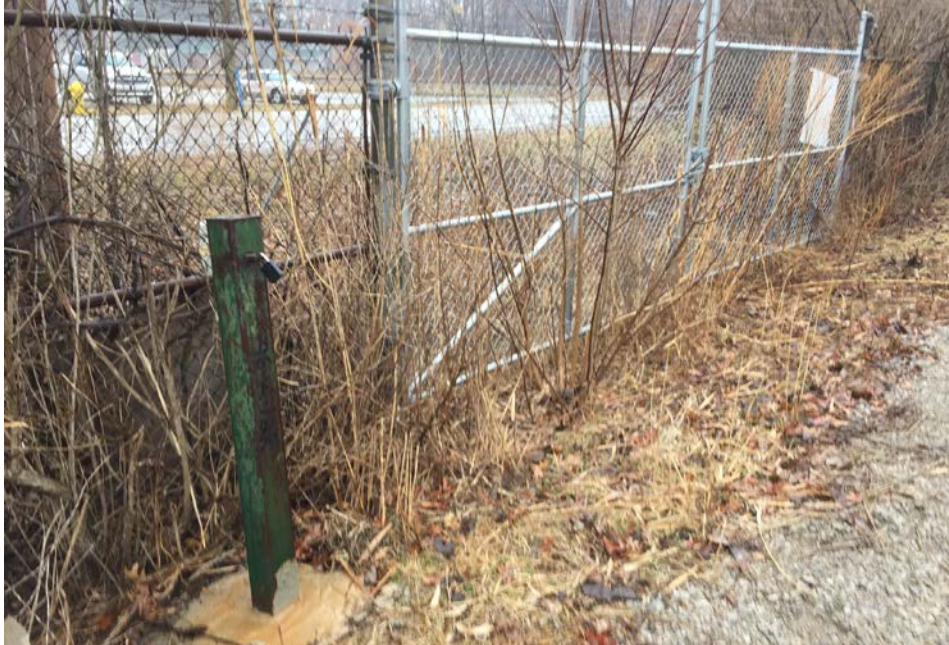
21. View of East Side Gate (Locked) and Piezometer PZ-96-2R.

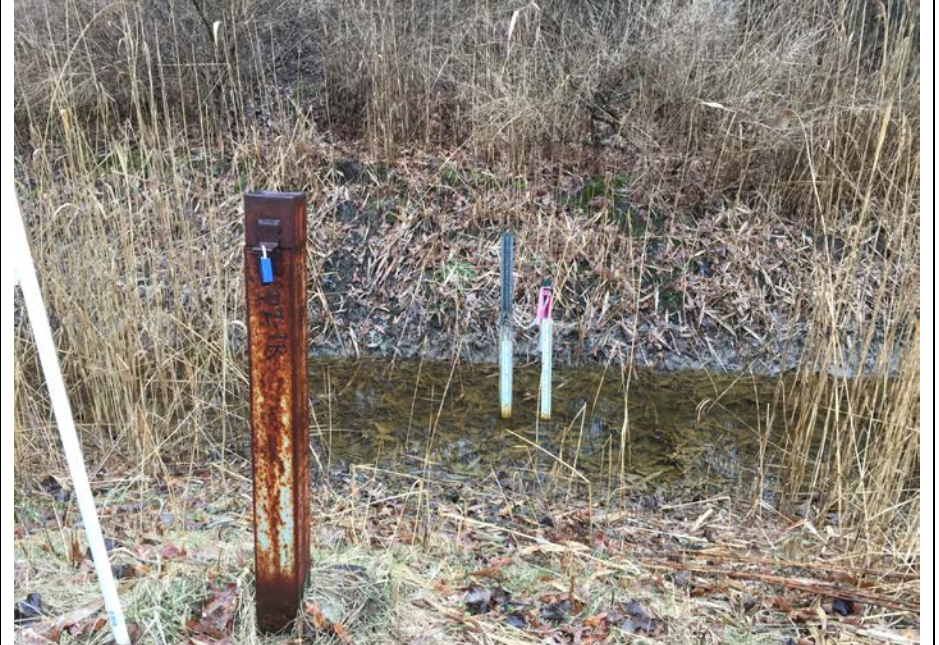
22. Looking at Perimeter Ditch Staff Gauge SG-02 and Piezometer PZ-1R. No Visible Flow in Ditch.

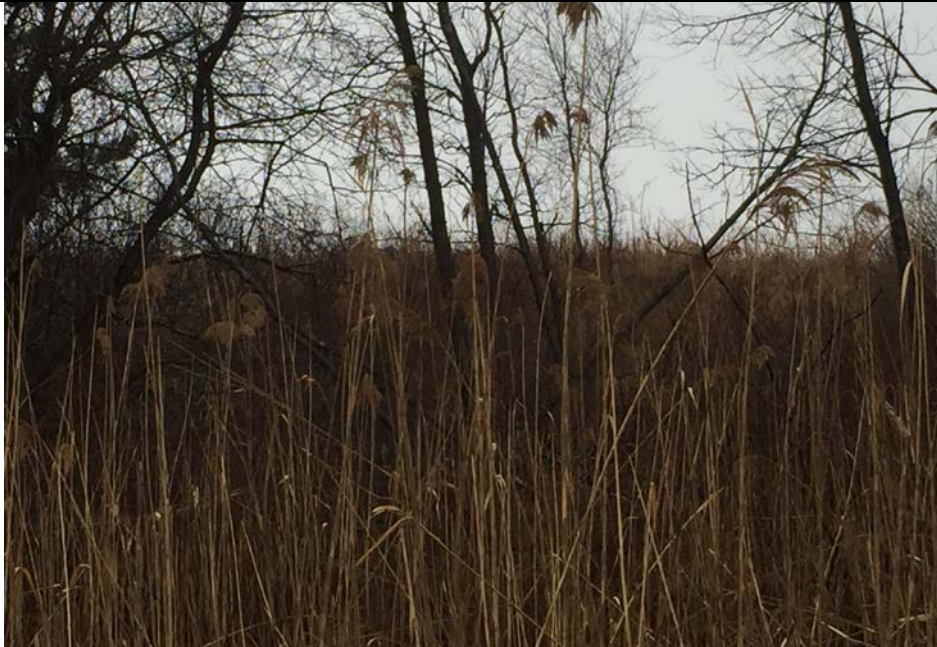
25. View of Outside Slope of Historically Closed Area of Landfill. Trees Present Have not Resulted in Any Visible Slope Stability Problems.

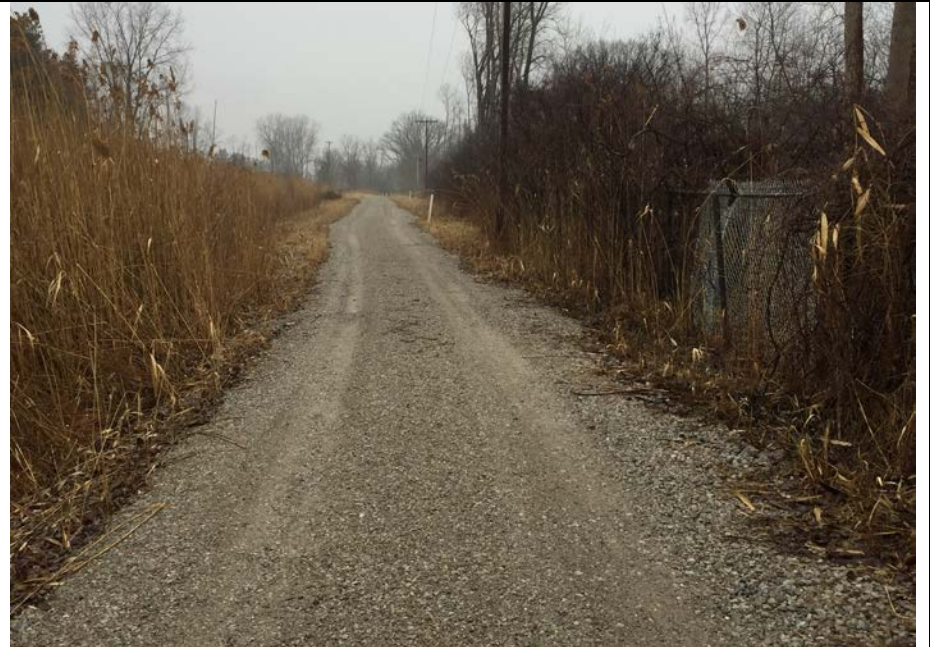
26. View of Perimeter Road Left Side Ditch. Road was Up-graded Making Maintenance/Monitoring More Accessible. Slurry Wall Marker Shown.

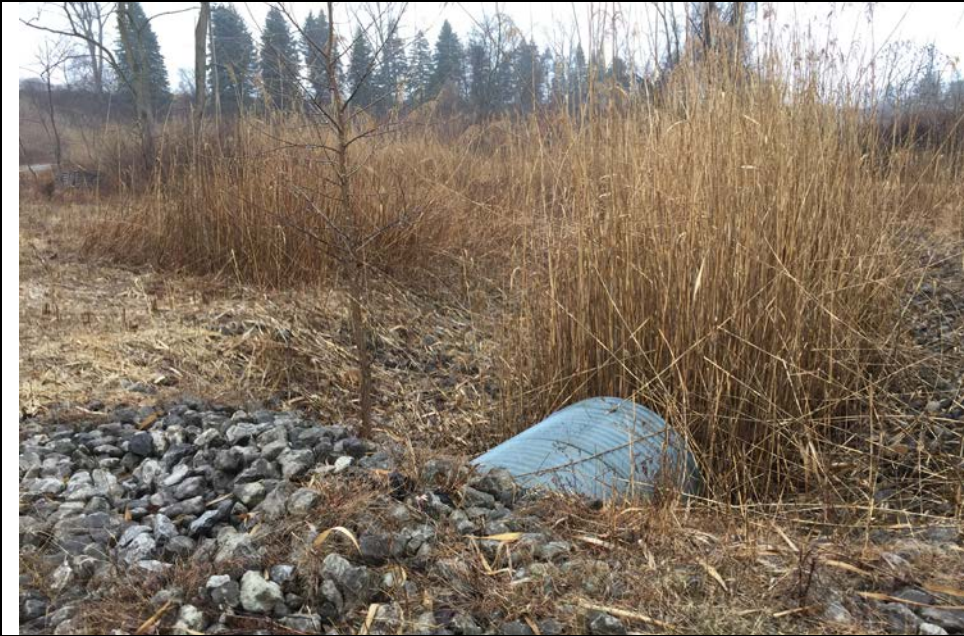
29. View of East Side Ditch Crossing Culvert with Heavy Vegetation at Flow Entrance. Road Crossing to Access Top of Landfill.

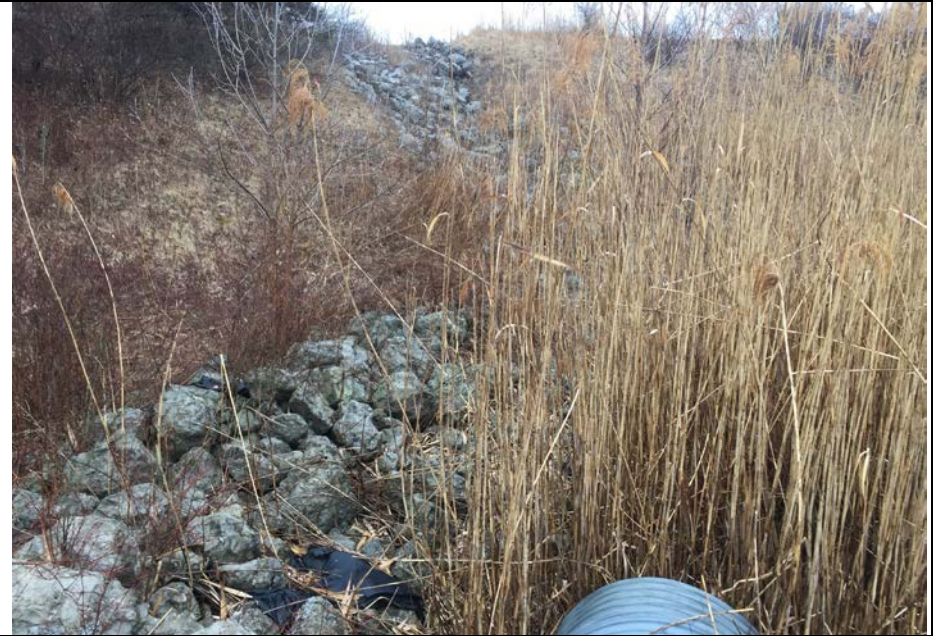
30. View of Culvert Further North at Ditch and Riprapped Downchute, both Along East Side.

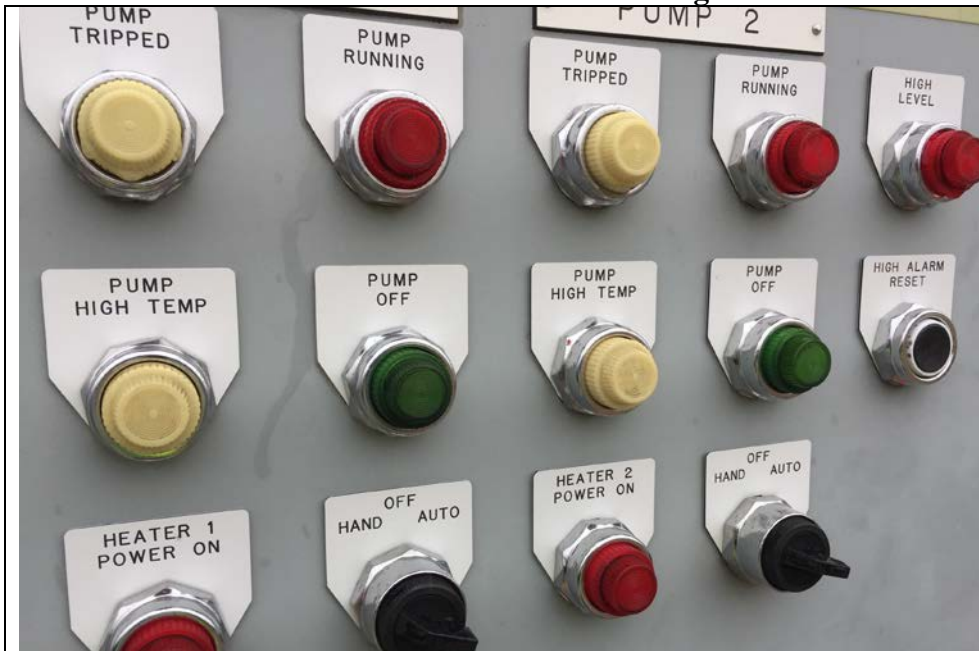
33. Control Panel at NW GW Capture System. No Pumps Currently Running, but Later Pumps were Checked for Correct Operation. Alarm Reset Cover Missing.

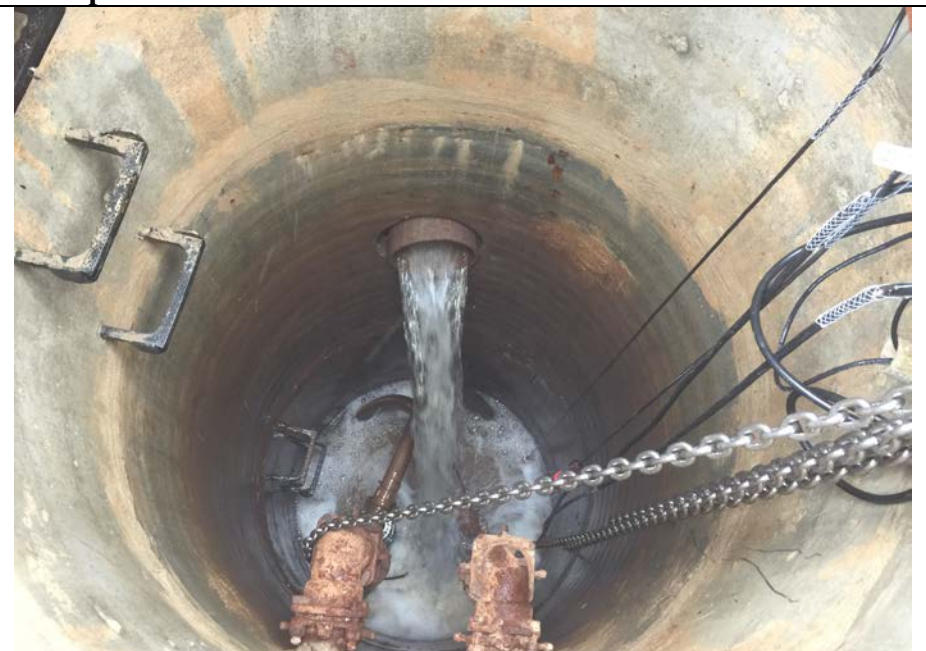
34. Sump Showing Increased Flow from Collection Ditch (See Photo 35) after Blocking Vegetation Removed by DTE During Inspection.

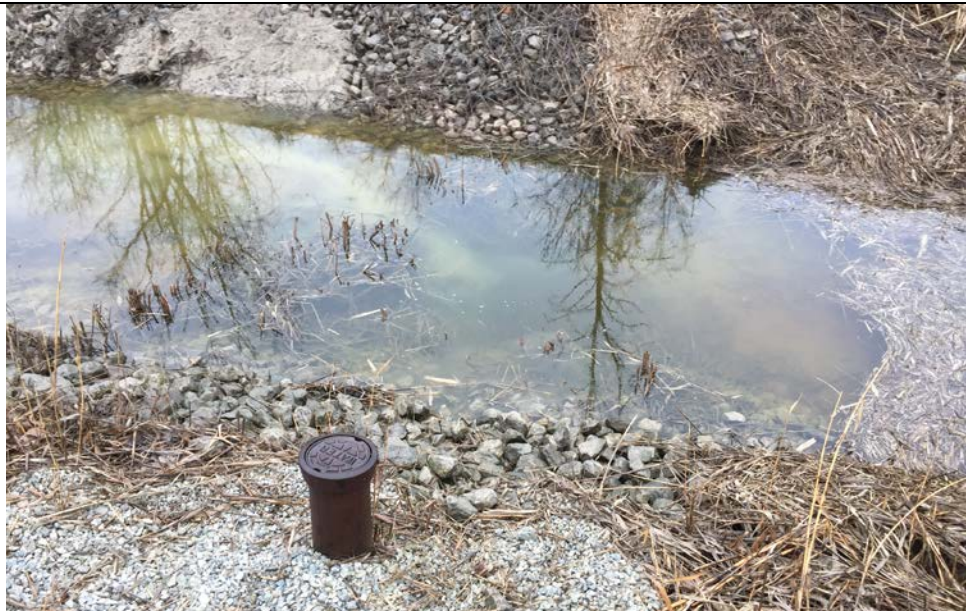
35. Collection Ditch and Intake to Sump at NW Groundwater Capture System. Vegetation Debris was Removed at Intake to Increase Flow to Sump.

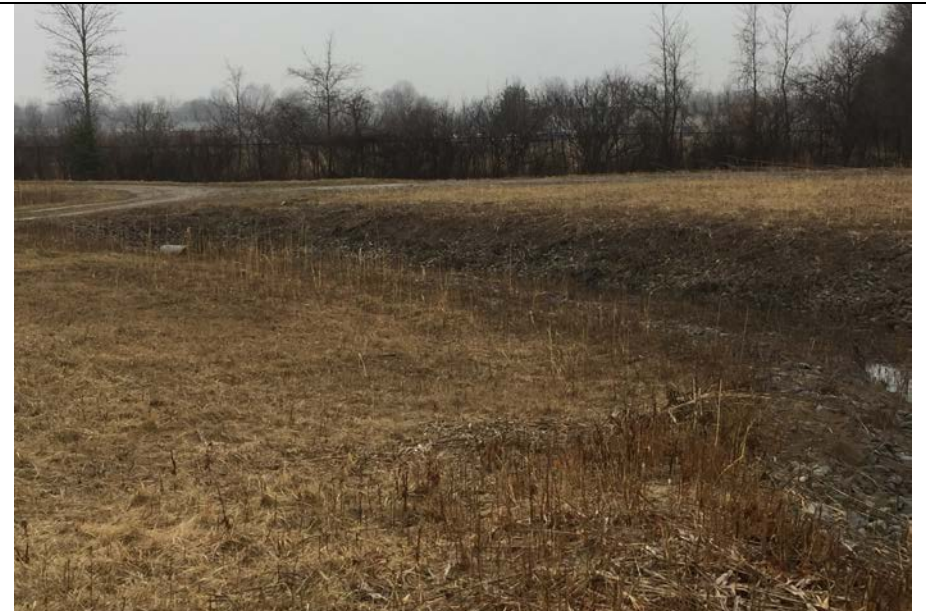
36. Perimeter Ditch where Vegetation Maintenance Completed in Late 2017. Culvert Beneath Road Crossing Clear of Vegetation.

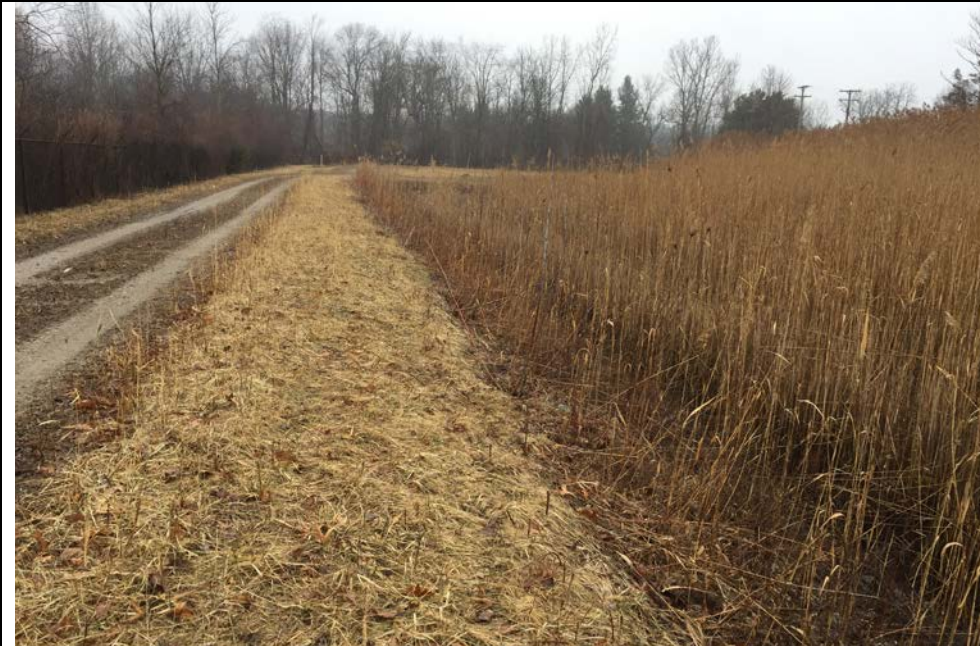
37. Looking East Along North Side of Perimeter Road and Ditch. Road and Slope in Good Condition.

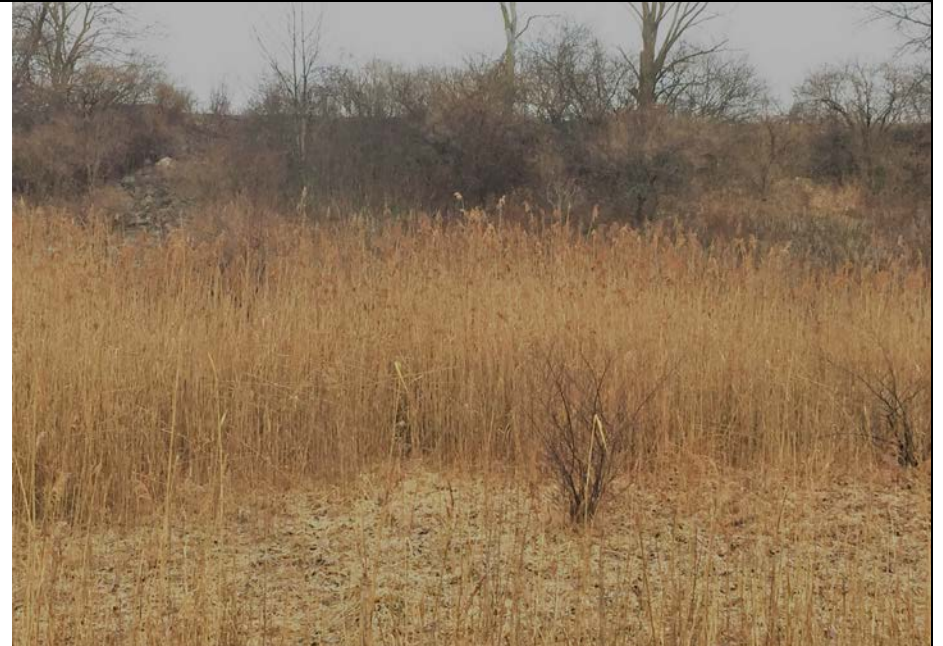
38. View of Closed Landfill Slope with Trees and Brush on Slope. A Riprap Downchute Visible. No Slope Erosion Noted During Close-up Inspection.

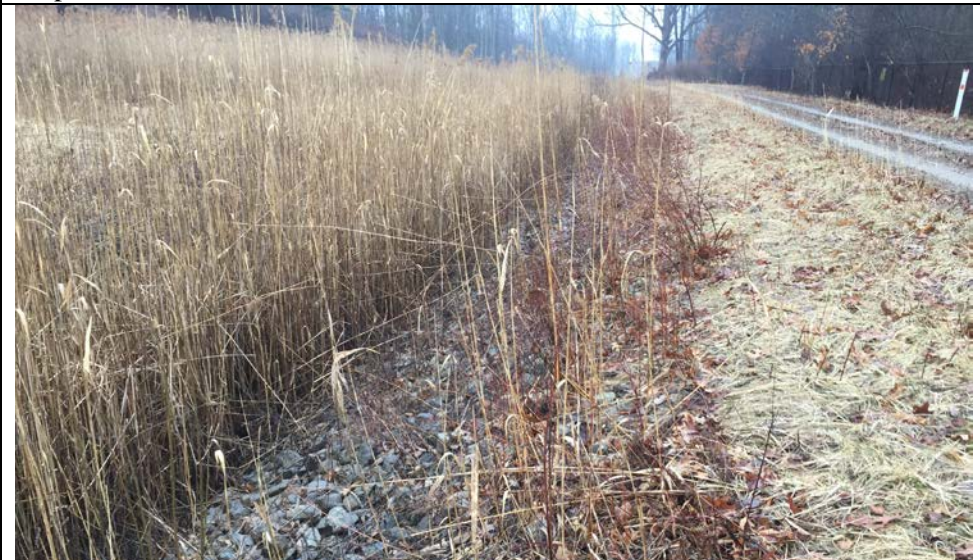
39. Perimeter Ditch Vegetation and Riprap Along Slope. Road in Good Condition. Slurry Trench Marker on Side of Road.

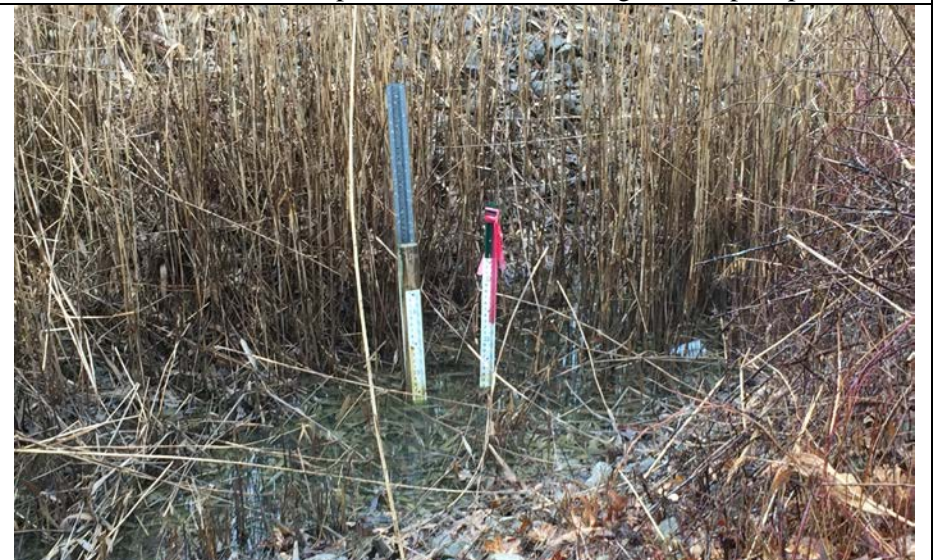
40. View of Perimeter Ditch at SG-01. No Visible Flow Noted.

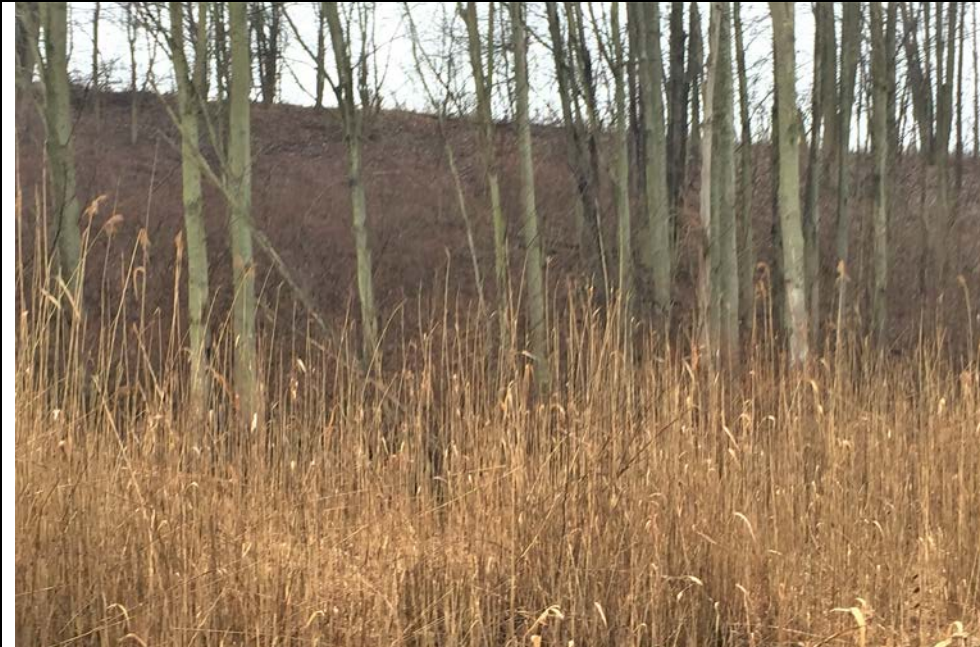
41. Tree Growth Heavy Along Closed Landfill Toe, Less on Slope. No Stability or Erosion Problems Noted on Slope. Top of Slope Inspected Later in Day.

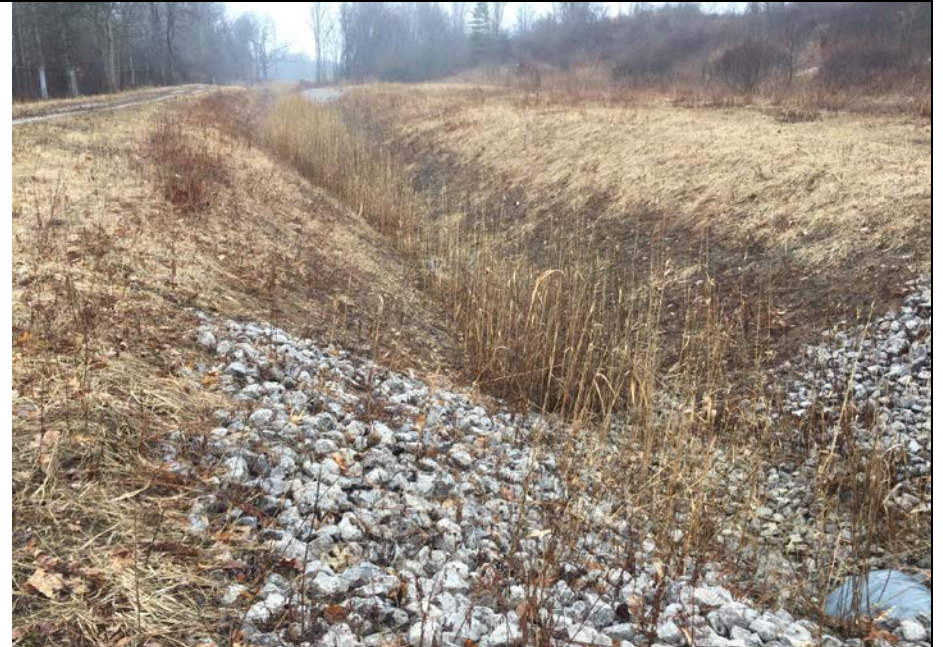
42. View of Perimeter Ditch with Little or No Water Flow. Slopes Appeared Stable and Culvert Not Blocked.

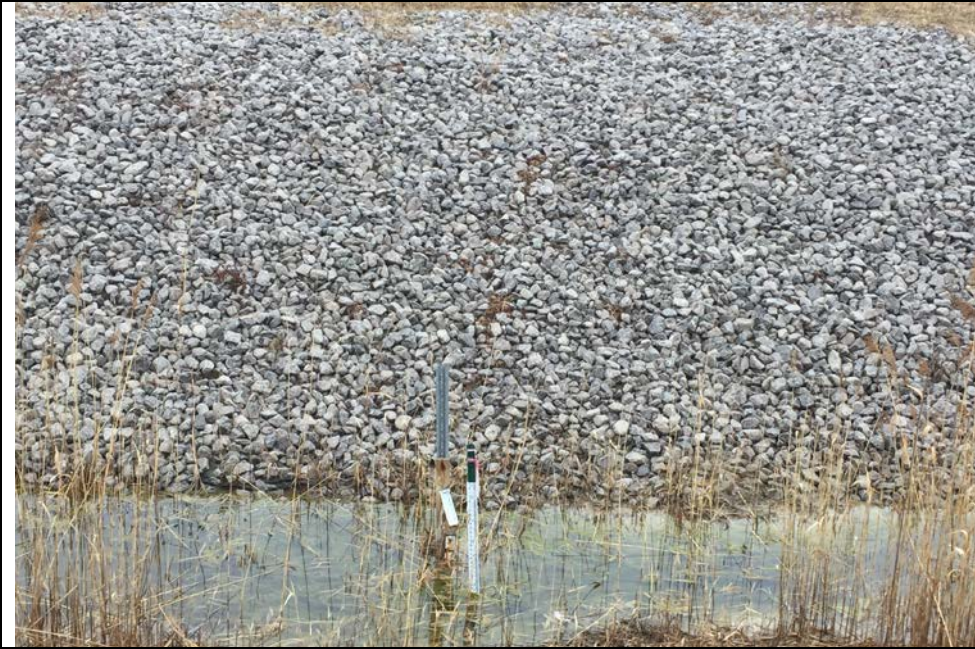
45. View of Stoned Slope and Staff Gauge SG-09 Located West Side of Closed Area F1.

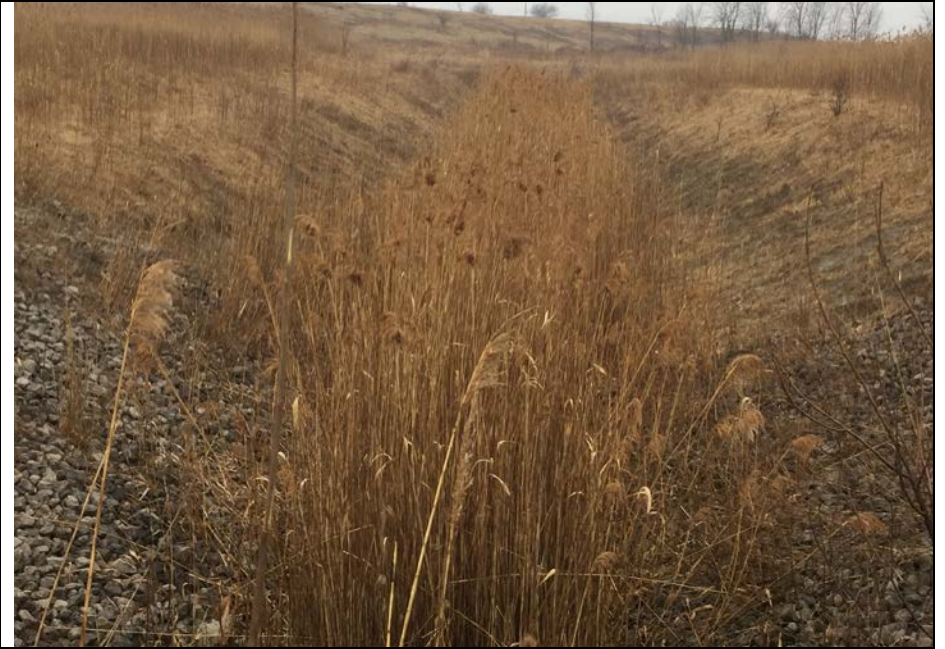
46. Looking South at Perimeter Ditch. Far Slopes at Top of Photo is Un developed Portion of Landfill. Ditch Slopes were Stable and Erosion Free.

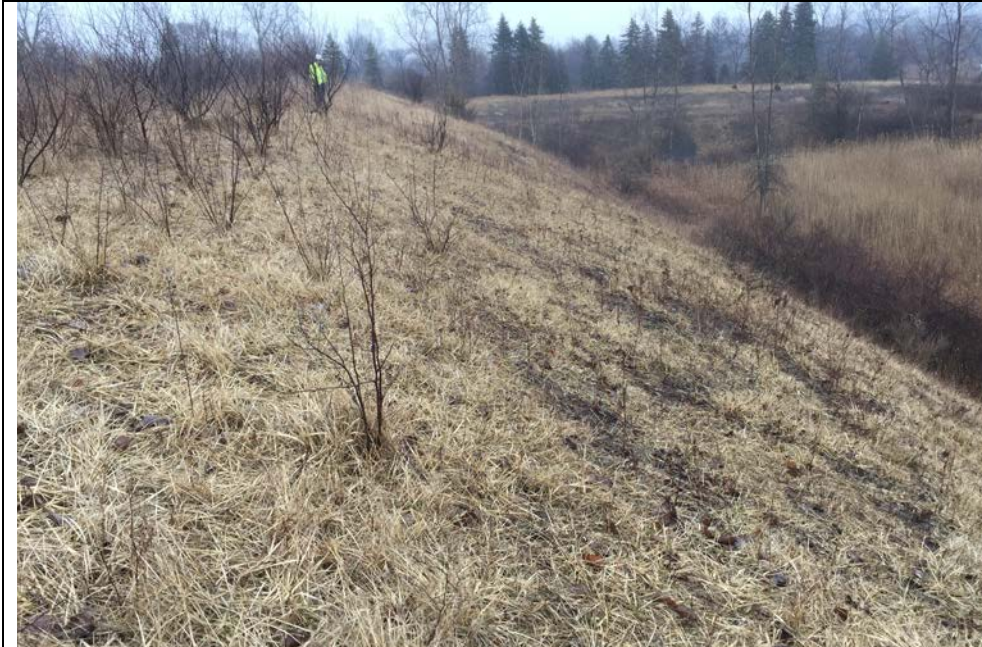
49. Looking at East Slope of Closed Area D1. Slope Appeared Stable, Some Small Woody Vegetation and Person Standing at Top of Ditch in Photo 50.

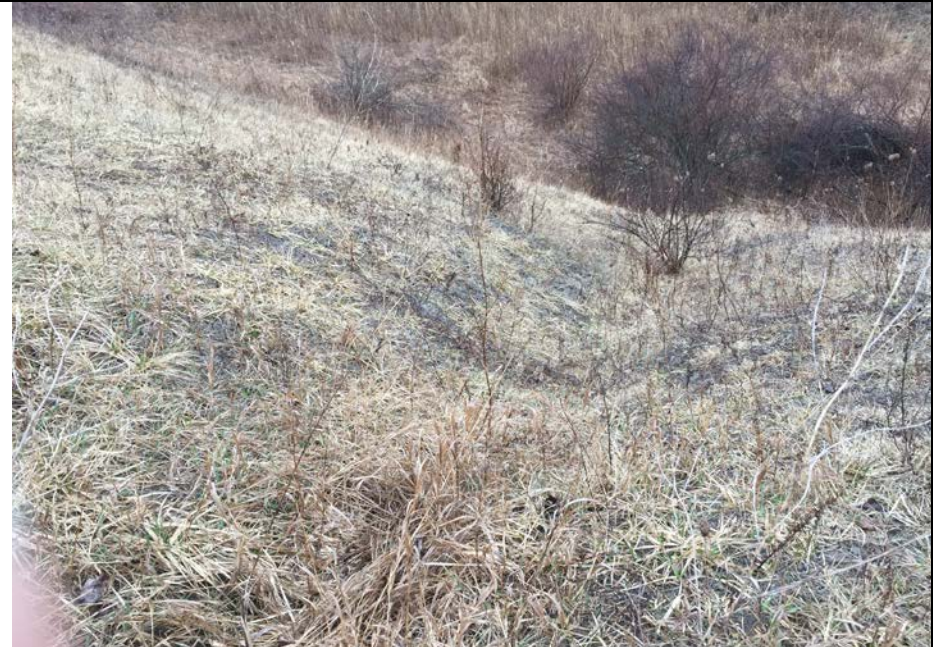
50. Close-up of Drainage Ditch Cut to Drain Landfill Surface Water. Ditch Appeared Stable and Well Vegetated.

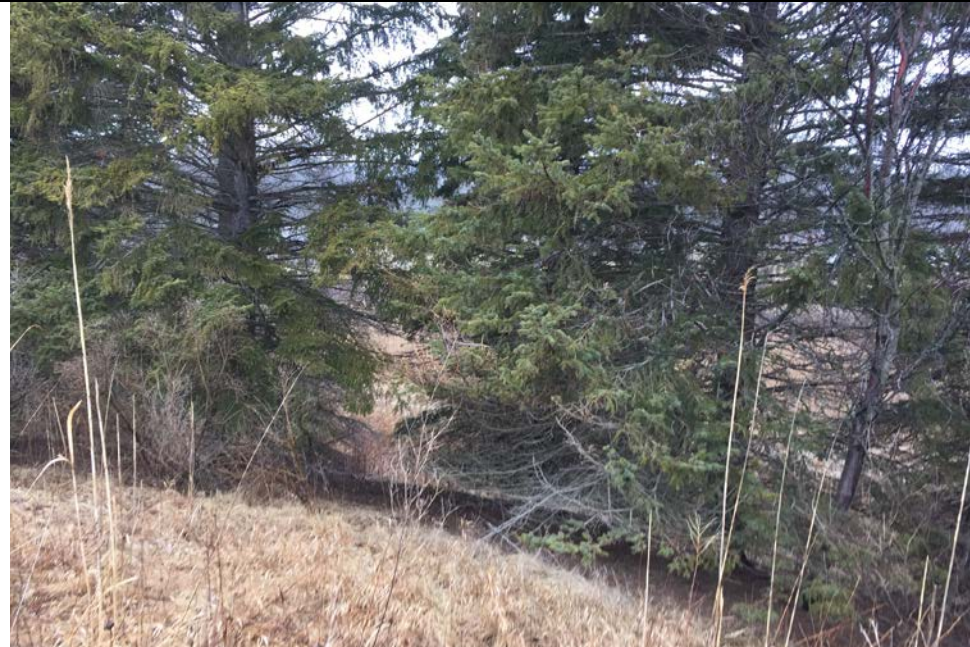
53.. Looking from Top of Landfill at Some of the Largest Trees on North End of Closed Area B Slope. Inspection of Slope Appeared Stable and Erosion Free.

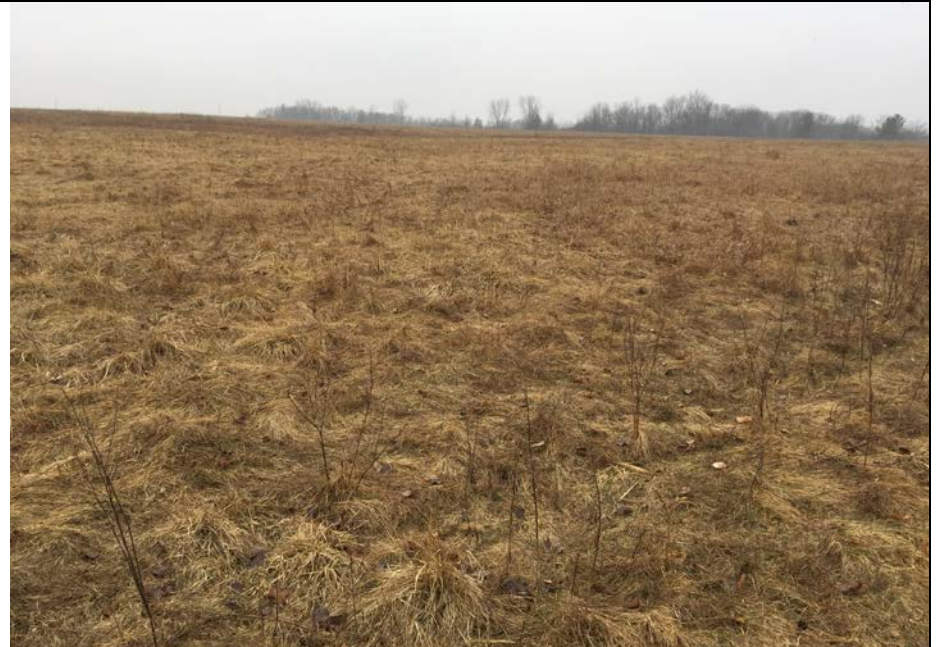
54. Typical View of Top of Landfill Surface Areas at the Northern Half of Landfill. Areas Erosion Free and Generally Free of Nuisance Vegetation.

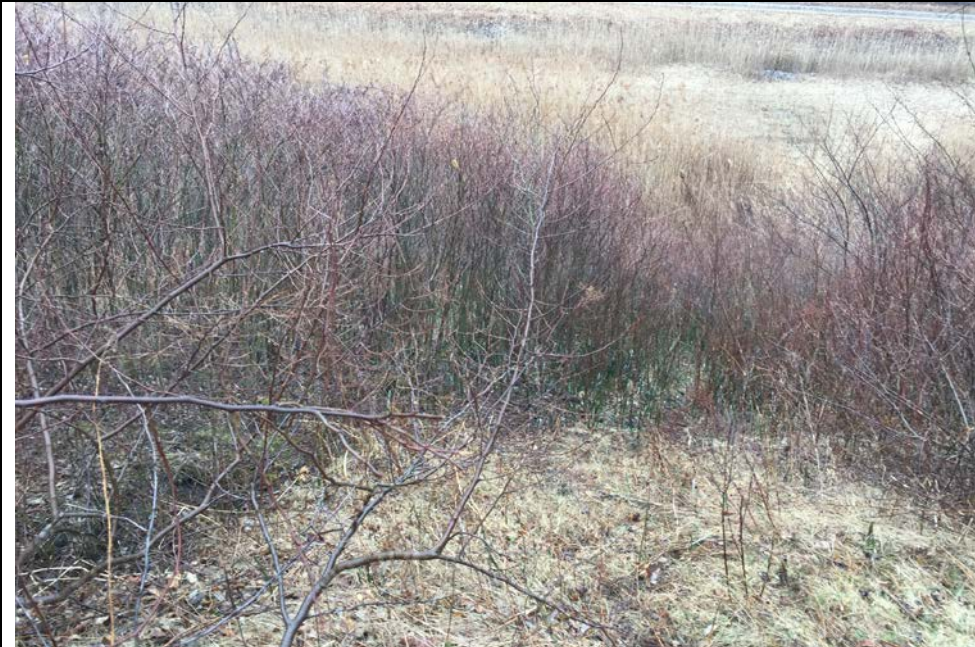
57. Looking Downslope Appearing from Road Below to be a Significant Erosion Gully, was Actually a Minor Gully at the Top and a Deer Run Down the Slope.

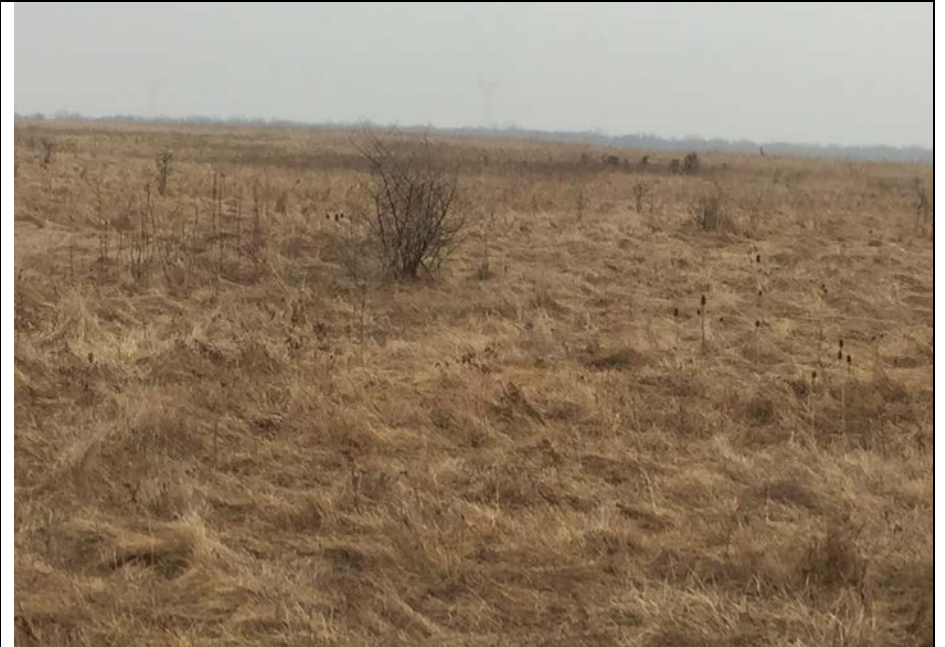
58. View of Top of a Closed Landfill Area Containing Some Minor Small Woody Vegetation. Top Well Vegetated and Free of Erosion.

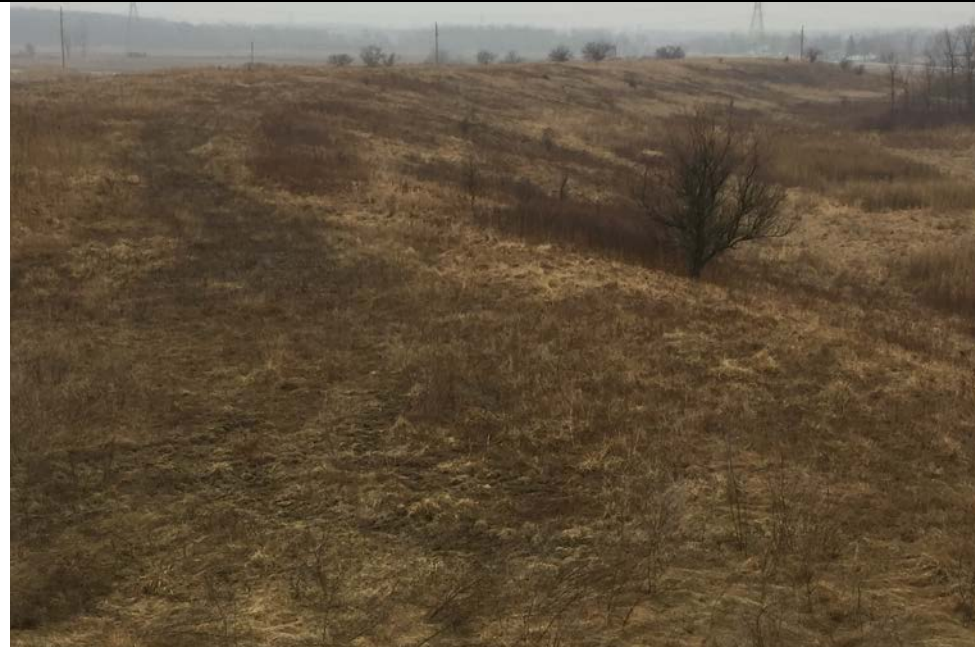
61. View of Outside Slope of Northeast Side of Landfill. Area downslope is Not a Closed, Active or Future Landfill Area. Minor Woody Vegetation on Slopes.

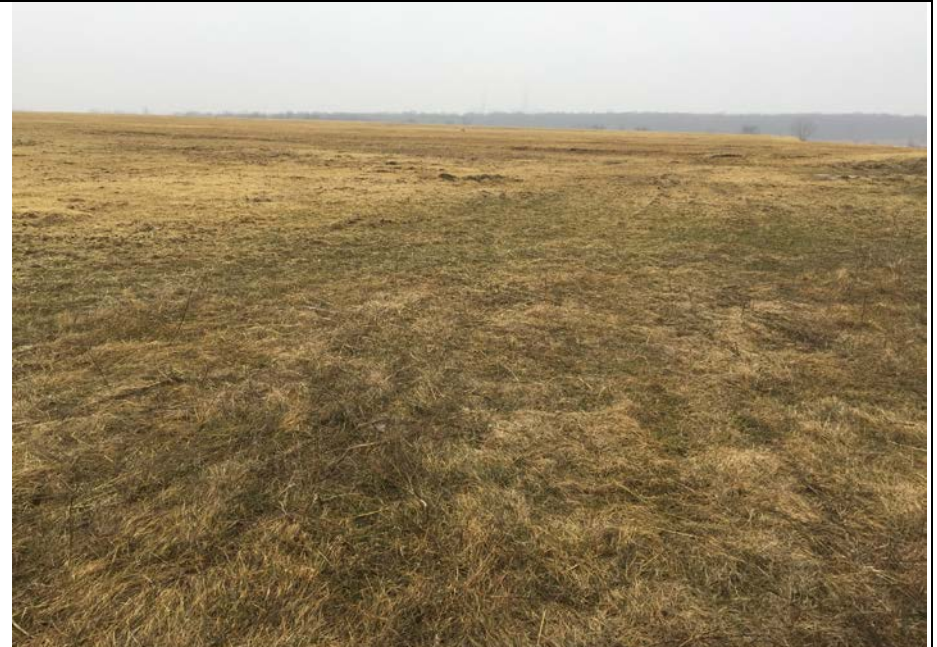
62. Looking NE from Closed Area F2 at Southeast Side of Seeded Final Cover of Area F3. Seeding Completed Late in 2017,
