**2018 ANNUAL INSPECTION REPORT  
RANGE ROAD LANDFILL  
ASH DISPOSAL FACILITY**

**China Township, St. Clair County, Michigan**

January 2019

**APPENDIX B**  
**DTE Range Road Landfill Annual Inspection 29 March 2018**

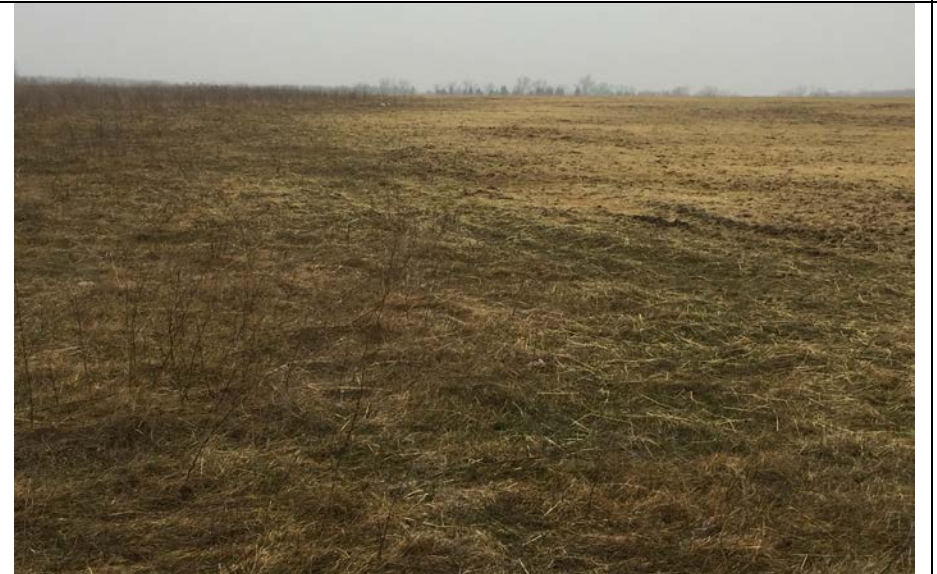
64. Another View, Left of Photo 63, of Seeded Final Cover of Area F3. No Visible Significant Surface Erosion, Although Small Tire Ruts Noted.

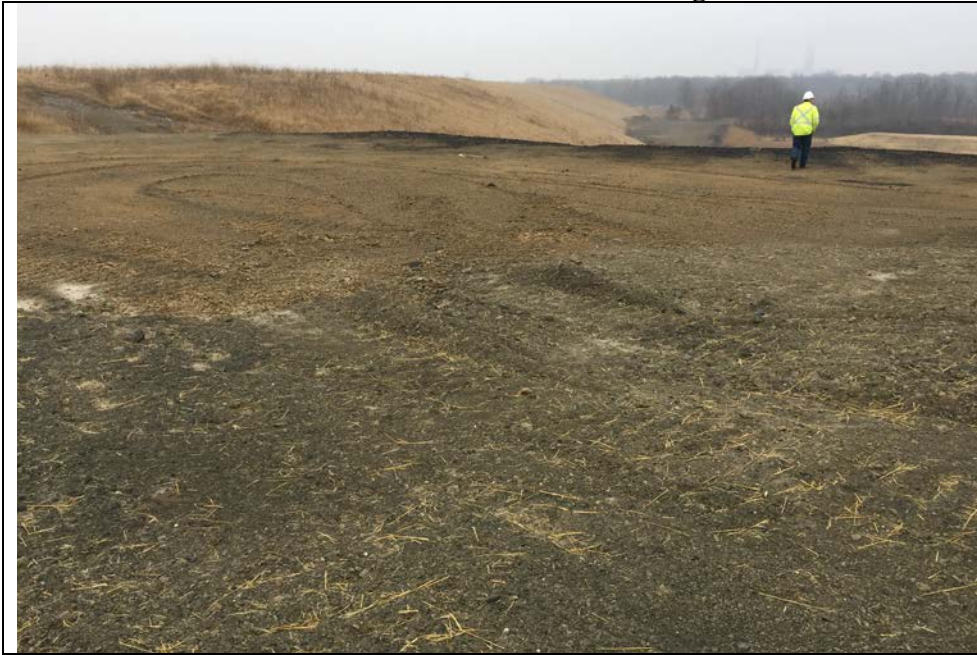
In conclusion, the top and final slopes of the closed landfill final cover areas appeared well vegetated and are consistent with recognized and generally accepted good engineering standards. Some minor woody brush removal has been recommended. This has also been observed and noted in the DEQ 3<sup>rd</sup> and 4<sup>th</sup> Quarter Inspections. Area F3 that is identified as “Closed” in Table 2 had its final cover area graded and seeded at the time of site inspection, but the area was not entirely complete or not yet showing vegetation growth and therefore had not yet been certified by the responsible CQA Certifying Engineer. Current documents now indicated that the area is awaiting or pending certification approval. Photos of the final cover of Area F3 include Photographs 62-64, 104 and 105. The area identified as F3-D3 has had temporary cover placed but did not appear to have reached final grade. Area F3-D3 is shown in Photograph 65.

65. Portion of the North End of Areas F3 and/or D3 where Seeding and Final Grading May Not be Completed. No Visible Surface Erosion. Edge Berm Shown.

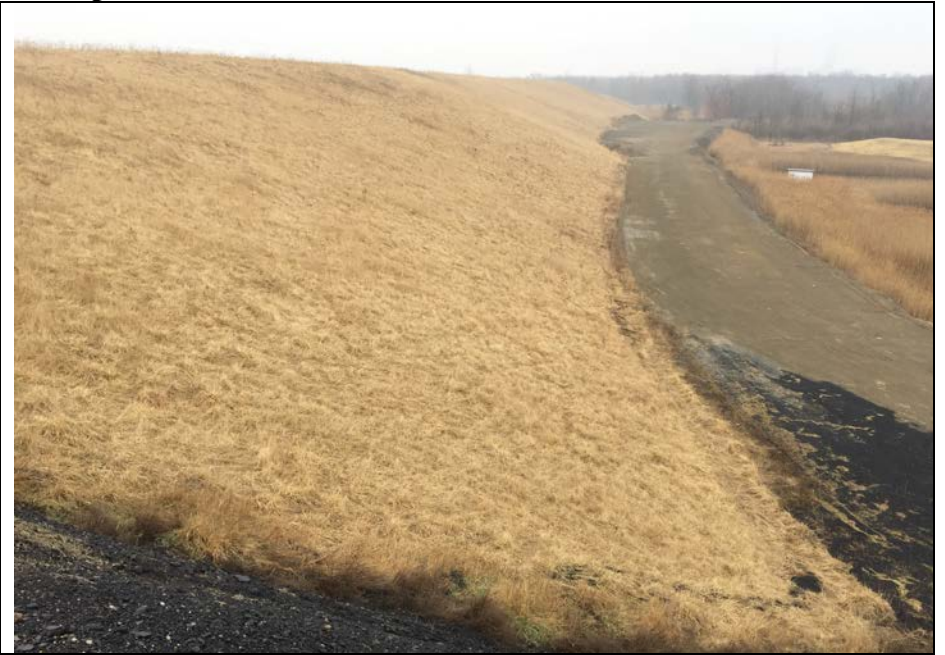
66. Looking North at Slope of Closed Area D2. Slope Appears Stable and Well Vegetated.

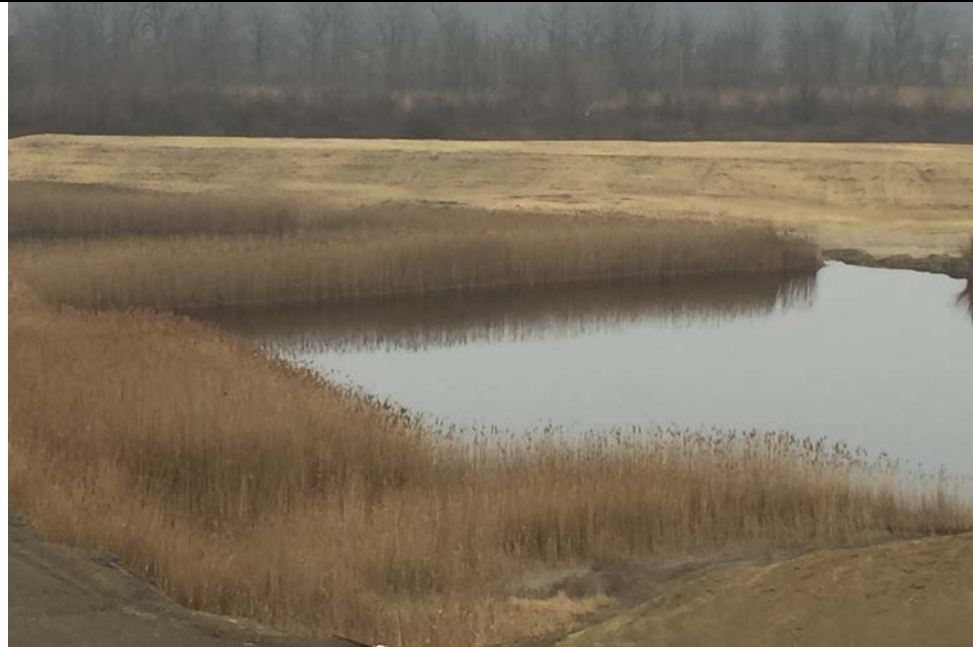
69. Close-up View of Seeded Fill Stockpile Shown in Photo 67. Erosion Gully Draining Runoff to Pond Also Visible.

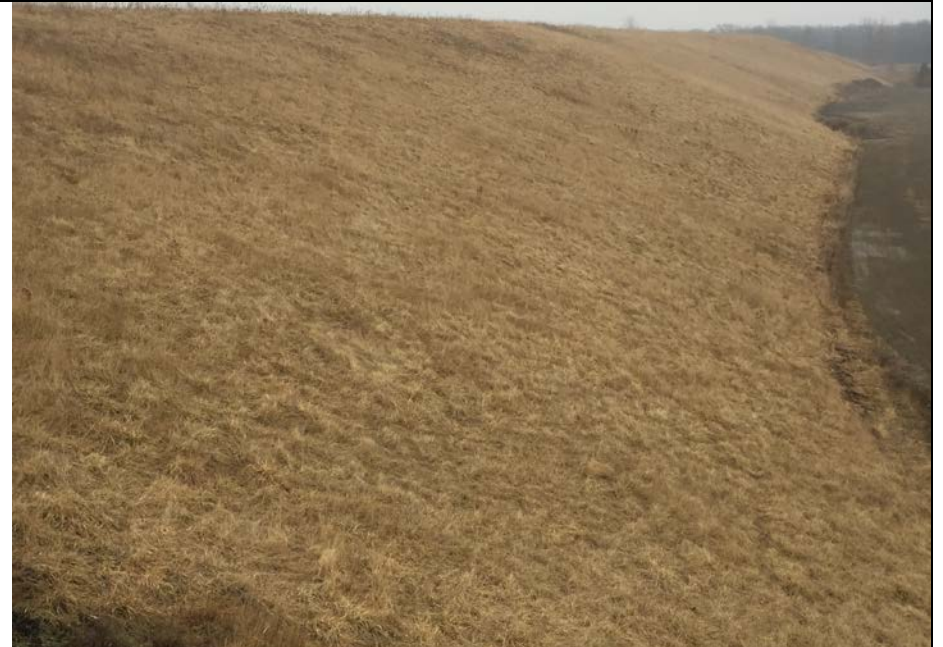
70. Another Close-up View of Slope of Closed Area D2 Shown in Photo 66. Slope Appeared Stable and Well Vegetated.

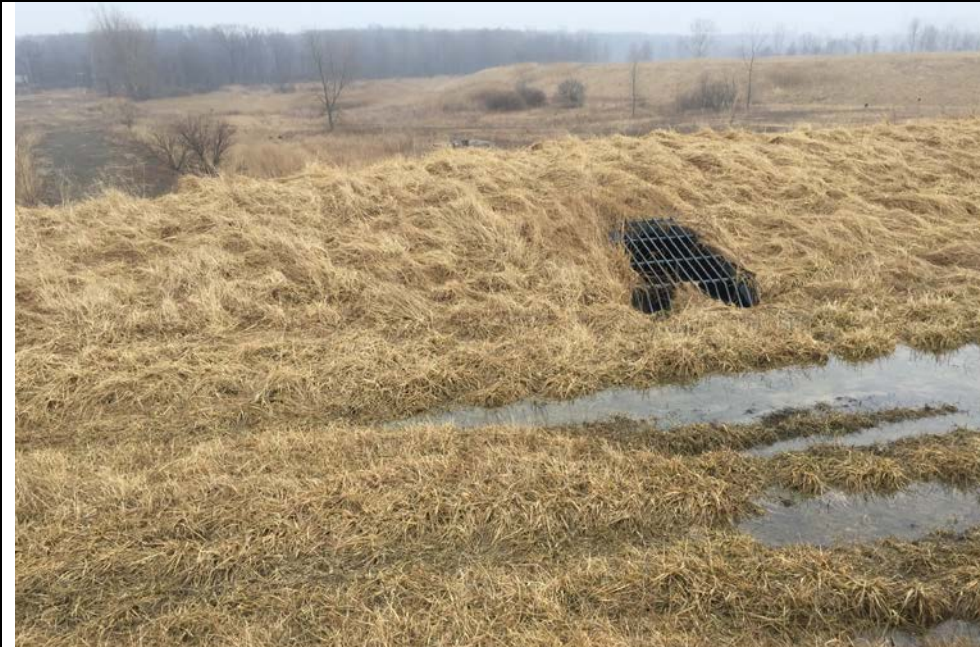
73. Collection Swale & Berm with Downslope Drainage Pipe with Steel Grate. No Blockage but Some Minor Wheel Ruts in Surface Area.

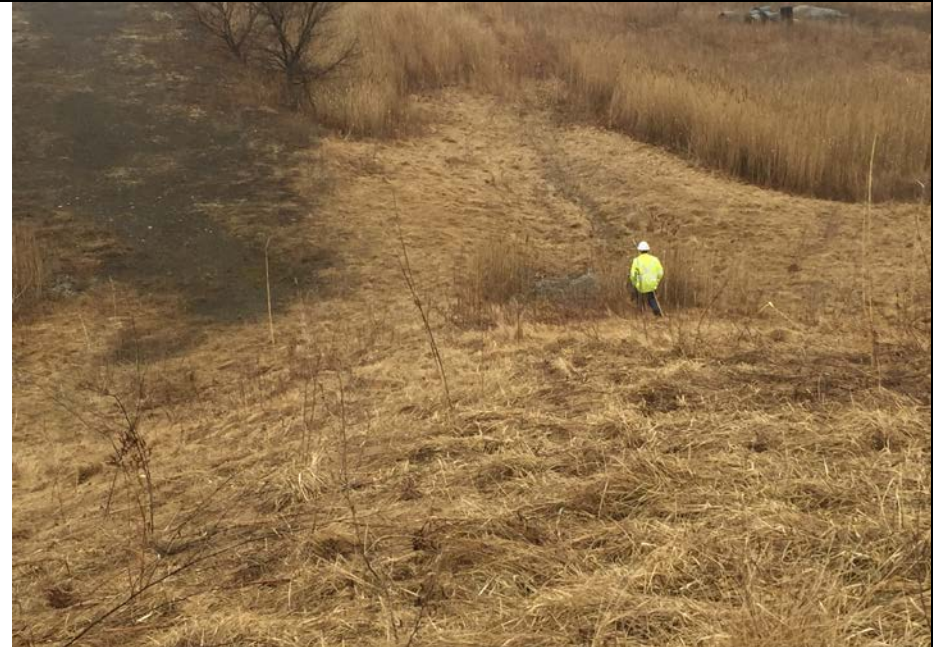
74. DTE Person Checking Outlet of Downslope Drainage Pipe. No Blockage and Acceptable Flow Conditions Reported.

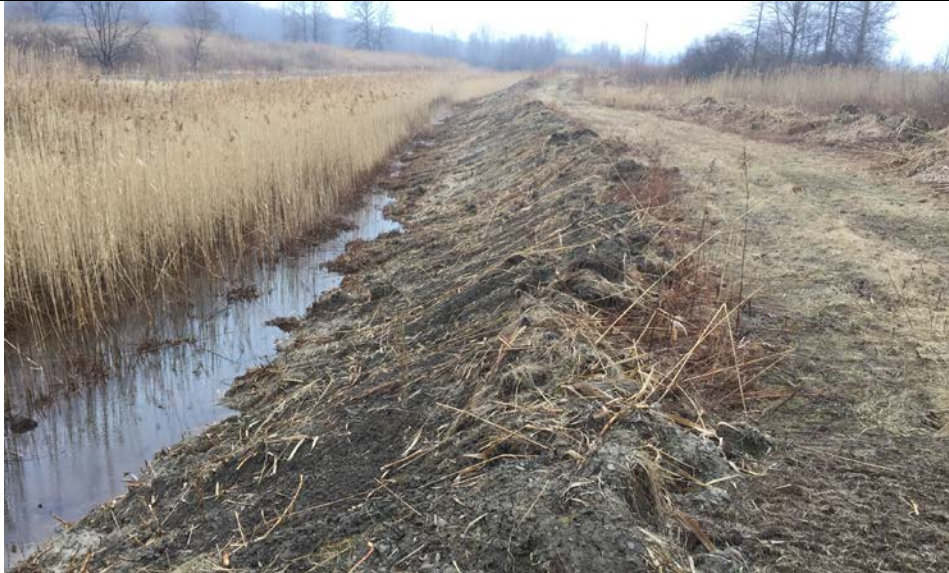
75. Ditch Maintenance Clearing Vegetation and Flow Grades.

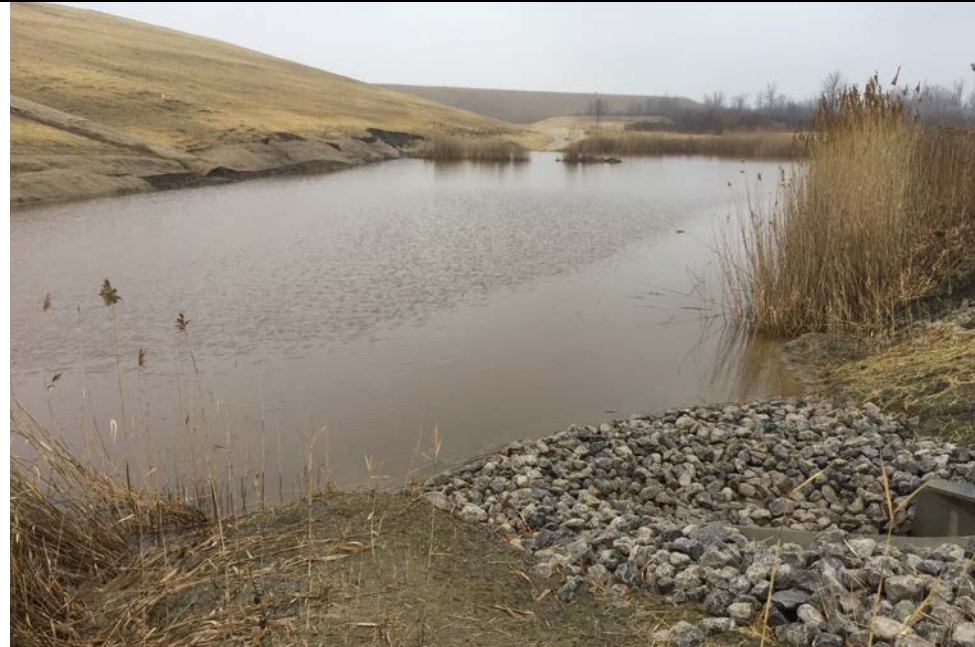
77. Pond Side of New Outlet Culvert with Riprap Check Dam. Culvert Discharge Side Shown in Photo 76.

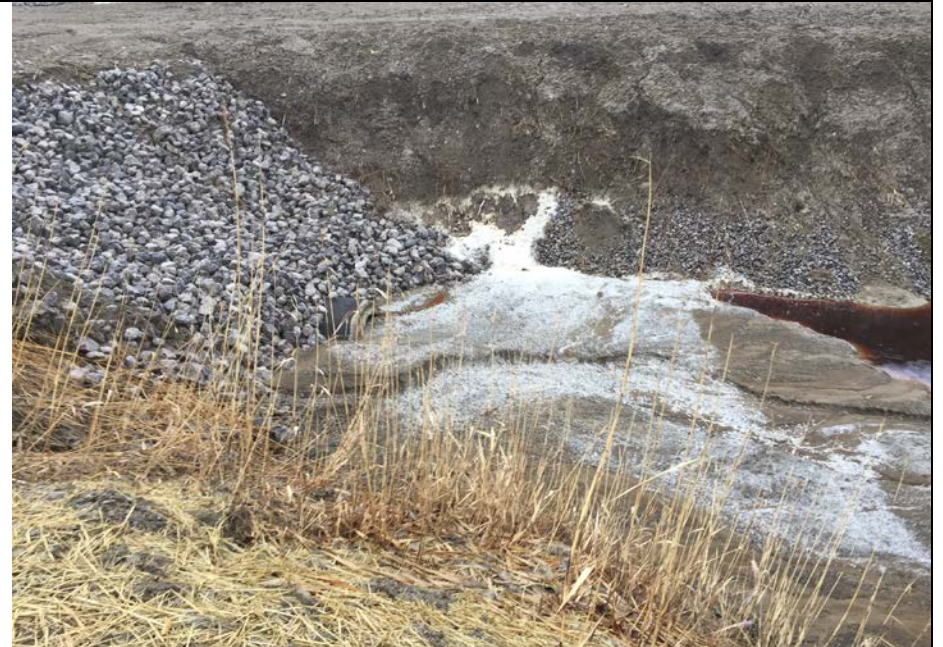
78. Previous Location of Old Culvert and Discharge from Pond in Photo 77. New Culvert Crossing Beneath Main Haul Road Installed Late 2017.

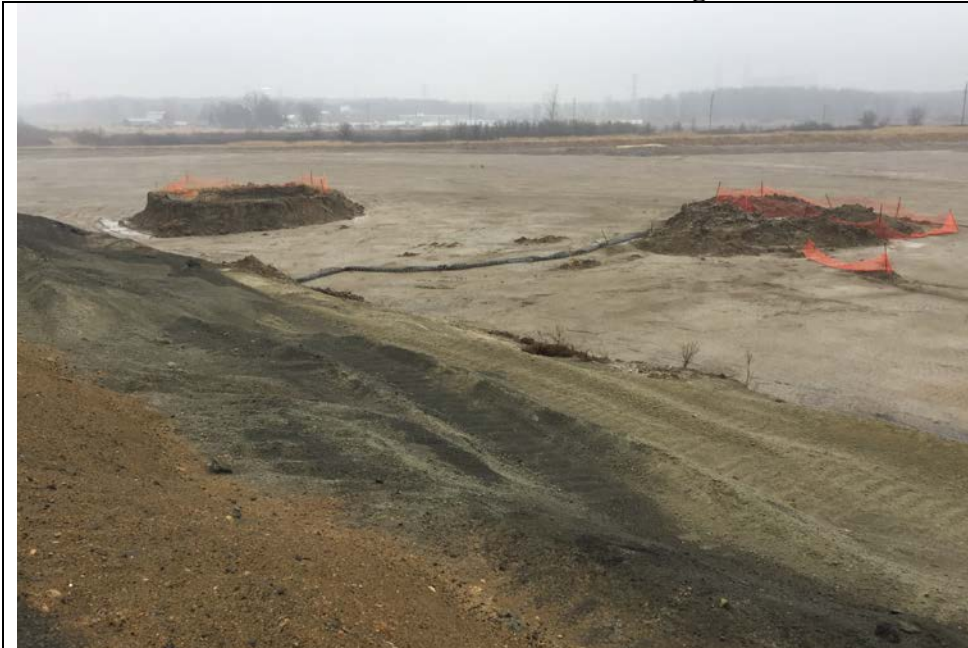
81. Active Area G2 Phase I where an Abandoned Gas or Oil Well was Located.

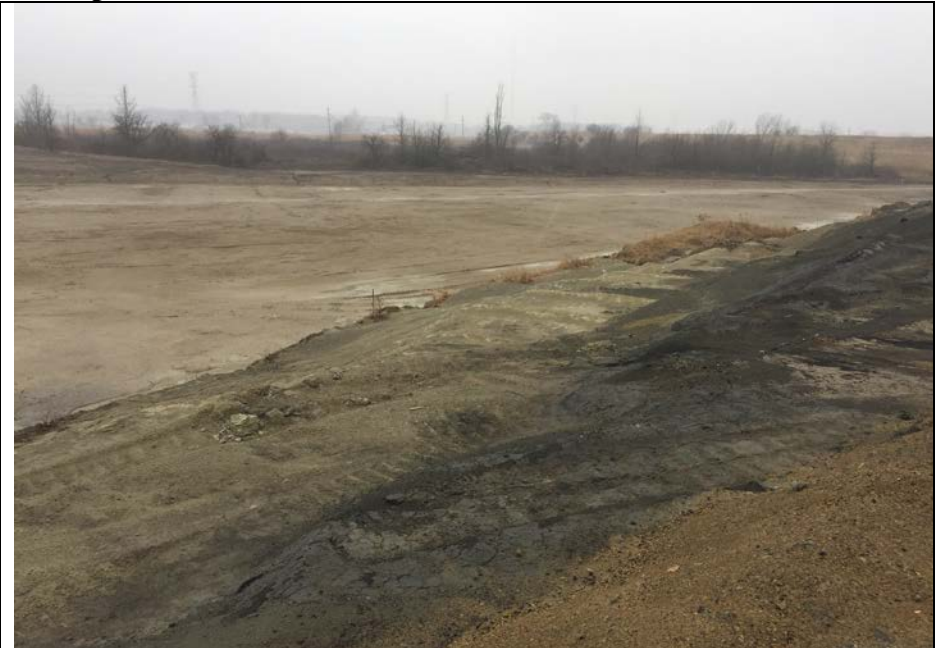
82. View of Active G2 Phase I Waste Placement Area. Bottom Area is Composed of Existing Clay Soil.

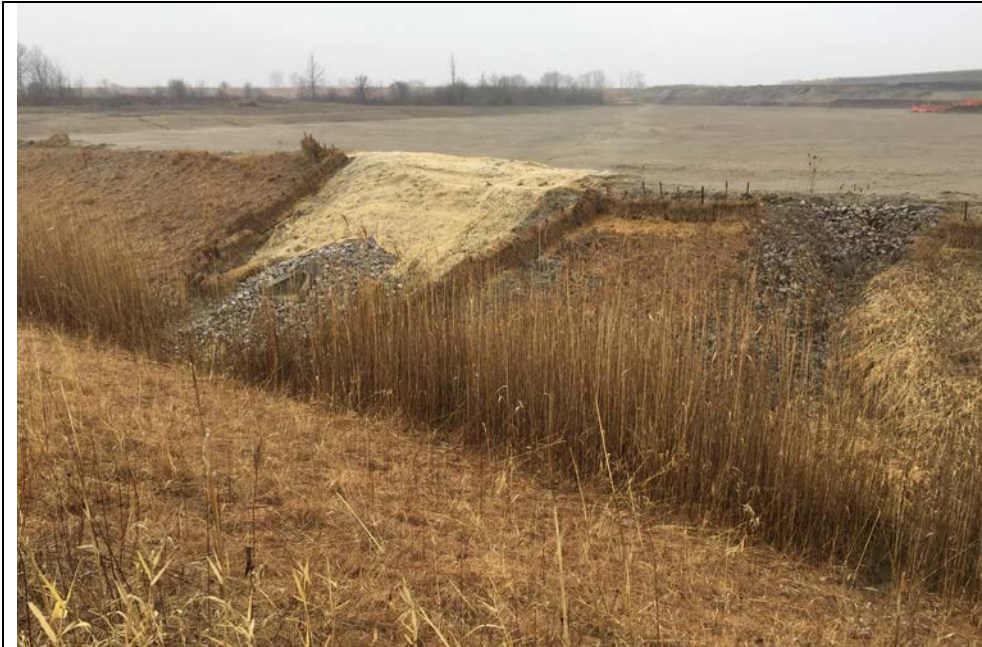
85. Perimeter Ditch Alongside G2 Area. Right Side Gully Filled with Riprap from Previous Repair. New Pipe Discharge Chute from G2 Surface Runoff Flow.

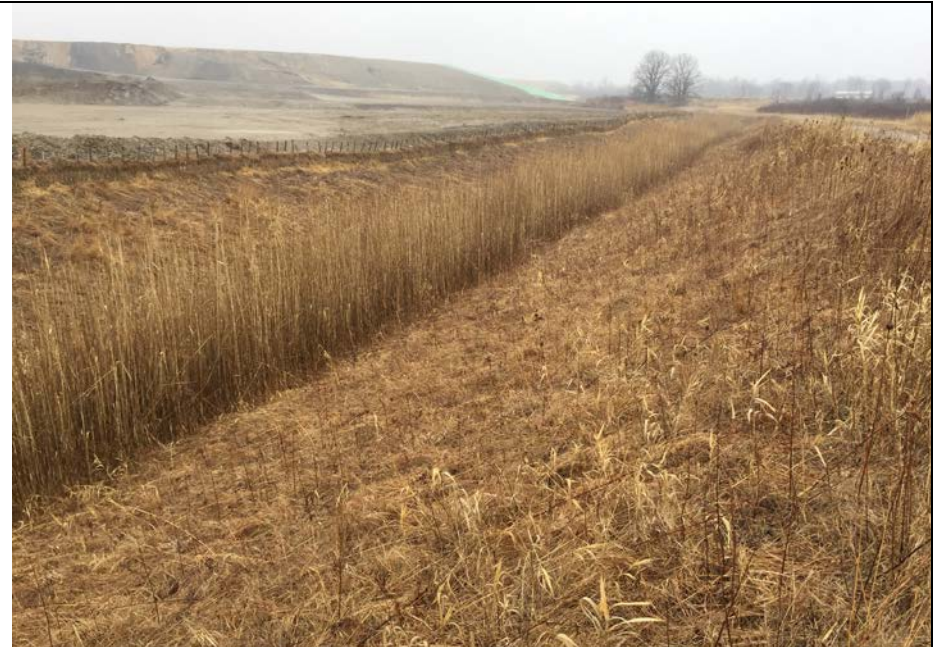
86. Looking NE at Perimeter Ditch and G2 Area. Ditch Slopes were Reconstructed in 2010, Appear Stable, and Well Vegetated.

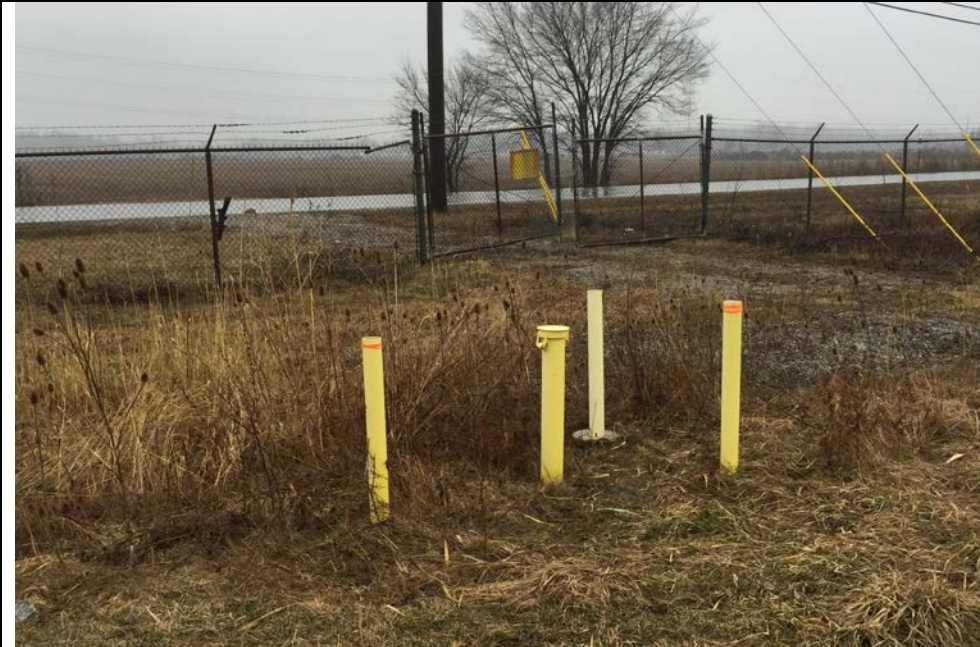
89. GW Monitoring Well 16-05 and Site Fencing and Gate Along Puttygut Road. Fence Fabric is Strung Across Chained Opening Blocking Unauthorized Entry.

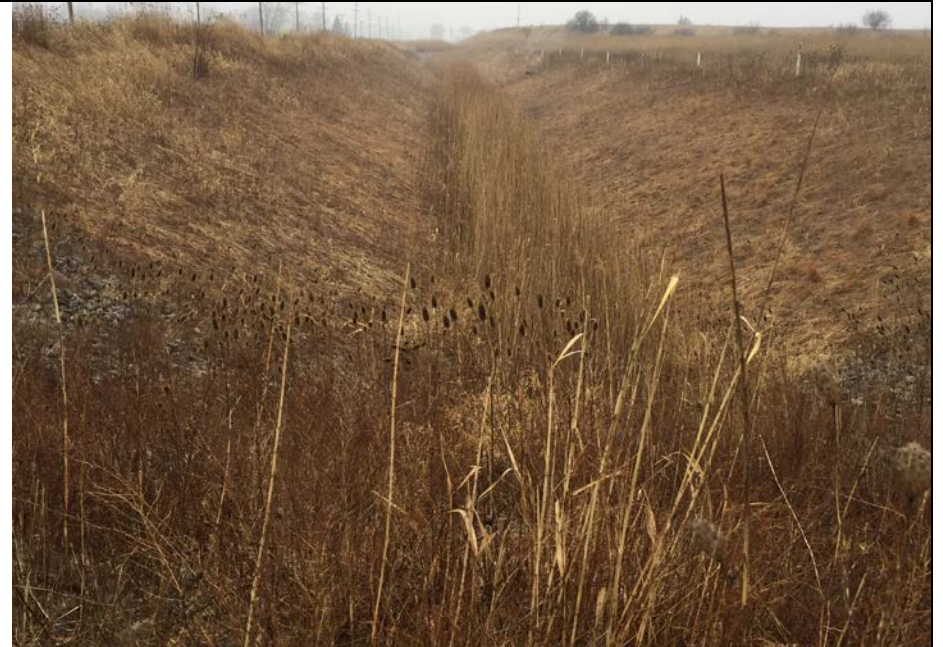
90. Looking West at Perimeter Ditch West of Gate Location. Slopes Stable and Well Vegetated. Ditch Slopes were Reconstructed in 2010.

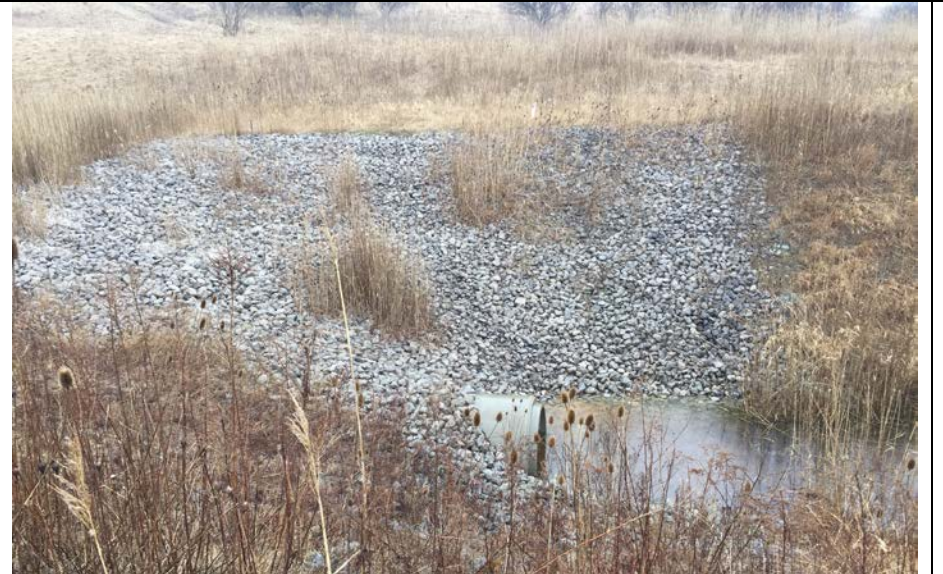
92. End of Concrete Pipe Installed as Ditch Replacement where Ditch Could Not Have Slopes Flattened Due to Adjacent Steep Slope. Flow Noted.

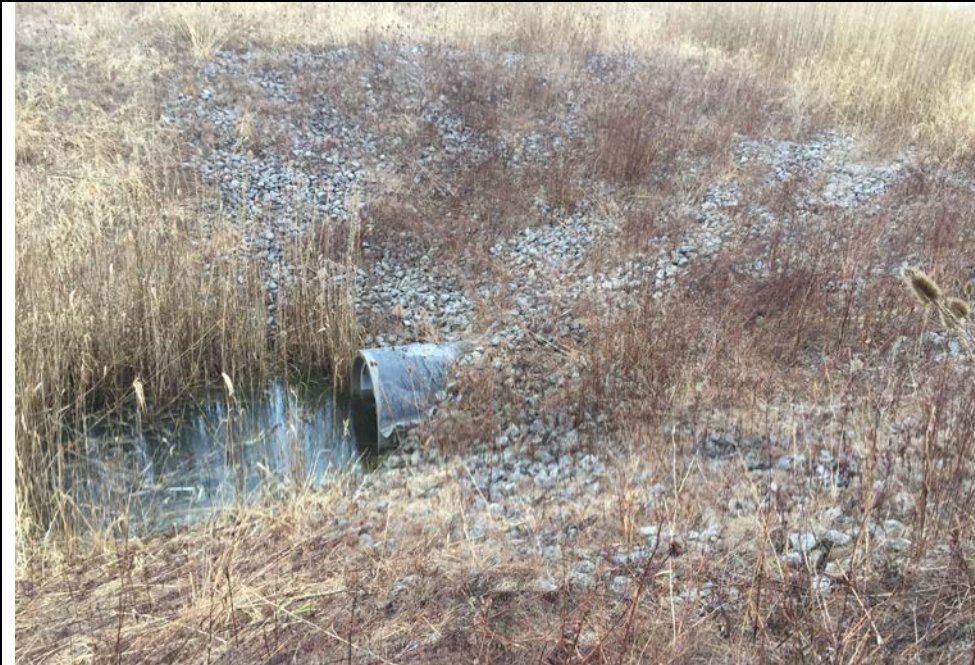
93. Upstream End of Concrete Pipe Shown in Photo 92.

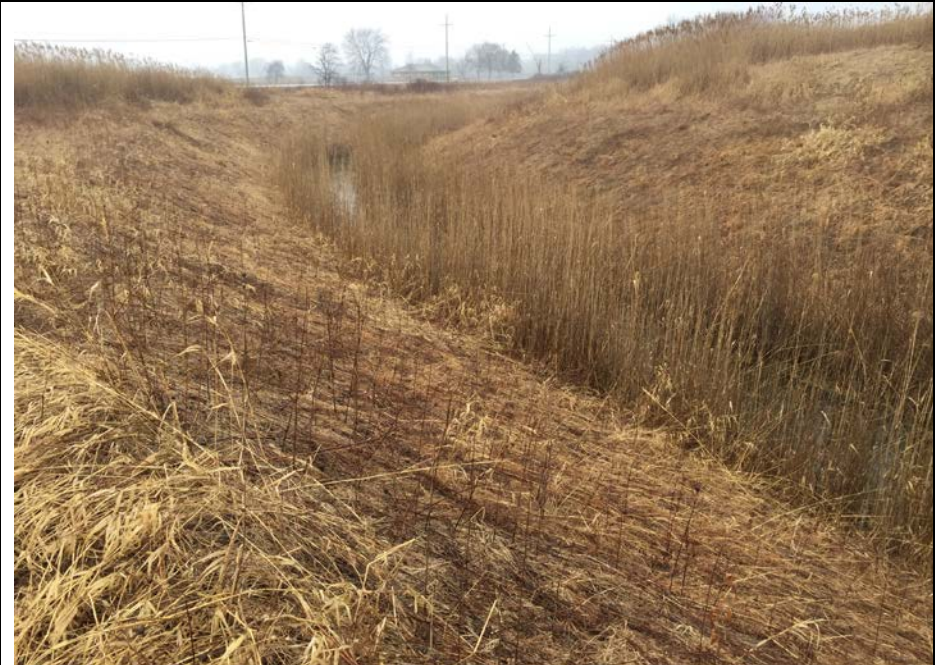
94. Landfill Perimeter Ditch at Southwest Corner of the Site. No Road Construction Alongside of Ditch. Slopes Stable and Well Vegetated.

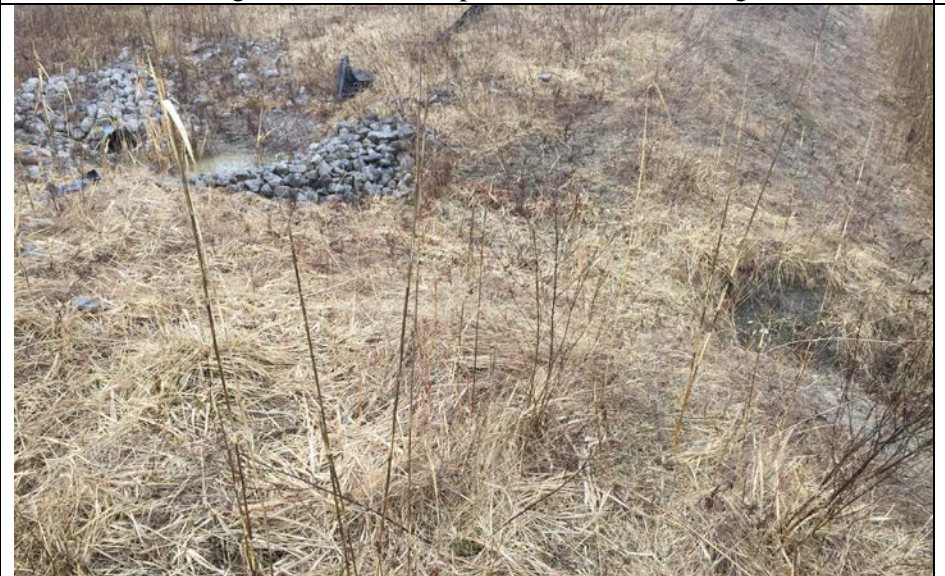
96. Culvert and Riprap Check Dam with Flow Draining into Perimeter Ditch. Some Slope Runon Erosion Noted Along Ditch.

slope erosion near the southwest corner and shown in Photographs 96, 97 and 99 be scheduled for repair. One or more of these repair recommendations may have already completed.

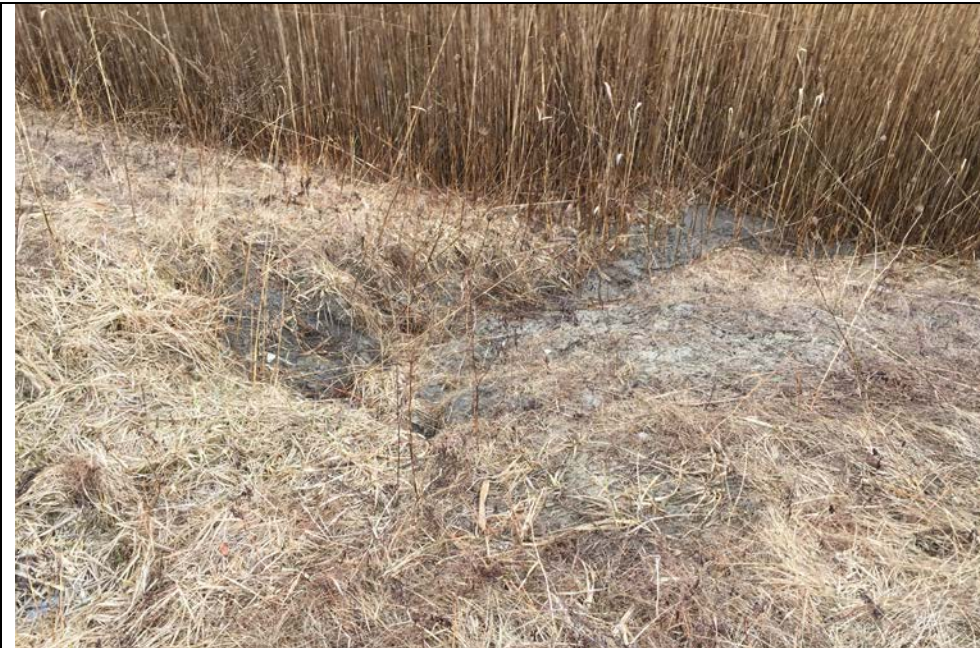
97. Photo of Ditch Bottom Slope Erosion Shown in Photo 96.

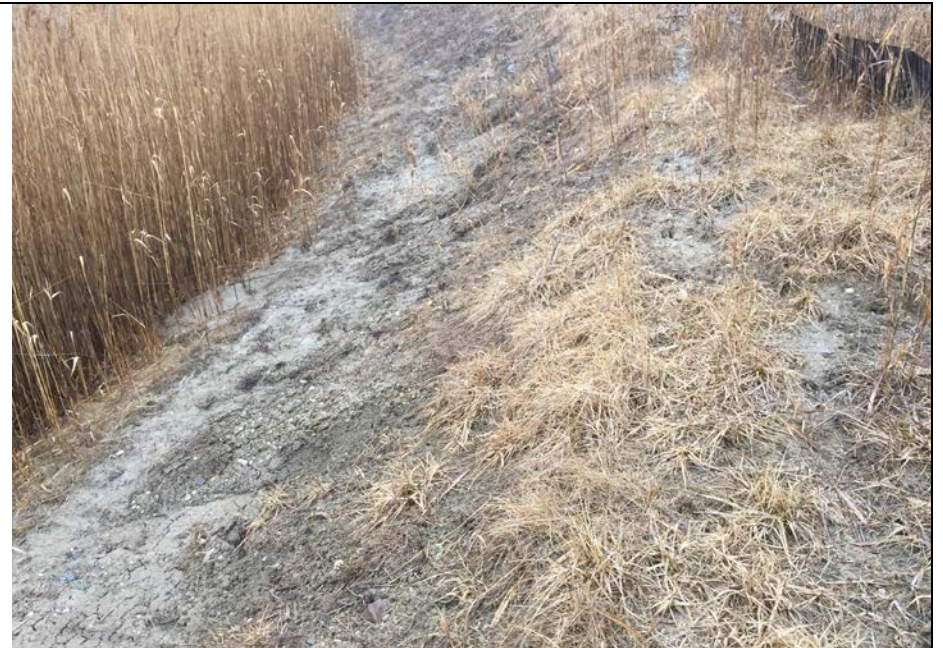
98. Portion of Ditch Near Gas Piping Fence Enclosure that has been Graded. Slope Appeared Stable but Vegetation is Sparse and May Regrow in Spring.

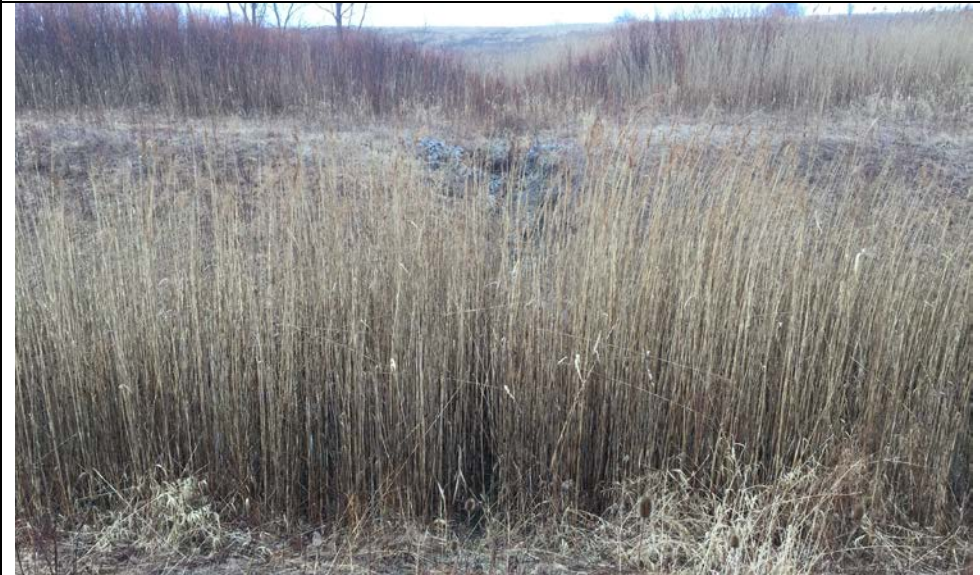
99. View of Erosion Gully Along Landfill Side of Perimeter Ditch at SW Corner Parallel to King Road. Additional Gully Repair Recommended.

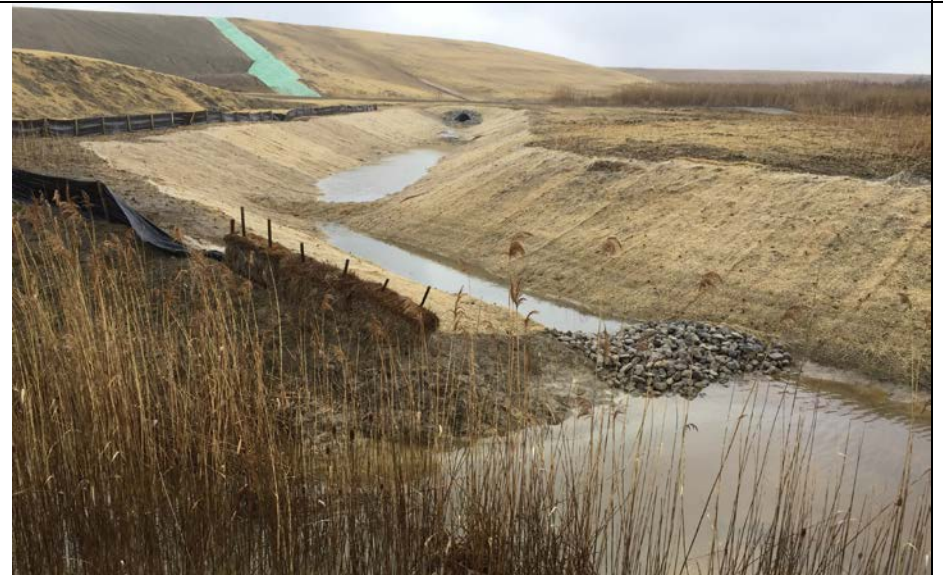
100. View of the New Internal Ditch from Point of Intersection with Perimeter Ditch. New Ditch Also Shown in Photo 76.

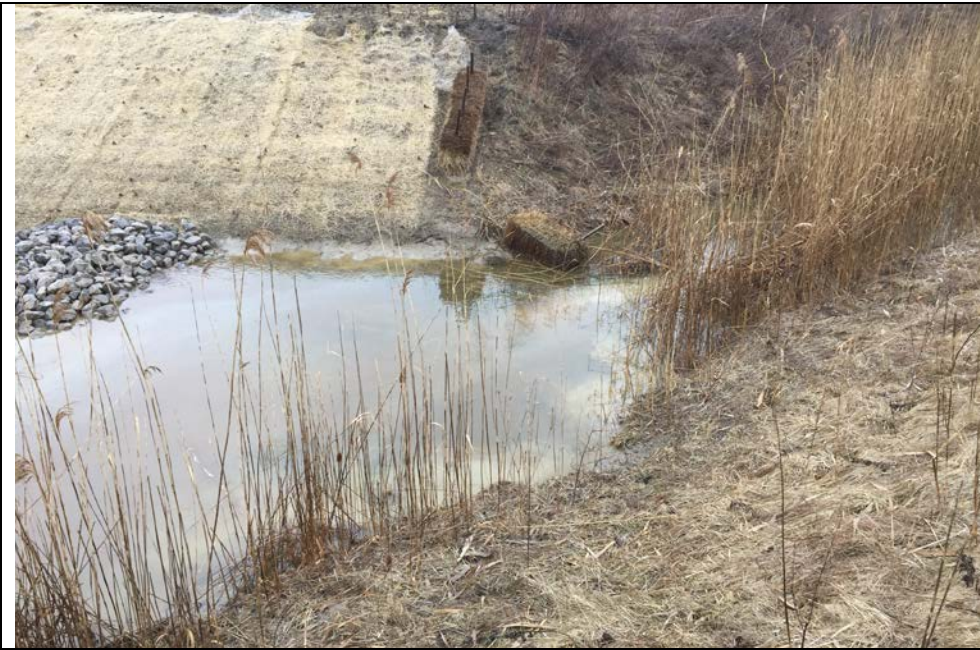
101. Pool of Water from Internal Drainage Pond. Future Slope Work Required.

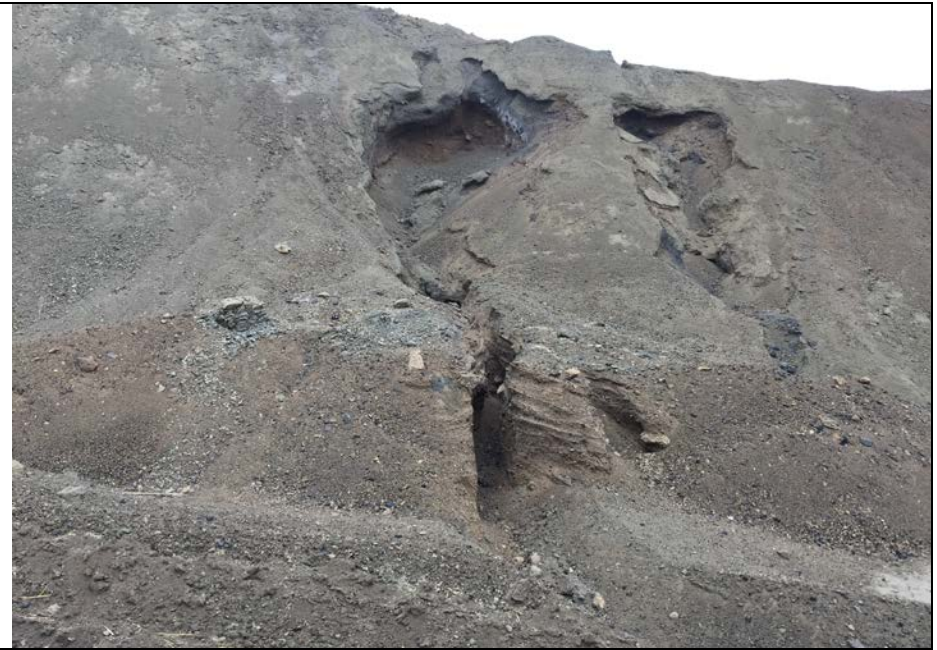
One significant area of temporary slope runoff erosion is along the southeast side of Active Area F3 cover construction and road ramp up to the work areas. This eroded temporary slope is shown in Photographs 102 and 103. The slope erosion may have already been repaired as DTE planned to discuss a repair with the onsite contractor. If not, the erosion does represent a safety stability problem because the runoff and gullies cross an active haul road, as shown in the photographs.

102. Significant Runoff Erosion Gully Present on Fill Slope Alongside Road to Top of Landfill at Area F3. DTE to Discuss Repair with Contractor.

In addition to clearing the culvert vegetation blockage shown in Photograph 18 and runoff erosion on the temporary waste slope shown in Photographs 102 and 103, it is recommended that ditch

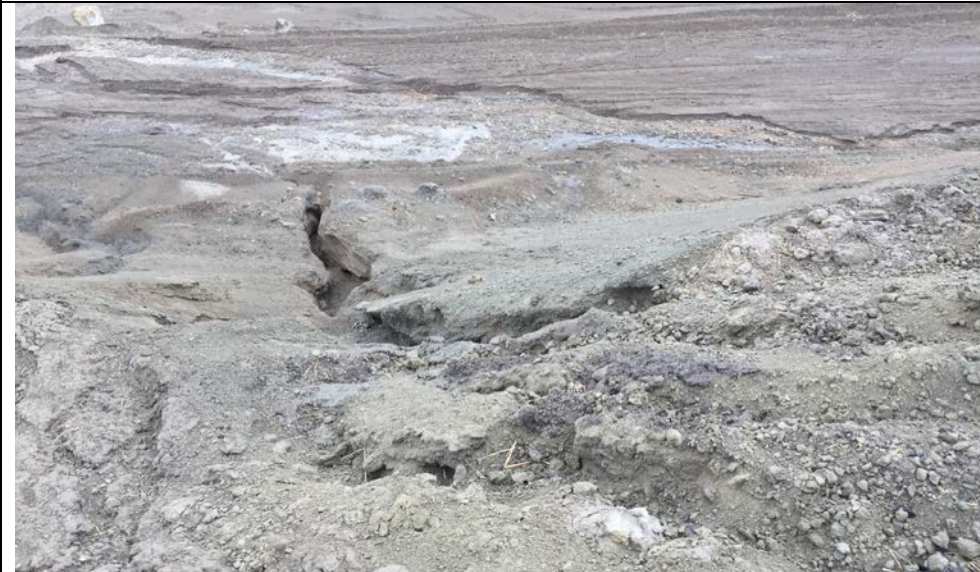
103. Top of Erosion Gully Shown in Photo 102. Runoff from Cover Surface Flow from Area F3. Haul Road Shown at Top of Photo with Gully Flow Across Road. Repair Needed

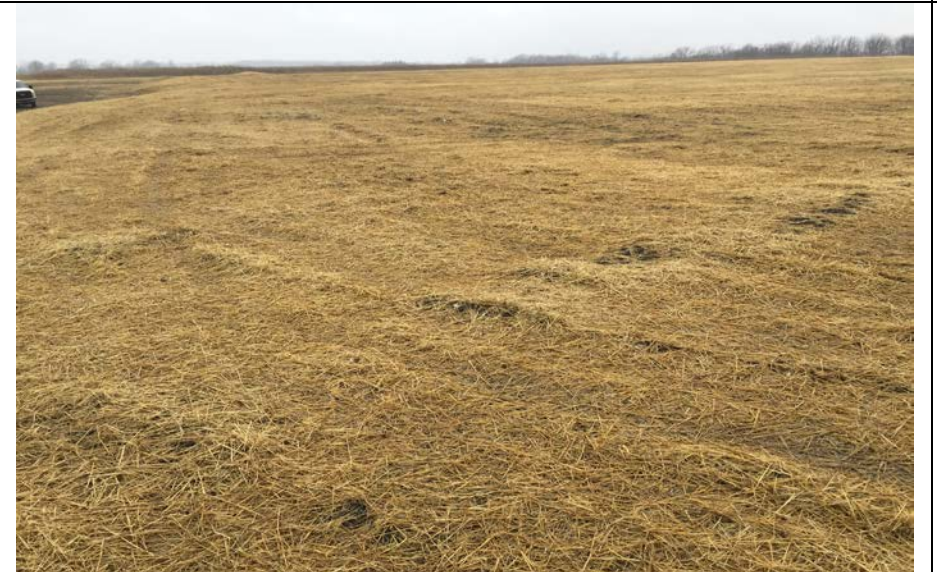
104. Final Cover Surface in Area F2. Drainage to F3 Corner that Drains to Fill Slope Shown in Photo 103.

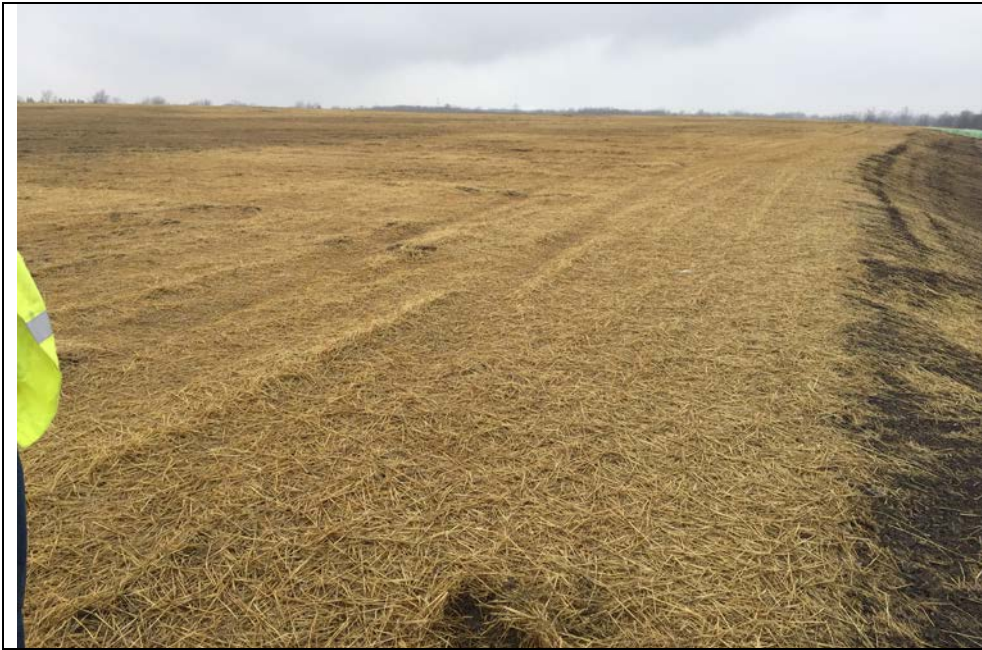
105. Another View of Grading and Final Cover Seeding at Area F2.

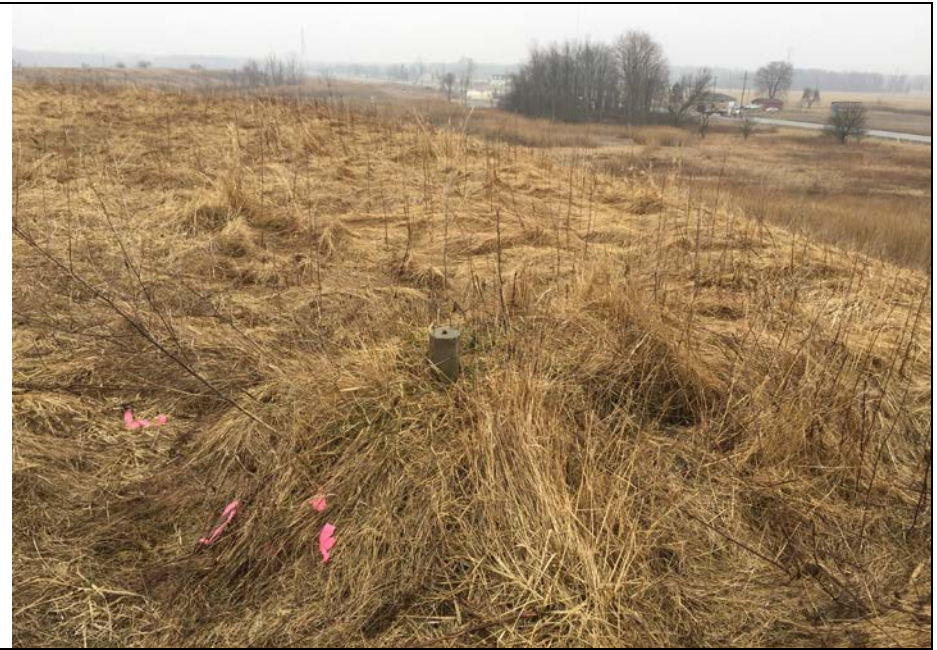
106. View of Construction Survey Monument Top of Closed Area F1 Along the West Slope.

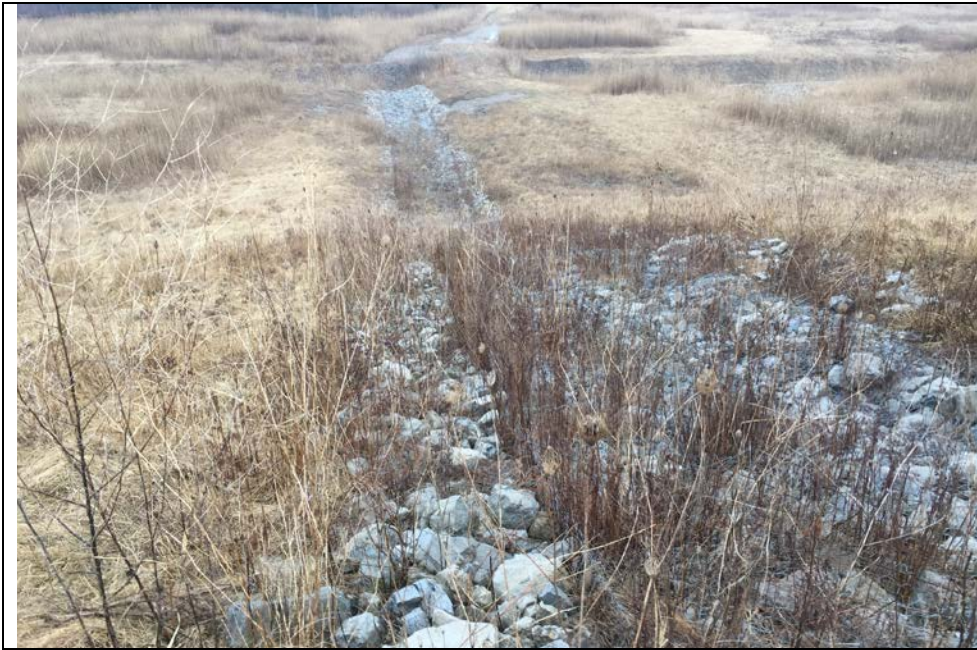
109. Area F2 Downchute Filled with Riprap and Screened Drains into Riprapped Perimeter Ditch. Road Crossing Right Side with Culvert. Slope & Chute Stable.

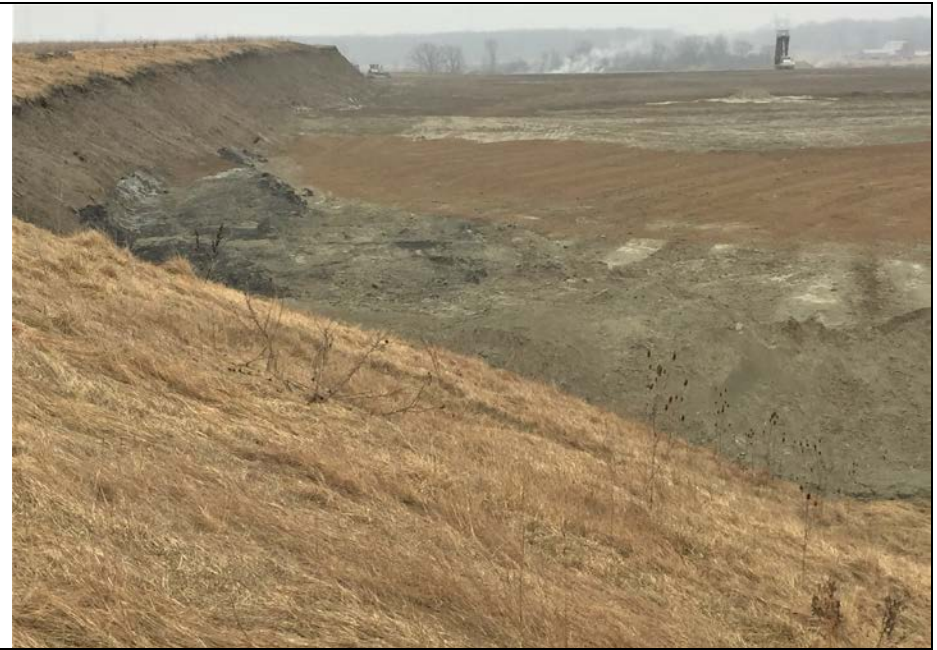
110. Looking SE at Active Area G2 Phase 1. Waste Placed at Bottom Slope, but Not Graded or Compacted Yet. Steep F1 Slope Cemented and Stable.
