**2019 ANNUAL INSPECTION REPORT
RANGE ROAD LANDFILL
ASH DISPOSAL FACILITY**

China Township, St. Clair County, Michigan

January 2020

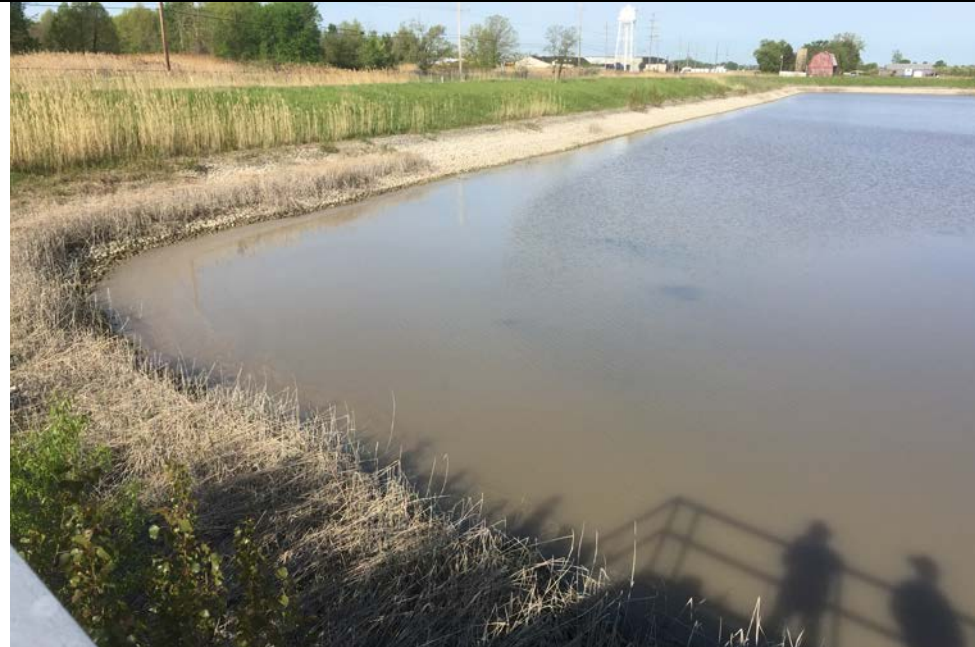
1. Storm Water Detention Basin (SWDB), S & W Sides. Slopes are Protected with Stone. No Visible Slope Erosion on all Sides. Same for N & E Sides.

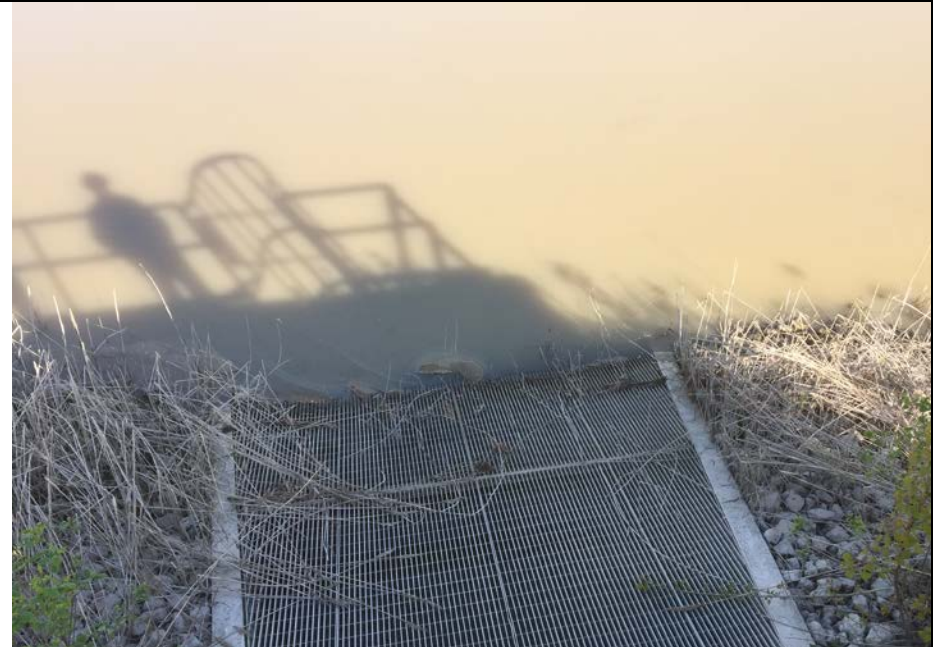
2. Intake Screens at SWDB. Water from Basin is Pumped Back to Power Plant Using One or More of 3 Pumps. DTE Inspects Daily and Records

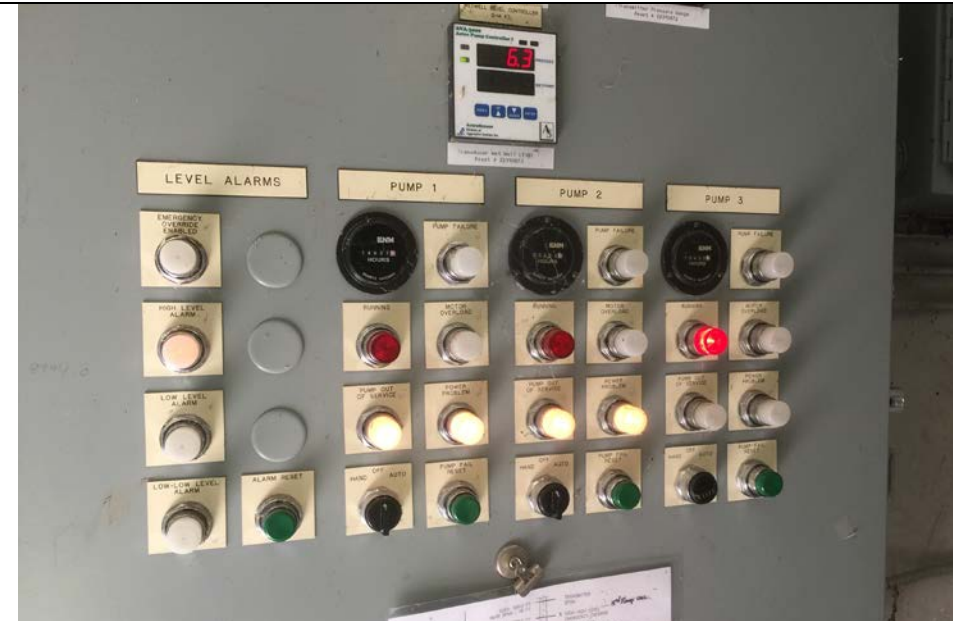
3. Pump Control Panel. Pump #3 Running. Pumps 1 & 2 Identified as Out of Service. Wall Flow Meter (Not Shown) was Operating. Pumps Observed.

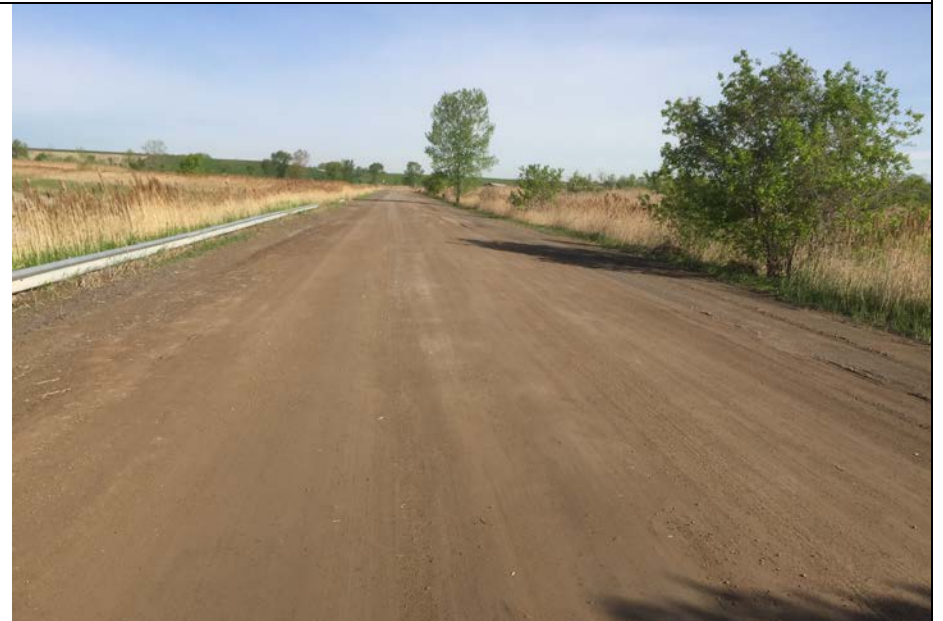
4. Looking at Well Maintained Haul Road within Landfill Limits. Condition Typical of Main Haul Roads to Waste Placement Areas.

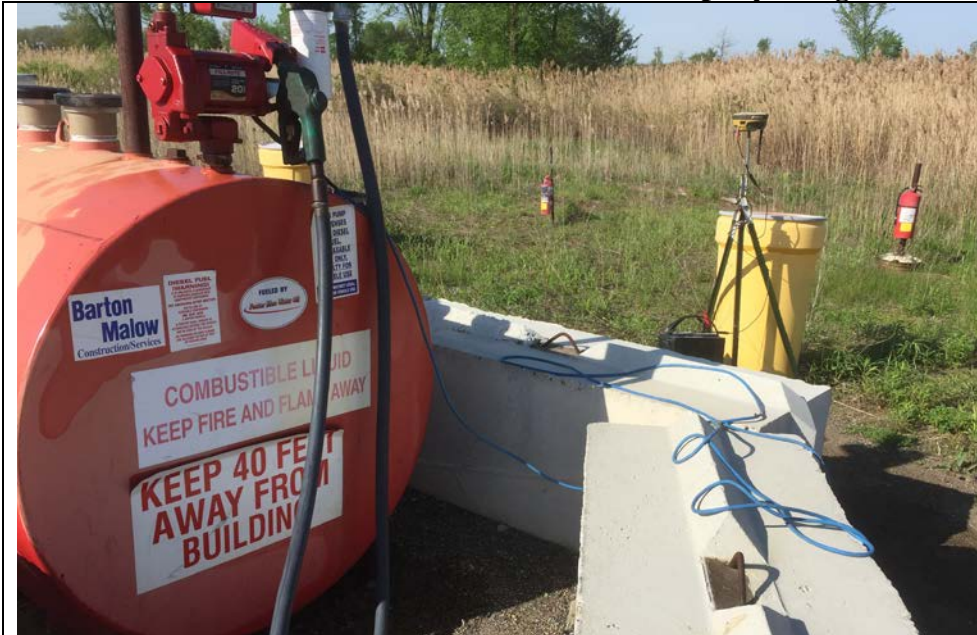
6. AST Inspection	<input type="checkbox"/>	<input checked="" type="checkbox"/>	<input type="checkbox"/>	5	Observed a possible dispensing leak. DTE & Contractor Alerted and Repair Planned.

5. Second Fuel Tank Appeared to have Possible Dispensing Leak. DTE Informed Contractor Management and Repairs were Later Reported Completed.

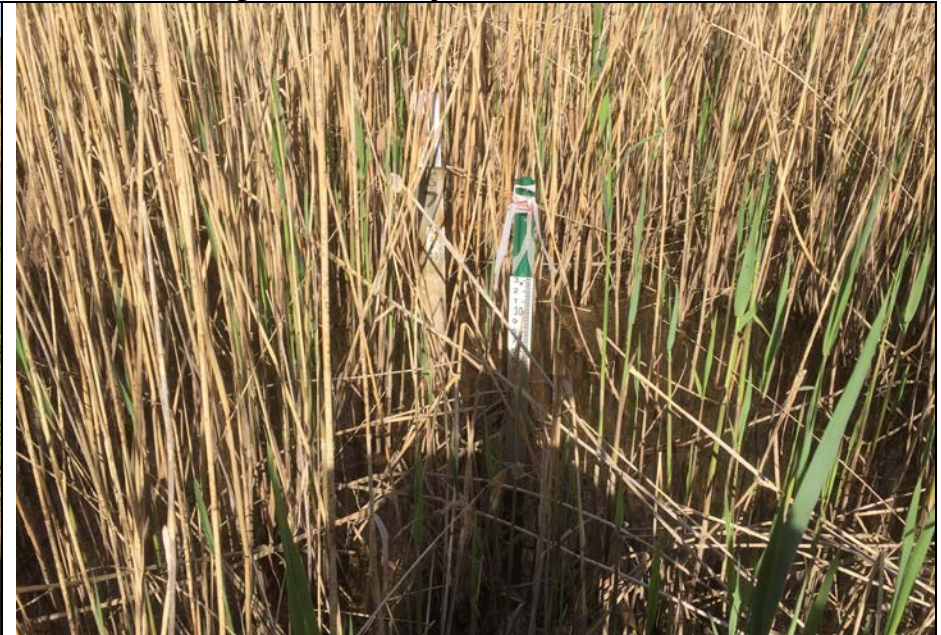
6. Perimeter Ditch Staff Gauge SG-07. Heavy Vegetation. No Flow Noted. Water Present. Vegetation Approx. Typical at Staff Gauges 13, 10, 6, 5 & 3.

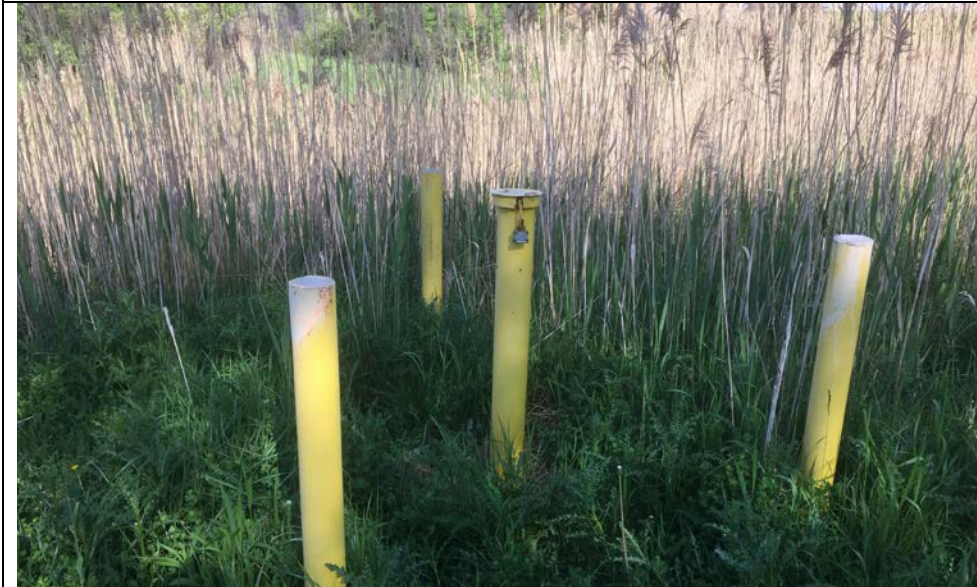
7. Monitoring Well 16-02. Well Protected and Cap Locked. Well Protection and Capping Typical of Inspected Above Ground Monitoring Wells (16-03,04,05&06).

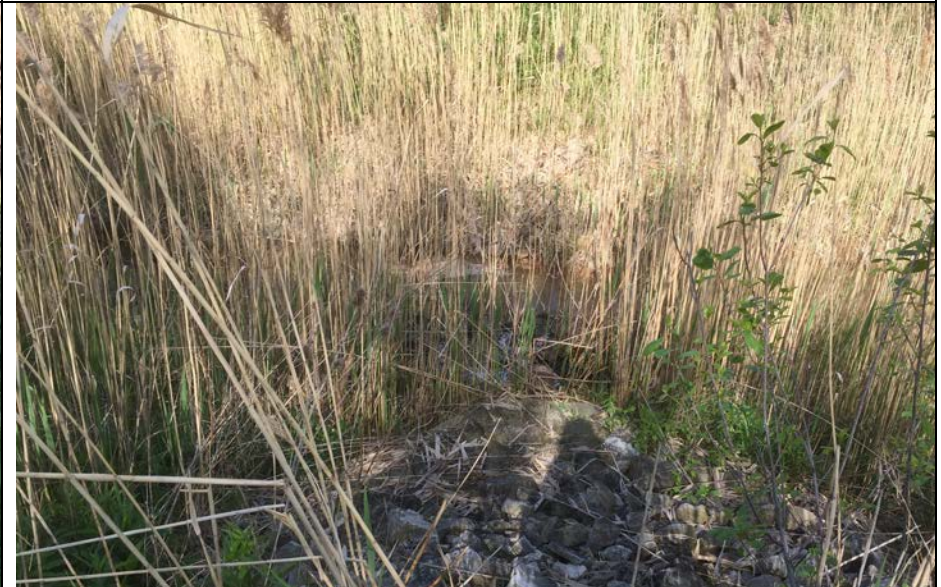
8. View of Area where Discharge Flow into Perimeter Ditch from NE Off-Site GW Capture System. Ditch Slope Vegetation was Cleared in 2017.

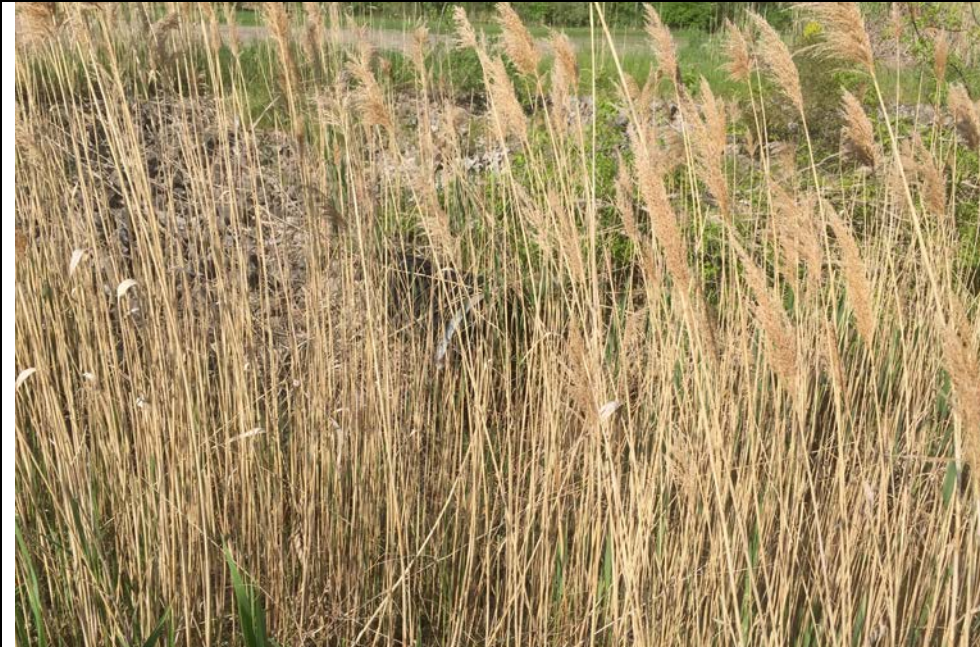
9. View of End of Large Culvert at Crossing Near Staff Gauge SG-5. Culvert Opening and Not Blocked.

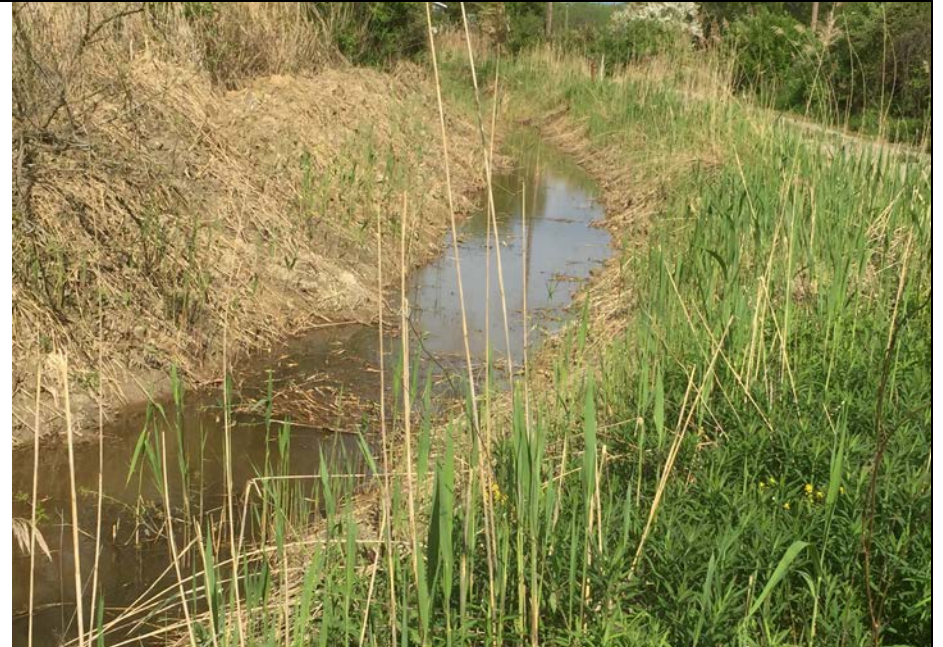
10. Looking at Last Year's Maintenance Along East Side Perimeter Ditch. Ditch Cleared of Vegetation. Road Also Remains in Good Condition.

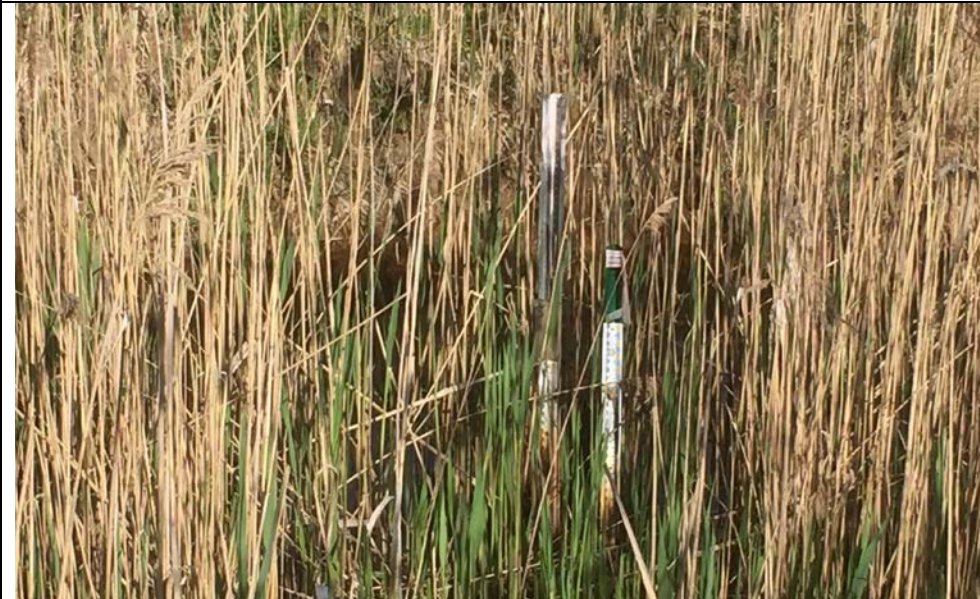
11. Looking at SG-03. Ditch Flow Observed. Vegetation Thick but Not Blocking Flow.

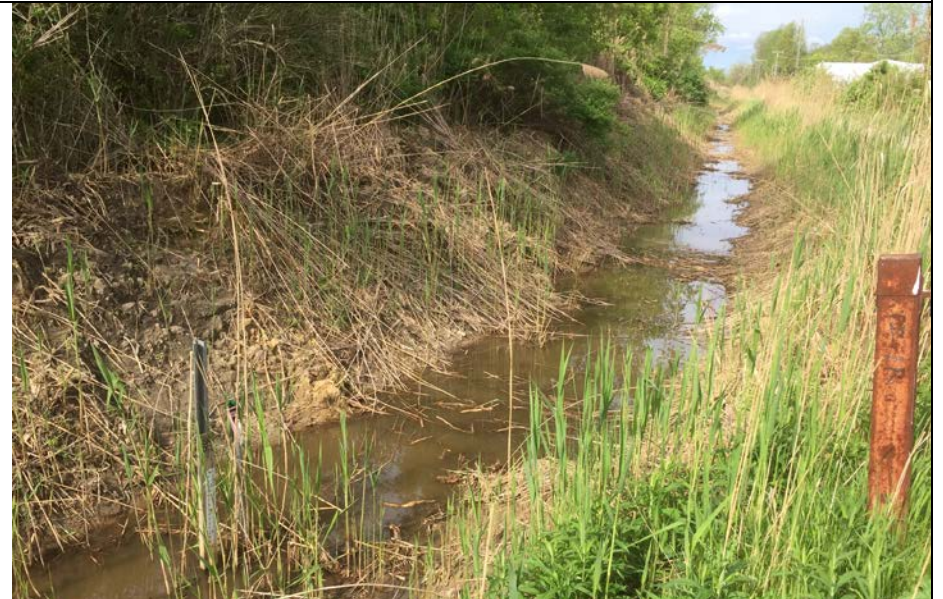
12. Looking at Perimeter Ditch, Staff Gauge SG-02 and PZ-1R. Ditch Cleared of Vegetation in 2018. Same Type Clearing at SG-01 and

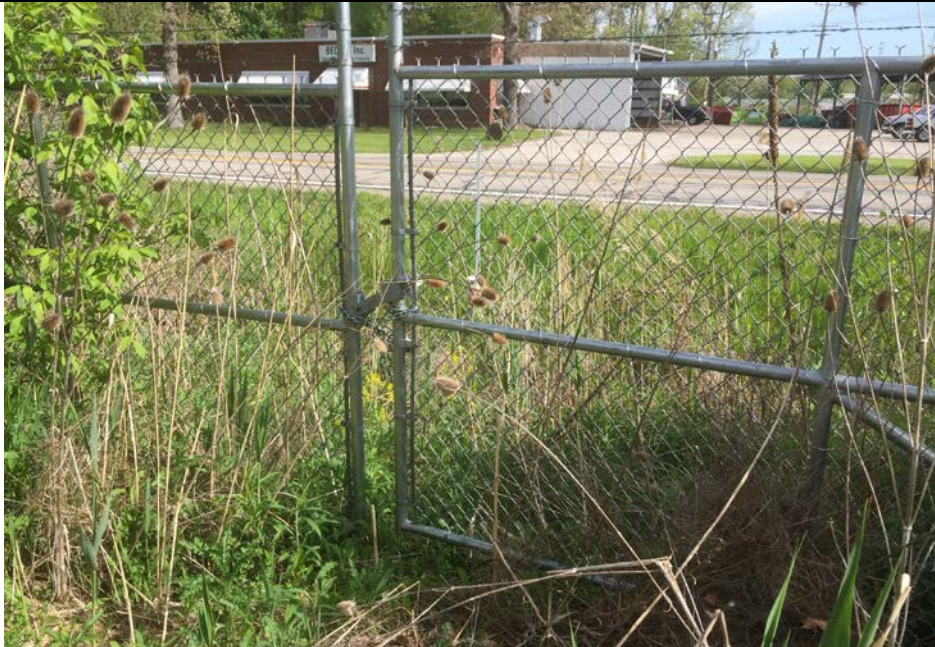
13. Locked Gate in Security Fence Along Perimeter Ditch. Signage not Visible but is Located on Right Side of Gate.

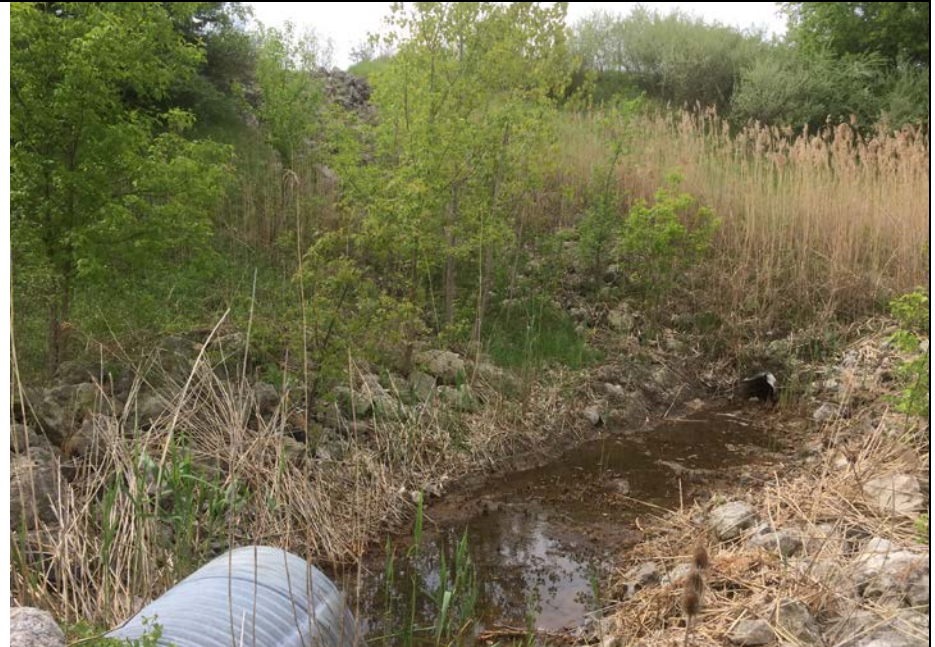
14. Large Culvert and Small Culvert. There was No Blockage of Small Culvert. Riprap Downchute from Closed Landfill Area Slope Visible.

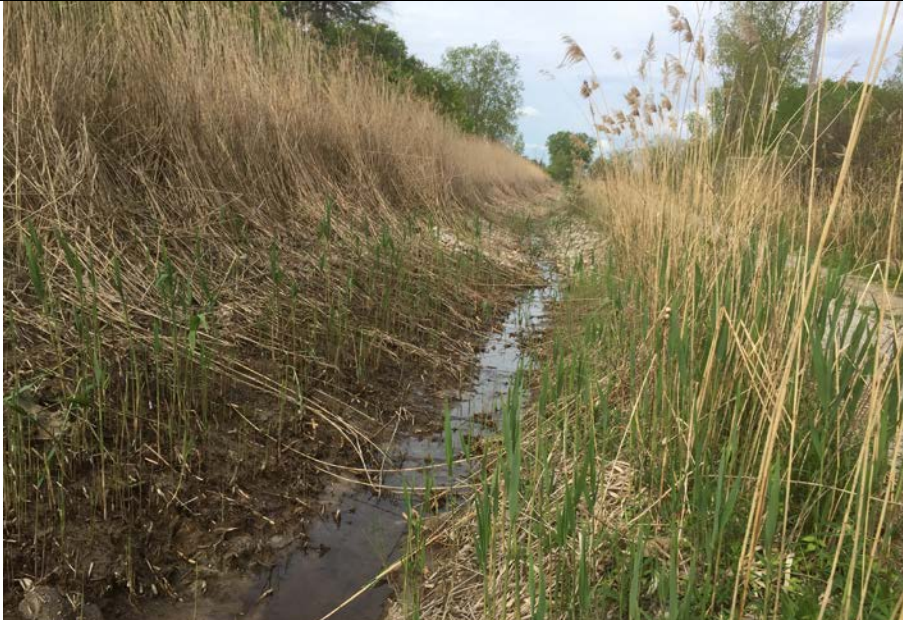
15. Perimeter Ditch Shown Here was Previously Cleaned. Riprap Along Ditch Noted. Flow Observed.

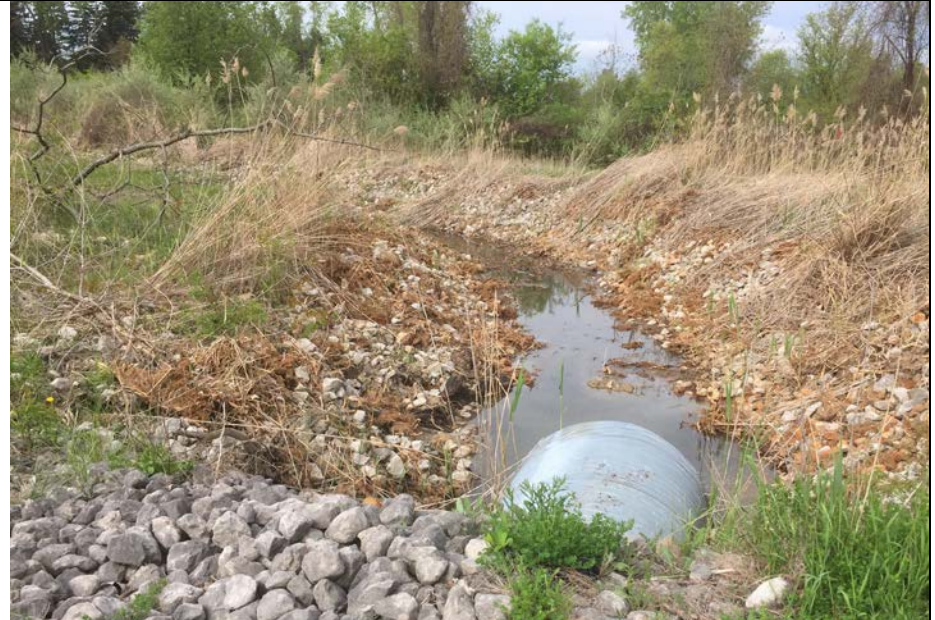
16. Previous Maintenance Along Perimeter Ditch and Culvert Crossing. Both Sides of Culvert Open and Ditch Cleared of Vegetation.

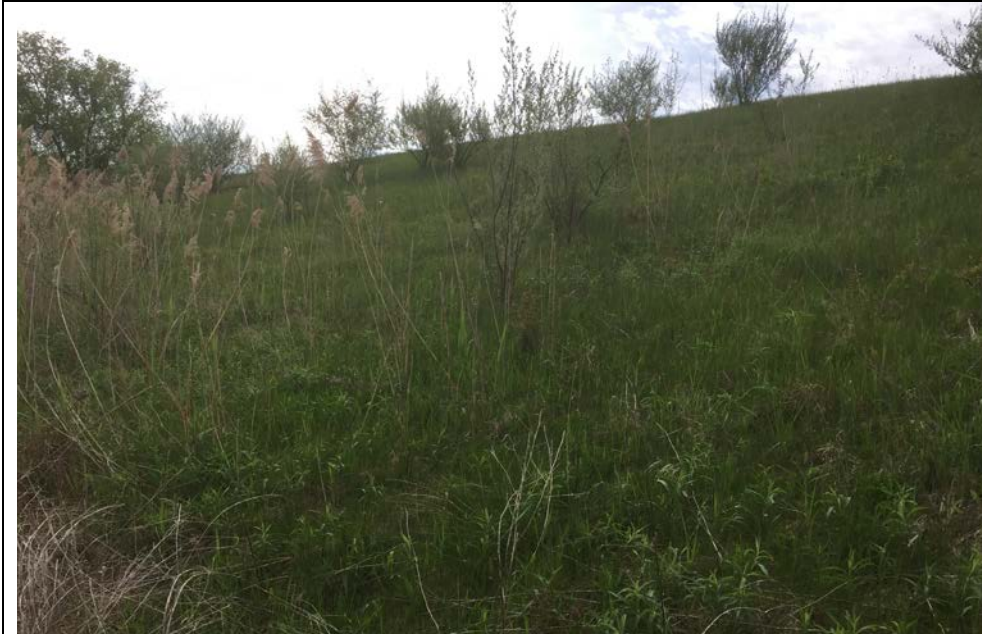
17. Landfill Slope on North Side Shown. Appeared Stable and Well Vegetated.

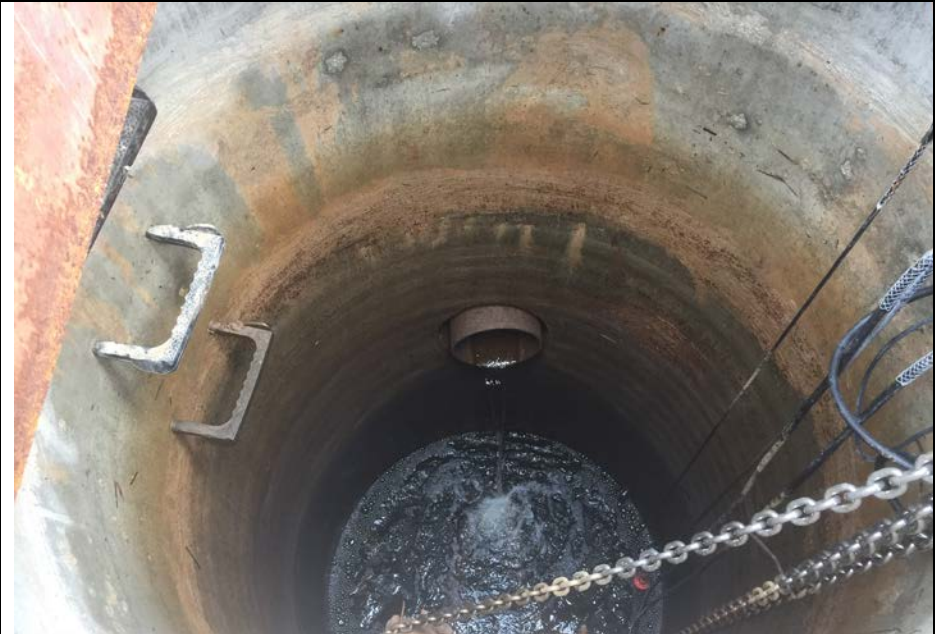
18. Sump Where 2 New Pumps Installed Last Year. Off-site GW Inlet Pipe Shown. Control Panel and Pump Operation Verified by DTE Inspector.

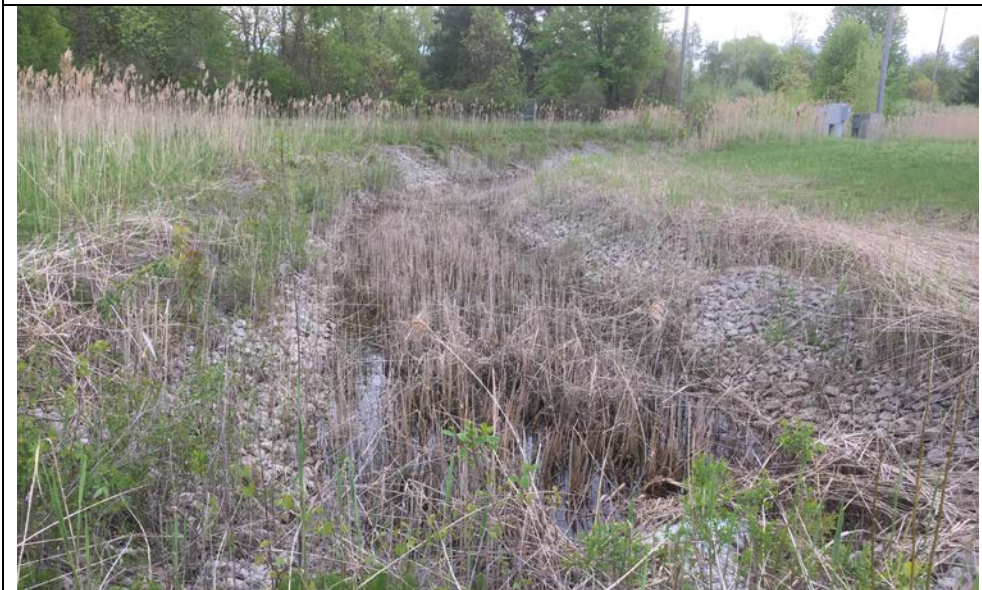
19. Perimeter Ditch Vegetation and Riprap Along Slope. Vegetation Partially Removed but Ditch Flow Appeared Not Blocked.

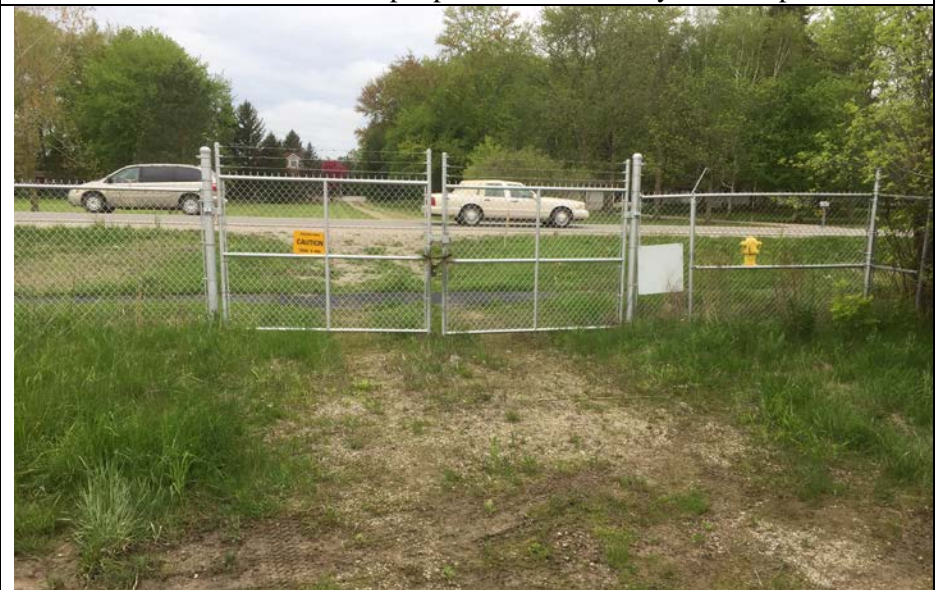
20. Security Fence and Gate at West Side of Landfill. Gate Locked and Signage Present. Typical of Gates Around Landfill Perimeter.

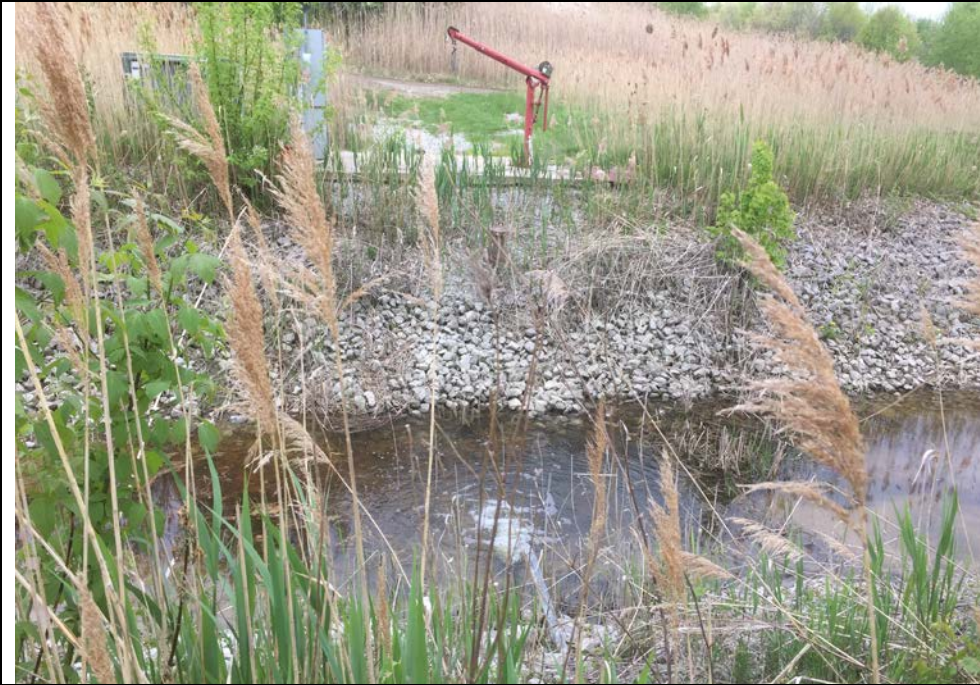
21. Photo of Offsite GW Capture System Flow into Perimeter Ditch at Pump and Control Panel Location.

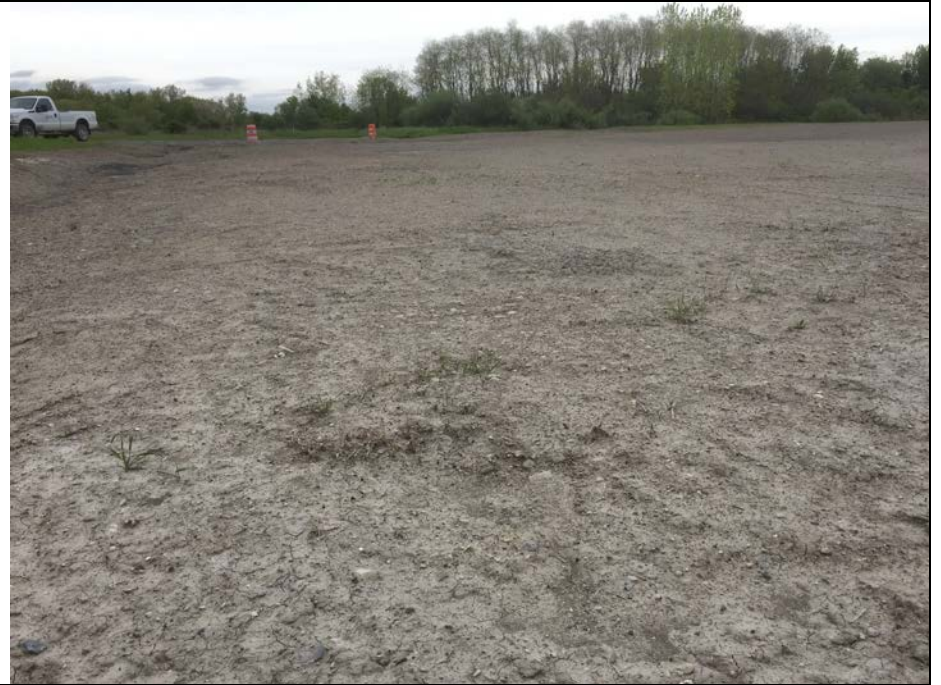
22. Top of Clay Stockpile for Later Use. Surface Graded for Drainage. Rainfall Previous Day/Night.

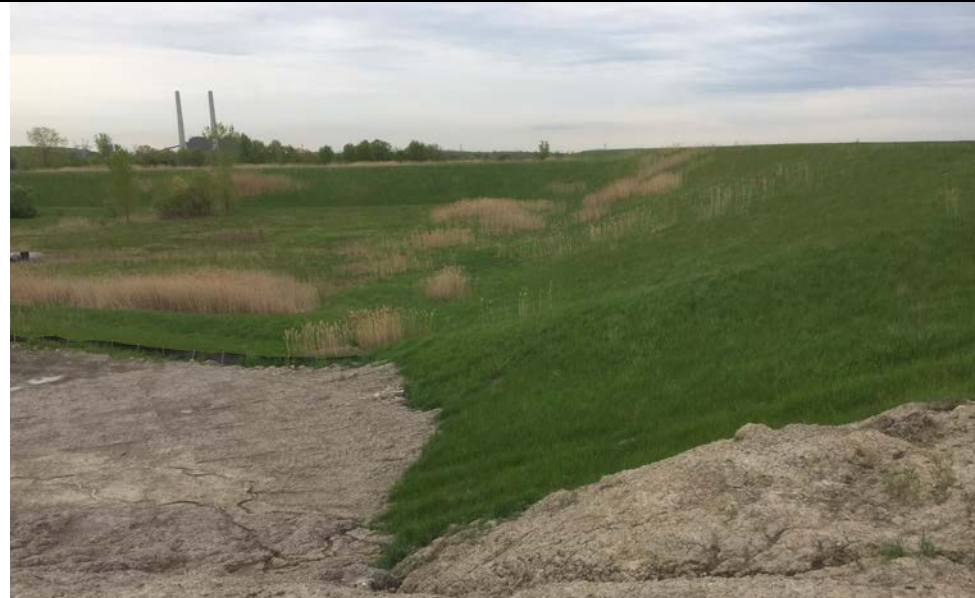
23. View of Perimeter Landfill Slope Along East Side.

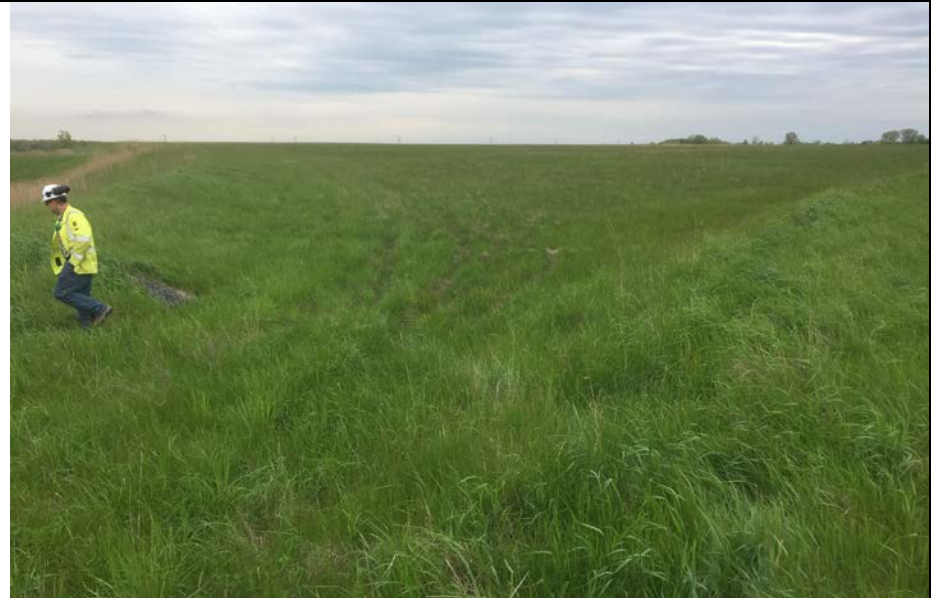
24. DTE Inspector Checking Slope Drainage Channel. Channel Swale Open and Well Protected with Slope Vegetation.

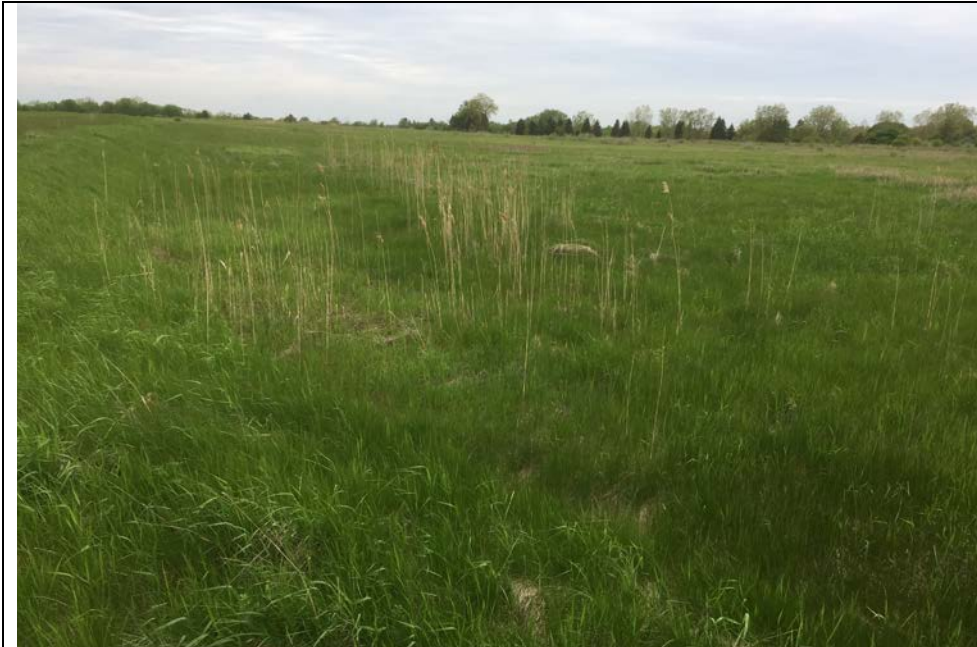
25. View of a Cover Surface Collection Swale Along the Perimeter at the Top of Landfill. Swale Well Vegetated and Typical of Surface Swales Elsewhere.

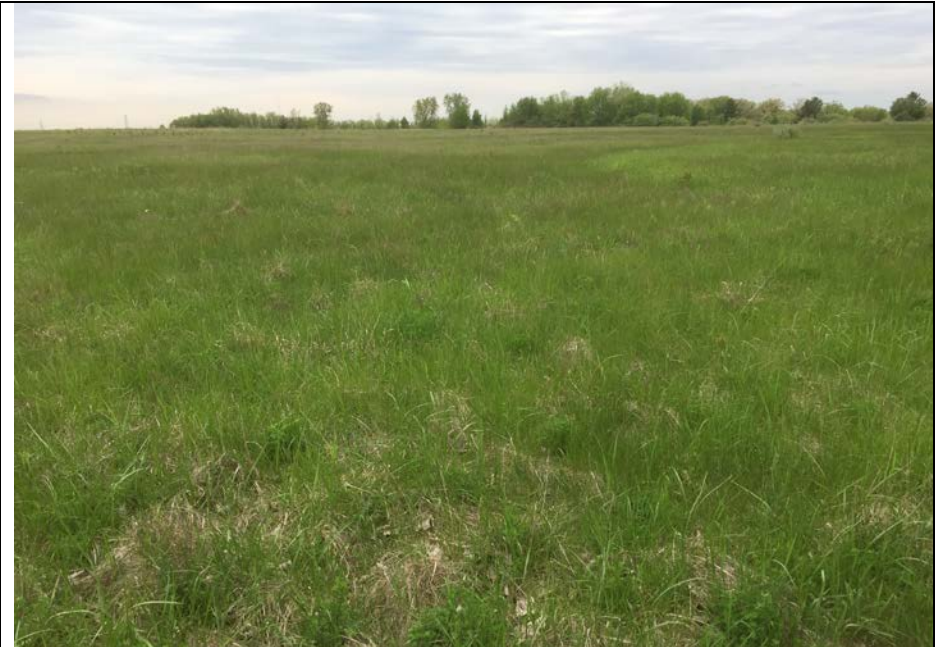
26. View of the Top of Closed Portions of the Landfill with Center Swale. Top Well Vegetated. No significant Surface Erosion Noted During Travel.

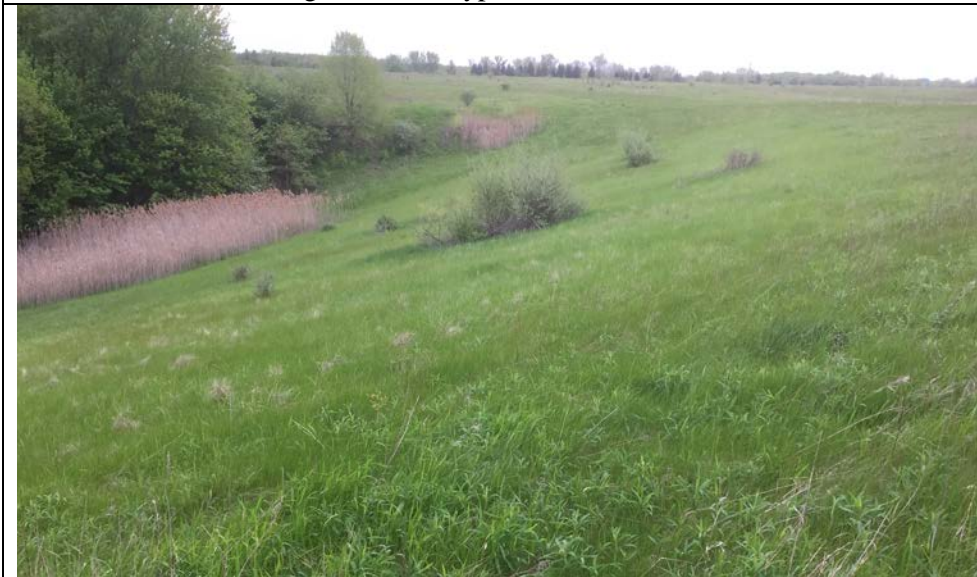
small woody vegetation remains on berm slopes west side of unconstructed areas of Area G2 and along the east side of the northern most historically closed areas, as shown in Photographs 27, 28 and 31. DTE indicated in 2016 that woody vegetation will be removed in the G2 area when the slope is prepared for development into an active placement and containment area. No new locations of woody vegetation were observed on top of the closed landfill areas. Photographs 24, 25 and 26 show final cover surfaces and slopes of closed landfill areas. The small woody brush on cover areas and PE-certified approved area slopes, as typically shown in 2018 Annual Inspection Photographs 58, 61, 91 and 107 have been removed after the annual inspection was performed, as recommended. There were no observed significant areas of pooled water on the top cover from the recent rain.

27. View of Perimeter Slope East Side. Well Vegetated, Appearing Stable but with a few Clumps of Brush Vegetation.

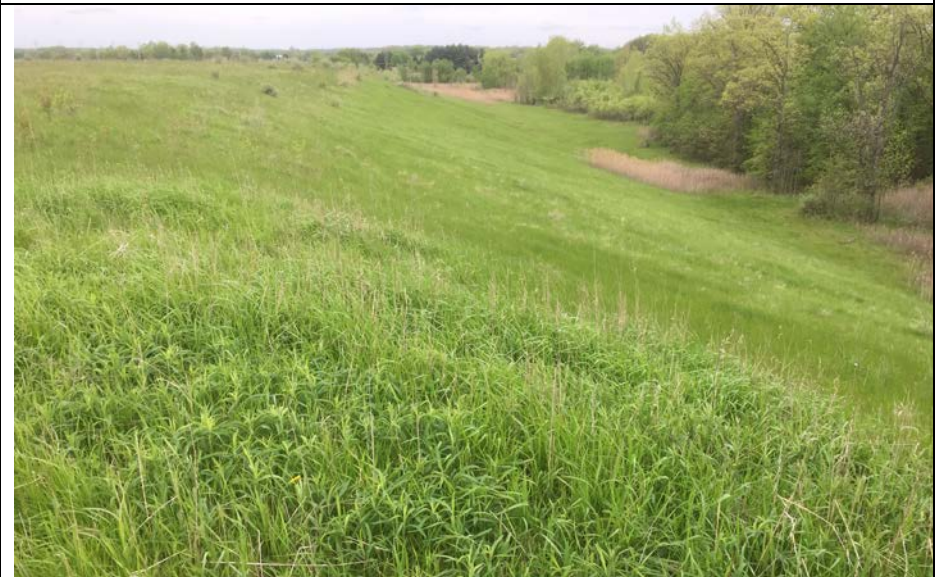
28. A Look Back at Perimeter Slope of Closed Portions of the Landfill. Slope Well Vegetated and No Visual Evidence of Stability Problems.

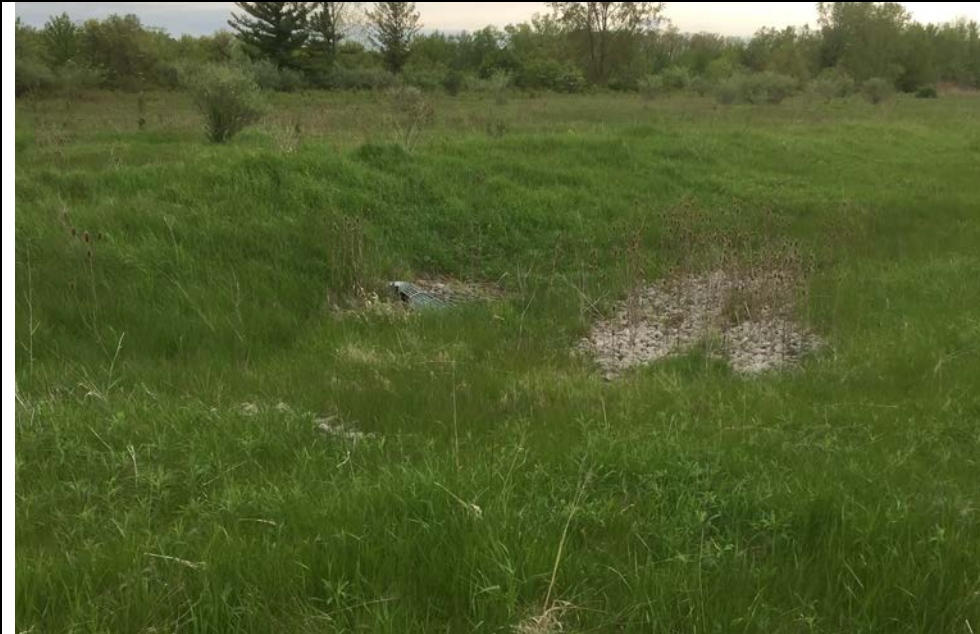
29. Termination of One Drainage Swale Top of Landfill at Downslope Pipe. Riprap was Added Years Ago to Control Erosion During Heavy Rainfall.

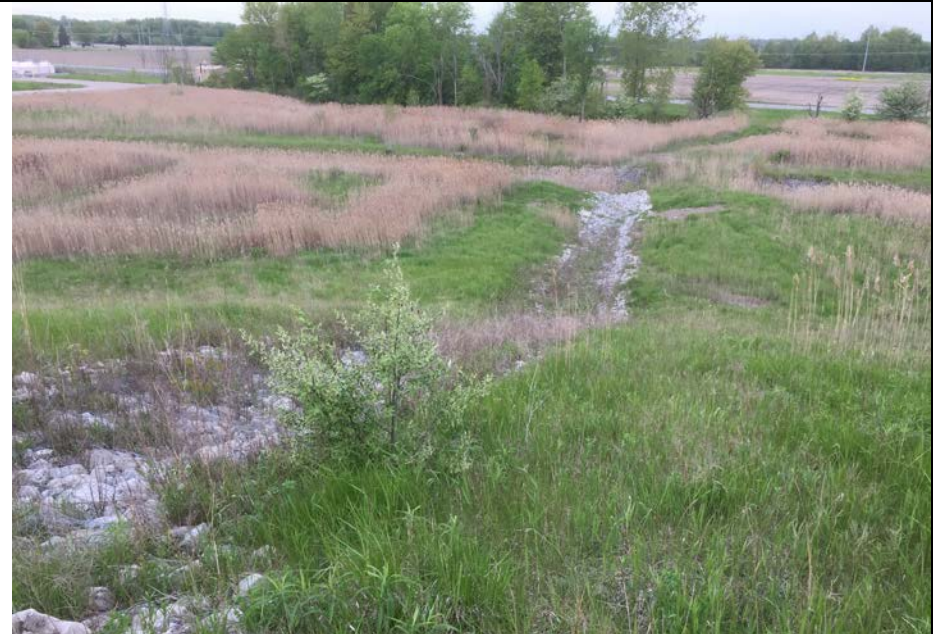
30. Looking Downslope at Downchute of South Slope of Closed Area F2. Small Tree Brush Present Not Causing Any Blockage.

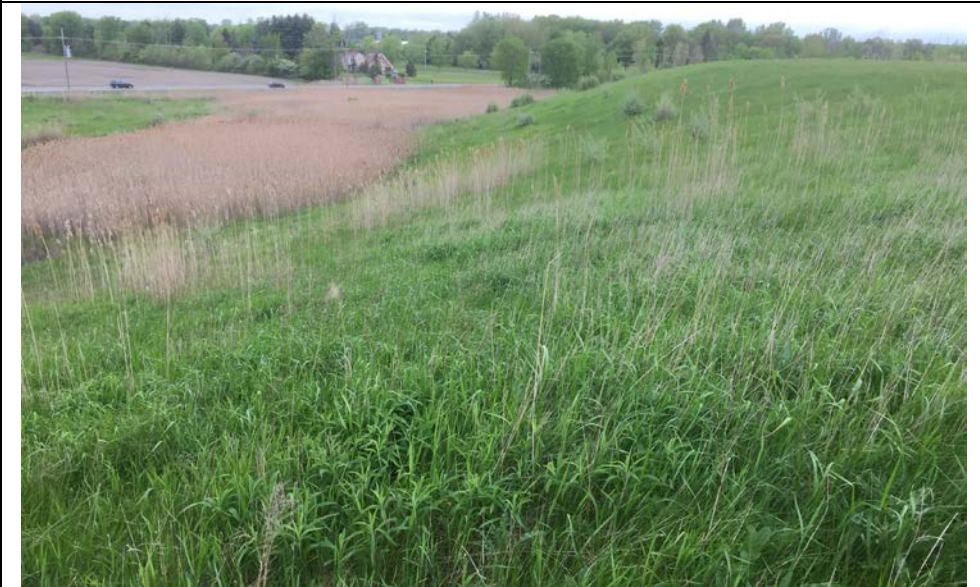
31. Looking West at Landfill Perimeter Slope in Area F1 from Corner of F2. Small Tree/Brush Vegetation Portion of F1 Downstream Slope.

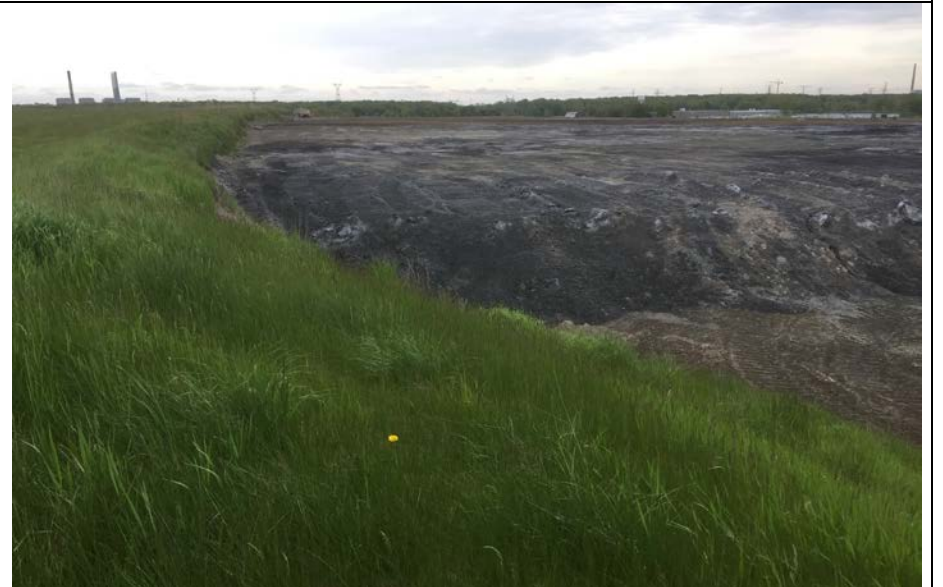
32. Waste Placement in Area G2 Phase 1 Along Temporary Slope of Area F2.

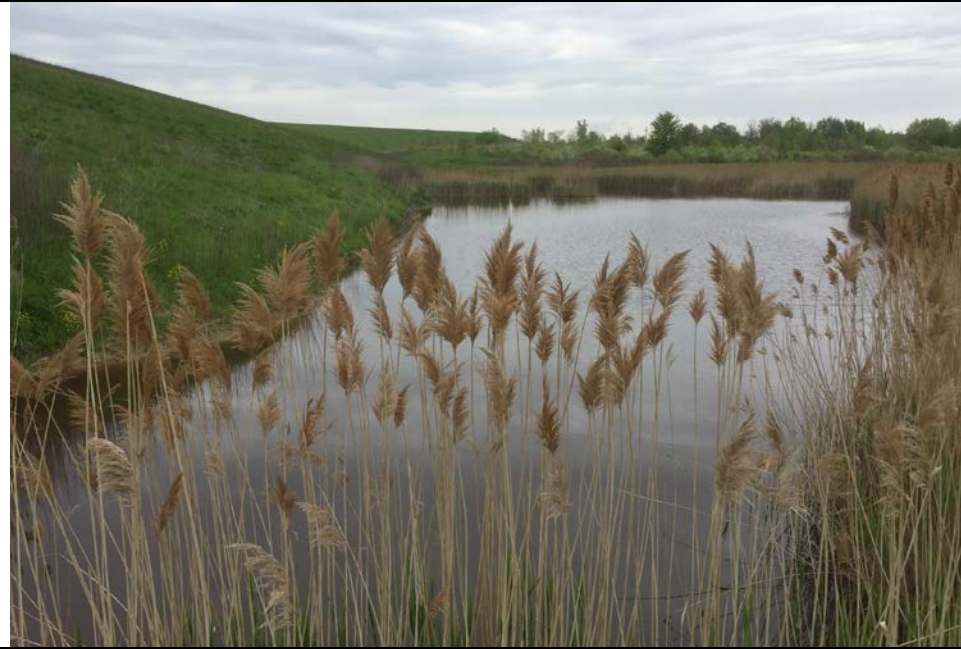
33. Runoff Collection Pond within Landfill Limits. Landfill Area Slopes on Left Appeared Stable and Well Vegetated.

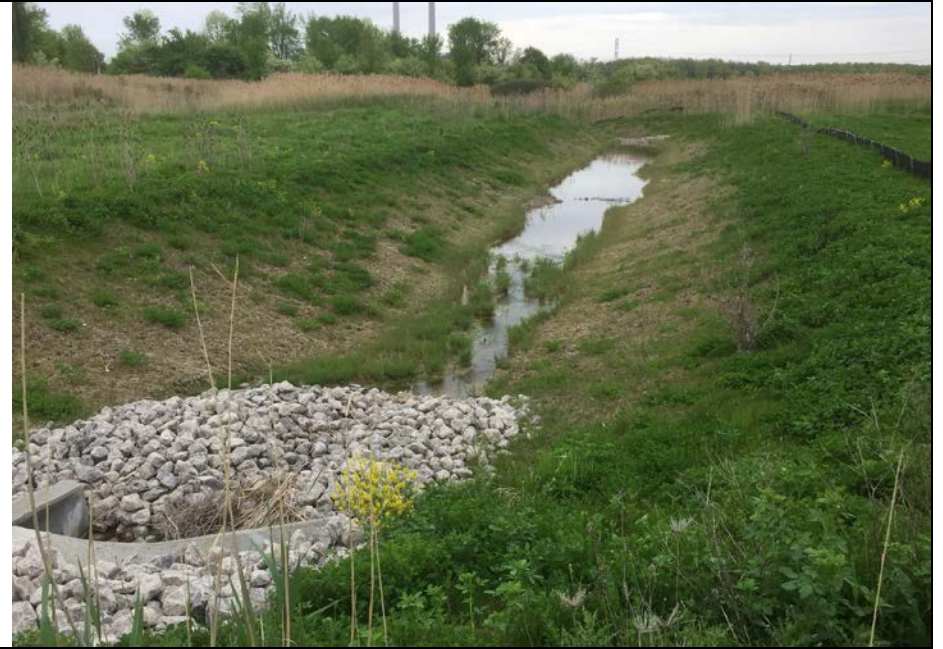
34. Interior Landfill Drainage Ditch. New Routing of Ditch. Slopes Appeared Stable. Check Dam at Far End of Photo. Same as 2018 Photo 76.

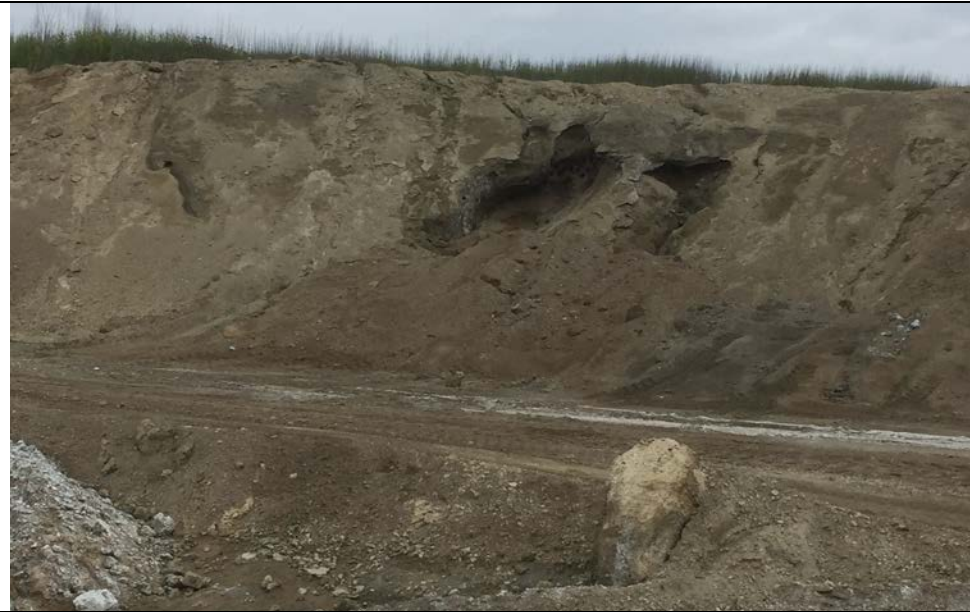
Temporary slope runoff erosion was noted along the southeast side of Active Area F3 cover construction and road ramp up to the work areas. This eroded temporary slope was identified in 2018 and had some repair (Photograph 35), but as noted during this inspection and by an EGLE inspection, additional repair was needed. DTE completed repairs on the eroded slope shortly after this inspection.

4. Access Roads and Construction Site Roads	<input checked="" type="checkbox"/>	<input type="checkbox"/>	<input type="checkbox"/>	4, 35, 37 & 44	All very good. Ramp to top of landfill (Photo 35) subject to runoff. DTE to discuss with contractor erosion and repair. conditions.

35. Slope where Some Runoff Erosion Noted Along Side of Active Haul Road.

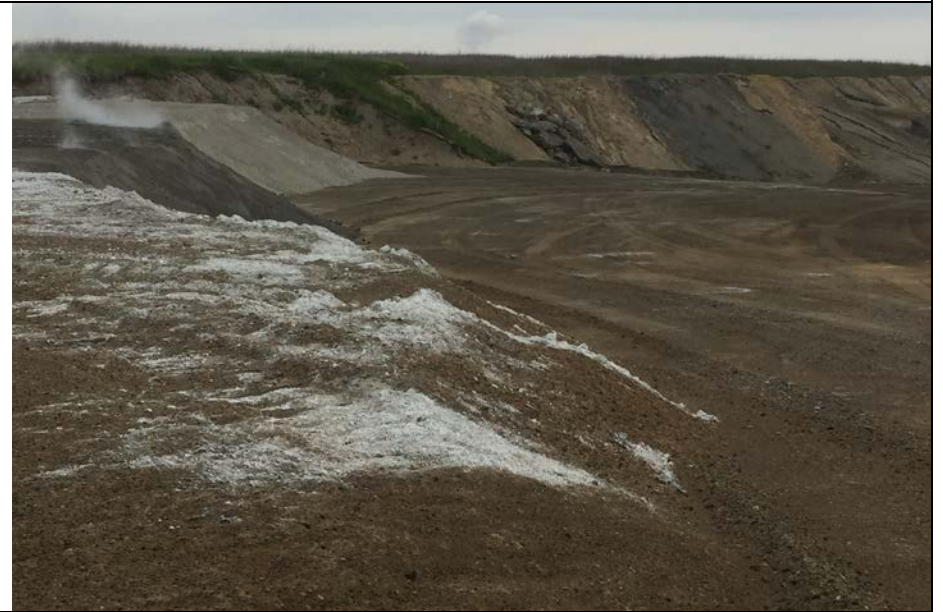
36. Active Waste Placement Area.
