**2019 ANNUAL INSPECTION REPORT
RANGE ROAD LANDFILL
ASH DISPOSAL FACILITY**

China Township, St. Clair County, Michigan

January 2020

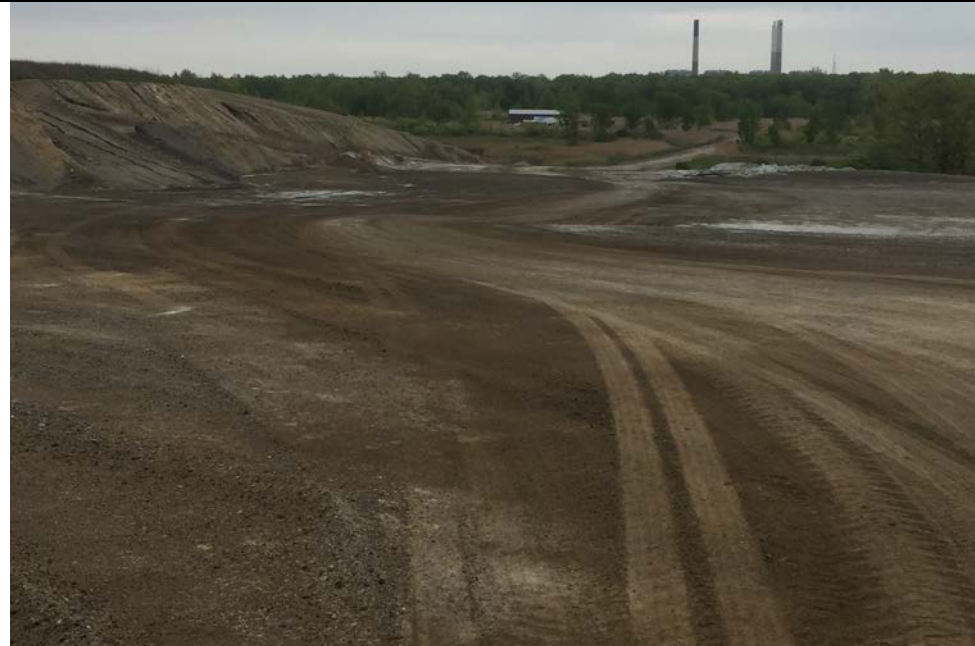
37. Interior Haul Road Leading into Active Waste Placement Area G2. Compacted Waste Supporting Haul Trucks without Rutting.

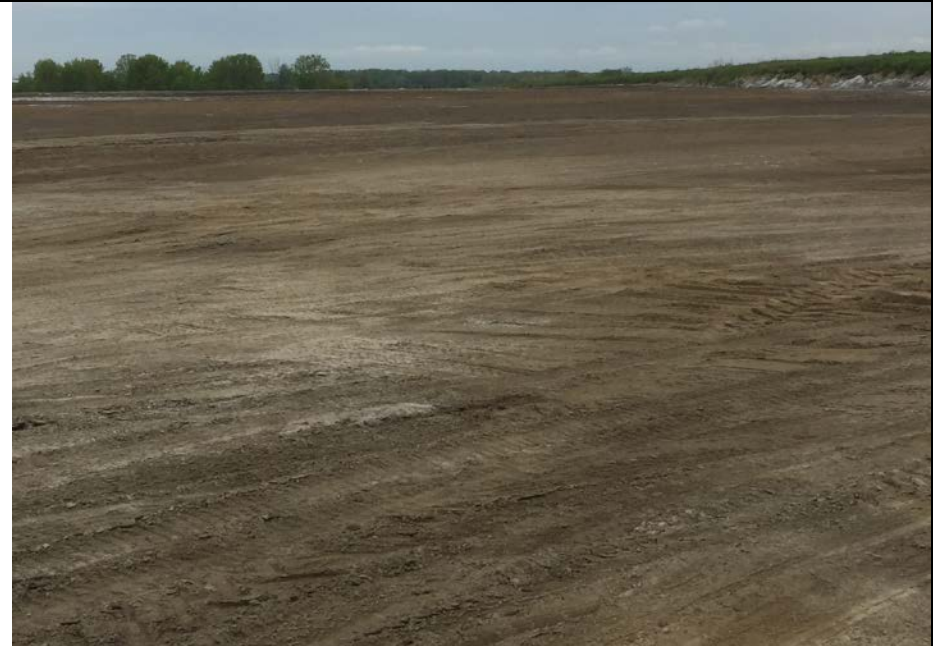
38. Top of Active Placement Area G2, Graded and Used as Interior Haul Road.

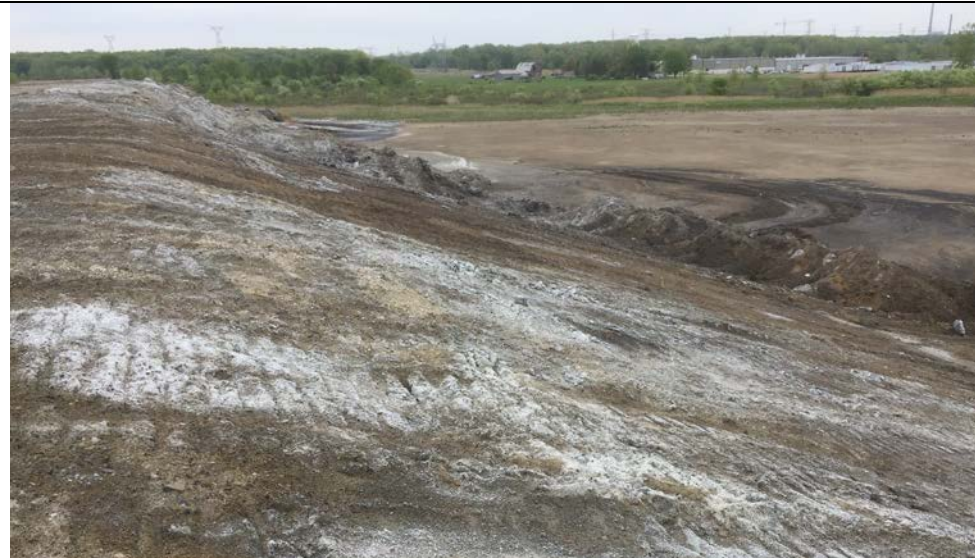
39. View of Interior Waste Slope in Area G2. Truck Dumping at Toe of Slope. Bottom of Slope Runoff Causes Some Wet Conditions as Shown in Photos.

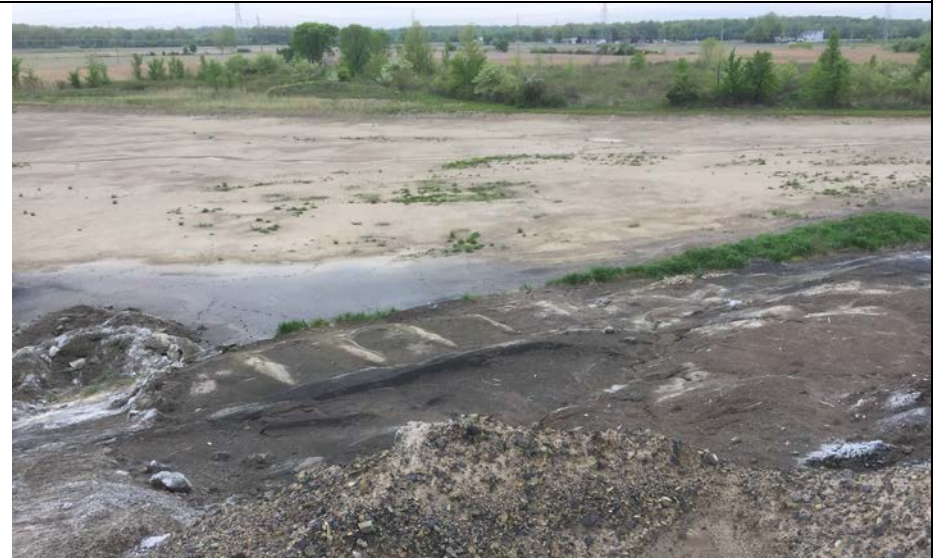
40. Future Waste Placement Area G2 Phase 2.

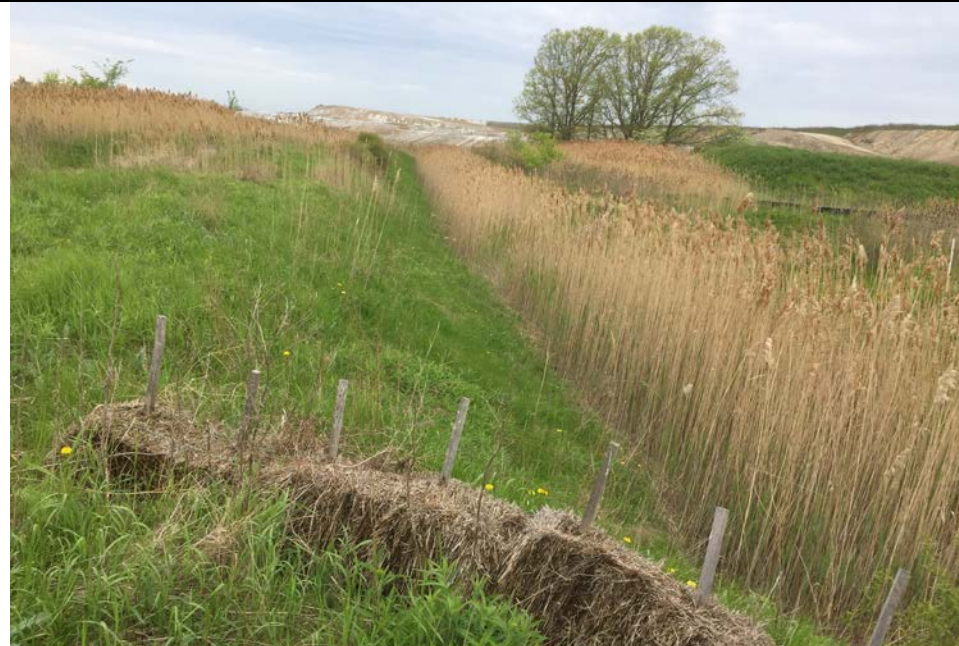
41. Slope Along Internal Ditch. Erosion Control Bails Placed. Vegetation Appeared Heavy and Typical of This Internal Ditch.

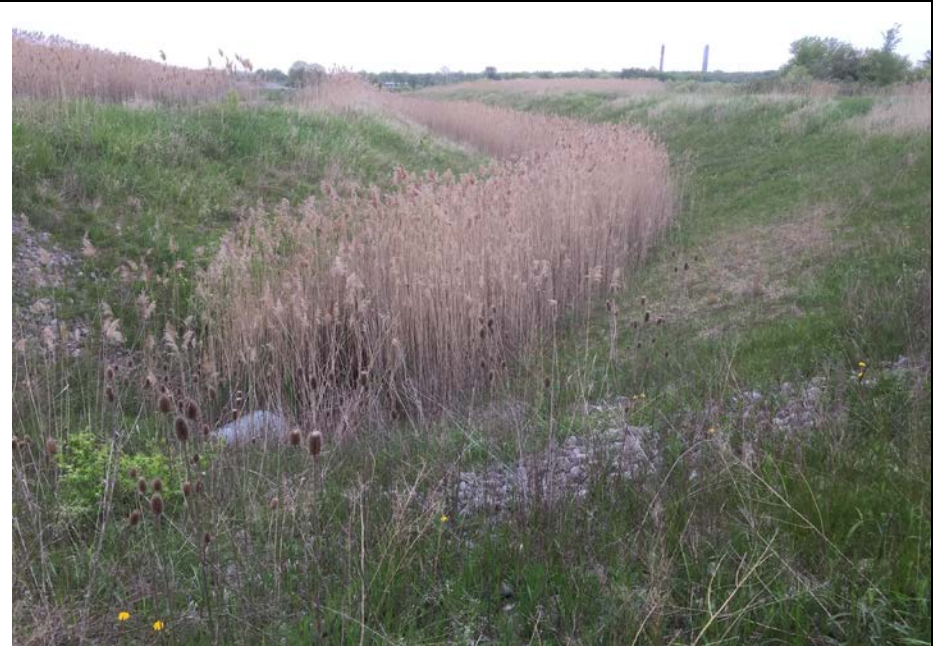
42. Looking East at Perimeter Ditch from Southwest Corner of Property. Culvert for Road Crossing Near Monitoring Well 16-05.

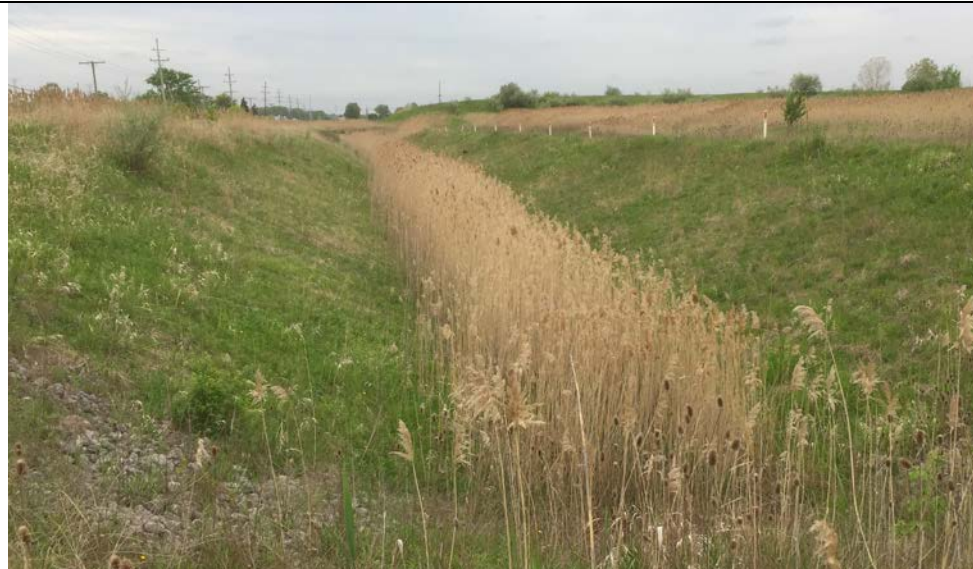
43. Looking West at Perimeter Ditch and Slopes Along NW Landfill Corner. Slopes Appeared Stable and Typical. Riprap at Inlet of Culvert Road Crossing.

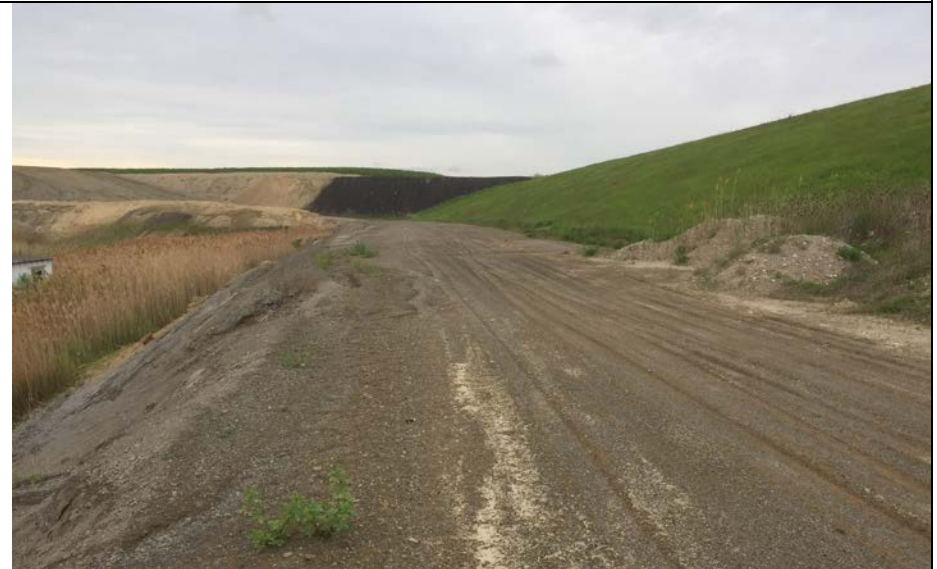
44. View of Interior Haul Road/Inspection Road. Interior Pond on Left in Photo. Area Slope Appeared Stable and Well Vegetated.

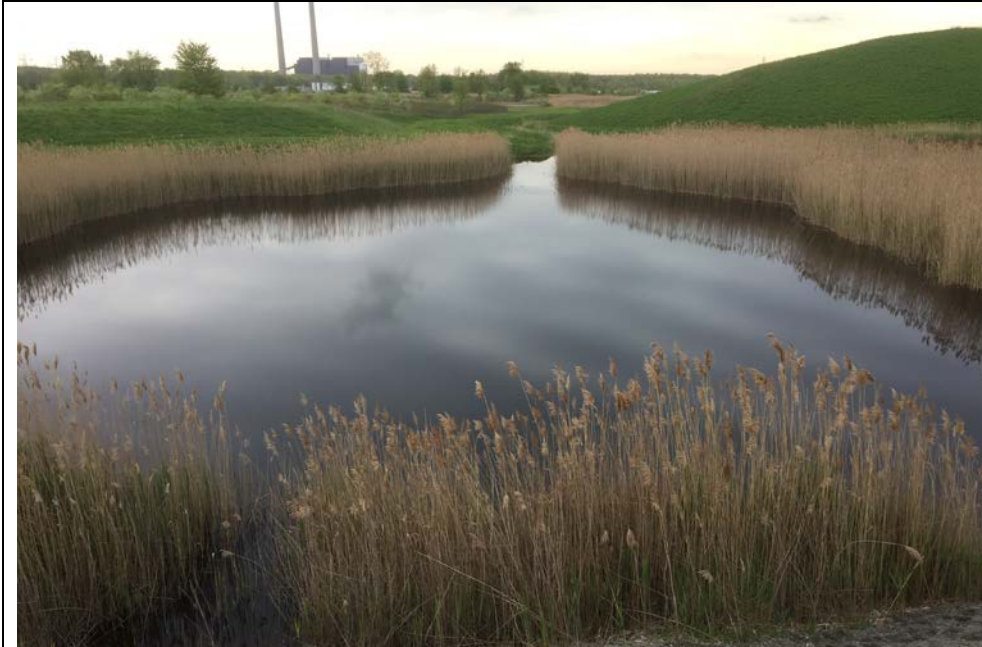
45. Left Side of Pond where Water Exits to Interior Drainage Ditch. Interior Landfill Slope in Background.

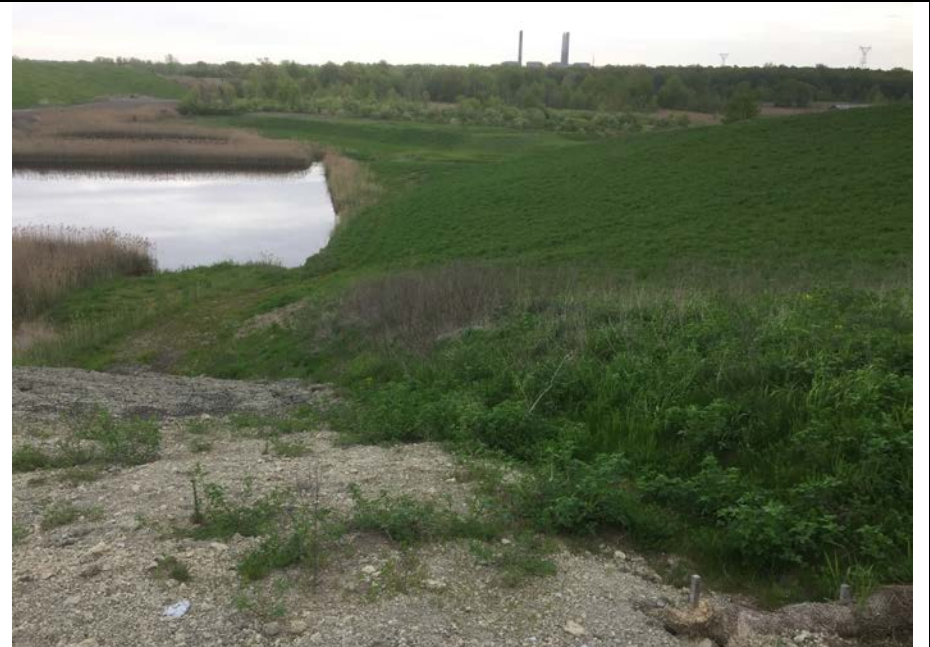
46. Right Side of Collection Pond. Landfill Slopes Appeared Stable. Surface Runoff Ditch from Interior Road.

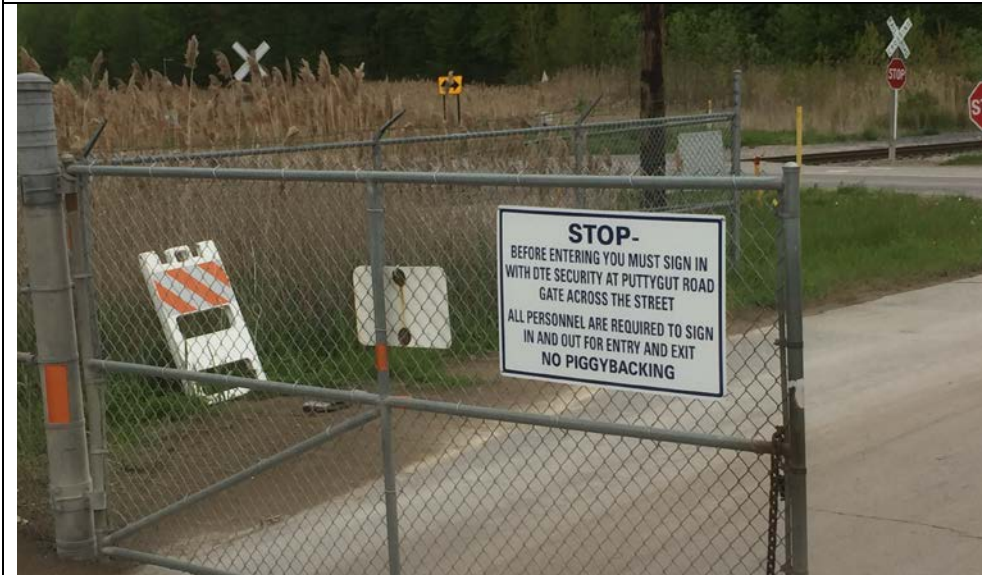
47. Main Entrance Gate to Landfill. Plant Area Road and Security Gate Manned Office to the Right (Not Shown). Gate Opened for Our Exit by Inspector.

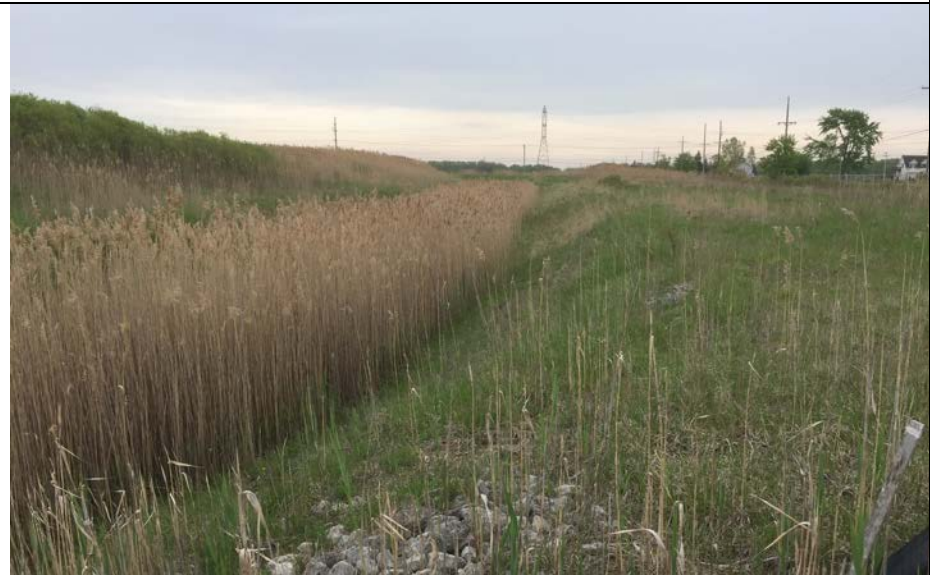
48. Perimeter Ditch on West Side of Landfill Property Looking East from Road Crossing. Ditch Vegetation Typical. Slopes Appeared Stable.
