# **2020 ANNUAL INSPECTION REPORT RANGE ROAD LANDFILL ASH DISPOSAL FACILITY**

**China Township, St. Clair County, Michigan**

January 2021

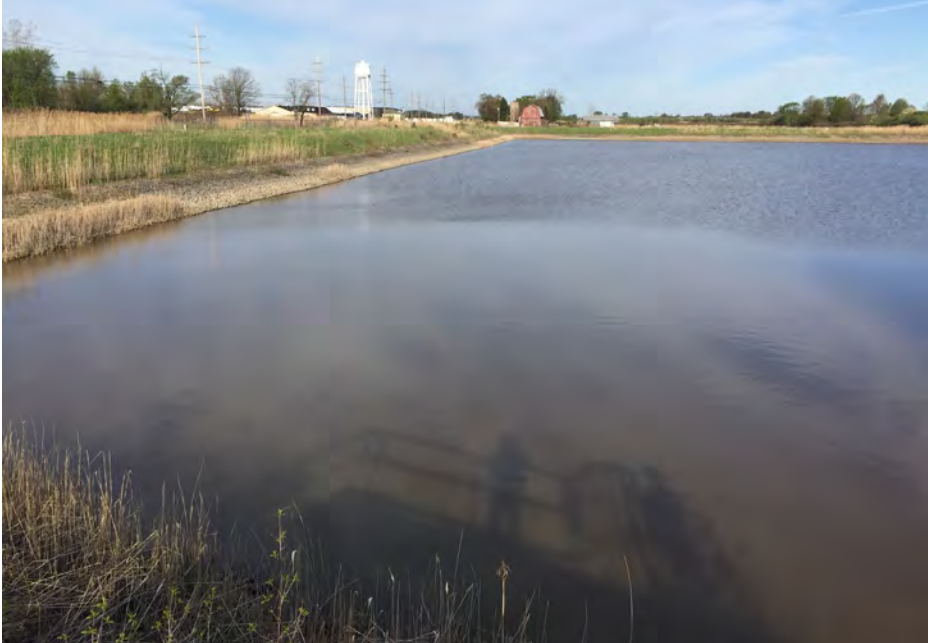
SDB: The SDB appeared in good condition. Basin slopes and intake screens are shown in Photographs 1, 2 and 4. The pump control panel is shown in Photograph 3. Pumps 1 and 2 were tagged out of service at the time of the inspection. DTE later reported that service was restored. The basin intake screen was unblocked as shown in Photograph 2.

1. Storm Water Detention Basin (SWDB), S & W Sides. Slopes are Protected with Stone. No Visible Slope Erosion on All Sides. Same for N & E Sides.

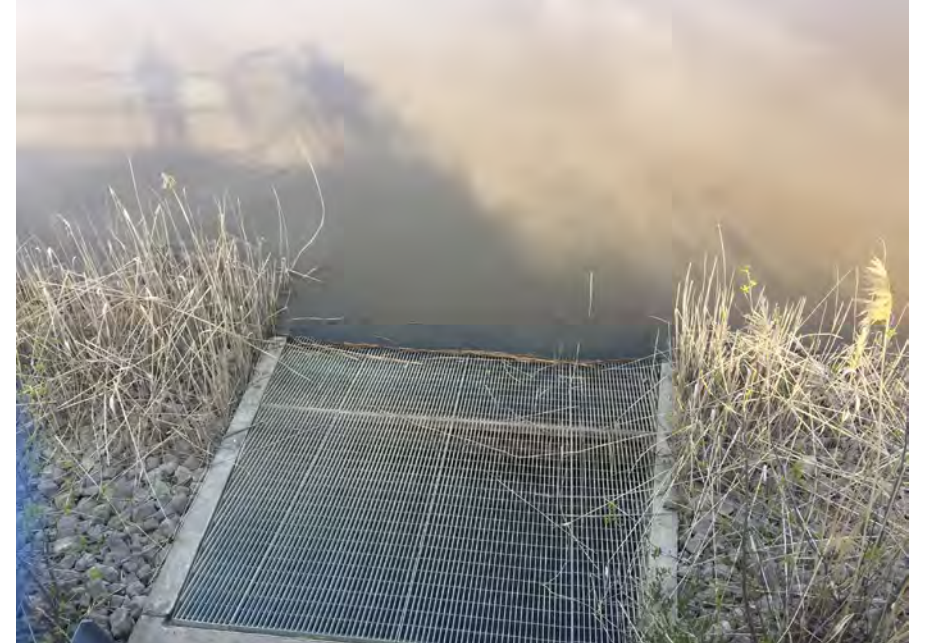
2. Intake Screens at SWDB. Water from Basin is Pumped Back to Power Plant Using One or More of 3 Pumps. DTE Inspects Daily and Records.

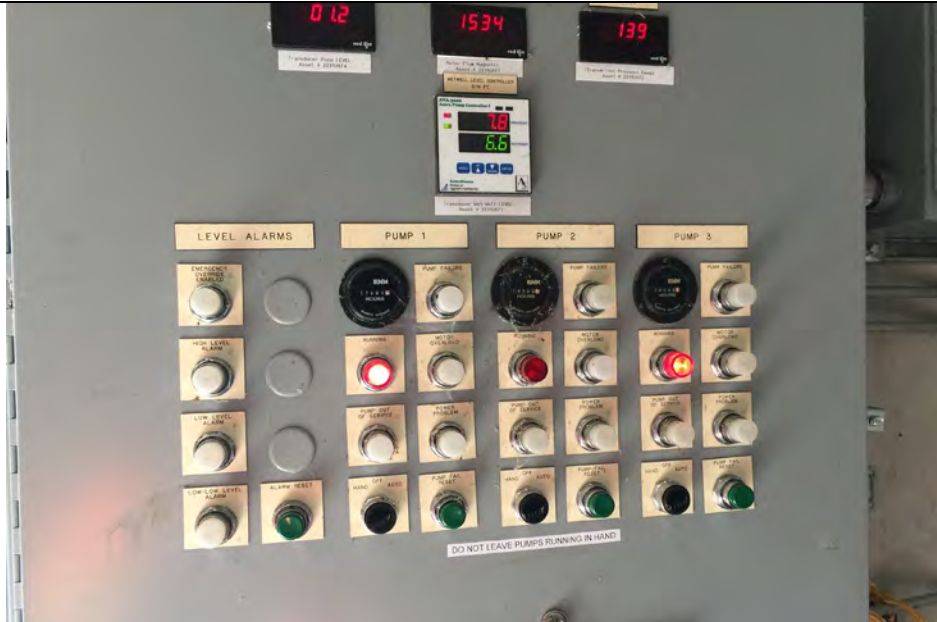
3. Pump Control Panel. Pump #3 Running. Pumps 1 & 2 Identified as Out of Service. Wall Flow Meter (Not Shown) was Operating. Pumps were Observed.

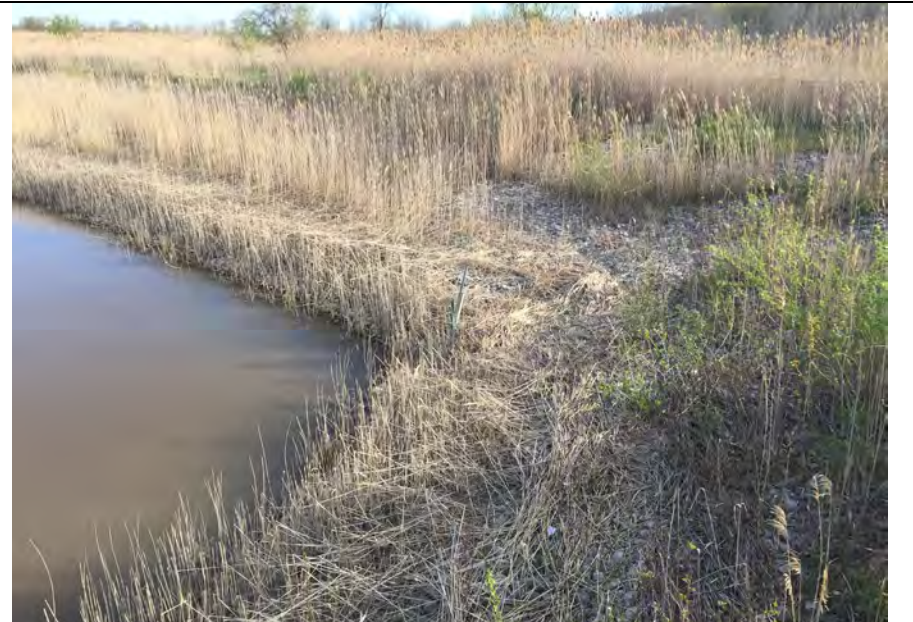
4. Looking at North East Corner of SWDB. Slope Protected from Erosion with Stone. Staff Gauge SG-13 in Middle of Photo Just Above the Water.

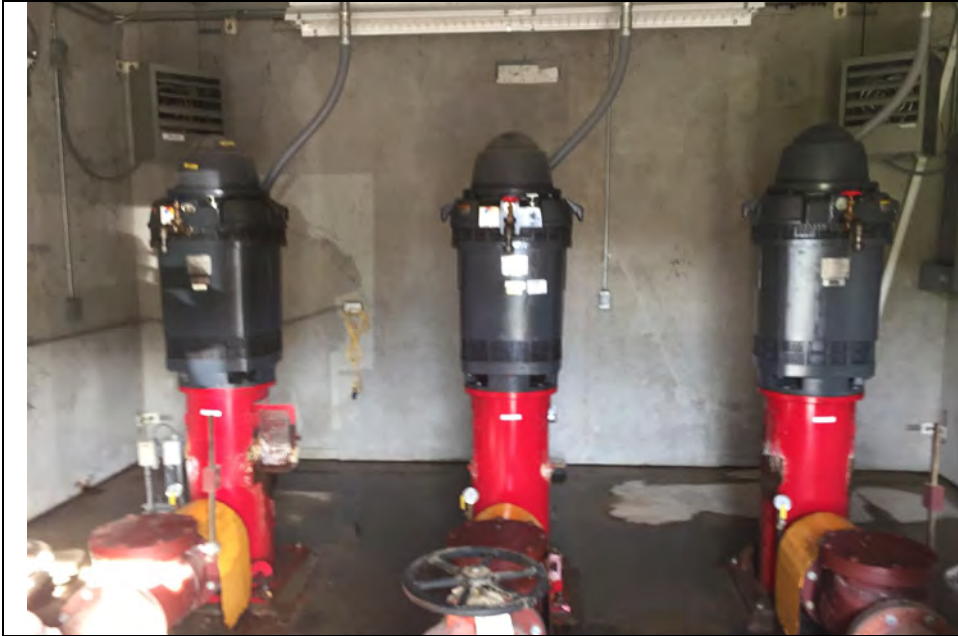
5. The 3 SDB Pumps. Pump No. 3 (Middle) was Verified as Running per Run Light.

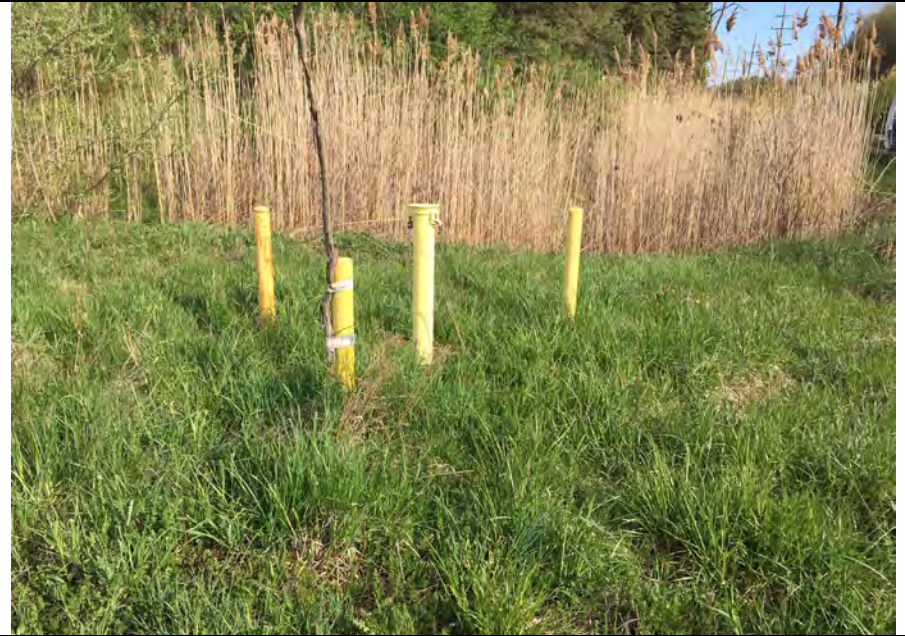
6. Monitoring Well 16-03. Well Protected and Cap Locked. Well Protection and Capping Typical of Inspected Above Ground Monitoring Wells.

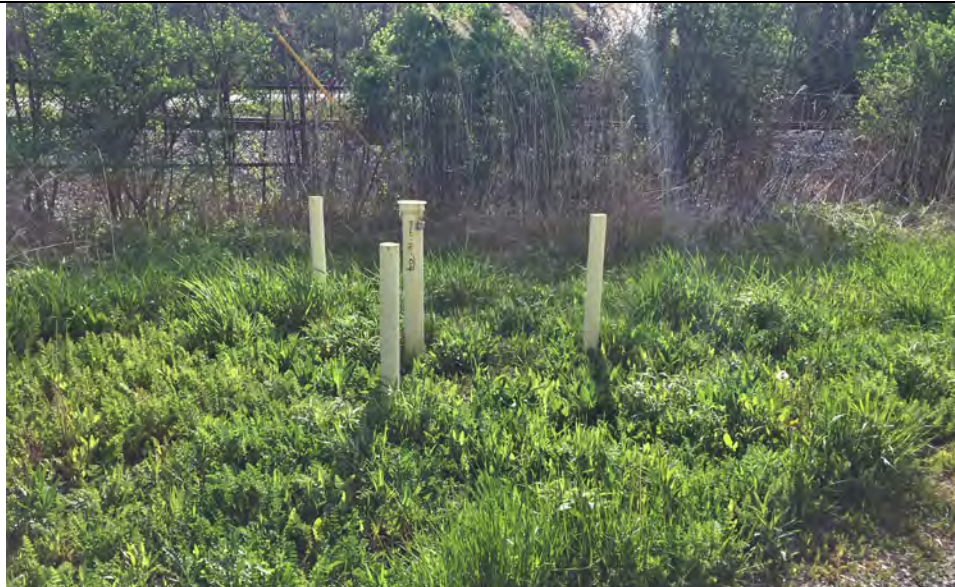
7. Monitoring Well 16-04. Well Protected and Cap Locked. Well Protection and Capping Typical of Inspected Above Ground Monitoring Wells.

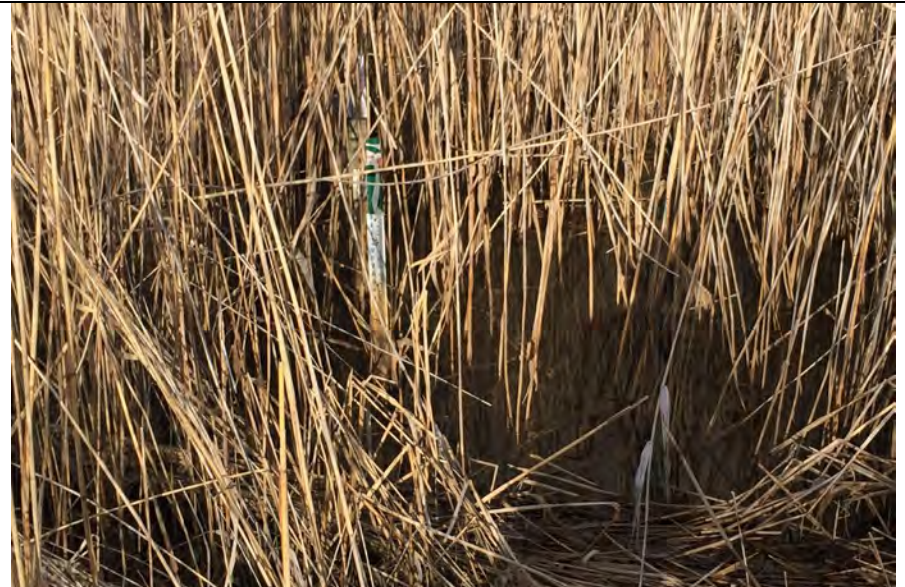
8. Perimeter Ditch Staff Gauge SG-07. No Flow Noted. Water Present. Typical at Most Staff Gauges..

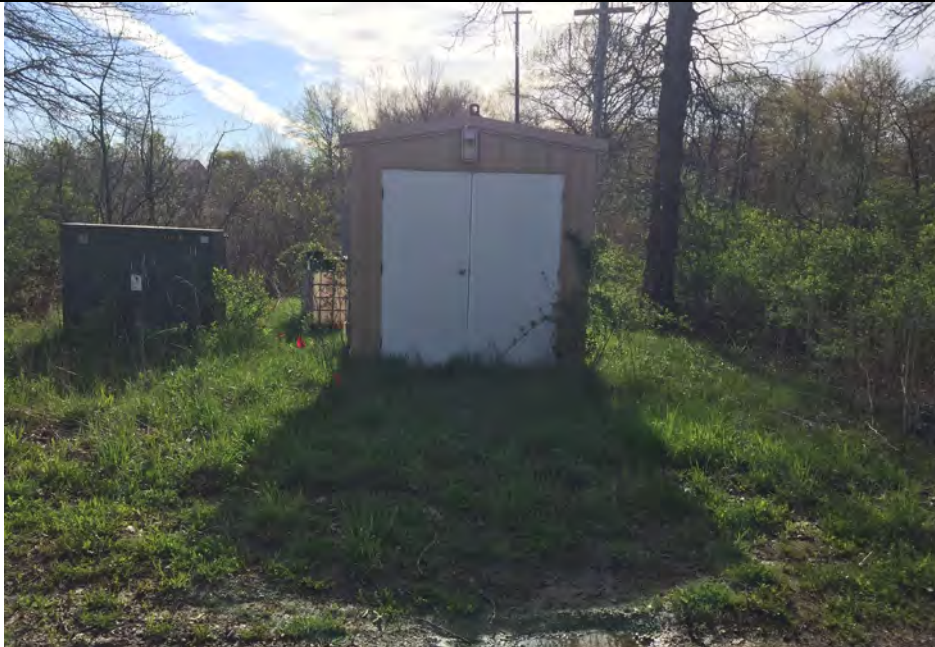
9. View of Locked Control Panel Building for East Side Groundwater Offsite Collection System. Panel Not Observed. Pipe Flow to Ditch Observed.

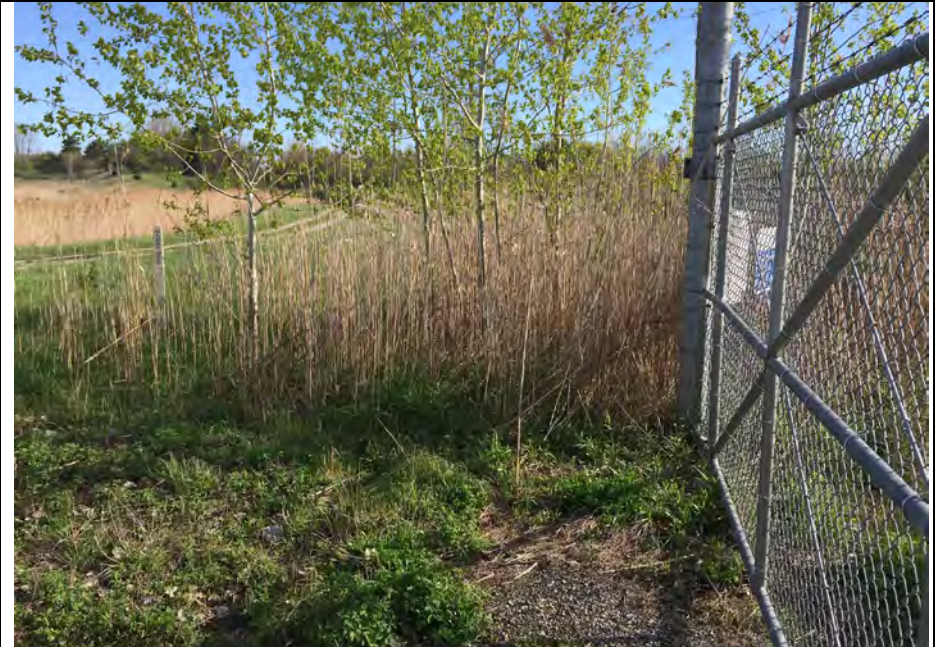
10. Side View of Locked Gate with Signage and at Far-Left Typical Slurry Wall Location Marker. All Gates had Signage.

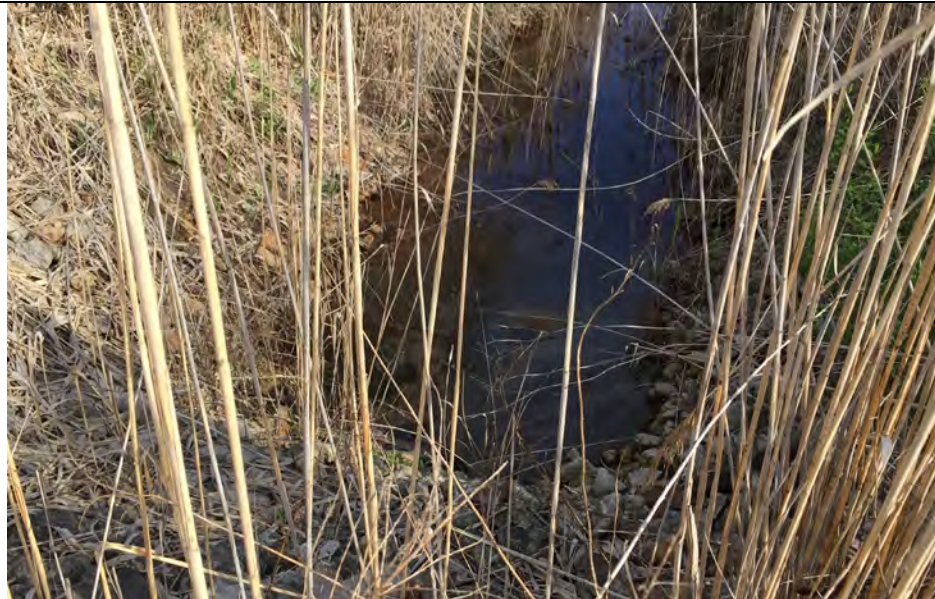
11. Looking at Perimeter Ditch Upstream of Culvert Under Site Road. Condition Typical of Unobstructed Flow into Culverts Along Perimeter Ditch Alignment.

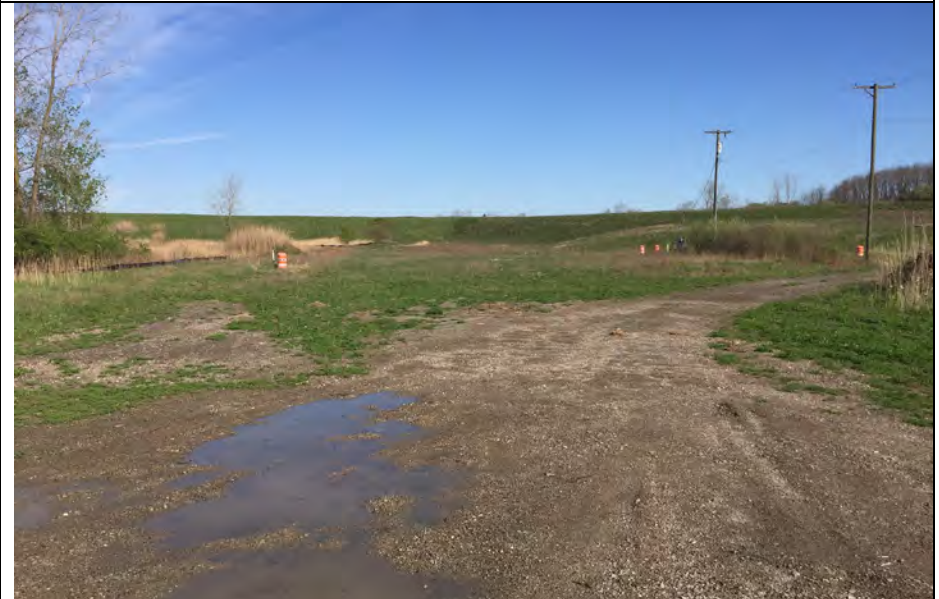
12. Looking at Barrels Locating and Protecting White Markers for Underground Electric Utility.

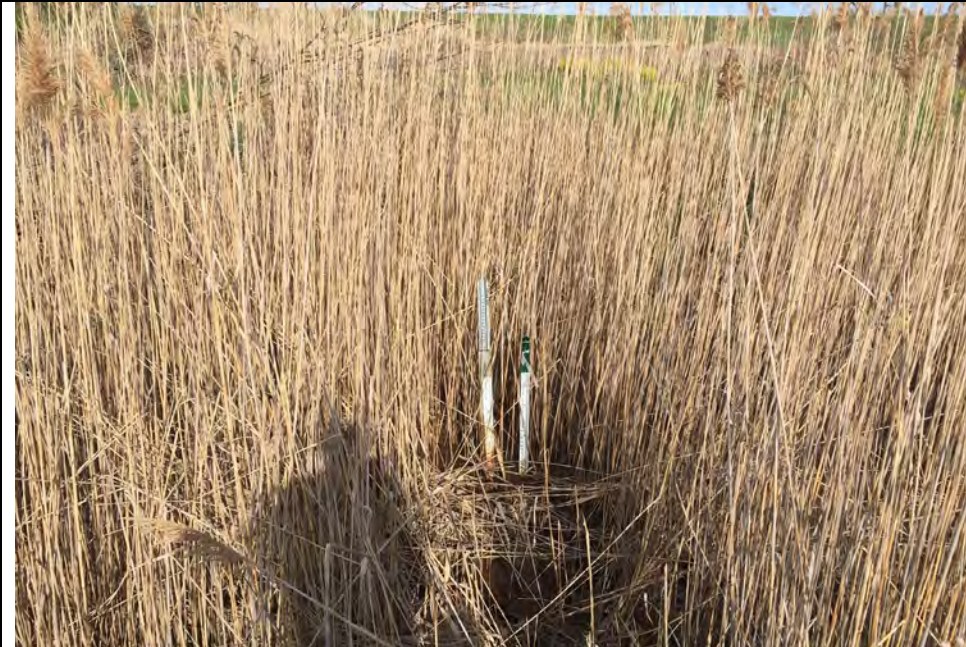
13. Looking at Location of Staff Gauge SG-03. Water Present. No Visible Flow Noted.

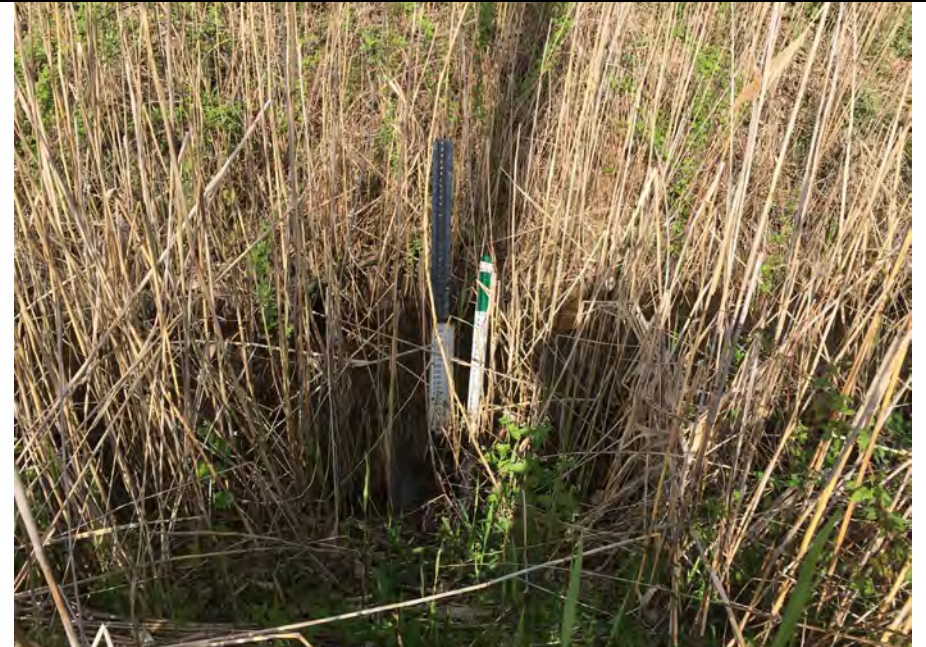
14. Looking at Location of Staff Gauge SG-02. Water Present. No Visible Flow Noted.

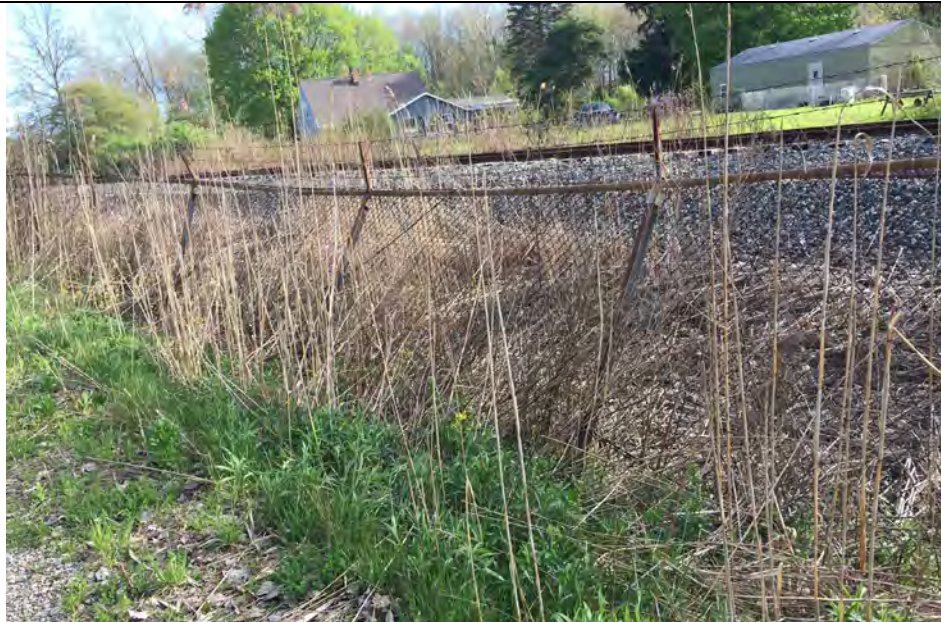
15. Perimeter Fence Leaning. However, Posts Appeared Solid when Attempted to Move.

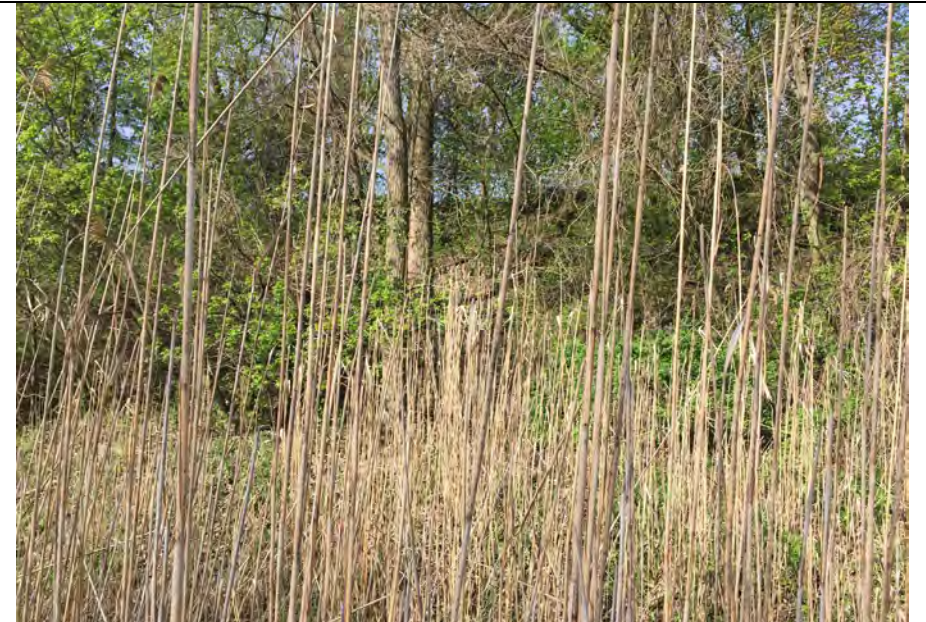
16. Typical Tree Growth Along Portions of East and North Closed Historical Landfill Areas A and B. Slopes Appeared Stable w/ No Significant Erosion.

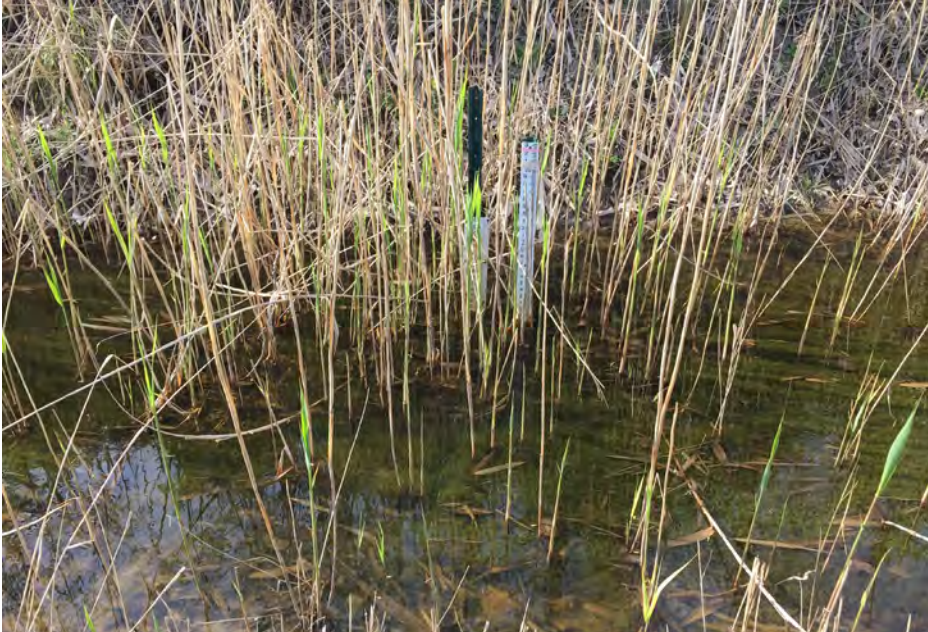
17. Looking at Location of Staff Gauge SG-01. Water Present. No Visible Flow Noted.

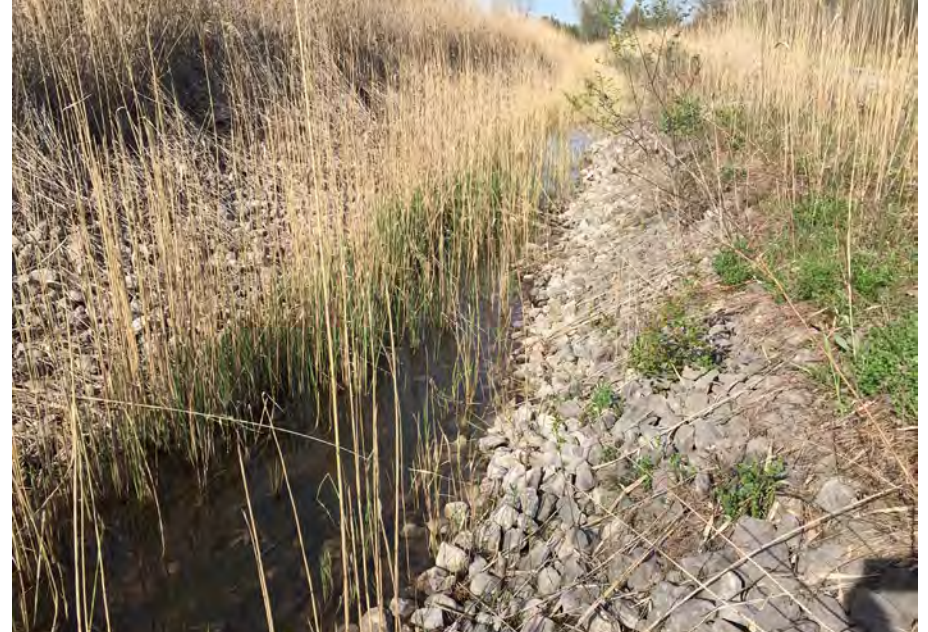
18. Looking at Portion of Perimeter Ditch Alignment Cleared of Vegetation Last March. Little Flow Noted.

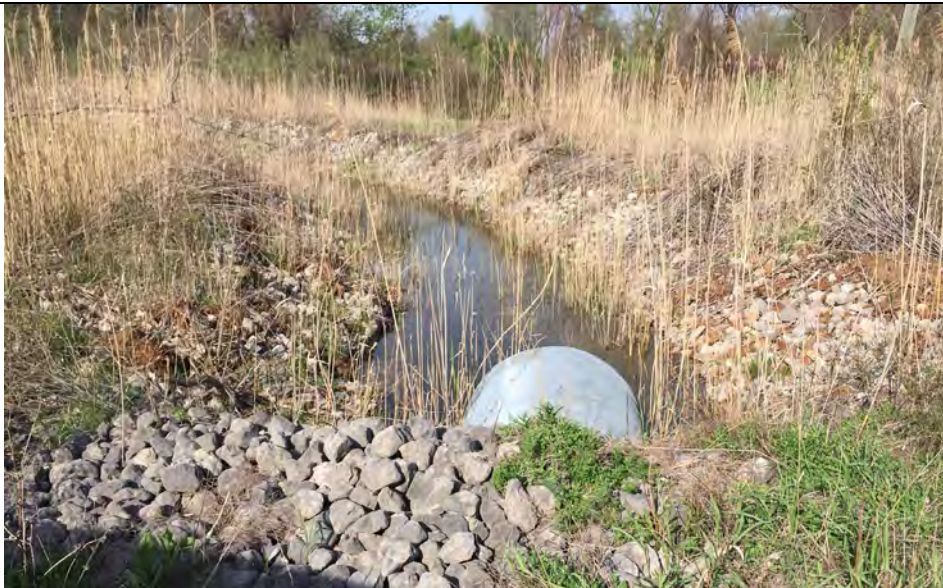
19. Another View of Portion of Perimeter Ditch Cleared of Vegetation During Routine Maintenance Activity.

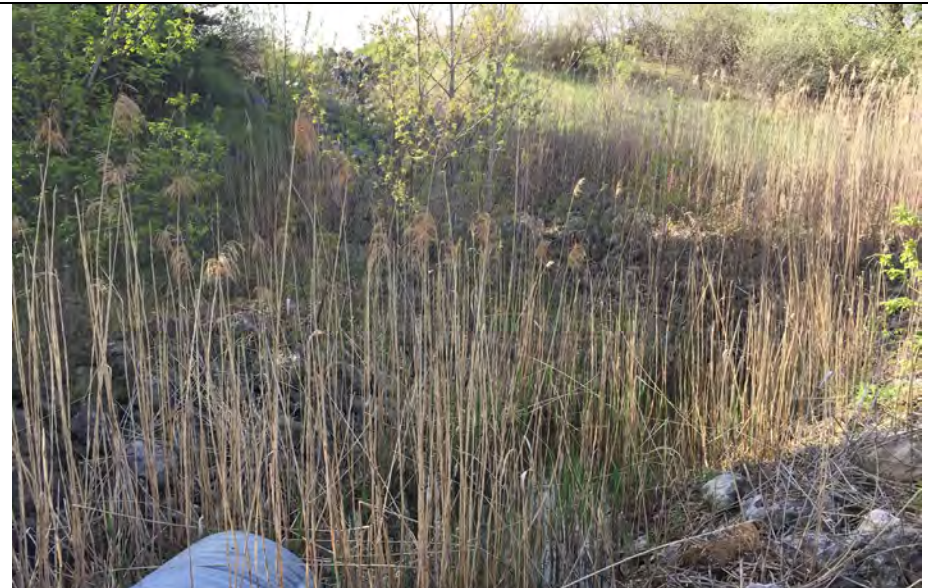
20. Culvert and Riprap Downslope Where Ditch Clearing of Vegetation Had Not Recently Occurred. Flow did not Appear to be Blocked.

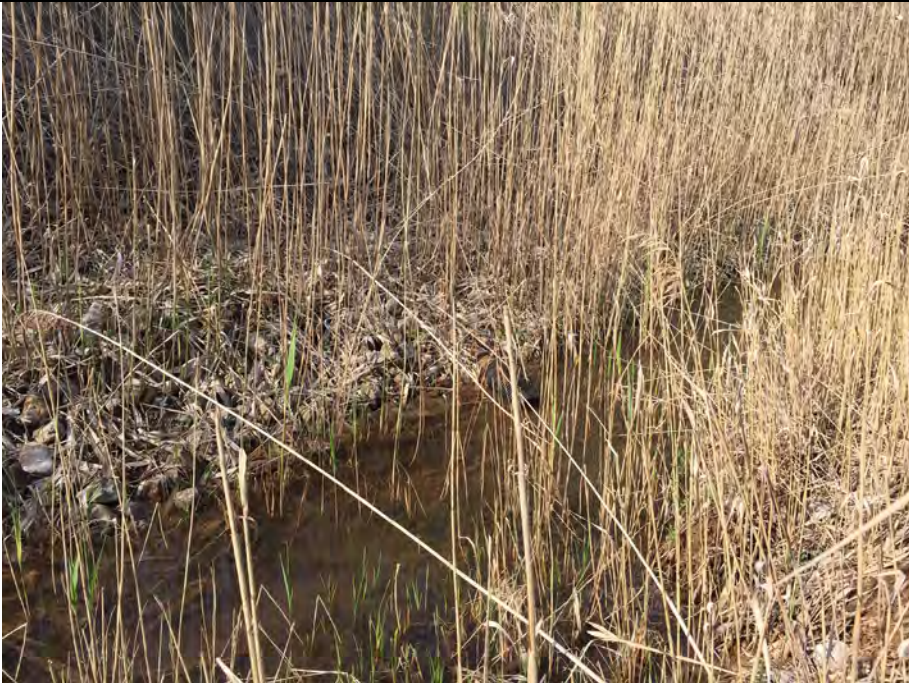
21. Looking at Perimeter Ditch North Side of Landfill. At Photo Center is Black Corrugated Pipe Likely Collecting Slope or Gully Drainage. About 6 Noted.

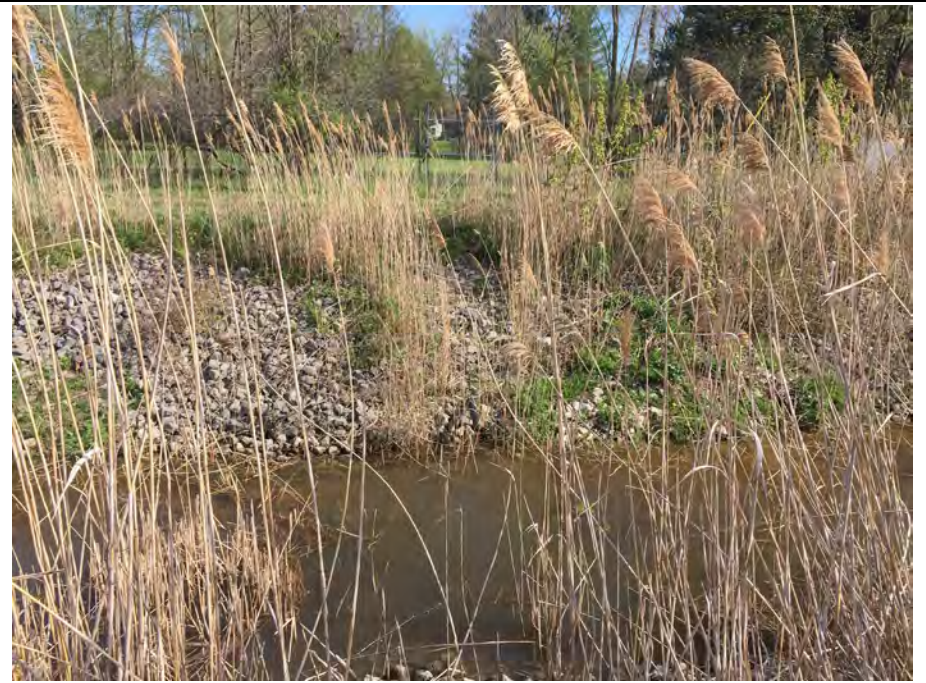
22. Location of Discharge Pipe from Offsite GW Capture Area. Locked Gate in Background Easily Noticed in Photo when Zoomed in.

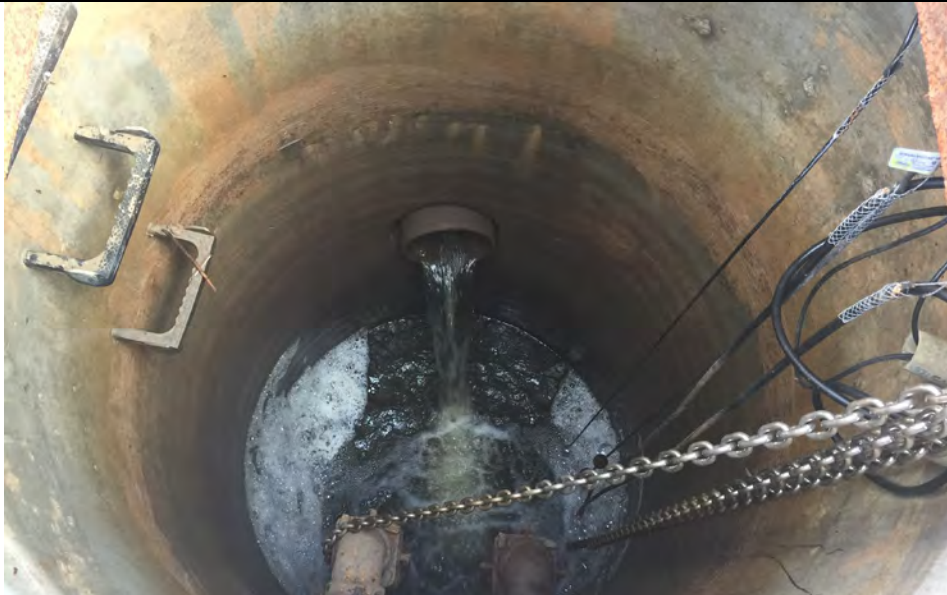
20. NW Corner Lift Station Operating Condition	<input checked="" type="checkbox"/>	<input type="checkbox"/>	<input type="checkbox"/>	23 & 32	See also Item 19 above. Both pumps operated when checked.

23. Sump Where 2 New Pumps Installed 2018. Pump Operation Verified by DTE Inspector. Panel Lights Operation to be Rechecked by DTE.

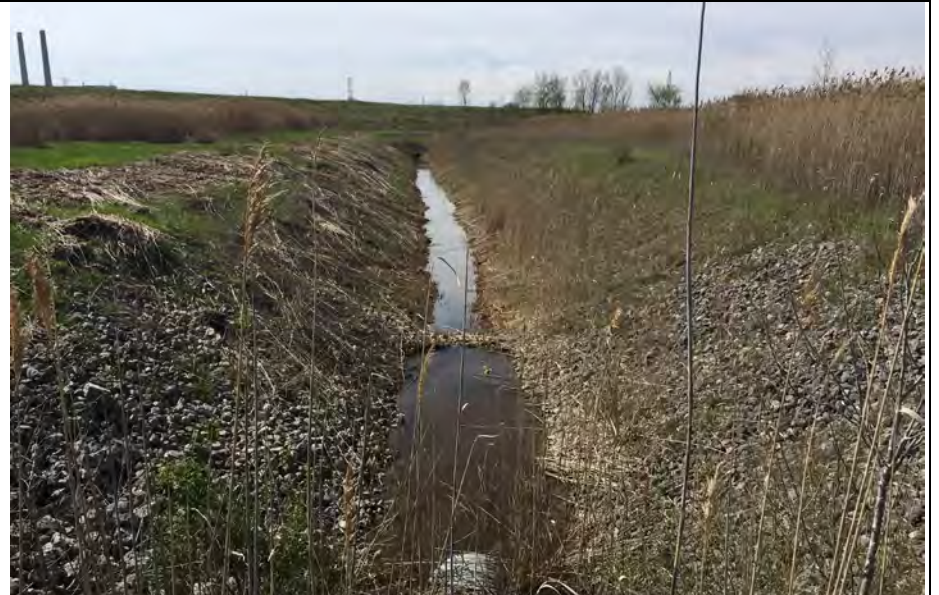
24. Perimeter Ditch West Side of Landfill Opposite Area B Looking South. Small Stone Check Dam Shown. No Visible Blockage or Flow.

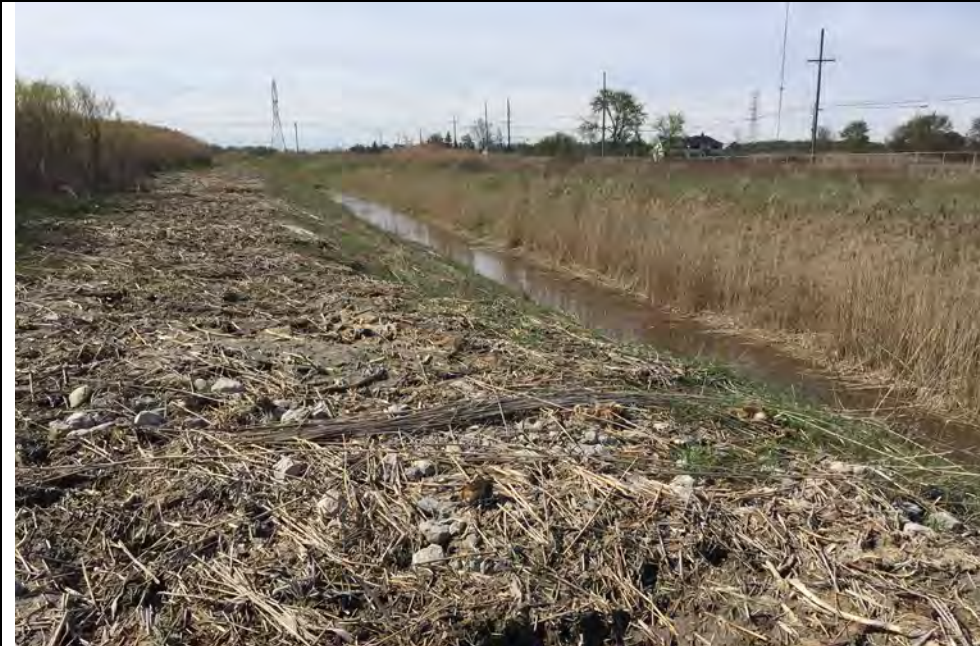
25. Another View of West Side Perimeter Ditch Where Recent Vegetation Removal Has Occurred.

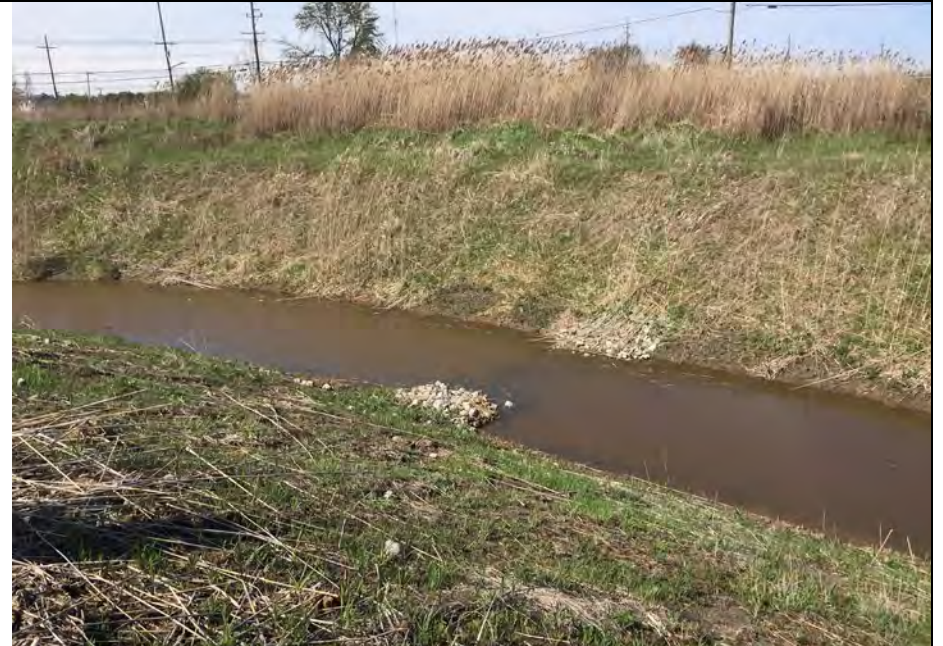
26. Perimeter Ditch Southwest Side. Check Dam Shown. No Ditch Blockage.

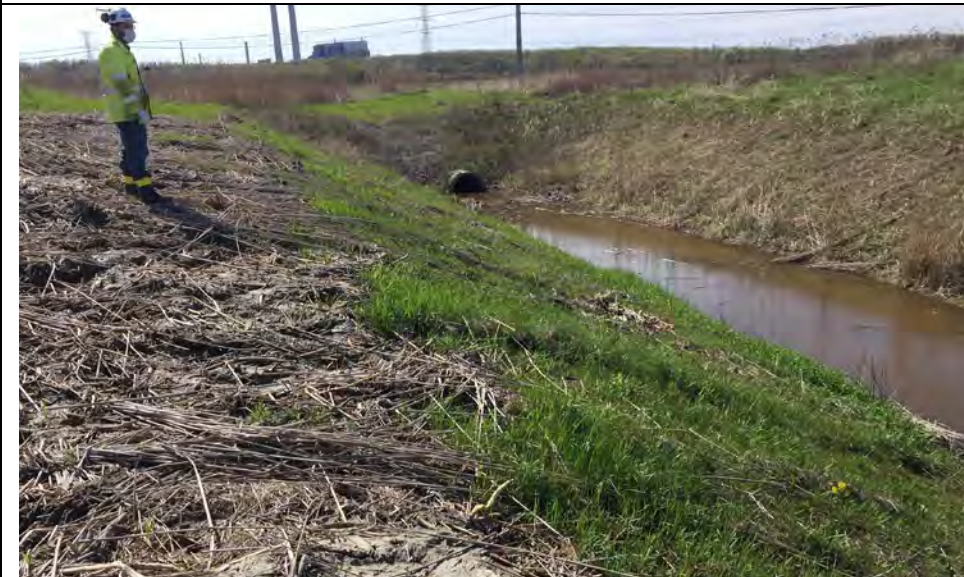
27. Another Photo of Ditch Area Where Maintenance has Occurred and Slope Grass Vegetation Growing.

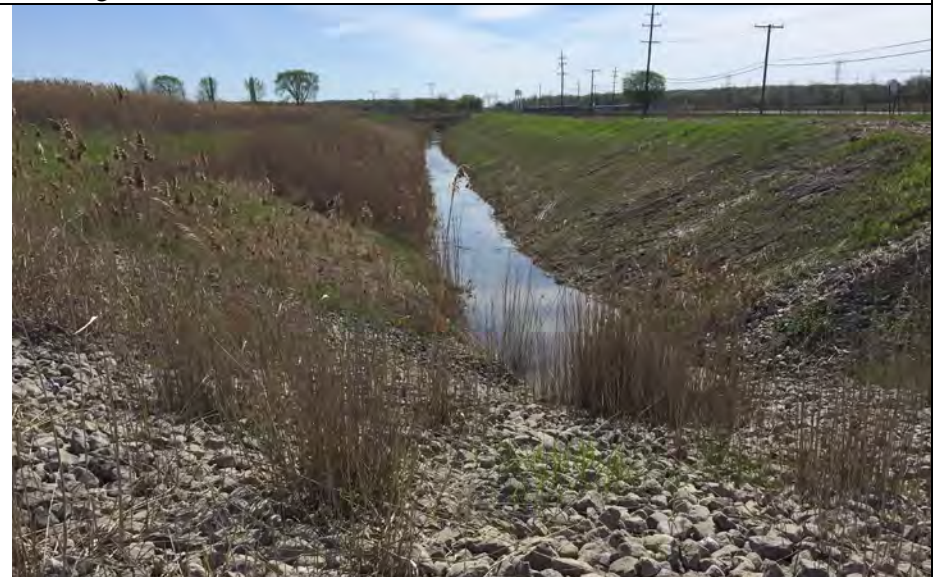
28. Perimeter Ditch Along South Side Looking East.

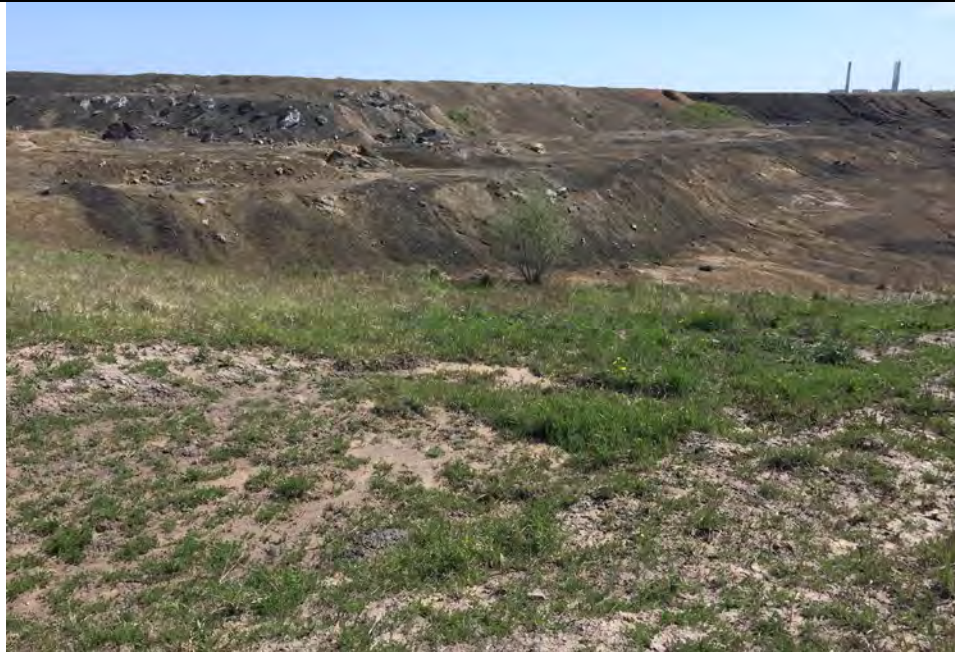
29. View of South Side of Active Disposal Area Slopes. Photo Taken from Outside of Active G2 Area Along the West Side Existing Berms.

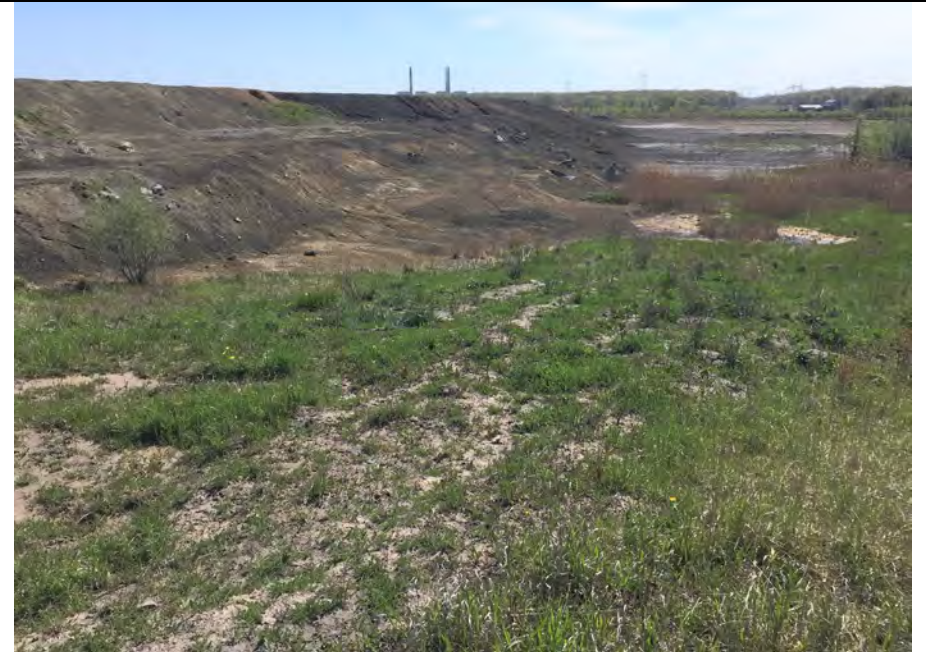
30. Continuation of Photo 29 as Top of Area F2 Slope Meets Portion of Area G2 Approved for CCR Disposal.

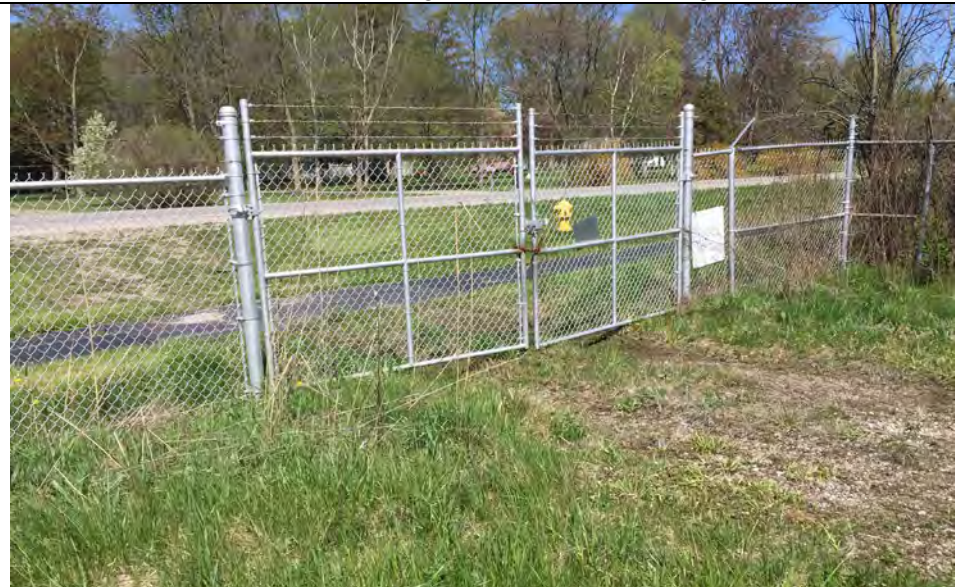
31. Northwest Corner Fence and Locked Gate, Signs Posted.

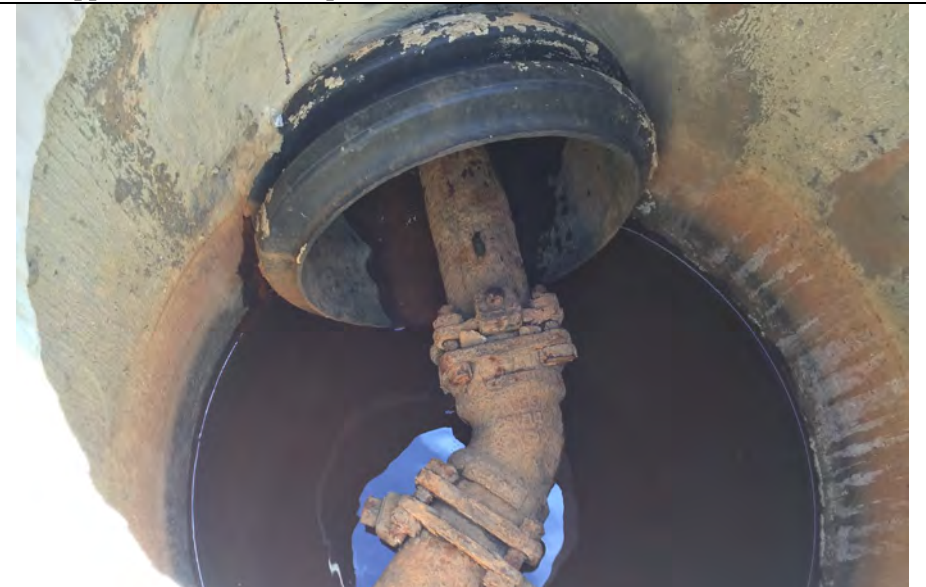
32. Inspection Sump and Piping from Pumps Shown in Photo 23. Inspected by DTE to Confirm Pump Operations and Flow (Flow Sound Within Pipe).

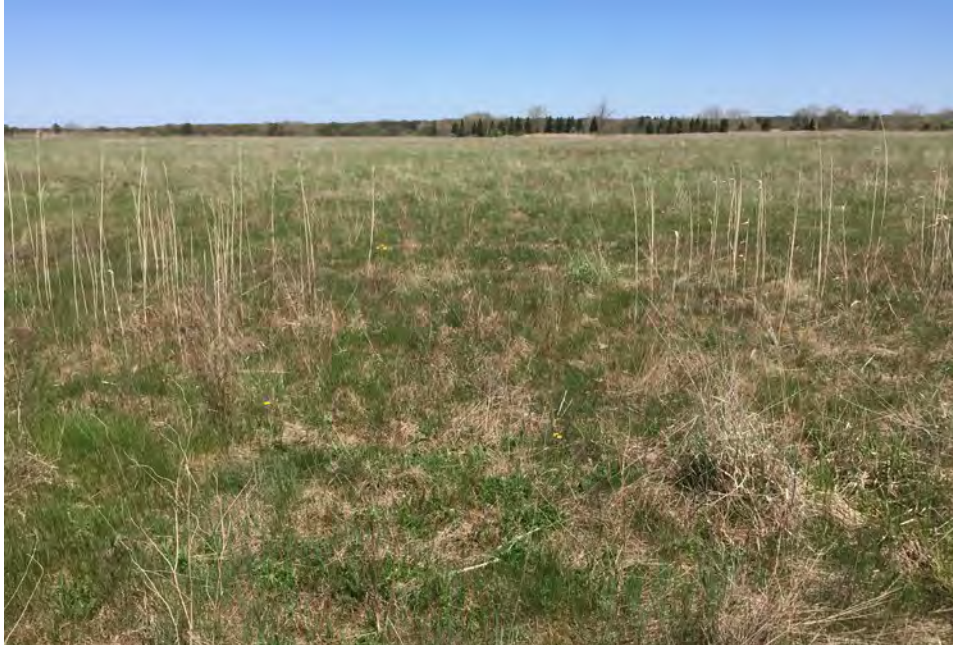
33. Typical Top of Closed Landfill Areas D and B. Recent rains made travel a little surface spongy.

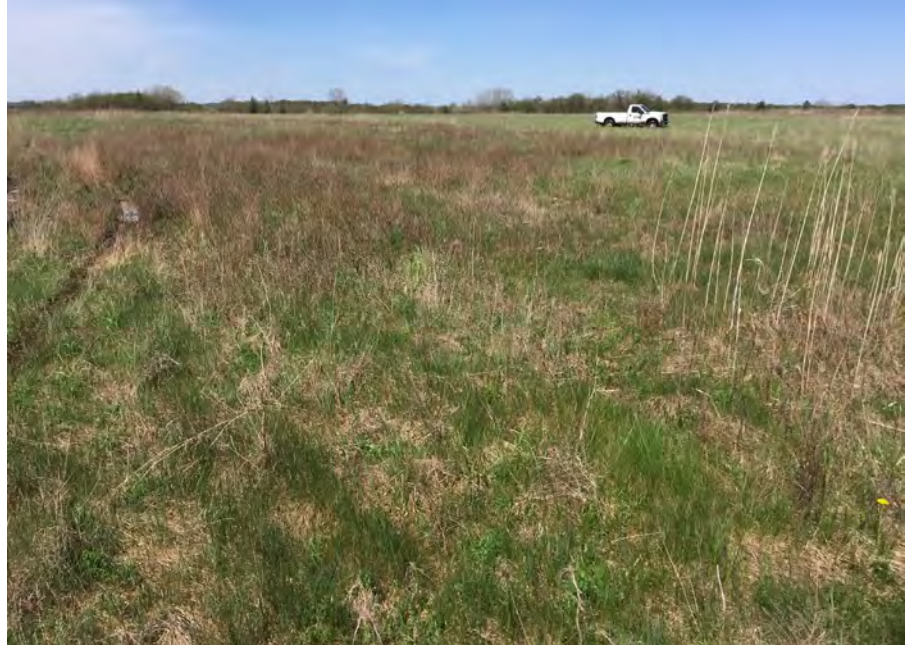
34. Same as Photo 33 except truck rut shown. No surface brush vegetation shown in these photos. Recent heavy rain previous days.

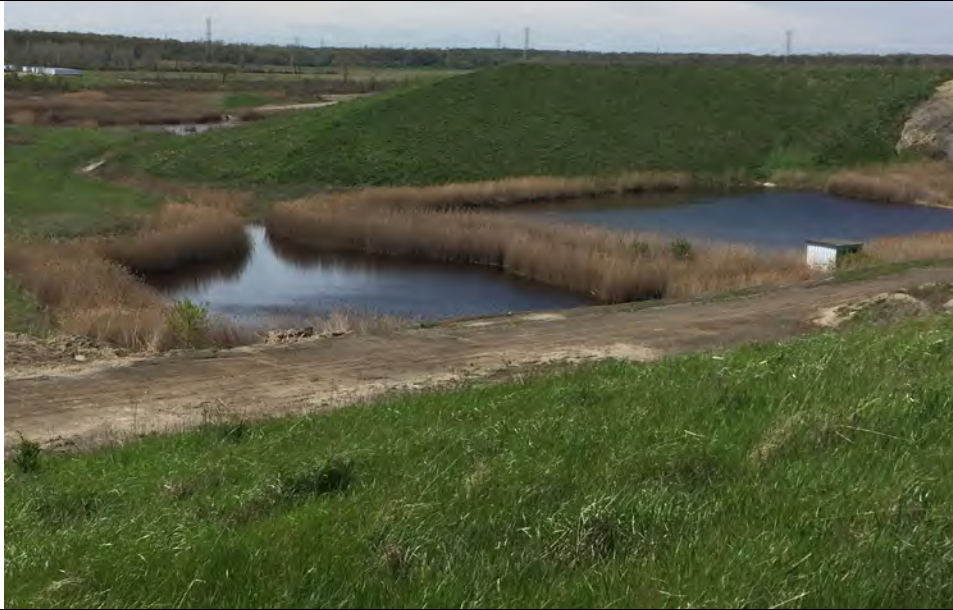
35. Runoff collection pond within landfill limits. Landfill area slopes appeared stable and well vegetated.

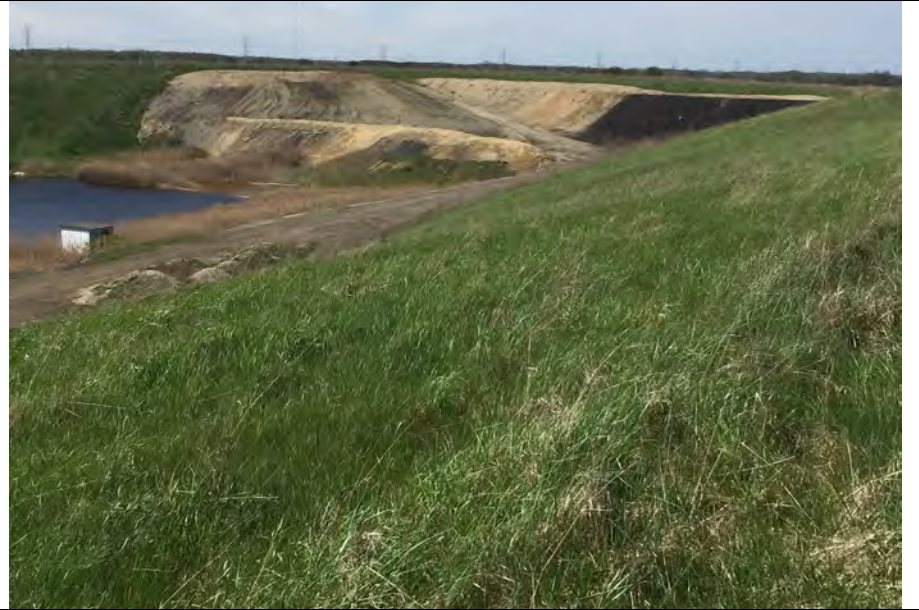
36. Right side of runoff collection pond within landfill limits. Area F3D3 in corner where road ramps shown to top of landfill.

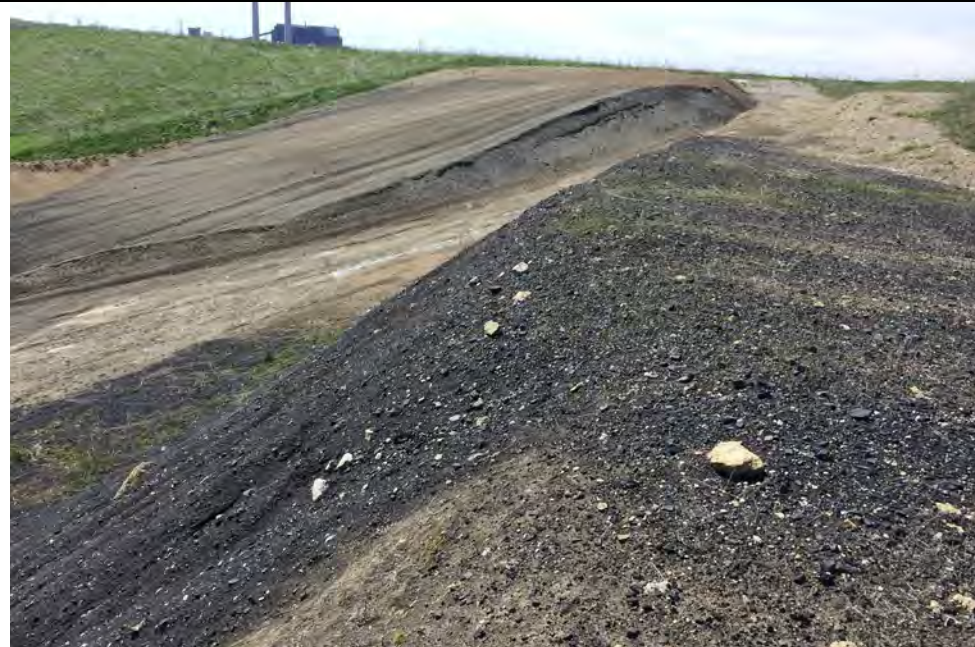
37. Interior Haul Road Leading Down into Active Waste Placement Areas. Compacted Waste Supporting Haul Trucks Without Rutting.
