# **2020 ANNUAL INSPECTION REPORT RANGE ROAD LANDFILL ASH DISPOSAL FACILITY**

**China Township, St. Clair County, Michigan**

January 2021

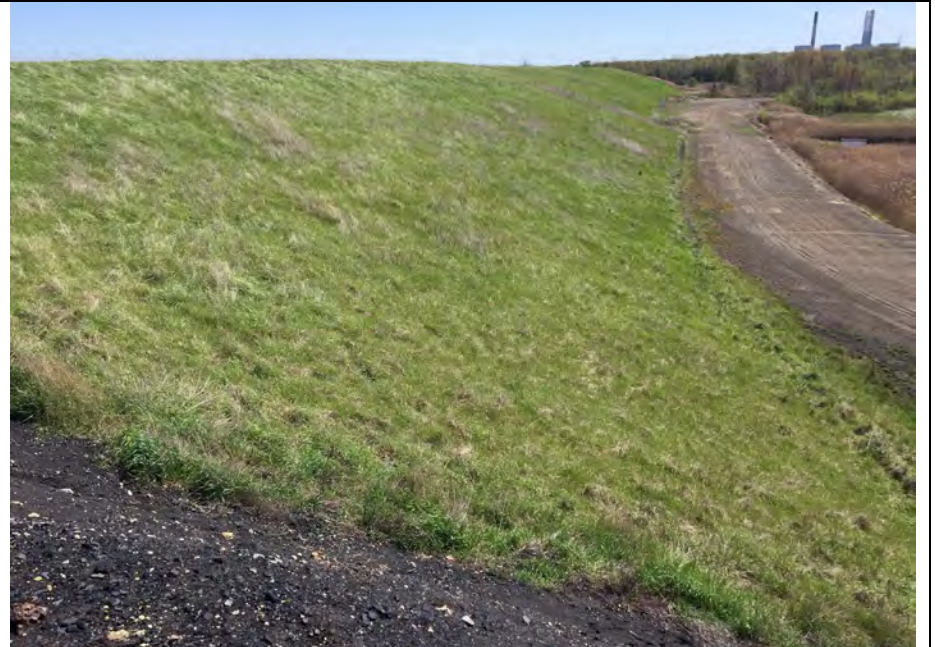
38. Embankment Slope Well Vegetated and Maintained. Area D2 Slope Looking East from Portion of Active Area D3.

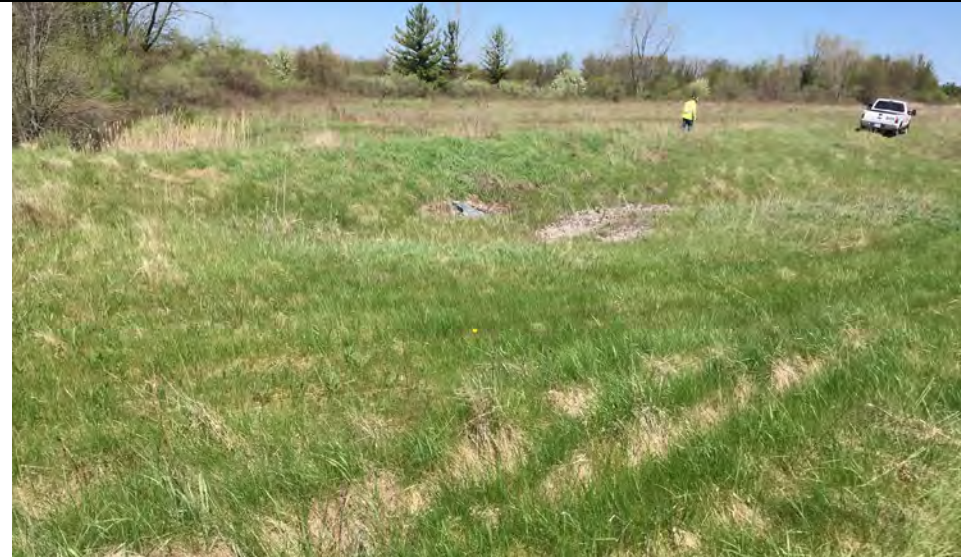
39. View of Top of Cover where Cover Drainage Swale Terminates at Exit Culvert Draining Flow to Outside of Landfill Cover.

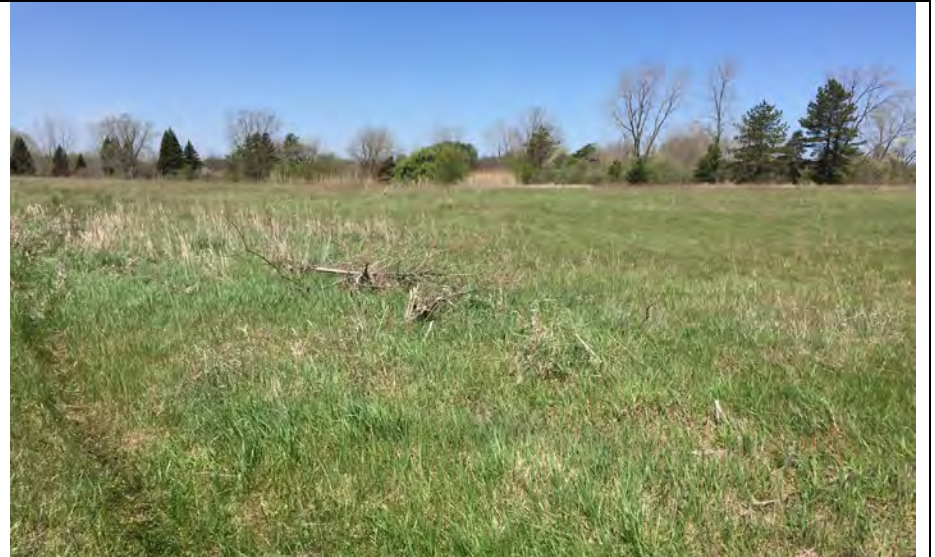
Landfill Final Cover: Closed work area phases were inspected including slopes. Conditions appeared generally good considering agreements approved with the MDEQ allowing trees remaining along and on the downstream slope at the north end of the Landfill, predominately in historical Areas A and B. These slopes were observed from the perimeter toe and intermittently along the top of slope from the landfill cover. Photograph 16 shows typical tree growth and ground vegetation on the outside slope of the closed landfill along the north and northeast sides of the landfill. Greater detail of trees and vegetation on outside slopes was provided in the 2018 inspection. The top cover of historical areas A and B were well vegetated with occasional small woody vegetation recently cut, as typically shown in Photograph 40.

40. View of Typical Closed Area Top of Landfill Showing Small Woody Vegetation that had been Cut. Cut Vegetation was Typically Left In-place.

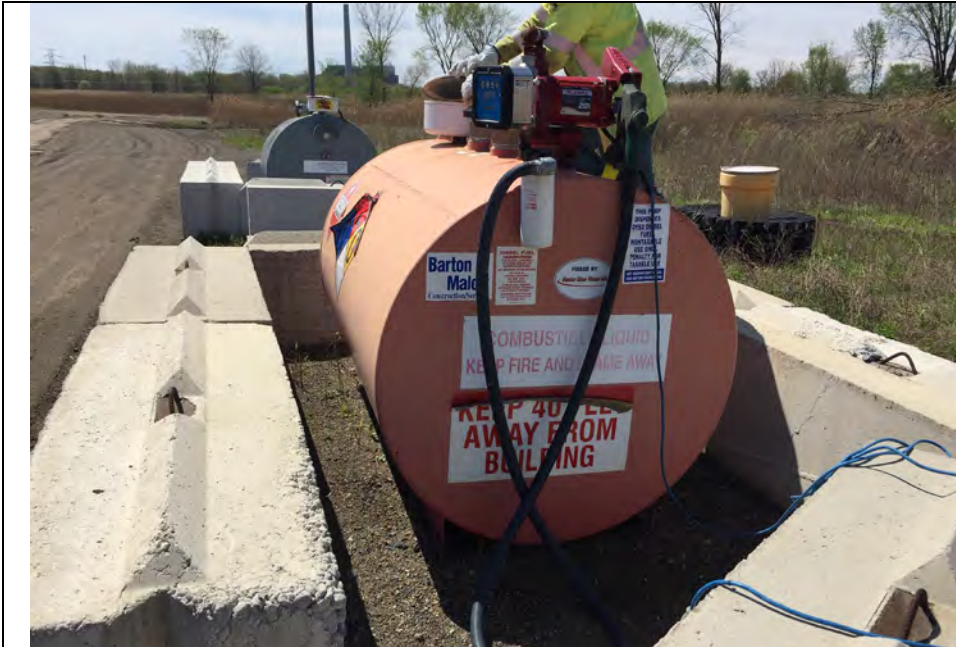
41 Second Fuel Tank that had Possible Dispensing Leak Repaired in 2019 after Inspection. Both Tanks Viewed in this Inspection and No Visible Leaks Noted.

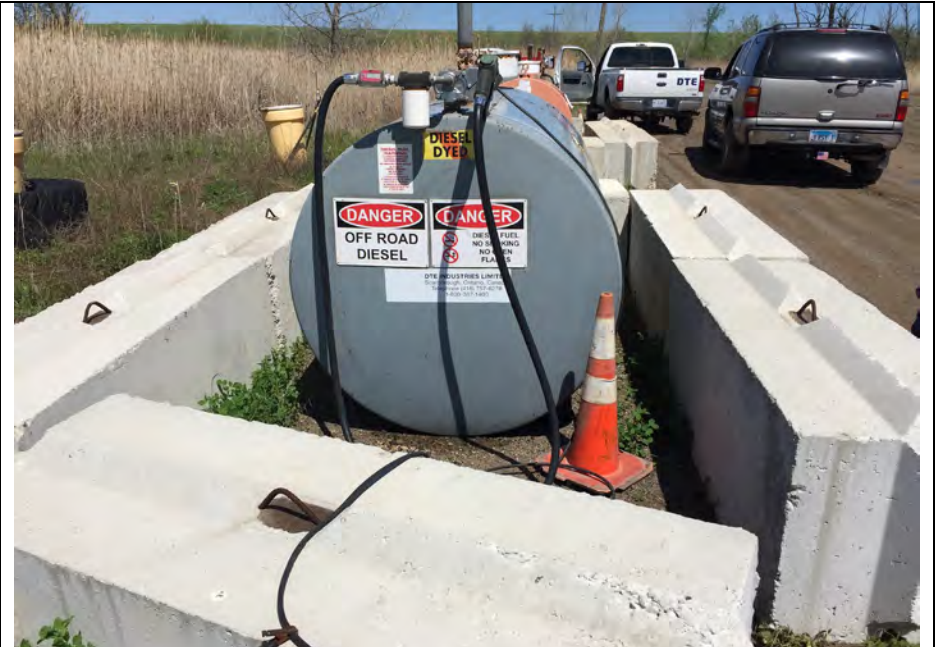
42. Looking at First Fuel Tank and Protection Containment and Signage.

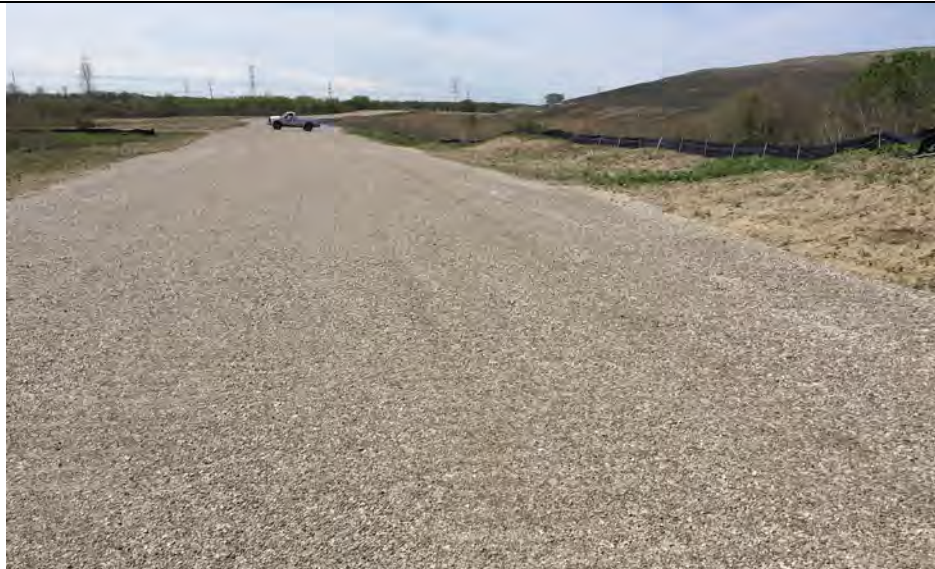
43. Newly Constructed Interior Landfill Haul Road.

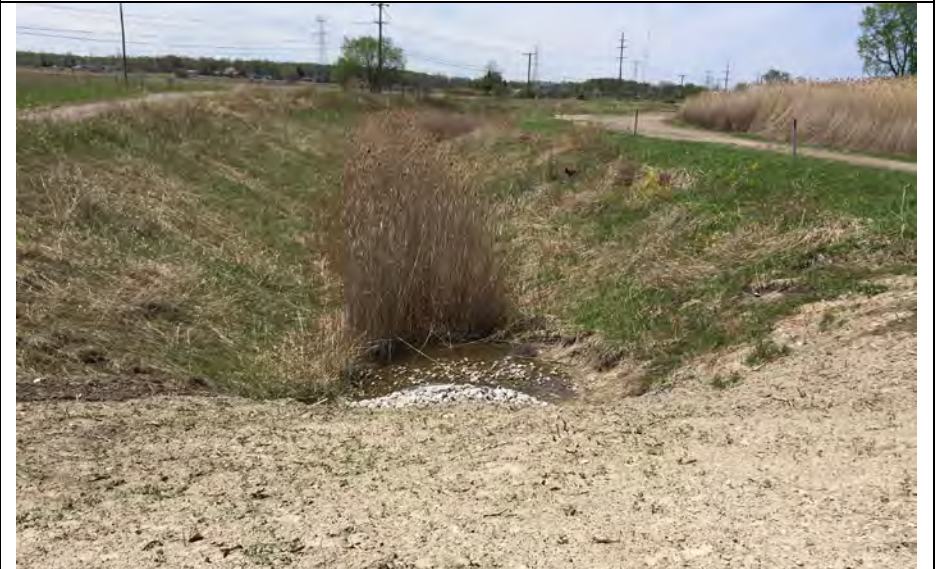
44. Perimeter Ditch South Side. Some Bottom Vegetation but No Flow Blockage.

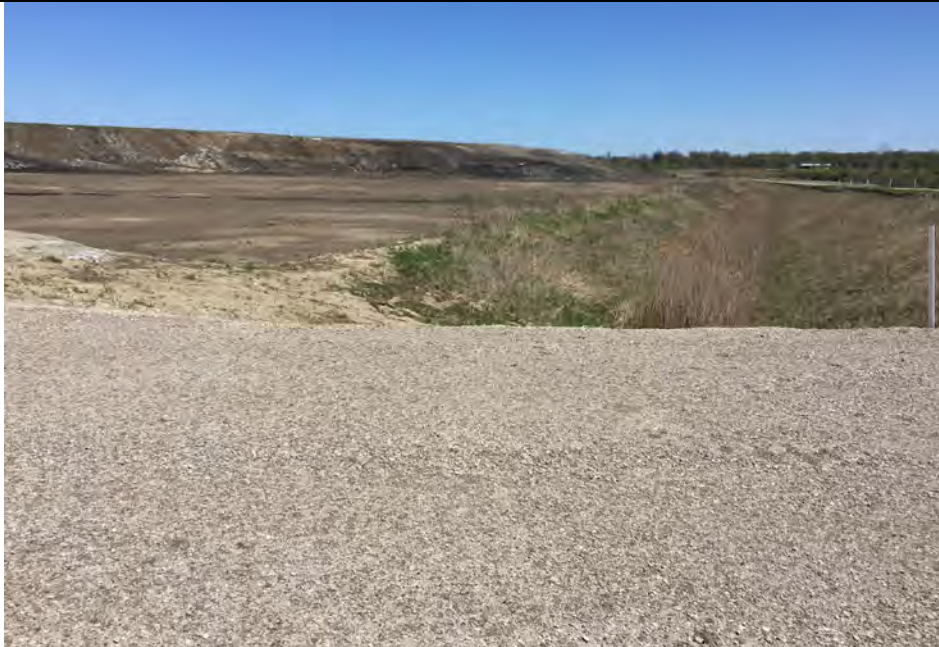
45. Landfill Ditch Seen from Haul Road. Active Area G2 Top Left.

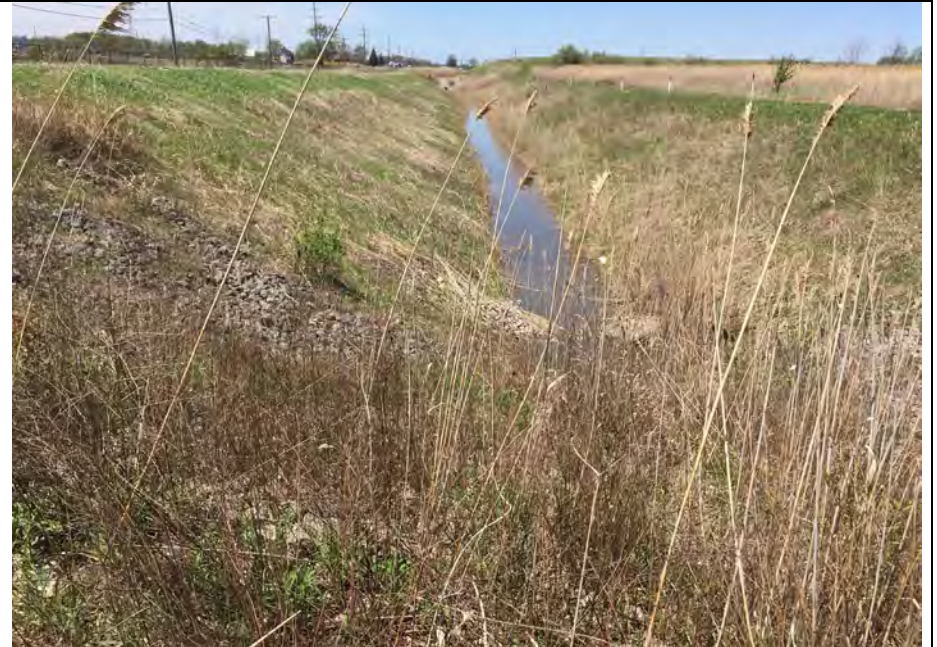
46. South Side Perimeter Ditch Looking West. Small Riprap Place at Road Crossings and Around Drainage Pipe Inlets and Outlets to Prevent Blockage.

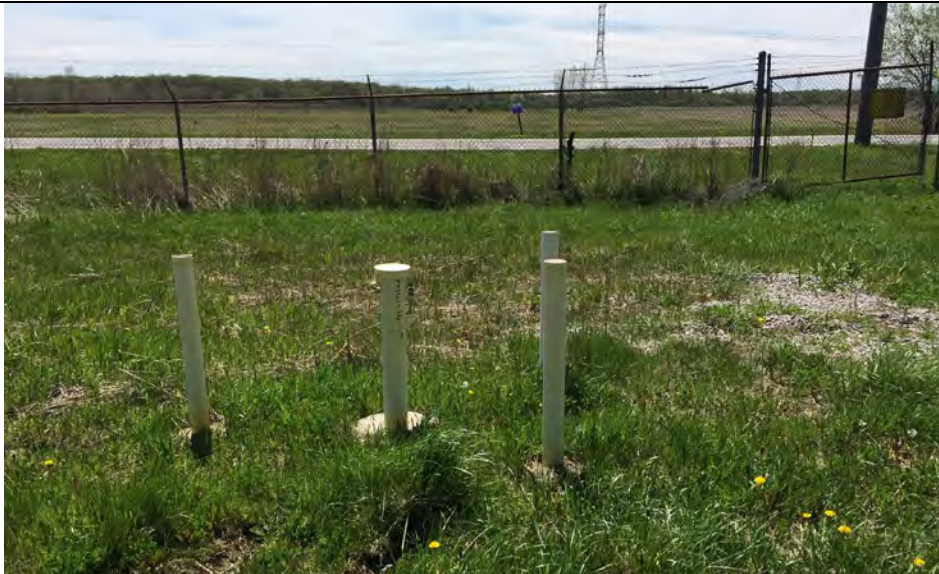
47. Monitoring Well 16-05. Property Fence and Gate Along South Side and Puttygut Road. Slurry Wall Alignment Between Well and Fence.

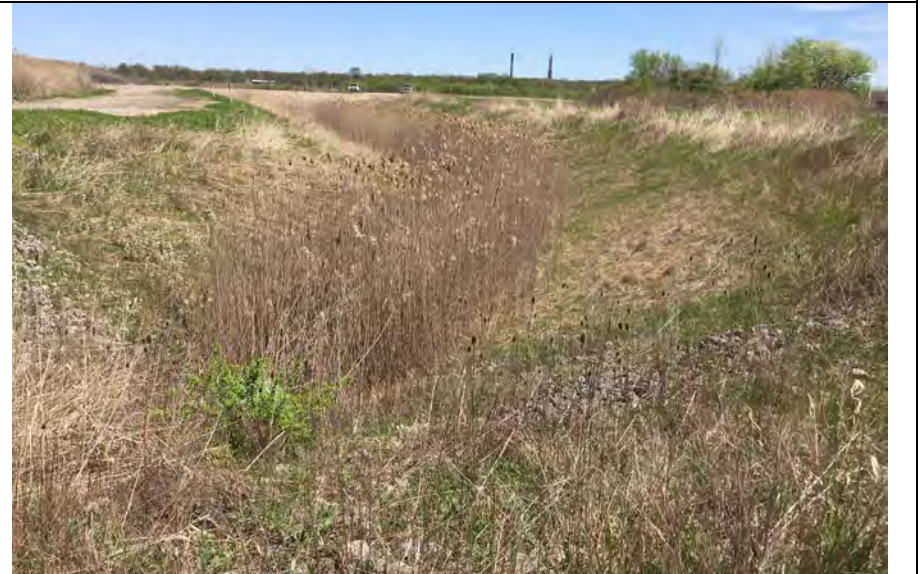
48. Looking at South Side Perimeter Ditch Where it Bends to the NE. Some Vegetation Present in Bottom but No Blockage Noted.
