**2021 ANNUAL INSPECTION REPORT  
RANGE ROAD LANDFILL  
ASH DISPOSAL FACILITY**

**China Township, St. Clair County, Michigan**

January 2022

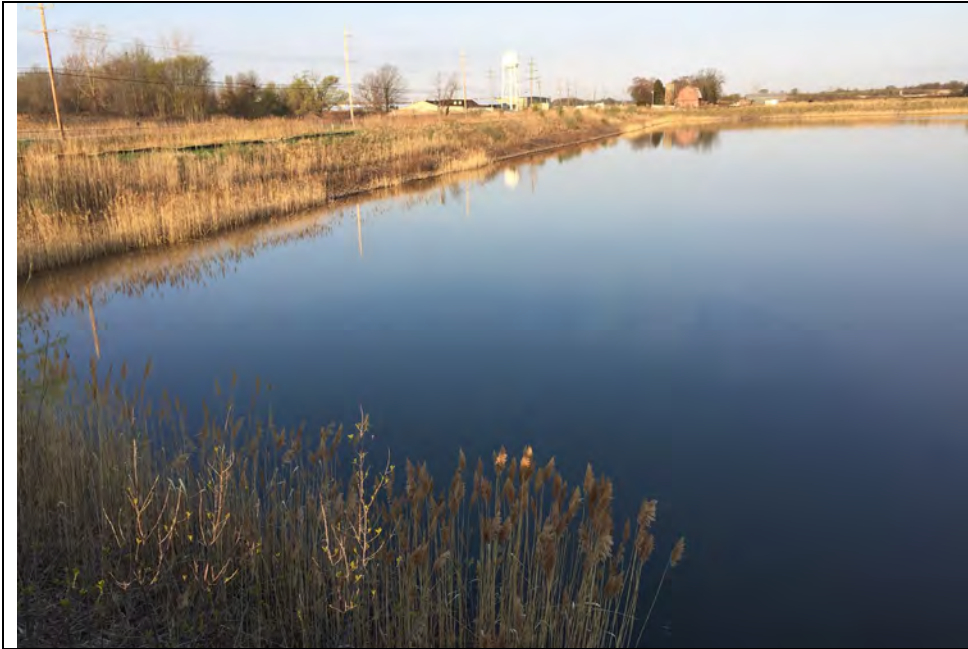
1. Storm Water Detention Basin (SDB), S & W Sides. Slopes are Protected with Stone. No Visible Slope Erosion on All Sides. Same for N & E Sides.

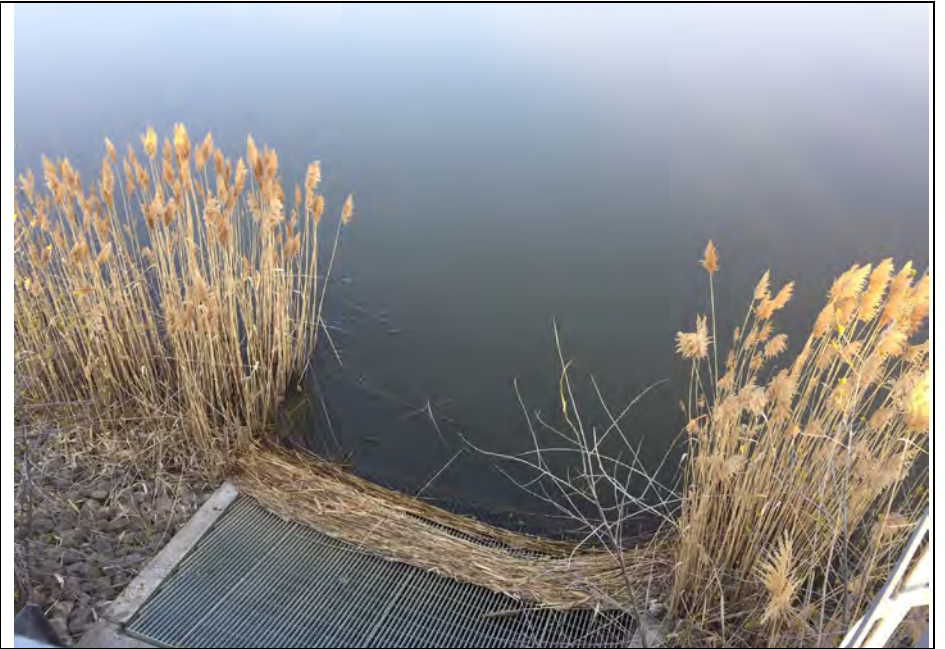
2. Intake Screens at SDB with Some Vegetation at Bottom. Water from Basin is Pumped Back to Power Plant Using One or More of 3 Pumps.

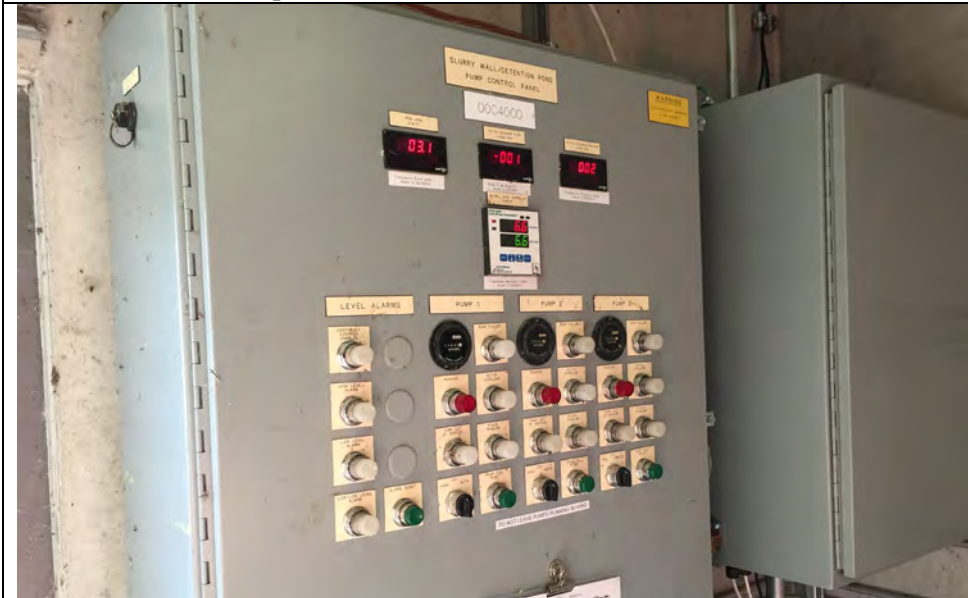
3. Pump Control Panel. All 3 Pumps were Available for Use. Wall Flow Meter (Not Shown) appeared OK. Pumps were Observed but not Pumping at the Time.

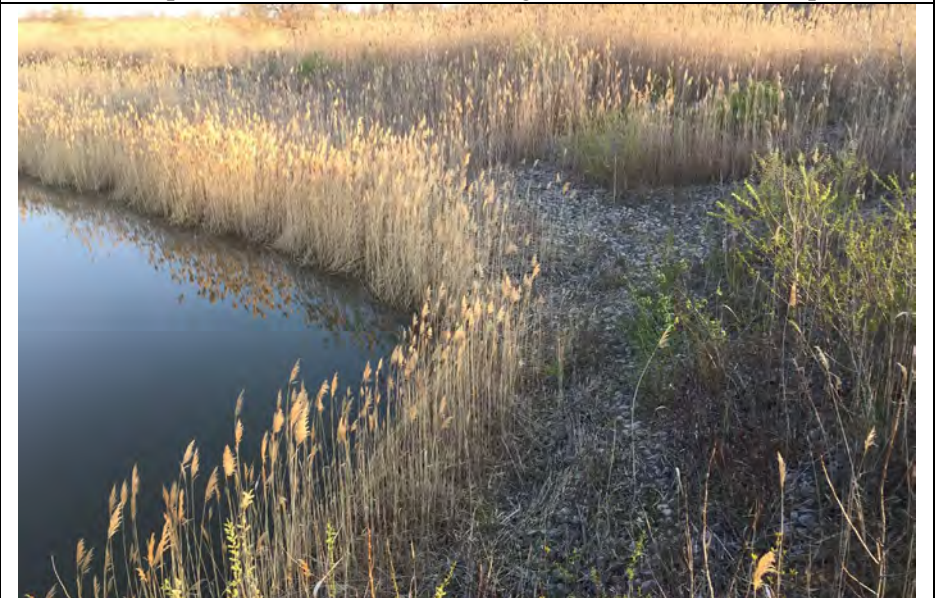
4. Looking at NE Corner of SDB. Slope Protected from Erosion with Stone. Staff Gauge SG-13 in Middle of Photo at or Just Above the Water.

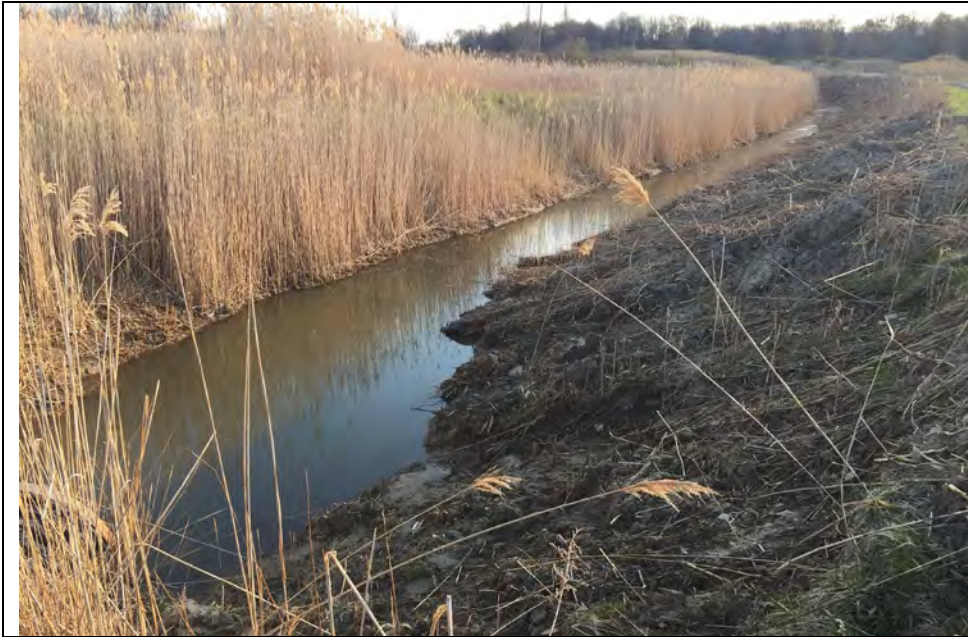
5. Ditch Maintenance Along One Side where Access from Road Easiest.

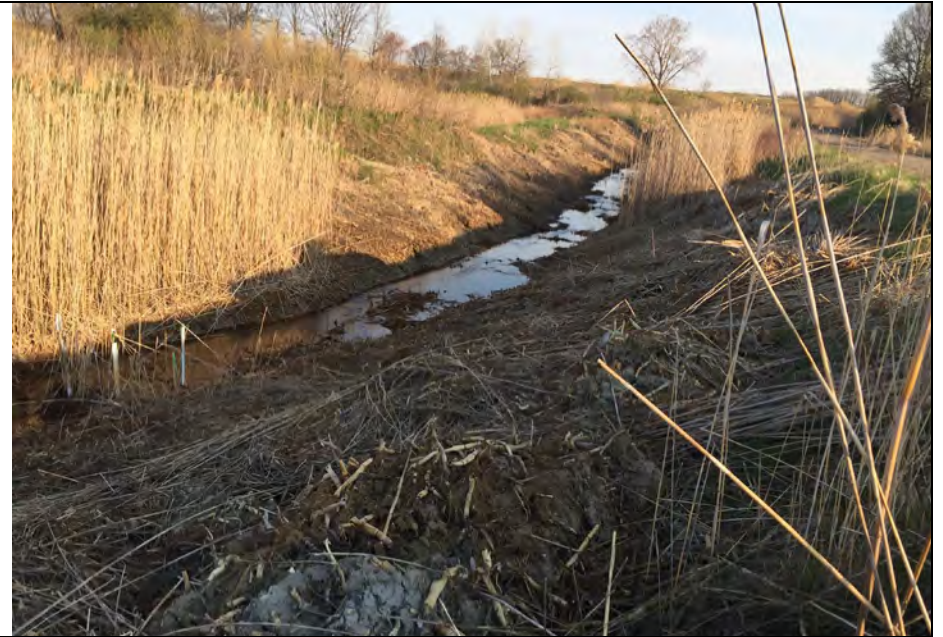
6. Again Ditch Maintenance Along One Side or the Other. Flow Maintained. Staff Gauge SG-7 Shown.

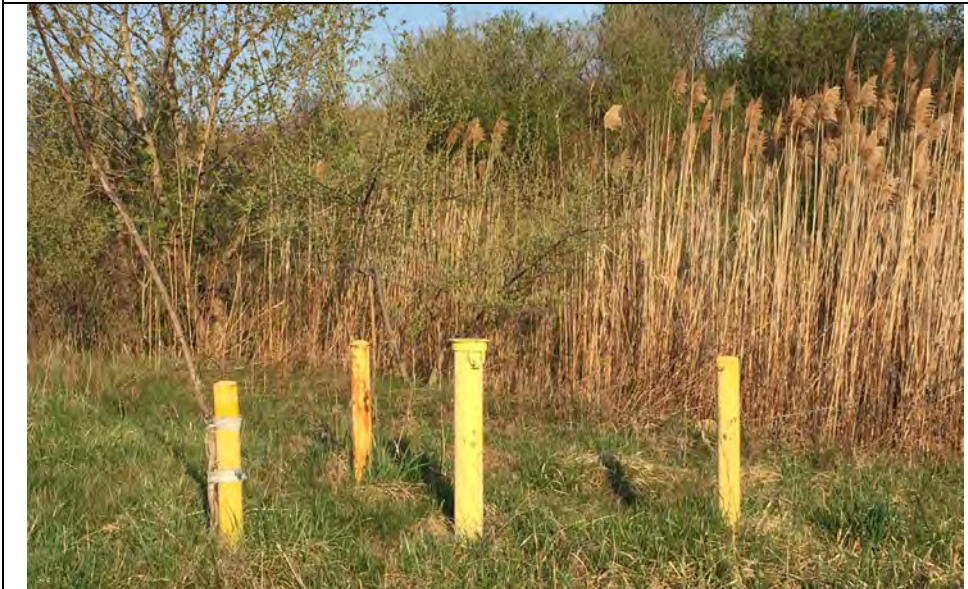
7. Monitoring Well 16-03. Well Protected and Cap Locked. Well Protection and Capping Typical of Inspected Above Ground Monitoring Wells.

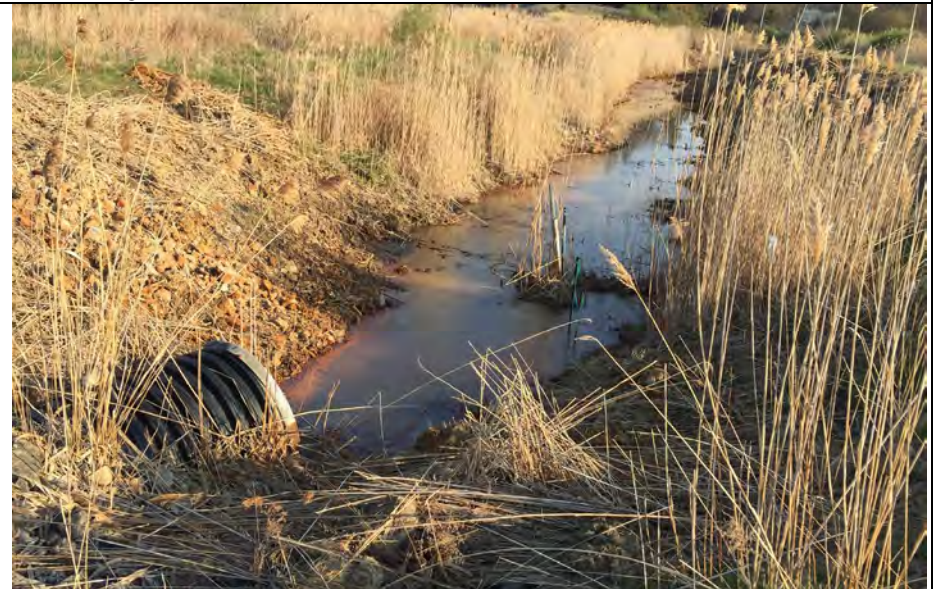
8. Perimeter Ditch Culvert and Staff Gauge SG-5. Culvert Entrance Open for Flow.

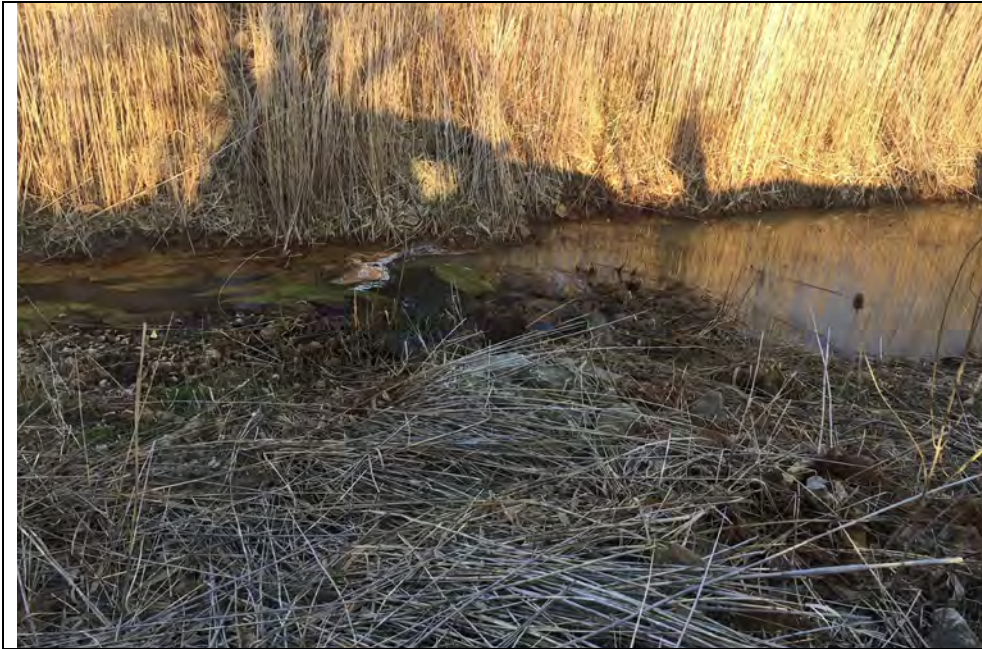
9. View of Location of Discharge of East Side Groundwater System into the Landfill Perimeter Ditch.

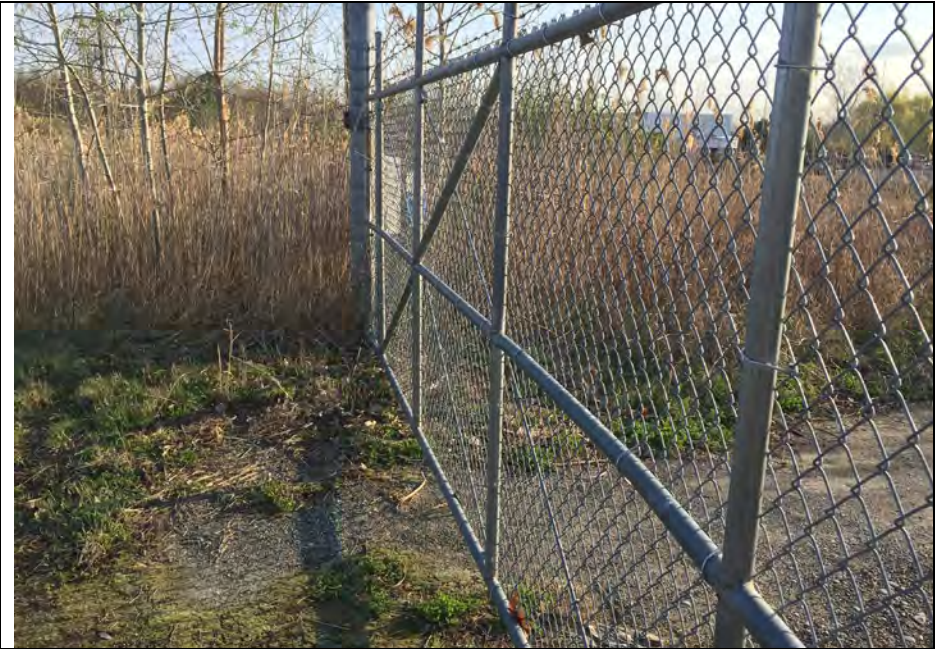
10. Side View of Locked Gate with Signage. All Gates observed had Signage and were Locked.

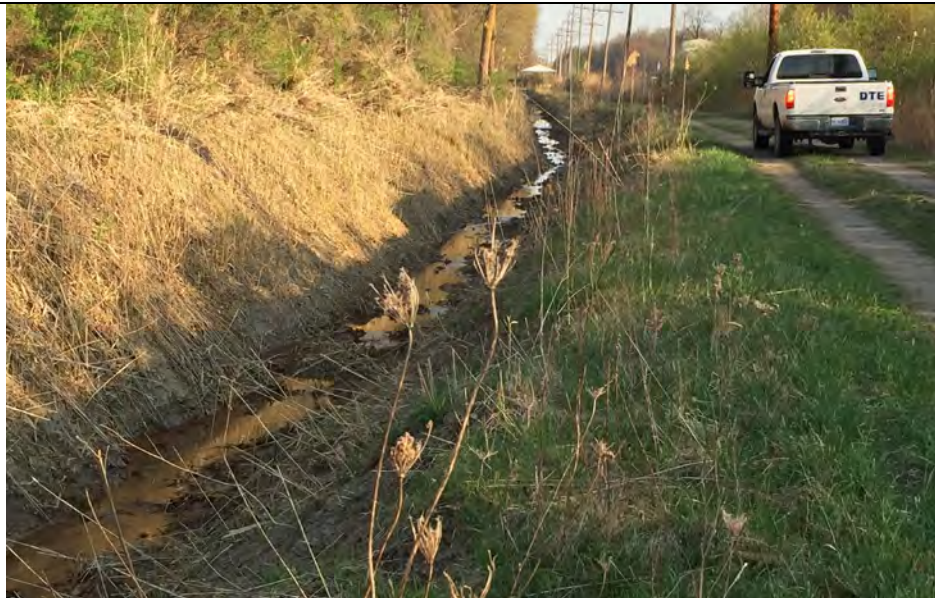
11. Looking at Perimeter Ditch where Recent Maintenance Performed. Ditch Flow Observed.

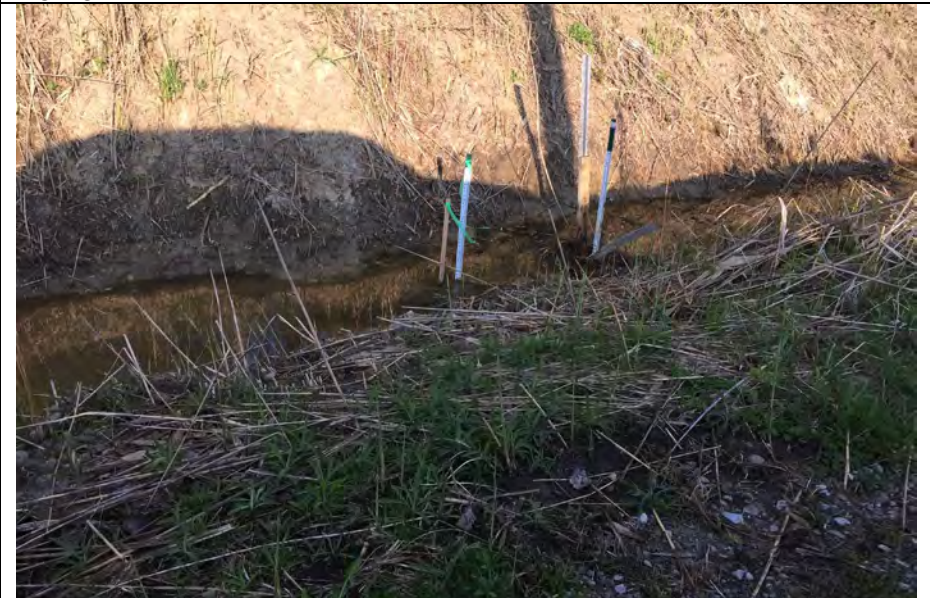
12. Looking at Ditch and Staff Gauge SG-03. Ditch Flow Observed.

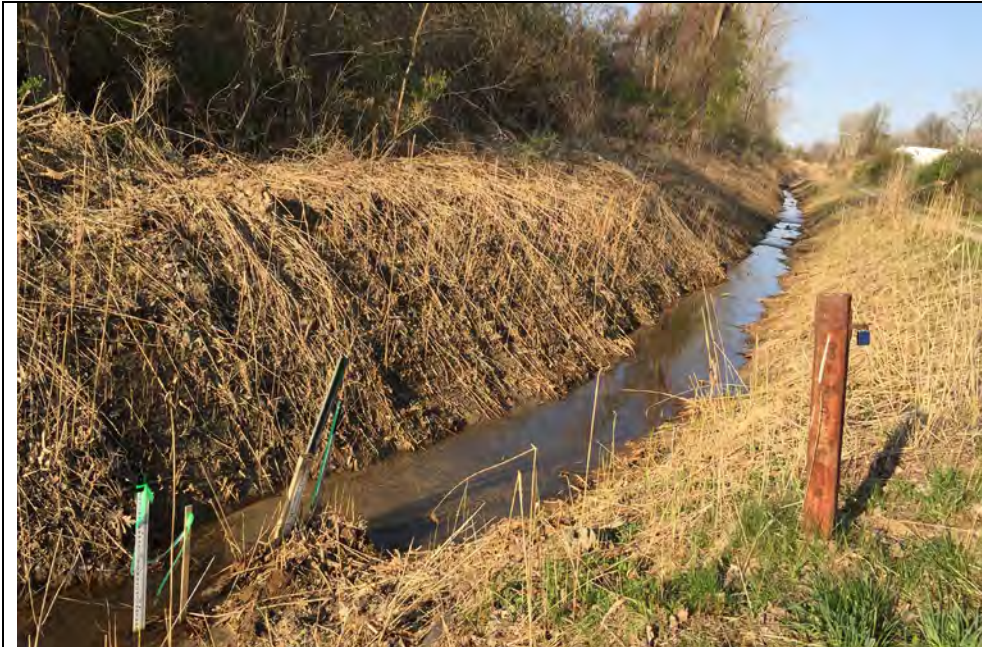
13. Looking at Location of Staff Gauge SG-02. Water Present. No Visible Flow Noted.

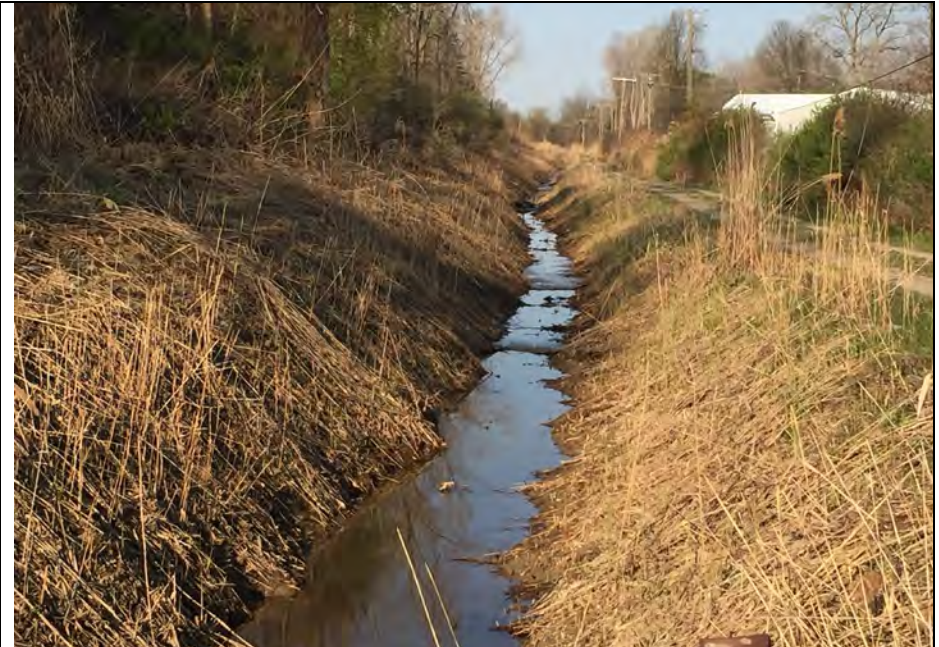
14. Looking at Ditch Alignment Approximately 200 ft Further Upstream than in Photo 13. Ditch Clear Except for Small Soil Run-in from Slope.

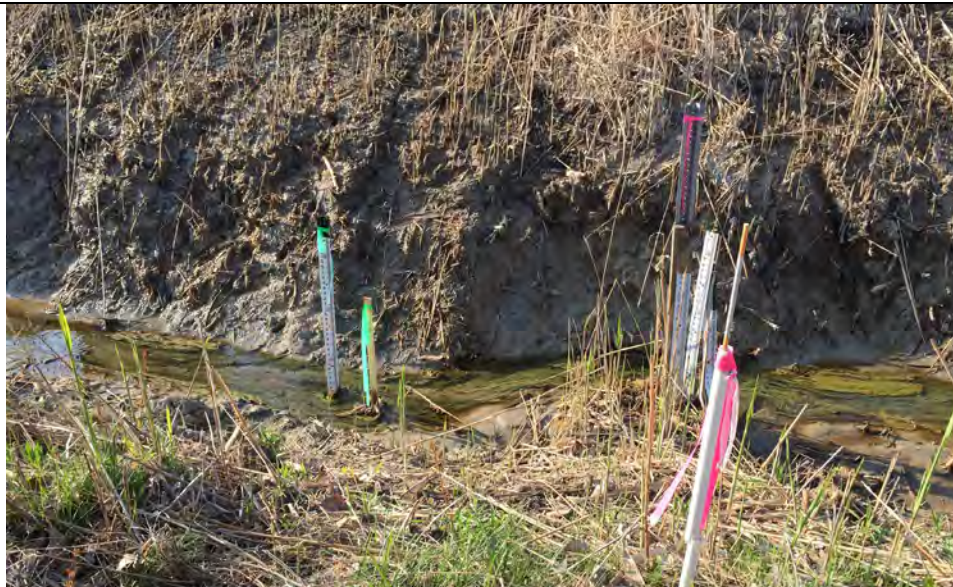
15. Looking at Location of Staff Gauge SG-12. Water Present and Slight Flow Noted.

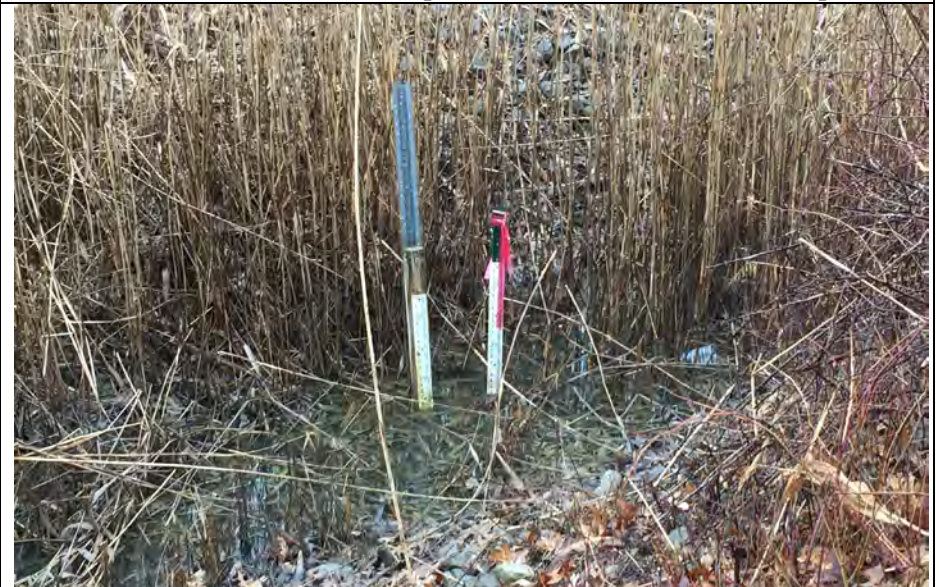
16. 2018 Photo of Staff Gauge SG-10 Prior to Ditch Cleaning Occurring in 2019 and/or 2020.

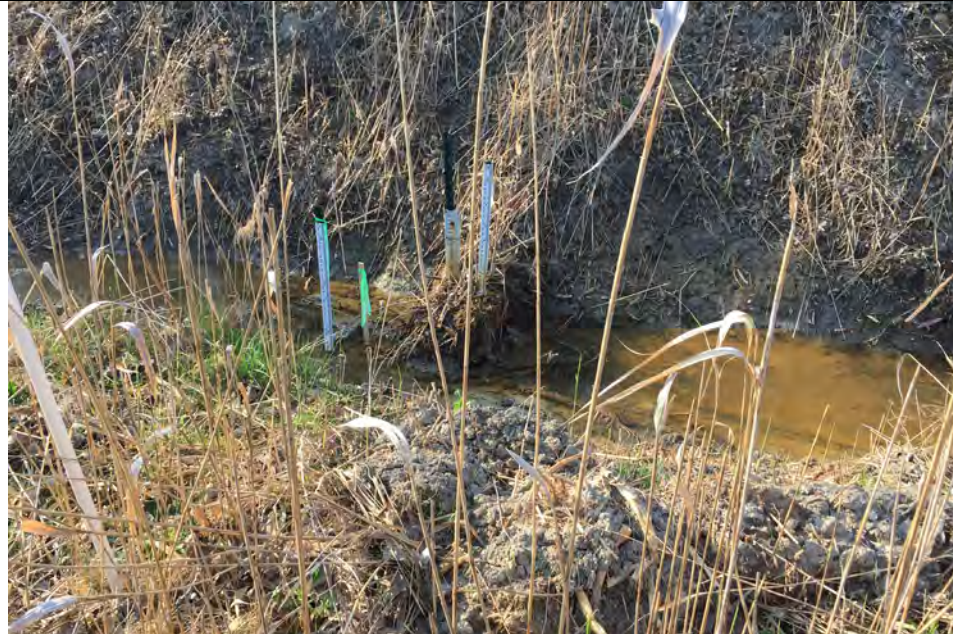
17. Looking at Location of Staff Gauge SG-01. Water Present. No Visible Flow Noted.

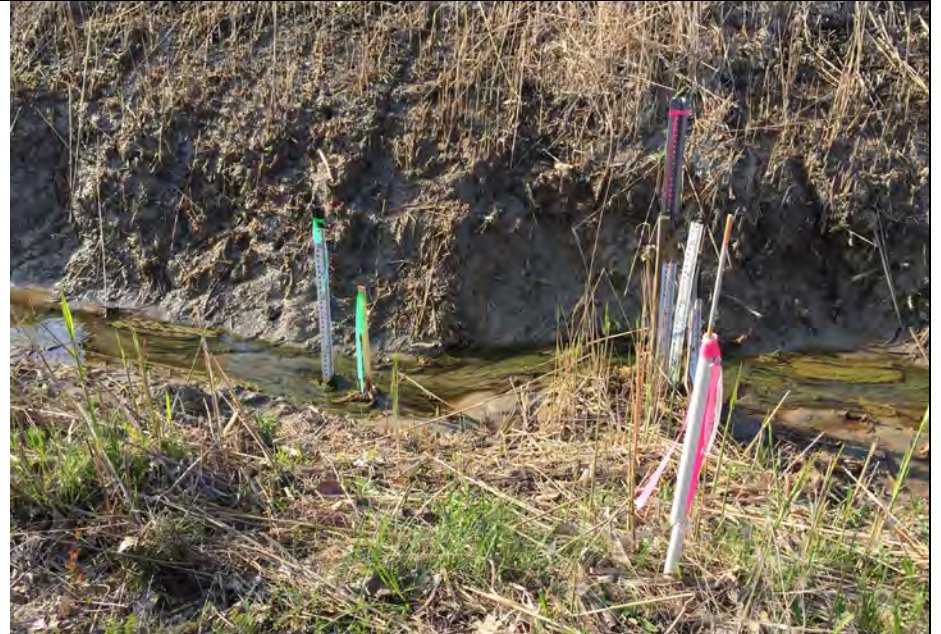
18. Looking at Portion of Perimeter Ditch Alignment Cleared of Vegetation Last March. Little Flow Noted.

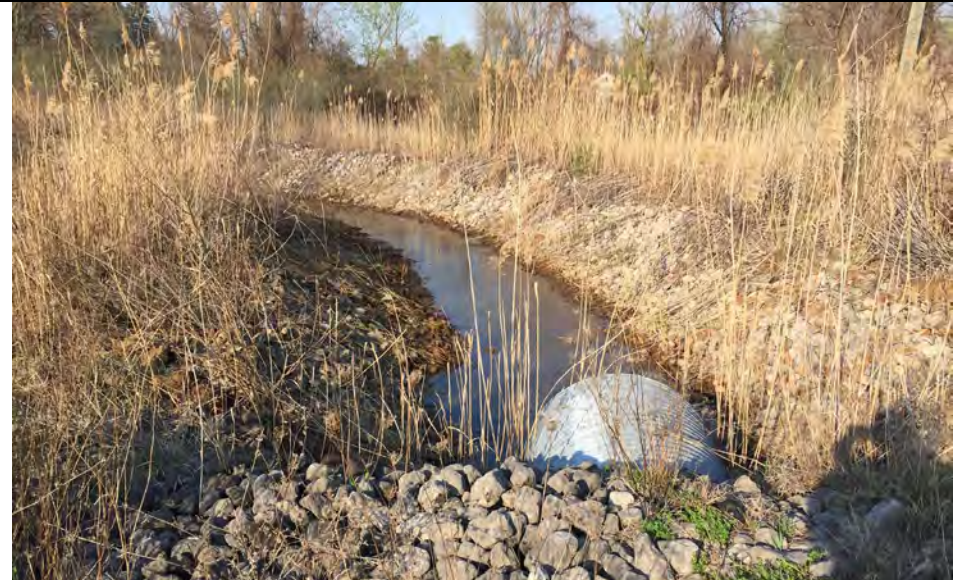
19. Another View of Portion of Perimeter Ditch Cleared of Vegetation During Routine Maintenance Activity. Culvert Open and Clear of Vegetation.

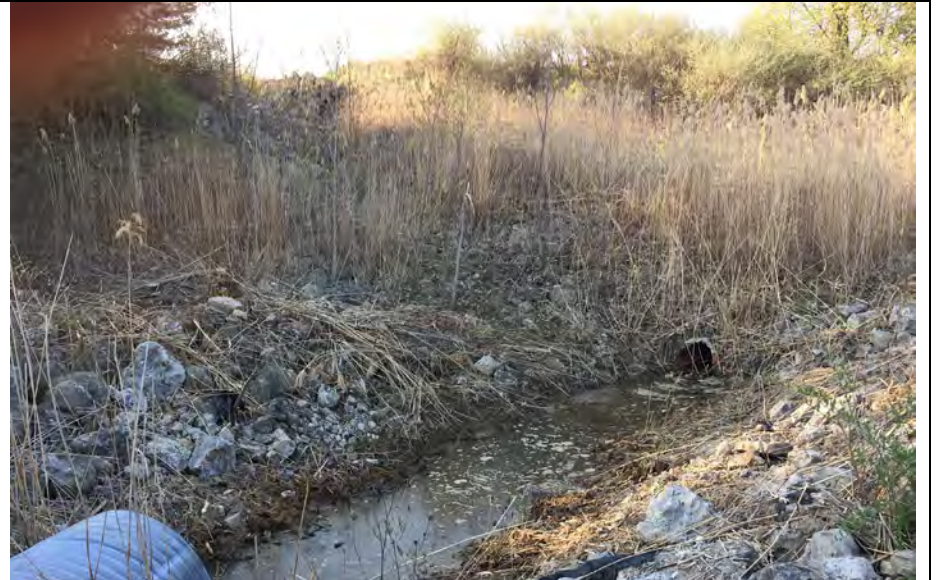
20. Culvert and Riprap Downslope Where Ditch Clearing of Vegetation Had Not Recently Occurred. Flow did not Appear to be Blocked.

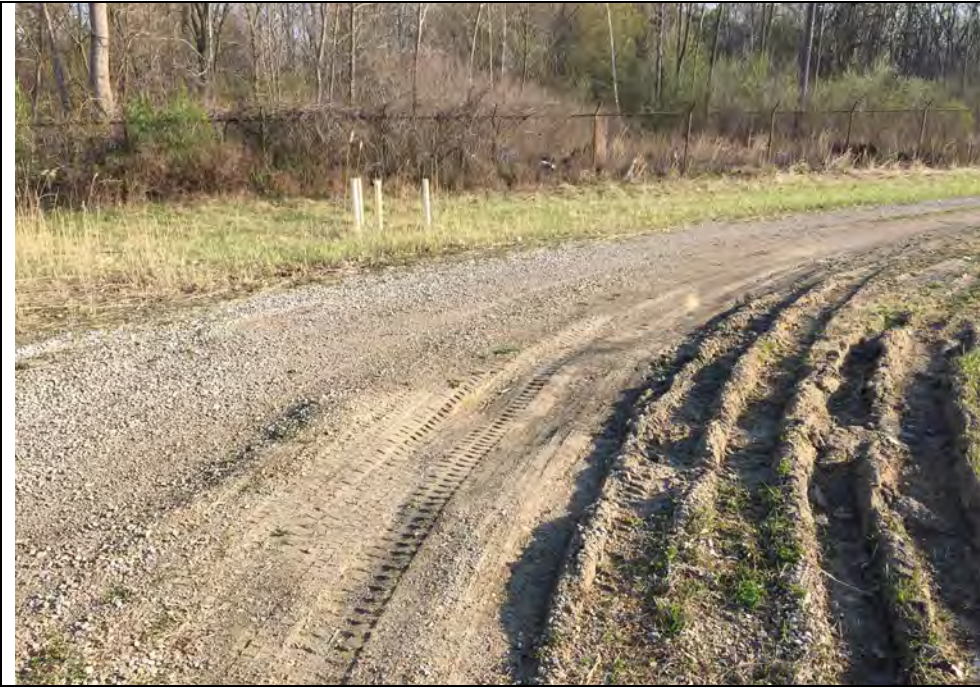
Specific results of the visual inspection are summarized below and in the **Appendix B Inspection Log**. Photographs are provided in **Appendix B**. The weather on the day of the inspection was partly cloudy to sunny with temperatures ranging from 50° F to a high of 65° F in early afternoon. Scattered showers had occurred at the end of the previous work week, but no rain fell during the inspection. Some minor tire rutting from previous travel was noted along the inspection road as shown in Photograph 21.

21. Perimeter Road and GW Monitoring Well 16-06. Well Protected and Locked. Unusual Rutting from Maintenance Equipment Used as Part of Ditch Cleaning.

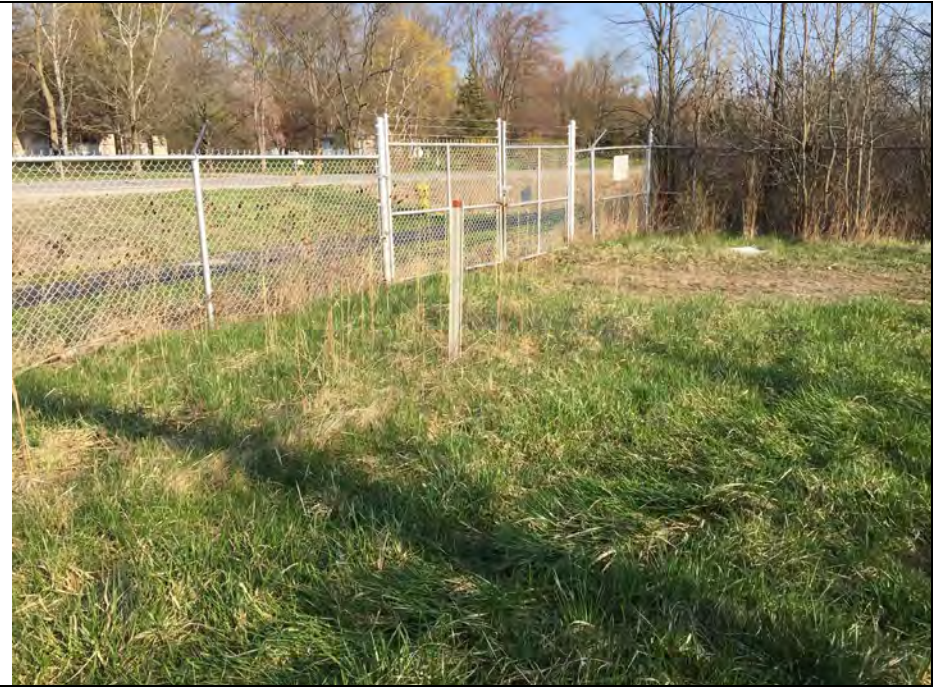
22. Property Fence and Locked Gate Along NW Corner of Landfill and King Road. Signage Present. One Slurry Wall Marker (Red Tip) Shown.

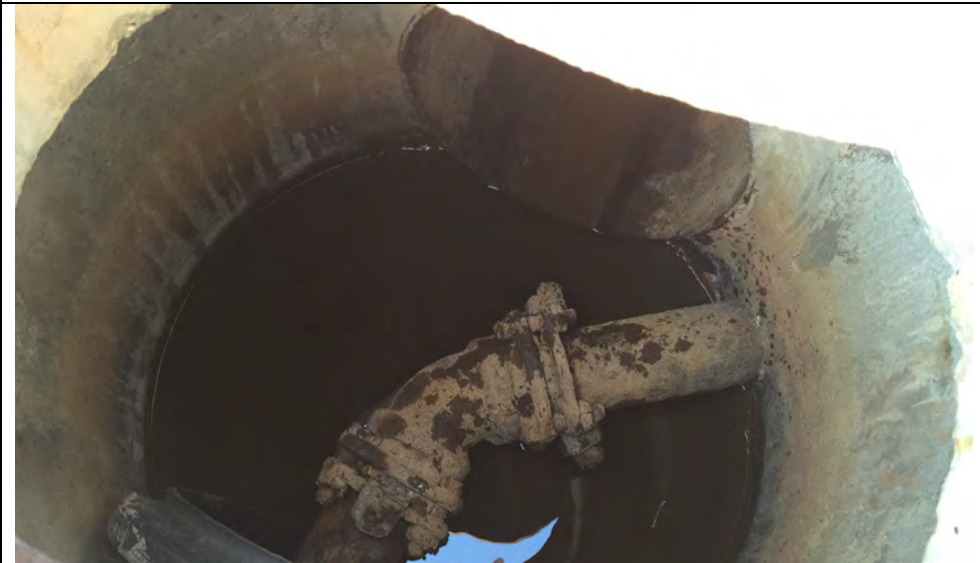
23. Manhole Containing Discharge Piping from Sump Pumps at Location Shown in Photo 24. Discharge will be to Culvert Connected to Ditch.

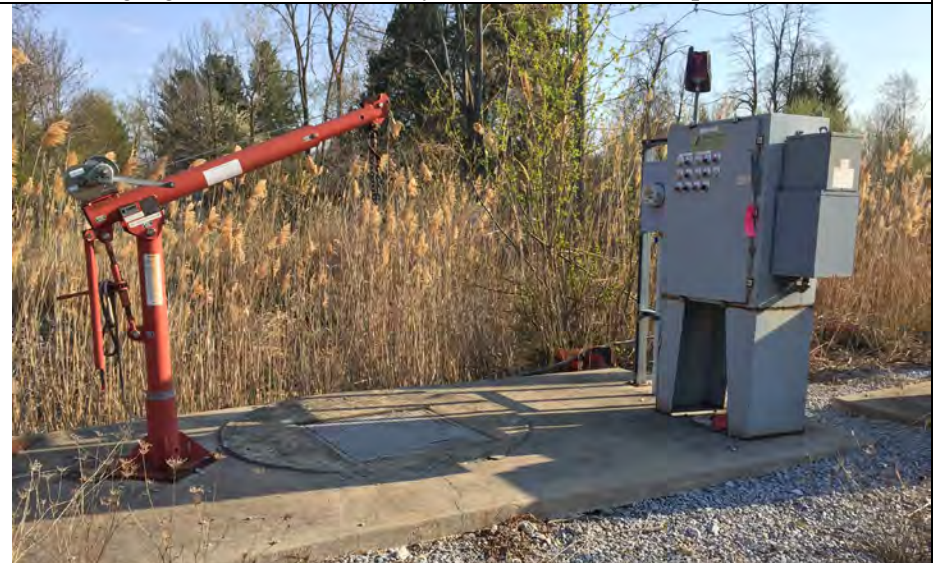
The northwest groundwater capture system and collection has had its two pumps replaced in late 2017. The pumps are used to transfer the captured water to the perimeter ditch for gravity flow to the SDB. At the time of the inspection one pump was operating normally. One lens on the control panel was broken.

24. Sump Where 2 New Pumps Installed 2018. Pump #2 Operation Verified. Pump #1 Tripped and Scheduled for Maintenance.

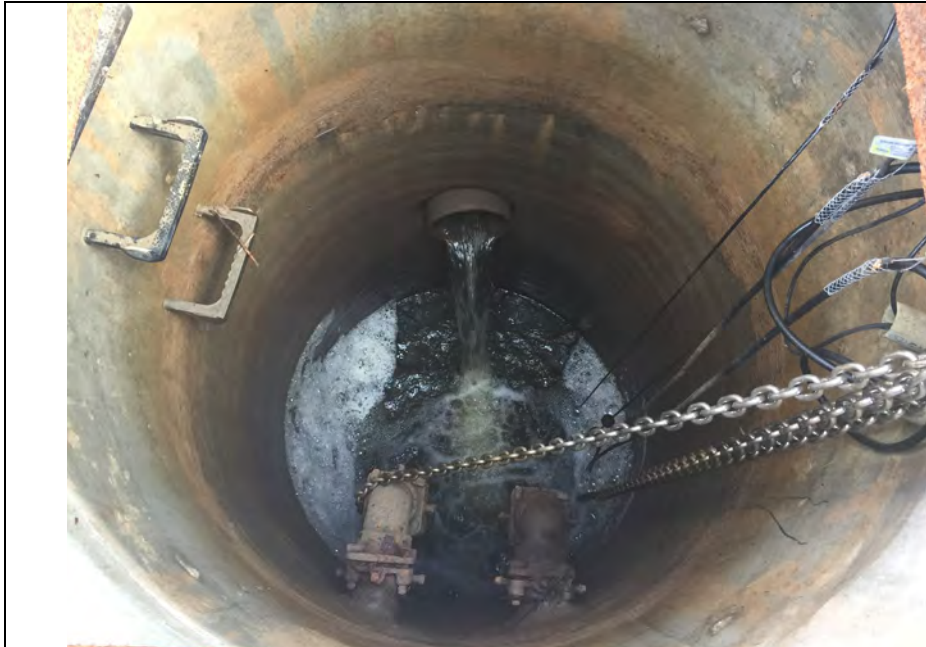
25. View Inside Pump Manhole During 2020 Inspection (No Photo for 2021; Manhole Observed. Offsite Flow into Manhole. One Running Kept up to Flow.

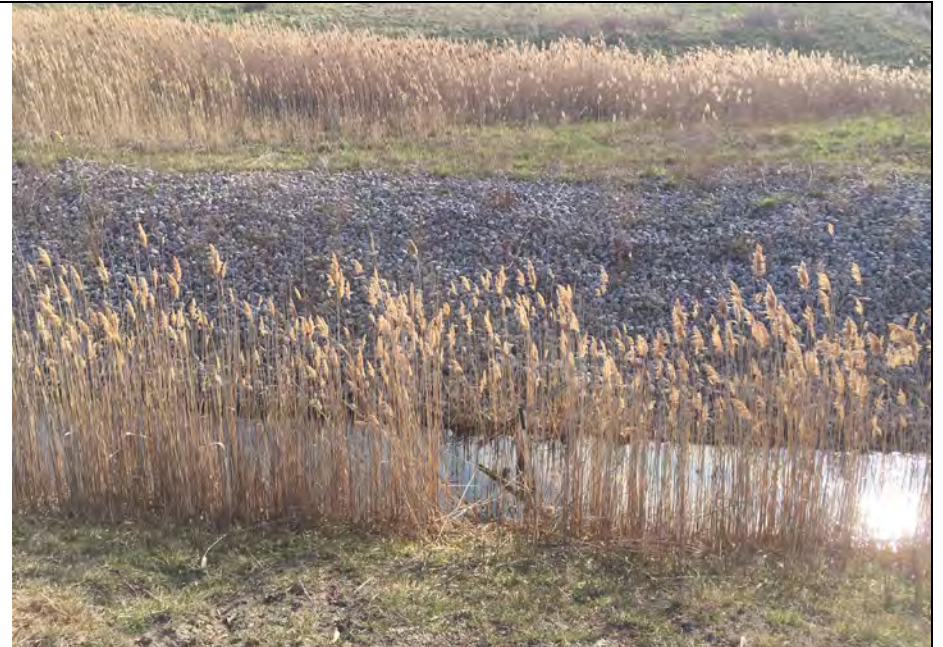
26. Perimeter Ditch West Side at Location of Staff Gauge SG-09. No Blockage but No Staff Gauge Location Number Visible.

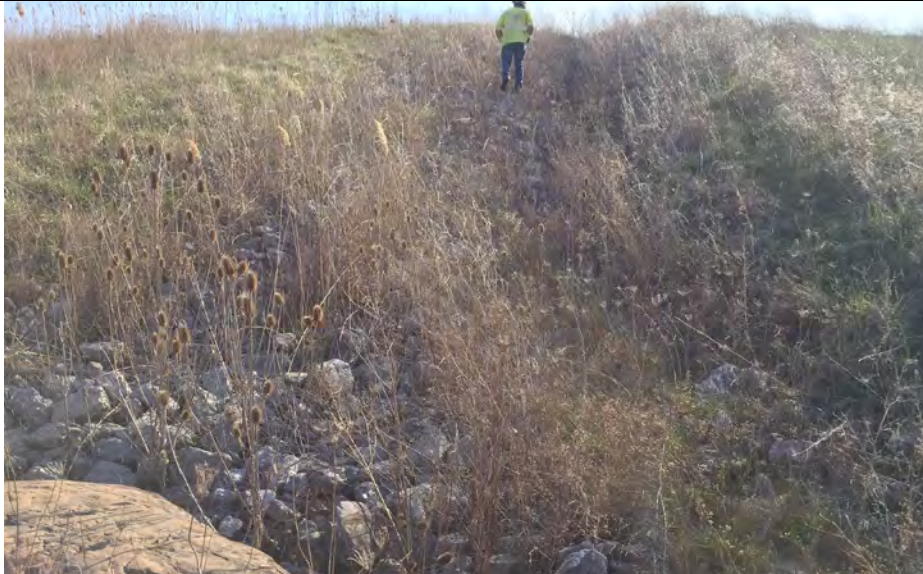
large downslope riprapped drainage channel located at the west intersection of Areas F1 and F2 and shown in Photograph 27 continues to show some bottom/bedding area erosion exposing gully like soil rutting under the riprap. The voids between and under some of the riprap stones could possibly be filled with smaller bedding type stone as a repair. The original design was unclear as to the type of bedding that was provided. Photograph 28 was an attempt to show an example of the voids present. However, the DTE inspector did examine the area closely.

27. Inspection of Riprap Down Drain with Surface Net. Visual Voids Between and Below Riprap Suitable for Filtering in Small Size Stone, per DTE.

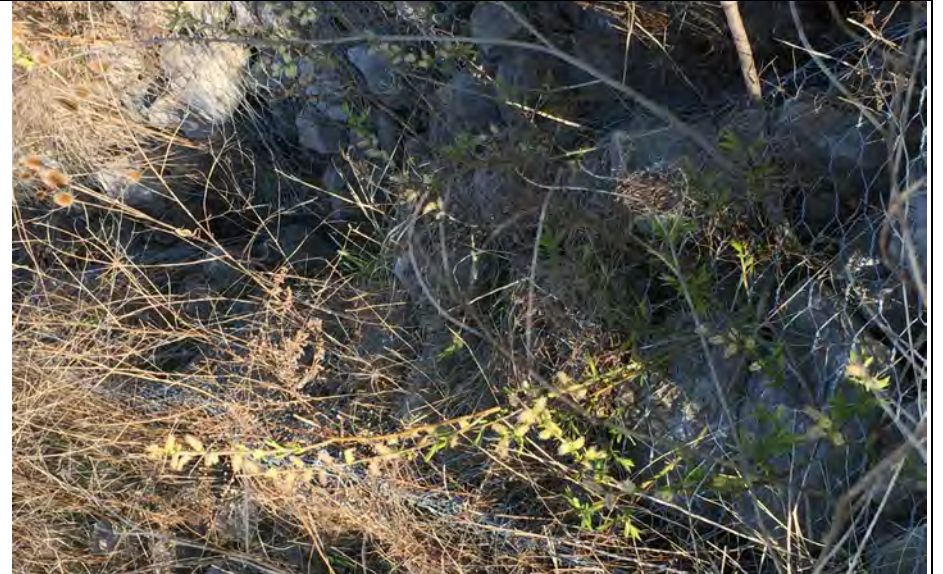
28. Photo Showing Large Void Between Riprap that can be Filled with Smaller Size Stone. Alternative Maintenance Methods are Possible.

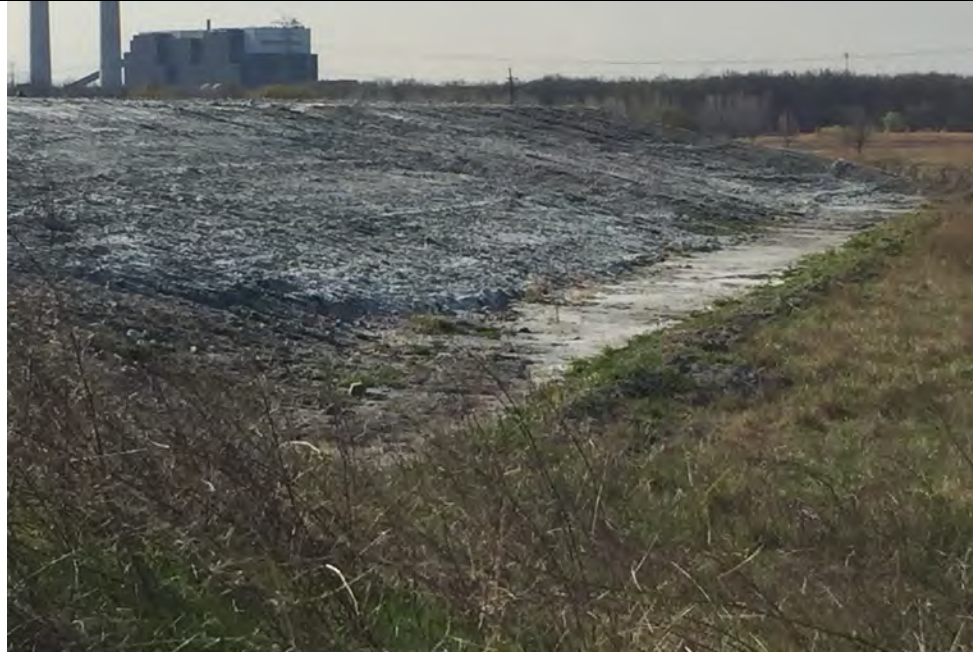
29. View of South Side of Active Disposal Area Slopes. Photo Taken from Outside of Active G2 Area Along the West Side Existing Berms.

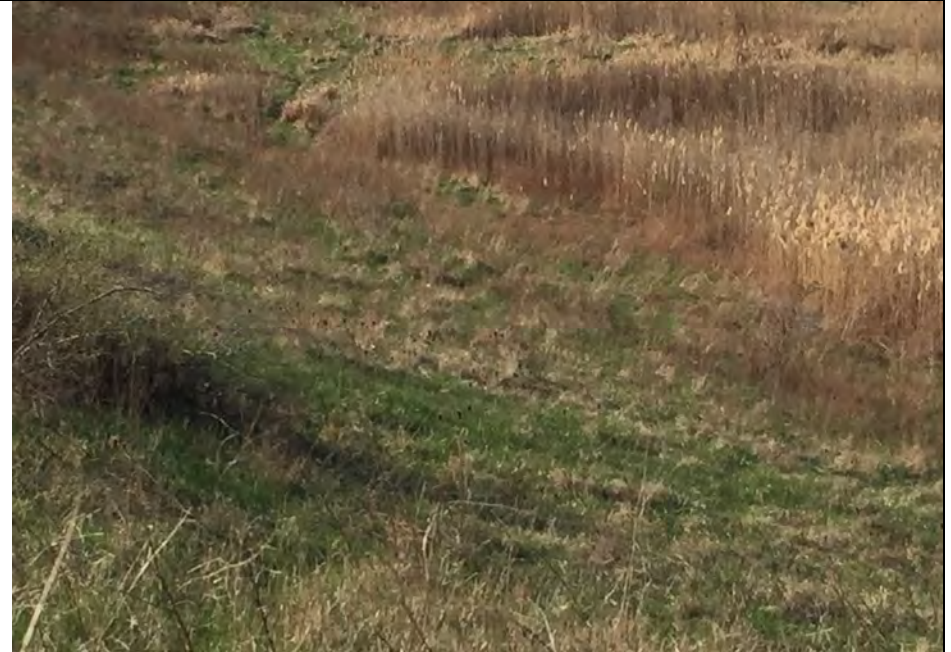
30. Western Side of Area G2 that is Not Yet Developed for Use.

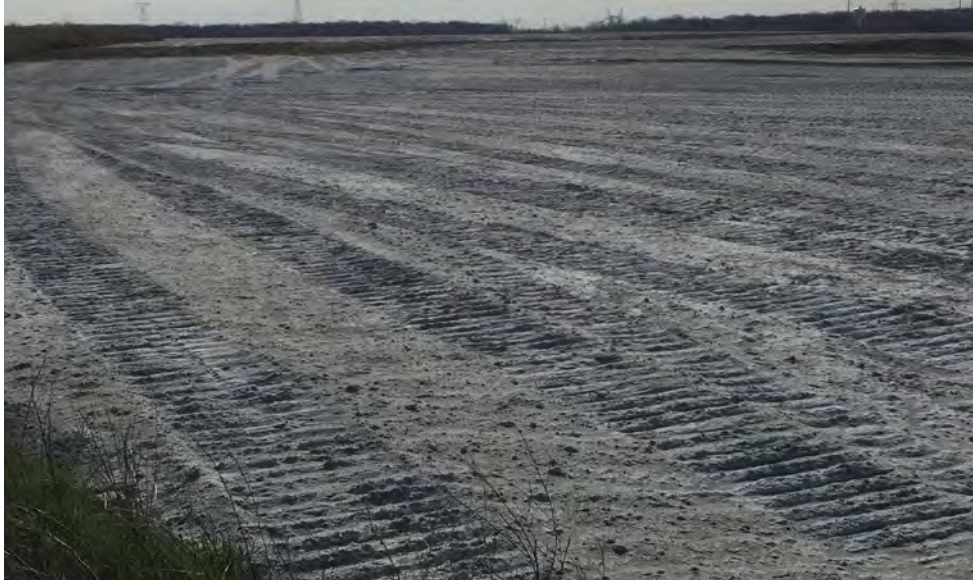
31. View of Top of Area G2 that has been Graded and Nearing Ready to be Capped in accordance with Landfill Cover Design. CCR Partially Cemented.

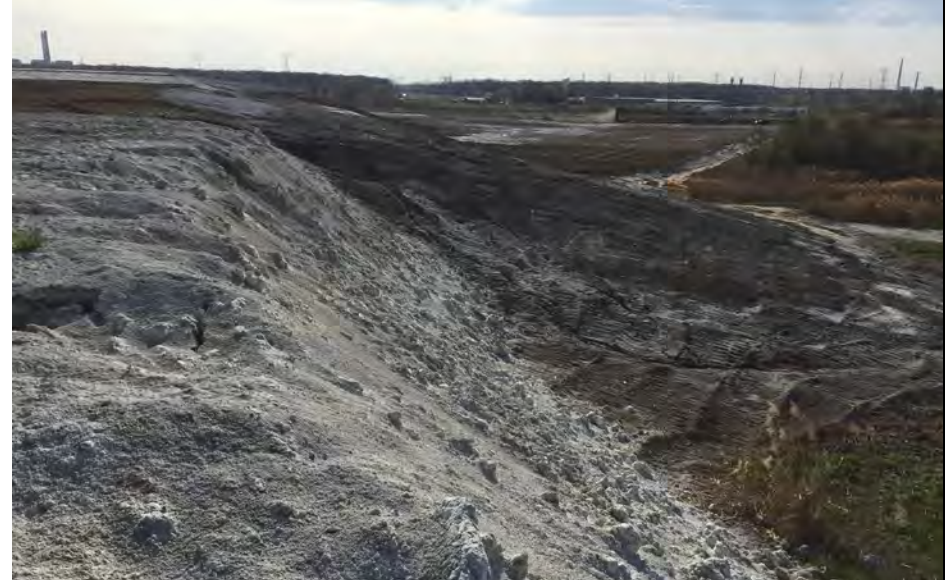
32. Temporary Slope of CCR Placement Southwestern Side.

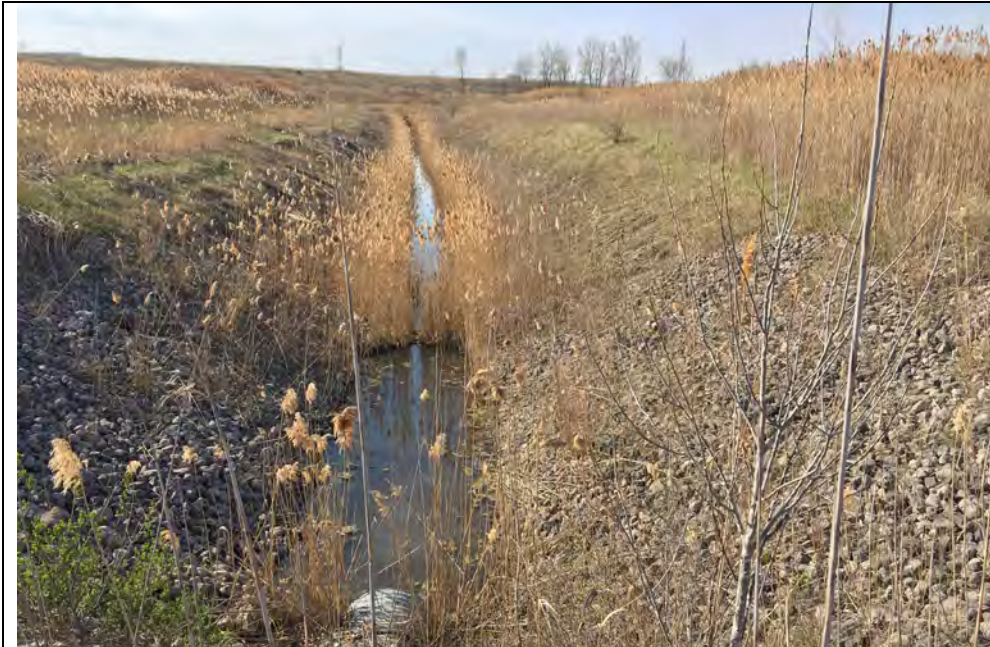
33. Older Internal Drainage Ditch within Landfill Draining to the Perimeter Collection Ditch.

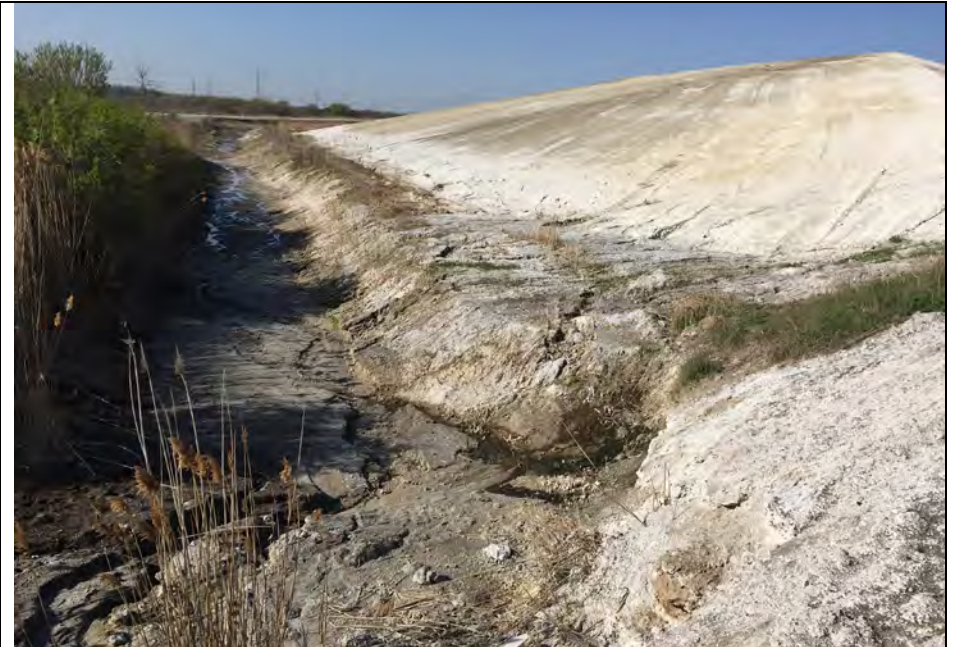
34. Temporary CCR Slope in Area G2 Along South Side. Toe Ditch Installed to Collect Directed Runoff. Slope Appears Stable and Well Graded.

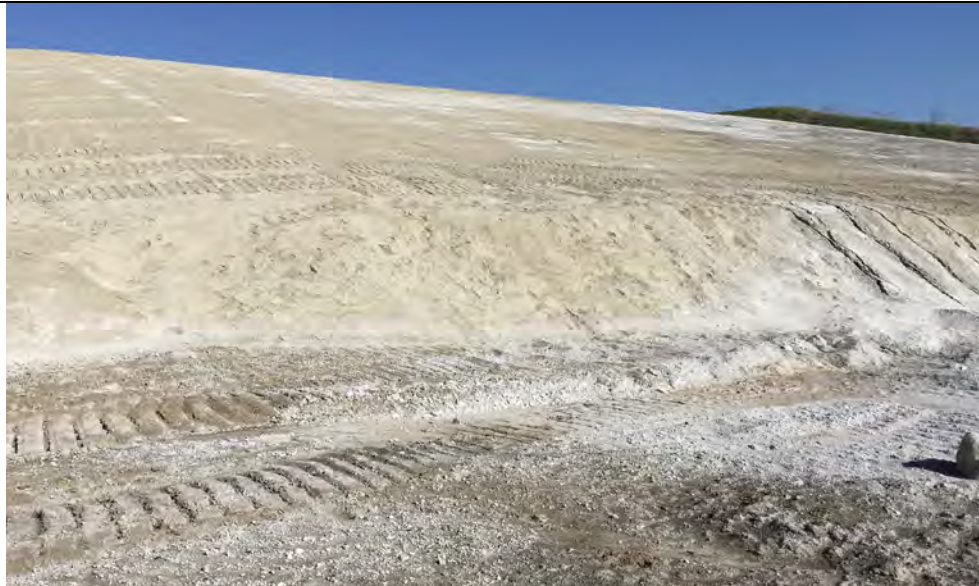
35. Active CCR Slope with Grading InProgress. Area G2.

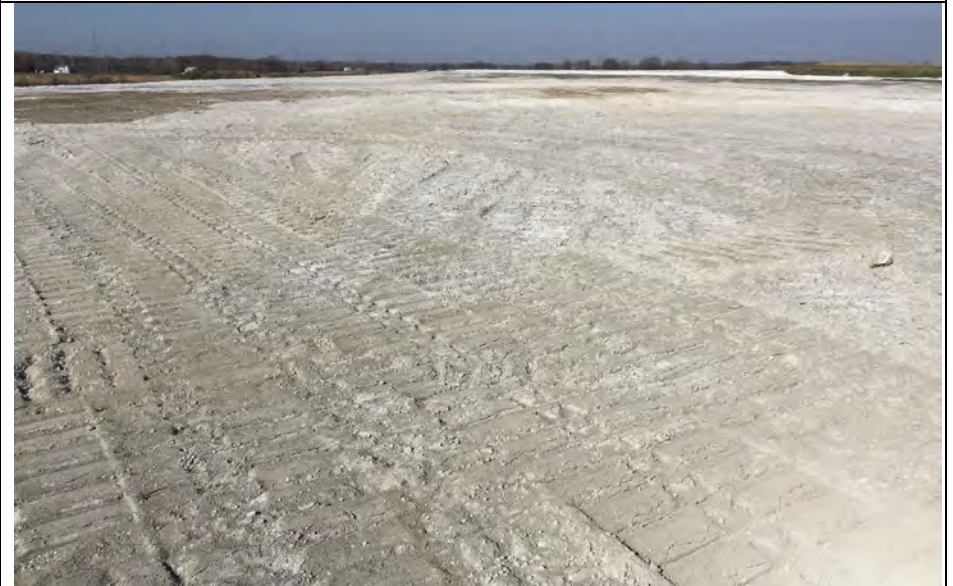
36. Active Area G2 CCR Surface. Similar Location as in Photo 31.
