**2021 ANNUAL INSPECTION REPORT  
RANGE ROAD LANDFILL  
ASH DISPOSAL FACILITY**

**China Township, St. Clair County, Michigan**

January 2022

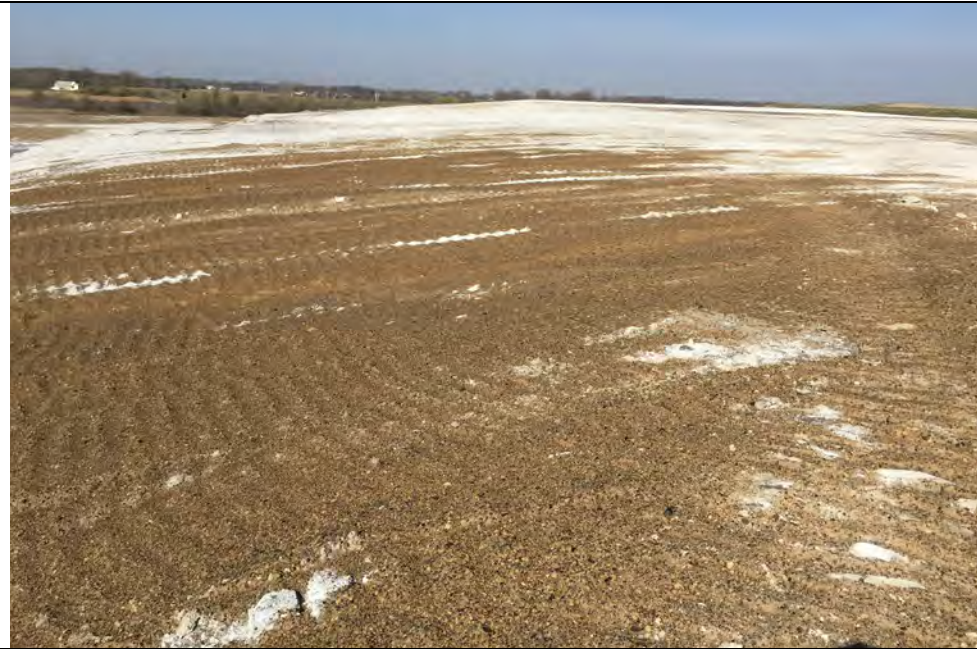
37. Another View of Graded Landfill CCR Sloped Surface. Area G2.

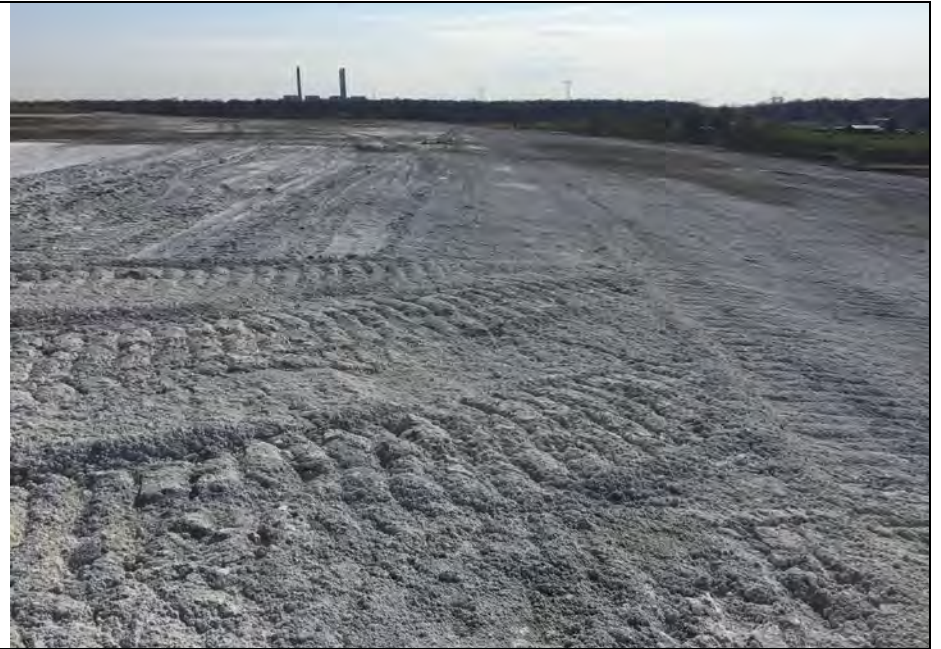
38. Another View of Graded Landfill CCR Sloped Surface.

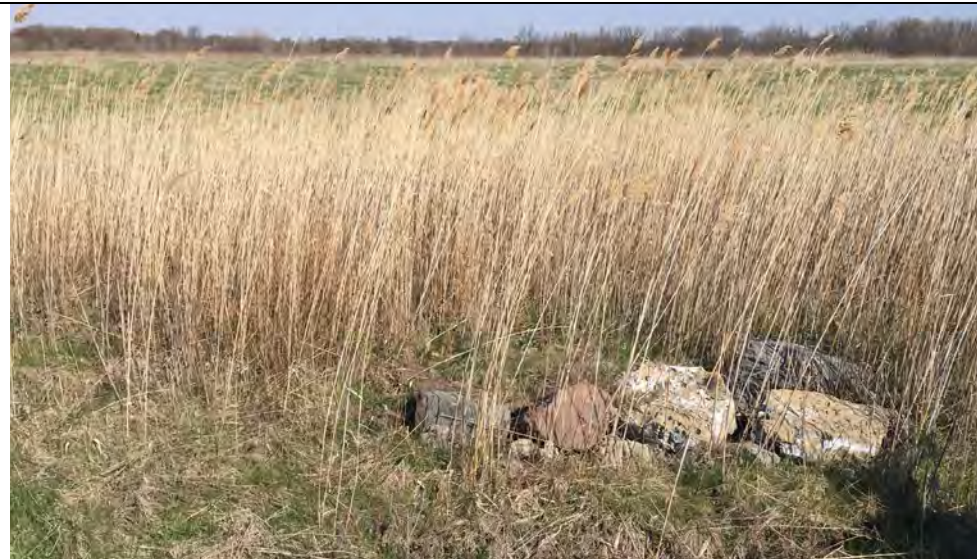
39. Area F3 Cap with a Temporary Pile of Large Stones.

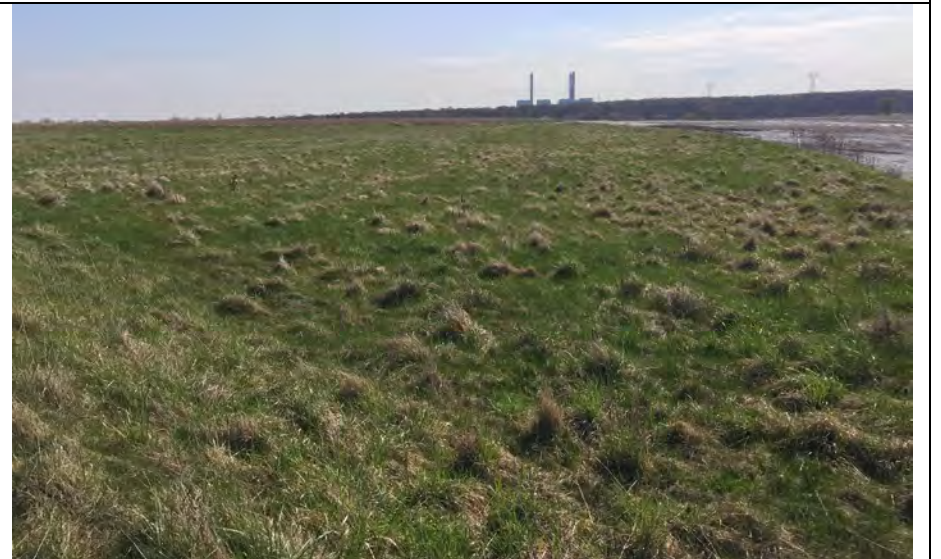
40. View of Typical Closed Area Top of Landfill

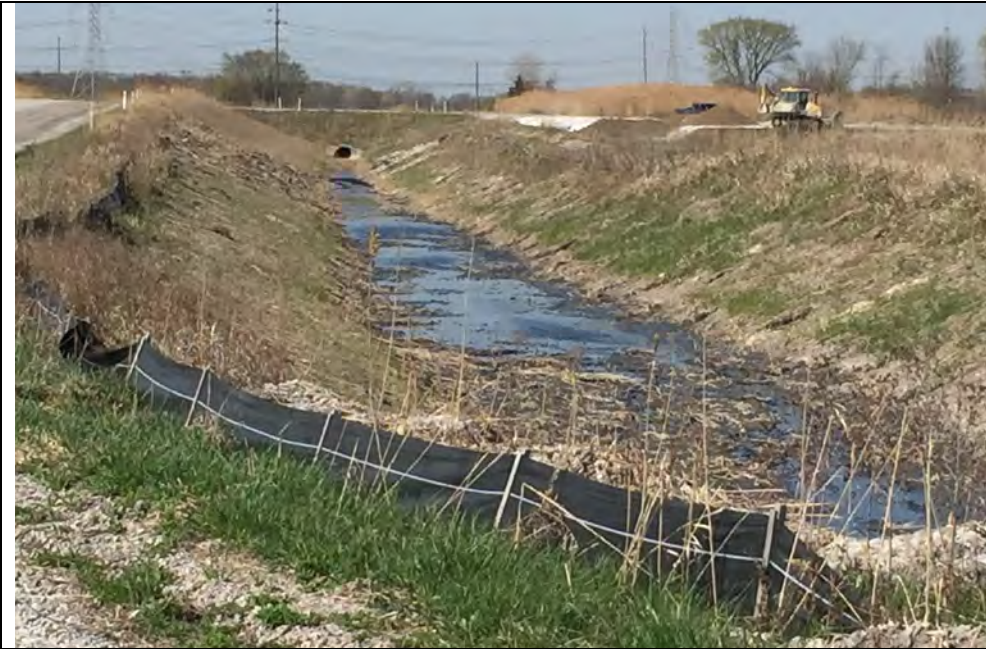
41. Internal Drainage Ditch Located South of Active Area G2

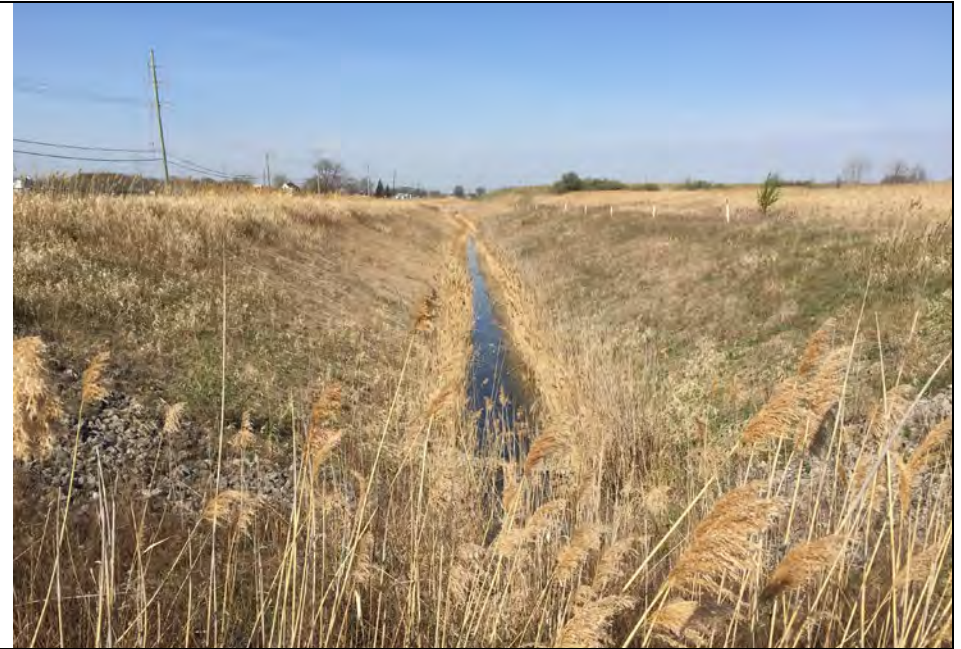
42. Perimeter Ditch Looking West Along South Side Near Puttygut Road.

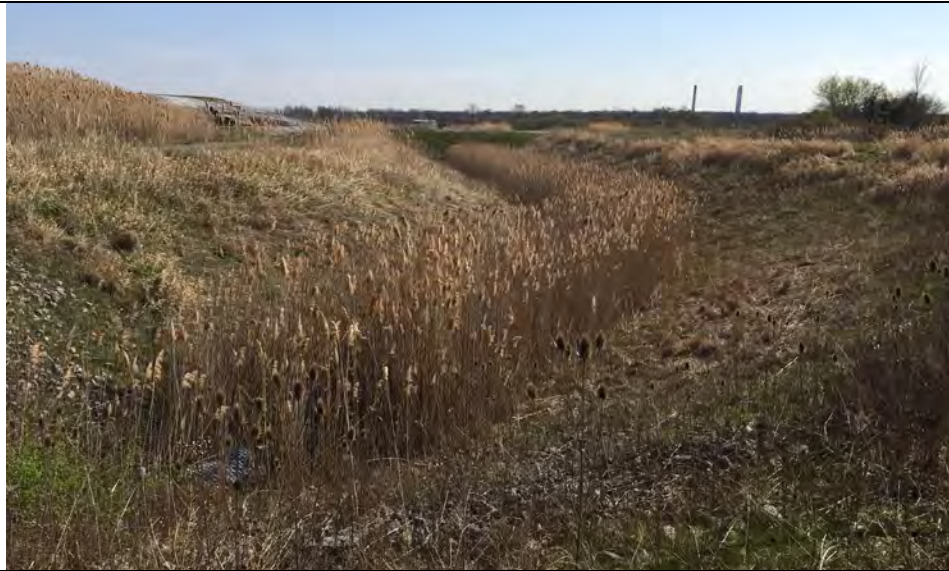
43. Perimeter Ditch Looking East.

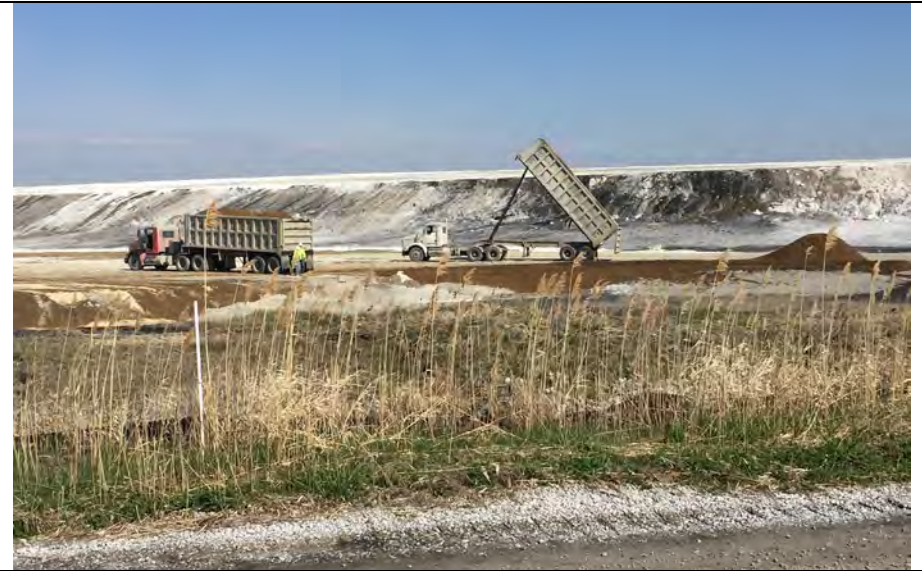
44. CCR Haul Trucks Safely Unloading What from a Distance Appears to be Bottom Ash and/or Fly Ash.

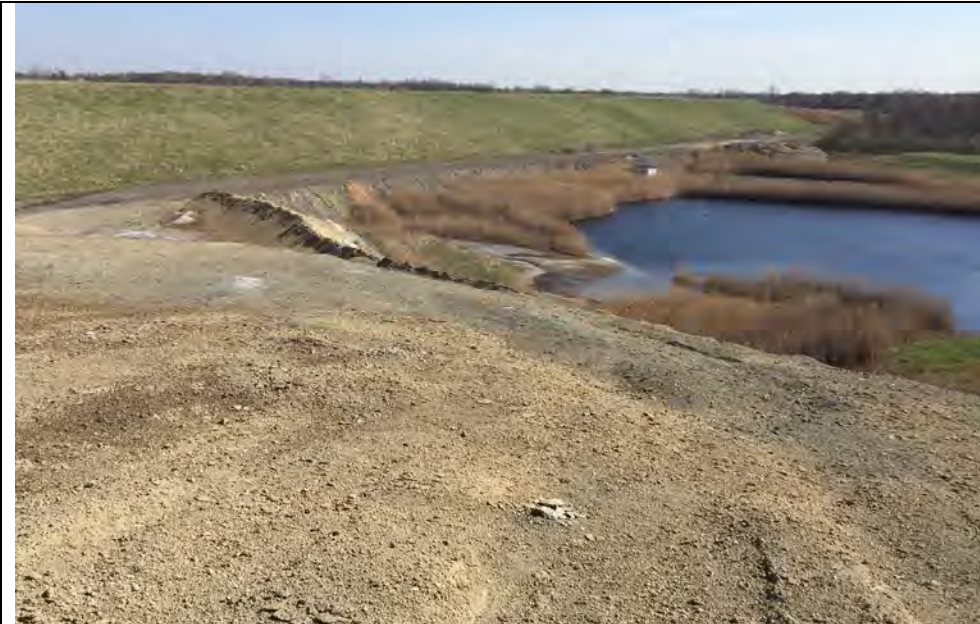
45. Runoff Collection Pond within Landfill Limits. Landfill Area Slopes Appeared Stable and Well Vegetated.

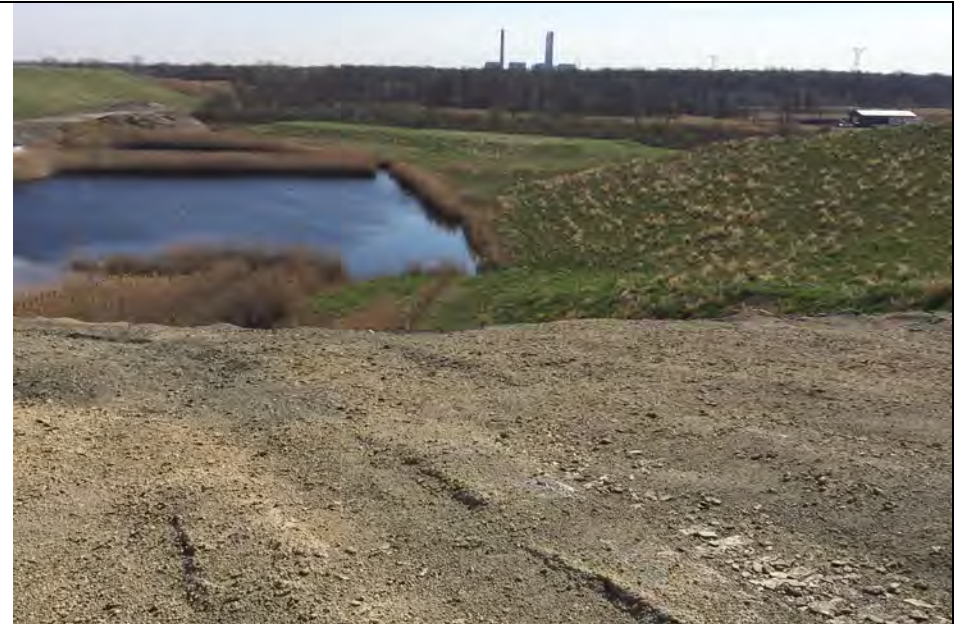
46. Another View of Runoff Collection Pond and Landfill Slope South of Pond. Slope Appeared Well Vegetated and Stable.

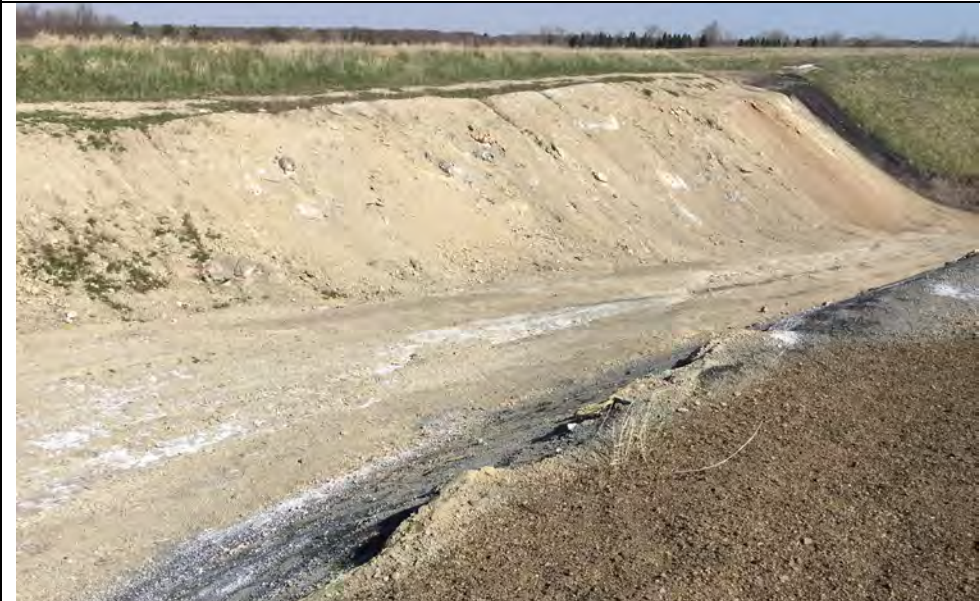
47. View of Active Haul Road to Top of Landfill Near Area F3D3. Slope Shown Part of Active Area F3. Minor Rutting in Road Surface.

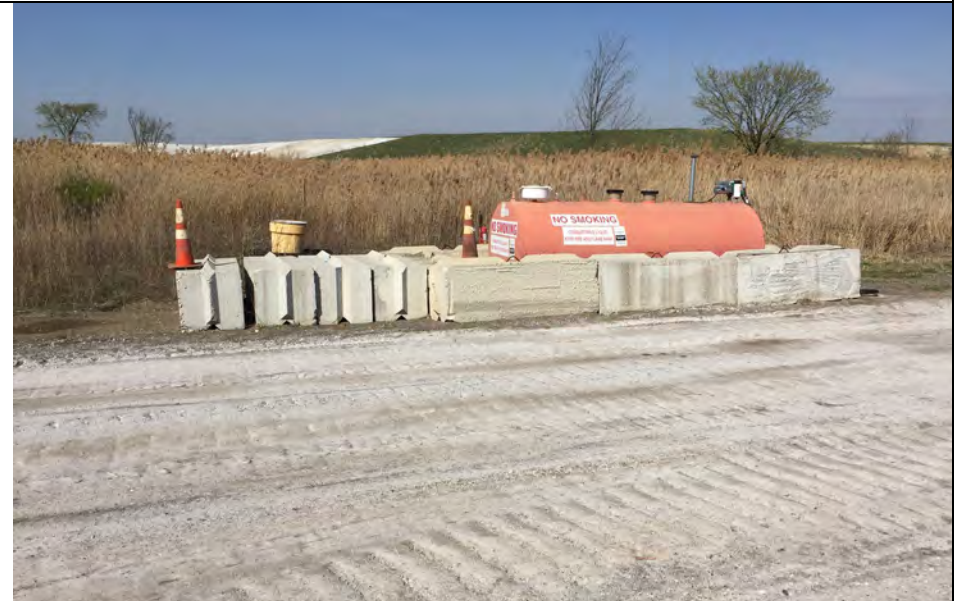
48. View of Single Fuel Tank and Enclosure Protection. Second Tank had been Removed and May No Longer be Needed.

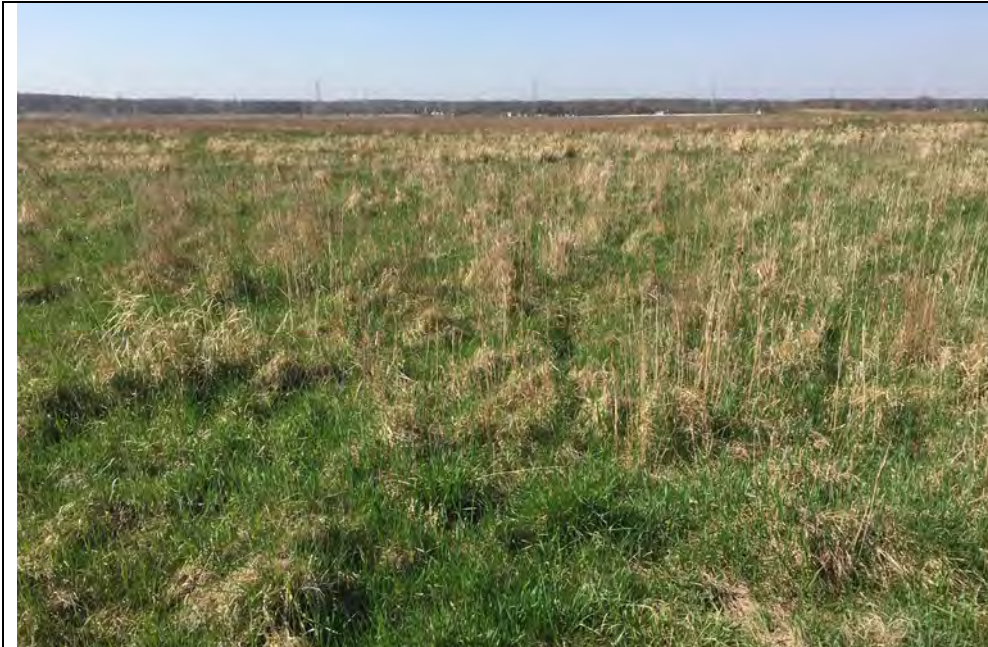
49. View of Typical Top of Landfill in Closed Area B. Small Brush was Cut During the 2018-2019 Construction Season.

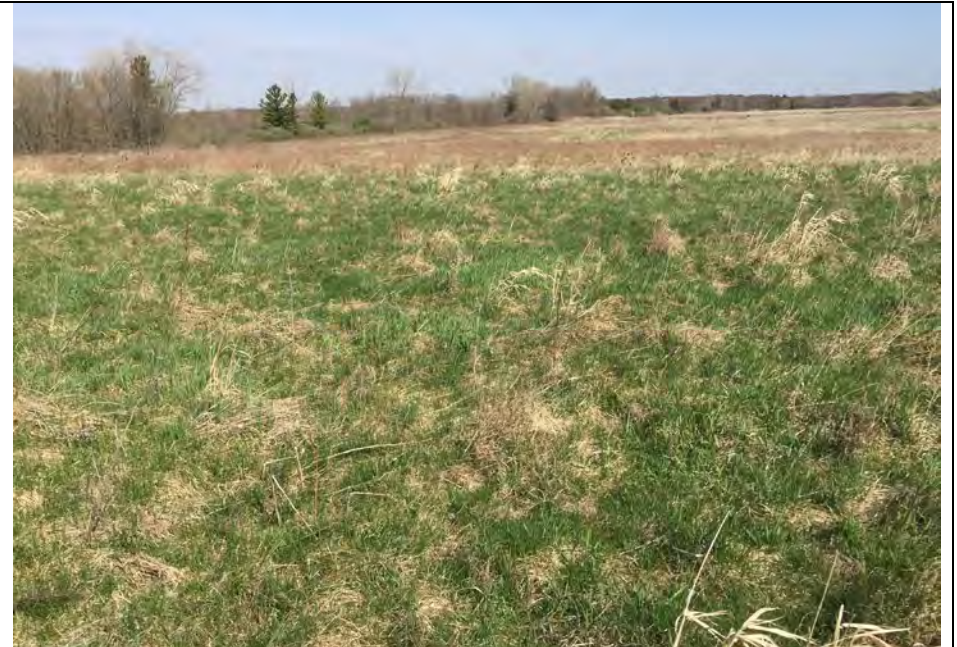
50. Another View of Typical Top of Landfill in Closed Areas. Area B.

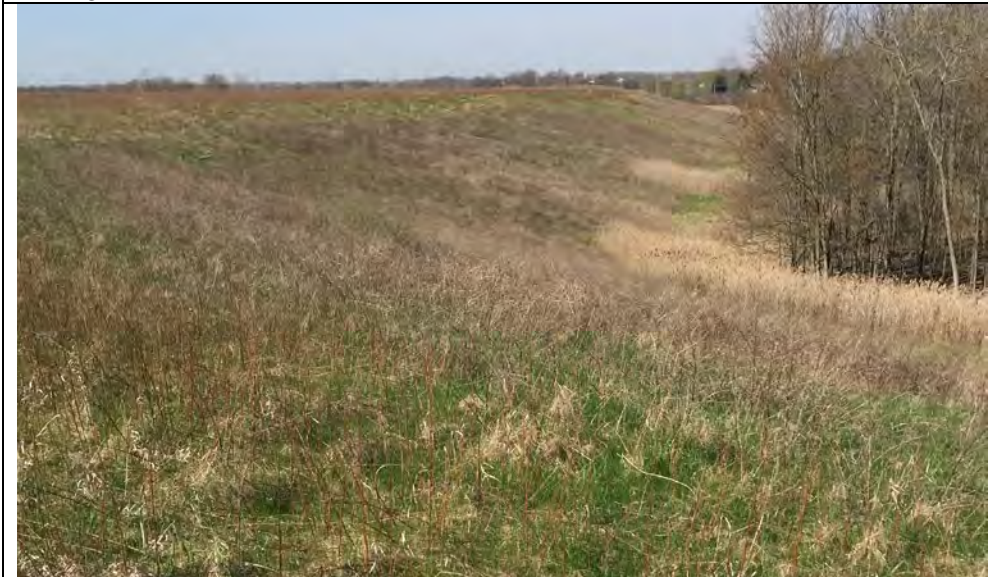
51. Outside Perimeter Slope Along Closed Area F1. Slope Appeared Stable and Well Vegetated.

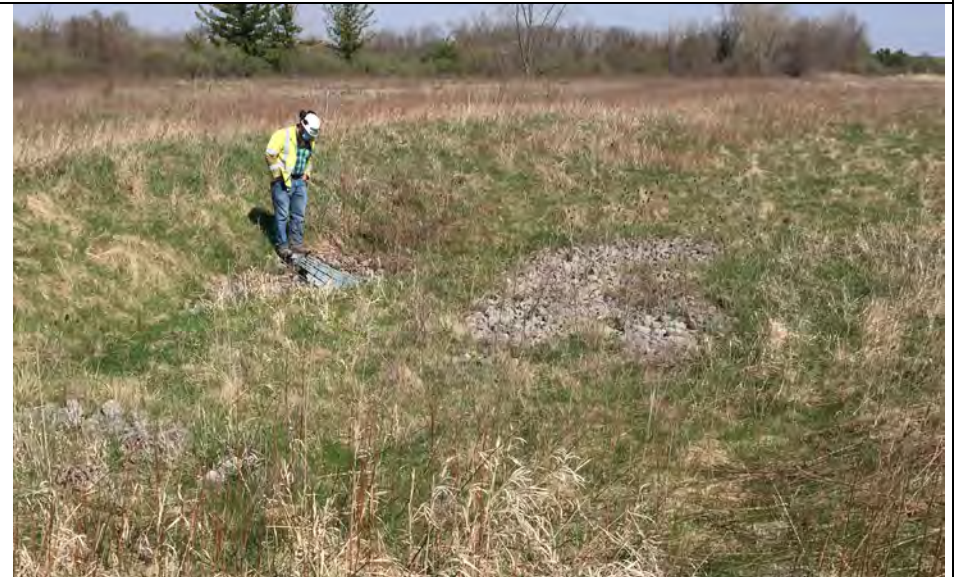
52. Inlet Side of Downslope Drainpipe with Small Riprap Grading to Prevent Gully Erosion.

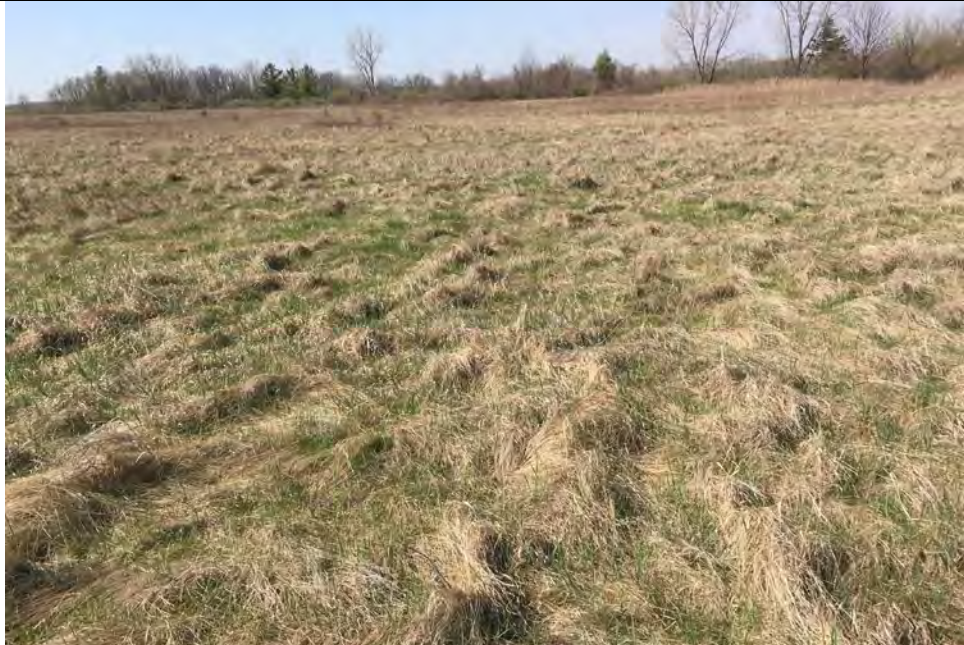
53. Typical Top of Landfill in Historically Closed Areas. Well Vegetated with Occasional Brush Growth, as Shown in Distance.

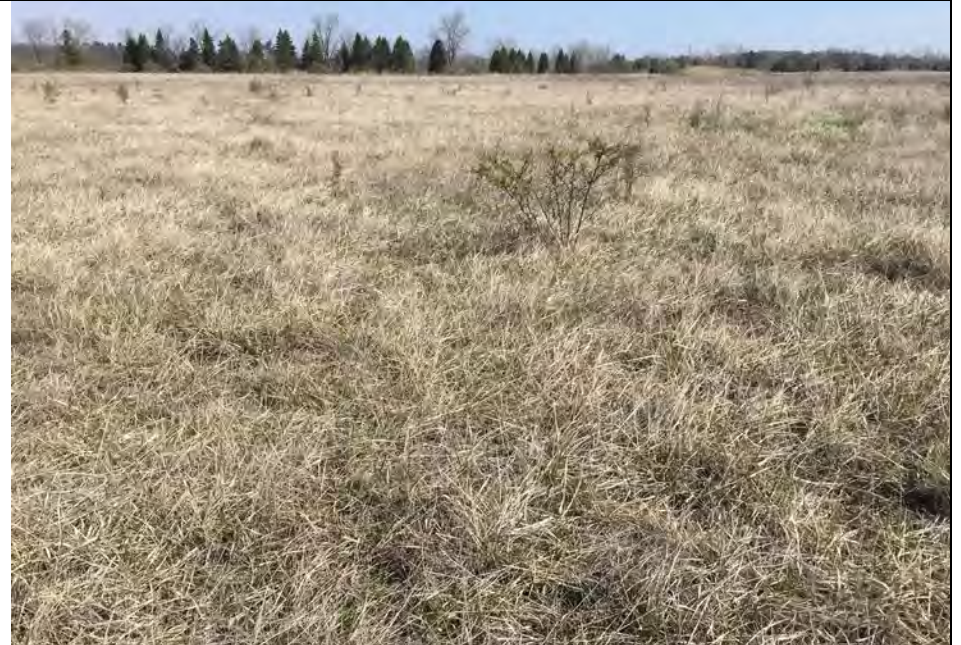
54. Another View of Top of Landfill, Likely Closed Areas B and A. Some Minor Small Brush Noted, but Tops of Closed Areas were Well Vegetated.
