DTE Electric Company
One Energy Plaza
Detroit, Michigan 48226

2016 ANNUAL INSPECTION REPORT SIBLEY QUARRY LANDFILL

Trenton, Michigan

January 2017

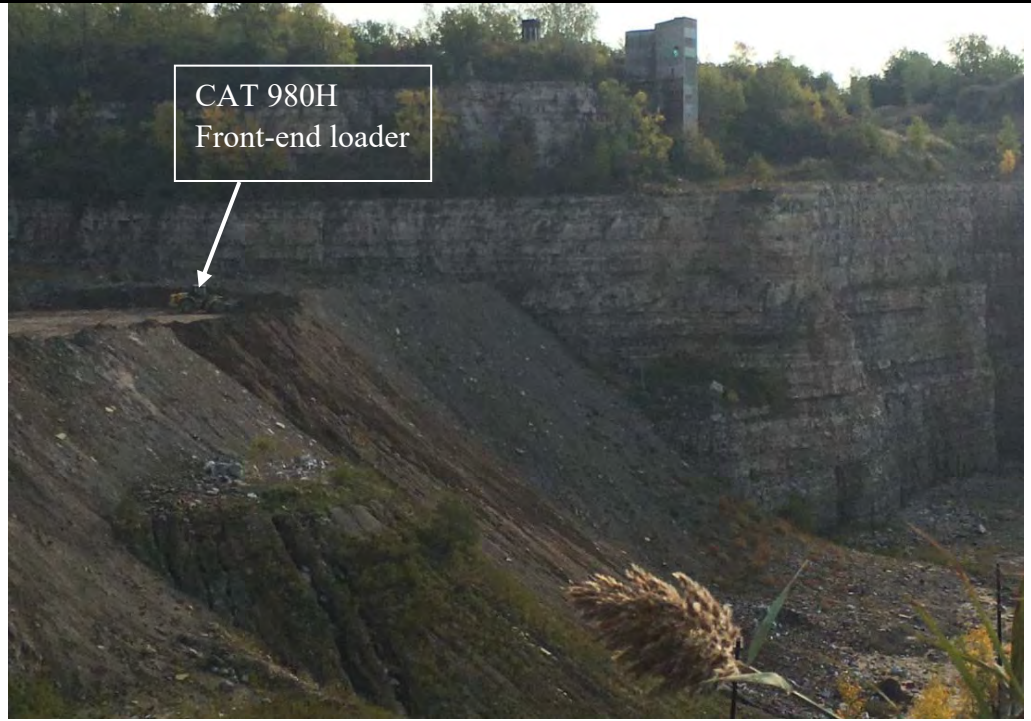
Comments: Active filling area. Facing east. Front-end loader is at the top of CCR slope pushing recently brought CCR down the slope.

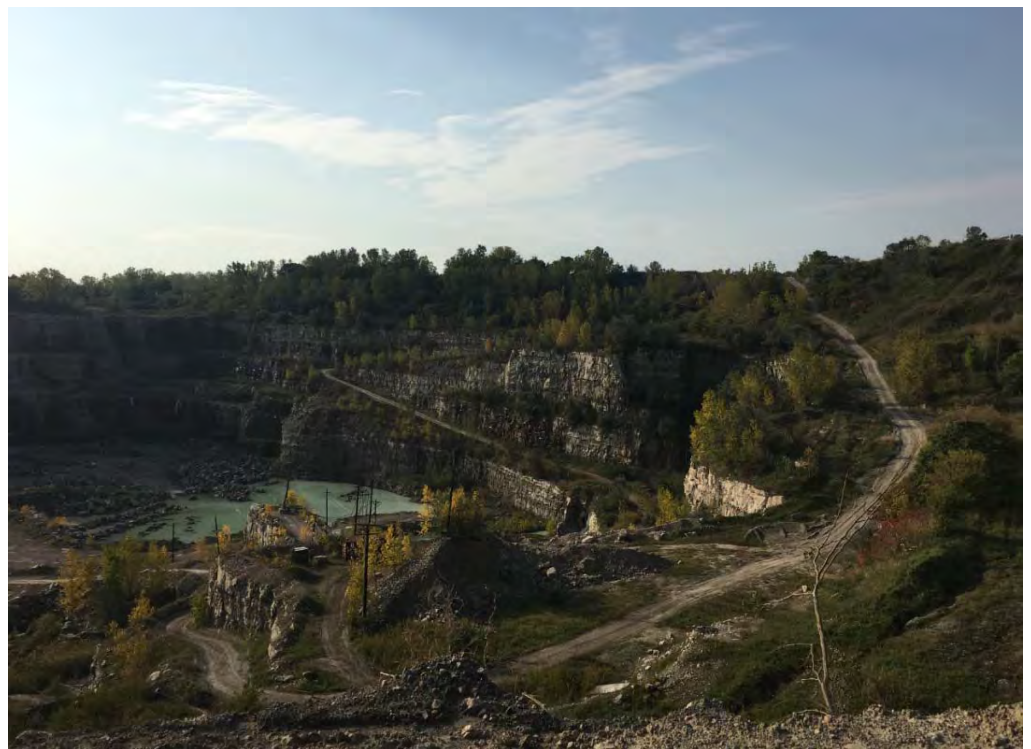
Photograph 2

Comments: View from the active filling area facing west.

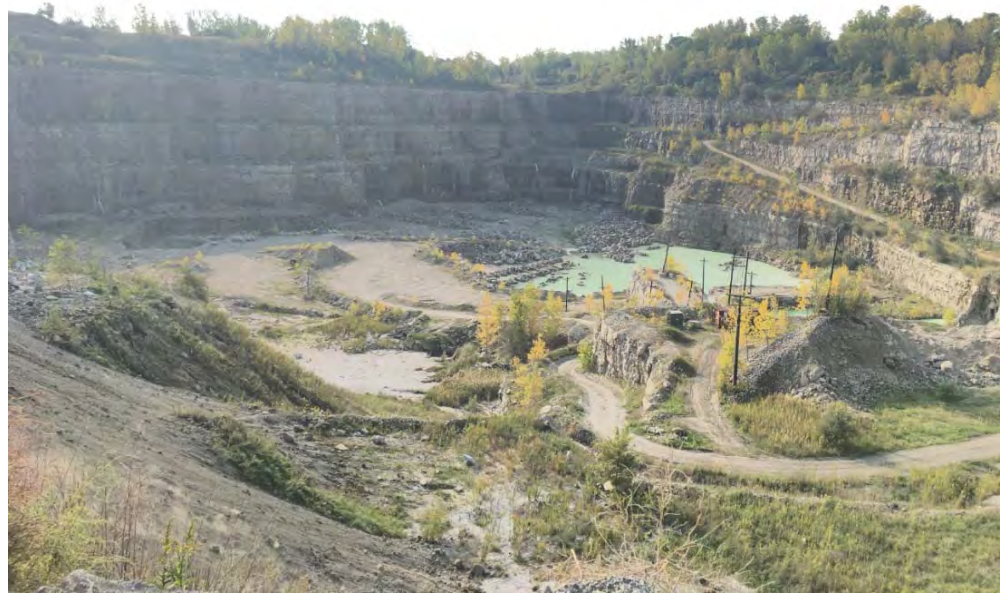
Comments: View from the active filling area facing southwest.

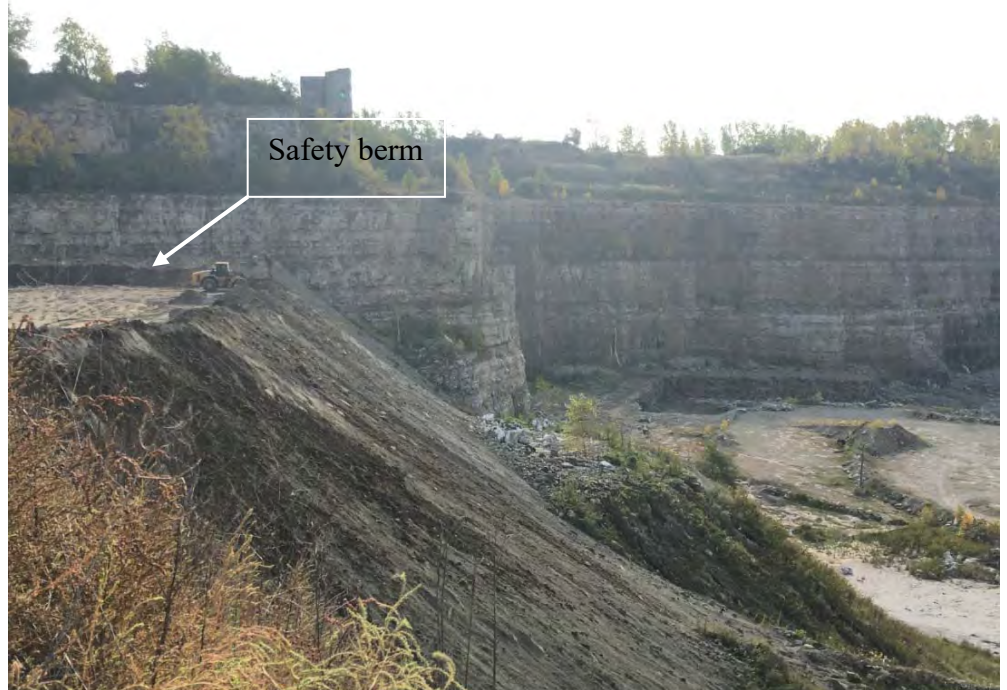
Photograph 4

Comments: Active filling area. Facing East

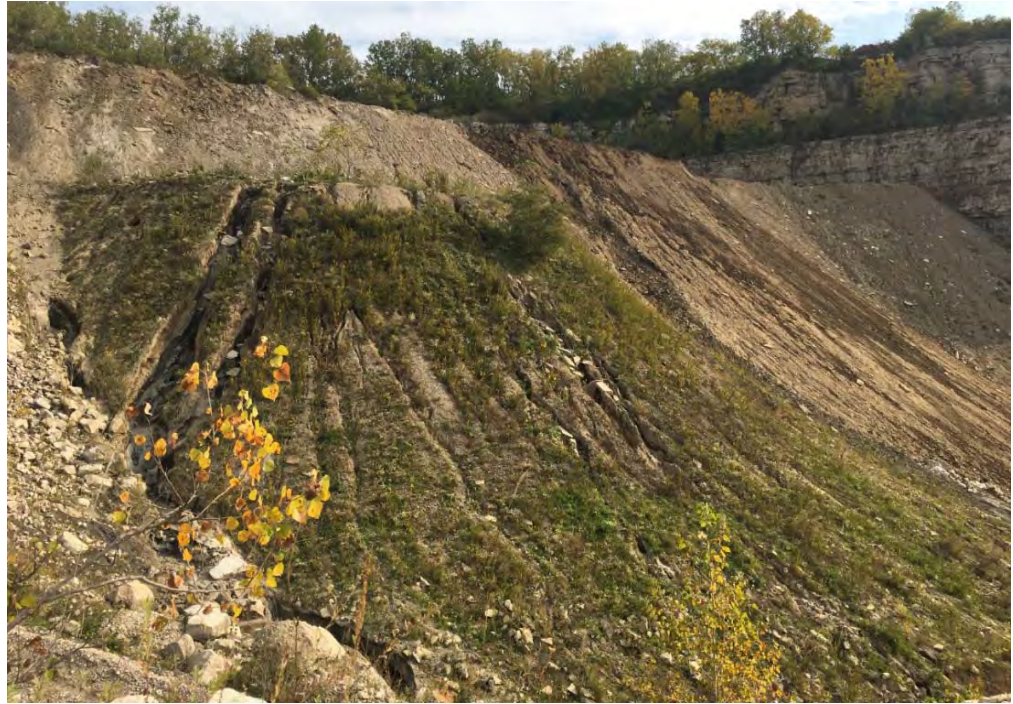
- 8) Based on topographic information, the Landfill does not appear to have direct run-on from the adjacent areas.
- 9) Erosion gullies on the CCR slopes (see Photograph 5) were observed. These gullies do not have to be maintained due to the incised nature of the Landfill.

3. Are there indications of erosion on the landfill slopes? Yes No
If 'Yes', describe what type and its condition (rill, gully, dimensions, etc.) _____
Gully erosion was observed on the active face of the CCR disposal area. There are no outer slopes because the CCR is contained within the quarry.

Comments: Erosion gullies on the active face of CCR fill slopes.

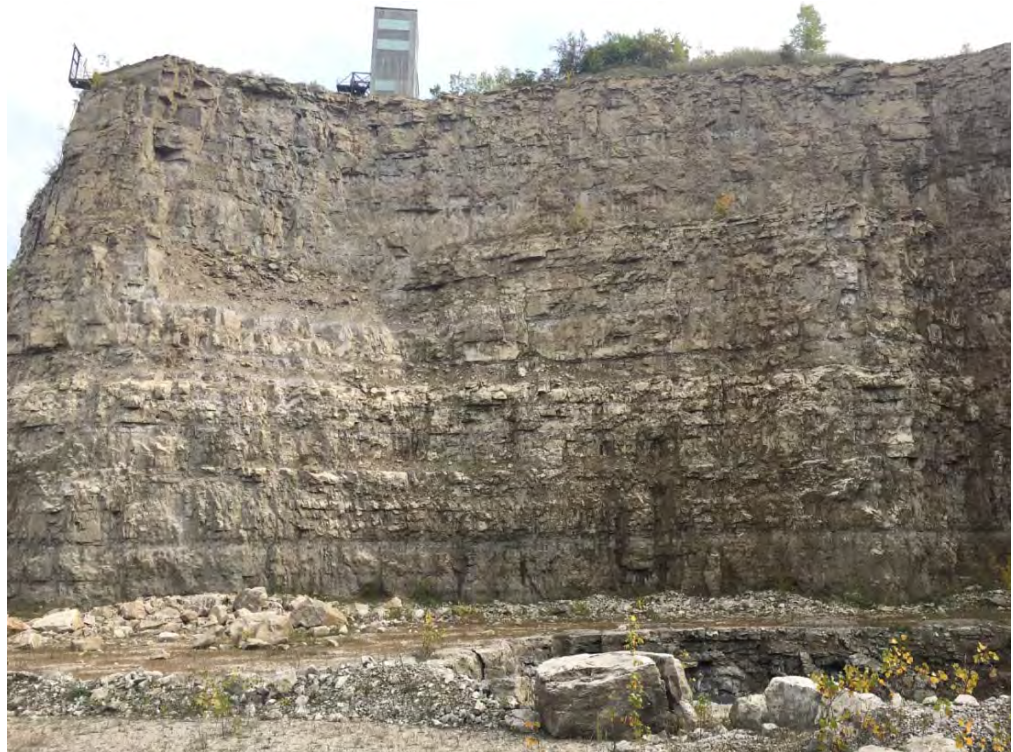
Photograph 6

- 5) The quarry bedrock side walls are fractured (see Photograph 6).
- 6) Portions of the exposed quarry side walls appeared to be damp or have active groundwater flow from a seam or bedrock layer interface (see Photographs 7 and 8).

5. Are there any depressions, ruts, or holes on the access ramp or road? Yes No
If 'Yes', describe (size, location, etc.) _____
6. Are there any fractures on side walls? Yes No
If 'Yes', describe (length and width, location and direction of cracking, slough, or distress, etc.) _____
There are bedrock fractures on the quarry sidewalls.

3. Are there any areas of potential concern? Yes No
 If 'Yes', describe. _____
 There are two main concerns. One concern is that rock pieces may fall from the side walls during daily operations is a serious situation. The other concern is that the CCR slopes are relatively steep, 1.25 horizontal to 1 vertical (1.25H:1V) and as much as 180-ft high for a single CCR slope. Failure of CCR slopes is a serious situation.

Comments: The quarry bedrock side walls are fractured.

Two safety concerns for site personnel were observed and should be addressed through site operating procedures. The two concerns were: (i) filling operations near steep slopes and (ii) working near fractured bedrock side walls. Warning signs were observed at vehicle entrance points to the Landfill, warning personnel of these safety concerns.

A draft Fill Plan was recently developed to address the safety concerns identified during the inspection. It is currently under review by DTE.

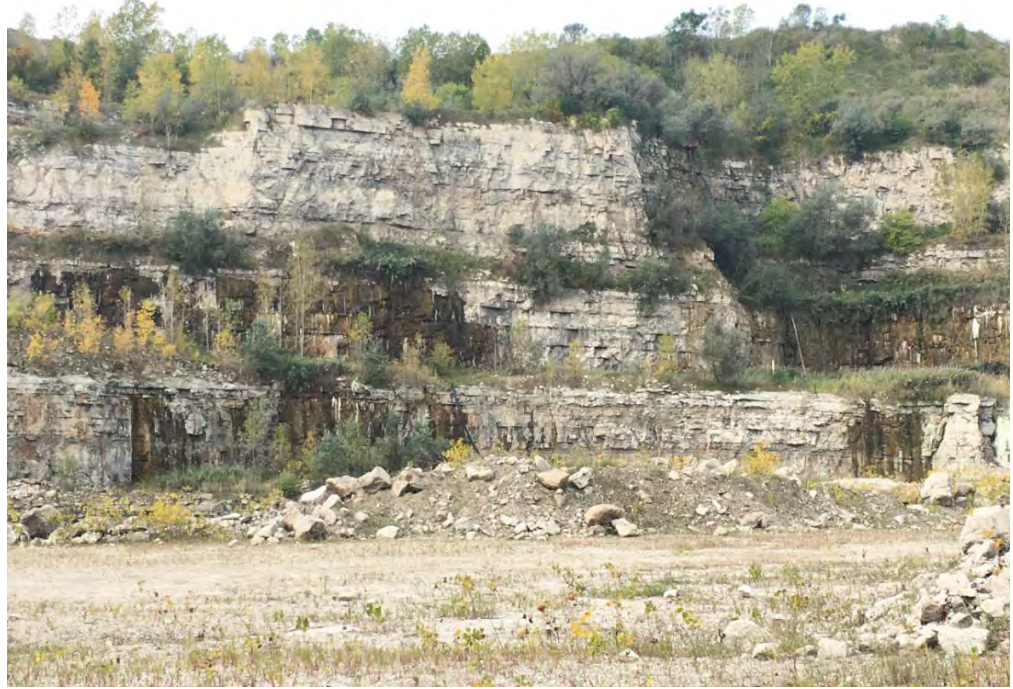
7. Are there wet areas that indicate seepage through the side walls? Yes No
If 'Yes', describe (size, location, etc.) _____
Multiple areas on the quarry sidewalls show damp conditions or
natural groundwater seepage.

Comments: Areas on the side walls that appear to be darker are damp or there is active groundwater seepage.

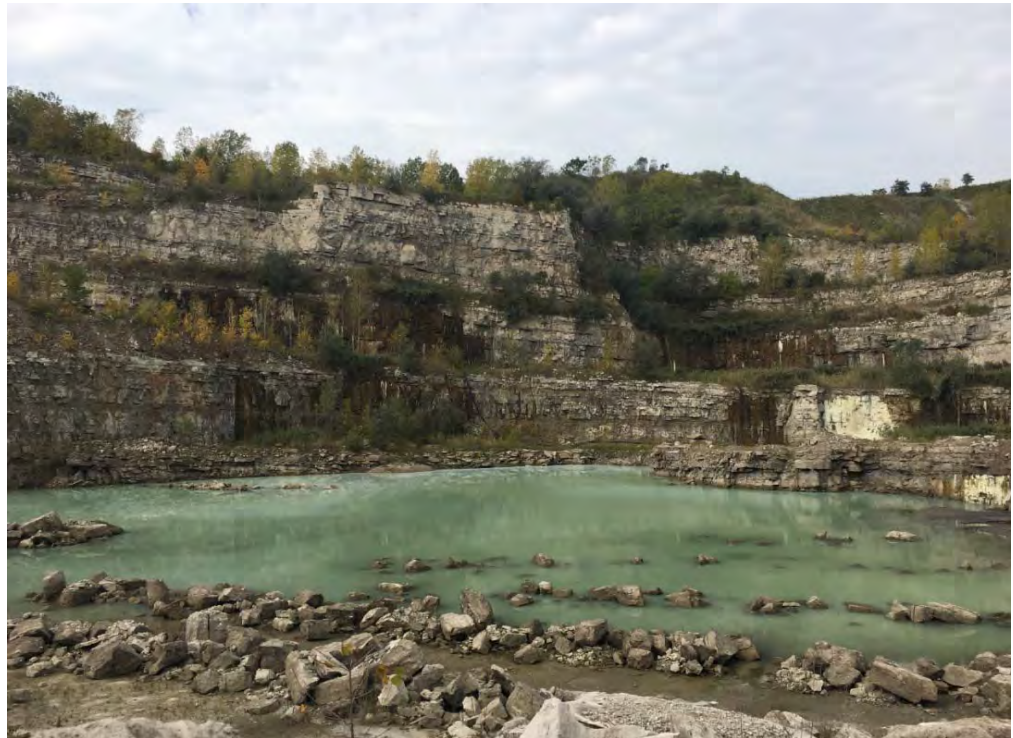
Photograph 8

Comments: Areas on the side walls that appear to be darker are damp or there is active groundwater seepage.

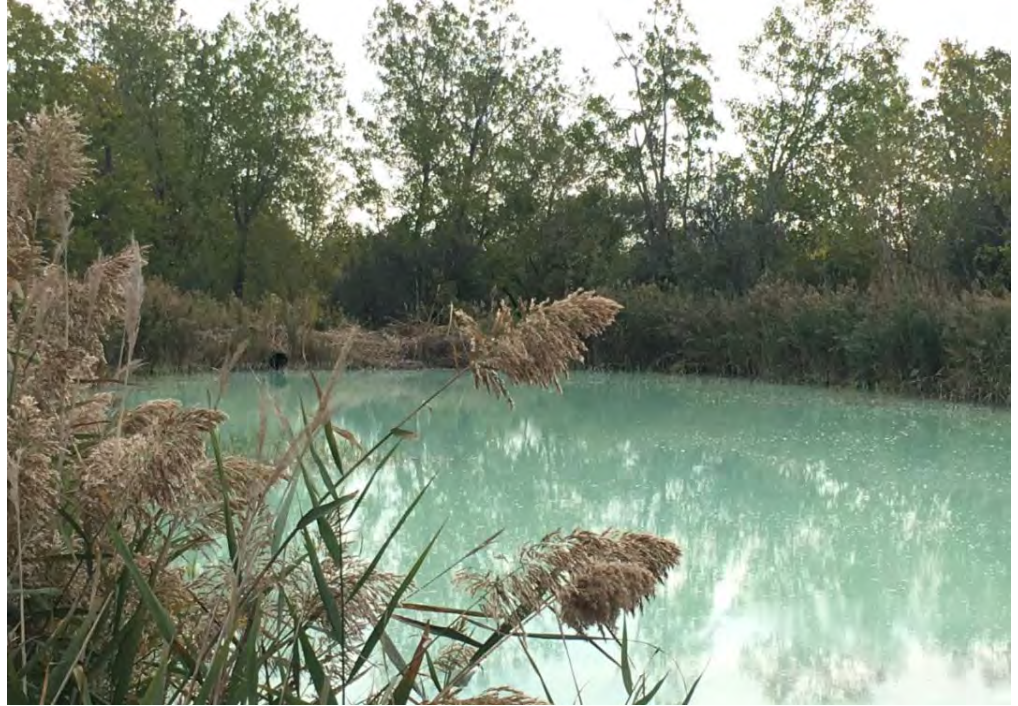
Comments: View of upper ponds. Water is discharged into the conveyance channel through a culvert. Facing south.

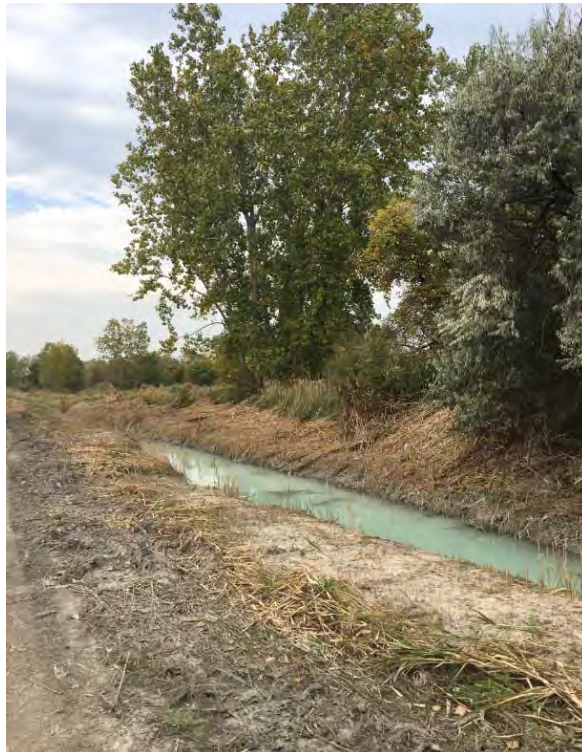
Photograph 10

Comments: Conveyance channel. Facing west.

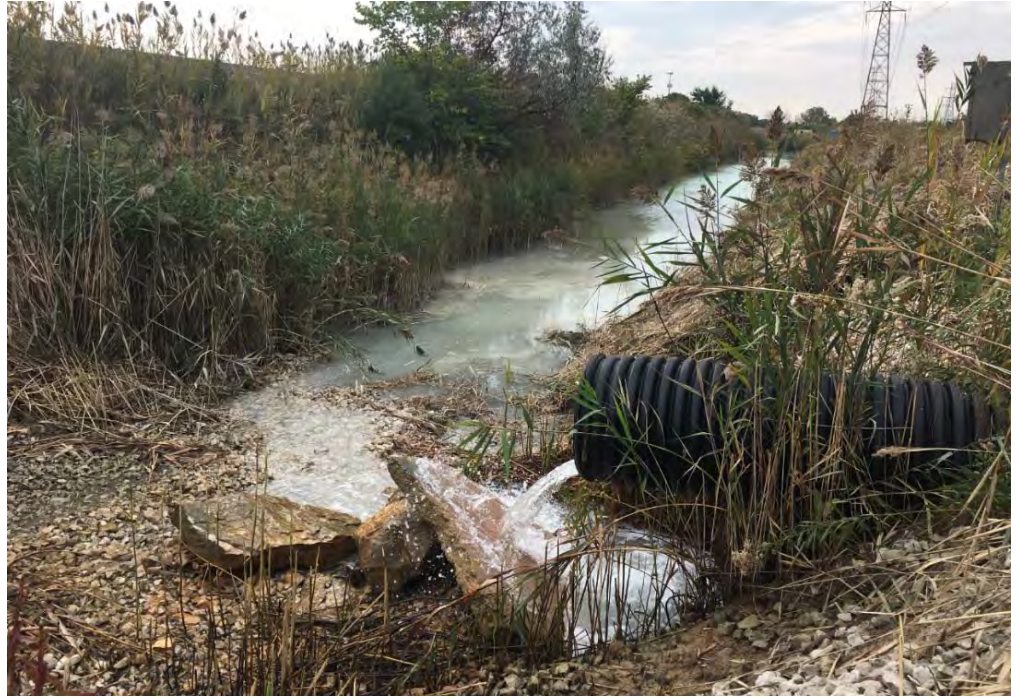
- 10) The Quarry sump, sump pump, upper ponds, conveyance channel and settling ponds appeared to be in good condition. Water discharging from the conveyance channel to settling Pond #4 appeared to be clear (see Photograph 11).
- 11) No fugitive dust complaints were observed in the Landfill Operating Record.

Comments: Culvert
connecting
conveyance channel
to Settling Pond #4
(facing south).
Discharge water
appeared to be clear.

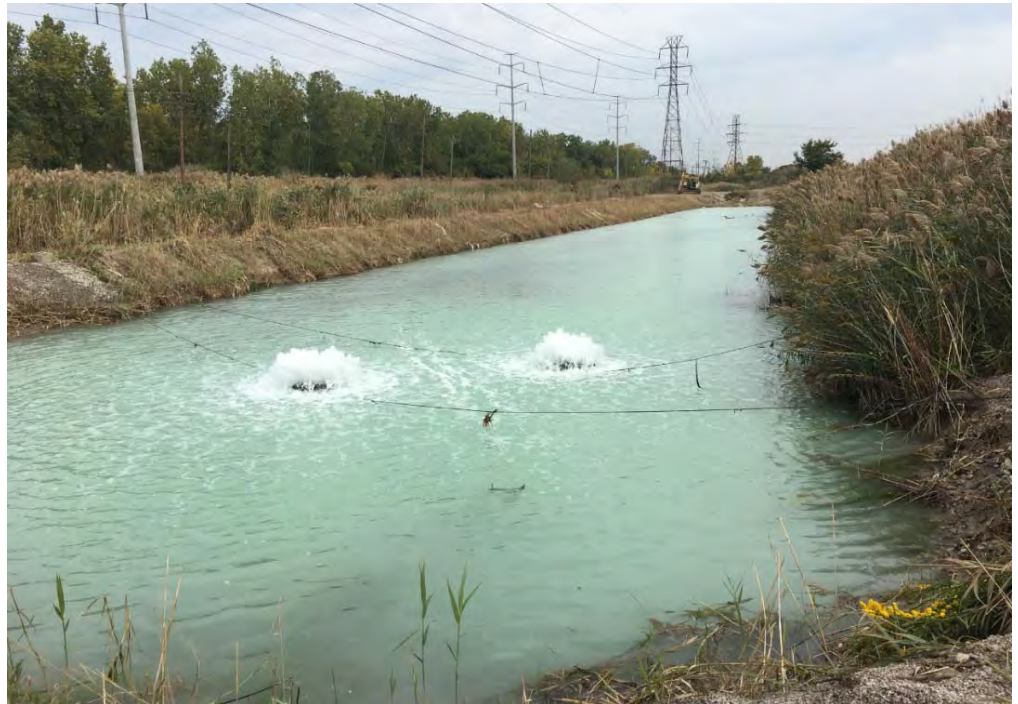
Photograph 12

Comments: View
from the downstream
end of Settling Pond
#3 near the NPDES
discharge pump
house.
