DTE Electric Company
One Energy Plaza
Detroit, Michigan 48226

2017 ANNUAL INSPECTION REPORT SIBLEY QUARRY LANDFILL

Trenton, Michigan

January 2018

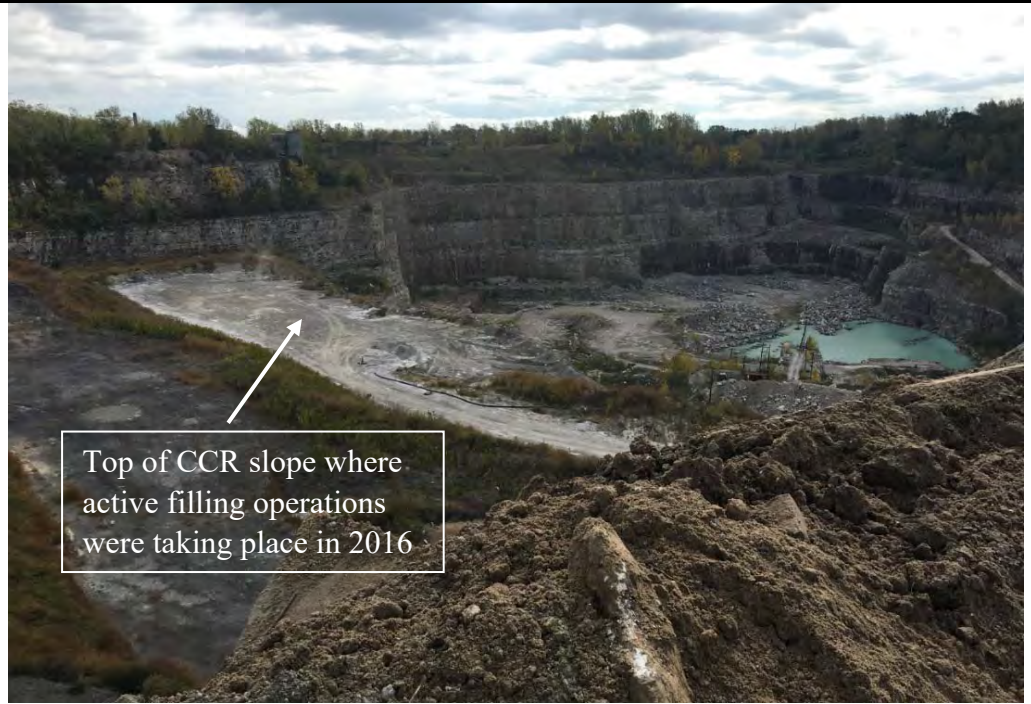
Photograph 2

- 1) The Landfill was originally operated as a limestone quarry, with mining of limestone and dolomite to a depth of approximately 300 bgs.
- 2) CCR is disposed in the Landfill by end-dumping and spreading. Trucks haul CCR to the active filling area using the access roads built with CCR and crushed limestone. Trucks dump CCR at the top of CCR slope near the crest. Then, a front-end loader or dozer pushes CCR onto the slope. There are several CCR slopes in the active disposal area. They are separated with two main setbacks (Photographs 1 and 5). The slopes are as high as approximately 180 ft with grades as steep as 1.25 horizontal to 1 vertical (1.25H:1V). Based on the current operations, CCR is placed from the top of most upper slope (Photographs 2 and 5).

Comments: Material piled at the top of active filling area.

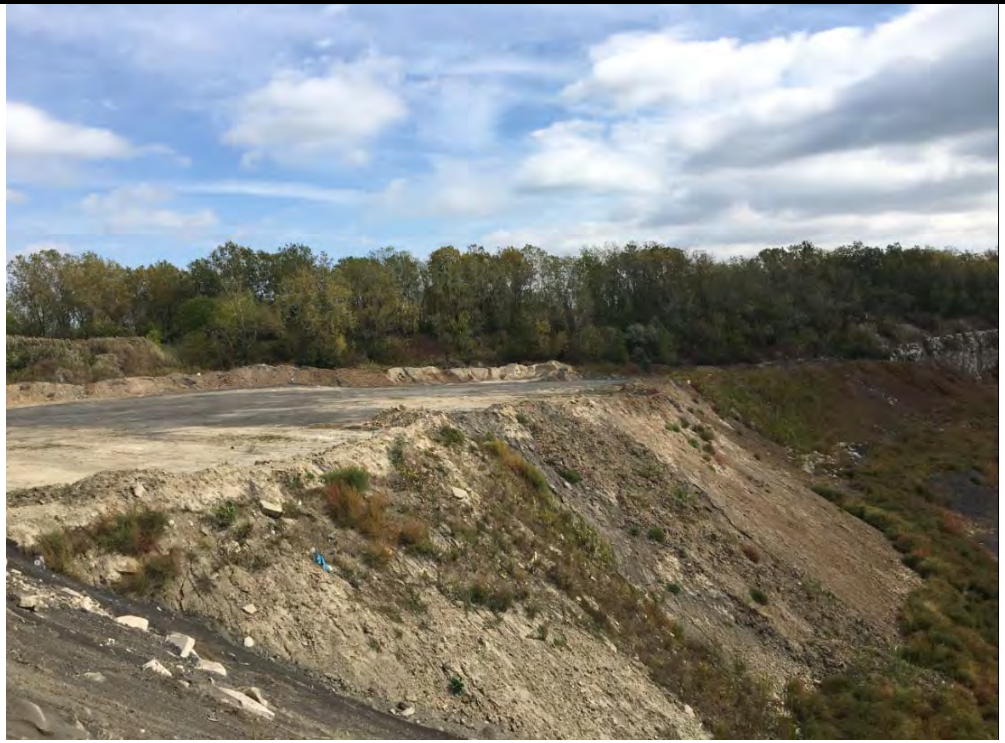
Photograph 4

- 3) There were no indications of slope instability on the CCR slopes at the time of inspection.
- 4) For fugitive dust control purposes for CCR, DTE stated that inert material is placed in the same manner as described in Item 2 upon CCR disposal. DTE is also utilizing sprinkler system for dust control in the active filling area where trucks operate (see Photograph 4).

Comments: DTE is utilizing a sprinkler system for dust control in the active filling area where trucks operate.

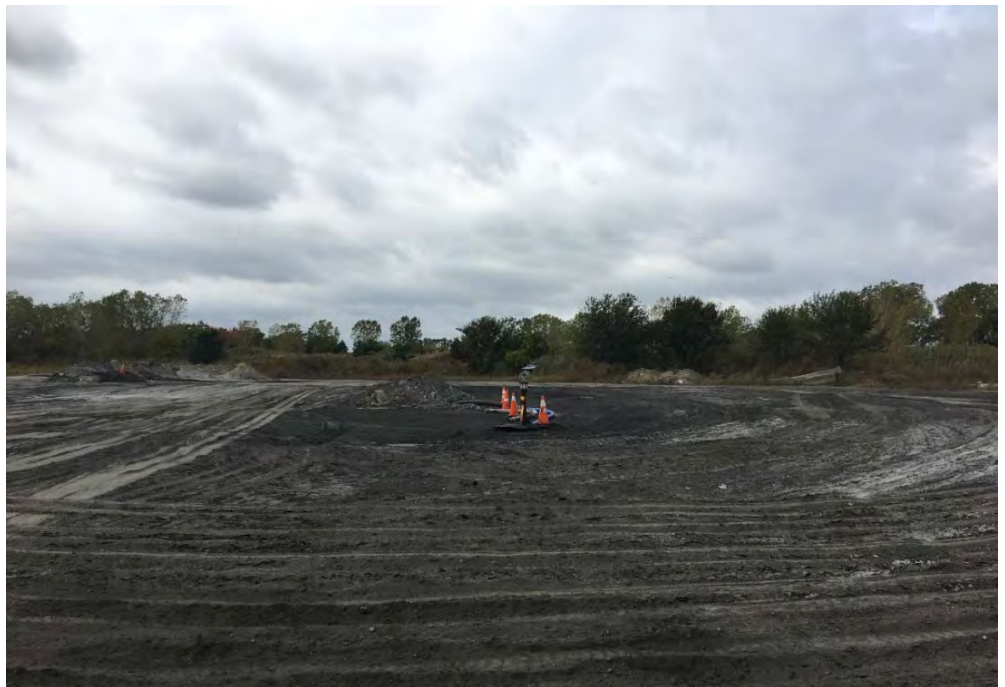
- 8) Based on topographic information, the Landfill does not appear to have direct run-on from the adjacent areas.
- 9) Erosion gullies on the CCR slopes (see Photograph 5) were observed. These gullies do not have to be maintained due to the incised nature of the Landfill.

Comments: View of the active filling area, facing northwest.

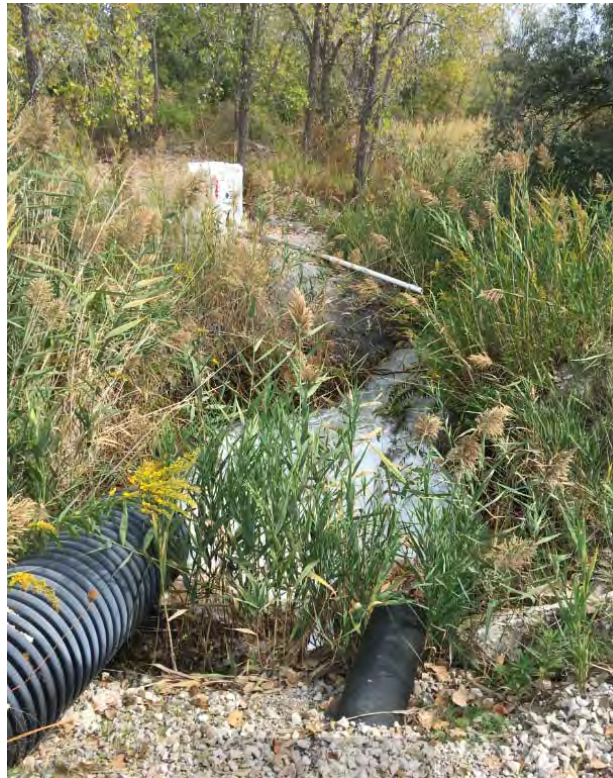
- 7) Groundwater and stormwater that occurs within the quarry drains by gravity to the sump at the bottom of the quarry. Drainage channels were observed along the access roads, conveying water to lower elevations (see Photographs 11 and 12). There is a culvert at a low spot underneath the access ramp conveying water to the sump. Based on discussions with the site personnel, the pump operating at the sump discharges approximately 1.5 MGD to keep the sump elevation at approximately 300 feet above mean sea level, approximately 300 feet bgs.

Comments: A typical stormwater channel along access roads.

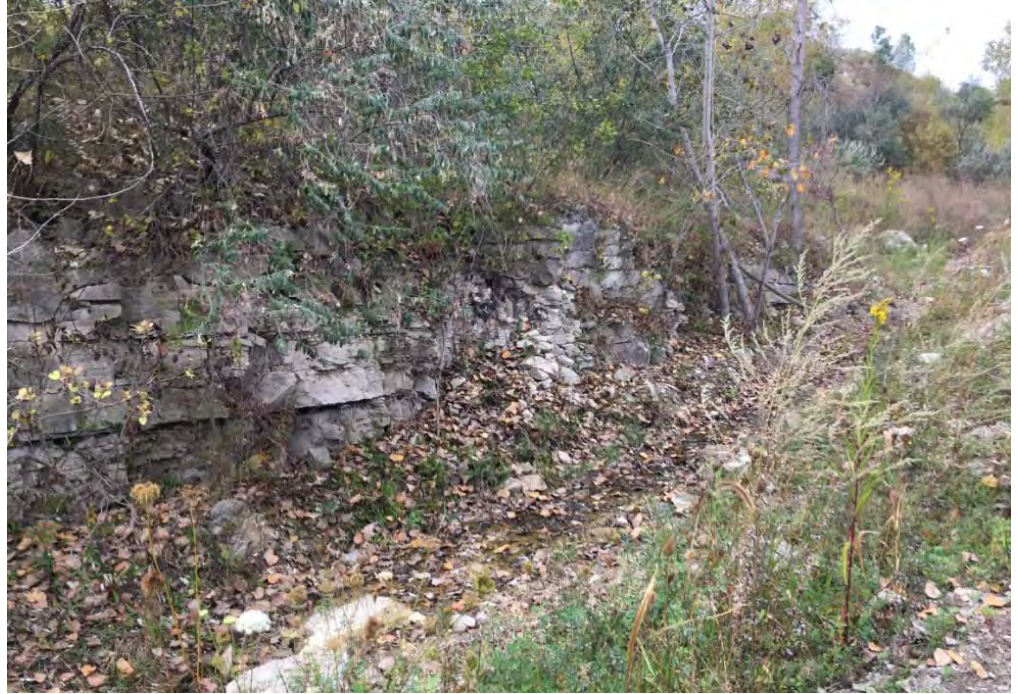
Photograph 12

Comments: A typical stormwater channel along access roads.

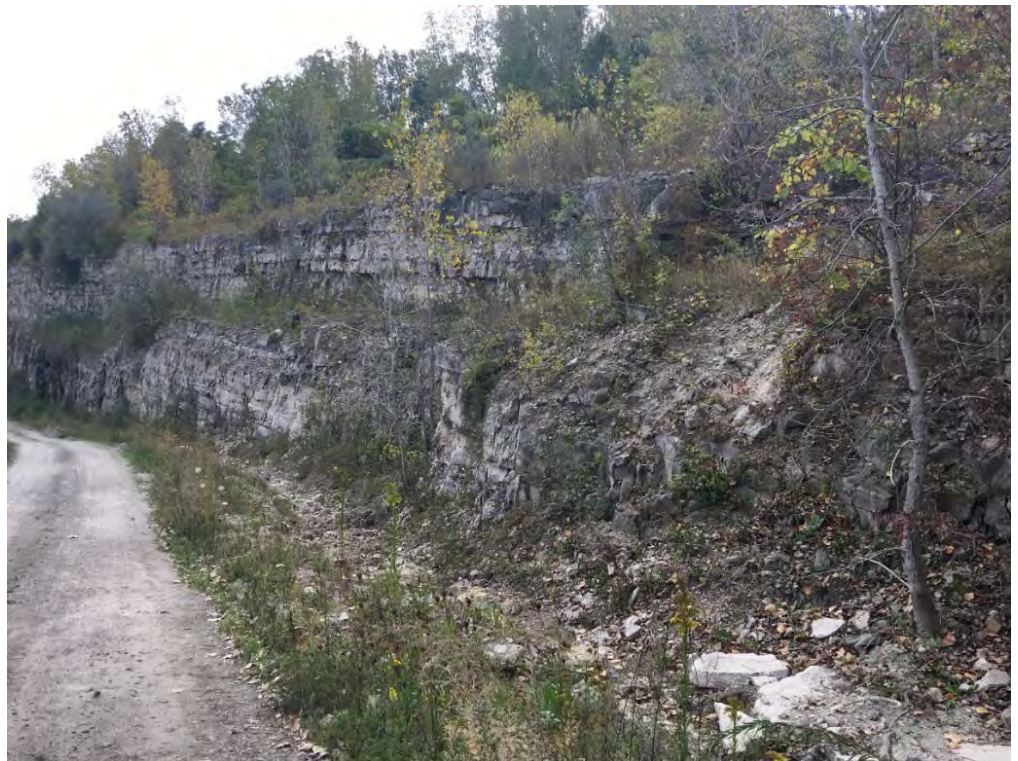
- 5) The quarry bedrock side walls are fractured (see Photograph 14).
- 6) Portions of the exposed quarry side walls appeared to be damp or have active groundwater flow from a seam or bedrock layer interface (see Photograph 13).

Comments: Active seepage was observed on quarry walls.
