DTE Electric Company
One Energy Plaza
Detroit, Michigan 48226

2018 ANNUAL INSPECTION REPORT SIBLEY QUARRY LANDFILL

Trenton, Michigan

January 2019

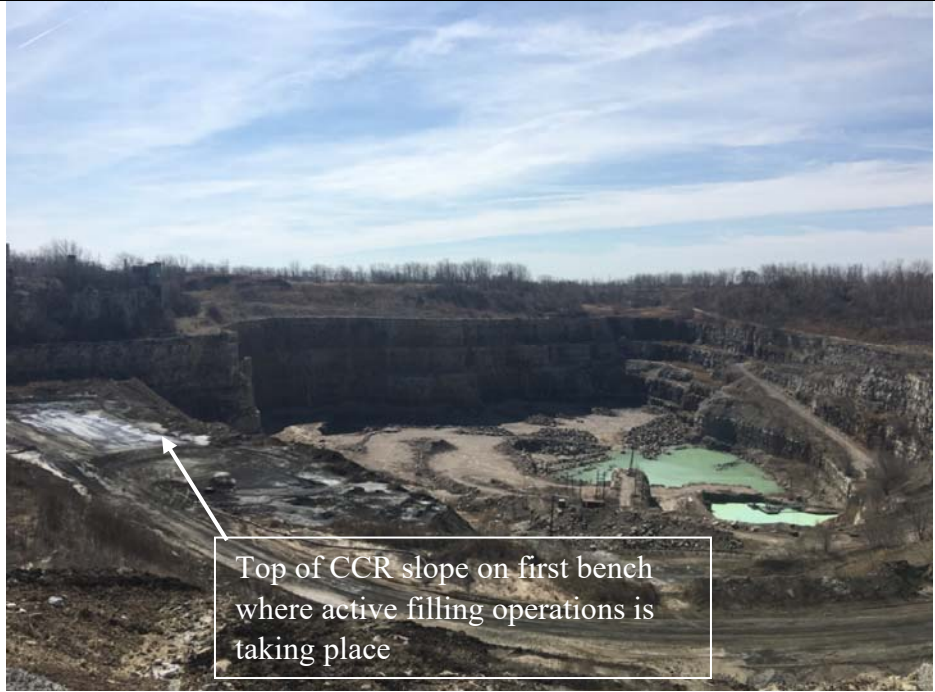
Photograph 1

Comments: Sibley Quarry Landfill.
Facing south.

Top of CCR slope on first bench where active filling operations is taking place

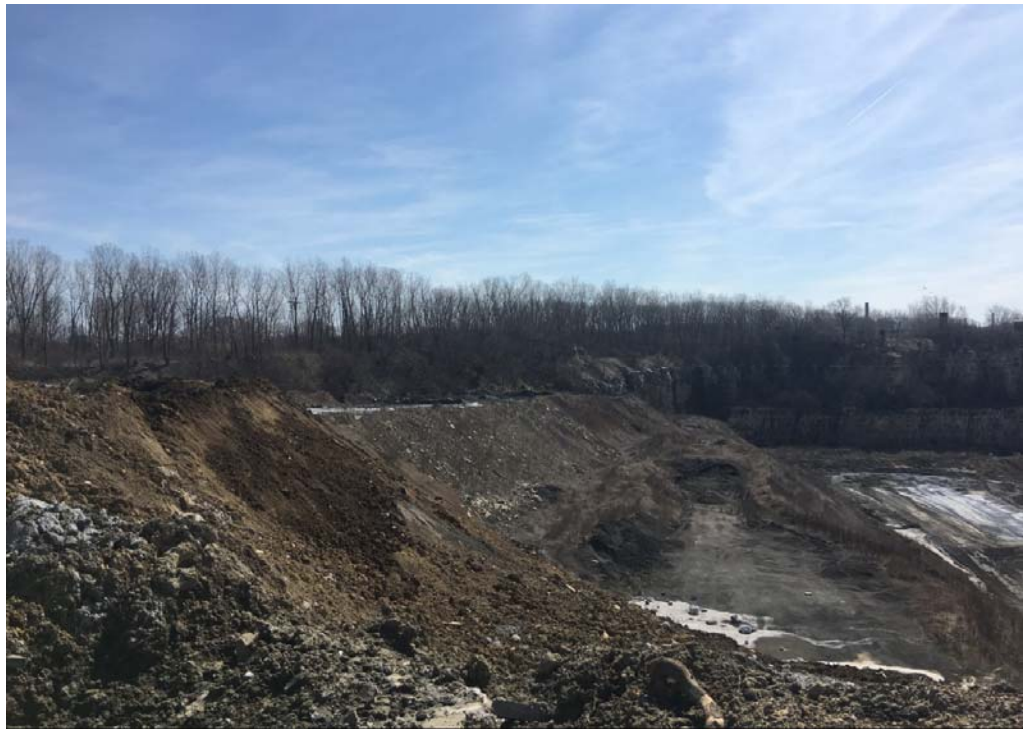
Photograph 2

- 1) The Landfill was originally operated as a limestone quarry, with mining of limestone and dolomite to a depth of approximately 300 bgs.
- 2) There were no disposal activities on the day of inspection. Based on discussions with the site personnel, CCR is disposed in the Landfill by end-dumping and spreading, which is consistent with the activities observed in the previous years. Trucks haul CCR to the active filling area using the access roads built with CCR and crushed limestone. Trucks dump CCR at the top of CCR slope near the crest. Then, a front-end loader or dozer pushes CCR onto the slope. There are several CCR slopes in the active disposal area. They are separated with two main setbacks (Photographs 1 and 5). The slopes are as high as approximately 180 ft with grades as steep as 1.25 horizontal to 1 vertical (1.25H:1V). Based on the current operations, CCR is placed from the top of most upper and lower slopes (Photographs 2 and 3 show active filling areas).

Comments: Active filling area. Facing east.

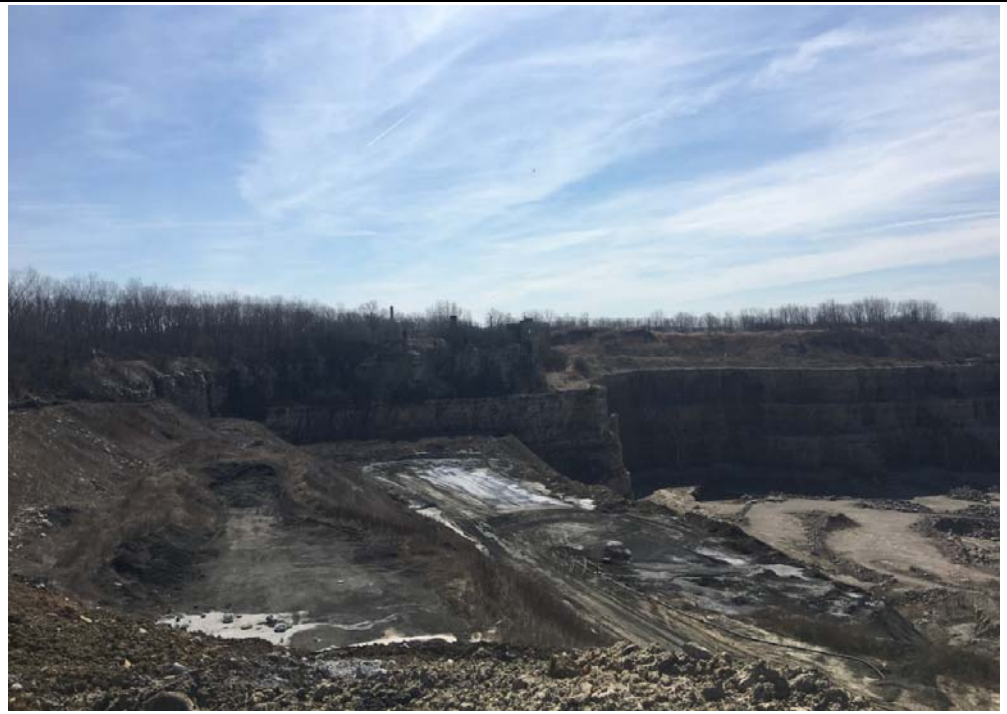
Photograph 3

Comments: Active filling area, facing east.

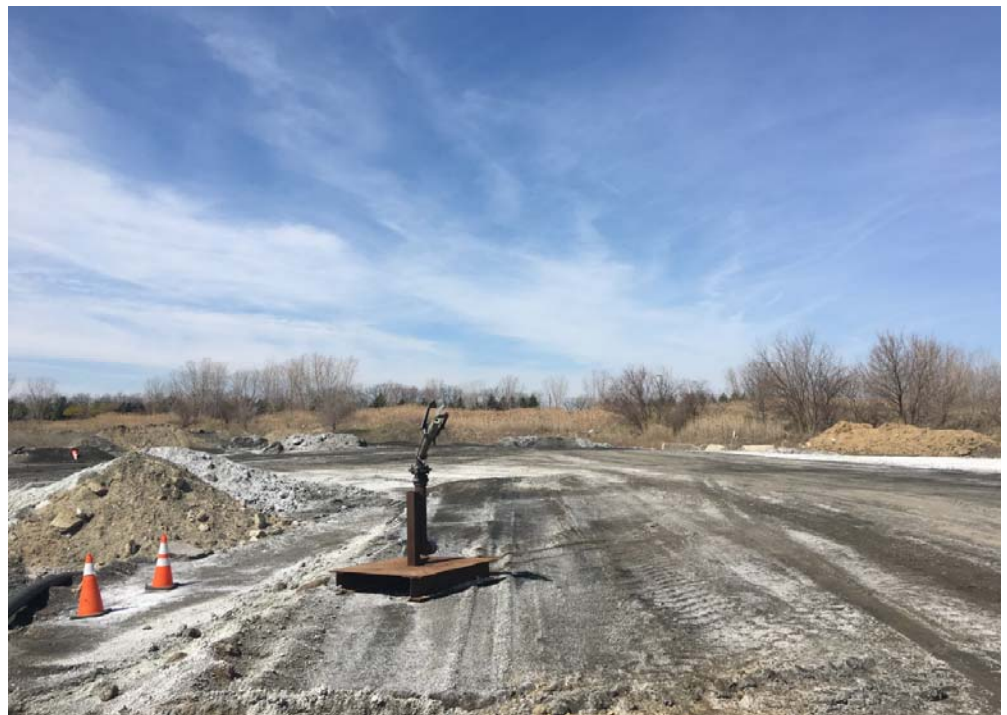
Photograph 4

- 5) For fugitive dust control purposes for CCR, DTE stated that inert material is placed in the same manner as described in Item 2 upon CCR disposal. DTE is also utilizing sprinkler system for dust control in the active filling area where trucks operate (see Photograph 4).

Comments: DTE is utilizing a sprinkler for dust control on the top bench of active filling area when trucks are operating.

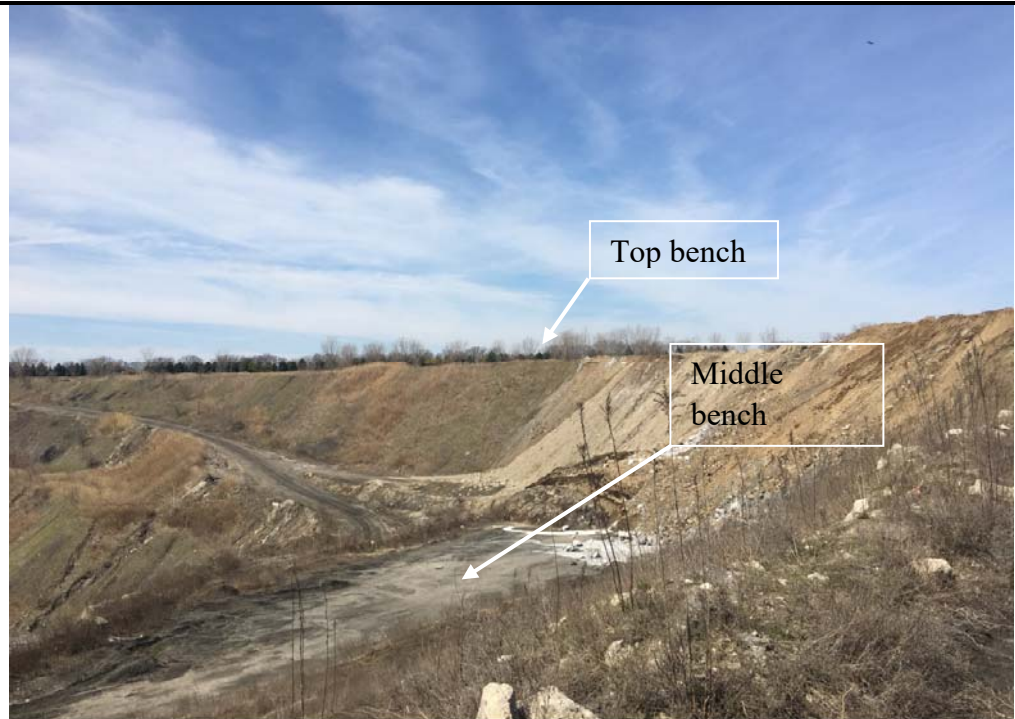
Photograph 5

- 10) Based on topographic information, the Landfill does not appear to have direct run-on from the adjacent areas.
- 11) Erosion gullies on the CCR slopes (see Photograph 5) were observed. These gullies do not have to be maintained due to the incised nature of the Landfill.
- 12) The Quarry sump, sump pump, upper ponds, conveyance channel and settling ponds appeared to be in good condition. Water discharging from the conveyance channel to Settling Pond #4 appeared to be clear (see Photograph 6).
- 13) No fugitive dust complaints were observed in the Landfill Operating Record.

3. Are there indications of erosion on the landfill slopes? Yes No
If 'Yes', describe what type and its condition (rill, gully, dimensions, etc.) _____
Gully erosion was observed on the active face of the CCR disposal area. There are no outer slopes because the CCR is contained within the quarry.

Comments: View of the active filling area, facing northwest.

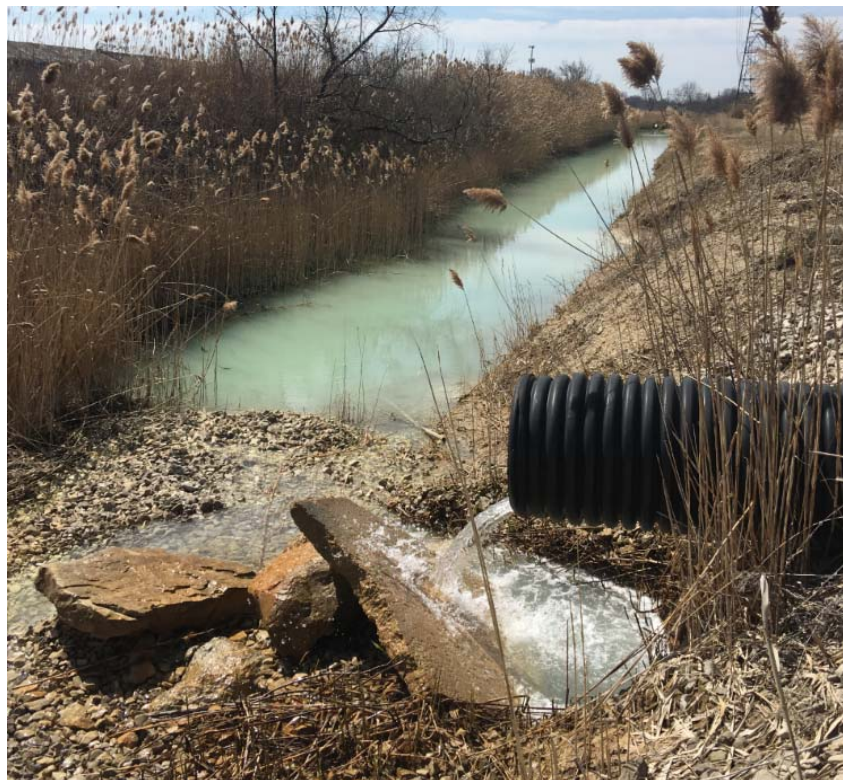
Photograph 6

Comments: Culvert connecting conveyance channel to Settling Pond #4 (facing south). Discharge water appeared to be clear.

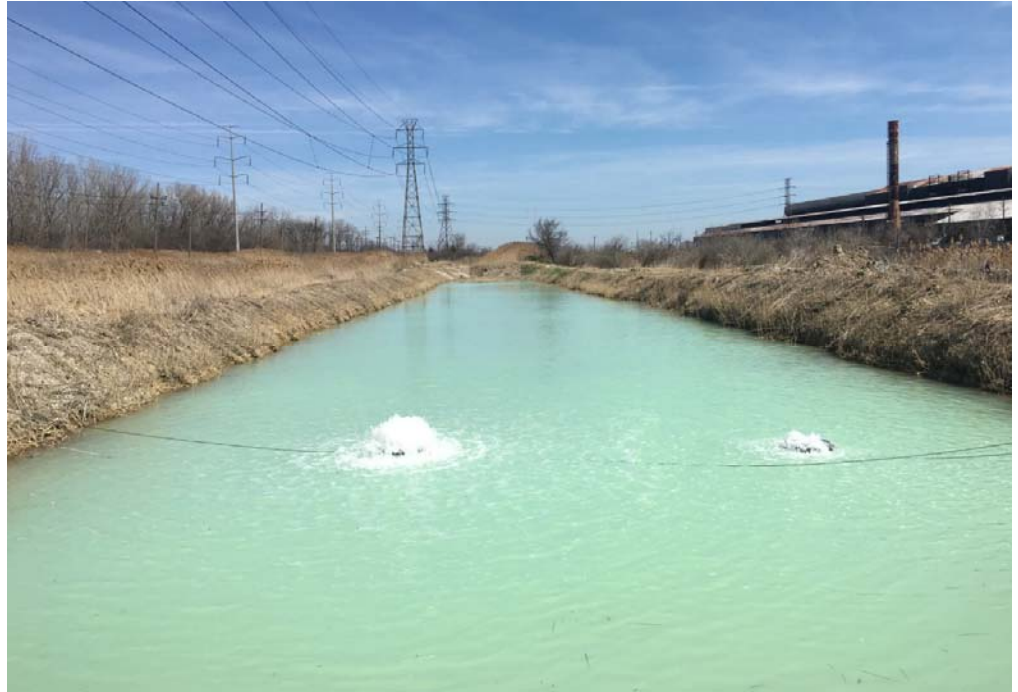
Photograph 7

Comments: View of Settling Pond #3 from the pump house where the aerators are located.

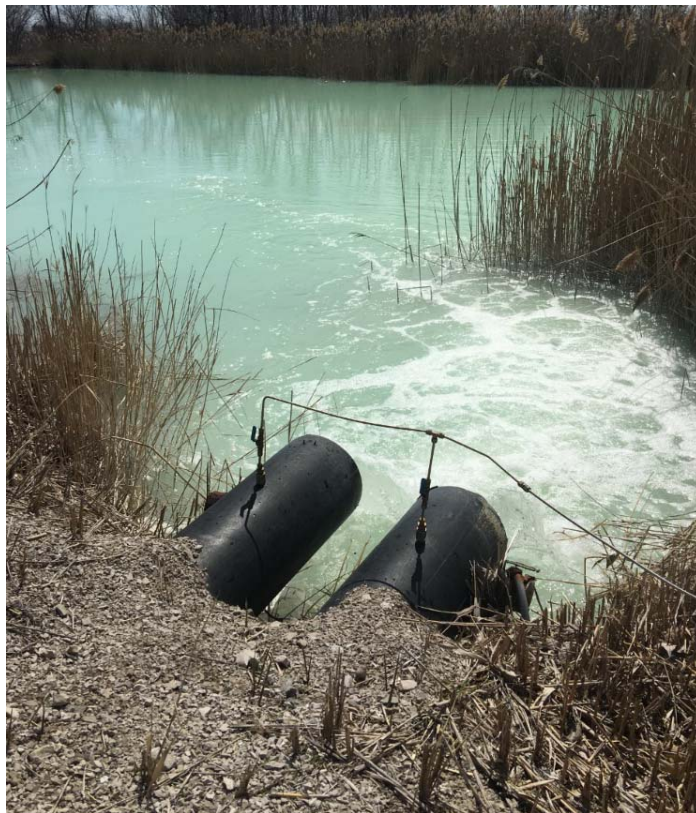
Photograph 8

Comments: Water from the quarry is transferred to upper ponds.

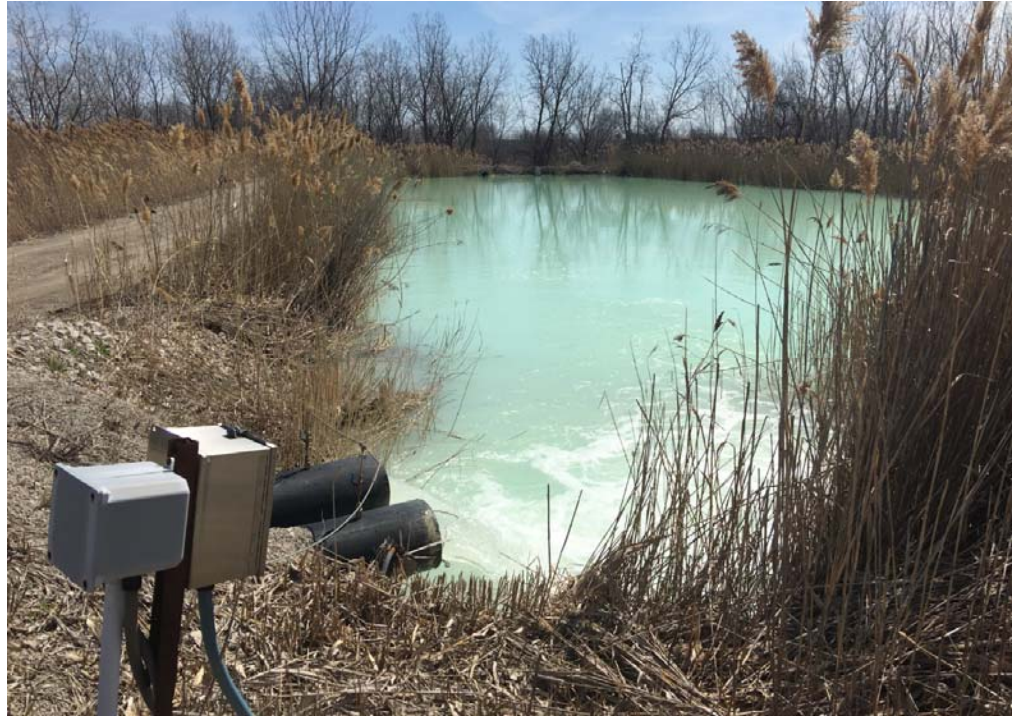
Photograph 9

Comments: View of upper ponds. Water is discharged into the conveyance channel through a culvert. Facing east.

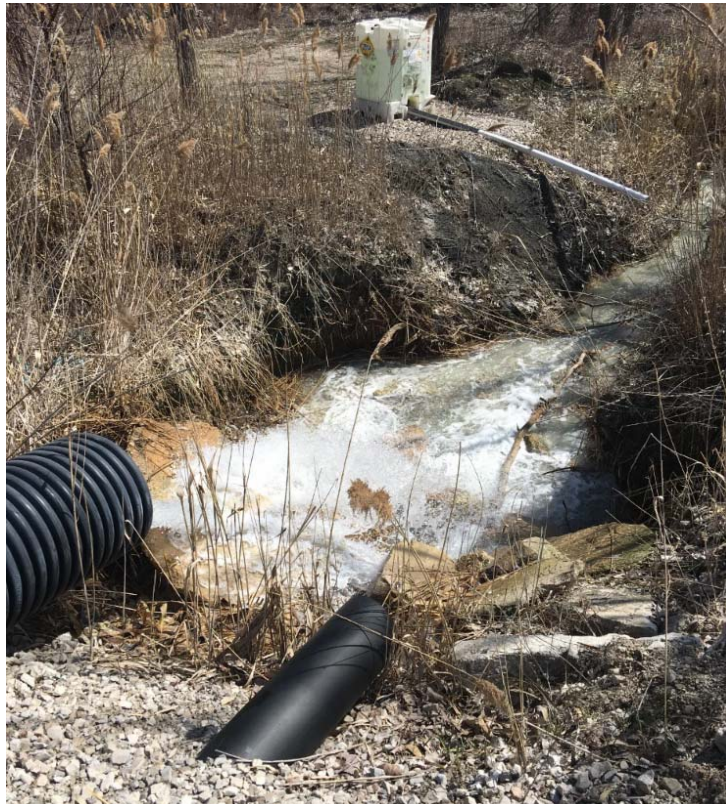
Photograph 10

Comments: Upstream end of the conveyance channel. Facing east.

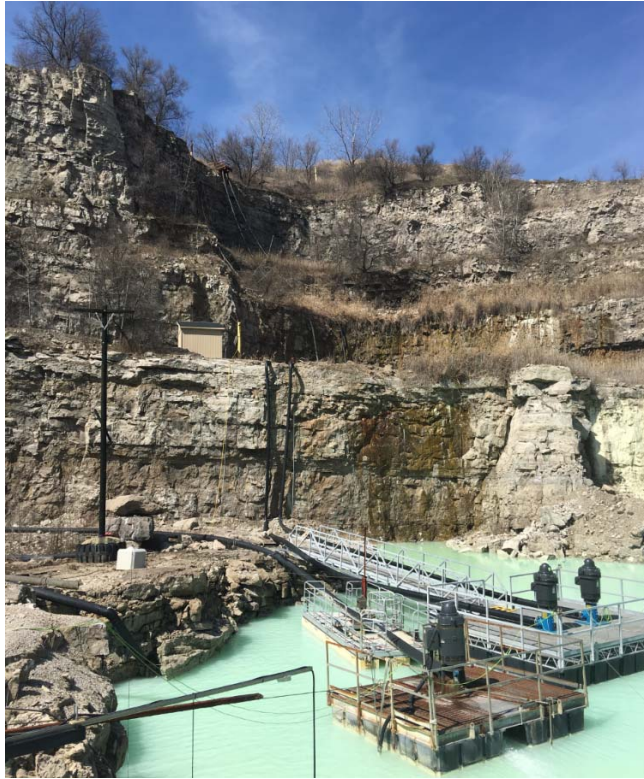
Photograph 11

- 9) DTE is currently in the process of installing two new pumps to replace the existing single pump. Site personnel reported that the new pumps will have the same daily discharge rate.

Comments: DTE is in the process of replacing existing single pump to double pumps.

Main sump pump is in the process of being replaced.

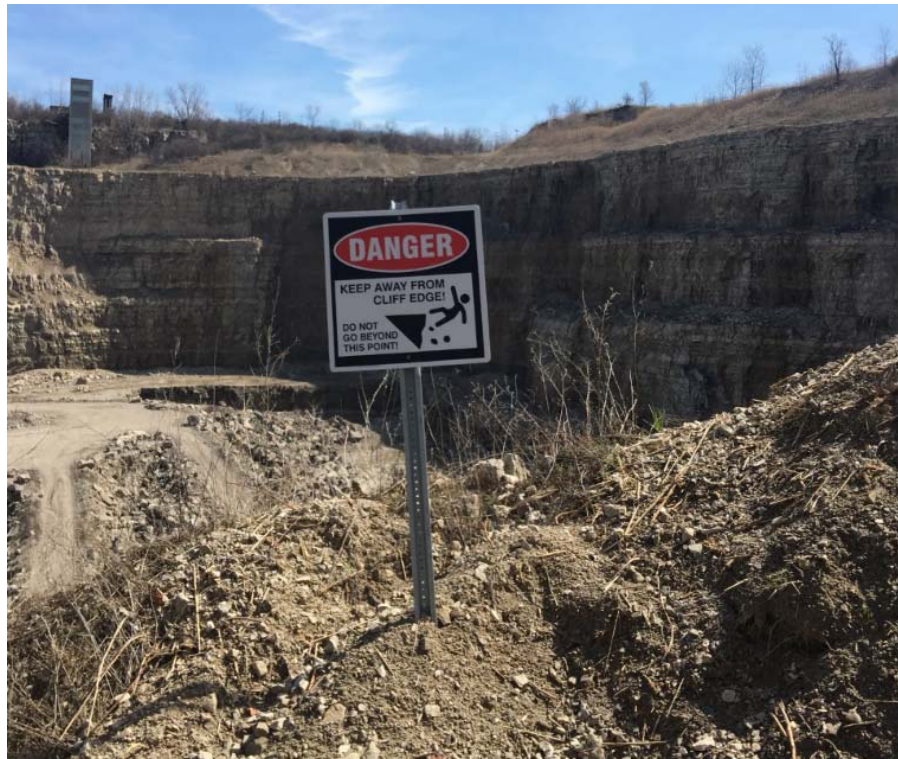
Photograph 12

Comments: "Danger" signs are located along the haul roads.

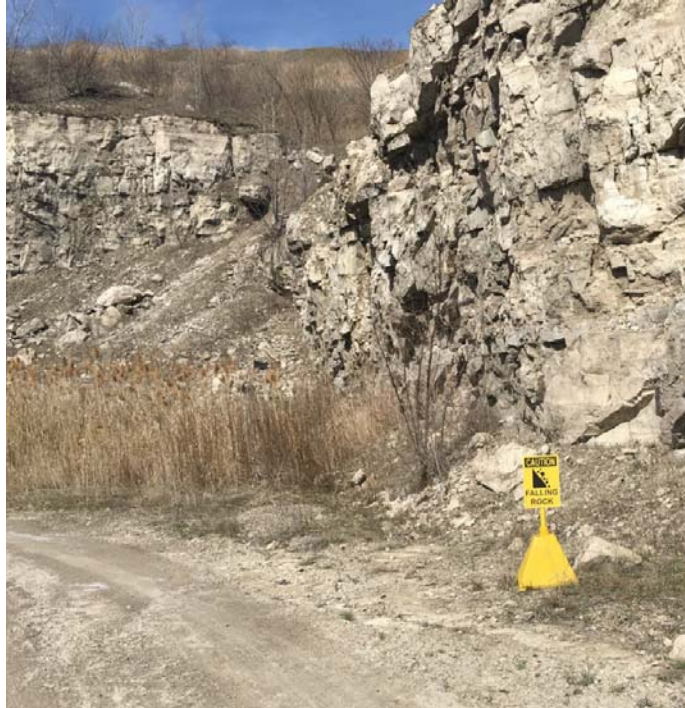
Photograph 13

- 6) The quarry bedrock side walls are fractured (see Photographs 13 and 14).
- 7) Portions of the exposed quarry side walls appeared to be damp or have active groundwater flow from a seam or bedrock layer interface (see Photograph 14).

Comments: "Caution" signs for falling rock are located along highwalls.

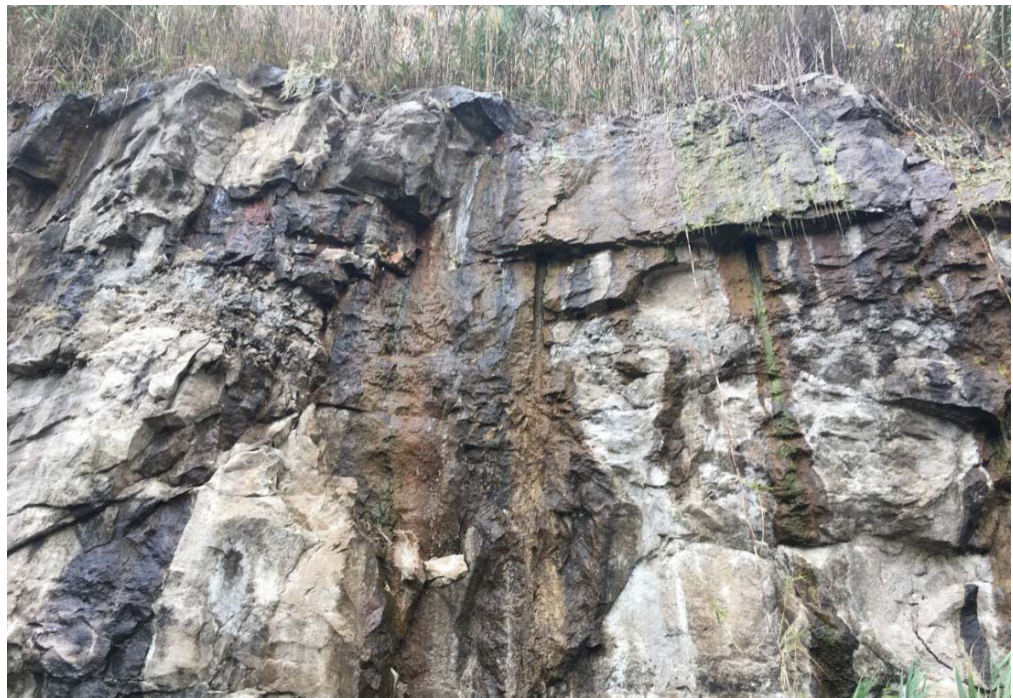
Photograph 14

7. Are there wet areas that indicate seepage through the side walls? Yes No
If 'Yes', describe (size, location, etc.) _____
Multiple areas on the quarry sidewalls show damp conditions or
natural groundwater seepage.

Comments: Active groundwater inflow was observed on quarry walls.
