**DTE Electric Company**  
One Energy Plaza  
Detroit, Michigan 48226

# **2019 ANNUAL INSPECTION REPORT SIBLEY QUARRY LANDFILL**

**Trenton, Michigan**

**Geosyntec**

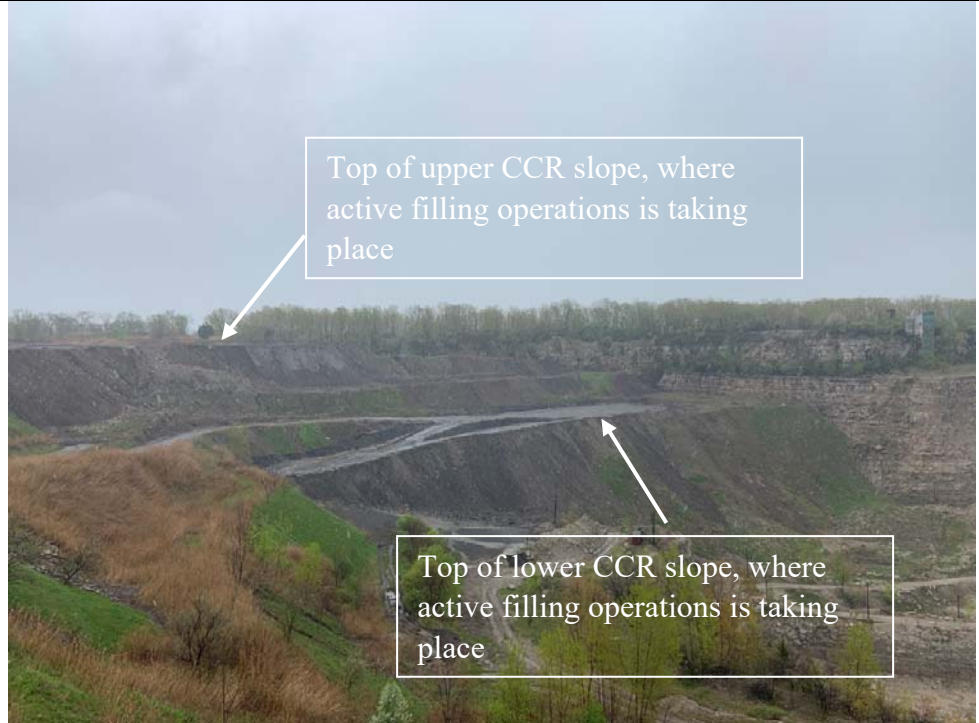
Photograph 1

Comments: Sibley Quarry Landfill active fill area. Facing northeast.

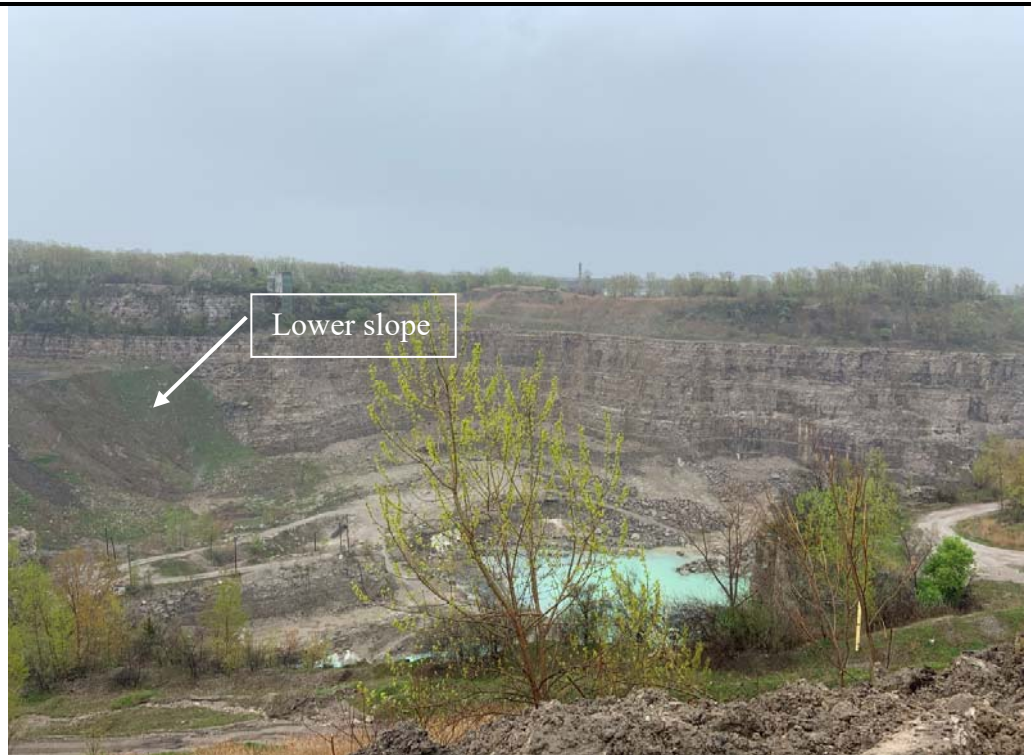
Photograph 2

Comments: Sibley Quarry Landfill. Facing east.

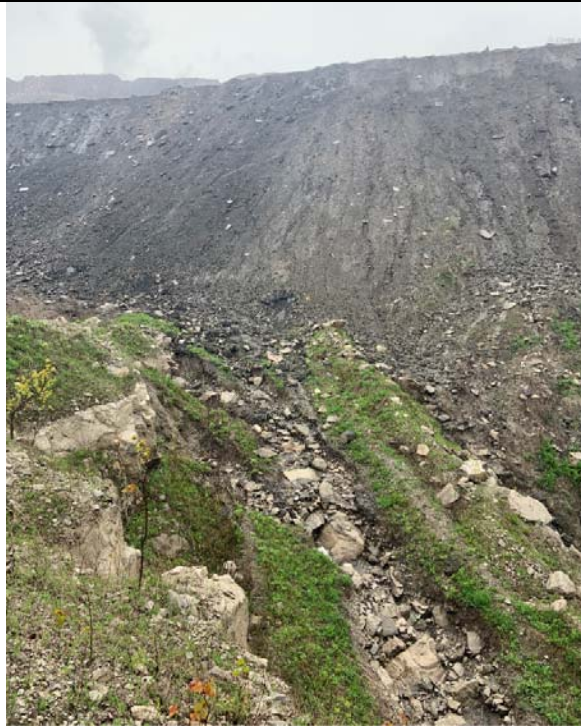
- 10) Based on topographic information, the Landfill does not appear to have direct run-on from the adjacent areas.
- 11) Erosion gullies on the CCR slopes (see Photograph 3 showing a typical erosion gully) were observed. These gullies do not have to be maintained due to the incised nature of the Landfill.

Gully erosion was observed on the active face of the CCR disposal area (Photograph 3). There are no outer slopes because the CCR is contained within the quarry.

Comments: Erosion on lower slope along a rock knob. Facing north.

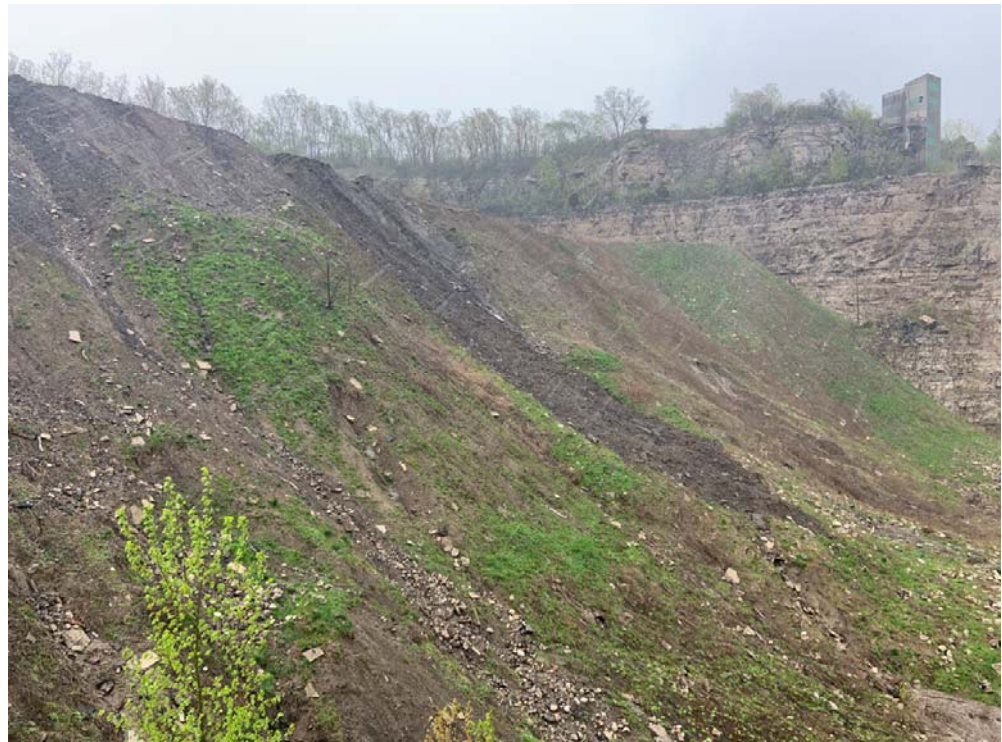
Photograph 4

Comments: Lower Slope. Facing east.

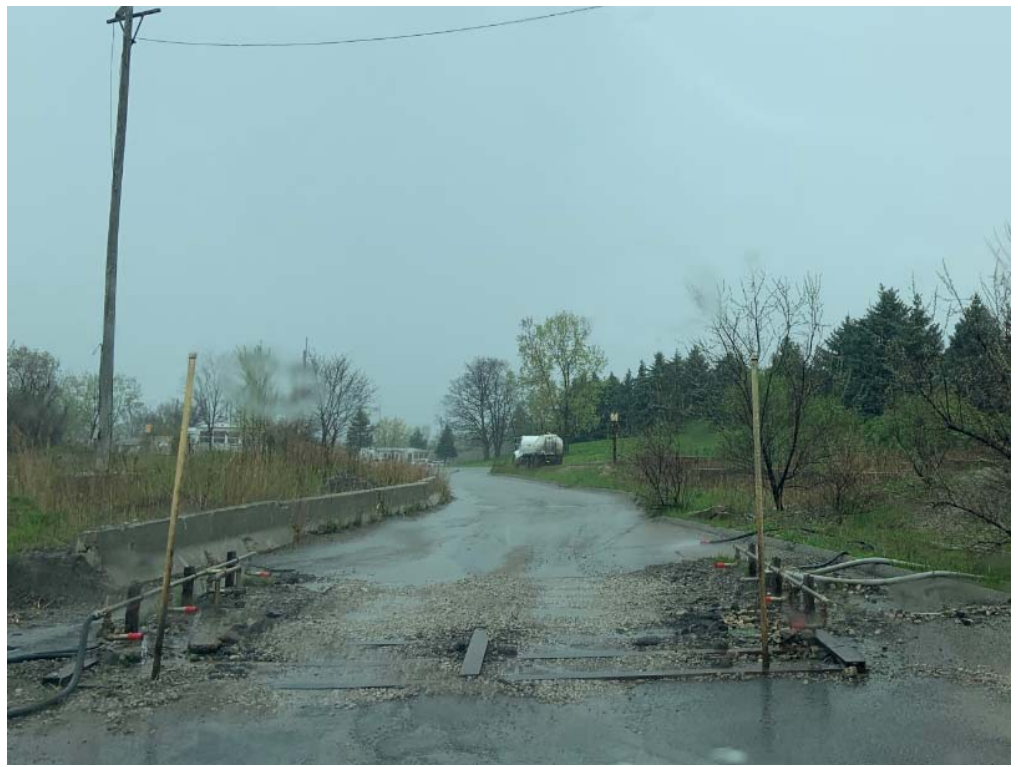
Photograph 5

Comments: Wheel wash area in working condition. Facing west.

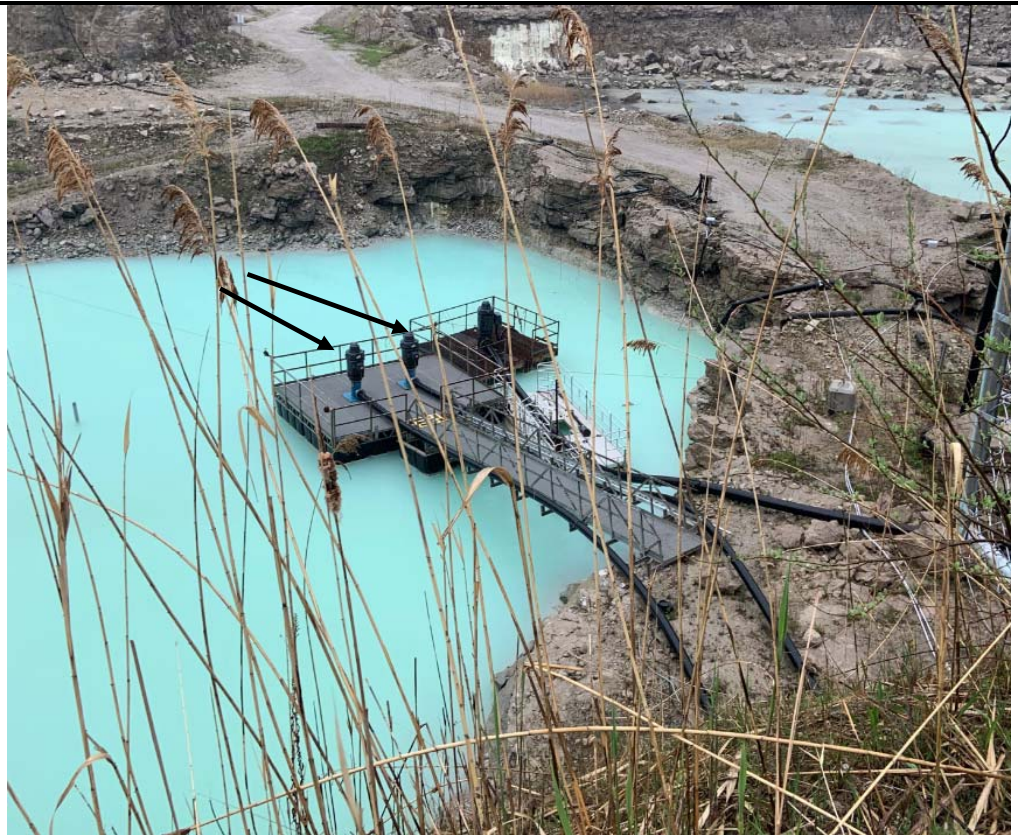
Photograph 6

- 8) DTE has recently installed two new pumps to replace the existing single pump. Site personnel reported that the new pumps will have the same daily discharge rate but are not in operation yet.

Main sump pump is in the process of being replaced. Two new pumps have been installed, but not in operation yet.

Comments: Two new pumps have been installed. But they are not in operation yet.

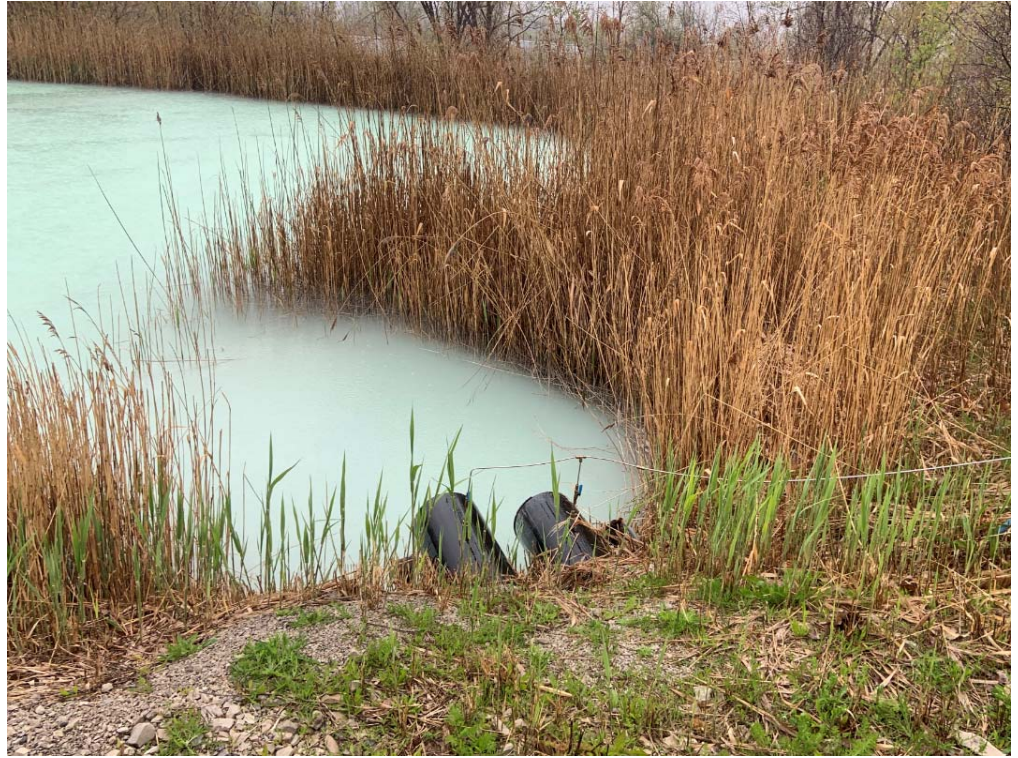
Photograph 7

The upper ponds act as a leachate collection system since the CCR contact water may drain into the quarry sump, which is pumped to the upper ponds along with groundwater for treatment (Photograph 7 and 8).

Comments: Water from the quarry is transferred to upper ponds.

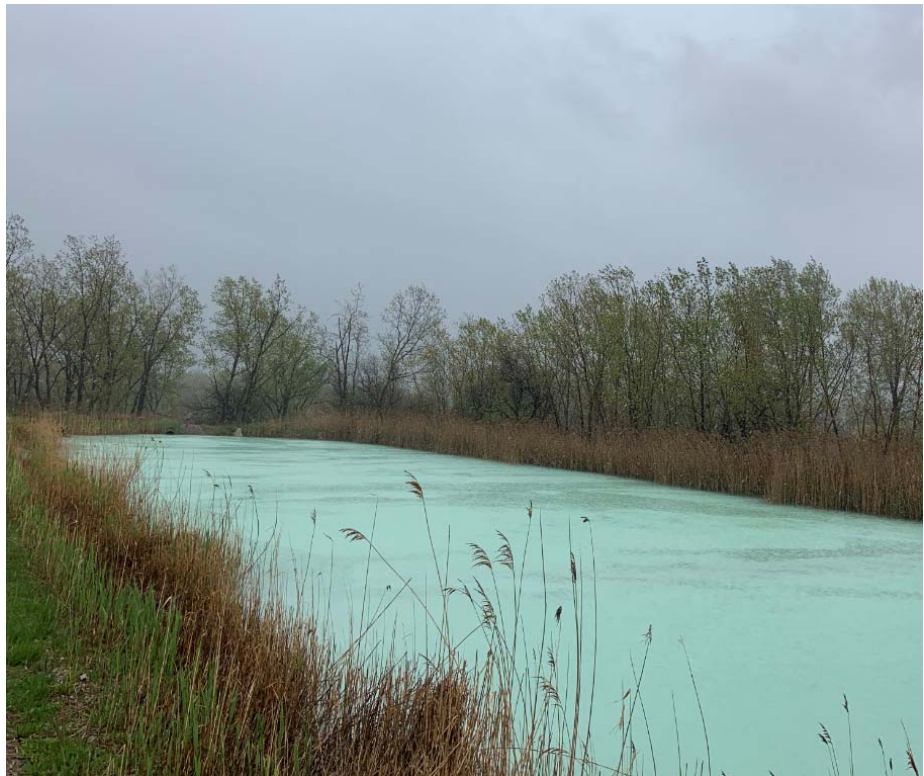
Photograph 8

Comments: Water from the quarry is transferred to upper ponds. Facing east.

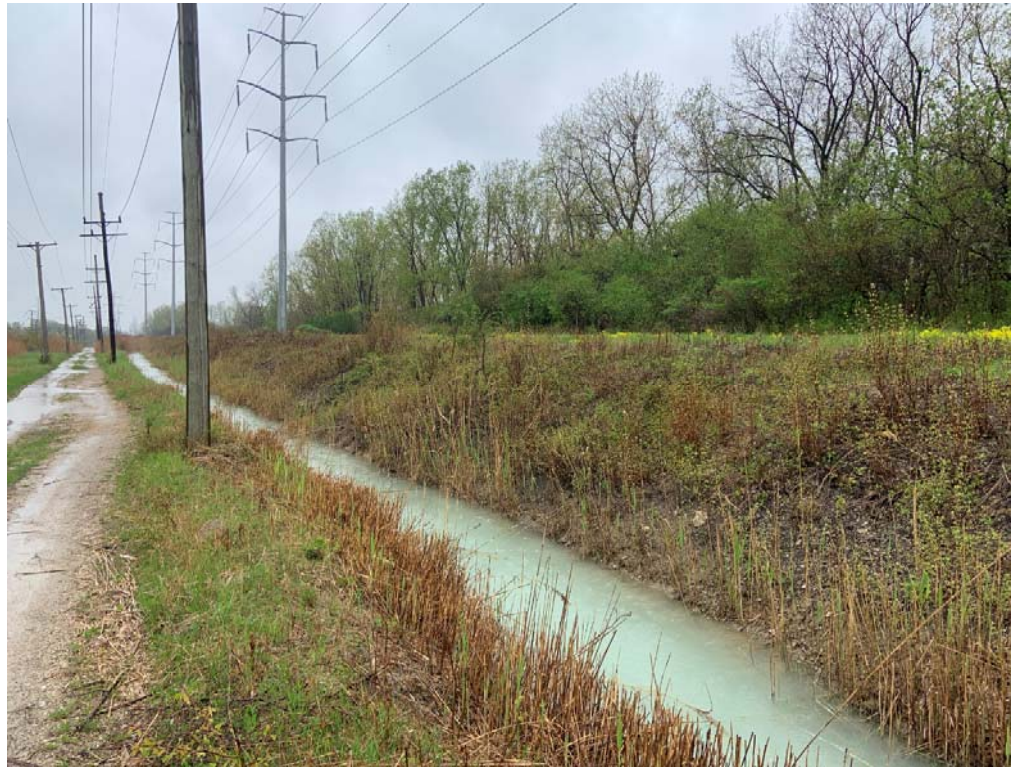
### Photograph 9

Comments: View of conveyance channel connecting upper ponds to Settling Pond #3. Facing south.

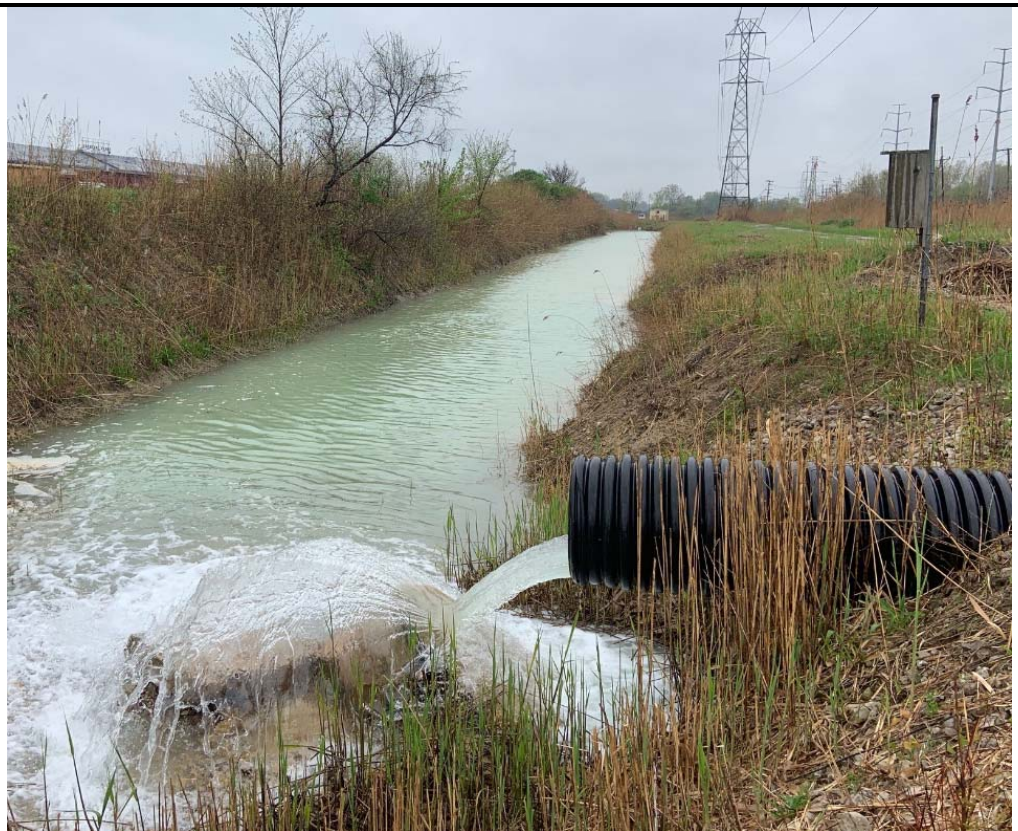
### Photograph 10

- 12) The Quarry sump, sump pump, upper ponds, conveyance channel, and settling ponds appeared to be in good condition. Water discharging from the conveyance channel to Settling Pond #4 appeared to be clear (see Photograph 10).

Comments: View of Settling Pond #4. Water discharging appears to be clear. Facing south.
