DTE Electric Company
One Energy Plaza
Detroit, Michigan 48226

2020 ANNUAL INSPECTION REPORT SIBLEY QUARRY LANDFILL

Trenton, Michigan

January 2021

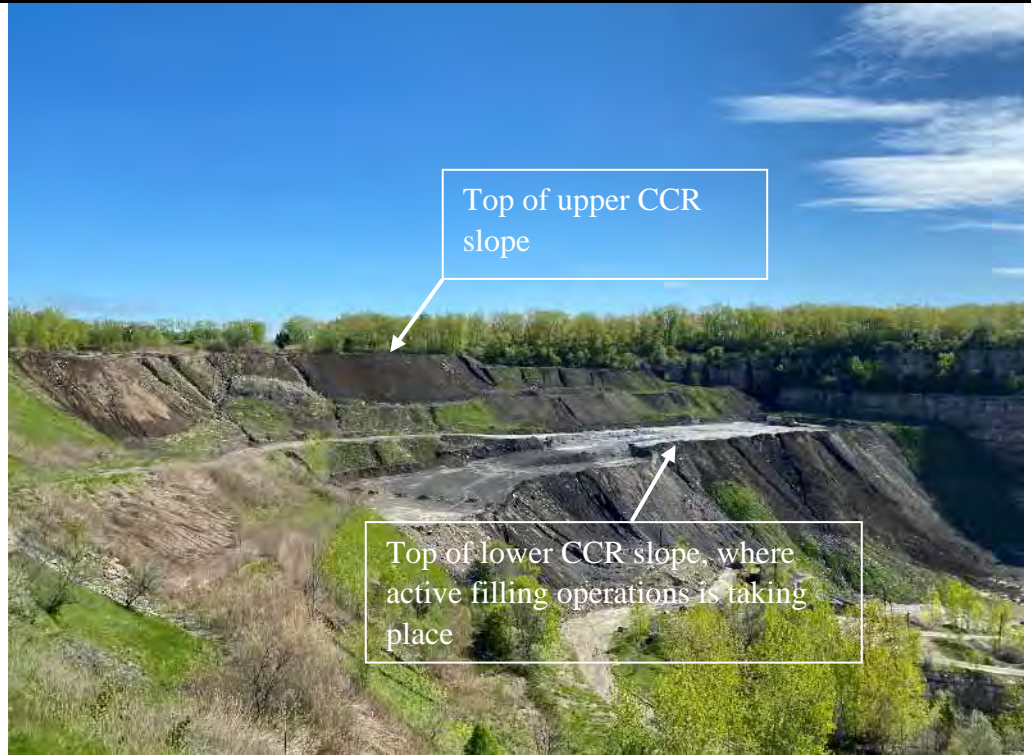
Photograph 1

Comments: Sibley Quarry Landfill active fill area. Facing northeast.

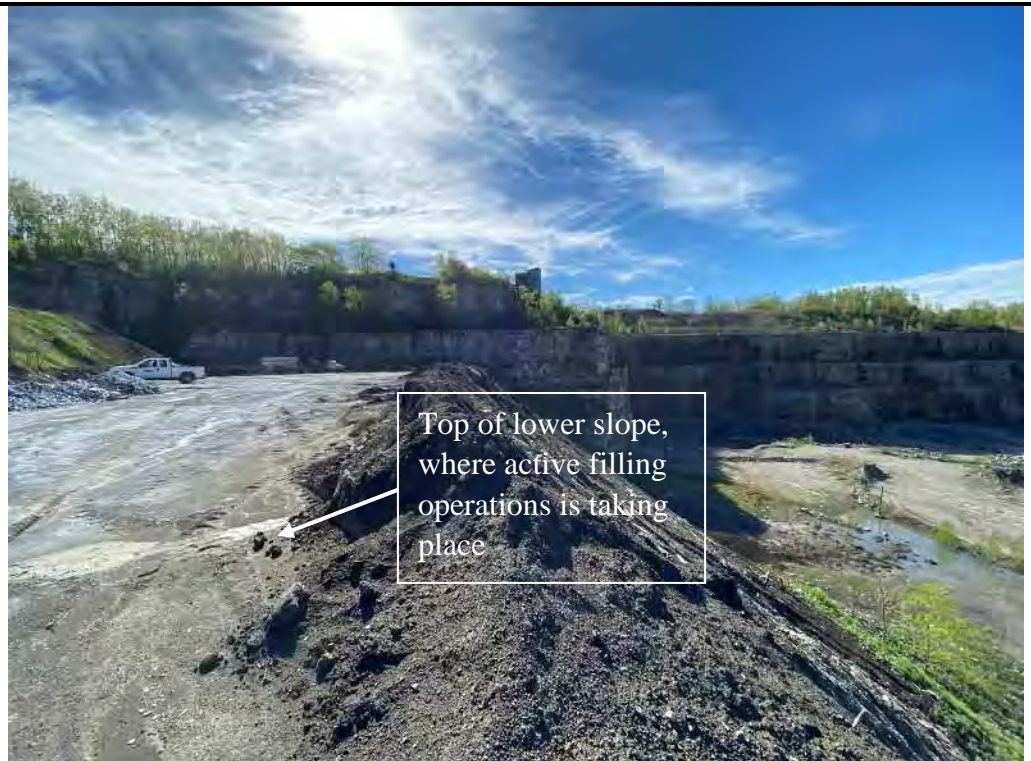
Photograph 2

- 1) There were no disposal activities on the day of inspection. Based on discussions with the site personnel, CCR is disposed of in the Landfill by end-dumping and spreading, which is consistent with the activities observed in the previous years inspections. Trucks haul CCR to the active filling area using the access roads built with CCR and crushed limestone. Trucks dump CCR at the top of the CCR slope near the crest. Then, a front-end loader or dozer pushes CCR onto the slope. There are two main CCR slopes, upper slope, and lower slope, in the active disposal area. They are separated with a setback (Photograph 1). The slopes are as high as approximately 150 ft, with grades as steep as 1.25 horizontal to 1 vertical (1.25H:1V). Based on the current operations, CCR is placed from the top of the lower slope (Photograph 2).

Comments: Sibley Quarry Landfill. Facing east.

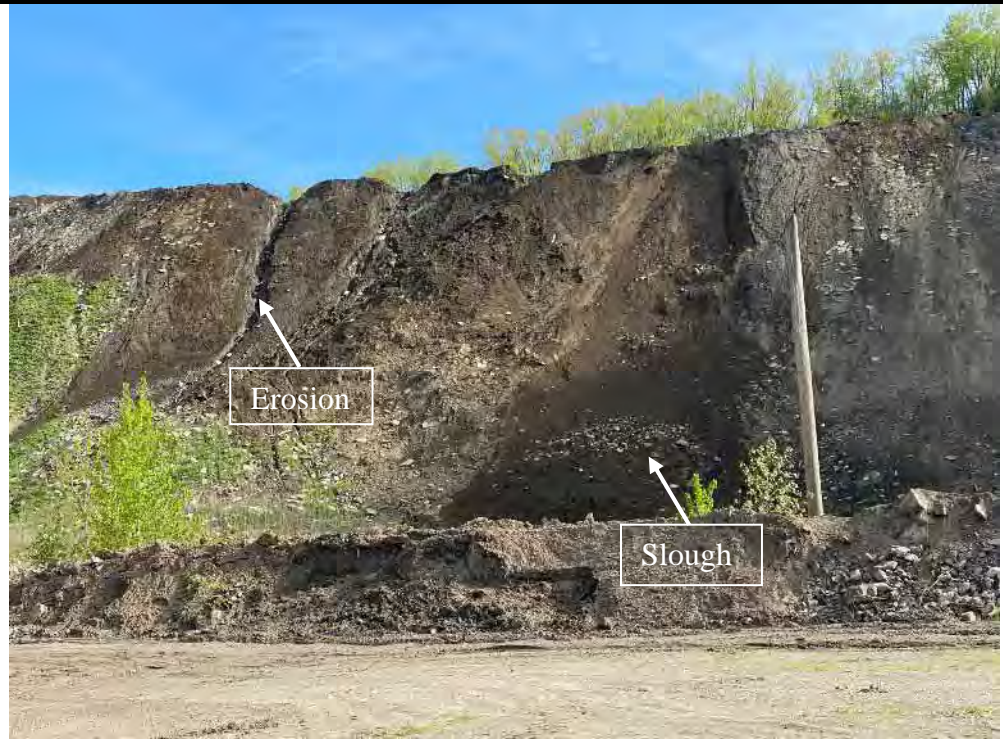
- 3) There were no visual indications of slope instability at the top of CCR slopes at the time of inspection. However, a slough was observed on the lower slope extending to the crest of the lower slope (Photograph 3). This slough has been addressed since date of visual inspection.

- 7) Based on topographic information, the Landfill does not appear to have direct run-on from the adjacent areas.
- 8) Erosion gullies on the CCR slopes (see Photograph 3 showing a typical erosion gully) were observed on the face of the CCR slope. These gullies do not have to be maintained due to the incised nature of the Landfill; furthermore, safety would be a concern if an attempt is made to address these erosion features.
- 9) The Quarry sump, sump pump, upper ponds, conveyance channel, and settling ponds appeared to be in good condition. Water discharging from the conveyance channel to Settling Pond #4 appeared to be clear (see Photograph 10).
- 10) No fugitive dust complaints were observed in the Landfill Operating Record.

Gully erosion was observed on the active face of the CCR disposal area (Photograph 3). There are no outer slopes because the CCR is contained within the quarry.

A slough is observed on the lower CCR slope of active filling area.

Comments: Erosion and slough on the lower slope. Facing north.

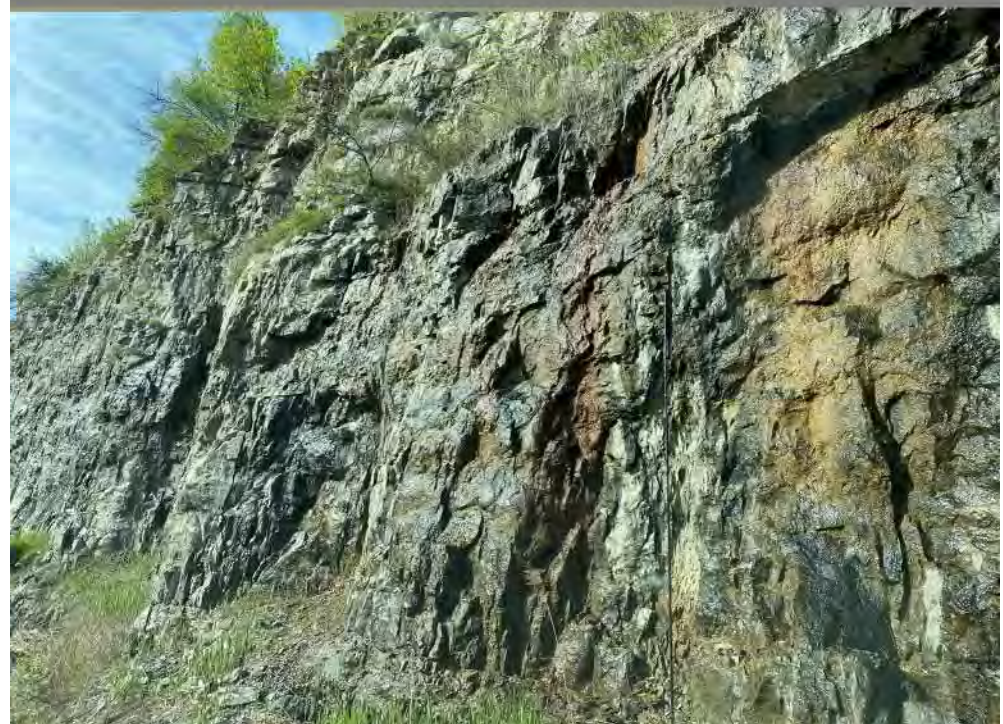
Photograph 4

- 5) The quarry bedrock side walls are fractured, and groundwater inflow is observed at several sections (see Photograph 4).
- 6) Groundwater and stormwater within the quarry drain by gravity to the sump at the bottom of the quarry. Drainage channels were observed along the access roads, conveying water to lower elevations to the sump at the bottom of the quarry. Based on discussions with the site personnel, the pump operating at the sump discharges approximately 1.5 MGD to keep the sump elevation at approximately 300 feet above mean sea level, which is coincidentally, approximately 300 feet bgs. DTE reported that the 300-hp pump had been replaced.

7. Are there wet areas that indicate seepage through the side walls? Yes No
If 'Yes', describe (size, location, etc.) _____
Multiple areas on the quarry sidewalls show damp conditions or
natural groundwater seepage (Photograph 4).

Comments: Active groundwater inflow was observed on quarry walls.

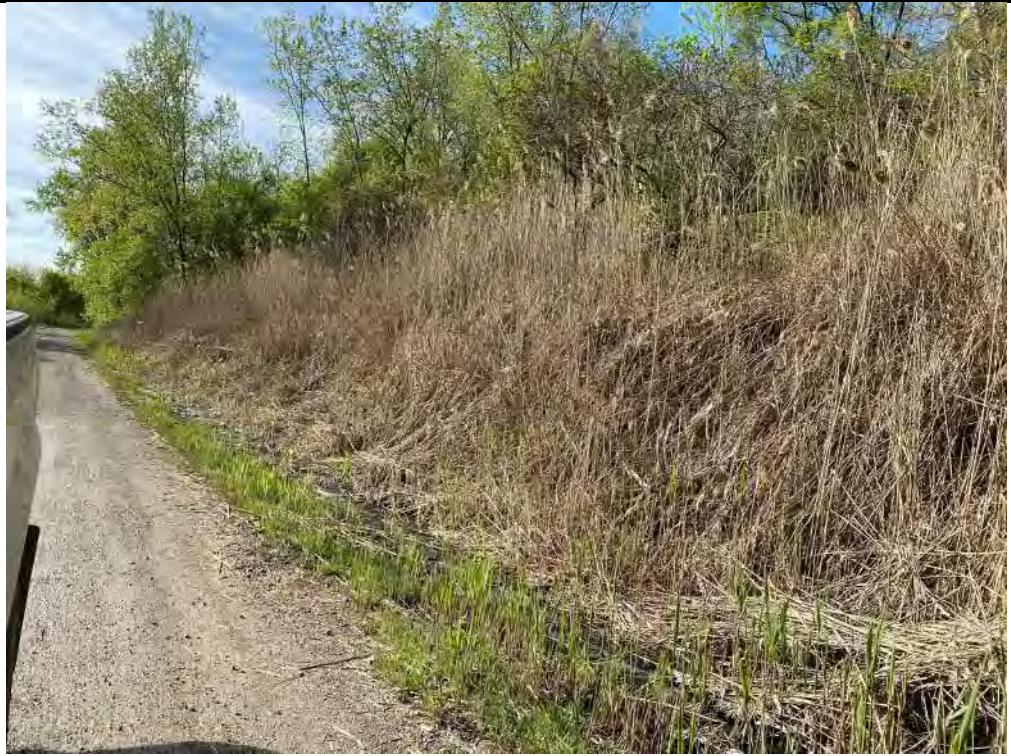
Photograph 5

Comments: Typical vegetation along the access roads to the bottom of the quarry.

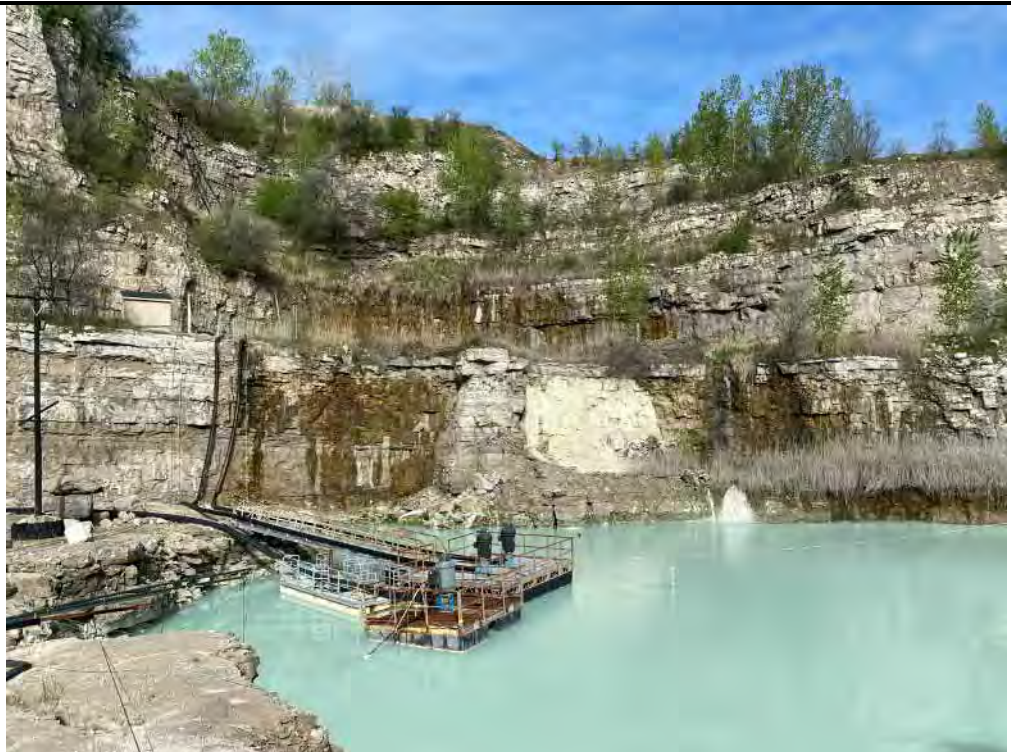
Photograph 6

The pond located at the bottom of the quarry is considered as the leachate collection pond (Photograph 6). The upper ponds act as the leachate treatment ponds. Groundwater and CCR contact water that accumulates in the lower pond is pumped to the upper ponds along for treatment (Photograph 7 and 8). Both ponds appear to be in good working condition.

Comments: Sump area at the bottom of the quarry. Facing northwest

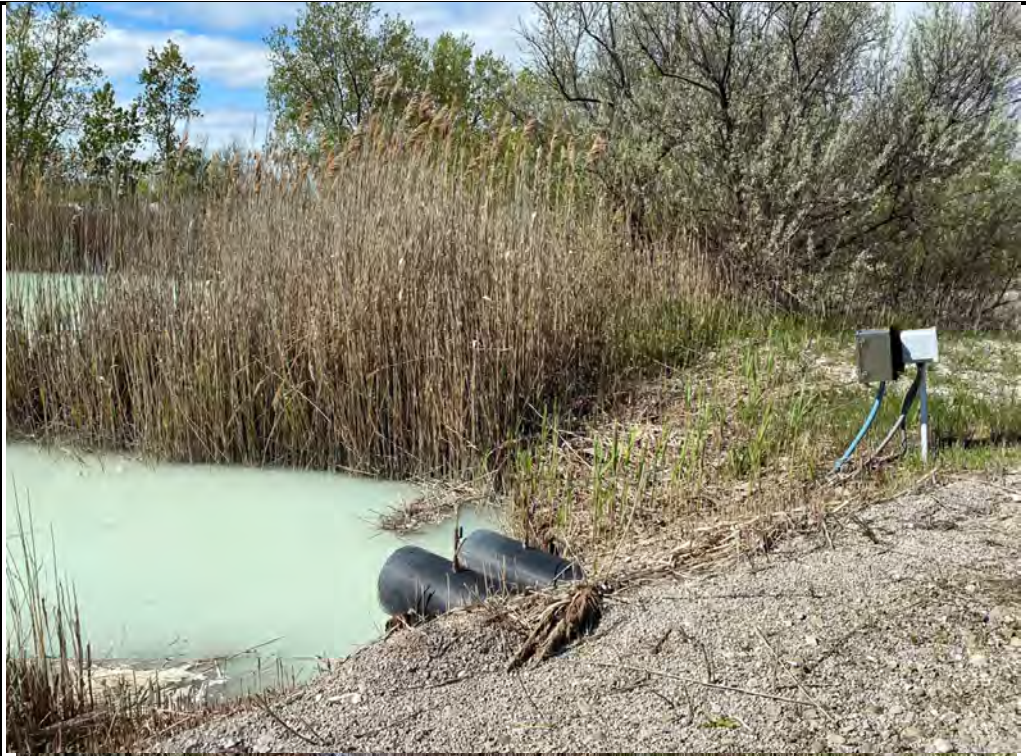
Photograph 7

Comments: Water from the quarry is transferred to upper ponds. Facing southeast.

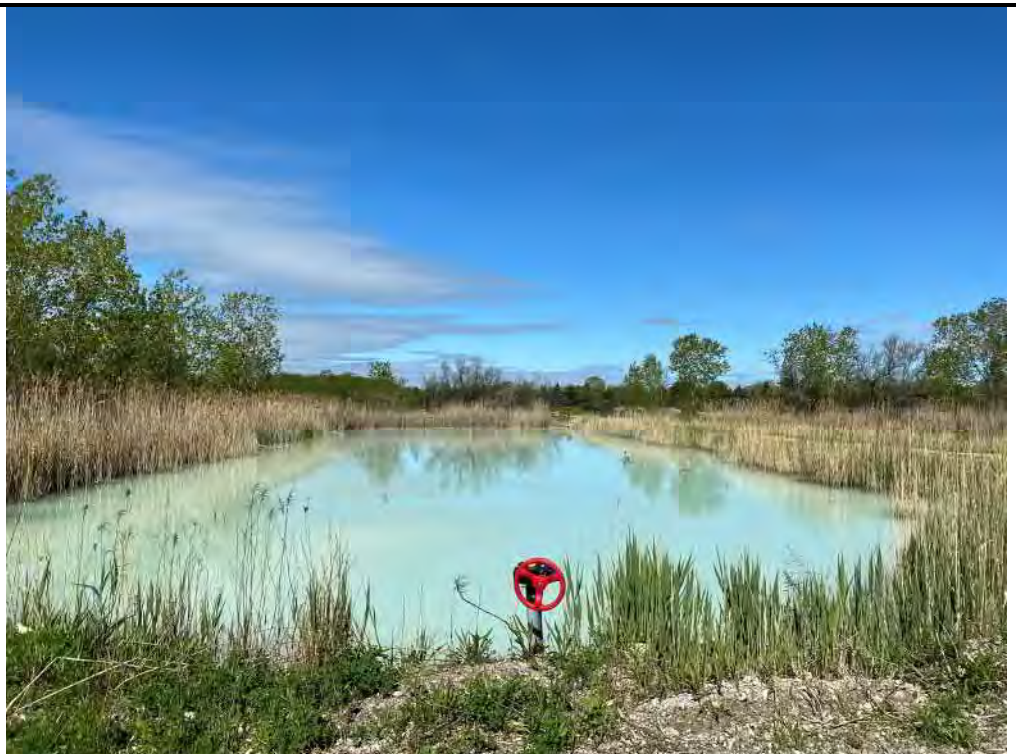
Photograph 8

Comments: Water from the quarry is transferred to upper ponds. Facing west.

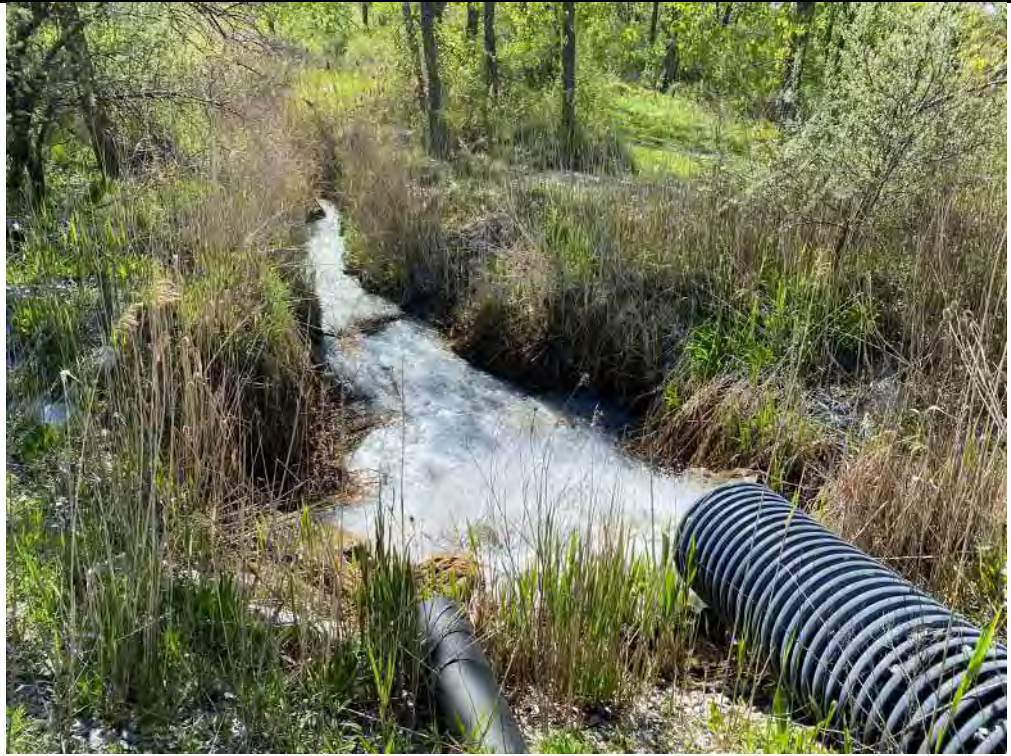
Photograph 9

Comments:
Discharge location
from settling ponds to
conveyance channel.
Facing east.

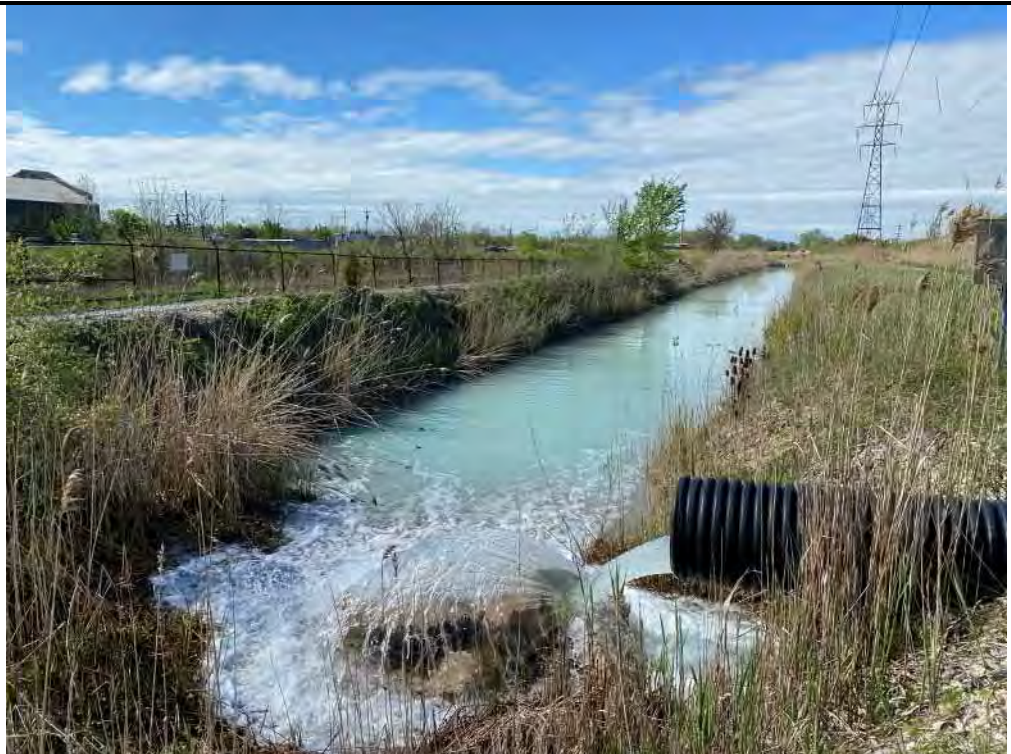
Photograph 10

Comments: View of
Settling Pond #4.
Water discharging
appears to be clear.
Facing south.

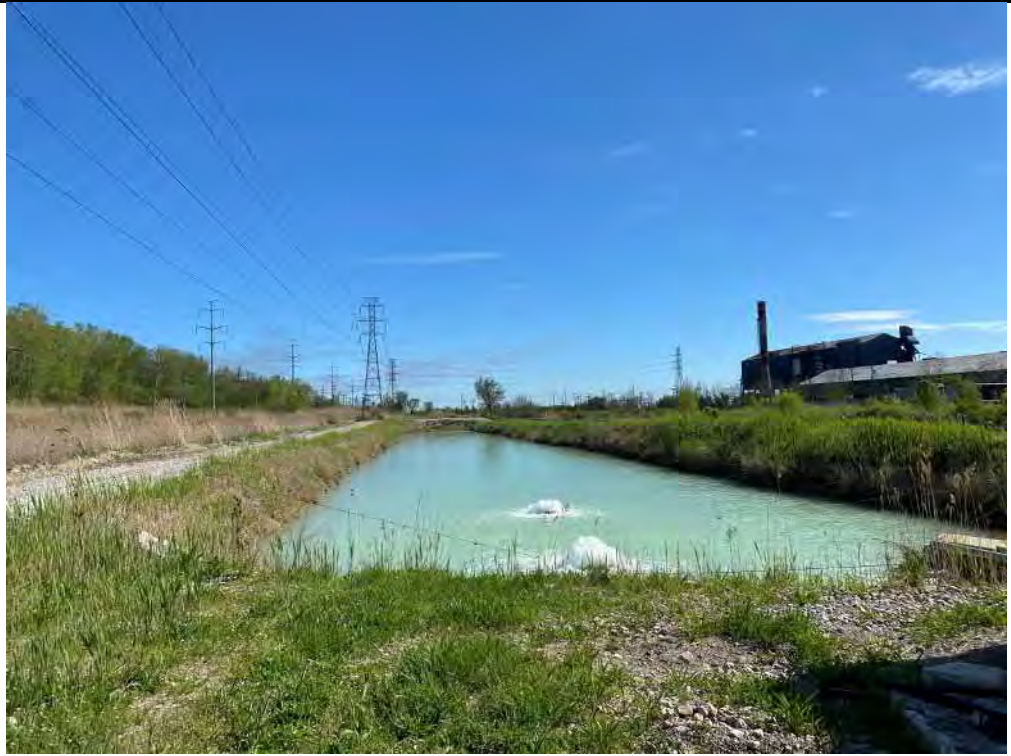
Photograph 11

Comments: View of
Settling Pond #3 from
the pump house.
Facing north.
