DTE Electric Company
One Energy Plaza
Detroit, Michigan 48226

2021 ANNUAL INSPECTION REPORT SIBLEY QUARRY LANDFILL

Trenton, Michigan

January 2022

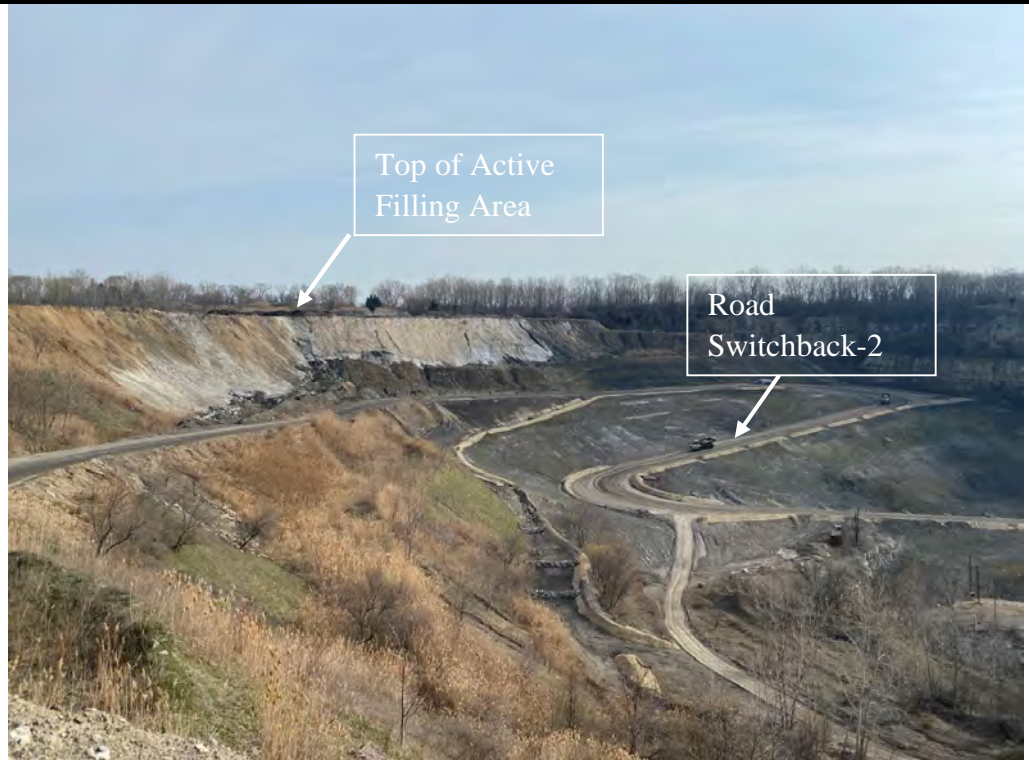
Photograph 1

- 1) Capital improvements are being implemented at the site. The following changes have been observed at the site since the 2020 inspection:
 - a. A new road called “Switchback-2” has been constructed since the last annual inspection. Switchback-2 provides DTE with the ability to haul material to the bottom of the quarry.

Comments: View of active filling area and the recently built Switchback-2. Facing Northeast.

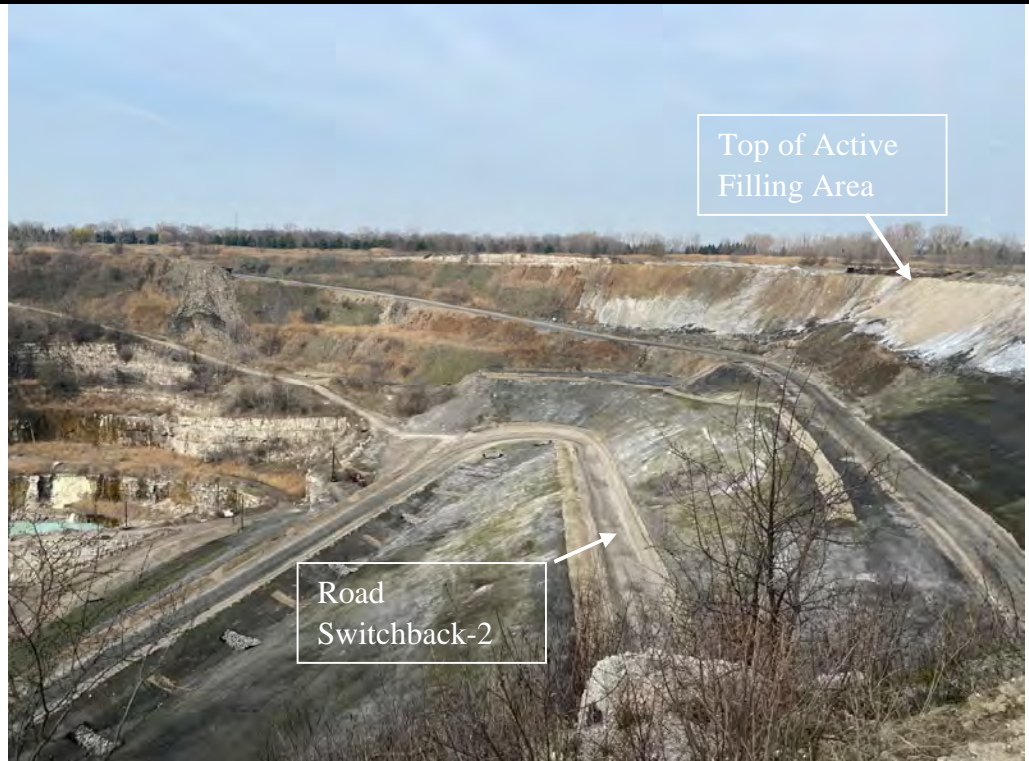
Photograph 2

Comments: View of the active filling area and Road Switchback-2 leading to the bottom of quarry. Facing West.

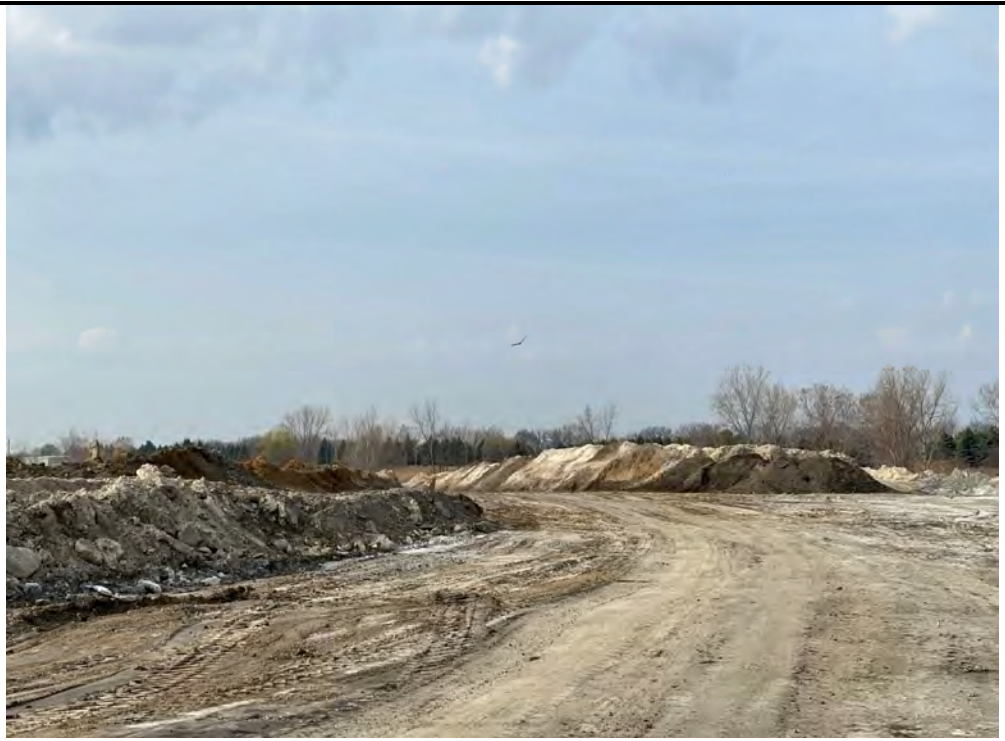
Photograph 3

- e. DTE has installed a new gate and re-constructed the asphalt road at the top of the quarry.
- 2) The disposal operations consist of stockpiling material at the top of the active filling area (see Photographs 1 and 2) while the bottom of the quarry is prepared for active filling. The outer face of the active filling area is steep; ranging from approximately 1H:1V to 1.7H:1V. Material is stockpiled along the edge of the slope and within the area farther away from the edge of the slope (See Photographs 3 and 4).

There is a concern for safety and slope stability during stockpiling on the bench near the edge of the slope at the top of the active filling area. Stockpiling at the edge of the slope adds load to the top of the slope and may cause a slope stability failure.

Comments: The active filling area with disposed material stockpiled across the area. Facing west.

Geosyntec provided a recommendation upon the annual inspection that: (i) no material be stockpiled at the top of active fill area; (ii) no water is allowed to flow onto the slope; (iii) top of active fill area graded to avoid ponding within minimum 100 ft of the top of the slope; and (iv) stability of slopes assessed. Since the recommendations, DTE has implemented changes to operating procedures, and there is no longer stockpiling at the top of active fill areas. In addition, DTE flattened part of the active fill slopes to increase stability and conducted a site investigation to obtain data for a slope stability assessment. The slope stability analysis has been initiated and is in progress. Additional recommendations may be made to DTE pending the results of the study.

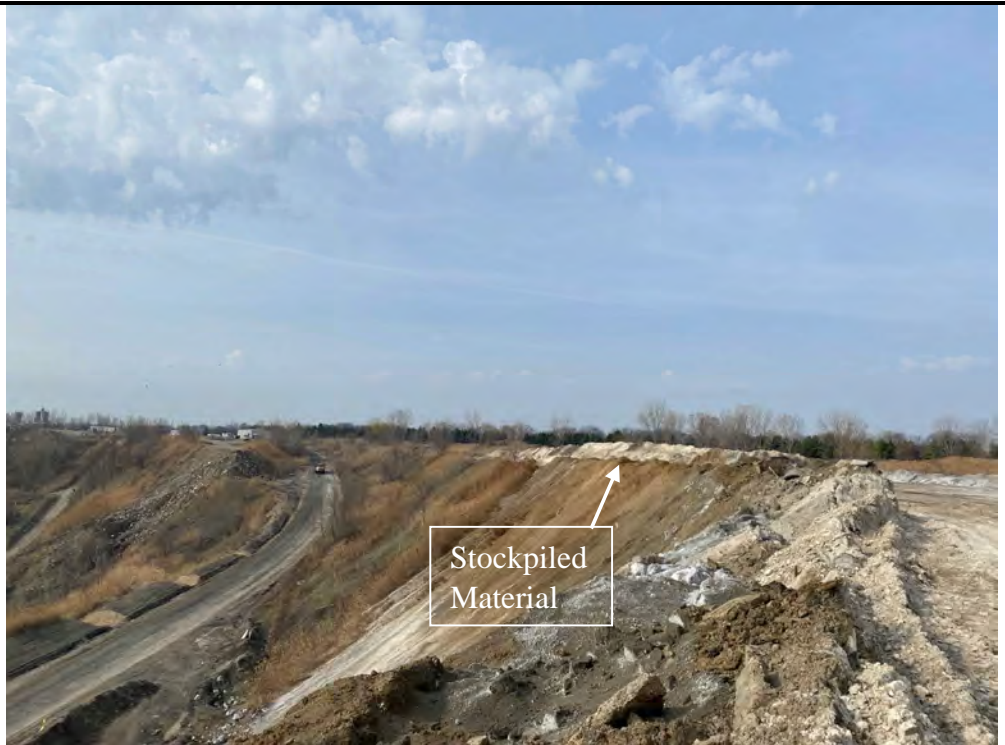
Photograph 4

Comments: View from the edge of slope at the active filling area. Facing West.

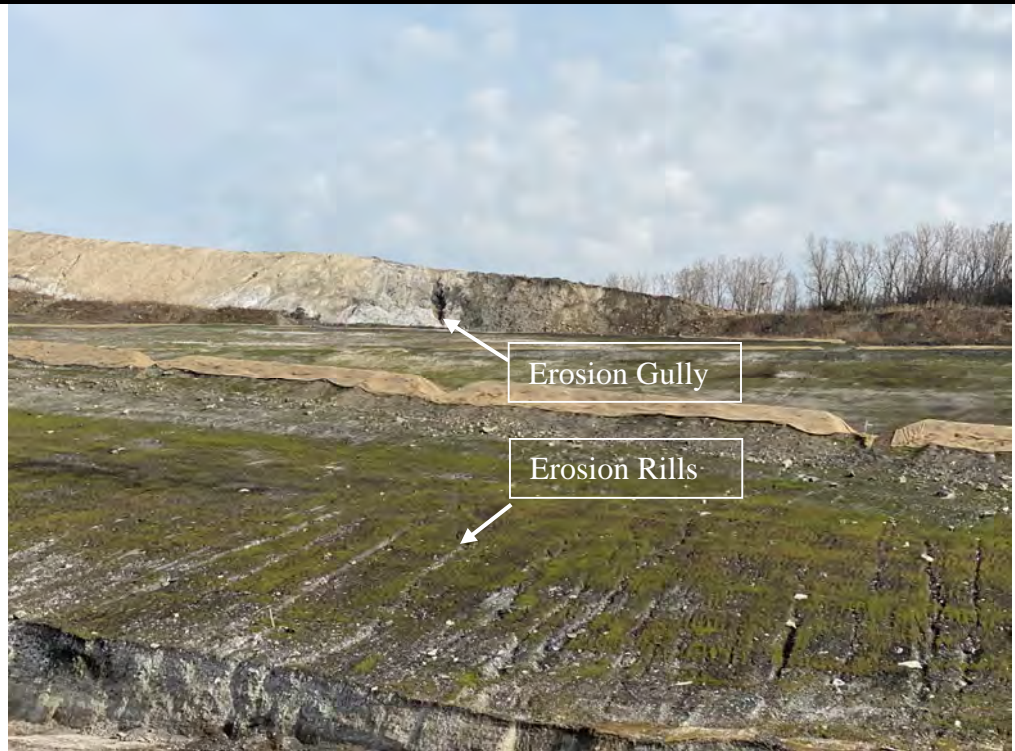
Photograph 5

- 6) Erosion rills and a gully were observed on the CCR slopes (see Photograph 5). These erosion features do not have to be maintained due to the incised nature of the Landfill.
- 7) The Quarry sump, sump pump, upper ponds, conveyance channel, and settling ponds appeared to be in good condition. Water discharging from the conveyance channel to Settling Pond #4 appeared to be clear (see Photograph 10).
- 8) DTE reported that a dust complaint was filed on March 24, 2021. On that day, the facility received wind gusts of up to approximately 40 miles per hour. To respond to the event, an additional water truck was mobilized to the facility on that day to help control the dust. The facility applied a dust suppressant to the exposed slopes on March 25, 2021 to control fugitive dust.

Comments: Erosion features on internal fill slopes. Facing North.

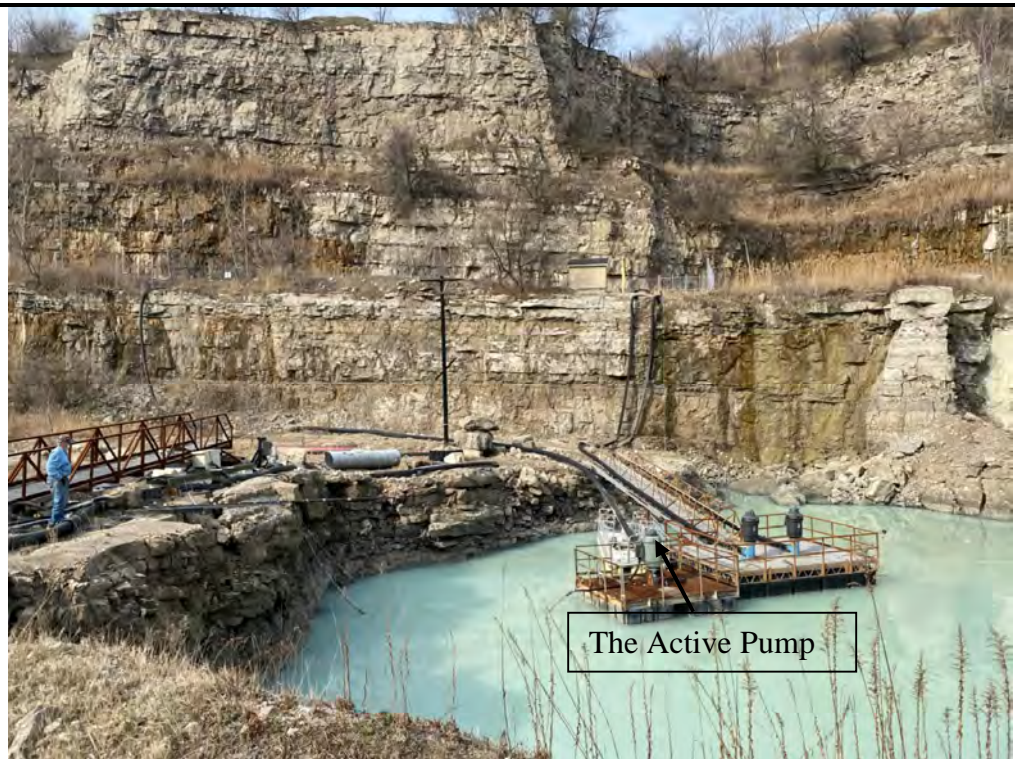
Photograph 6

The pond located at the bottom of the quarry is considered as the leachate collection pond (Photograph 6). The upper ponds act as the leachate treatment ponds. Groundwater and CCR contact water that accumulates in the lower pond is pumped to the upper ponds for treatment (Photograph 8). Both ponds appear to be in good working condition.

Comments: The main sump pump operating at the bottom of the quarry. Facing West.

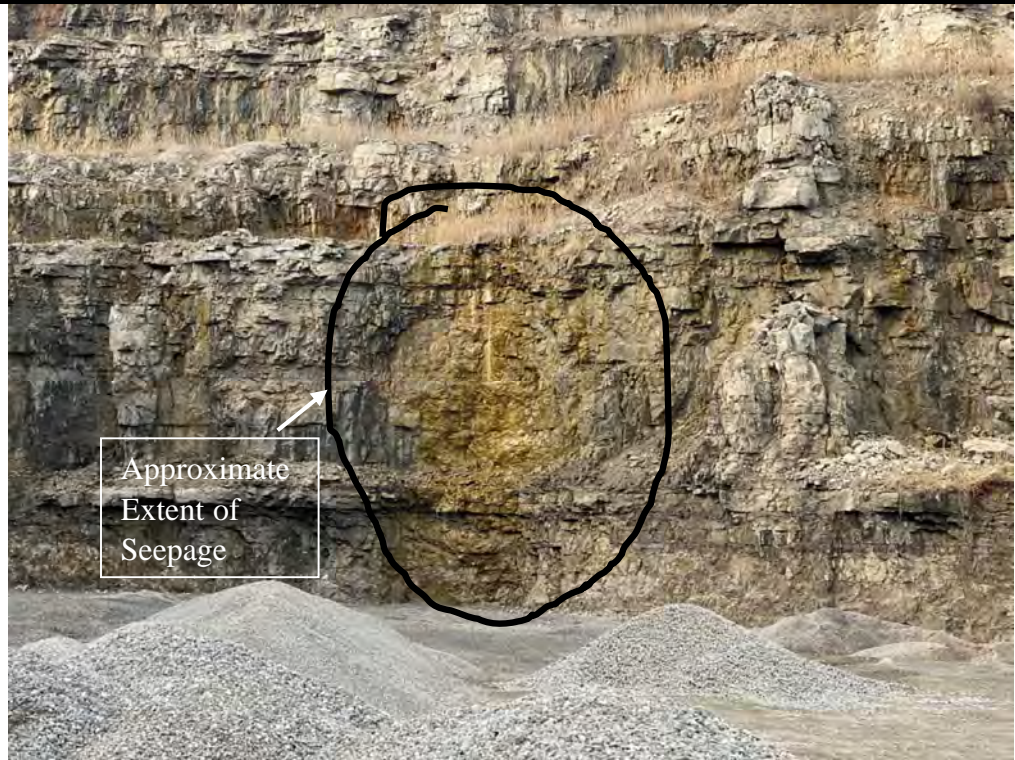
Photograph 7

- 3) The quarry bedrock side walls are fractured, and groundwater inflow is observed at several sections (see Photograph 7).
- 4) Groundwater and stormwater within the quarry drain by gravity to the sump at the bottom of the quarry. Drainage channels were observed along the access roads, conveying water to lower elevations to the sump at the bottom of the quarry. Based on discussions with the site personnel, the pump operating at the sump discharges approximately 1.5 MGD to keep the sump elevation at approximately 300 feet above mean sea level, which is coincidentally, approximately 300 feet bgs.

7. Are there wet areas that indicate seepage through the side walls? Yes No
If 'Yes', describe (size, location, etc.) _____
Multiple areas on the quarry sidewalls show damp conditions or
natural groundwater seepage (Photograph 7).

Comments: Typical seepage area on the quarry side wall. Seep areas generally have brownish color.

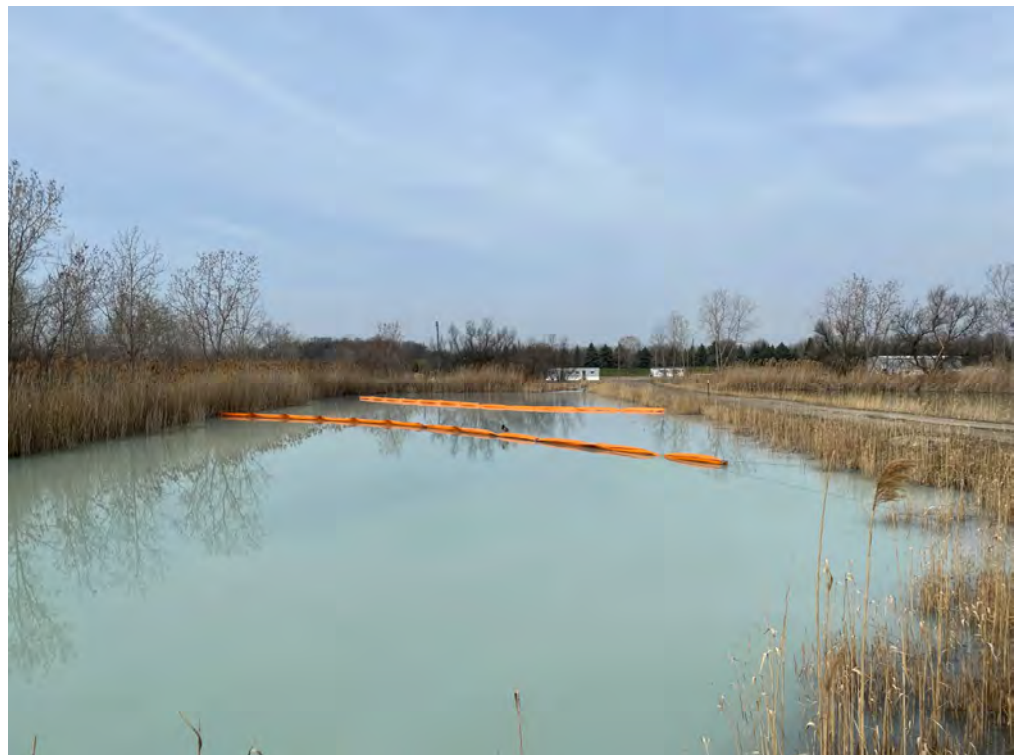
Photograph 8

Comments: View of upper pond, facing West; water from the sump pump is discharged into upper pond.

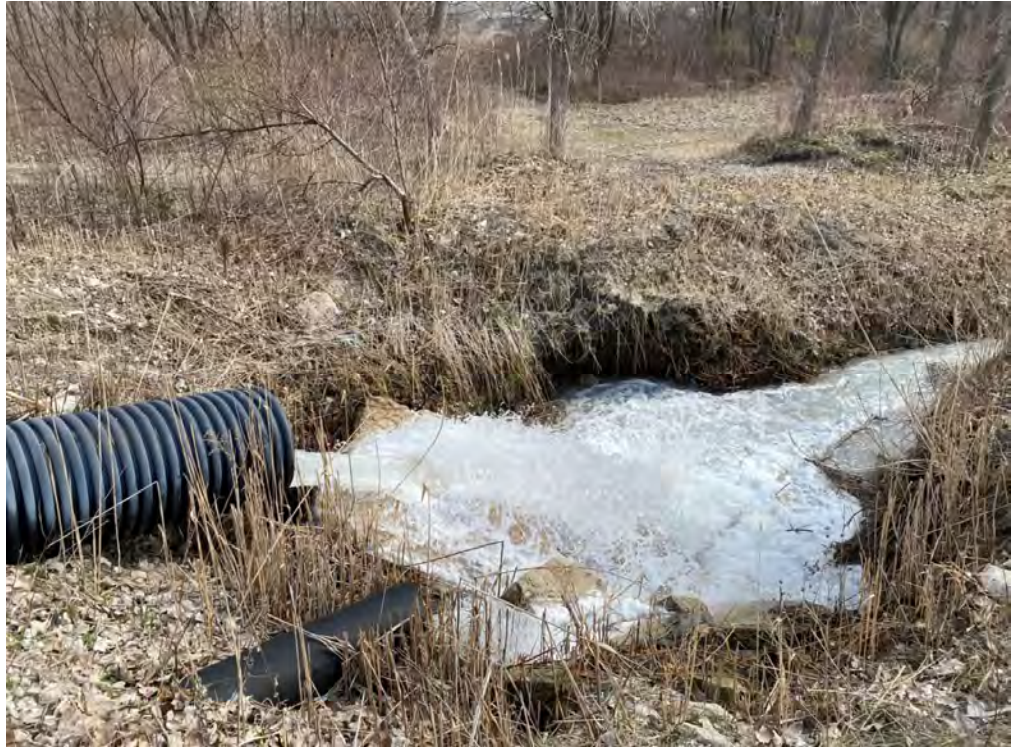
Photograph 9

Comments: Outlet of the upper pond.

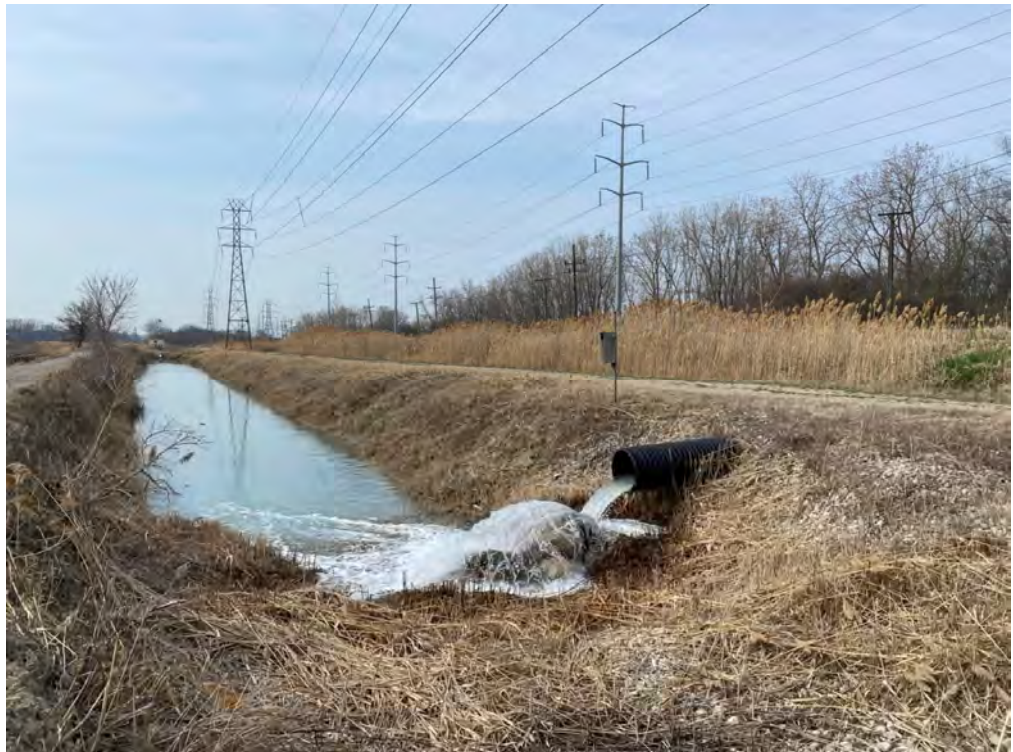
Photograph 10

Comments: Water from the upper pond is conveyed into Settling Pond #4. Facing South.

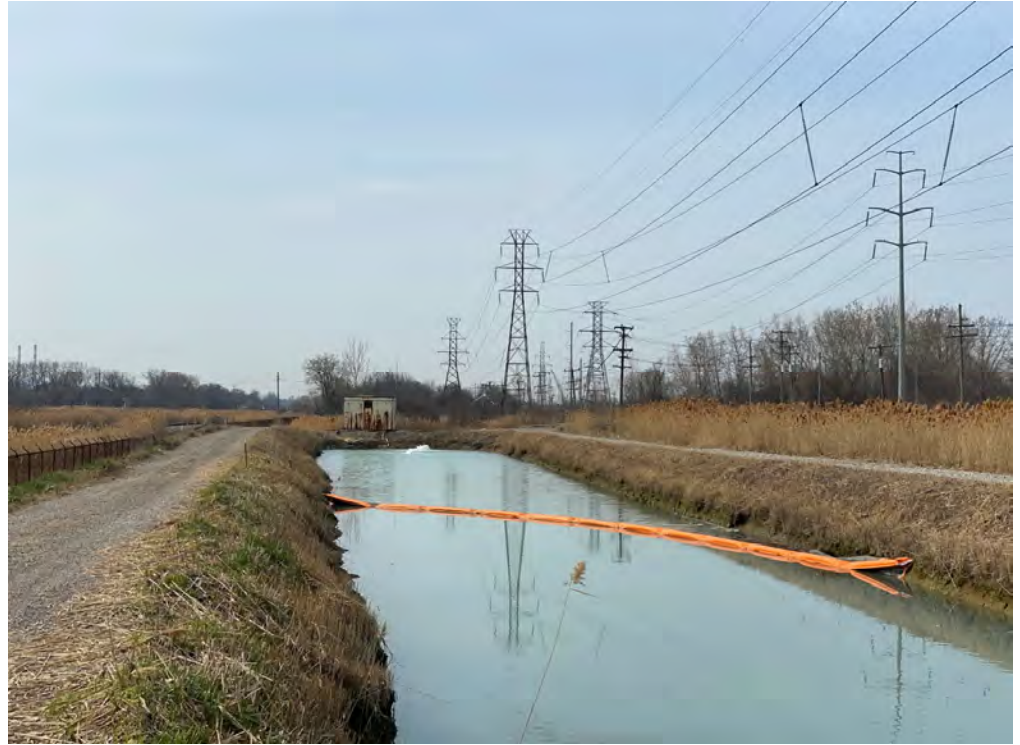
Photograph 11

Comments: View of Settling Pond #3, where the pump house is located. Facing South.
