**DTE Electric Company**  
One Energy Plaza  
Detroit, Michigan 48226

**2022 ANNUAL  
INSPECTION REPORT  
SIBLEY QUARRY LANDFILL**

**Trenton, Michigan**

January 2023

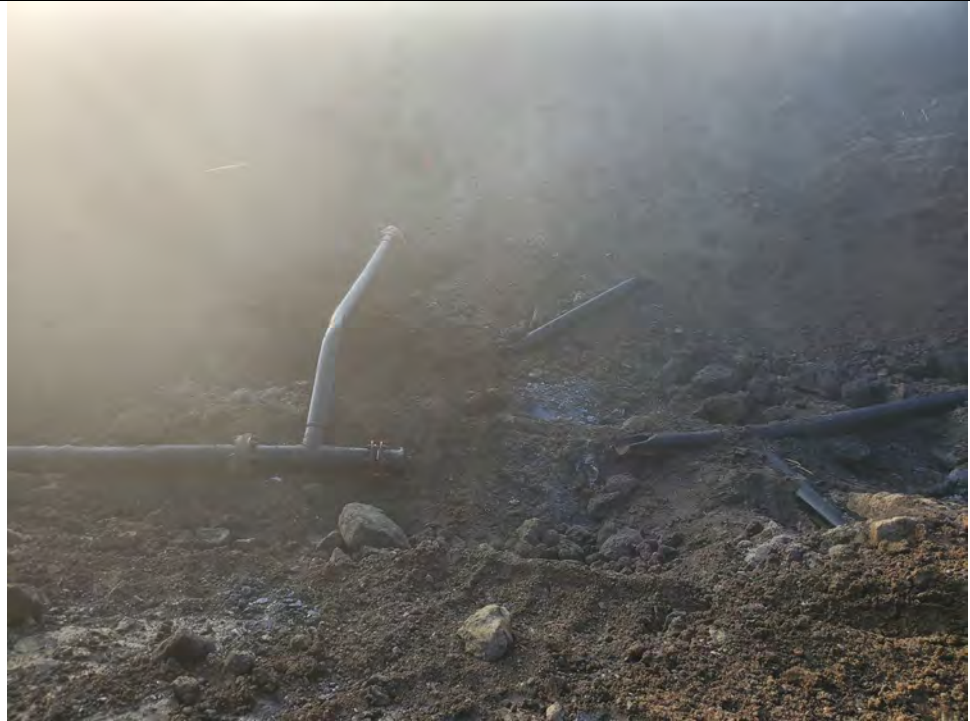
- 3) A pipe used to convey water for the fugitive dust control system was damaged during the regrading of the northern slopes of the active filling area (see Photograph 1). The damaged pipe was repaired after the inspection.

The pipe used to convey water for the fugitive dust control system was damaged and represented a condition that could affect the operation of the Landfill; however, DTE personnel repaired the pipe after the visual inspection. No other existing structural weaknesses or existing conditions disrupting the operation and safety of the Landfill were observed during the 2022 annual inspection. However, while the following conditions identified during the 2022 annual inspection do not pose an immediate threat, they could potentially disrupt the operation and safety of the Landfill in the future if not monitored.

Comments: Broken pipe used to convey water for fugitive dust control system. Pipe was repaired after the visual inspection. (South)

After the visual inspection, DTE repaired the damaged pipe for the fugitive dust control system and placed coarse aggregate against the quarry walls to prevent ponding of water and growth of algae. Geosyntec provides the following recommendations to address observed conditions related to the quarry side walls and erosion rills on the CCR slopes.

Moderate - Repair damaged portion of pipe used in the fugitive dust control system (Photograph 1). [Addressed]

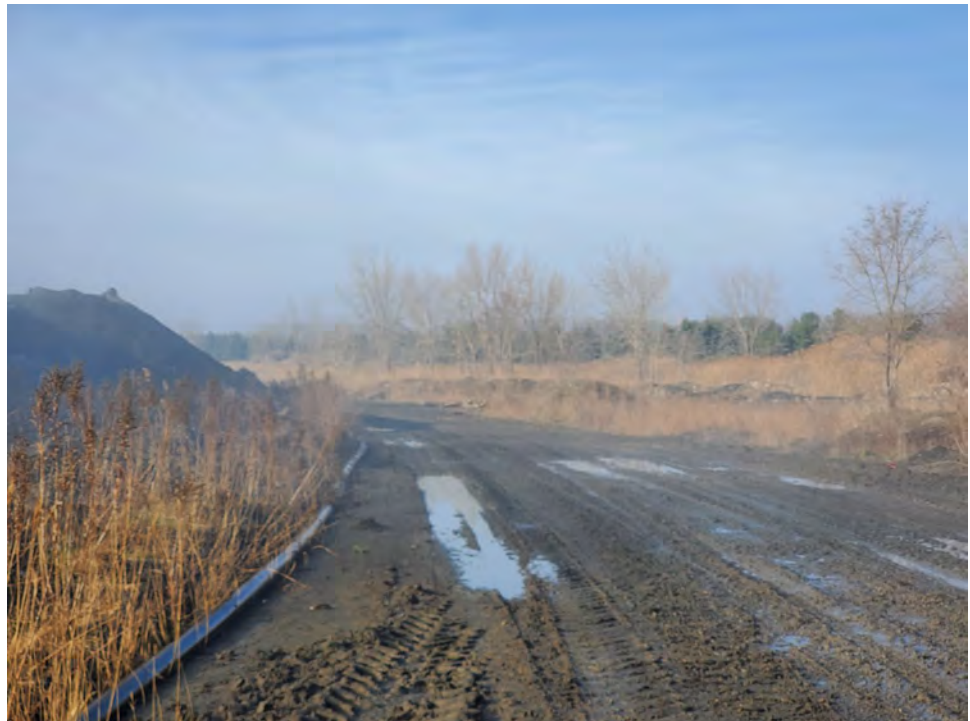
Photograph 2

Comments: Approved area for expansion of the stockpile in the top of the active filling area. (West)

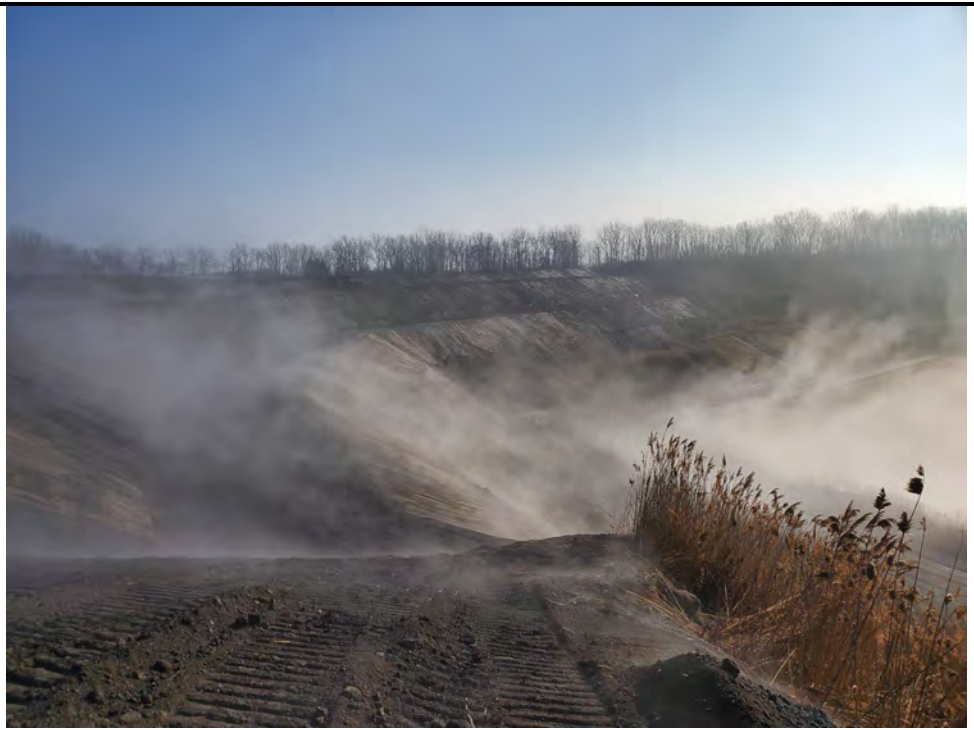
The northern slopes in the top of the active filling area were recently regraded to 1.5H:1V slopes and appear to be in good condition (Photographs 3, 5, and 7).

Comments: Regraded northern slopes (1.5H:1V) of the active filling area. (Northeast)

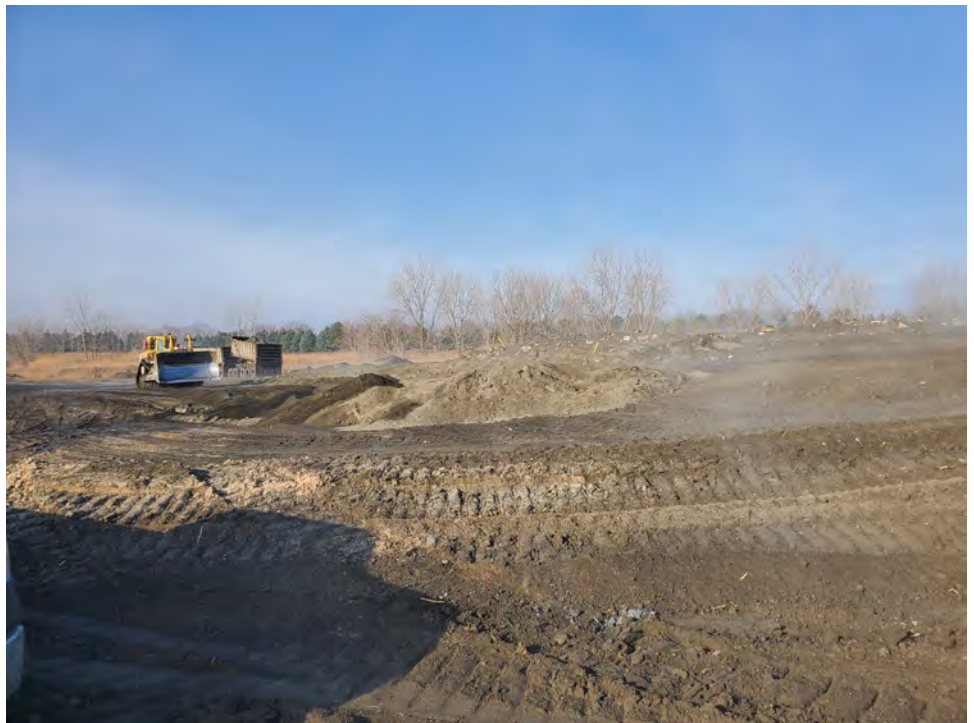
Photograph 4

Comments: Stockpiled material from regrading of northern slopes in the top of the active filling area. (North)

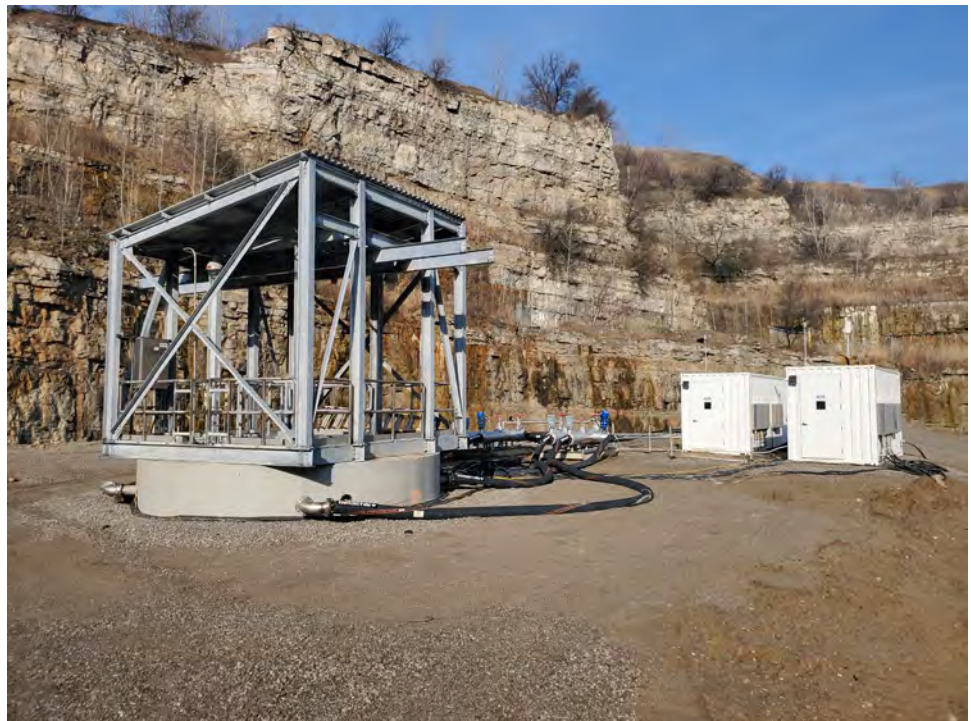
Photograph 12

- d. A new chimney sump and four sump pumps have been installed at the bottom of the quarry (see Photograph 12). At the time of the inspection, only two pumps were active. The other two sump pumps are being replaced due to electrical and mechanical issues. The new sump and VFD sump pumps replace the pump previously used to convey water from the quarry to the upper ponds for treatment.

Comments: New  
chimney sump and  
sump pumps installed  
at the bottom of the  
quarry. (West)

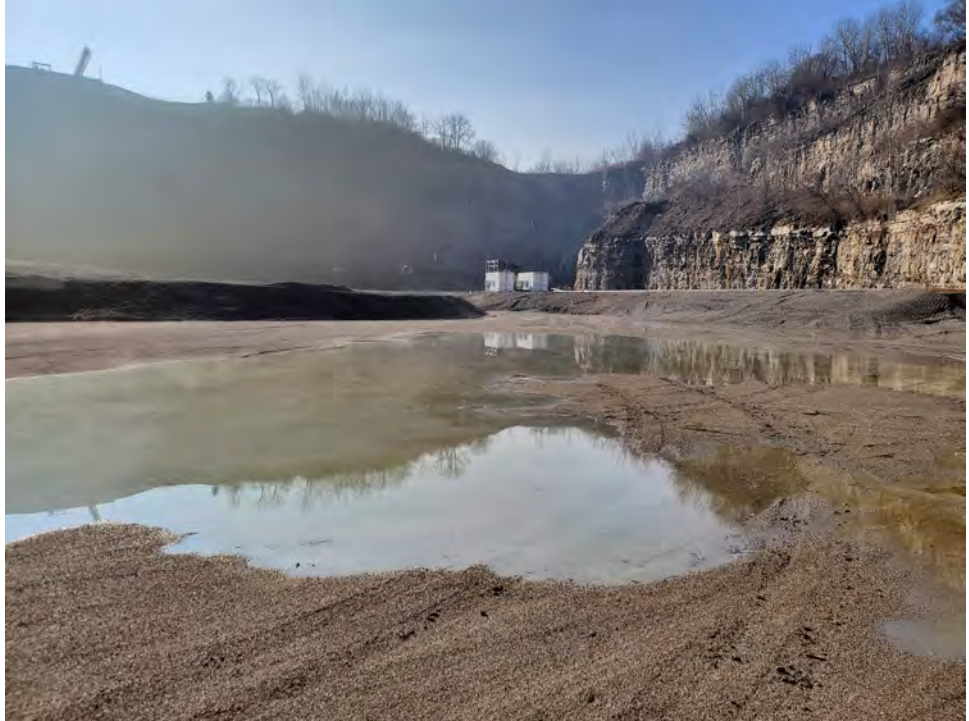
- 7) The quarry bedrock side walls are fractured and groundwater inflow is observed at several locations (see Photograph 14).
- 8) DTE is studying algae growth in the pond at the bottom of the quarry (see Photographs 13 and 14). After the inspection, potential algae growth was addressed by placing coarse aggregate against the quarry walls to prevent ponding.

The pond located at the bottom of the quarry is considered as the leachate collection pond (Photograph 14). The upper ponds act as the leachate treatment ponds. Groundwater and CCR contact water that accumulate at the bottom of the quarry is pumped to the upper ponds for treatment (Photographs 18-20). Algae growth in the leachate collection pond is being studied. The leachate collection pond and treatment ponds appear to be in good working condition.

Comments: The pond at the bottom of the quarry. Algae growth in the pond was studied by DTE. Coarse aggregate was placed against the quarry walls after the inspection to prevent ponding of water and algae growth. (South)

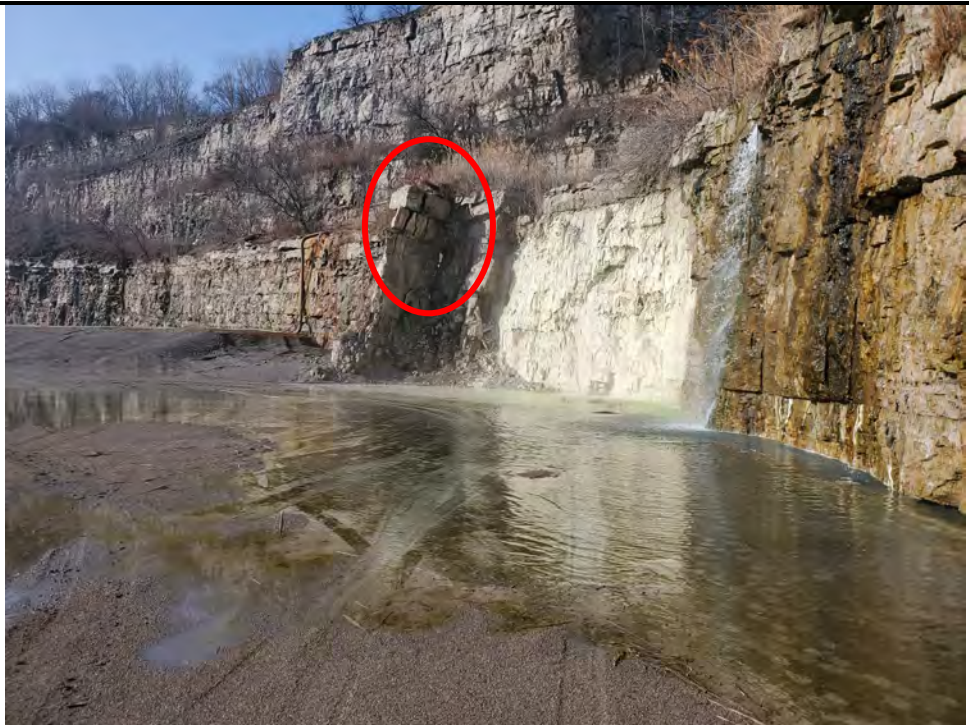
### Photograph 14

There are bedrock fractures on the quarry sidewalls. One of concern is along the north quarry sidewall near the pond at the bottom of the quarry (Photograph 14), though safety measures are in place to keep a 50-foot buffer between the sidewalls and personnel working in the bottom of the quarry.

Multiple areas on the quarry sidewalls show damp conditions or natural groundwater seepage (Photograph 14).

Comments: The quarry bedrock side walls are fractured, and groundwater inflow is observed at several sections. Potential rock block failures could pose a safety concern (circled) but are addressed by maintaining a 50-foot safety buffer with the active working area. (West)

- 1) DTE should continue to maintain the 50-foot buffer between the quarry side walls and the active working area.
- 2) The CCR slopes should continue to be monitored to limit the formation of additional rills and gullies or expansion of existing rills and gullies. If these erosion features continue to develop or expand, Geosyntec recommends DTE work with a professional engineer to develop additional stormwater management measure(s).

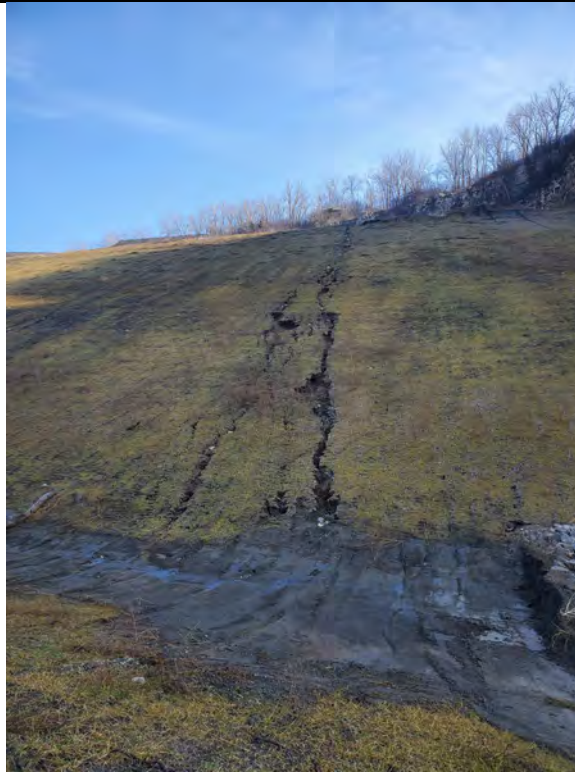
- 5) Erosion rills and gullies were observed on the CCR slopes (see Photographs 15 and 17).
- 6) The Landfill has a perimeter ridge that prevents surface water run-on for events up to and exceeding a 25-year, 24-hour storm as stated in the Run-on Run-off Control Plan for the Landfill.

- 3) The observed erosion rills and gullies on the CCR slopes are not considered to represent a structural weakness due to the incised nature of the Landfill (i.e., eroded material is transported to the bottom of the Landfill). However, if additional rills and gullies form or existing features expand, these features have the potential to disrupt the operation and

Comments: Erosion rills on northeastern CCR slopes. Erosion features should continue to be monitored. (Northeast)

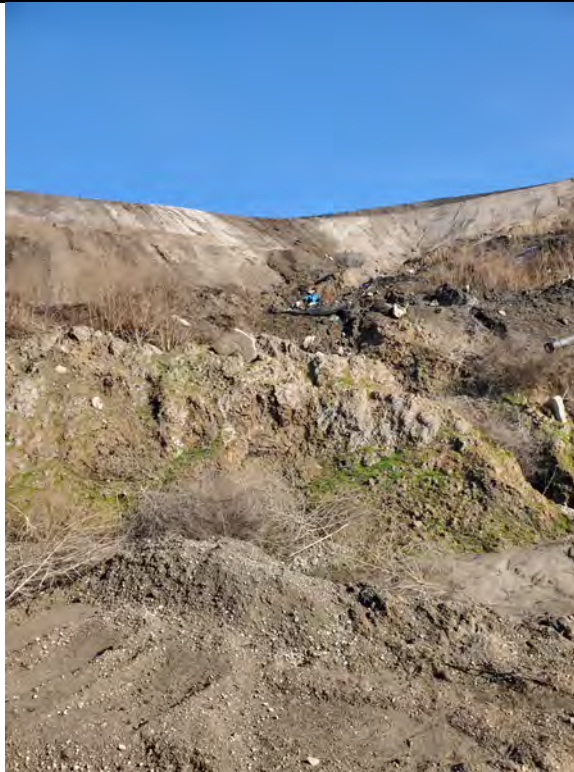
Several erosion rills and gullies were observed on the slopes (Photographs 15 and 17). Run-off flows alongside switchback two (Photographs 7 and 16) to the bottom of the quarry and the chimney sump. The erosion features do not represent an existing condition disrupting the operation and safety of the Landfill because eroded material is transported to the bottom of the Landfill within the footprint of the Landfill.

Comments: Large erosion gully on the northwestern CCR slopes. Erosion features should continue to be monitored. (Northwest)

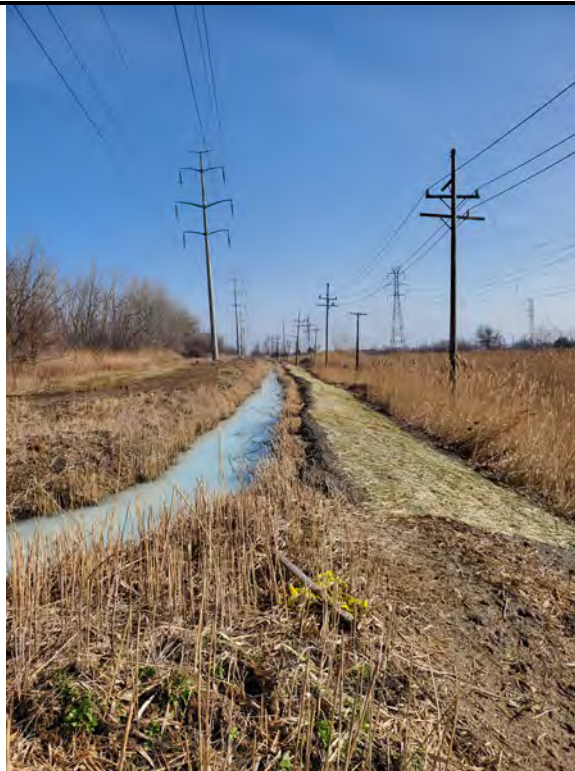
Photograph 22

- e. The crest of the outer embankment of the canal conveying water from the upper ponds to the settling ponds was raised approximately one foot near the settling ponds (see Photograph 22). The crest was raised to accommodate increased water levels observed in the canal after the new chimney sump and sump pumps were installed.

Comments: Conveyance channel west of the settling ponds. The crest of the outer embankment was raised approximately one foot after the new chimney sump and sump pumps were installed. (North)
