DTE Energy St. Clair Power Plant

Unit 6 Scrubber Basins CCR Rule Compliance Project

Annual Inspection Report - 2017

June 30, 2017

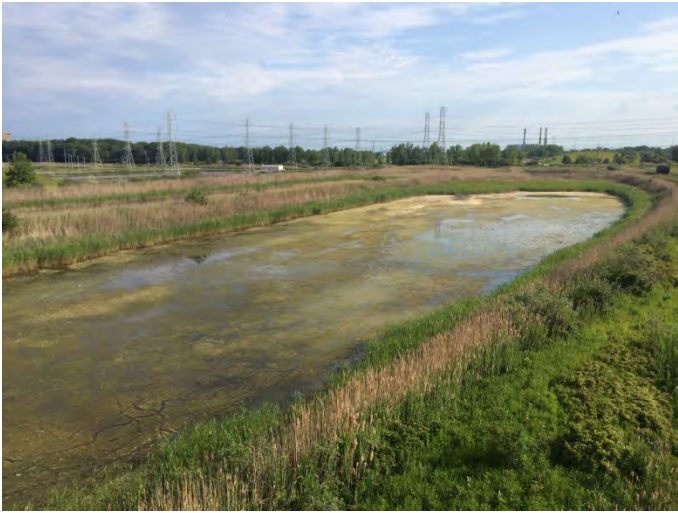
Photo 1: West Basin, picture taken from coal conveyor, 06/09/17

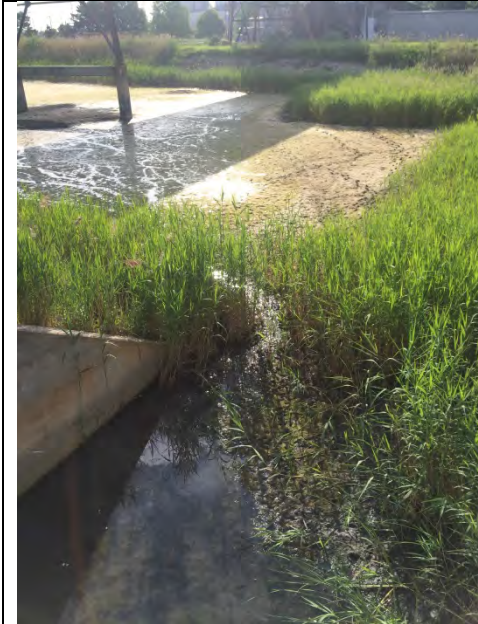
Photo 2: Headwall and East Basin, 06/09/17

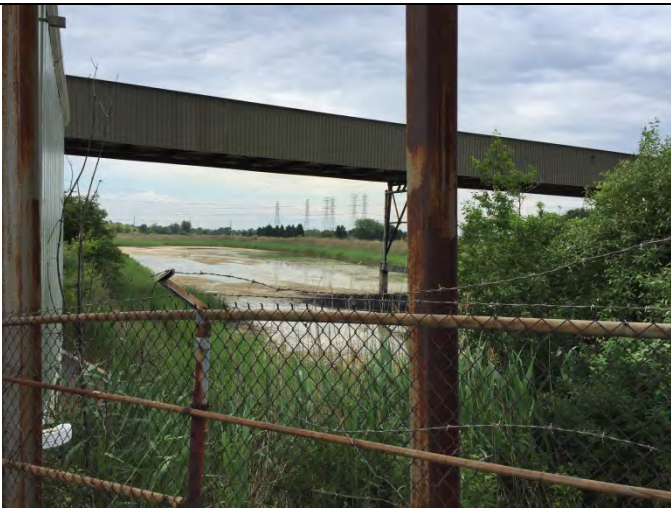
Photo 3: East Basin, view from south, 06/16/17

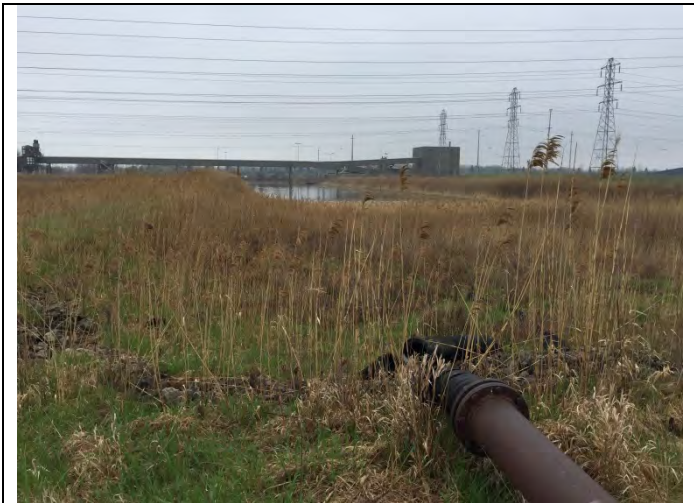
Photo 4: West basin, view from north, 04/20/17
