2017 ANNUAL INSPECTION REPORT VERTICAL EXTENSION LANDFILL

MONROE POWER PLANT

Monroe, Michigan

January 2018

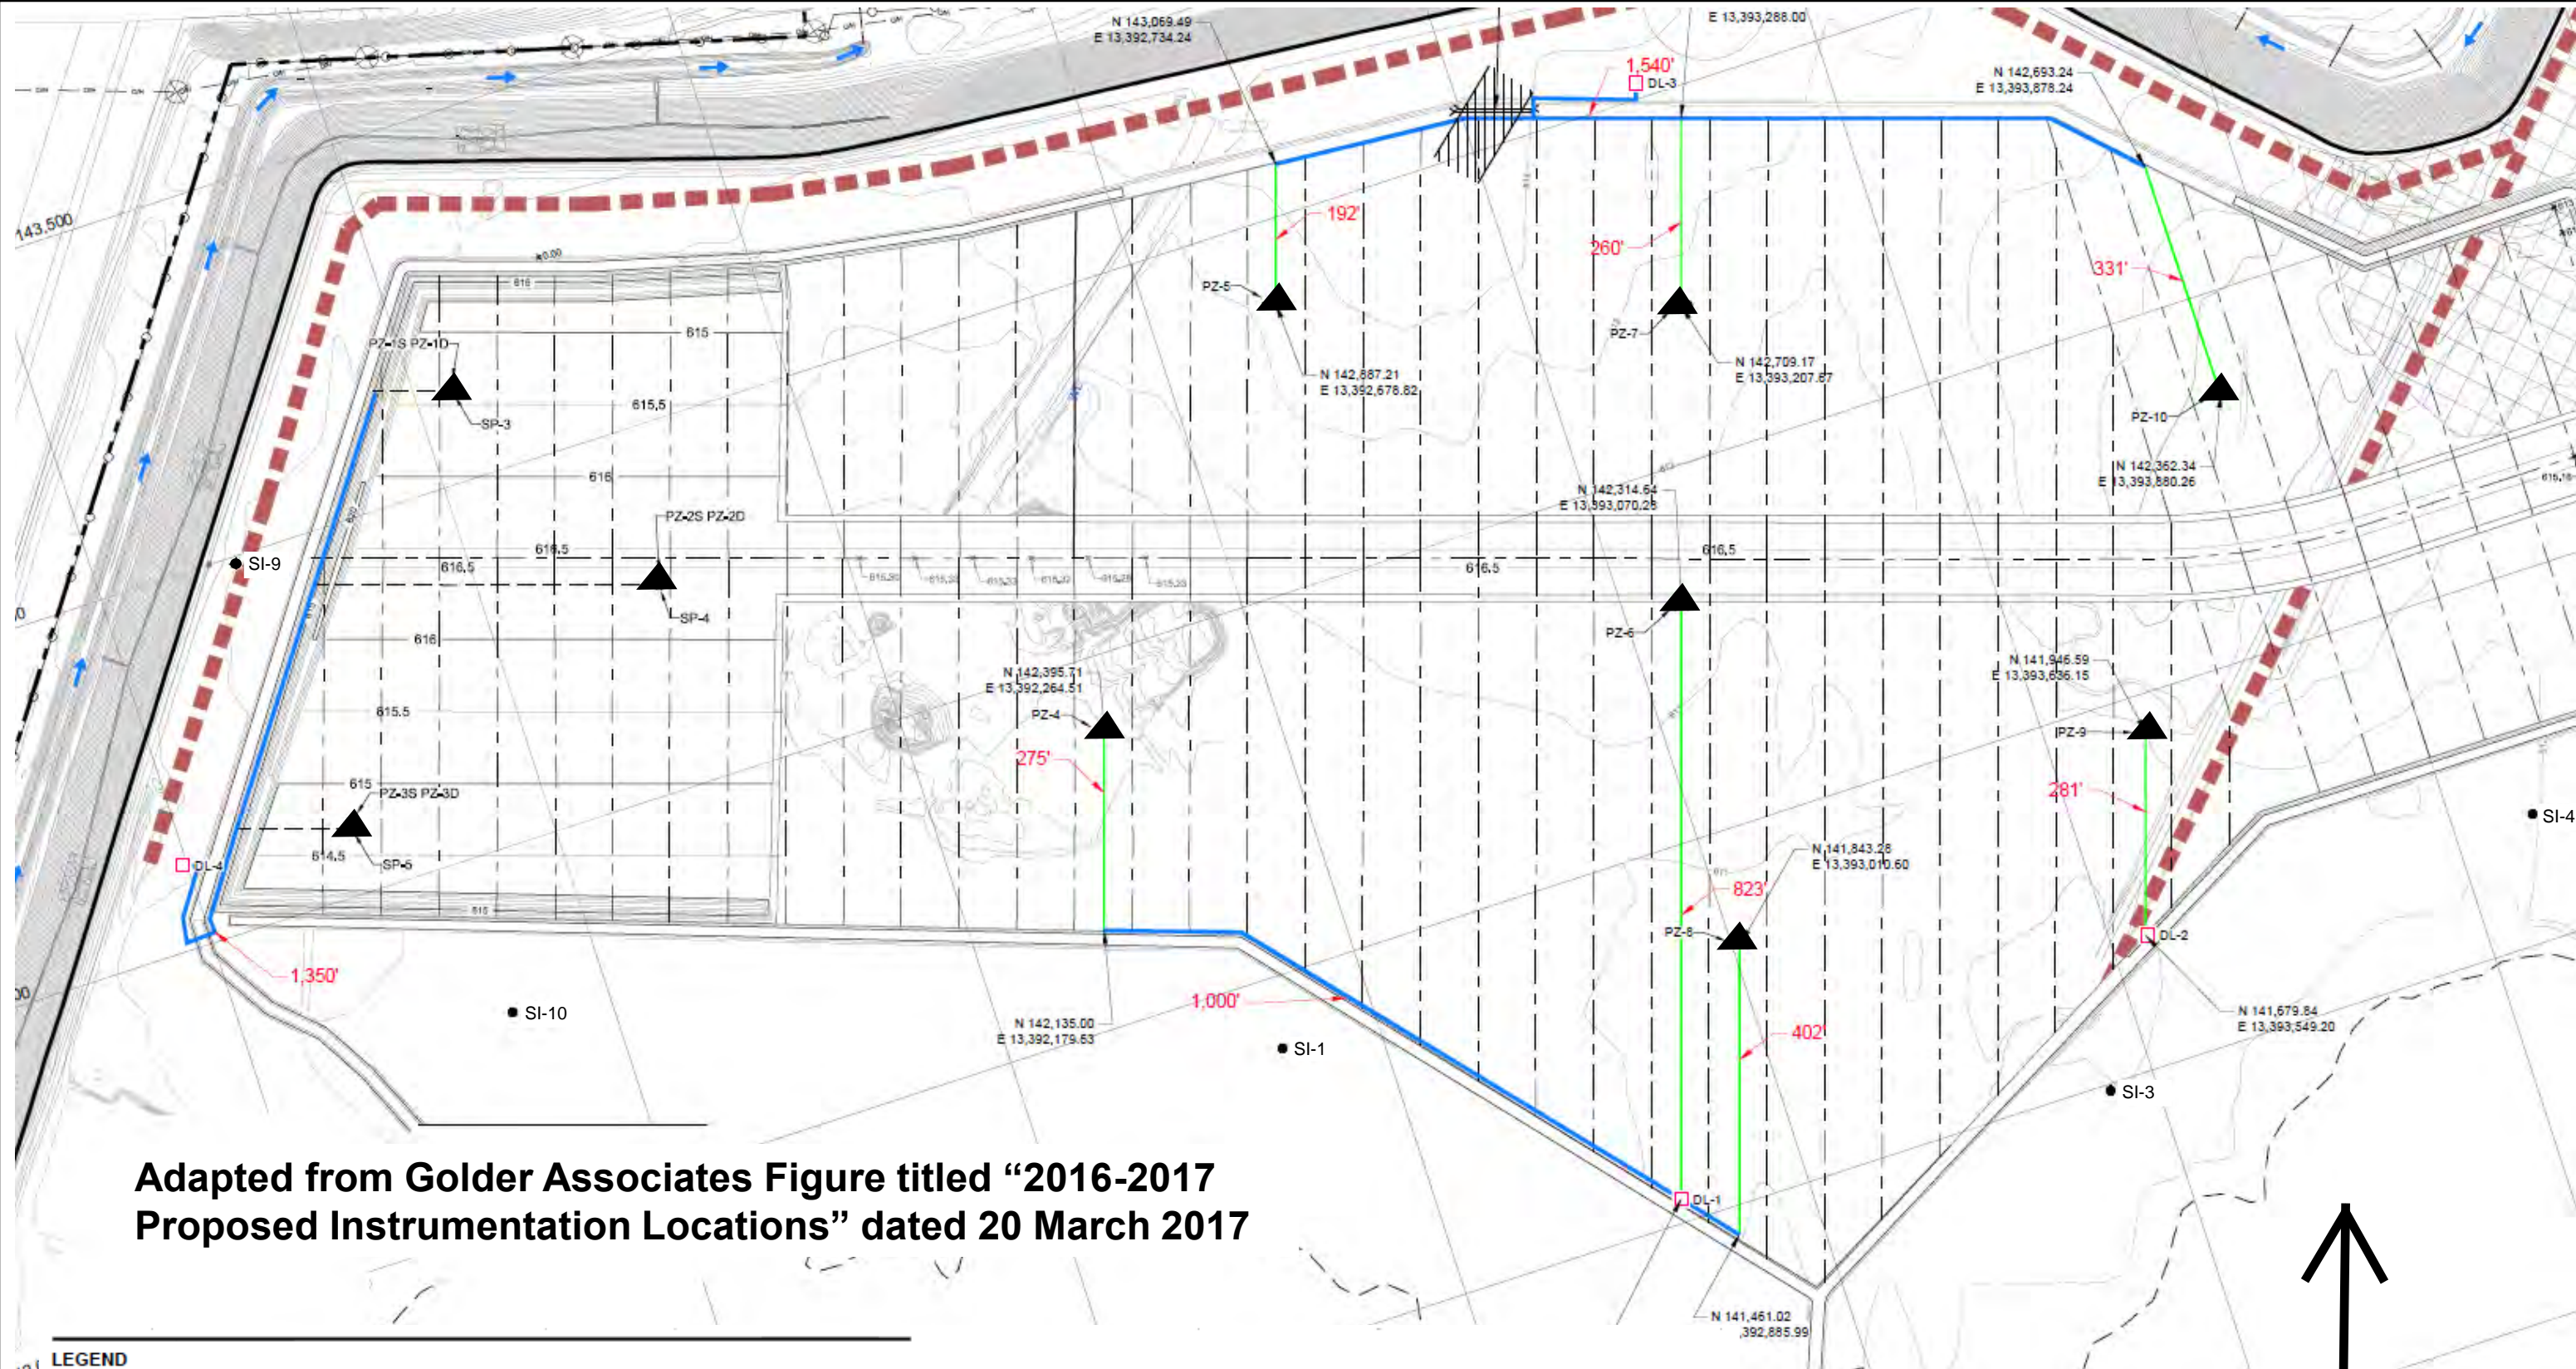
MONROE ASH BASIN VERTICAL EXTENSION LANDFILL INSTRUMENTATION LAYOUT		
2017 ANNUAL INSPECTION NOVEMBER 2017		Figure 2

Slope inclinometer (SI) locations (6) are shown on Figure 2. Readings were obtained at least monthly. Four of the SIs were installed in mid-2017.

Phase 1 settlement plate (SP) locations (3) are shown on Figure 2. SP-3, SP-4, and SP-5 have been read upon installation and prior to filling operations. Subsequent readings were obtained approximately every two weeks since February 2016. SP-1 and SP-2 are associated with ongoing construction to the east of the certified portion in Phase 1 and are not required to be read until after certification of construction. However, SP-1 has been read since June 2016 and SP-2 has been read since February 2016.

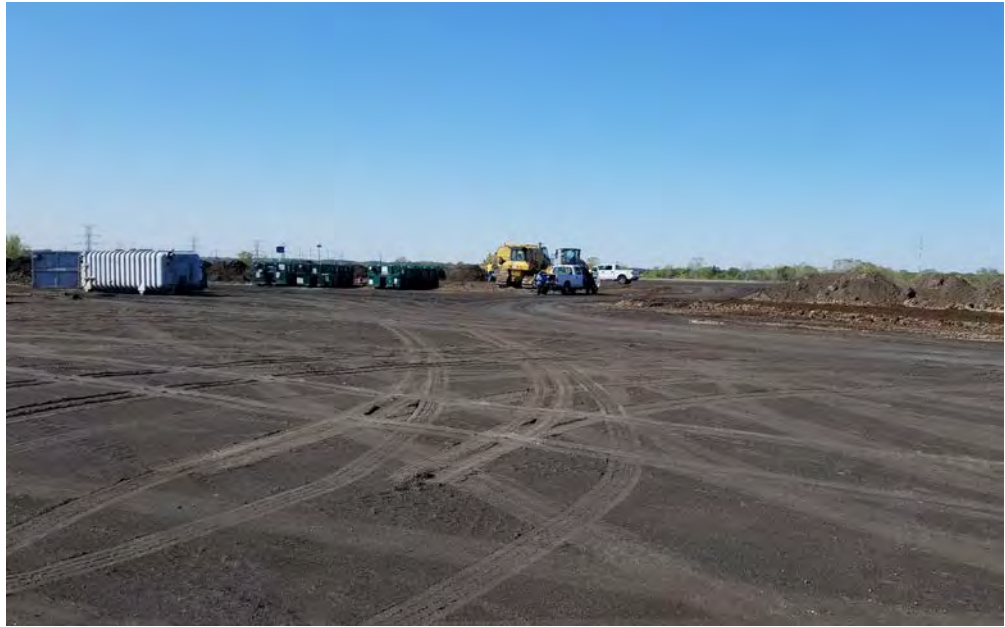
Comments: The active face of the landfill. Ash base in foreground and ash piles behind equipment.

Looking SW

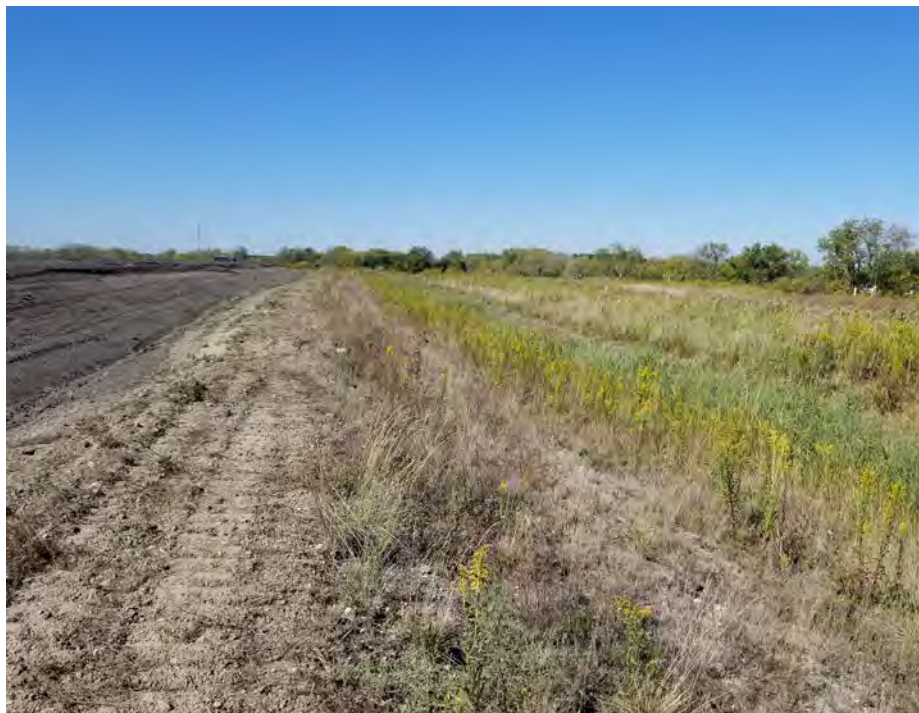
Photograph 2

Comments: Perimeter Swale on the north side of the landfill looking west.

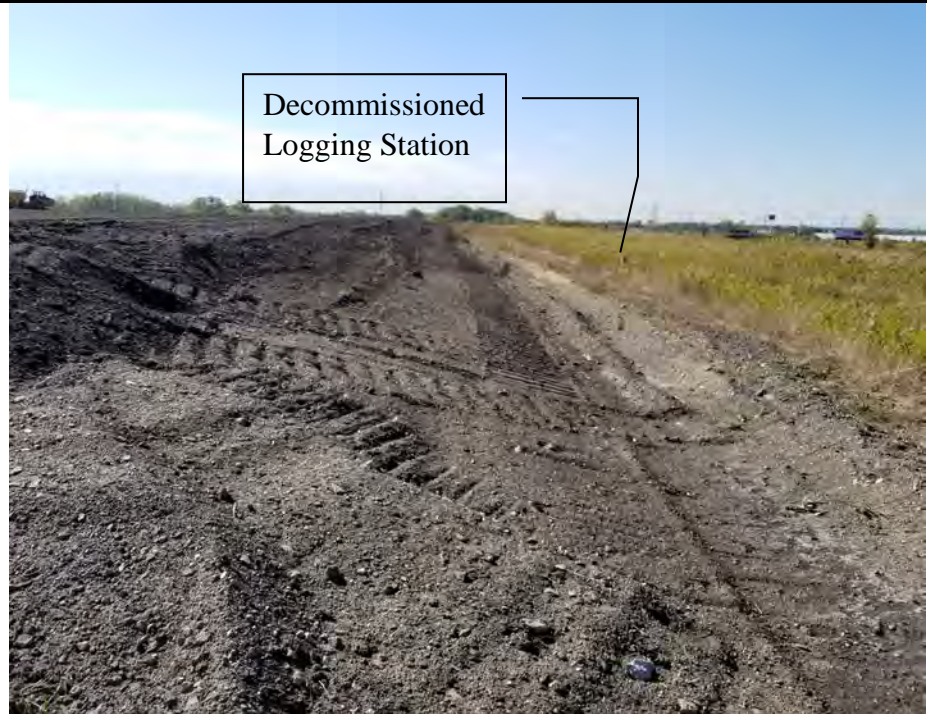
Comments: A decommissioned logging station (center right) for a phase 1 piezometer on the west side of the landfill looking South. Perimeter ditch to the east of the logging station.

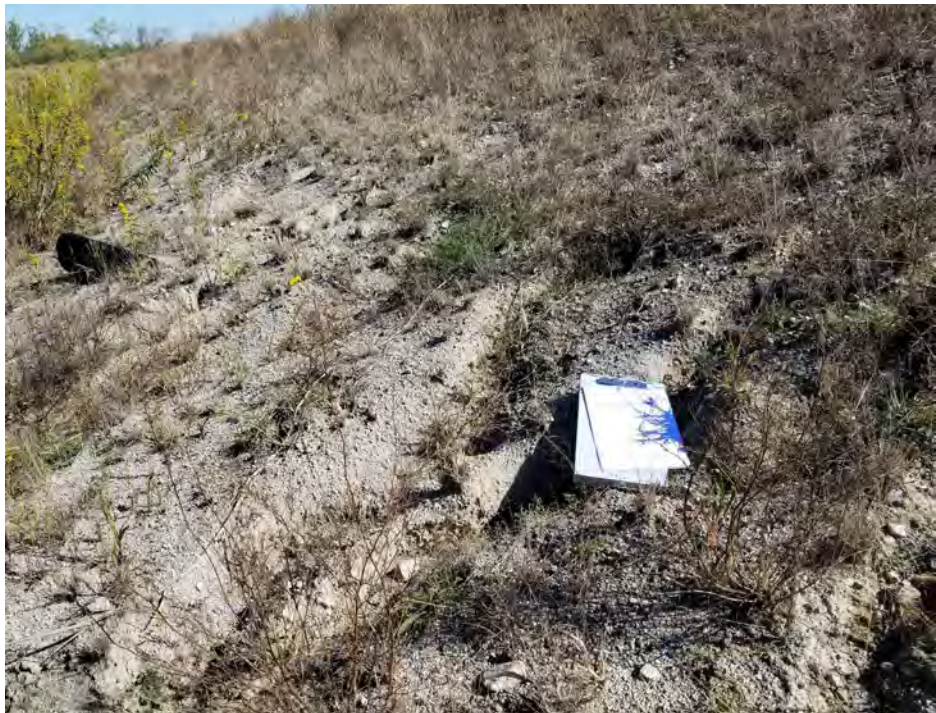
Photograph 4

3. Are there indications of erosion on the landfill perimeter berm? Yes No
If 'Yes', describe what type and its condition (rill, gully, dimensions, etc.)
Minor ruts on north side. Not impacting the structure or function of the berm.

6. Is the underdrain collection system draining? Yes No
Describe flow conditions. No flow. It had been very dry for a couple of weeks and drainage would not be expected.

Comments: A dry underdrain and an erosion rut is shown exiting into the west perimeter ditch of the landfill.

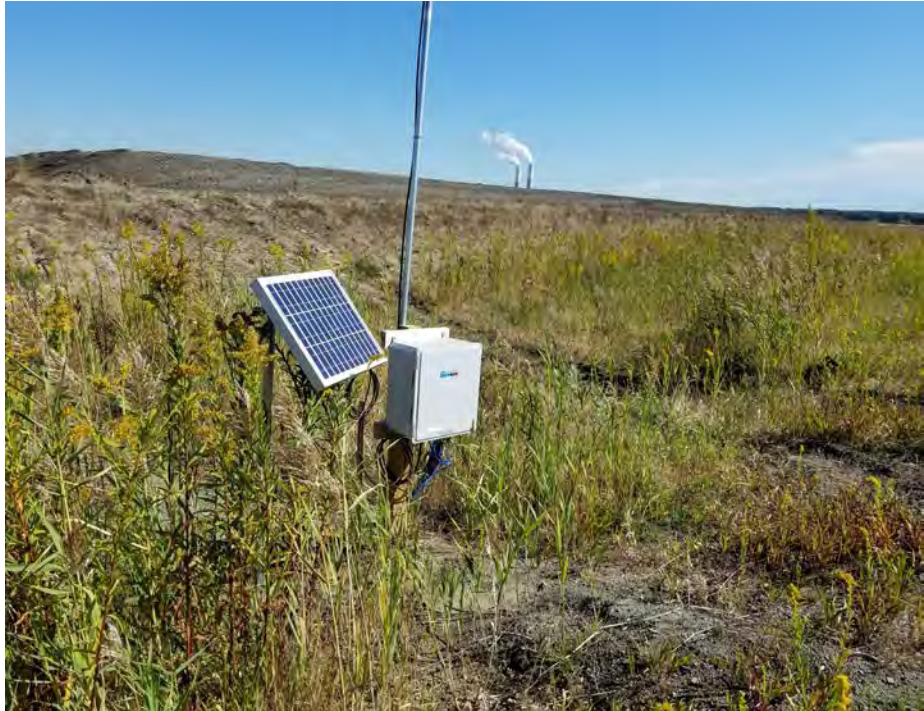
Comments:
Piezometer PZ3S/3D datalogger near the southwest corner of the landfill. Landfill is in the background. Looking NE.

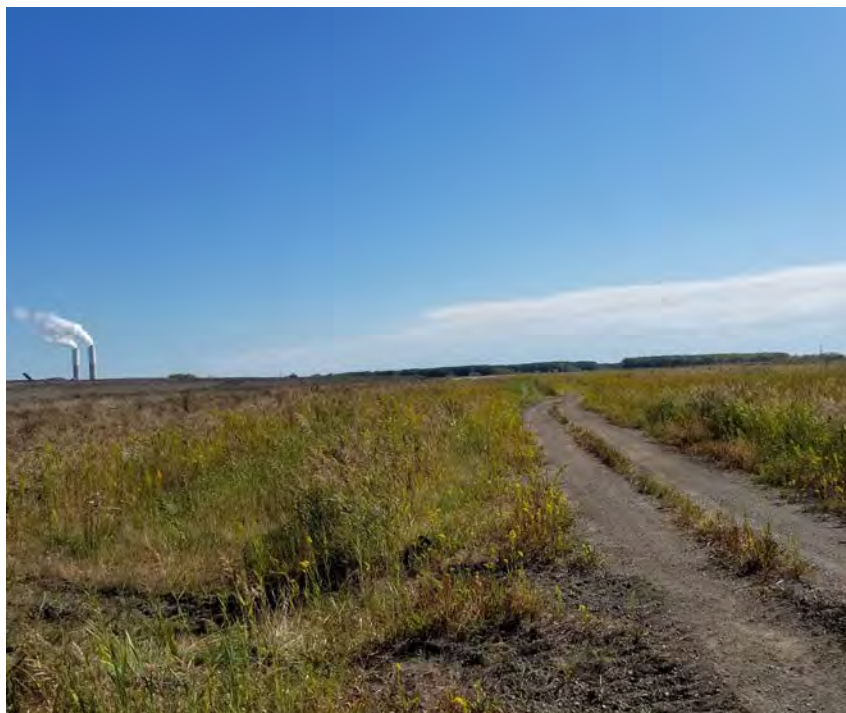
Photograph 6

Comments: The south outer perimeter road looking east. Perimeter swale is to the north (left) and landfill is to the left of the ditch.

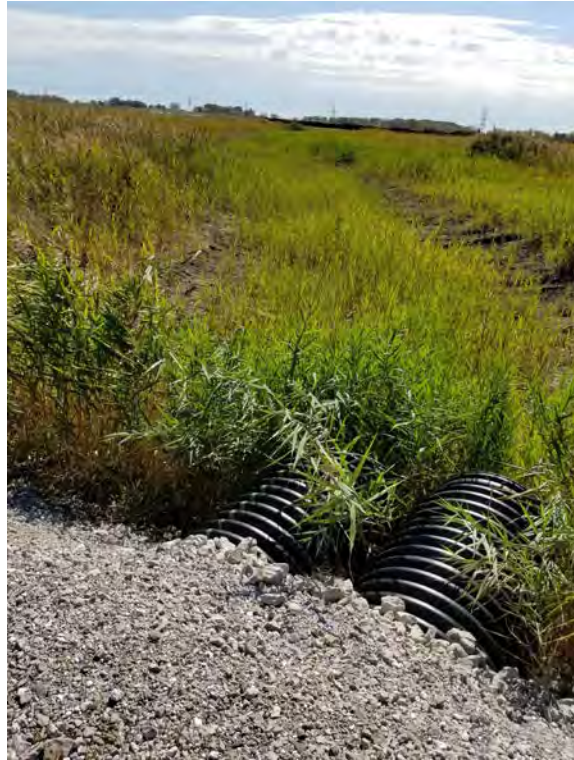
Maintenance had not been performed or required as of the time of the inspection. However, moderate vegetation growth was visible in portions of the perimeter ditch.

Comments: South side perimeter drainage culverts under the outer perimeter road looking SE. Moderate vegetation present.

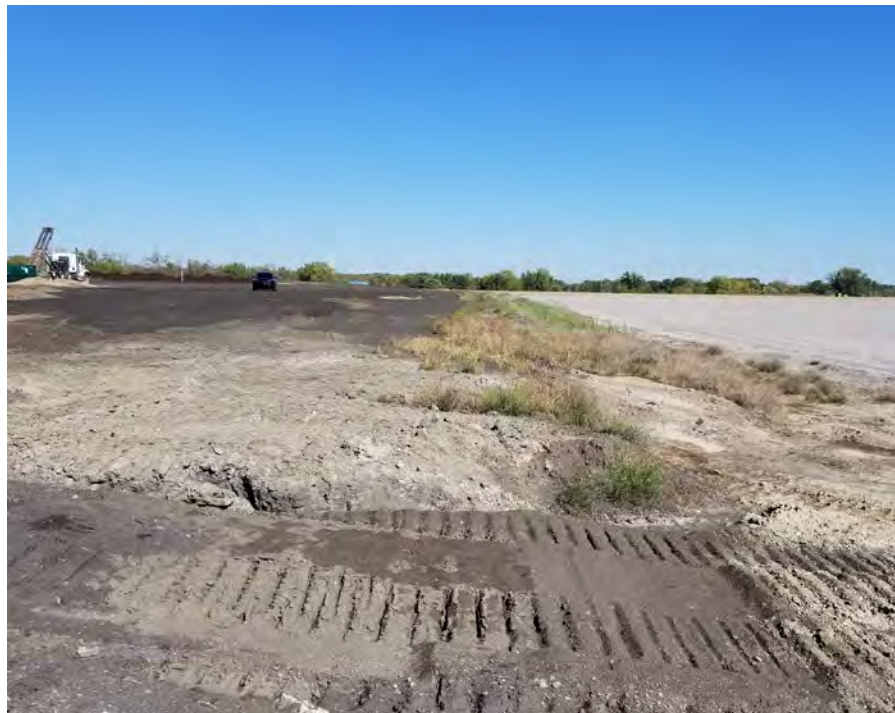
Photograph 8

Comments: The east side of the licensed area showing separation distance with the newly constructed area that is not yet licensed. Looking north.
