2020 Annual Groundwater Monitoring Report

**Range Road Coal Combustion
Residual Landfill
3600 Range Road
China Township, Michigan**

January 2021

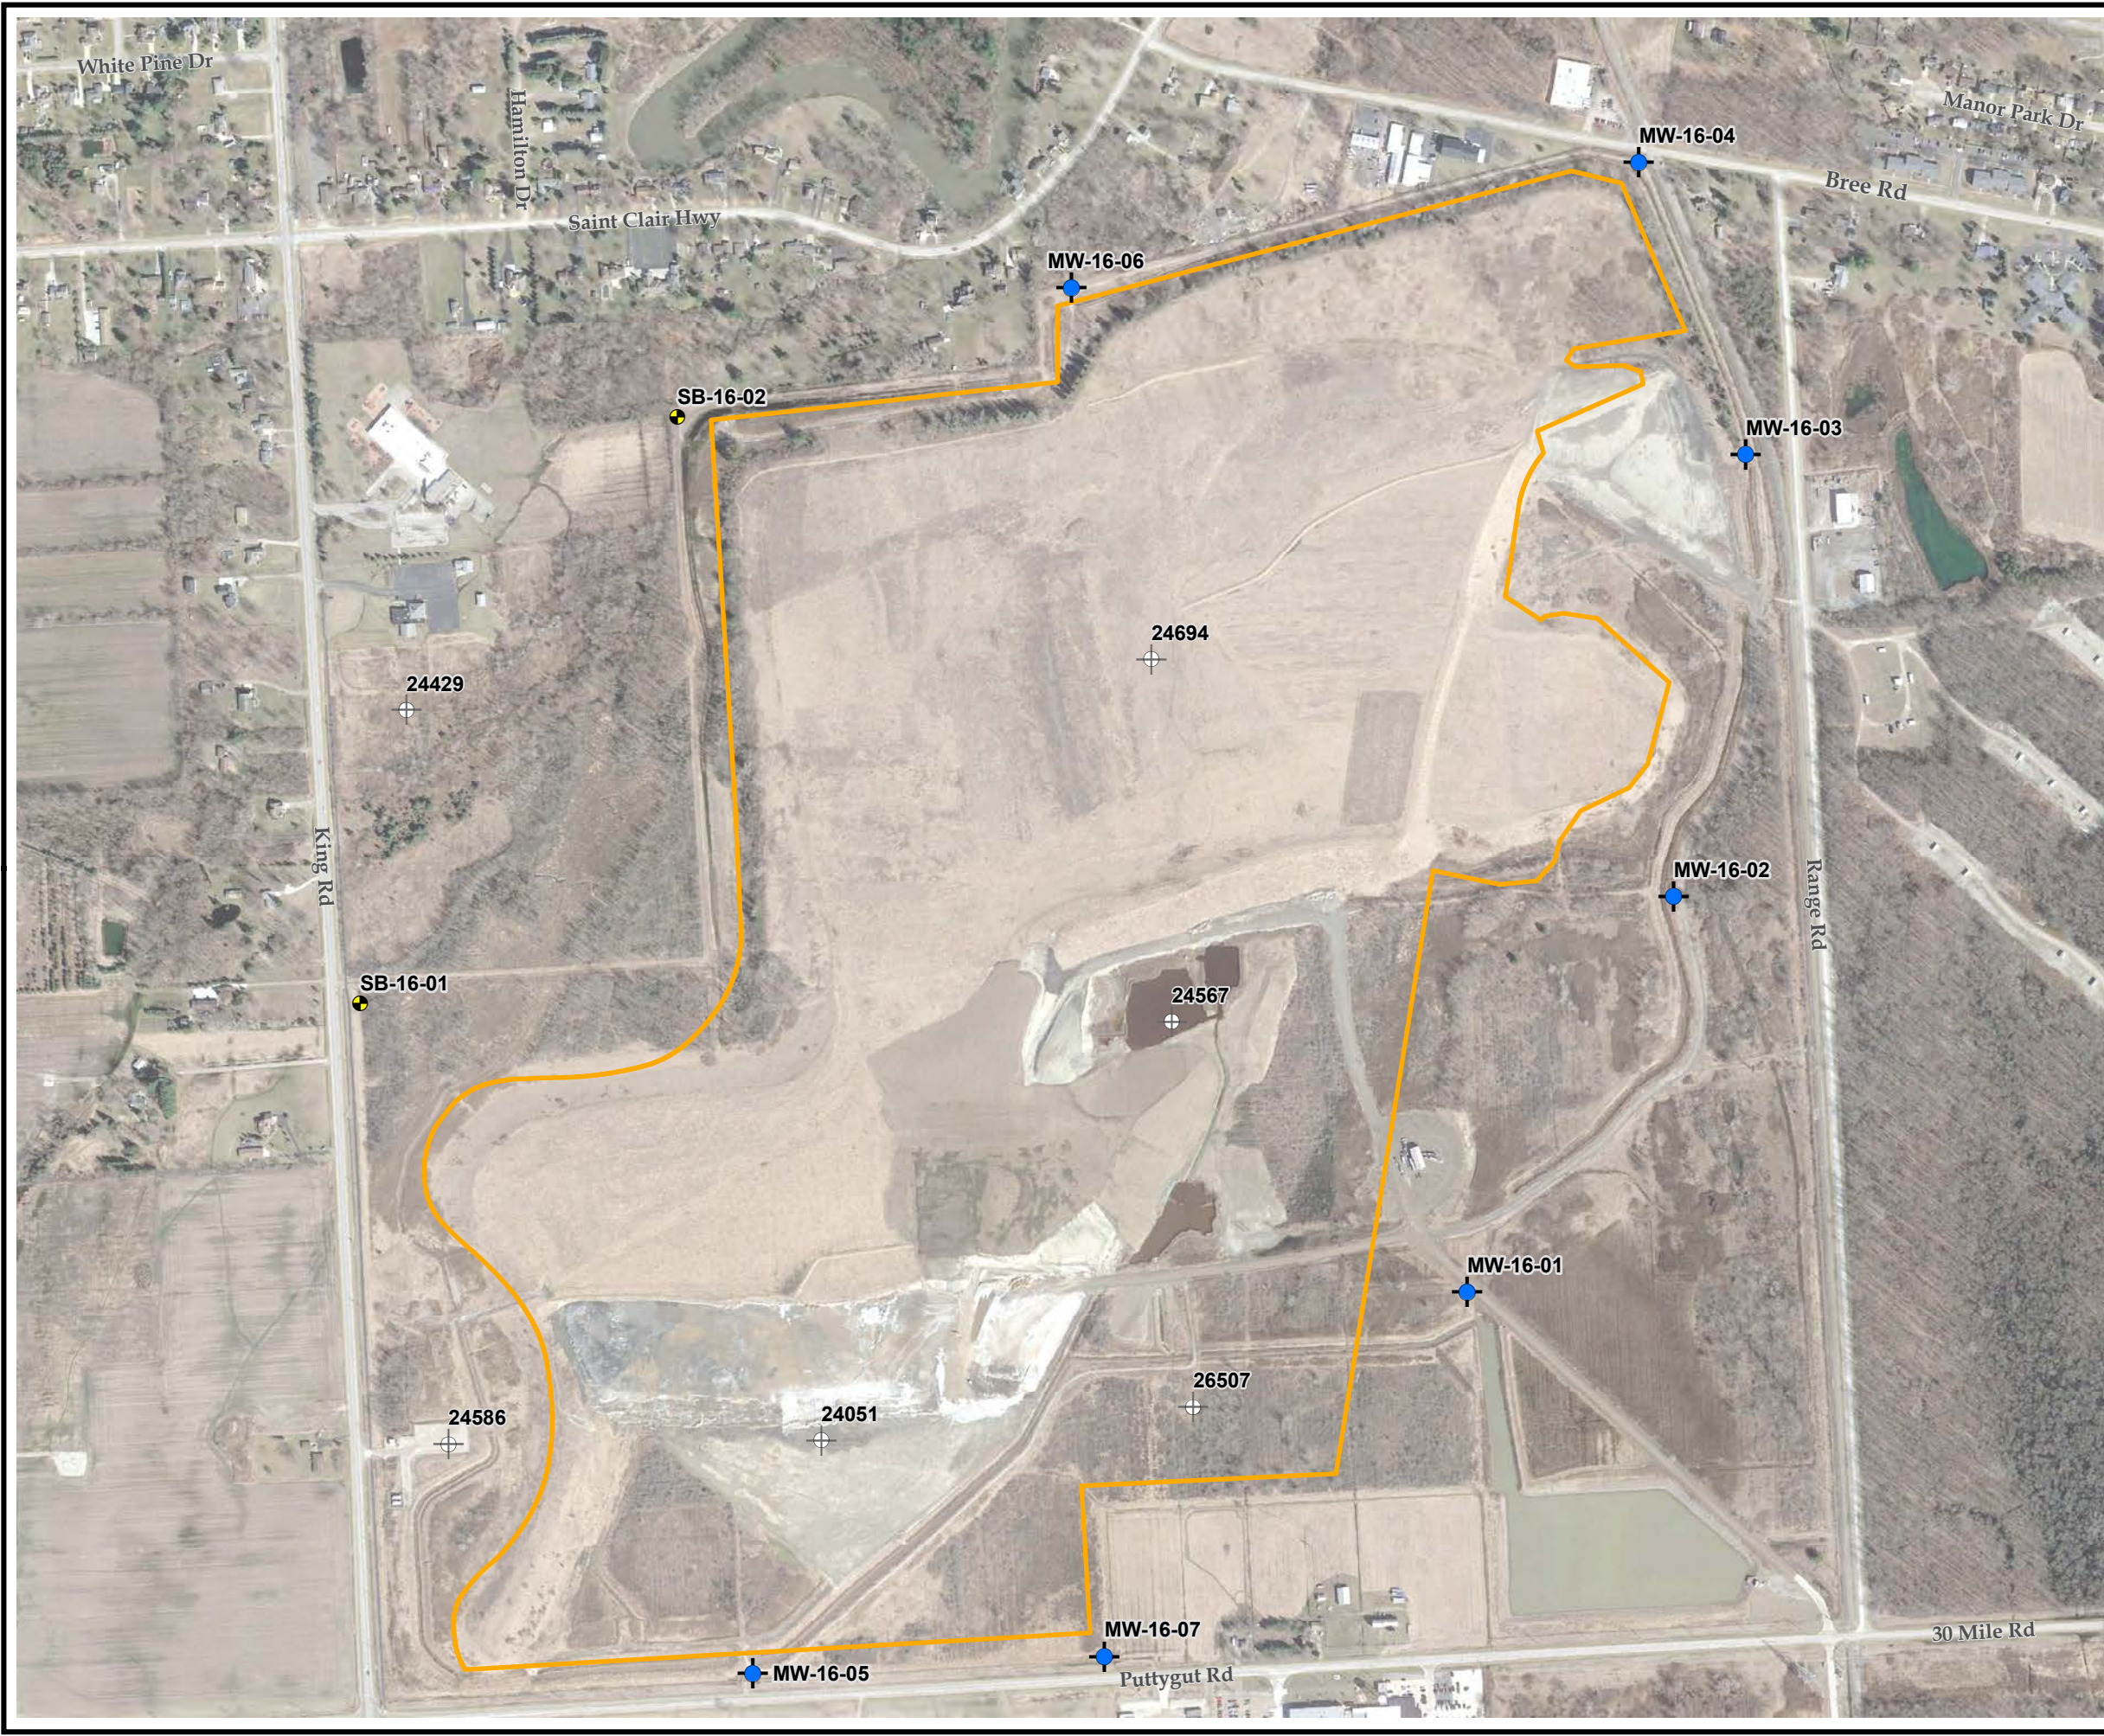
A groundwater monitoring system has been established for the RRLF CCR unit as detailed in the Groundwater Monitoring System Summary Report – DTE Electric Company Range Road Coal Combustion Residual Landfill (GWMS Report) (TRC, October 2017). The detection monitoring well network for the RRLF CCR unit currently consists of seven monitoring wells that are screened in the uppermost aquifer. Monitoring wells MW-16-01 through MW-16-07 are located around the north, east and south perimeter of the RRLF and provide data on both background and downgradient groundwater quality that has not been affected by the CCR unit (total of seven background/downgradient monitoring wells). The monitoring well locations are shown on Figure 2.

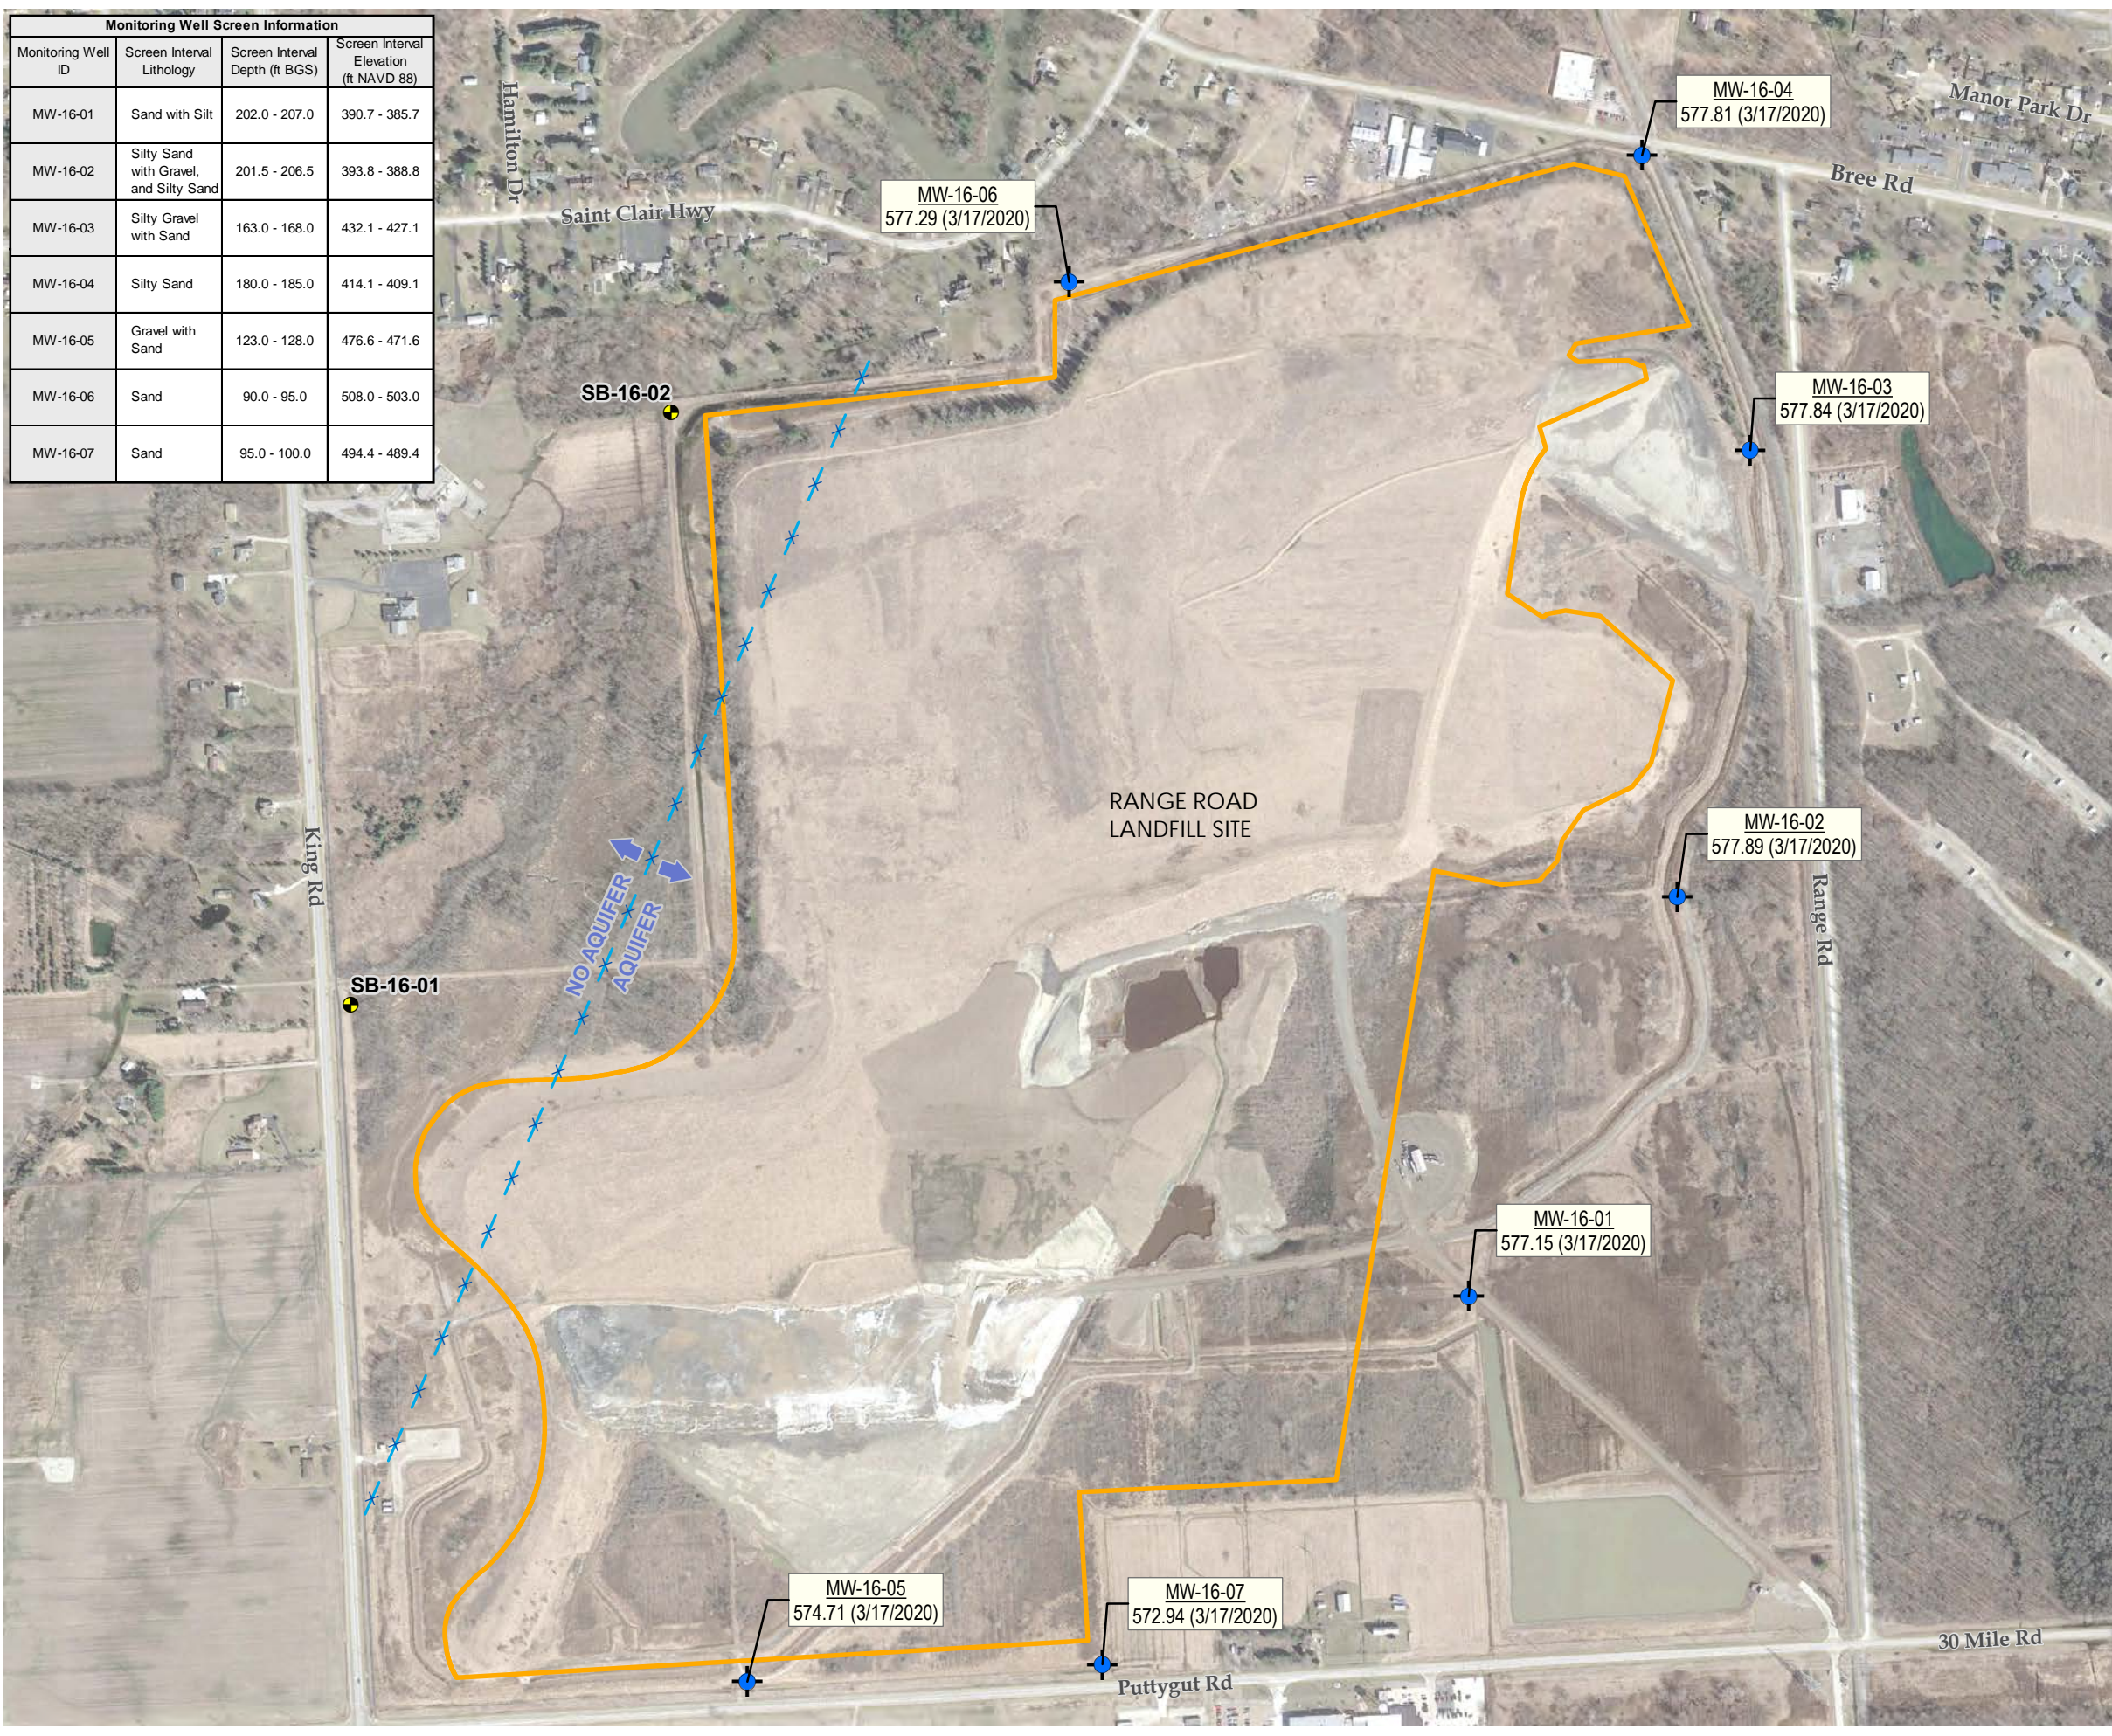
PROJECT:	DTE ELECTRIC COMPANY RANGE ROAD LANDFILL 3600 RANGE ROAD CHINA TOWNSHIP, MICHIGAN		
TITLE:	GROUNDWATER PONTENTIOMETRIC ELEVATION SUMMARY MARCH 2020		
DRAWN BY:	S. MAJOR	PROJ NO.:	370029.0000
CHECKED BY:	J. KRENZ	FIGURE 3	
APPROVED BY:	V. BUENING		
DATE:	JANUARY 2021

As presented in the GWMS Report, and mentioned above, given the horizontally expansive clay with substantial vertical thickness, the heterogeneity of the glacial deposits (with the top of the uppermost aquifer elevation across the RRLF CCR unit varying up to 100 feet vertically), the no-flow boundary to the west, and the lack of hydraulic interconnectedness of the uppermost aquifers encountered at the site in some areas, it is not appropriate to infer horizontal flow direction or gradients across the site. Groundwater elevations measured across the Site during the March 2020 sampling event are provided on Table 1 and are summarized in plan view on Figure 3. Groundwater elevations measured across the Site during the October 2020 sampling event are provided on Table 1 and are summarized in plan view on Figure 4.

Groundwater elevation data collected during the most recent sampling event show that groundwater conditions within the uppermost aquifer are consistent with previous monitoring events and continue to demonstrate that the downgradient wells are appropriately positioned to detect the presence of Appendix III parameters that could potentially migrate from the RRLF CCR unit.

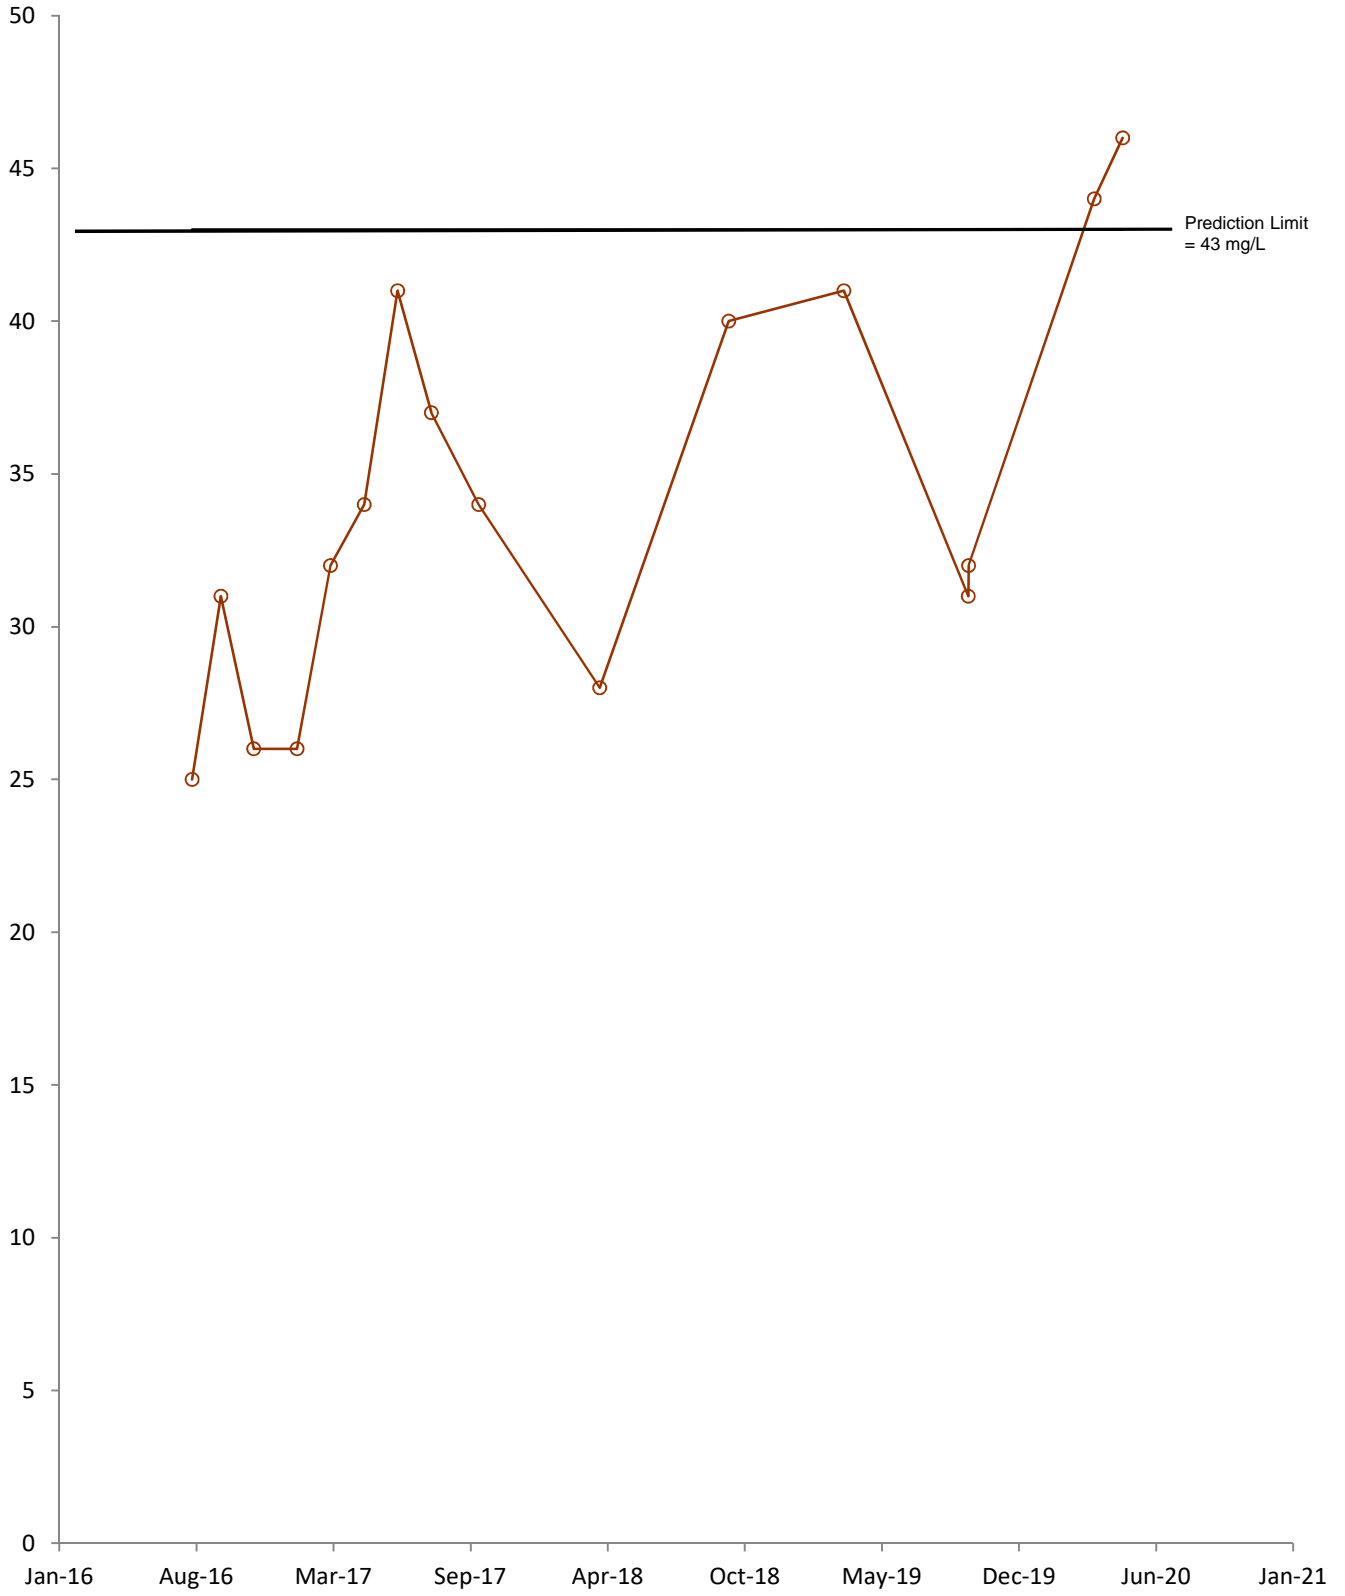
Sulfate (mg/L), MW-16-01

- **Spatial variability in groundwater quality** – After 8 background sampling events, the prediction limits calculated for each of the 7 monitoring wells range from 10 mg/L to 120 mg/L. This variability in groundwater quality across the site, which covers an approximately half square mile area, shows that the sulfate concentrations vary spatially throughout the uppermost aquifer and support that the confirmed sulfate SSI at MW-16-01 is attributed to spatial variability, well within the range of concentrations observed throughout the well network.

- **Insufficient background sampling timeline to account for long-term trends** – Variability in sulfate concentrations observed in the groundwater at RRLF during the background sampling events provides evidence of the heterogeneity of this constituent in groundwater. The short duration of the background sampling events limits the ability of the statistical analysis to capture the natural temporal trends in the groundwater quality at the RRLF.

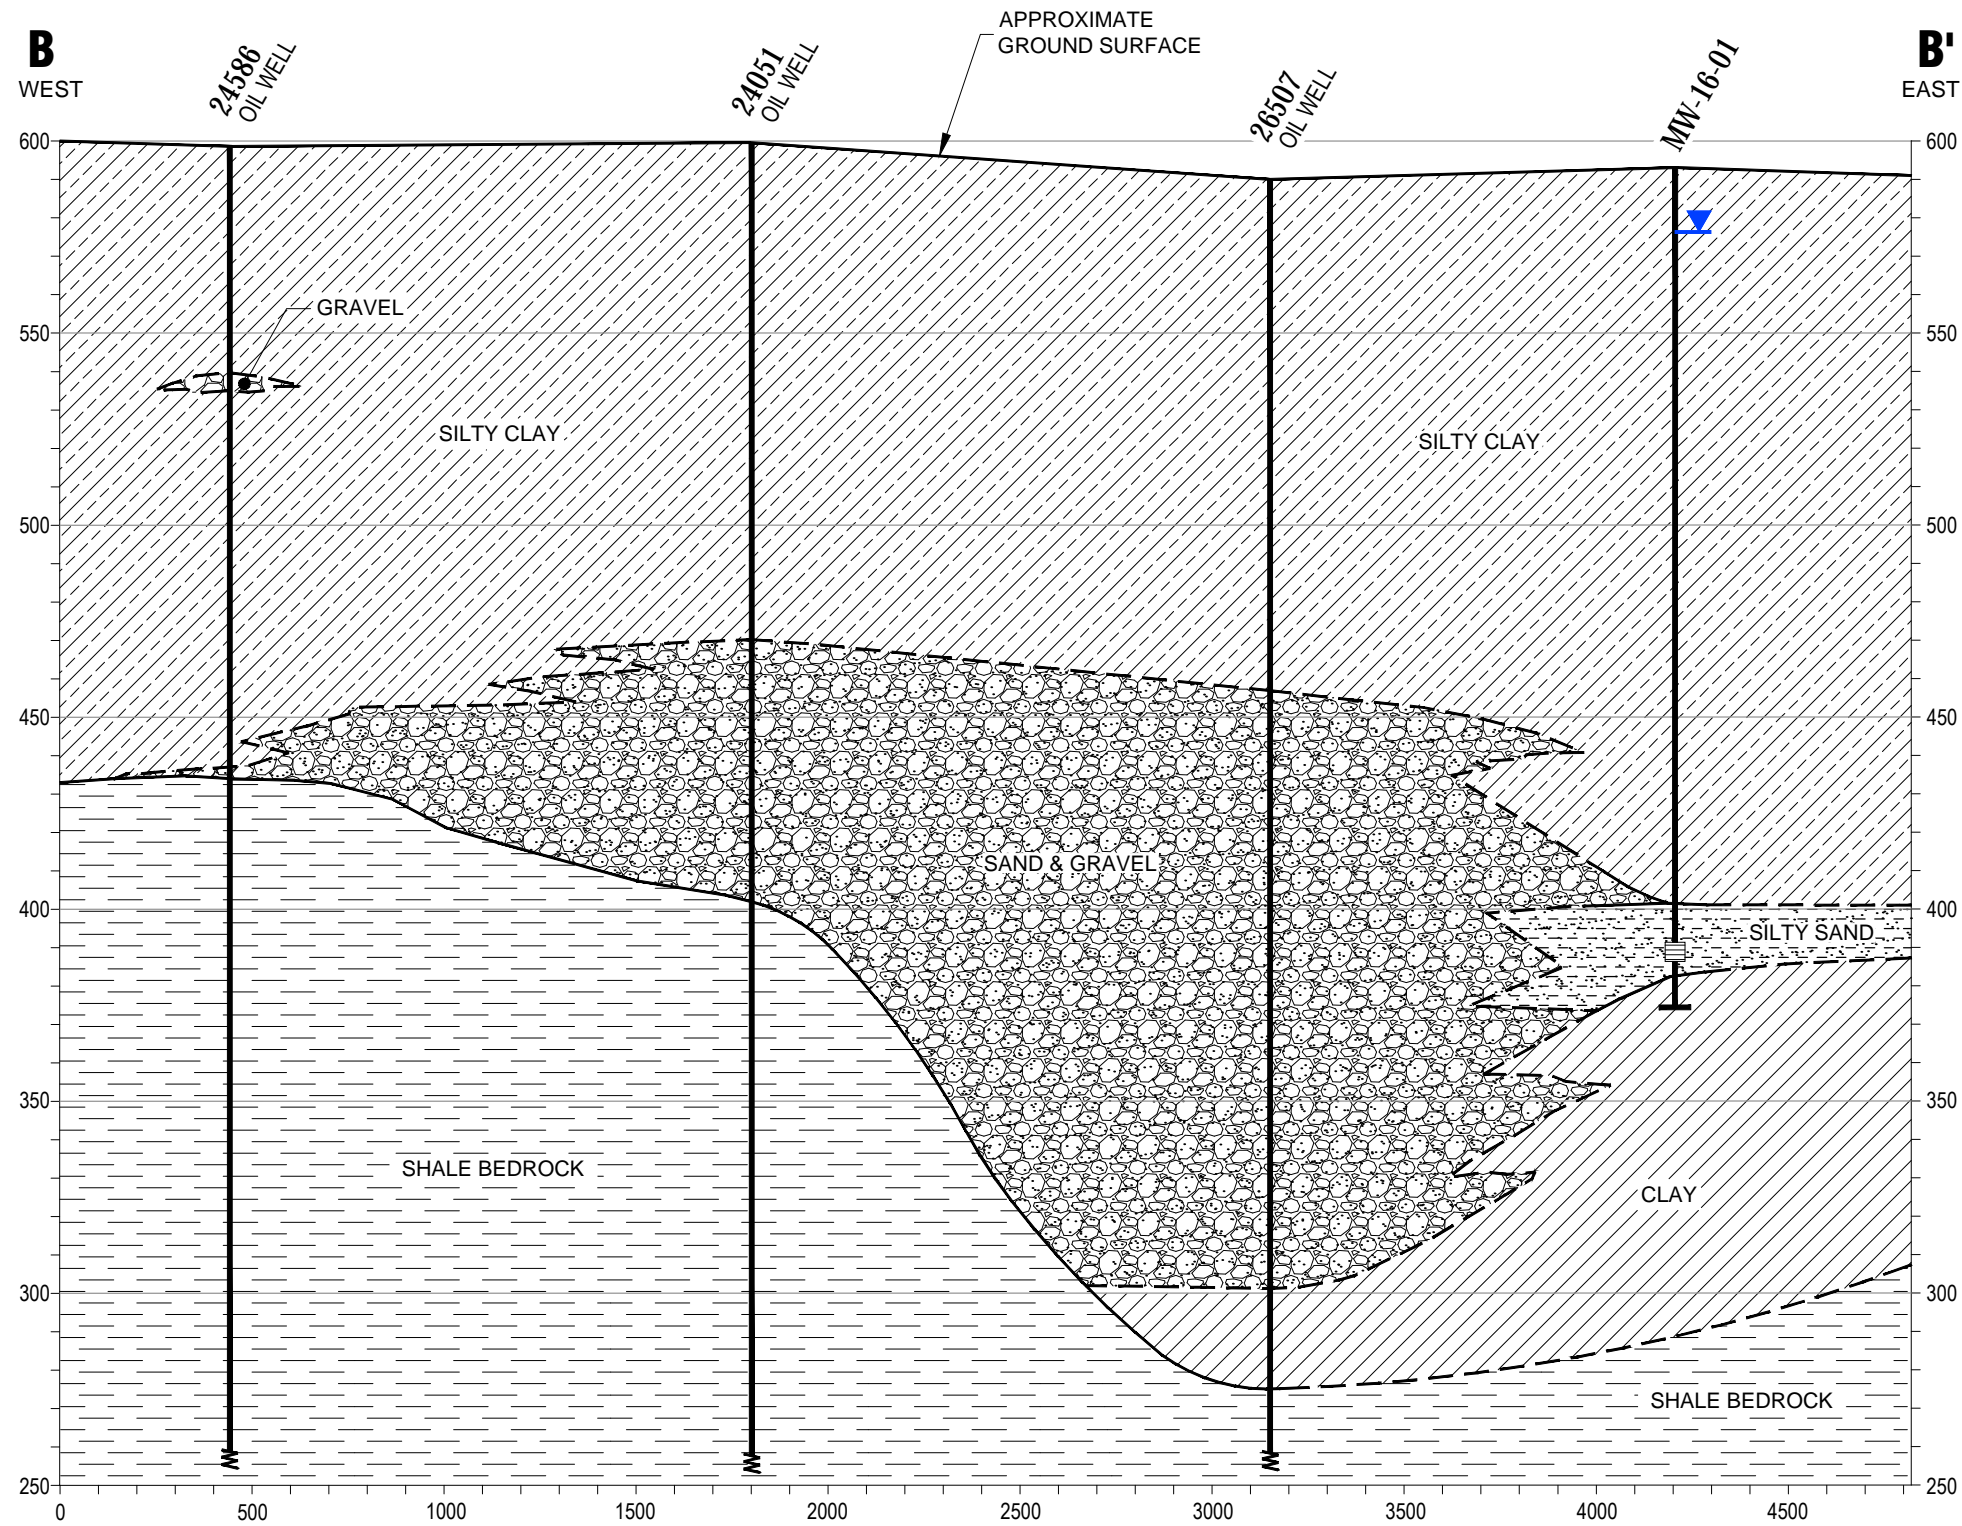
PROJECT:	DTE ELECTRIC COMPANY RANGE ROAD LANDFILL CHINA TOWNSHIP, MICHIGAN	
TITLE:	GENERALIZED GEOLOGIC CROSS-SECTION B-B'	
DRAWN BY:	D.STEHLER	PROJ NO.: 320511.0000.01.01
CHECKED BY:	S.HOLMSTROM	FIGURE 5
APPROVED BY:	V.BUENING	
DATE:	AUGUST 2019	
FILE NO.:	320511.0000.01.01.04-06.dwg
