DTE Electric Company
One Energy Plaza
Detroit, Michigan 48226

**2022 ANNUAL
INSPECTION REPORT
ASH BASIN**

MONROE POWER PLANT

January 2023

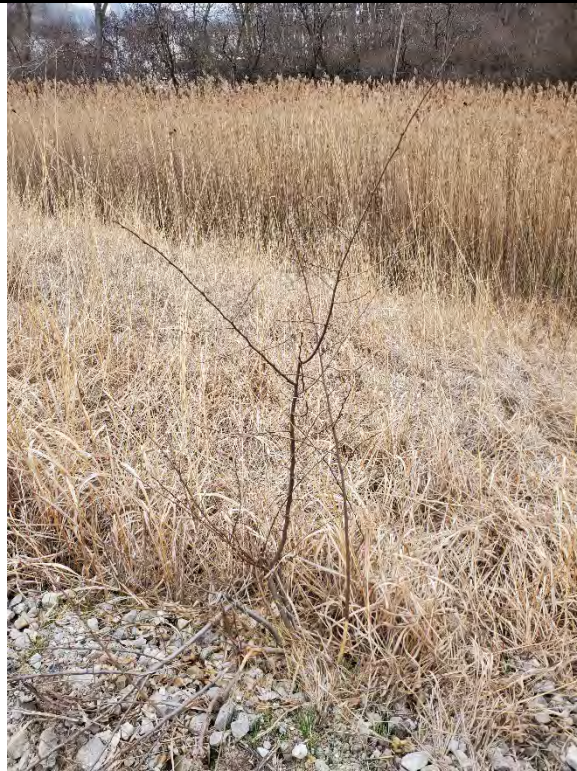
Photograph 1

5. Small Autumn Olive shrubs (see Photograph 1) were observed on portions of the perimeter embankment slopes in the northeast (approximate Stations 0+00 to 15+00), northwest (approximate Stations 55+00 to 65+00), and east (approximate Stations 150+00 to 160+00) (see Photograph 3).

- Small Autumn Olive shrubs (Photograph 1) were observed on the slopes from Sta 0+00 to 15+00, Sta 55+00 to 65+00, and Sta 150+00 to 160+00 (Photograph 3).

Comments: Example of Autumn Olive shrub observed at some locations on the Ash Basin perimeter berm. Chemical sprays were applied to the embankment slopes after the visual inspection to kill the shrubs and prevent future growth.

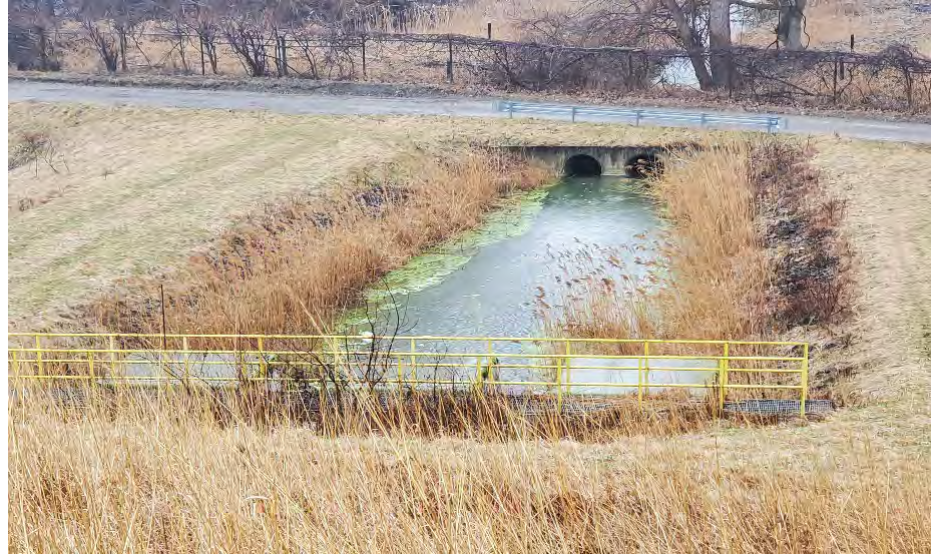
Comments: Exit from discharge structure to discharge canal was not obstructed. No slope disturbances were observed.
