# **2015 ANNUAL INSPECTION REPORT ASH BASIN EMBANKMENT**

**MONROE POWER PLANT**

**Monroe, Michigan**

January 2016

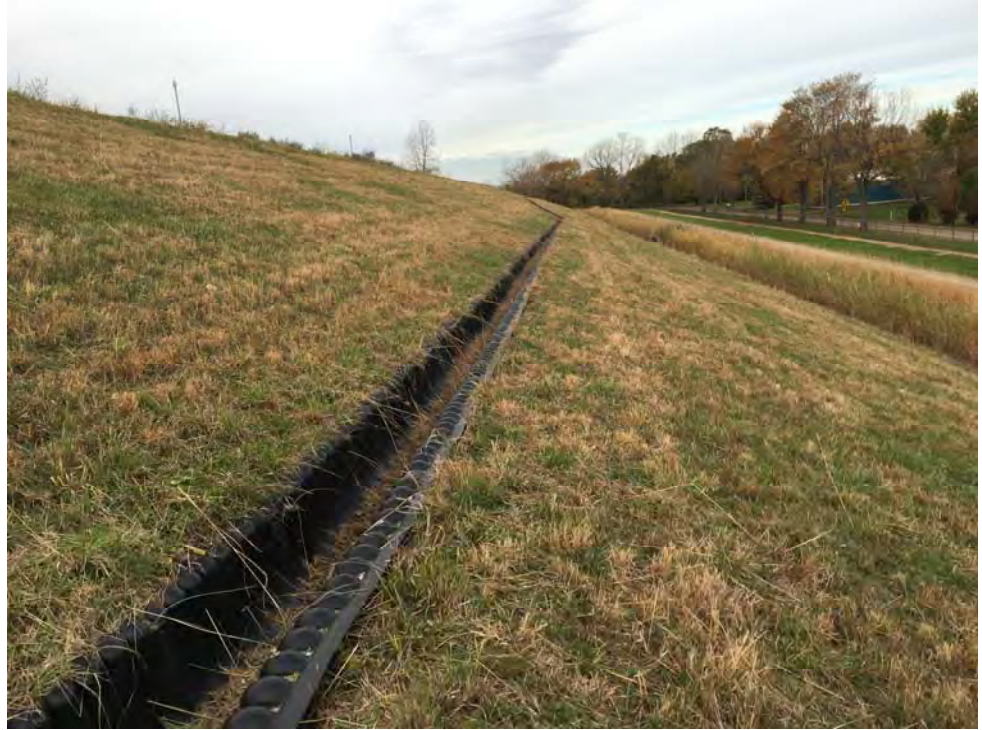
Comments: Photo taken at Station ~22+00, facing west. The northern embankment between Stations 4+00 and 45+00 appeared to have uniform slopes without sign of distress.

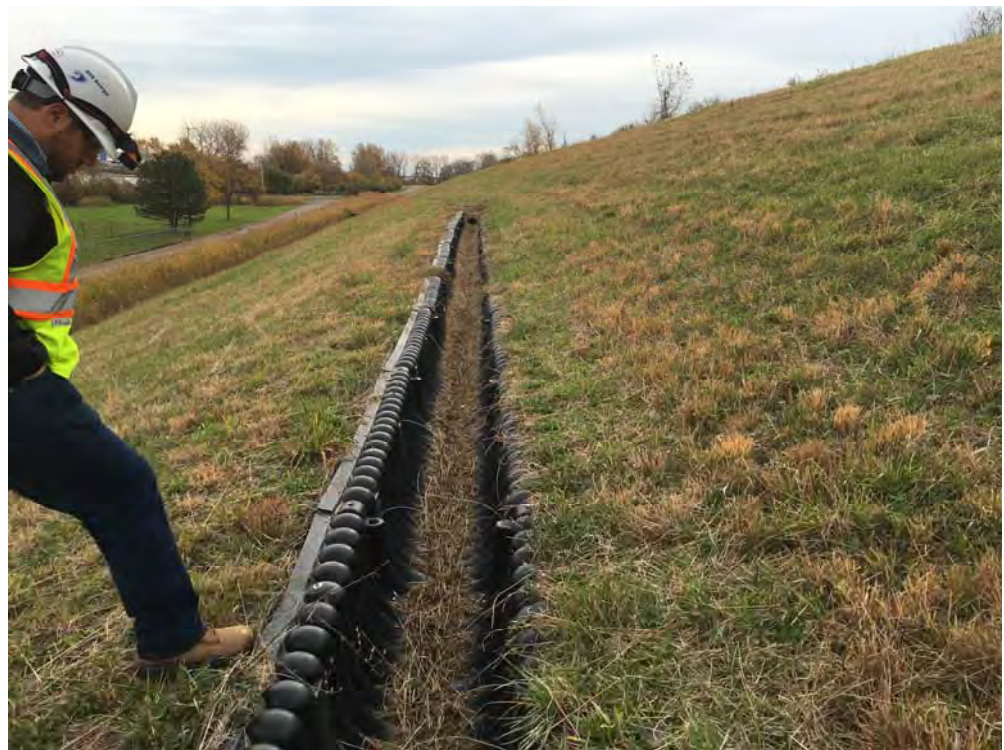
Photograph 2

Comments: Photo taken at Station ~16+00, facing east. The northern embankment between Stations 4+00 and 45+00 appeared to have uniform slopes without sign of distress.

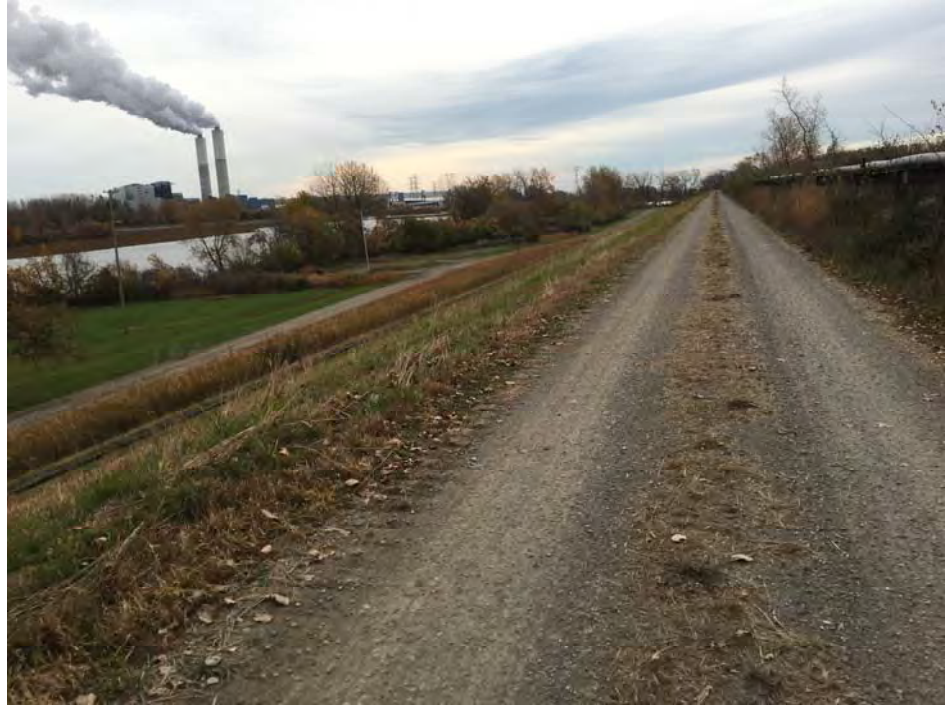
Comments: Photo taken at Station ~20+00, facing east. The crest between Stations 4+00 and 45+00 appeared to be level without sign of distress.

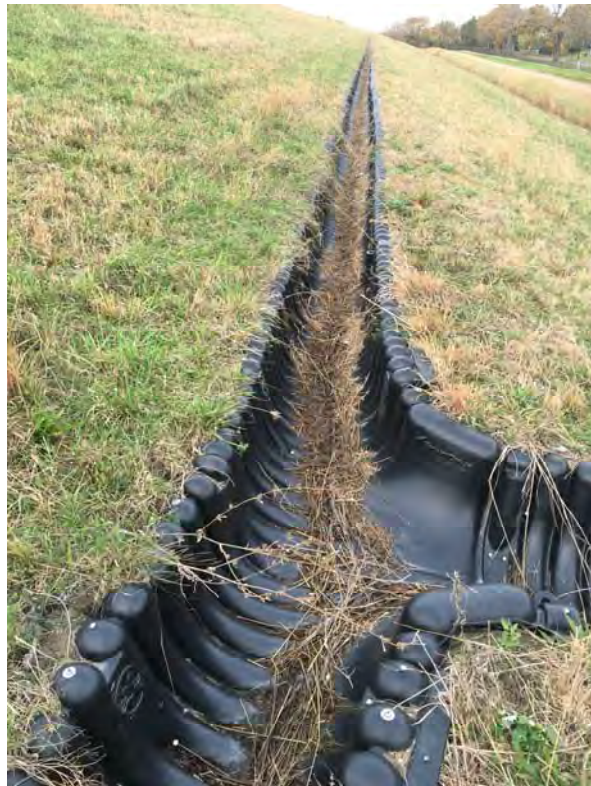
Photograph 6

Comments: Photo taken at Station ~18+00, facing west. The midslope stormwater ditch appeared to have good contact with adjacent soil between Stations 14+00 and 35+00.

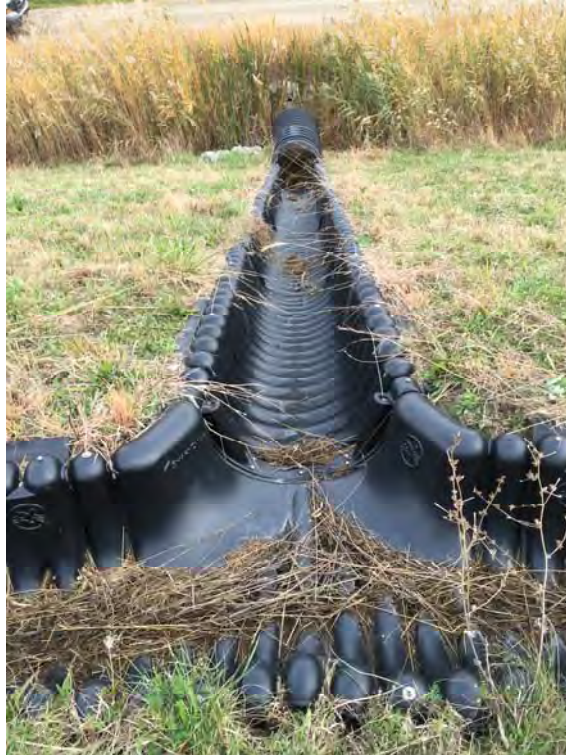
Comments: Photo taken at Station ~18+00, facing north. The downchute at this station appeared to be in good condition.

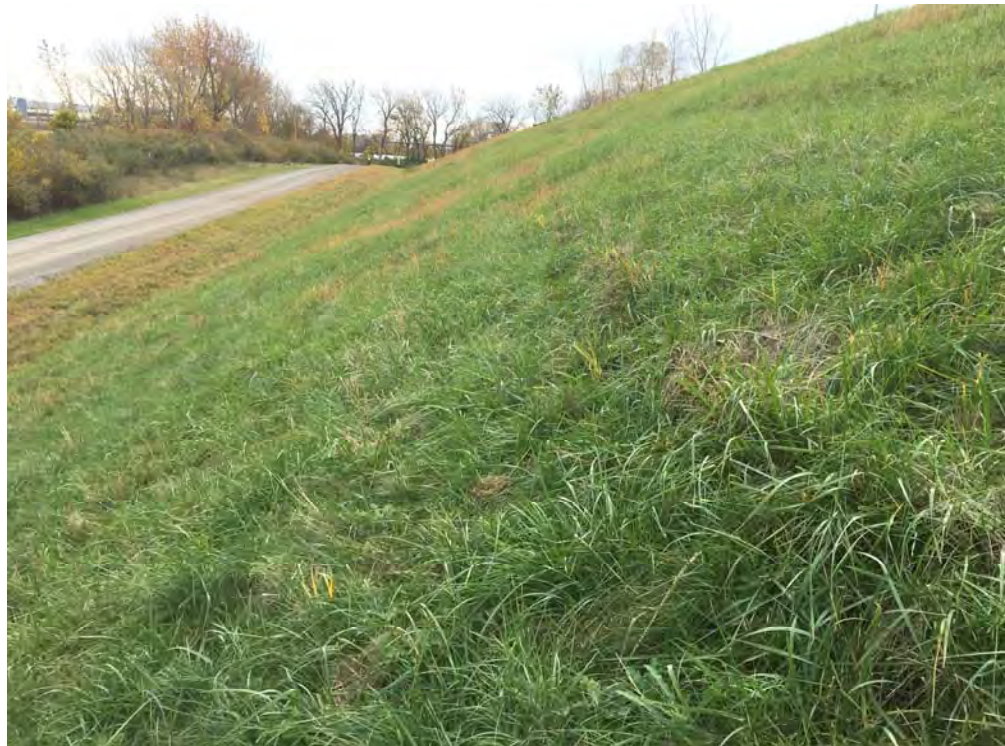
Photograph 8

Comments: Photo taken at Station ~12+00, facing east. The northern embankment between Stations ~4+00 and ~12+00 had vegetation that was approximately 12-in long. Additional care was given to inspection in this area.

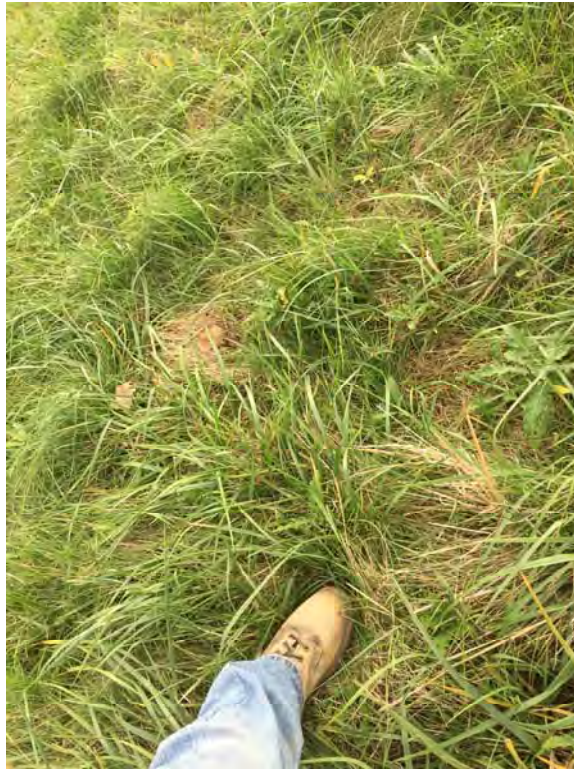
Comments: The northern embankment between Stations ~4+00 and ~12+00 had vegetation that was approximately 12-in long. Additional care was given to inspection in this area.

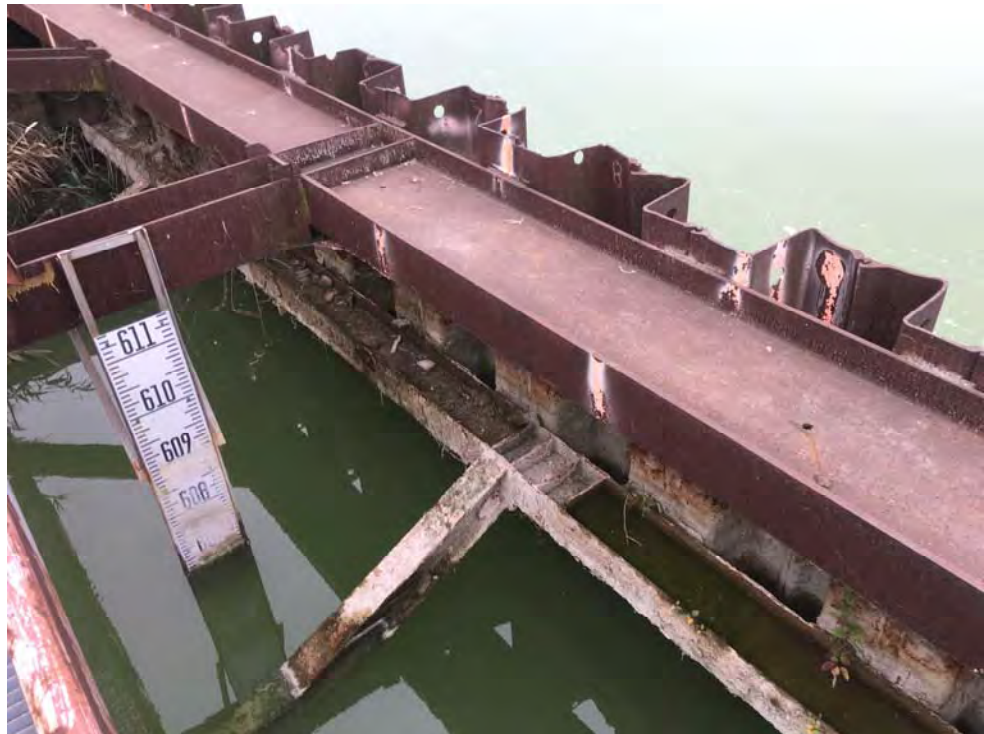
Comments: Photo taken at Station 179+00 at the discharge structure. Water level in the ash basin was approximately at 606.8 ft (IGLD55) = 608.3 ft (NGVD29) at the time of inspection.

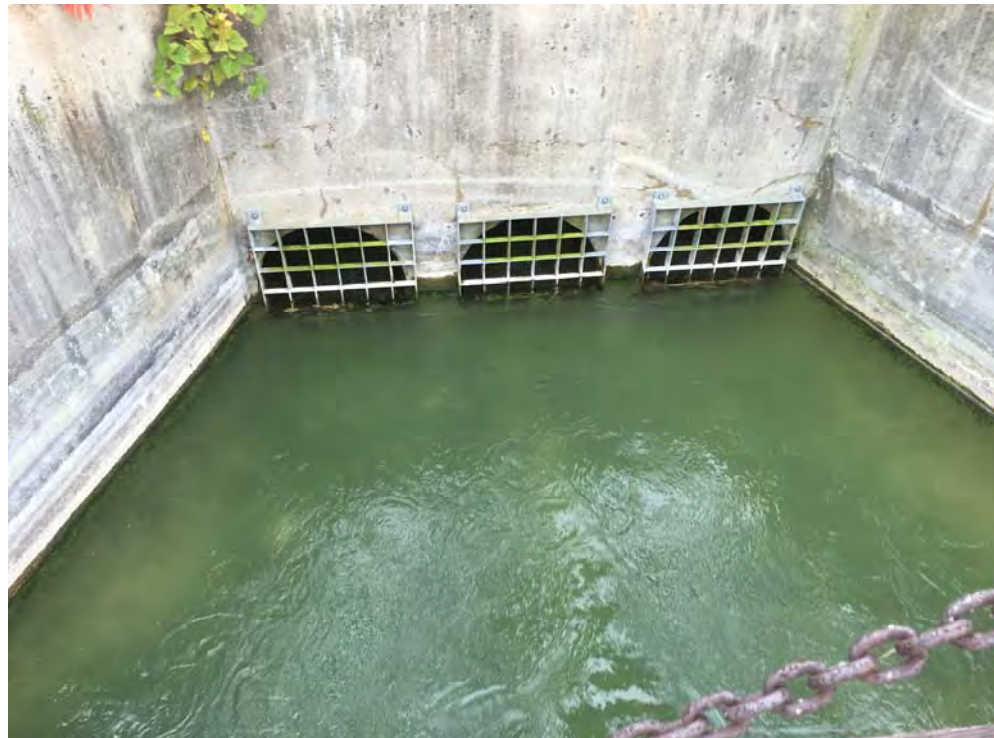
Comments: Photo taken at Station 179+00 at the discharge structure. Water flows through the discharge pipes without obstructions.

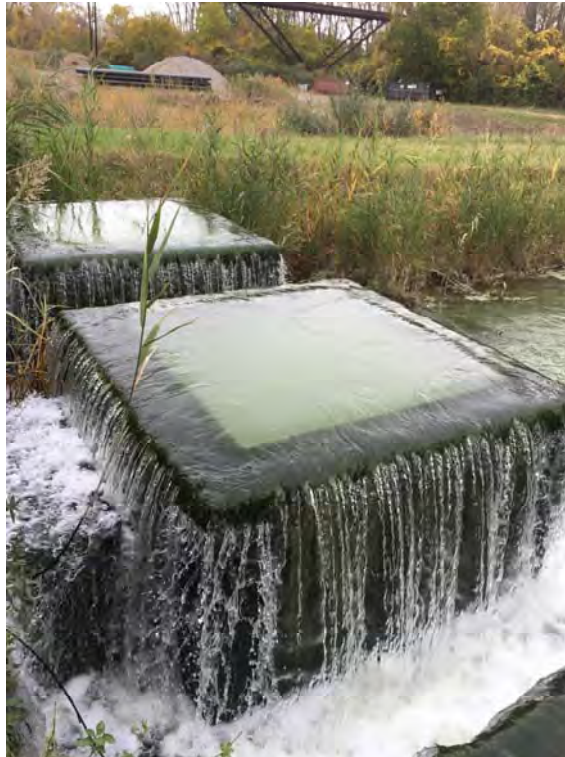
Comments: Photo taken at Station 179+00 at the discharge outlet. Water appeared to be clear coming out of the discharge outlet pipes, indicating no internal erosion.

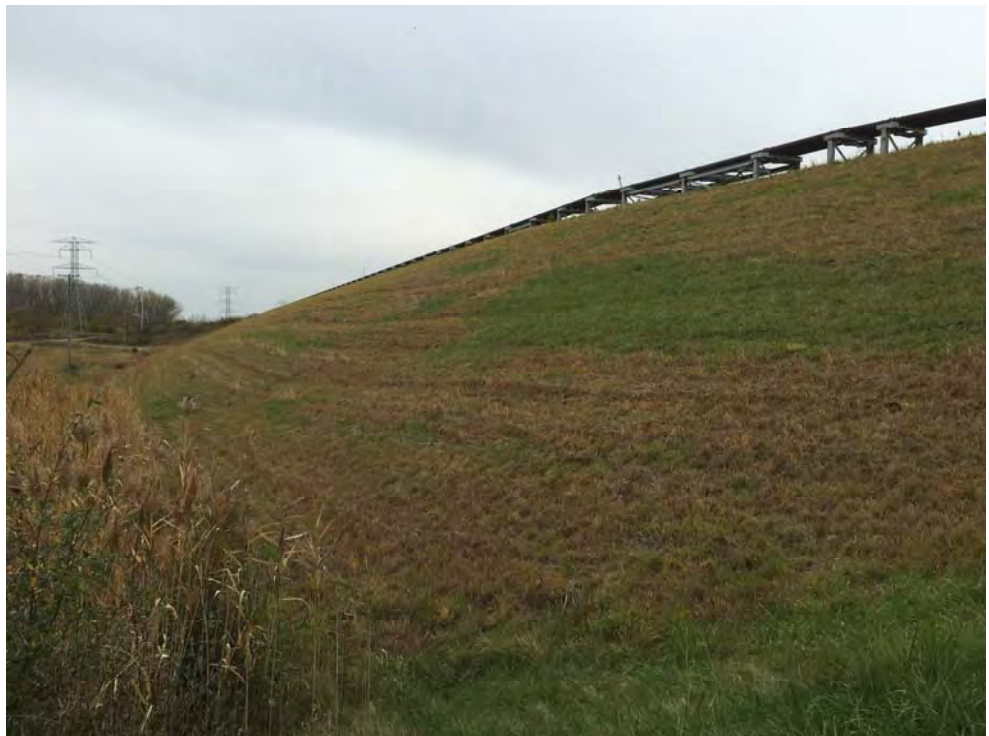
Photograph 16

Comments: Photo taken at Station ~169+00, facing south. The eastern embankment between Stations 4+00 and 162+00 appeared to have uniform slopes without sign of distress.

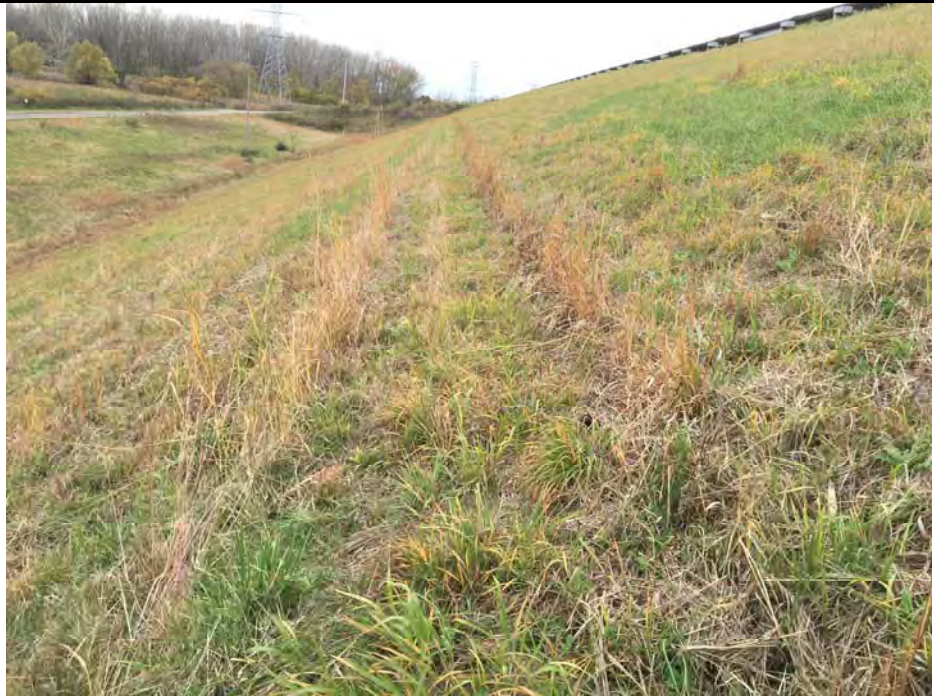
Comments: Photo taken at Station ~167+00, facing south. The eastern embankment between Stations 4+00 and 162+00 appeared to have uniform slopes without sign of distress.

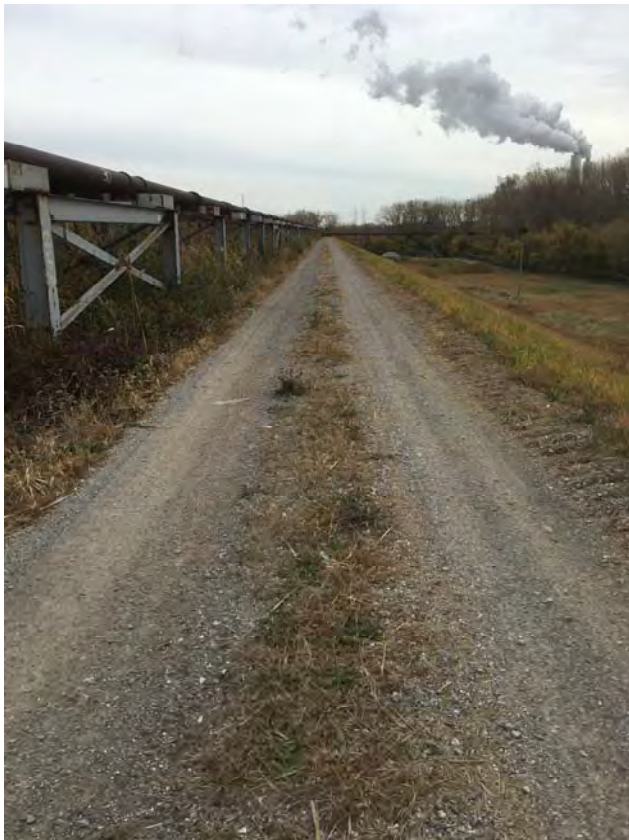
Photograph 18

Comments: Photo taken at Station ~165+00, facing north. The crest of the eastern embankment between Stations 4+00 and 155+00 appeared to be level without sign of distress.

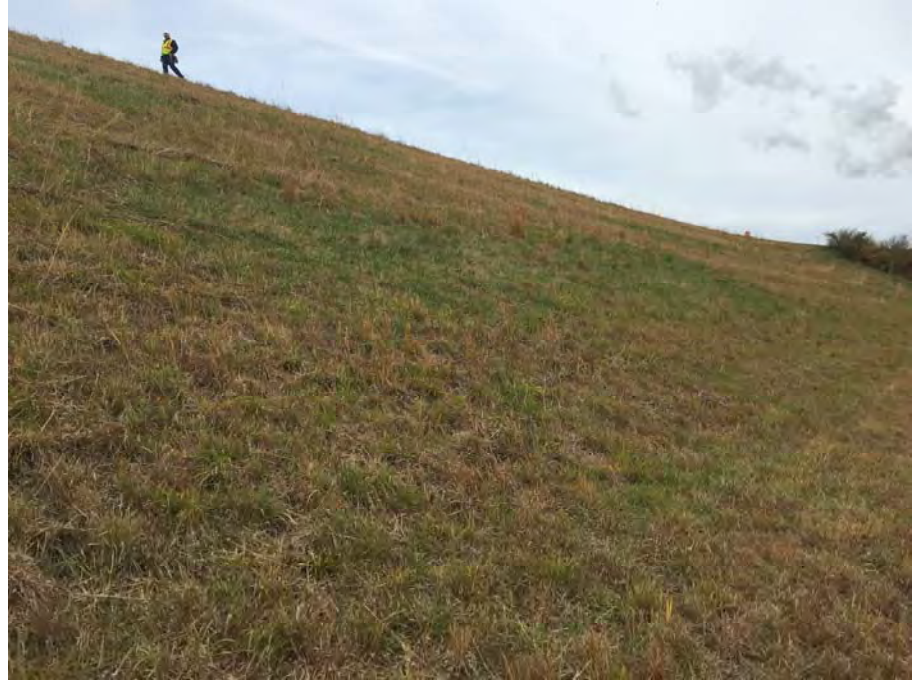
Comments: Photo taken at Station ~163+00, facing northwest. The eastern embankment between Stations 4+00 and 162+00 appeared to have uniform slopes without sign of distress.

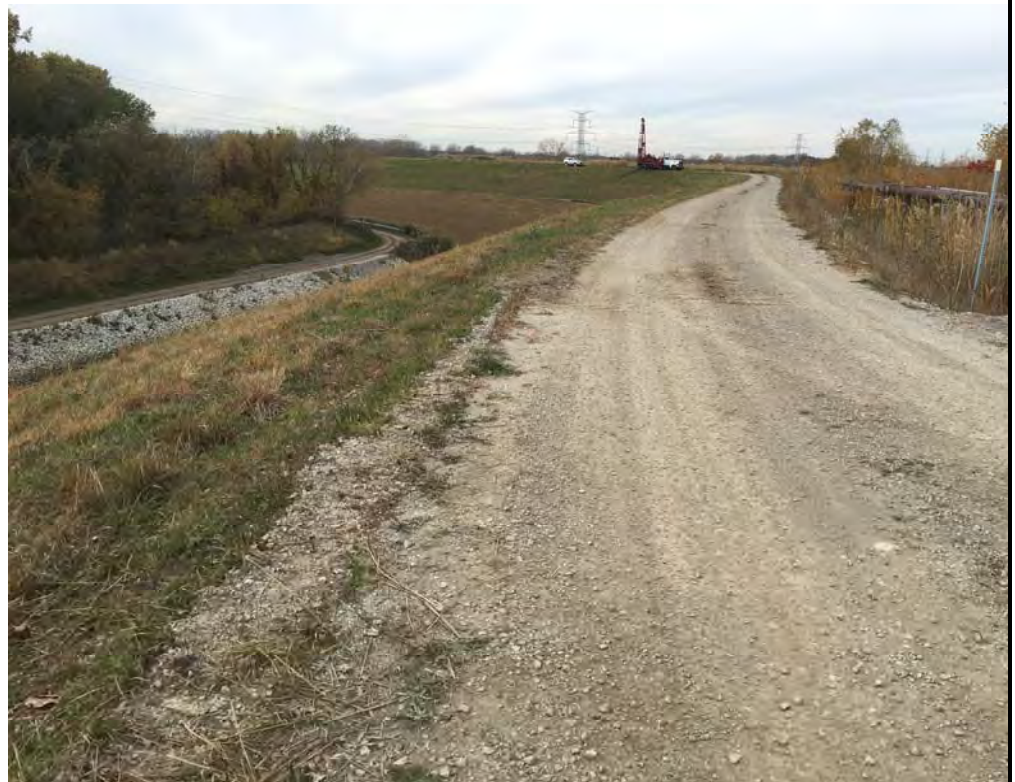
Comments: Photo taken at Station ~155+00, facing southwest. The crest of the southeastern embankment between Stations 139+00 and 155+00 appeared to be level without sign of distress.

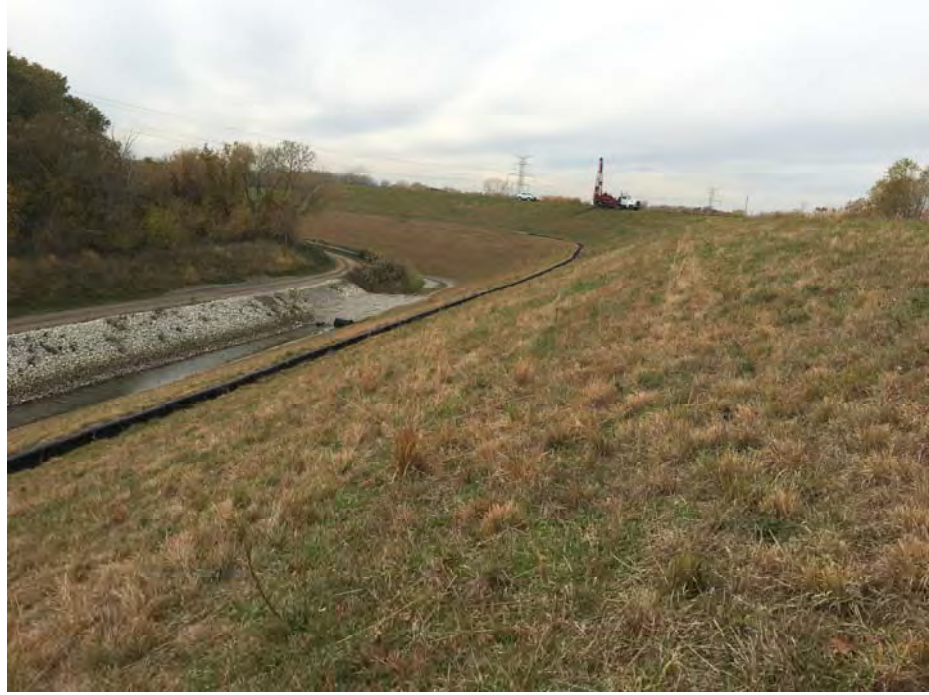
Comments: View of the southeastern embankment from Station 155+00, facing southwest.

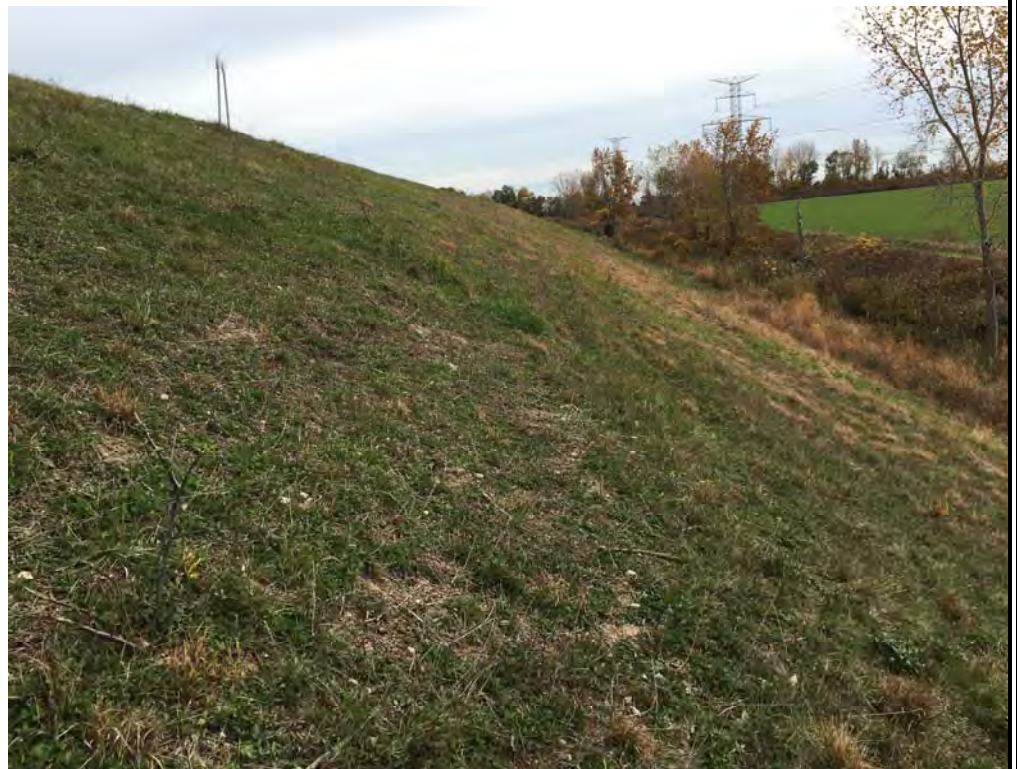
Comments: Photo taken at Station ~127+00, facing east. The southern embankment between Stations 110+00 and 139+00 appeared to have uniform slopes without sign of distress, except ~20-ft long stretch at Station ~122+00 (see Photographs 29-31).

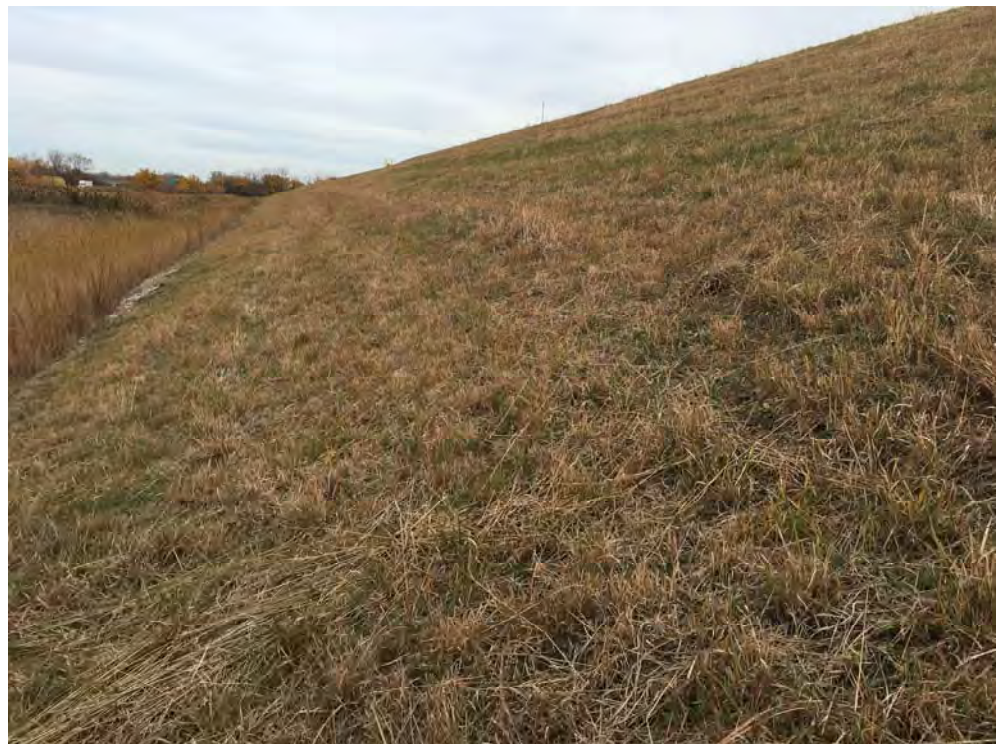
Comments: Photo taken at Station ~100+00, facing west. The southern embankment between Stations 88+00 and 110+00 appeared to have uniform slopes without sign of distress.

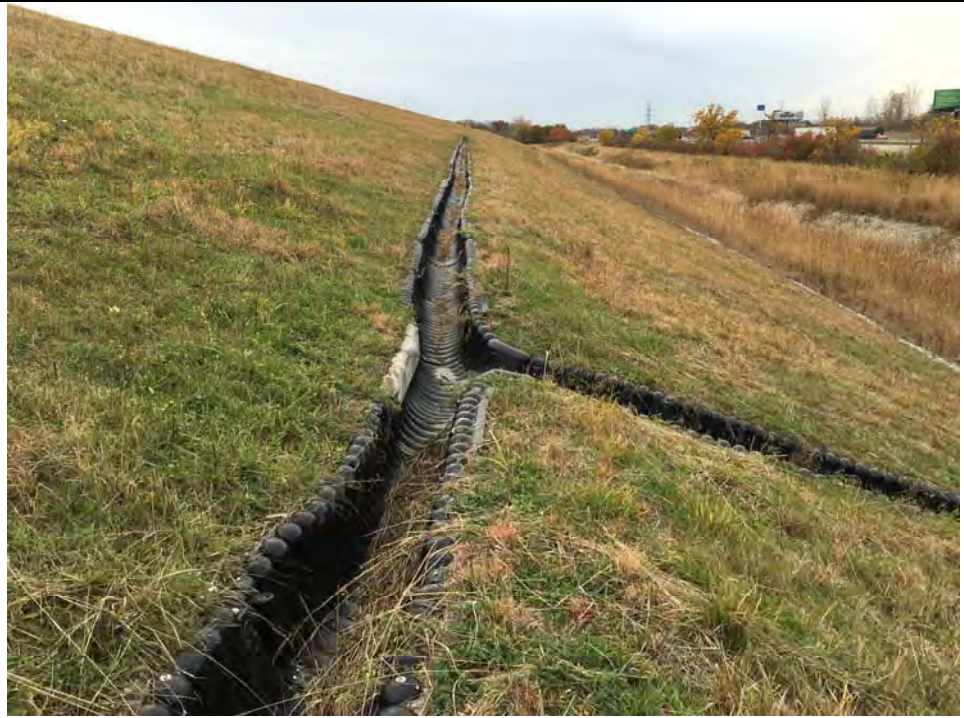
Comments: Photo taken at Station ~75+00, facing south. The western embankment between Stations 88+00 and 69+00 appeared to have uniform slopes without sign of distress, except a small section (see Photograph 36).

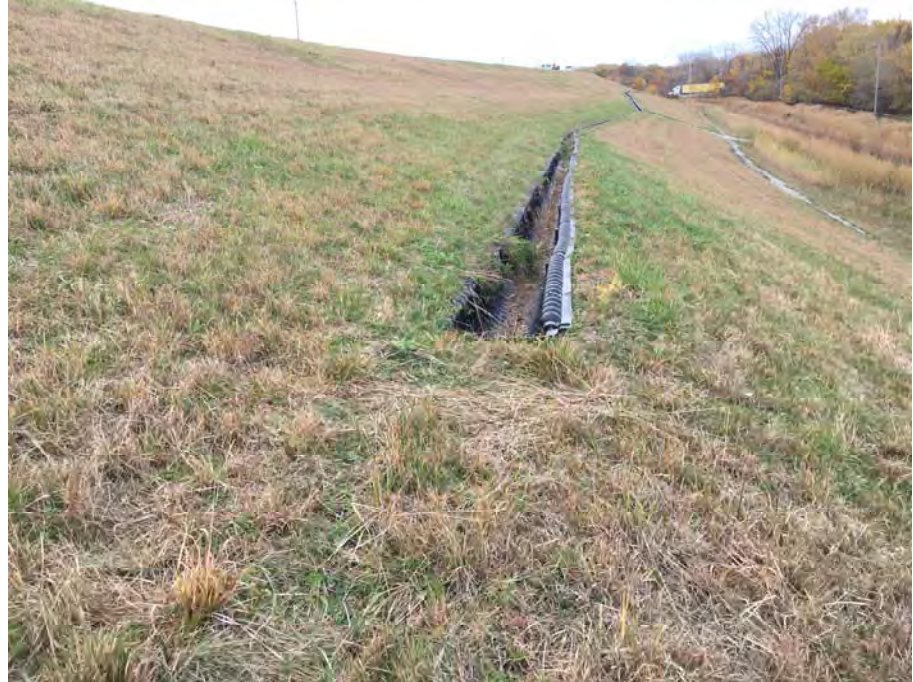
Comments: Photo taken at Station ~60+00, facing west. The northern embankment between Stations 45+00 and 49+00 appeared to have uniform slopes without sign of distress, except the sloughed area at Station ~67+00.

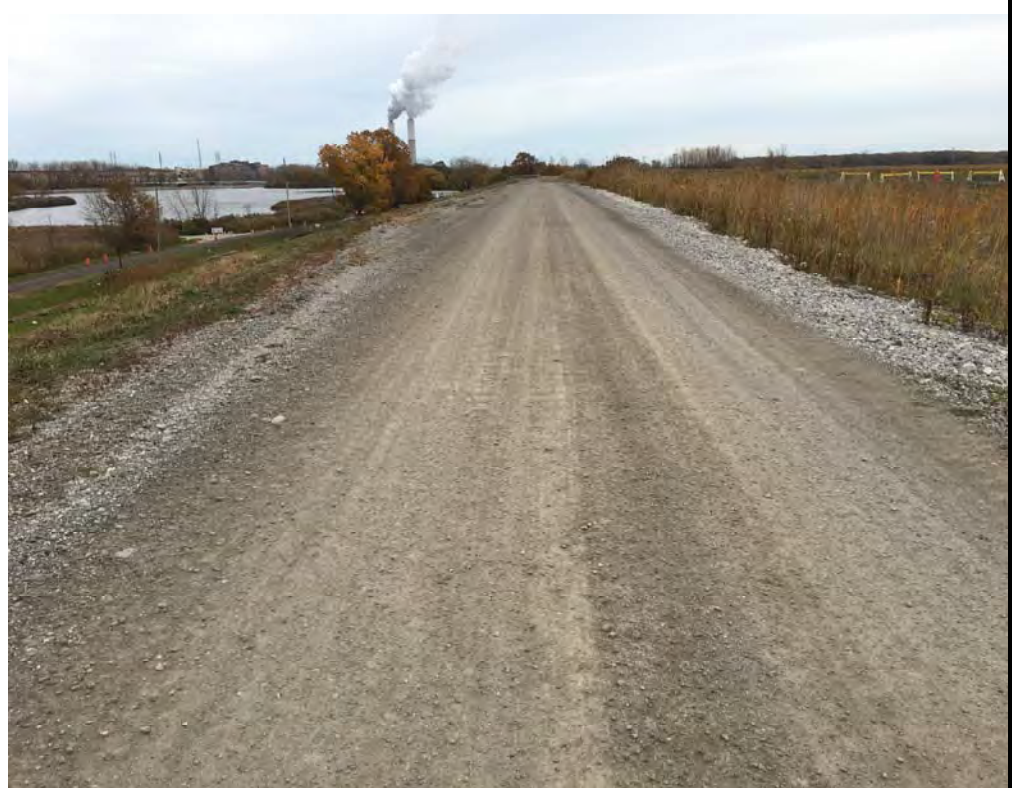
Photograph 42

Comments: Photo taken at Station ~59+00, facing east. The crest between Stations 45+00 and 69+00 appeared to be level without sign of distress.

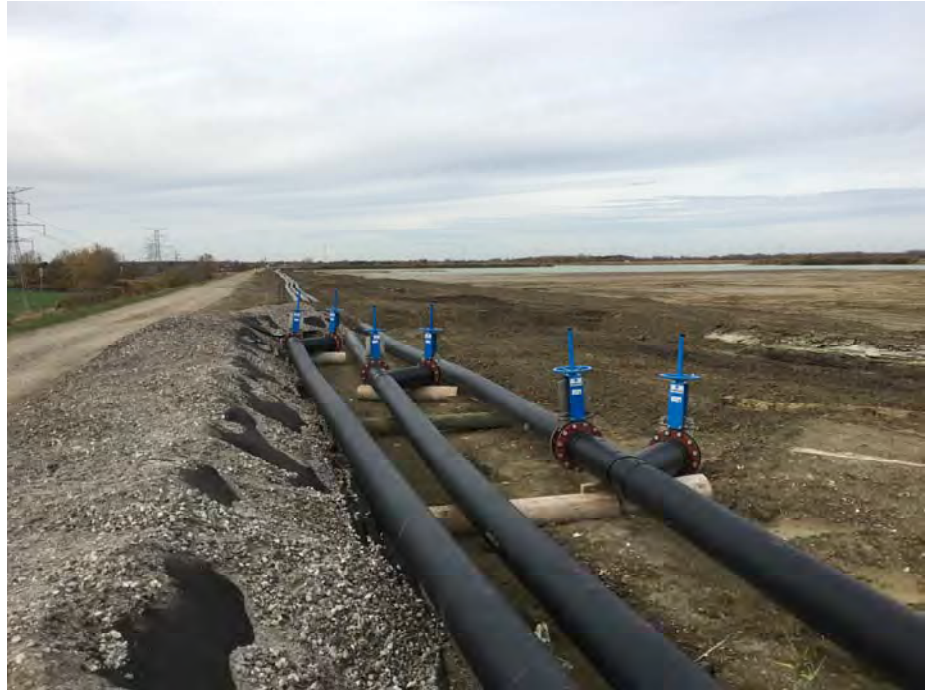
Comments: Photo taken at Station ~125+00, facing west. HDPE Slurry lines along the southern embankment.

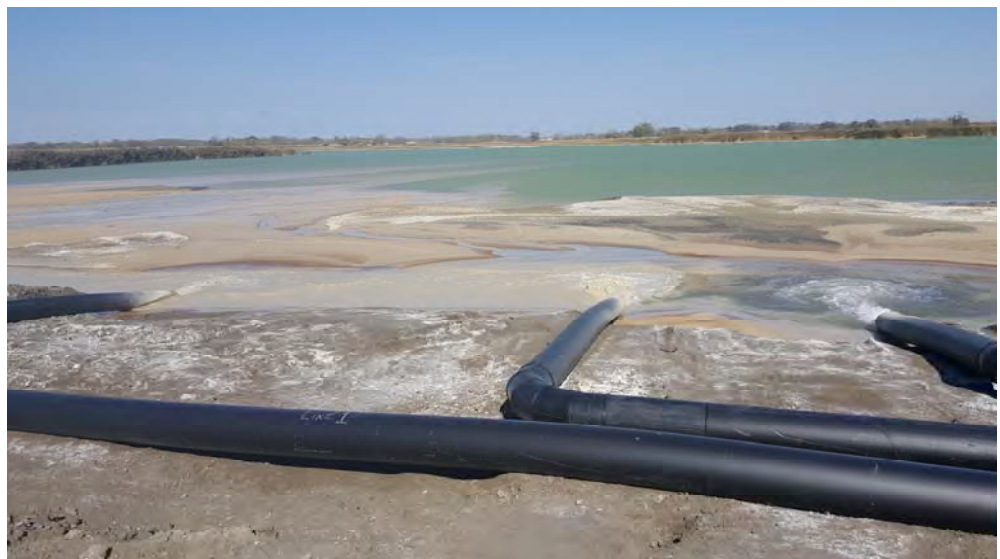
Photograph 44

Comments: Photo taken at Station ~115+00, facing north. Slurry appears to flow without obstructions.
