2016 ANNUAL INSPECTION REPORT ASH BASIN EMBANKMENT

MONROE POWER PLANT

Monroe, Michigan

January 2017

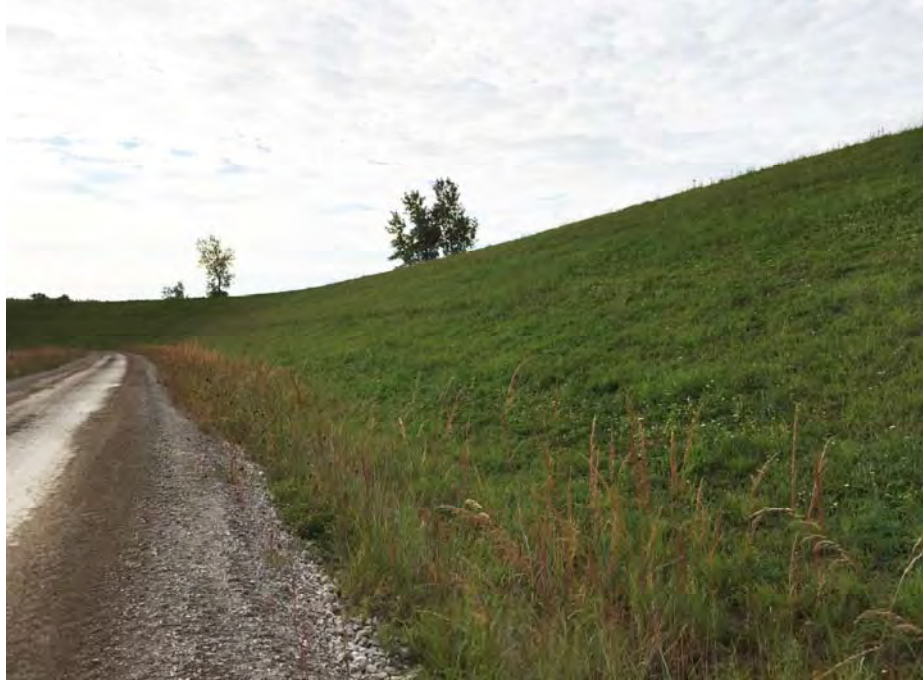
Comments: Photo
taken at Station
~45+00, facing east.
The embankment
appeared to have
uniform slopes without
sign of distress.

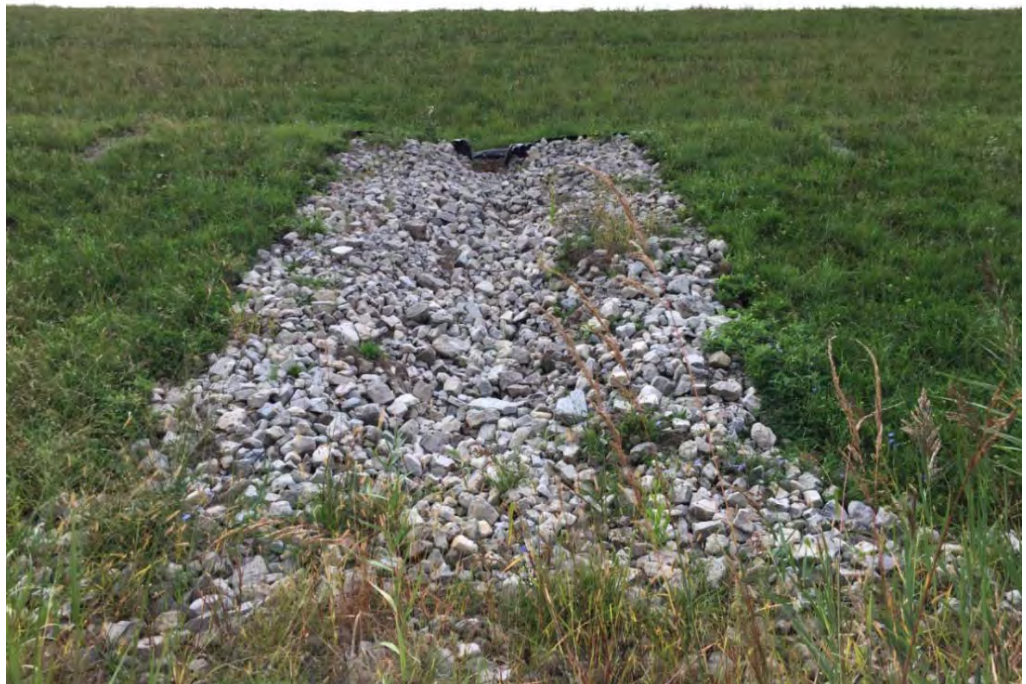
Photograph 2

Comments: Photo
taken at Station
~32+00, facing east.
HDPE downchute has
been replaced with a
riprap downchute.

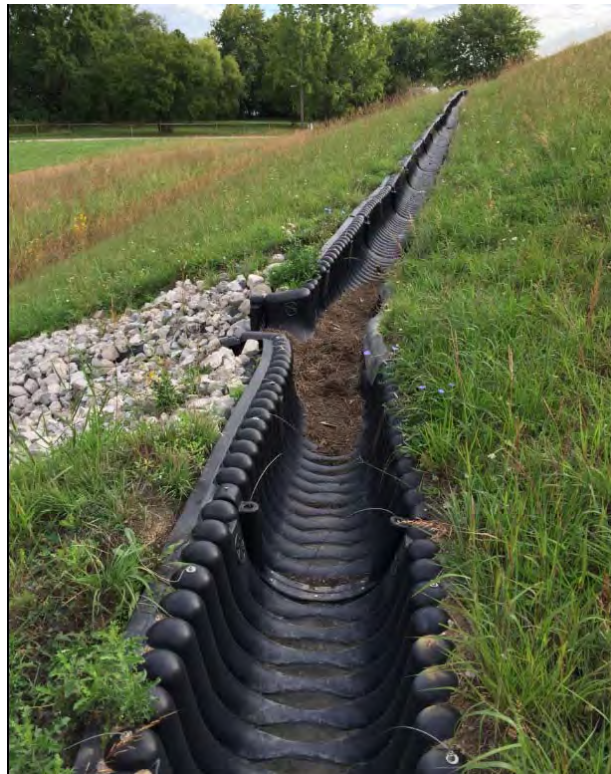
Comments: Mid-slope
ditch at Station 32+00
connecting to riprap
downchute. Vegetation
build-up was noticed in
the mid-slope ditch.

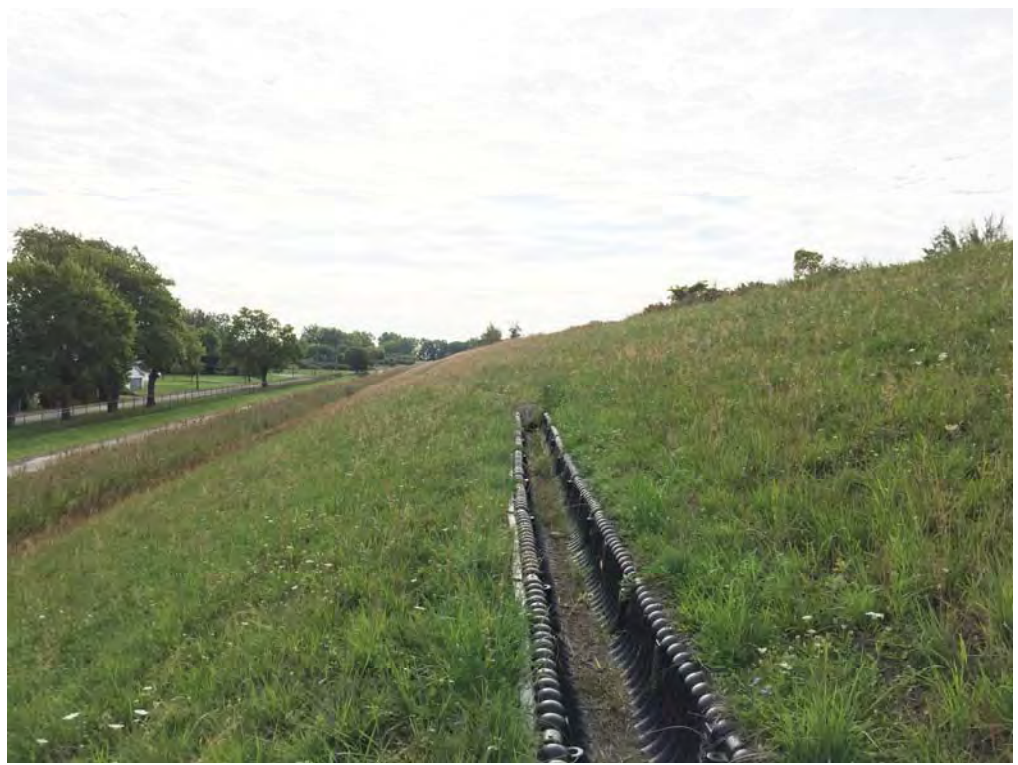
Comments: Photo taken at Station 29+50, facing east. The embankment appeared to have uniform slopes without sign of distress.

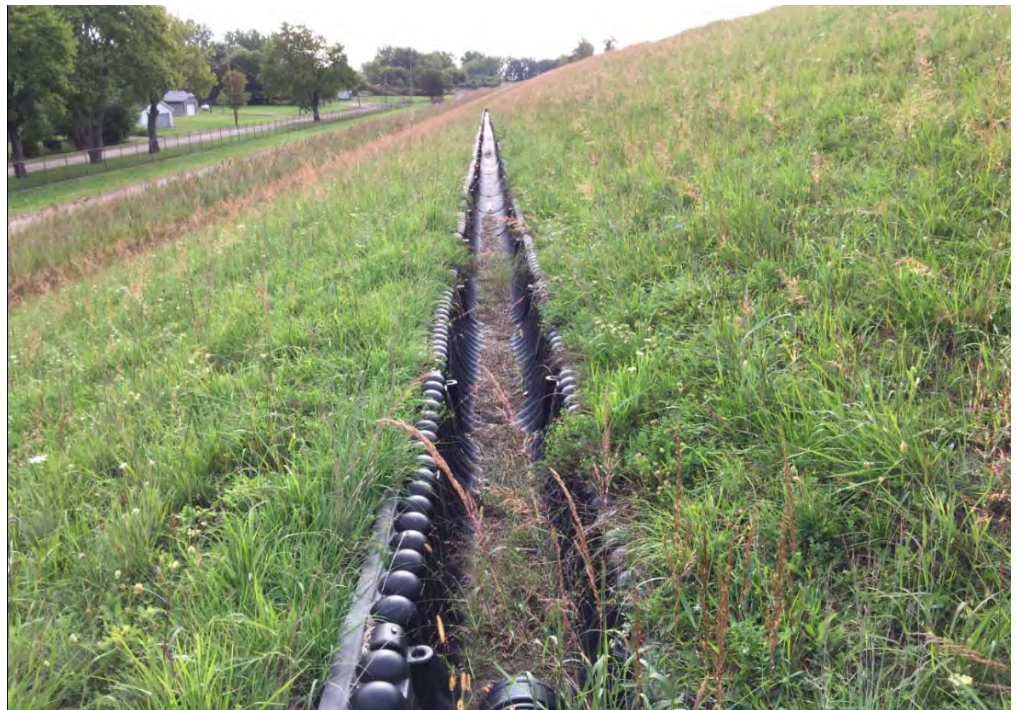
Photograph 6

Comments: Photo taken at Station 30+00, facing east. In general, the mid-slope ditch appeared to be in good condition. Vegetation build-up was observed in the mid-slope ditch at various locations.

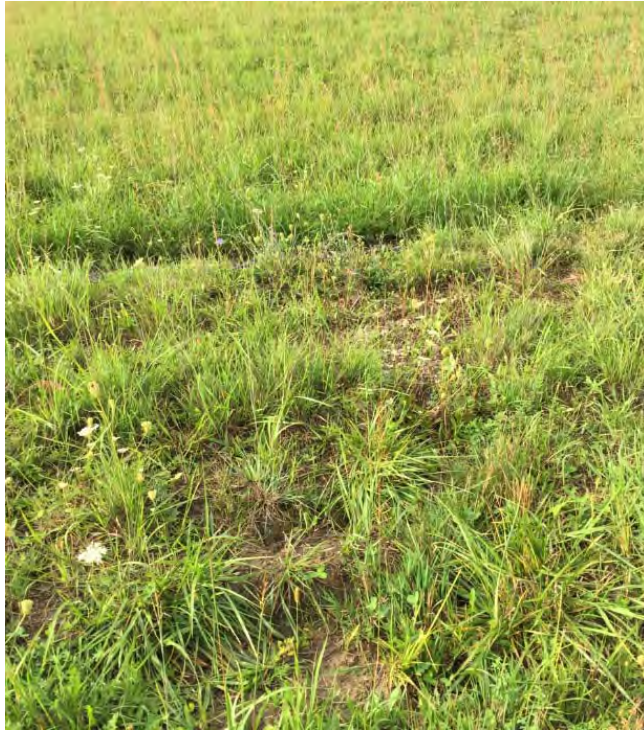
Comments: Sparse vegetation was noticed on the embankment at Station ~27+00. No erosion was observed.

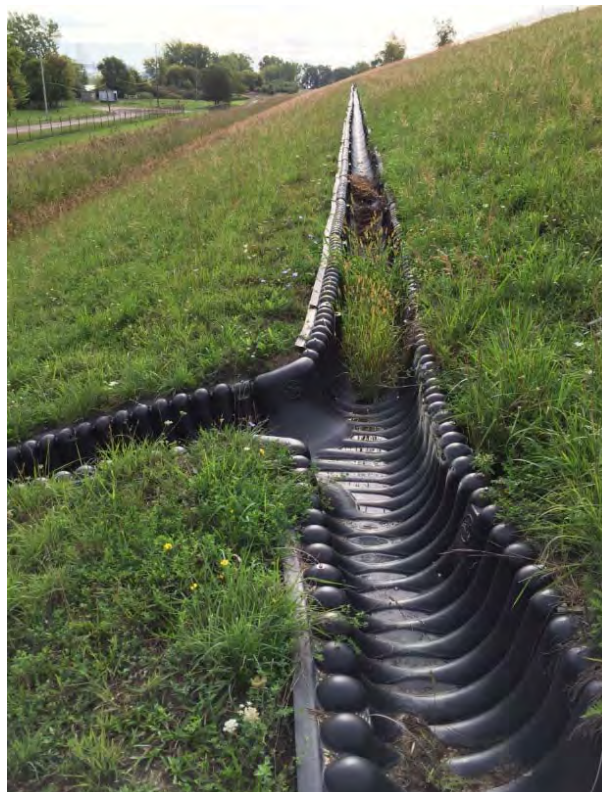
Photograph 8

Comments: Photo taken at Station ~26+00, facing east. Vegetation was observed in the mid-slope ditch.

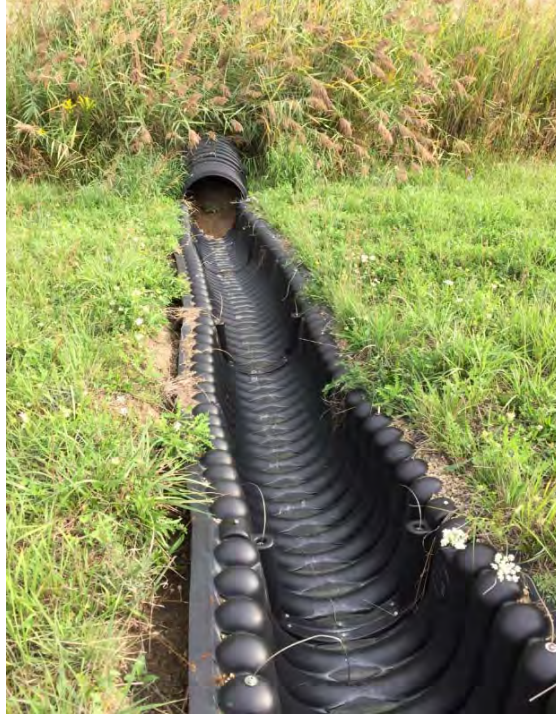
Comments: Downchute at Station 26+00. A gap up to six-inches wide was noticed between the flange and adjacent soil.

- The gap between midslope ditch flap and adjacent ground was observed at various sections along the embankment. These gaps do not represent an immediate concern for the safe operation or stability of the ash basin. However, gaps on the upstream side of the midslope ditch shall be filled in accordance with IMM Manual to direct stormwater into the midslope ditch.

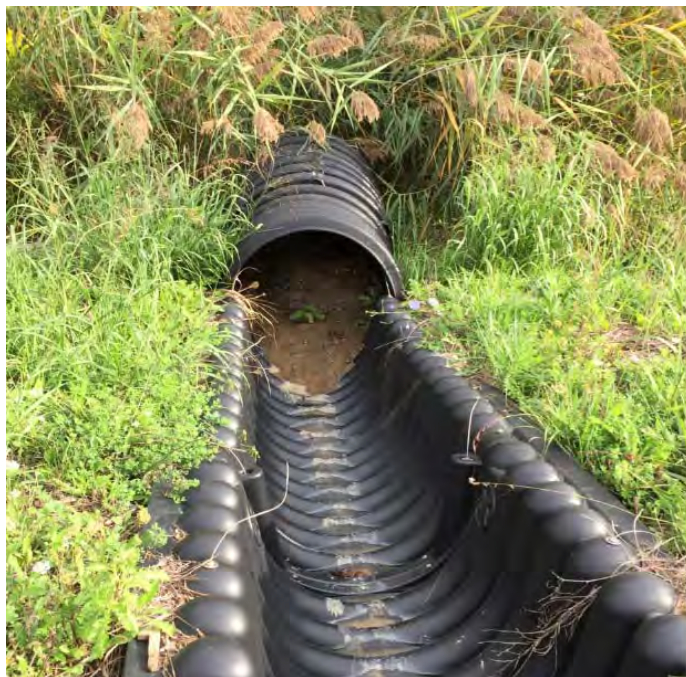
Photograph 10

Comments: Downchute at Station 26+00. Sediment build-up was noticed at the downstream end of downchute.

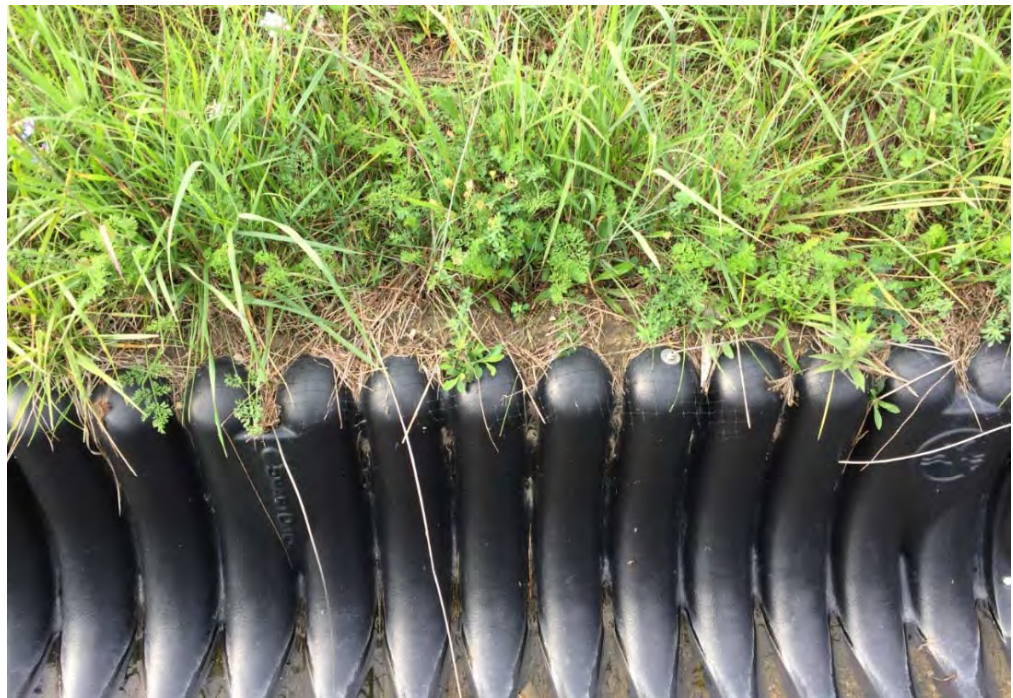
Comments: In general, good contact between the mid-slope ditch and upslope soil was observed.

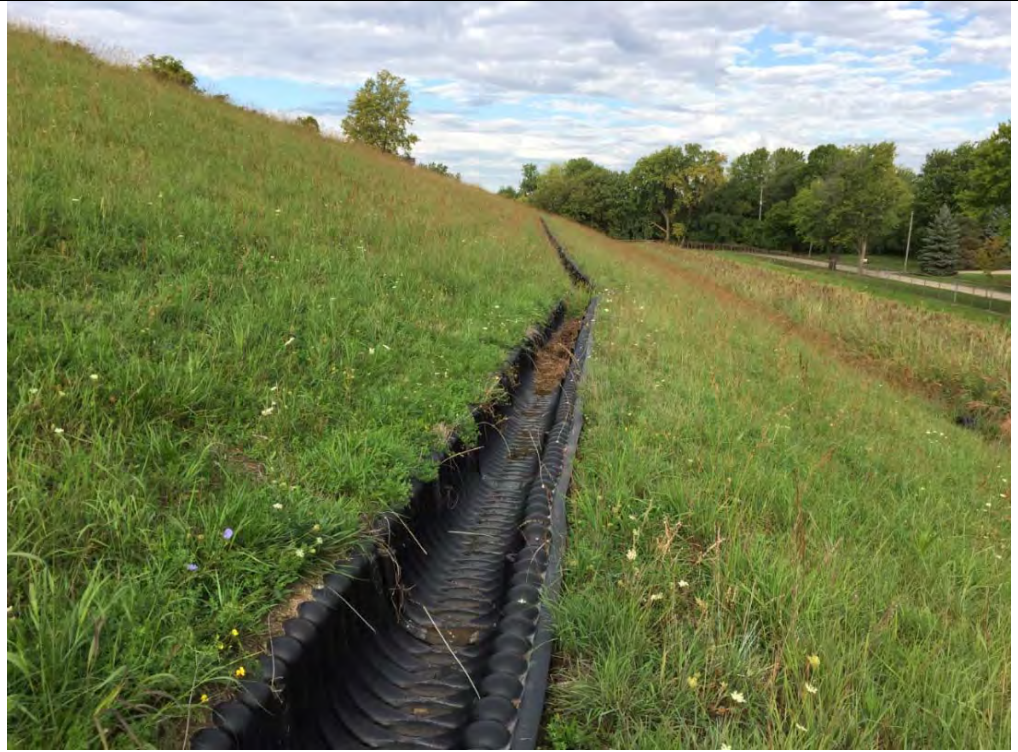
Comments: Photo taken at Station 25+00, facing west. The embankment appeared to have uniform slopes without sign of distress.

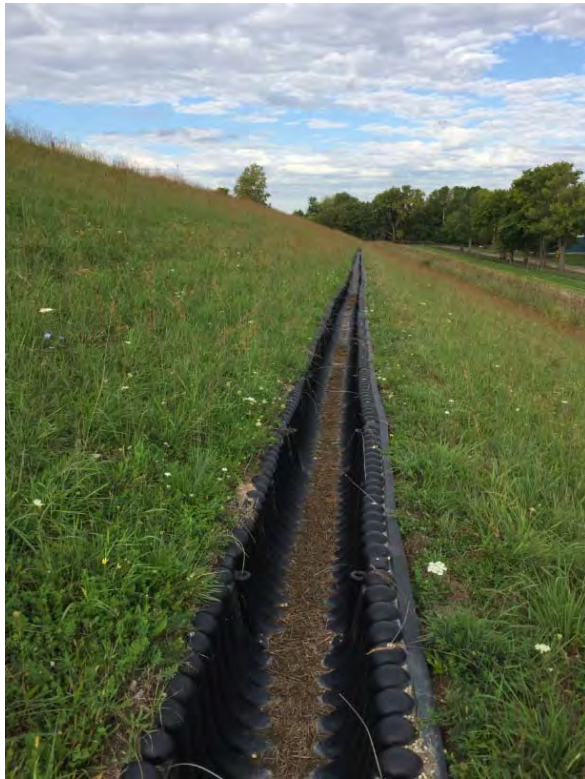
Comments: Photo taken at Station 22+00, facing west. The embankment appeared to have uniform slopes without sign of distress. Vegetation buildup was observed in the ditch.

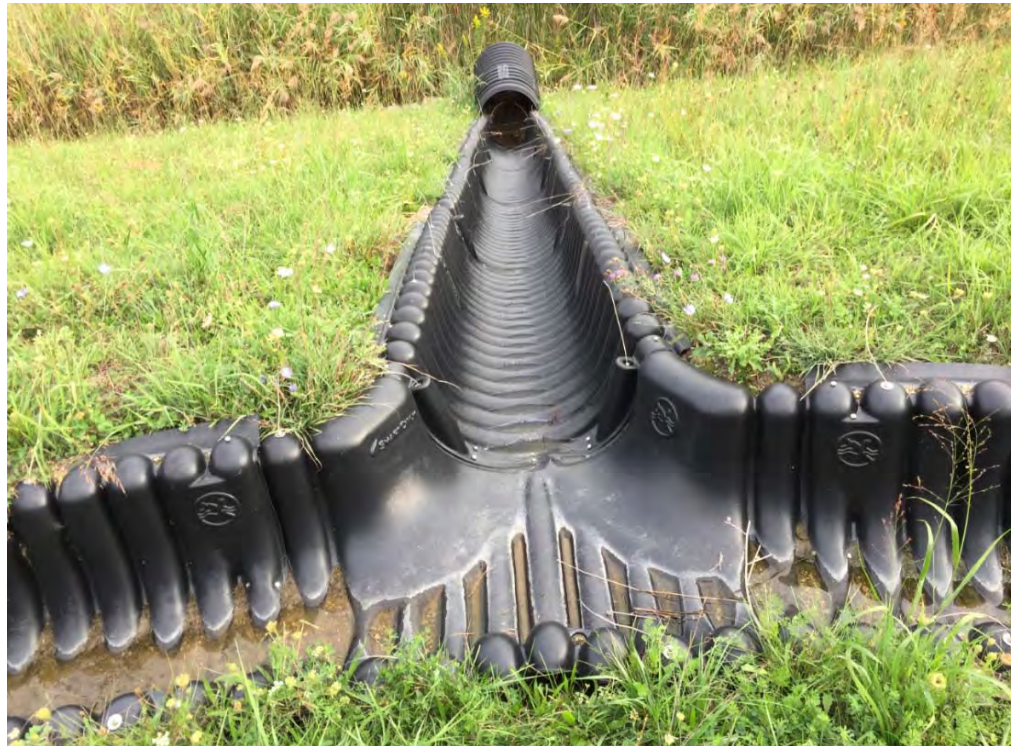
Photograph 16

Comments: Downchute at Station 18+00 appeared to be in good condition.

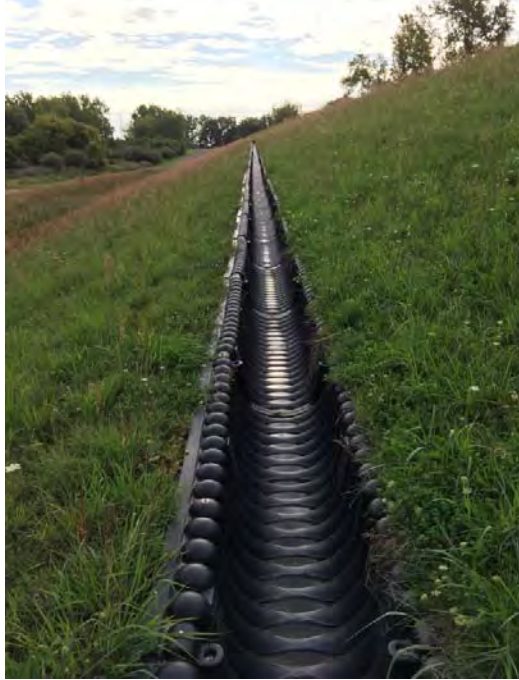
Comments: Photo
taken at Station 6+00,
facing east. The
embankment appeared
to have uniform slopes
without sign of
distress.

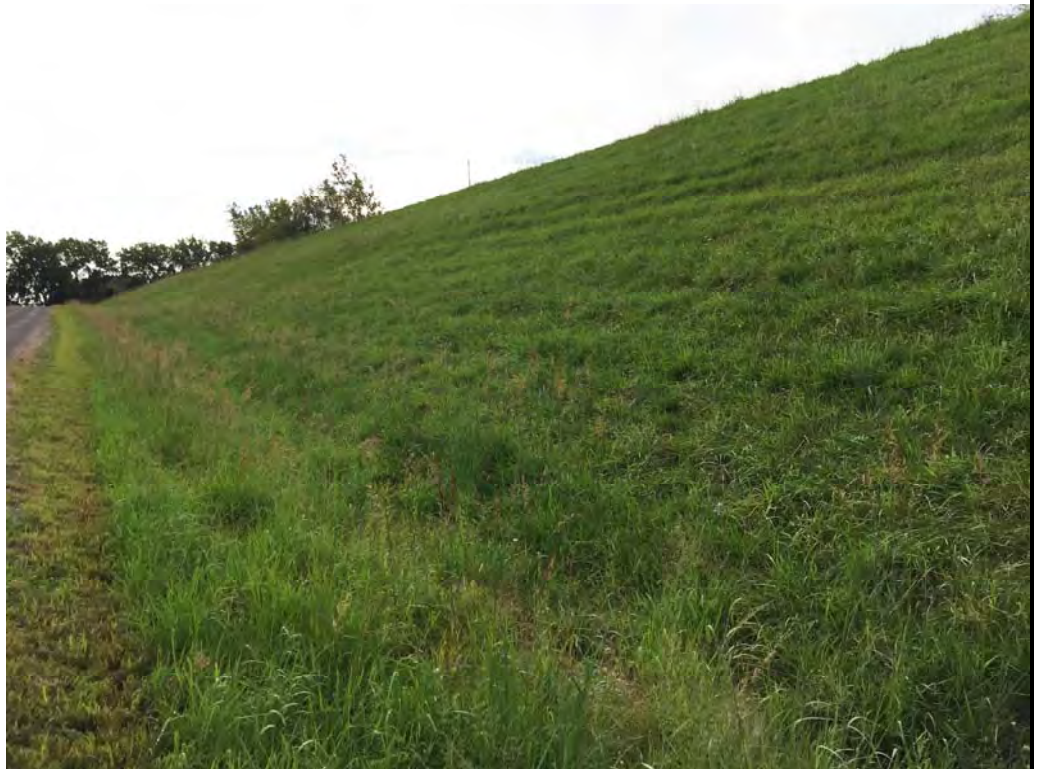
Photograph 18

Comments: Photo
taken at Station 13+00,
facing east. The
embankment appeared
to have uniform slopes
without sign of
distress.

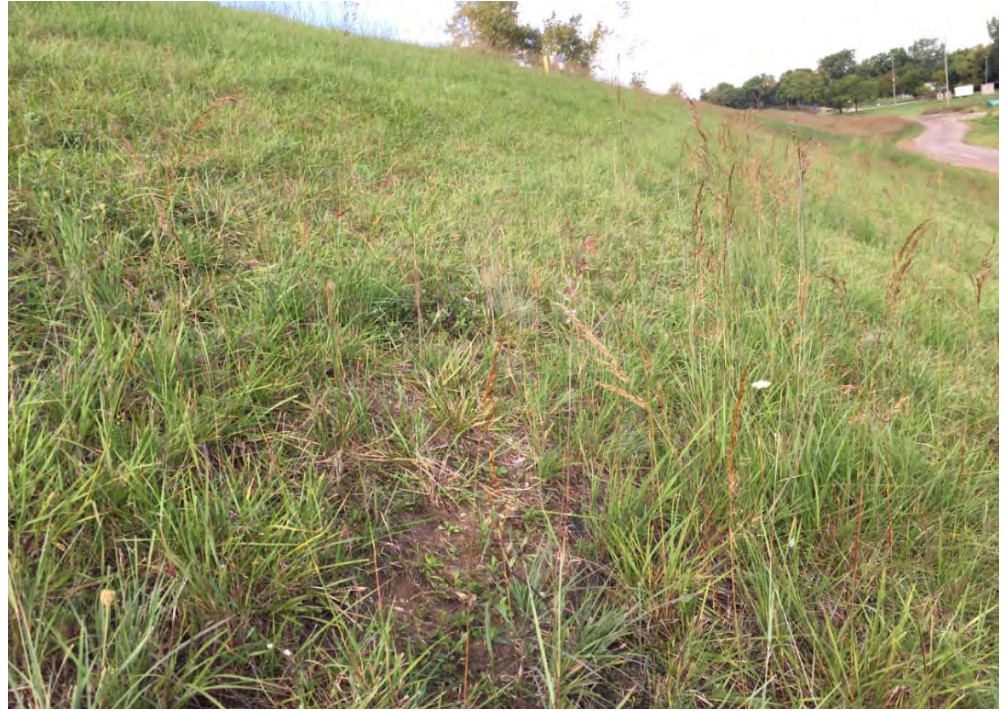
Comments: Sparse vegetation observed on the embankment at Station ~10+00. No erosion was observed.

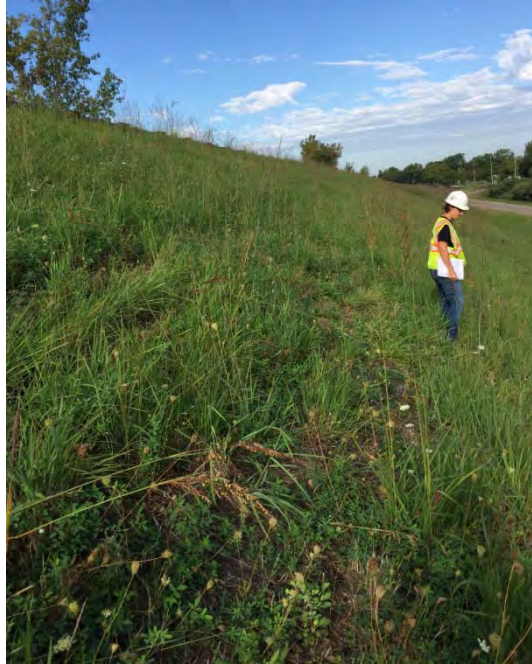
Comments: Vegetation
at Station ~8+00
appeared to be damaged
during mowing
operations.

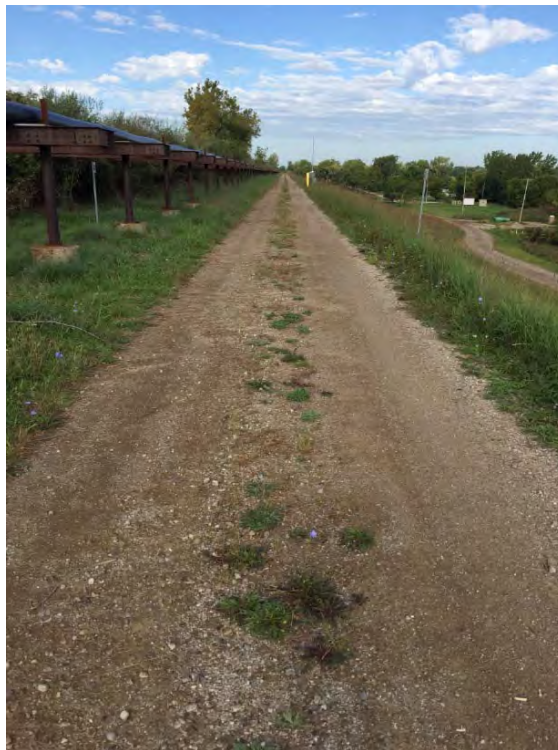
Photograph 22

Comments: Photo taken
at Station ~6+00, facing
west. Crest road
appeared to be in good
condition with no signs
of crack, ruts and pot
holes.

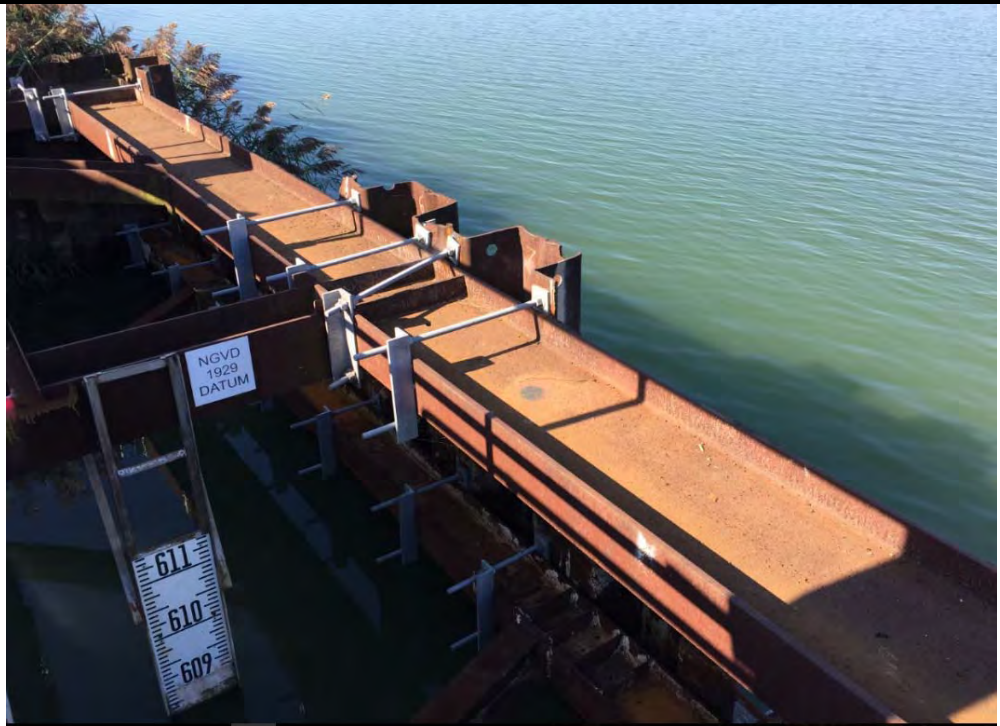
Comments: Discharge
structure appeared to be
in good working
condition. Water level
was at elevation 608.6 ft.

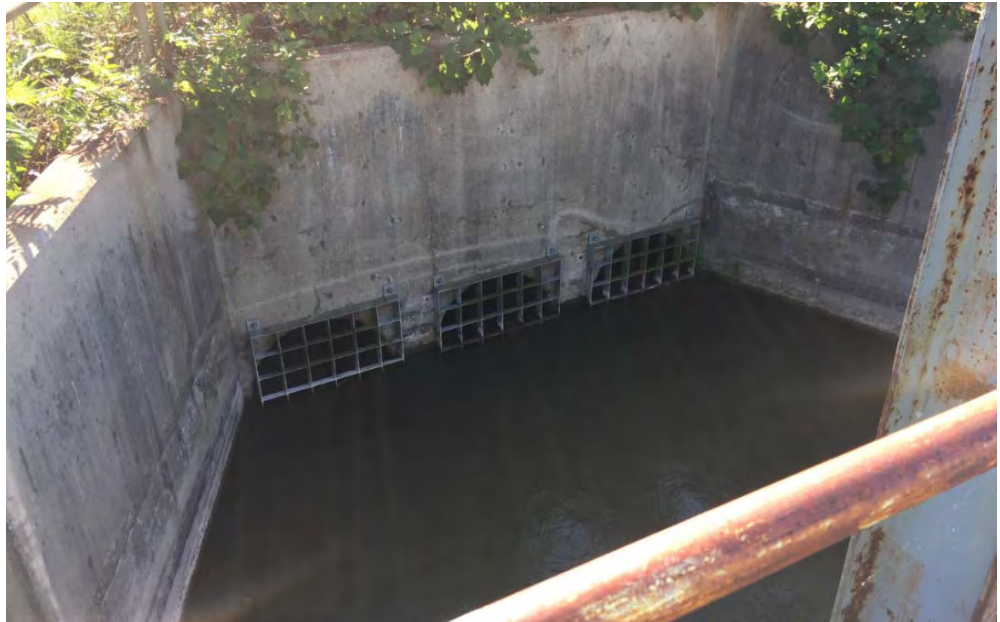
Photograph 28

Comments: Discharge
structure appeared to be
in good working
condition.

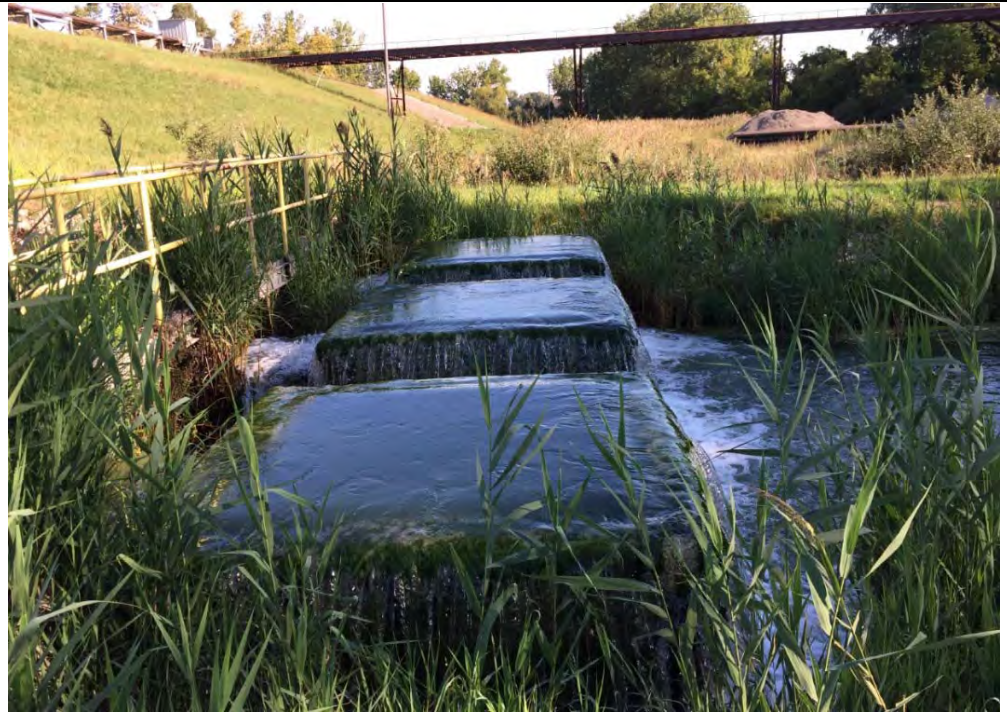
Comments: Water
discharging at the
concrete outlet appeared
to be clear.

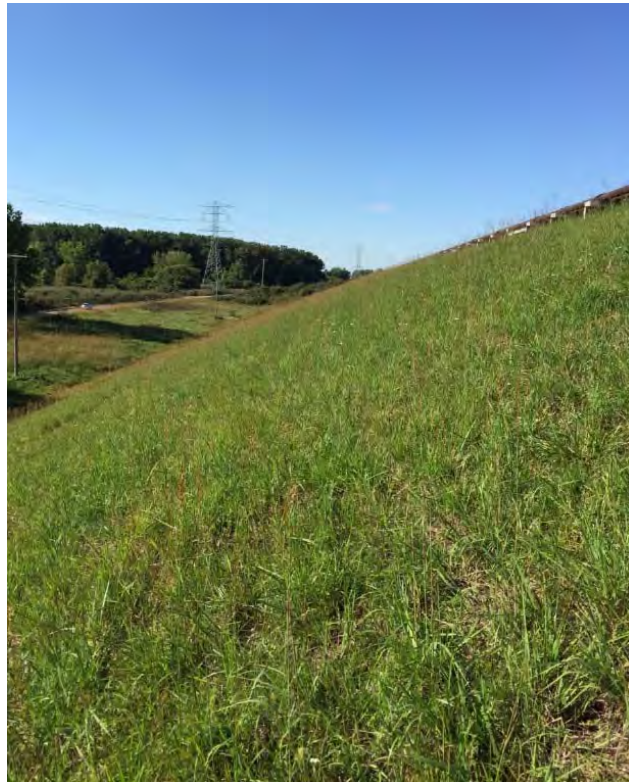
Photograph 30

Comments: Photo taken
at Station ~178+00,
facing south. The
embankment appeared to
have uniform slopes
without sign of distress.

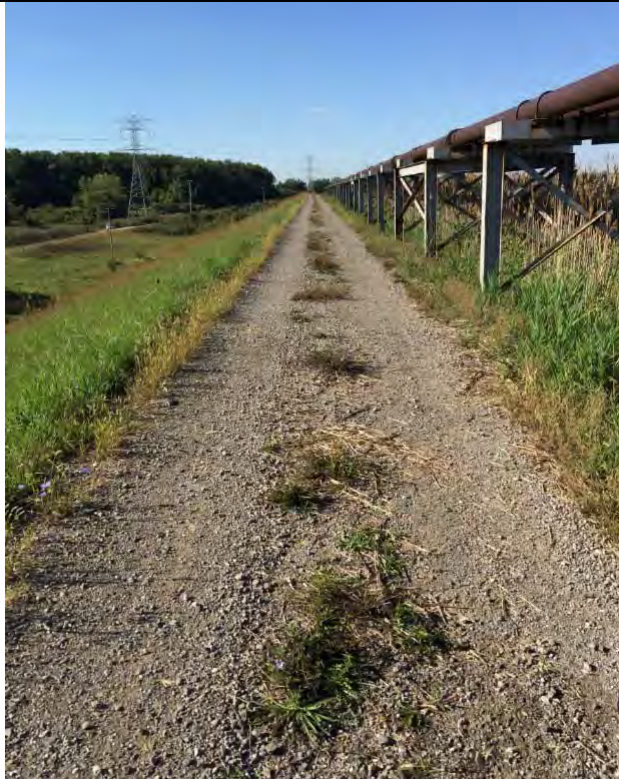
Comments: Photo taken
at Station ~176+00,
facing south. Crest road
appeared to be in good
condition with no signs
of crack, ruts and pot
holes.

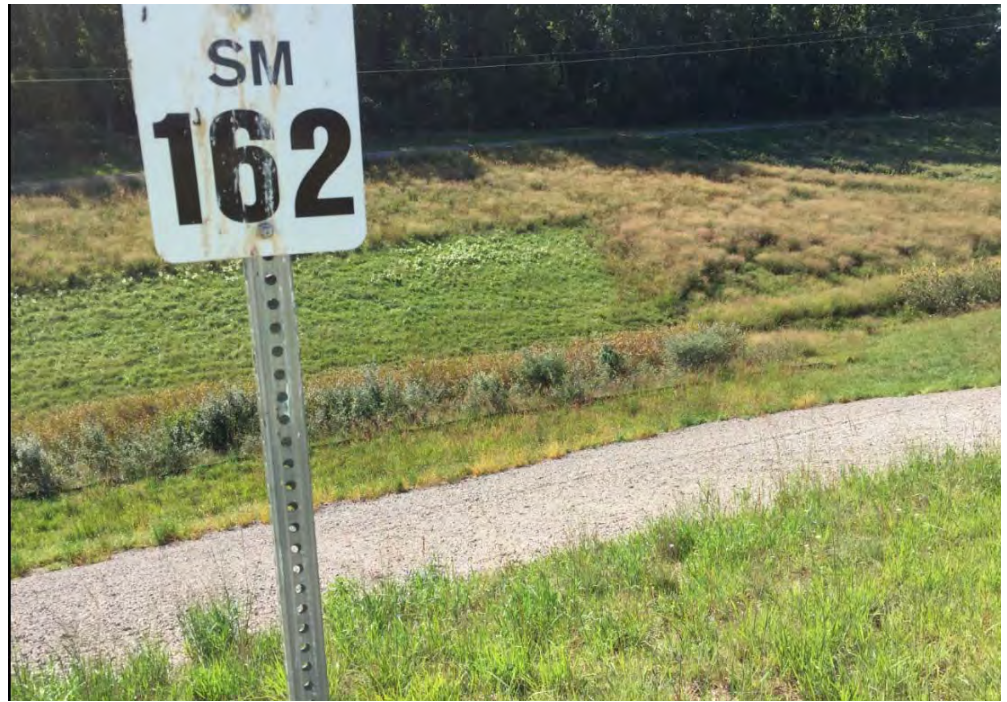
Comments: The area that was repaired last year at Station 161+75 appeared to be in good condition. However, cracks were observed upslope of the repaired area (see the next photo).

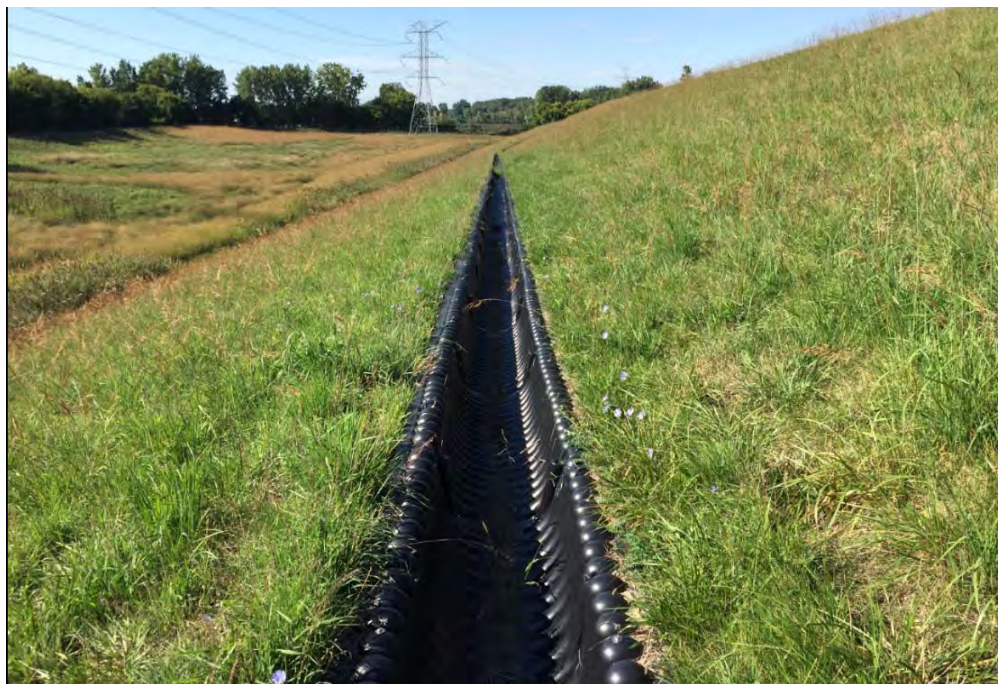
Comments: Photo taken
at Station ~160+00,
facing south. The
embankment appeared to
have uniform slopes
without sign of distress.

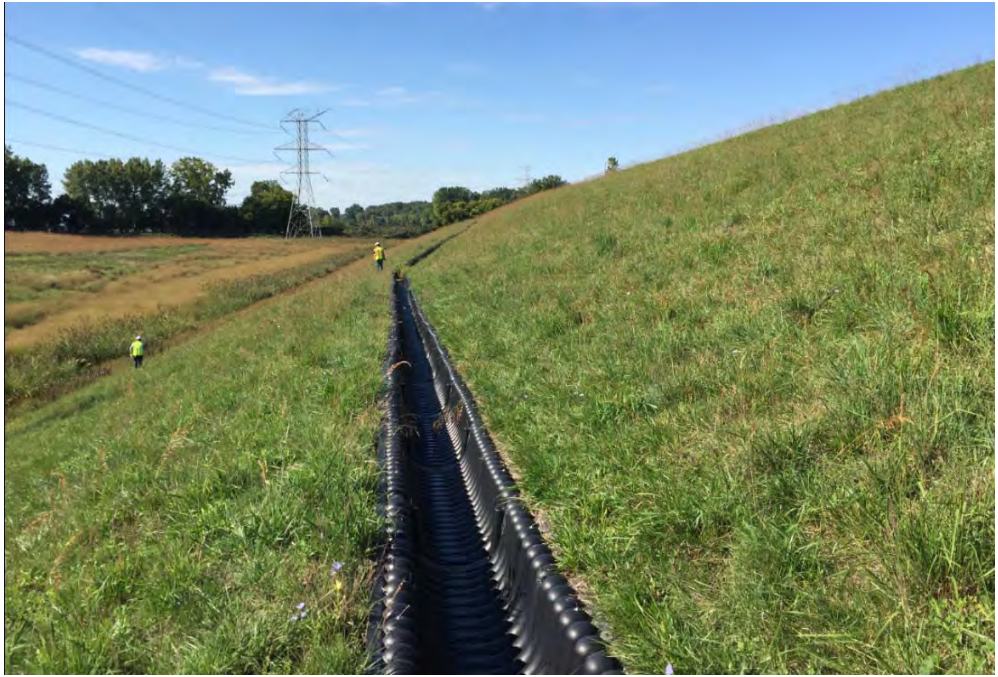
Comments: Photo taken
at Station ~156+00,
facing south. The
embankment appeared to
have uniform slopes
without sign of distress.

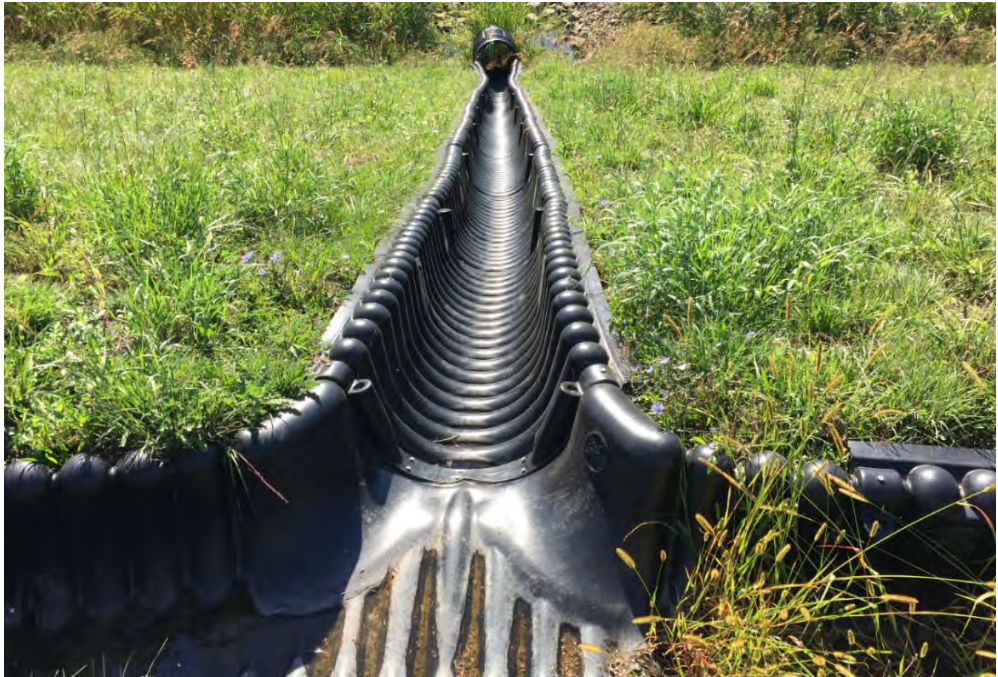
Photograph 42

Comments: Downchute
at Station 156+00
appeared to be in good
working condition.

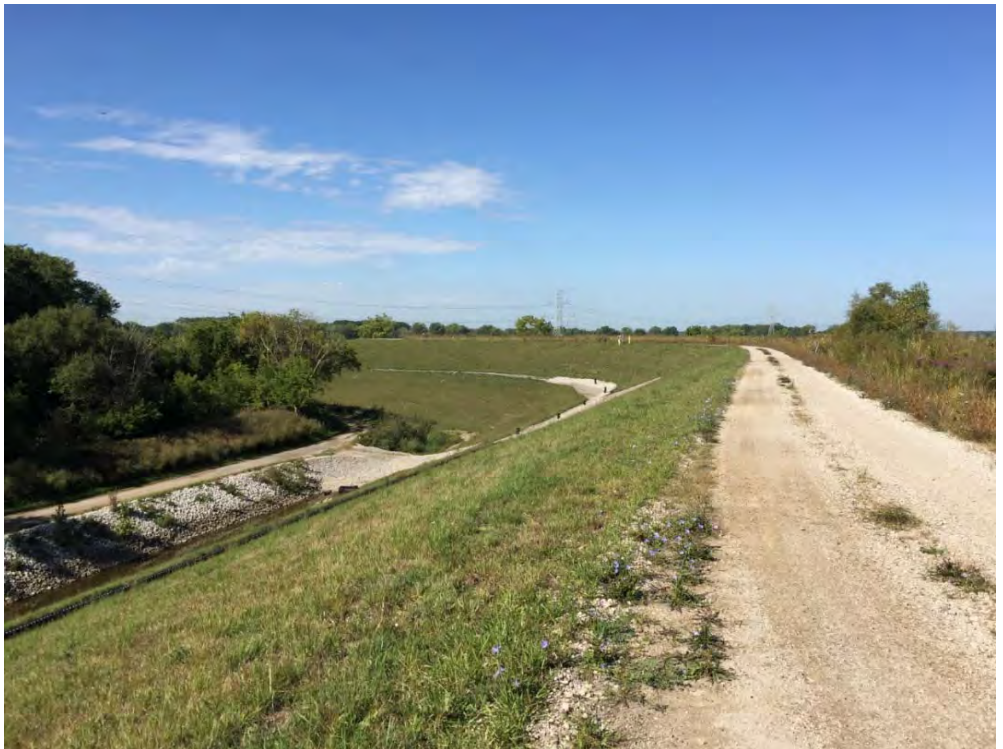
Comments: View of
southeast corner from
Station ~148+00 looking
southwest.

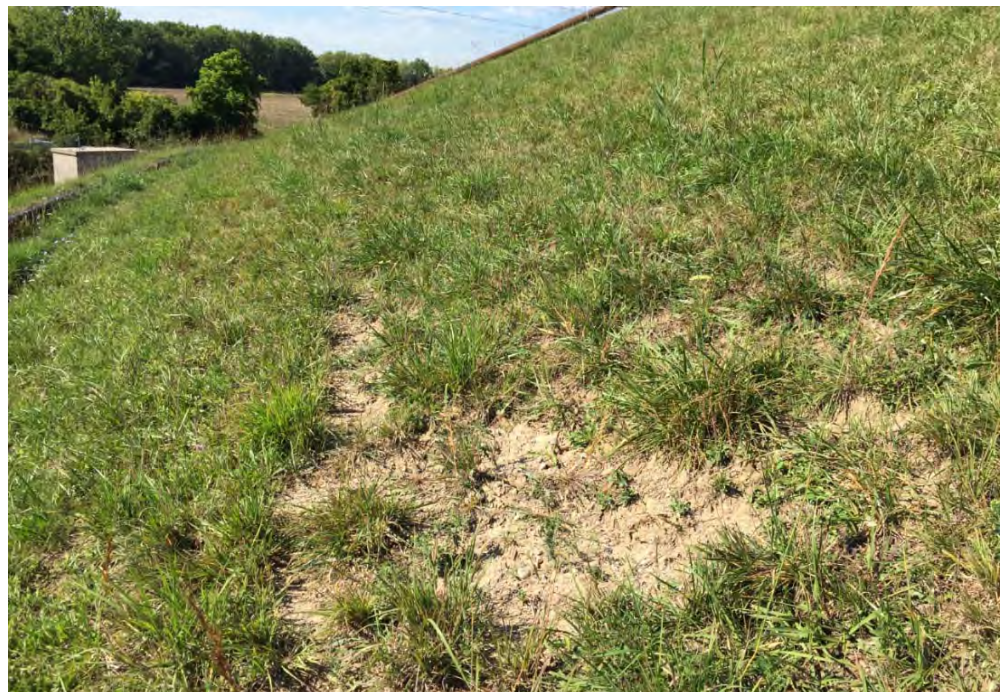
Comments: Sparse vegetation at Station 139+75 (~5 ft x ~4 ft).

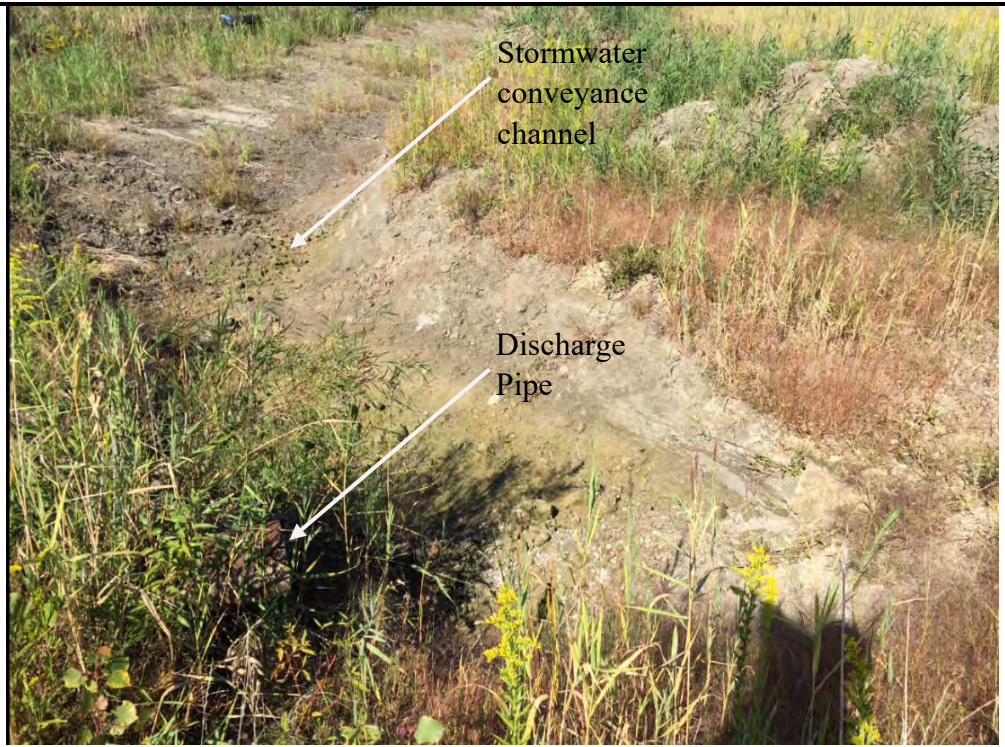
Comments: Pump house discharge pipe is not obstructed.

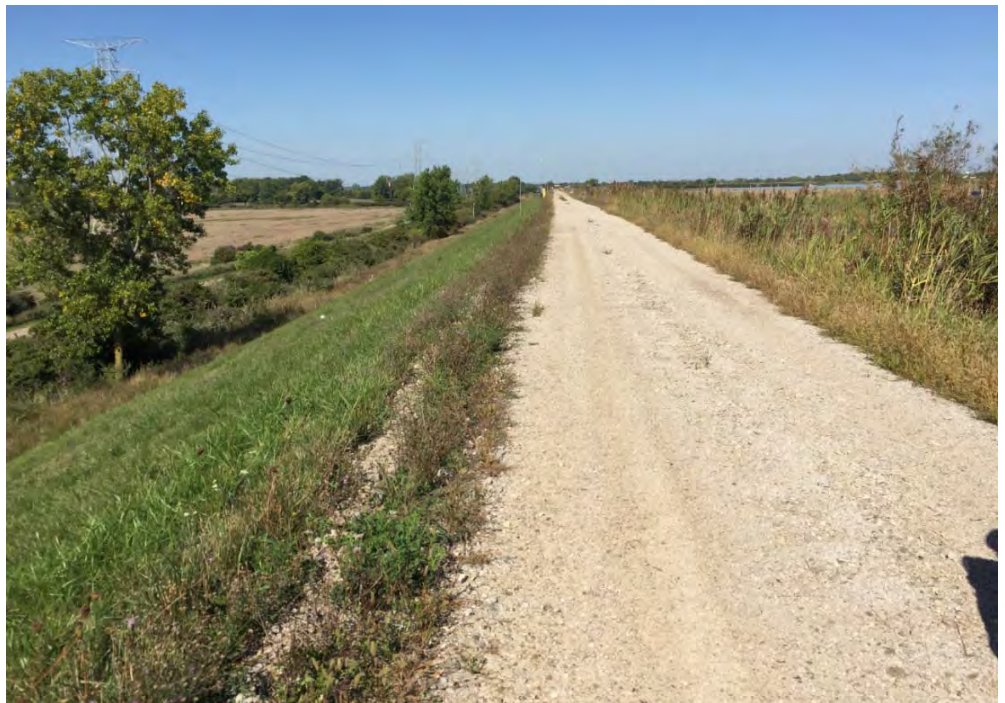
Photograph 52

Comments: Photo taken at Station ~135+00, facing west. Crest road appeared to be in good condition with no signs of crack, ruts and pot holes.

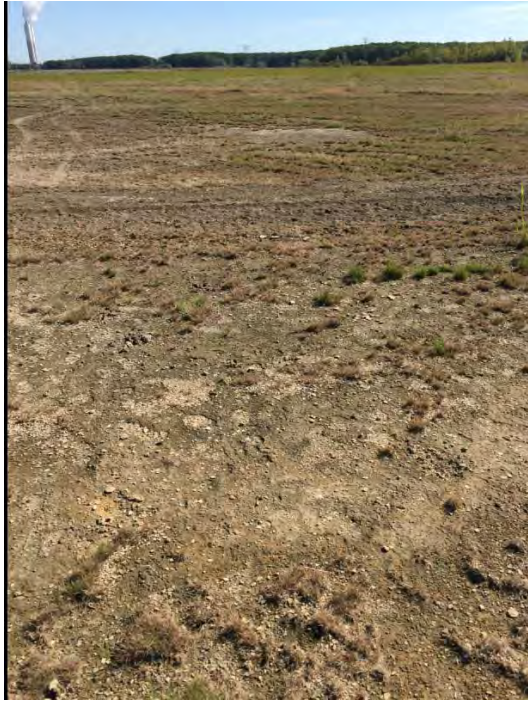
Comments: Exposed ash
at the southeast area has
bare to sparse
vegetation.

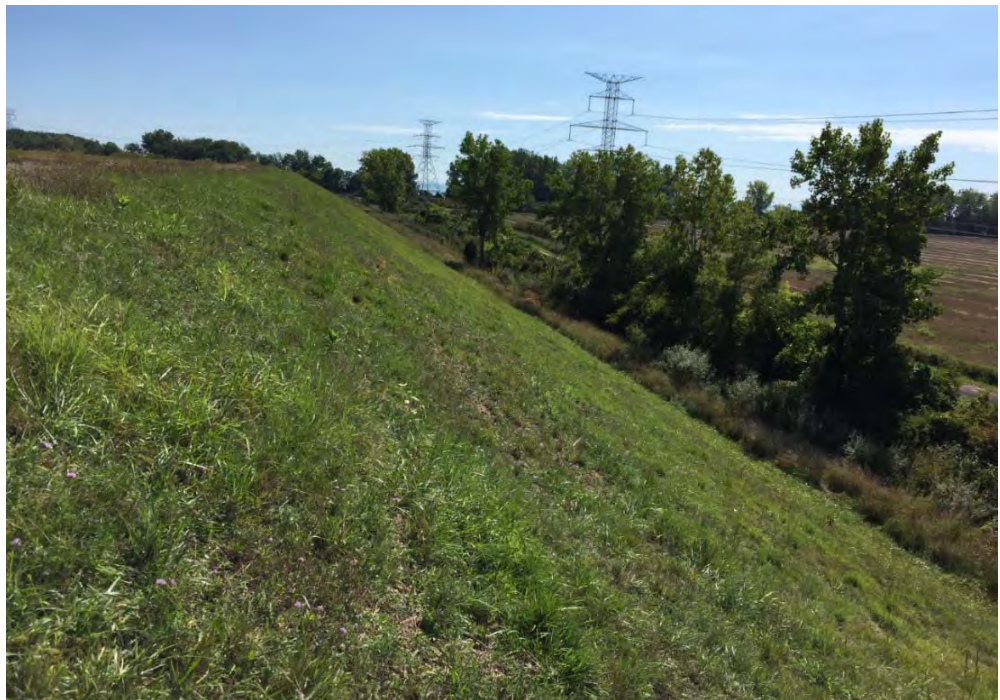
Photograph 54

Comments: Photo taken
at Station 130+00, facing
east. The embankment
appeared to have
uniform slopes without
sign of distress.

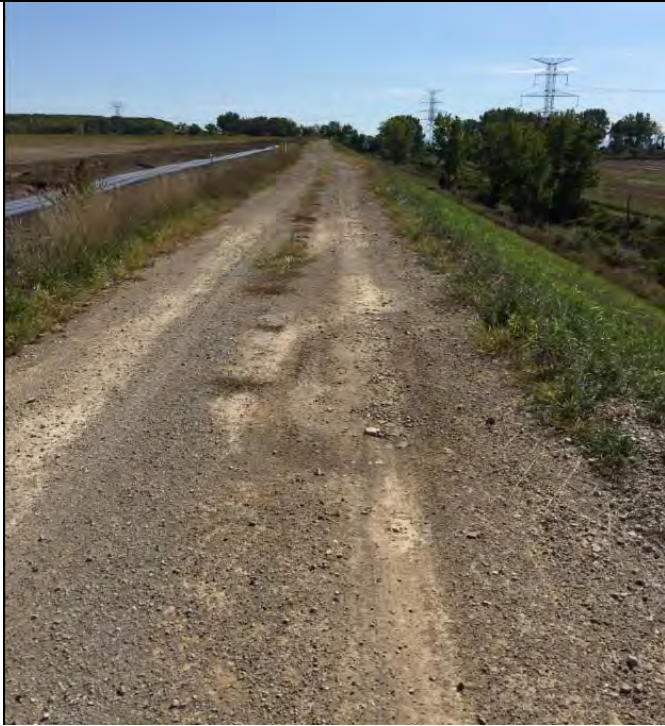
Comments: Low spot on the embankment crest at Station 119+00.

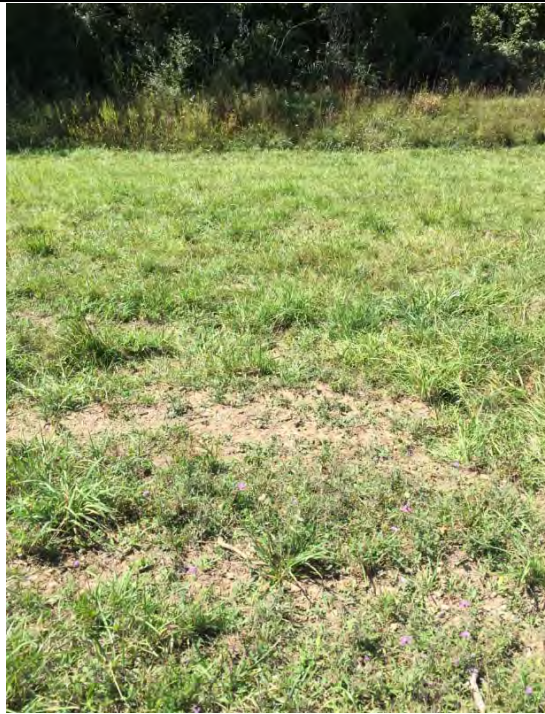
Comments: Sparse vegetation was observed on the embankment at Station 119+00 (~15 x ~3). No erosion was observed.

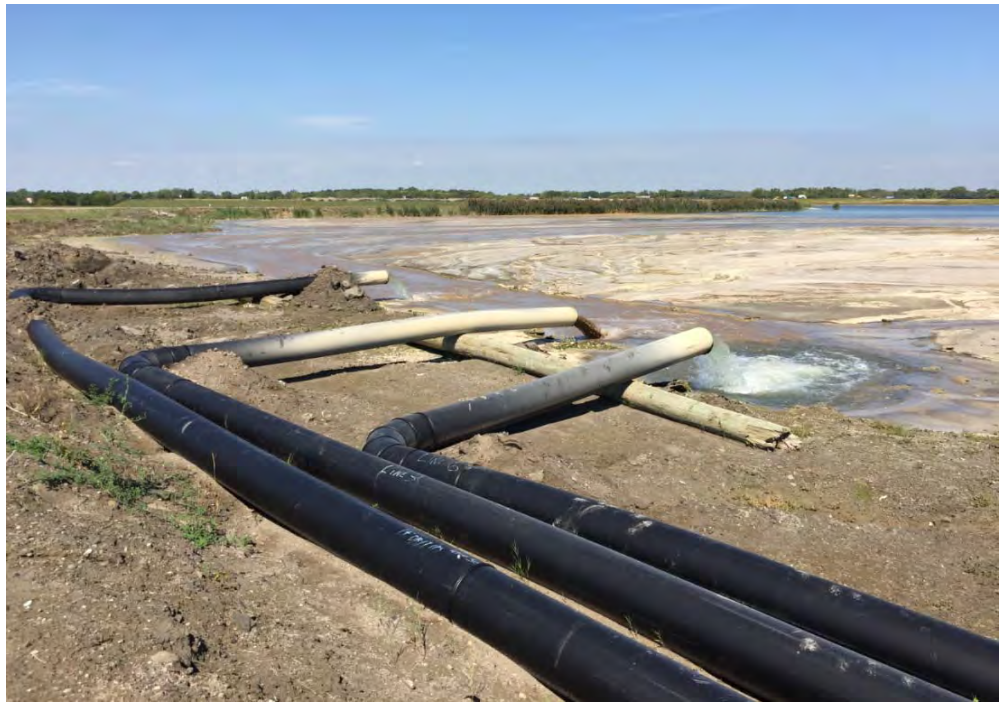
Comments: No
obstruction was
observed at the slurry
line discharge location at
Station 116+50.
