2016 ANNUAL INSPECTION REPORT ASH BASIN EMBANKMENT

MONROE POWER PLANT

Monroe, Michigan

January 2017

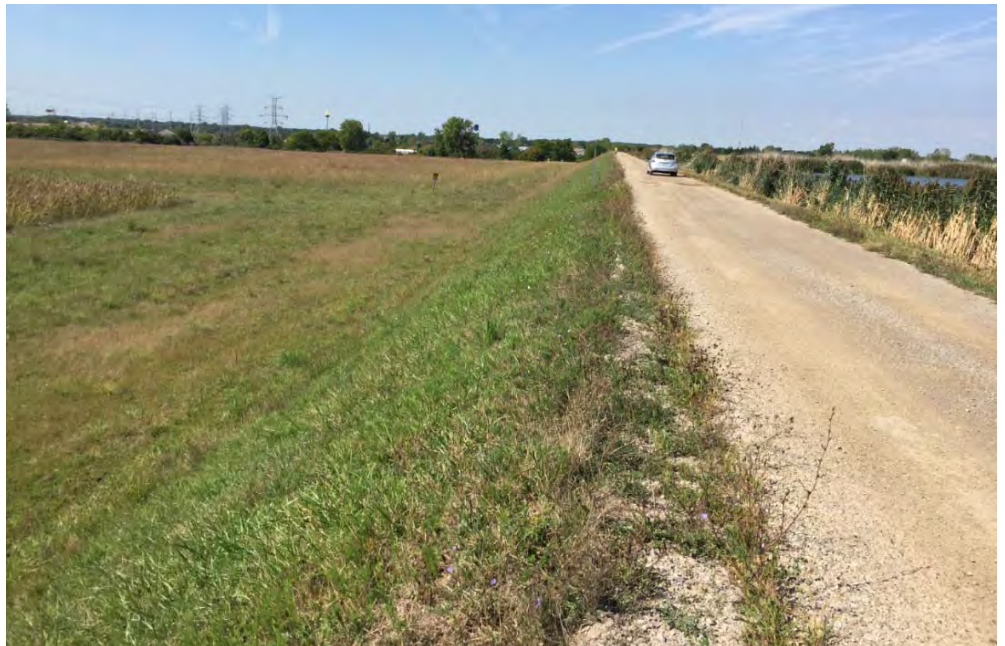
Comments: Photo taken at Station 102+00, facing west. The embankment appeared to have uniform slopes without sign of distress.

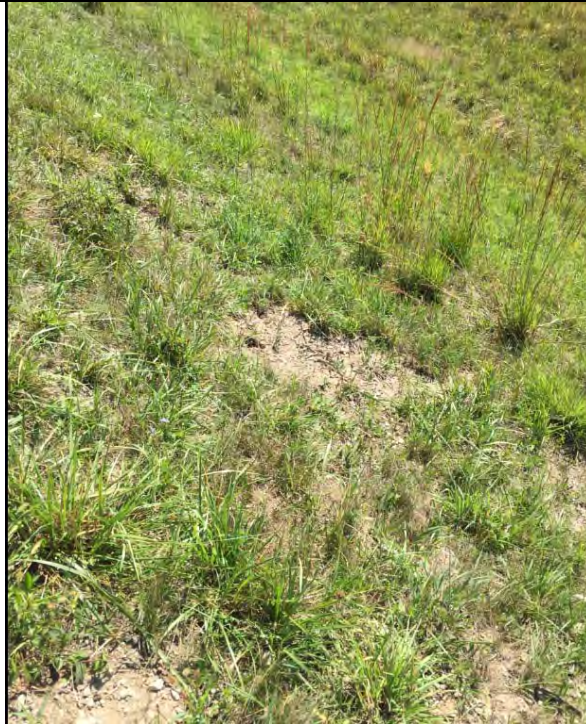
Photograph 66

Comments: Photo taken
at Station 87+00, facing
north. The embankment
appeared to have
uniform slopes without
sign of distress.

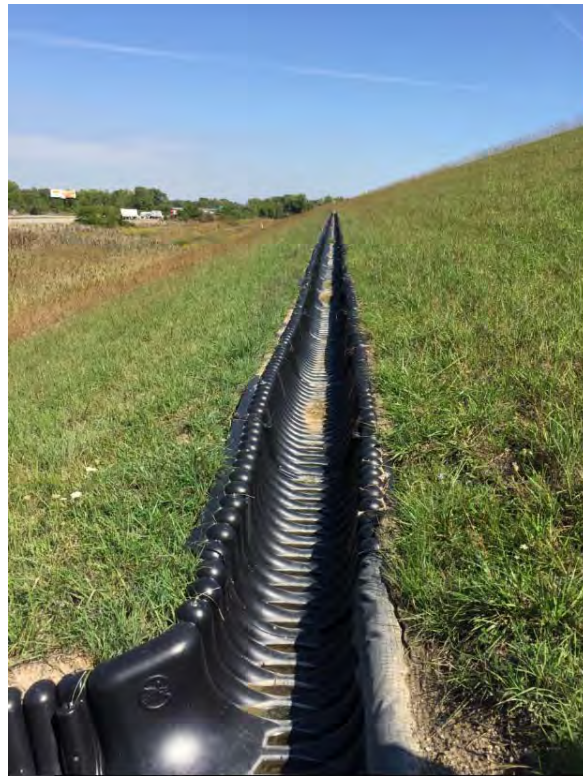
Comments: Downchute
at Station 87+00
appeared to be in good
condition.

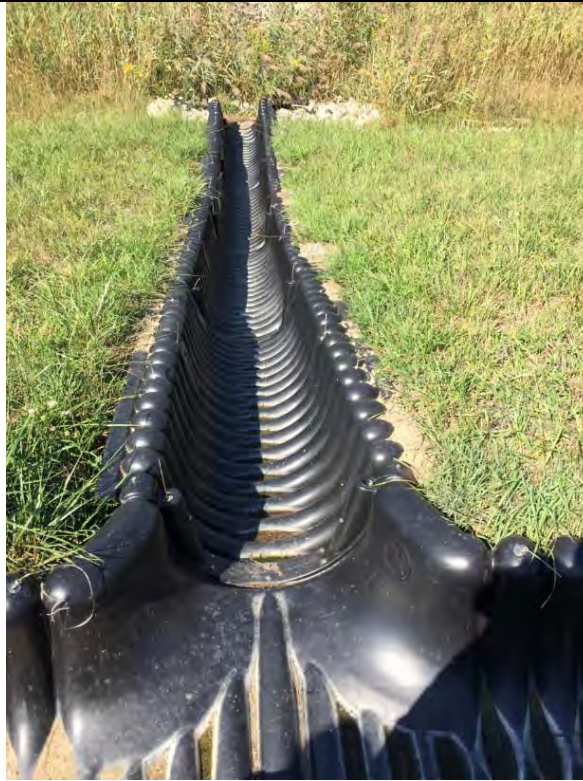
Photograph 68

3. Cracks that are one-inch wide or less were observed on the exterior slope of the embankment at two areas: (i) Station ~88+00 (Photographs 68 and 69); Station ~84+50 (Photographs 68 and 69); and (iii) Station ~75+00 (Photograph 74).

Comments: Cracks (less
than an inch wide) were
observed at Station
~84+50 across 30 ft.
These cracks are
flagged. Similar cracks
were observed at Station
88+00 (towards the top
of embankment, by the
crest).

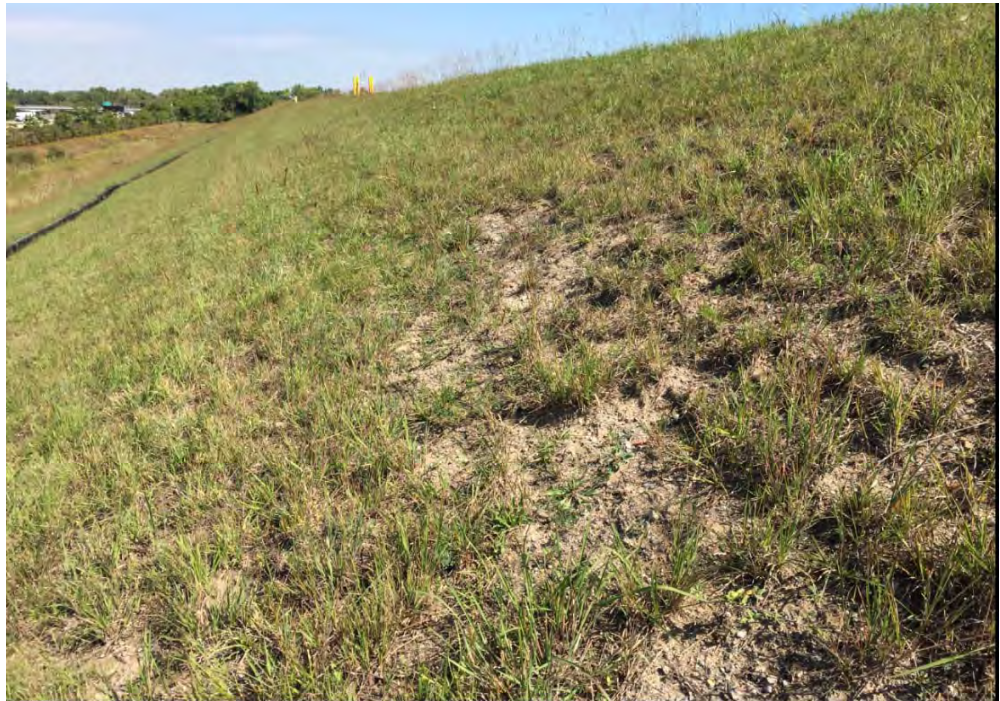
Comments: Photo taken
at Station ~82+00,
facing south. The
embankment appeared to
have uniform slopes
without sign of distress.
Sparse vegetation was
observed (~20 ft x ~5 ft).
Erosion was not
observed.

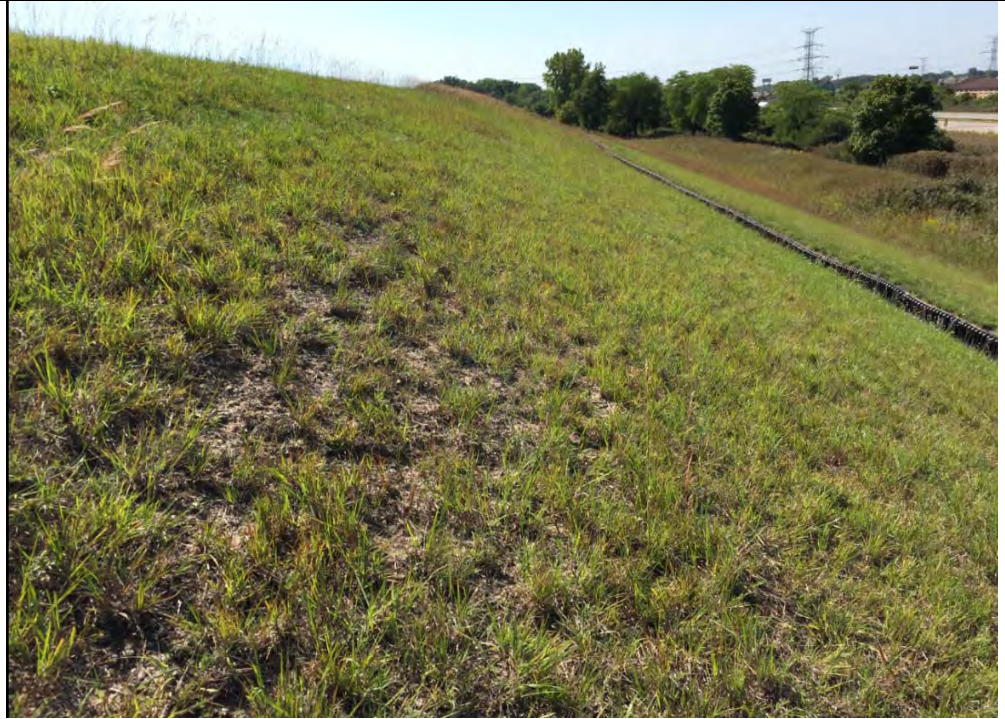
Photograph 72

- Station 26+00 (Photographs 9 thru 11)
 - Station 145+00 (Photograph 45)
 - Station 81+00 (Photograph 72)
7. Potholes and ruts on the embankment crest were observed along the southern embankment, which are scattered between Stations 110+00 and 139+00 (Photographs 55, 58, and 60).

Comments: Downchute
at Station 81+00
appeared to be in
working condition.
However, the soil along
the sides have been
washed off.

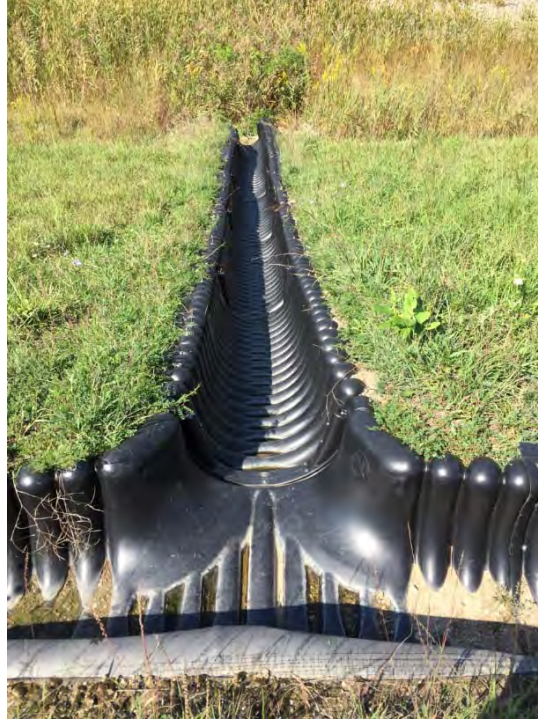
Photograph 74

Comments:
Approximately one-inch
wide, 25-ft long cracks
were observed at Station
~75+00 towards the top
of the embankment.

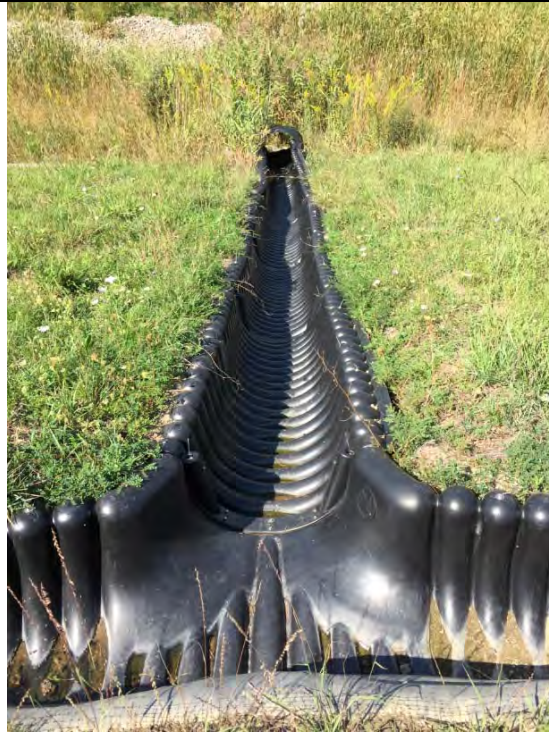
Photograph 76

- Station ~68+00 (Photograph 76).
9. Sparse vegetation was observed at multiple locations around the embankment. These areas and dimensions are summarized in Appendix A.

(i) Station 0+00 - depression was observed (Photograph 26) and (ii) Station 162+00 to 168+00 - bulging at the toe was observed (Photograph 36). Several areas had erosion rills. These areas are at: (i) Station ~22+50 (Photograph 14); (ii) Station ~0+00 (Photographs 24 and 25); (iii) Station ~110+00 (Photograph 61 and 62); (iv) Station ~68+00 (Photograph 76); (v) Station ~35+00.

Comments: Erosion rills were observed within the area that was repaired in 2015 (Station ~68+00).
