**2017 ANNUAL INSPECTION REPORT  
RANGE ROAD LANDFILL  
ASH DISPOSAL FACILITY**

**China Township, St. Clair County, Michigan**

January 2018

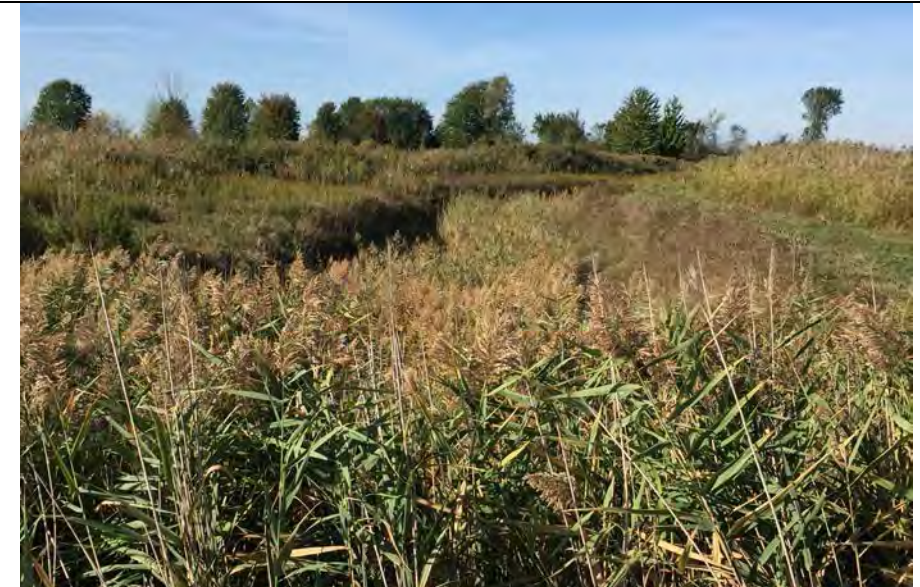
8. View of Vegetation in Portion of Internal Drainage Ditch.

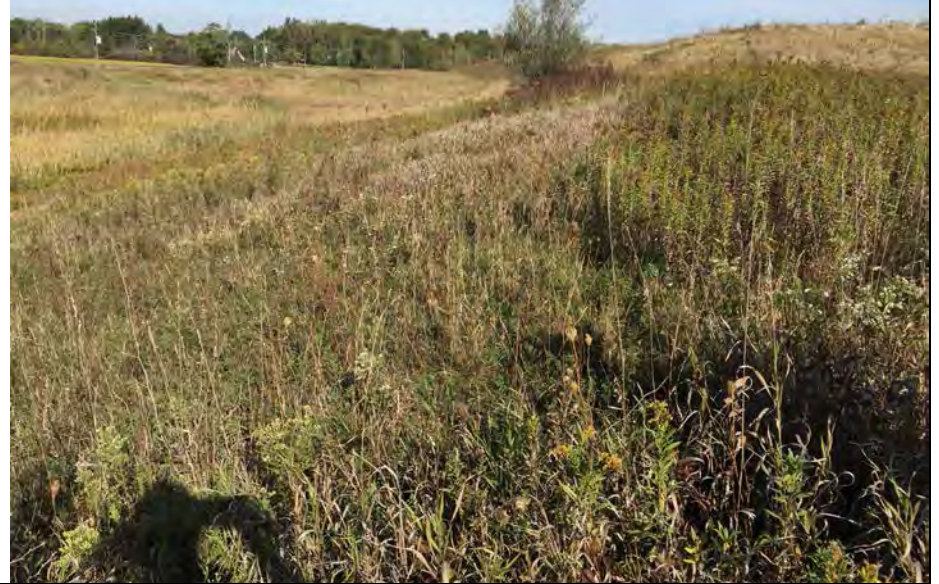
18. Looking North at West Side of Unconstructed G2 Area. Some Woody Vegetation Present. In F Areas Slope were Cleared of Small Trees in 2016.

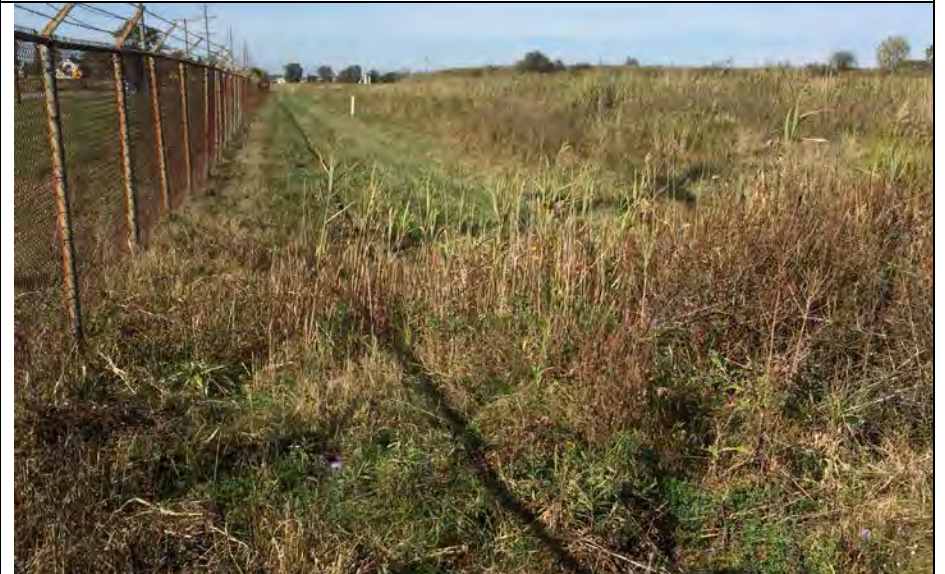
28. Looking North Along Property Fence Line. White Marker is Alignment of Perimeter Slurry Wall.

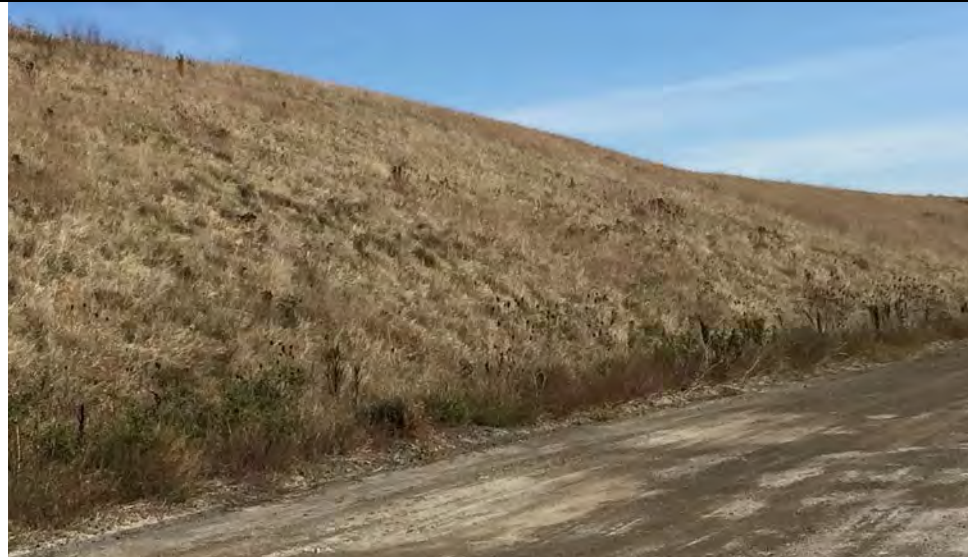
39. View of Slope of Closed Area C. Slope Well Vegetated and Appearing Very Stable.

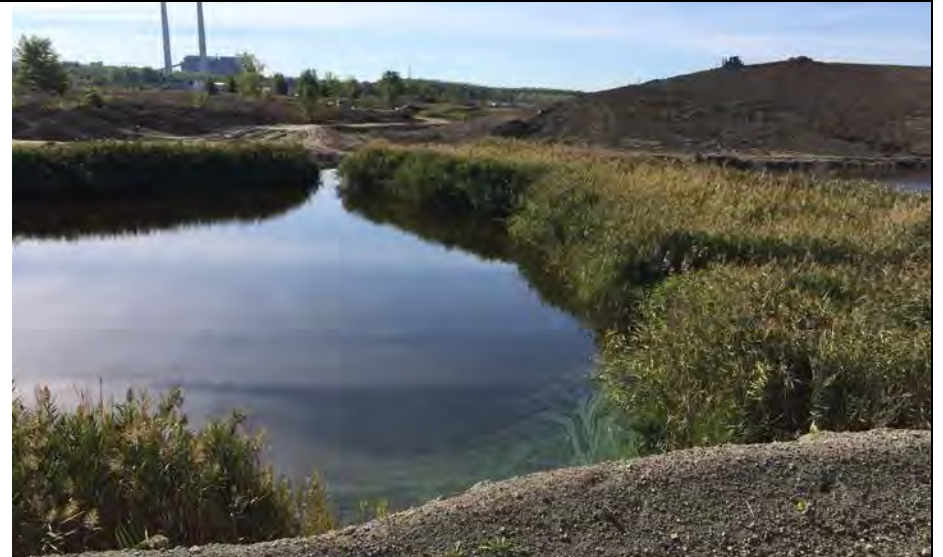
40. View of East Side of Internal Water Collection Pond.

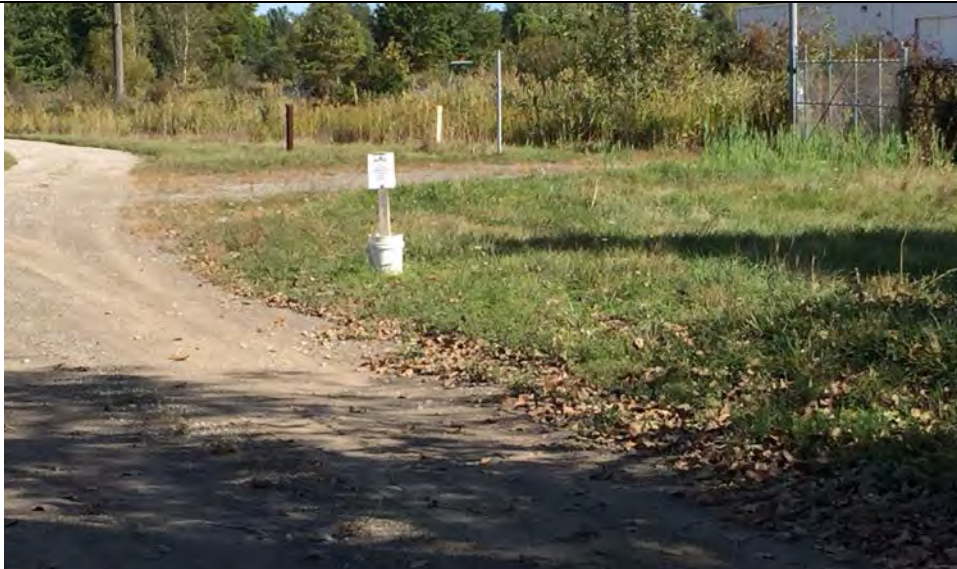
43. View of Signage on Watering Restriction at Areas of Gate Entrances and Exits.

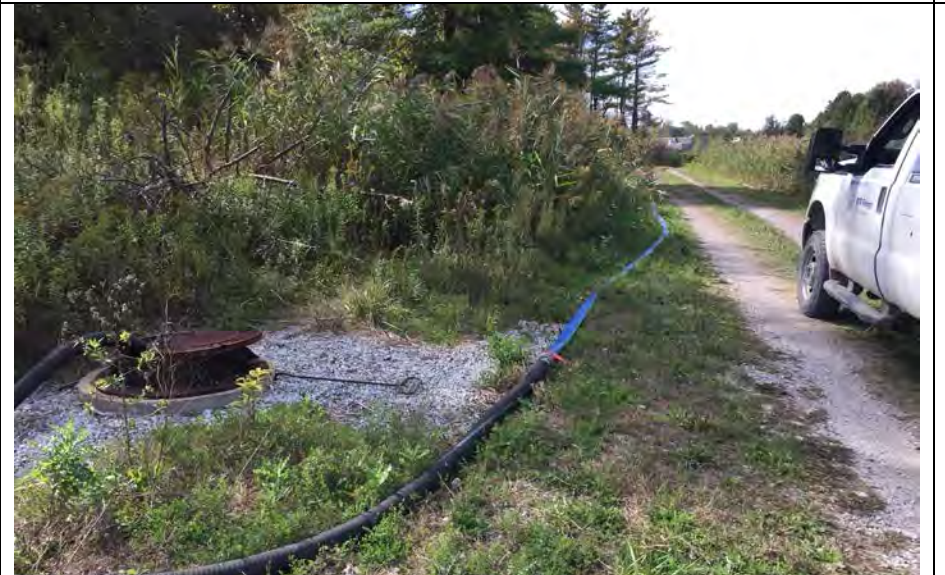
60. Sump Collecting Pumped NW Groundwater that then Drains by Pipe to Perimeter Ditch on Other Side of Truck.

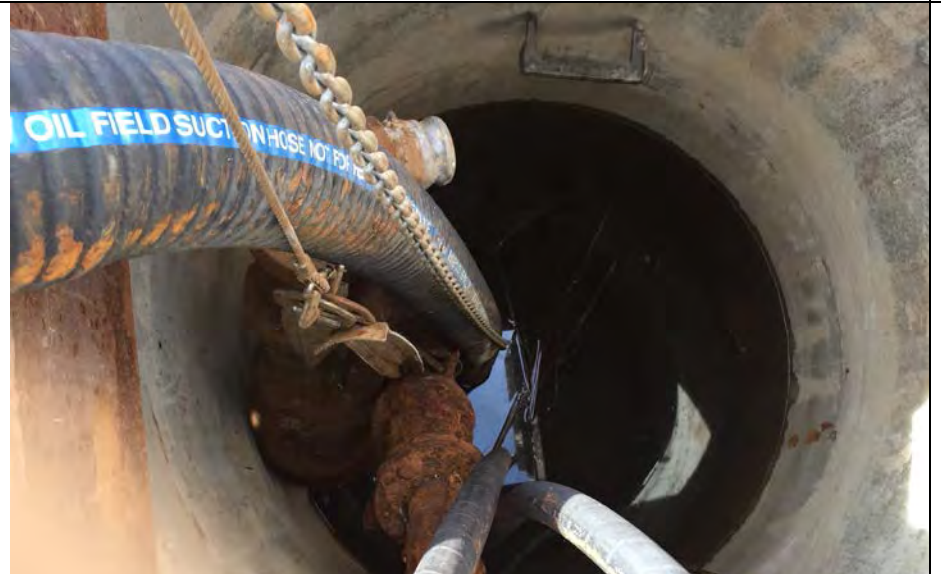
64. Sump at NW Groundwater Capture System with Old Pumps Partially Removed. New Pumps to be Installed in October 2017, per DTE.

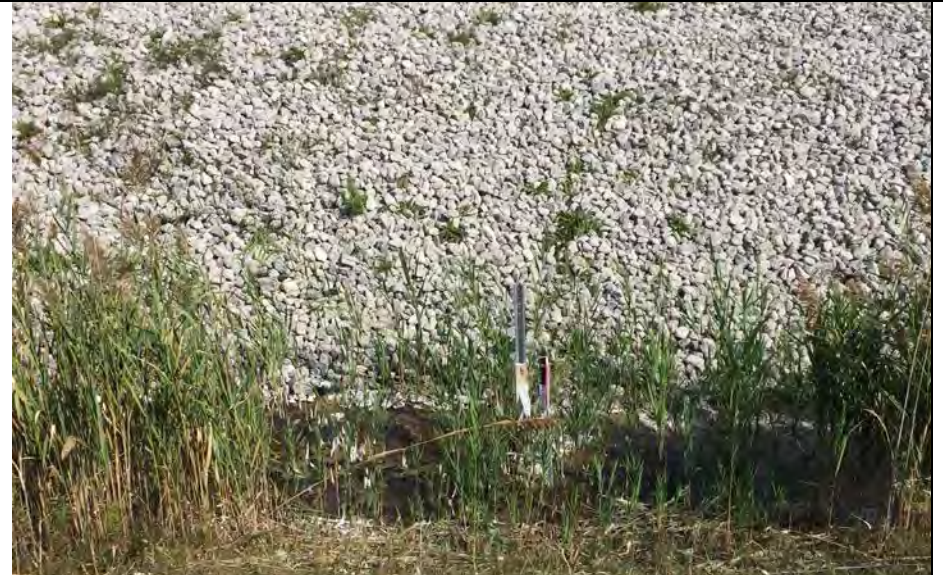
68. View of Perimeter Ditch Staff Gauge SG-09 and Stoned Slope. Gauge Not Numbered or No Longer Readable, as was Most Gauges.

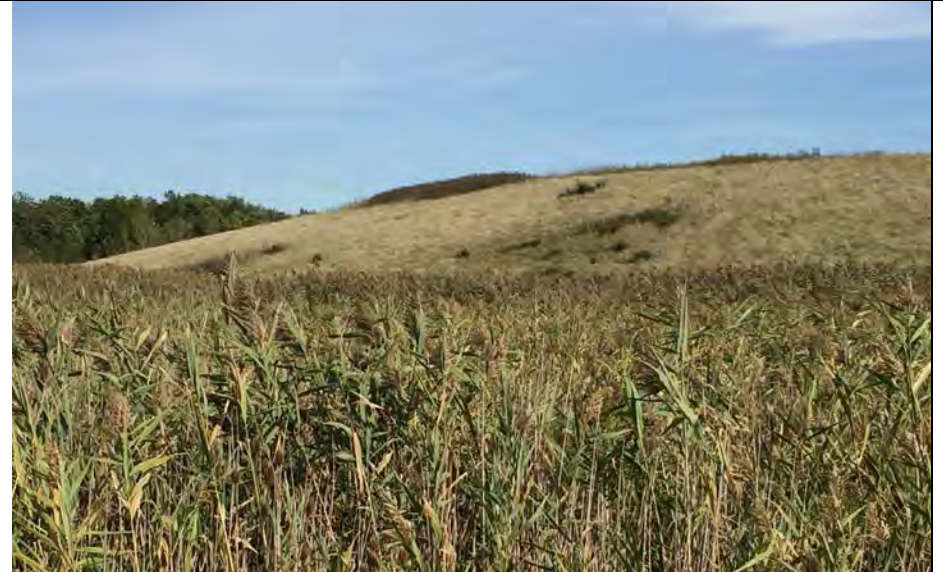
72. Looking at a Closed Area Landfill Slope.

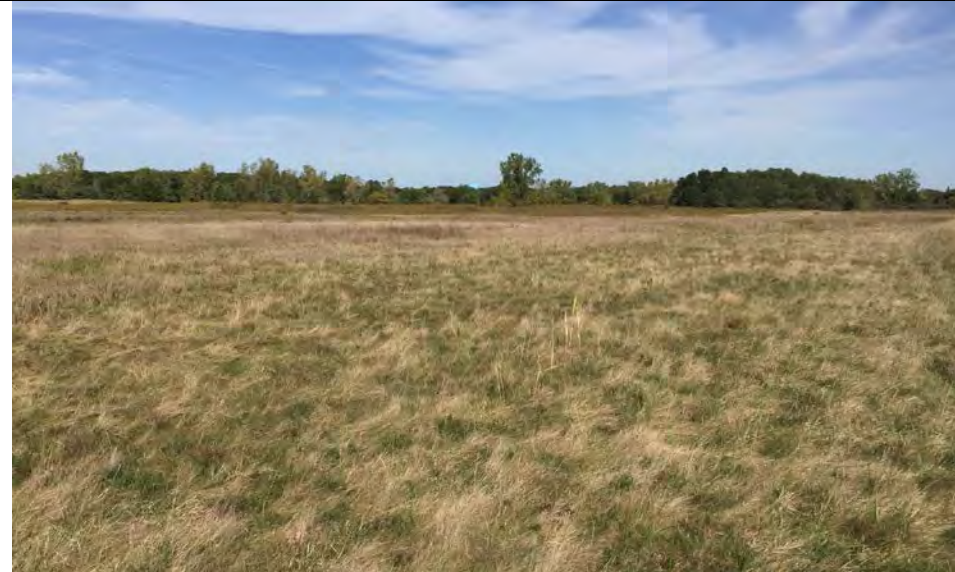
79. Another View of Typical Top of Closed Landfill Areas. Some Previous Small Woody Vegetation had been Removed.
